Earthquake Commission

Report into the History of the Development of the Kuirau Park side of Tarewa Road Rotorua, as it relates to Geothermal Activity

Jack T Just
Consulting Engineer
13 Holland Street
Rotorua

22 July, 1998

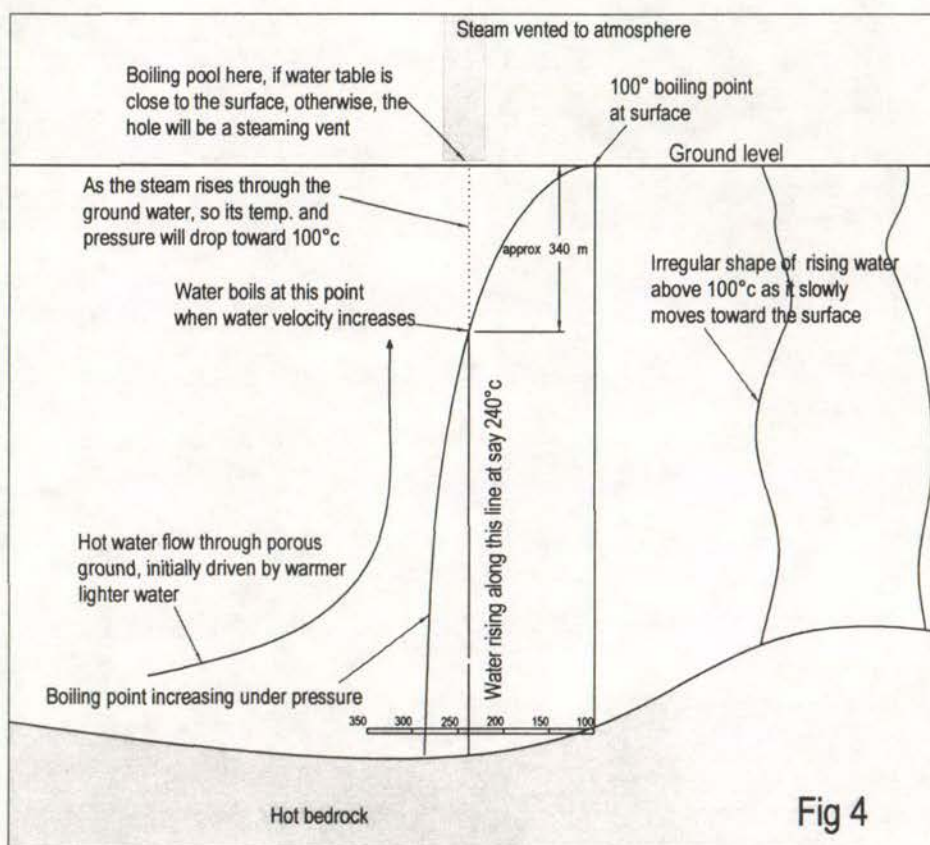
Fig 4

As that steam-water mix moves upward, so the weight of water above it reduces. This reduced weight means the pressure and hence its boiling point (see Fig 4) will drop too. This in turn means less energy will be required to boil the water and the excess will convert more water to steam. That excess energy is converted into ever more steam at ever reducing temperatures, so displacing ever more water and making it lighter again. As it rises, so that water-steam mixture will continuously drop in temperature (and the amount of steam will increase) along the line on that graph in Fig 4. The process continues to the surface, when the steam is finally discharged at its boiling point of 100°C into the atmosphere.

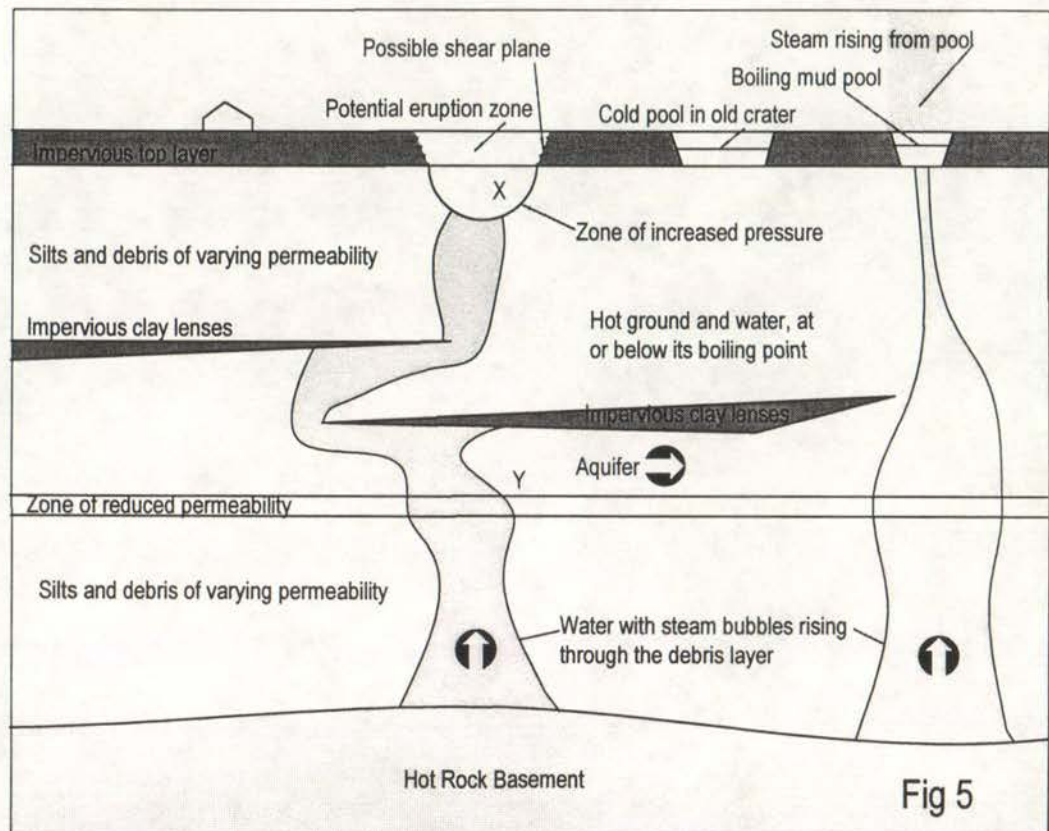
But when that ultimate shear strength is exceeded, a sudden and violent eruption must result. The sudden reduction in pressure below the impervious layer, will cause the water to boil violently to some depth, and result in the stored energy being converted into work. The steam will expand and force the overburden up like a huge piston in a steam engine. The energy in that steam will lift not only the impervious overburden but also a considerable mass of water and solids below it, into the air. Once the eruption has released that excess energy, the resulting crater may well settle back to a quiet boiling pool, mud pool or other surface feature like we see in Kuirau Park, perhaps never to erupt at that point again for aeons.

At the centre of Fig 5, I show a potential eruptive zone before the eruption occurs, and to the right, a crater after an eruption, with boiling water in it. The range and condition of the surface features will vary between wide limits. In the centre is a cold pool in an old crater. The crater may or may not have been refilled with mud to form another impervious seal.

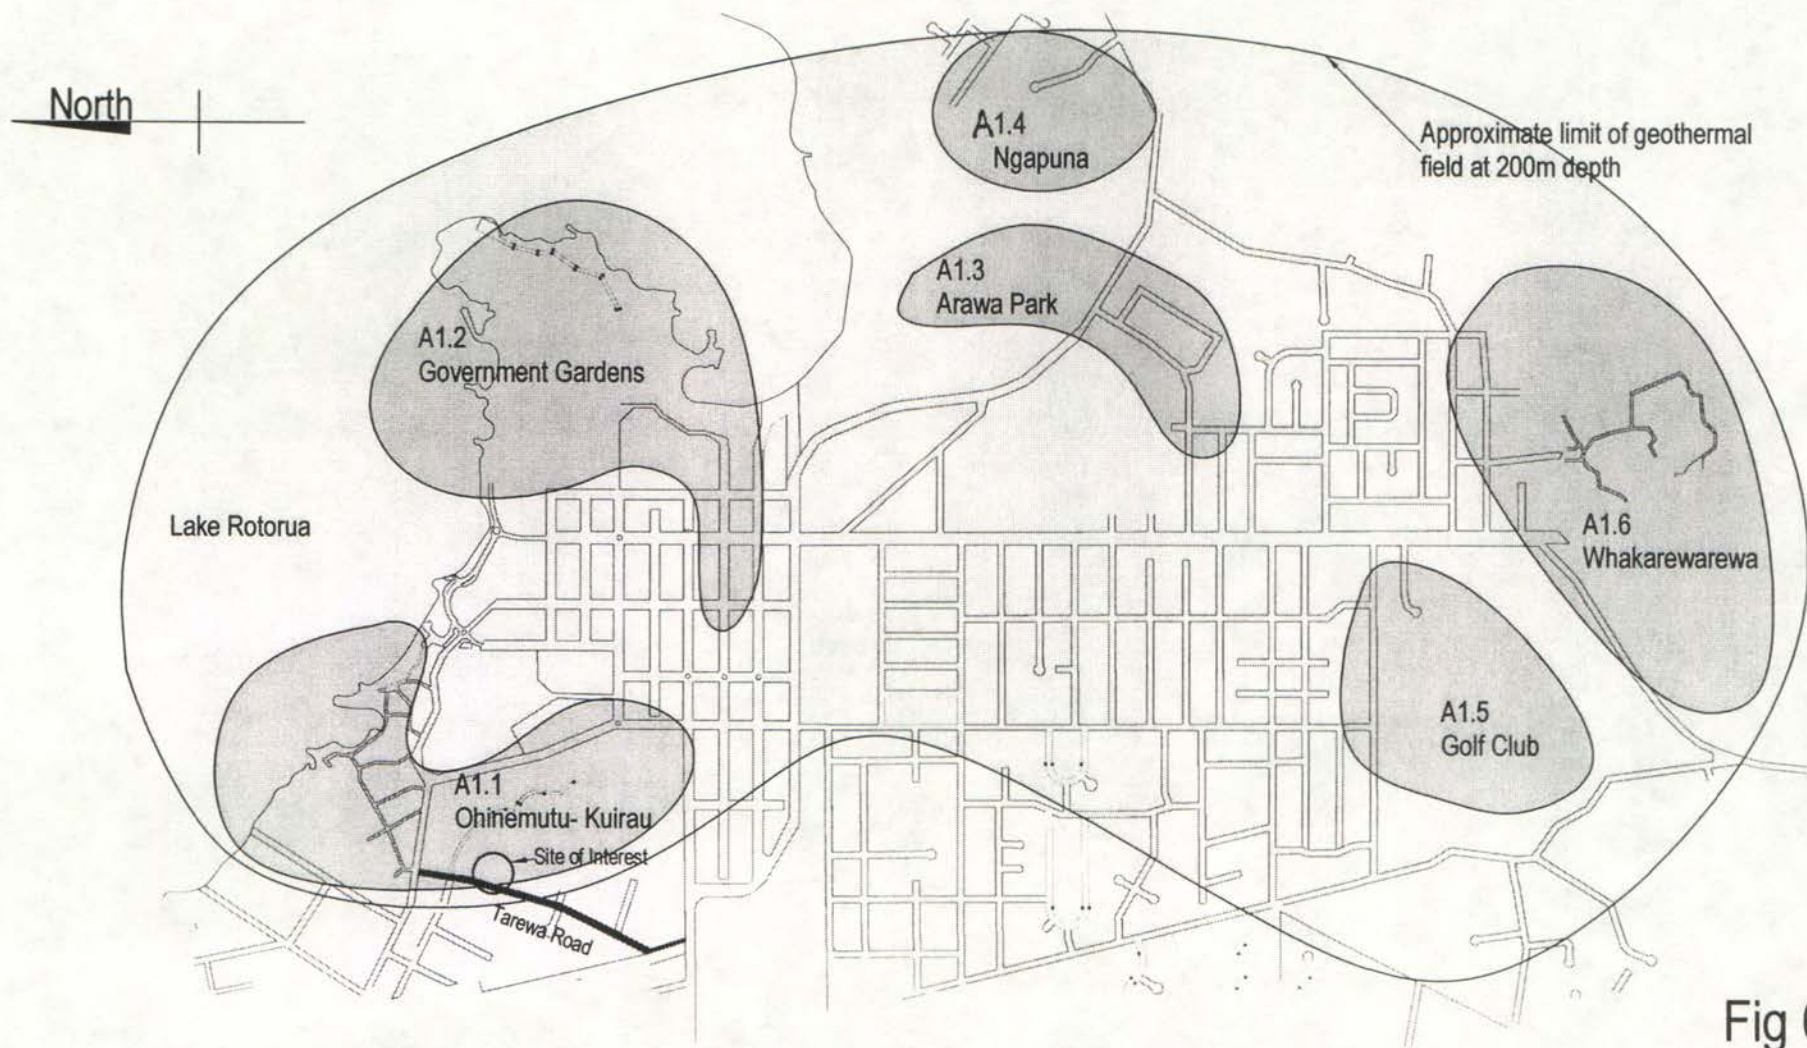
Fig 6

Ground level is close to lake level and the water table is high. I believe that crater creation in this area will continue, and water level changes will affect geothermal activity. Most of the area is parkland and the rest is zoned for residential use. There is a history of blowouts (explosive craters) and changing geothermal activity in the area. In the cradle of this area is Pukeroa (or Hospital hill) which I understand is considered one of the major sources of upwelling geothermal energy. Hydrogen sulphide gas emissions here seem to be lower than elsewhere. This area should be of special interest to EQC.

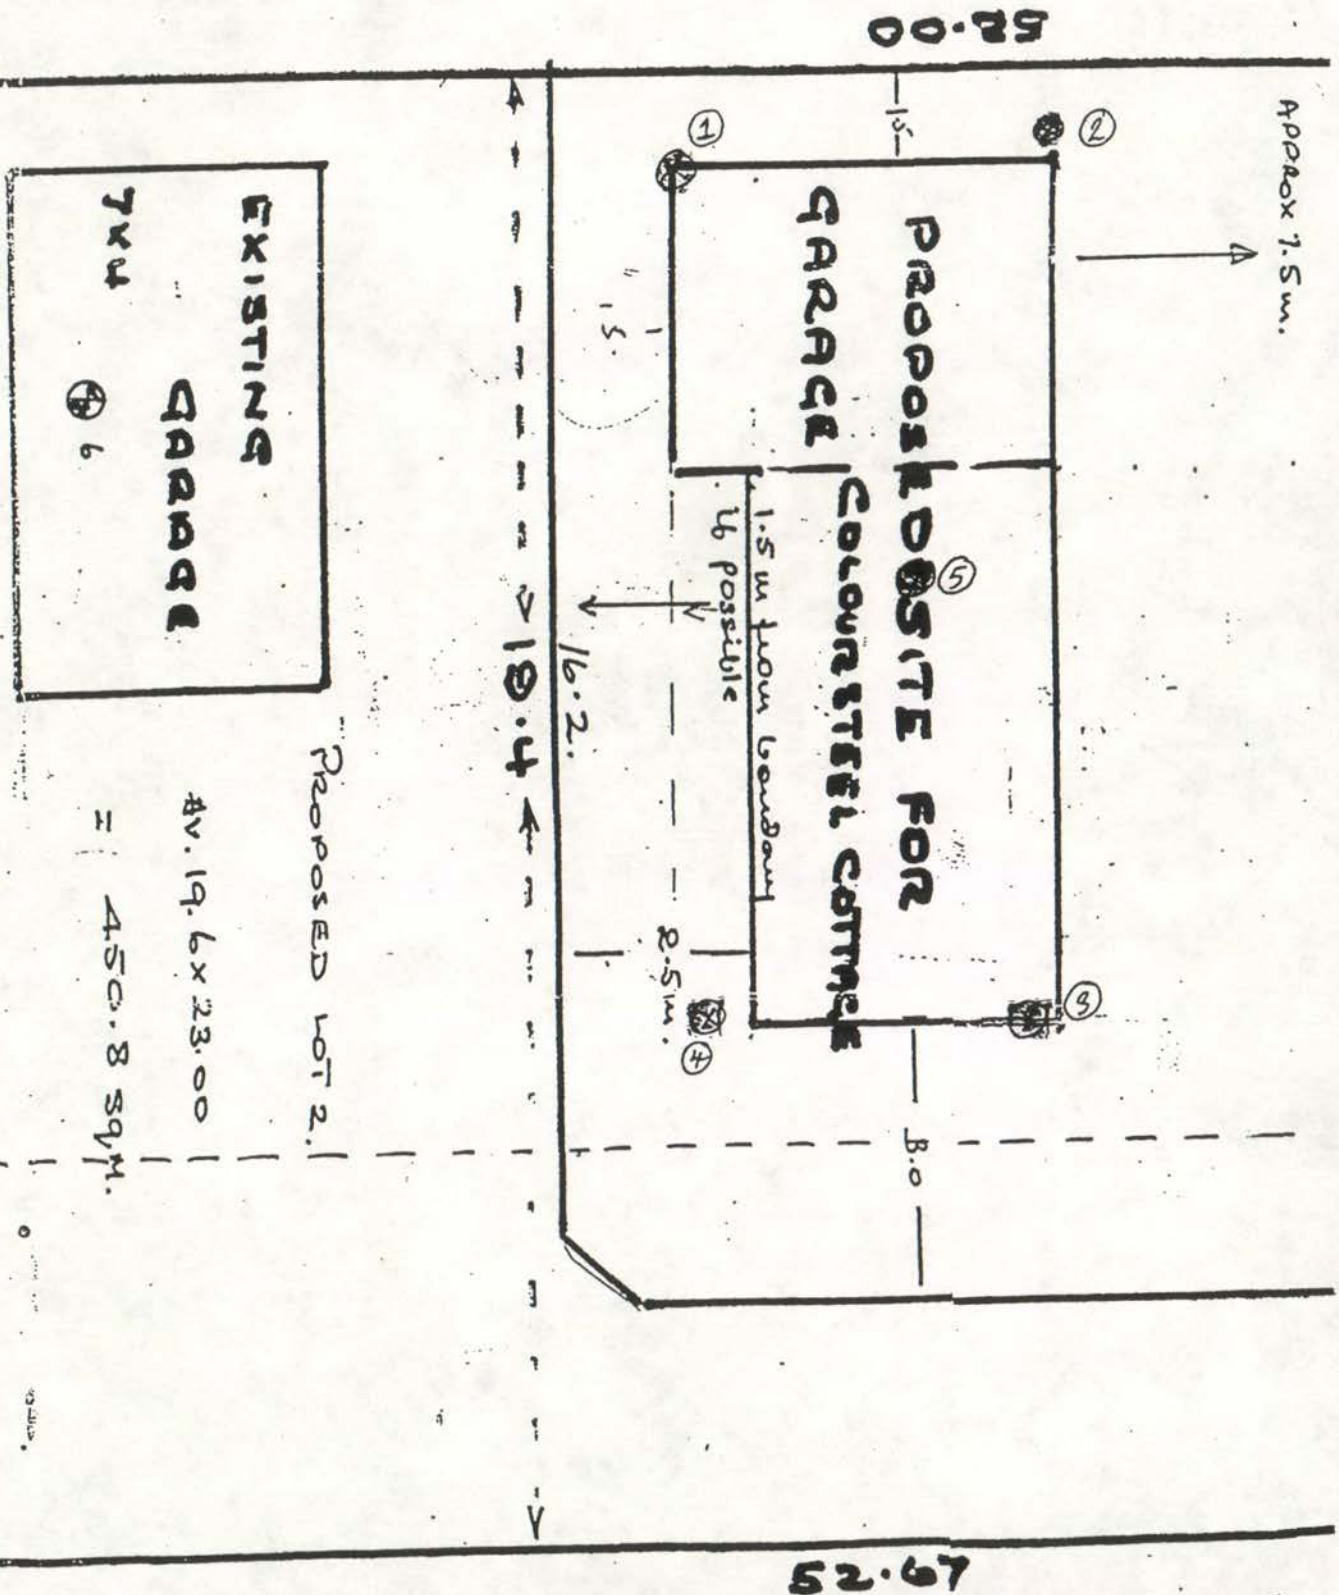
PENETROMETER TESTS 2/5/95

Unfortunately the ground bearing for most of the tests indicated ground of poor or low bearing strength, not suitable for standard pile foundations in normal ground.

Bearing in mind the recommendation by Mr Cody that site excavations should be limited to 0.4m, to prevent penetration of the underlying sinter layer, we would suggest that your proposed dwelling be founded on piles set in reinforced concrete strip footing foundations.

Such foundations should be a minimum of 300mm x 300mm, 20 MPa concrete, reinforced with 4 D12 rods and R10 ties at 300 crs, continuous around the perimeter and along internal pile lines. We also recommend that the concrete footings be poured in 250 grade polythene, to act as a moisture barrier between the ground and concrete foundation.
