NHC PROJECT # 4454: SEISMICALLY RESILIENT PARTITION

WALL DESIGN AND TESTING

Final Report

Submitted to: Natural Hazards Commission Toka Tū Ake

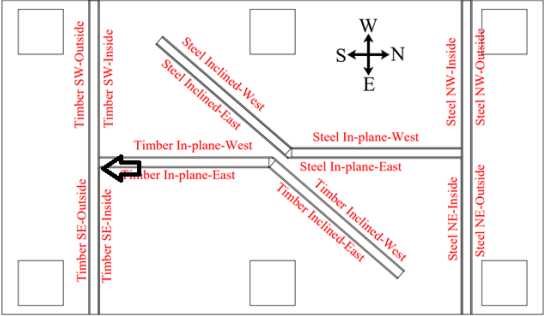
Location	Observation	Photo
<p data-bbox="288 591 756 645">Timber SE inside and Timber in-plane East Junction</p>

<p data-bbox="858 734 963 860">Hairline shrinkage cracks of plaster</p>

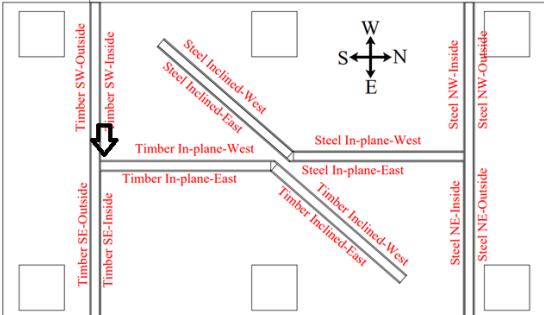
<p data-bbox="277 1518 767 1572">Timber In-plane West and Timber SW Inside junction</p>

<p data-bbox="836 1682 986 1778">No visible shrinkage plaster cracks</p>

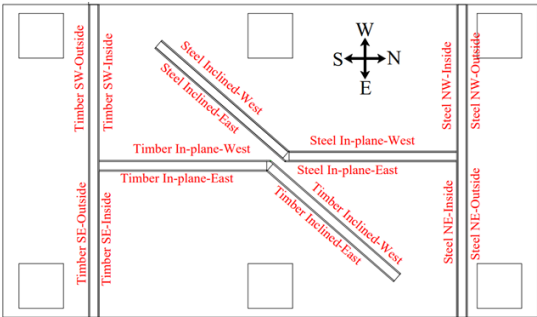
<p style="text-align: center;">Timber SE outside near top corner</p>

<p>Slight crack in plasterboard</p>

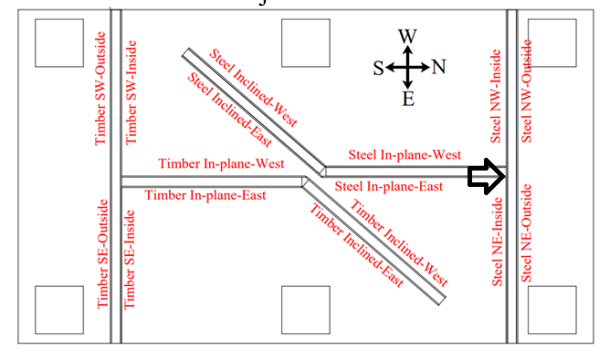
<p>At the bottom of Steel NE inside and In-plane East wall junction</p>

<p>Hairline crack in the plasterboard</p>

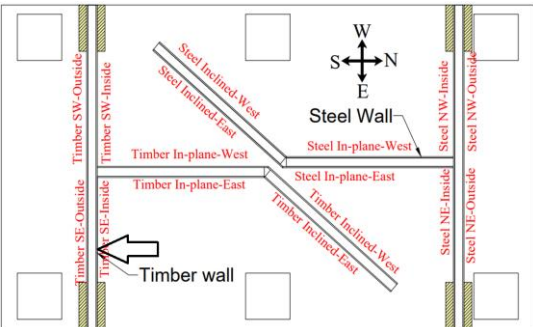
<p>At the top of the plasterboard at Timber wall SE inside near the end of the DHT</p>

<p>Progressive damage – crack at the top of the plasterboard</p>

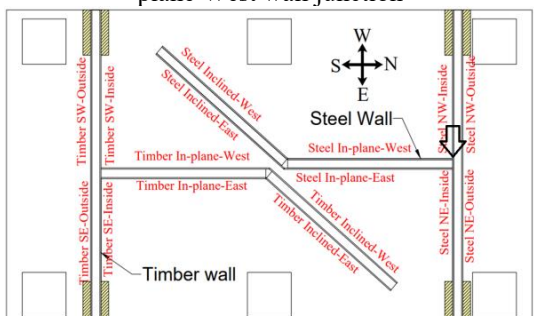
Location	Observation	Photo
<p>At the top of the Steel NW inside and Steel in-plane West wall junction</p>

<p>Progressive damage: Tear in the plaster paper</p>

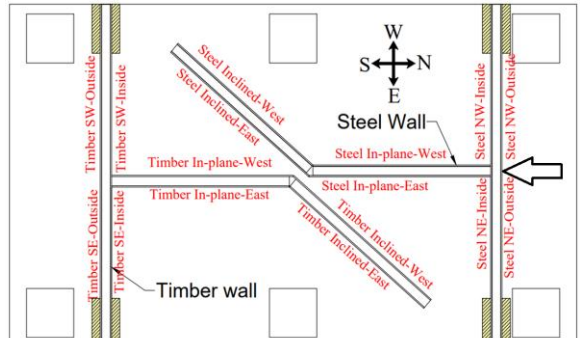
Location	Observation	Photo
<p>At the top Steel wall NW/NE outside at mid-length</p>

<p>Crack in the plasterboard</p>

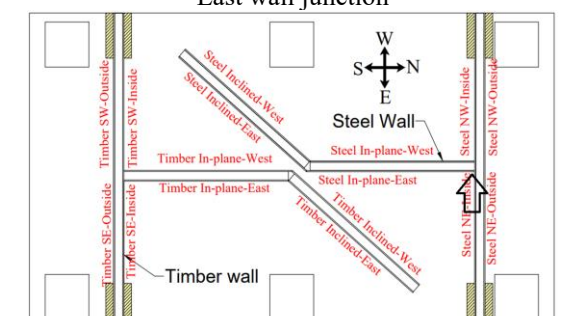
<p>At the top of the Steel NE inside and Steel in-plane East wall junction</p>

<p>Progressive damage: Tear in the plaster paper</p>

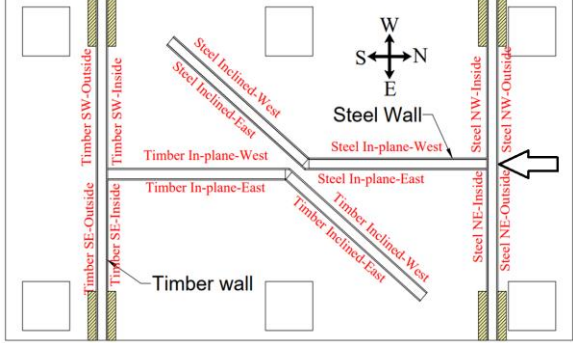
Location	Observation	Photo
<p>Steel wall NW/NE outside at mid-length</p>

<p>Progressive damage: Crack throughout the 1/3rd height of the plasterboard from the top</p>

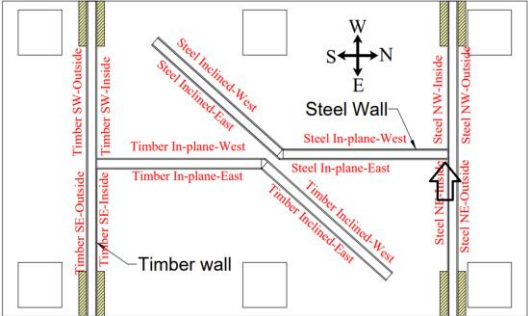
<p>At the top of the Steel NE inside and Steel in-plane East wall junction</p>

<p>Progressive damage: Tear in the plaster paper</p>

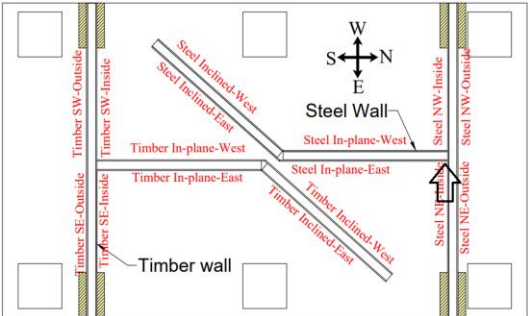
<p>Near the top Steel NE inside and Steel in-plane East wall junction</p>

<p>Cracks are slightly wider than hairline</p>

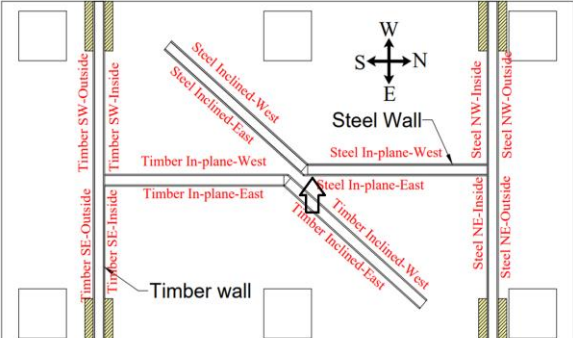
<p>At the top of the Steel inclined east wall at the Steel in-plane East junction</p>

<p>Crack in the plasterboard</p>

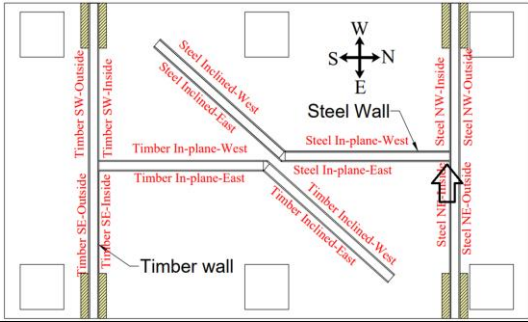
Location	Observation	Photo
<p>At the top of the Steel NE inside and Steel in-plane East wall junction</p>

<p>Progressive damage: Tear in the plaster paper</p>

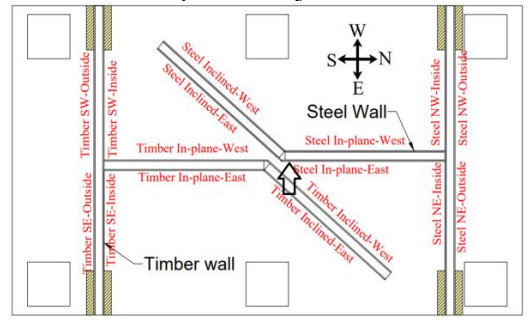
<p>At the top of the Steel inclined east wall at the Steel in-plane East junction</p>

<p>Progressive damage: Crack in the plasterboard</p>

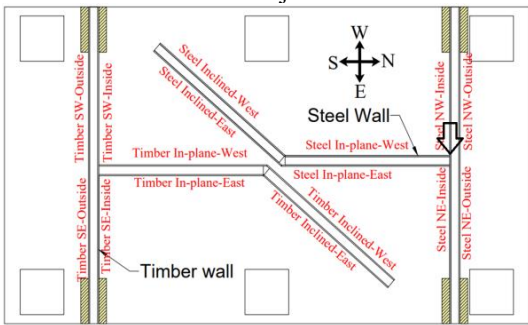
<p>At the top of the Steel NW inside and Steel in-plane West wall junction</p>

<p>Progressive damage: Tear in the plaster paper</p>

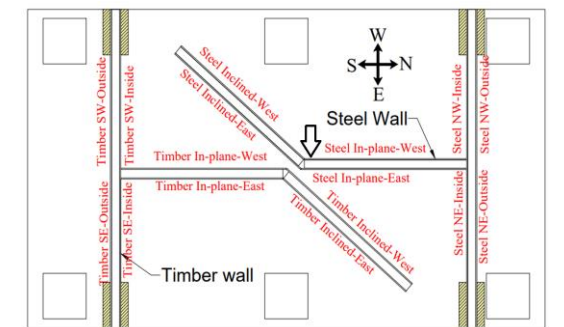
Location	Observation	Photo
<p>At the top of the Steel in-plane West at junction with Steel inclined west wall</p>

<p>Crack in plaster</p>

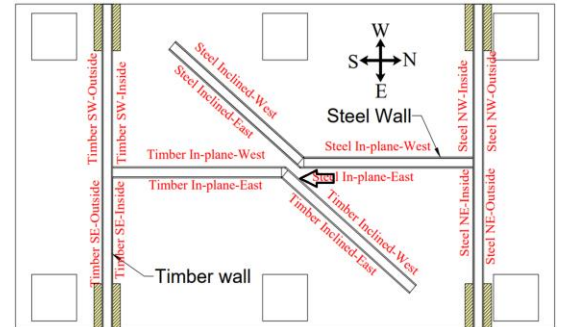
<p>At the top corner of the steel inclined east wall at the steel in-plane east junction</p>

<p>Crack in the plasterboard</p>

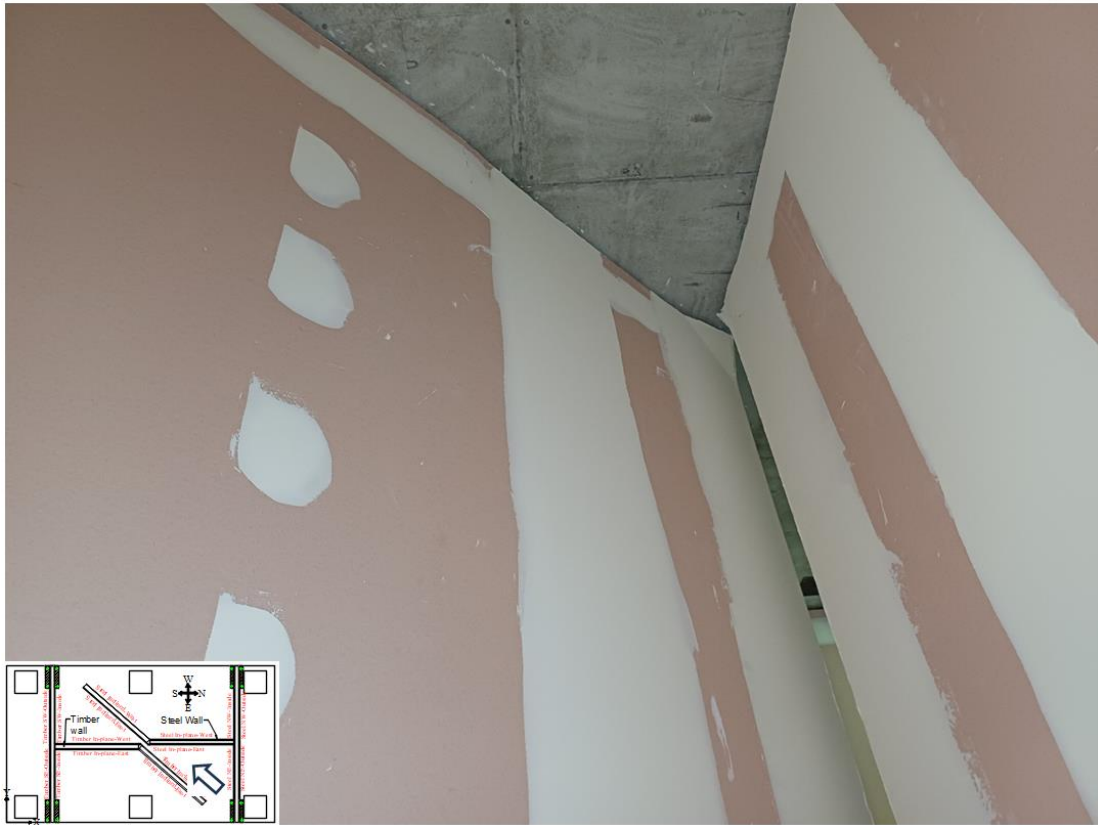
Figure 2.70. Timber wall inclined junction West and Steel wall inclined junction East after motion 18 - 3 % inter-storey drift

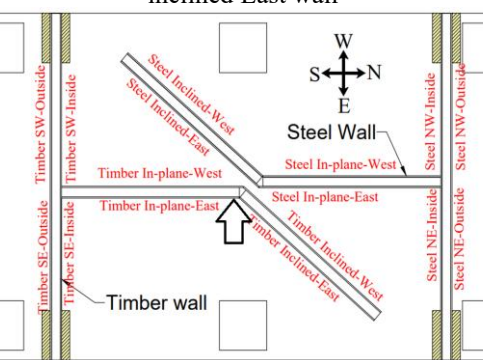
<p style="text-align: center;">At junction of Timber in-plane east and Timber inclined East wall</p>

<p style="text-align: center;">Damage to steel plate due to the interaction with DHT</p>

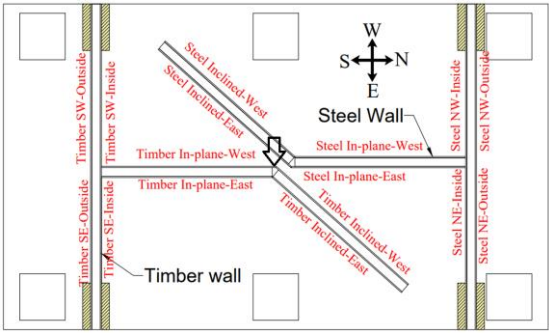
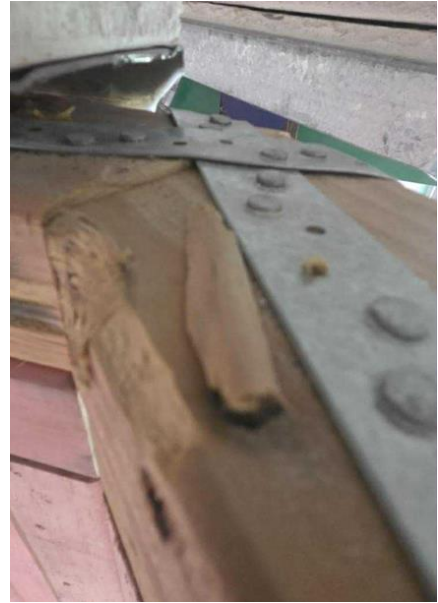
<p style="text-align: center;">At the timber inclined West wall junction</p>	<p style="text-align: center;">Damage to top timber plate, break in the steel strap, and DHT damage</p>

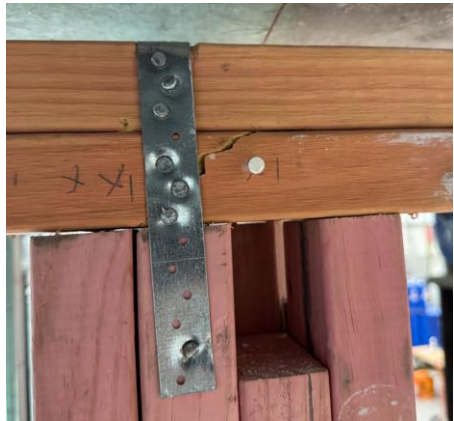
Crack in the top plate

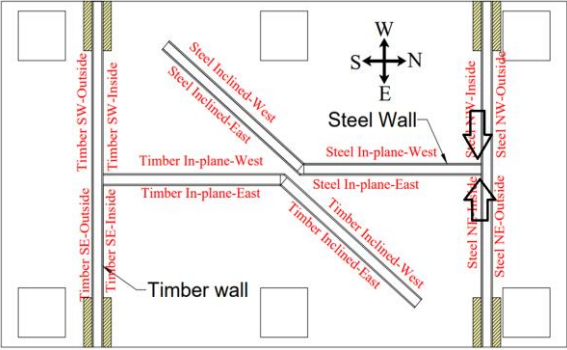
Location	Observation	Photo
<p data-bbox="248 277 817 338">NW/NE wall and the Steel in-plane wall frames due to yielding of the DHT</p>

<p data-bbox="858 539 1011 663">Separation of the connected steel Frames (studs)</p>

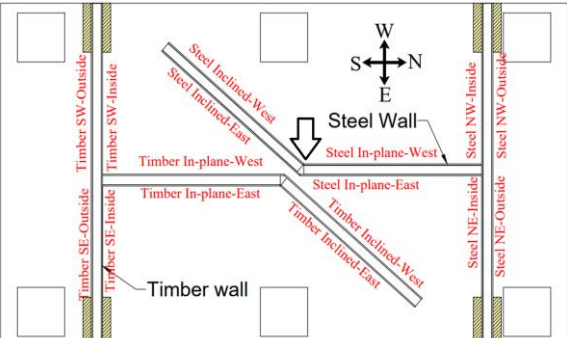
<p data-bbox="261 927 804 987">In steel inclined wall West and Steel in-plane west junction</p>

<p data-bbox="852 1375 1011 1559">Damage to DHT and studs due to interaction with steel angle plate</p>

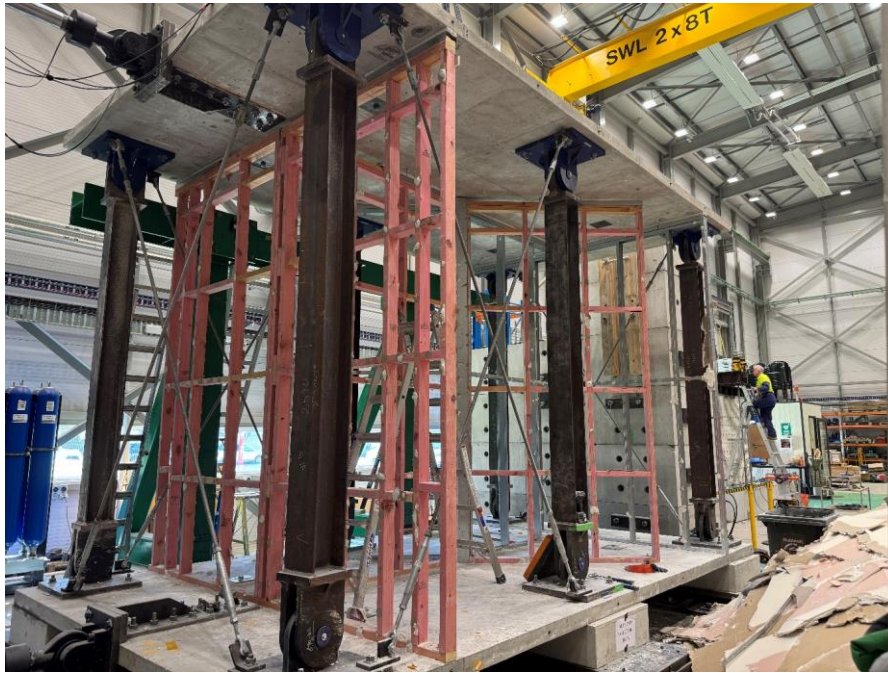
Figure 2.71. Photo of wall frames after motion 18 - 3 % inter-storey drift (Southeast elevation)

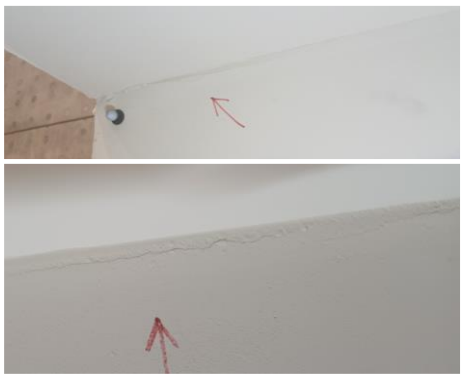
<p>Corner joint interface between the SW-Inside wall and the west ceiling</p>

<p>Cracks on the Plaster and Flaking of the paper tape</p>

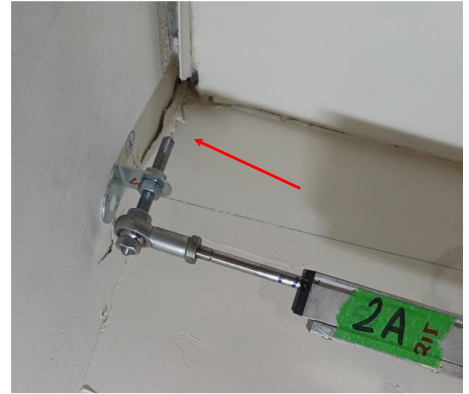
Top corner of the NW inside wall near its corner joint with the west bulkhead and the west ceiling

Crack in the plasterboard

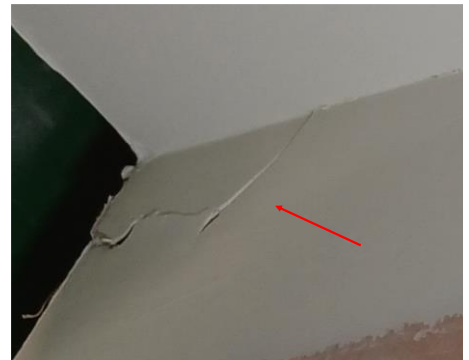
Corner joint interface between the In-plane west wall and the west ceiling

Crack in the plasterboard

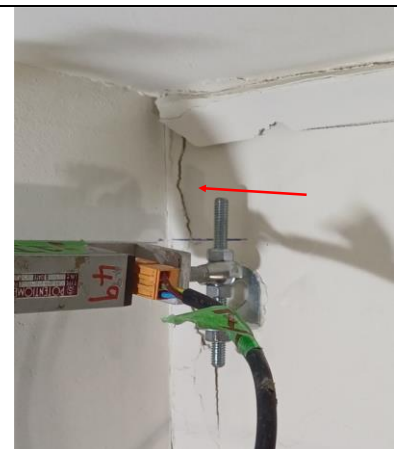
<p>Inside the plenum — joint between the SW-inside wall and the west ceiling</p>

Crack in the plasterboard

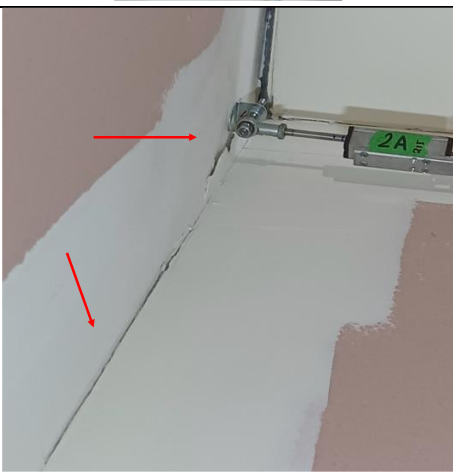
<p>Top corner of the NW inside wall near its corner joint with the west bulkhead and the west ceiling</p>

<p>Crack in the plasterboard</p>

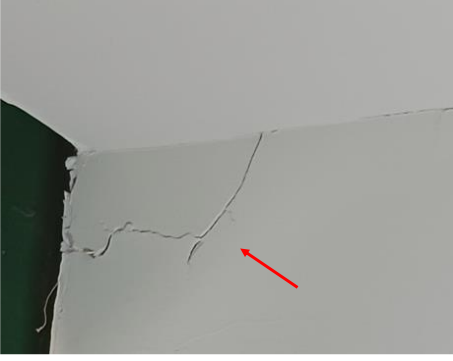
<p>Inside the plenum — joint between the NW-inside wall and the west ceiling</p>

<p>Crack in the plasterboard</p>

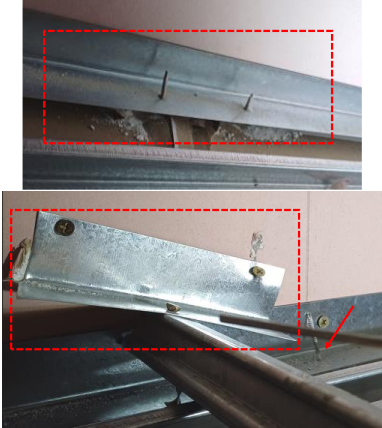
<p>Top of the T-junction between the in-plane wall and the Northern wall</p>

<p>Screw pull-out and damage to the wall track and ceiling plasterboard</p>

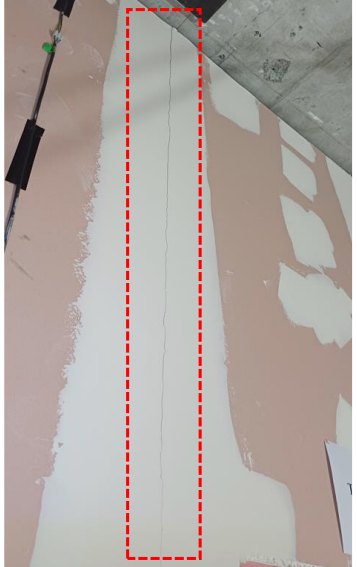
<p>Top corner of the SE-Inside wall near the restraining timbers</p>

<p>Crack in the plasterboard</p>

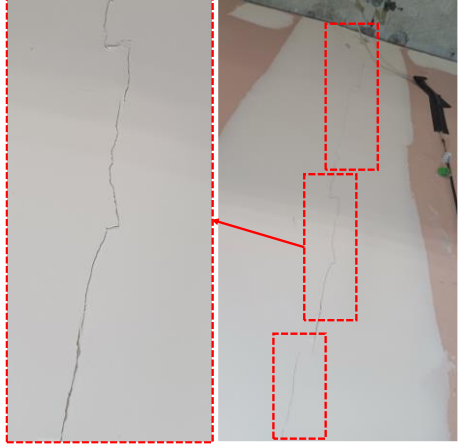
<p>Corner joint interface between the NW-Inside wall and the west ceiling</p>

<p>Crack in the plasterboard</p>

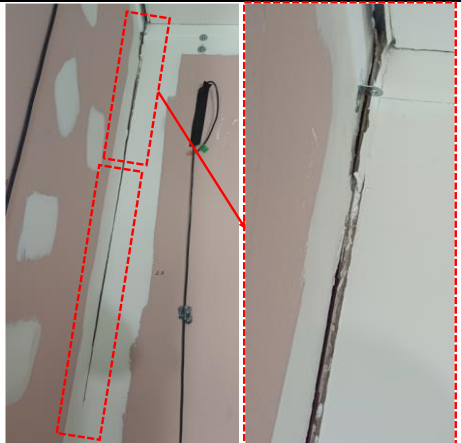
<p>Top corner of the NW inside wall near its corner joint with the west bulkhead and the west ceiling</p>

<p>Major Crack in the plasterboard</p>

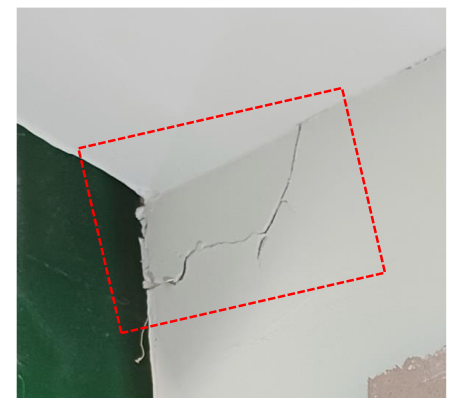
<p>Corner of the SW-inside wall near the joint with the in-plane west wall (from top to middle)</p>

<p>Crack in the plasterboard</p>

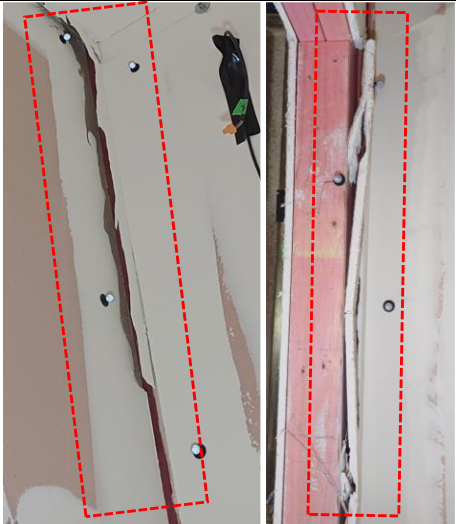
<p>Corner joint interface between the SE-Inside wall and the east ceiling</p>

<p>Major cracking and crushing in the plasterboard</p>

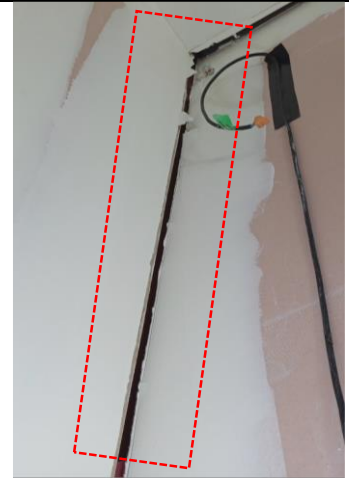
Top corner of the NW inside wall near its corner joint with the west bulkhead and the west ceiling

Major Crack in the plasterboard
