Earthquake And War Damage Commission

**EARTHQUAKE RISK ASSOCIATED WITH
1935 - 1975 REINFORCED CONCRETE
BUILDINGS IN NEW ZEALAND**

E.L. Blaikie

D.D. Spurr

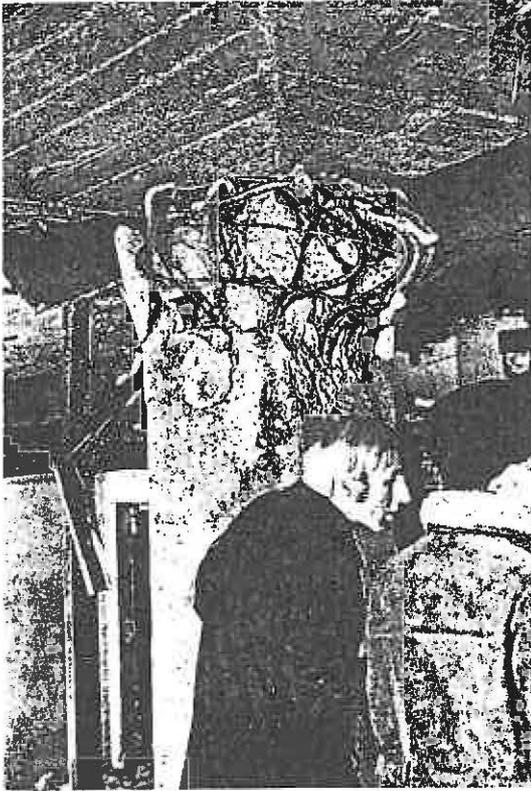
(d)

Romania 1977	<ul style="list-style-type: none"> Bucharest Computing Centre. Columns in 1st floor of three storey flat slab building failed in shear. Reinforcement in ground floor columns was high ($p = .03$, $F_y = 510 \text{ MPa}$) but $\frac{1}{2}$ this was terminated at $\frac{3}{4}$ height of storey. 32 pre World War II buildings between seven and 14 storeys collapsed. Of these 15 inspected and found to have at least four of following defects: (1) f'c low (i.e. down to 12 MPa) (2) low column reinforcement ($p < .005$ plain mill steel) (3) wide spacing of ties ($s \geq 250 \text{ mm}$) and ties anchored with short 90° hooks (4) Columns designed for axial stress only (5) no shear reinforcement in beam/column joints (6) Short laps in column bars (< 20 bar diameter). 	C C	2.1(d)	49 49

Computing center
column failure in ground story

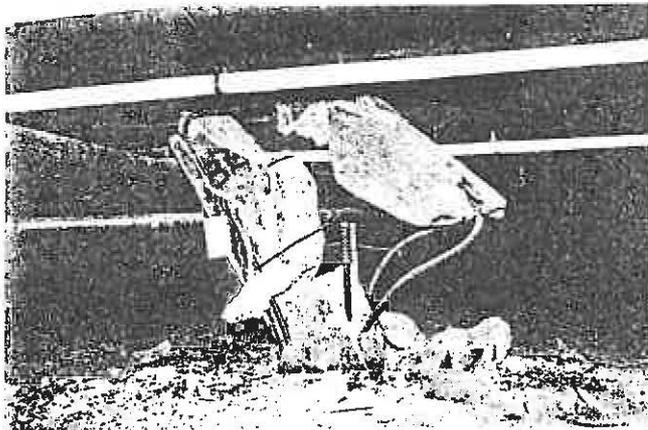
—Olive View Hospital, medical treatment and care unit.
Complete collapse of tied column located in pipe space area near
north wall.

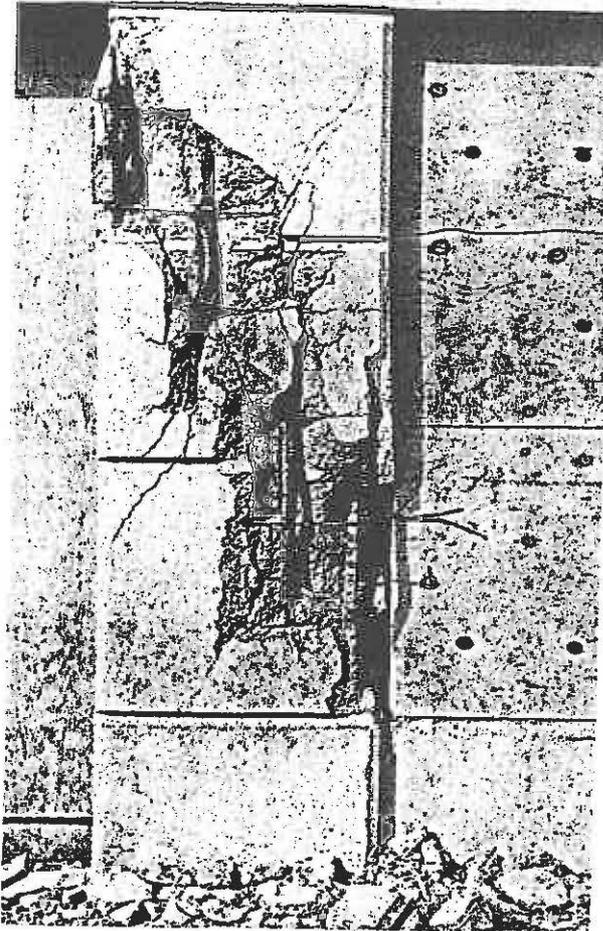
(k)

Column Failure in South Face

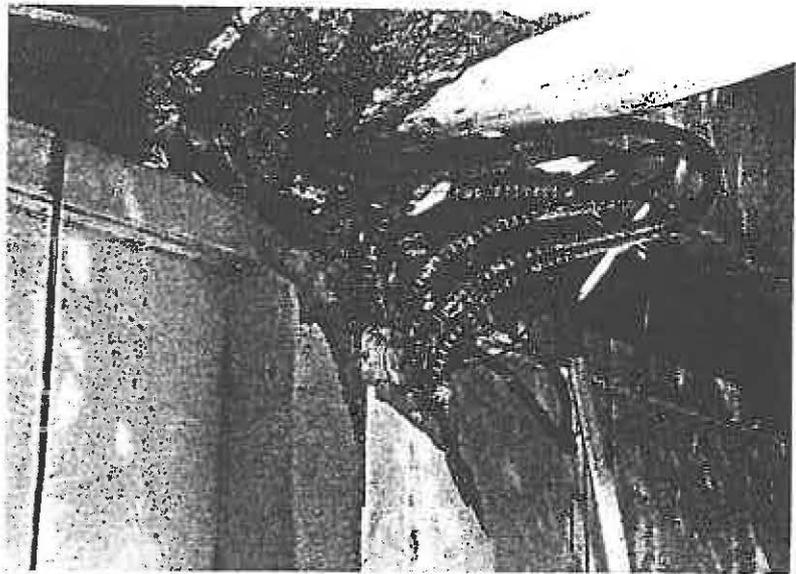
- Short-column failure at the Benjamin Bloom Children's Hospital.

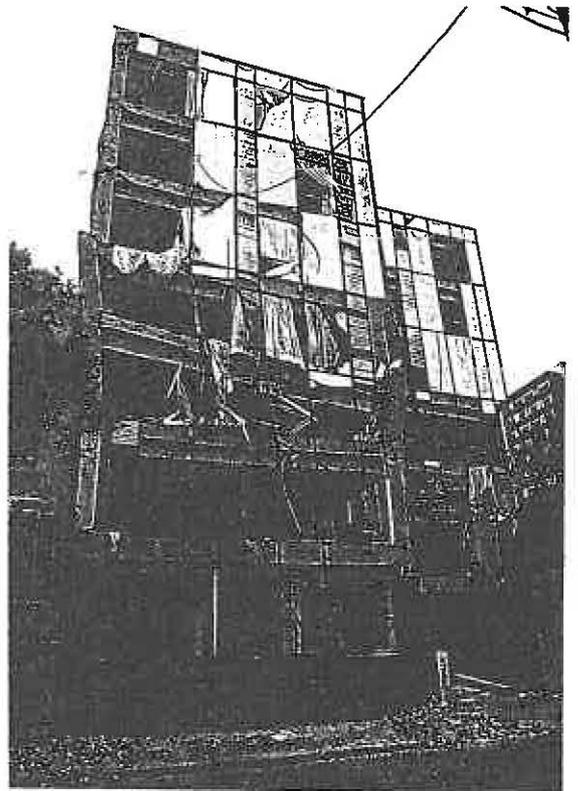
(t)

This residential building became a total loss due to the lack of reinforcement members and inadequate connections between the columns and ceiling slabs. Presumably the rigid neighbouring building (left) also contributed to the collapse of the middle floors

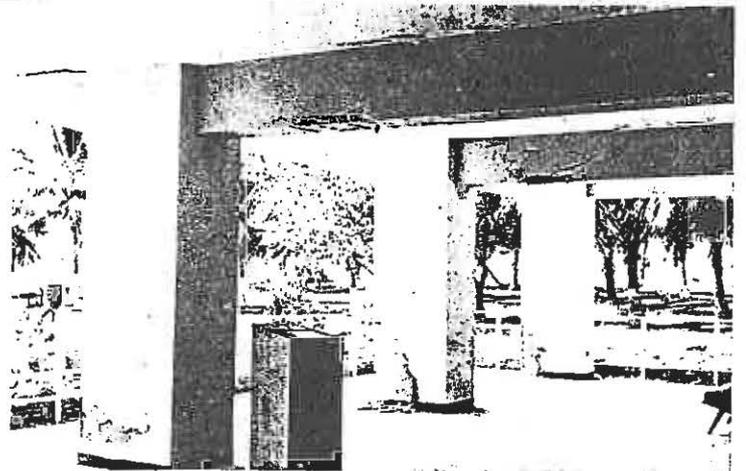
Caracas, 1967	<ul style="list-style-type: none"> Laguna Beach Building. A 14 storey RC frame building with hollow masonry infill panels. The 1st floor beams suffered shear failures just outside the normal hinge zone. Beam torsion may have contributed to the cracks. 	-	2.1(z1)	43
Mexico City, 1957	<ul style="list-style-type: none"> Two Storey School Building. Some spectacular beam shear failures occurred without causing the buildings to collapse. The major diagonal crack shown in Figure 2.1(z3) passes through a section where the main steel is cut off. 		2.1(z2), (z3),(z4)	30
Chile, 1960	<ul style="list-style-type: none"> Elevated Water Tank Support Frame. Photo shows beams with very little residual strength after failing in shear. However the tank did not collapse. 		2.1(z5)	30

Laguna Beach, damage to beams and columns of the first storey, north-west corner.

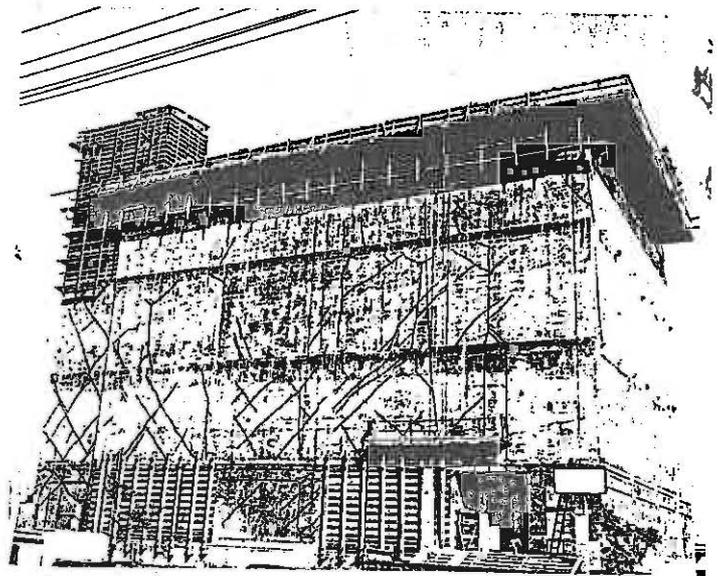
—Museum for Antique Cars. Building north wall, with repair of wall cracks in progress.

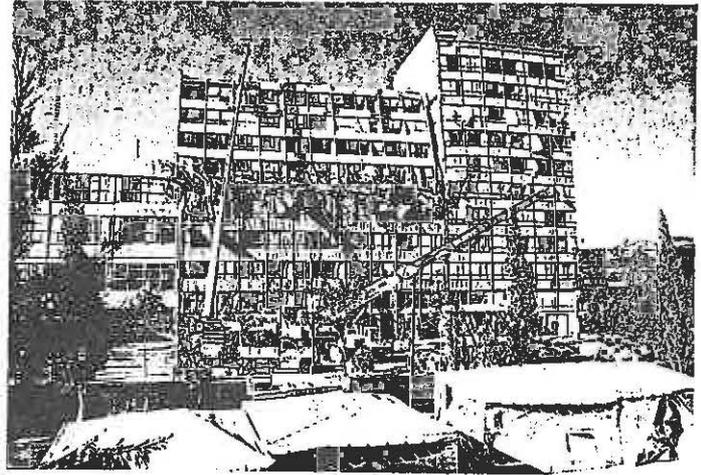
(b)

IMPACT DAMAGE. SEVERE DAMAGE TO
WINDOWS AND COLUMN FACINGS AT THE
LEVEL OF THE ADJACENT ROOF.

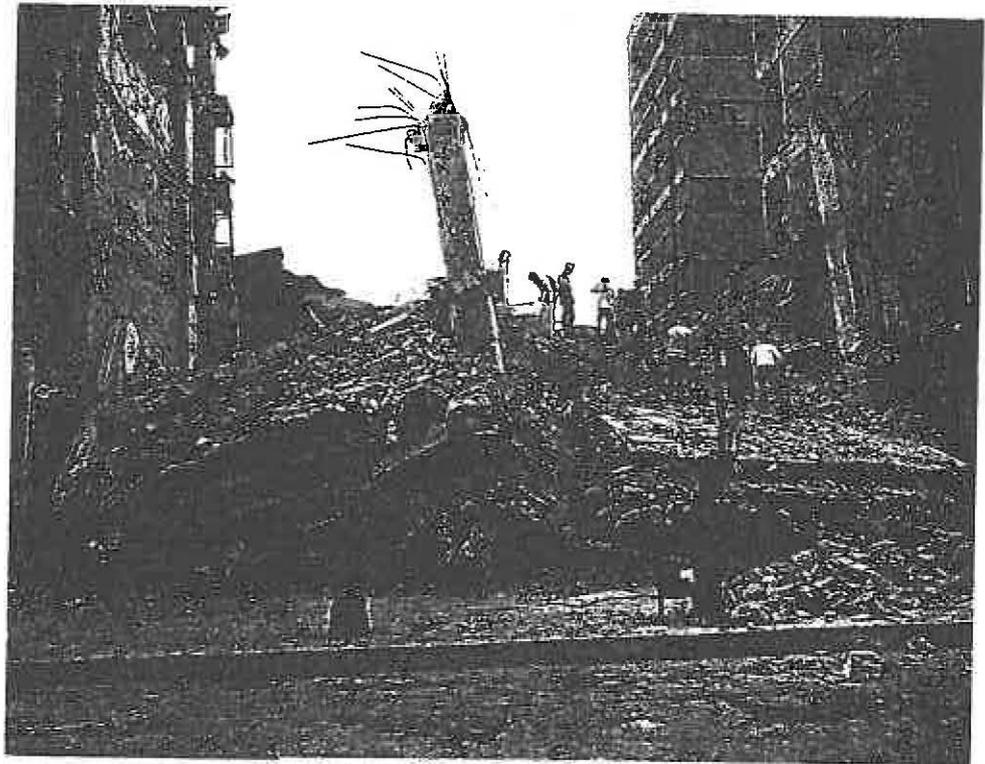
In this building as in many others, the load-bearing column was forced like a punch through the concrete ceilings which collapsed like a sandwich

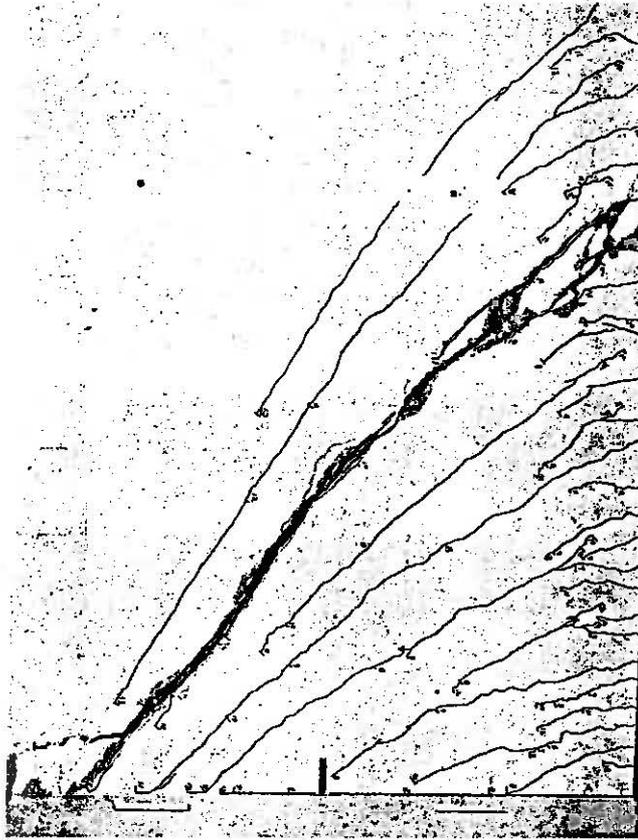
Fig 3.26 Flexural shear failure of a rectangular shear wall
(obtained from reference [23])
