**Two-Directional Cyclic Racking of Corner Curtain Wall Glazing**

*S J Thurston and A B King, BRANZ*

NO. 44 (1992)

BRANZ Study Report SR 44

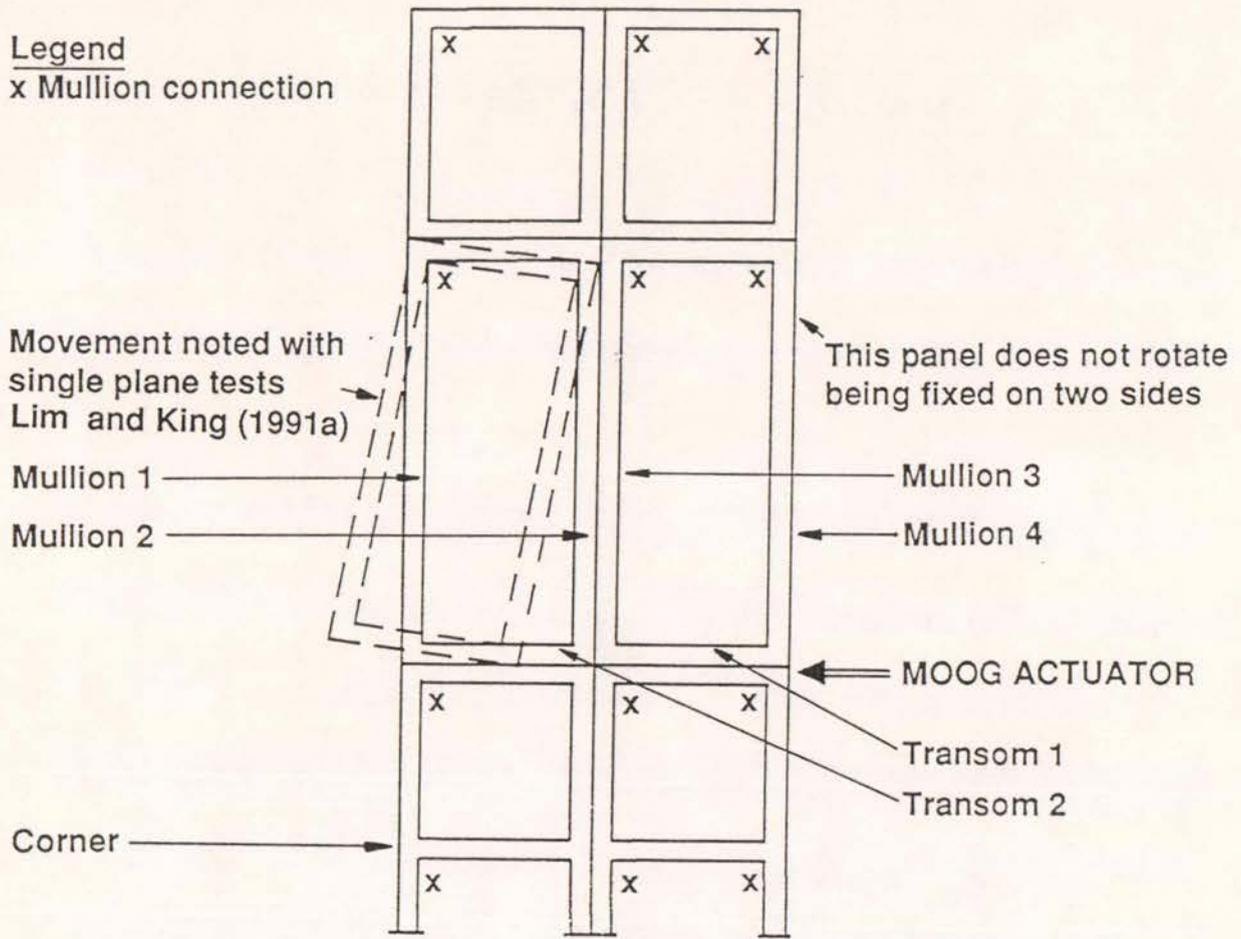
Figure 11c Location of mullion connections (wall S4)

There was negligible slip of glass relative to the frame by shear distortion of the silicone sealant. The distortion mechanism was as shown in Figure 11c with panel 7 rotating and sliding on the bottom transom and panel 8 not rotating but sliding on the bottom transom. The slip in panel 8 was responsible for 70 to 80% of the applied deflection. This is clearly illustrated in Figures 27 to 29. There was negligible vertical movements of mullions 1, 3 and 4; mullion 2 did have significant vertical movement. Top and bottom half-sized panels appeared to remain undistorted. There was no glass damage or frame failure at test completion.

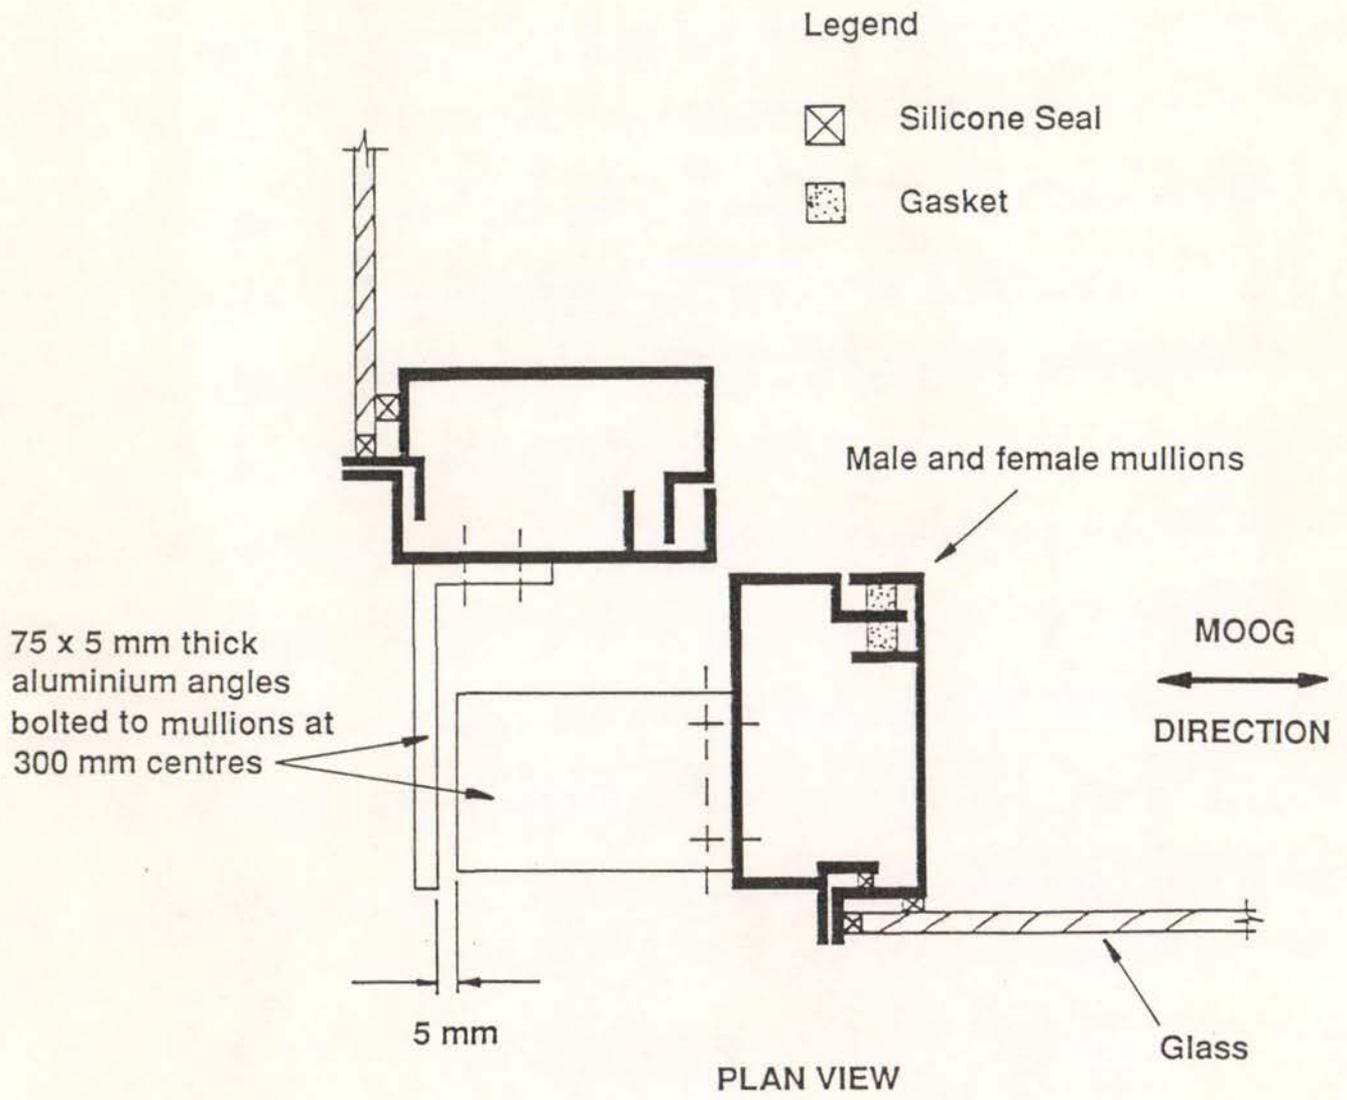
Figure 11e Corner detail used (Wall S4)

At applied deflections of between 20 mm and 60 mm, the aluminium angles at the corner (shown in Figure 11e) clashed at peak push, offering some restraint to the slip mechanism of Figure 11c. Above 60 mm, the out-of-plane distortion at the corner resulted in no clashing. The interlocking mullions at the corner (Figure 11e) withdrew and were pushed back together during cycling as (see Figure 28). At 60 mm plus, the Dowty actuator was deformed statically before cycling the Moog actuator. This resulted in some clash on the inner edges of the panels at the corner, but did not cause any damage.

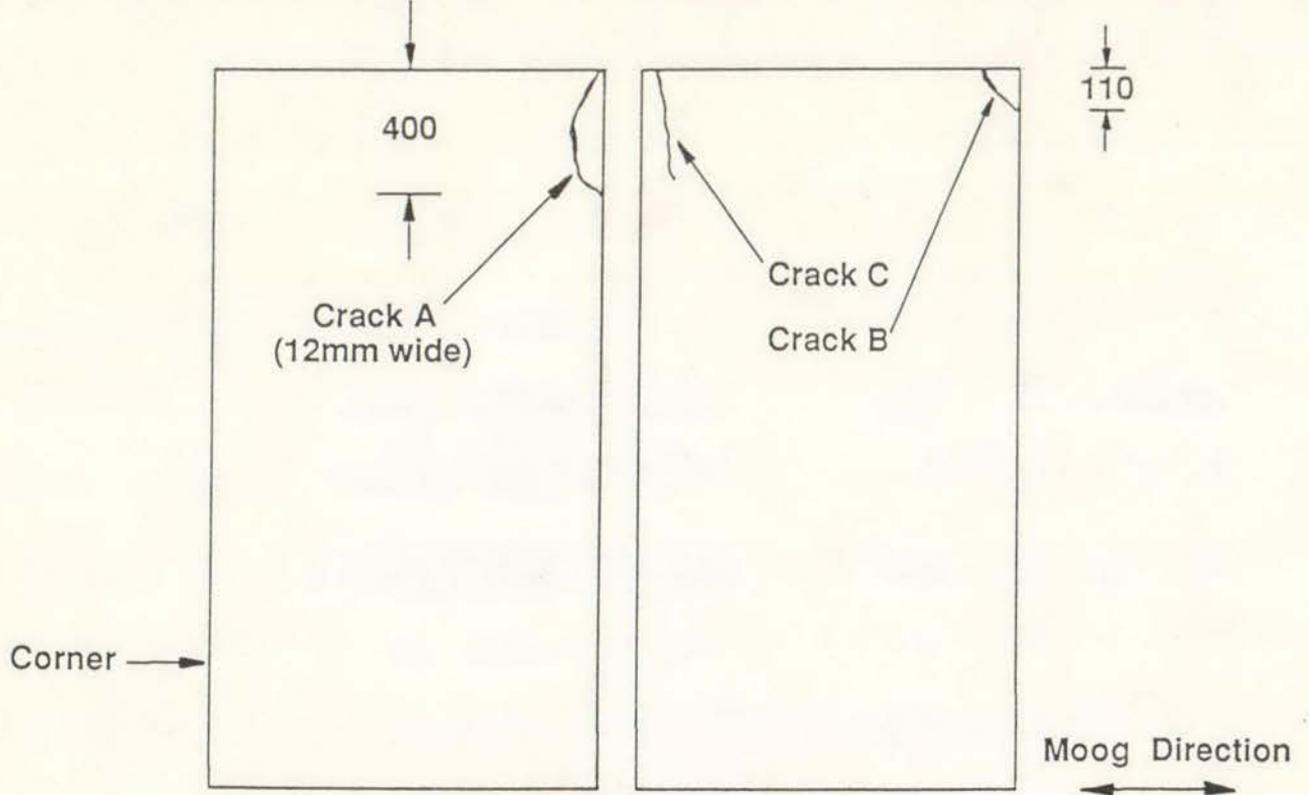
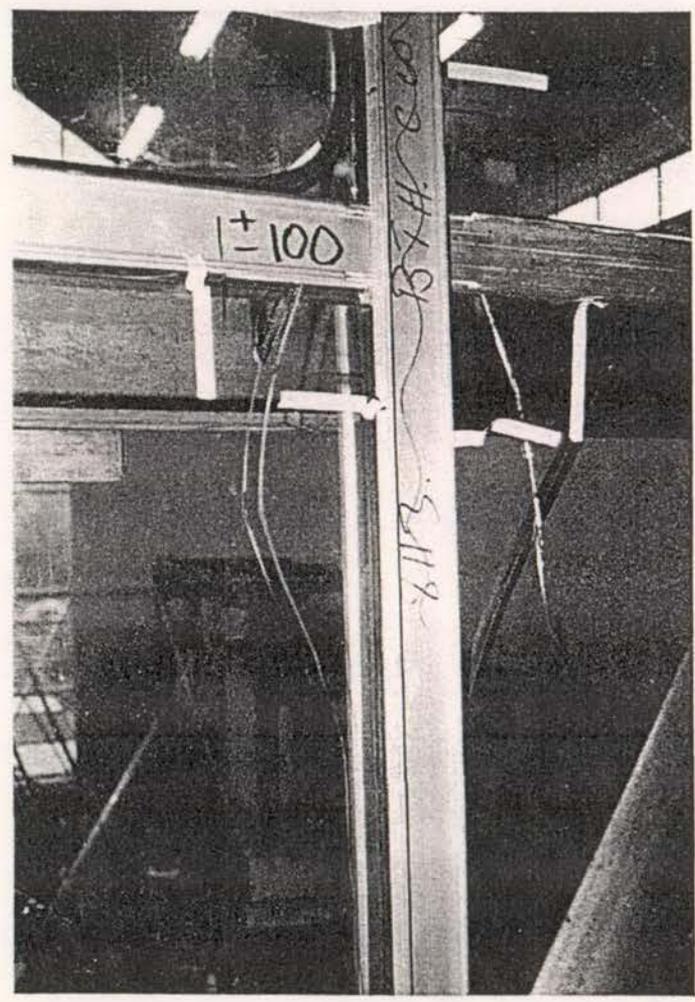
Figure 12 Cracking in gasket glazed windows (Wall NG)

When the glass was replaced, four cycles were imposed at 80 and 100 mm at 0.25 hertz. On the 4th cycle at 100 mm, the newly replaced glass cracked at the top corner as shown in Figure 12 (Crack A). A small crack also developed in the top corner of the adjacent pane (Crack B, Figure 12). Unfortunately, after this test the pane with Crack A was accidentally knocked out by scaffolding planks. Tests continued without this pane with the video camera focused on Crack B. 24 cycles at amplitude 105 mm were then imposed (the maximum deformation the rig would allow) without any further cracking or crack extension. The glass pane was then replaced again and four cycles to 100 mm imposed. On the fourth cycle a crack occurred that was almost identical to the original one shown in Figure 12. As the video camera had been focused on this spot, a good record of the crack development was obtained. During the subsequent four cycles to this deformation about 20% of the glass pane fell out and crack C (Figure 12a) occurred. A further 30 cycles were imposed and glass loss from this particular pane increased to 80% but the rest of the panes remained virtually intact and no further cracking occurred.

2. The glass in the gasket glazed system cracked in the 4th cycle at an in-plane inter-storey displacement of 100 mm (3.6% drift) and out-of-plane inter-storey displacement of about 45 mm. When the glass was replaced, a repeat test produced an almost identical result and the glass fell out. Although cracked in both top corners, the other panel survived a large number of cycles at 100 and 105 mm displacement without any glass falling out. From these observations and results reported by Lim and King (1991a) it was concluded that the most constrained glass panels generally broke first. The only exception was wall S2. Deschenes et al. (1991) found that the gasket glazed system they tested was able to sustain a large number of cycles of imposed severe inter-storey drifts without glass failure.

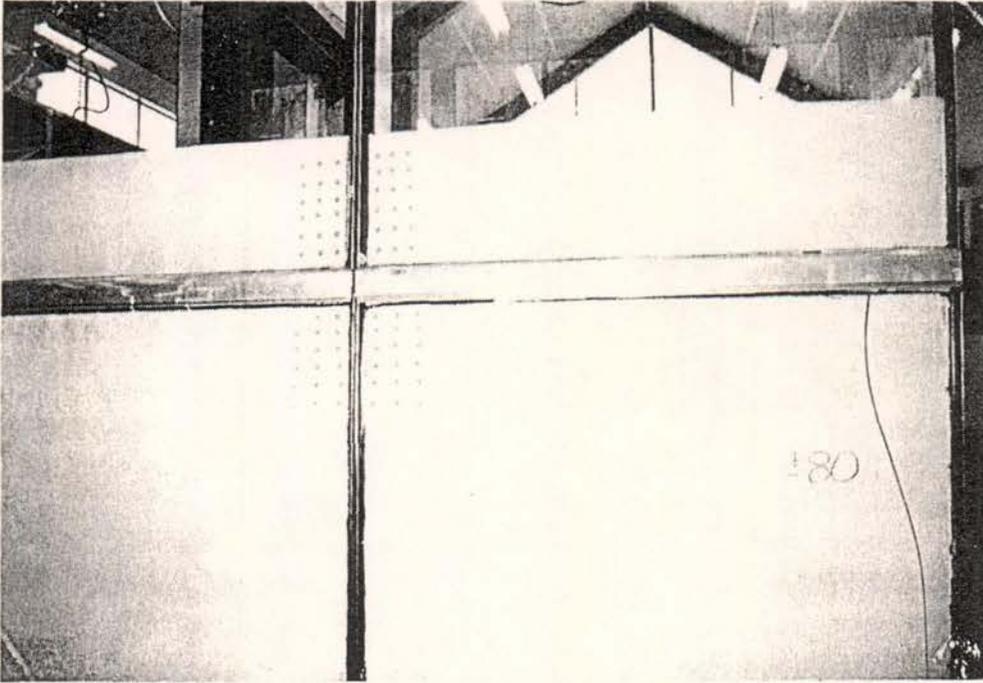
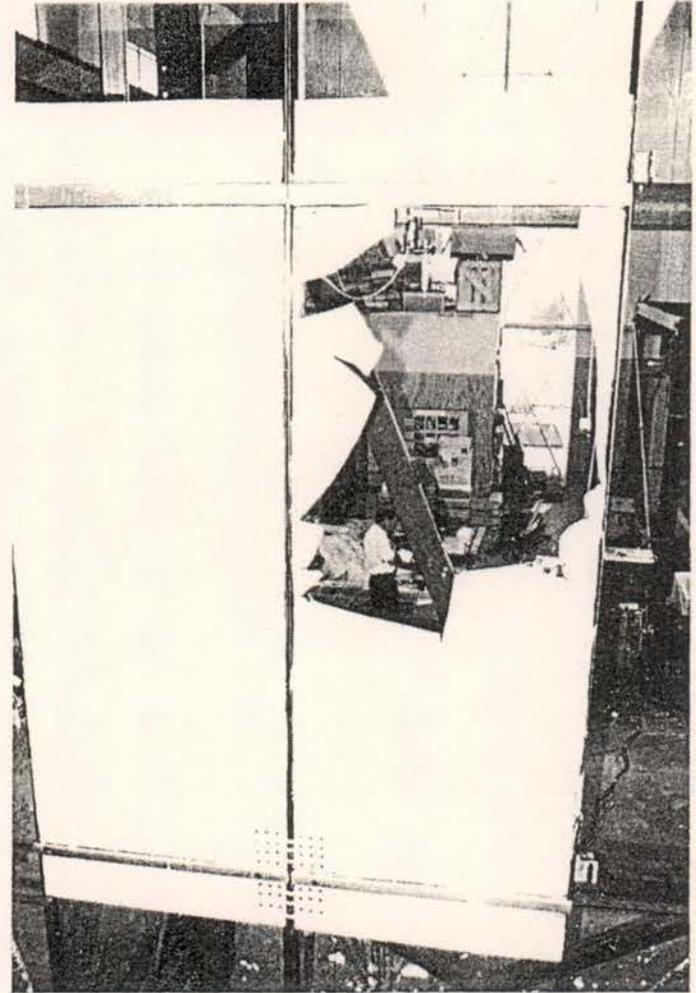
Figure 21 Failure mechanism S2 Curtain wall

In all tests on this curtain wall the two actuators moved in phase. Three tests, each of three sinusoidal cycles at 0.5 hertz, were performed at amplitudes 10, 20, 30 and 40 mm. An extra 30 cycles at 40 mm were then imposed for the purposes of video camera recording, and then normal test loading of nine cycles to 60 mm at 0.25 hertz was recorded. No damage was noted. All deflection gauges, apart from those shown in Figure 20 were then removed to prevent damage. Next, three cycles to 80 mm at 0.25 hertz on the Moog actuator (and 62 mm on the Dowty actuator) was applied. During the latter half of these three cycles, a crack formed in the glass (see Figure 21a) at the locations shown in Figure 9a. During the subsequent three cycles to 100 mm at 0.1 hertz, a large portion of glass fell out leaving the panel as shown in Figure 21b. A further 70 cycles were then imposed to 105 mm with no further damage occurring to either the glass or frame. The broken glass in panel 1 remained attached to the silicone sealant at the edge.

3. Shear distortion of the silicone sealant bonding the glass to the frame accounted for only about 25% of the drift with the glazed two-sided silicone wall. The main source of movement appeared to be the sub-frame rotating within the mechanical fixing attaching it to the support beams. The glass cracked during cycling at an in-plane inter-storey displacement of 70 mm and an out-of-plane displacement of about 48 mm. Some glass fell out at an inter-storey drift of 90 mm (3.2% drift), although the edge portions remained fastened to the silicone sealant.

(a) Cracking of glass after 3 cycles to  $\pm 80$ mm

(b) Glass after 3 cycles to  $\pm 100$ mm

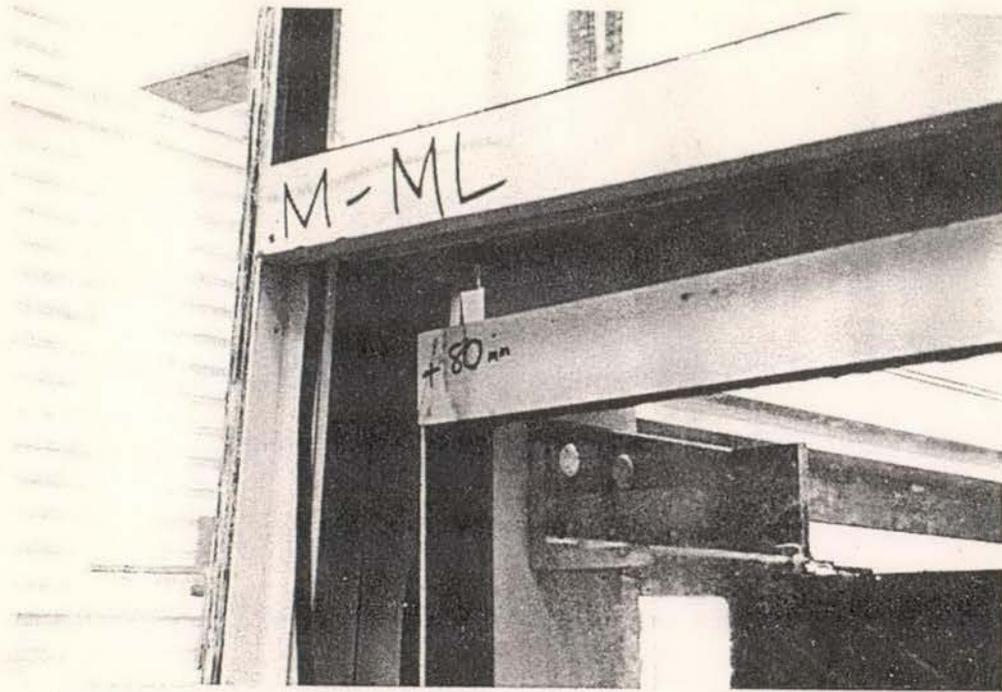
4. There was negligible slip of the glass relative to the frame by shear distortion of the silicone sealant with the four-sided silicone system. The distortion mechanism was due to corner panels rotating and sliding on the bottom transom and other panels not rotating but sliding on the bottom transom. This accounted for the bulk of the imposed inter-storey deflection. There was no glass damage or frame failure at test completion, which included 30 cycles at 100 mm (3.6% drift) imposed inter-storey deflection. The corner panel became partially disengaged from the bottom transom and wedged in the deformed position at 80 mm imposed inter-storey deflection.

(a) Panel 7 and 11 Wedged apart at the corner, as slotted mullion becomes misaligned with transom runners
