GEOTECHNICAL REPORT

ABBOTSFORD LANDSLIDE

THE EARTHQUAKE & WAR DAMAGE COMMISSION

BRICKELL MOSS RANKINE & HILL CONSULTING ENGINEERS

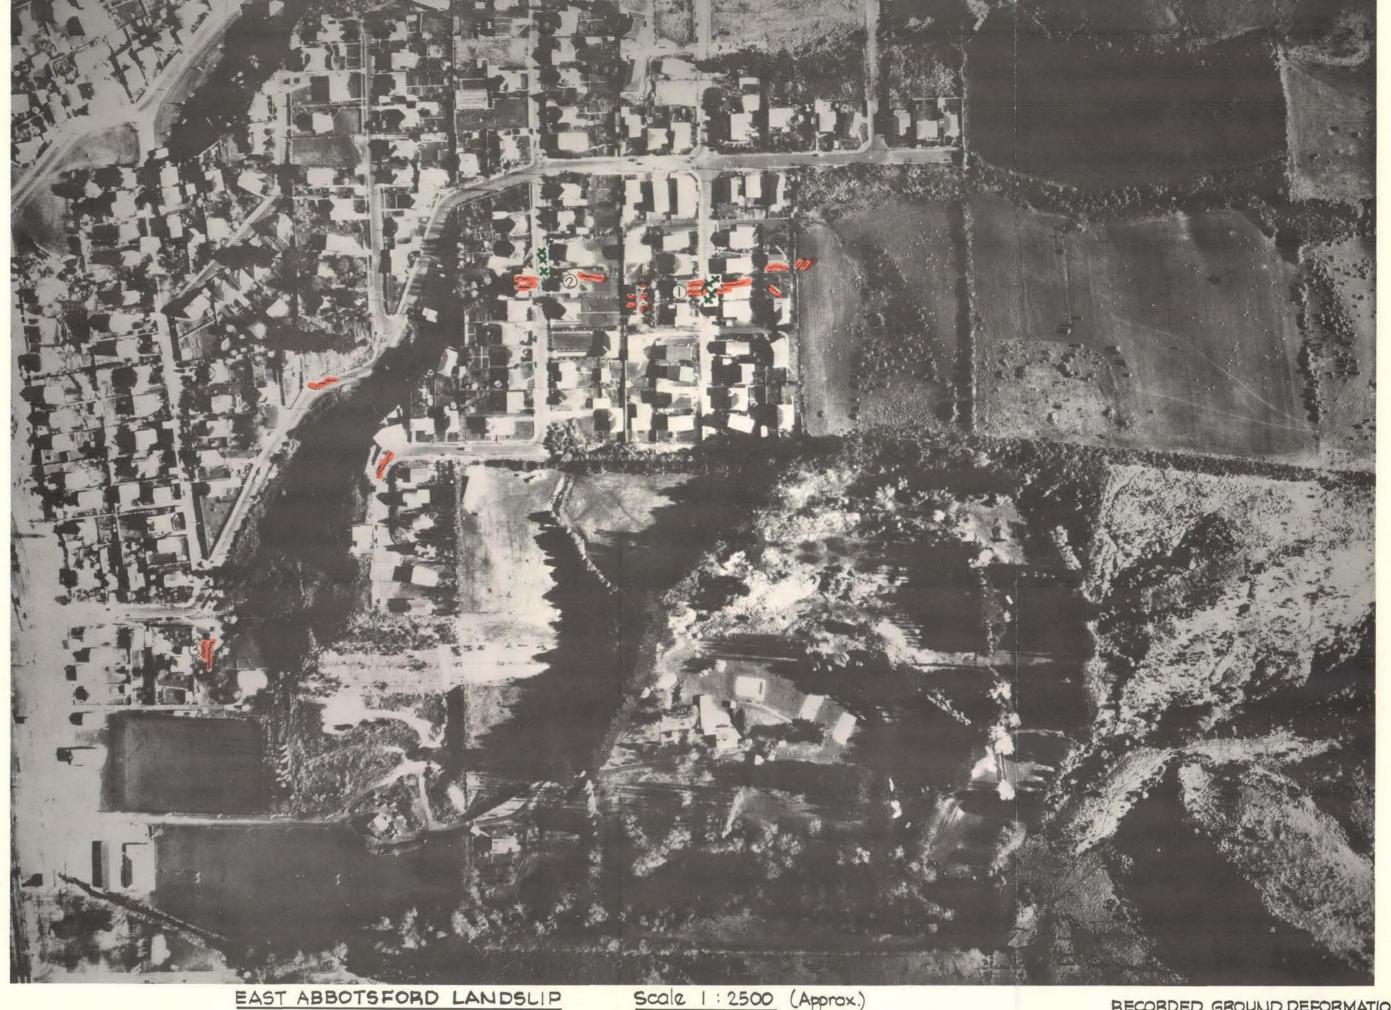
RECORDED GROUND DEFORMATION AS AT JULY 4, 1979

- 16 Mitchell St. : some damage noted October/November 1978. Possibility of some damage in basement prior to 1974. 11 Edward St. : minor cracking of garage/basement floor noted in October/November, 1978. 5 Christie St. : movement of ground surface beneath house first recorded in April, 1972.
- 3
