Darfield Earthquake 4 September 2010  
Geotechnical Land Damage Assessment  
& Reinstatement Report

## STAGE 1 REPORT

**October 2010**

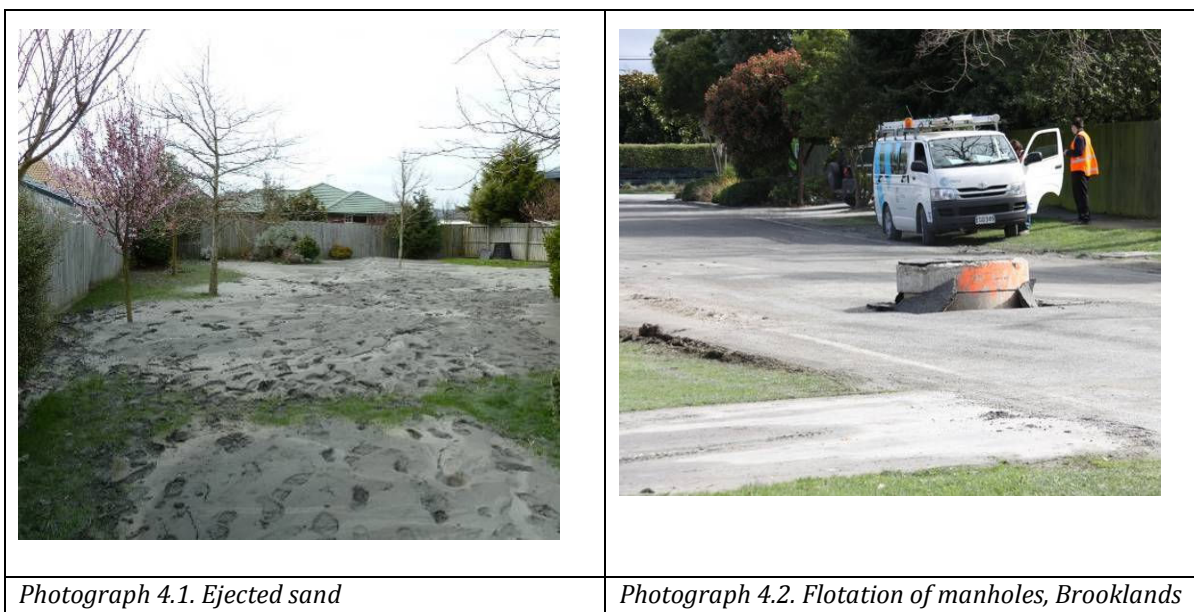
the ground below the water table has occurred, for example the large quantities of sand ejected (Photograph 4.1) to the ground surface in Kaiapoi and Bexley.

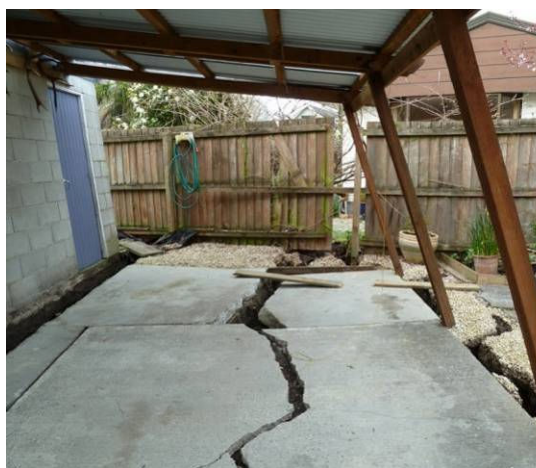
Manifestations of very severe land damage include the formation of large cracks adjacent to and through buildings; inundation of sand adjacent to and throughout some buildings and rupturing of pipe networks. Examples of this type of damage are shown in Photographs C.1 and C.2.

*Photograph C.1. Very severe land damage (lateral spreading)*

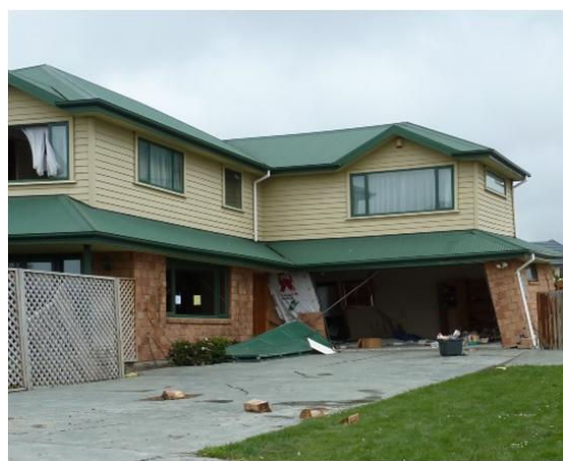
*Photograph C.2. Very severe land damage (lateral spreading)*

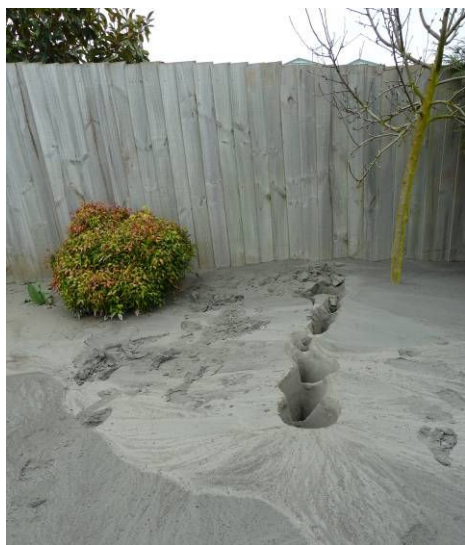
Photographs C.3 and C.4 illustrate the effects of major land damage. Approximately 300 mm of silt and sand was observed on the ground surface in some suburbs as shown in Photograph C.3. Sand, silt and water was ejected from below the ground surface at the location of the building shown in Photograph C.4 and this resulted in the non-uniform settlement of the building shown in this photograph.

*Photograph C.3. Major land damage*

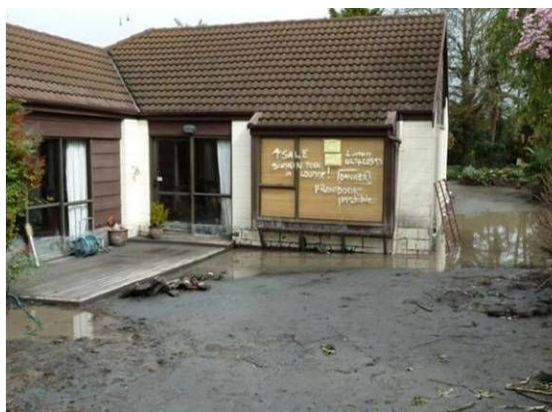
*Photograph C.4. Major land damage*

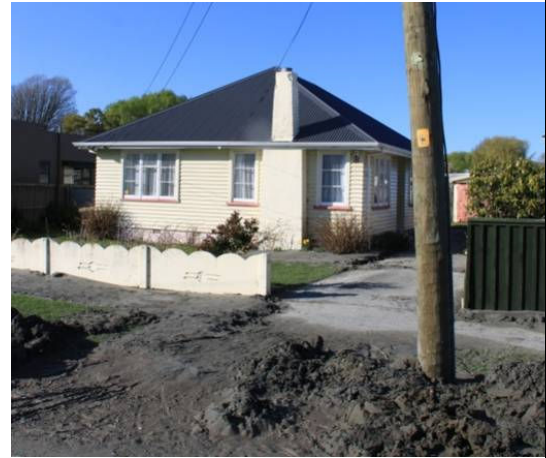
Moderate land damage is illustrated in Photographs C.5 and C.6. Sand, silt and water was ejected from below the ground surface at each of these properties and this has resulted in the non-uniform settlement of the buildings shown in the photographs below.

*Photograph C.6. Moderate land damage*

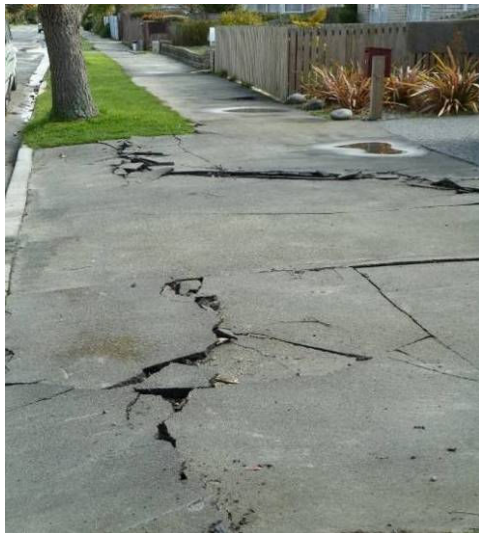
Photographs C.7 and C.8 illustrate the effects of minor land damage. No obvious damage to buildings from land movement only building damage from ground oscillations. Land damage evidence however was observed with minor cracking of the paved surfaces in and around buildings such as shown in the following photographs.

*Photograph C.7. Minor land damage*

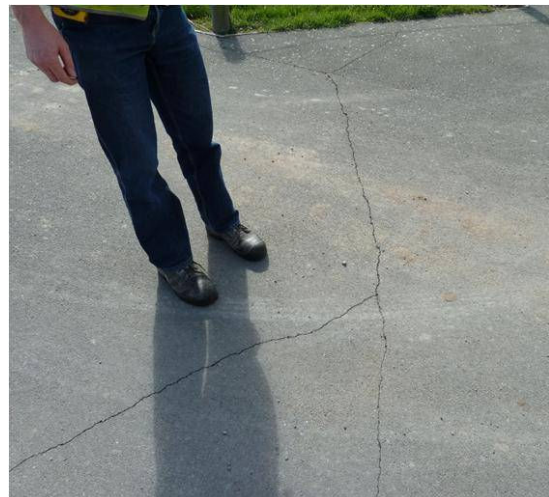
*Photograph C.8. Minor land damage*

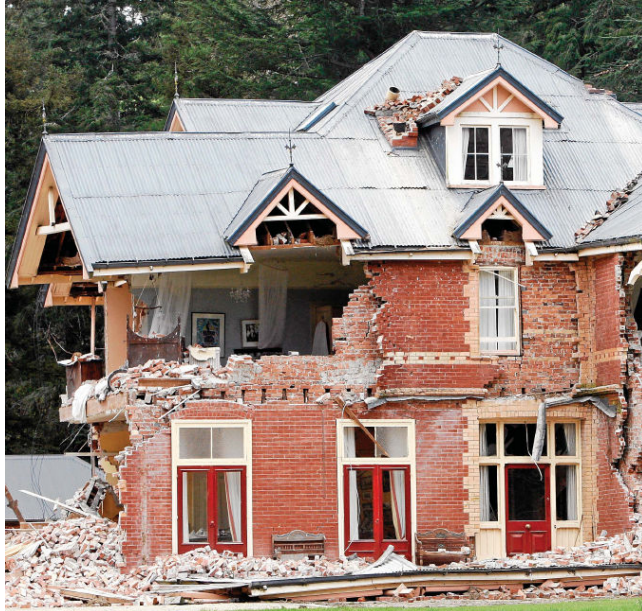
Photographs C.9 and C.10 illustrate the effects of earthquake shaking alone causing building damage but with no apparent land damage nor any signs of liquefaction at the surface. Chimney damage is prevalent.

*Photograph C.9. Building damage*

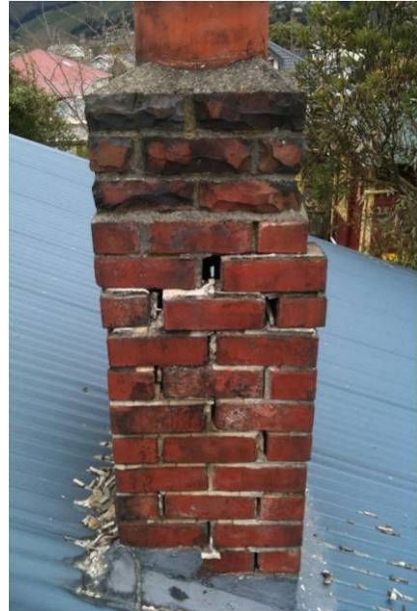
*Photograph C.10. Chimney damage*
