Earthquake Commission

Canterbury Earthquakes 2010 and 2011
Land report as at 29 February 2012

Report prepared for: Earthquake Commission
Report prepared by: Tonkin & Taylor
Distribution: Earthquake Commission, Electronic copy and
Tonkin & Taylor, Electronic copy (File)

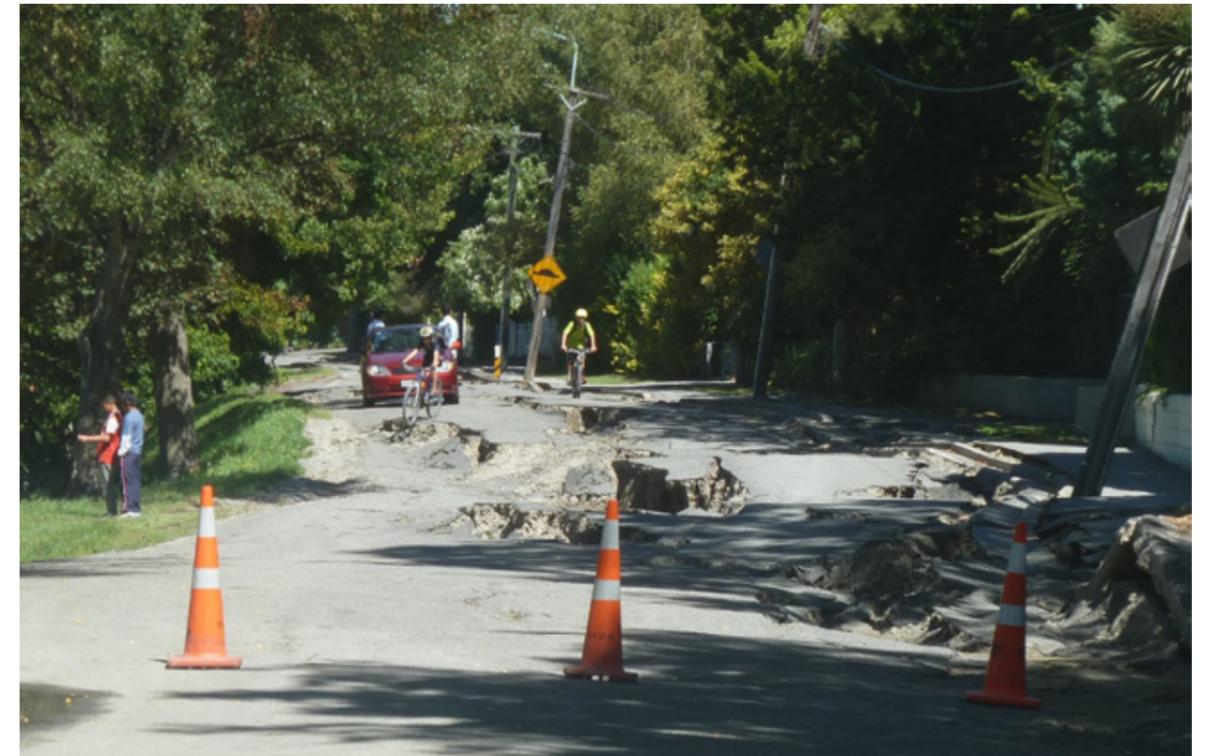
Cracking as a result of lateral spreading, Christchurch city.

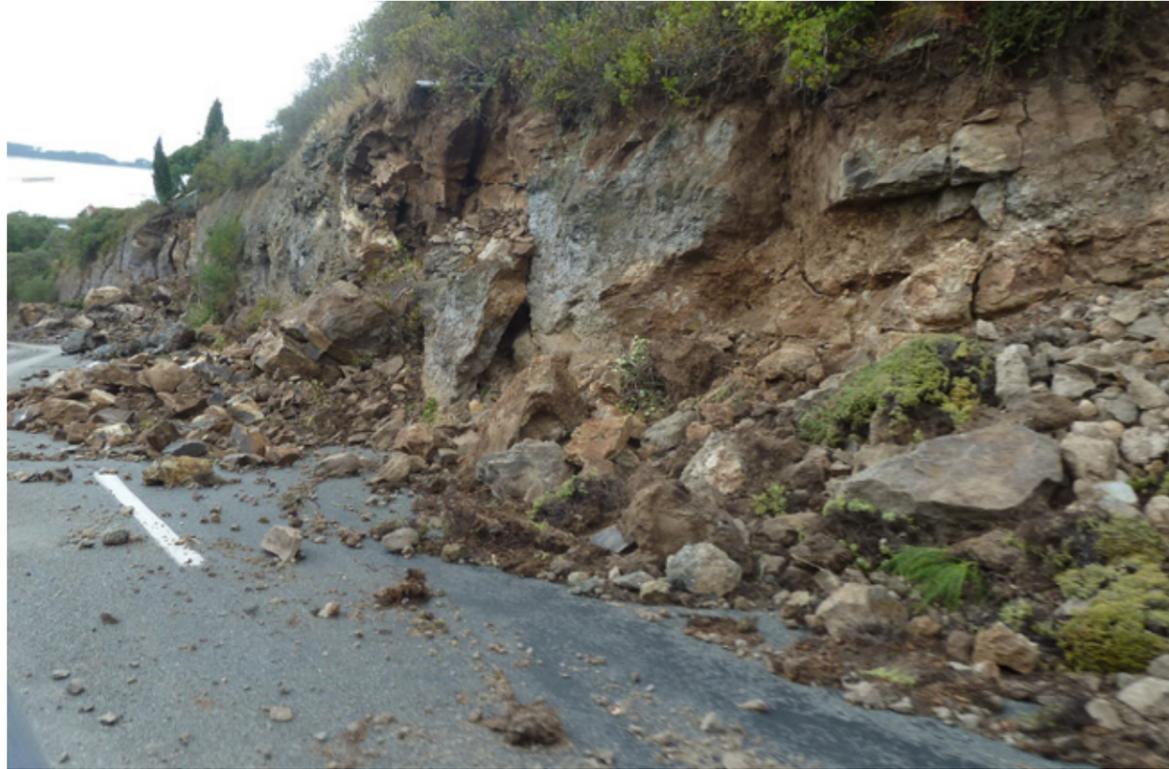
Cut slope failure, Port Hills. Photo: Tonkin & Taylor

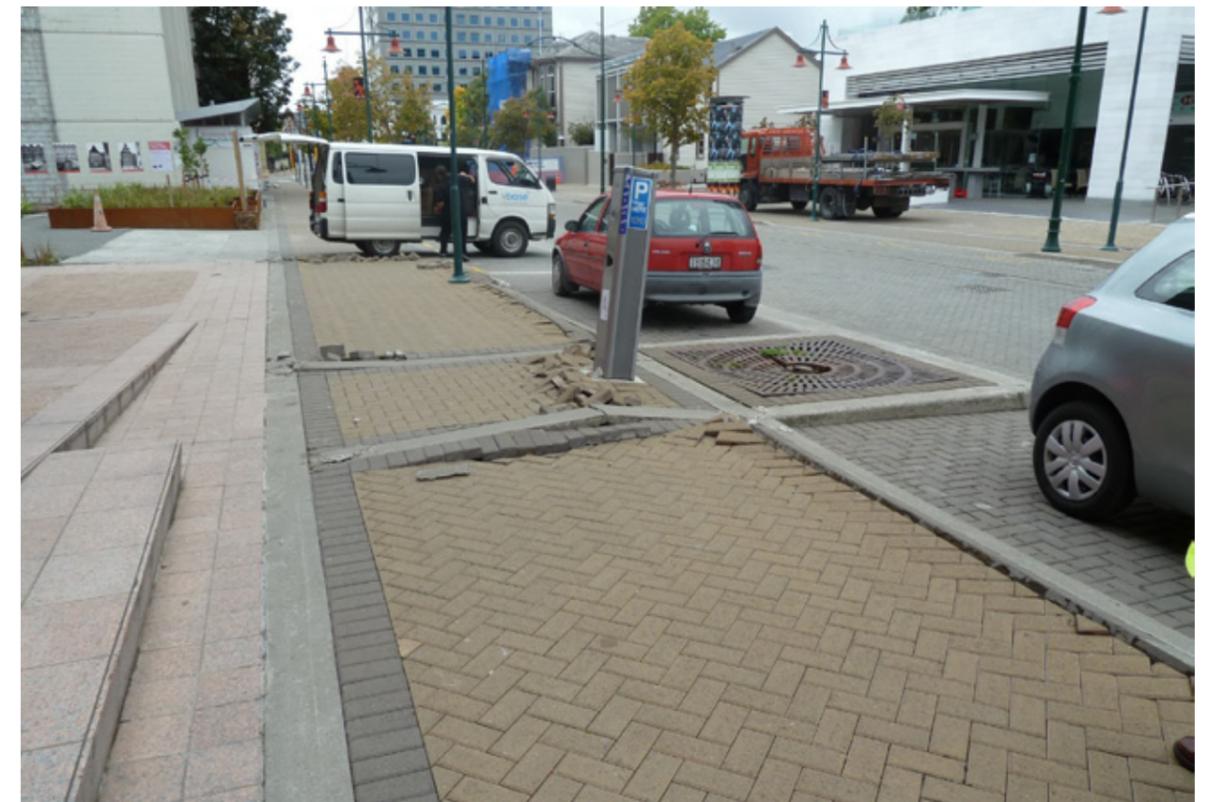
Pavement damage from ground oscillation, Christchurch city.

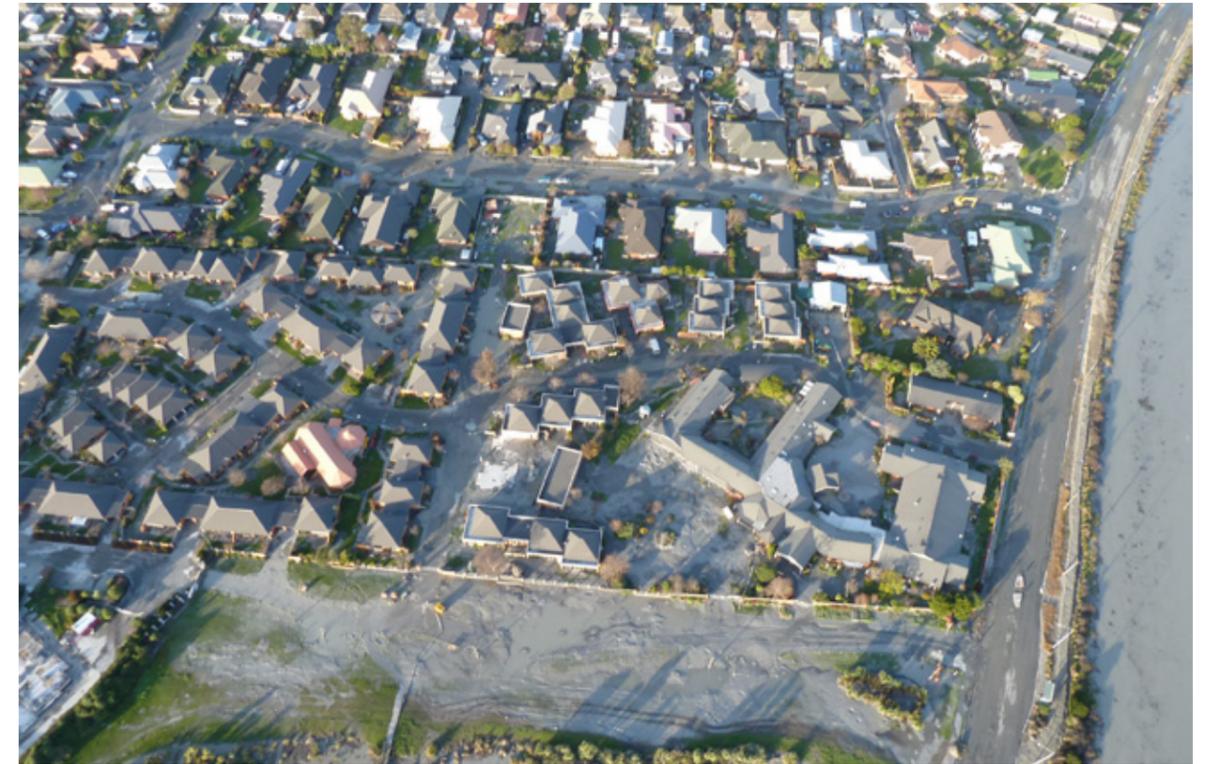
Ejected sand and silt covering land, and lateral spreading adjacent to the estuary, Christchurch city. Photo: Tonkin & Taylor

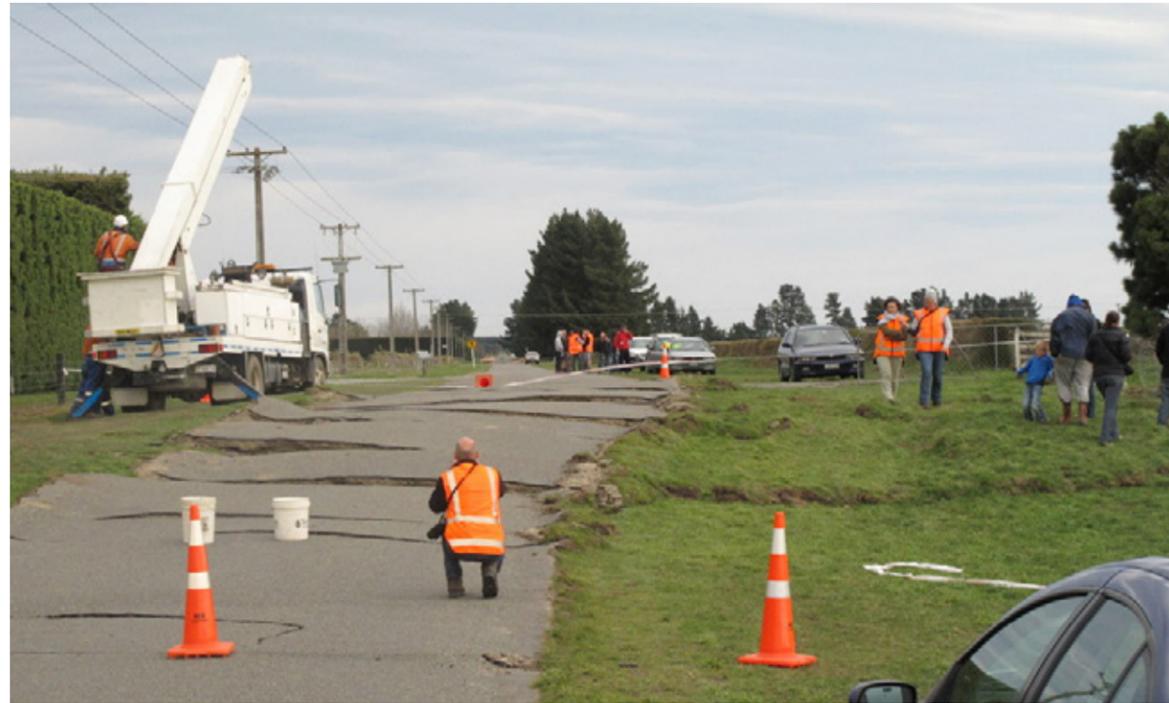
The September 2010 earthquake Greendale Fault trace. Photo: GNS Science

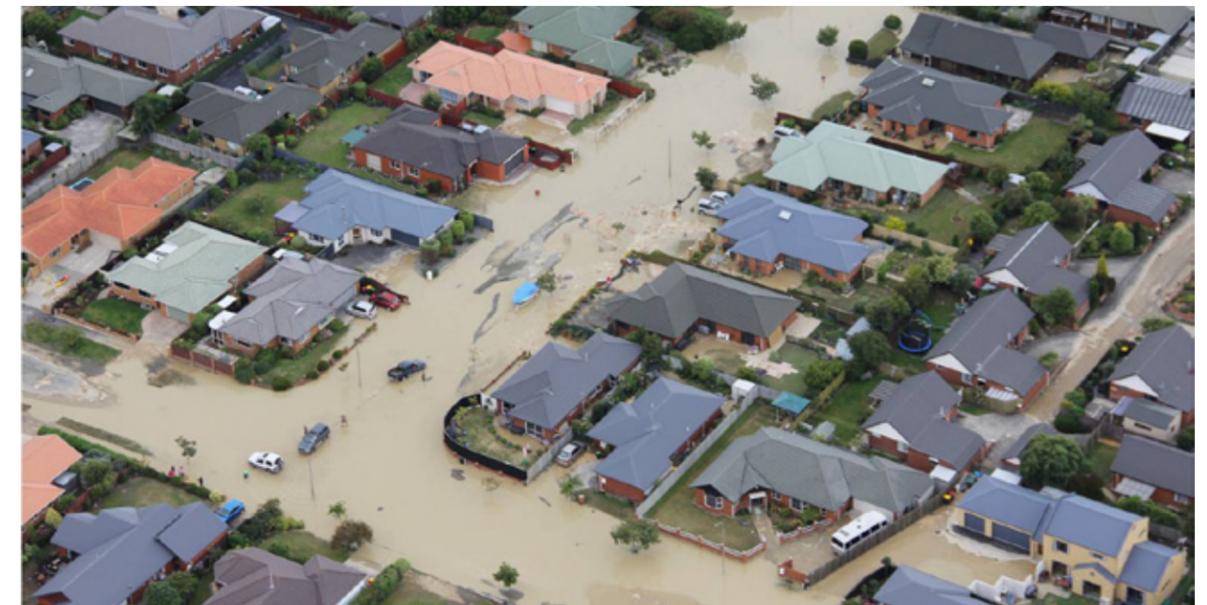
An aerial view of liquefaction and flooding after the 22 February 2011 earthquake. Photo: Tonkin & Taylor.

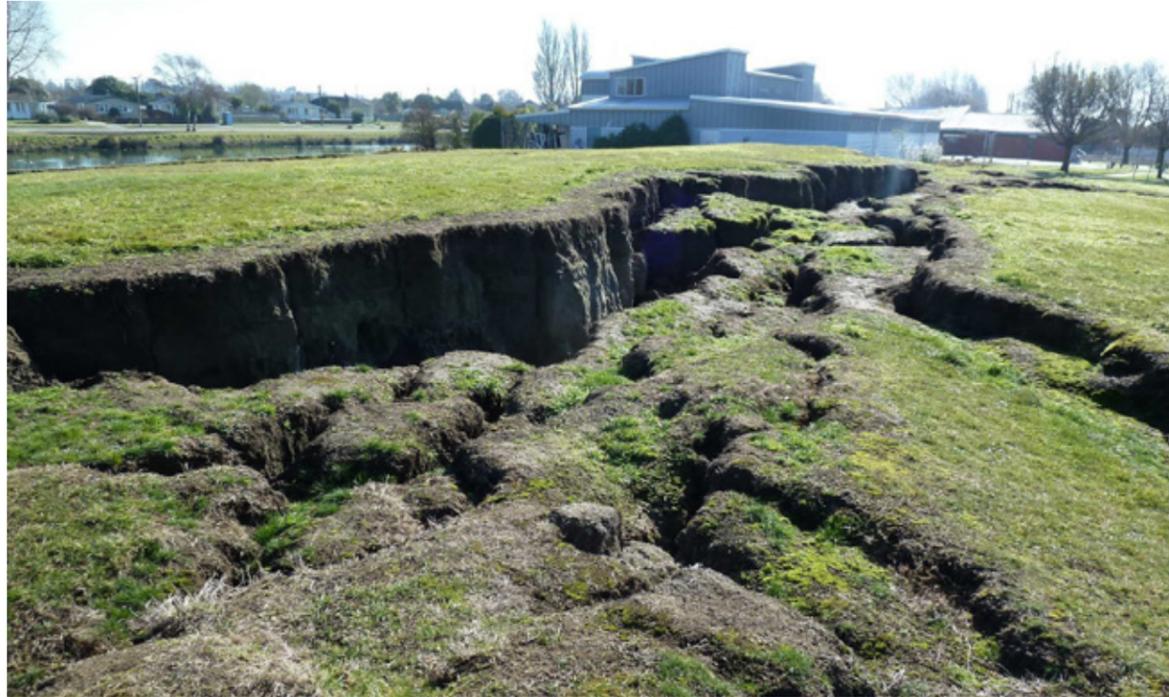
Lateral spread alongside the Avon River. Photo: Tonkin & Taylor

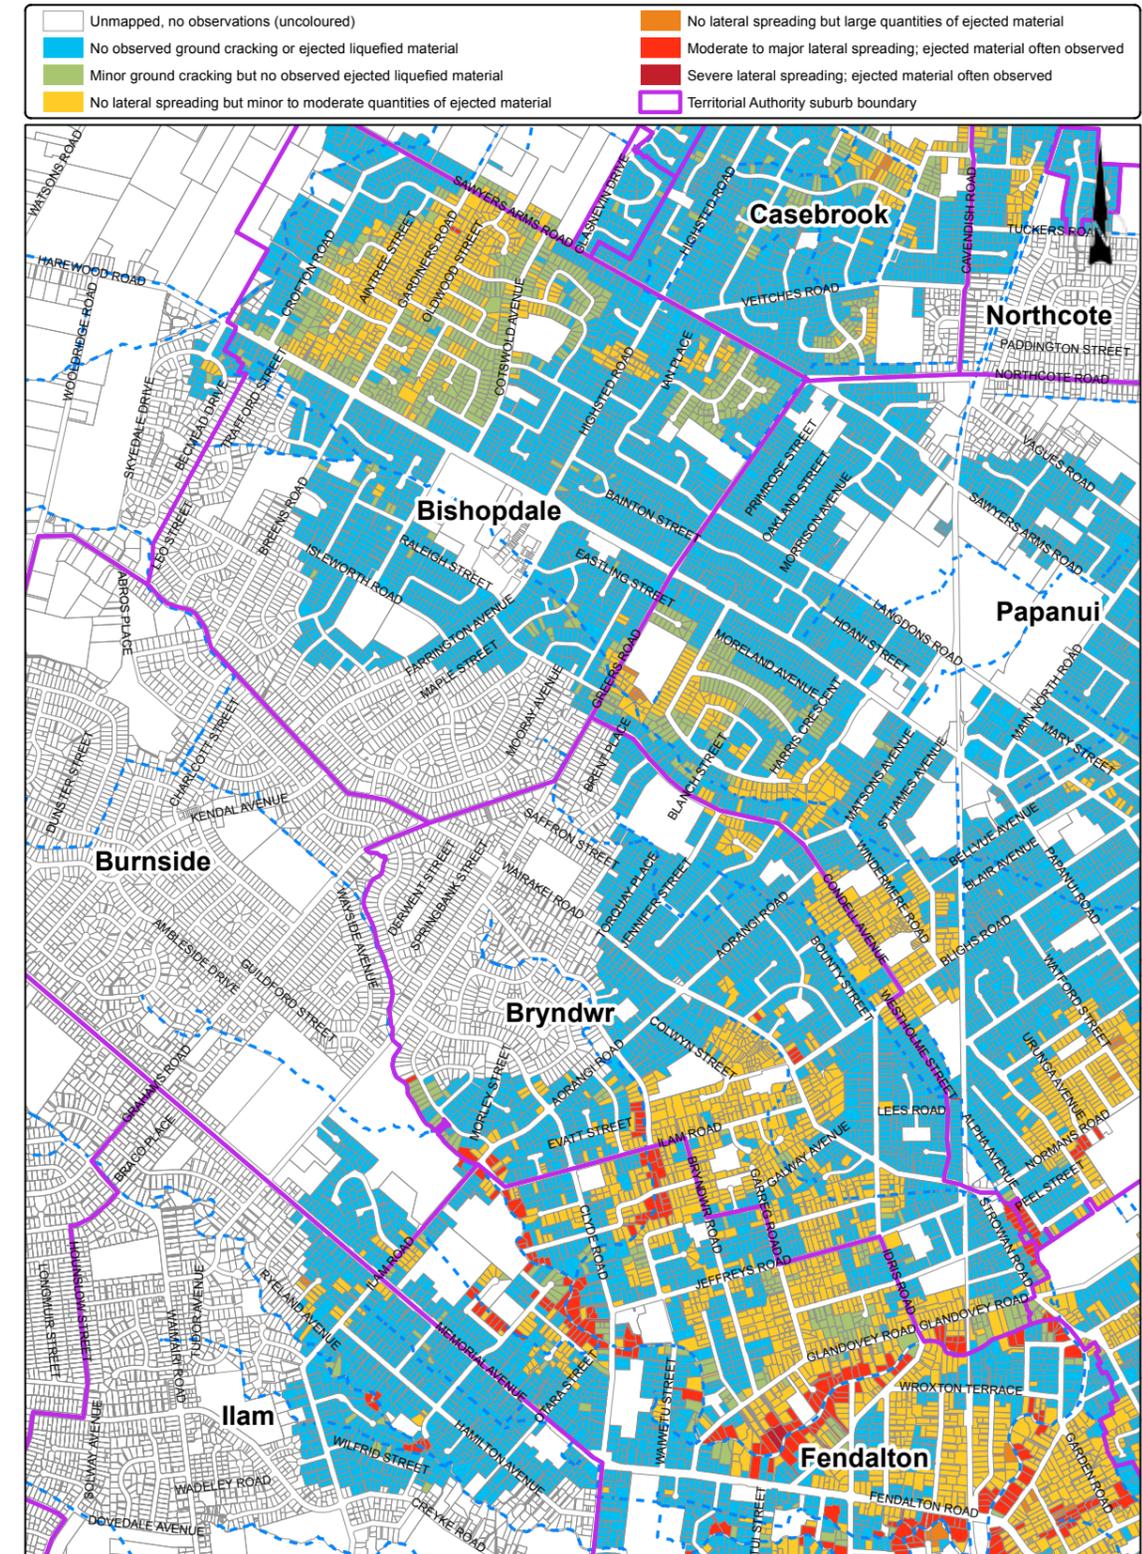
Figure C6.1 - Overview of liquefaction and lateral spreading observations, aggregated from mapping undertaken following the earthquakes of 4 September 2010 and 22 February 2011.

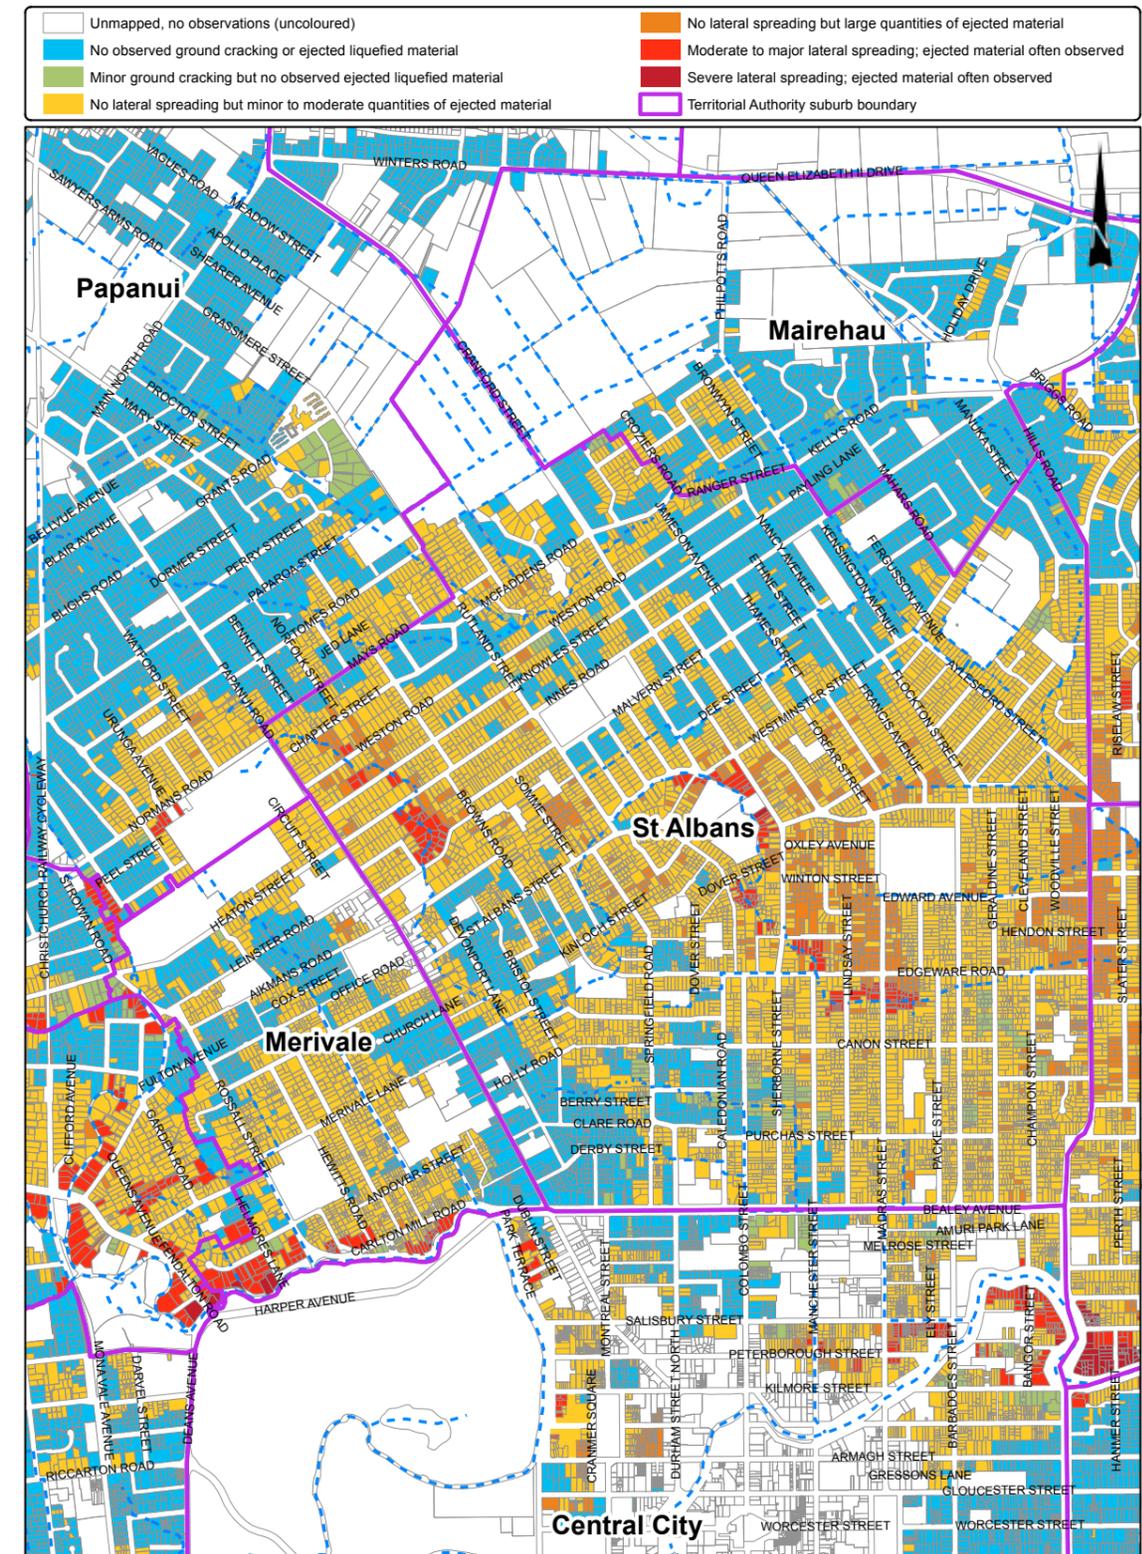
Figure C7.1 - Overview of liquefaction and lateral spreading observations, aggregated from mapping undertaken following the earthquakes of 4 September 2010 and 22 February 2011.
