# Earthquake Reconnaissance in Bangkok, Thailand, following the 28 March 2025 Mandalay Earthquake

Prepared by: Andrew Stolte, Catalina Miranda, Andrew Baird, Jitendra Bhatta, Jitendra Bothara, Chungwook Sim, and Lucas Hogan

March 2026

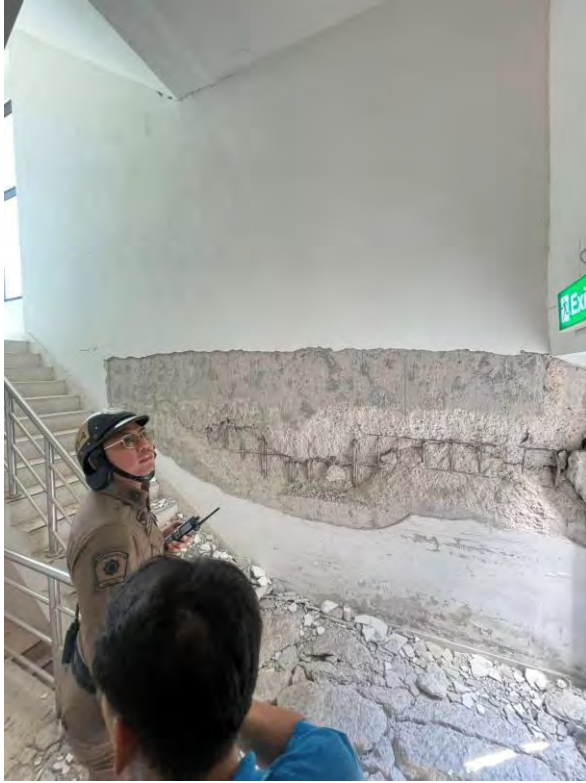
(a) Through-thickness failure of the wall along gridline Y9

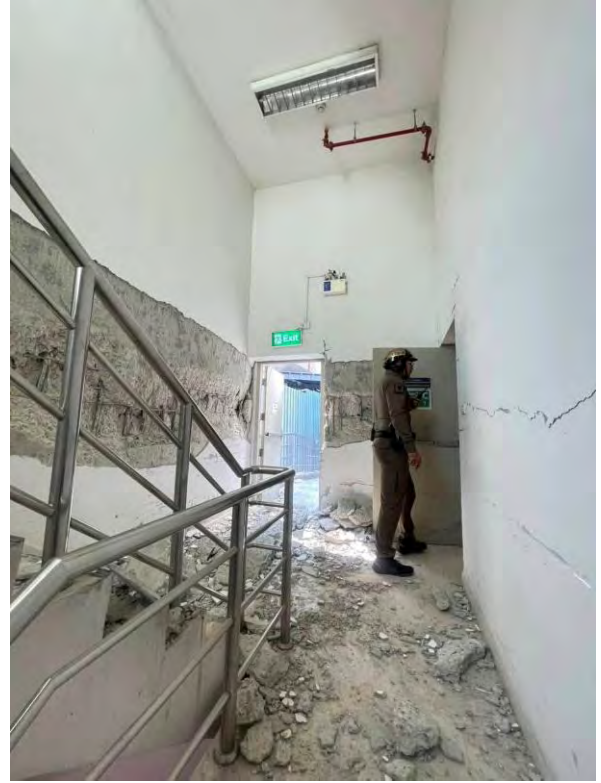
(b) Through-thickness failure of the wall before repair

During the reconnaissance visit, the wall was being repaired with a concrete jacket (Figure 12). Loose concrete had been removed, and 90-degree hooks had been epoxied into the original wall. Jacket reinforcing was welded onto these hooks.

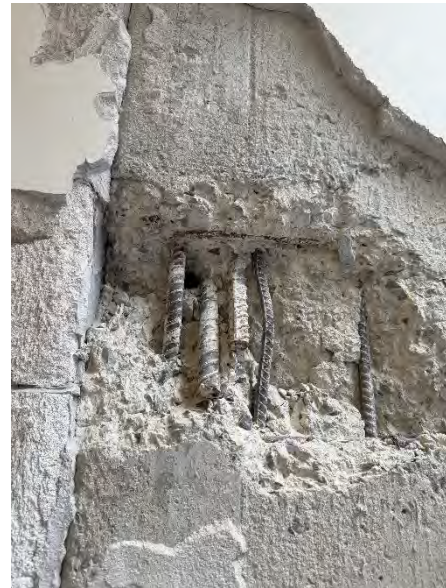
(d) Rebar splicing in the short reinforced concrete wall along the X-direction

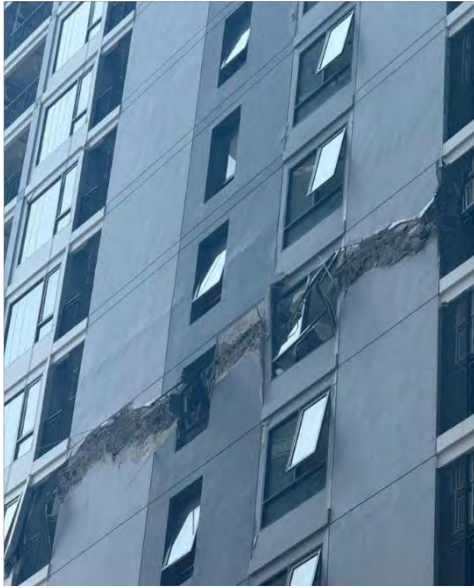
*(c) Wall damage on the 9<sup>th</sup> floor*

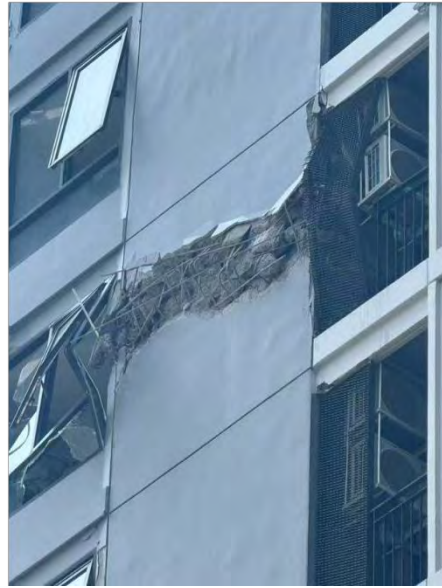
*(d) Wall damage on the 9<sup>th</sup> floor*

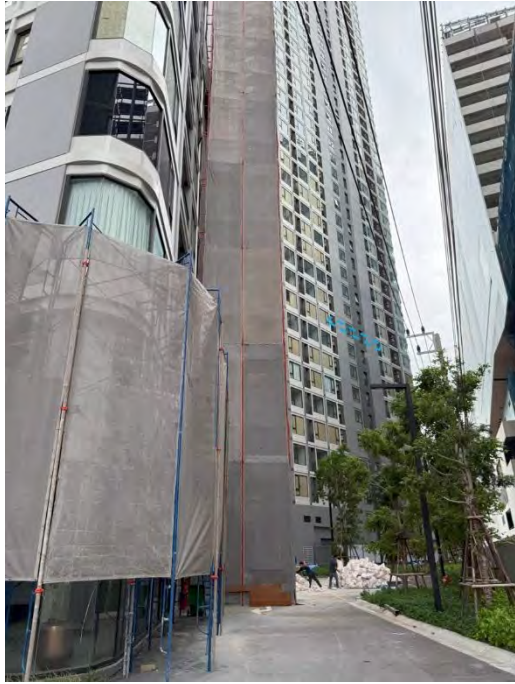
(a) Adjacent Building

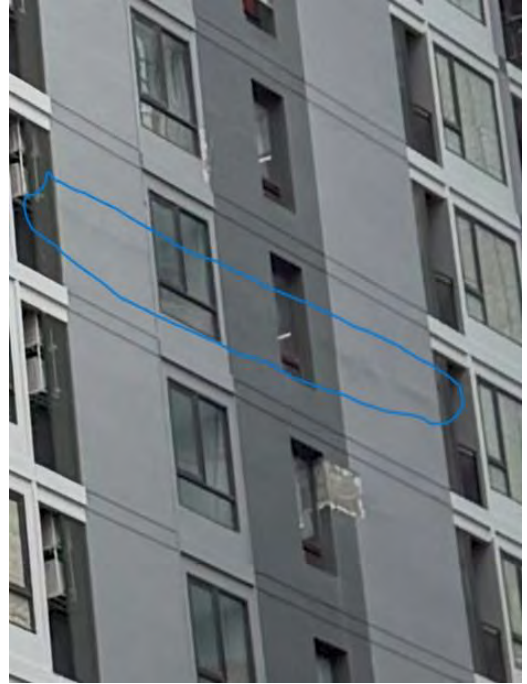
(b) Observed bulging on the adjacent building

Figure 15: Potential damage to the building adjacent to Building R1. Further investigation did not find any damage to the building in the photograph, nor to the other two buildings. Note that all four buildings have the same architectural and structural configuration, but some minor differences in height and orientation.

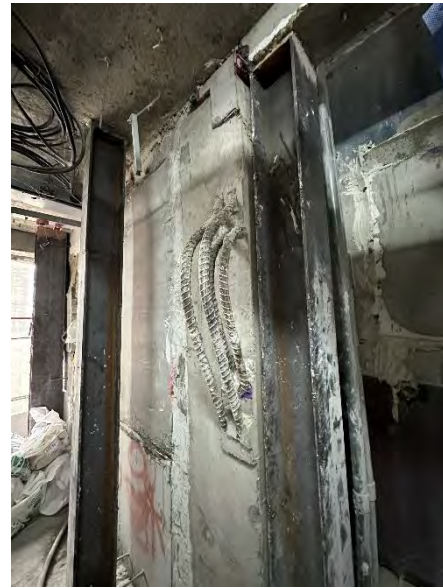
(d) Buckled bars left exposed, 9<sup>th</sup> floor

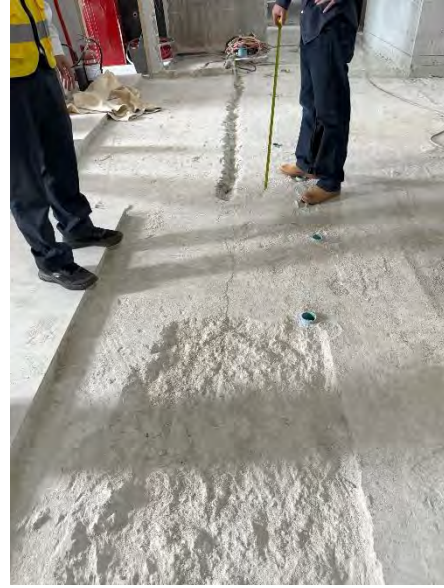
(f) Damage to the floor

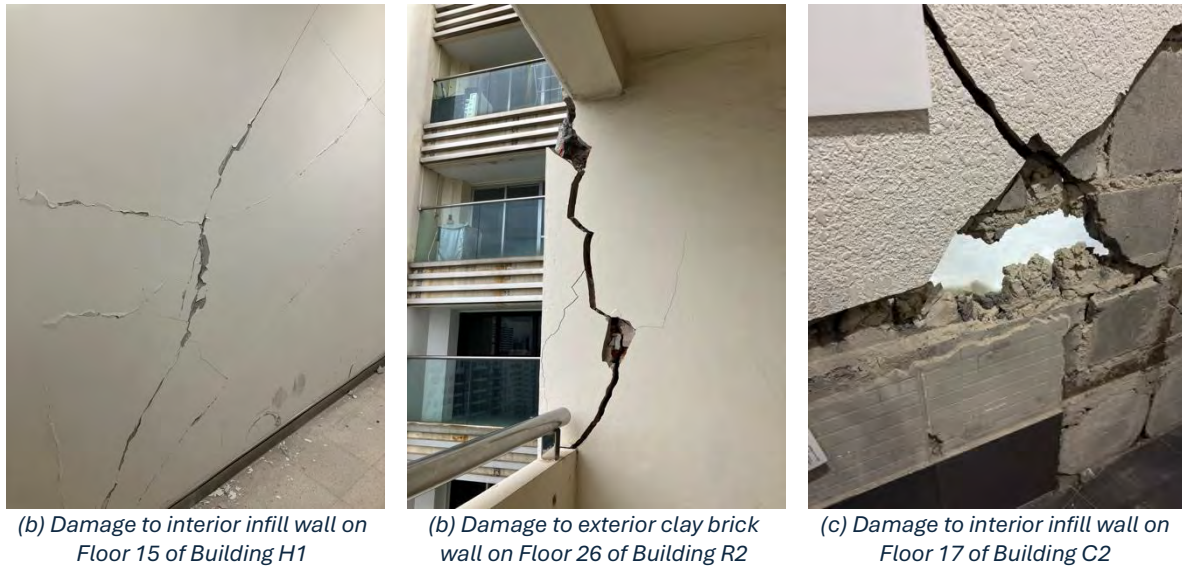
Material performance varied significantly where traditional clay brick infills (in building R2) exhibited brittle failure at building setbacks, while modern cold-formed steel infills (in building C4) demonstrated superior performance with only minor cracking at the interface of structural walls and infills. However, newer buildings using lighter but brittle materials (e.g., aerated blocks) still suffered cracking, suggesting the need for improved seismic detailing. The vertical setback at the 14th floor of building R2 created a stiffness discontinuity that exacerbated exterior wall damage, highlighting how architectural features can amplify seismic vulnerability. Overall, damage was especially prominent at the interface between infill walls and structural elements, indicating deformation incompatibility, stress concentrations and insufficient detailing at these junctions. Typical damage to infill walls is shown in Figure 18.

Figure 18: Photos showing typical damage observed in infill walls

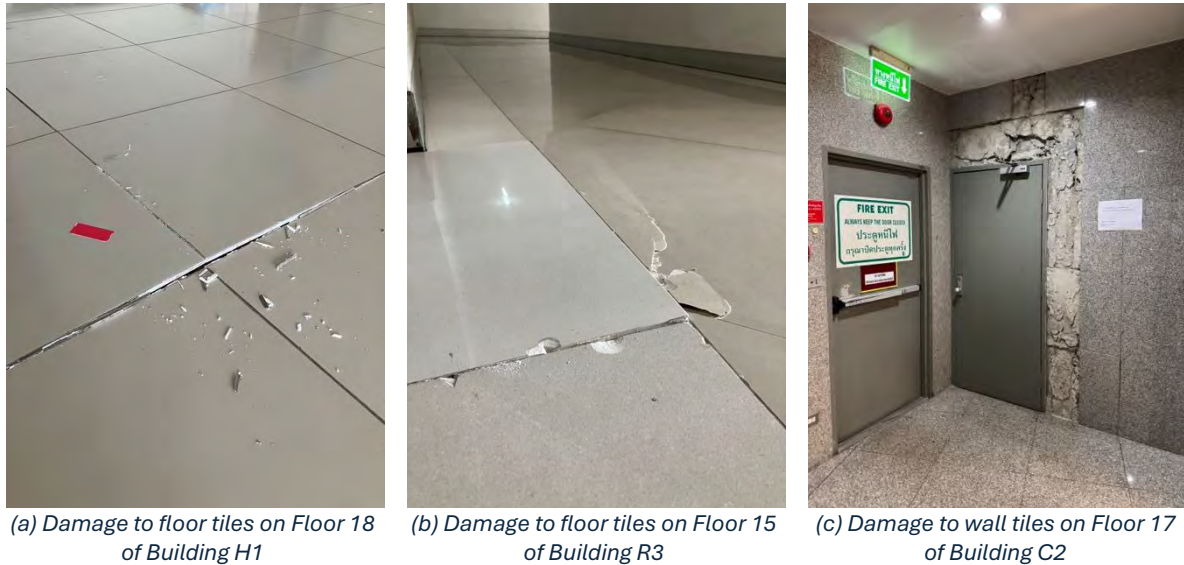
greater tile damage, likely due, local deformation or differential movement between structural elements and finishes. In buildings C2 and C3, granite tiles detached and fell, posing potential safety hazards. It is a possible indication of poor anchorage or bonding of the tiles to the substrate.

Figure 21: Typical damage observed to floor and wall tiles

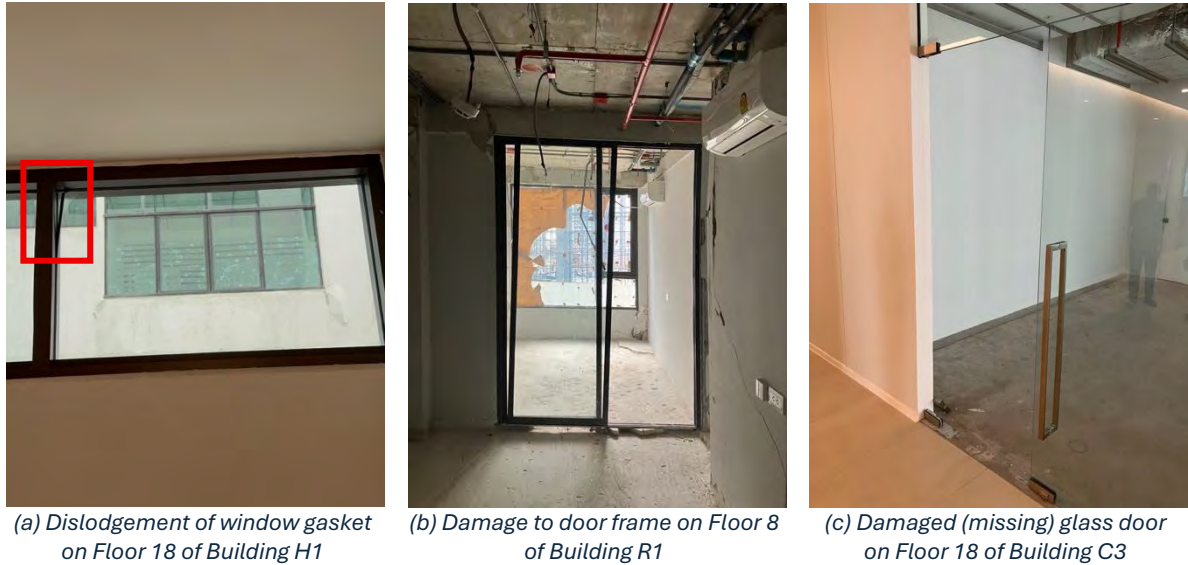
Jammed doors (in building R1) and damaged glass door (in building C3) lateral deformation in buildings. Moreover, 70% of the 10 inspected buildings, spanning residential, commercial, and hospital occupancies, experienced at least one lift becoming non-operational following the earthquake. This recurring issue suggests that lift systems may be particularly vulnerable to seismic shaking, even in cases where structural damage was minimal. Typical damage to door frames and glass doors is shown in Figure 22.

Figure 22: Photos of typical damage to doors and windows

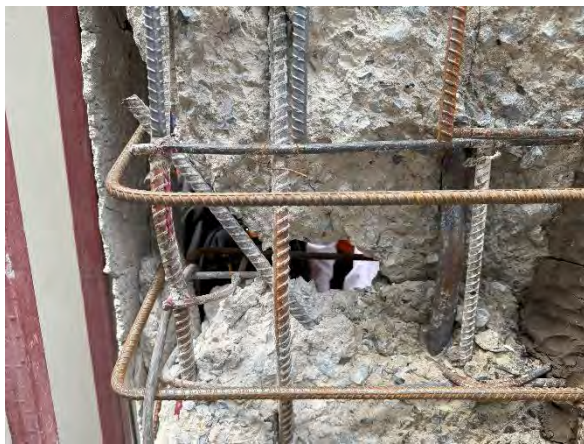
(g) Damage to wall on gridline Y9 the perimeter (next to stair)

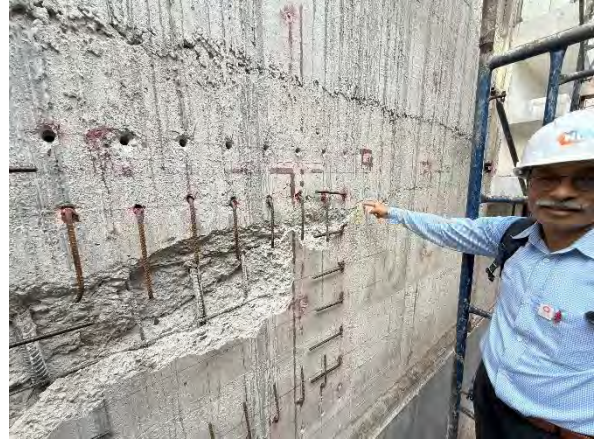
*(j) Damage along cold joint*

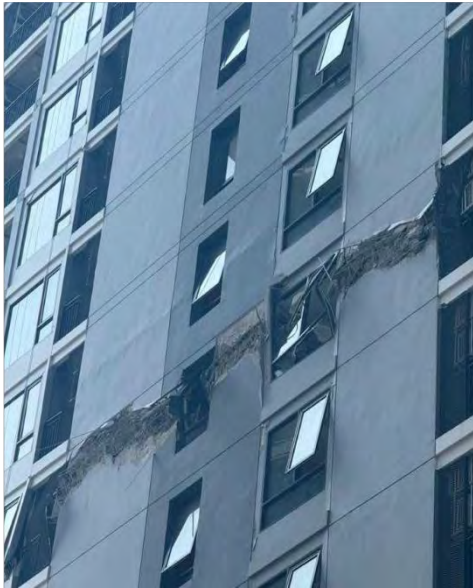
(c) Wall damage on 9<sup>th</sup> floor

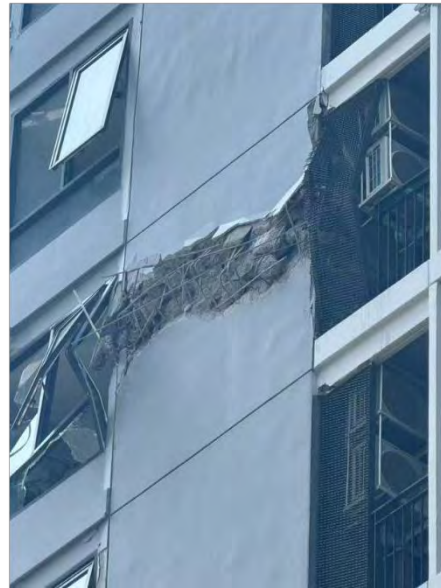
(d) Wall damage on 9<sup>th</sup> floor

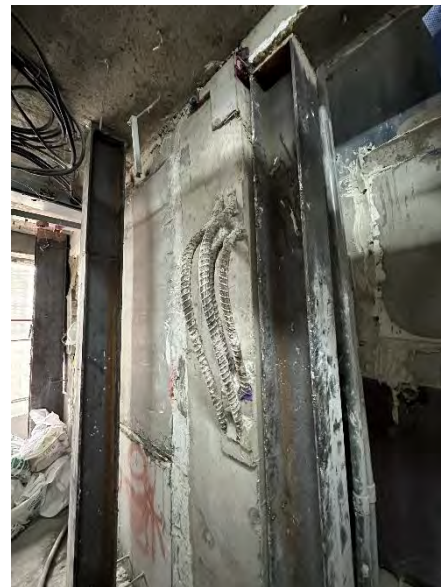
(d) Buckled bars left exposed, 9<sup>th</sup> floor

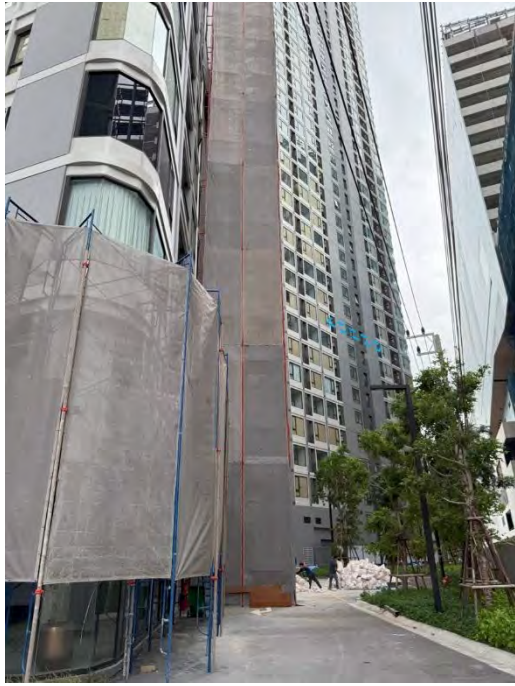
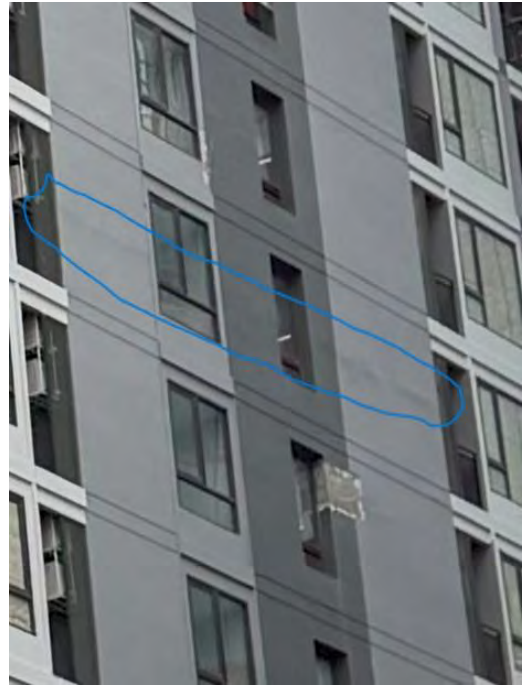
| Special note | <p>At least one adjacent building has the following potential damage:</p> <ul style="list-style-type: none"> <li>• Onset of buckling of rebars of the external wall at level 9 along the staircase and lift core. Buckling of rebars is indicated by the rippling of the concrete surface as visible from the driveway. Spalling of concrete not seen.</li> </ul> |

Figure 34: Potential damage to the adjacent building to Building R1

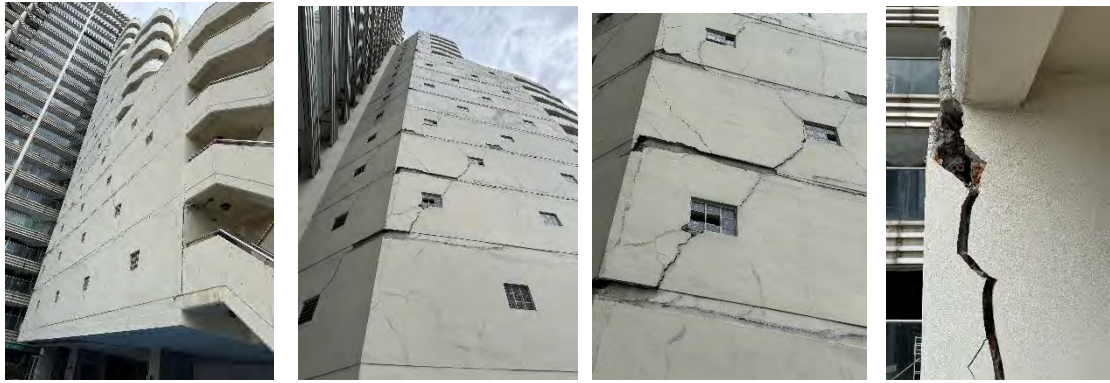
(a) Damage to exterior clay brick wall as seen from outside

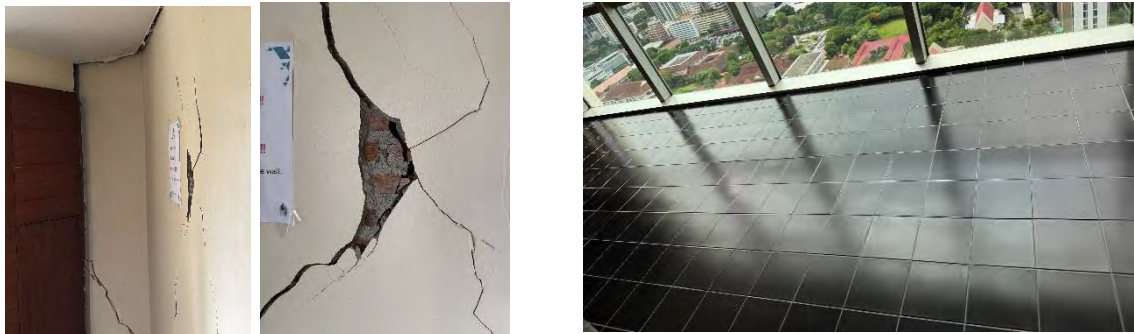
(b) Damage to exterior clay brick wall as seen from inside (storey 26)

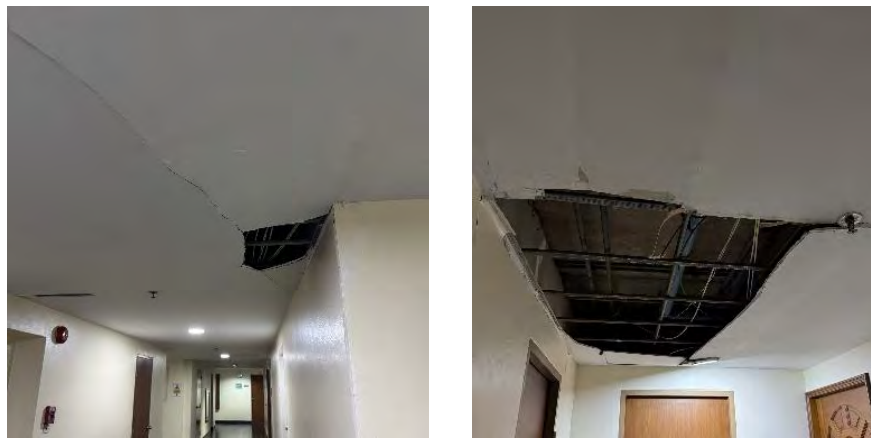
(d) Damage to plasterboard ceiling (storey 18)

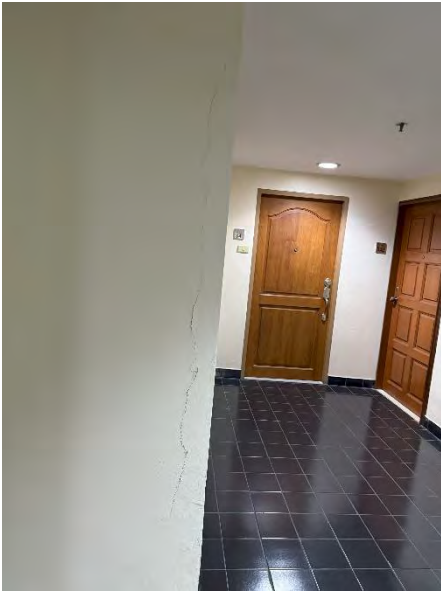
*(e) Cracking to non-structural wall junction*

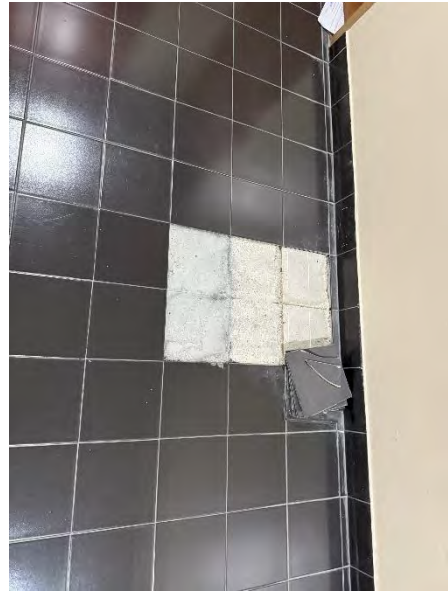
*(f) Tile spalling*

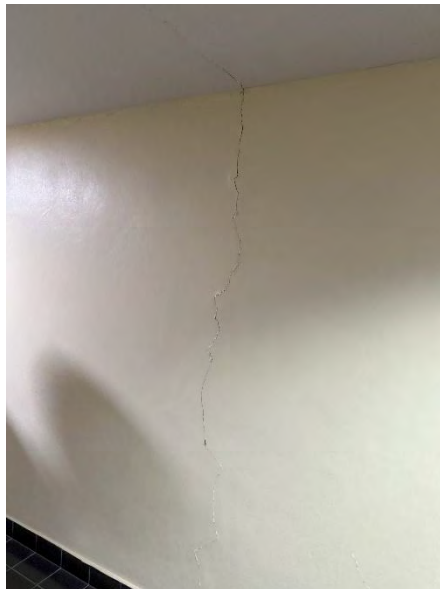
*(g) Cracking to wall and ceiling*

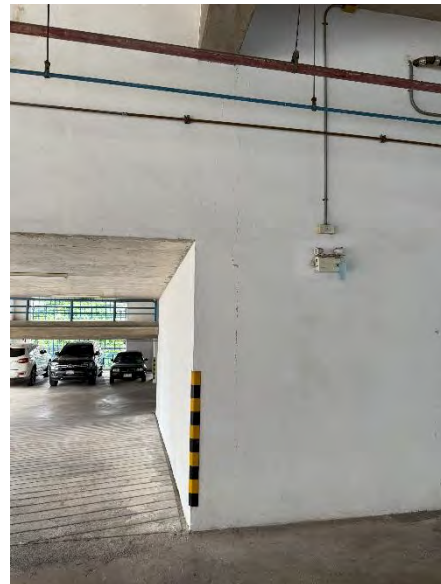
(h) Cracking at the interface of the structural and non-structural wall

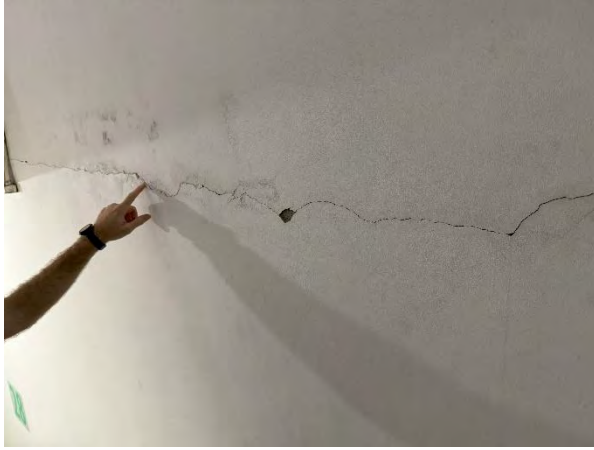
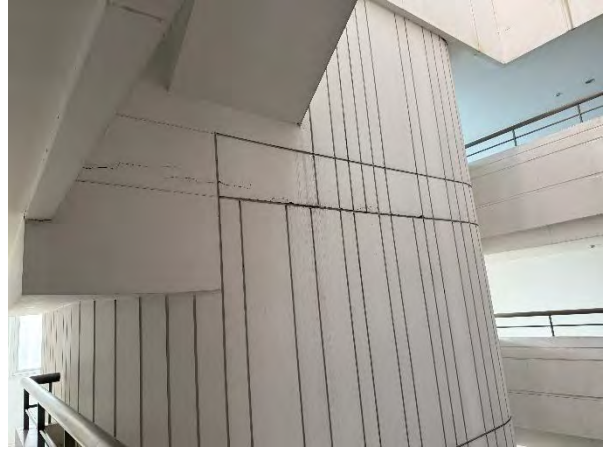
*Figure 40: Damage at the interface of floor slab and non-structural walls (Level 28) in Building R3*

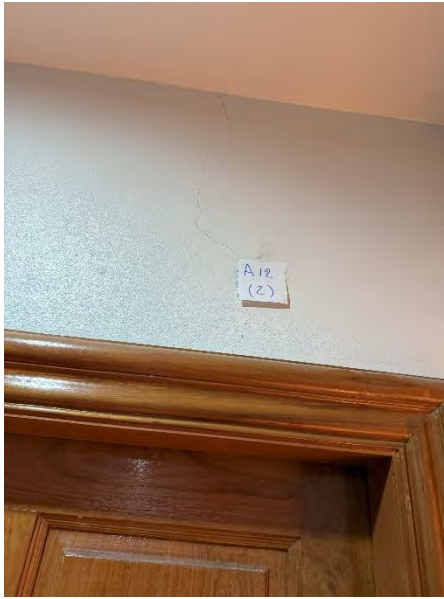
*Figure 42: Cracking to non-structural wall in Building R4.*

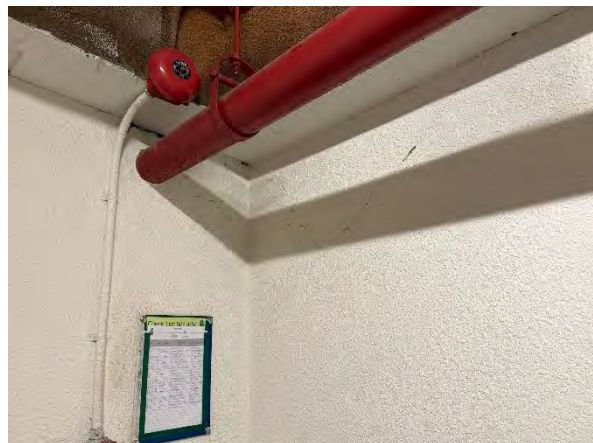
(b) Close-up of damage to infill wall

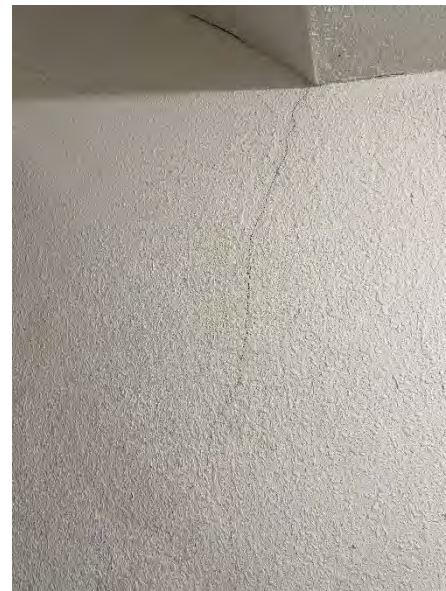
(h) Cracking damage at the interface of infill and structural wall.

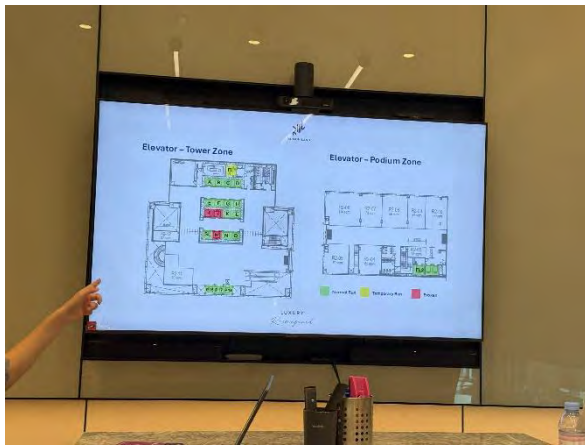
(g) Non-functioning lifts

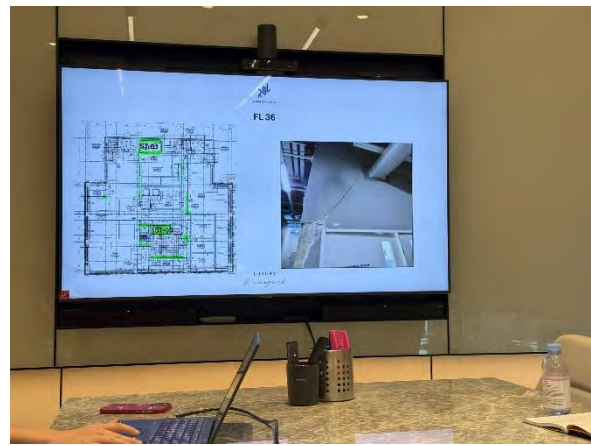
(h) Non-structural damage to various areas of Floor 36
