Repair and reinstatement of earthquake damaged houses -Derivation of repair techniques

STUDY REPORT No. 100 (2001)

Repair and Reinstatement of Earthquake Damaged Houses – Derivation of Repair Techniques

BRANZ Study Report SR 100 (2001)

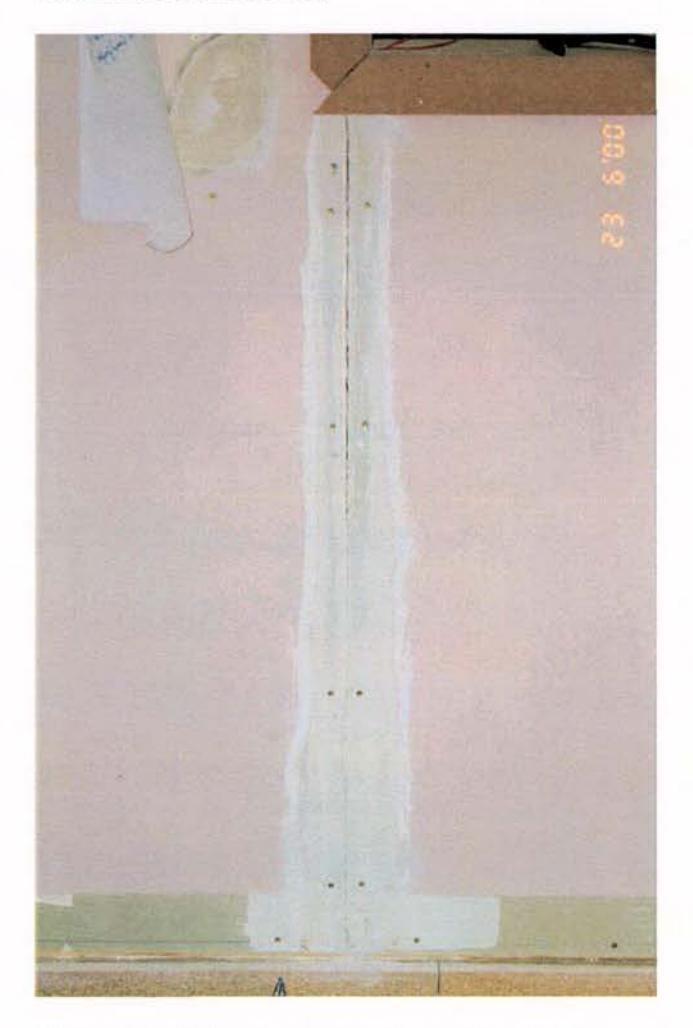
Cycling continued to $\pm 10 \text{ mm}$ and $\pm 15 \text{ mm}$ (3 cycles each). During these cycles the gypsum plasterboard joint adjacent to the window opening on the painted side sheared up to 11 mm and the remaining tape at the bottom of the joint tore. On the opposite side the wallpaper sheared with the joint and repair would require removal of the wallpaper and re-stopping. In accordance with the manufacturer's advice, the plaster surface was scraped back to the paper tape and the tape removed (Figure 7). Then the plaster beneath the tape was slightly V-ed without damaging the paper surface of the board. The joint was then stopped in the normal manner. Extra nails were installed along the edge of the sheets (Figure 7) at the joint adjacent to the damaged ones and the bottom edge of the plasterboard sheets was nailed at 300 mm centres once the skirting board had been removed.

Figure 7: Painted gypsum plasterboard joint prepared for stopping after 15 mm displacement cycles

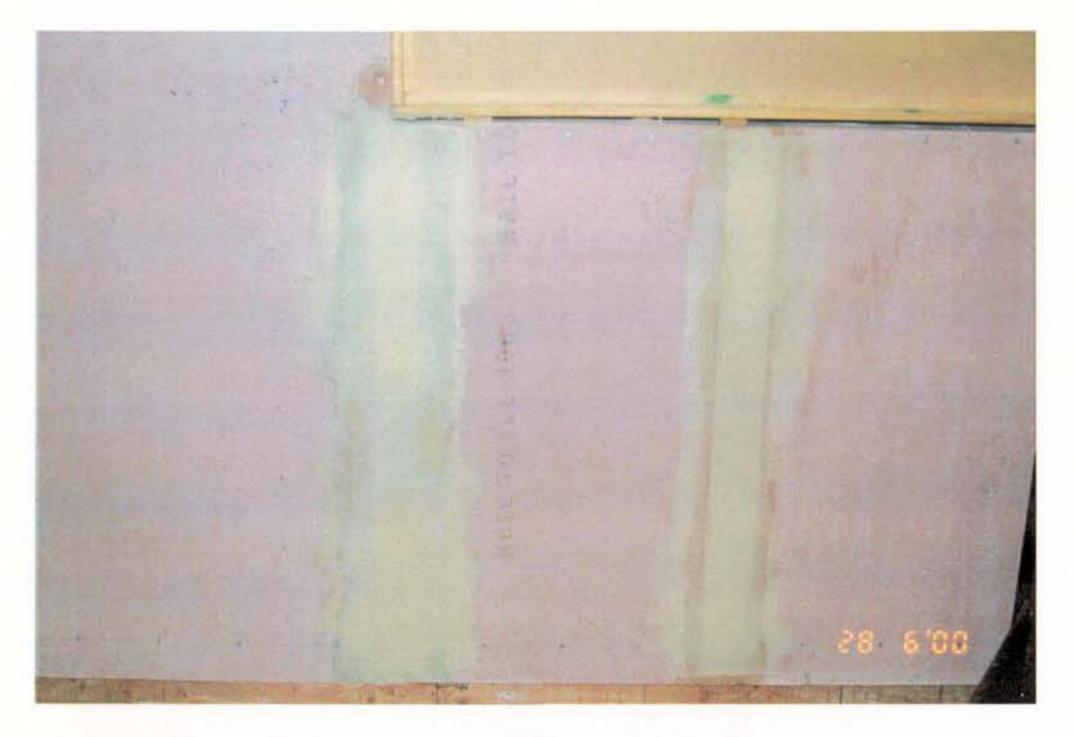
Figure 8: Repaired fibre cement board joints on left side

The left side joint was ground back to original sheet face and the joint V-ed out. The repair involved the application of a water-based primer and then filling with joint filler 3 (Figure 8).

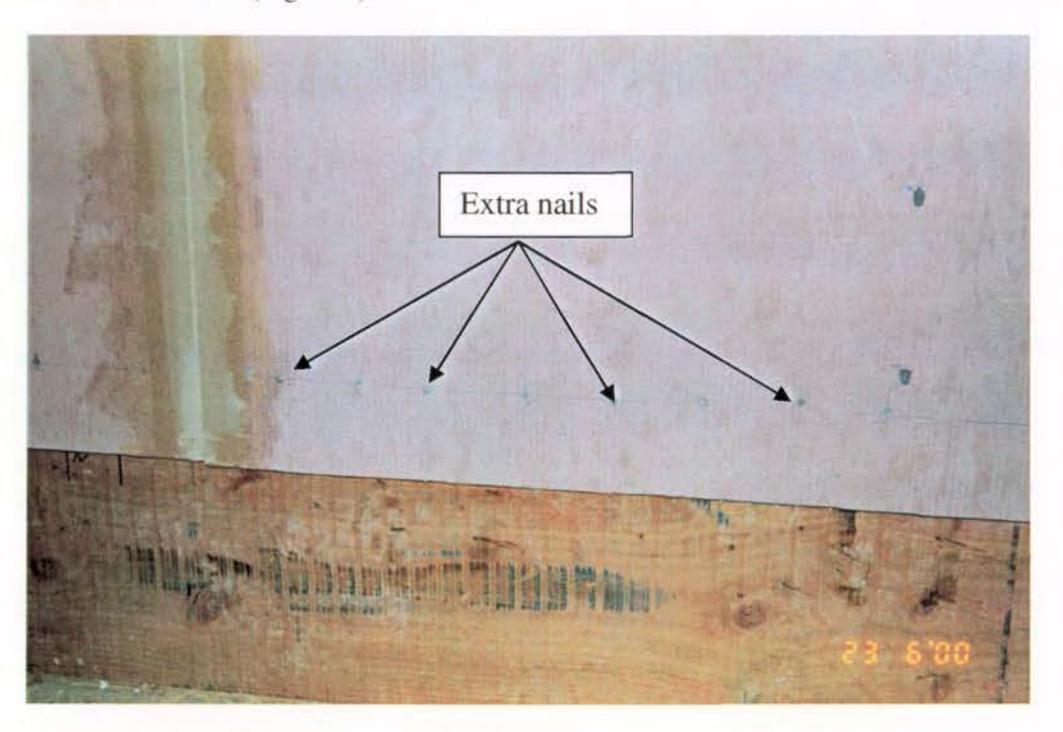
Figure 9: Extra nails added at bottom plate

When the old filler was removed nails were added to the sheet at the joint. An extra nail was added at each gap between the existing nails. Also, the top and bottom corners of the 2.4m long "bracing panel" were nailed to the plates with an extra nail between each of the first four nails in the horizontal row (Figure 9).

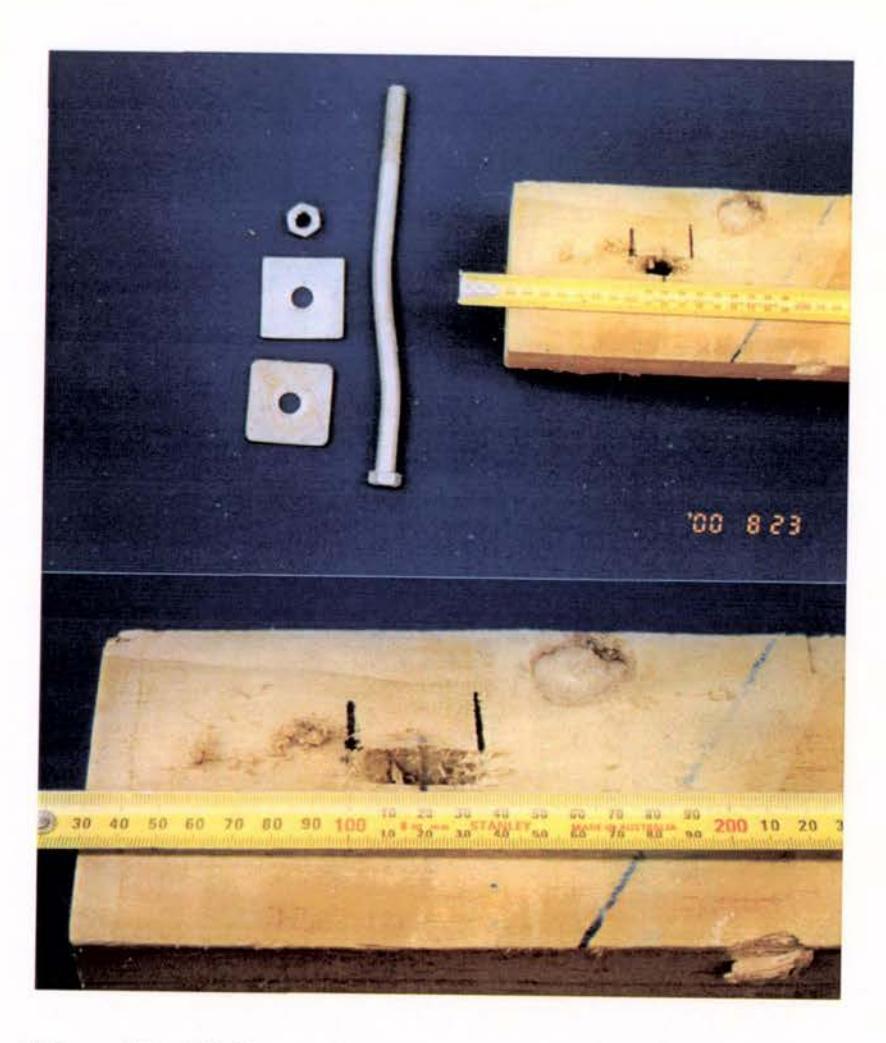
When the bolts were finally removed, there was a large slot in the timber of both members (particularly the brace) and the bolt was significantly bent (Figure 14).

Figure 14: Pile brace after removal showing bent bolt and slot in brace

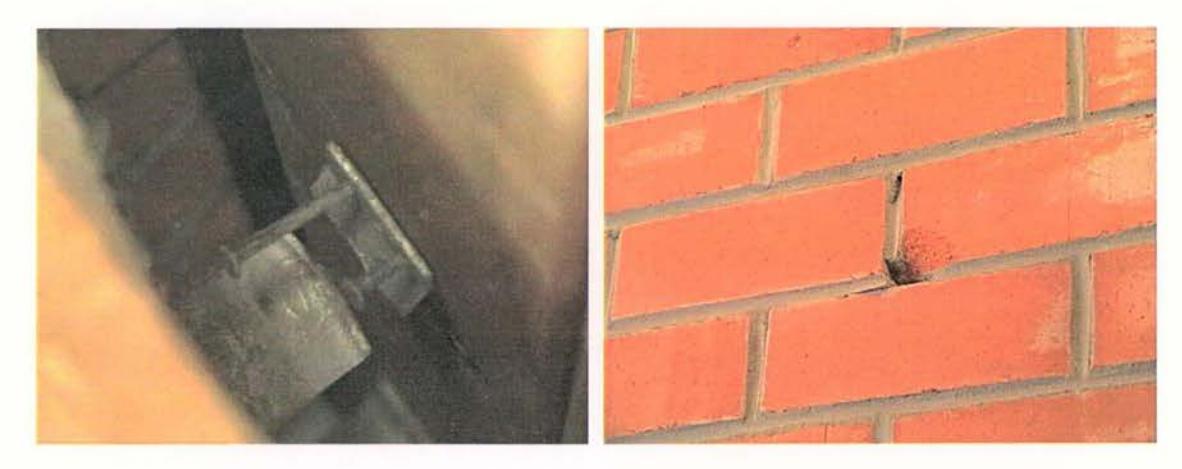
Figure 23: Nails pulled from frame and tie broken

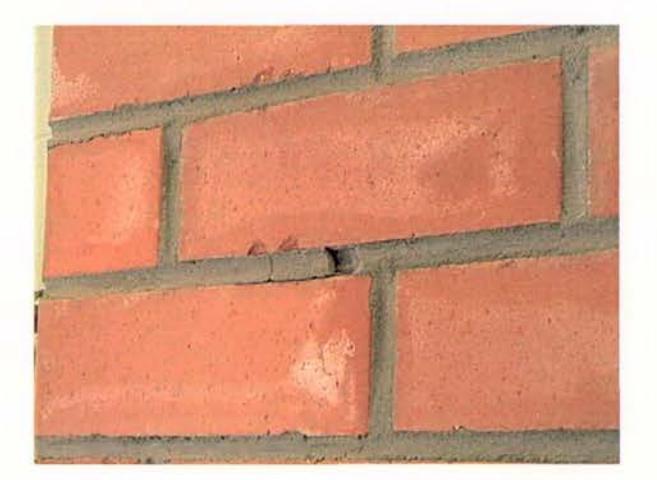
Figure 25: Section of mortar punched out by tie

The plasterboard was re-nailed to the studs at positions 50 mm away from the original nail positions and the tape was replaced at the corner junction. The wall was re-stopped.

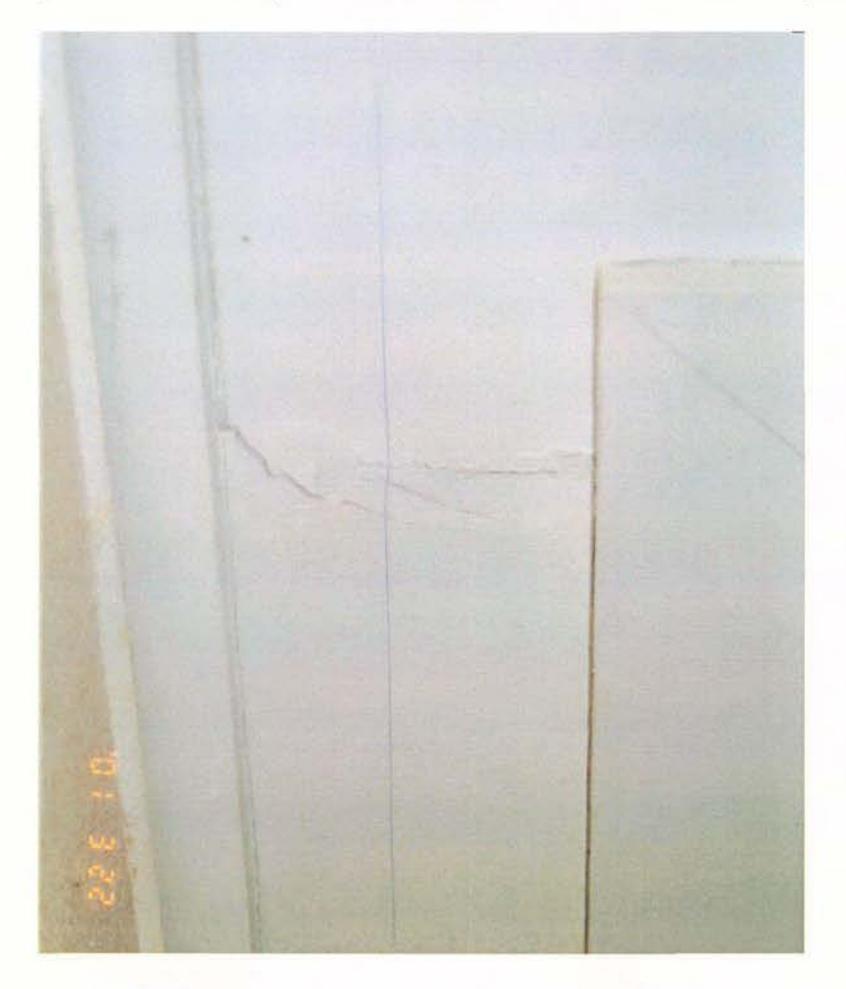
In the hallway, cracking was evident in the ceiling lining adjacent to the manhole to the roof space, where a stress concentration was occurring (Figure 30). The loaded wall was showing signs of minor distress. The wallpaper was concertinaing on vertical lines above the top corners of doorways (Figure 31) where joints in the lining were forcing together and the skirting boards were lifting (Figure 32) and slipping horizontally along the floor a small amount. When the loading direction was reversed, the concertinaed wallpaper straightened out and then tore under tension load as the lining joint opened. The skirting board also returned to its original position in contact with the floor boards. A hole was cut in the lining near to the bottom plate at the ends of the two wall panels so that the state of the nails securing the bottom plate to the floor could be established. It was discovered that the nails had remained firmly embedded in the bottom plate and were being extracted and then re-driven into the flooring as the cycling progressed.

Figure 30: Upper storey ceiling damage at the edge of the roof space access hole

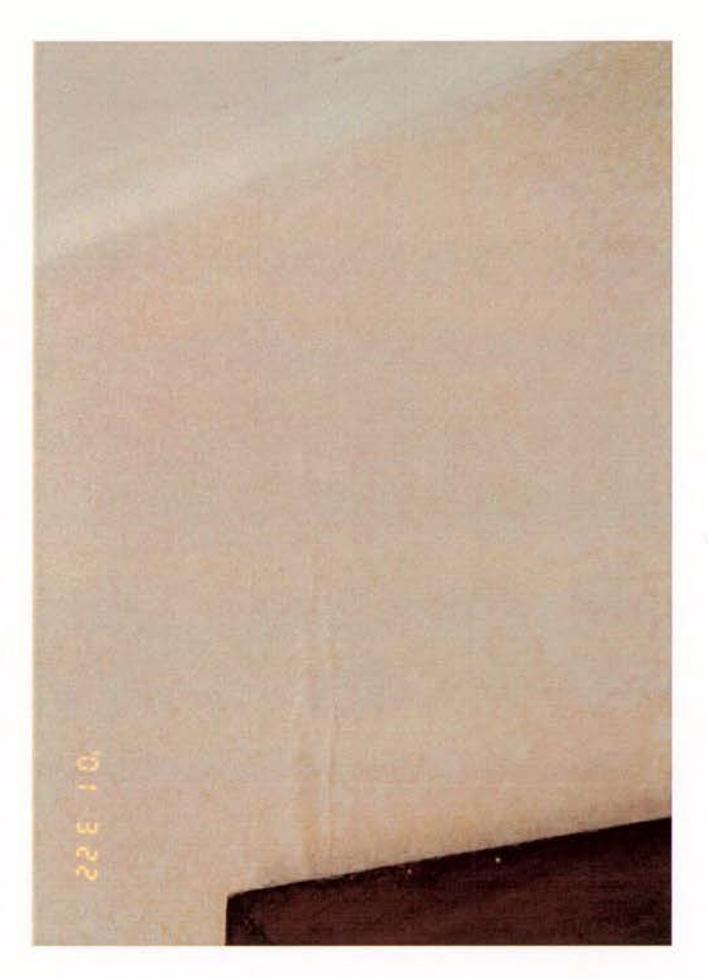
Figure 31: Wallpaper concertinaing under racking load

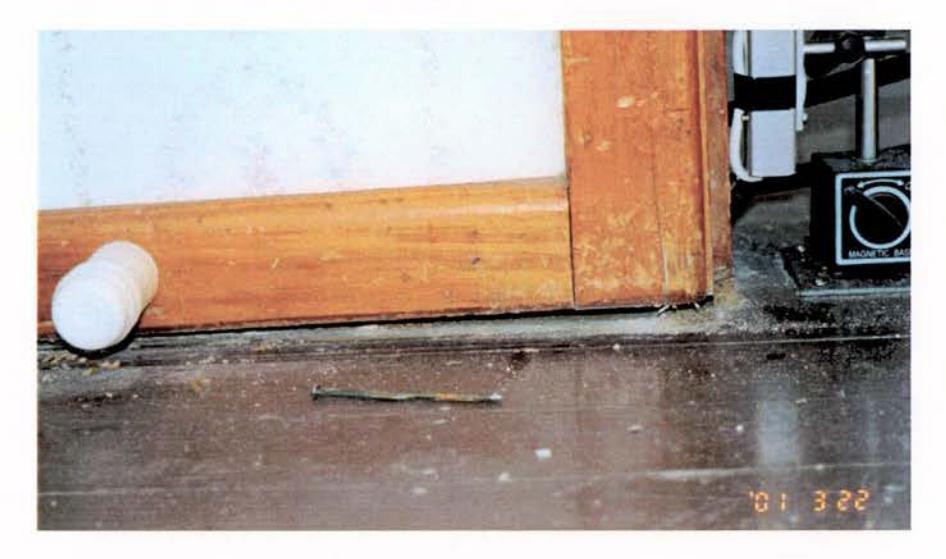
Figure 32: Upper floor skirting board lifting

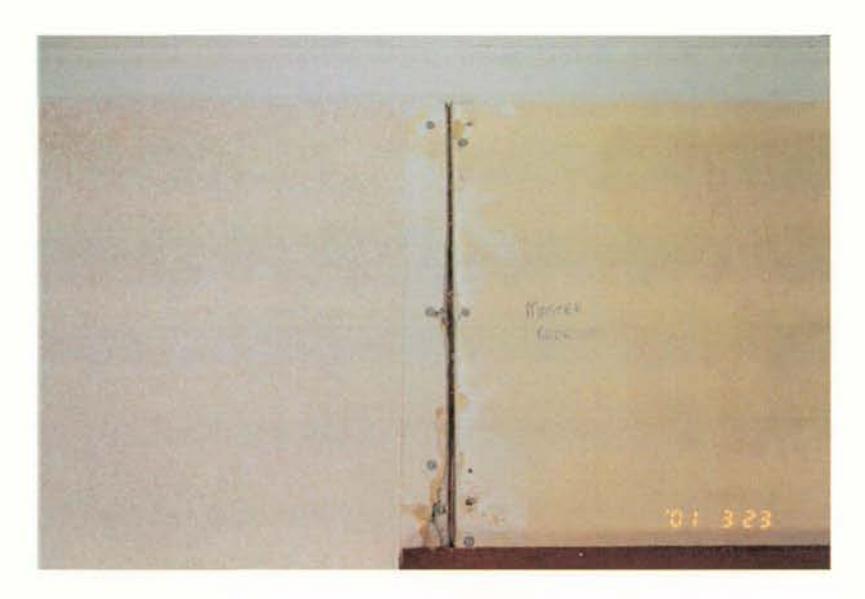
Figure 33: Prepared gypsum plasterboard joint ready for re-stopping

The damage to the wall elements appeared to be mainly cosmetic. There was a 100 mm x 25 mm diagonal brace in the larger of the two elements and this appeared to have sufficient strength to resist the applied load. Because the damage was cosmetic, simple repairs were undertaken. The damaged joints between the gypsum plasterboard sheets were V-ed out, the edges of the sheets were re-nailed with 30 mm x 2.5 mm galvanised clouts at 150 mm centres (Figure 33) and then the joint was re-stopped with paper tape reinforcement included.

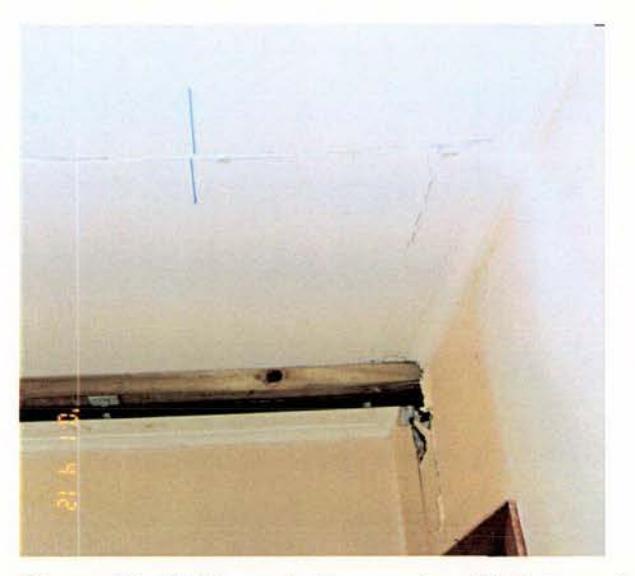
During these cycles a definite misalignment had occurred across the saw cut made in both the lounge and the kitchen ceilings and a stopped joint adjacent to the transverse hallway wall was beginning to open (Figure 38). Bottom plate uplifts and horizontal slippage were negligible.

Figure 38: Ceiling misalignment and joint opening

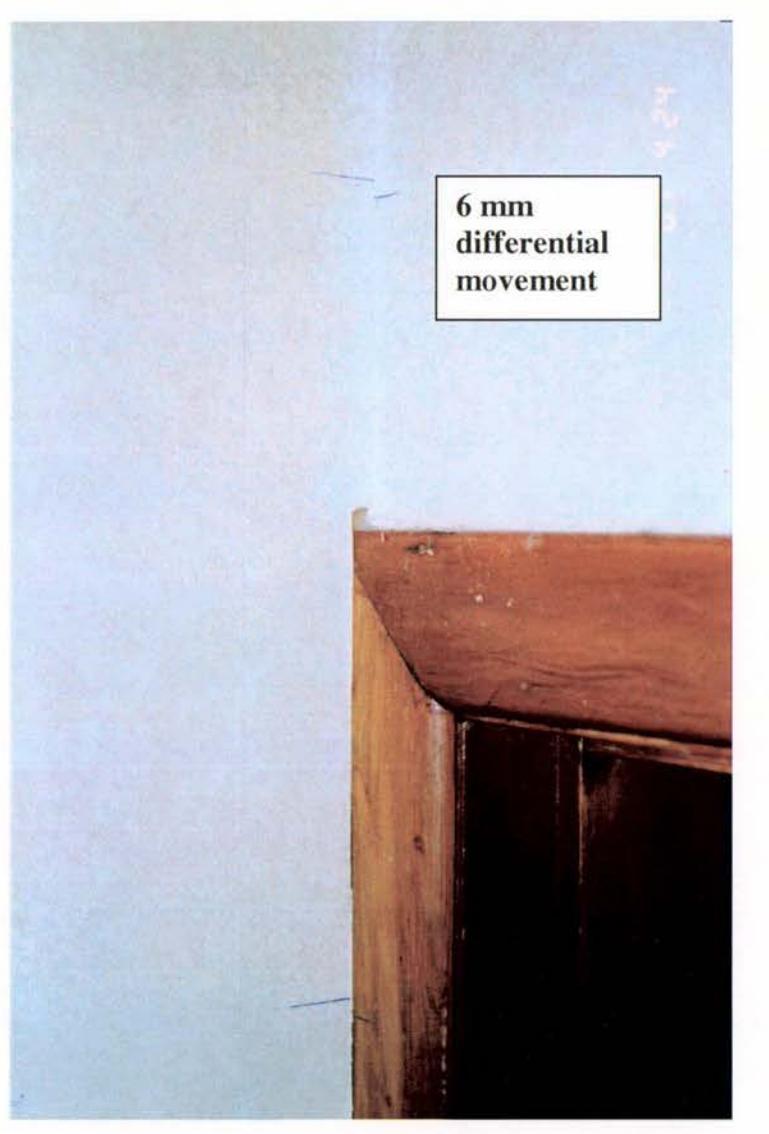
Figure 40: Differential movement between the test wall and the transverse hall wall

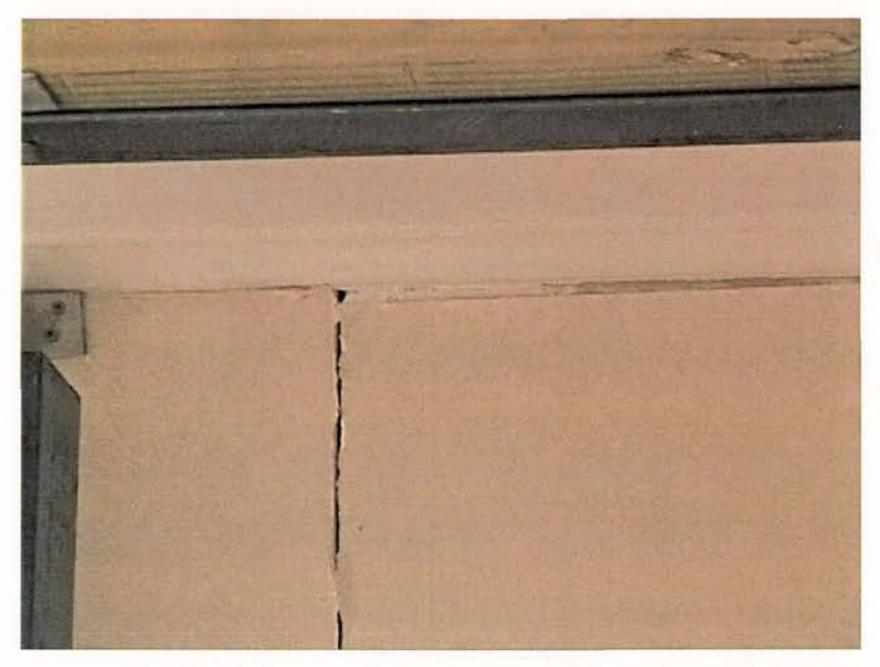
Sheet damage was limited to around the perimeter of the individual sheets and could be repaired by removal of the skirting boards and scotias and re-nailing and re-stopping. Replacement of the sheets would not be necessary.

Figure 43: Shear slippage between lining sheets in lounge

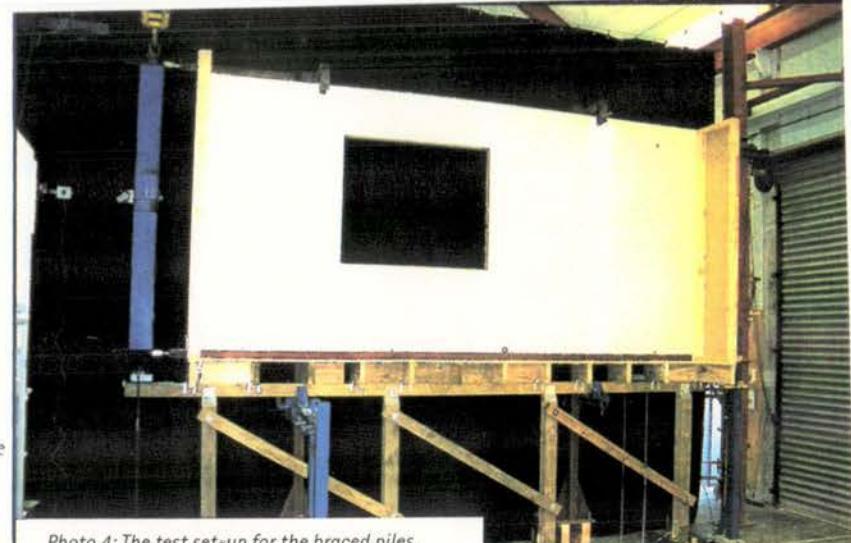
Photo 4: The test set-up for the braced piles. The most serious damage was not visible until the pile joints were dismantled.
