**Vulnerability analysis of unreinforced masonry  
churches (EQC 14/660) - Final Report**

**GNS Science Report 2016/53  
June 2016**

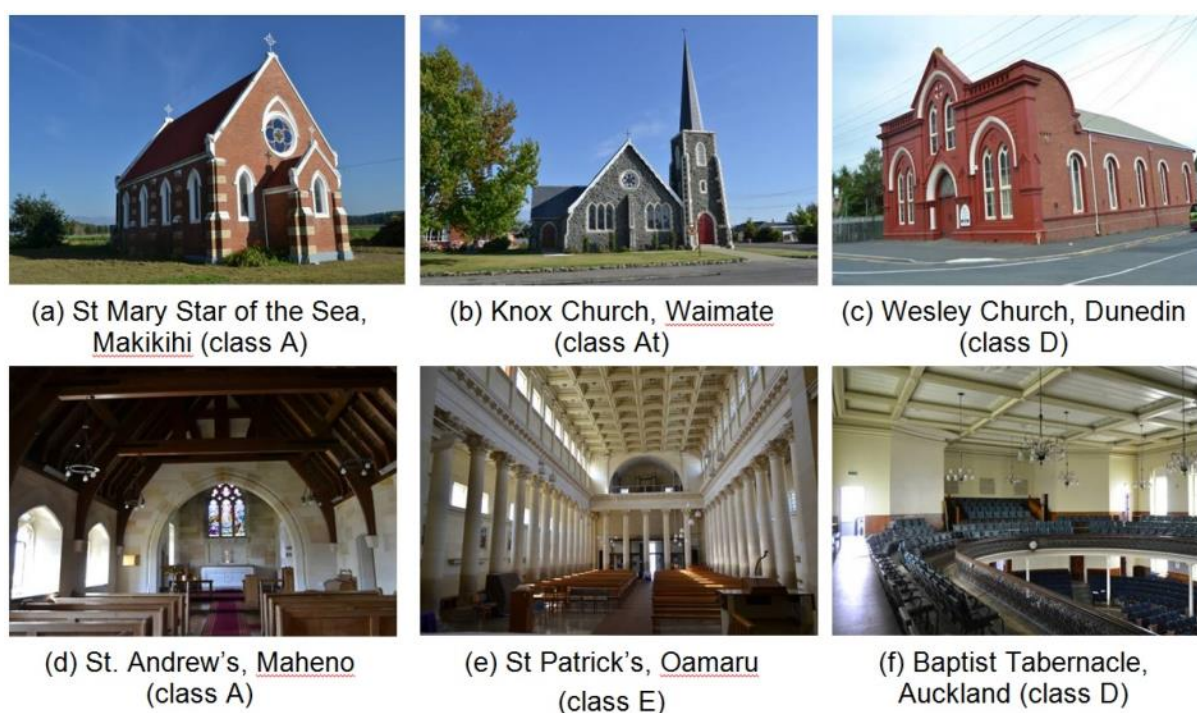
**Figure 4.2** Examples of different URM churches typologies in New Zealand.

According to the typology classification of URM churches in New Zealand into six types shown in Figure 4.1, examples of churches from different typologies are shown in Figure 4.2.

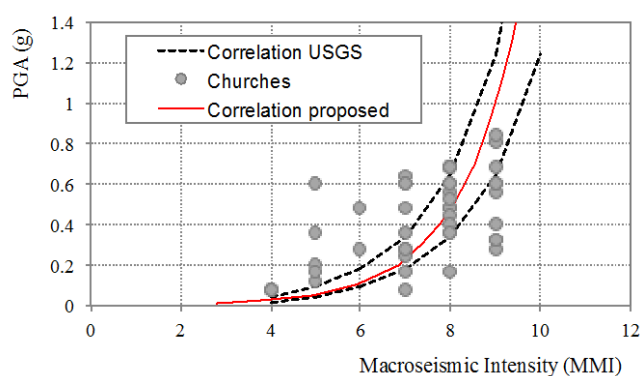
**Figure 4.12** Correlations between Intensity and PGA; a) USGS Shakesmaps (USGS, 2011); b) This study (modified from Figure 4.9).

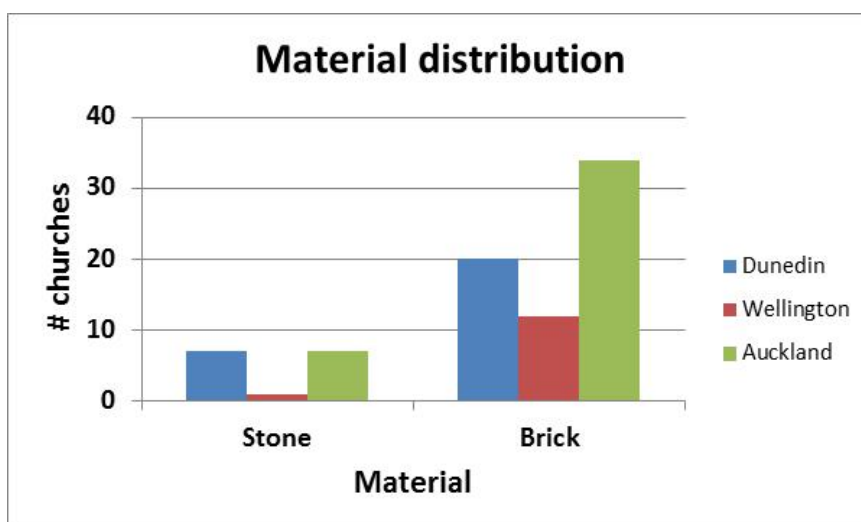
Once the vulnerability index method was specifically developed for New Zealand URM churches (see Section 4.5 and Appendix 5), it was tested on churches in three cities, chosen for their different seismic activities: high (Wellington, 13 churches), intermediate (Dunedin, 27 churches) and low (Auckland, 41 churches). Seismic scenarios have been developed for all the URM churches in these 3 cities where data was collected (a total of 81 churches, Table 4.2). Most of the churches are made of brick (66) and only 15 churches are made of stone (Figure 4.30).

**Figure 4.30** Material distribution for the URM churches in Dunedin, Wellington and Auckland.

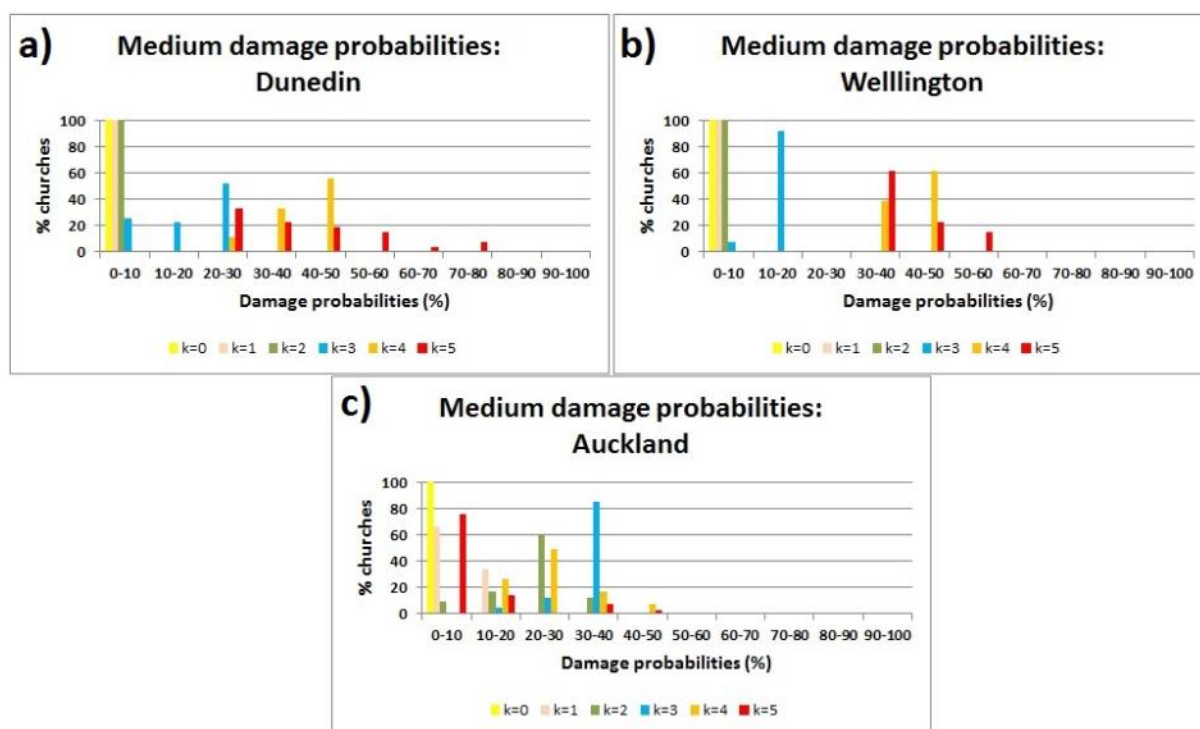
Figure 4.32 show the medium damage probabilities distribution for the Dunedin, Wellington and Auckland URM churches. If the medium damage probabilities are considered, it can be seen that for Dunedin churches, 52% will have 20–30% probabilities of having moderate damage (grade 3), and the majority of them (88%) will have a 30–50% probability of having heavy damage (damage grade 4), and. About 25% of the Dunedin churches could have 50 to 80% probabilities of suffering total collapse (damage grade 5) if the Akatore fault should rupture.

For the Auckland churches (Figure 4.32c), the probabilities of higher damage are lower than for the Dunedin and Wellington churches, being the highest probability of 30–40%, corresponding to moderate damage. About 50% of the churches might suffer heavy damage with a 20–30% probability. In addition, the probability of collapse is very low for the Auckland churches, with 75% of them showing a very low probability (less than 10%) of suffering collapse.

**Figure 4.32** Distribution of medium damage probabilities obtained for Dunedin (a), Wellington (b) and Auckland (c) URM churches. Total number of URM churches in Dunedin = 27; Wellington = 13 and in Auckland = 41.

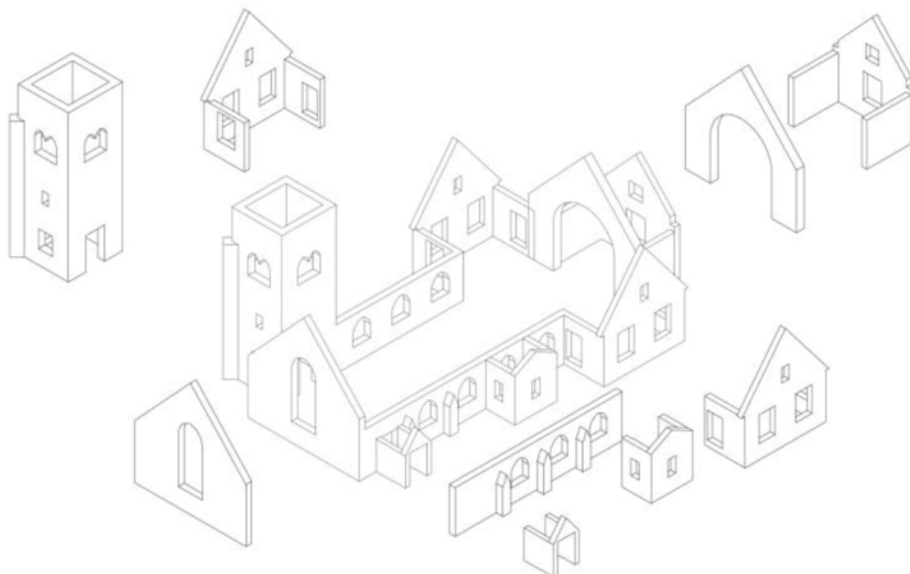
macroelements are defined (step 3), paying attention to the direction of the response. In fact according to the direction of analysis, a macroelement can exhibit different seismic response. For example, for the central nave the “Rocking of multi macro blocks kinematics” (number 4 of Table A3.2) longitudinally refers to response of the colonnade, in the case of a church with a nave and side aisles; while, transversely, concerns the overturning of the lateral walls.

**Figure A3.1** Composition of the church in the macroelements.

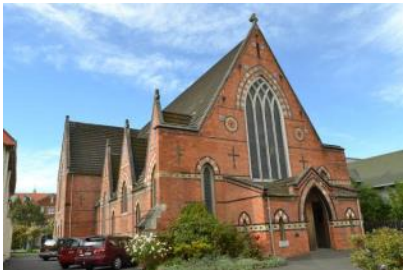
<b>At</b> <ul style="list-style-type: none"> <li>- Longitudinal plan</li> <li>- One nave</li> <li>- Transept</li> <li>- Buttresses</li> <li>- Sloping roof</li> </ul>

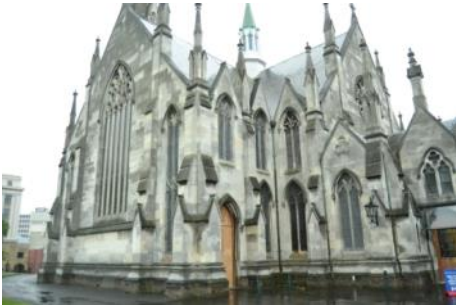
<b>C</b> <ul style="list-style-type: none"> <li>- Central Plan</li> </ul>

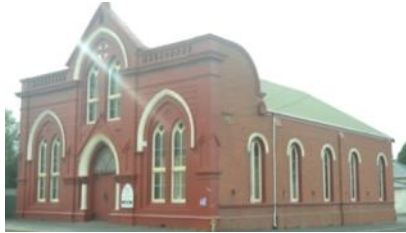
<p>D</p> <ul style="list-style-type: none"> <li>- "Box-type" behaviour</li> <li>- Large hall without internal walls</li> <li>- Façade and perimetral walls as a building</li> </ul>

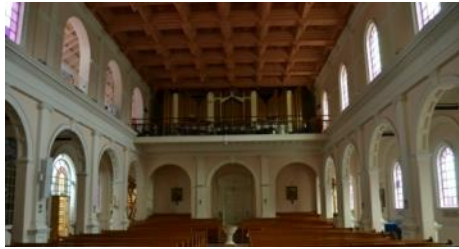
<p>E</p> <ul style="list-style-type: none"> <li>- Catholic Basilica</li> </ul>
