**Behaviour of Reinforced Concrete Interior Beam-Column Joints
Designed Using High Strength Concrete and Steel**

*Xian Zuo Xin, supervised by R Park and H Tanaka, Department of
Civil Engineering, University of Canterbury*

July 1992

**A Research Report Based on the
Master of Engineering (Civil) Thesis**

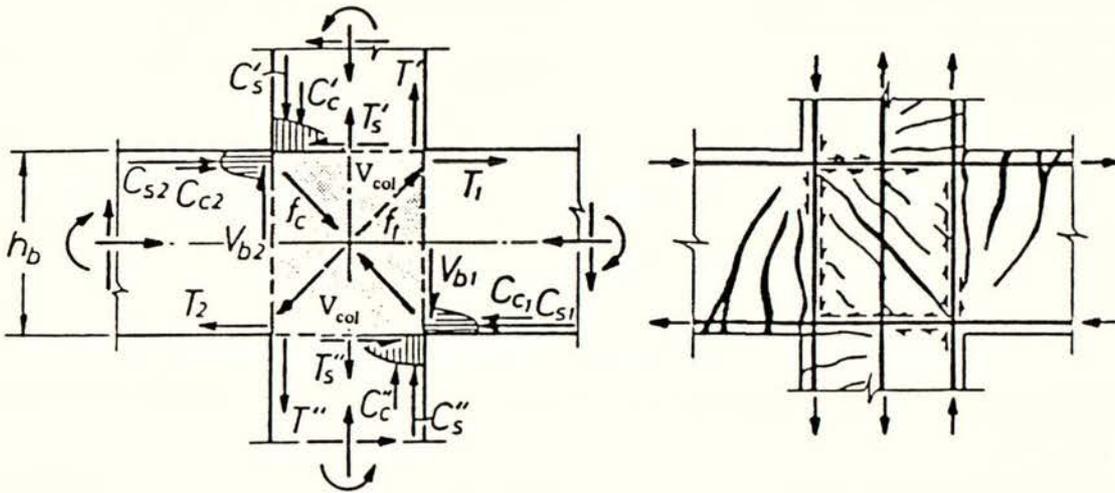
Fig.1.1 Internal forces on an interior beam-column joint core

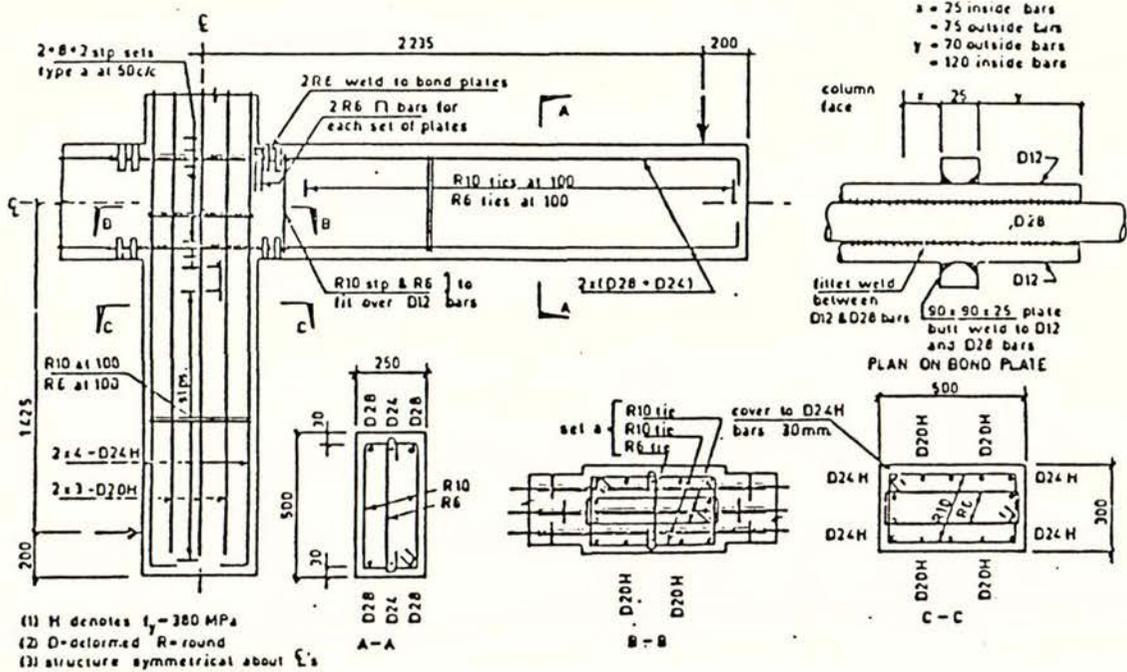
Fig.1.2 Joint with steel bond plates [16]

Over the last ten years, some test programmes [15, 16,17] (See Fig.1.2 and 1.3) have been conducted in New Zealand, which attempted to look for new effective construction techniques to reduce the content of joint core shear reinforcement, and to improve the bond condition in the joint region, have been conducted in New Zealand.

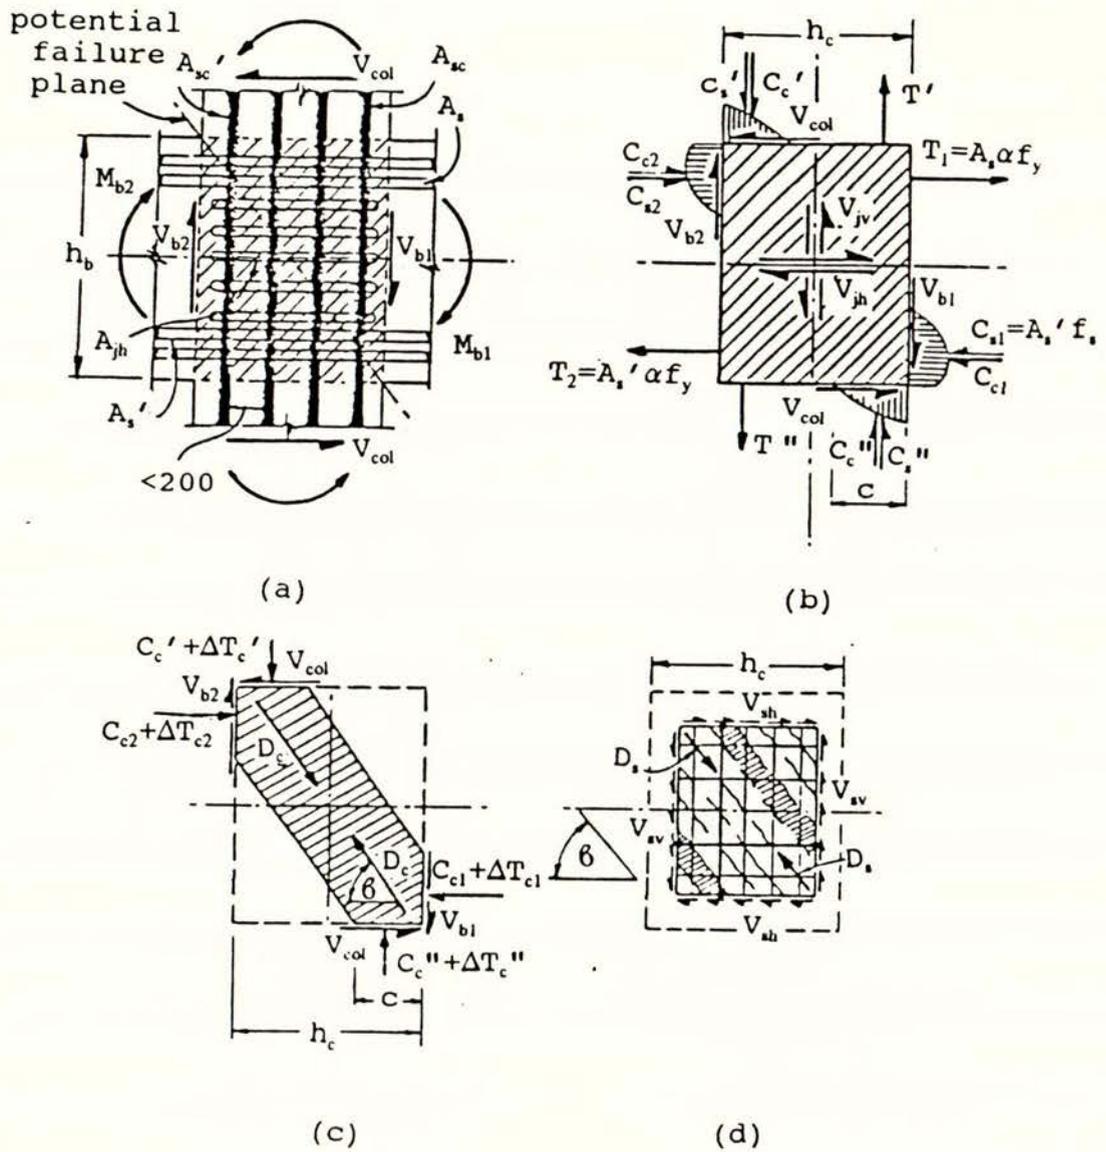
Fig. 2.4 Principal mechanisms of shear resistance of an inelastic interior joint core [3]

The current provisions of the New Zealand concrete design code [12] for the design of joints for shear resistance is based on strut and truss mechanisms (See Fig. 2.4) proposed by Park and Paulay. The strut mechanism has a diagonal compression strut acting along the diagonal of the joint panel as the resultant of concrete compression and shear forces around the joint (See Fig. 2.4(c)). The truss mechanism is made up by the bond force of the vertical and horizontal reinforcement and forces in the corner regions of the joint (See Fig. 2.5(d)).

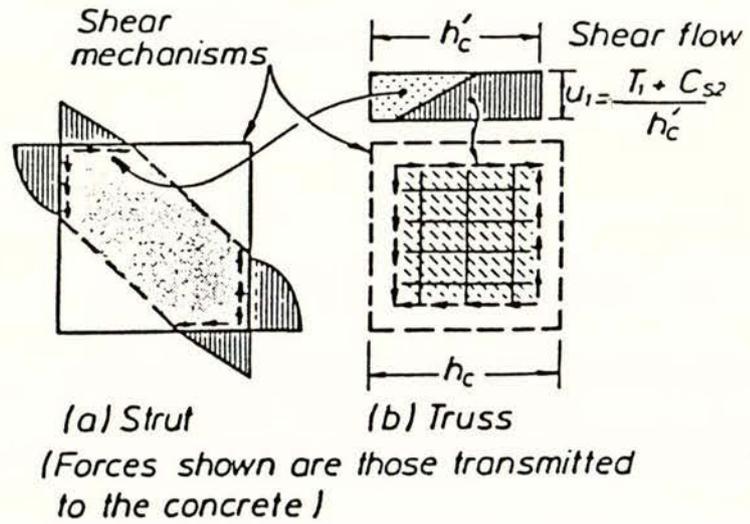
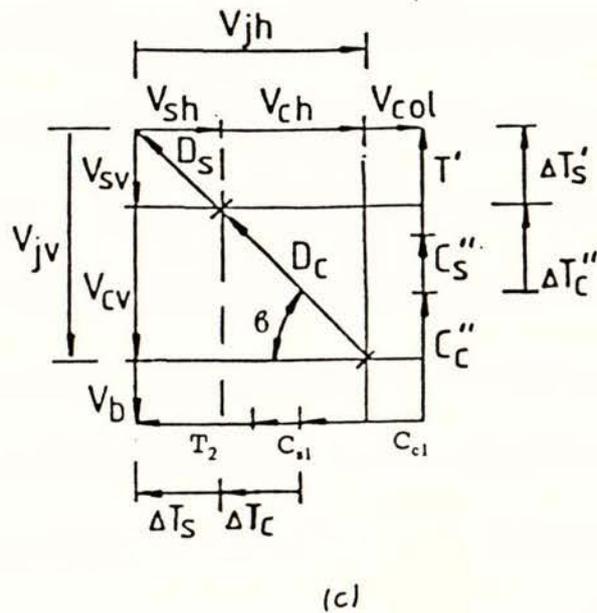
Fig. 2.6 Bond and shear mechanisms in a joint core in the elastic range [14,22]

If the conditions in the joint core when yielding of the top beam bar first occurs are considered, a vector diagram of forces may be constructed as illustrated in Fig. 2.6(c). At this stage it is assumed that stress distribution in the top beam bars as they pass through the joint core, is linear and thus the bond stress, given by the rate of change of the steel stress, is constant as shown in Fig. 2.5(c). It is evident in Fig. 2.6 that the diagonal compression strut is maintained by that portion of the bond force previously defined as ΔT_c together with the concrete compression forces and column shear force in the horizontal direction and similar column internal forces in the vertical direction. Evidently the truss mechanism V_{sh} does not resist the entire joint shear force V_{jh} . Only the parts of the beam and column bar bond forces not utilised here will need to be maintained by the truss mechanism (See Fig. 2.4(d)).

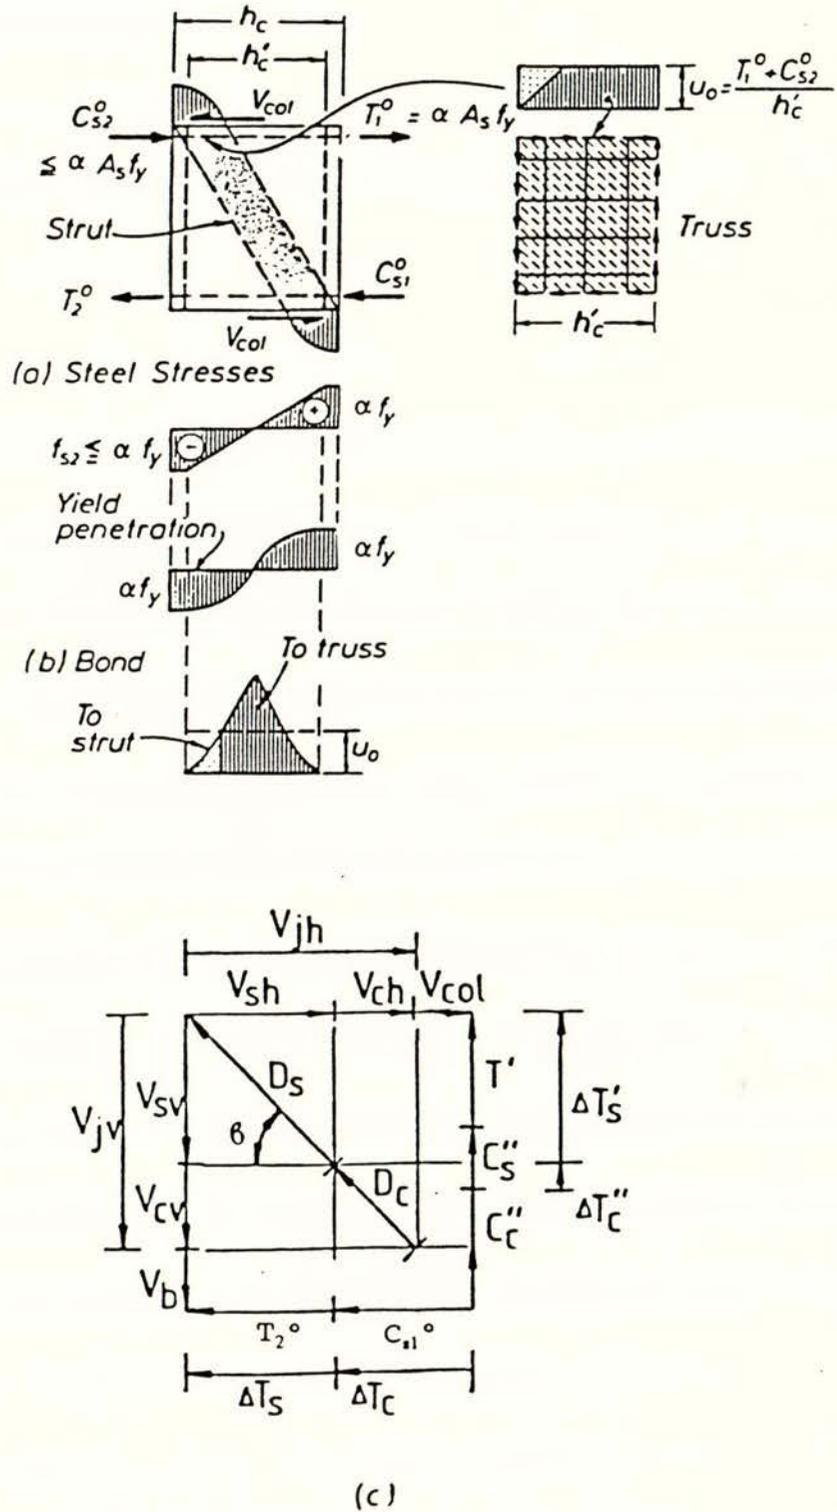
Fig. 2.7 Bond and shear mechanisms in a joint core in the inelastic range assuming perfect bond and strain hardening of beam bars [14,22]

Fig. 2.7(a and b) illustrate the steel and bond stresses and bond after significant yield penetration and strain hardening. The truss mechanism resists nearly the total input horizontal shear force. In other words, the horizontal shear resistance of the concrete

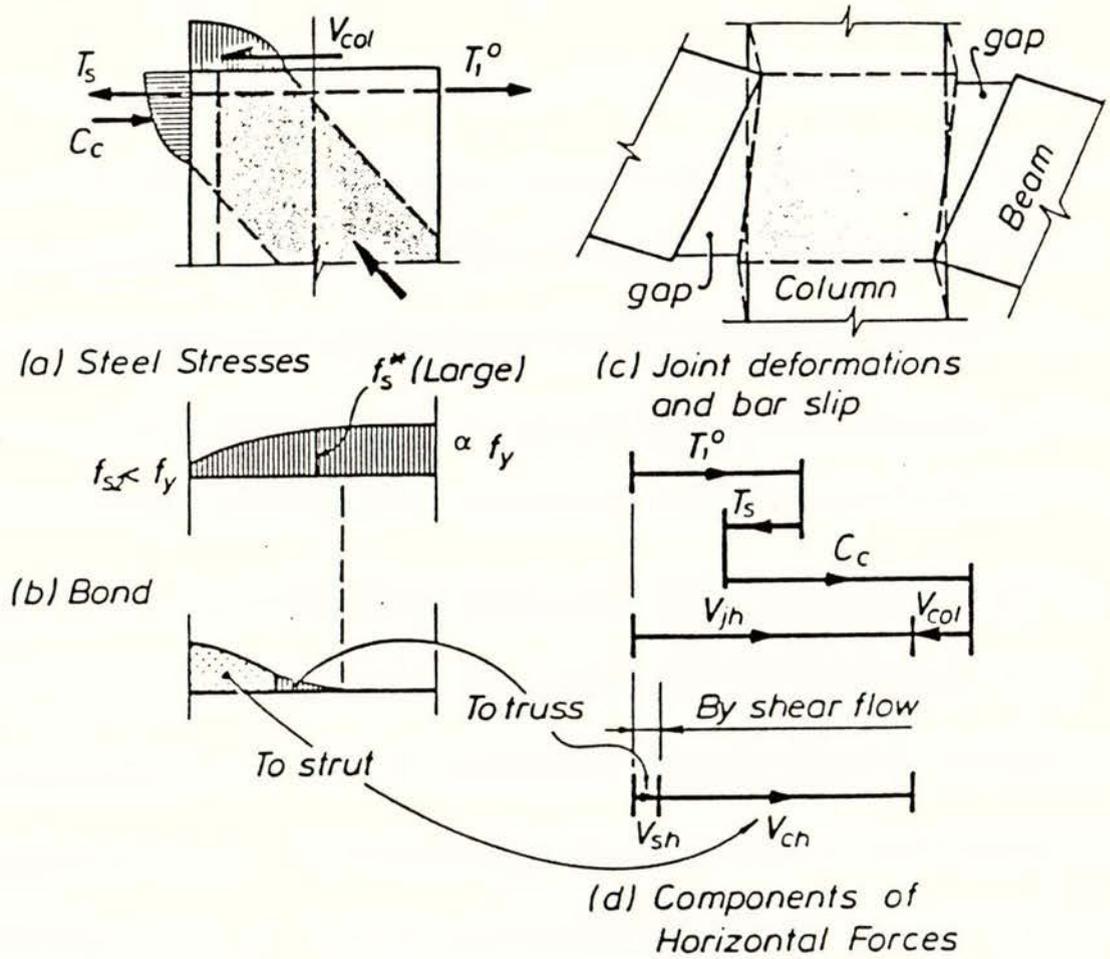
Fig. 2.10 Joint core in inelastic range with bond failure of beam bars [22]

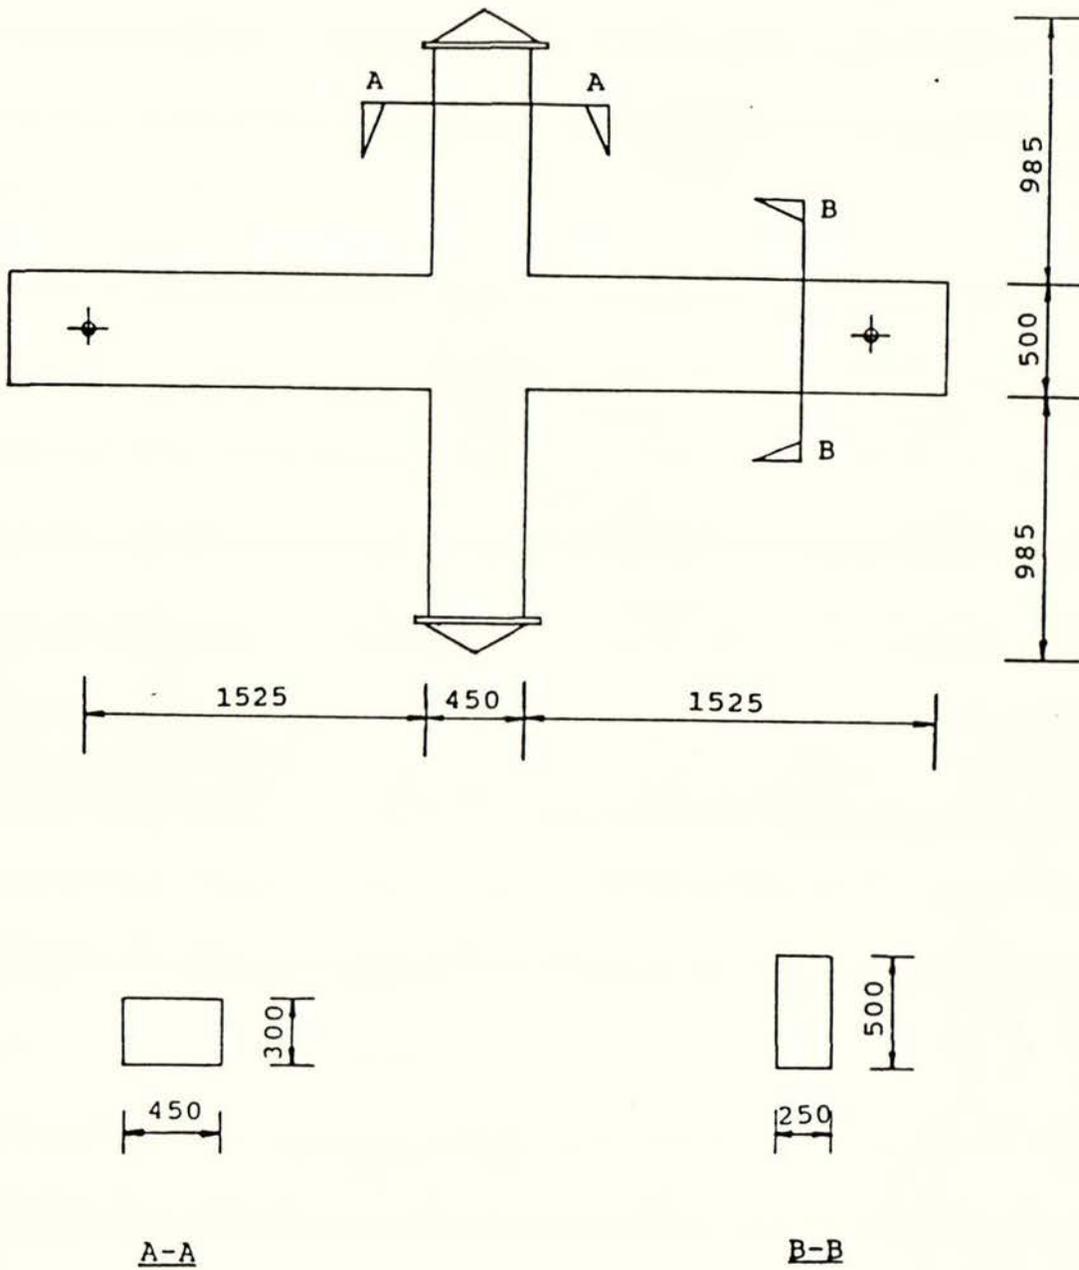
Fig. 4.1 Dimensions of the test units

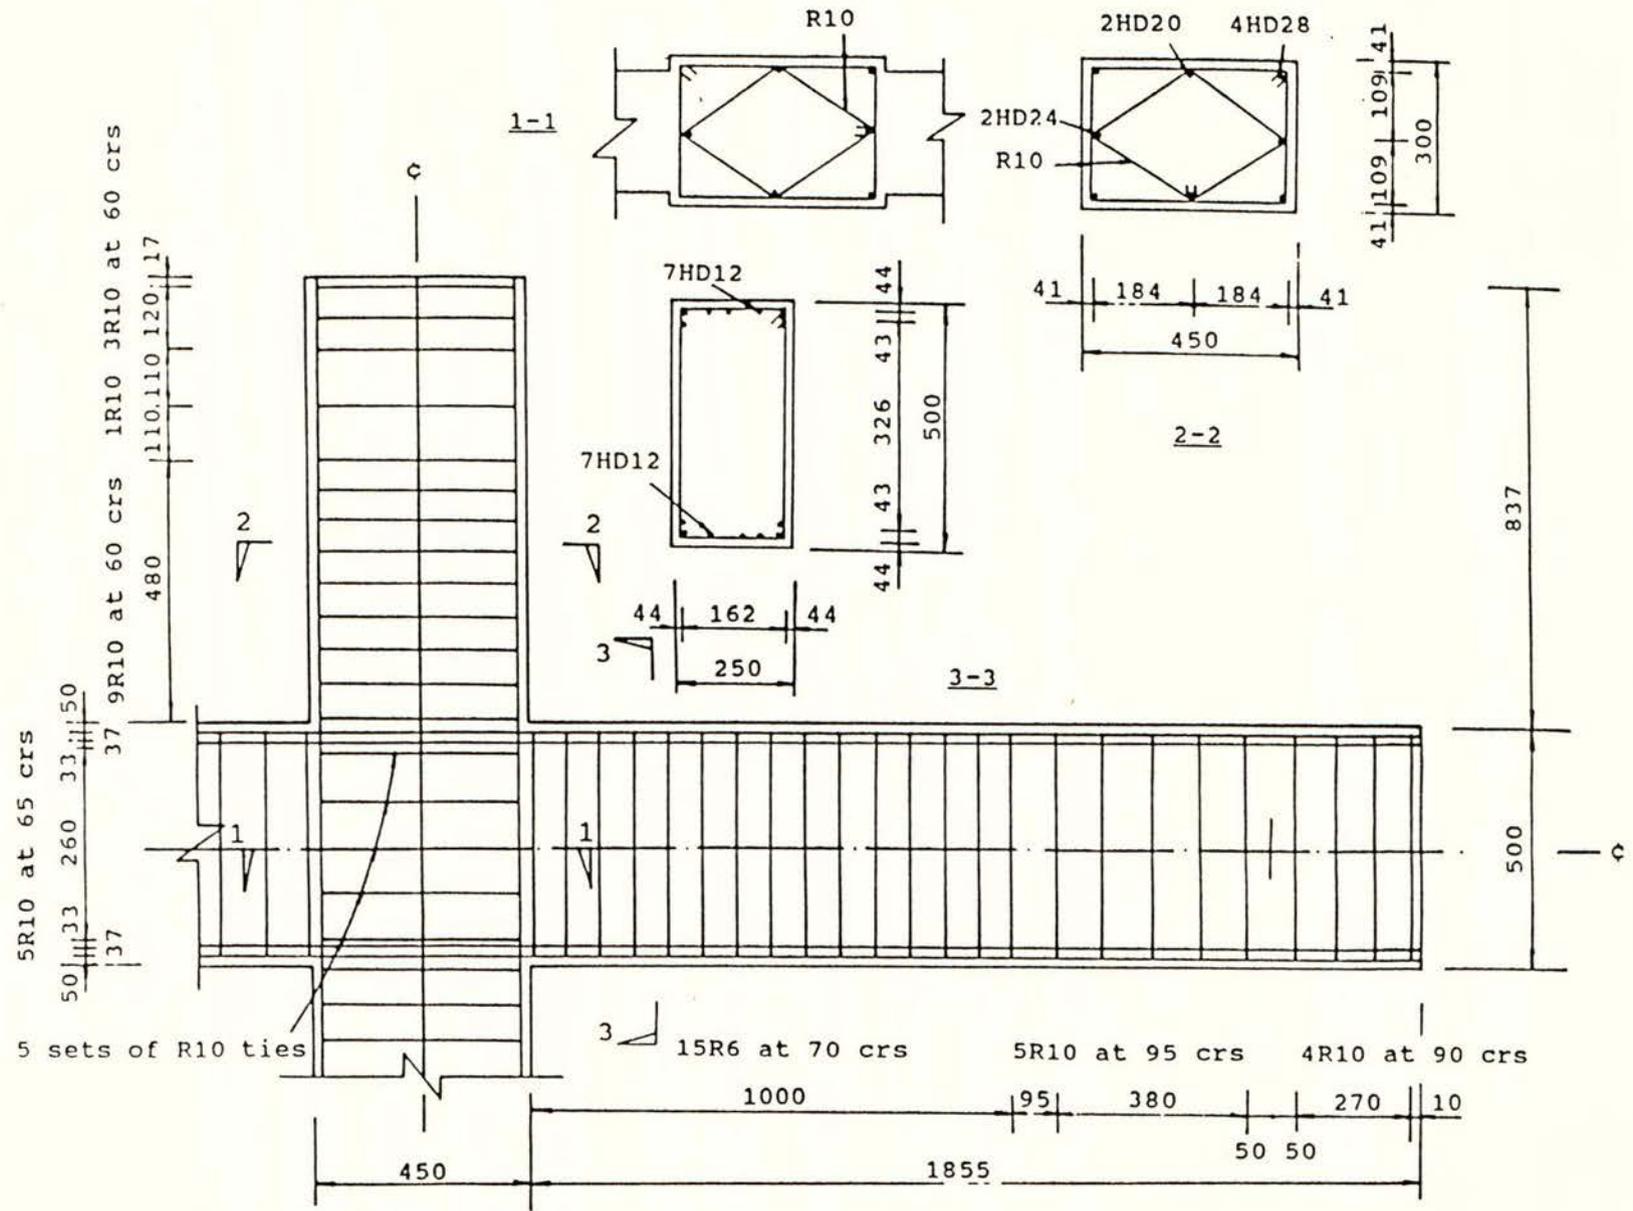
UNIT 1: The detail of the reinforcement for Unit 1 is shown in Fig. 4.2. HD12 steel bars, seven in the top and seven in the bottom, were used as flexural reinforcement in

Fig.4.2 Detail of reinforcement of Unit 1

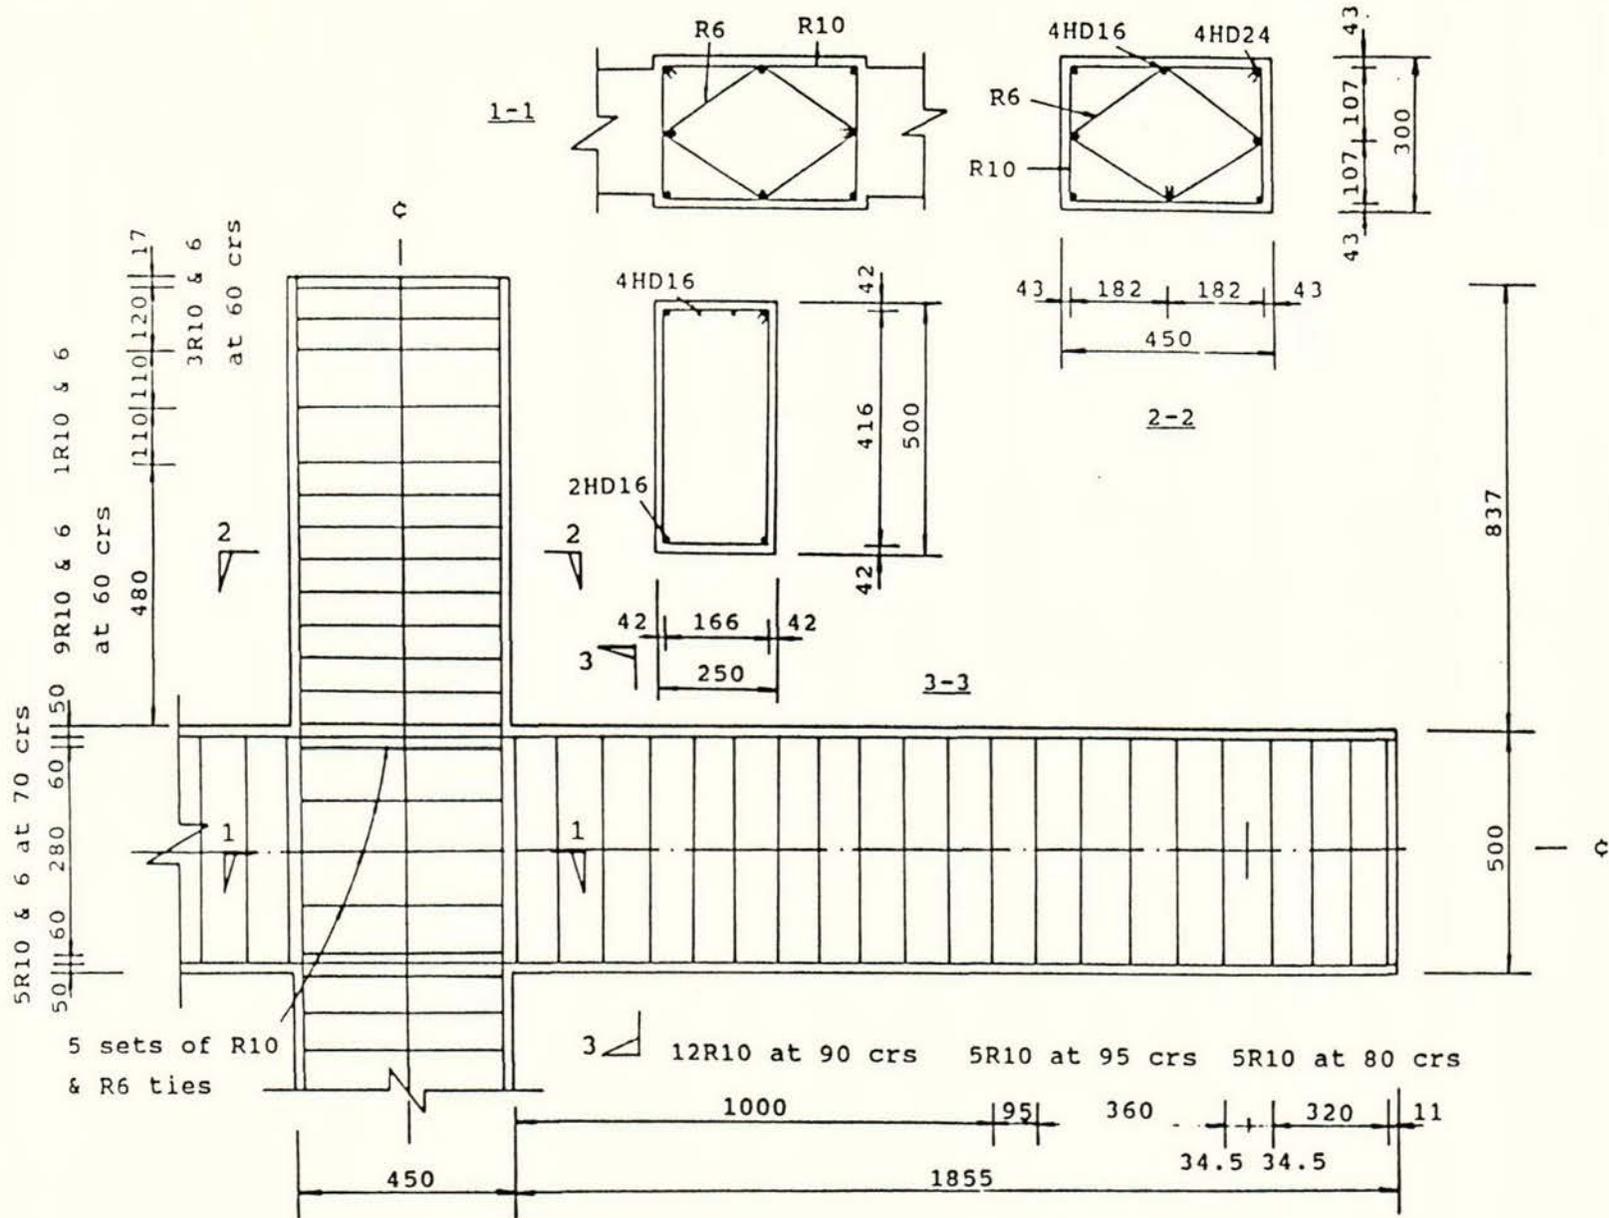
Fig.4.3 detail of reinforcement of Unit 2

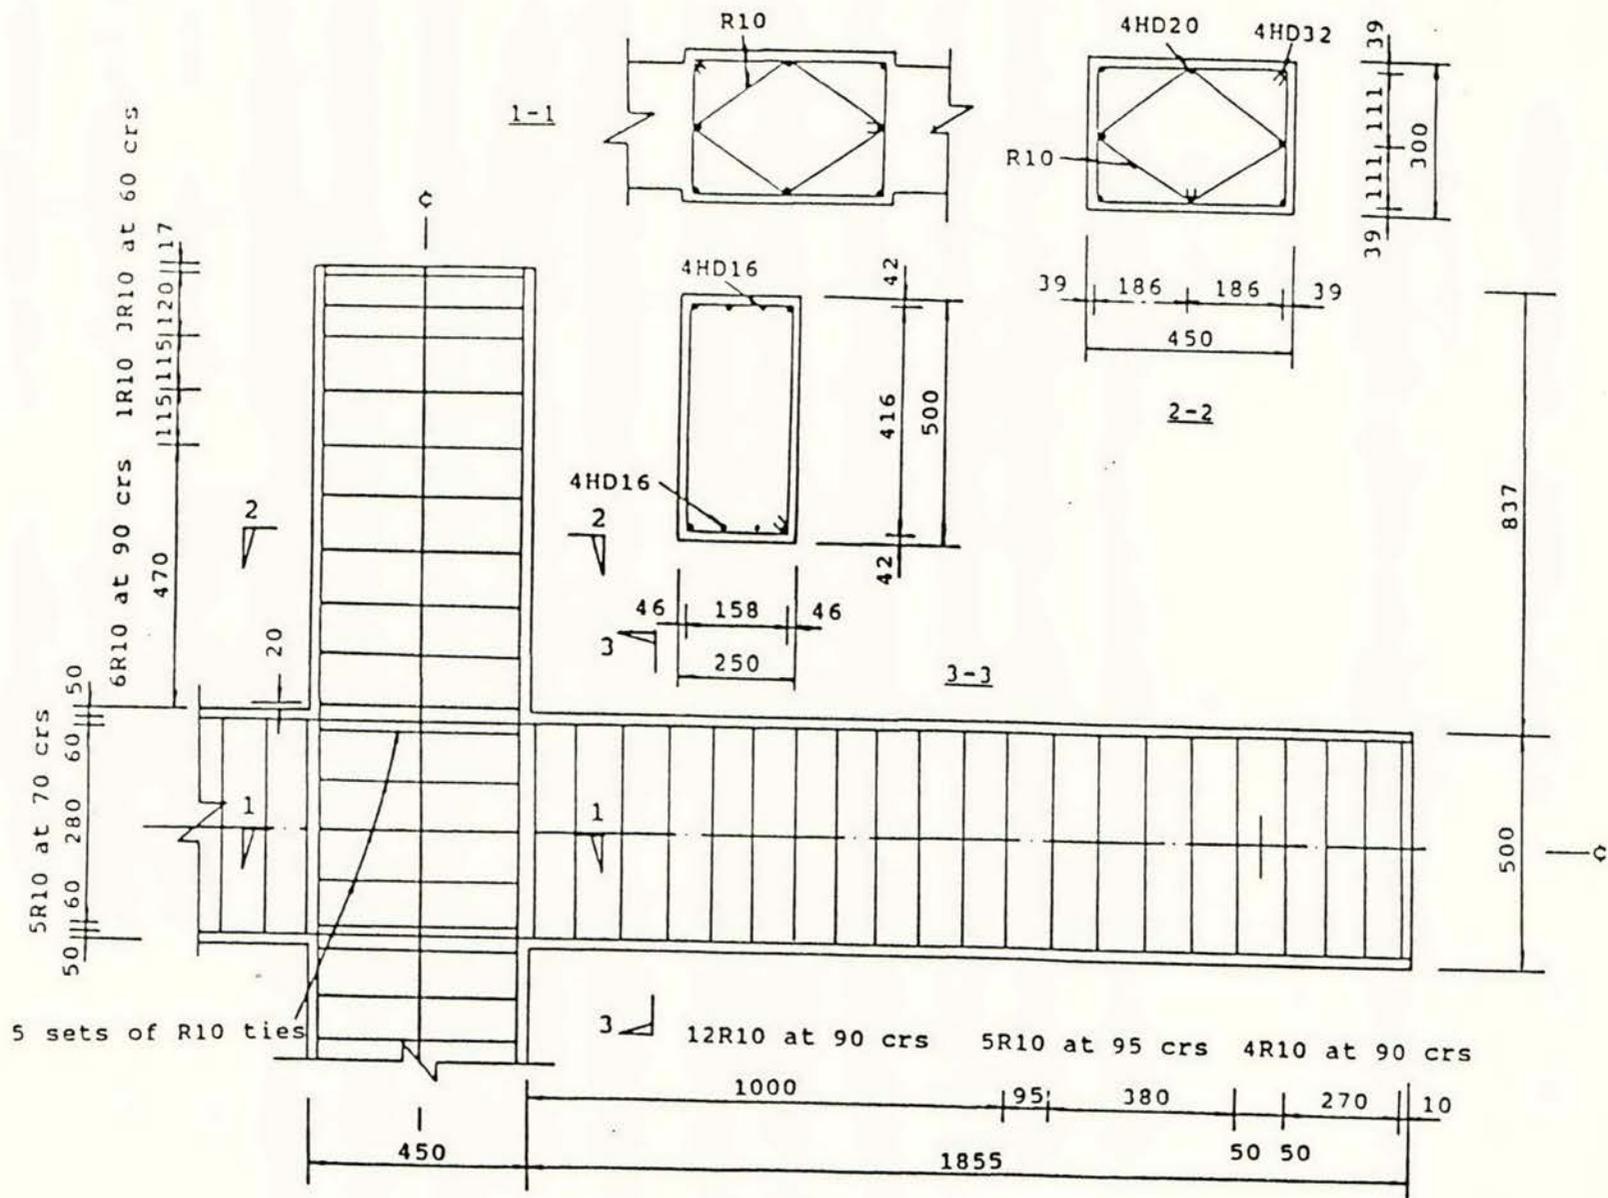
Fig.4.4 Detail of reinforcement of Unit 3

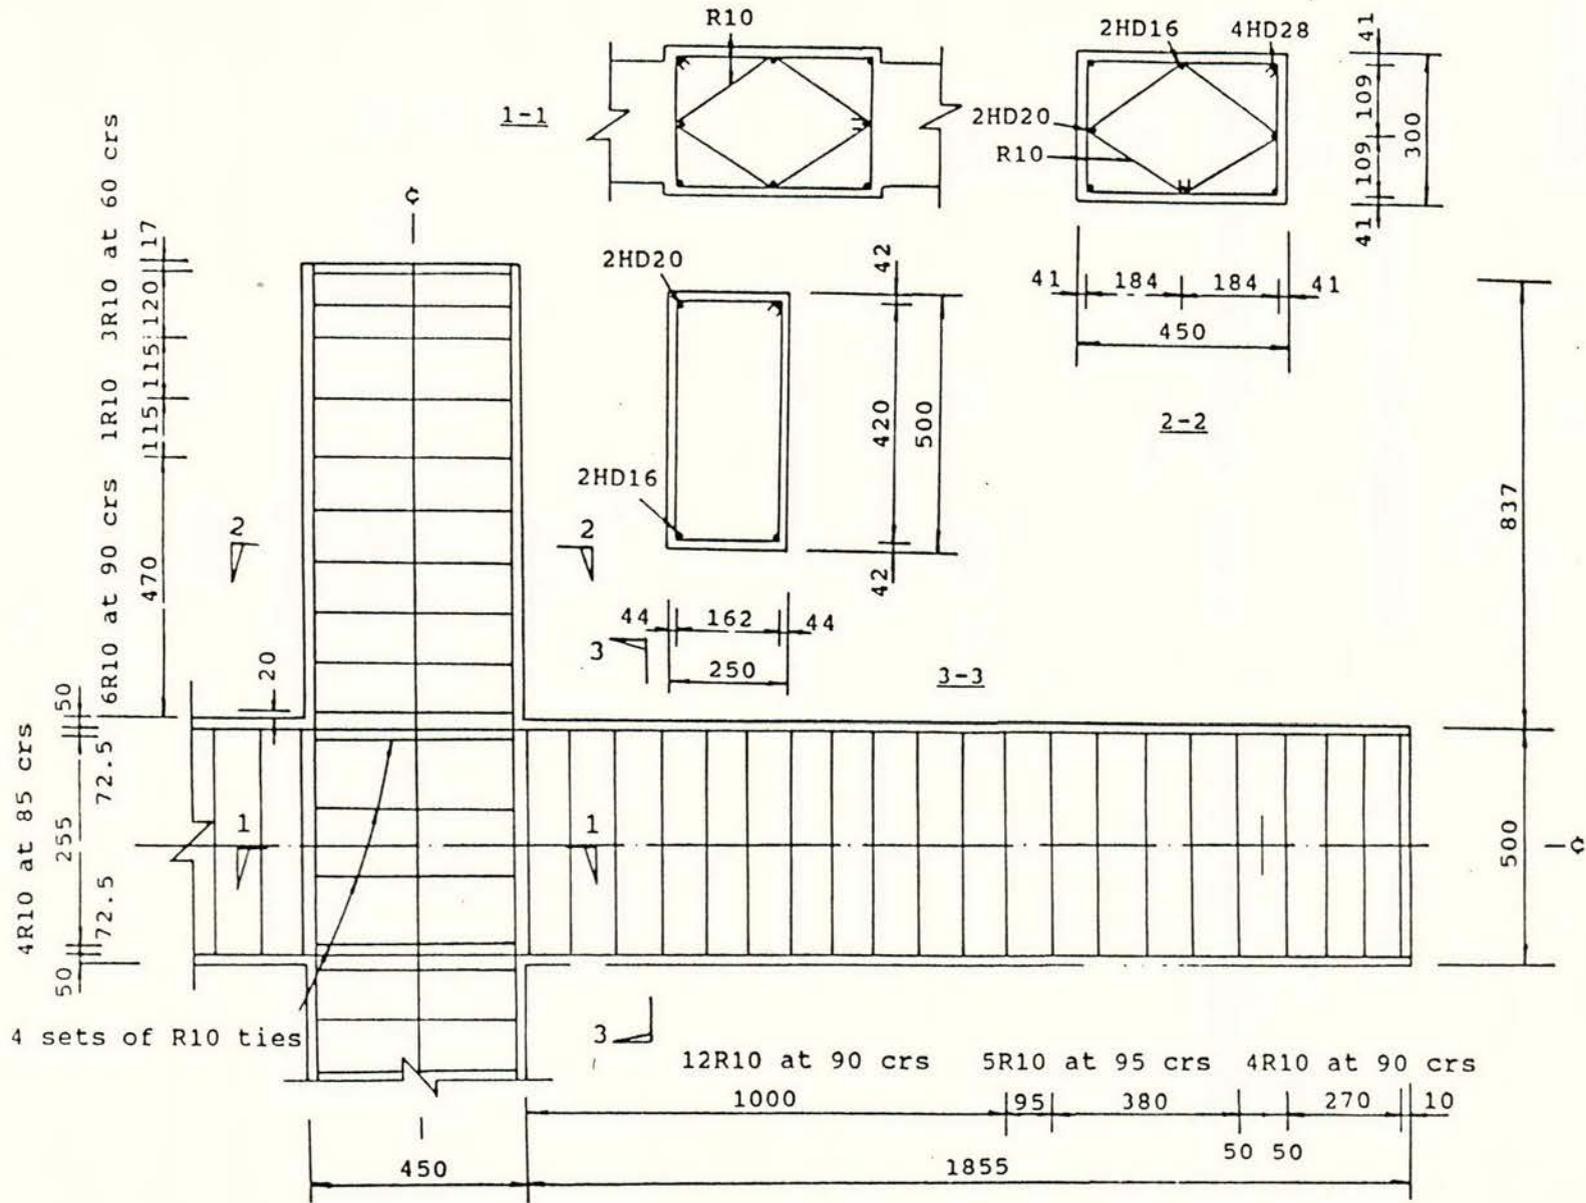
Fig.4.5 Detail of reinforcement of Unit 4

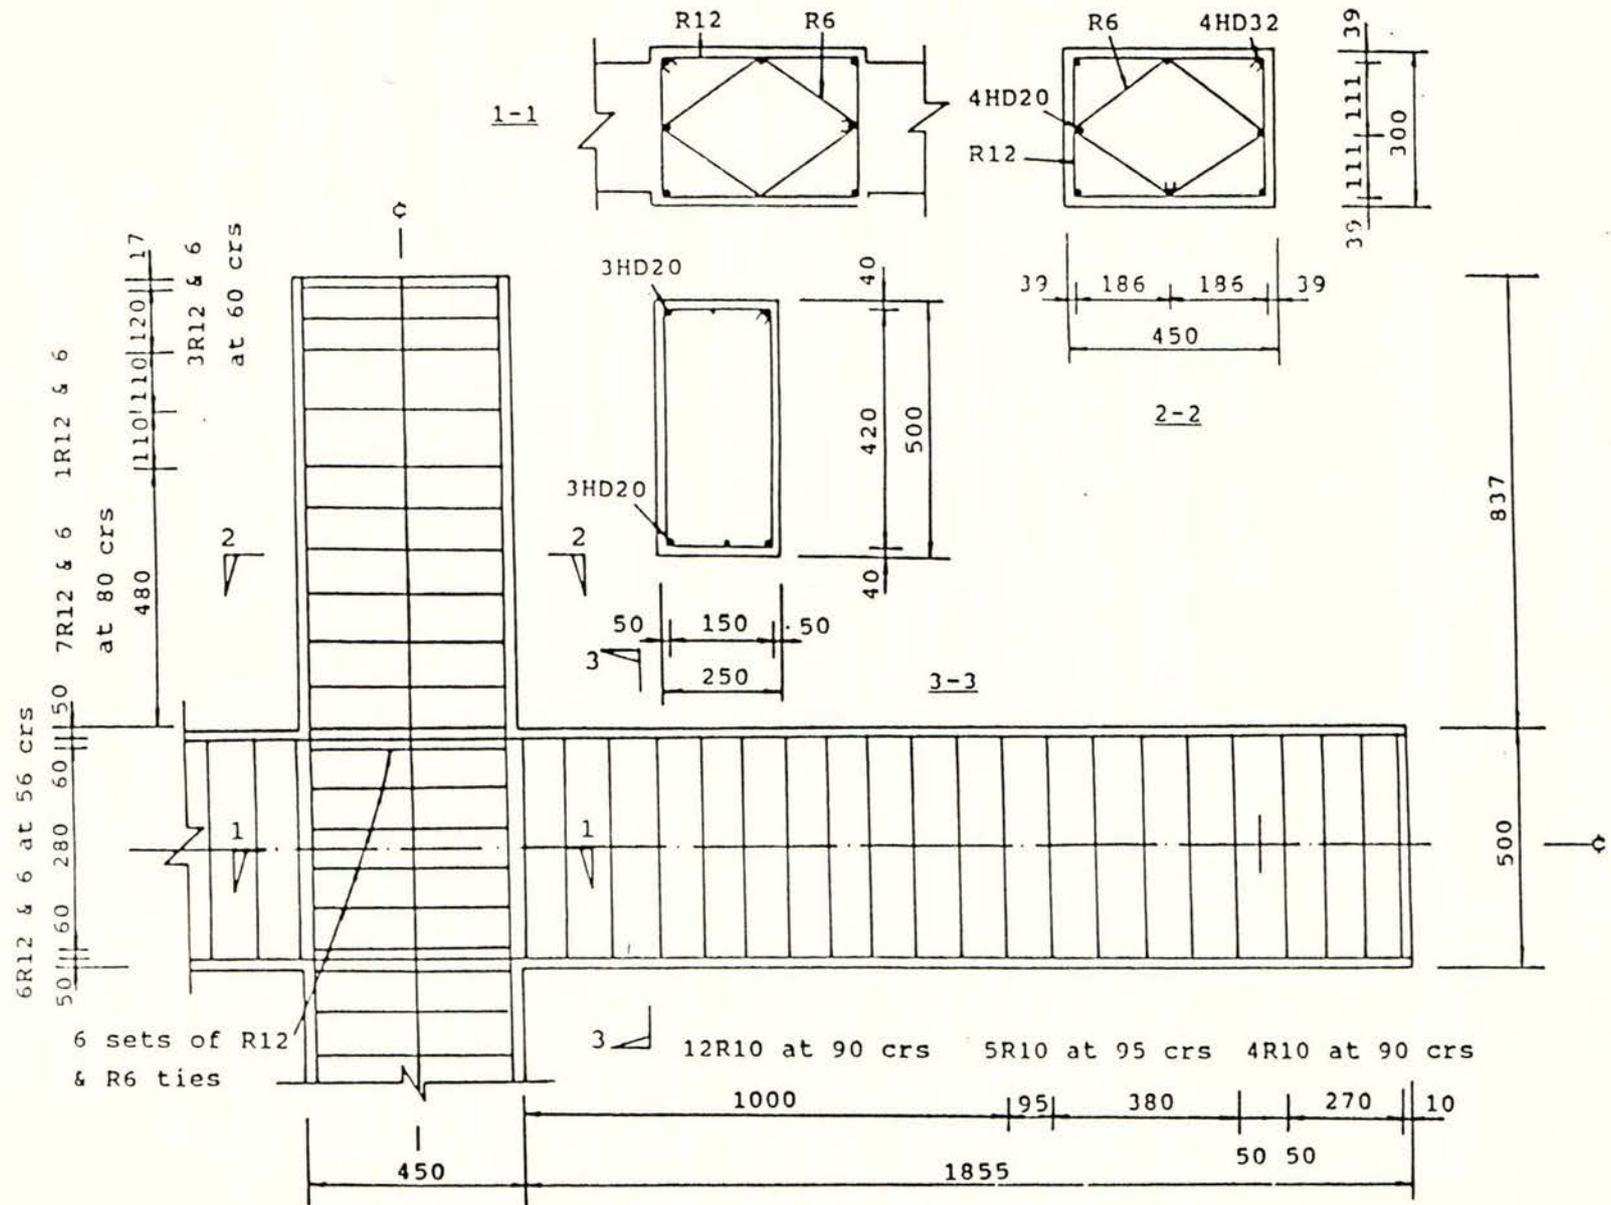
Fig.4.6 Detail of reinforcement of Unit 5

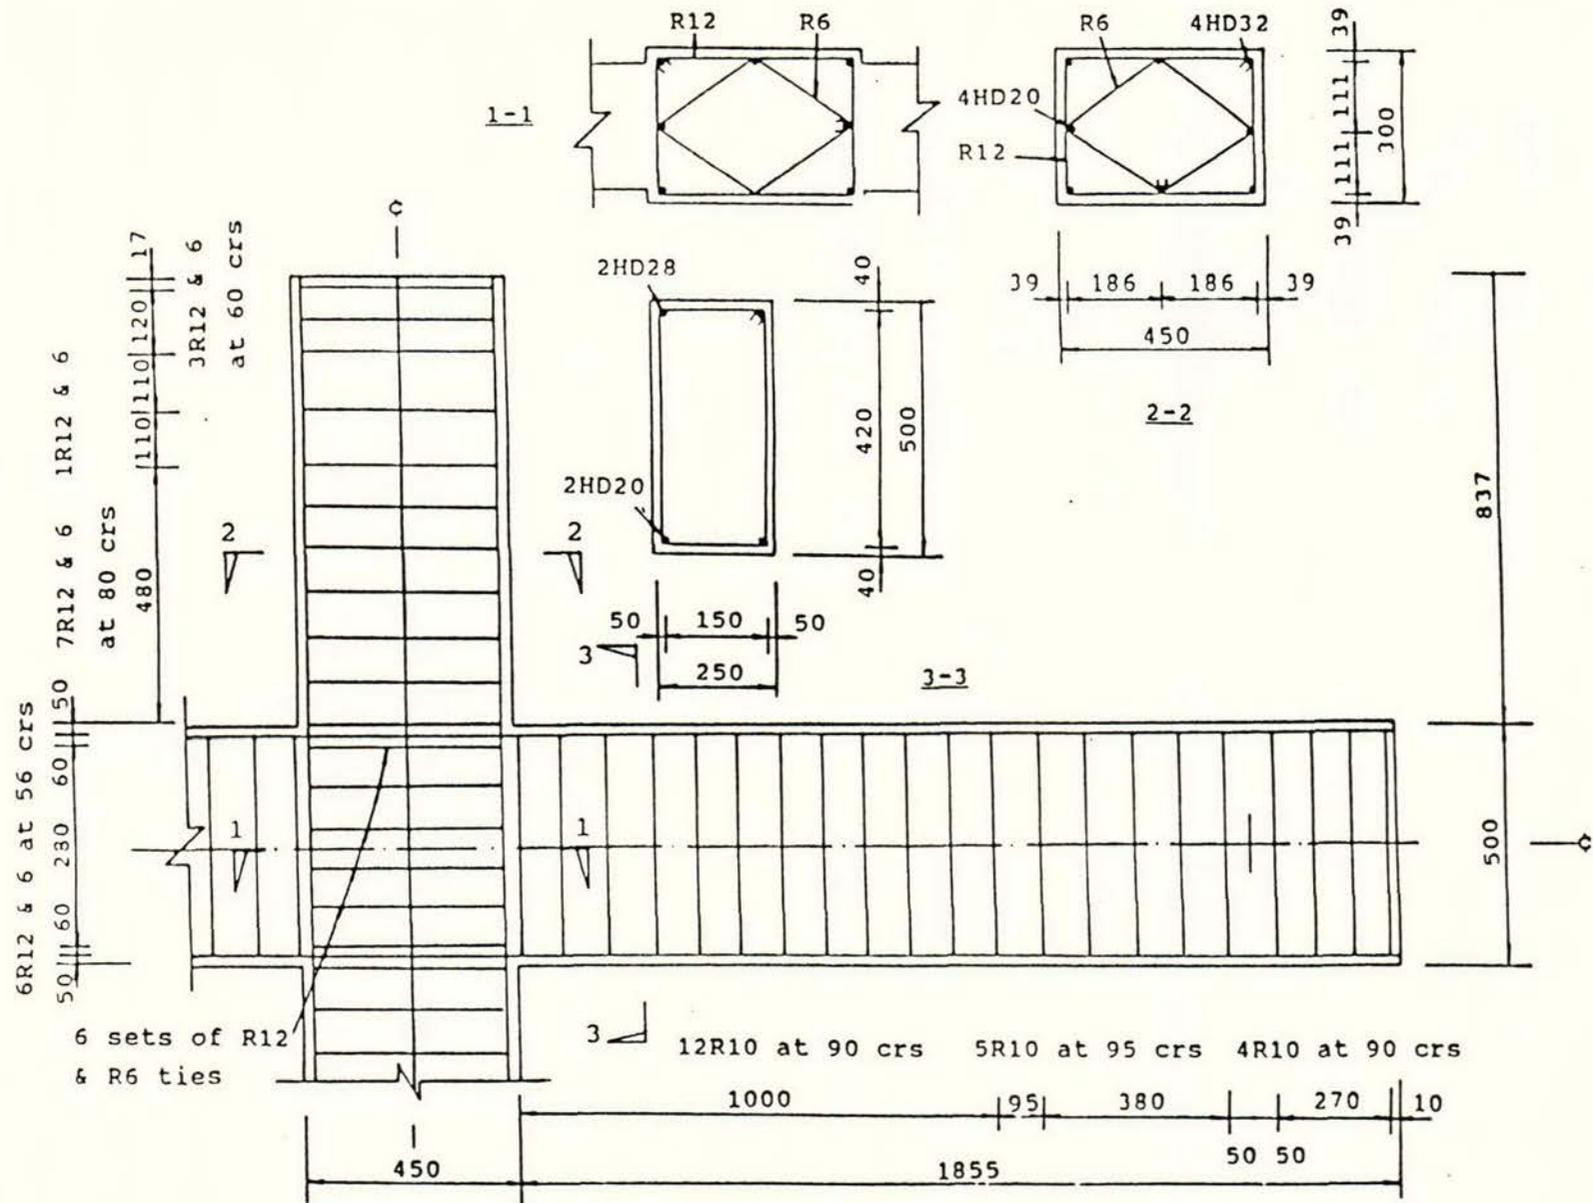
Fig.4.7 Detail of reinforcement of Unit 6

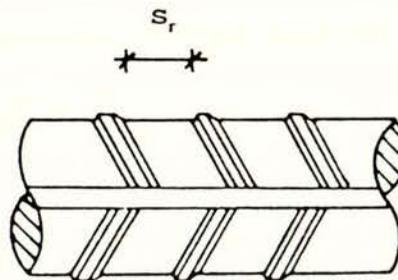
Fig. 4.8 Span of ribs in a steel bar

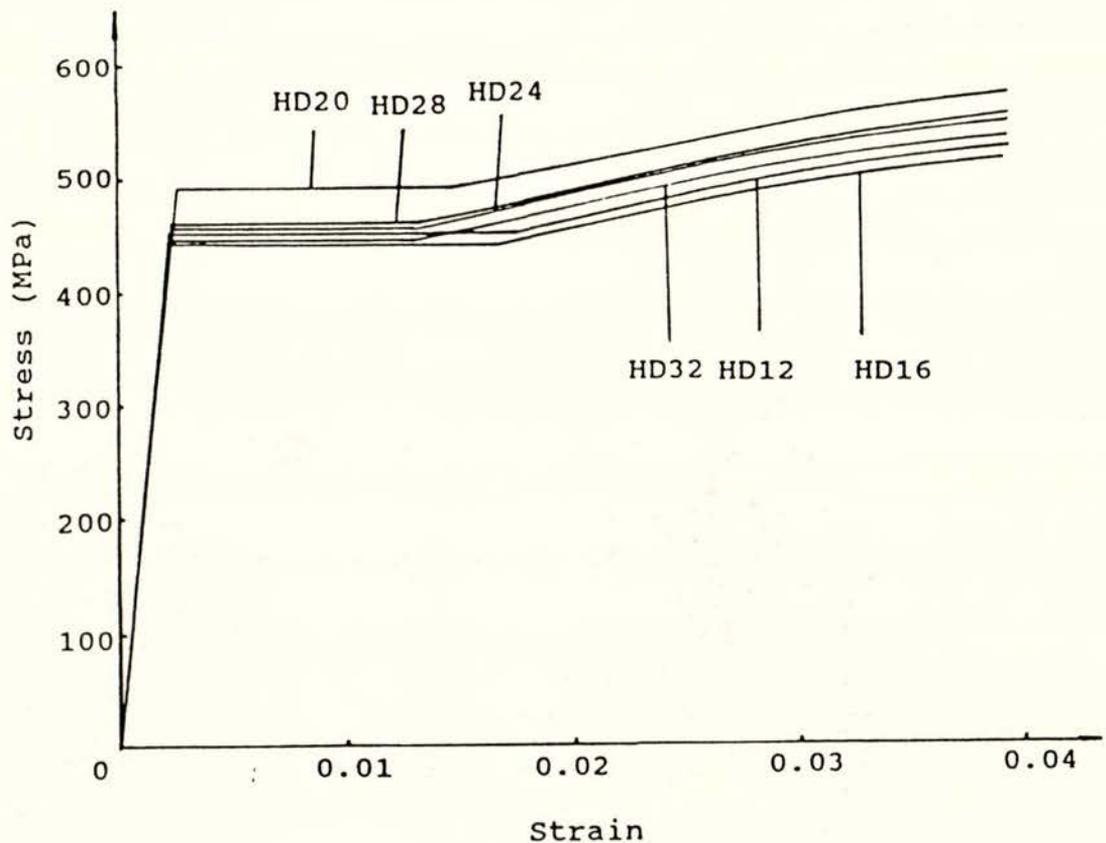
Fig. 4.9 Stress-strain curves for Grade 430 steel bars

In order to minimize experimental scatter, the majority of the steel reinforcement was obtained in one delivery so that the properties were expected to be consistent. The tensile properties of the steel bars were obtained by testing under progressively increasing monotonic tensile loading in an Avery Universal Testing Machine of 100 or 1000 kN capacity with the strain being measured by a Baly mechanical extensometer of 50.8 mm gauge length. Typical stress-strain curves are shown in Fig. 4.9 while Table 4.2 summarizes the steel properties.

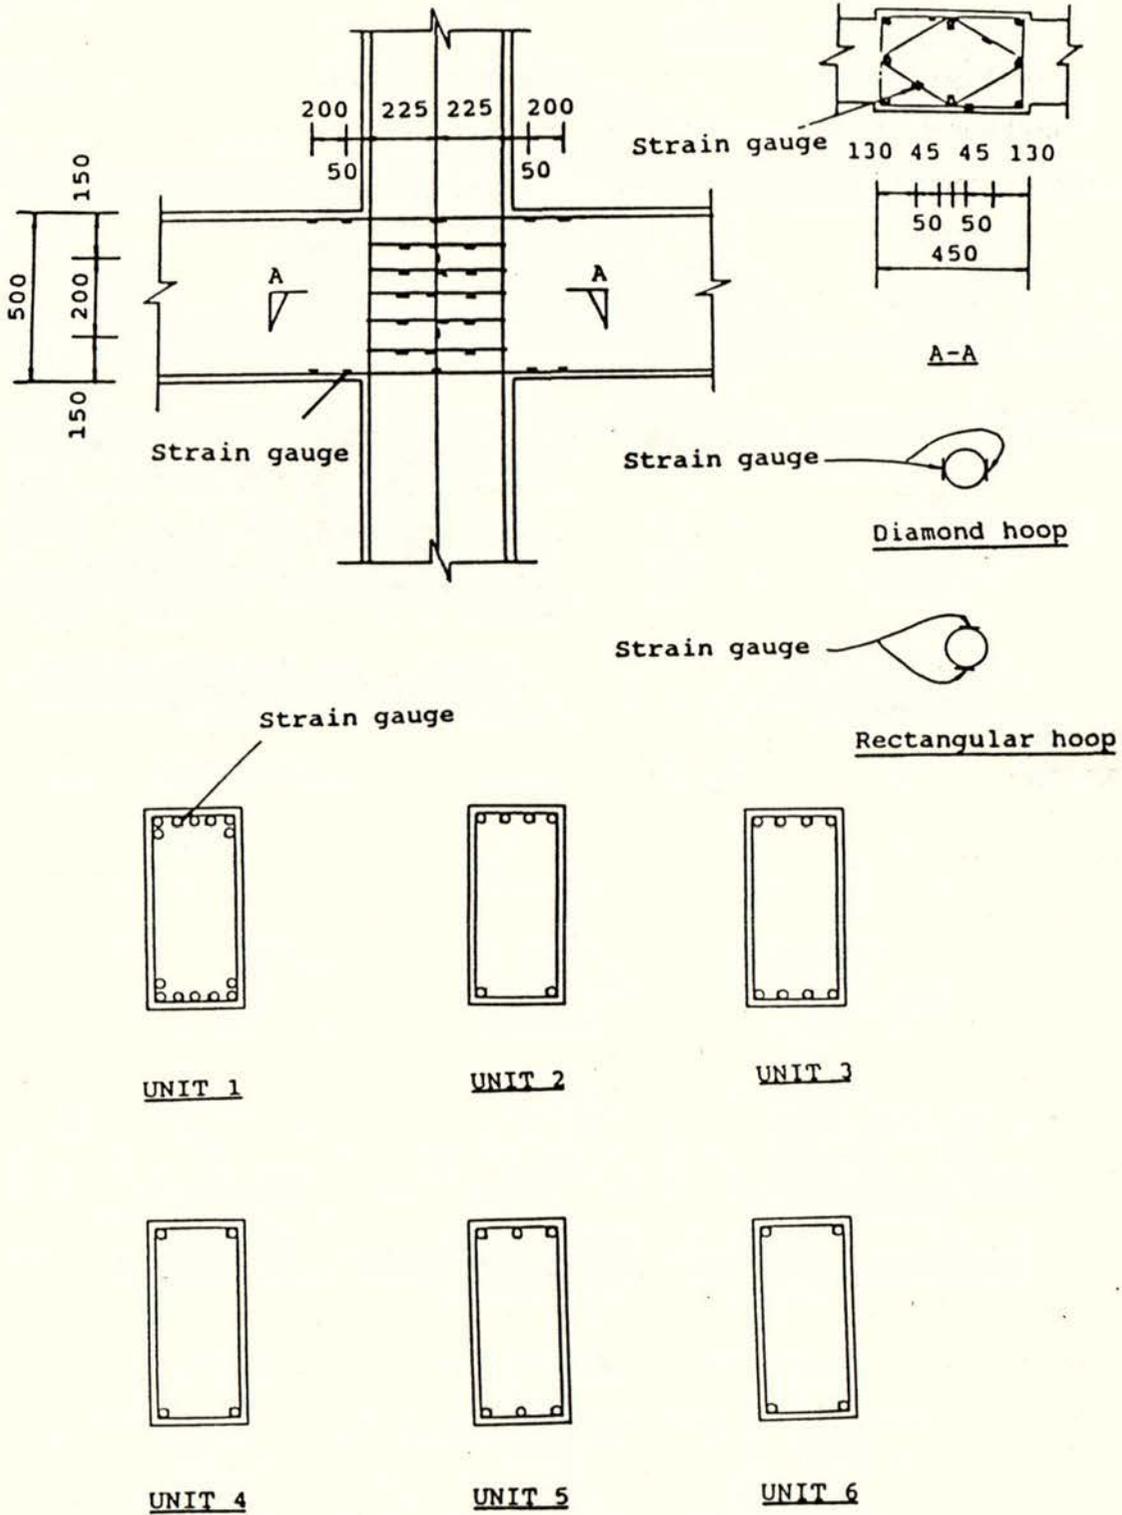
Fig. 4.14 Position of electrical resistance strain gauges on reinforcing steel of units

Electrical resistance strain gauges (SHOWA TYPE N11-FA-5-120-11) were used to measure the strain variations along the longitudinal reinforcing bars in the beam, intermediate column bars and horizontal hoops in the joint, as shown in Fig. 4.14. To eliminate as far as possible the effect of bending strains due to bending of the bar, the strain gauges were placed at the mid-depth of the longitudinal bars. The strain gauges on the joint core hoops were attached in pairs above and below the rectangular hoop bar and at the mid-depth of the diamond hoop bar in the direction of shear transfer. Six clip gauges were used to measure the strains in the beam bar in the joint region (See Fig. 4.11).
