**Behaviour of Reinforced Concrete Interior Beam-Column Joints
Designed Using High Strength Concrete and Steel**

*Xian Zuo Xin, supervised by R Park and H Tanaka, Department of
Civil Engineering, University of Canterbury*

July 1992

**A Research Report Based on the
Master of Engineering (Civil) Thesis**

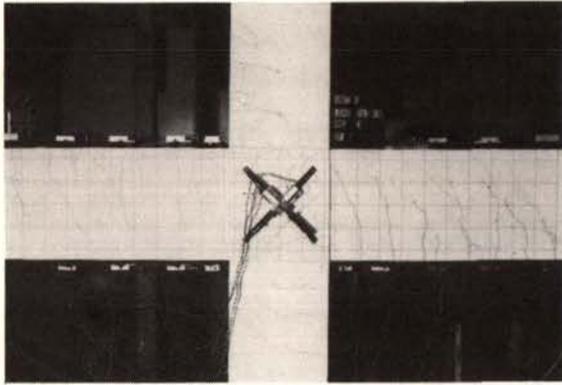
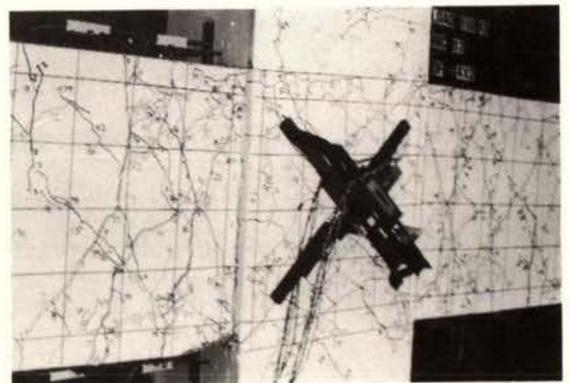
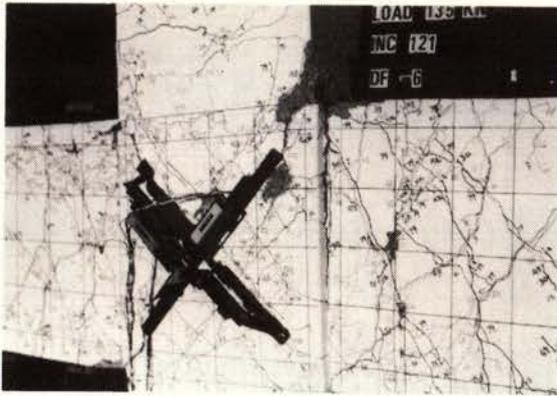
(a) $\mu = 0.75$, cycle 1

(f) $\mu = -4x2$, cycle 5

Fig. 5.1 Progressive crack development for Unit 1

(g) $\mu = -6$, cycle 6

The development of cracking is illustrated by a series of photographs taken at the various peaks of the displacement level, as shown in Fig. 5.1. A few flexural cracks appeared in the beam and column, before several diagonal cracks appeared in the joint, when the storey shear was about 60% of the theoretical strength based on measured properties in the initial stage of loading [See Fig. 5.1 (a and b)]. At the peaks of first cycle to $\mu = \pm 0.75$, the beam was still in the elastic range. At this stage, the cracks were very fine in both the joint core and the beam. According to the conventional method for defining to the yield displacement at this university, the measured yield displacement Δ_y was 20.7 mm after the movement of the rigid body of the unit was deducted. The yield storey drift Δ_y/L_c was 0.84%.

of the column face. More cracks formed in the joint core as shown in Fig. 5.1(c). No more new cracks appeared at the second cycle with same ductility factor, but the maximum surface crack width became wider in the joint core. The maximum crack width was 0.33 mm in the joint core and 2.0 mm in the beam close to the column face. The crack in the beam at column face closed under load reversal.

At the peak of first cycle to $\mu=4$, concrete crushing were observed first in the compression zone of the beam as shown in Fig. 5.1(d). More cracks developed and the width of cracks in the beam and the joint core became wider. The maximum crack width was 1.0 mm in the joint core. The joint core tended to expand. It was observed that the top beam bars moved slightly in the joint region. Crushing of concrete occurred in the joint core and slip of both the top and bottom beam bars occurred after the second cycle of loading to $\mu=-4$. However the pinching of hysteresis loops was not serious. The yield strain was reached in all rectangular joint hoops and in the diamond joint hoops positioned in the top parts of the joint.

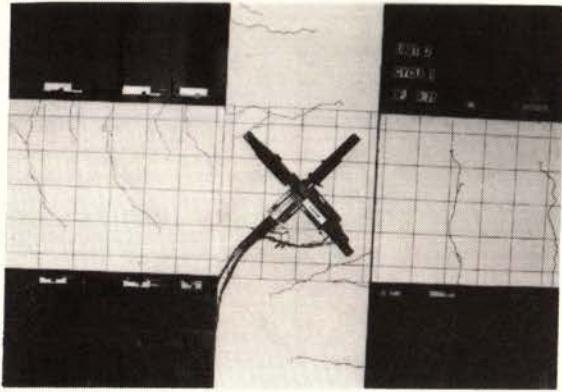
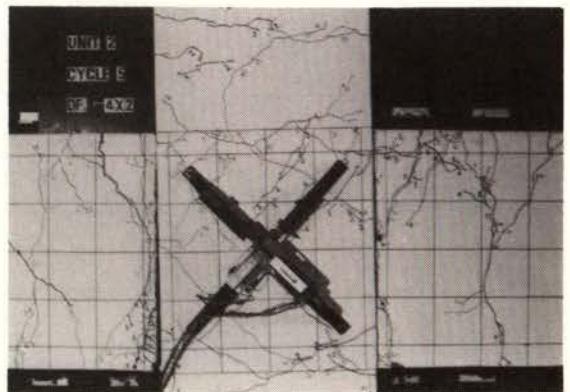
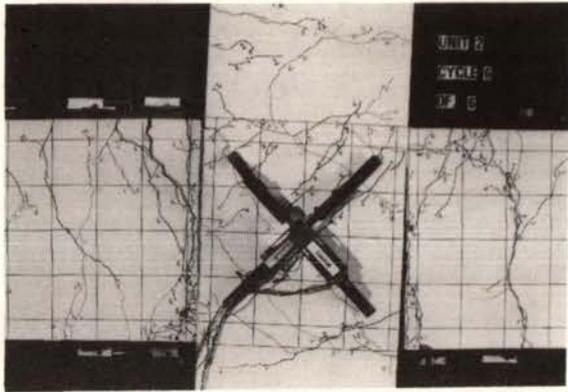
(a) $\mu = 0.75$, cycle 1

(f) $\mu = -4 \times 2$, cycle 5

Fig. 5.2 Progressive crack development for Unit 2

(g) $\mu = 6$, cycle 6

The development of cracking is illustrated by a series of photographs taken at the various peaks of the displacement level, as shown in Fig. 5.2. A few flexural cracks appeared in the beam and column when the storey shear was between 50% and 60% of the theoretical strength based on measured properties in the initial stage of loading (See Fig. 5.2(a and b)). At the peaks of the first load cycle to $\mu = \pm 0.75$, no cracks appeared in the joint core and the beam was still in the elastic range. The measured yield displacement Δ_y was 14.4 mm after the movement of the rigid body of the unit was deducted. The yield storey drift Δ_y/L_c was 0.58%.

After the bottom beam bars slipped slightly, some cracks that were almost horizontal appeared in the beam close to the column face as shown in Fig. 5.2 (g,h,i and j). Even though the slip of the bottom beam bars was significant, the storey shear still kept above the theoretical strength at the peaks of the cycle loading, until the slip of the top beam bars occurred at the second cycle to $\mu = \pm 8$.

The yield strain was not measured in all joint core hoops when the test was terminated. The joint core region was almost integral and the number of cracks was greater on the top than on the bottom of the joint core regions shown in Fig. 5.2(l). Buckling of beam bars was not observed that during the test. The beam depth was almost unchanged after the test. The crack at the column face on the bottom of the beam closed and the two surfaces of the crack at the column face at the top of the beam contacted each other under load reversal throughout the test.

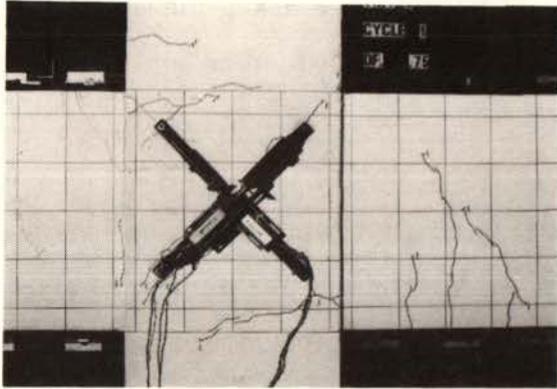
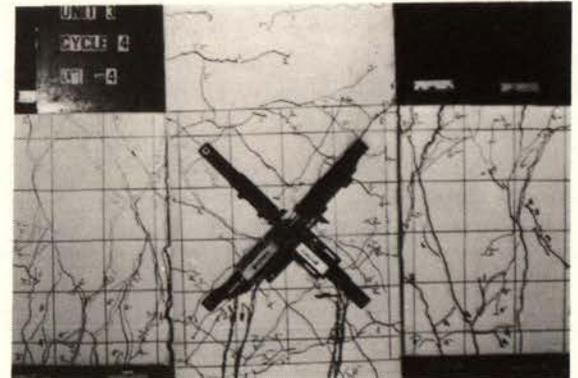
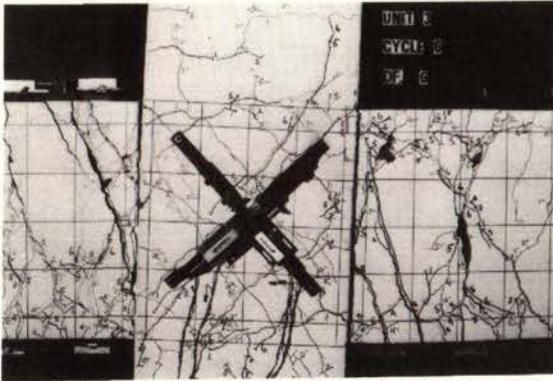
(a) $\mu = 0.75$, cycle 1

(f) $\mu = -4$, cycle 4

Fig. 5.3 Progressive crack development for Unit 3

(g) $\mu = 6$, cycle 6

The development of cracking is illustrated by a series of photographs taken at the various peaks of the displacement level as shown in Fig. 5.3. A few flexural cracks were observed in the beam and column, before a diagonal crack in the joint core appeared when the storey shear was about 62% of the theoretical strength based on measured properties in the initial stage of loading [See Fig. 5.1 (a)]. At the peaks of first cycle to $\mu = \pm 0.75$, the beam was still in the elastic range. At this step, the maximum diagonal crack width in the joint core was about 0.2 mm. The measured yield displacement Δ_y was 16.5 mm after the movement of the rigid body of the unit was deducted. The yield storey drift Δ_y/L_c was 0.67%.

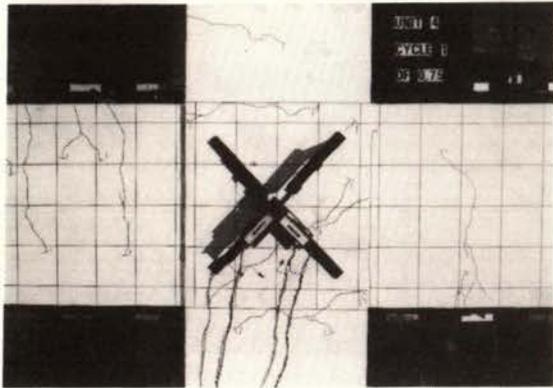
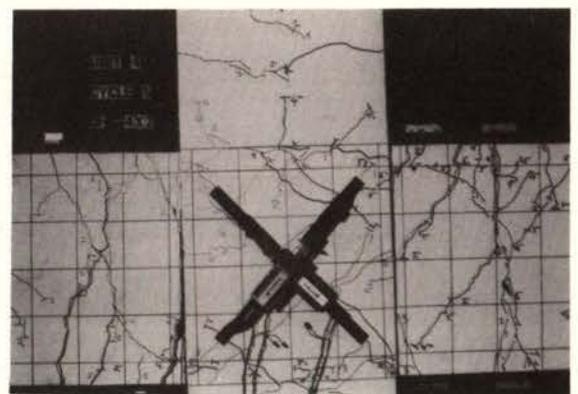
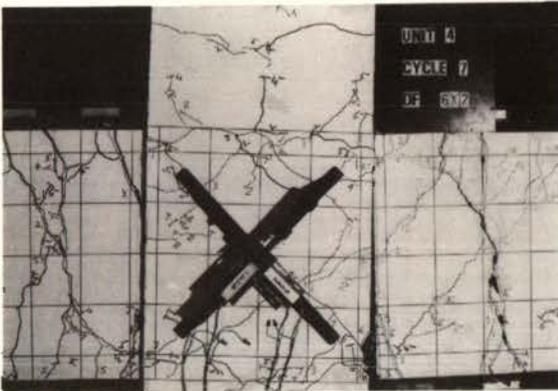
(a) $\mu = 0.75$, cycle 1

(f) $\mu = -4x2$, cycle 5

Fig. 5.4 Progressive crack development for Unit 4

(g) $\mu = 6x2$, cycle 7

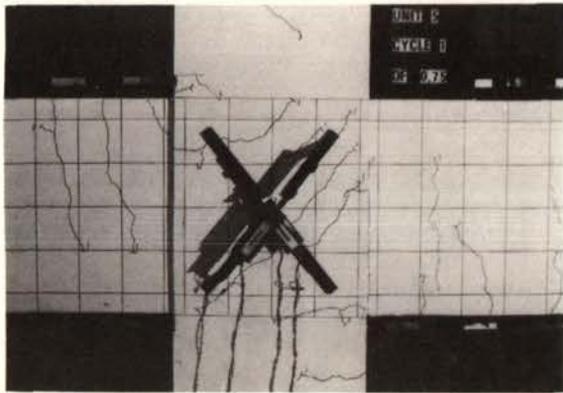
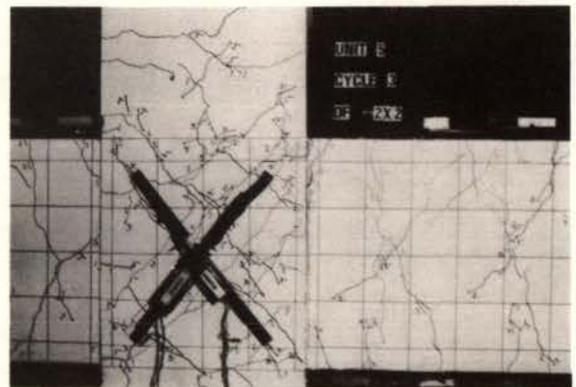
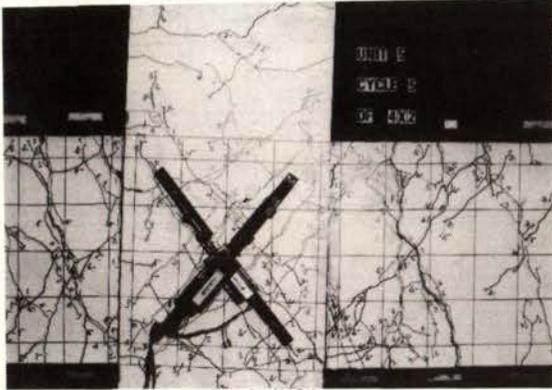
(a) $\mu = 0.75$, cycle 1

(f) $\mu = -2x2$, cycle 3

Fig. 5.5 Progressive crack development for Unit 5

(g) $\mu = 4x2$, cycle 5

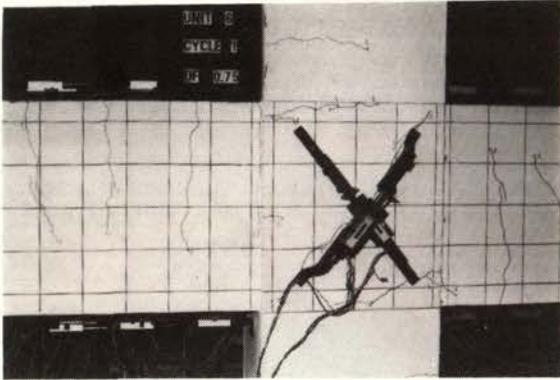
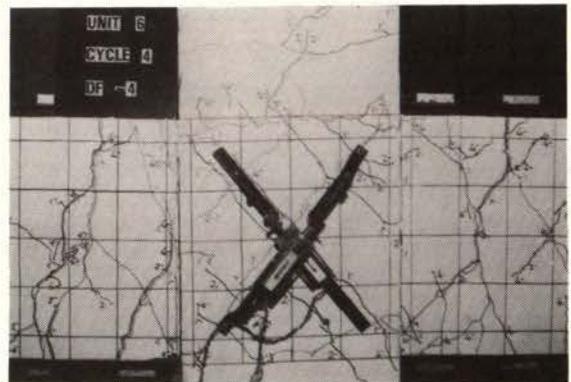
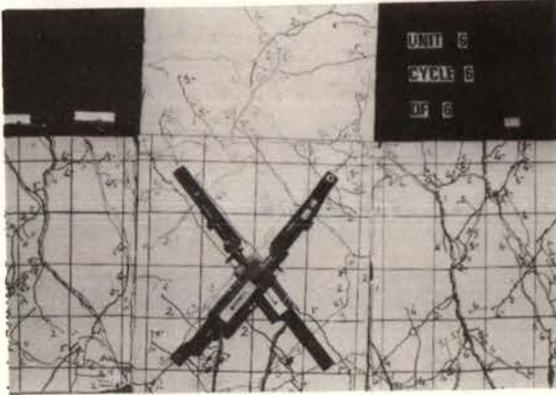
(a) $\mu = -0.75$, cycle 1

(f) $\mu = -4$, cycle 4

Fig. 5.6 Progressive crack development for Unit 6

(g) $\mu = 6$, cycle 6

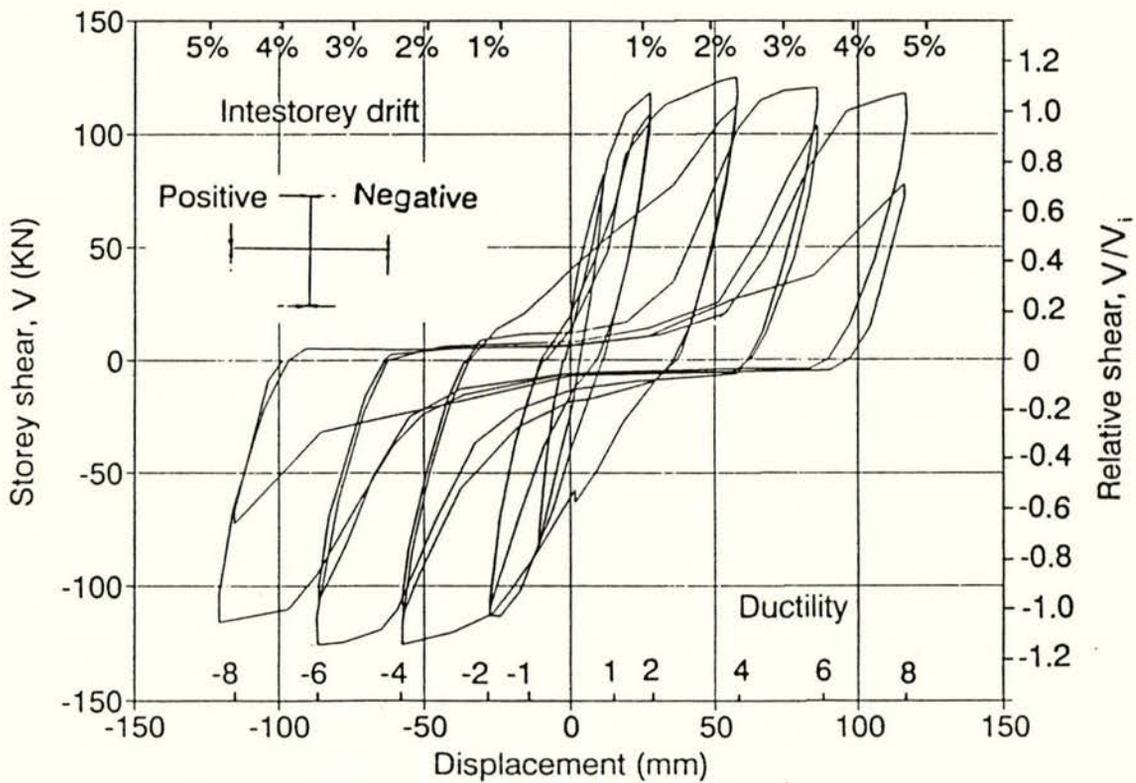
Fig. 5.8 Storey shear versus displacement loops, Unit 2

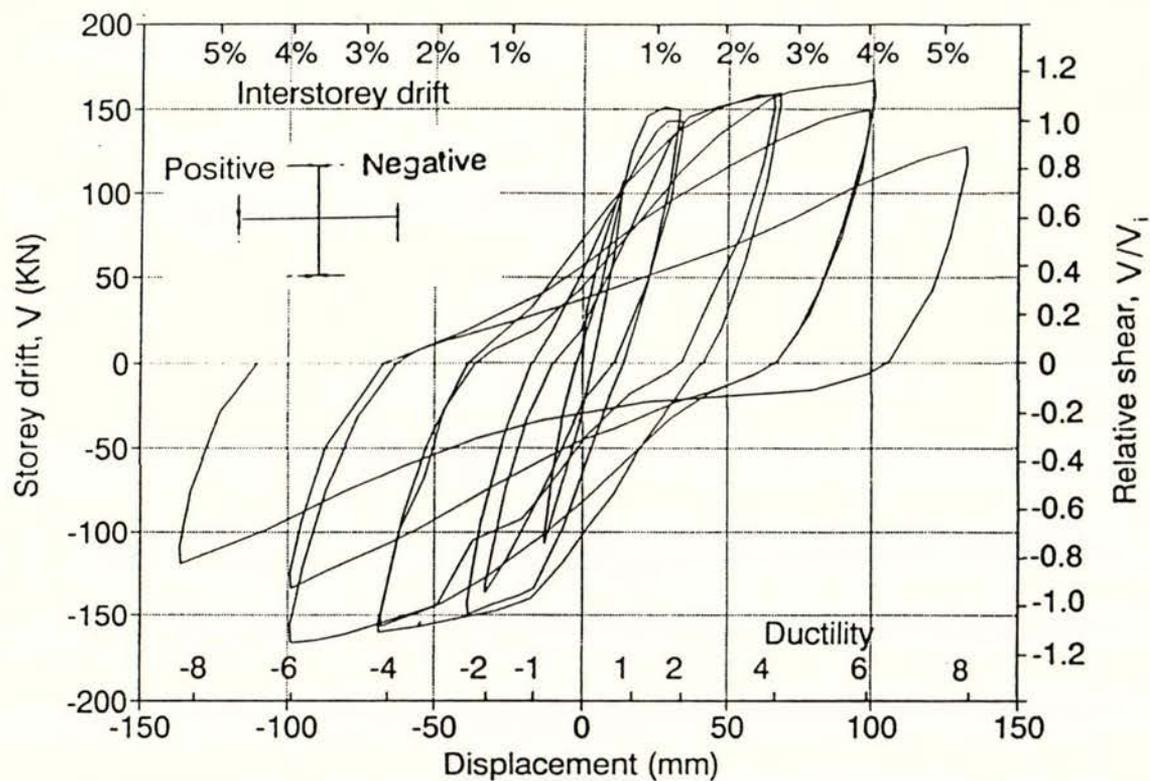
Fig. 5.9 Storey shear versus displacement loops, Unit 3

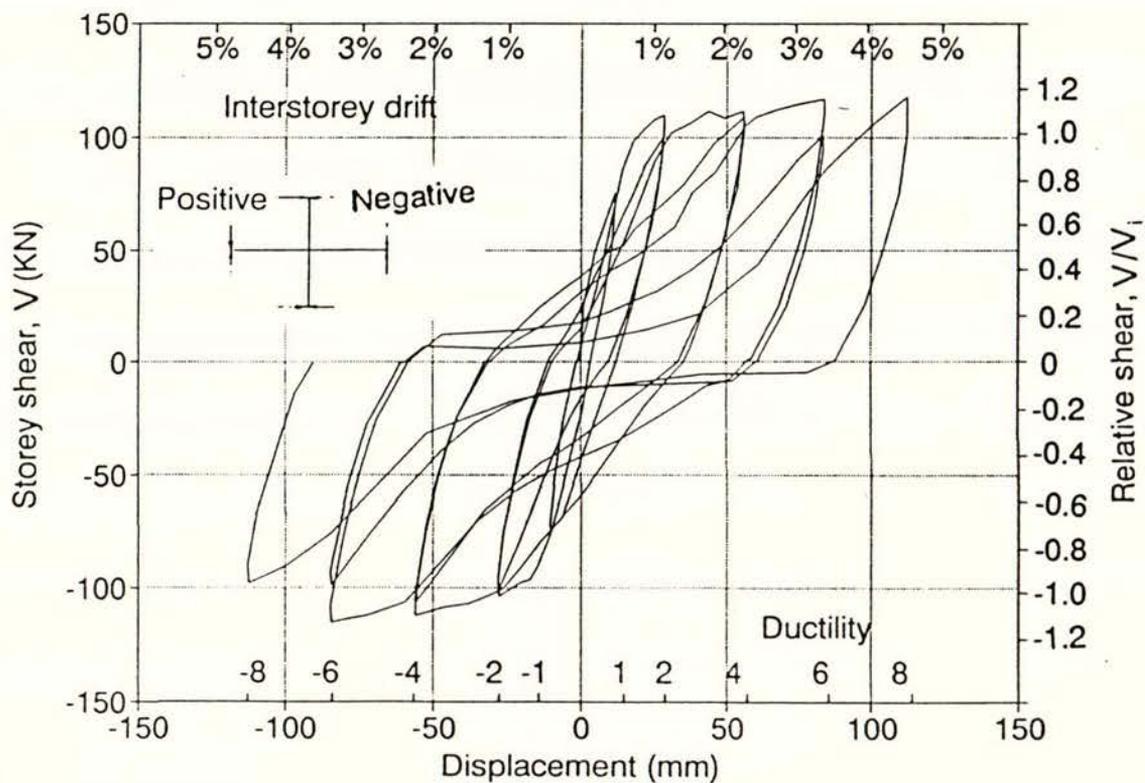
Fig. 5.10 Storey shear versus displacement loops, Unit 4

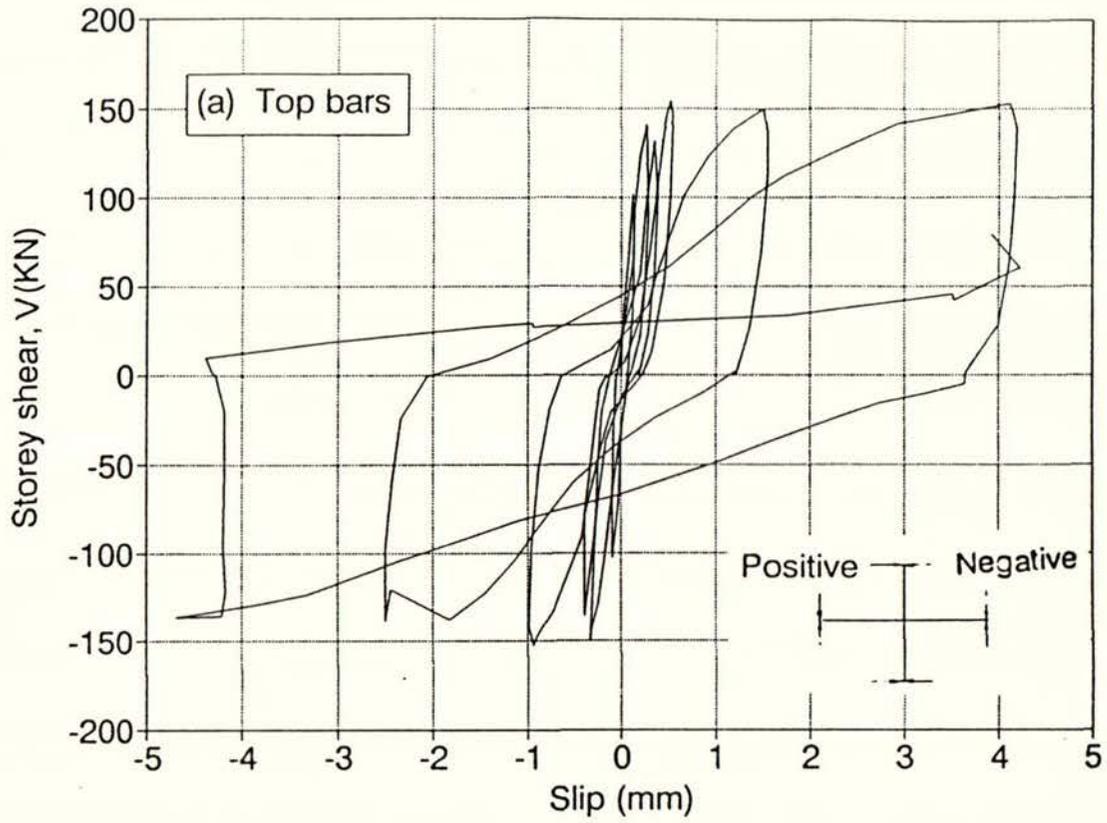
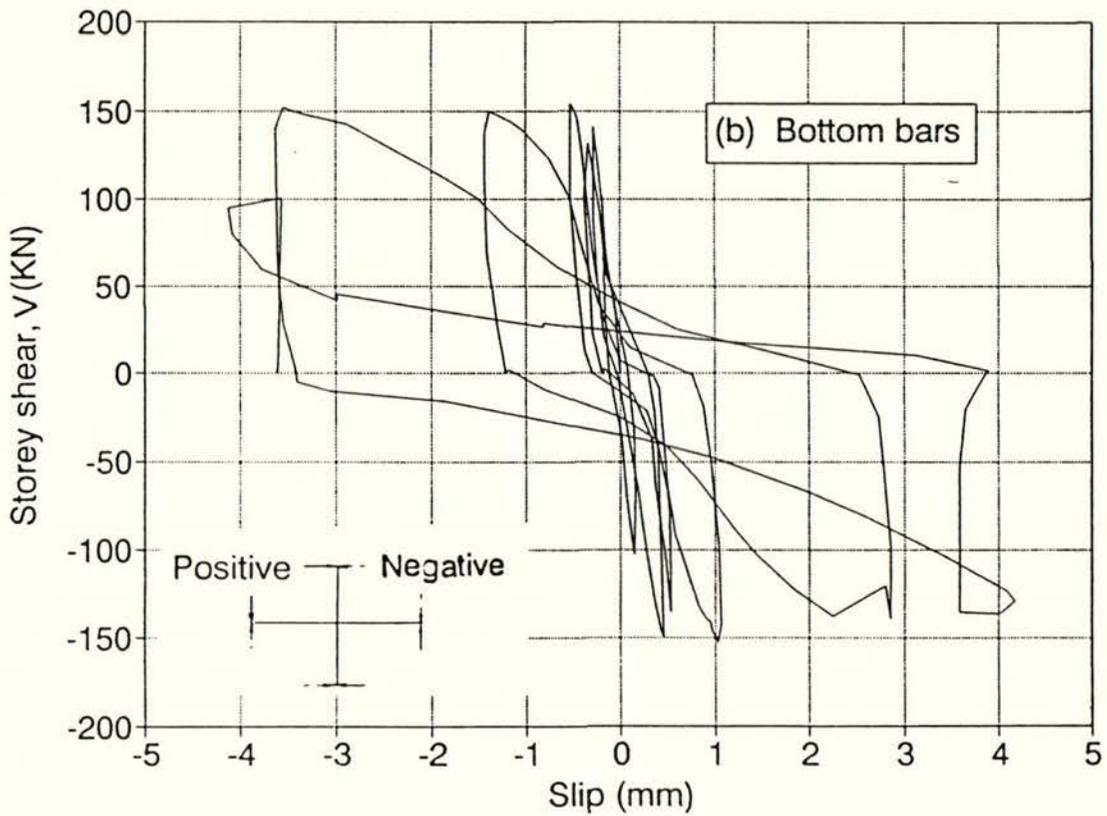
Fig. 5.13 Slip of beam bars within the joint core, Unit 1

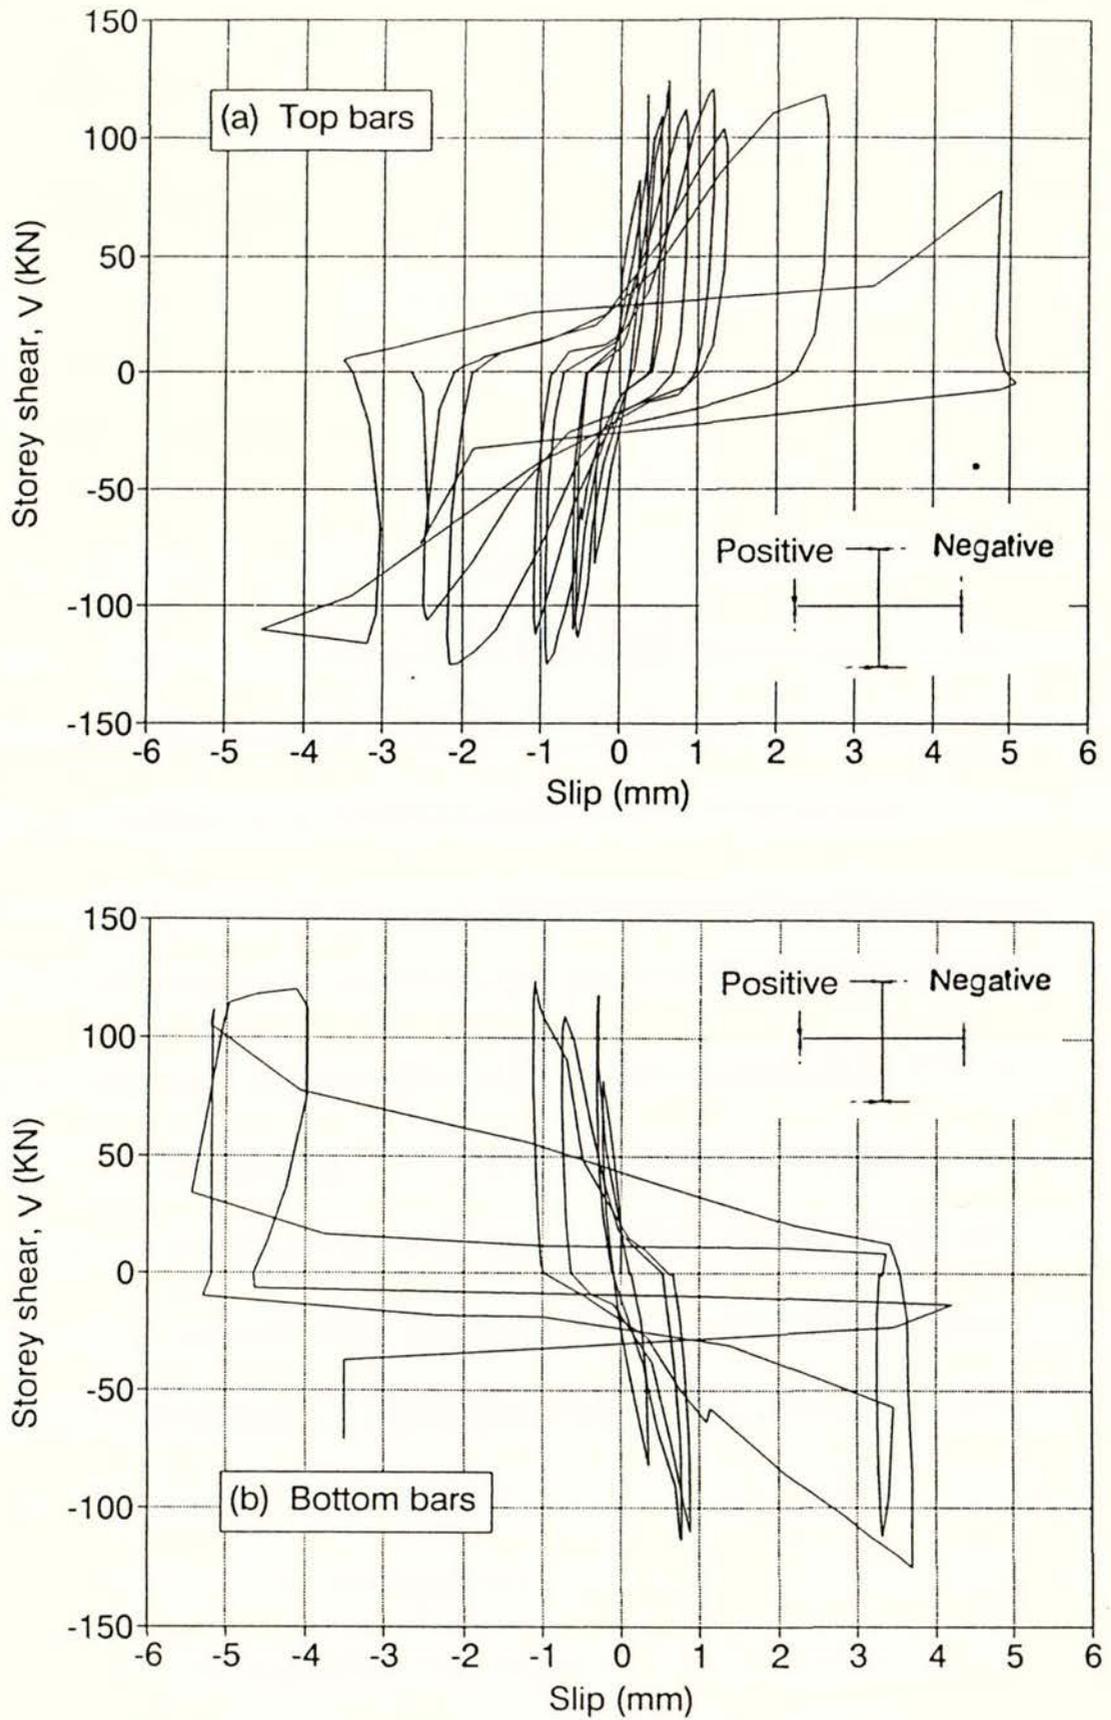
Fig. 5.14 Slip of beam bars within the joint core, Unit 2

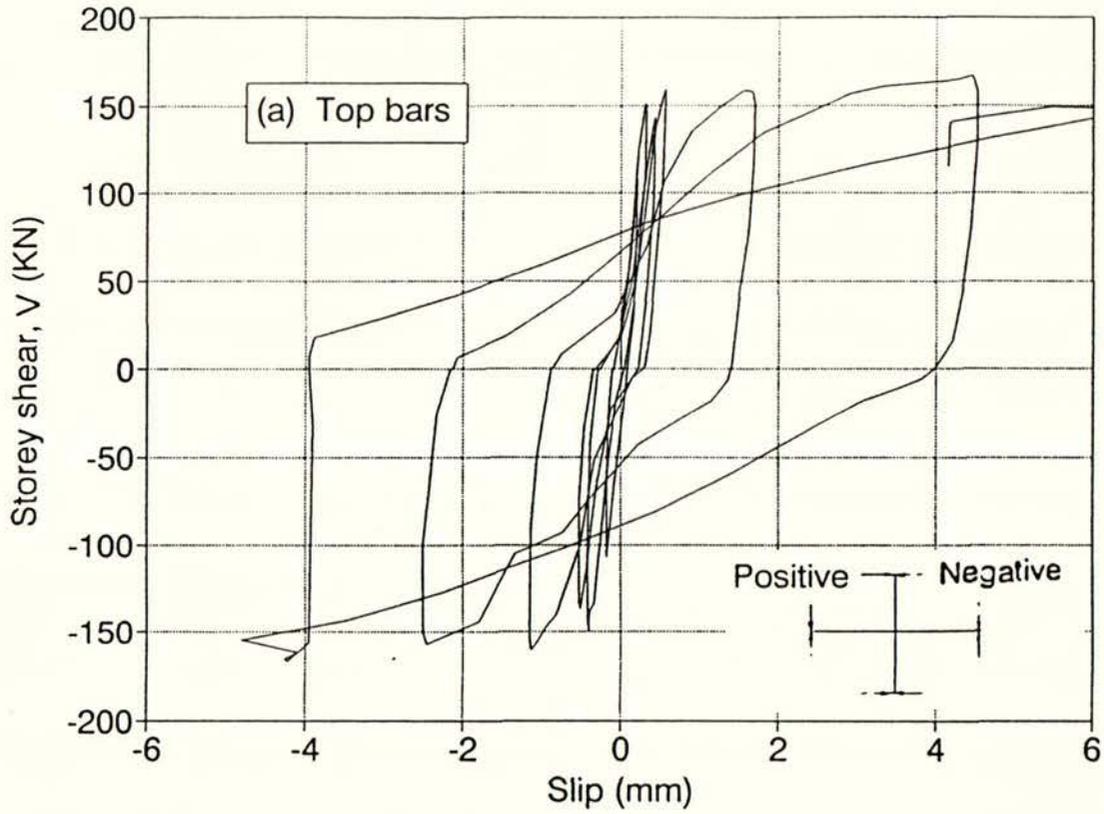
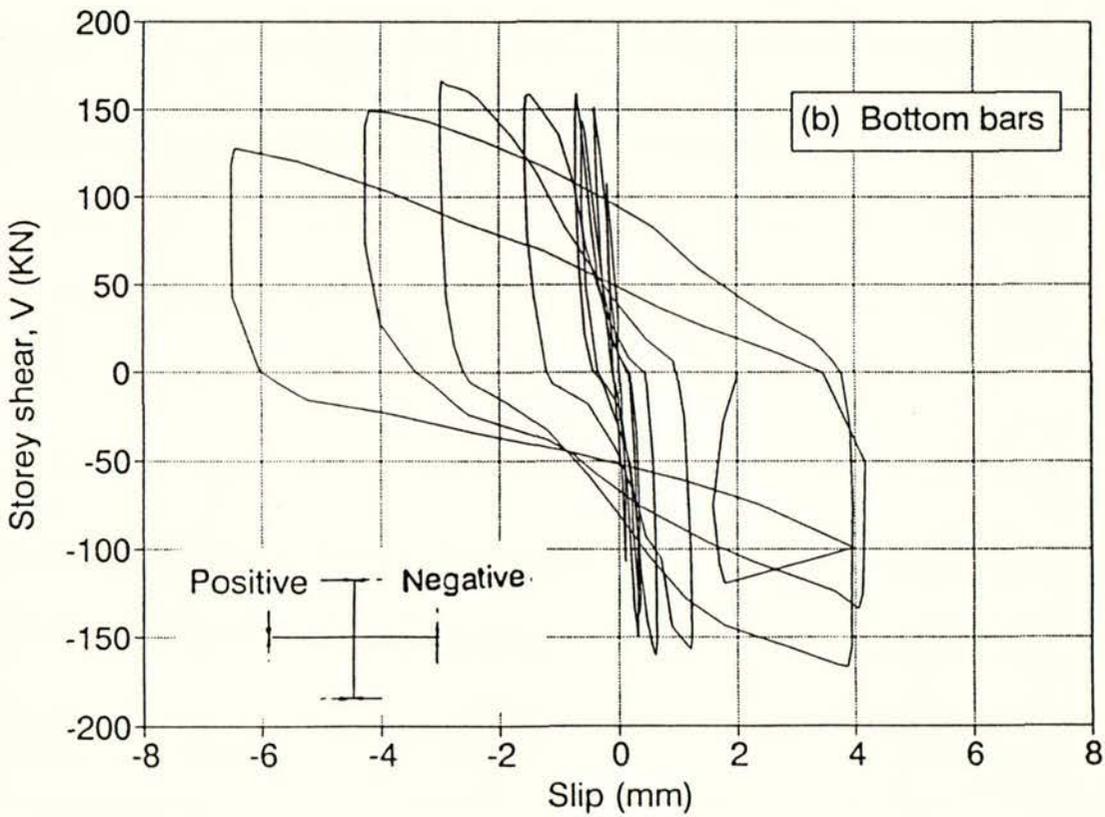
Fig. 5.15 Slip of beam bars within the joint core, Unit 3

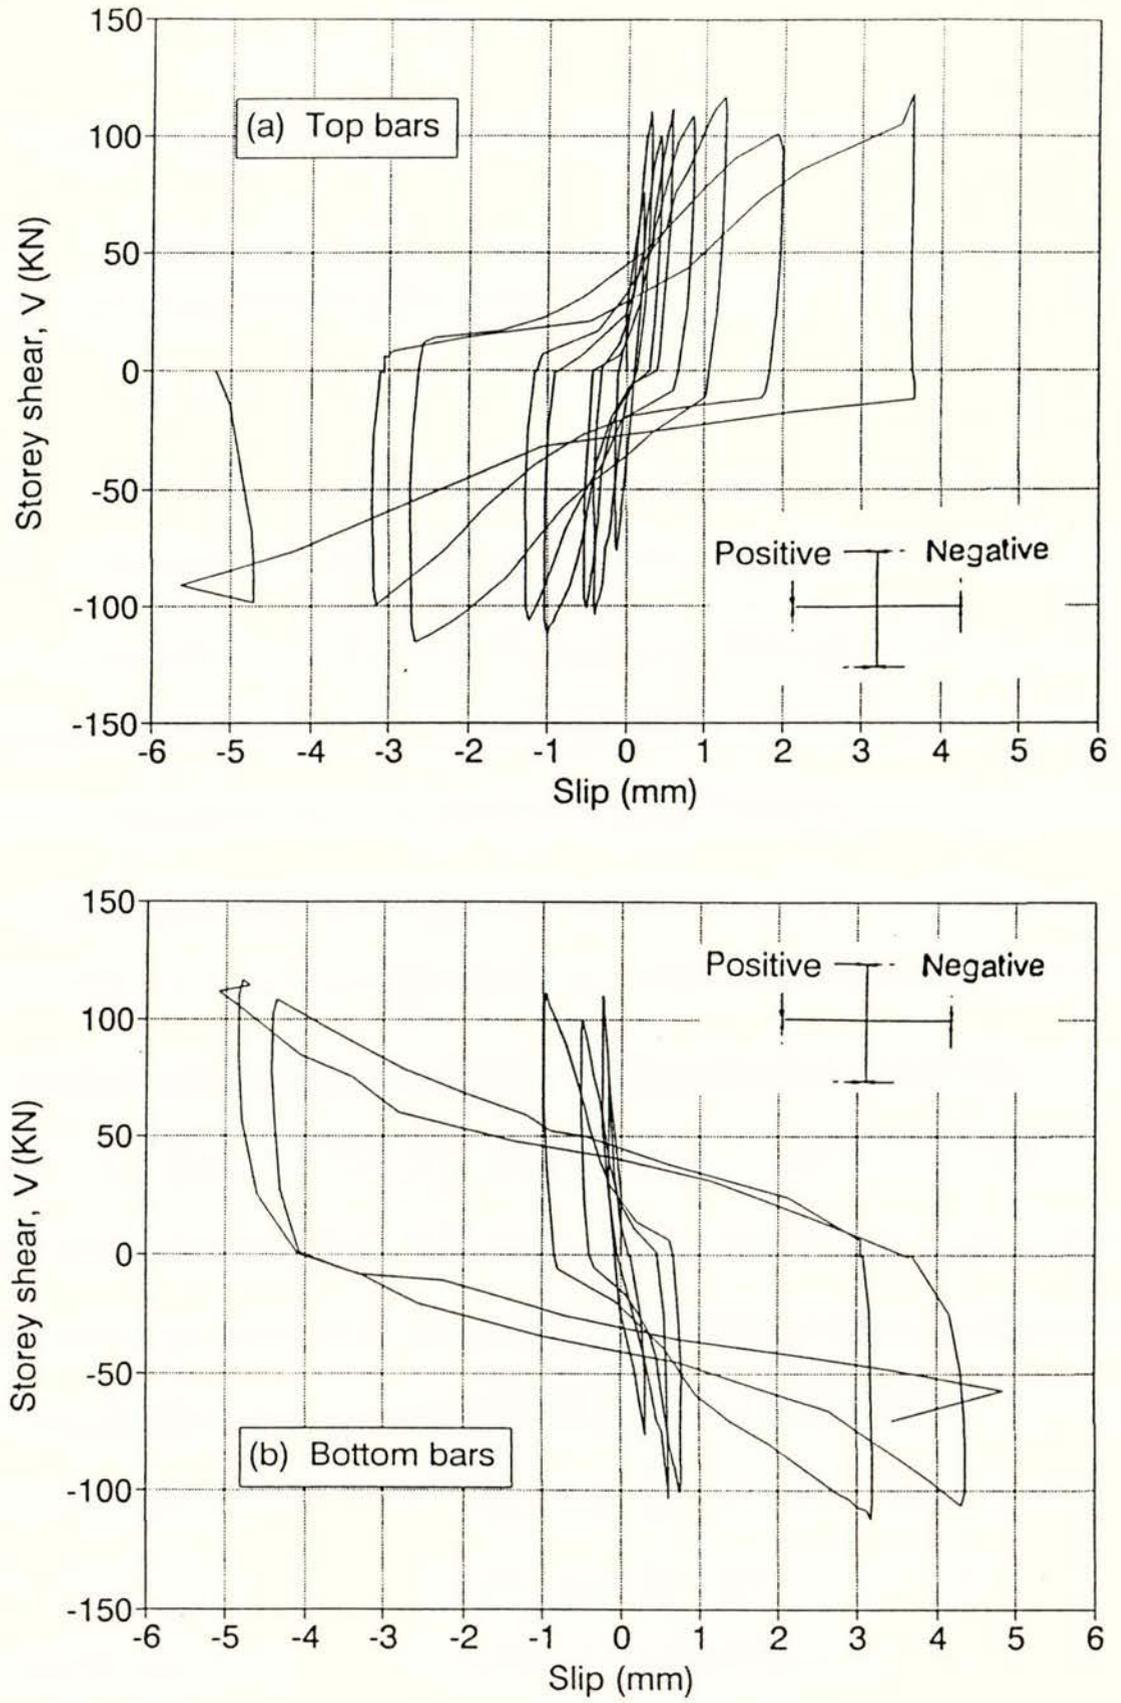
Fig. 5.16 Slip of beam bars within the joint core, Unit 4

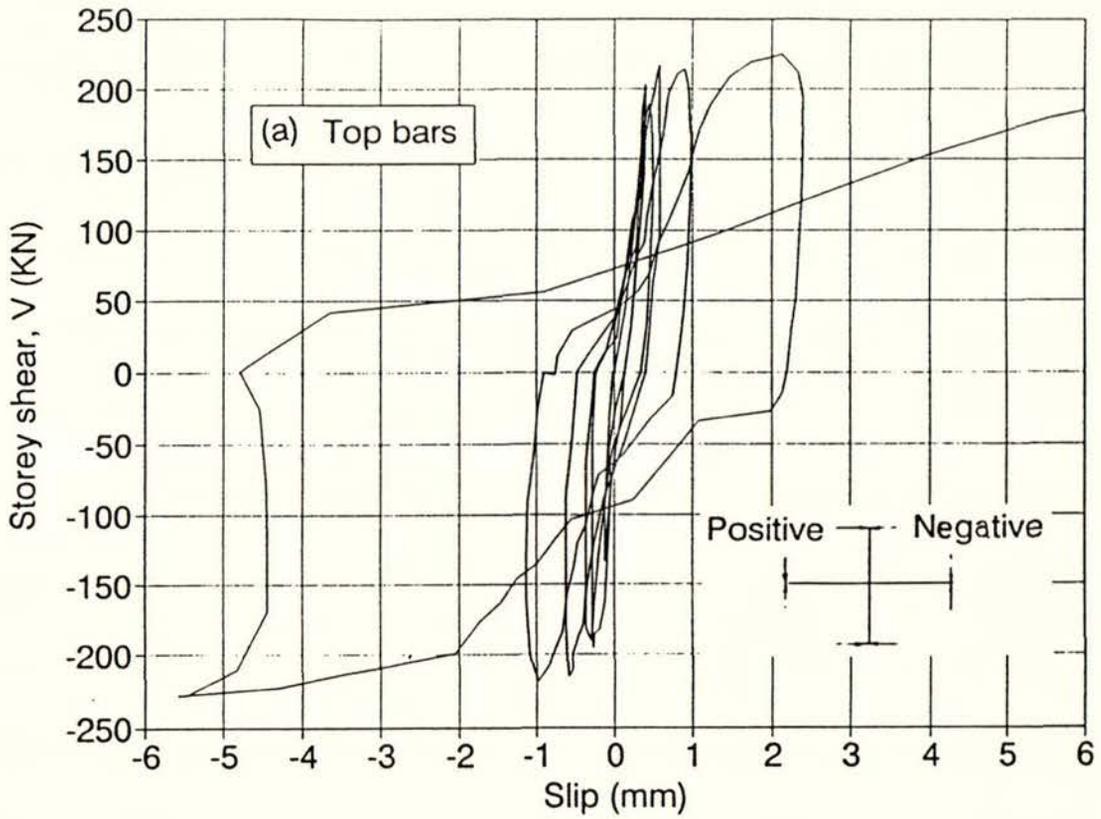
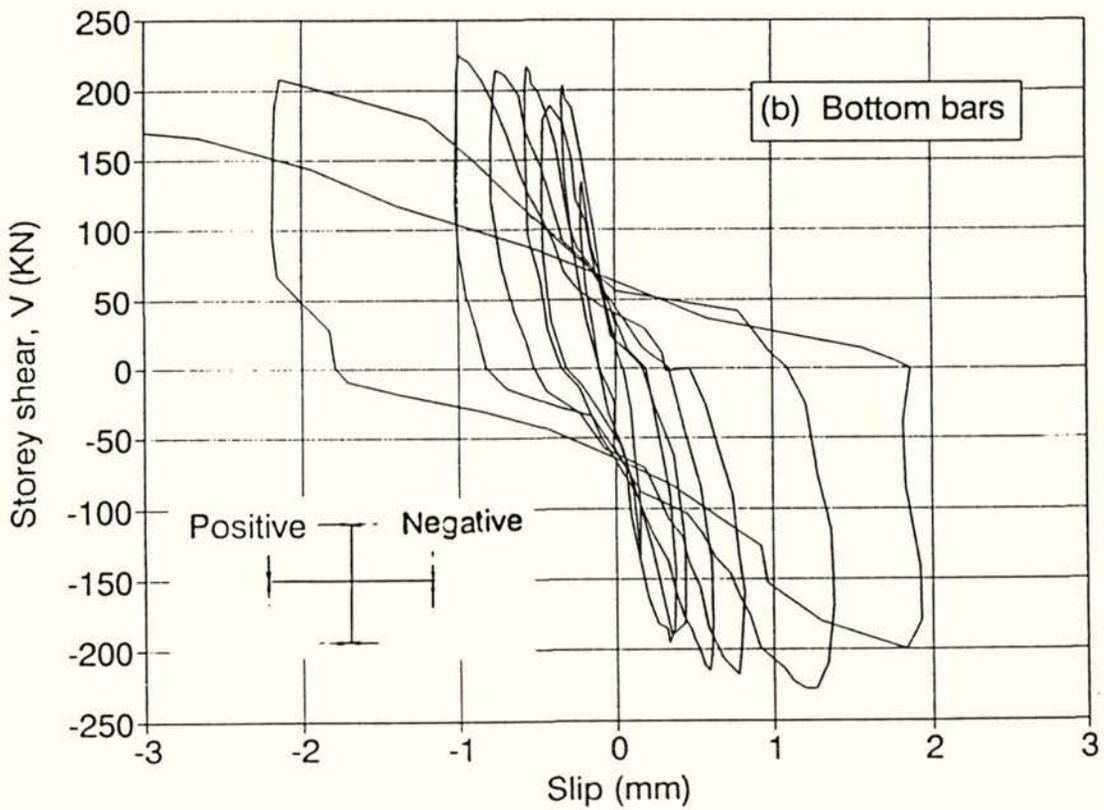
Fig. 5.17 Slip of beam bars within the joint core, Unit 5

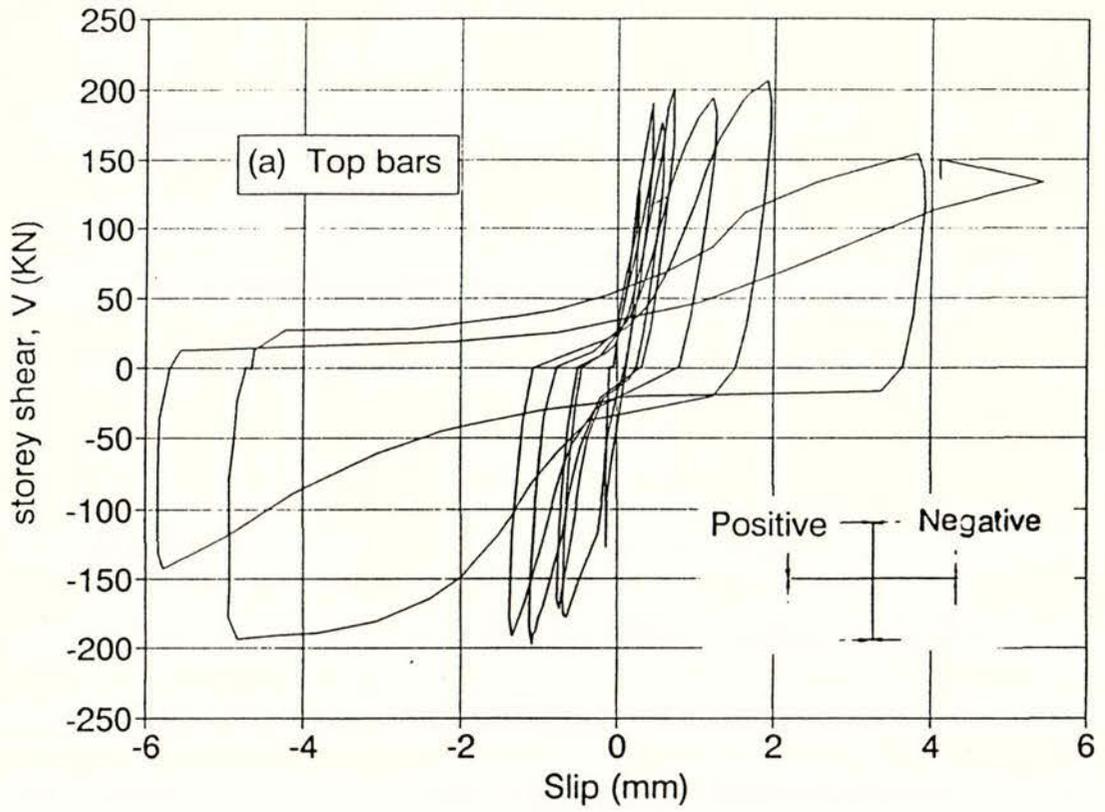
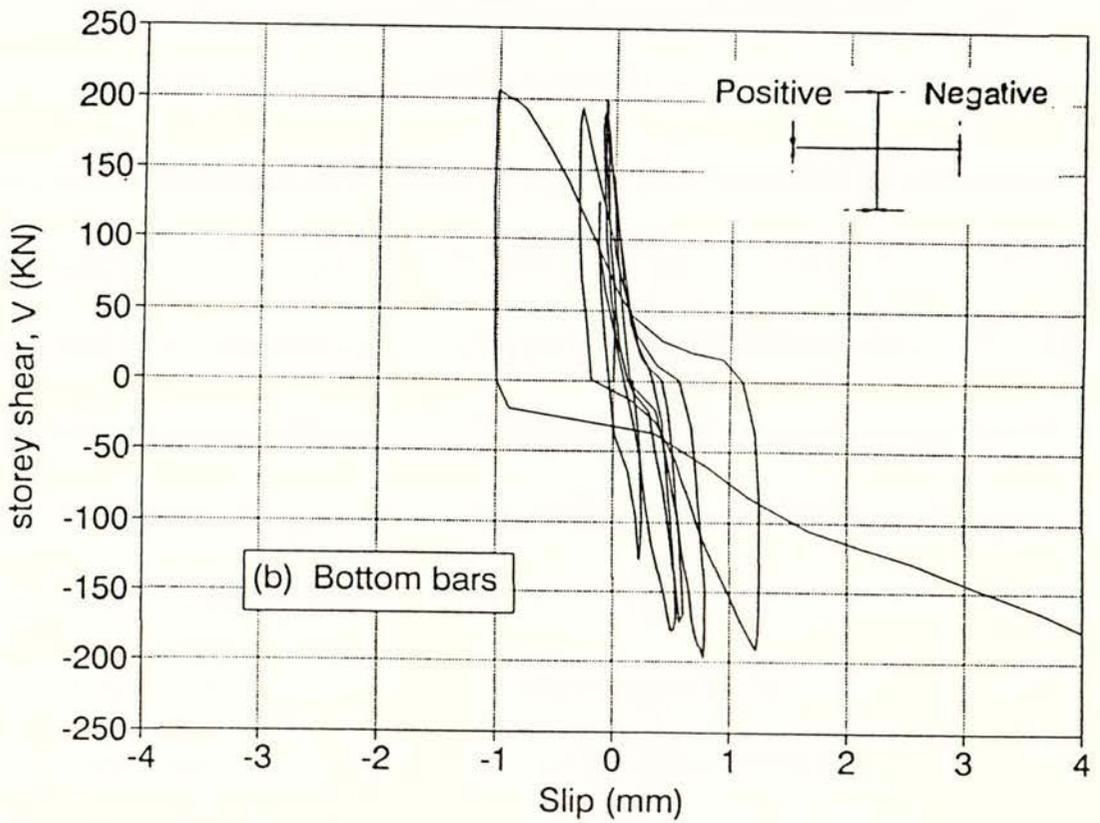
Fig. 5.18 Slip of beam bars within the joint core, Unit 6

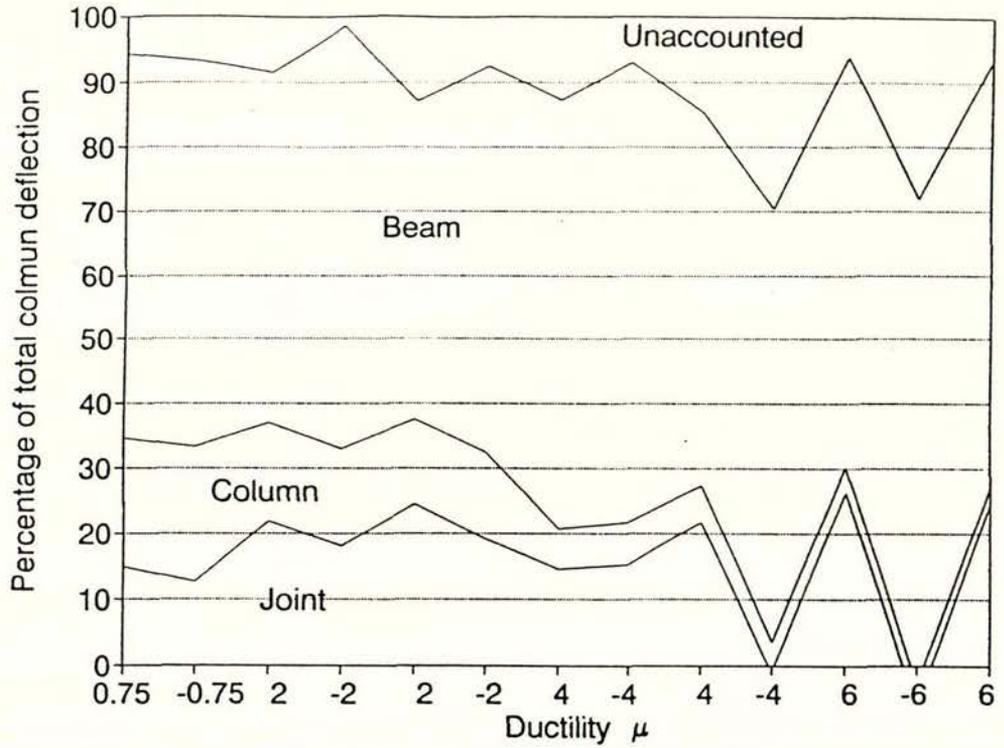
(a) Contribution to interstorey displacement from joint, column & beam deformation

Fig. 5.24 Components of displacement, Unit 6

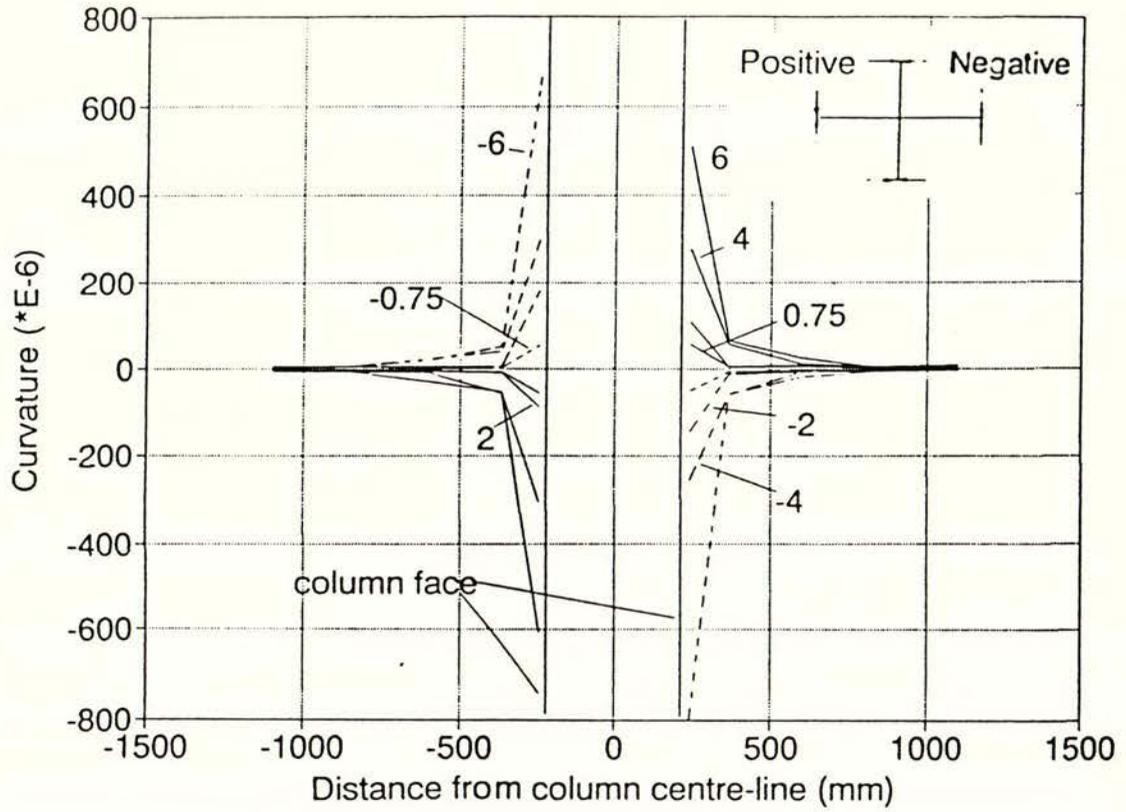
Fig.5.25 Distribution of curvature along the beam, Unit 1

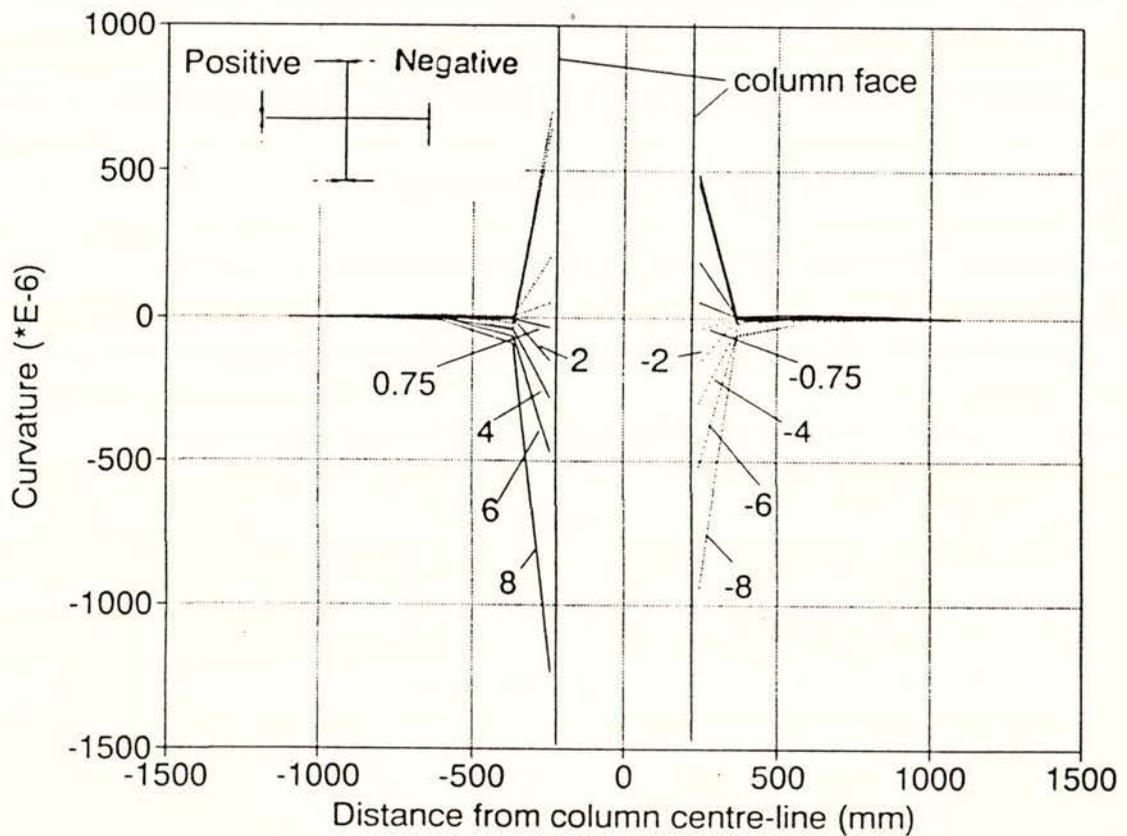
Fig.5.26 Distribution of curvature along the beam, Unit 2

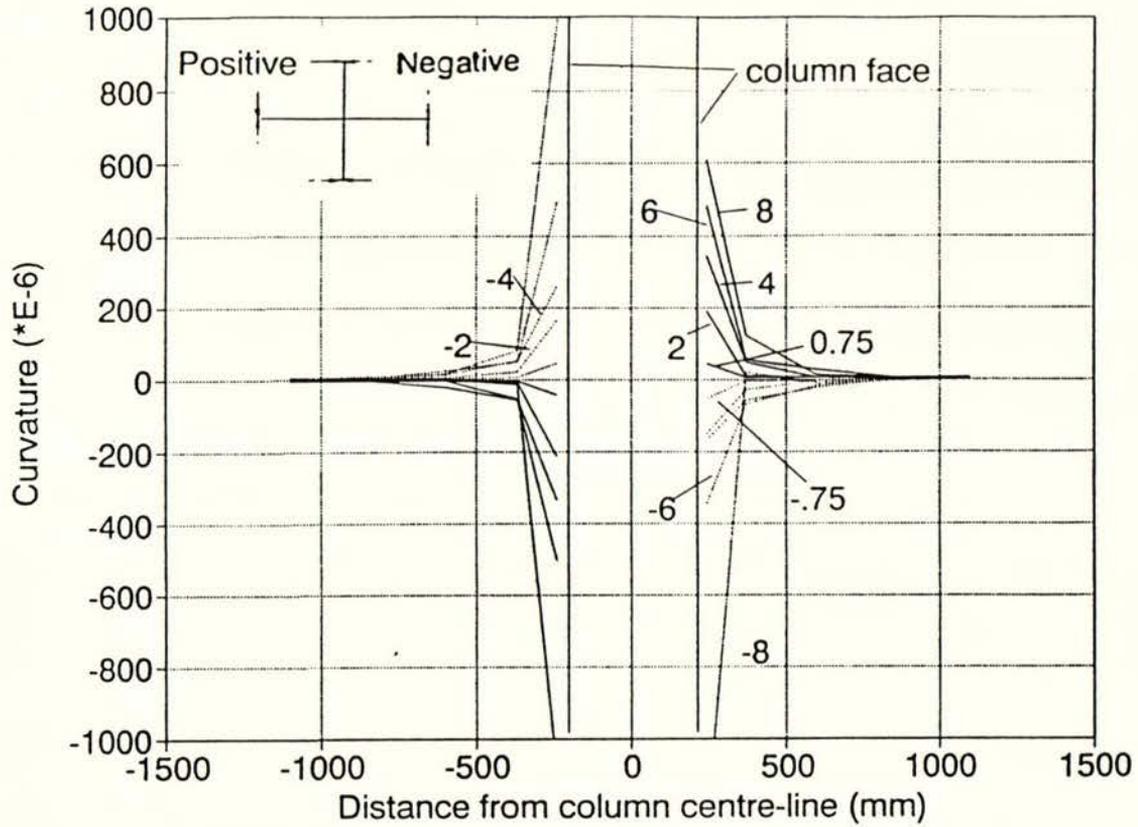
Fig.5.27 Distribution of curvature along the beam, Unit 3
