**Behaviour of Reinforced Concrete Interior Beam-Column Joints
Designed Using High Strength Concrete and Steel**

*Xian Zuo Xin, supervised by R Park and H Tanaka, Department of
Civil Engineering, University of Canterbury*

July 1992

**A Research Report Based on the
Master of Engineering (Civil) Thesis**

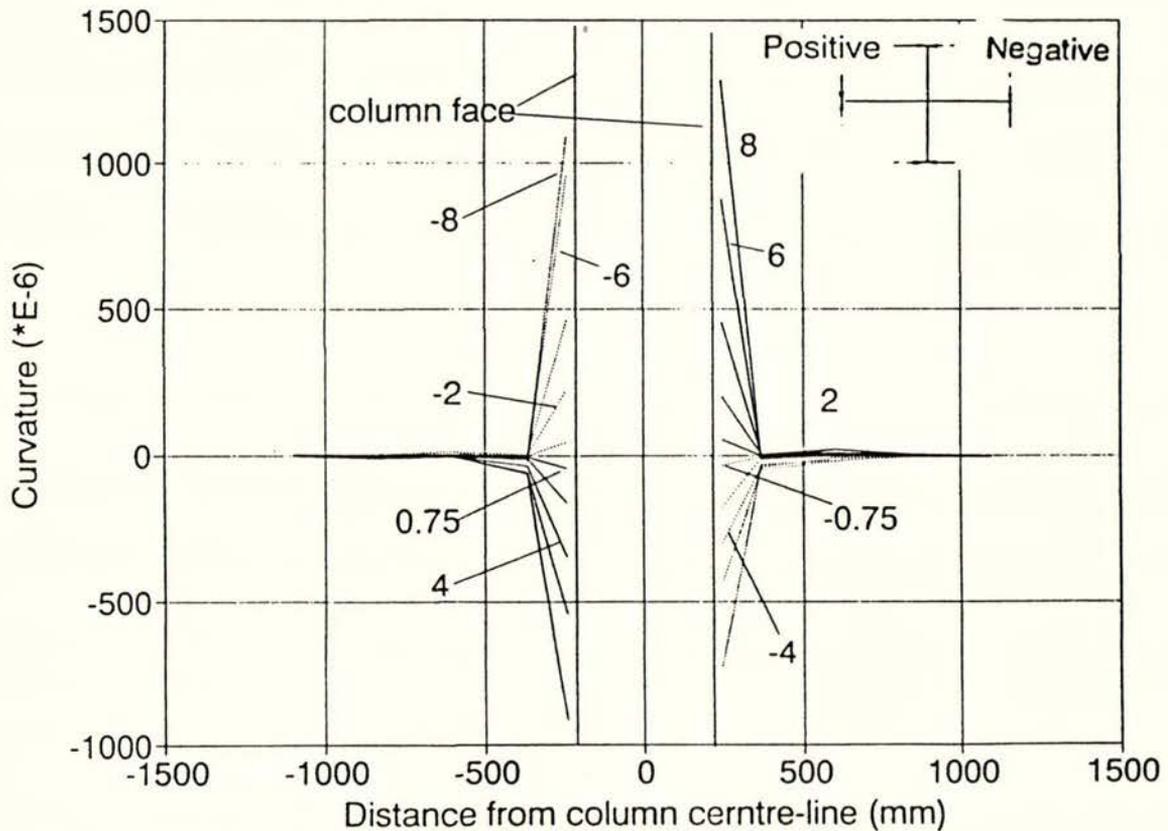
Fig.5.28 Distribution of curvature along the beam, Unit 4

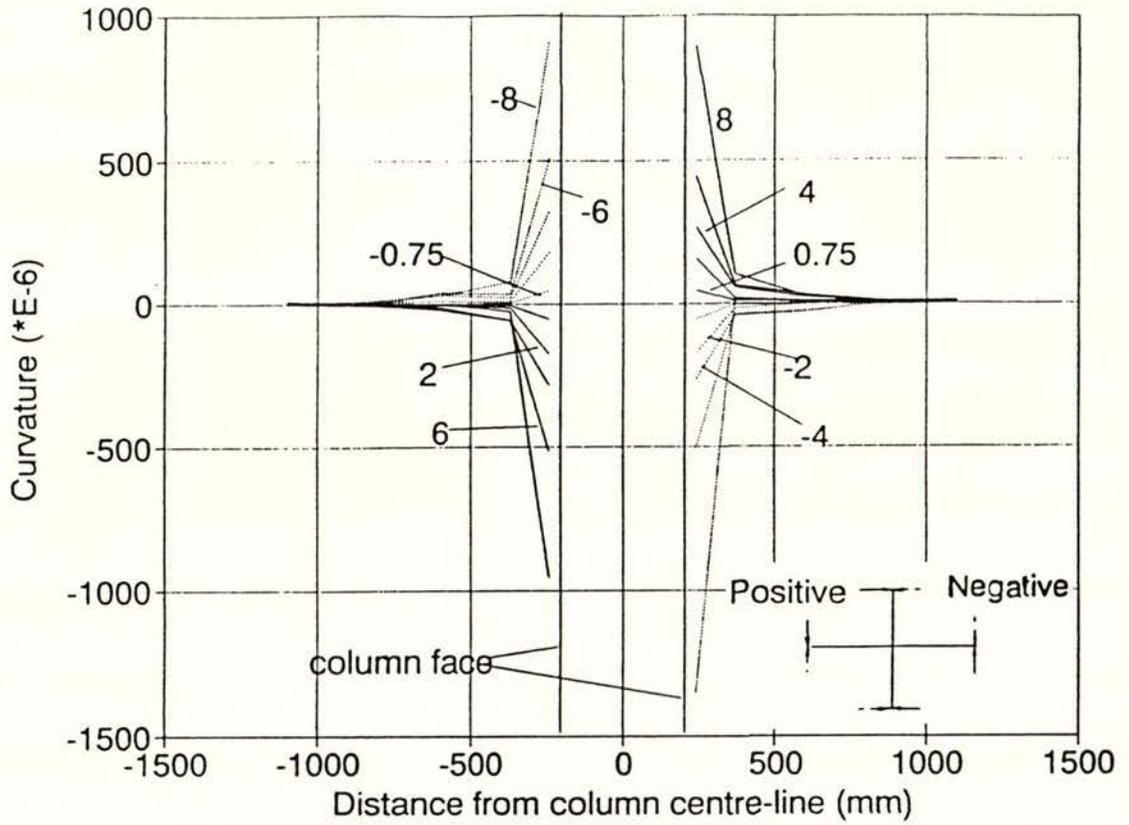
Fig.5.29 Distribution of curvature along the beam, Unit 5

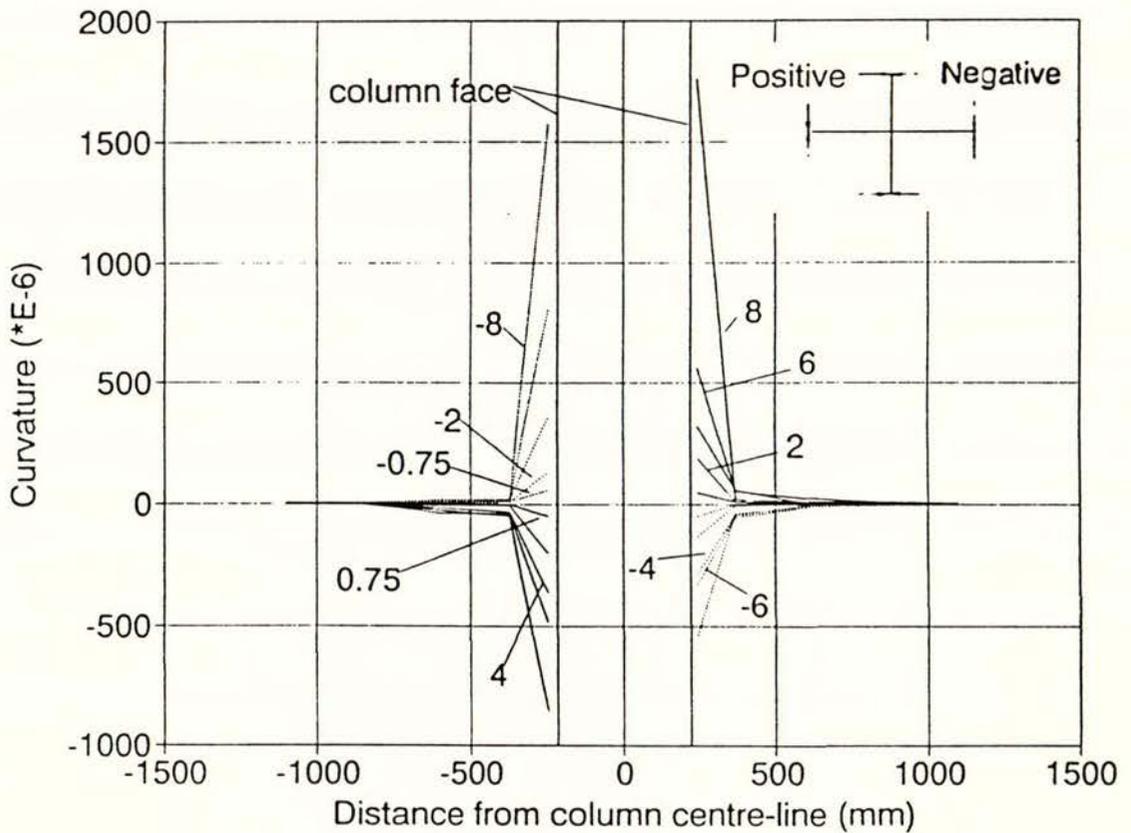
Fig.5.30 Distribution of curvature along the beam, Unit 6

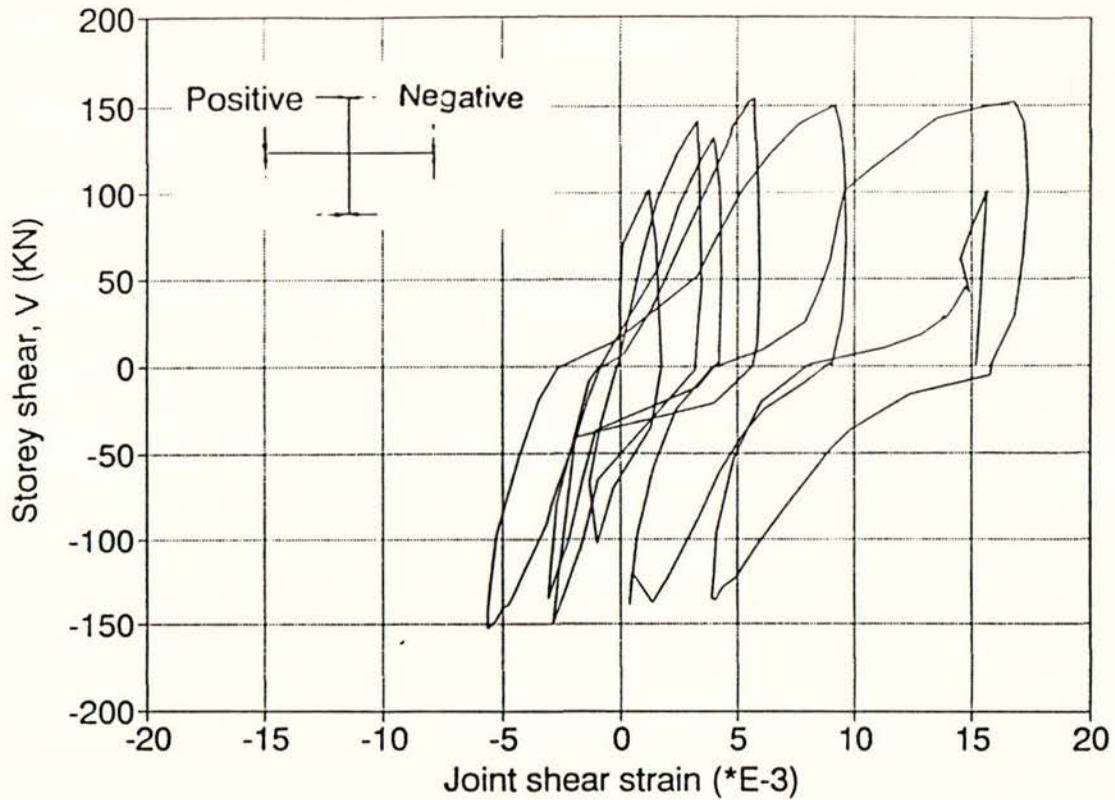
Fig.5.31 Shear deformation of the joint core, Unit 1

It was found that the measured joint shear distortion was unsymmetric during cyclic load in the course of a test, as shown in Fig. 5.31 to Fig. 5.36. This phenomenon was caused by the different widths of the main diagonal cracks in the two diagonal directions.

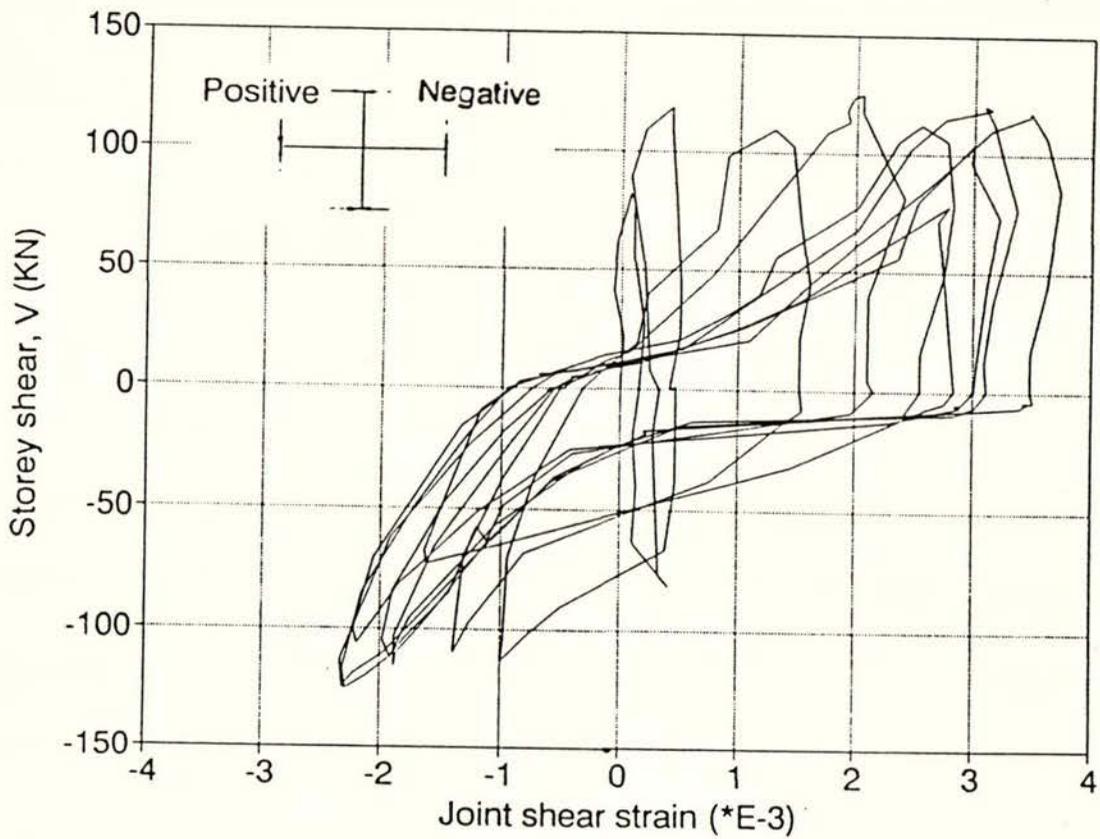
Fig.5.32 Shear deformation of the joint core, Unit 2

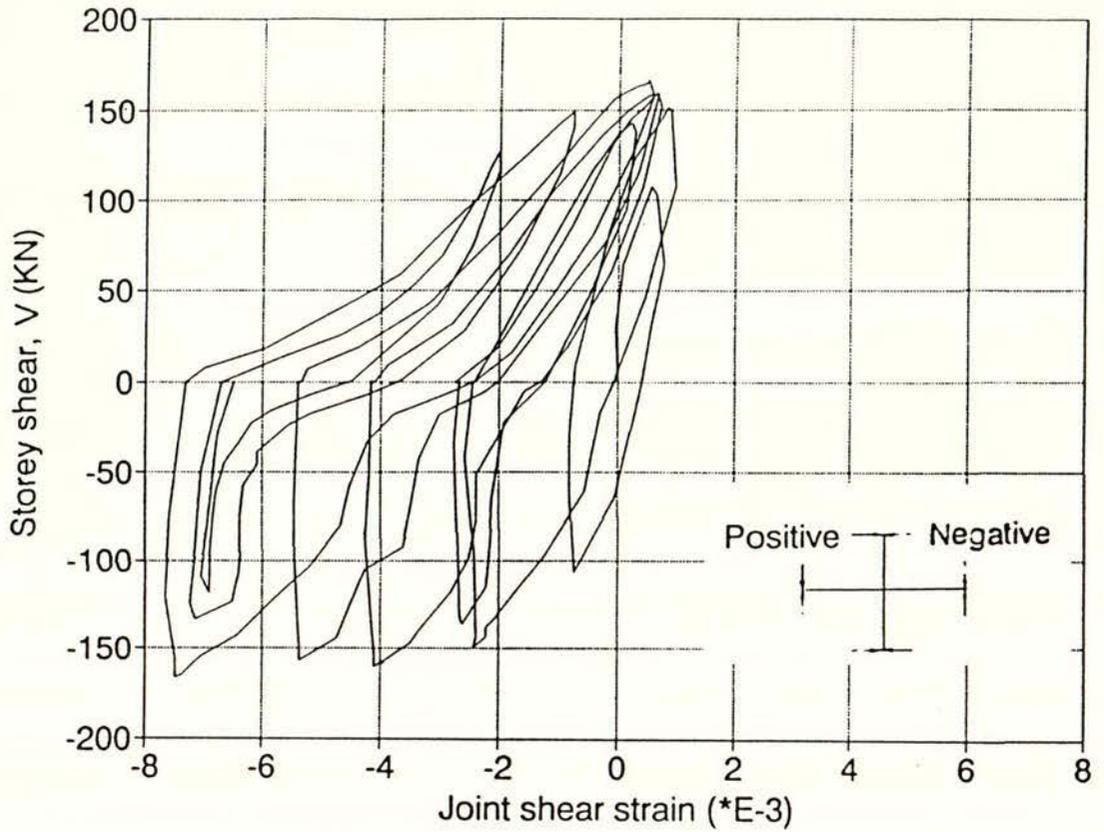
Fig.5.33 Shear deformation of the joint core, Unit 3

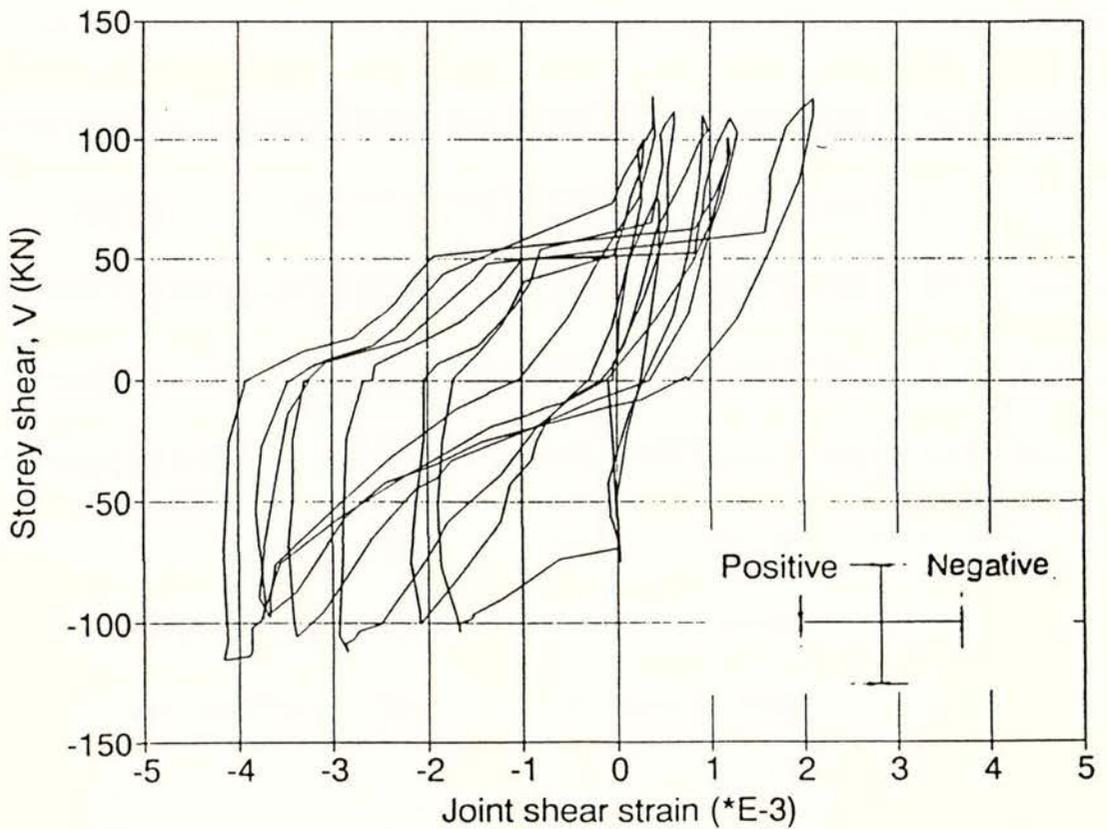
Fig.5.34 Shear deformation of the joint core, Unit 4

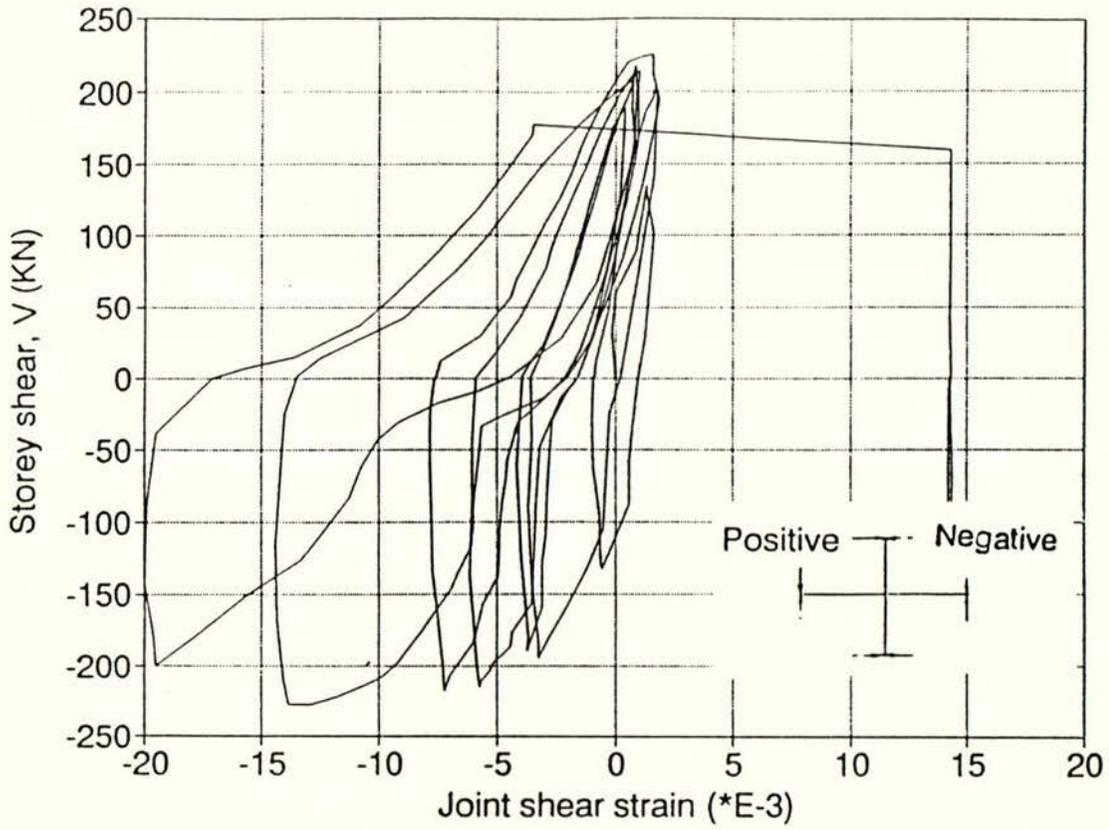
Fig.5.35 Shear deformation of the joint core, Unit 5

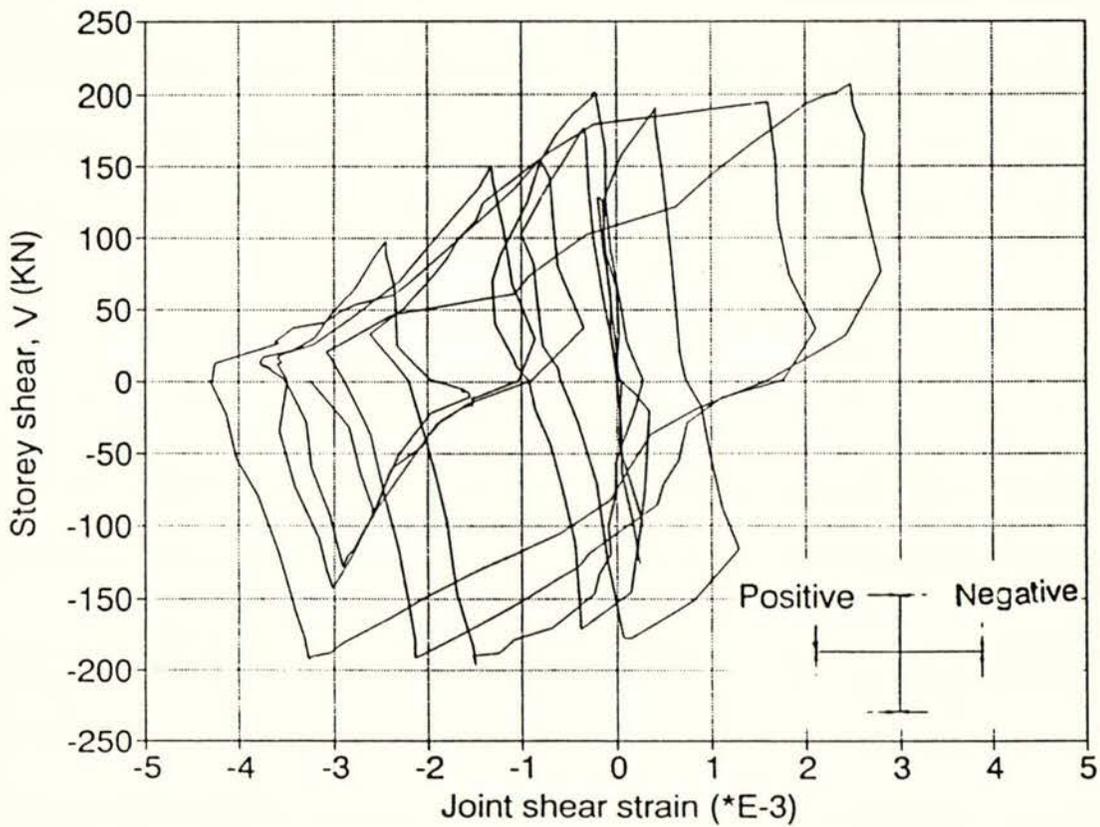
Fig.5.36 Shear deformation of the joint core, Unit 6

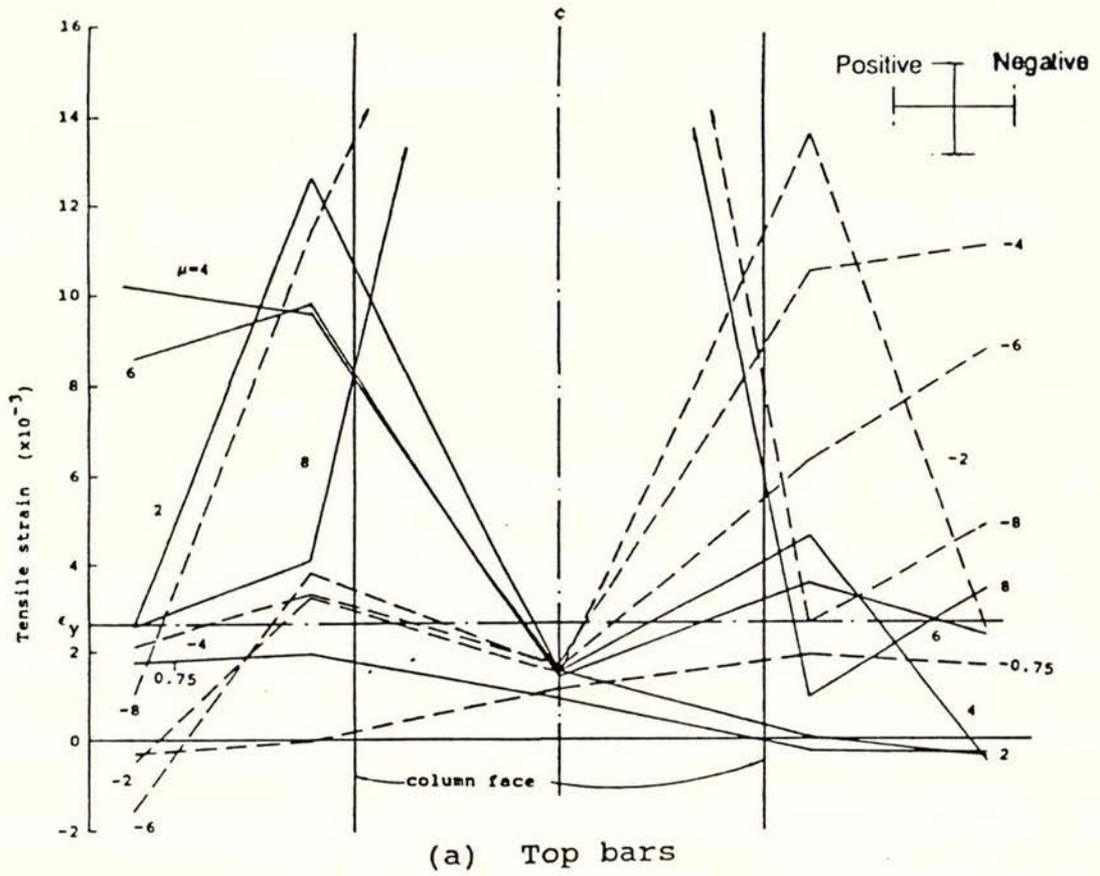
Fig. 5.41 Strain variation along beam bars, Unit 5

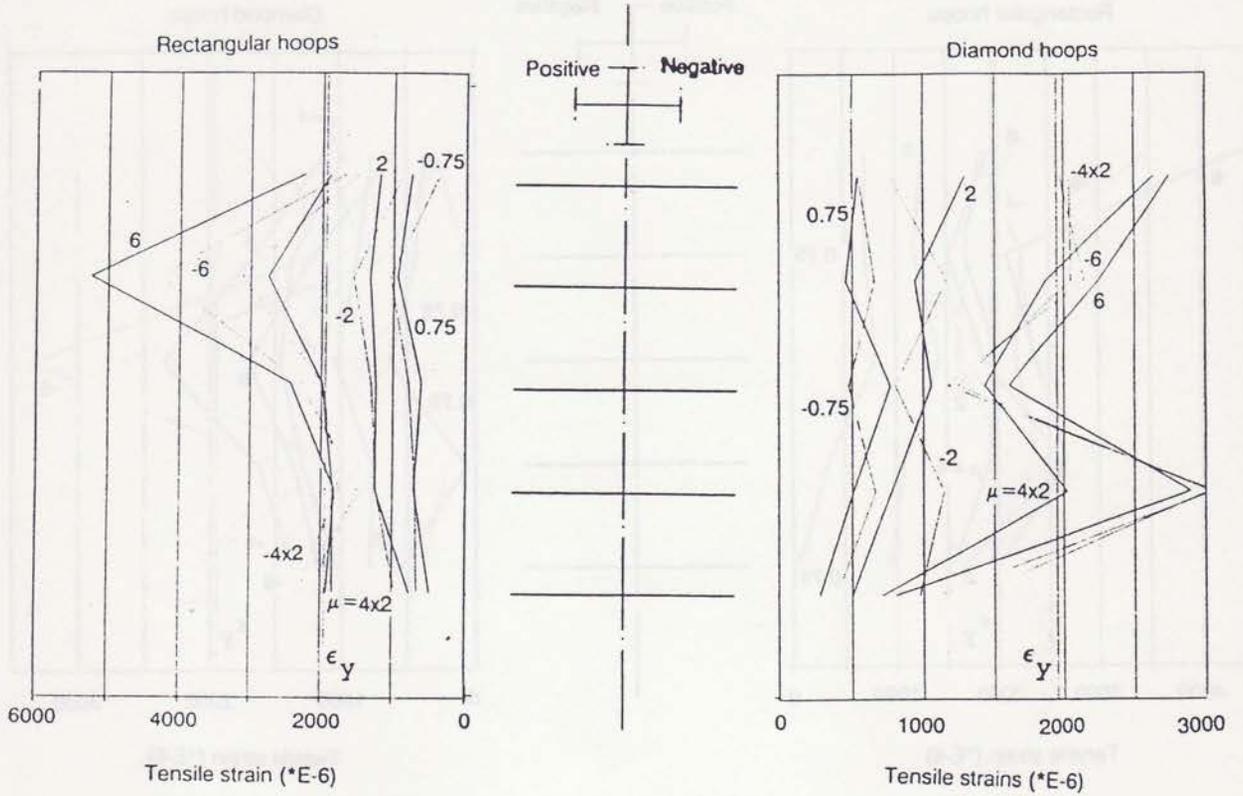
Fig. 5.43 Strain variation of joint core hoops, Unit 1

Fig. 5.43 to Fig. 5.48 show the variation of strain measured on the horizontal rectangular and diamond joint hoops of all six units. The yield strain of the joint core hoops was reached at higher displacement ductility factors in those units with good bond conditions for longitudinal bars, as Unit 1, 3 and 5. During the test, the joint cores tended to swell.

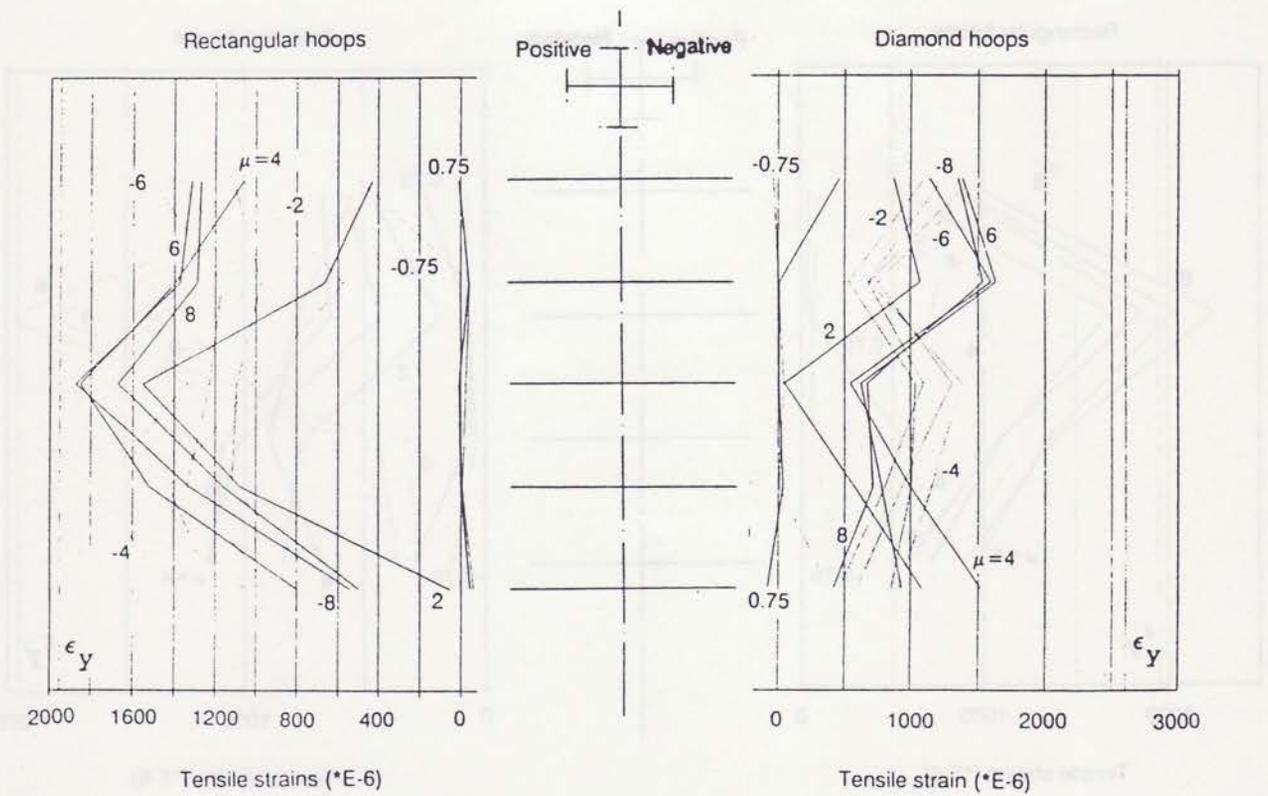
Fig. 5.44 Strain variation of joint core hoops, Unit 2

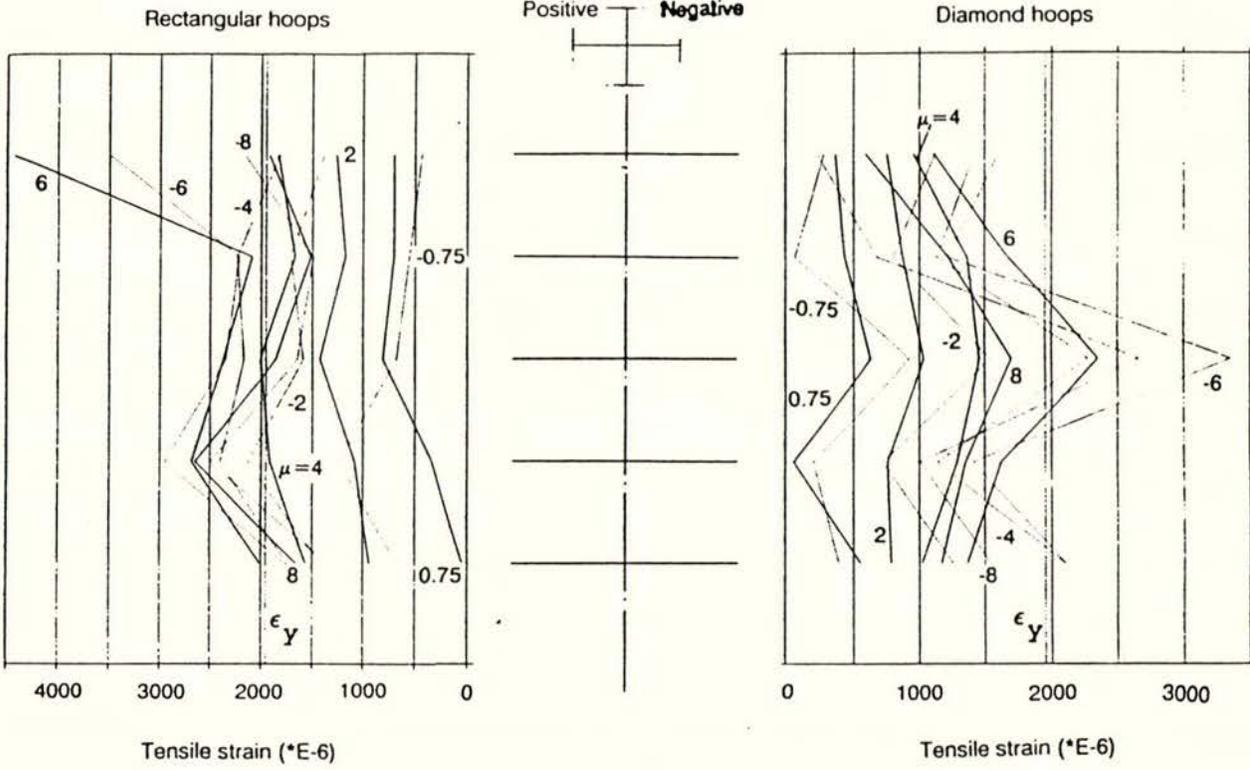
Fig. 5.45 Strain variation of joint core hoops, Unit 3

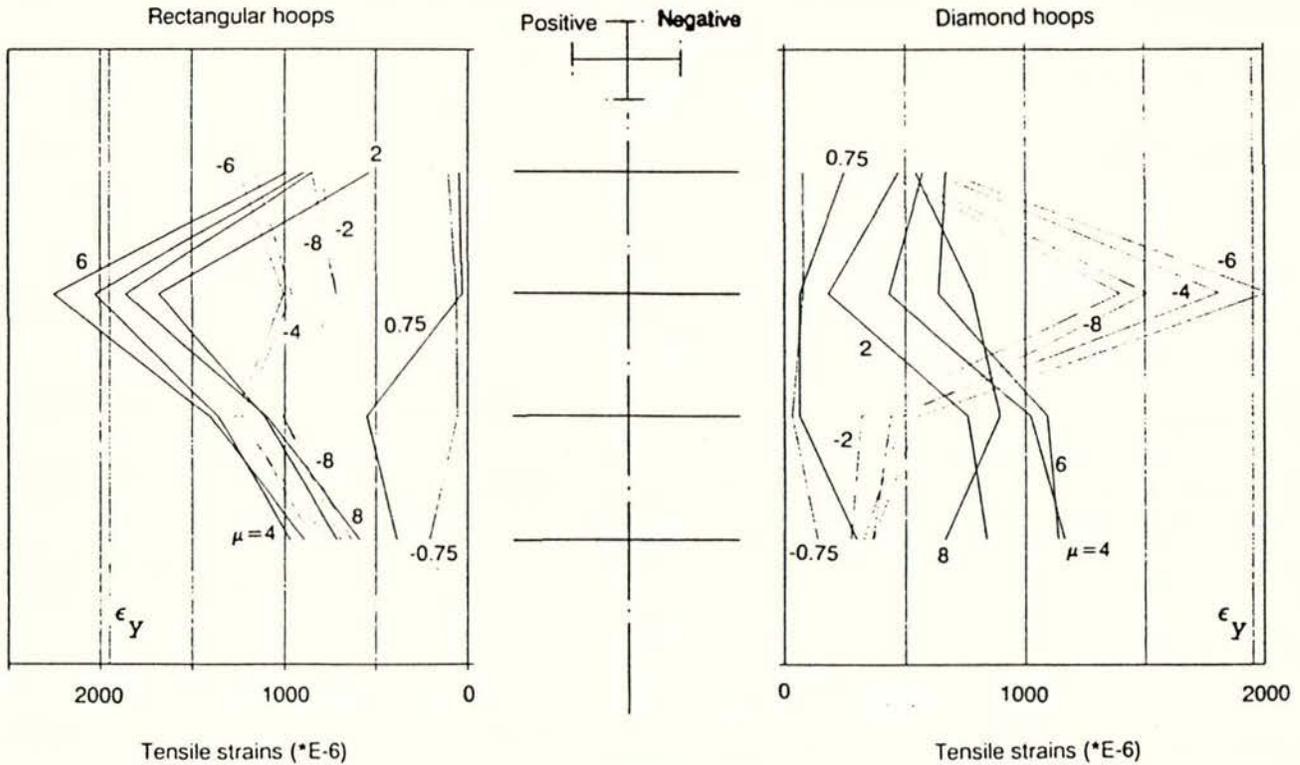
Fig. 5.46 Strain variation of joint core hoops, Unit 4

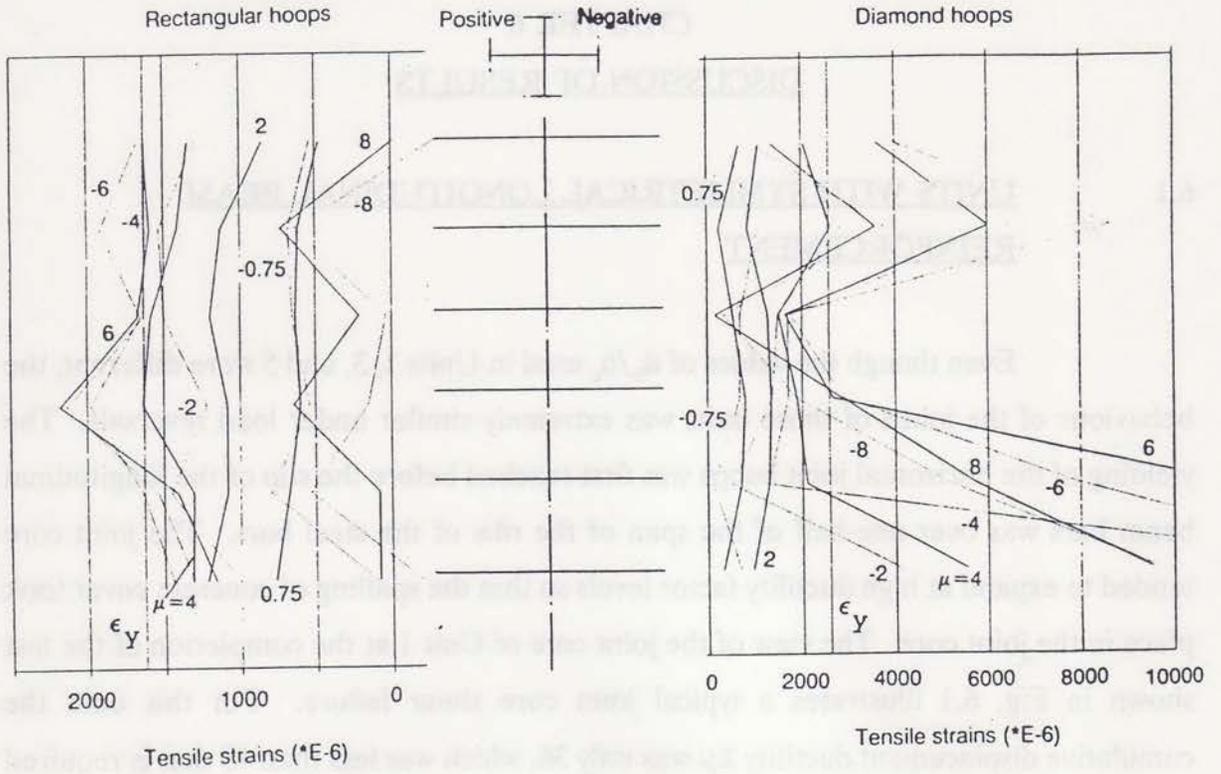
Fig. 5.47 Strain variation of joint core hoops, Unit 5

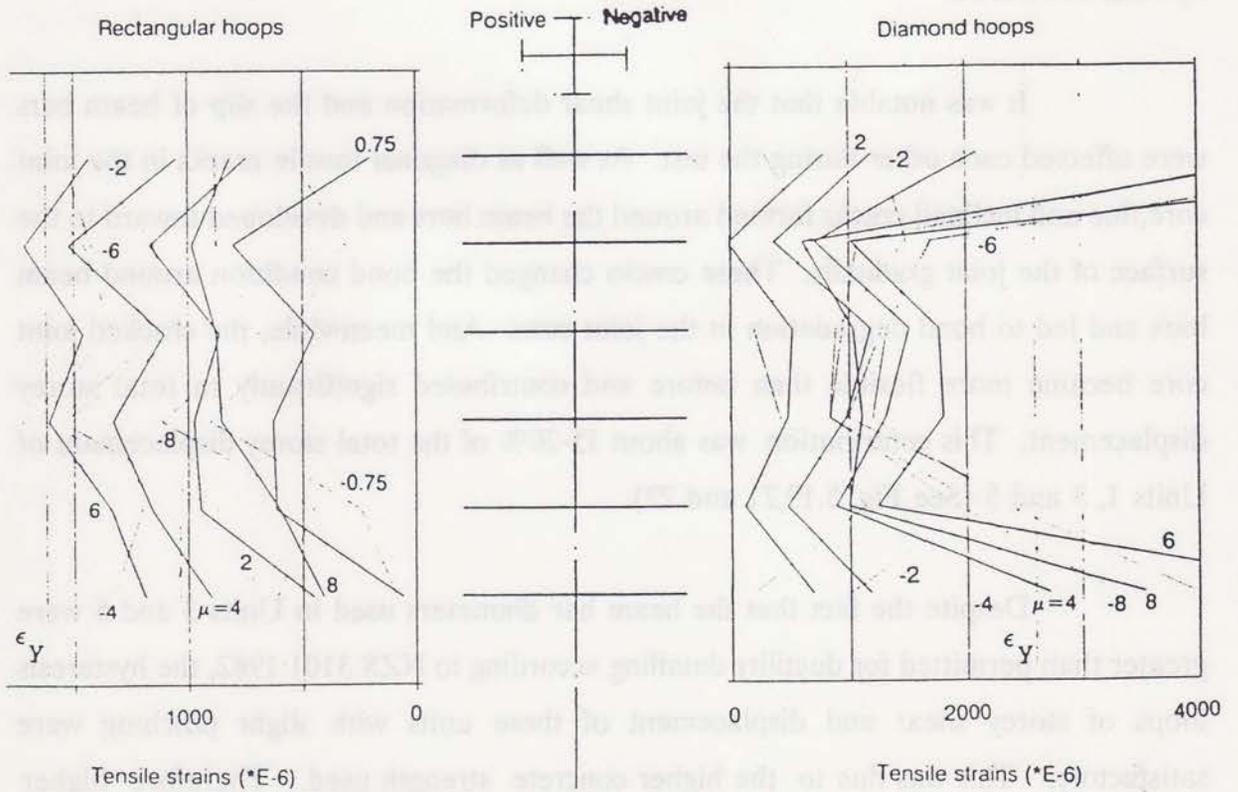
Fig. 5.48 Strain variation of joint core hoops, Unit 6

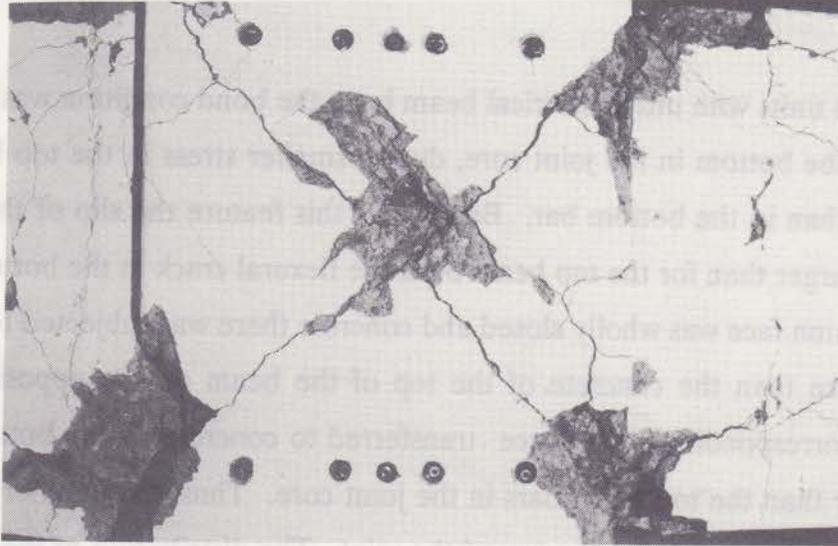
Fig. 6.1 Feature of shear failure in the joint core, unit 1

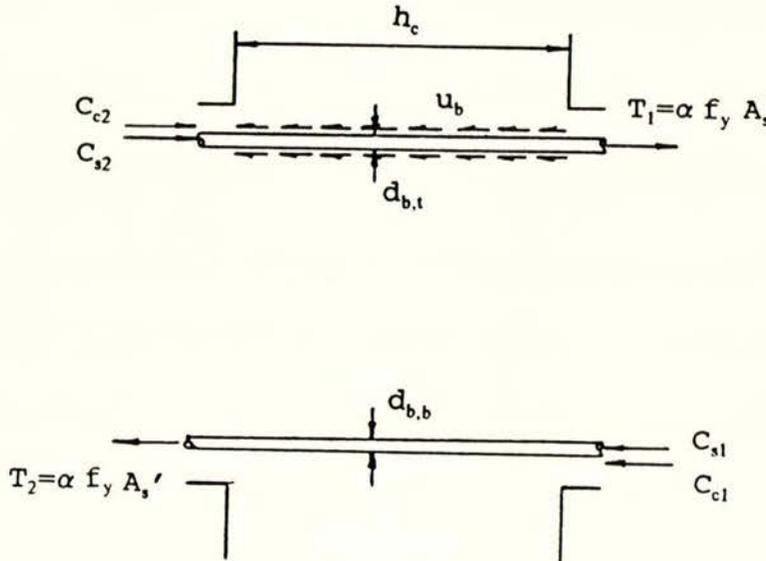
Fig. 6.2 Force acting on the beam bars across an interior beam-column joint core

The above code limit expressed by Eq. 6.1 was derived considering the most severe stress condition attained when beam bars were subjected to overstrength simultaneously in tension at one column face and in compression at the opposite column face [31]. That is, it was assumed that the resultant forces of steel T_1 and C_{s2} in Fig. 6.2 could reach $\alpha f_y A_s$ at the same time, where α = overstrength factor of steel. This situation can occur if the bond condition is extremely good and hence the beam bars do not slip during cyclic loading.
