Precast Concrete Floor Unit Support and Continuity Report on the performance of current details: effects of frame dilation and translation on extruded hollow core flooring

M D Herlihy, Department of Civil Engineering, University of Canterbury (Supervised by: Professor R Park, Mr D K Bull)

Project 93/103 Precast Concrete Floor Unit Support and Continuity

Report on the performance of current details: effects of frame dilation and translation on extruded hollow core flooring

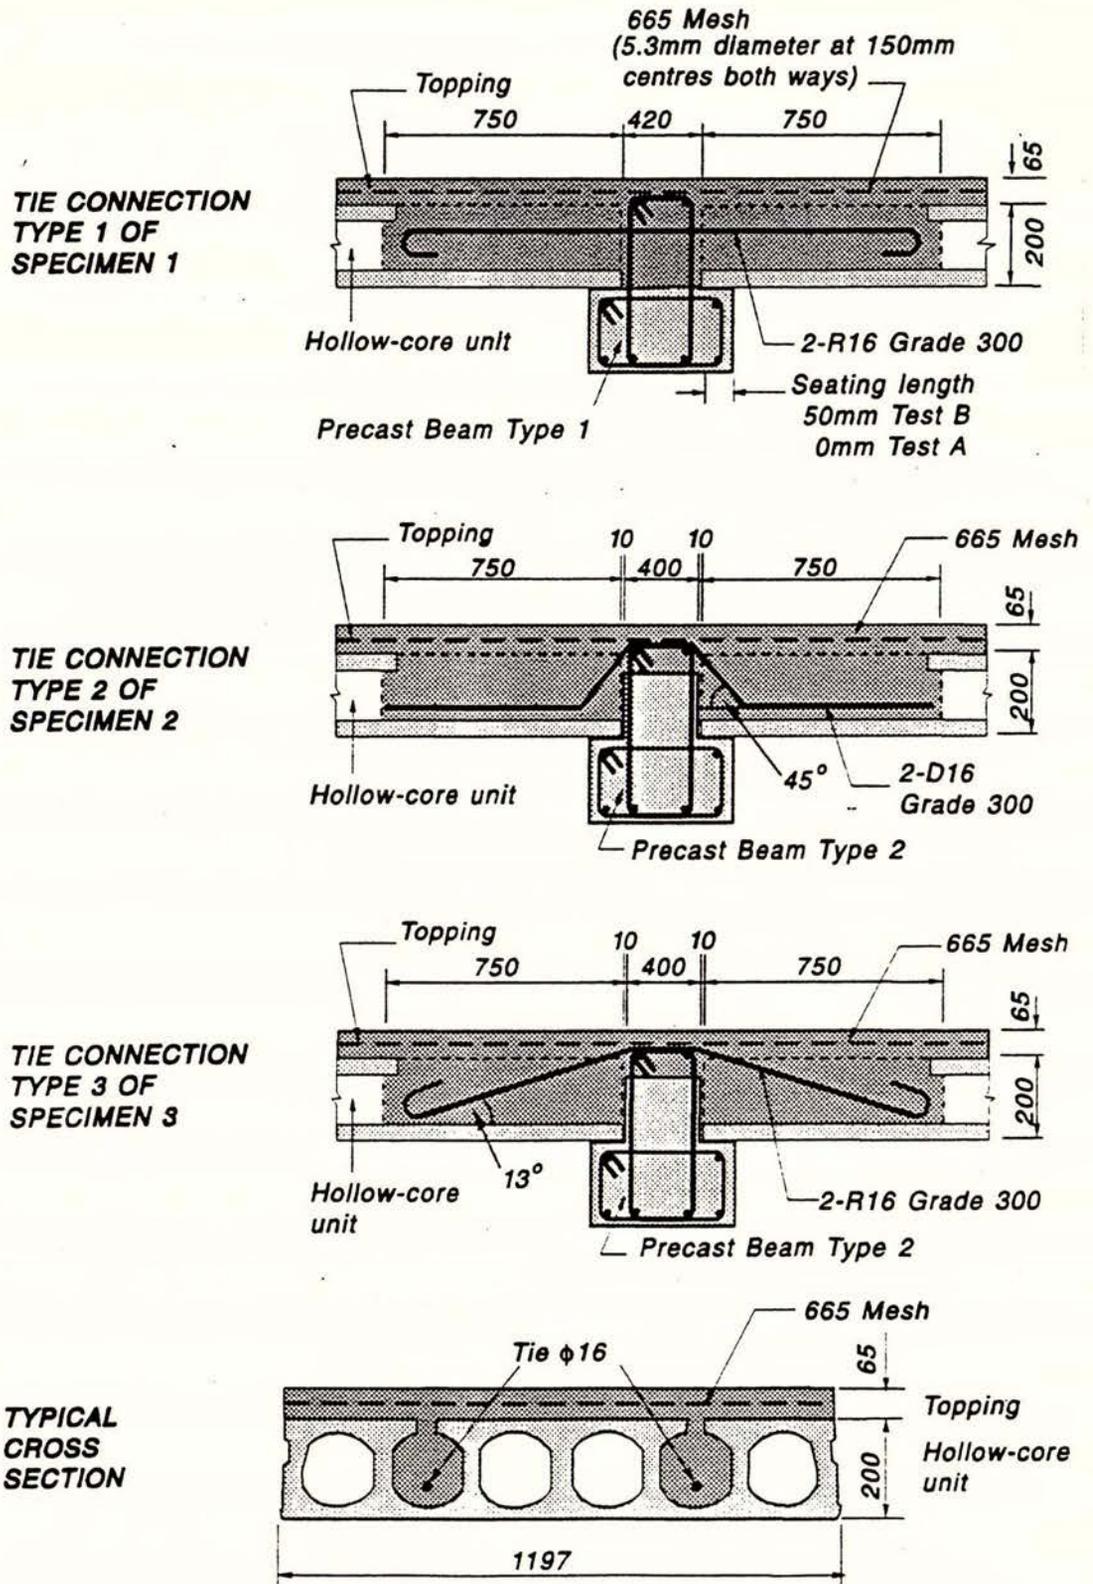
Fig 1.2: Tie connection details reported by Mejia and Park [6].

*Note: Connection Type 2 is not recommended for horizontal displacement loading.

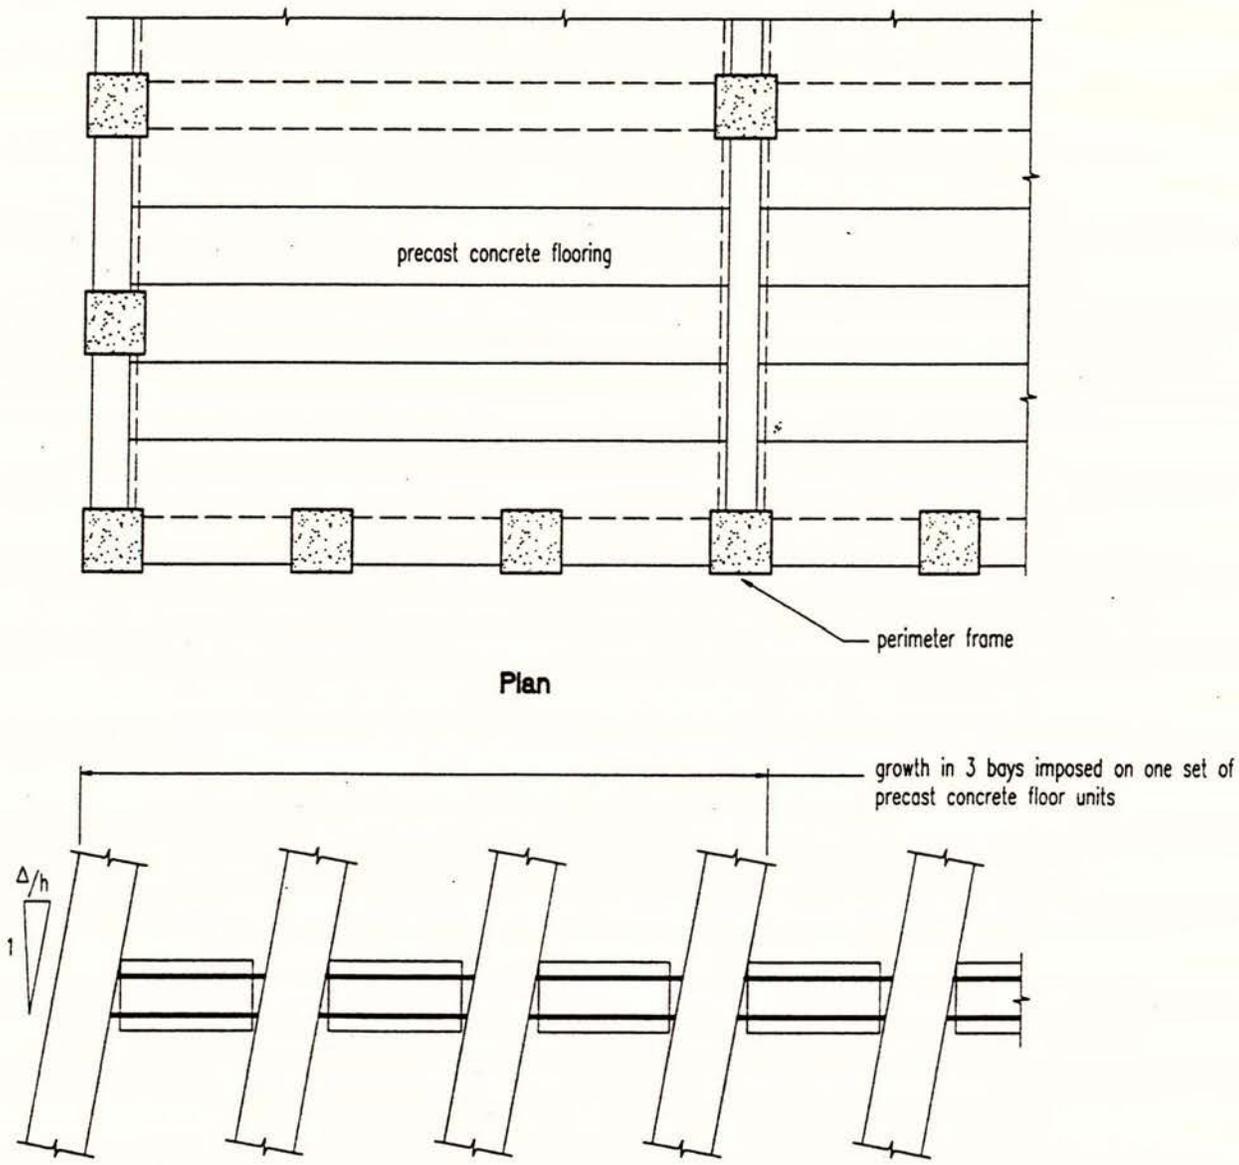
Fig 2.1: The expansion of a perimeter frame through sway displacements.

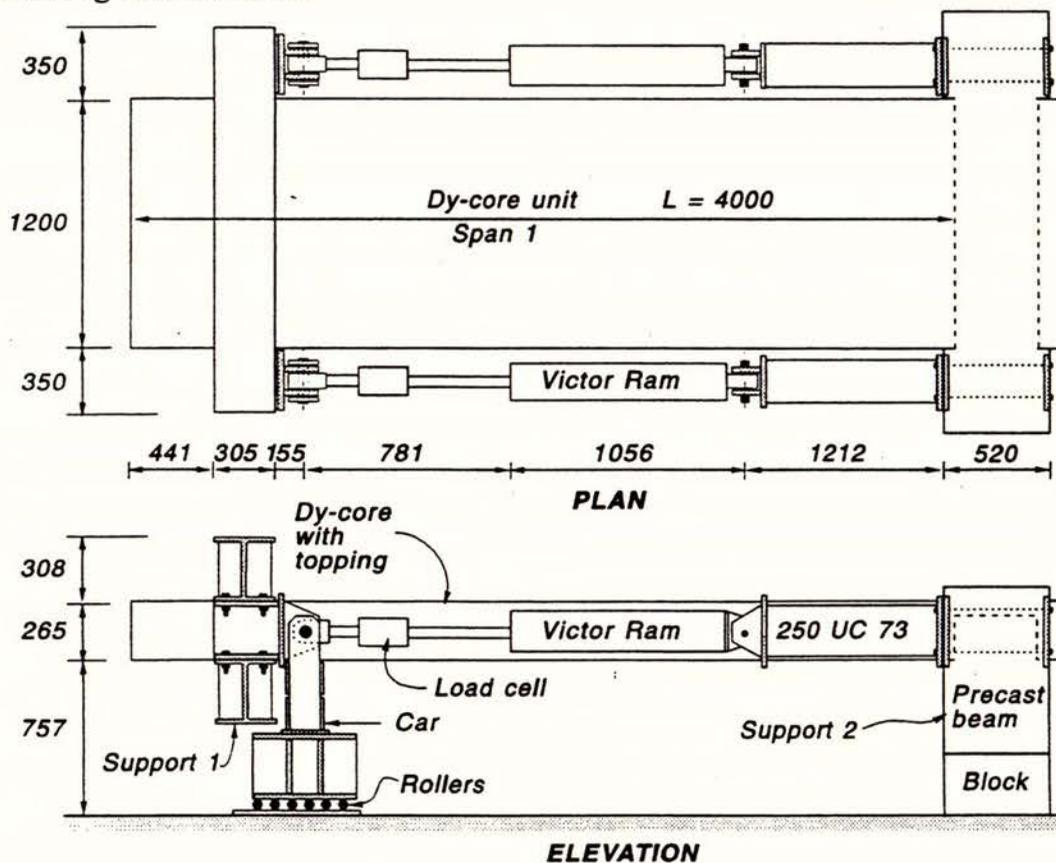
The horizontal force was applied to the test specimens via two parallel acting rams, each rated at 43 tons. These rams were attached directly to the support beam blocks, and hence the system was self stressing and had no reliance on external reactions. At the other end, the rams were each connected to a hinging carriage device that permitted both horizontal and rotational displacements. The Hollow Core unit was secured to the support carriages by two 310 UC 97 beams that were placed above and below the precast section, and bolted to it by eight 24mm diameter threaded rods. The threaded rods were made effective in shear by allowing the topping concrete to fill the Hollow Core voids for approximately 600mm from the end of the unit. Additional reinforcing was placed at the composite topping interface to develop the horizontal force through shear friction.

Fig 2.2: Method for horizontal loading.

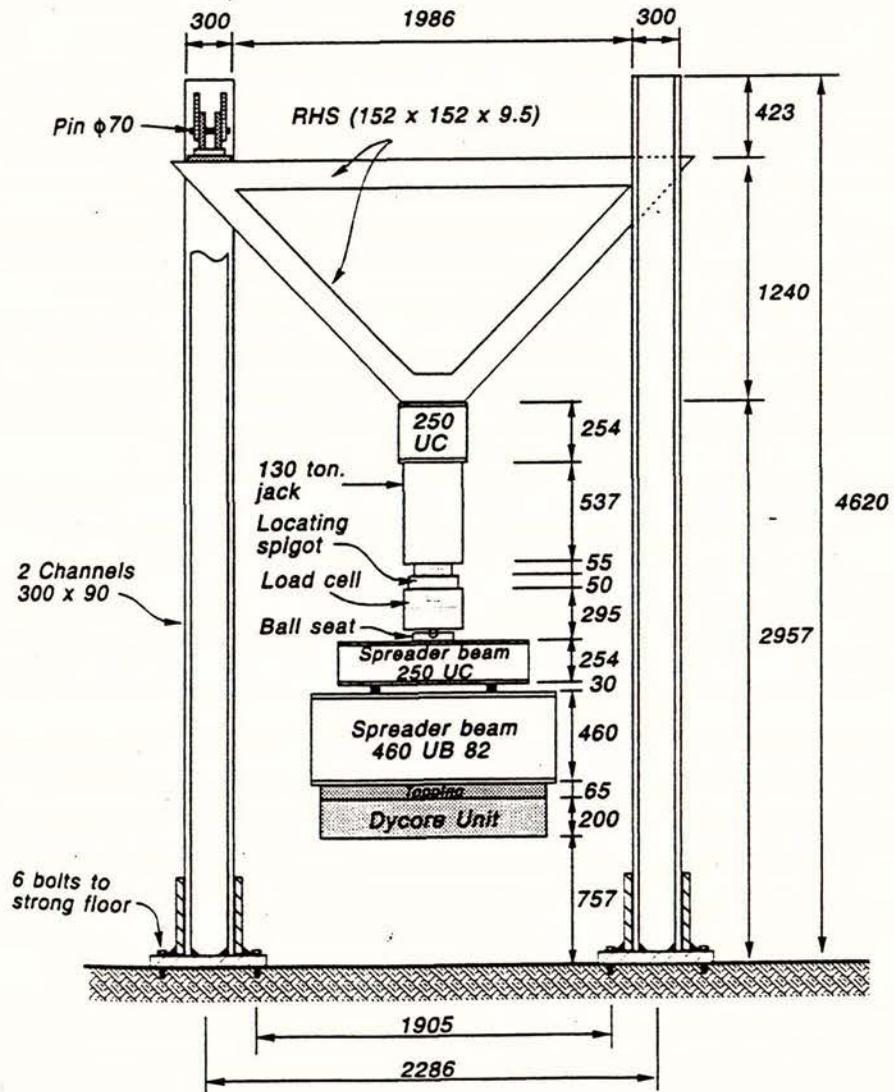
The provision for vertical force, in addition to unit self weight plus rig, was made available by the existing test apparatus used for support loss tests. This device utilises a 130 ton hydraulic ram acting through a series of spreader beams. The spreader beams were each seated onto a bedding of either plaster of Paris, or cement sand mortar where the steel contacted with concrete. A superimposed dead load of 3.25 kPa was provided over 60 % of the plan area of the unit by placing two layers of standard 40 kg cement bags. This load was present throughout all stages of testing, and represented a static floor service load reaction at the support equivalent to a U.D.L of 1.5 kPa.

Fig 2.3: Method for vertical loading.

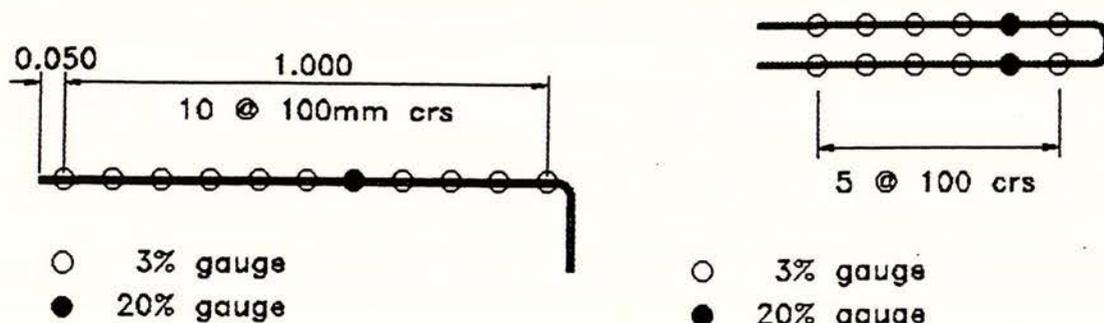
At the critical section, where the support line crack was expected to form, 20% strain gauges were attached. These gauges were supplied by Tokyo Sokki Kenkyujo Co, and were gauge type YL-5, 120Ω, of 5mm gauge length. Because of the sizeable strains involved, special adhesive was used that was recommended for use with large extension strain gauges, namely Armstrong A-12 epoxy. This adhesive was applied as a bedding for the gauge, and was then oven dried. Previous tests on this adhesive at the University of Canterbury showed that 19% extensions could be attained with the YL-5 gauge. At bar positions away from the critical section, ordinary 3% strain gauges were used. These were supplied by Tokyo Sokki Kenkyujo Co, gauge type FLA-5-11, 120Ω, of 5mm gauge length. Surface preparations and the method of fixing Electrical Resistance Strain Gauges were carried out in accordance of the departmental guidelines [8].

Fig. 2.5: Positions of strain gauges used in tests A and B

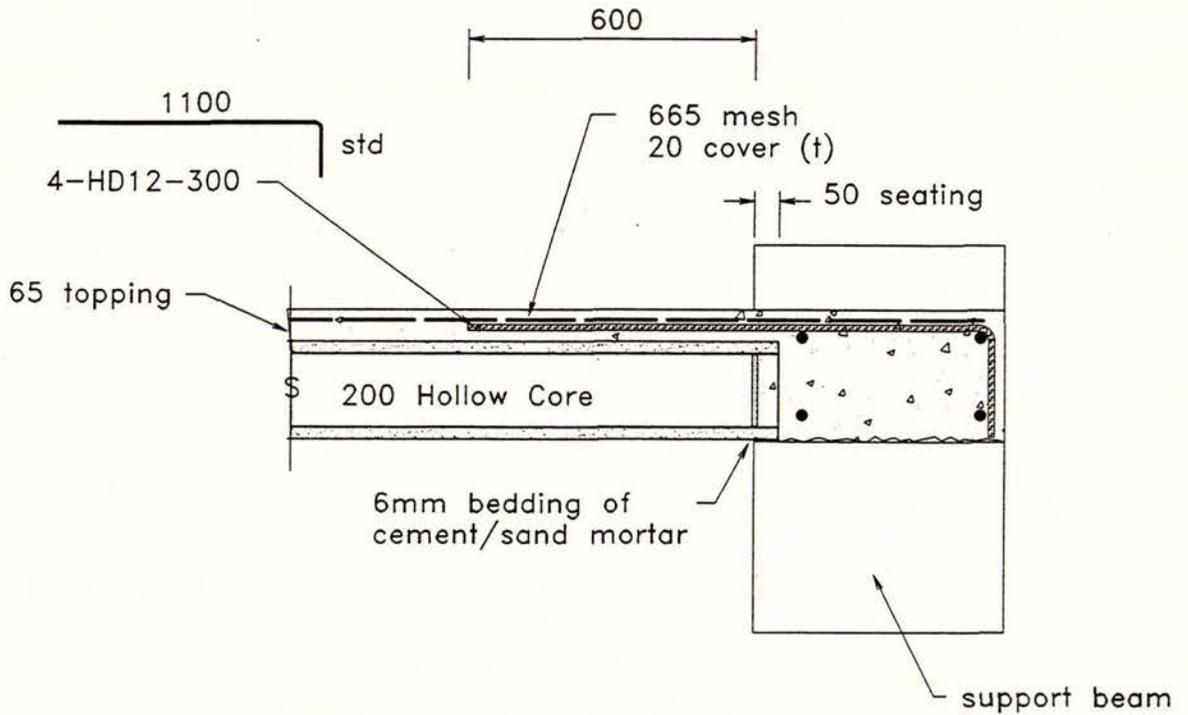
This test examined a support detail that may be regarded as the standard adopted by structural designers throughout New Zealand (Figs. 3.1)

Fig. 3.1 a: Section, typical of support details.

Fig 3.1 b: Example of a typical detail

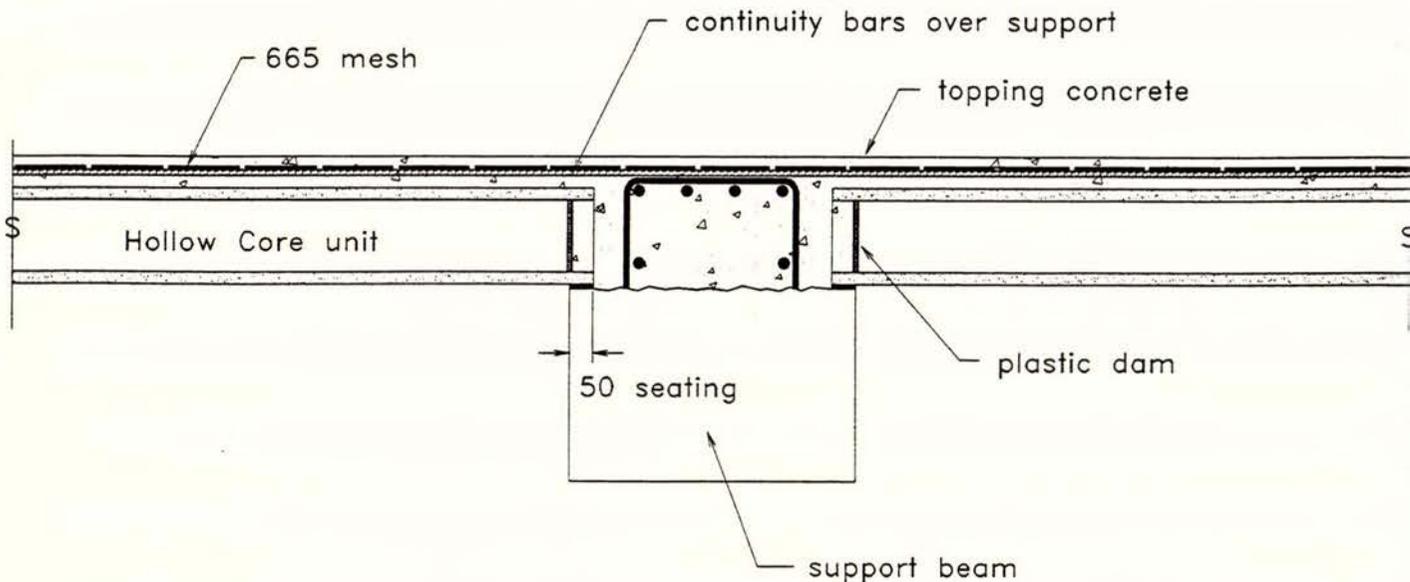
This detail may be made continuous when flooring units are supported on both sides of the support element, Fig 3.2:

Fig 3.2: Continuity over supports

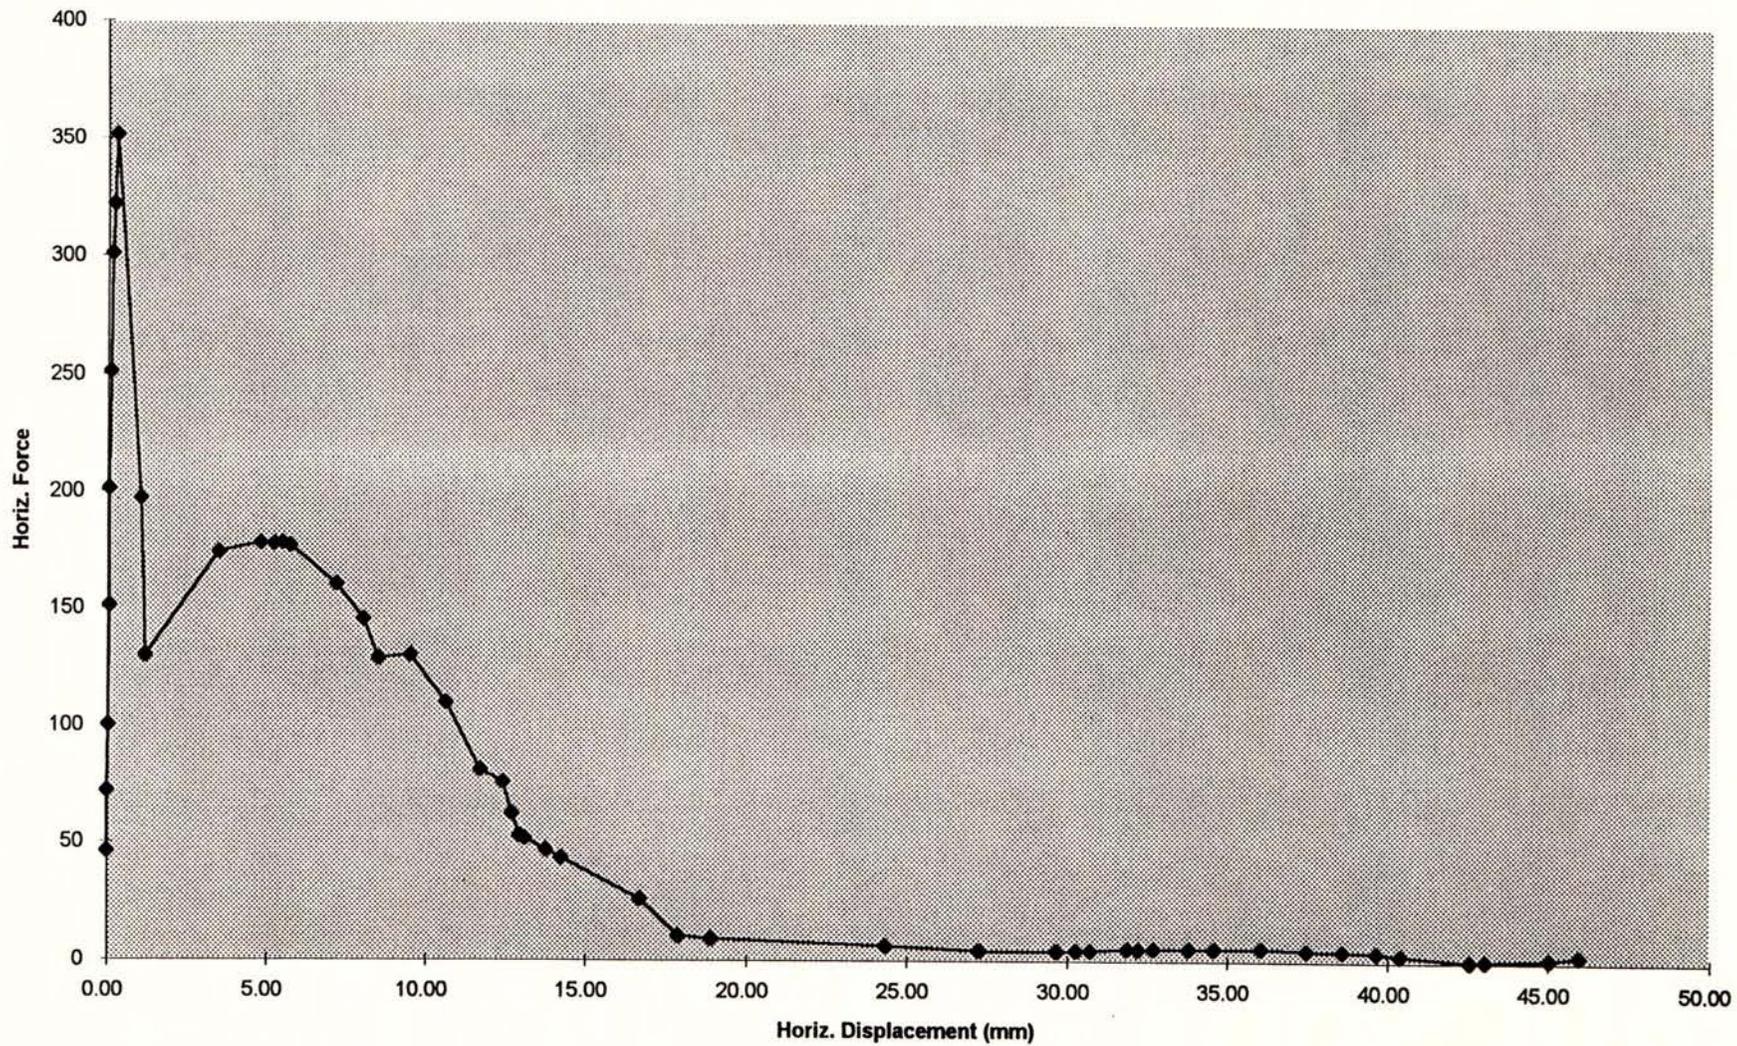
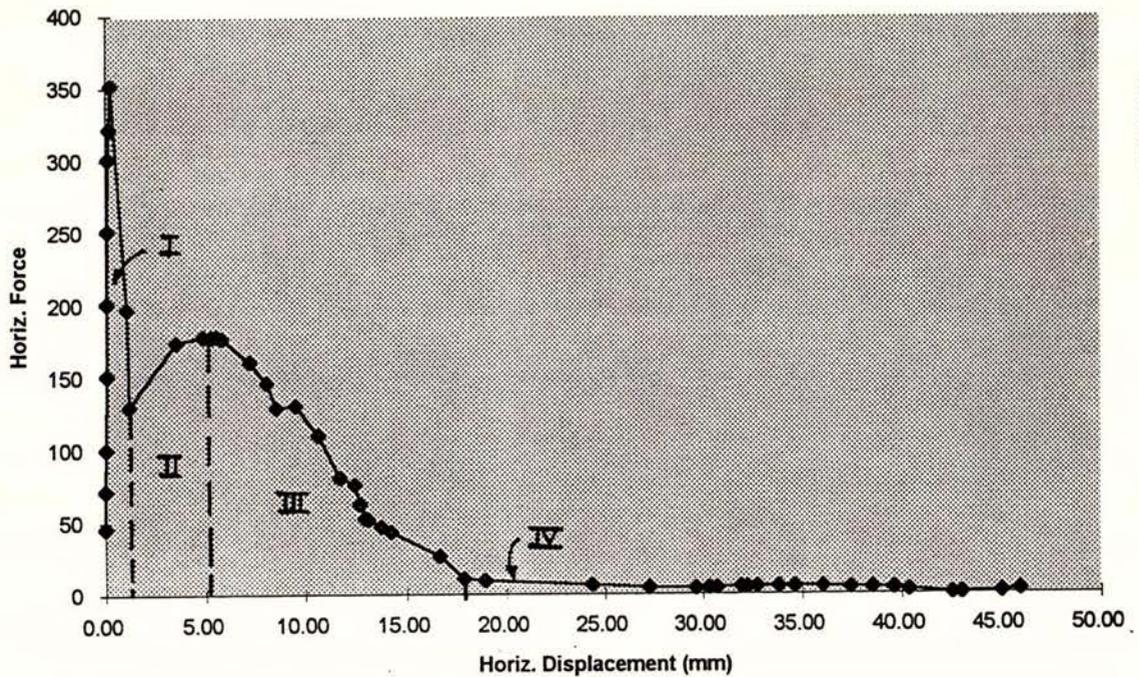
The initial response to loading produced little movement, with a displacement of only 0.27mm at the peak horizontal load of 352 kN. The first cracks appeared across the topping above the end of the Hollow Core unit at a load of 250 kN, with an maximum topping crack width at the peak load level of approximately 0.4mm.

At 352 kN, a sudden fracture took place through the end of the precast Hollow Core section. This resulted in a major crack 0.6mm wide occurring through the topping 650mm from the face of the support beam, beyond the point of starter bar curtailment. From here the nature of the test changed completely. The horizontal force dropped to 130 kN, and reached a post fracture maximum of 178 kN at a displacement of 5mm. The force requirement decreased steadily out to a displacement of 18mm, with intermittent fracturing of mesh wire throughout this phase. Once the contribution of the topping mesh was completely lost, only residual sliding friction forces acted against the rams.

Fig. 3.3 a: Load-Displacement diagram for Test A

Fig. 3.3 b: Load-Displacement curve divided into regions of significance

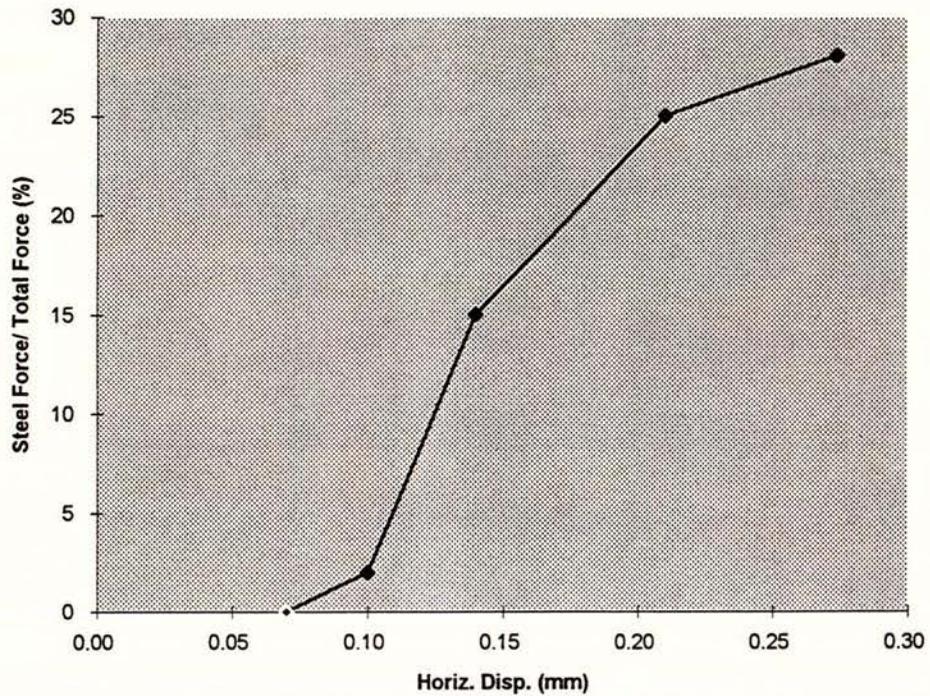
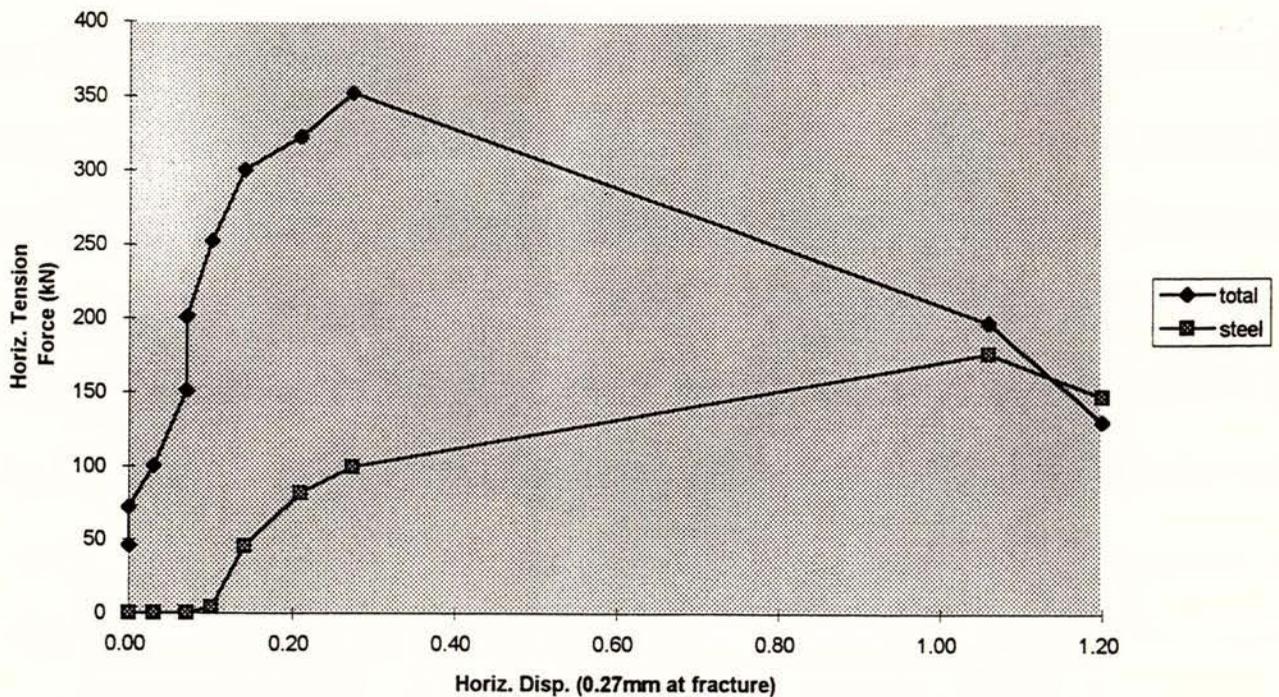
Initial cracking had appeared at approximately 250 kN and the effect of this on the proportion of load carried by reinforcing is illustrated in Fig. 3.4 a, which shows a marked increase in steel force at this load level. As displacement increased beyond 0.1mm, the steel contribution to resistance increased, but at a sharply decreasing rate. In other words, the steel was proving not to be the primary stiff element that would resist the total force, and at peak load contributed only 28% of the total reaction.

With the total horizontal force as the upper line (Fig 3.4 b), and the steel force (starters plus mesh) across the support region as the lower line, the proportion of load carried by the concrete is the difference between the two lines. The deduced value is almost constant at 250 kN up to fracture at 0.27mm displacement. This implies that the concrete section was mobilised, showing increased displacement for no increase in load. However, the small displacements involved would have not been sufficient to overcome the post cracking tensile strength of the infill concrete around the Hollow Core voids, and the influence of edge effects caused by wedging between the sides of the precast unit and support block was becoming prominent. The

combined result is a tendency of increasing total stiffness in the system immediately prior to fracture (Fig. 3.4 b).

Fig. 3.4 a: Proportion of total horizontal force resisted by starters and mesh over the support region prior to fracture

Fig 3.4 b: Total force and Steel force (starters and mesh) over the support region

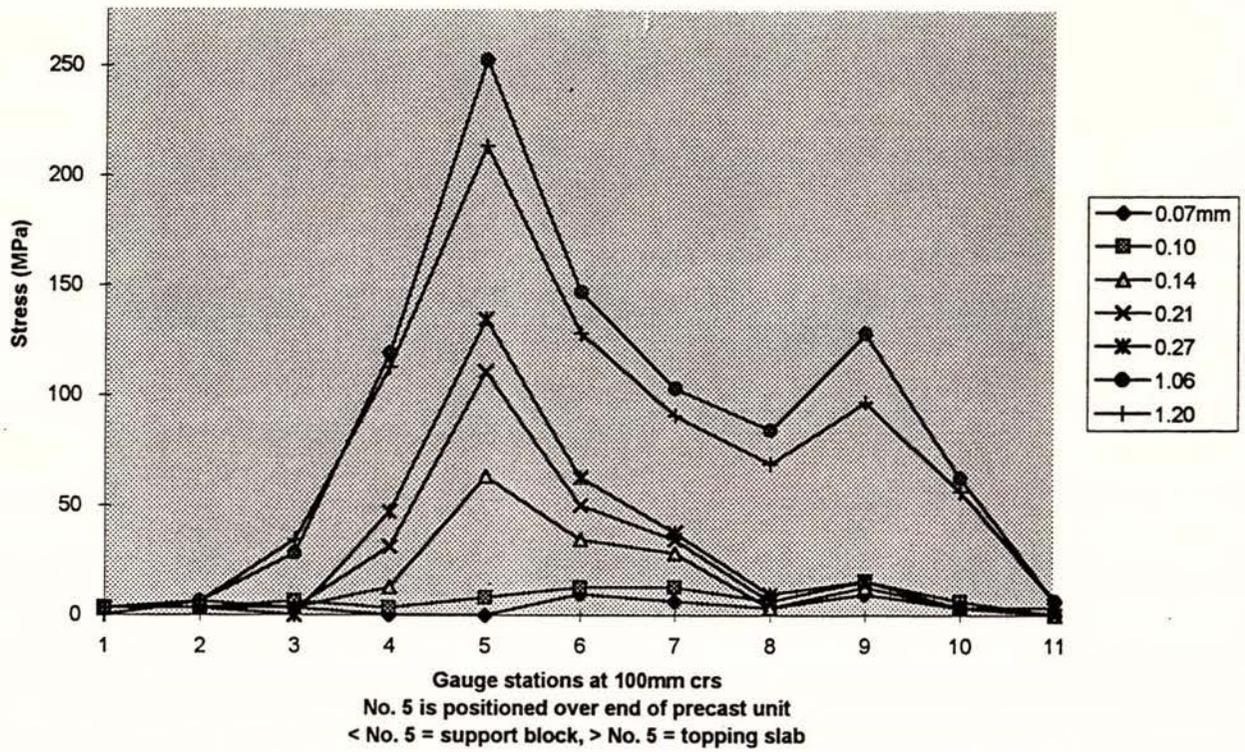
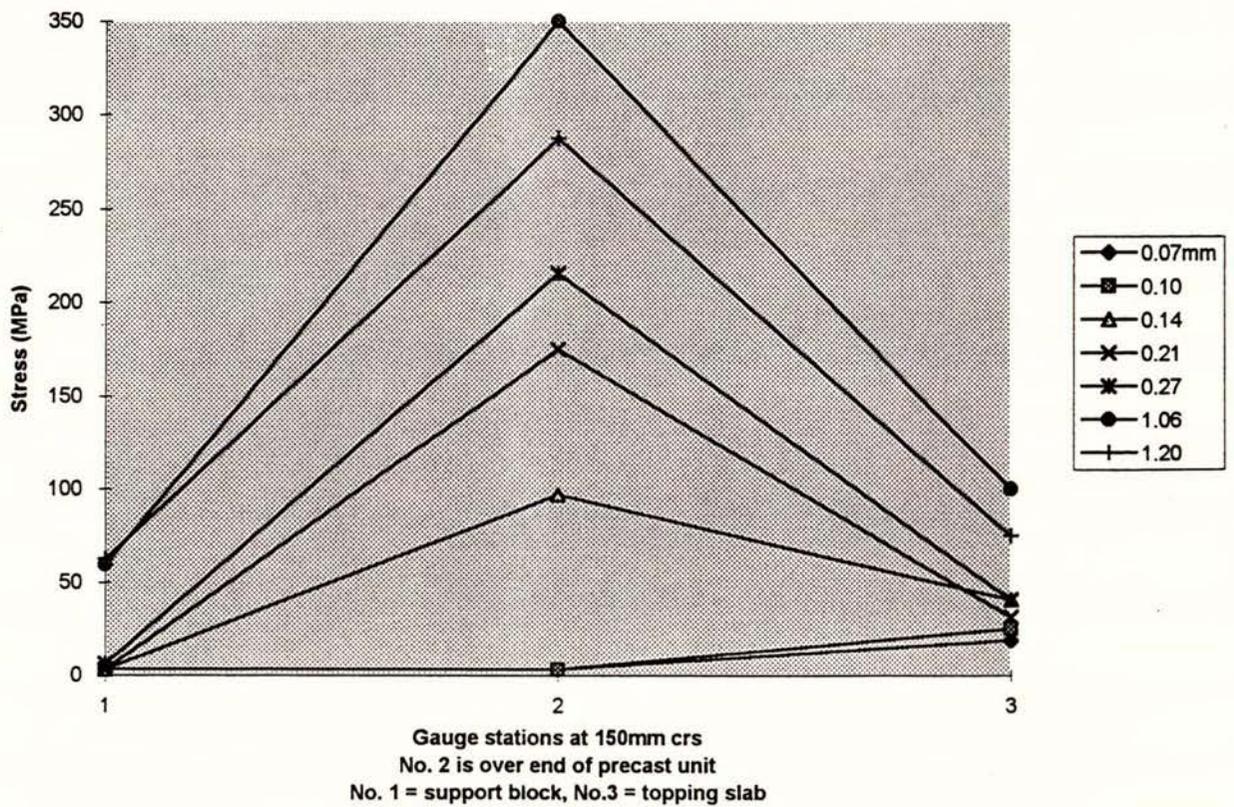
The starter bar diagram 3.5 a indicates a sudden increase in stress at station No. 9, and this is due to a sizeable crack that formed across the topping at this point when the unit fractured. Evidence that this crack was forming is indicated by the slight increase in stress at this point immediately prior to fracture.

The diagram also suggests that the bar bond efficiency was greater in the insitu beam concrete than on the topping slab, as indicated by the respective slopes on either side of the support line crack at station No. 5.

Fig 3.5 a: Avg. stress distribution along HD12 starter bars at stage I of test

Fig 3.5 b: Avg. stress distribution in mesh over support region at stage I of test

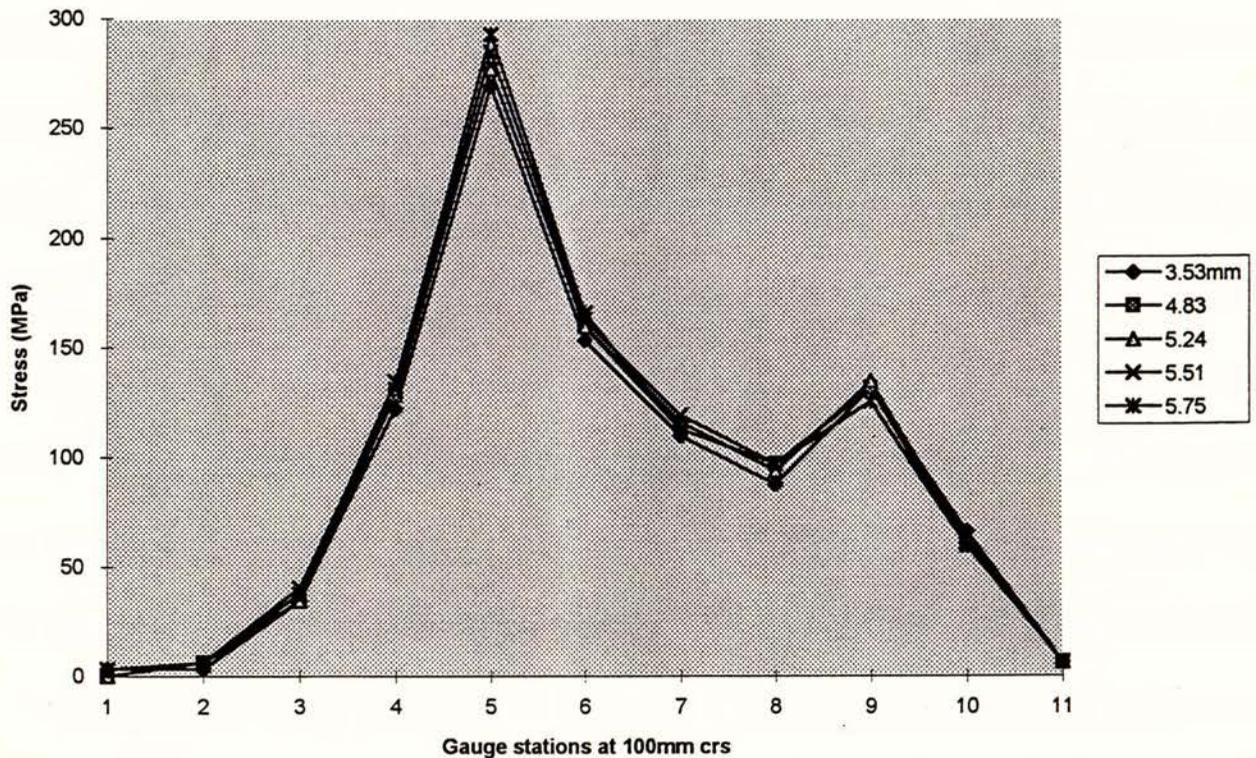
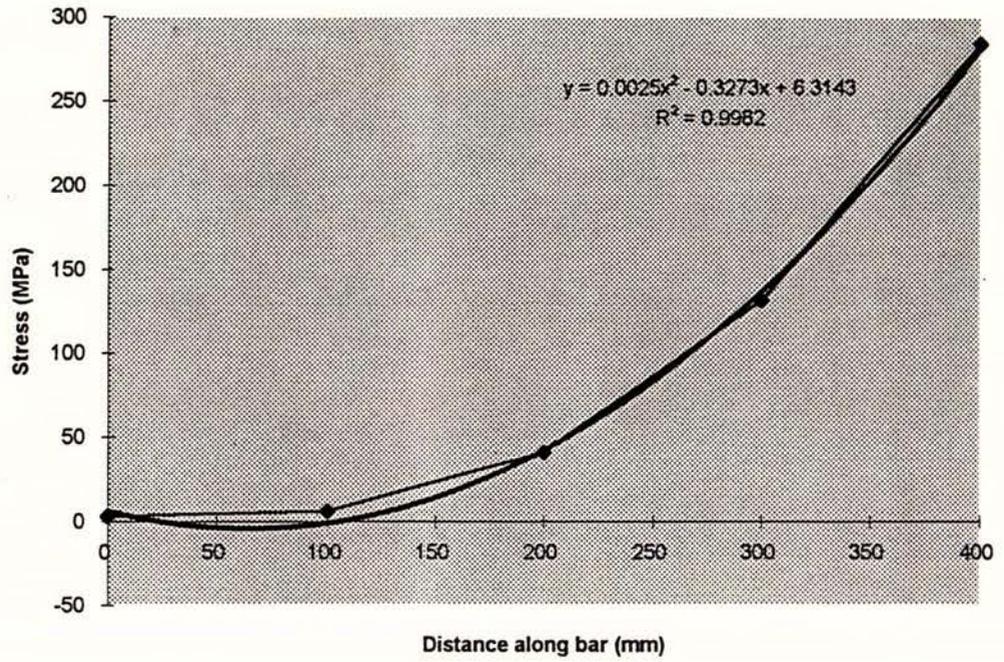
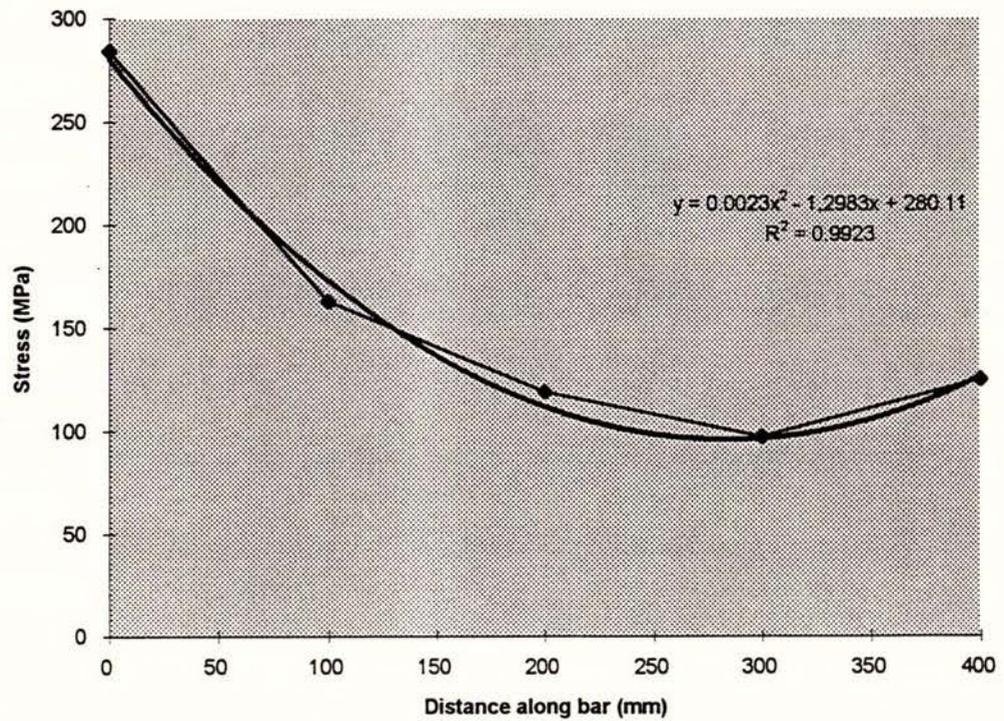
The maximum starter bar stress that was registered during the test occurred over the support line of the Hollow Core unit at the post-fracture peak load, and was 316 MPa at a displacement of 5.5mm. The maximum mesh wire stress over the support region was 338 MPa, less than 375 MPa recorded in stage I of the test. Fig 3.7 a shows the average starter bar stress distribution at the peak post-fracture load. Figs 3.7 b & c illustrate a curve fit of the bar stress profile.

Fig. 3.7 a: Avg. stress distribution along starter bars up to post-fracture peak load

Fig 3.7 b: Fitted curve of starter bar stress distribution over the support block at post-fracture peak load

Fig 3.7 c: Fitted curve of starter bar stress distribution into the topping slab at post-fracture peak load

Figs 3.7 b & c indicate a strong correlation between the measured stress distribution calculated from strain gauge readings and the fitted parabolas. This would indicate a linear variation of bond stress along the bars under this level of bar stress. The fitted equation for the bar stress for the embedment length over the support block is:

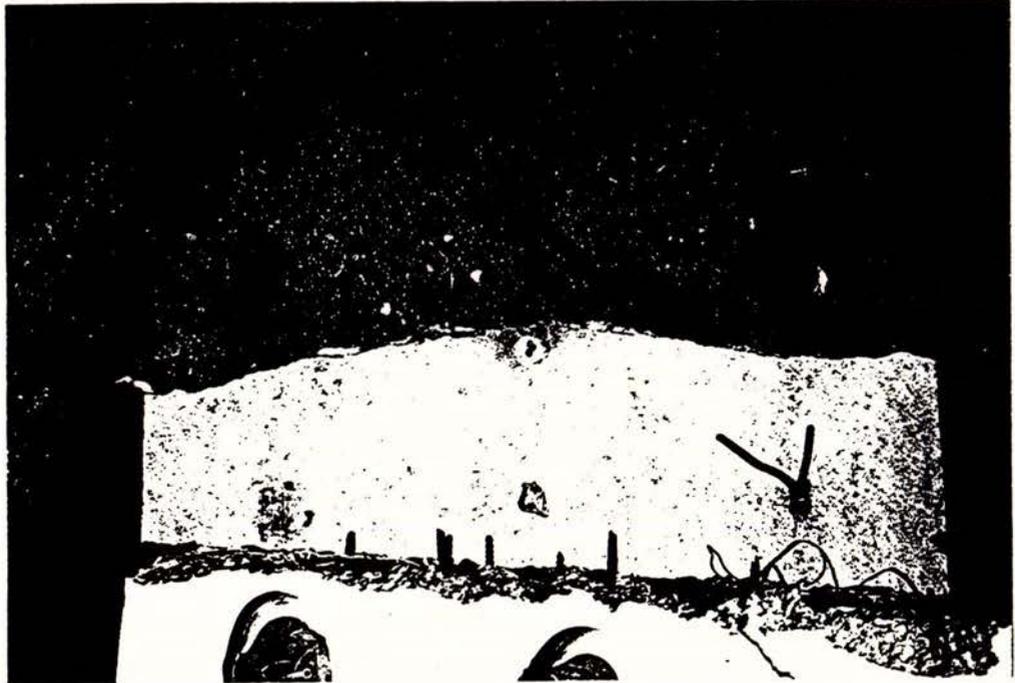
The actual failure planes of the test unit are shown in Fig. 3.12 a, and the orientation of these planes, caused by shear and tension interaction at the support, are about 13° and 9° to the axis of the unit. It can be seen that fracture occurred through the entire section of the unit except a small portion at the central web, measuring 30mm (web width) wide by 40mm (Fig. 3.12 b).

Fig 3.12 a: Plan of fractured end of Hollow Core unit

Fig 3.12 b: End view of fractured section

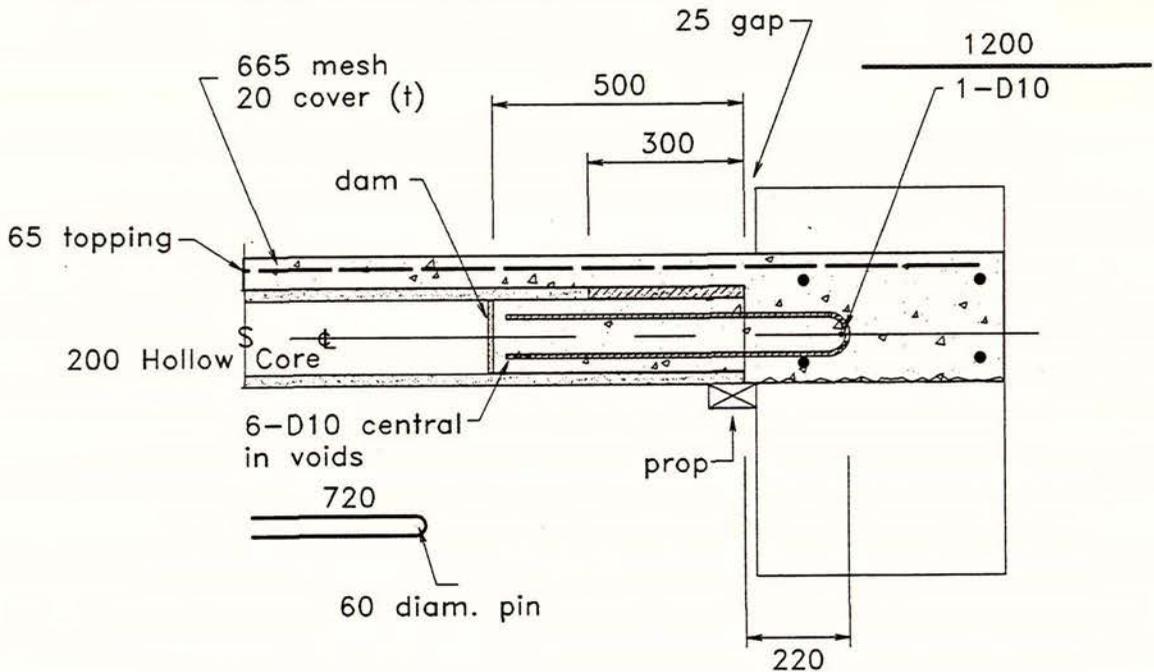
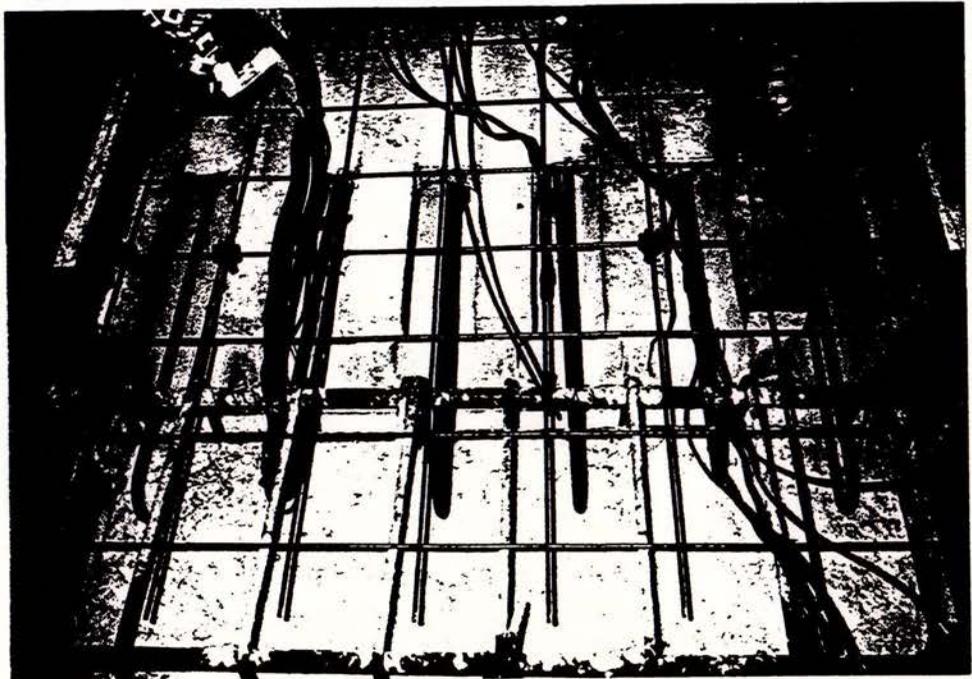
This test examined a support detail that has been developed by Firth Stresscrete for short seating or nil seating applications (Figs 4.1).

Fig 4.1 a: Firth Stresscrete nil seating detail for 200mm Hollow Core

Fig 4.1 b: Example of the nil seating detail

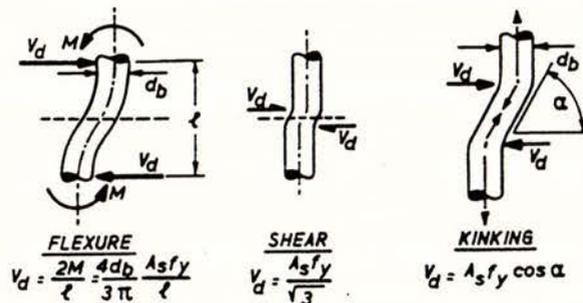
Fig 4.2: Mechanisms of dowel action across a shear interface

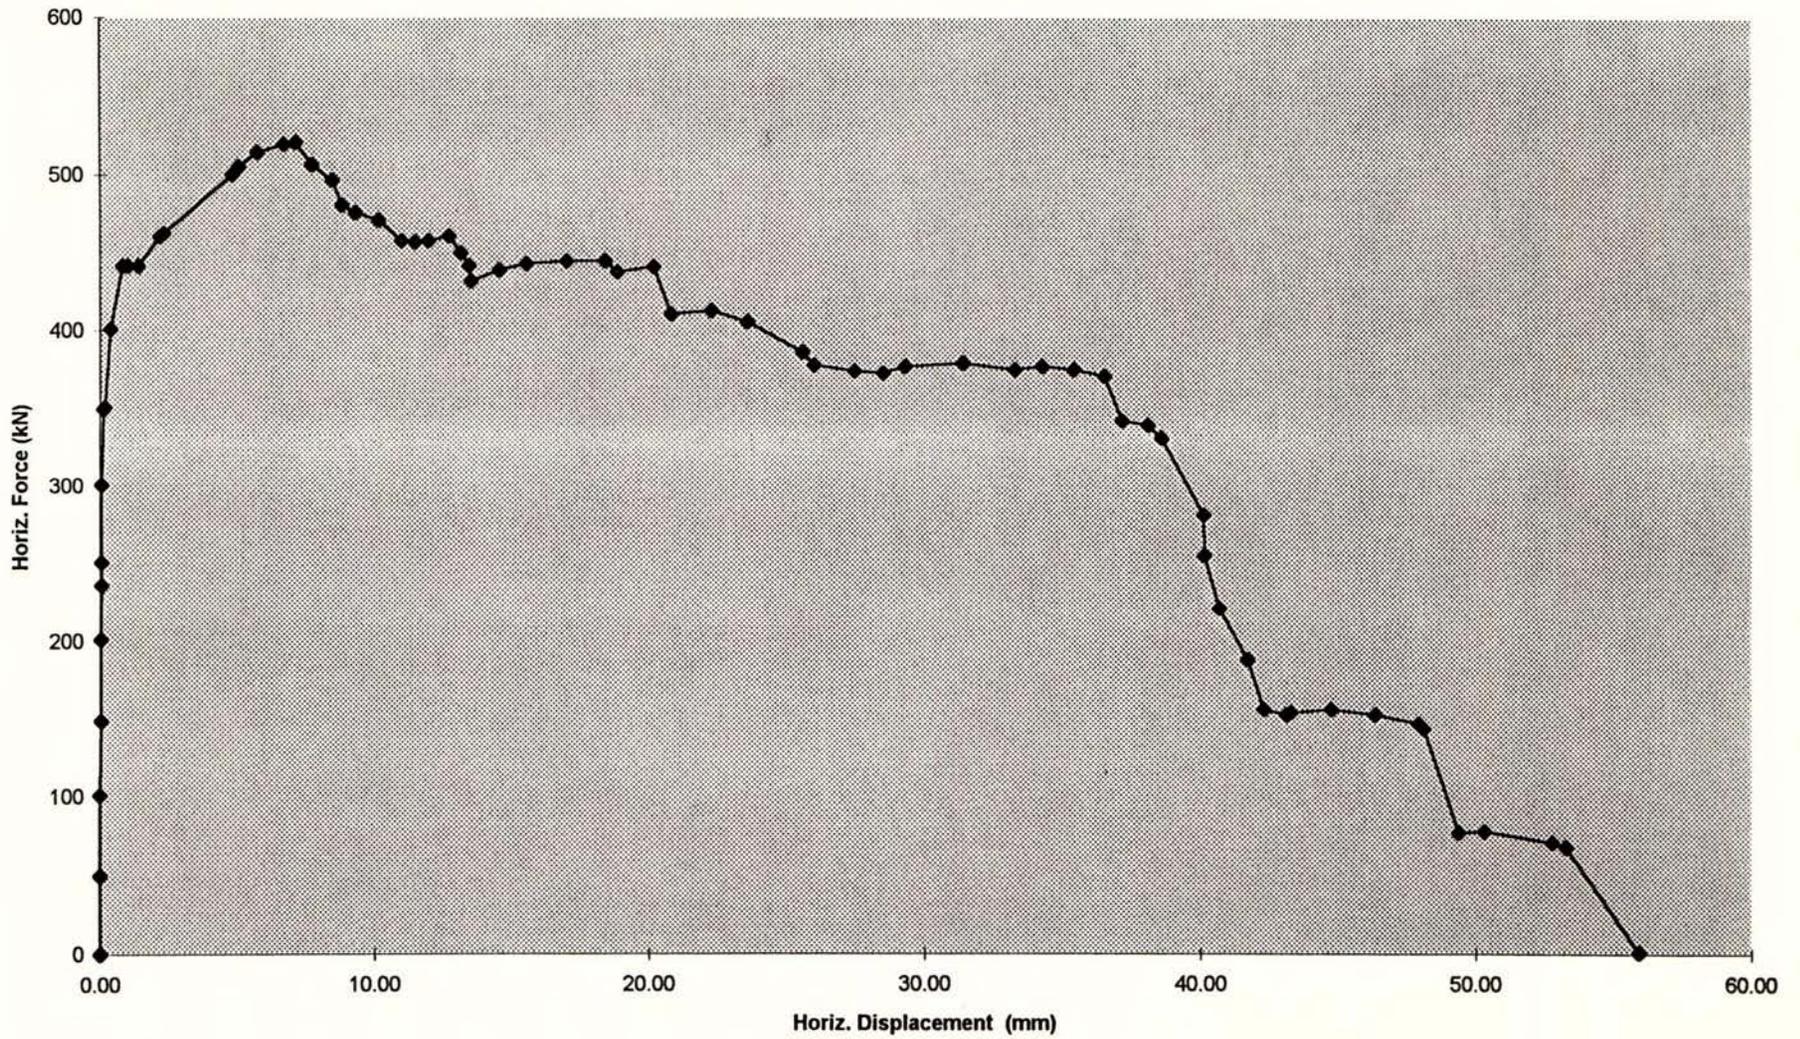
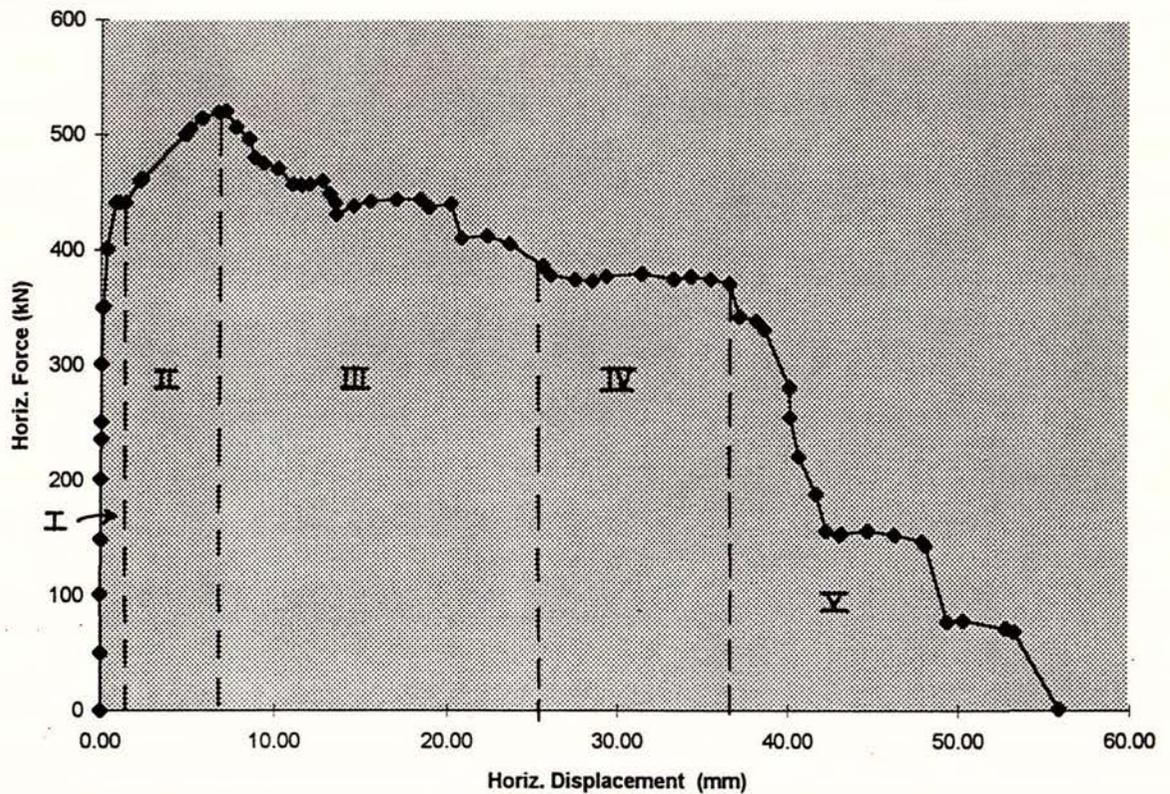
Fig 4.3 a: Load-Displacement diagram for test B

Fig 4.3 b: Load-Displacement diagram divided into regions of significance
