Precast Concrete Floor Unit Support and Continuity Report on the performance of current details: effects of frame dilation and translation on extruded hollow core flooring

M D Herlihy, Department of Civil Engineering, University of Canterbury (Supervised by: Professor R Park, Mr D K Bull)

Project 93/103 Precast Concrete Floor Unit Support and Continuity

Report on the performance of current details: effects of frame dilation and translation on extruded hollow core flooring

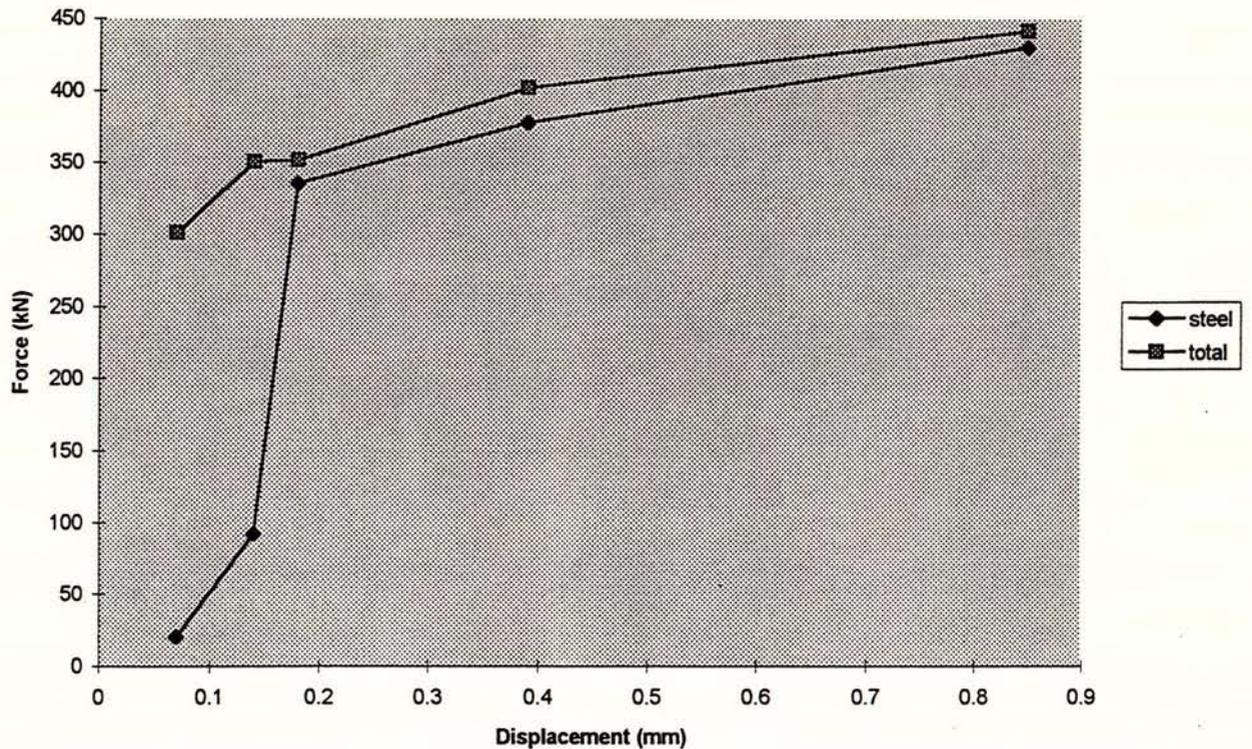
At 0.14mm displacement, the wire mesh had begun to register stress, and had achieved 150 MPa at 0.2mm, increasing to 400 MPa at 0.4mm. The D10 hairpins began to register stress at approximately the same time as the mesh, and had typically achieved yield stress by 0.4mm displacement. The proportion of force carried by the concrete is shown in Fig. 4.4 as the difference between the total force and the steel force. The steel force is calculated from the average of four gauge stations in the 25mm insitu infill strip between the Hollow Core unit and the support block. Fig. 4.4 indicates that the concrete lost practically all of its tensile capacity by 0.2mm displacement, but continued to have a small residual strength up to 0.8mm. The section as a whole behaved elastically up to 0.4mm displacement, and this would have been due to the D10 hairpins reaching yield strength.

Fig 4.4: Proportion of forces in section at stage I

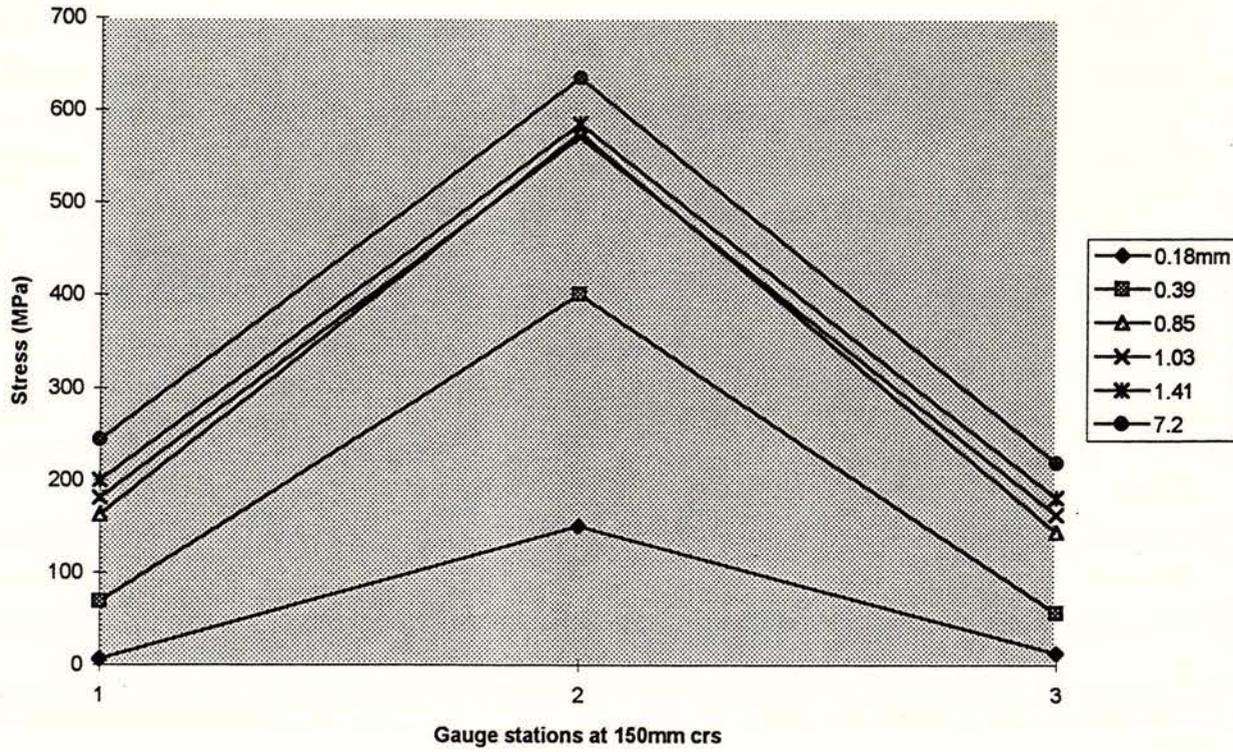
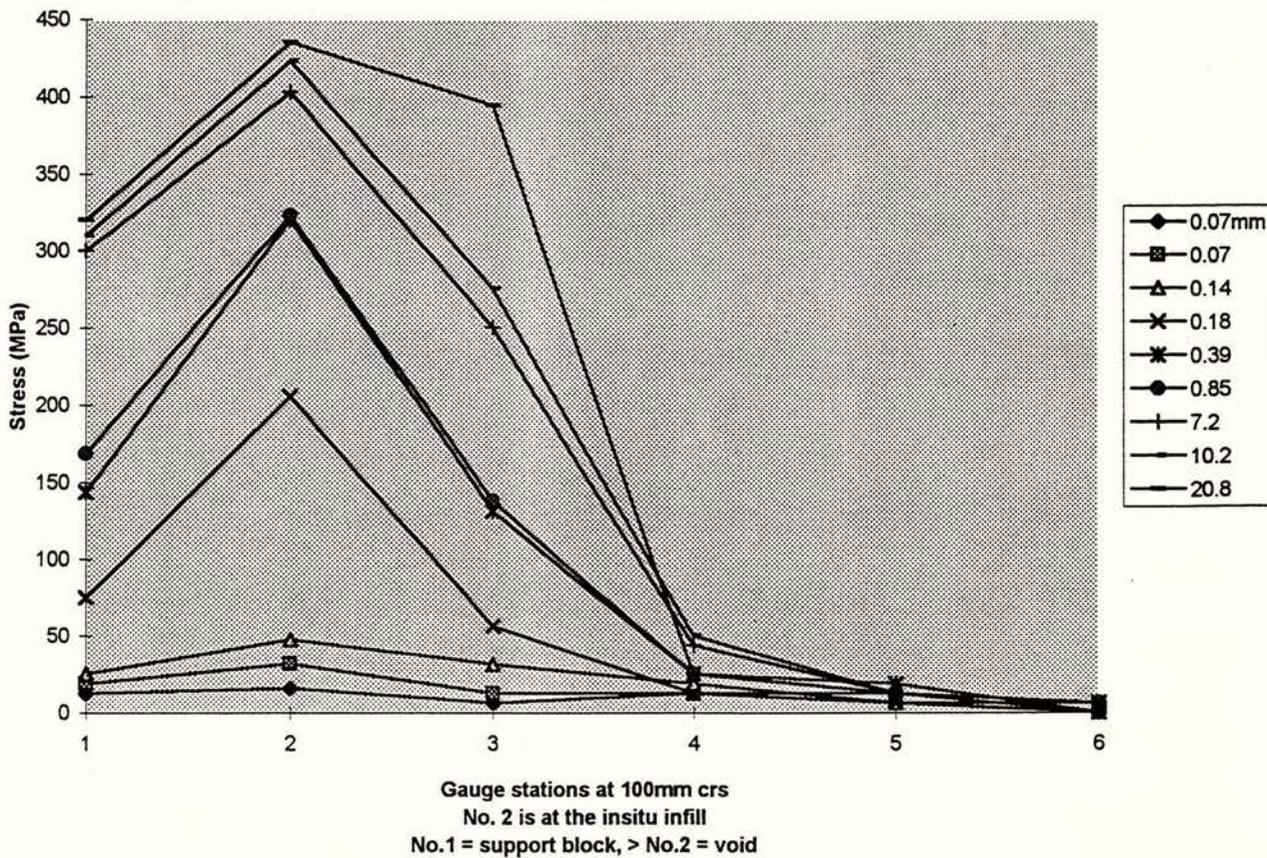
From peak load displacement at 7.2mm through to 22mm displacement, the reaction force dropped in two notable steps from 520 kN to 412 kN through fracture of the topping mesh. From 22mm to 26mm the reaction gradually dropped to 375 kN as the extension of the D10 hairpins moved past the peak stress plateau of the stress-strain relationship. The peak stress elongation had been reached during this stage of the test at approximately 15mm displacement. Figs. 4.6 show the respective stress distributions along the mesh wire and D10 hairpins. At 20mm displacement, the effects of bar slippage and strain penetration are indicated by the upper line on Fig 4.6 b.

Fig 4.6 a: Stress distribution along 665 mesh at the onset of fracture

Fig 4.6 b: Stress distribution along D10 hairpins up to end of stage III

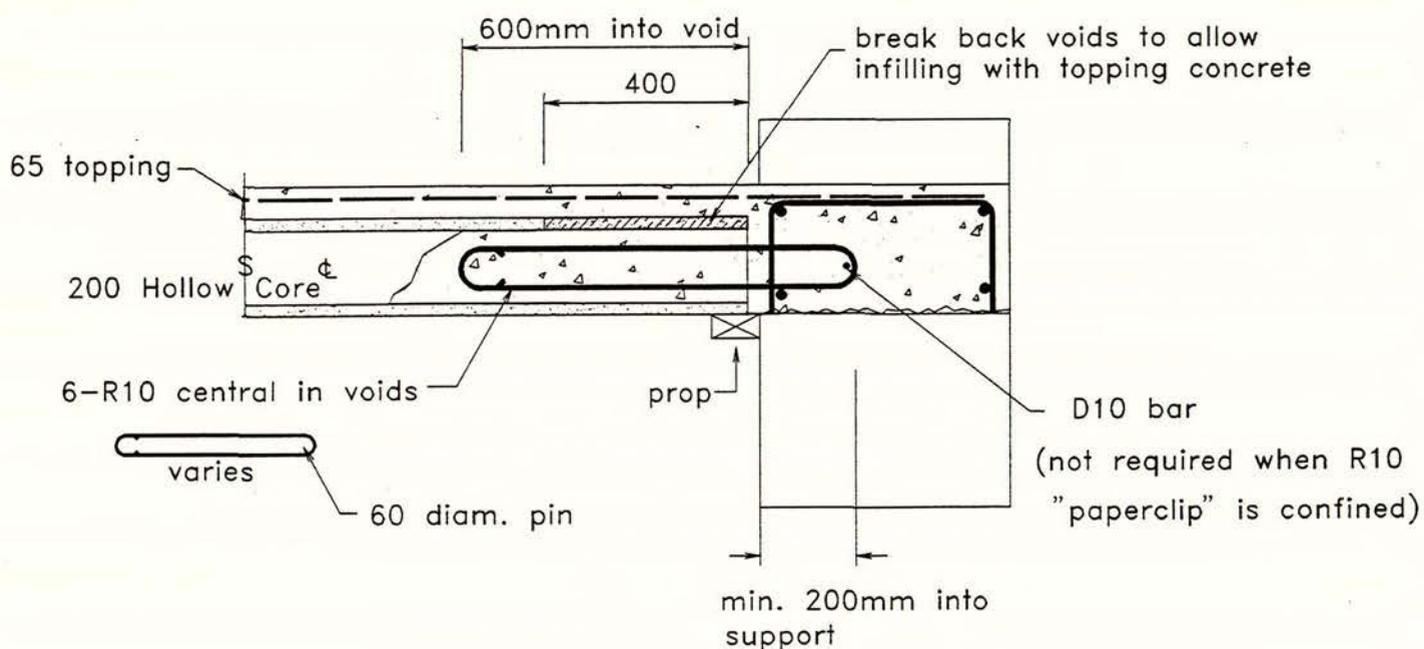
indicated satisfactory performance in this role [6], and plain bars are recommended by the FIP [7] for use in situations where large elongation is foreseen. An additional alteration to the existing detail is to allow a greater length of bar between the tangent of the hook and the location of the critical crack to allow slippage over this portion of the tie. It is suggested that the minimum distance from the edge of the support to the end of the tie is 200mm. On well confined support details, this also removes the need for a D10 anchor bar in the hook as was originally detailed. For a plain bar detail hook returns are required at both ends, hence, the term "paper clip".

Fig 4.7: Recommended detail for nil seating and loss of support

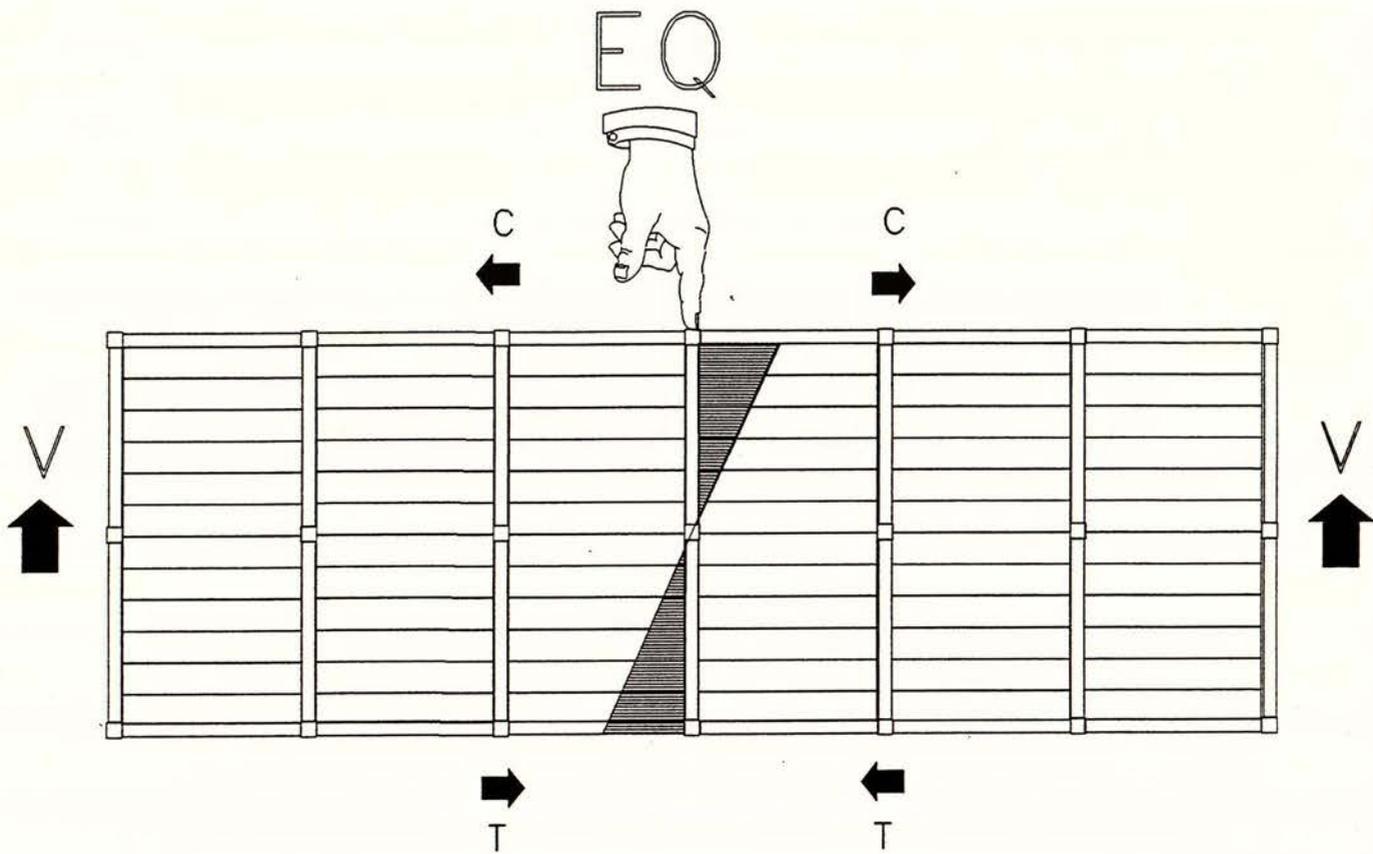
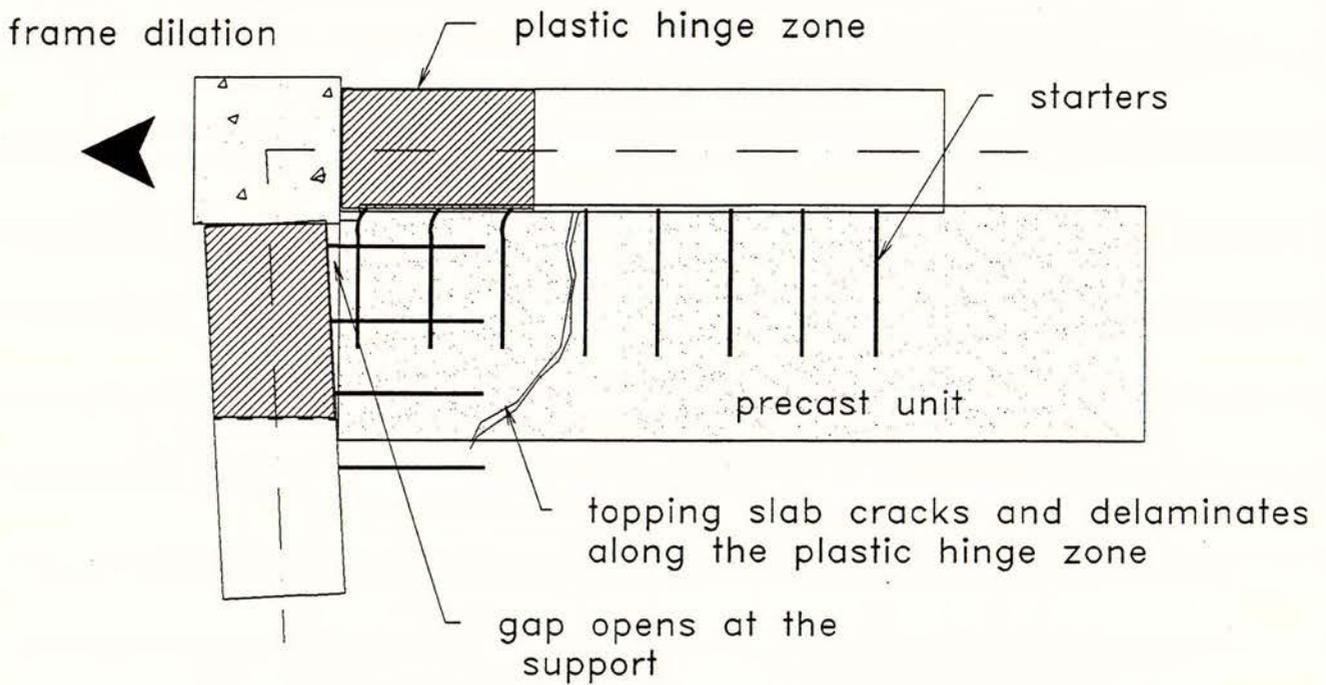
The degree of dilation that can occur in the plastic hinge of an unrestrained beam is known to be in the order of 2 to 8 percent of the beam depth [3]. Depending on the structural configuration, it is likely that dilations of reasonable magnitude could occur on a localised basis, especially at the junction of beams and columns. In the case of floor units seated into these areas, restraint provided by starter bar ties along the side of the unit may be of little consequence (Fig 5.1 b).

Fig. 5.1 a: Diaphragm beam action under seismic loading

Fig. 5.1 b: The effects of frame dilation in corner regions

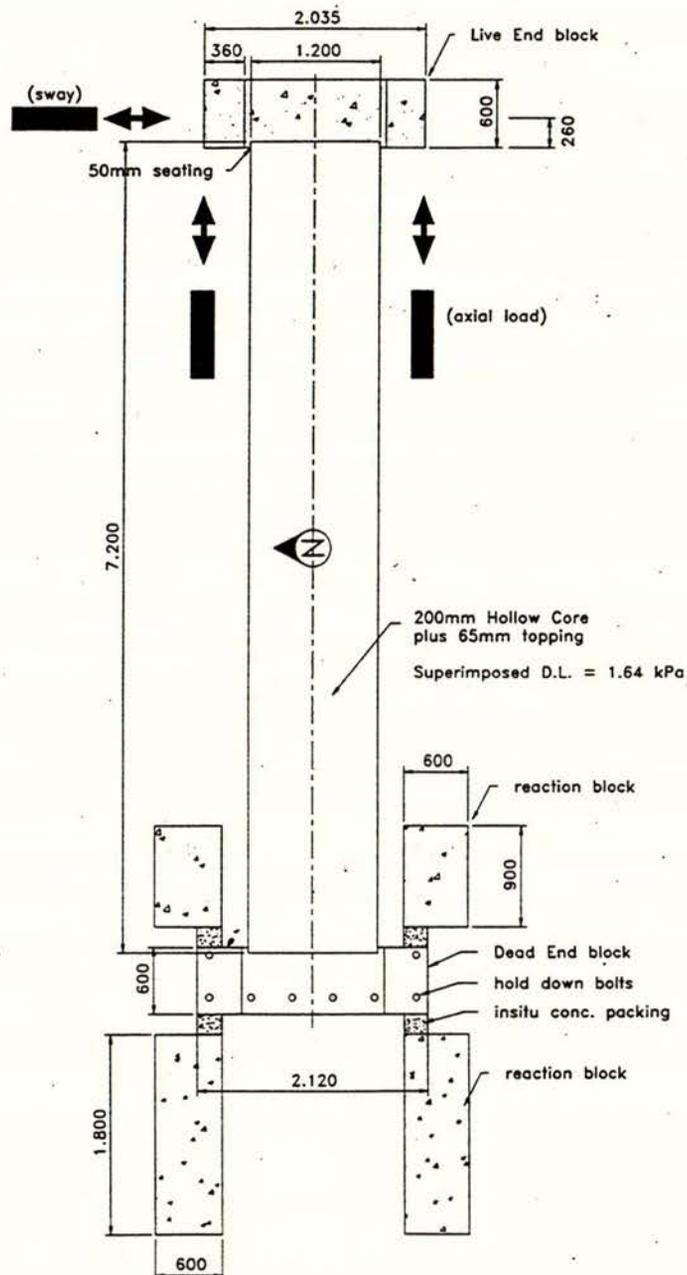
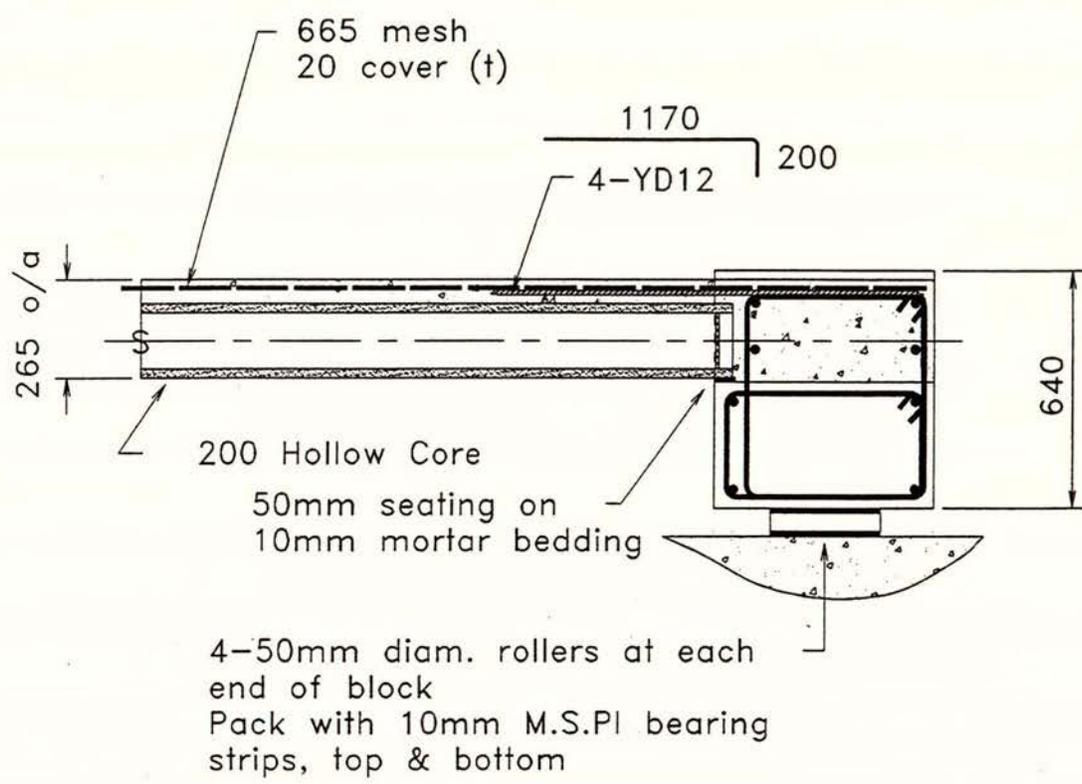
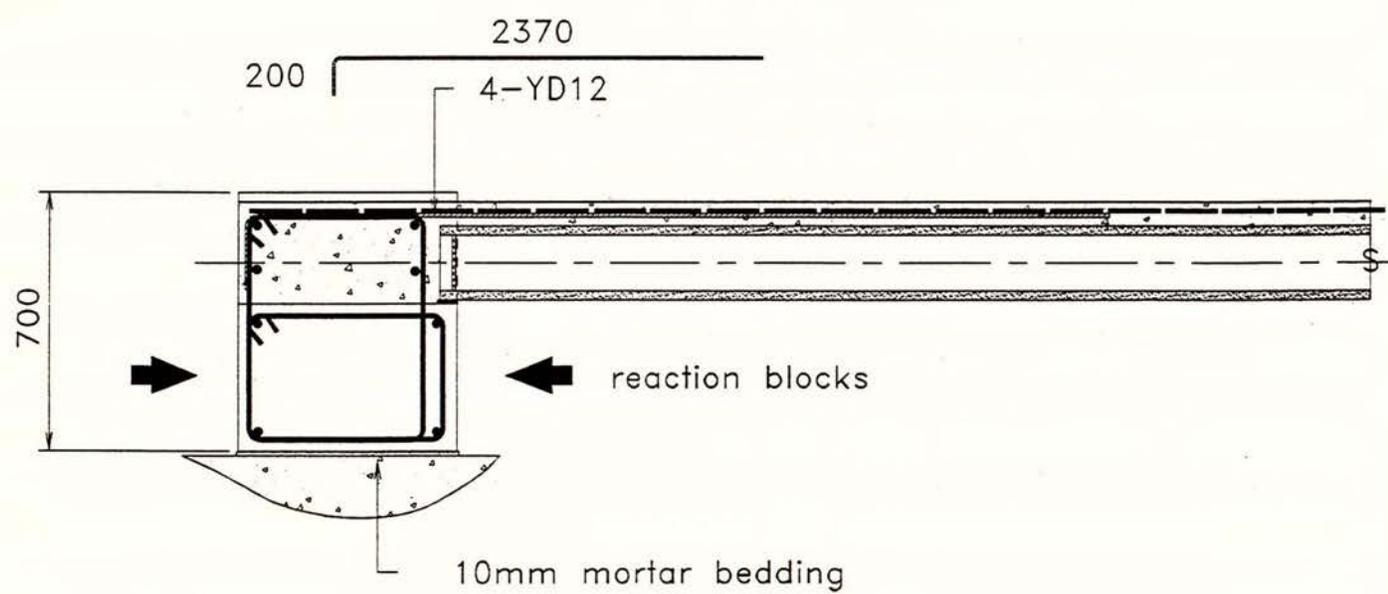
The basic layout of the test rig for combined translation and axial load is shown in Figs. 5.2. The support detail is identical to that used in the Loss of Support test A, representing the most commonly used detail in New Zealand for Hollow Core flooring. As discussed in section 3.1, this detail relies on the composite bond capacity between the precast unit and the composite topping for the transfer of diaphragm forces. It is therefore essential that adequate bond is maintained between the precast element and topping and that the integrity of the detail is not reduced by excessive spalling and loss of cover concrete. The performance of the detail can be observed for varying quantities and sizes of continuity and starter bars as they occur in real structures.

Fig 5.2 a: Plan of combined sway and axial load test rig

Fig 5.2 b: Elevation of sway end support

Fig 5.2 c: Elevation of fixed end support

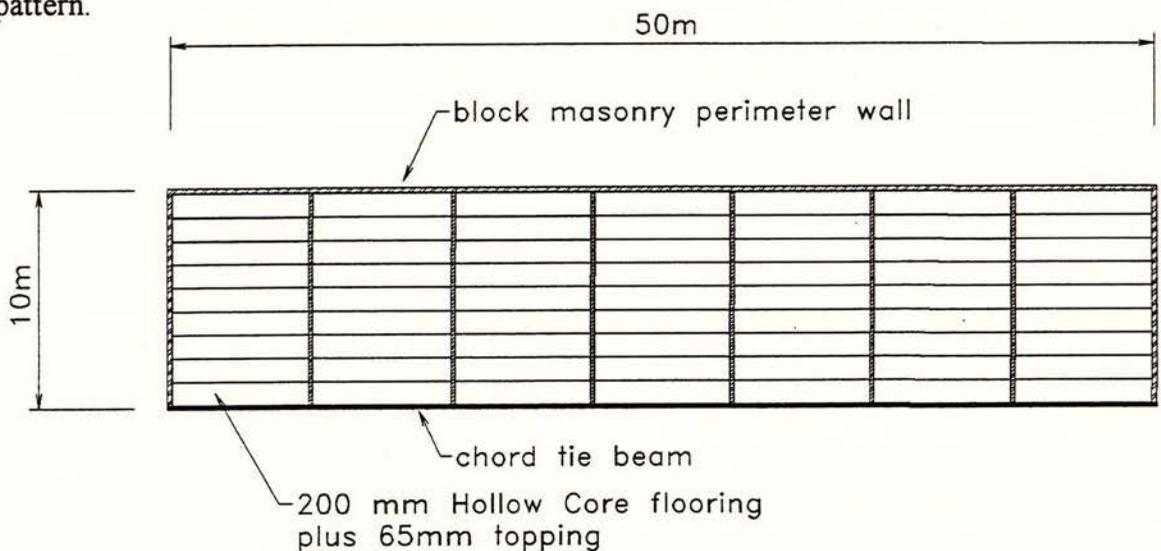
Fig 6.1: Plan of example structure

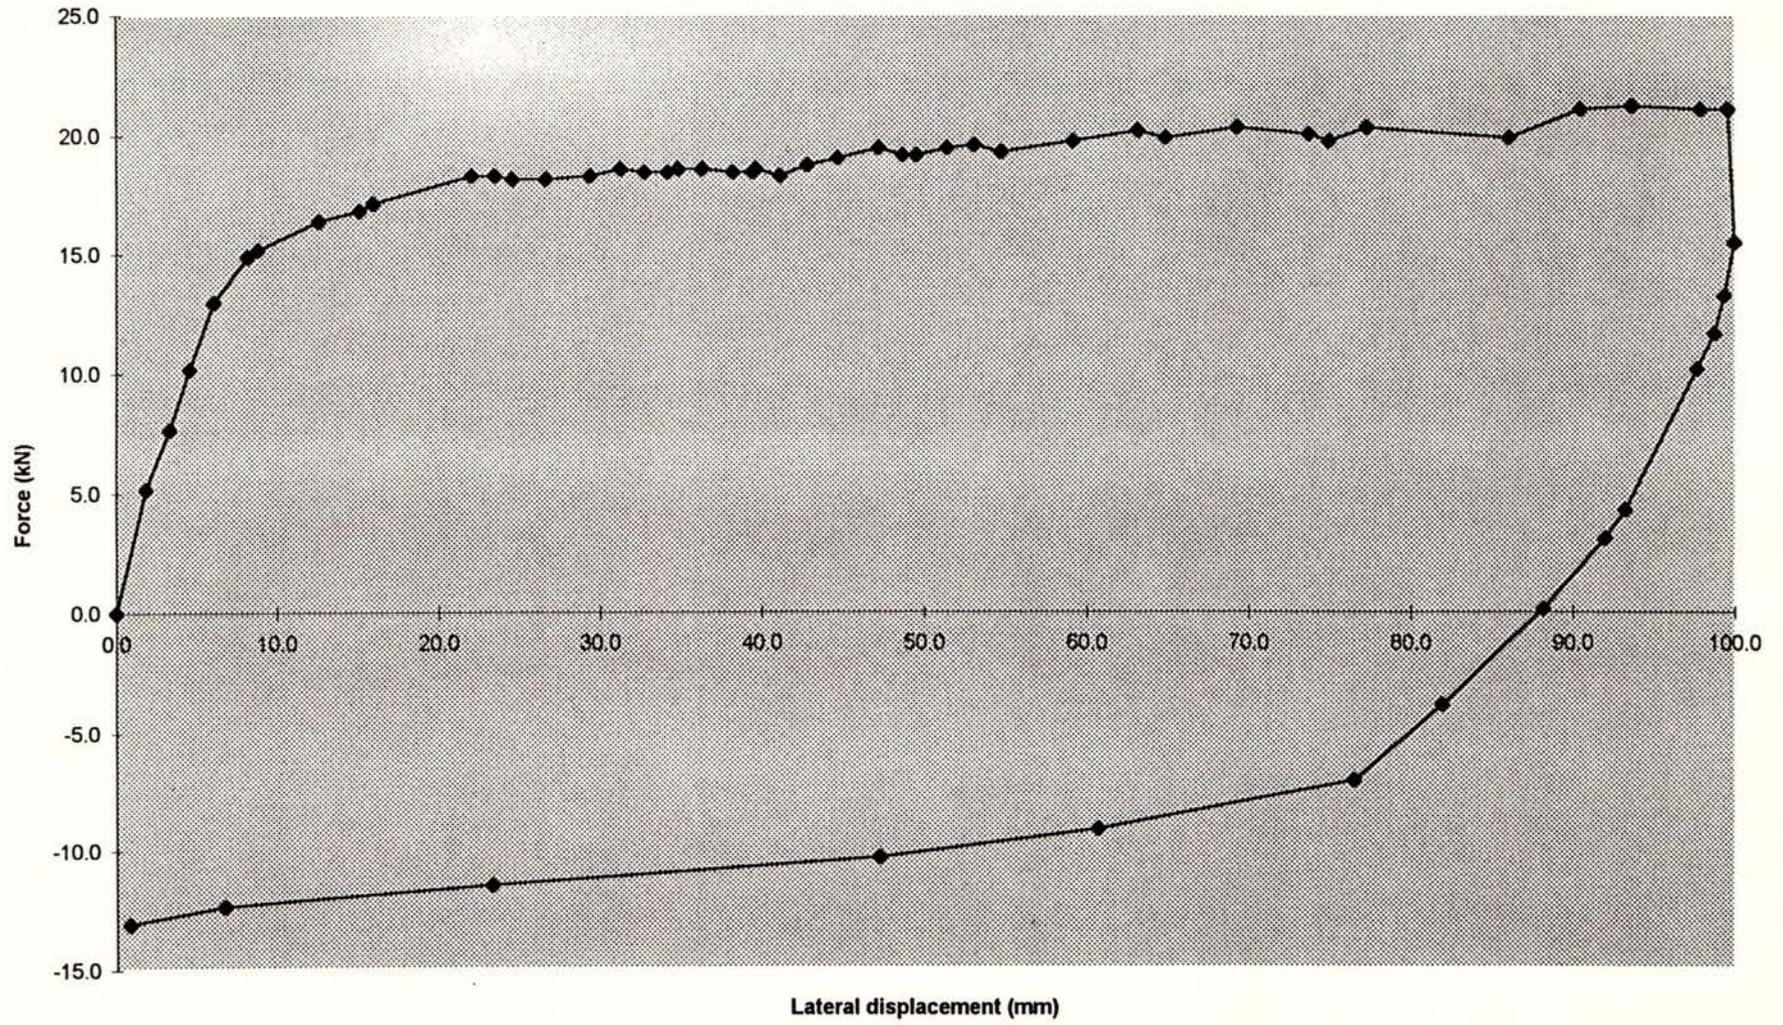
Fig 6.2: Load-displacement curve of initial loading stage

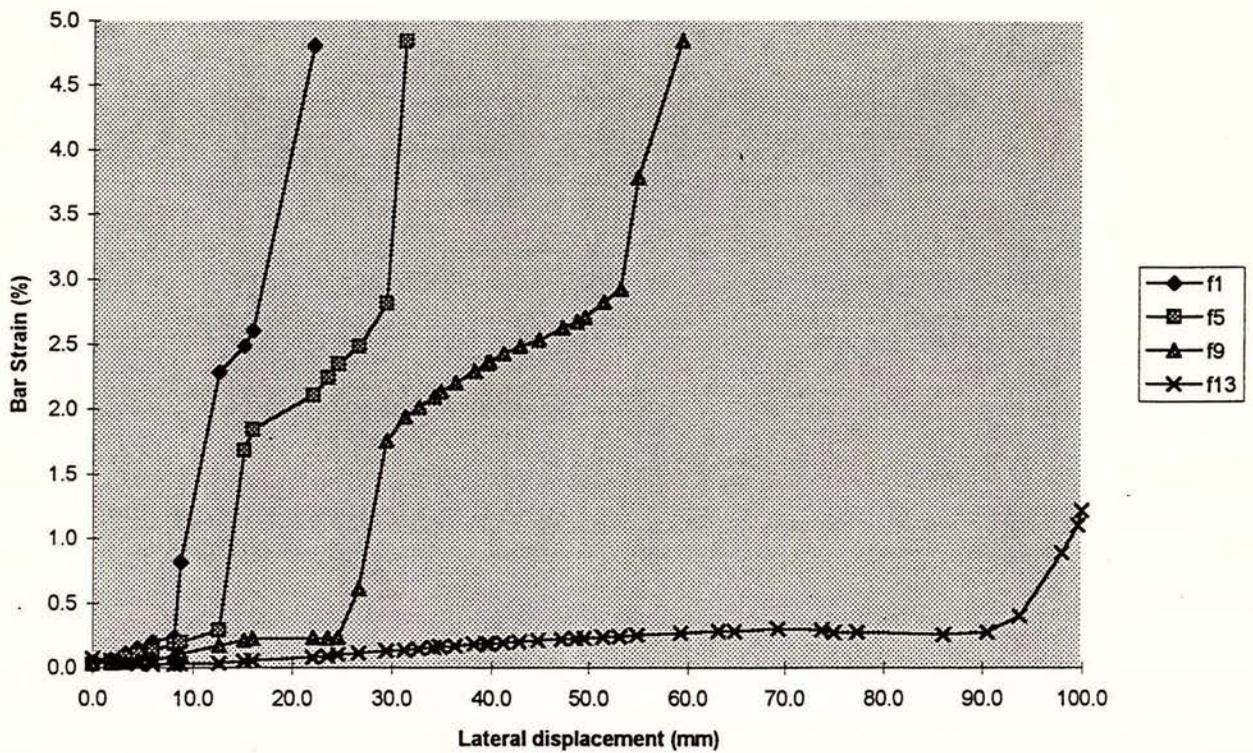
Fig. 6.3: Bar strain development under increasing lateral displacement

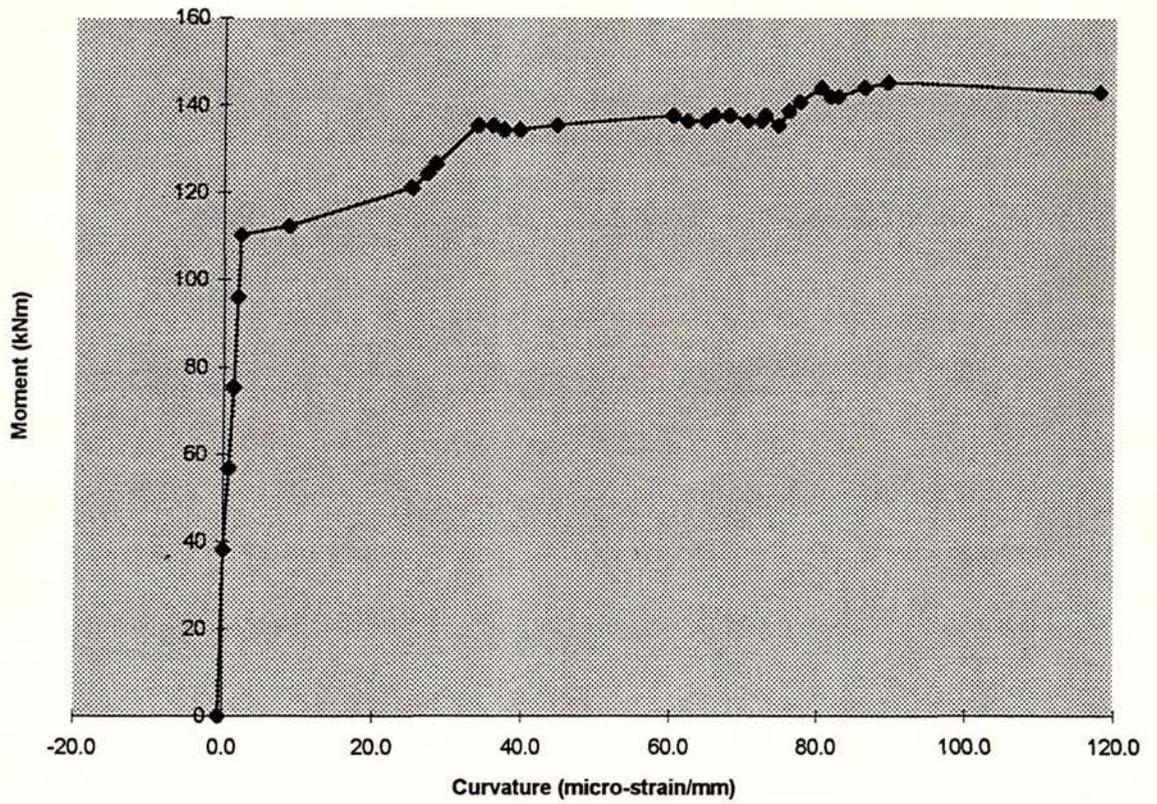
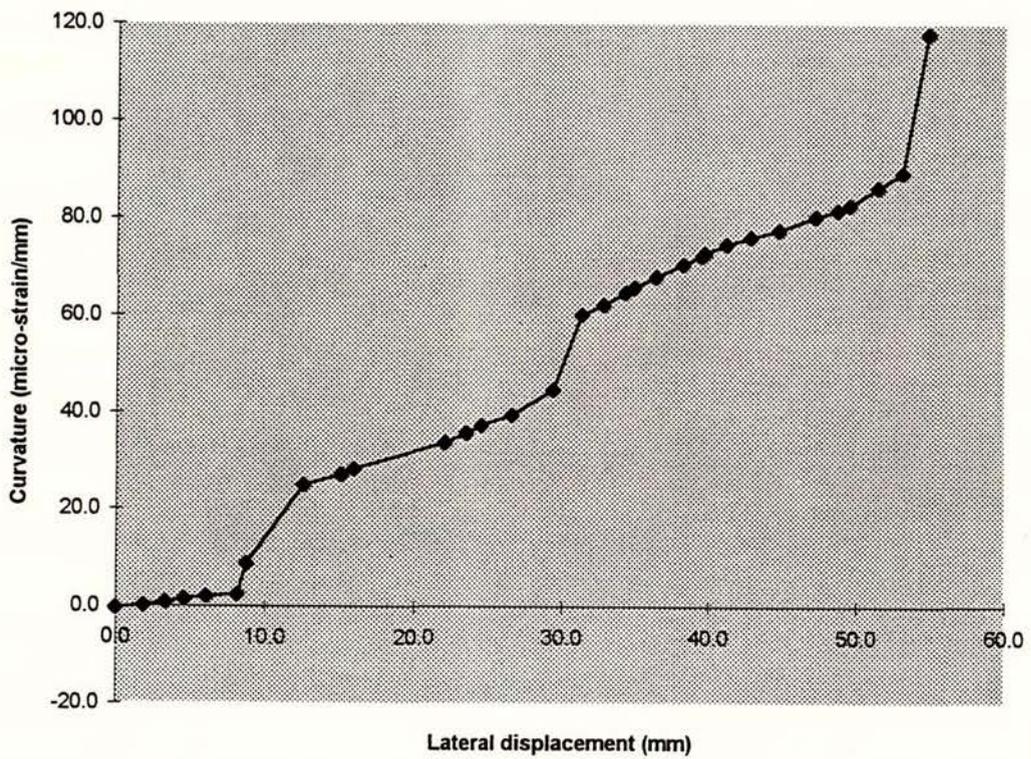
Fig. 6.4 b: shows a linear increase in the average curvature over the displacement range plotted. From these graphs, a moment curvature relationship may be constructed, where the moment is equal to the ram force P acting over a lever arm of 7.4m. The corresponding curvature is the average along the section, as plotted in Fig 6.4 b. The moment-curvature diagram is plotted up to a curvature corresponding to a lateral sway 55mm, which is approximately equal to a displacement ductility factor $\Delta u / \Delta y$ of 6.

Fig 6.4 a: Moment-curvature relationship for initial loading stage, 0 - 55mm

Fig 6.4 b: Average curvature plotted against lateral displacement

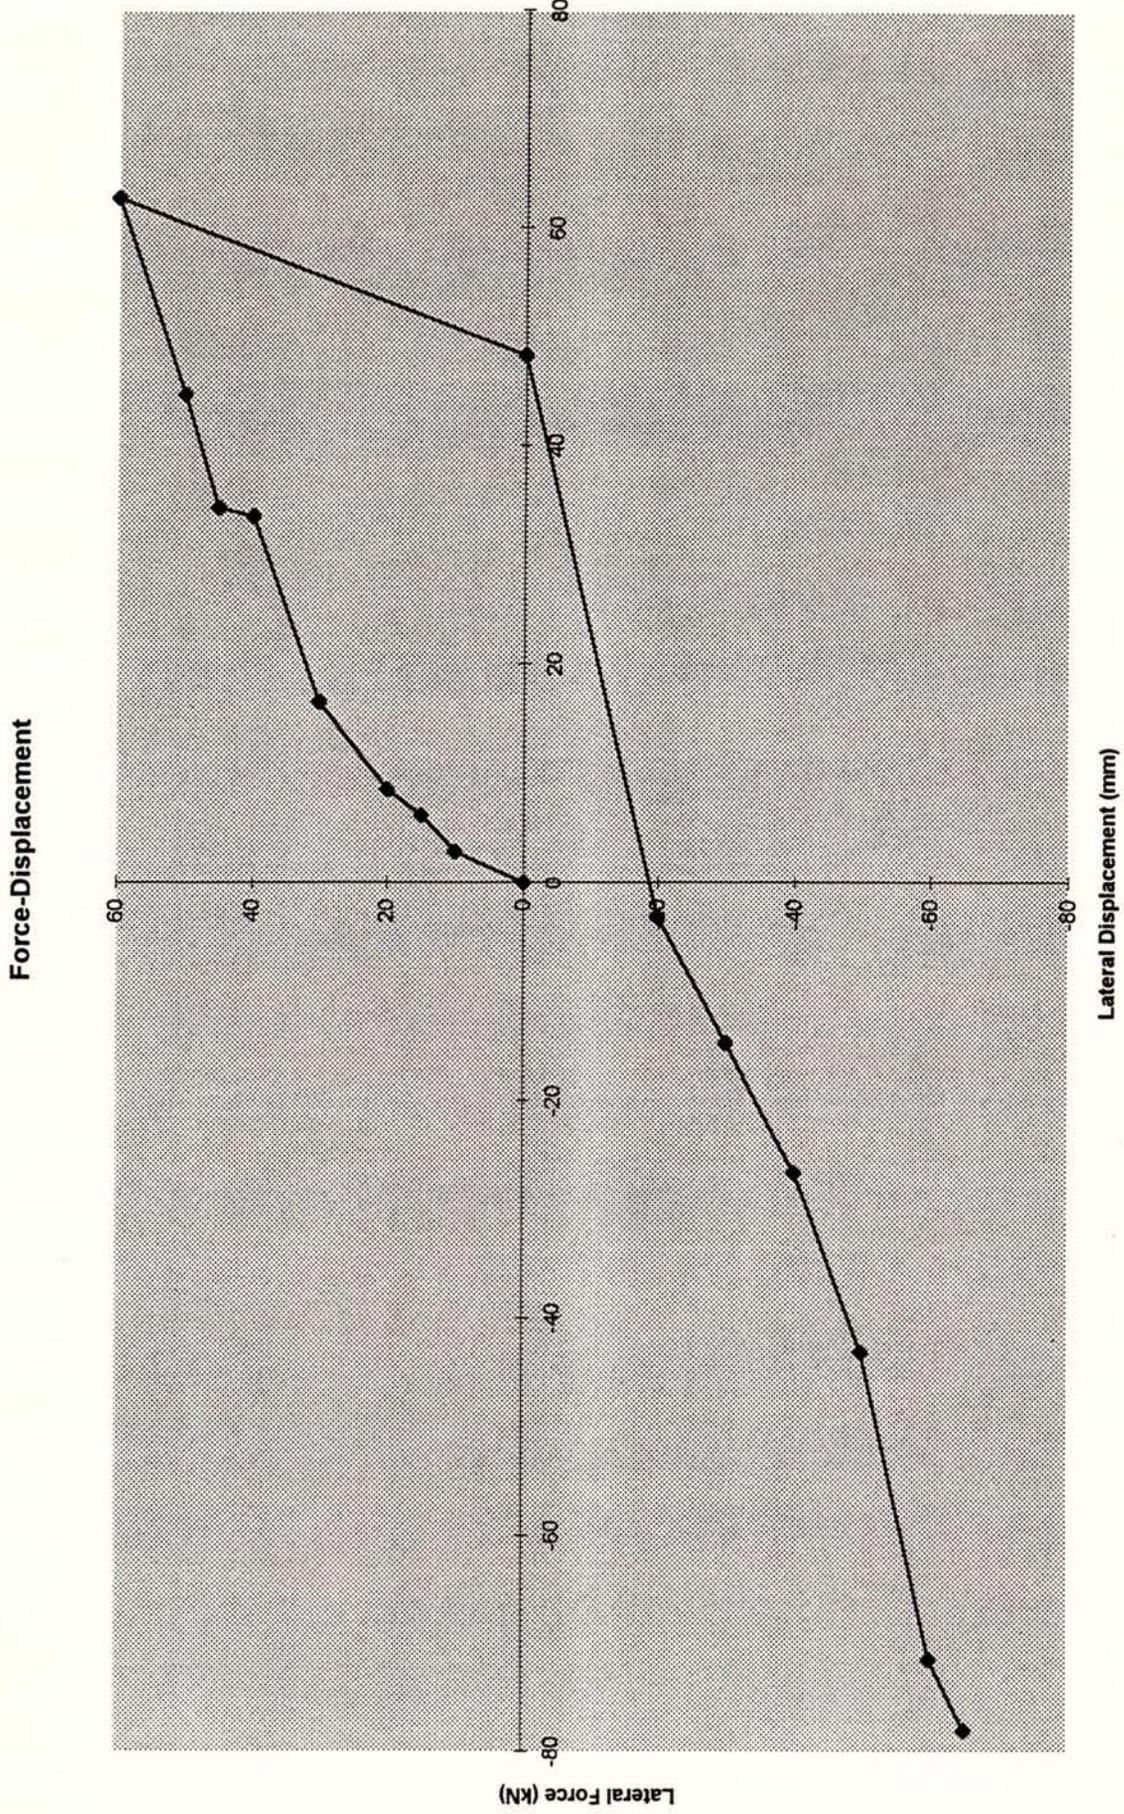
Fig 6.6: Load-displacement diagram for second load stage (400 kN compression)
