## Foundation Loads Due to Lateral Spreading at the Landing Road Bridge, Whakatane

96/10

FOUNDATION LOADS DUE TO  
LATERAL SPREADING AT THE  
LANDING ROAD BRIDGE, WHAKATANE

This report is identical to a project report of the same name submitted to the University of Canterbury in partial fulfilment of the requirements for a Master of Engineering degree.

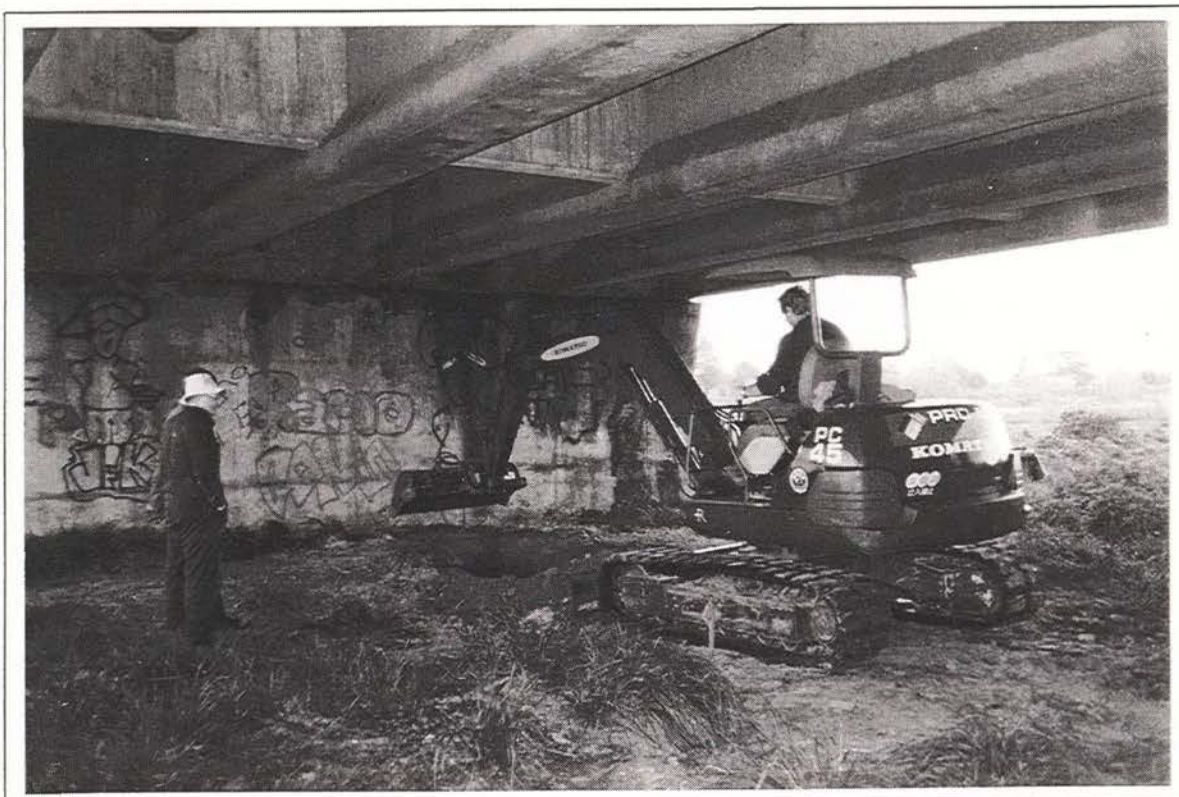
*Figure 4.5 Start of excavation at Pier C*

Headroom beneath the bridge was a very important consideration when choosing a hydraulic excavator to fit beneath the bridge superstructure and trench deep enough to examine the top of the piles. The minimum headroom available of 2.5 m occurred at pier C due to the bridge beams above. Approximately one metre extra working room was present in between the beams. Maximum excavation depths required were 2.5 to 3 m which is deep enough to inspect the top of the piles. Research of hydraulic excavators that could meet this criteria suggested that a 3 to 5 tonne machine would suffice. A Komatsu PC-45 hydraulic excavator owned by a local contractor in the Whakatane area was available and proved to be very versatile for this job. Figure 4.5 shows the start of excavation on the riverbank side of Pier C.

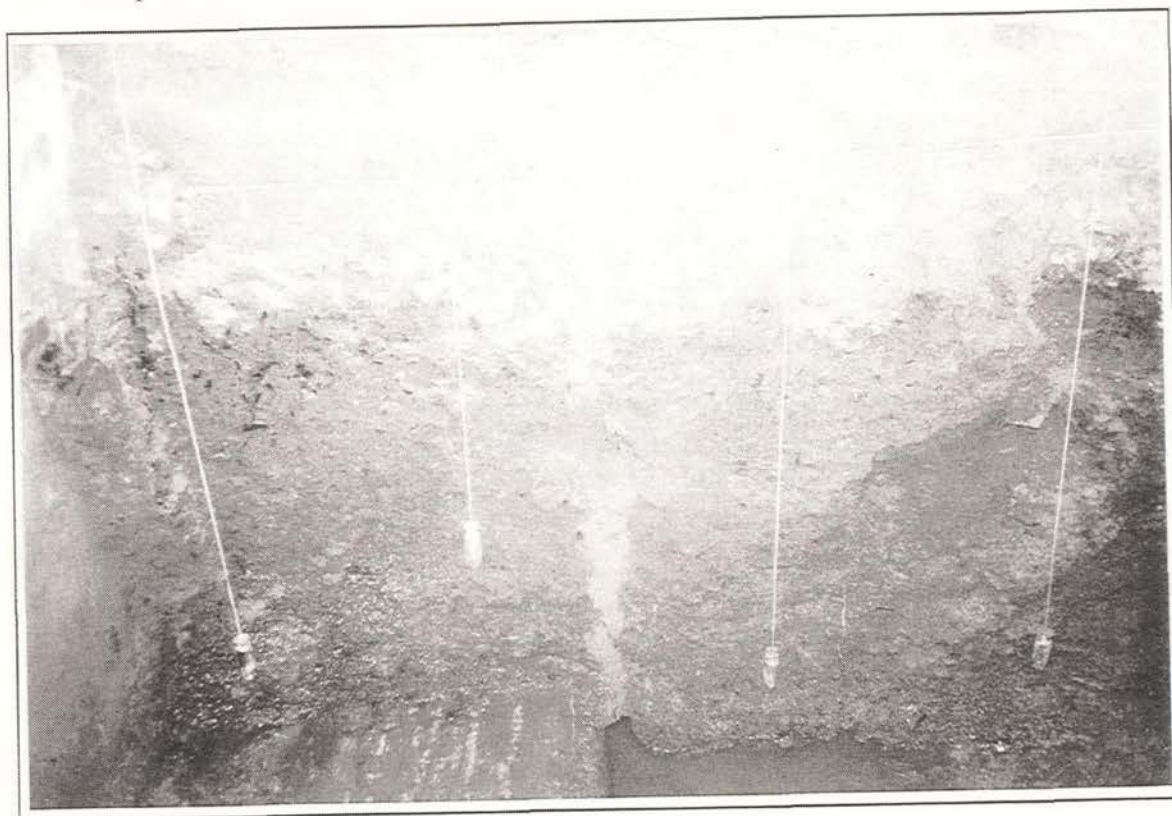
*Figure 4.8 Lateral spread crack near the river side of Pier C*

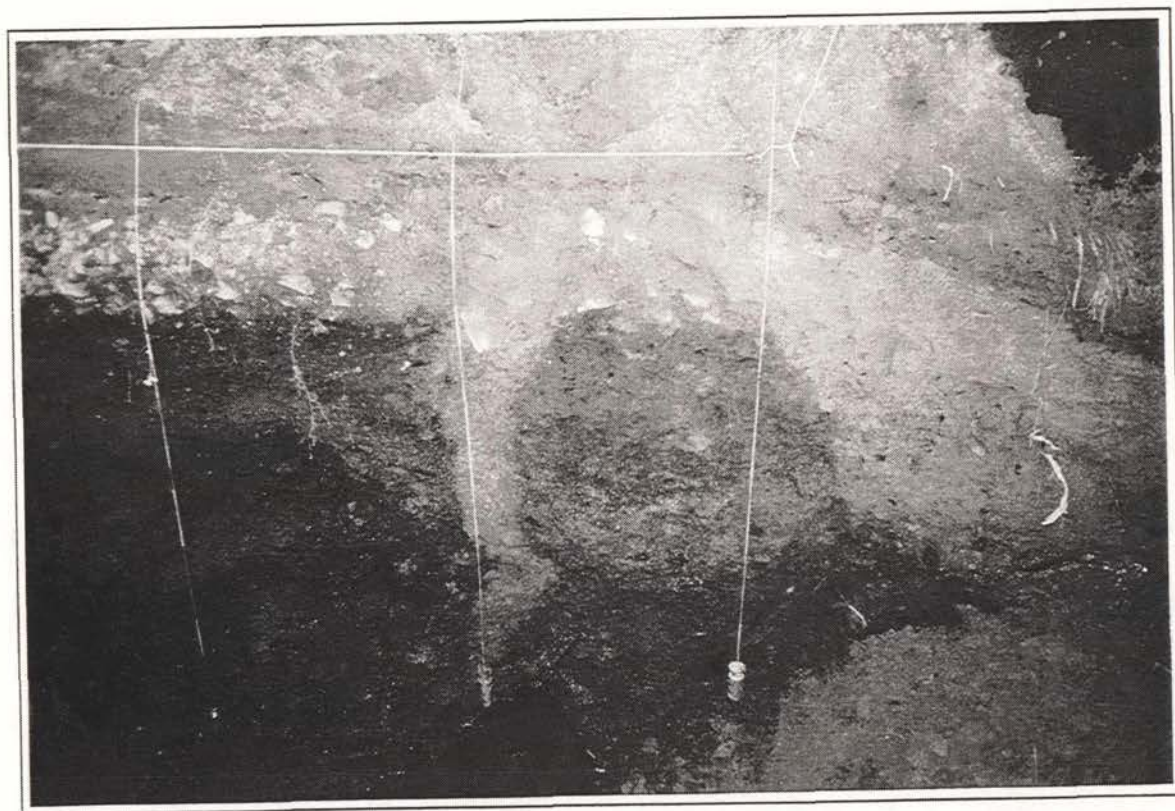
*Figure 4.9 Lateral spread crack about 2.5 m from the river side of Pier C*

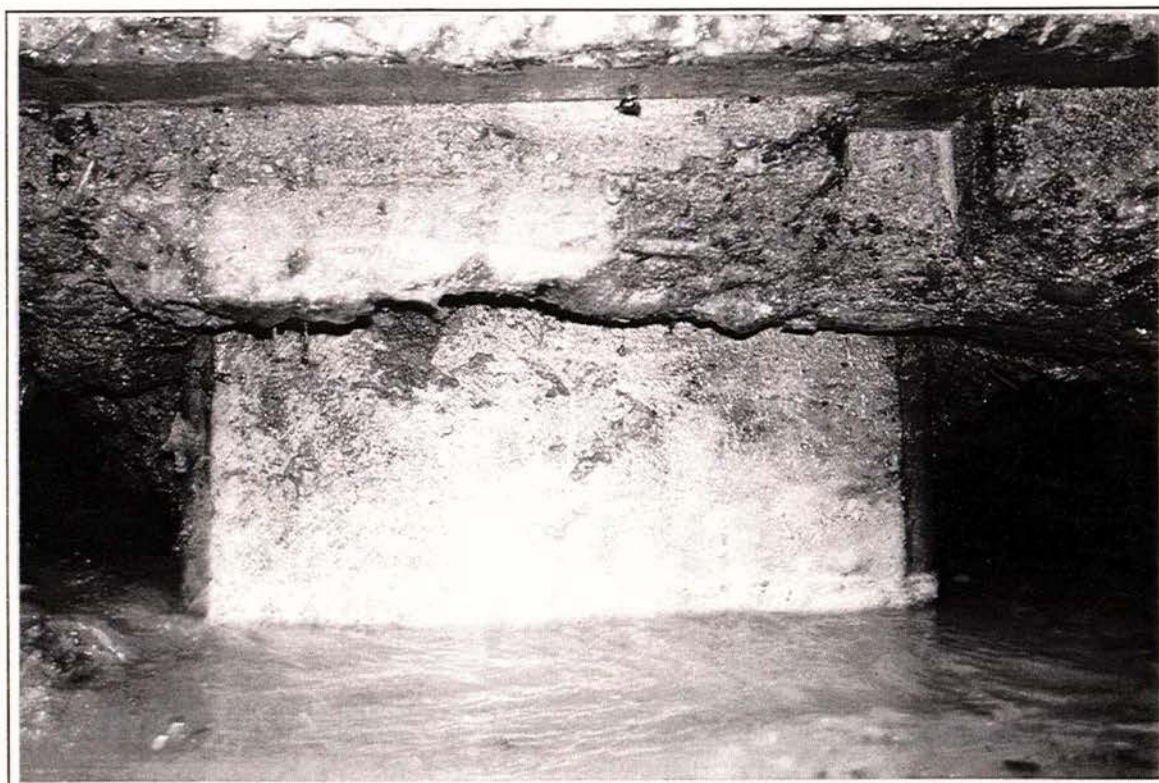
*Figure 4.11 Riverside view of the top of pile 3*

Figure 4.11 shows pile 3 which is 406 mm wide and a very small crack could be seen just beneath the interface over the width of the pile, but overall, the pile was very much intact at this location. This crack could have occurred during construction or perhaps by lateral spreading loads and we can not be certain what caused it to form. Figure 4.12 reveals that there are no cracks in the upper 200 mm of pile 4. In both cases there did not appear to be any separation between the top of the pile and the bottom of the pile cap. Some formwork (100 by 50 mm cross section timber) and non structural concrete was found beneath the pile cap and could not be removed. This may have hidden some of the possible movement or cracks.

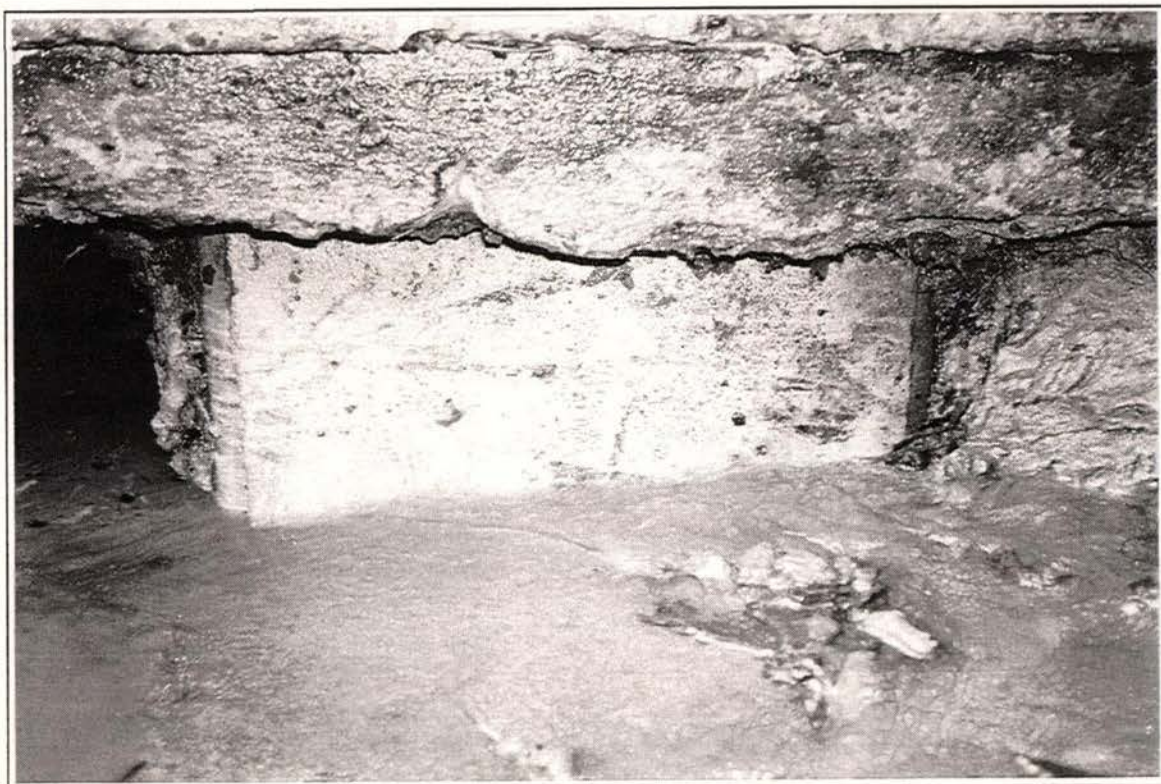
*Figure 4.12 Riverside view of the top of pile 4*

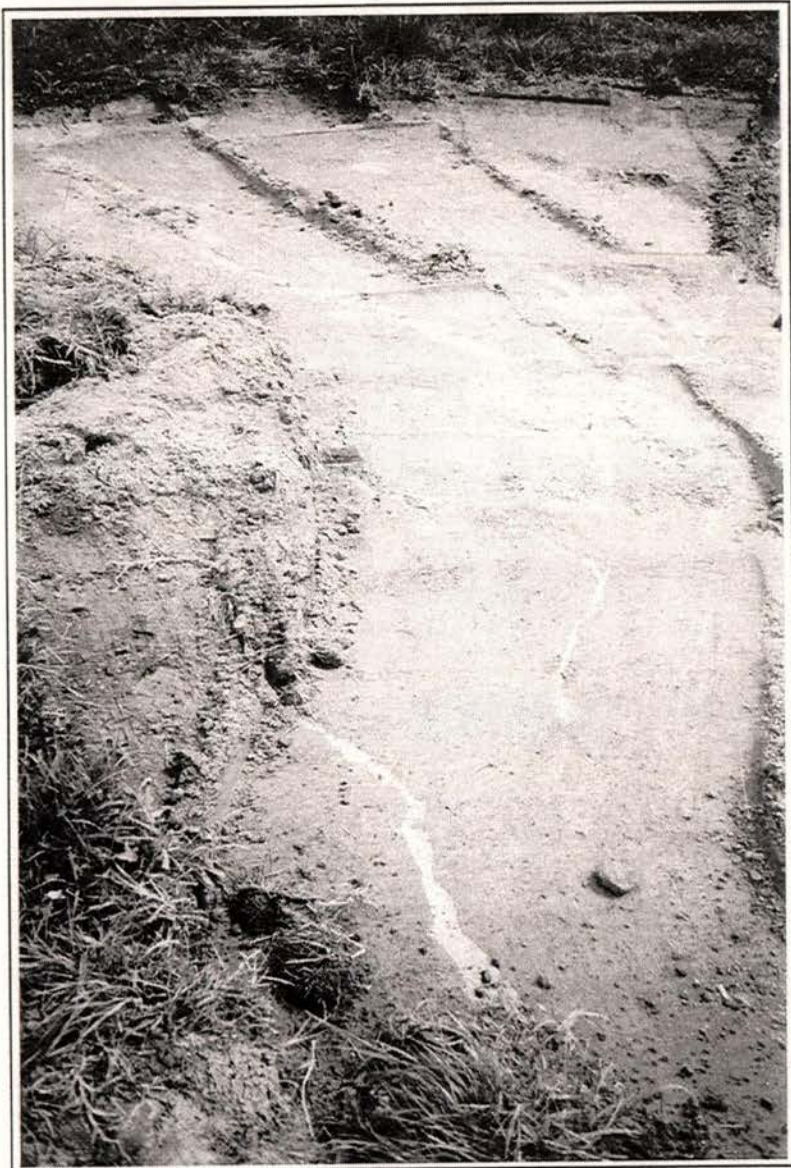
***Figure 4.14 Sand Filled Lateral Spread Cracks South of Trench 1***

Both of the sand filled fissures were traced back toward the bridge along the ground surface. Shallow excavation in the topsoil revealed other crack sequences in the crustal soil and other buried sand boils. Figure 4.14 shows some of the sand filled cracks just south of trench 1.
