Axial Behaviour of Bored Pile Foundations

K. J. McManus

January 1997

97-2

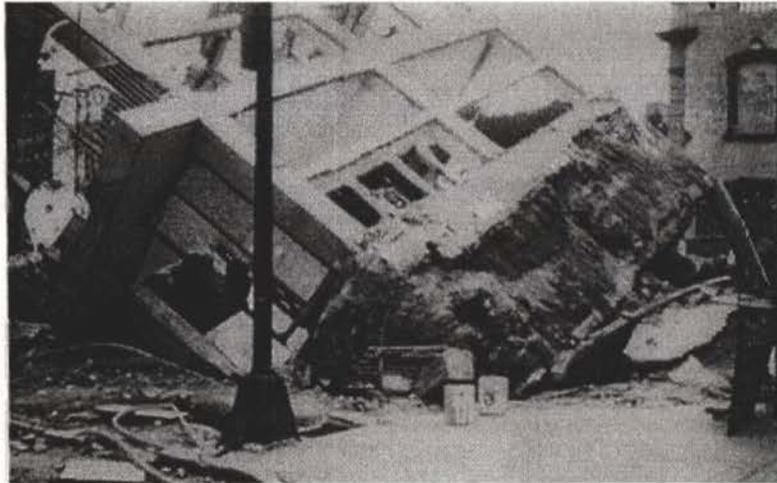
Figure 2. View of collapsed building.

Source: Mendoza and Auvinet [3]

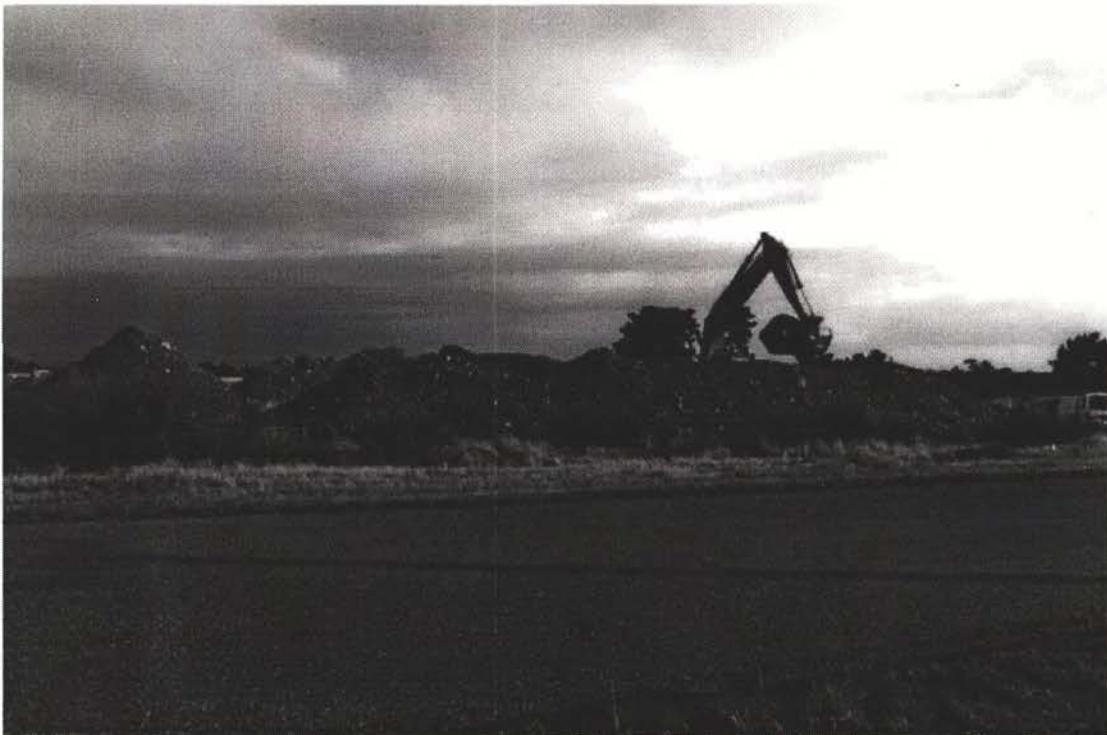
Figure 6. Test site during reworking of soil.

Extensive discussions and investigations led to the conclusion that the desired low water table, granular soil material, and low soil density were mutually exclusive properties, certainly in the Christchurch vicinity. Therefore, the decision was reached that the best solution would be to modify the in-situ soil density at the test site by mechanical means. A scheme was devised to excavate a large open pit at the Curraghs Road test site to a depth of 6 m and then to refill it using a large backhoe. Figures 6 and 7 show this work in progress. The test piles were then able to be constructed in the much looser material. The re-deposition of the material had benefits additional to reduction in density: The soil was mixed and re-deposited as a more uniform deposit, the soil gradation was better known, the soil in-situ stress state was better known, and any undesirable cementing of the soil was removed.

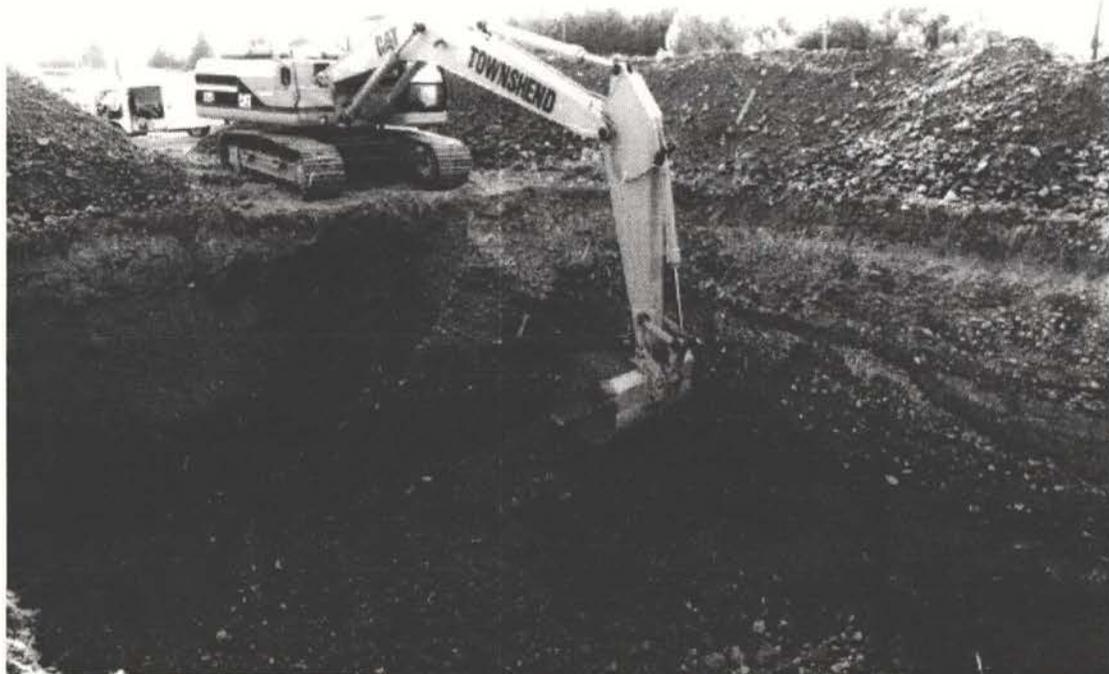
Figure 7. Excavation of test site.

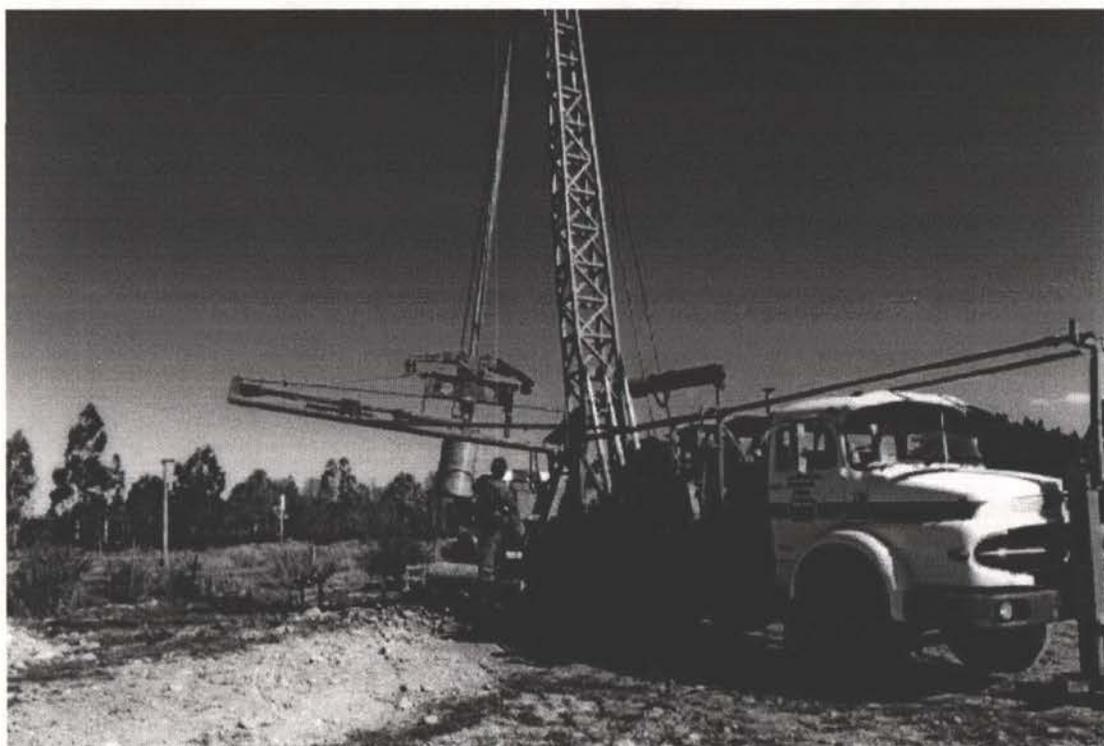
Figure 11. Truck mounted Calweld bucket auger rig.

Nine piles each of nominal size 750 mm diameter by 5.5 m deep were constructed on a three-by-three grid at 3.5 m spacing. The piles were constructed under contract by the Canterbury Drilling Company Ltd using a truck mounted Calweld bucket augur rig. First, a hole was bored to 2 m deep and then a temporary steel casing was stood and driven to the full depth of 5.5 m (Figures 11 and 12). Next, soil was removed from the inside of the casing using a bucket augur. This step proved to be the most time consuming as large size cobbles would get caught between the bucket and the casing causing the rig to stall frequently. The operator commented that a helical augur rig would have overcome this problem and would thus be more suitable for constructing bored piles in this soil type. Next the reinforcing cage was stood and set level in the hole ready to receive the concrete (Figure 13). Concreting proceeded in four steps: (a) concrete was poured to a depth of 2 m from the bottom of the hole, (b) the casing was pulled for about 1 m to make certain that it was not binding in the ground, (c) the remainder of the concrete was poured into the casing to a level of 1 m above the ground, and (d) the casing was pulled completely out of the ground (Figure 14). During the pulling of the casing the concrete level was observed to drop markedly, presumably because of a slight expansion of the hole under the pressure of the wet concrete. Finally, the concrete surface was struck off to the desired level and the protruding threaded portion of the reinforcing bars cleaned off.

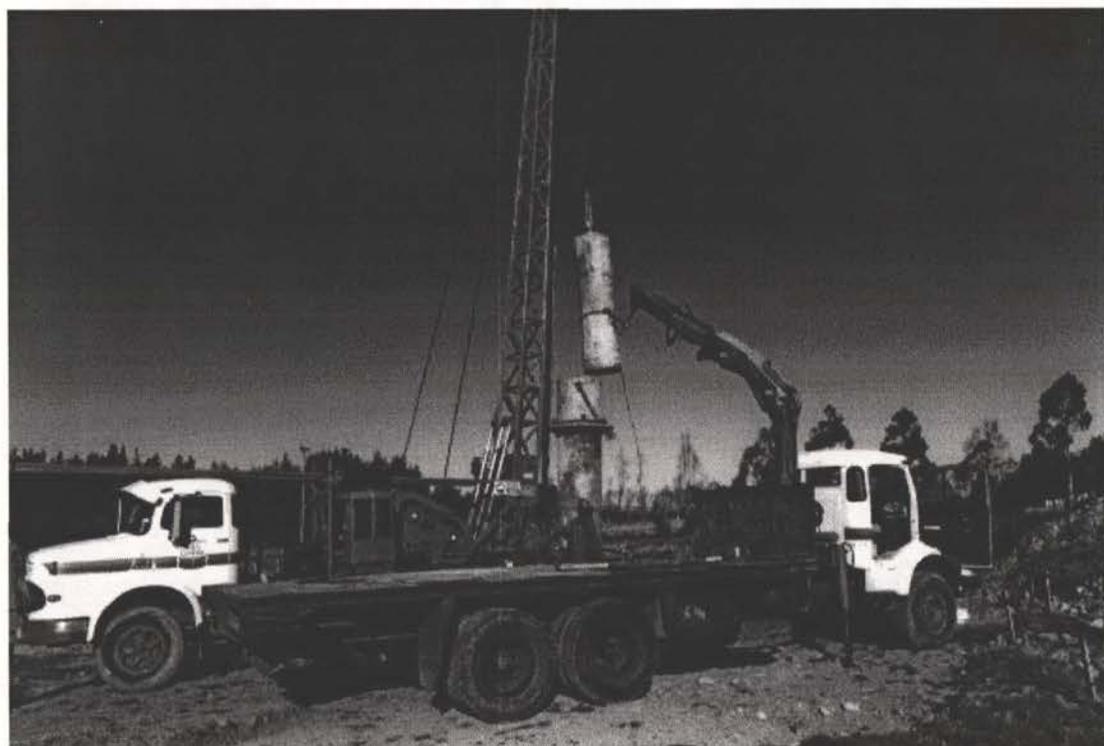
Figure 12. Preparing to drive the casing.

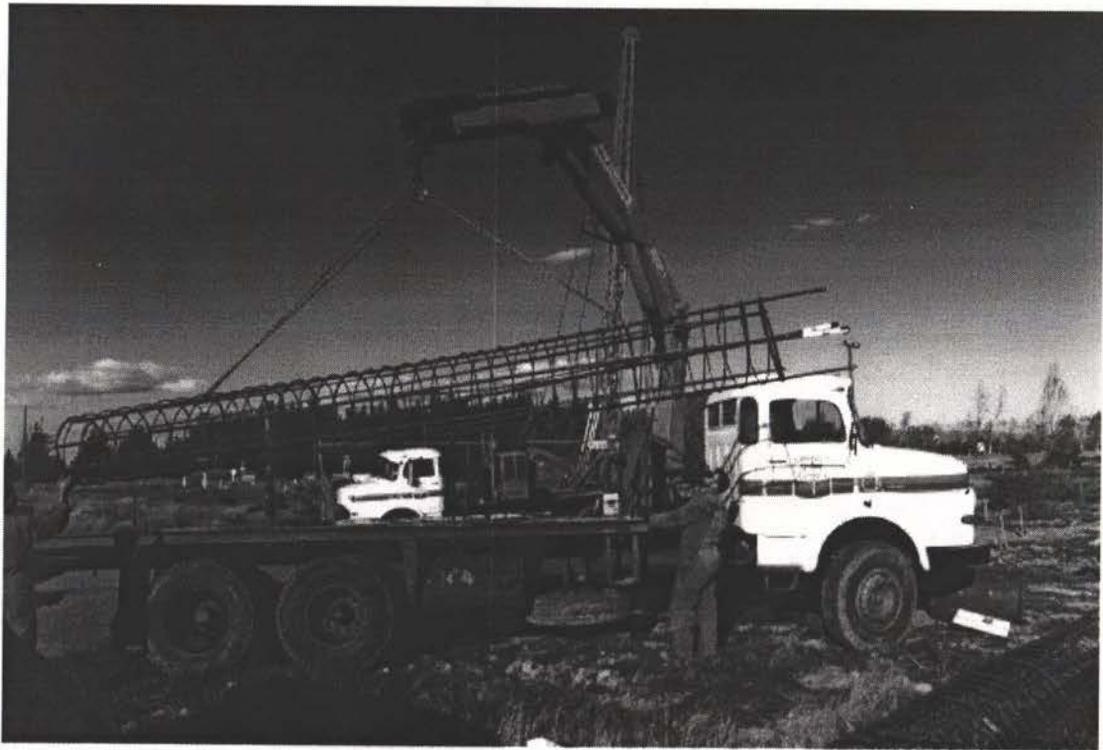
Figure 13. Unloading the reinforcing cage.

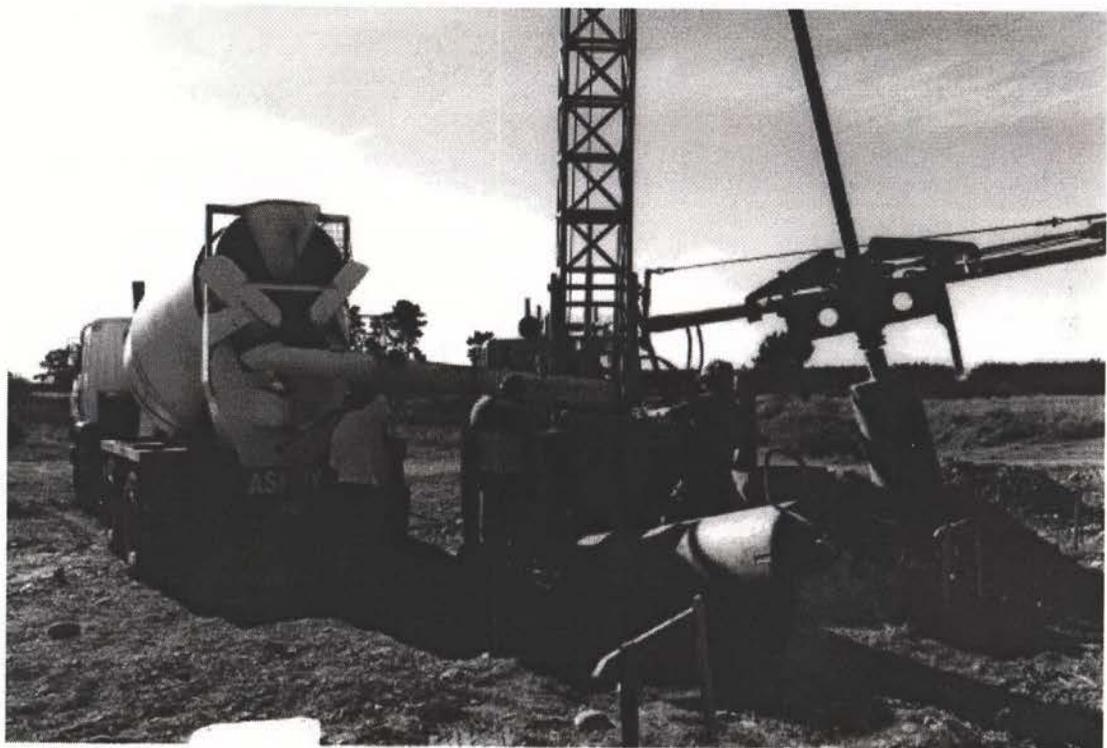
Figure 14. Pouring the concrete.

Concrete strength was nominally of 20 MPa and the slump was measured at each pour with an average value of 170 mm. A high slump was chosen to facilitate pulling of the pile casing. The reinforcing cage consisted of four D24 bars and four D16 with a 10 mm spiral at 150 mm pitch. The four D24 bars were made 500 mm longer than the pile and were threaded on the ends to provide a connection to the loading system.

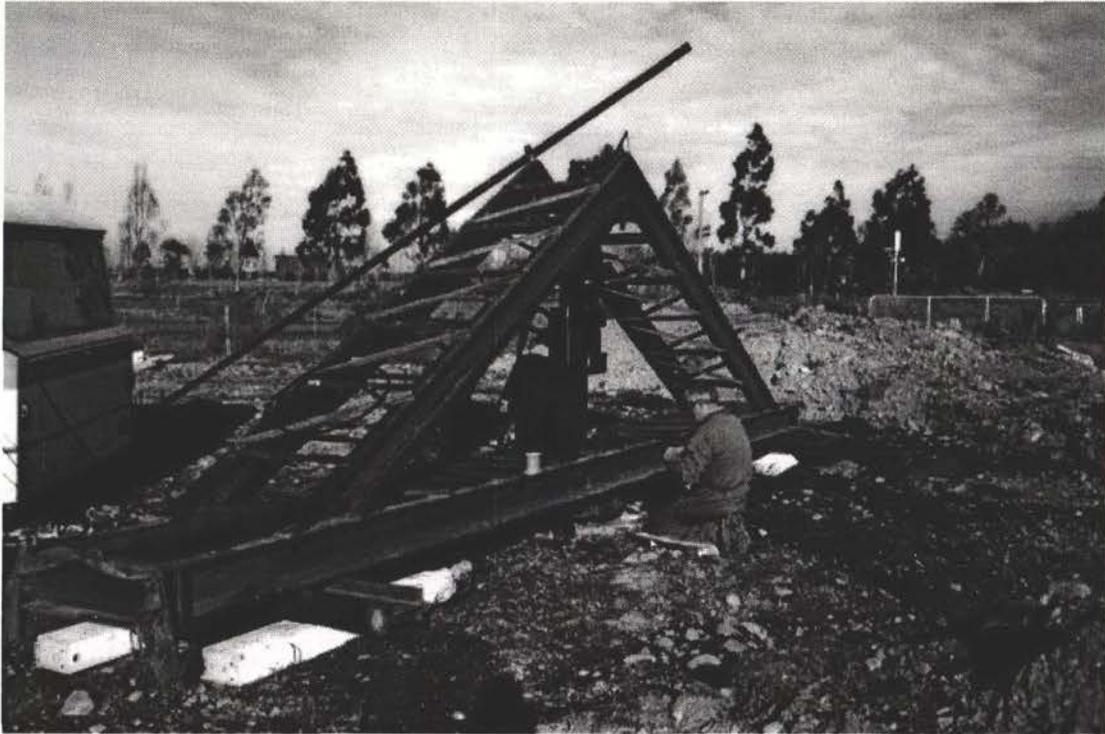
Figure 17. View of loading truss and actuator.

The servo-hydraulic actuator used was an MTS model 204.81 of 500 kN capacity and 152 mm stroke with an integral LVDT and an MTS model 72-233C servo-valve. A close-coupled load cell manufactured by the University of Canterbury, Department of Civil Engineering was used to measure load and heavy universal joints, also manufactured within the Department, were used at each end of the assembly to provide the necessary freedom from induced bending moments. Hydraulic power was provided by an MTS hydraulic power unit of 62 l/min capacity. Electrical power for this unit was provided by a 110 kVA mobile generator.

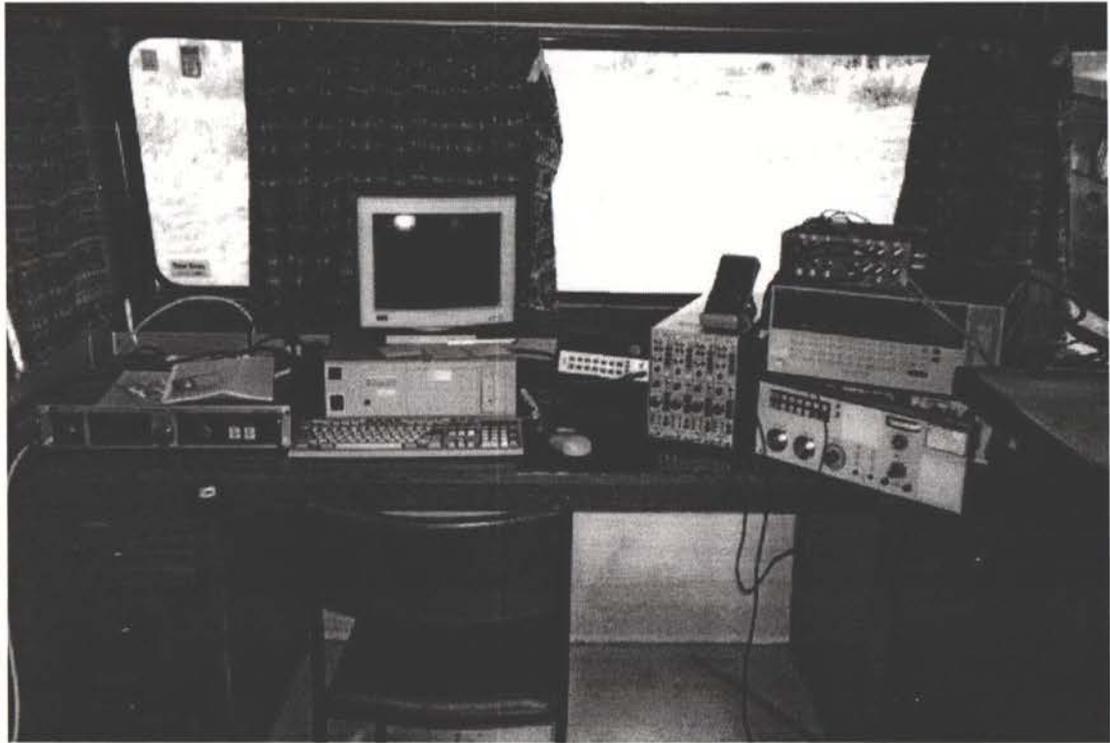
Figure 20. Control room setup inside the caravan.

All of the electronic control and data acquisition equipment was housed in a caravan for protection from the weather and also for security, with the caravan being removed from site at the end of each working day. The arrangement of equipment inside the caravan is shown in Figure 20.

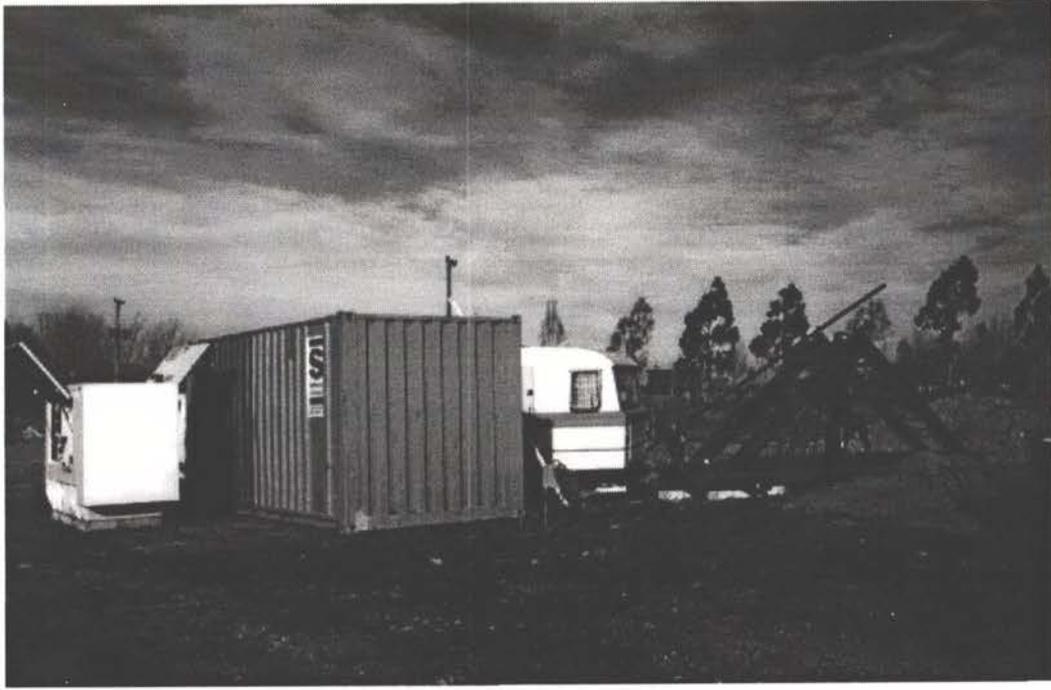
Figure 21. Arrangement of equipment on site.

The MTS hydraulic pump was housed inside a standard shipping container, also for reasons of security and weather-tightness. The mobile generator was self contained with a weather-tight, lockable enclosure. An overall view of testing in progress on site is given in Figure 21.
