**The Magnitude 8.3 June 23 2001 Southern Peru Earthquake  
and Tsunami: Reconnaissance Team Report**

**Client Report  
2002/50**

**May  
2002**

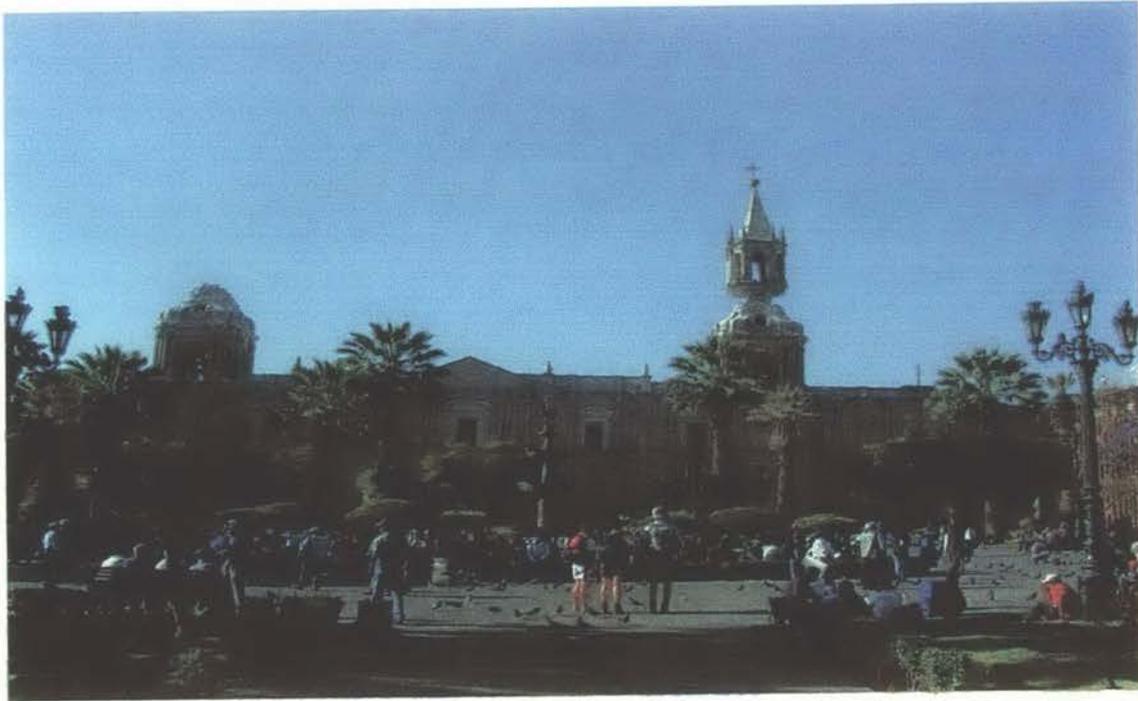
Figure 5

The Arequipa cathedral at the time of our visit, showing one spire absent as a result of the earthquake (a). In (b) the cathedral is shown during the actual earthquake shaking, moments before the spire fell through the cathedral ceiling (the picture is from the tourist brochure "Terremoto" which was being sold on the streets of Arequipa at the time of our visit).

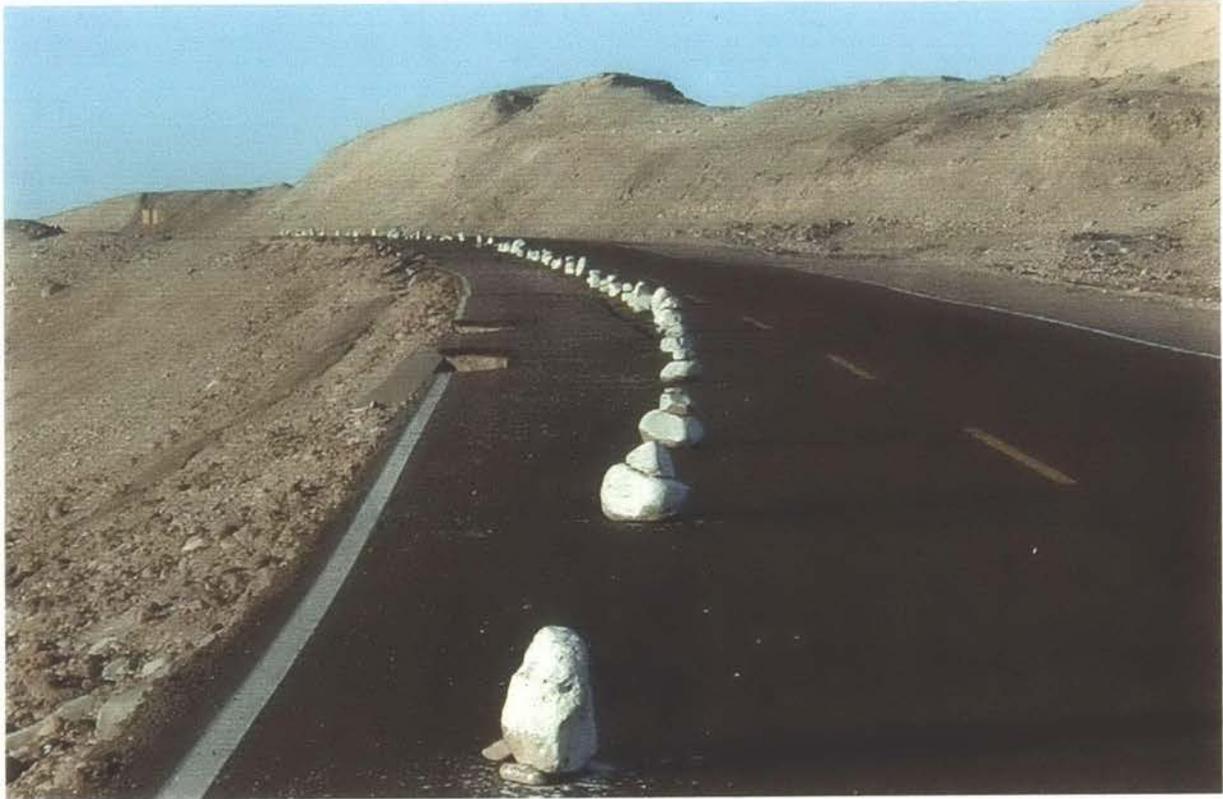
Figure 8  
Damage to the Pan American highway from failure of the slopes beneath the highway. Damage like this was widespread on the highways along the 300km long earthquake rupture zone, causing some considerable traffic jams.

Hillslope subsidence and slope failure damaged the Pan American highway and other main highways within the 300 km long earthquake zone. In Figure 8 we show typical damage to the highways and the use of white painted boulders to divert the traffic away from damage.

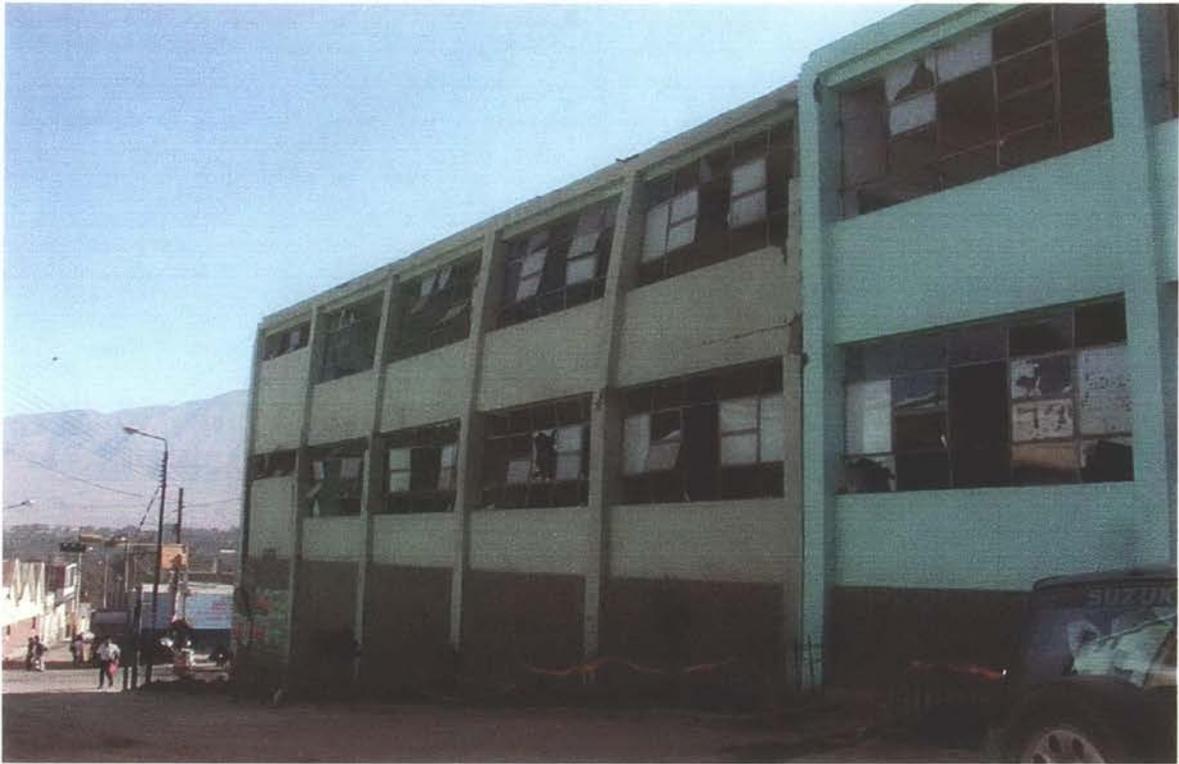
Figure 10  
Damage to the Moquegua College, a building probably of similar age to the Arequipa military mess building in Figure 7.

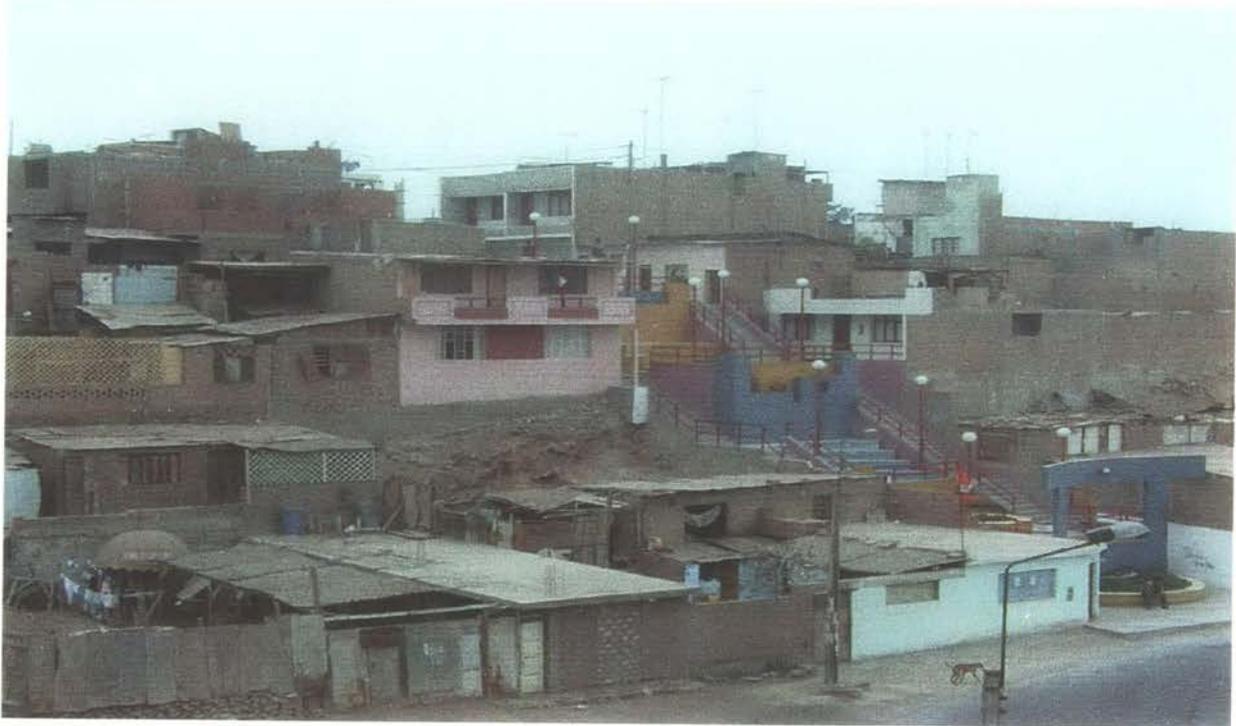
Figure 11  
Undamaged buildings on granite rock in Mollendo. No damage was observed in the city, even in the case of adobe buildings (as can be seen in the lower centre of the photograph).

In total contrast to Moquegua was the city of Mollendo, which showed a virtual absence of earthquake-related damage, despite being closer to the ruptured subduction interface than Moquegua. This city is located on granite, or “hard rock” in engineering terms. These site conditions were such that damage was light from the earthquake. Most buildings including those of adobe construction were undamaged (Fig. 11).

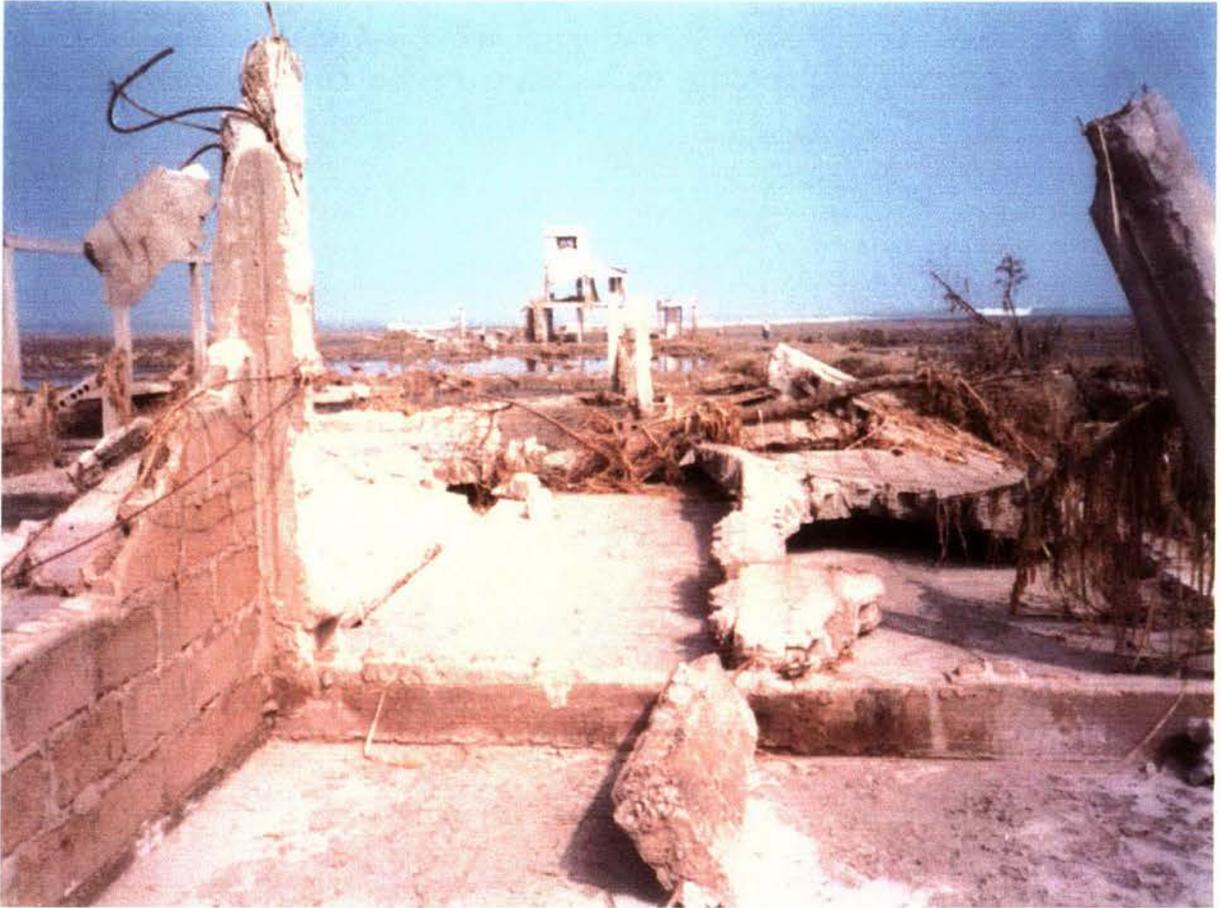
Figure 14  
Near total devastation to the coastal resort town of Camana by the tsunami.

On first arriving at Las Cuevas, we found it hard to imagine that the near total devastation of the coastal town was due to tsunami (Fig. 14). Instead, our impressions of the damage was that it was due to earthquake shaking. However, it was clear from the line of water-transported debris at the edge of the cliff at Las Cuevas (Fig. 15) and the distribution of debris throughout the ruins that the tsunami had violently impacted the area. The tsunami came several hundred metres in from the sea to the base of the cliff, smashing buildings and walls above high tide level, and depositing a layer of sand (up to 10cm thick) and debris across the entire area.

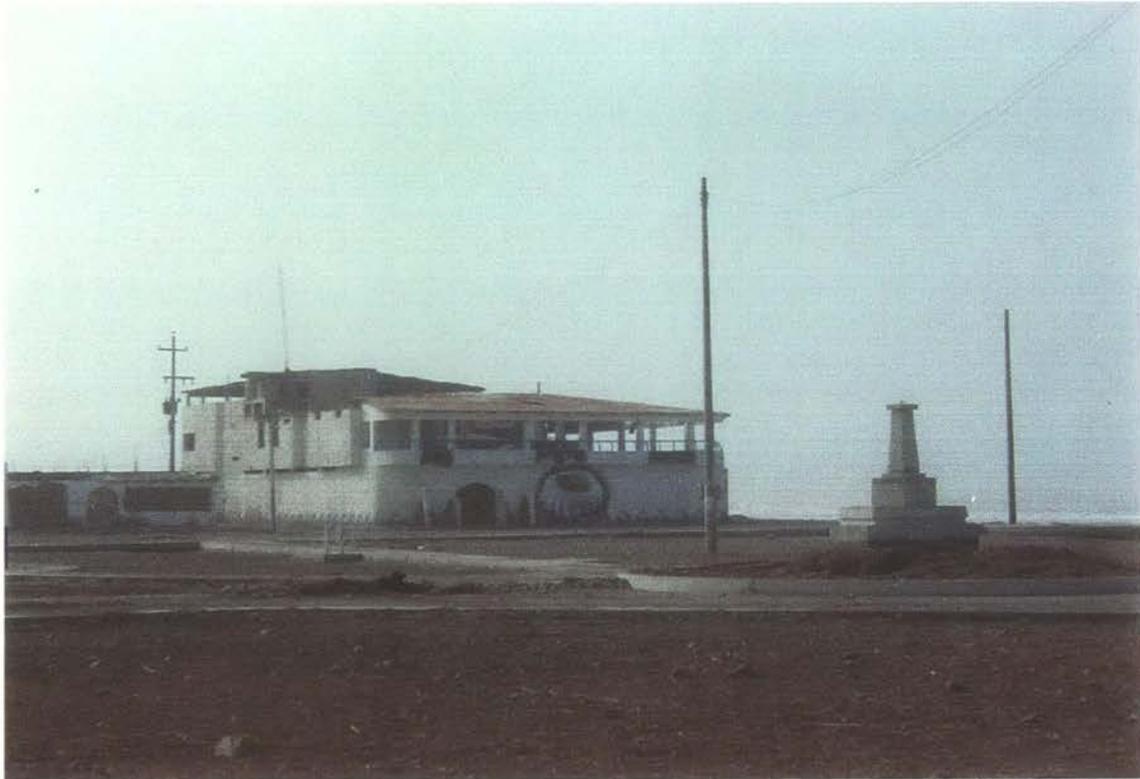
Figure 16

This photo gives an indication of the wave height reached by the tsunami. Eye witness accounts reported that the tsunami wave smashed through the roof of this disco and blew out the windows. The wave would therefore have been about 7m high, a height confirmed by the damage to the lamps of some tall lamp posts in the same area.

In the Las Cuevas-south Camana area, the eye-witness accounts of the tsunami impact were insightful in allowing us to differentiate between earthquake versus tsunami damage. People felt the earthquake shaking but did not report any damage associated with the earthquake. It was the impact of the black wall of water that produced the near total damage to the coastal part of the town. For example, the tsunami wave was observed to have come over the top of a two-storey discotheque, smashing through the roof and blowing out the windows (Fig. 16).

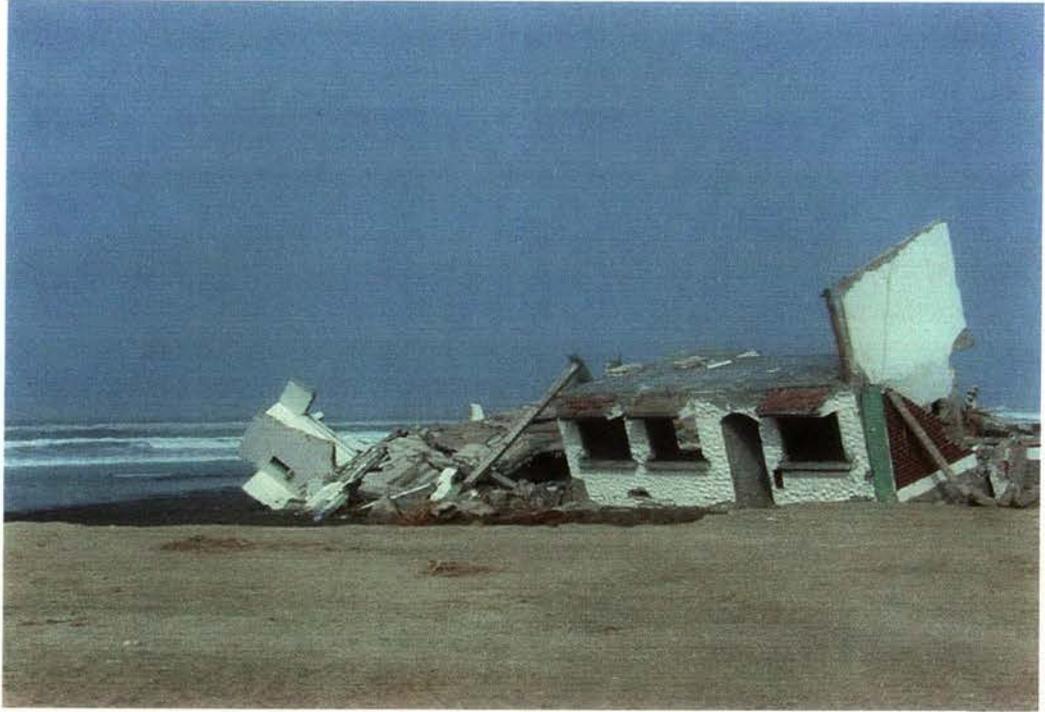
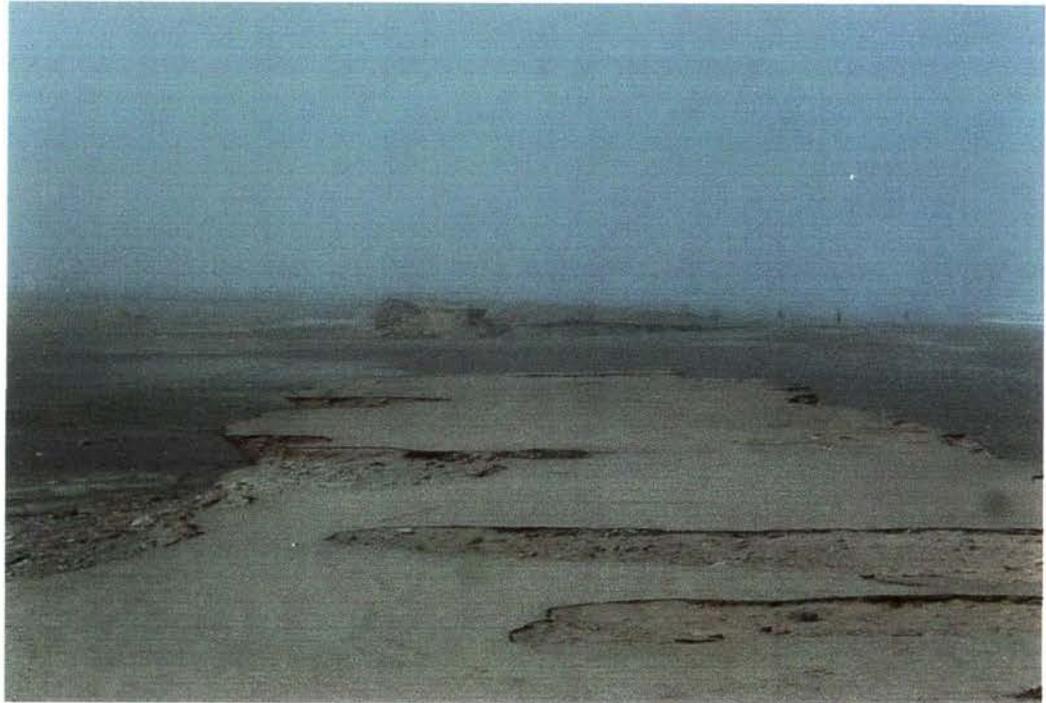
Figure 17

Possible evidence for coastal subsidence in Camana. The active beachfront was once 100 to 200m seaward of the ruined building shown in this photograph (a) but is now right at the building. This could be due to subsidence and also removal of sand by the retreating tsunami. The severe damage and southward lean to the building is largely due to the severity and obliquity of impact of the tsunami. The coastal promenade in (b) was once well back from the active beach front, but is now clearly at the active beachfront. In the 5 weeks following the earthquake it has been eroded and breached by the sea. This change in position of the active beachfront could also be due to coastal subsidence, and sand removal by the retreating tsunami.

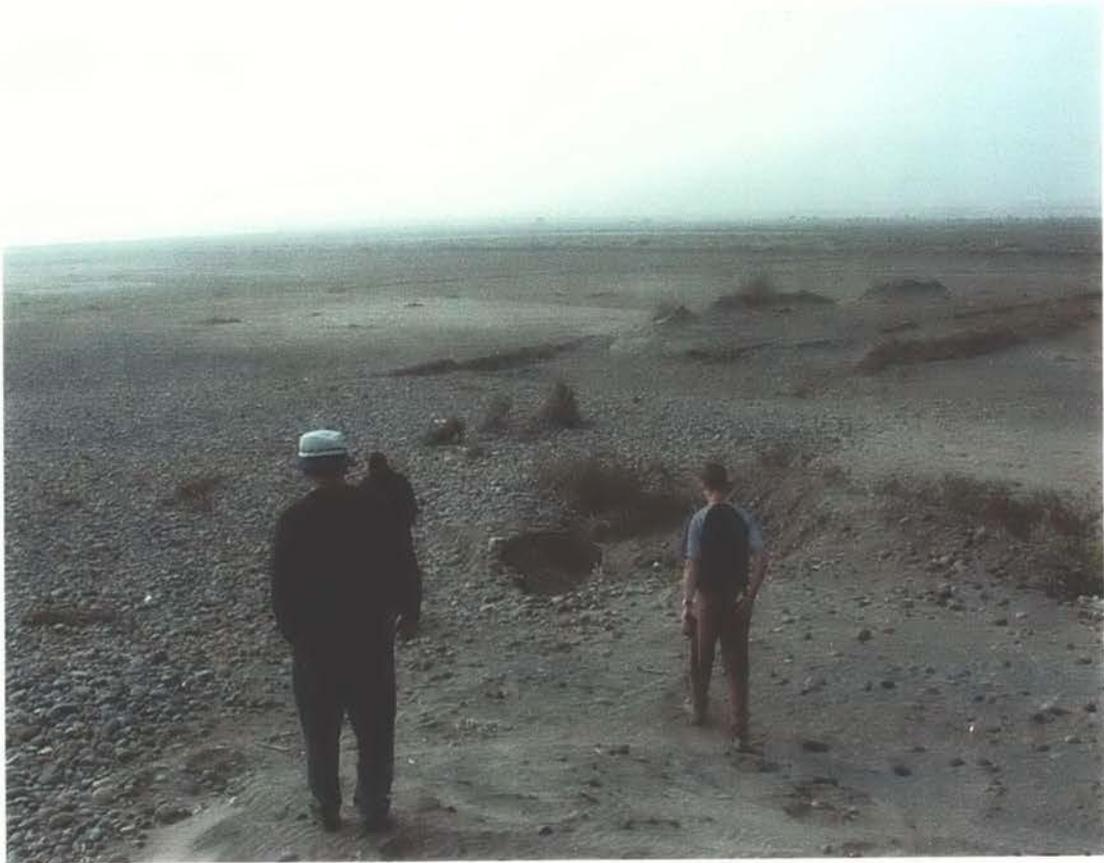
Figure 20  
Cobble gravel deposit formed by breaching of the natural beachfront bar during the tsunami.

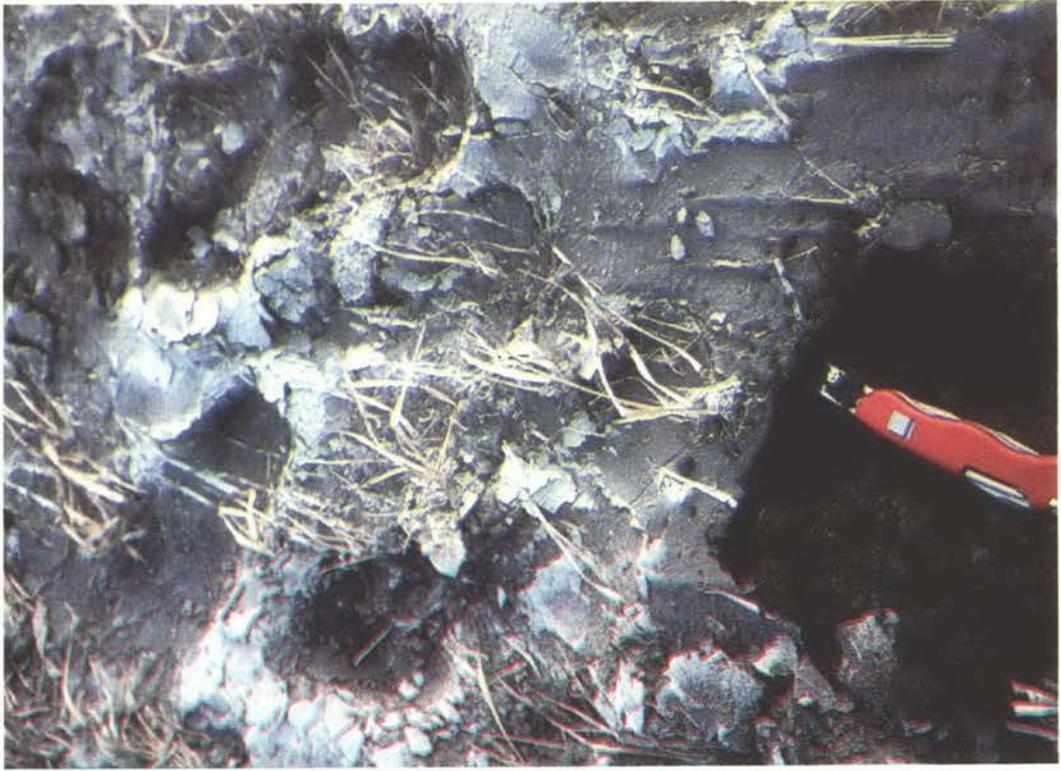
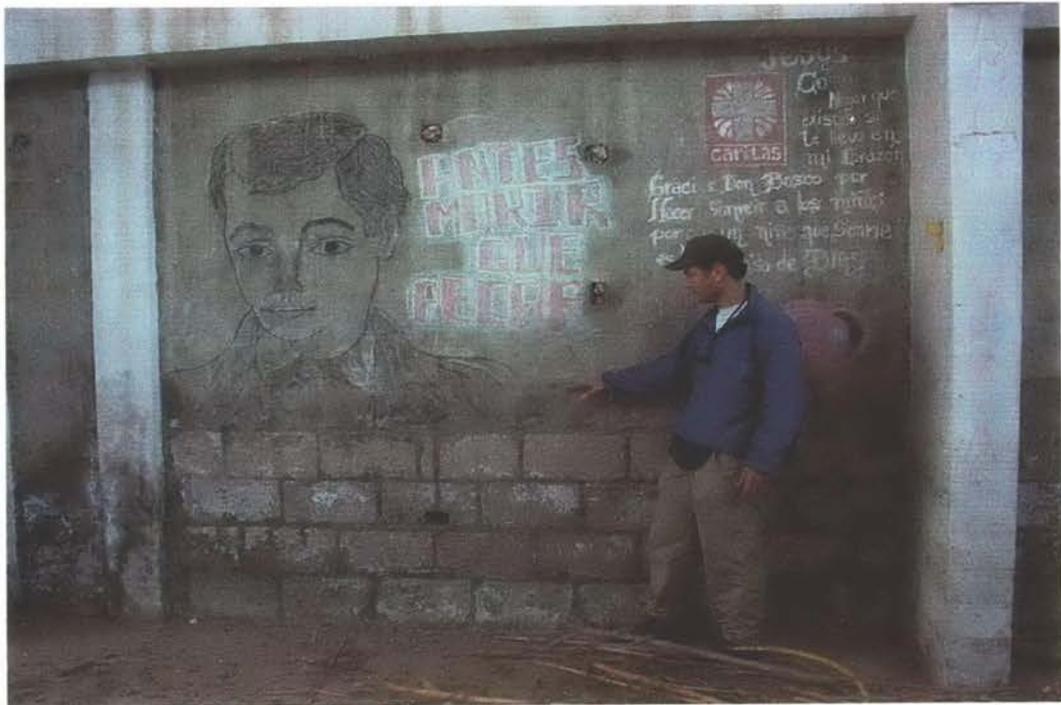
Figure 21

Tsunami deposits. In (a), vegetation has been laid down in the direction of wave motion (i.e. left to right) and buried by about 2cm of sand (see pocket-knife excavation to the right of the photograph) and the light colour on the surface of the deposit is a salt crust left behind after evaporation of the standing seawater. Tsunami deposits were also laid down inside many buildings in the Las Cuevas-Camana area, with the added problem of being highly erosive before deposition. In this church building in Las Cuevas (b) the sand-laden waters eroded the cement-veneered walls of the church enough to expose the underlying bricks.
