**Earthquake Vulnerability of Existing Unreinforced Masonry
Buildings**

E L Blaikie, D D Spurr (Works Consultancy Services)

This project was sponsored by the
New Zealand Earthquake and
War Damage Commission

December 1992

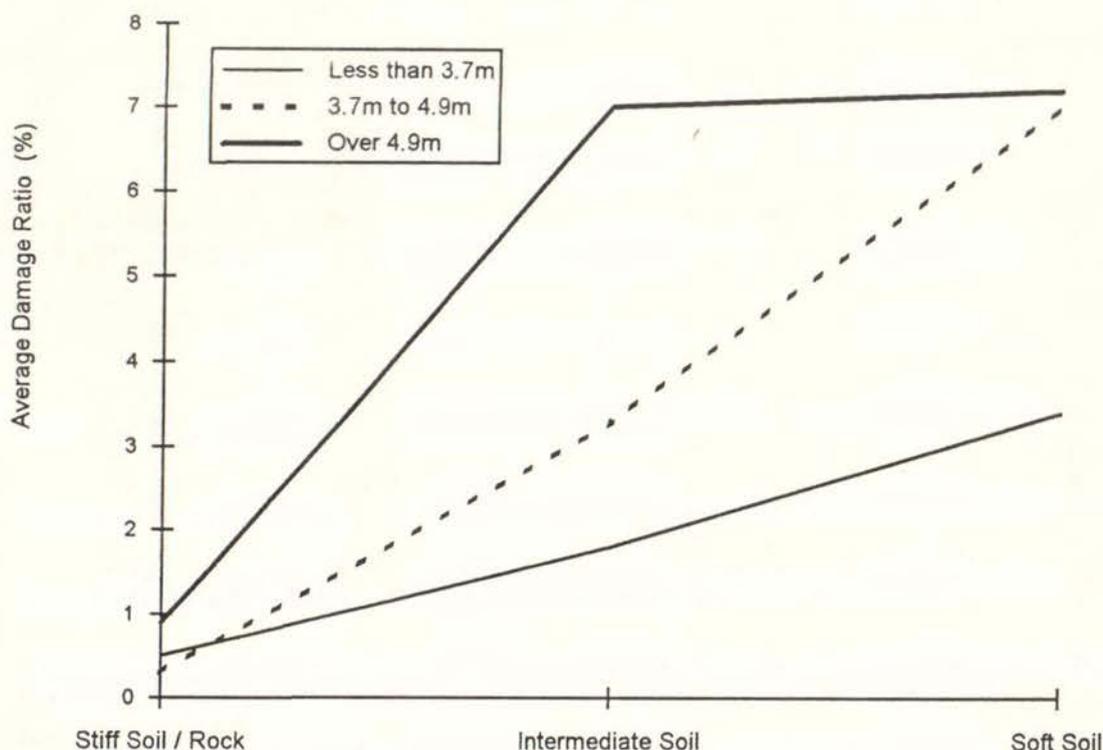
Figure 2.1: Influence of Soil Type and Storey Height on Average Damage Ratio for URM Buildings in San Francisco - 1989 Loma Prieta Earthquake (data from Holmes *et al*)

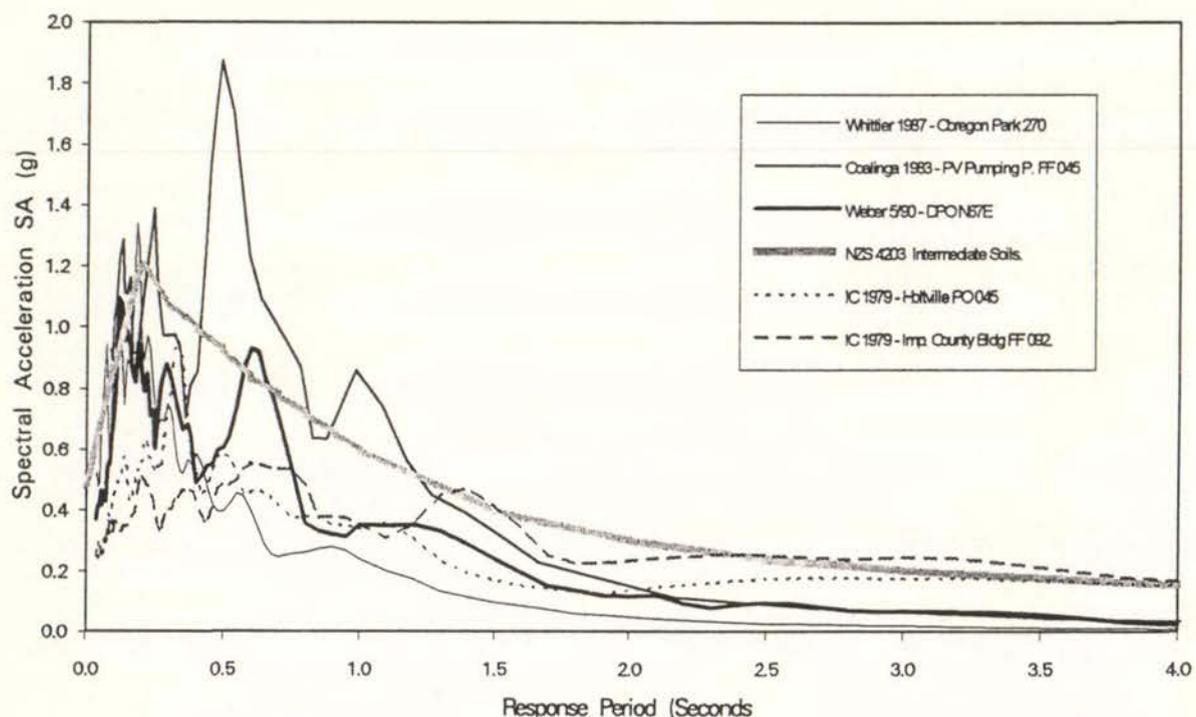
Figure 2.2: Acceleration Response Spectra From MM VII and MM VIII Zones

Acceleration response spectra from four of the earthquakes reviewed in Sections 2.1 - 2.7 are compared in Figure 2.2. Four records are shown from MM VII zones (Obregon Park from the Whittier Narrows earthquake; Holtville PO and Imperial County Services Building FF from the Imperial Valley earthquake; and Dannevirke PO from the Weber earthquake). The fifth record is from an MM VIII zone (Pleasant Valley pumping plant free field record from the Coalinga earthquake). In all cases the spectra shown are the stronger of the two horizontal components of the motion recorded. The 450 year design seismic hazard spectrum specified in the new SANZ Loadings Standard NZS 4203:1992 (33) for the high seismicity zone in central New Zealand, is also shown for comparison.

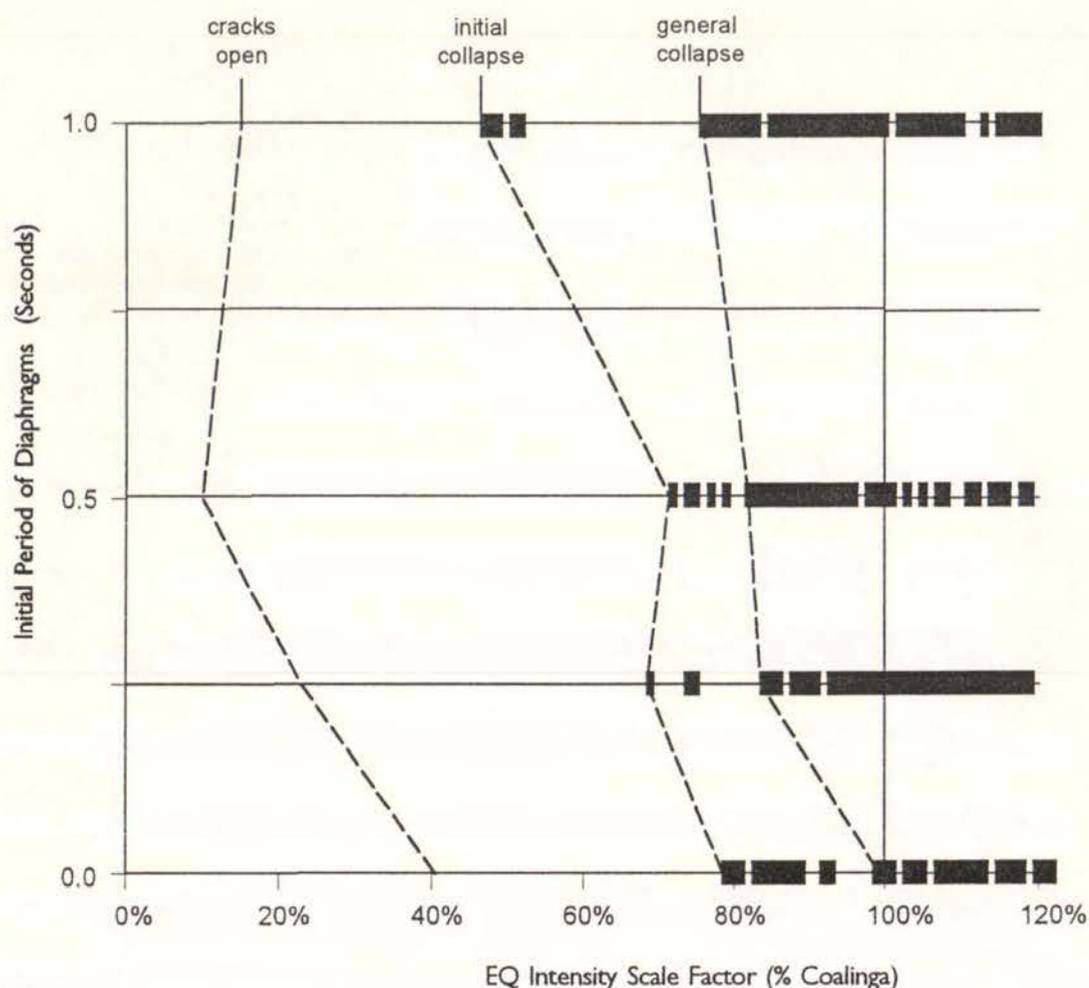
- Note:
- "Initial collapse" is the lowest load at which collapse occurred in the analyses.
 - "General collapse" is the load above which collapse generally occurred. Above this limit, the wall is only "stable" over load ranges of 2% or less of the full earthquake record. Some of the stable responses at high load intensities may be due to the top and bottom diaphragms responding out of phase with each other in the analyses.
 - Heavy black line shows ranges of EQ intensities over which the wall element collapses.

Results of the analyses for the Coalinga earthquake record (free field record from the Pleasant Valley pumping plant) are illustrated in Figure 2.3. Initial collapse of the modelled wall element occurred at a load intensity of between 0.47 and 0.79 times the Coalinga record, and general collapse at between 0.75 and 0.99 times the Coalinga record. Lower failure loads would be obtained for a two wythe wall with the same height/thickness (h/t) ratio. In practice, the capacity of many walls would be higher

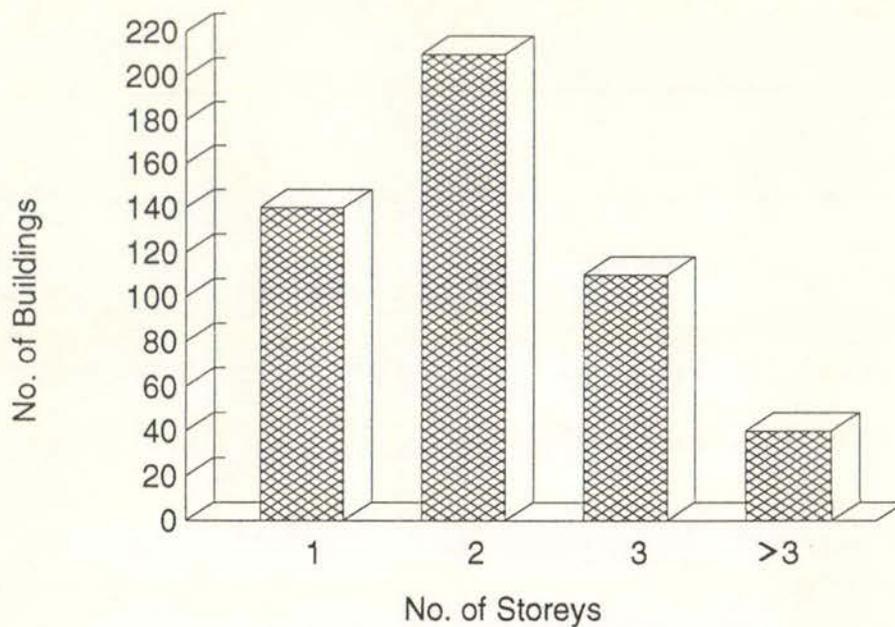
Figure 3.1 Earthquake Risk Buildings in Wellington City Classified According to Number of Storeys

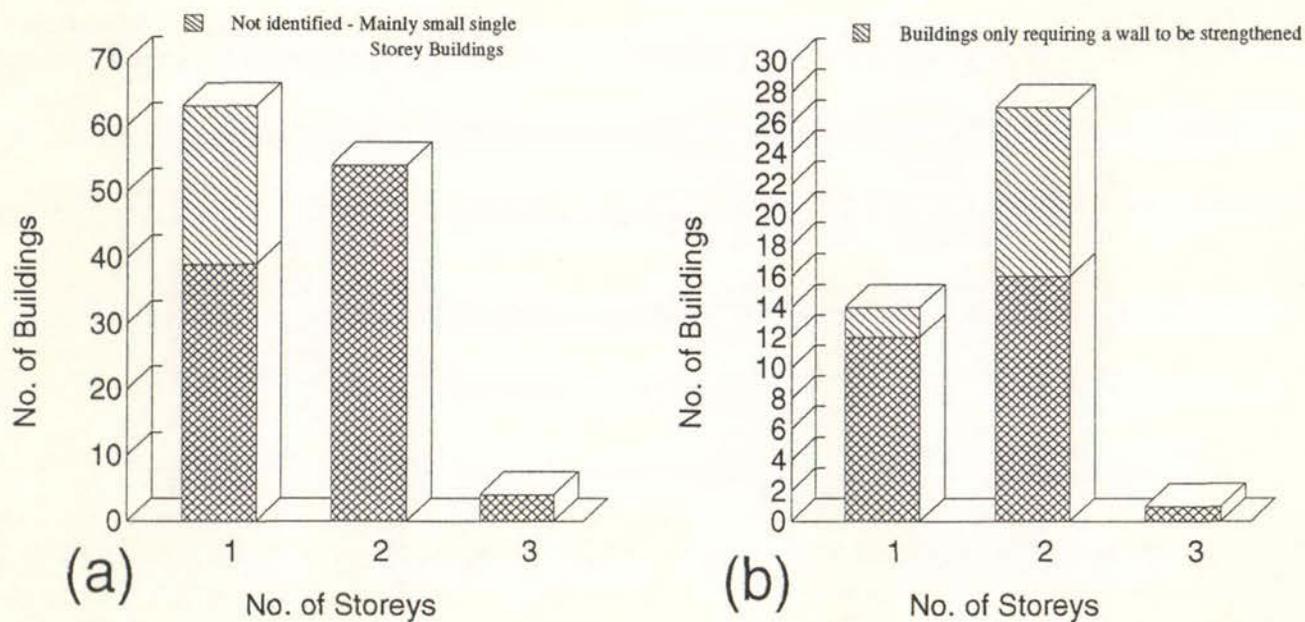
Figure 3.2 Earthquake Risk Buildings, Classified According to Number of Storeys in:

On closer examination it was found that 11 of the buildings did not come within the Act and (as at the 21.01.91) 29 have been demolished. A further 22 have either been strengthened (6), secured (14) or have had local hazards removed (2). Five buildings are yet to be inspected and classified. Of the 42 remaining buildings 13 only require attention to a brickwall to meet the Local Body Act's requirements. These buildings have been separately identified in Figure 3.2.(b).

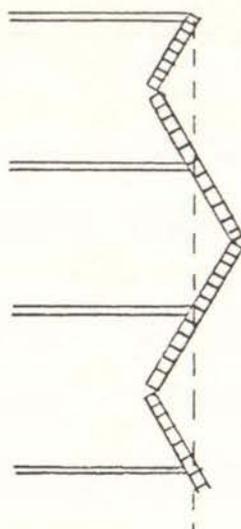
Figure 4.2 First mode Response of Face Loaded wall (reproduced from (43))

The face loaded wall specimens tested by ABK were only one storey high. This meant that any interaction between the response of the test specimens and any wall in a storey above or below the test specimen could not be included in the test setup. Zoutenbier's analysis of multi-storey face loaded walls indicated that the first mode response of the wall would involve alternate storeys moving in opposite directions (ie out-of-phase) as indicated in Figure 4.2. In this mode the wall elements in each storey have their lowest effective stiffness and hence the wall has its longest response period. This finding has implications when the boundary conditions are being modelled for a wall element that represents a single storey in a multi-storey wall. These implications will be discussed more fully in Section 6.1.

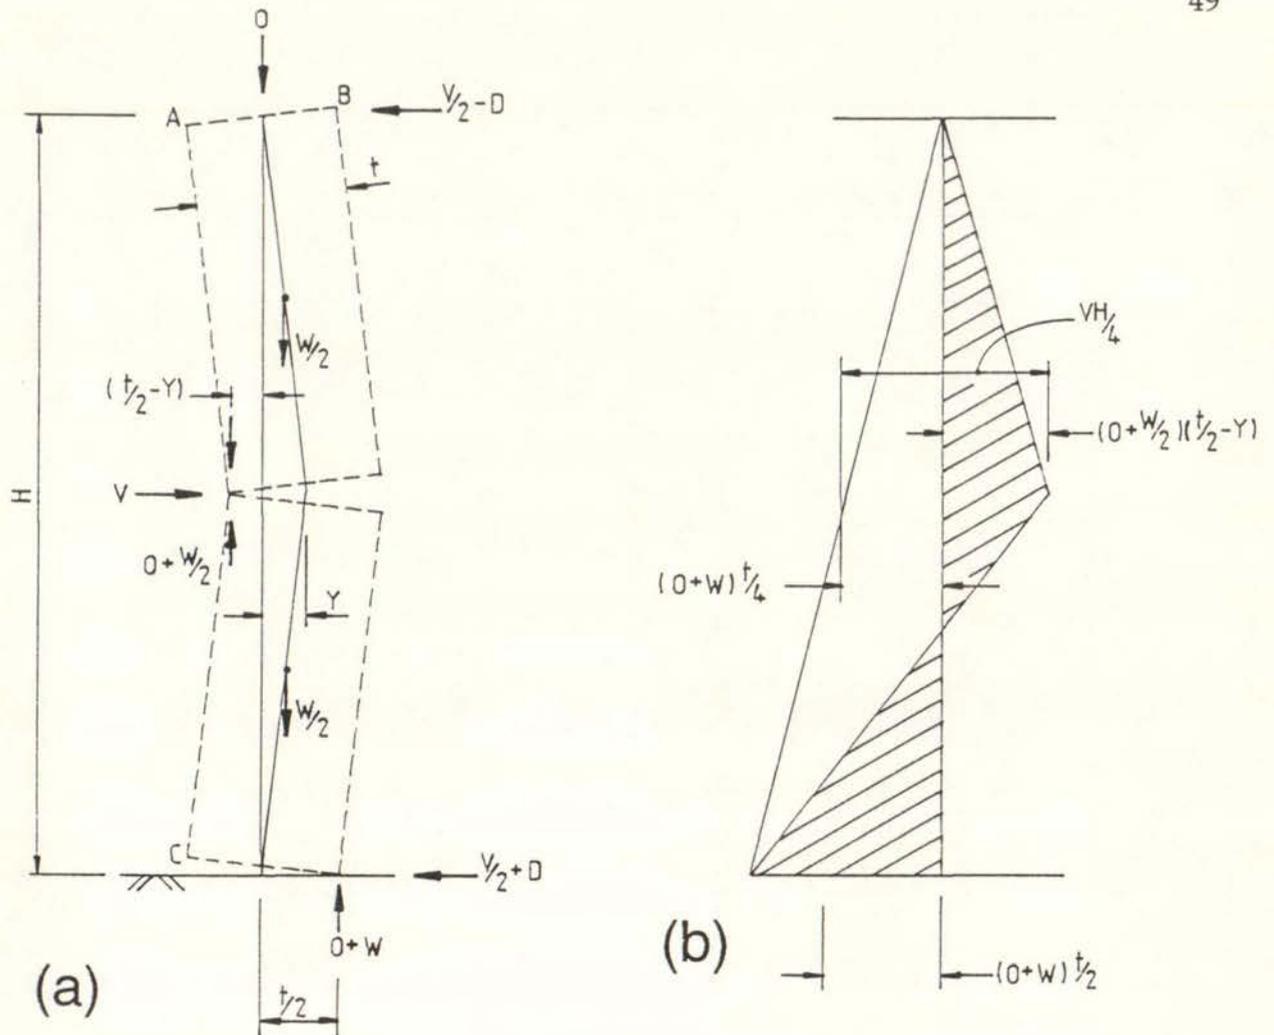
Figure 5.1 : Behaviour of face loaded wall under static loading

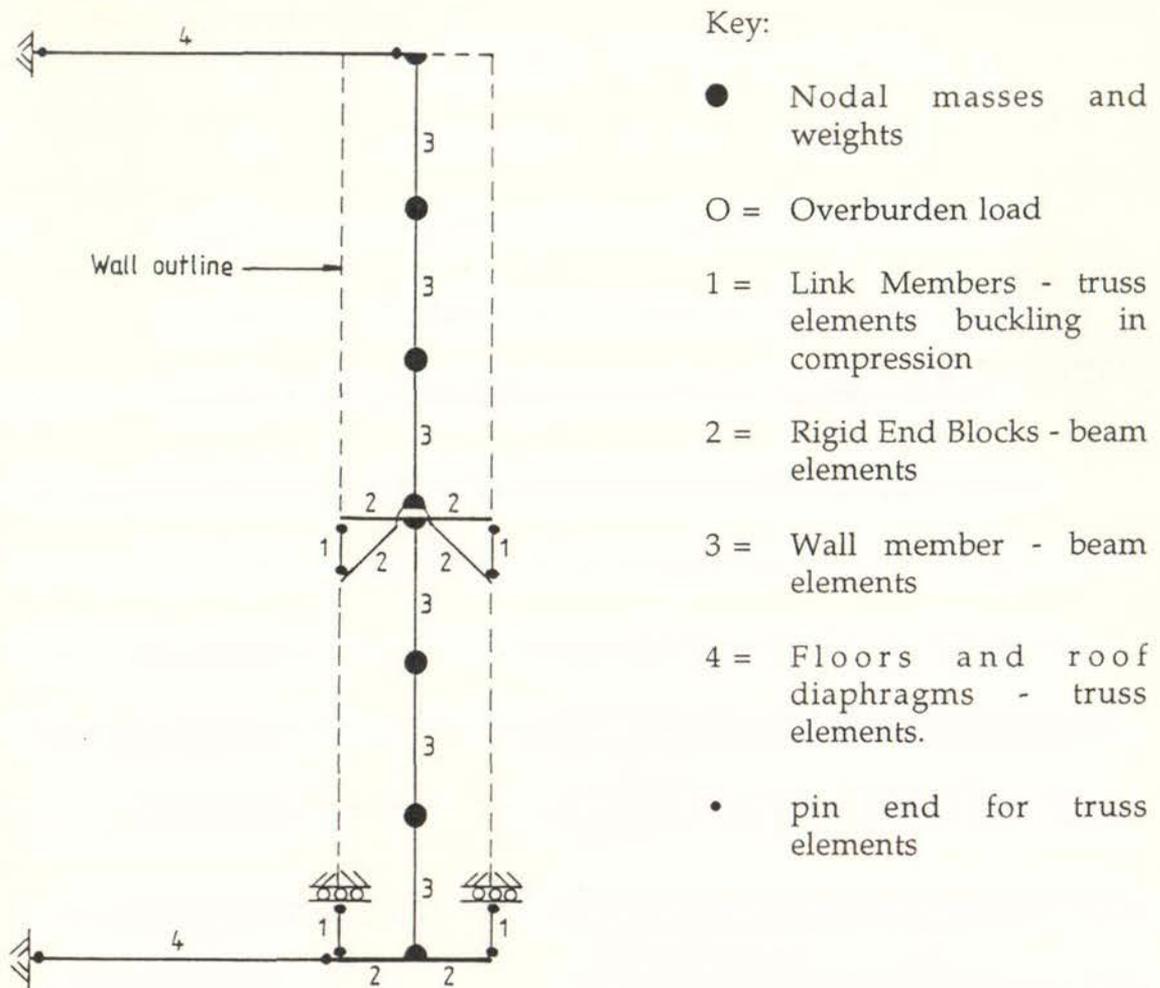
Figure 6.1 Computer Model for Face Loaded Wall. (Exaggerated Horizontal Scale)

Table 6.1 shows the properties assumed for various elements in the computer model and the scaling factors used to calculate the properties of the 1/2 and 2 x scale walls. These properties were used for all analyses except where explicitly stated otherwise. As noted in the table, the end block members were modelled as essentially rigid.

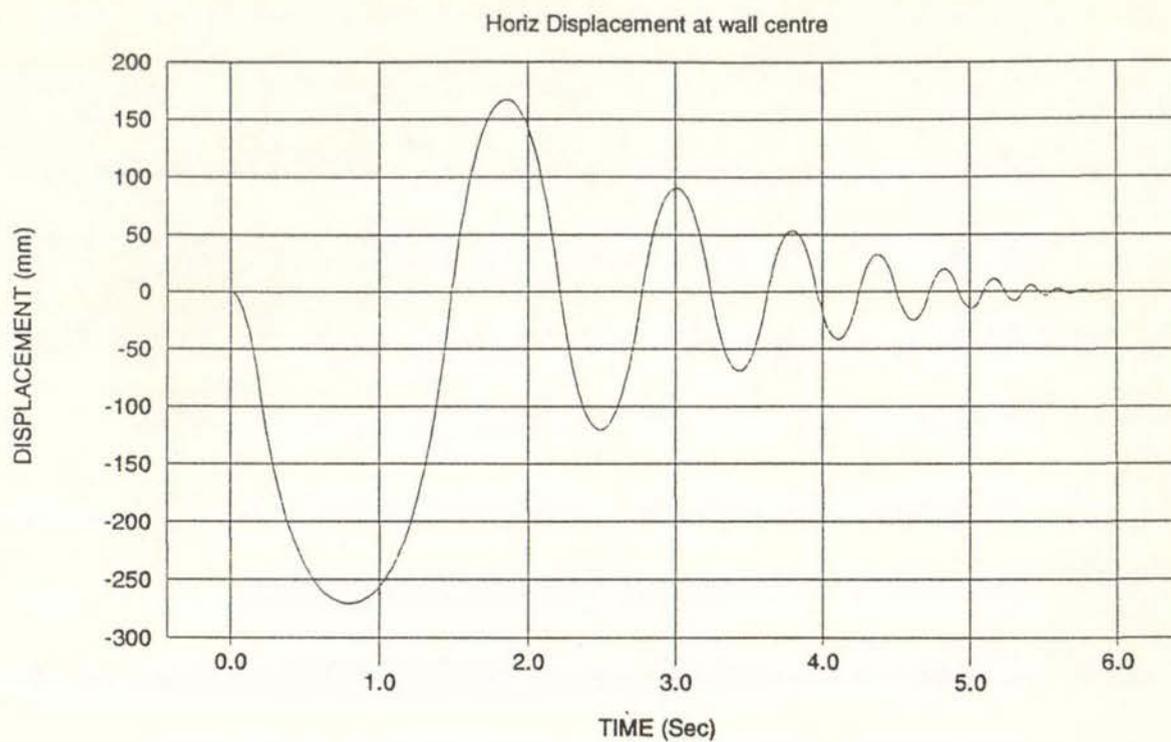
Figure 6.2(a) : Horizontal Displacement at Centre of 4.8 x .33m Wall When Wall Subjected to a 0.64g Pulse for 0.2 Seconds ($\alpha = .006$, $\beta = .004$)

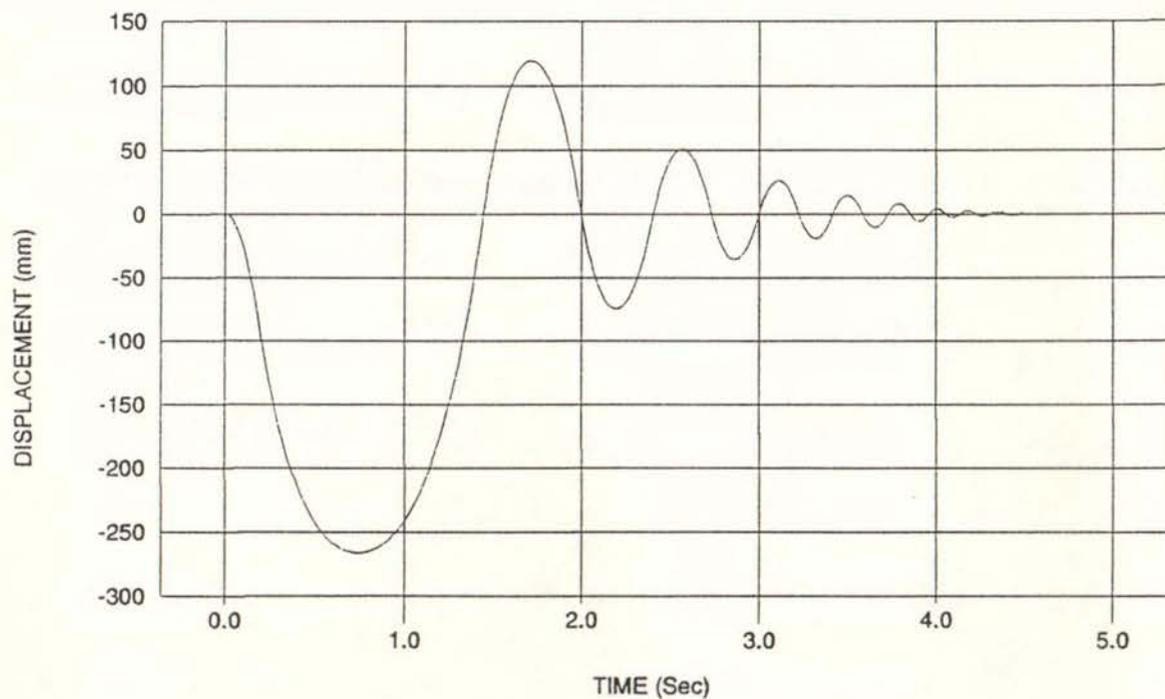
Figure 6.2(b) : As for (a) Except Pulse Magnitude Increased to 0.675g and Mass Damping Factor, α Increased to 0.6

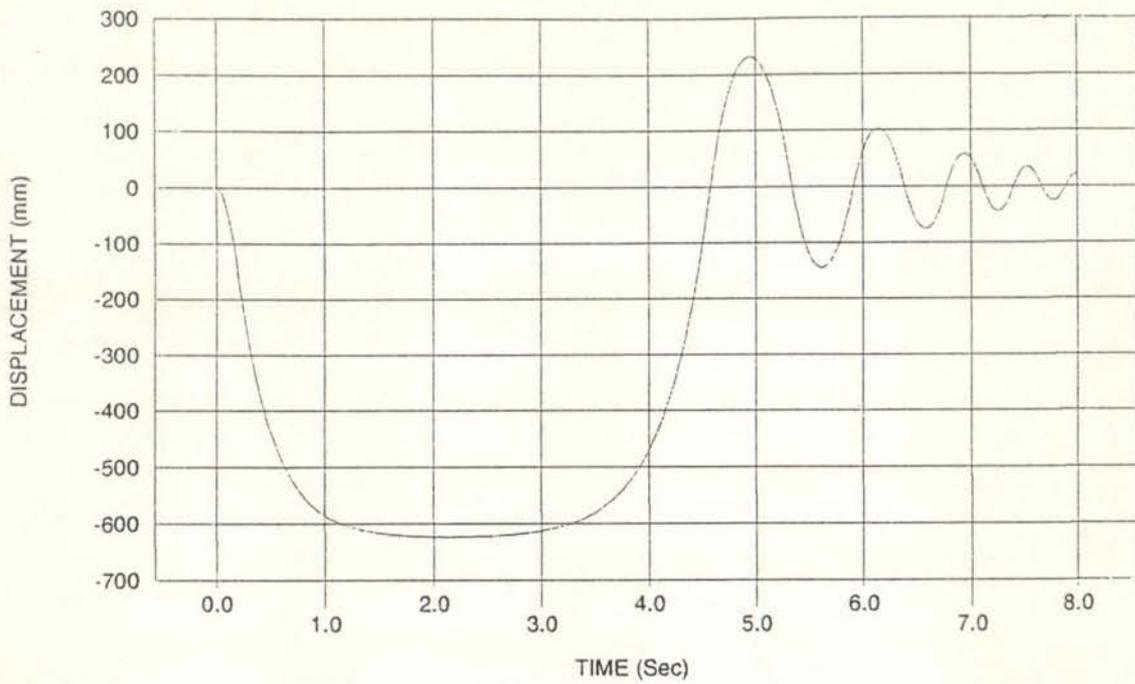
Figure 6.2(c) : Horizontal Displacement at Centre of 9.6 x 0.66 Wall When Wall Subjected to a 0.875g Pulse for 0.2 Seconds ($\alpha = .006$, $\beta = .004$)

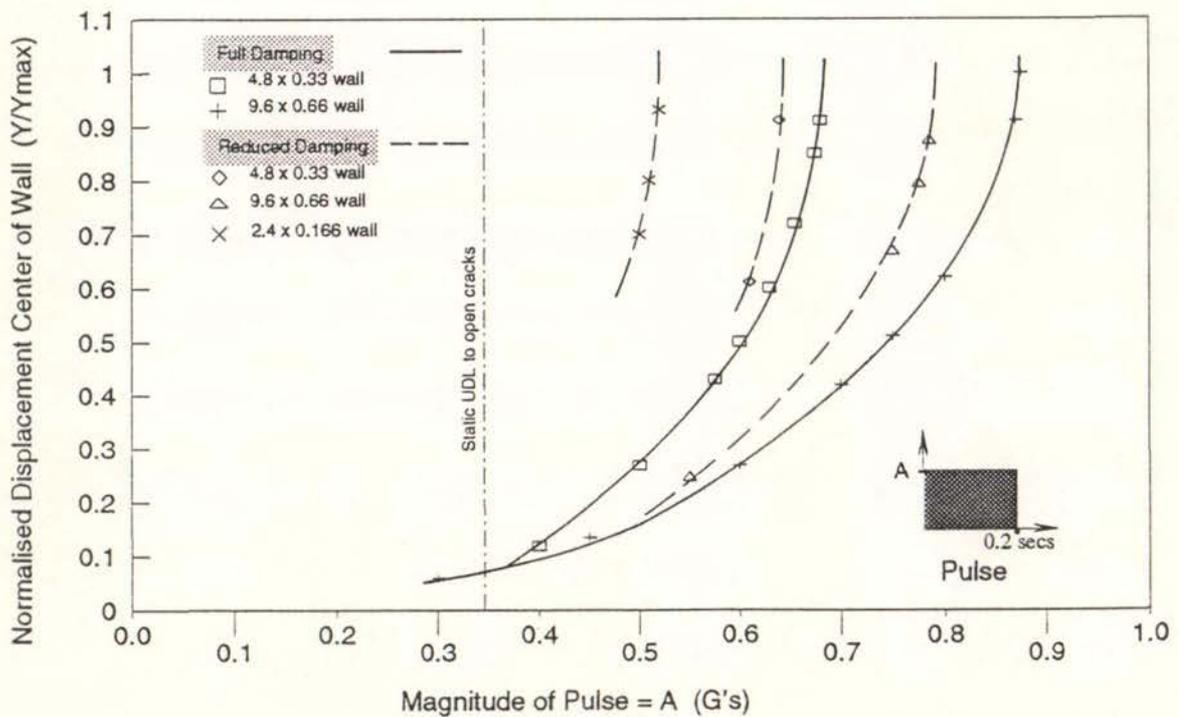
Figure 6.3 : Response of Face Loaded Walls to a 0.2 Second Pulse of Varying Magnitude.

Perhaps the most important conclusion to be drawn from Figure 6.3 is that once the wall displacement exceeds approximately 60% Y_{max} the response becomes very sensitive to small changes in the pulse magnitude. This sensitivity could have been anticipated from the load-deformation relationship shown in Figure 5.1(c) where it can be seen that as the displacement approaches Y_{max} the energy that needs to be input into the wall to increase the displacement incrementally becomes progressively smaller.

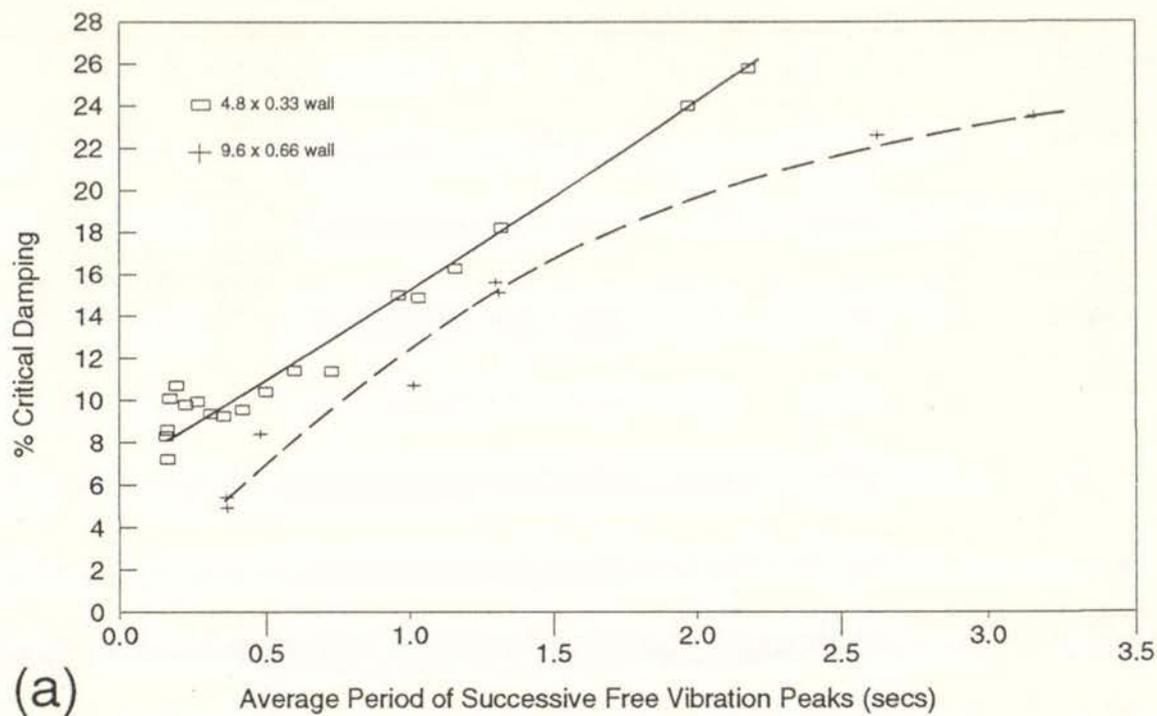
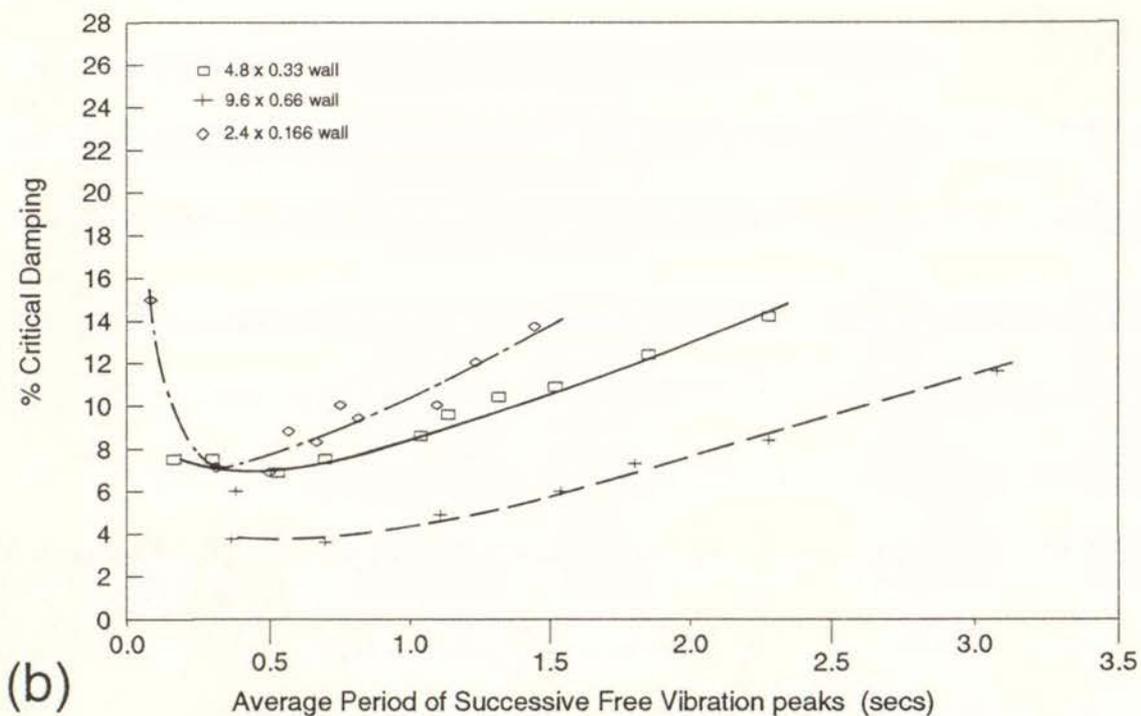
Figure 6.5 Damping calculated from free vibration response of walls using logarithmic decrement method.

In each case the damping curves for the various scale walls are shown starting at the damping value corresponding to the elastic response. This value is applicable until the wall cracks open and was calculated using equation 11 and the period in Table 6.1. The calculation ignores the use of zero stiffness damping for the link members.

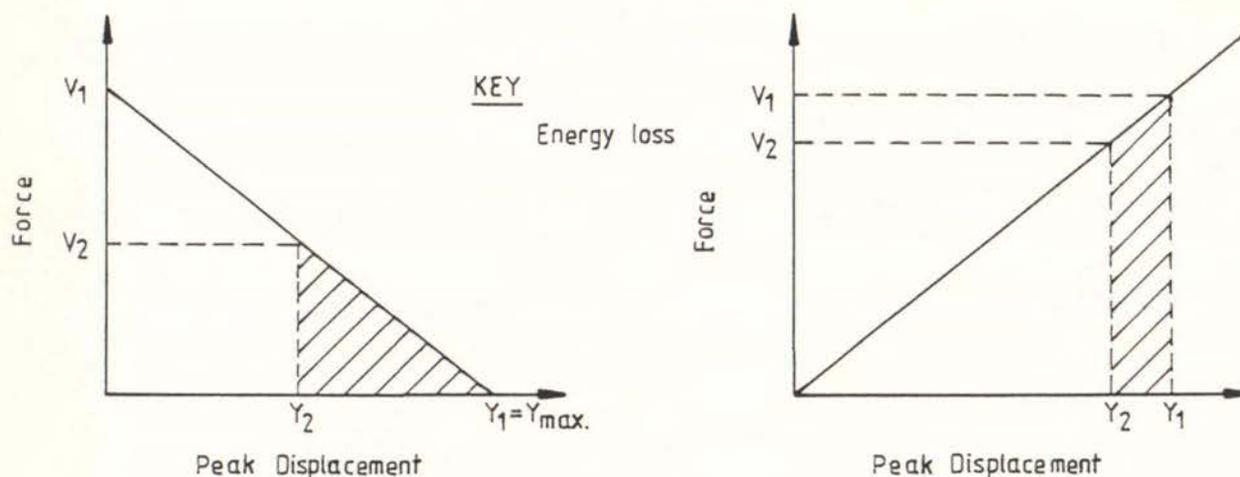
Fig 6.6 Reduction in Peak Displacement (Y_1 to Y_2) corresponding to 25% energy loss (a) for inelastic system representing a face loaded wall and (b) a linearly elastic SDOF system

For a linearly elastic system undergoing the same 25% energy loss in a half cycle, the ratio of Y_1/Y_2 is much smaller as illustrated in Fig 6.6 (b). In this case it can be shown, using simple geometry, that $Y_1/Y_2 = 1.155$. The corresponding damping evaluated using equation 12 is then only 4.5%.

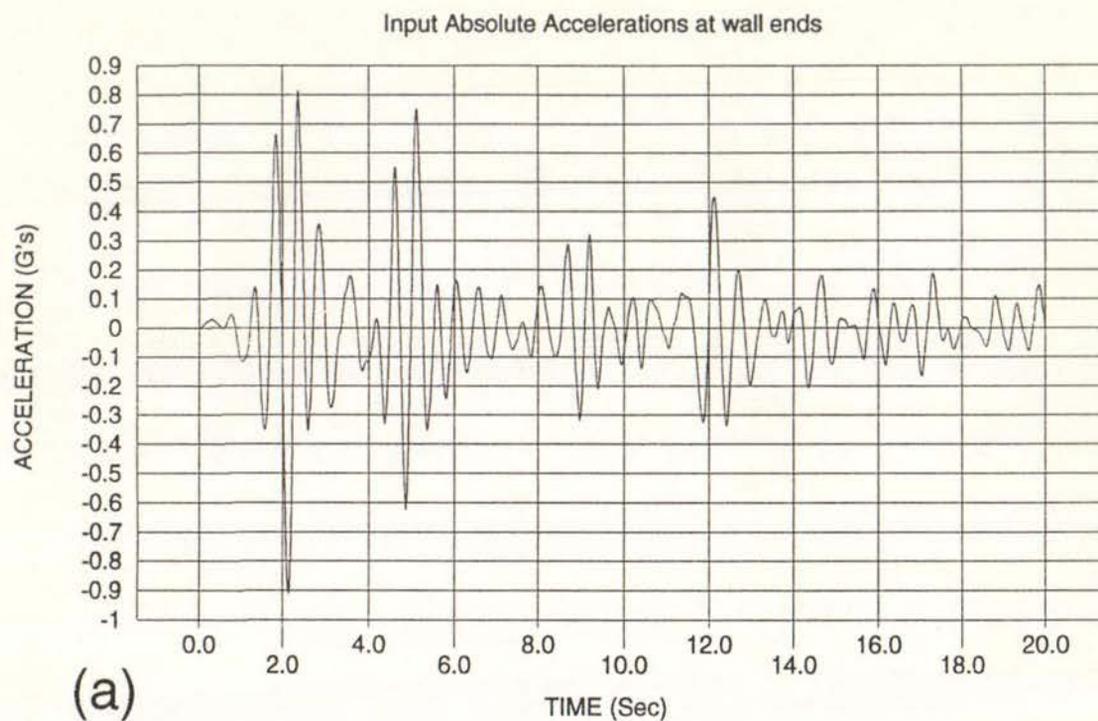
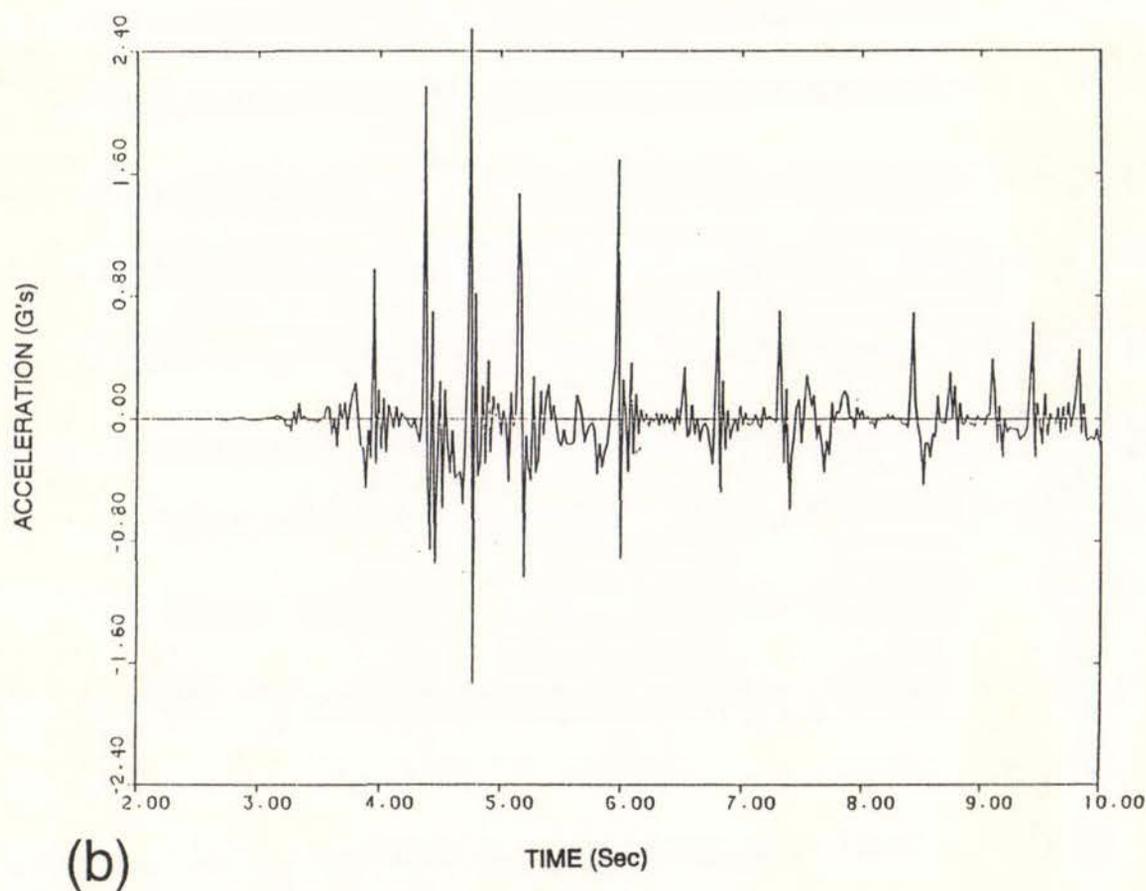
Figure 6.7 Input Accelerations at Top and Bottom of Wall
a) as used in computer model, and
b) as measured during testing of ABK wall 1

Figure 6.7 (a) shows the time history for the accelerations obtained using the SDOF diaphragm model. This is the acceleration time history used as the input motion at the top and bottom of the wall element in the wall computer model. The first 10

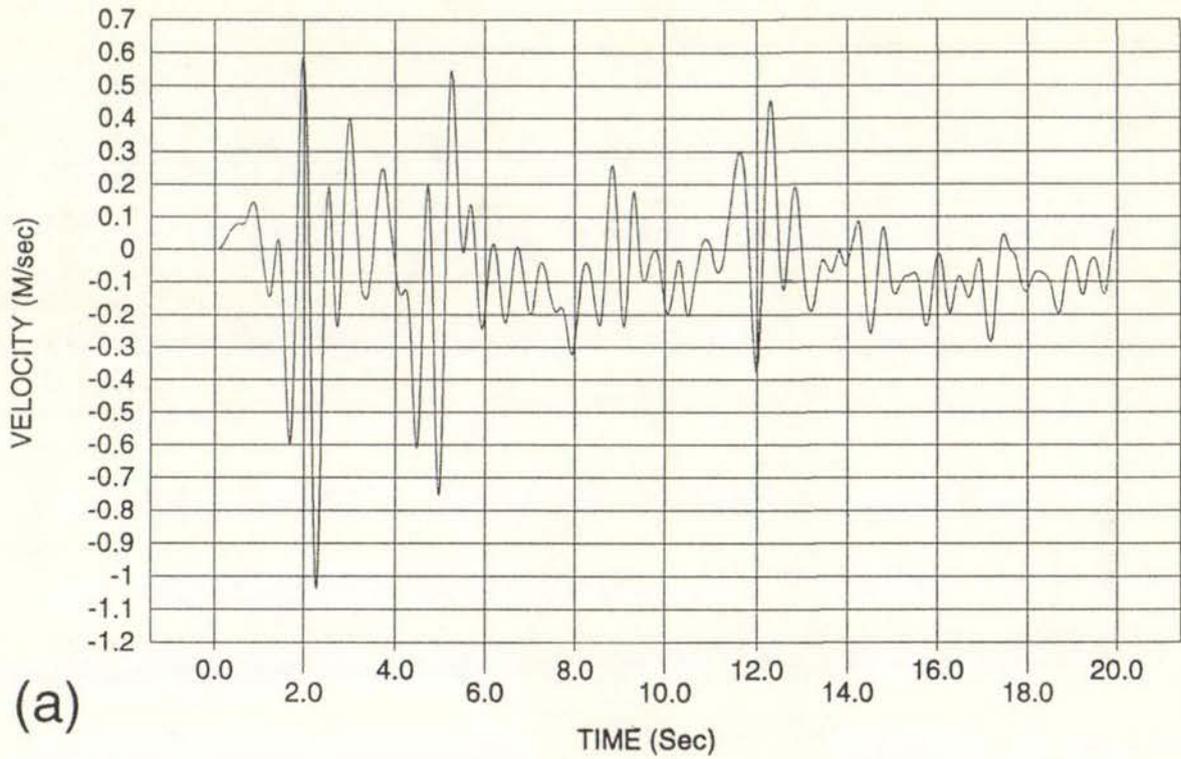
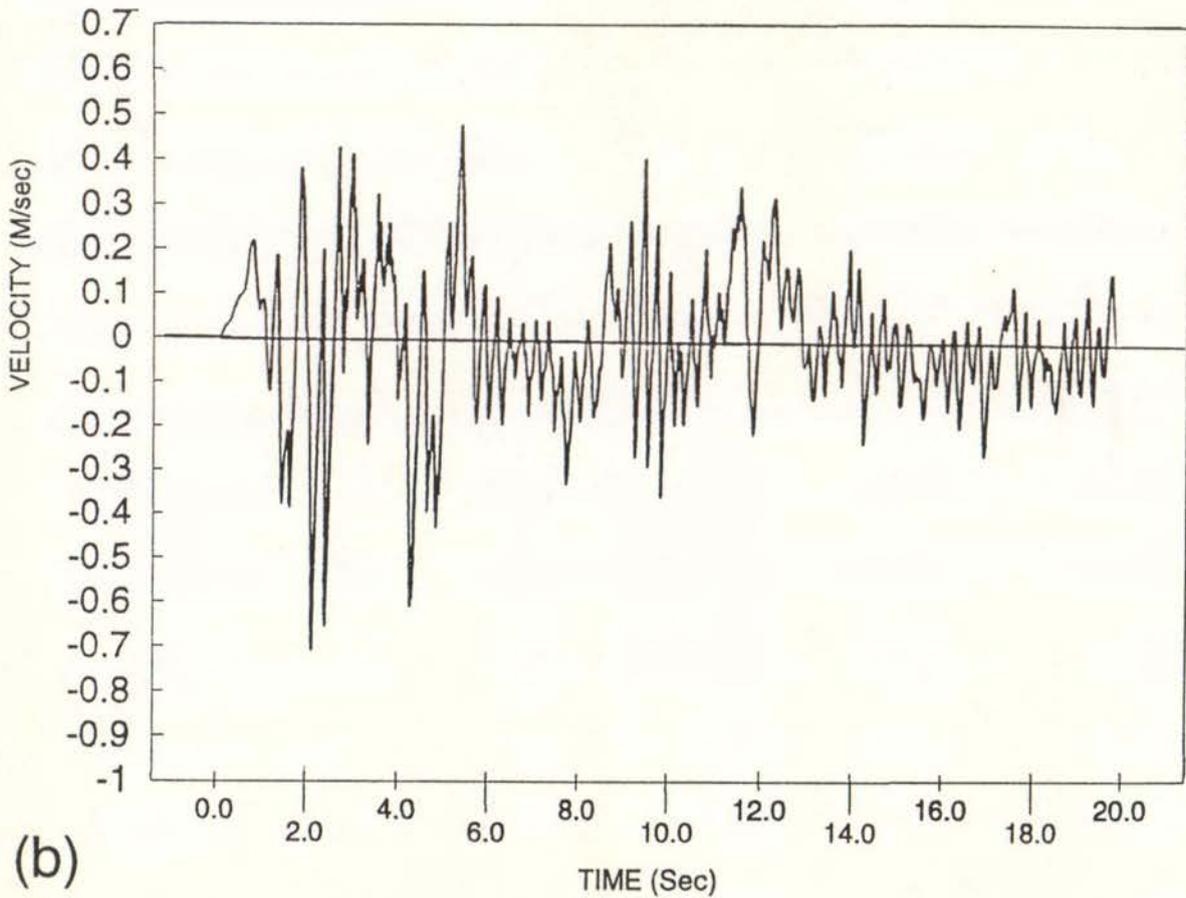
Figure 6.8 Input Velocity at Top and Bottom of Wall
a) as used in computer model, and
b) as measured during testing of ABK wall 1

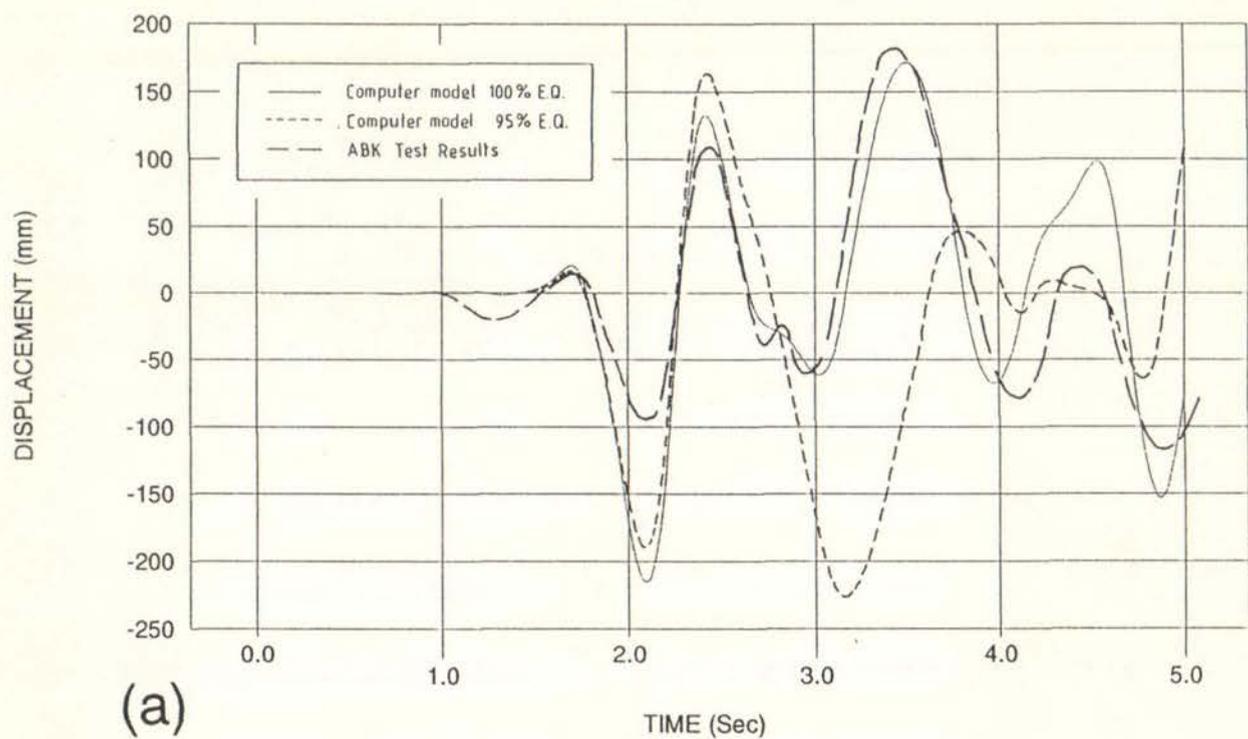
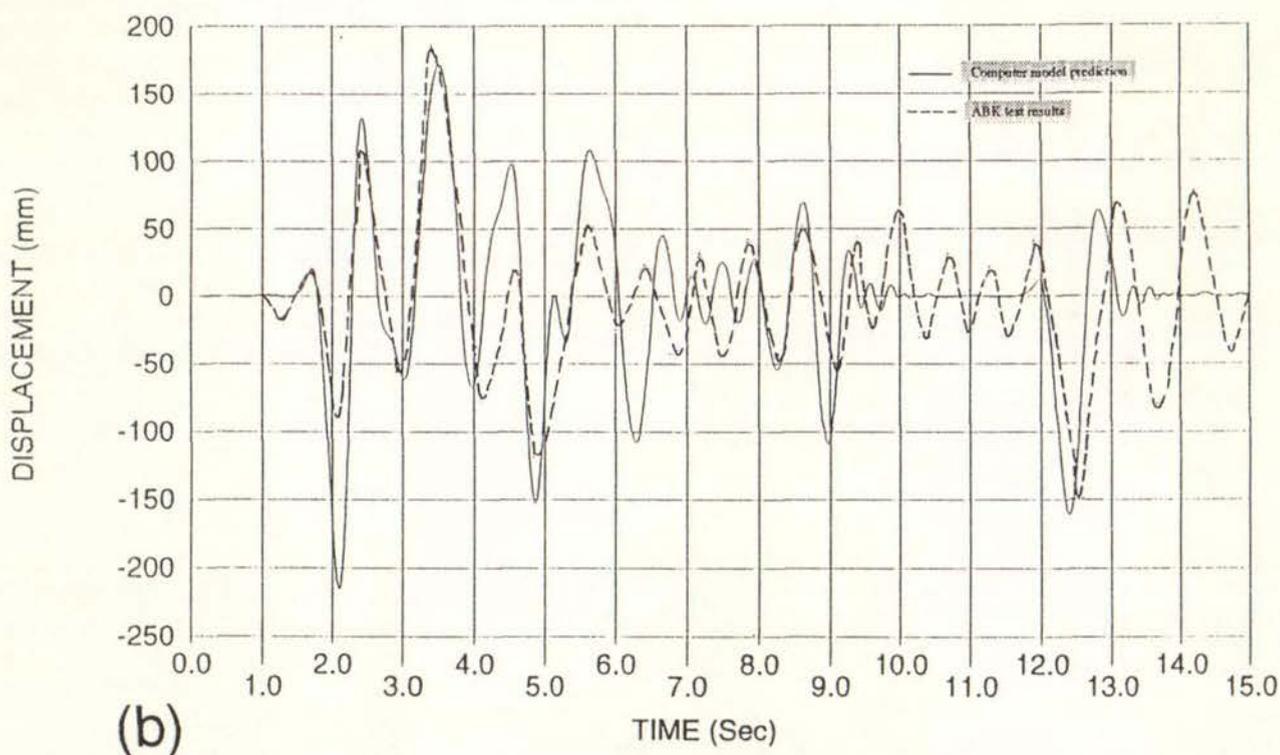
Figure 6.9 Comparison Between Face Loaded Wall Displacements Predicted by Computer Modelling and those Measured During Testing of ABK Wall Specimen No.1 for:

A comparison between the wall displacements predicted by the computer model and those measured during the testing of ABK's wall specimen is shown in Figure 6.9 (a) for the first five seconds of the walls response.

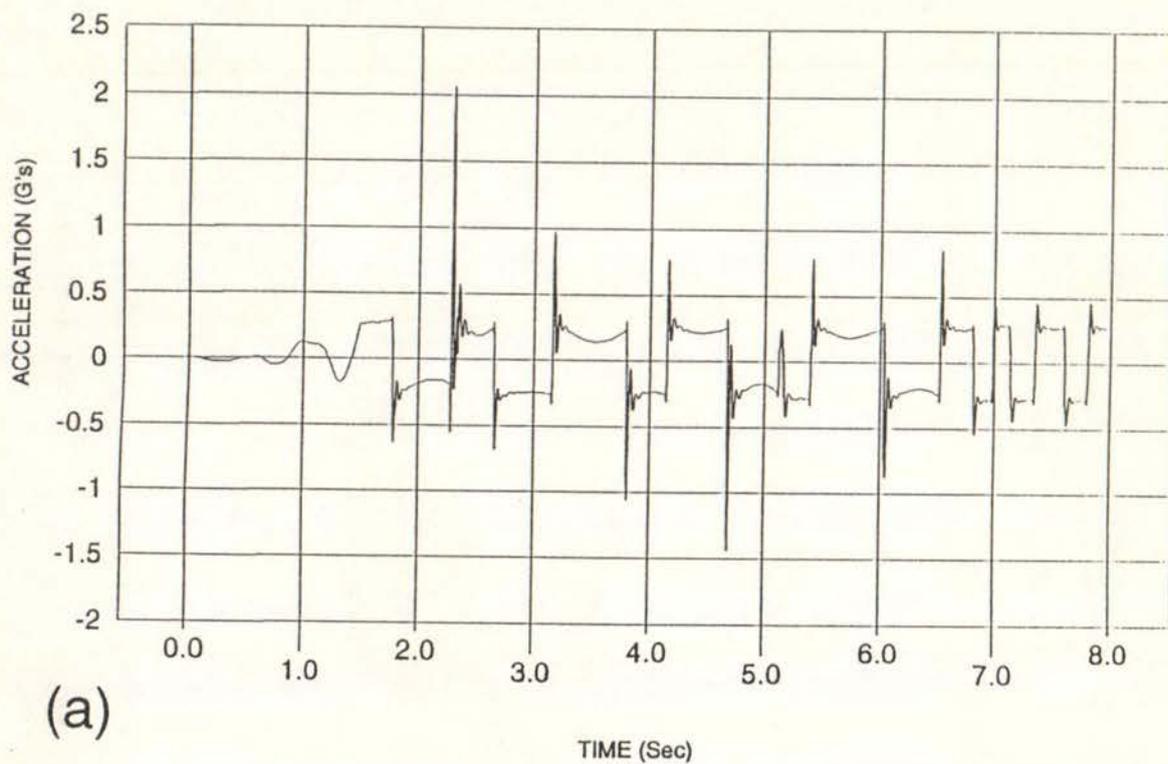
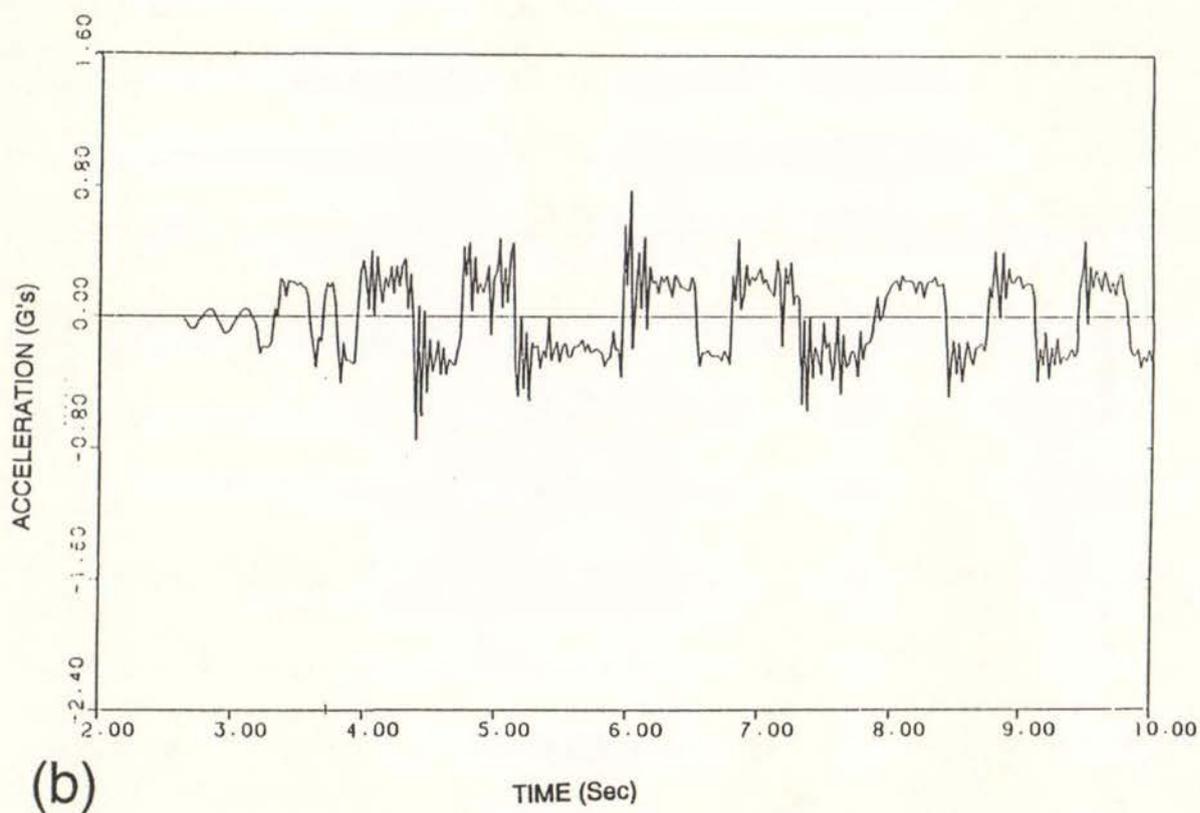
Figure 6.10 Accelerations at mid-height of the face loaded wall element

Predicted and measured horizontal accelerations at wall mid-height are shown in Figure 6.10. Those predicted by the computer model are shown in Figure 6.10(a) and those measured by ABK during wall testing are shown in Figure 6.10(b).

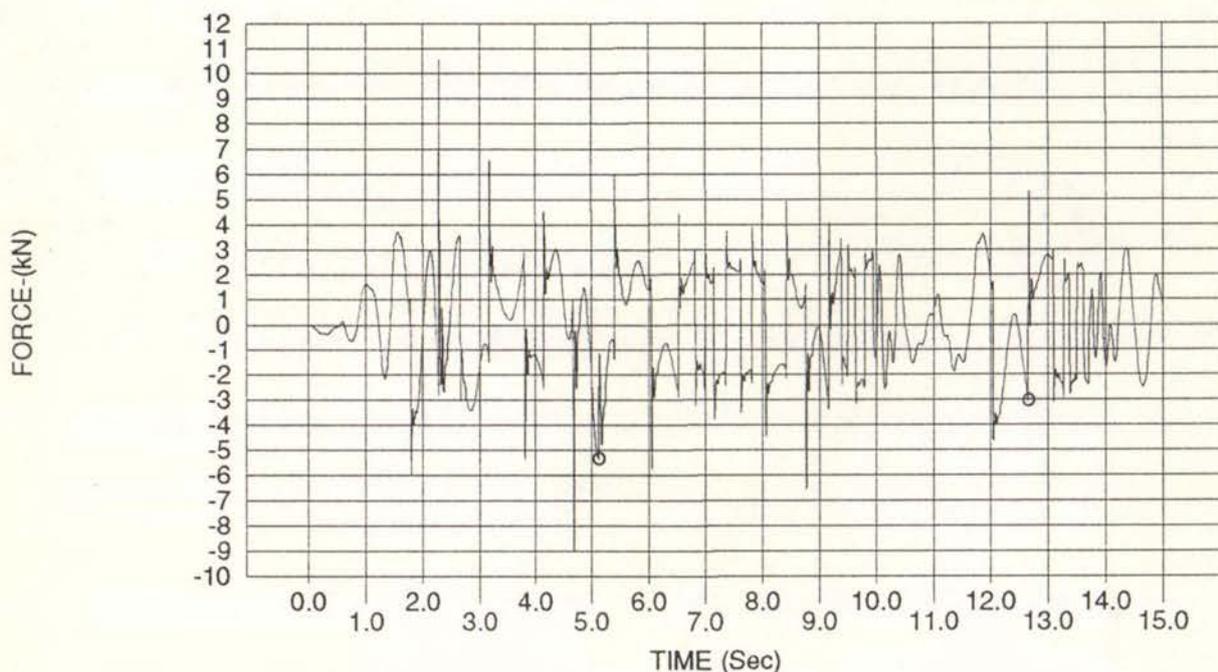
Figure 6.10(c) Force in top Diaphragm as predicted by Computer model (for rigid Diaphragm)

However, it is unlikely that the sharp spikes in the anchorage force response evident in Figure 6.10(c) would have been present in the test specimen response as these spikes correspond to impact. The reader can confirm the influence of impact on the anchorage forces by comparing the time histories in Figures 5.9(b) and 6.11.

Figure 6.10(c) is typical of the time histories obtained for the anchorage forces developed in the diaphragms using the computer model. If the short spikes associated with impact are ignored the peak diaphragm force in this time history occurs at approximately 5.1 seconds (as indicated by a small circle). The peak force in the top diaphragm of the full scale walls were evaluated from similar time history plots ignoring the sharp spikes and are shown in Figure 6.14(a).
