**Earthquake Vulnerability of Existing Unreinforced Masonry
Buildings**

E L Blaikie, D D Spurr (Works Consultancy Services)

This project was sponsored by the
New Zealand Earthquake and
War Damage Commission

December 1992

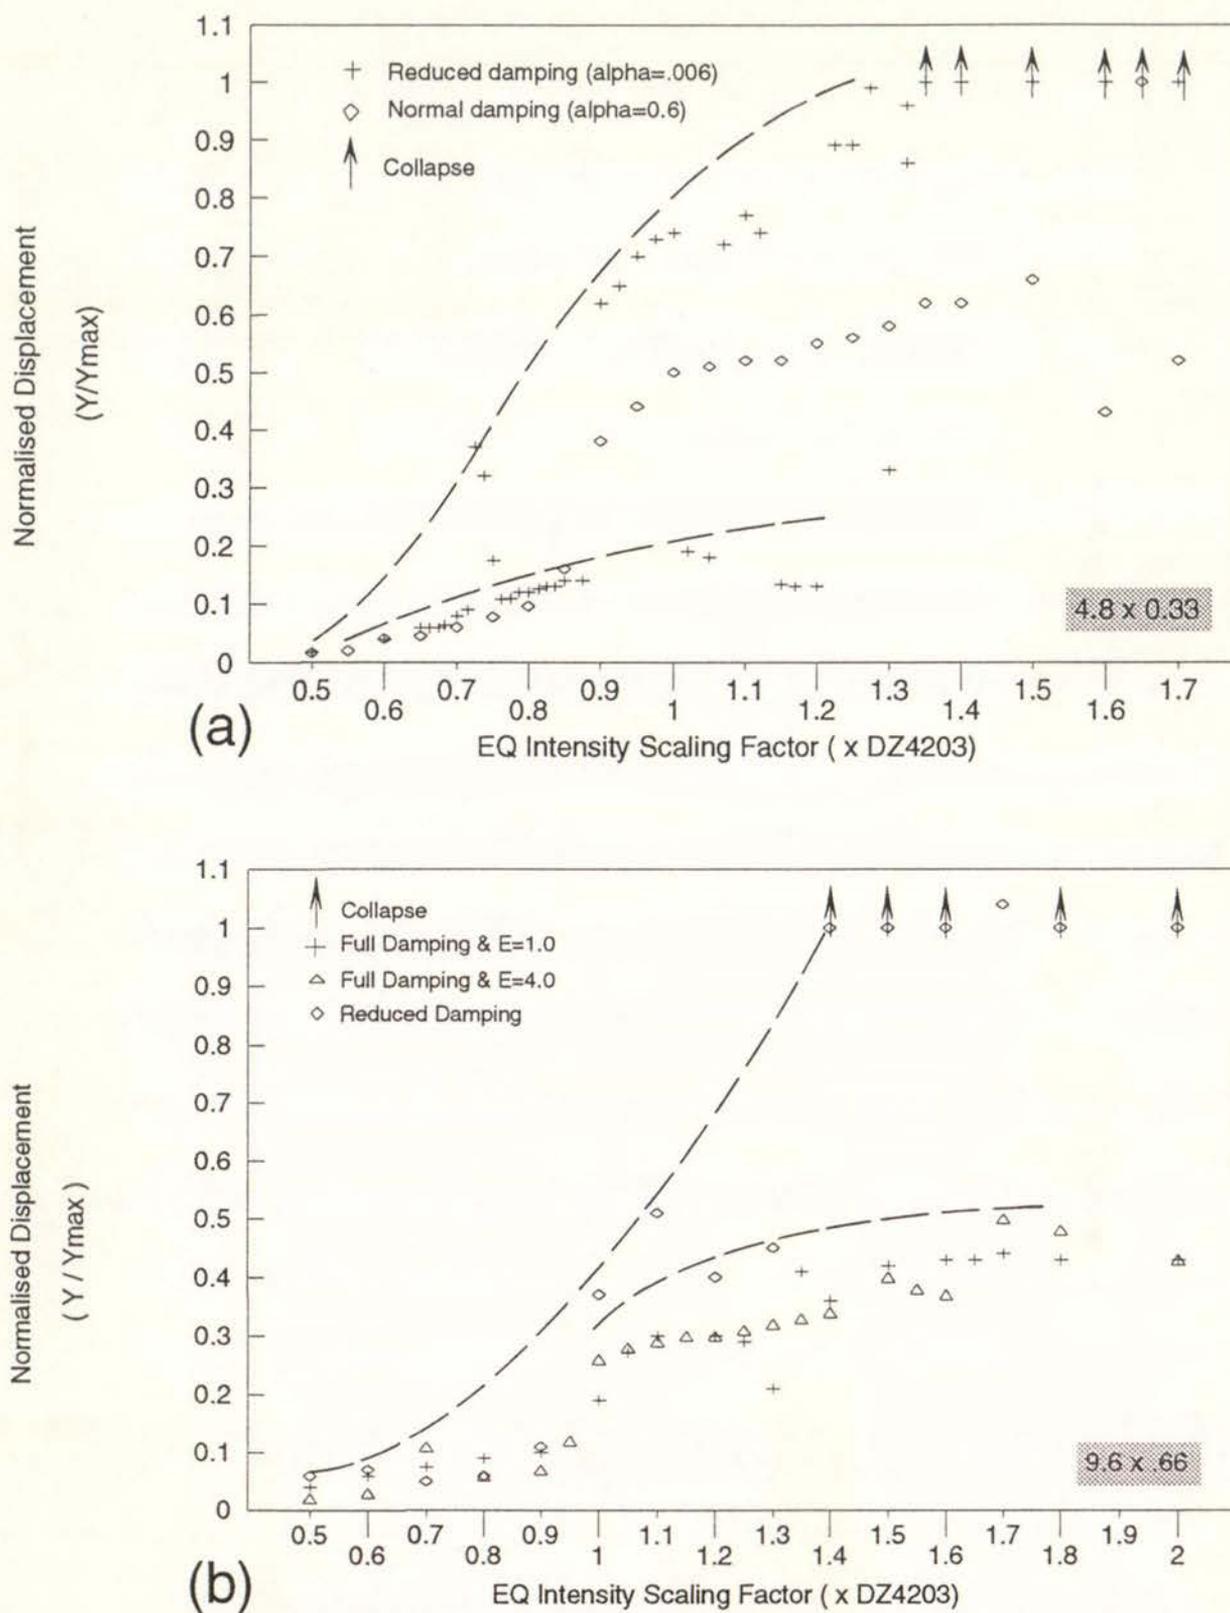
Figure 6.11 Normalised Displacements of wall at the Mid-height crack level vs the Scaling Factor applied to the DZ4203 Earthquake Motion.

It can be seen that the results for the lower (reduced) level of damping considered fall into two zones. The upper and lower envelopes of these zones are also shown. It can also be seen that the results that lie near the upper envelope correspond to narrow bands or windows of earthquake intensity. This behaviour demonstrates the sensitivity of the wall response to small changes in the earthquake motion.

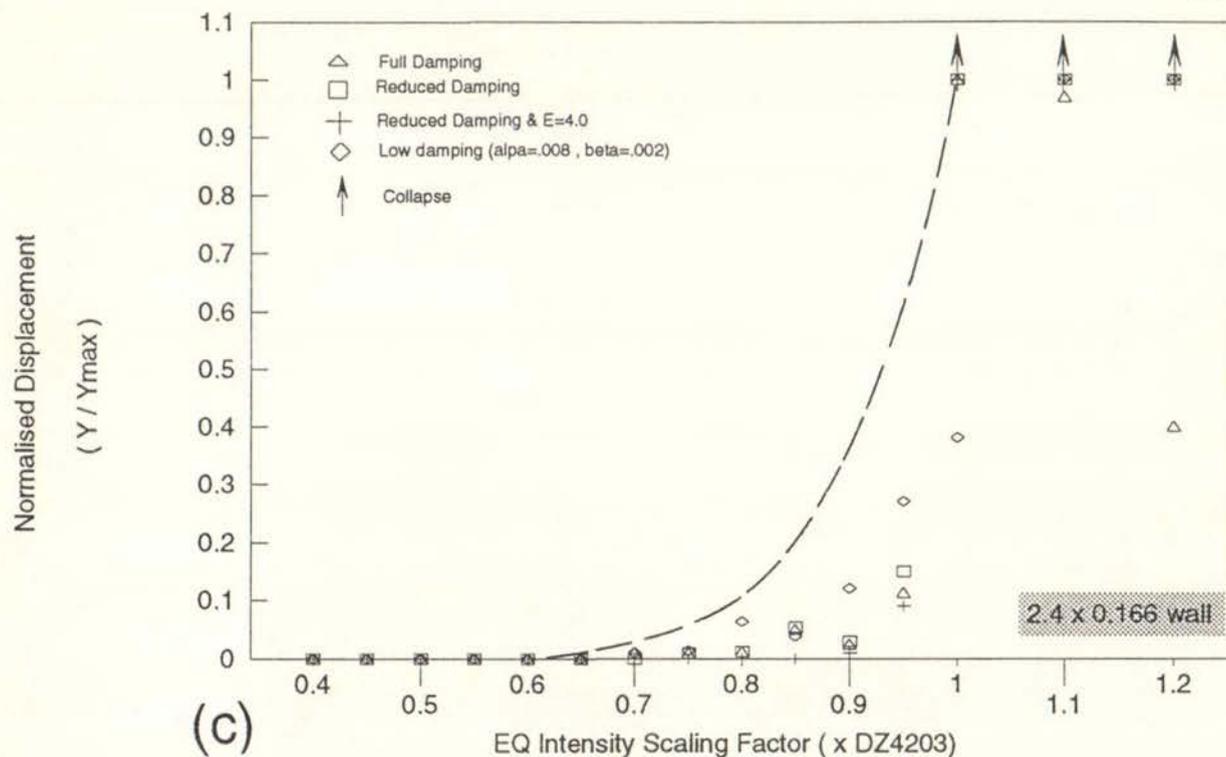
Figure 6.11(c) Normalised Wall Displacement at the Mid-Height Crack Level for 1/2 Scale Wall and DZ4203 EQ Motion

Results from the computer analysis of the $\frac{1}{2}$ x scale wall and the DZ4203 earthquake motion are given in Figure 6.11(c). It is evident that the wall responded practically elastically without significant opening of the wall cracks up to an earthquake intensity scaling factor of approximately 0.8. Only a small increase in the earthquake intensity was then required to cause the wall to collapse. With reduced damping the response of the wall increased but the collapse earthquake intensity was not significantly effected. Once again increased wall stiffness ($E = 4.0$ case) did not affect the results significantly.

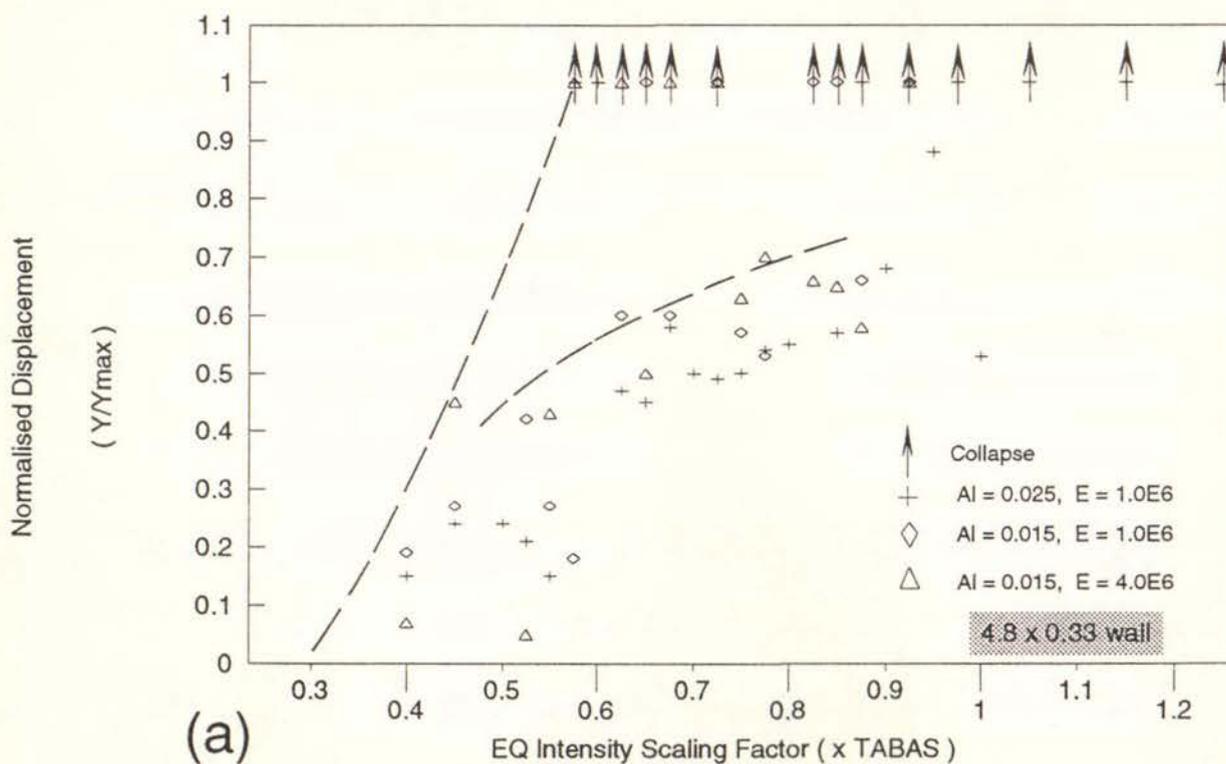
Figure 6.12(a) Normalised Wall Displacement at Mid-Height Crack Level for Full Scale Wall and TABAS EQ Motion. Reduced Damping Case Only ($\alpha = 0.0$, $\beta = 0.006$).

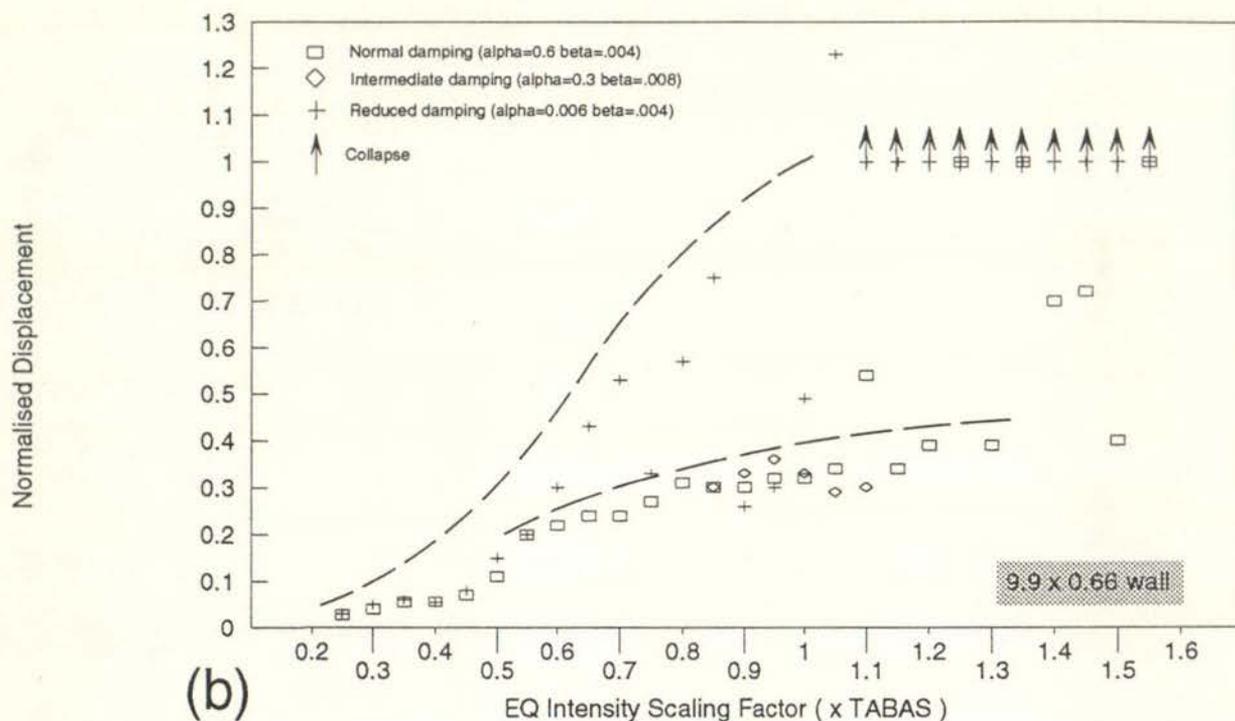
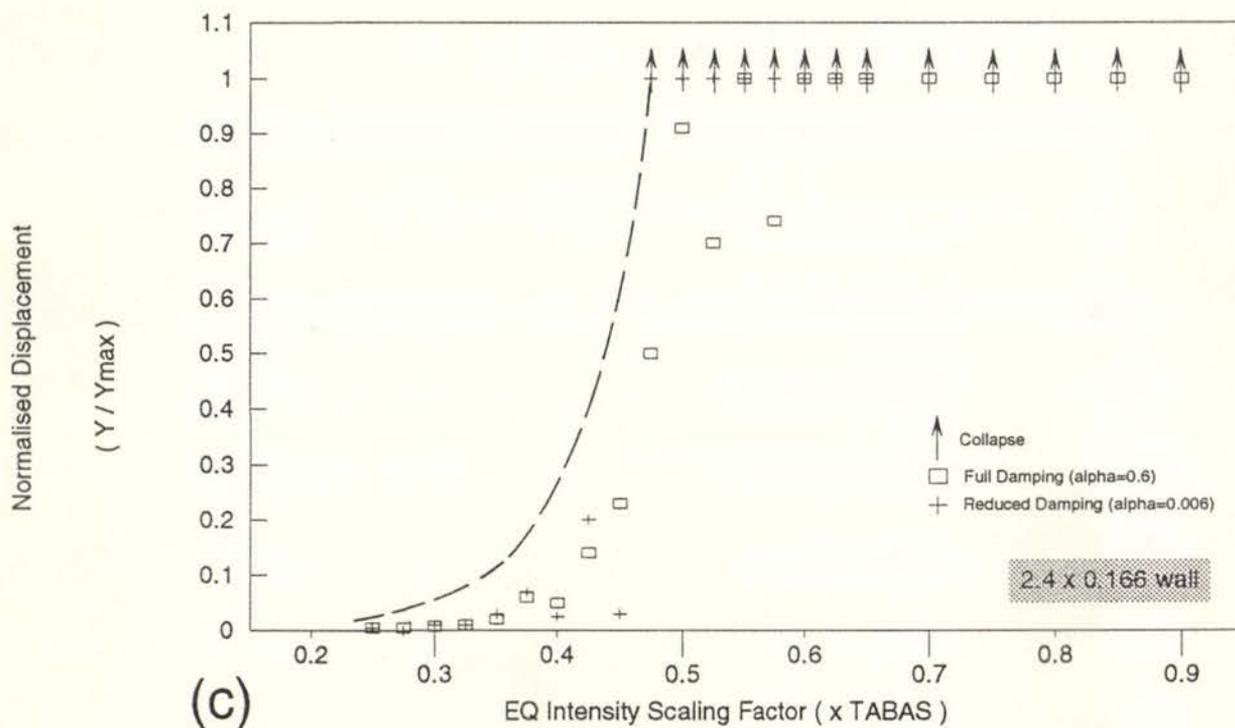
Figure 6.12(b) and (c) Normalised Wall Displacement at Mid-height Crack Level vs the Scaling Factor Applied to the TABAS EQ Motion. (b) for 2 x Scale Wall; and; (c) for 1/2 x Scale Wall

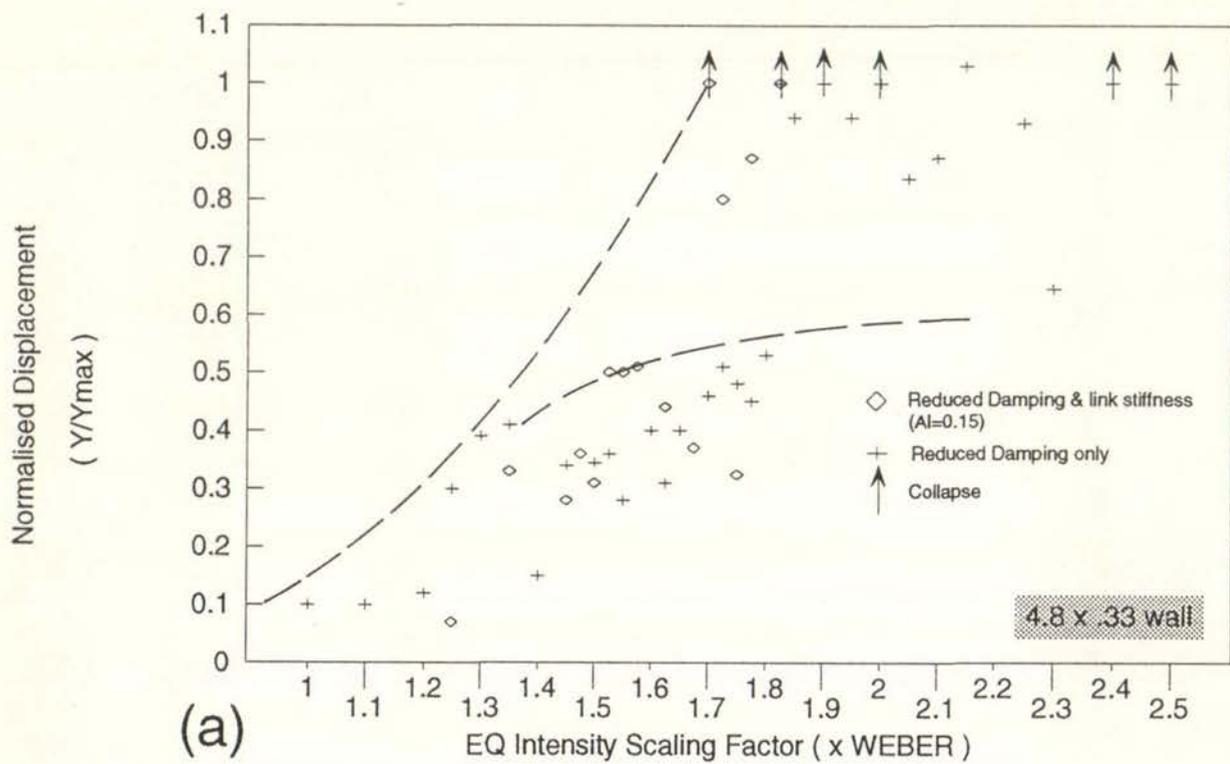
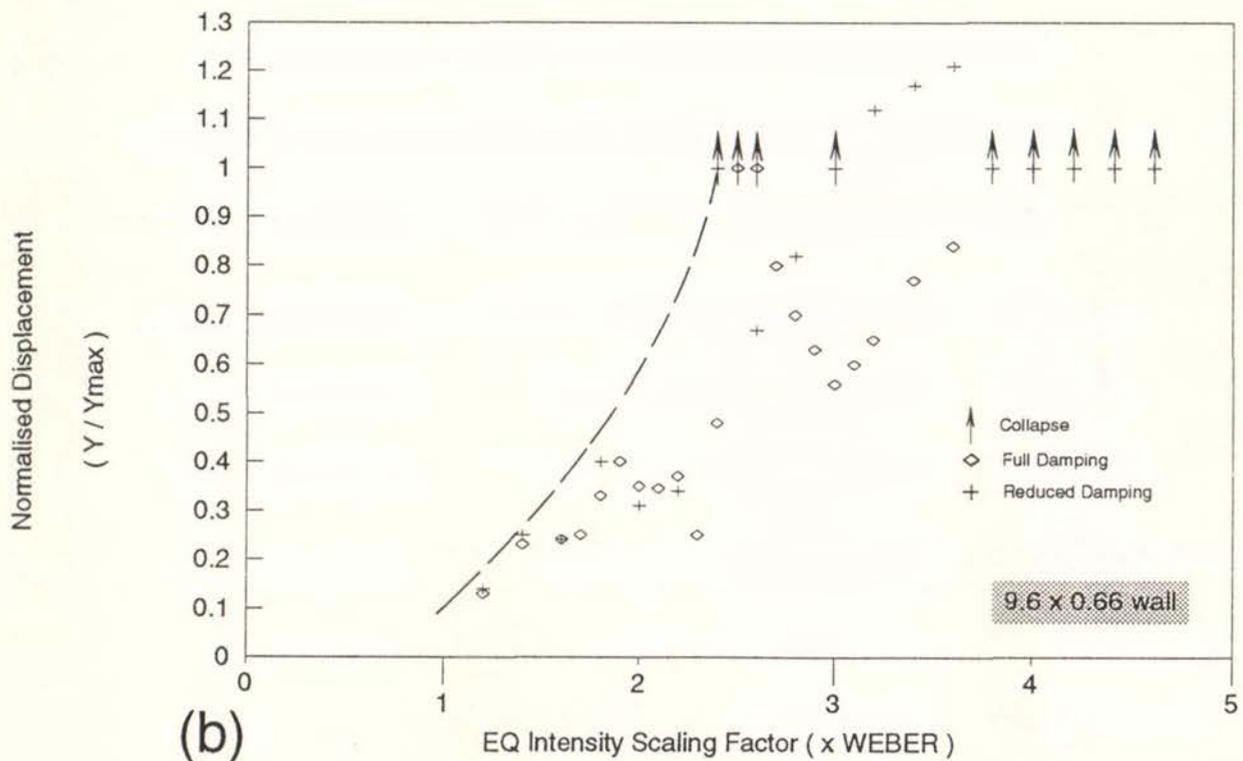
Figure 6.13 Normalised Wall Displacement at Mid-height Crack Level vs the Scaling Factor Applied to the WEBER EQ Motion. (a) for Full Scale (4.8 x .33m Wall) and; (b) for 2 x Scale Wall

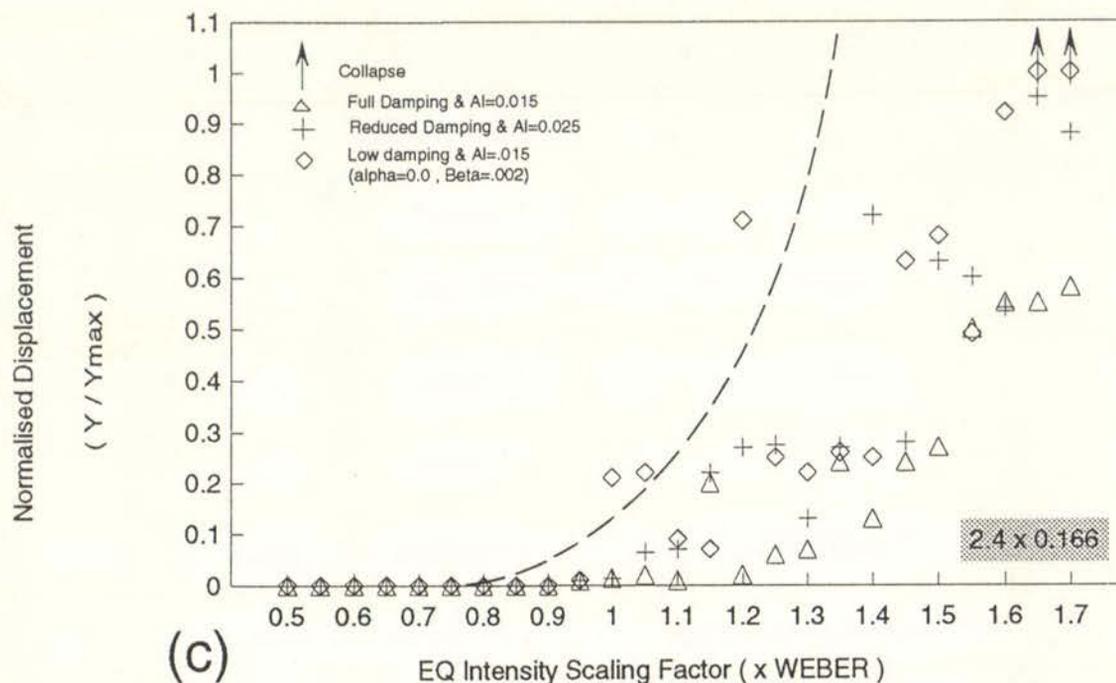
Figure 6.13(c) Normalised Wall Displacement at Mid-height Crack Level 1/2 Scale (2.4 x .166m) Wall and WEBER EQ Motion

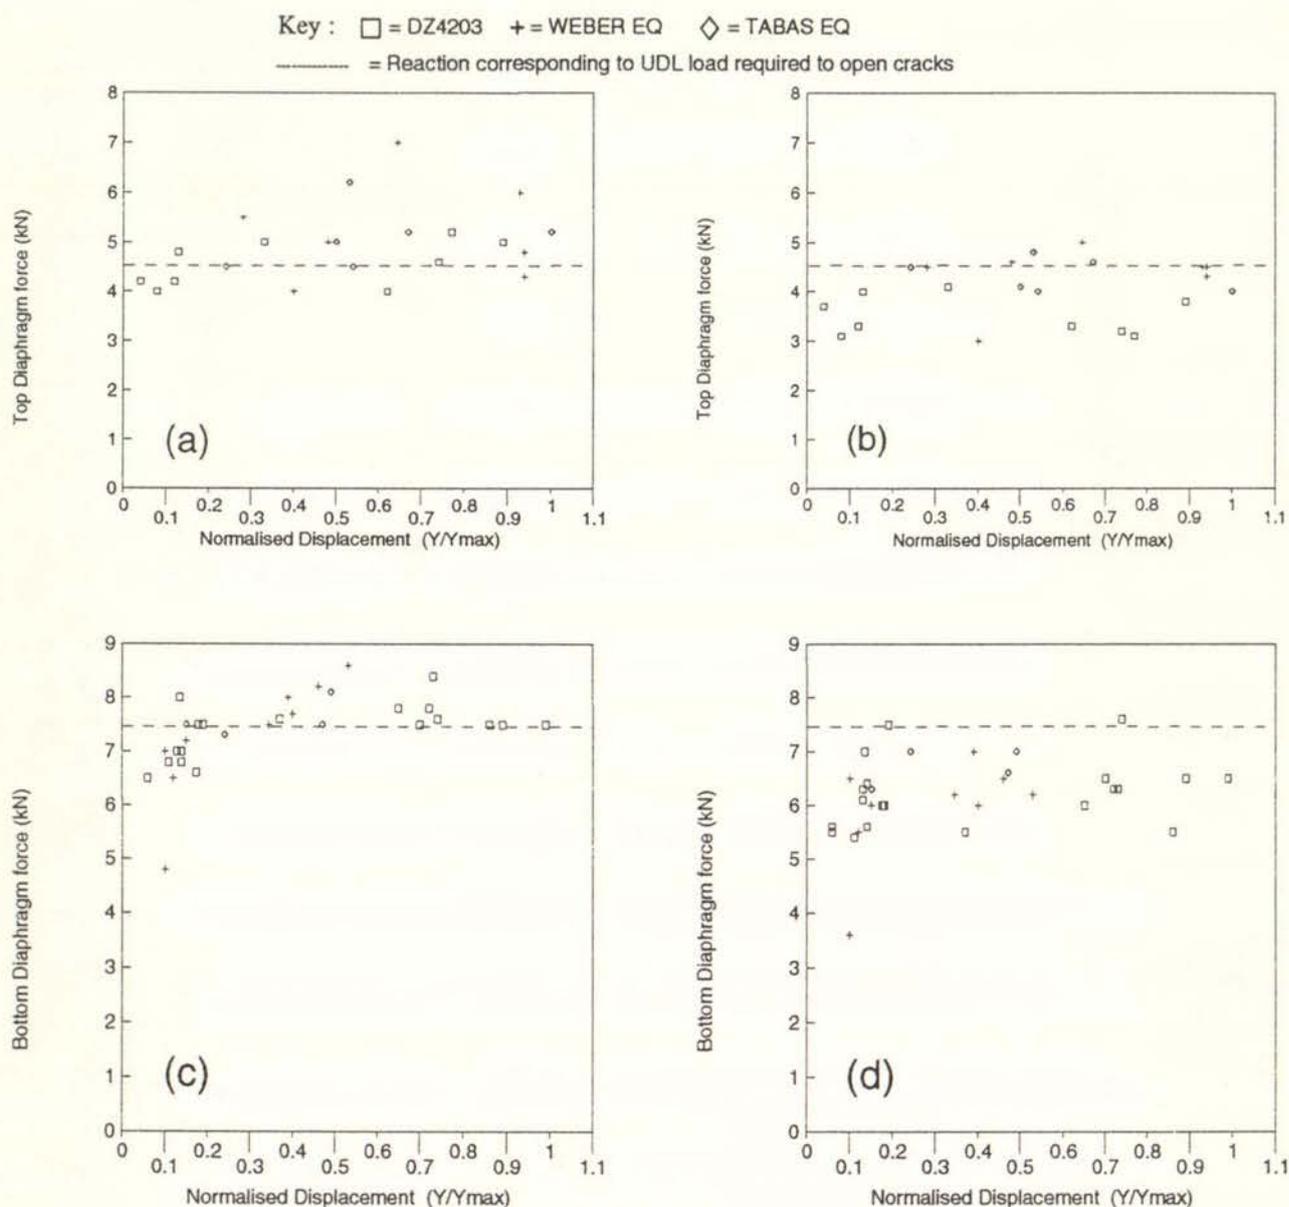
Figure 6.14 Anchorage Forces for Rigid Diaphragm and the Full Scale (4.8 x .33m) wall.

- (a) Peak Force in Top Diaphragm (ignoring 1st peaks due to Impact)
- (b) Force in Top Diaphragm (Maximum of Peaks Occurring just before Impact)
- (c) Peak Force in Bottom Diaphragm (ignoring 1st Peaks due to Impact)
- (d) force in Bottom Diaphragm (Maximum of Peaks Occurring Just Before Impact).

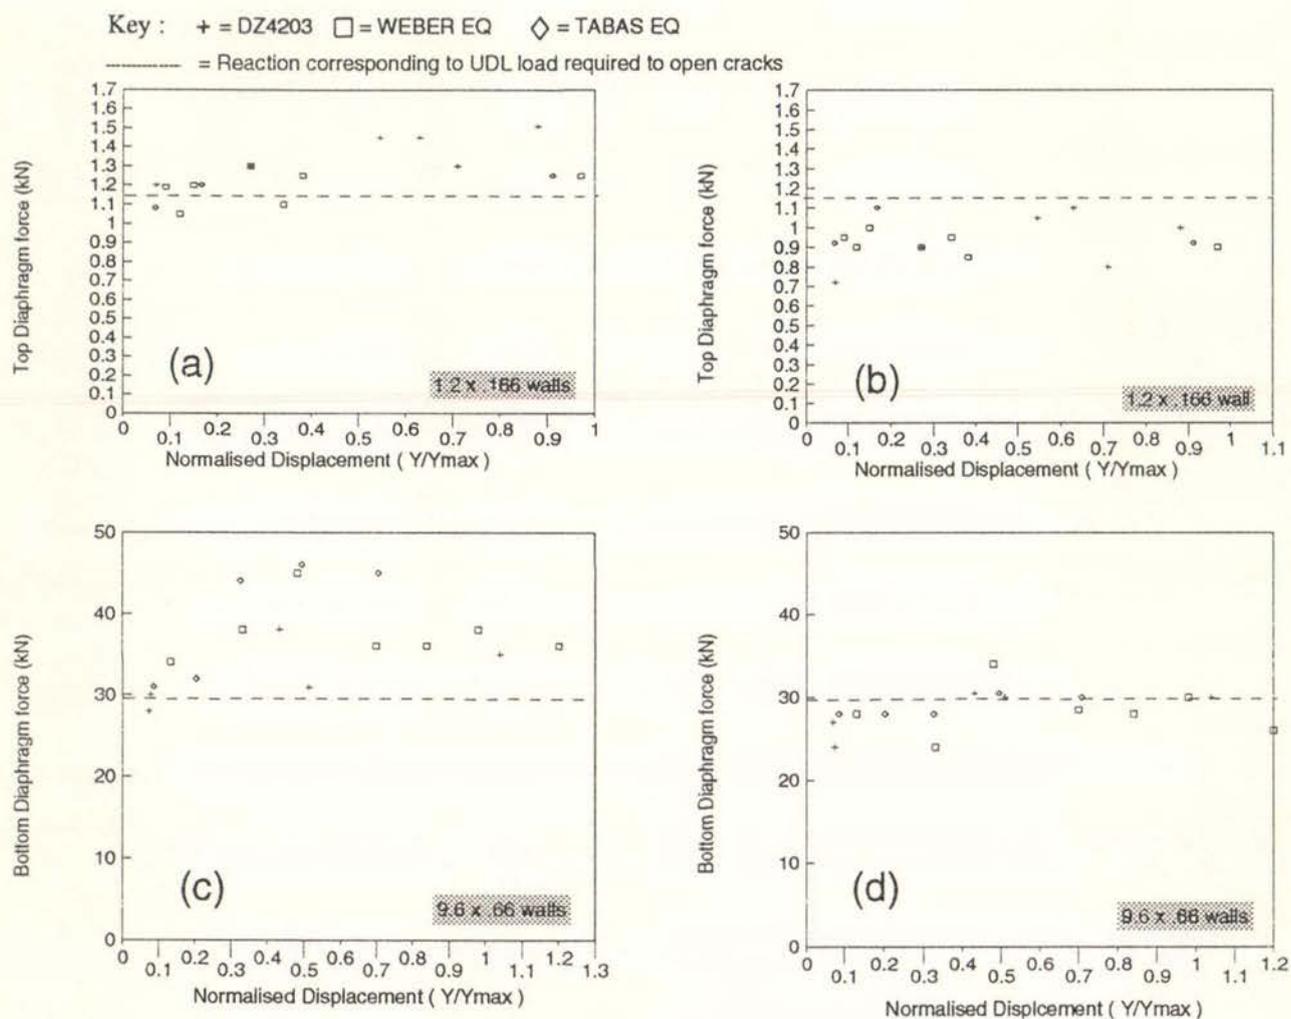
Figure 6.15 Anchorage Forces for Rigid Diaphragm;

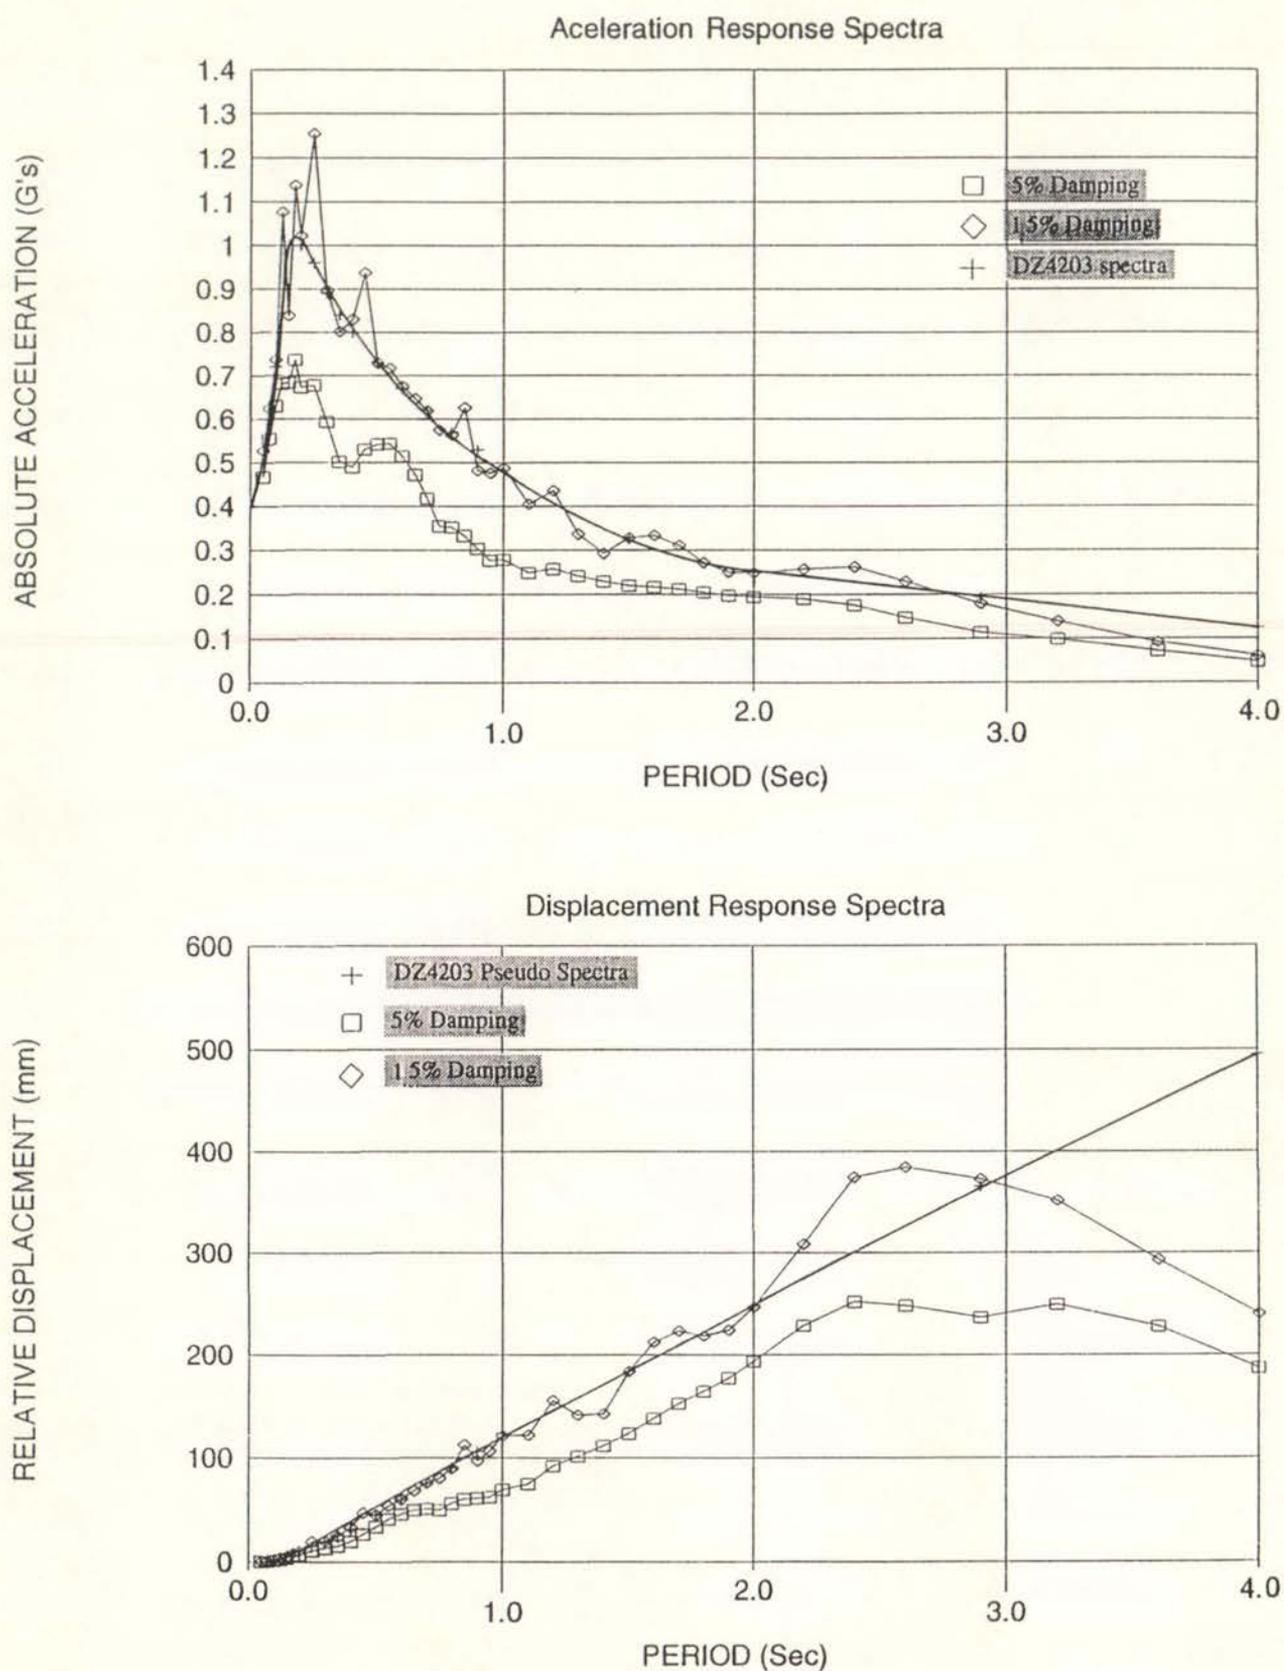
Figure 6.16 Elastic Response Spectra for first 15 seconds of the DZ4203 EQ Motion for:
 a) Acceleration and;
 b) Displacement

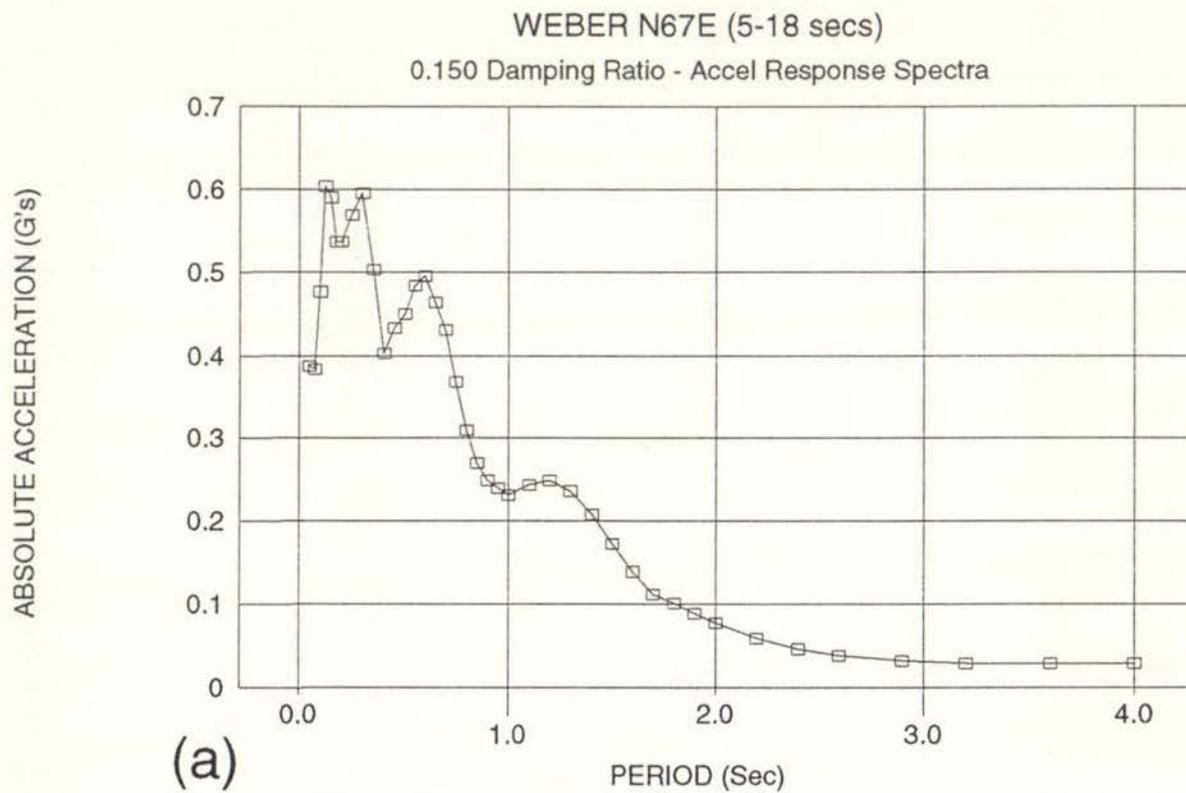
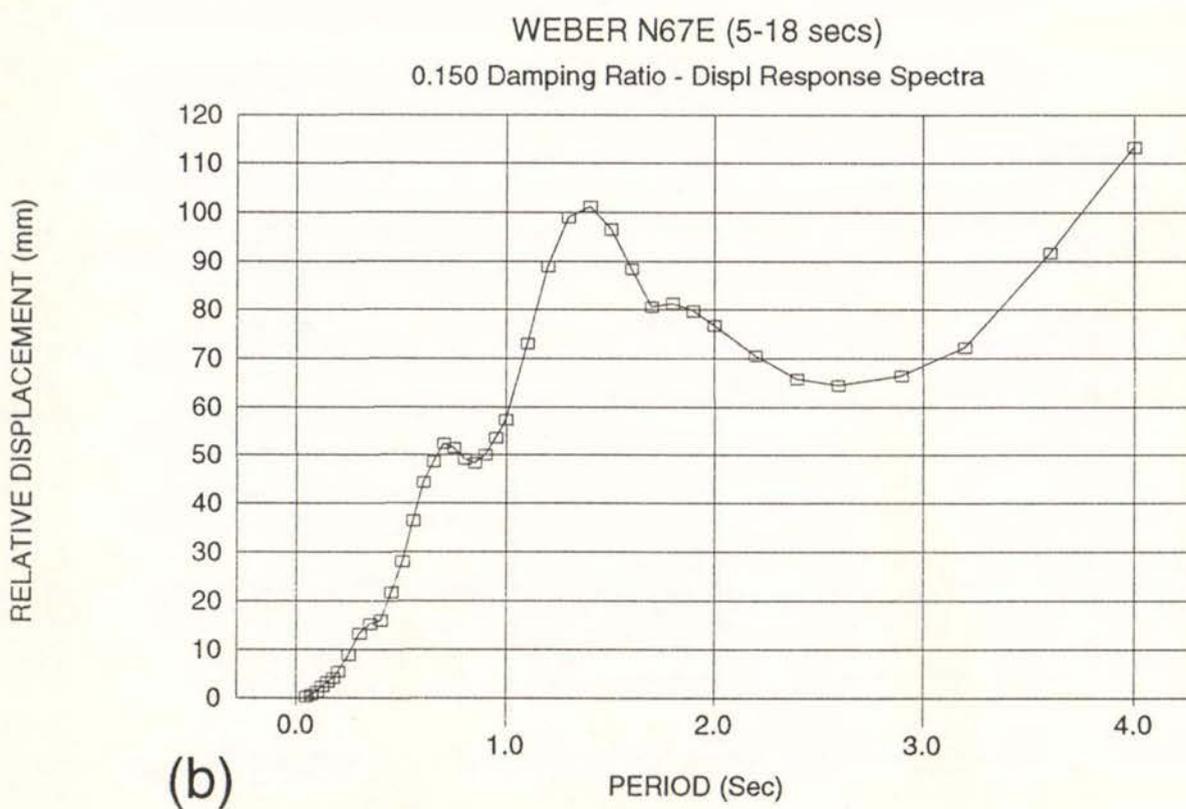
Figure 6.17 Elastic Response Spectrum for the Weber EQ Record.
a) Acceleration spectra and;
b) Displacement Spectrum

Response spectra for the Weber and Tabas earthquake records using 15% damping are also given in Figures 6.17 and 6.18 respectively.

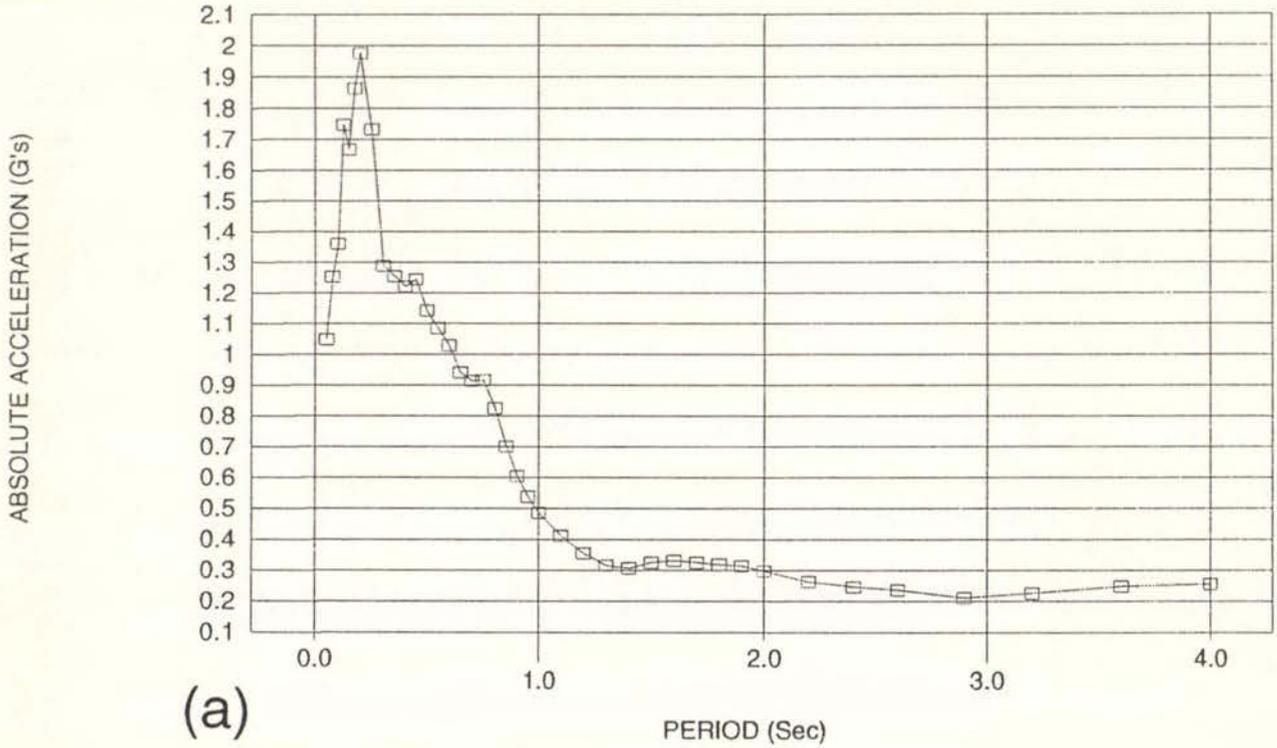
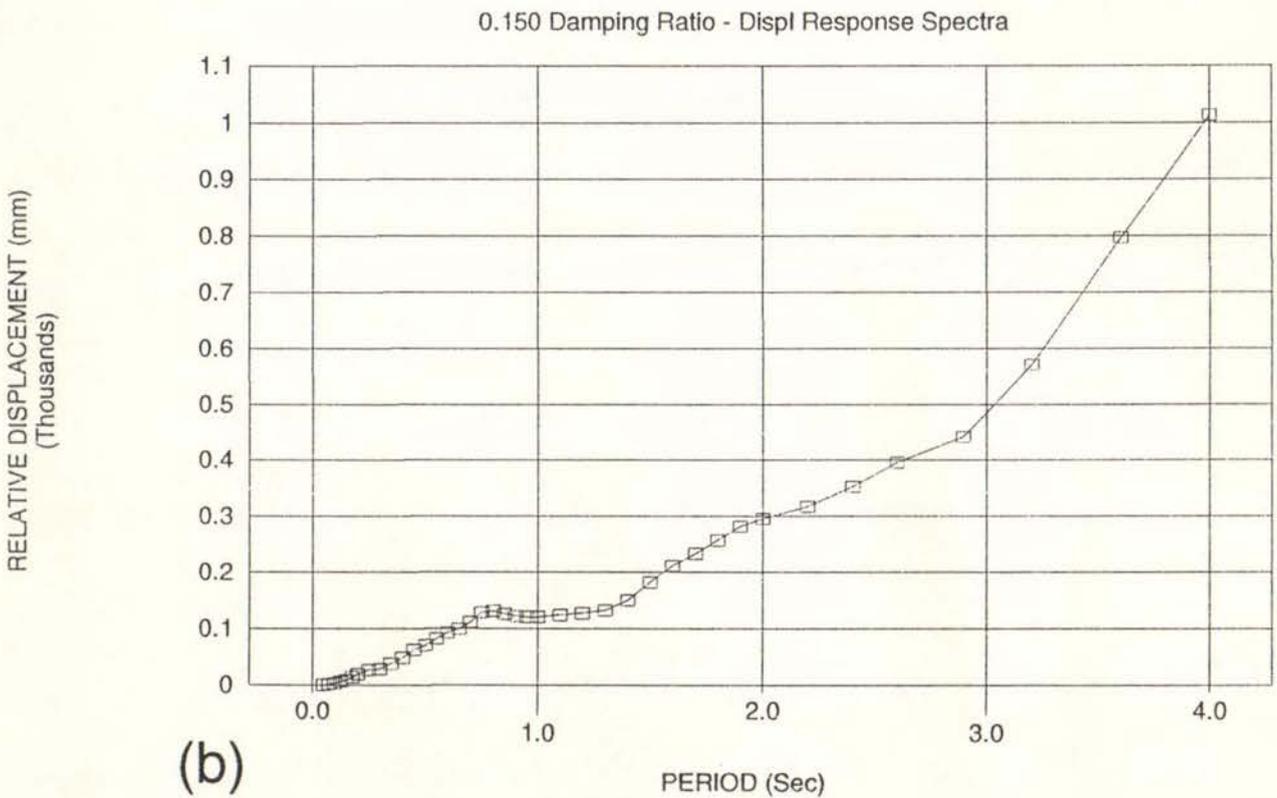
Figure 6.18 Elastic Response Spectra for the TABAS EQ Record. (a) Acceleration Spectrum and; (b) Displacement Spectrum

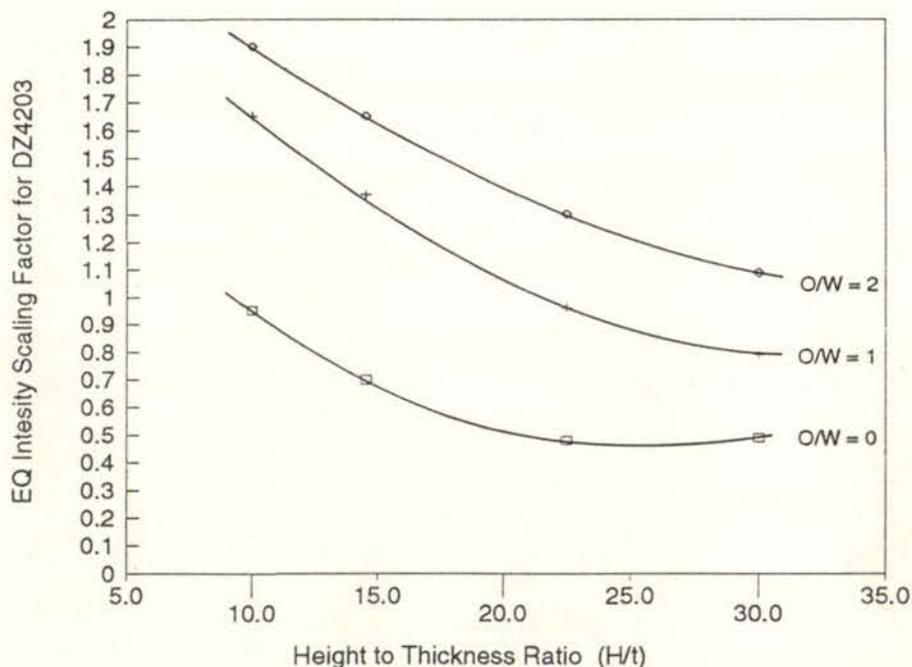
Figure 6.19 Predicted Seismic Resistance of a 330mm Thick URM Walls Using Proposed Formulae and DZ4203 EQ Intensity

Results of the computations are plotted in Figure 6.19.

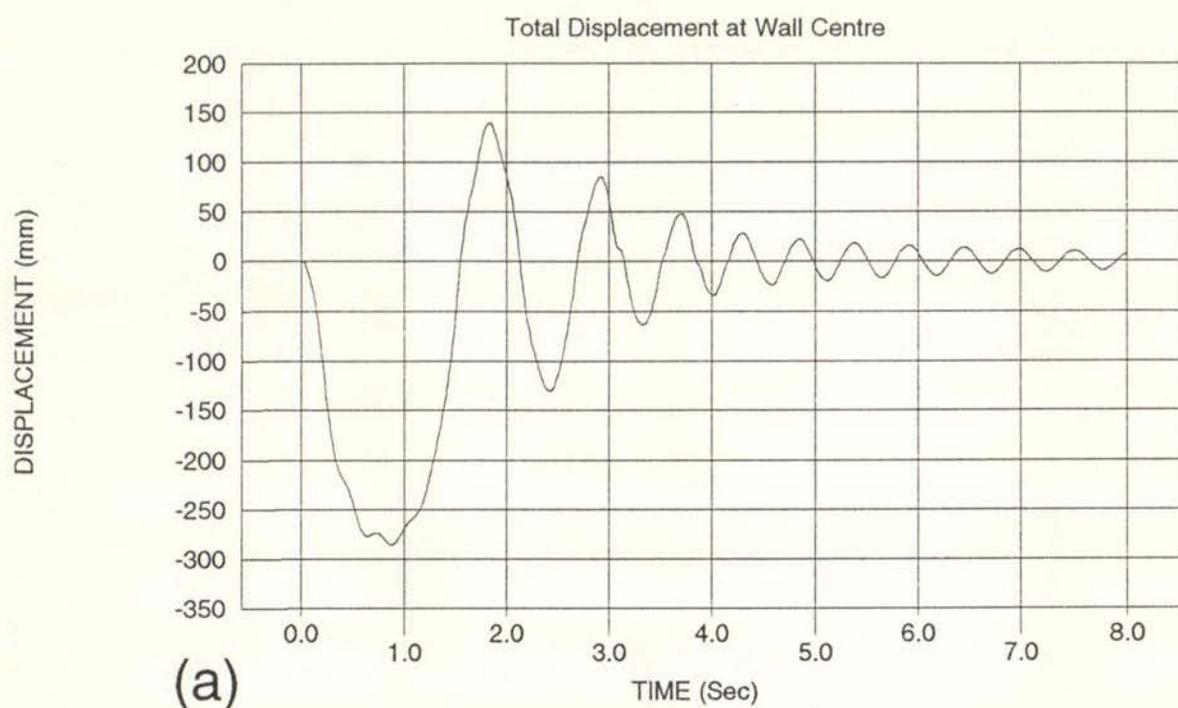
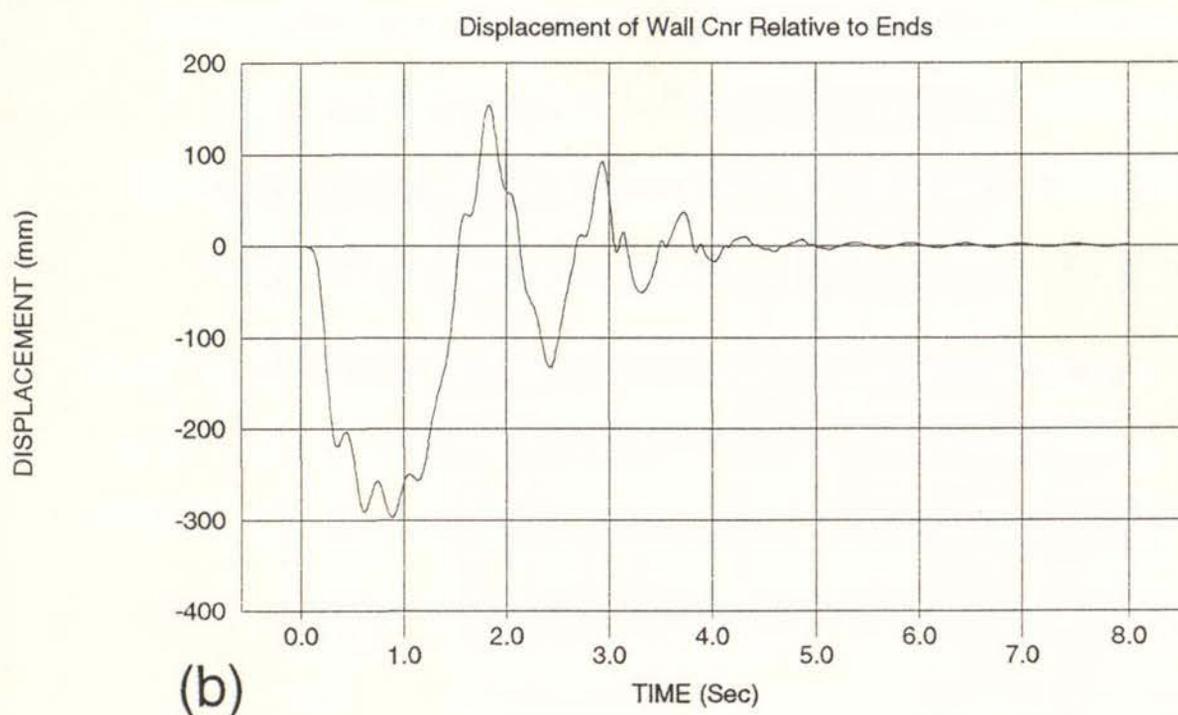
Figure 7.1 Displacement Time History at Mid-height of a Face Loaded Wall Modelled with 0.5 Second Period Diaphragms and subjected to an Acceleration Pulse for 0.2 seconds.

- a) Total Displacement at mid-height of wall including any components due to Deflection of Diaphragms and;
- b) Displacement at mid-height of wall excluding any components due to Deflection of Diaphragms.

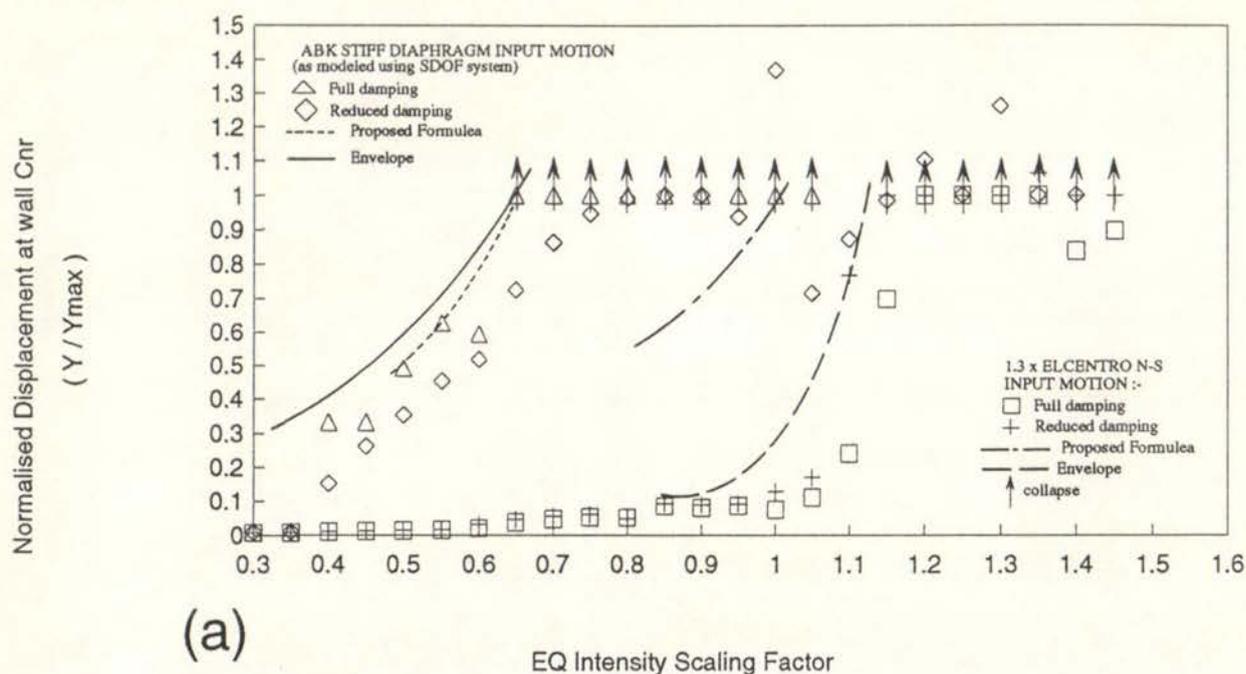
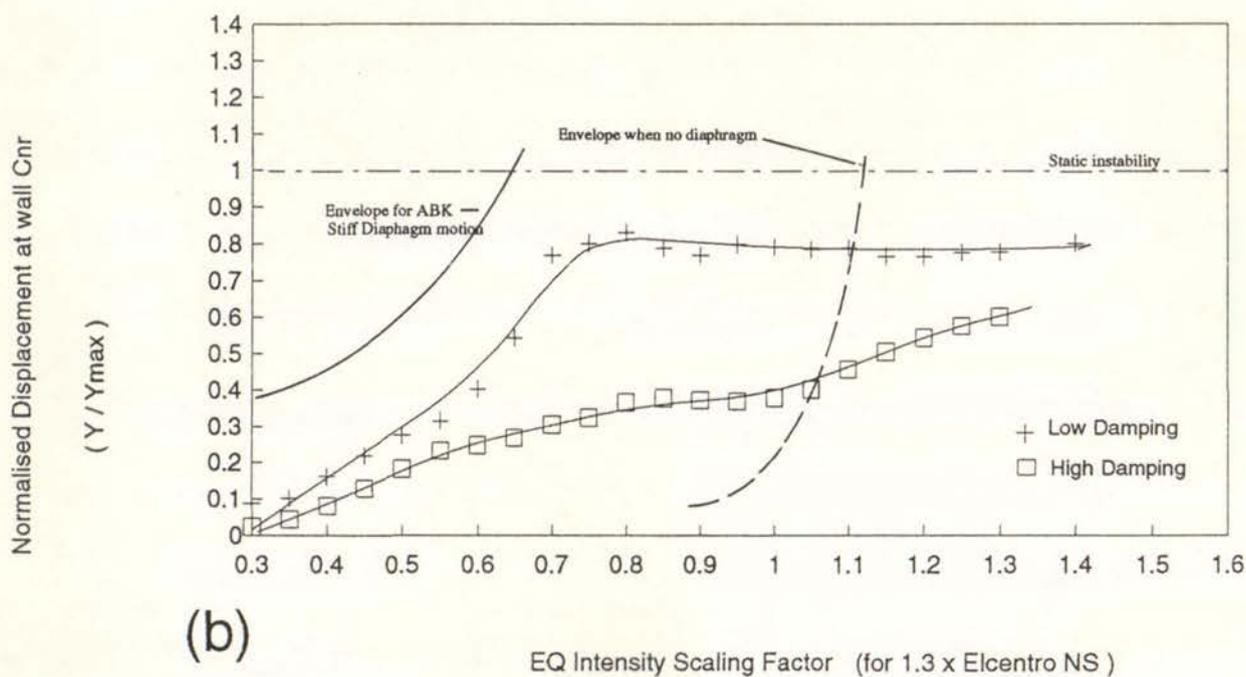
Figure 7.6 Peak Normalised Displacements at Mid-height of Face Loaded Wall Model Measured Relative to Line Joining Wall Element Ends.

The envelopes of the results indicate that the EQ Intensity Scaling factor corresponding to wall collapse would be reduced from 1.12 to 0.65 when diaphragms are included in the model and the ABK method of modelling the influence of the diaphragms is used. This corresponds to a reduction factor of 0.58 in the seismic resistance of the wall.
