**Earthquake Vulnerability of Existing Unreinforced Masonry
Buildings**

E L Blaikie, D D Spurr (Works Consultancy Services)

This project was sponsored by the
New Zealand Earthquake and
War Damage Commission

December 1992

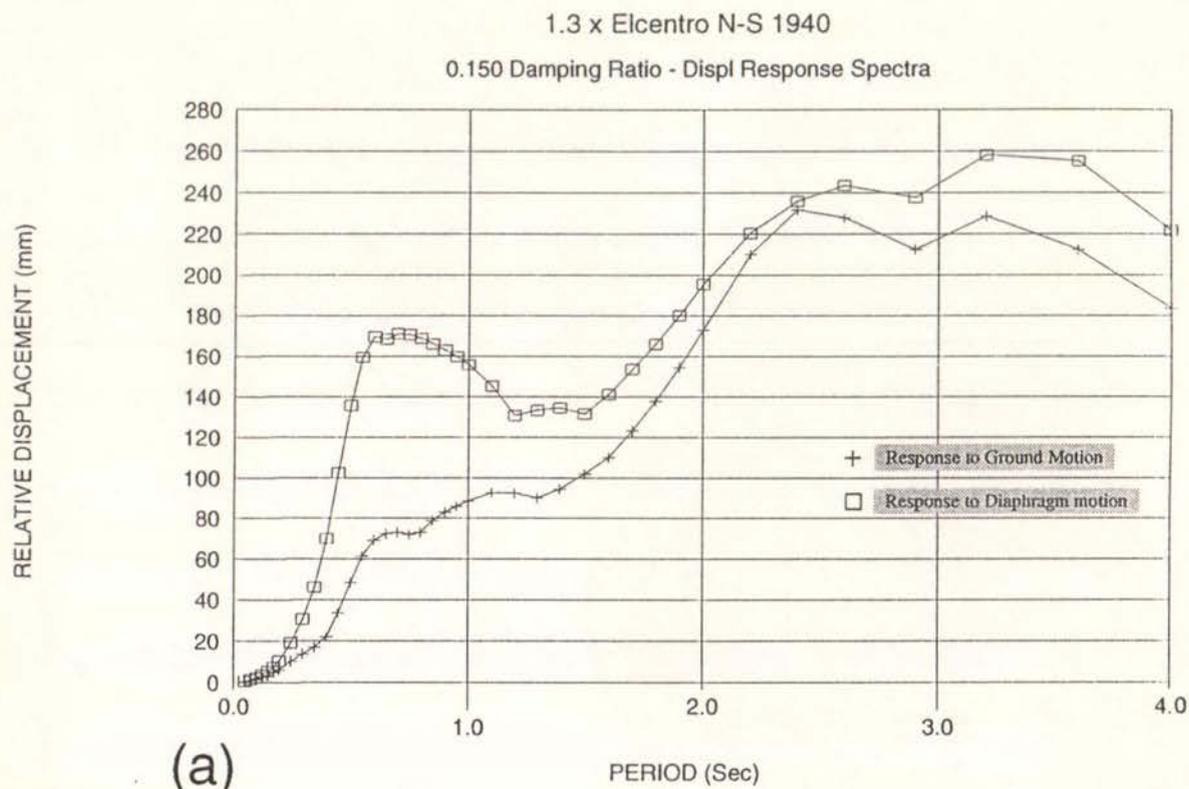
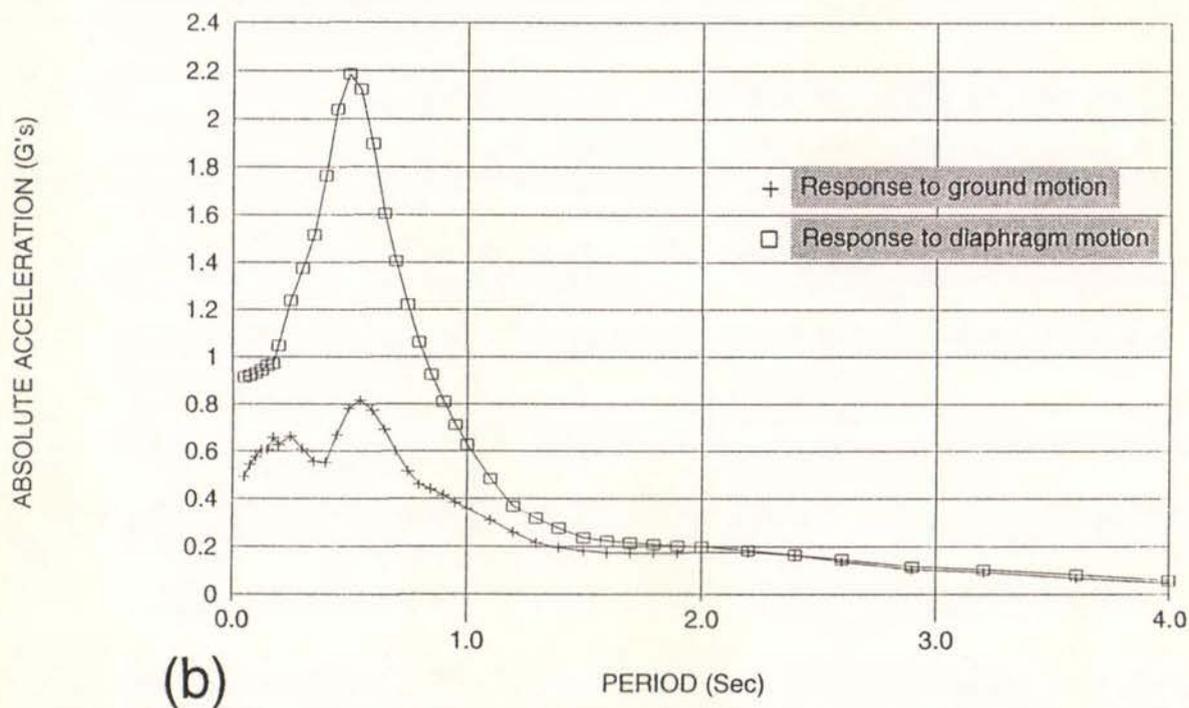
Figure 7.7 Elastic Response Spectra for 1st 15 seconds of the El Centro NS and ABK Stiff Diaphragm EQ Motions
 a) Displacement Response Spectra and;
 b) Acceleration Response Spectra

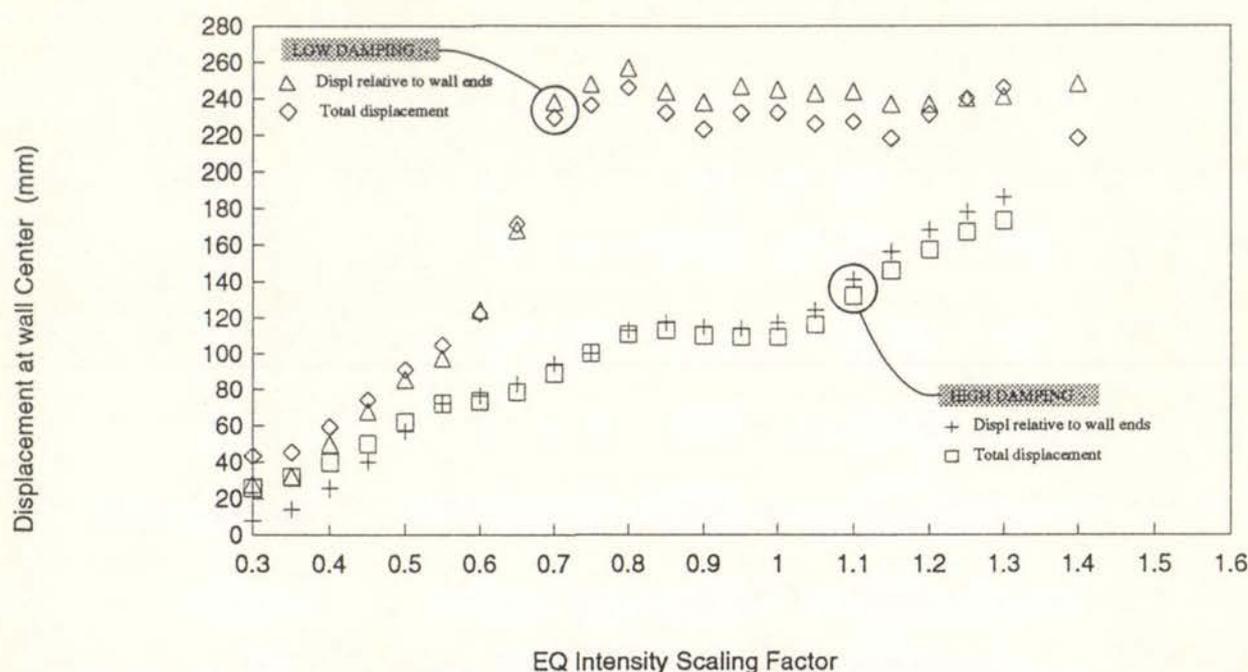
Figure 7.8 Peak Total and Relative Displacement at Mid-height of Face Loaded Wall when the wall is modelled with 0.5 second Diaphragms.

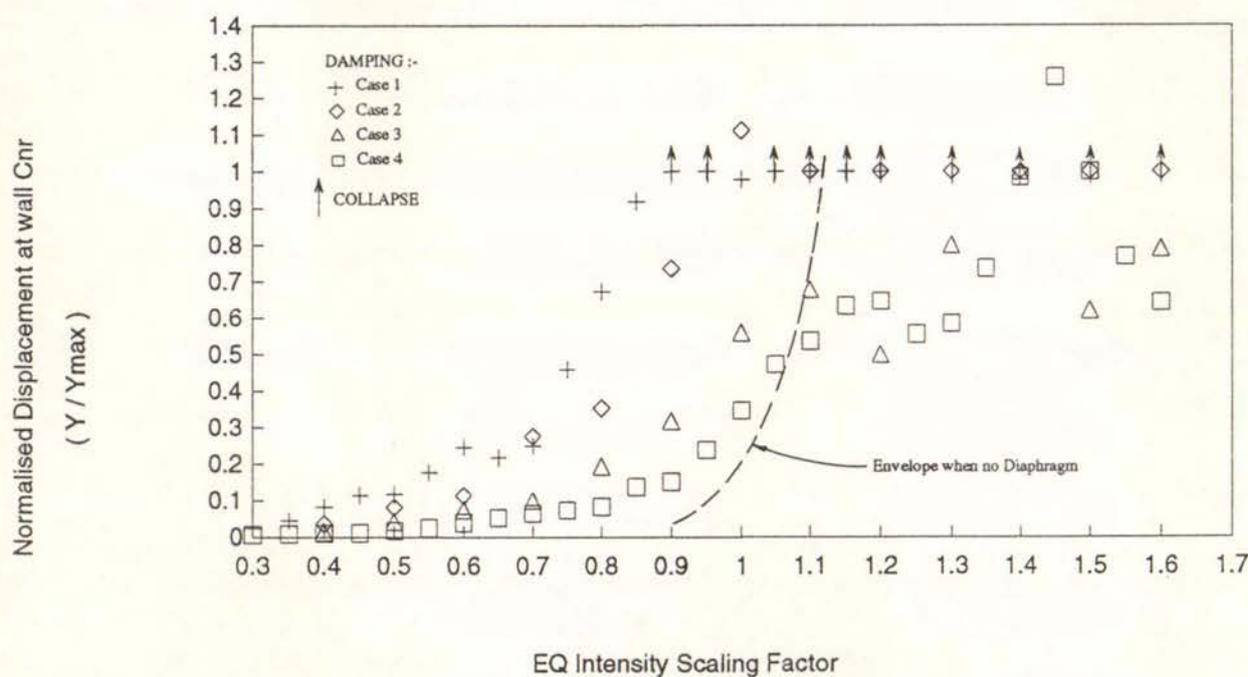
Figure 7.9 Peak Normalised Displacements at mid-height of Face Loaded Wall Model when the wall is modelled with 1.0 second Diaphragms. Displacements are measured Relative to Line Joining Ends of Wall Element and the input motion is 1.3 x El Centro NS (for details of Damping cases see Table 7.1).

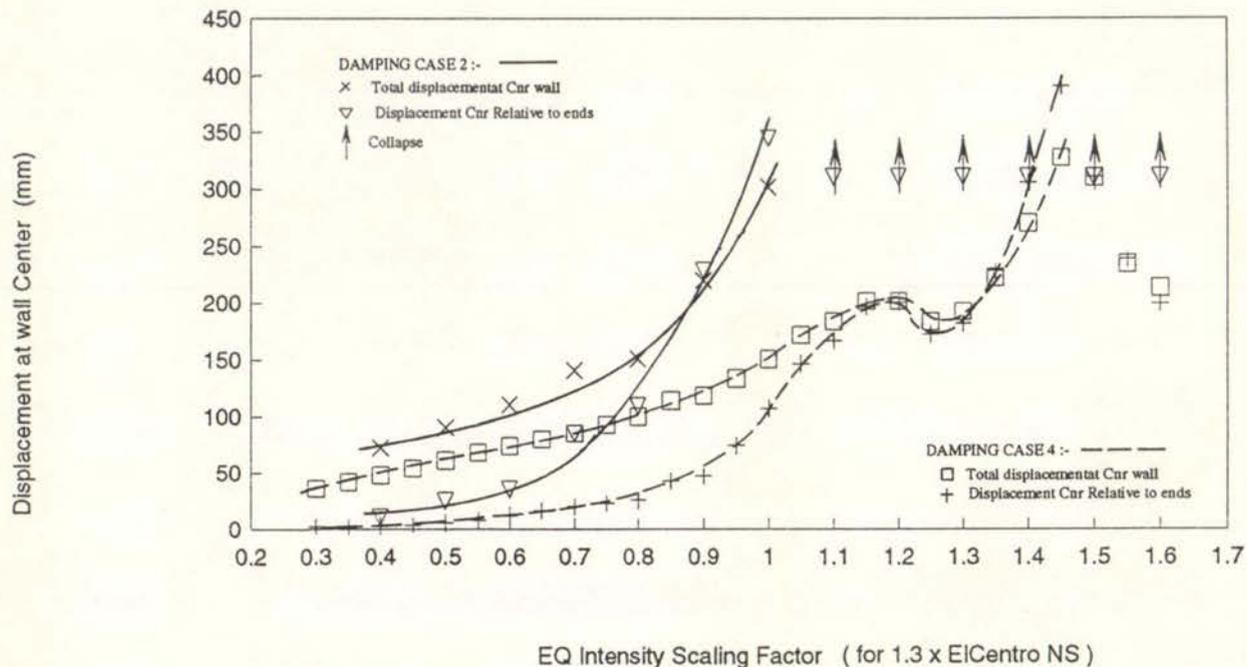
Figure 7.11 Total and Relative Displacements at the Mid-height crack level of Face Loaded Wall when wall modelled with 1.0 second period Diaphragms.

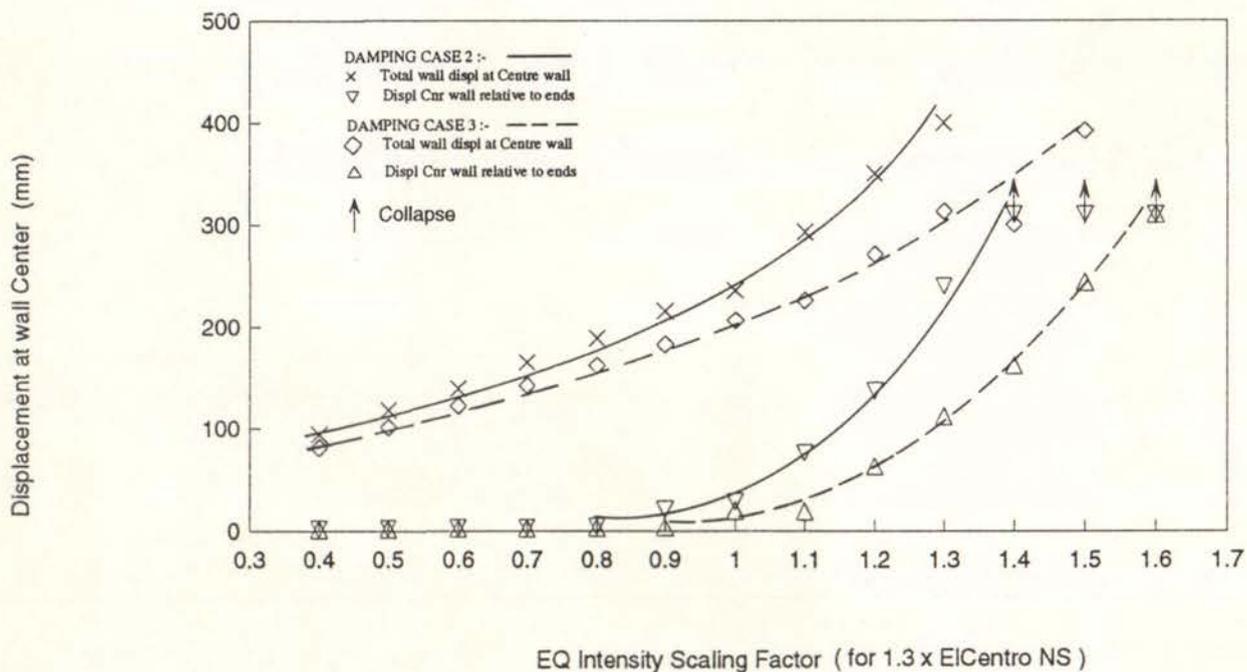
Figure 7.12 Total and Relative Displacements at Mid-height crack level of Face Loaded Wall when the Wall is modelled with 2.0 second Diaphragms

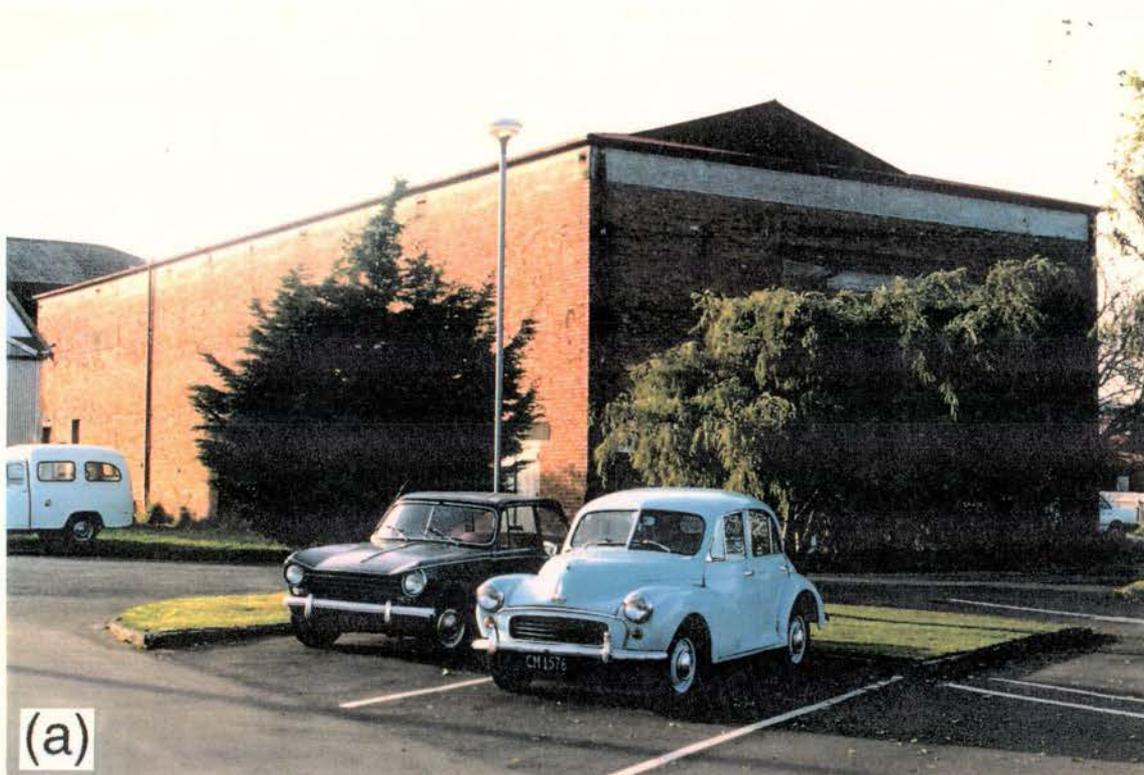
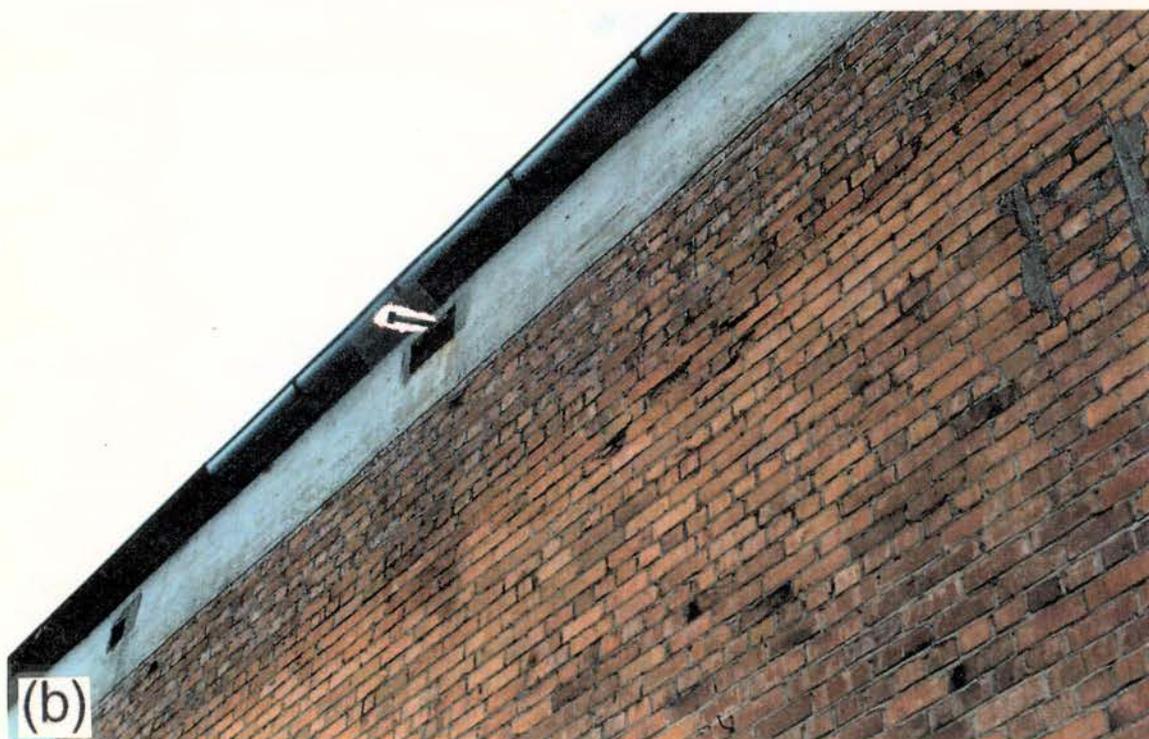
Figure 8.1 Regent Theatre Building Dannevirke

- a) Building viewed from South.
- b) SW wall of Building and Location of anchor rods protruding 200-250 from wall.

The theatre was built in 1918 with a large upper circle but this was removed after the 1934 Pahiatua Earthquake. The remaining building is essentially a large 38 x 15m rectangular box as shown in Figure 8.1(a). A concrete band and diagonal steel bracing were added to the building at roof level, probably after the 1934 earthquake. These features are shown in Figure 8.1(a).

After the Weber earthquake two nuts from the ends of the rods in one of the bracing bays were found on the ground. The nuts had been filled with mortar to hide the fact that they only engaged a few threads on the bracing rods. The other end of the rods with the missing nuts were projecting 200-250 mm from the wall (see Figure 8.1(b)). This is the only evidence found that significant wall displacements had taken place at roof level. The building has recently been divided in half (circa 1988) by a transverse fire wall. This is a timber stud wall lined on both sides with gib board. Lighting within the building during the site inspection was poor but the lack of observed damage to the gib wall suggests that the roof level displacement at the centre of the longitudinal walls did not exceed more than 50 to 75mm. This would indicate that the 200- 250mm protrusion of the failed diagonal bracing rods from the wall face was generated progressively during the earthquake and not during a single cycle of the response.

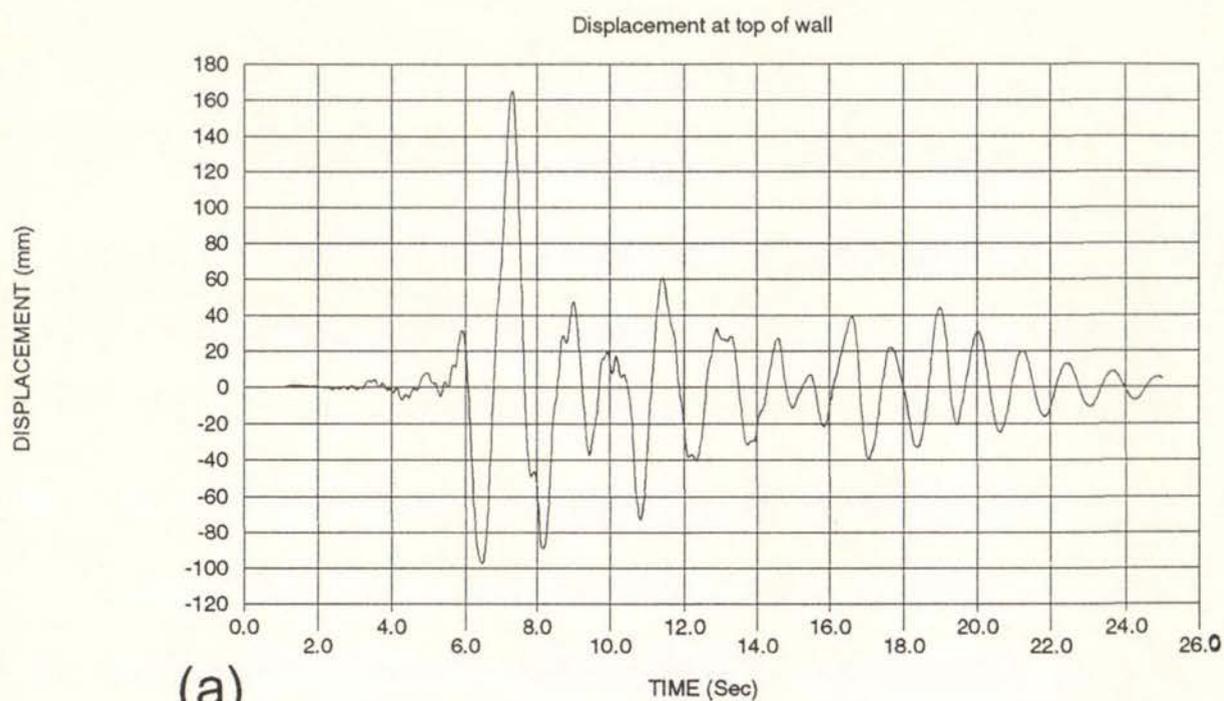
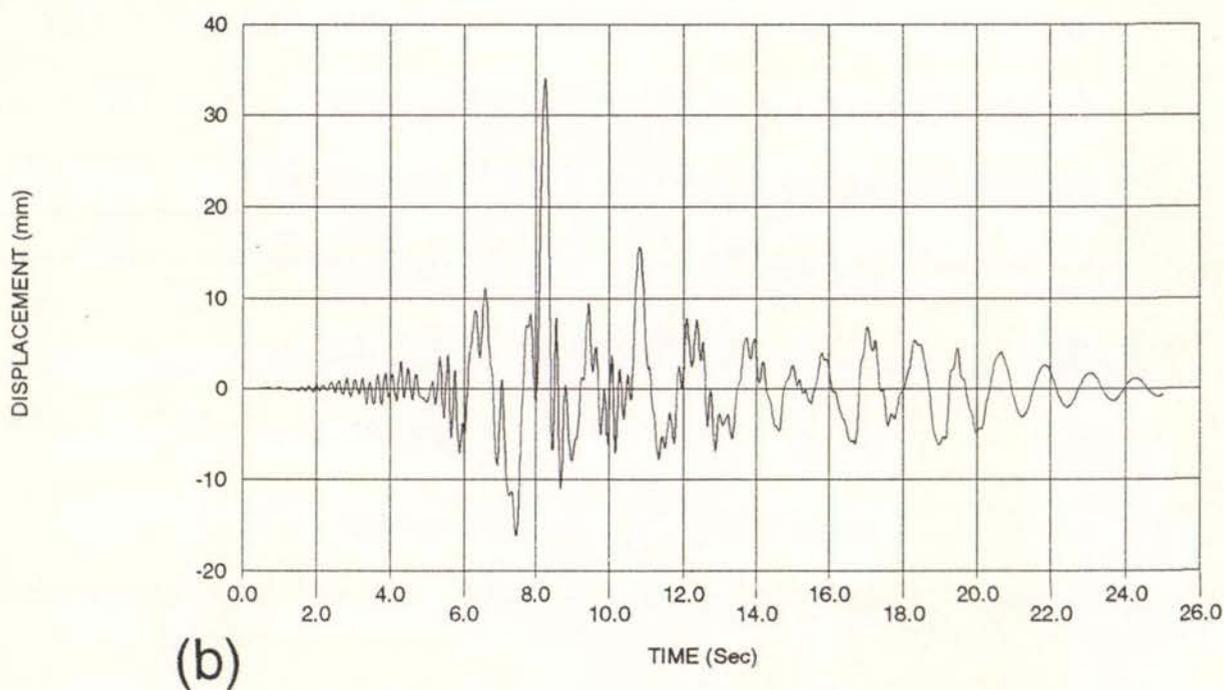
Figure 8.2 Displacement of Regent Theatre Longitudinal Walls when walls modelled without a Roof Diaphragm and subjected to 1.0 x WEBER EQ Motion.

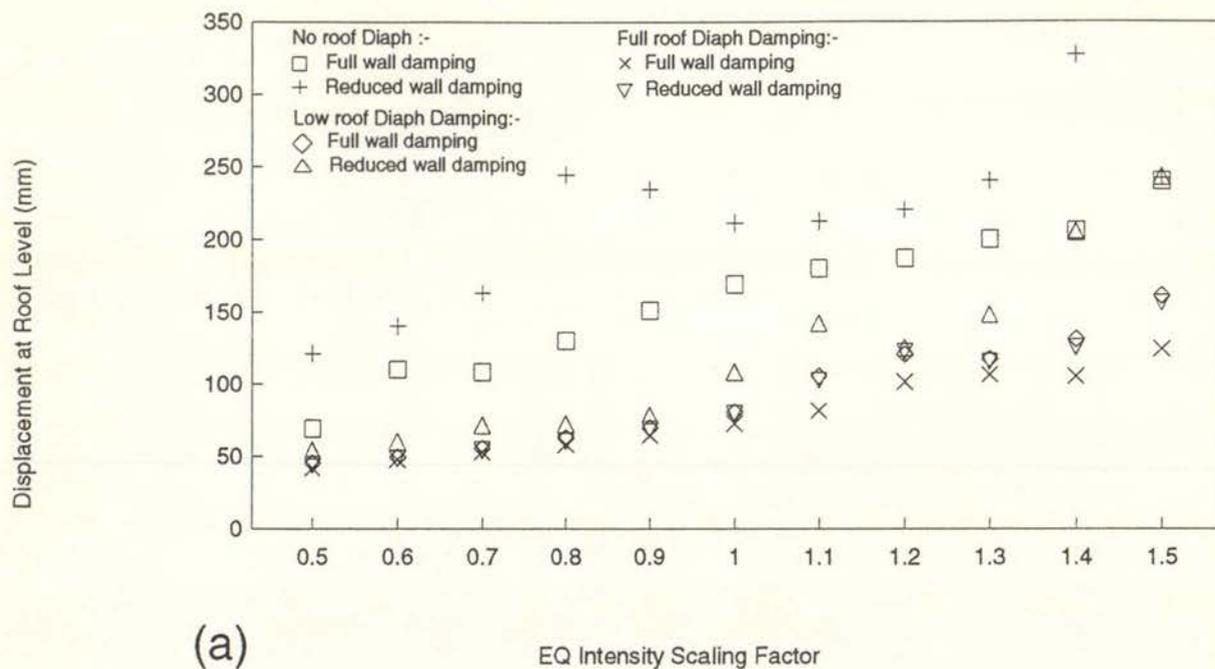
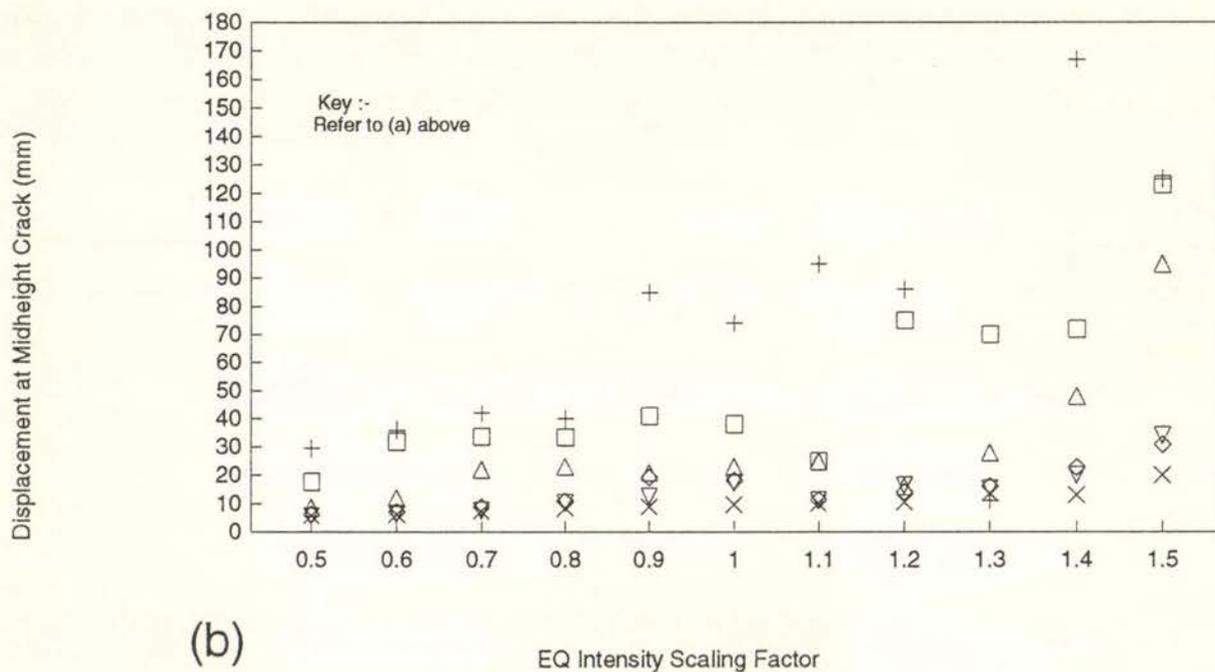
Figure 8.3 Displacement of Regent Theatre Longitudinal Walls Predicted by Computer Model for a Range of WEBER Earthquake Intensities and Damping Parameters.
