**Influence of Loading History on Ultimate Displacement of  
Concrete Structures**

*Darrin Liddell, Jason M Ingham, Barry J Davidson, Dept of Civil &  
Resource Engineering, University of Auckland*

School of Engineering  
Report No. 597

July 2000

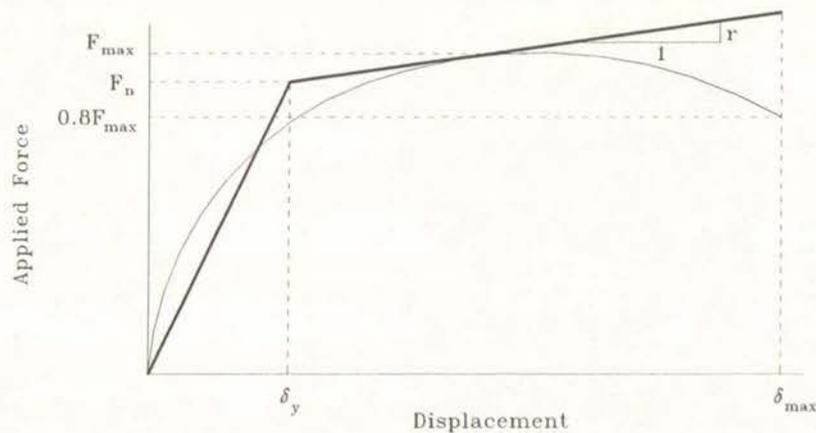
Figure 3-3 Bilinear Approximation

The damage index proposed by Roufaiel and Meyer and detailed in Section 3.5.3 is based upon the bilinear approximation to the force-displacement response illustrated in Figure 3-3. As for the elasto-plastic model, a straight line is drawn between the origin and  $(\delta_y, F_n)$ . A straight line of slope  $r$  is then drawn from  $(\delta_y, F_n)$  to the maximum displacement. This model is slightly more realistic than the elasto-plastic

model because it accounts for strain hardening after yielding has occurred.

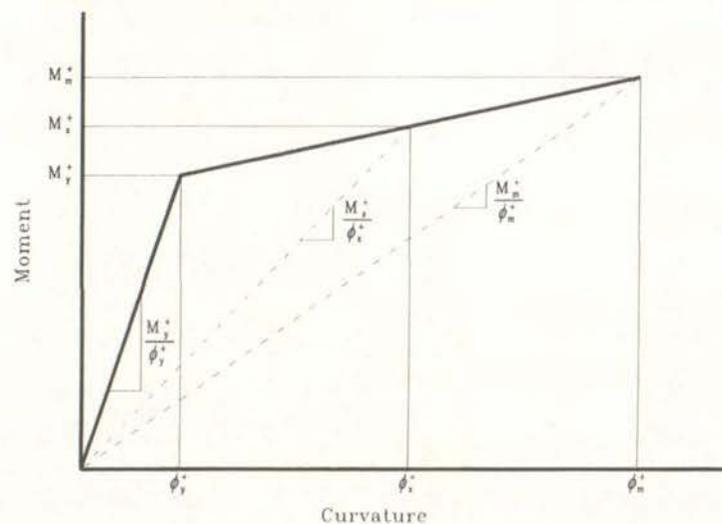
Figure 3-4 Definition of Modified Flexural Damage Ratio (Roufaiel and Meyer 1987)

As with the damage index proposed by Cosenza et al., the member is undamaged when the MFDR is less than or equal to zero, and has failed when the MFDR is equal

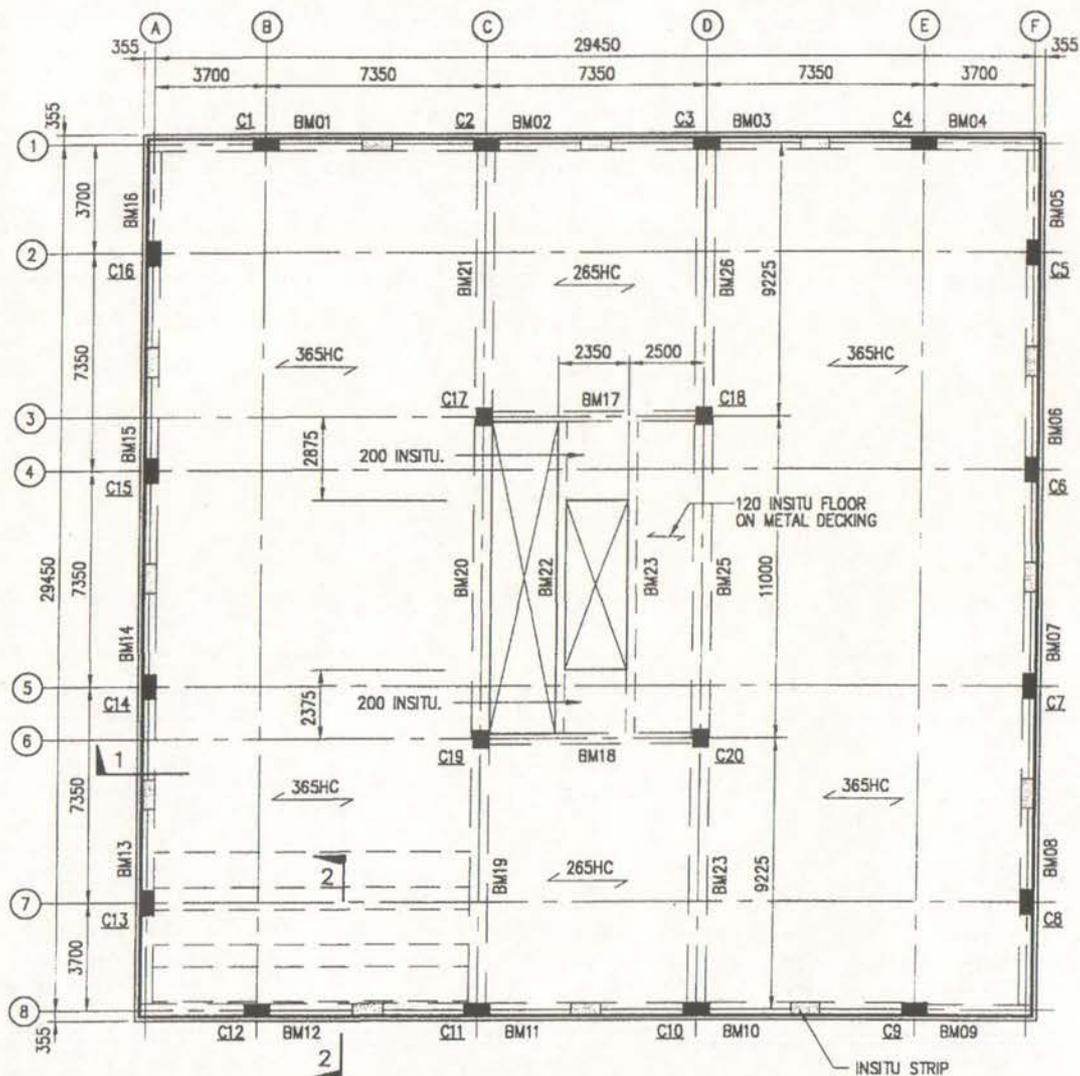
Figure 4-1 Frame Building Plan (C&CA 1998)

The three-dimensional analysis programme ETABS (Version 5.0) was used to complete the seismic analysis of the building model. The ETABS analysis indicated

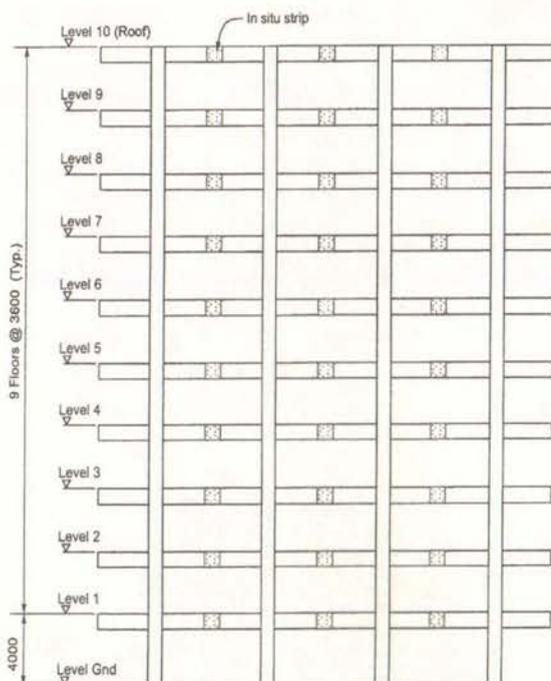
Figure 4-2(a) Perimeter Frame Elevation  
(C&CA 1998)

To simulate the response of a beam section under seismic loading it was necessary to base the design of the test assembly on a beam dominated by seismic loading. In 'The Red Book' example the perimeter frames were required to resist any lateral forces and, depending on the direction of the beam with respect to the orientation of the floor slab, varying amounts of gravity loads. The internal frames were designed as secondary elements because, while they resisted gravity loads, they played no part in resisting lateral forces. Therefore the beams where seismic loads were most dominant were those perimeter beams running parallel with the orientation of the floor slab.

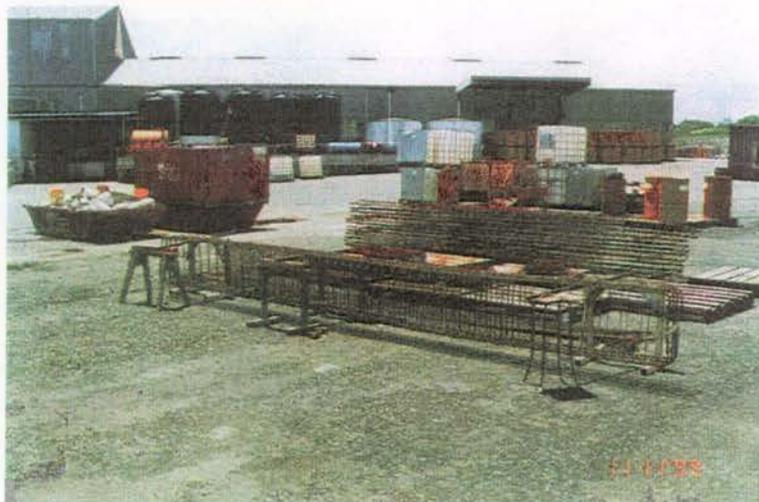
Figure 4-11 Reinforcement Cage in Upright Position

The reinforced concrete beam section of the test assembly was constructed off-site to accommodate space constraints in the university laboratory. Figure 4-11 shows that the transverse reinforcement was positioned and tied while the reinforcement cage were situated in an upright position. The reinforcement cage was then rotated 90

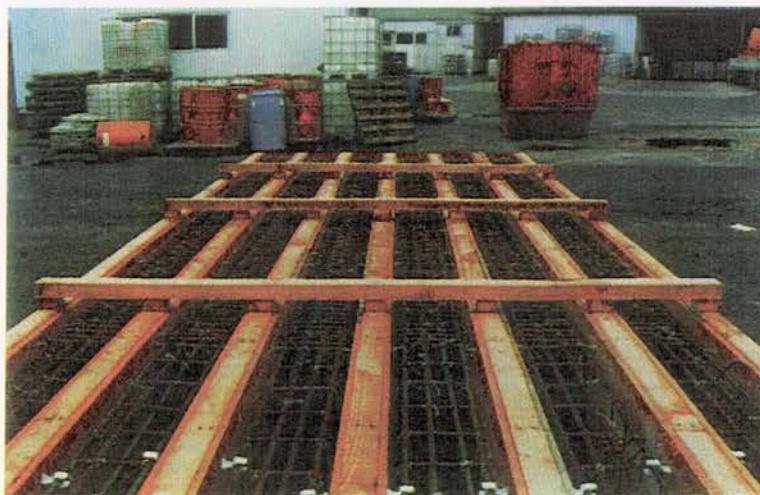
Figure 4-13 Reinforcement Cages Positioned in Boxing

Due to the lack of an overhead crane at the site, the boxing was constructed in its final upright position. The boxing consisted of a timber box beam placed either side of the reinforcement cage. The timber box beam was constructed from 75 x 50 timber and 20mm thick pinex floorboards, and was of sufficient strength to ensure that self-weight deflections were negligible. The beams were connected to bearers with M10-

120 coach bolts at 960mm centres. This prevented lateral deflection of the timber box beam at its base. Once the reinforcement cages had been positioned, cross bracing, as illustrated in Figure 4-13, was placed on top of the boxing to ensure that there was no lateral spreading at the top of the beams during the pouring of the concrete.

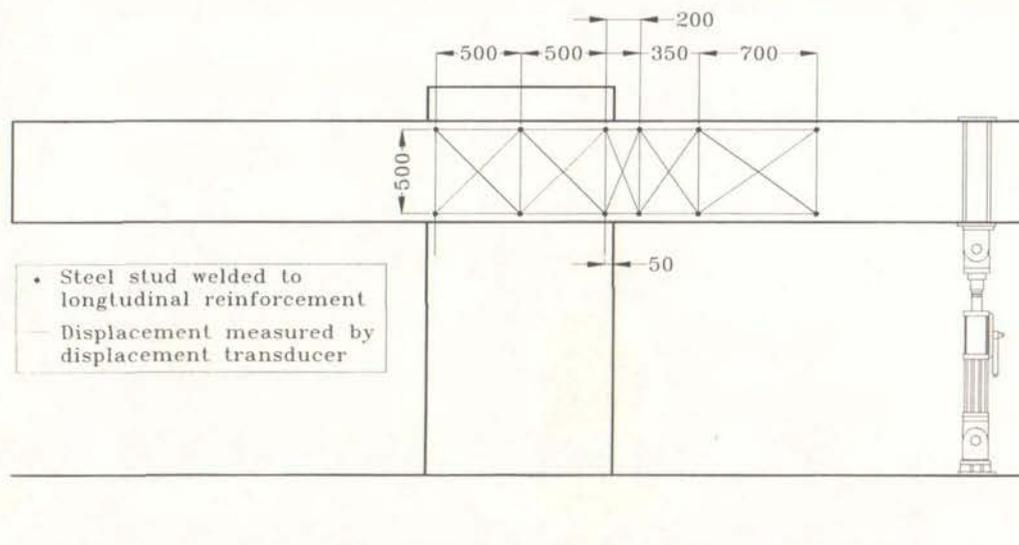
Figure 4-16 Instrumentation Layout

Once the studs had been welded to the longitudinal reinforcement, grease tape was wrapped around the stud. A plastic tube was then placed over the grease tape and the stud. Once the concrete had cured, the grease tape and plastic tube were removed to leave a small gap around each stud. This eliminated the affects of cover concrete on

the transducer readings.

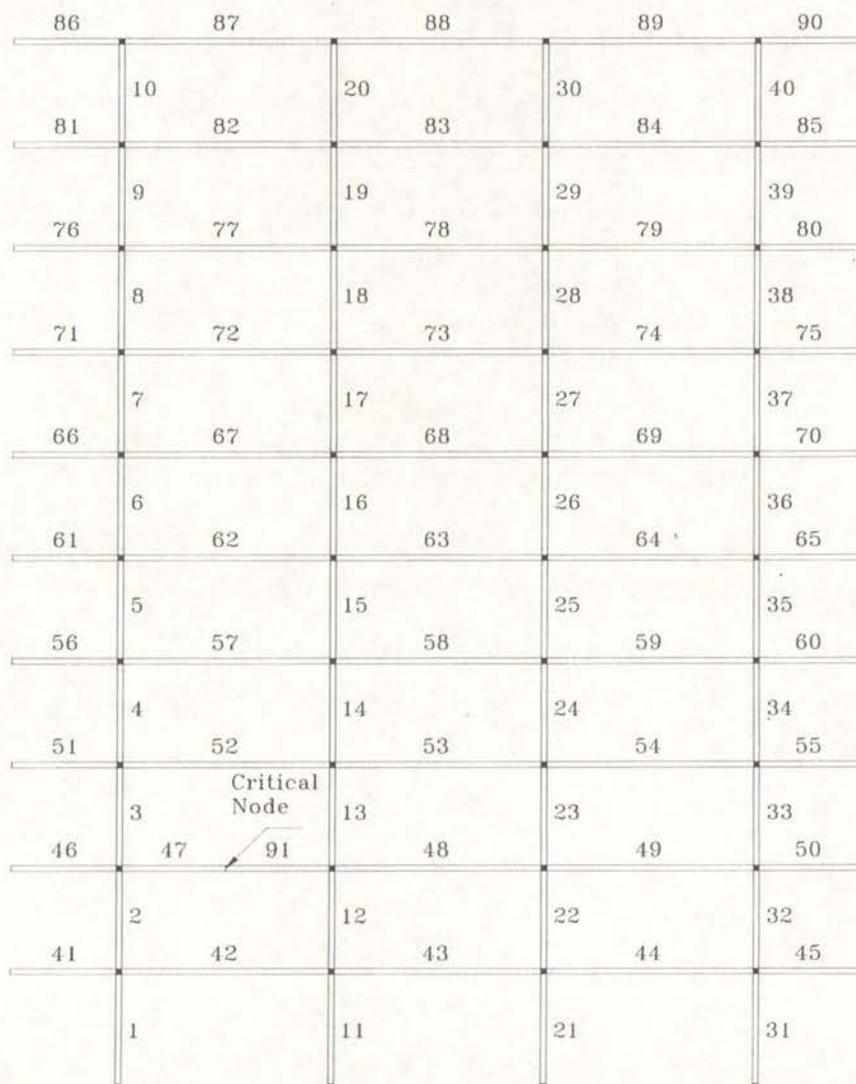
Figure 5-3 Ten-Storey Model with Beam Elements Numbered and Joint Elements Shaded

As previously mentioned, the model set up in Ruaumoko was based on the ETABS model presented in 'The Red book'. However, whereas material and section properties in the ETABS model were based on design values, the Ruaumoko model

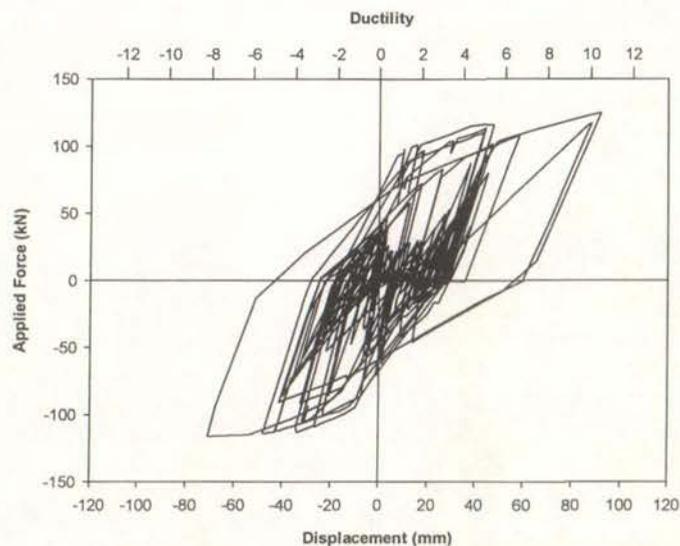
Figure 5-15 Predicted Force-Displacement Response (Acceleration History B)

Figure 5-15 details the predicted force-displacement response of the test subassembly for acceleration history B. Table 5-5 presents the resulting prediction of the damage indices' values. Figure 5-15 reveals that there were more cycles to high ductility values in this acceleration history than for acceleration history A. This is reflected in the predicted damage indices, where all five damage indices for this acceleration history are larger than the damage indices from acceleration history A.

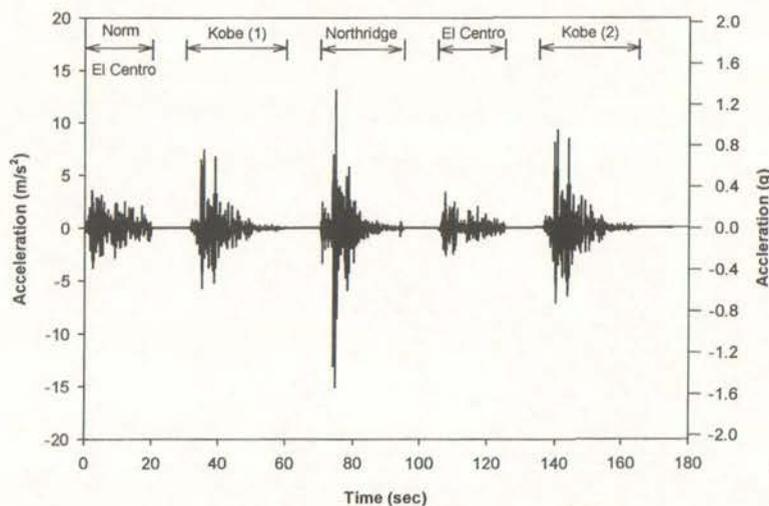
Figure 5-16 Acceleration History C

Figure 5-16 illustrates that an additional earthquake record was included in acceleration history C to ensure that failure occurred. The first four records in acceleration history C were scaled by the same factors as in acceleration history B. This enabled comparisons between the observed response and derived experimental data for the two tests to be made. However, the records were applied in a different order in this acceleration history than in acceleration history B. As with acceleration histories A and B, the first record was the artificial earthquake based upon the North-South component from the El Centro earthquake. The second and third records were the East-West component from the Kobe earthquake and the Northridge earthquake recorded at the Pacoima dam station respectively. The fourth record was the North-

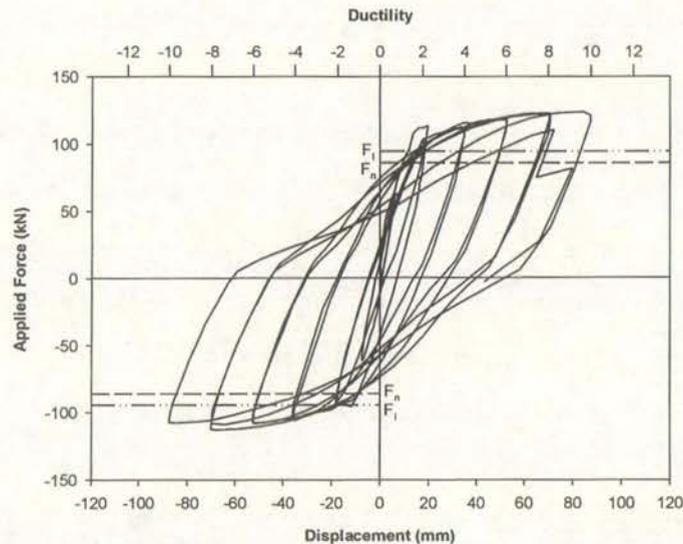
Figure 7-1 Force-Displacement Response (New Zealand Loading History)

Figure 7-1 presents the force-displacement response from testing using the New Zealand loading history and reveals that the beam reached a maximum ductility of 10. Figure 7-1 also indicates that the strength of the test assembly exceeded both the nominal design force and the ideal design force, which were defined in Section 3.1.

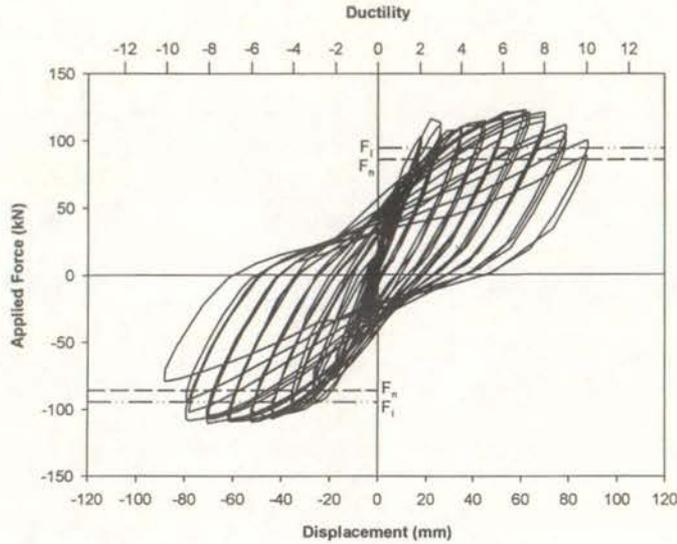
Figure 7-2 Force-Displacement Response (Berkeley Loading History)

Figure 7-2 illustrates that the beam also reached an ultimate ductility of 10 when the Berkeley loading history was applied. Failure also occurred after the rupture of a longitudinal reinforcement bar. However, in contrast to the failure from testing using the New Zealand loading history, rupture in this test occurred after significant strength degradation had taken place. Therefore the welding of instrumentation studs to the longitudinal reinforcement did not affect the local material properties of the reinforcement bar and hence, failure was attributed to low-cycle fatigue of the

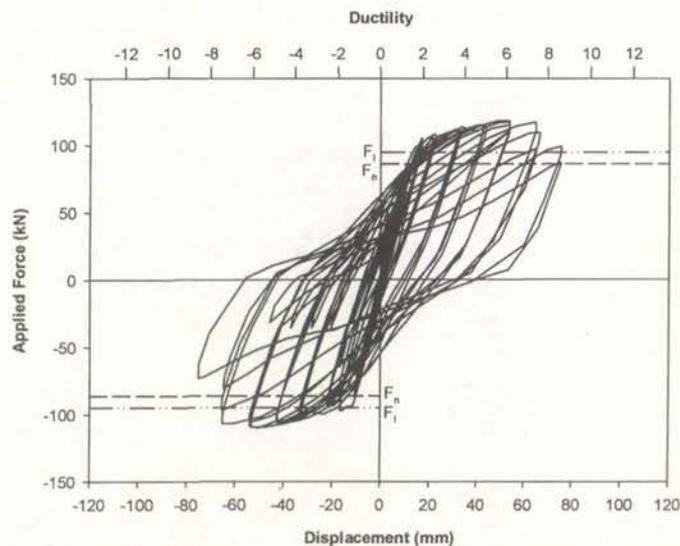
Figure 7-3 Force-Displacement Response (PRESSS Loading History)

Figure 7-3 presents the force-displacement response from testing that applied the PRESSS loading regime. The beam reached an ultimate ductility of 8.6 in the positive direction and 7.4 in the negative direction. Failure in this test was indicative of conventional tensile flexural failure described in Section 2.5.1.1 because the strength of the test specimen gradually decreased over a number of cycles. As with the response from testing using the New Zealand loading history, the nominal and

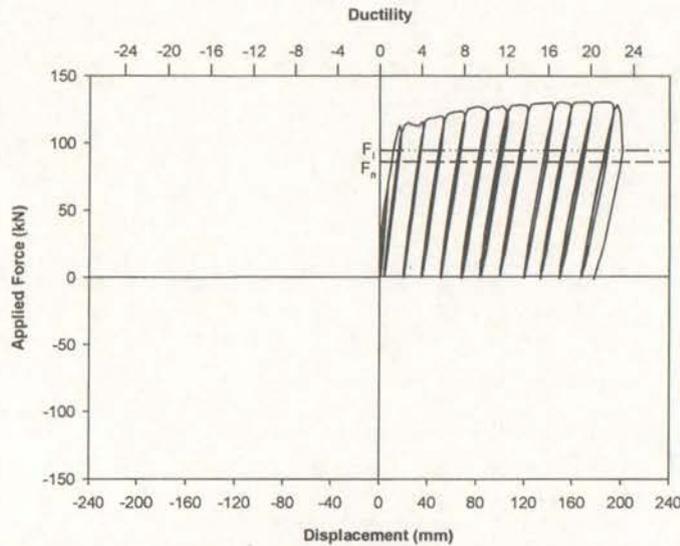
Figure 7-7 Force-Displacement Response (Unidirectional Loading)

Figure 7-7 reveals that the test subassembly reached an ultimate ductility of 22 under unidirectional loading before failure occurred. Failure was due to rupturing of a

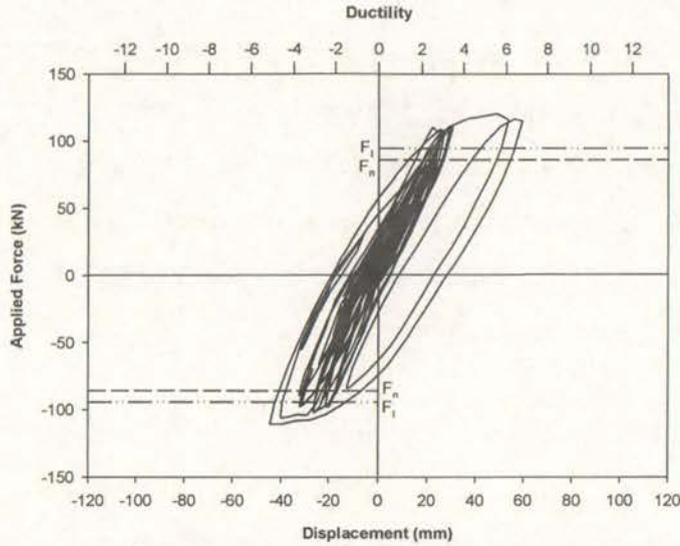
Figure 7-8 Force-Displacement Response (Acceleration History A)

This section details the force-displacement response from acceleration histories A-E. These are presented in Figures 7-8 through 7-12. In all cases the maximum strength exceeded the nominal and ideal design strength. However, in contrast to testing conducted using laboratory procedures, failure was not necessarily induced in these five tests. For acceleration history A, this was because the larger displacements in the displacement sequence established from modelling in Ruaumoko were not of sufficient size or number to promote degradation of the test specimen. For the remaining acceleration histories it also proved difficult to define failure when significant degradation took place. This was because the largest ductility cycles often did not require the application of a large force due to their position in the displacement sequence. Thus, it was difficult to determine whether any strength loss

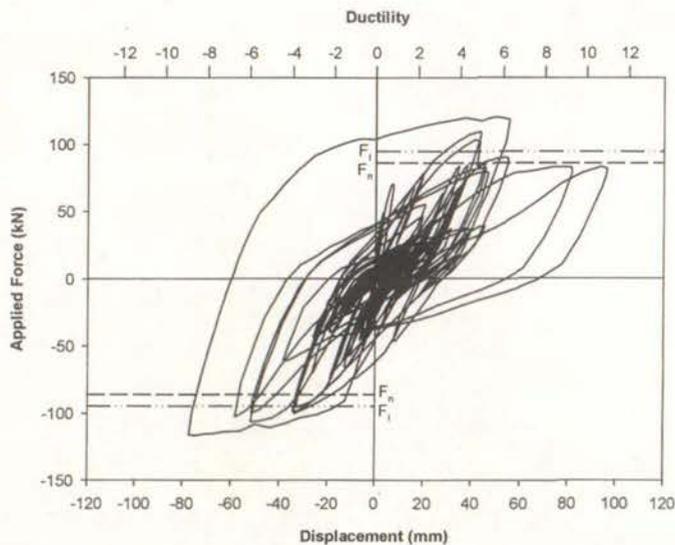
Figure 7-11 Force-Displacement Response (Acceleration History D)

The loading sequence from acceleration history D was the only loading sequence that definitely induced failure of the test specimen. Figure 7-11 reveals that significant strength degradation occurred during the test. This was due to rupturing of a longitudinal reinforcement bar occurring during application of the third record in the displacement sequence. However, this was a premature failure because the bar ruptured immediately next to an instrumentation stud and the rupture occurred prior to the application of the most damaging records. Therefore, it was established that

As was reported in Section 5.2.3, the Kobe earthquake record was repeated to induce failure of the test subassemblage. Of the four earthquake records applied prior to that record, two were from earthquakes where significant damage occurred. These were the Kobe record and the Pacoima Dam record from the Northridge earthquake (NZNSEE Reconnaissance Team 1995; NZSNEE Reconnaissance Team 1994). Thus, failure of the test subassemblage had still not occurred after being subjected to four earthquake records even though all four records were scaled up by various factors

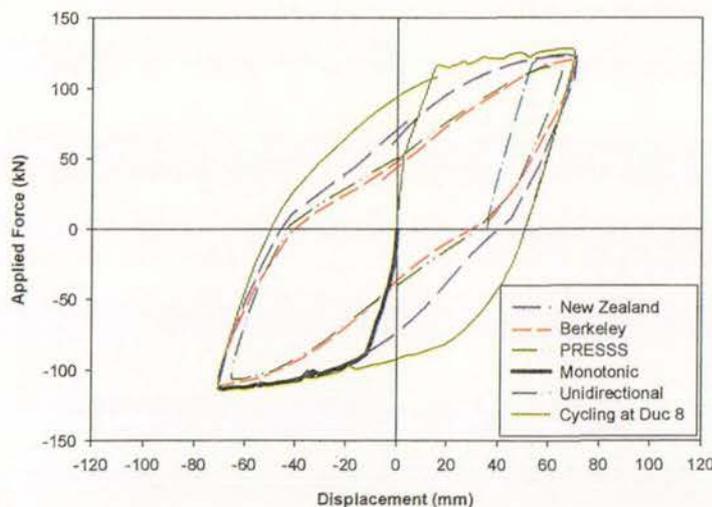
Figure 7-15 Comparison after Loading to Ductility 8

Response from testing using the Berkeley and PRESSS loading histories showed similar amounts of pinching. This observation was unusual given that the ultimate displacement established from testing using the PRESSS loading history was lower than the ultimate displacement established from applying the Berkeley loading history. This was attributed to rocking deformations accounting for a much larger percentage of the total vertical displacement in the test that applied the Berkeley loading history compared to the test that applied the PRESSS loading history, as illustrated in Figure C-10 and Figure C-17 in Appendix C. This accounted for the increased pinching in the hysteresis loops from testing using the Berkeley loading history because rocking deformations were elastic and hence dissipated low amounts

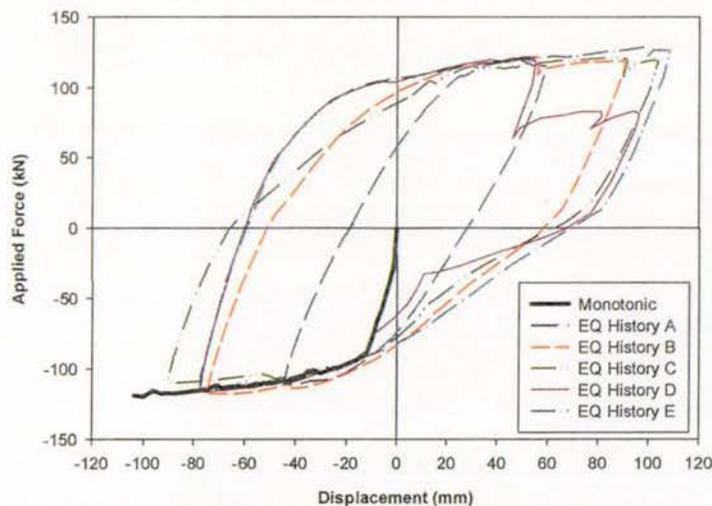
Figure 7-16 Comparison of Acceleration Histories' Envelope with Monotonic Response

The influence of the largest displacement cycles' position in the displacement sequence on the shape of the hysteresis loops was illustrated after the largest displacement in the negative direction had been applied. The maximum negative displacement for acceleration histories D and E was at the beginning of the first earthquake record whereas the maximum negative displacement for acceleration histories B and C was during the second and third earthquake records respectively. This was reflected in the greater amount of pinching in the hysteresis loops for acceleration histories B and C because of the degradation that had occurred prior to the application of the maximum displacements in the negative direction. The amount of pinching in the hysteresis loops after application of the maximum displacement in the positive direction was comparable for each acceleration history because these displacements were always applied near the conclusion of the test. However, even though variations in hysteresis behaviour occurred, comparable degradation at the

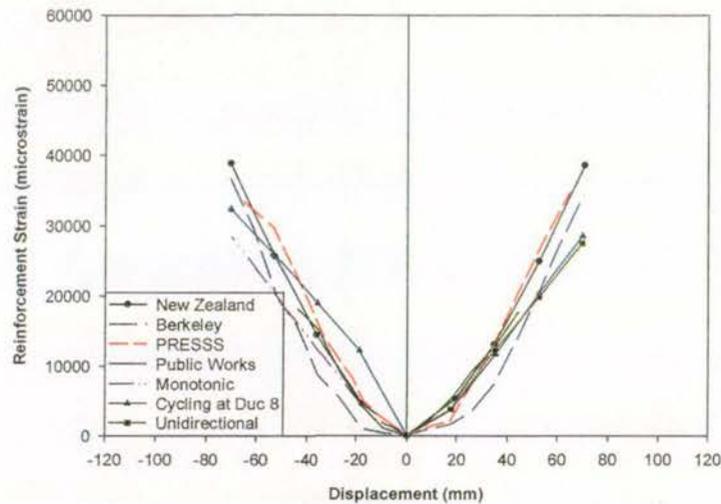
Figure 7-19 Comparison of Reinforcement Strain Envelopes for Laboratory Procedures

Figure 7-19 presents the reinforcement strain envelopes from the seven laboratory procedures for loading up to and including ductility 8, when the instrumentation devices were removed. At ductility 8 and in the positive direction, the values range from 38600 microstrain from testing using the New Zealand loading history to 27600 microstrain under unidirectional loading. At ductility 8 in the negative direction, the values range from 38900 microstrain from testing that applied the New Zealand

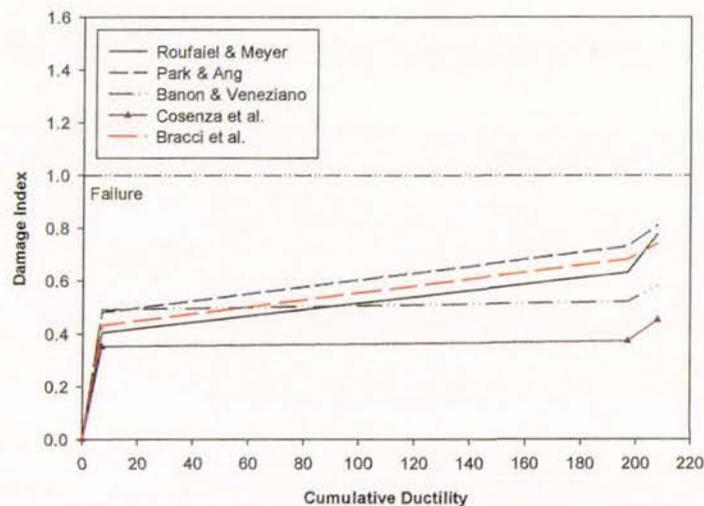
Figure 7-31 Damage Indices (Acceleration History D)

Figure 7-31 details the damage indices calculated from testing using acceleration history D. Figure 7-31 reveals that none of the five damage indices classified the test specimen as reaching its collapse stage. However, this was largely due to the premature rupture of a longitudinal bar. This led to significant strength reduction and a corresponding loss of energy absorbed, which reduced the values calculated by the

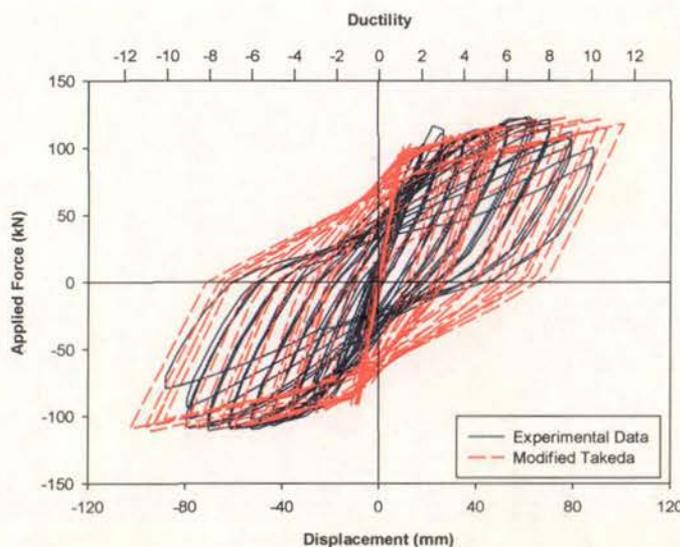
Figure B-1 Comparison of Experimental Data and Modified Takeda Model  
(Berkeley Loading History)

However, it would be necessary to investigate the influence of the model parameters reported on in Section 5.1.4 for future studies where different loading histories may be modelled. Therefore, the Berkeley loading history was applied to the model detailed in Section 5.1.4. Figure B-1 presents the comparison of the experimental data and the predicted response using the Modified Takeda hysteresis rule. Figure B-1 does not reveal the excellent agreement between the experimental response and the predicted response observed in Figure 5-4, with the model not distinguishing between the three cycles at each ductility level. The ultimate displacement of the test subassembly was predicted accurately. However, this was due to the ultimate displacement from testing using the Berkeley loading history being identical to that established from testing using the New Zealand loading history.

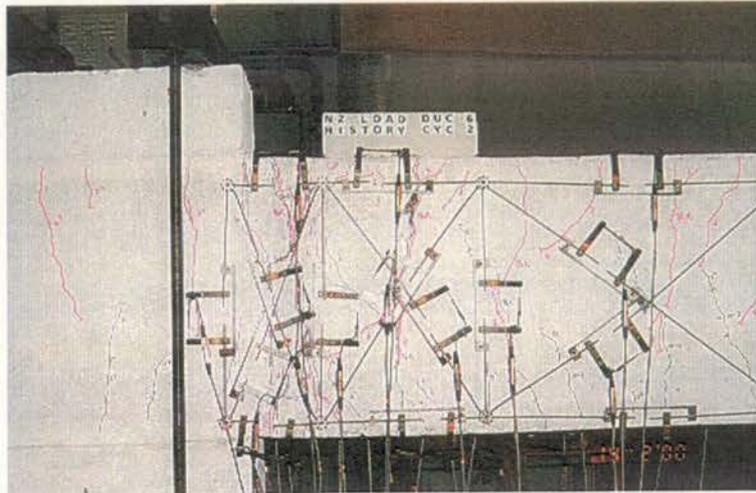
Figure C-1 Test Subassembly Condition at Ductility 6 (Cycle 2)

A small amount of additional cracking was identified after the first positive cycle to ductility 8. Further spalling of the cover concrete was also observed. Localised

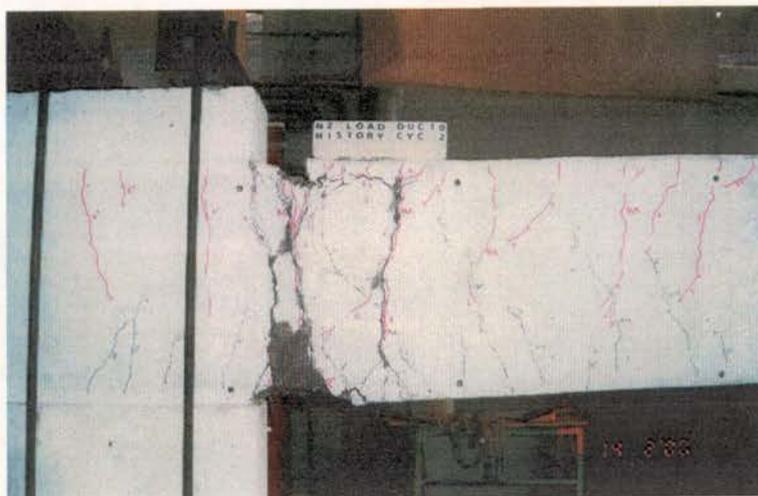
Figure C-2 Test Subassembly Condition at Ductility 10 (Cycle 2)

Further spalling of cover concrete occurred while the beam was being loaded to ductility 10. Figure C-2 illustrates the total amount of spalling that occurred up to and including loading to ductility 10. A longitudinal bar ruptured next to an instrumentation stud during the second positive cycle. This caused the maximum

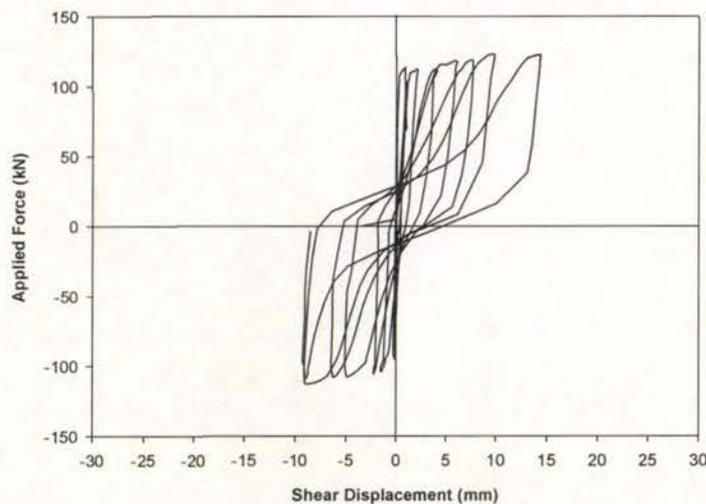
Figure C-4(b) Shear Displacement Component

4(a) reveals that the flexural deformations were symmetrical and their hysteresis shape followed conventional behaviour. Figure C-4(b) details the shear deformations for the same loading stages. As with the flexural deformations, the shear deformations were symmetrical and followed conventional behaviour. Figure C-4(c) presents the rocking deformation for the aforementioned period. Figure C-4(c) reveals that, as expected, the rocking deformations were elastic. However, the rocking deformations from testing using the New Zealand loading history were offset in the negative direction. This was due to crushing of the mortar base between the beam and its base occurring during negative cycles.

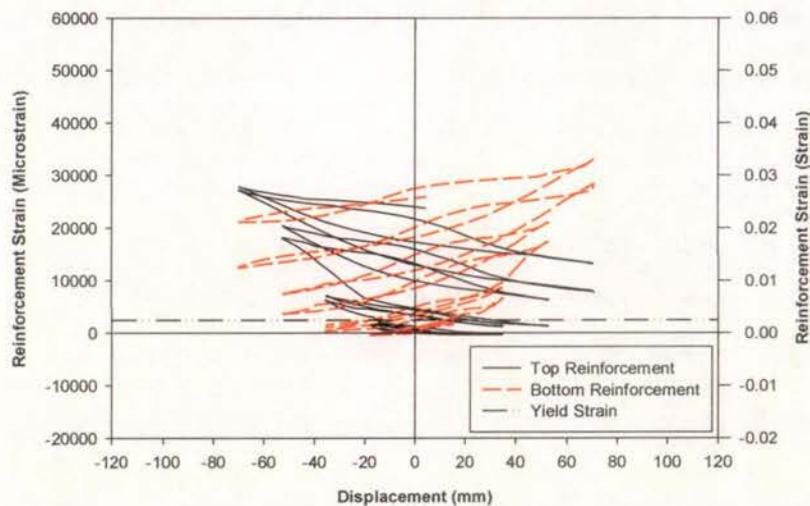
Figure C-7(b) Reinforcement Strains (Panel 2)

It has been observed in previous experimental studies on reinforced concrete frame members that the member's depth increases during testing. However the change in beam depth during the test was not included in this experimental study. It was established in Section 5.1.3 that the length of the plastic hinge zone was 430mm.

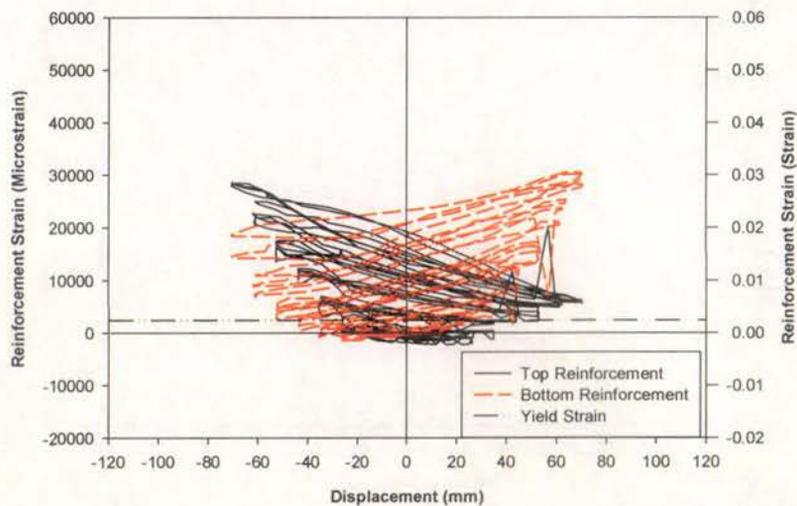
Figure C-14(b) Reinforcement Strains (Panel 2)

The response of the top and bottom reinforcement was symmetrical. Figure C-14(a) and Figure C-14(b) illustrate that the cracks did not close under reversal of load from ductility 3 in the first instrumentation panel and ductility 4 in the second instrumentation panel. This is similar to the results from testing using the New Zealand loading history. Figure C-14(c) demonstrates that yielding did not occur in the third instrumentation panel.

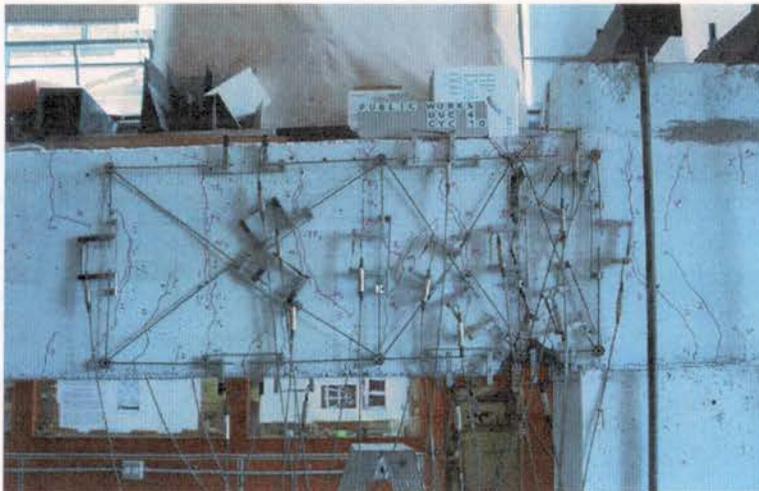
Figure C-23 Test Subassembly Condition at Ductility 4 (Cycle 10)

Figure C-23 shows that significant spalling had occurred by the tenth cycle at ductility 4. Removal of several large pieces of concrete from the bottom of the beam meant that the longitudinal reinforcement was visible for a distance of approximately 200mm. Spalling along cracks in the plastic hinge zone continued to occur. Pinching

was observed in the force-displacement response.

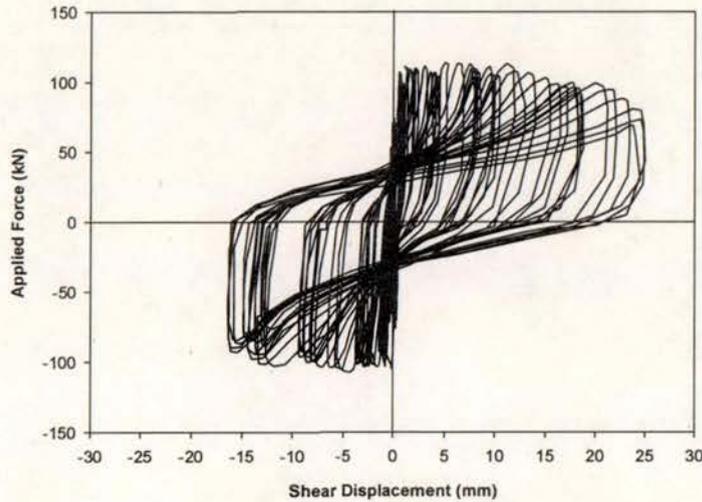
Figure C-25(b) Shear Displacement Component

symmetrical although the hysteresis behaviour did exhibit conventional behaviour.
