THE UNIVERSITY OF AUCKLAND
NEW ZEALAND

Department of
Civil and
Environmental
Engineering

**SHEAR STRENGTH OF CONCRETE
MASONRY WALLS**

School of Engineering
Report No. 611

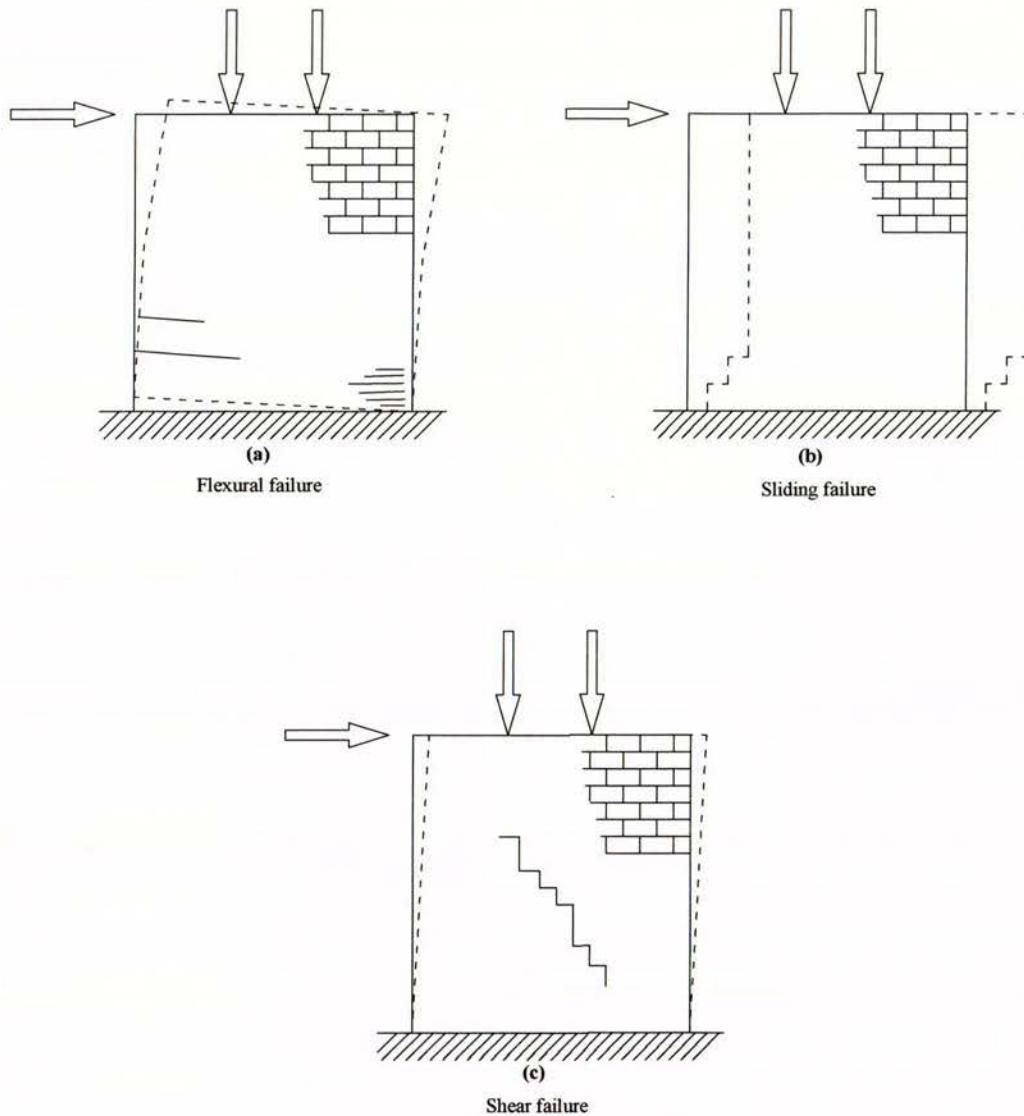
Figure 2.2 Reinforced masonry shear wall failure modes.

Shear walls are required to resist horizontal loads, often termed as ‘racking loads’. Excluding premature lap-splice or bond failure of reinforcement, a shear wall subject to horizontal loads may fail in one of three ways: by sliding horizontally, in flexure, or in shear (Park, 1986). The mode of failure will be influenced by many factors such as wall aspect ratios, axial compression stress levels, wall boundary conditions and the strength properties of the materials used in wall construction. These types of failure are shown diagrammatically in Figure 2.2. Therefore the name ‘shear wall’ may not be particularly representative since the dominant mode of failure of a shear wall may be other than shear.

This type of failure occurs due to yielding of the vertical reinforcement near the wall heel or crushing of the masonry at the wall toe when the wall behaves as a vertical cantilever. Generally this is the preferred mode, as failure is ductile and effectively dissipates energy in conjunction with reinforcement yielding.

Sliding shear is the movement of entire parts of the wall on the base or other mortar bed, and is resisted by dowel action of the vertical reinforcement anchored in the base and by friction on the mortar bed (Priestley, 1976). This type of failure may become significant in any situation where there is a low friction coefficient, such as when using a friction breaker or water proof membrane, or when the wall is positioned on a smooth finished slab. This failure mode may create a problem particular in unreinforced masonry walls.

This type of failure is characterised by the initiation of visible diagonal cracking along the shear wall when the principal tensile stresses exceed the tensile strength of the masonry under increasing imposed lateral displacements. Depending on the amount and anchorage of horizontal reinforcement, two types of shear failure are possible: a “ductile shear failure” and a “brittle shear failure” (Sveinsson et al., 1985).

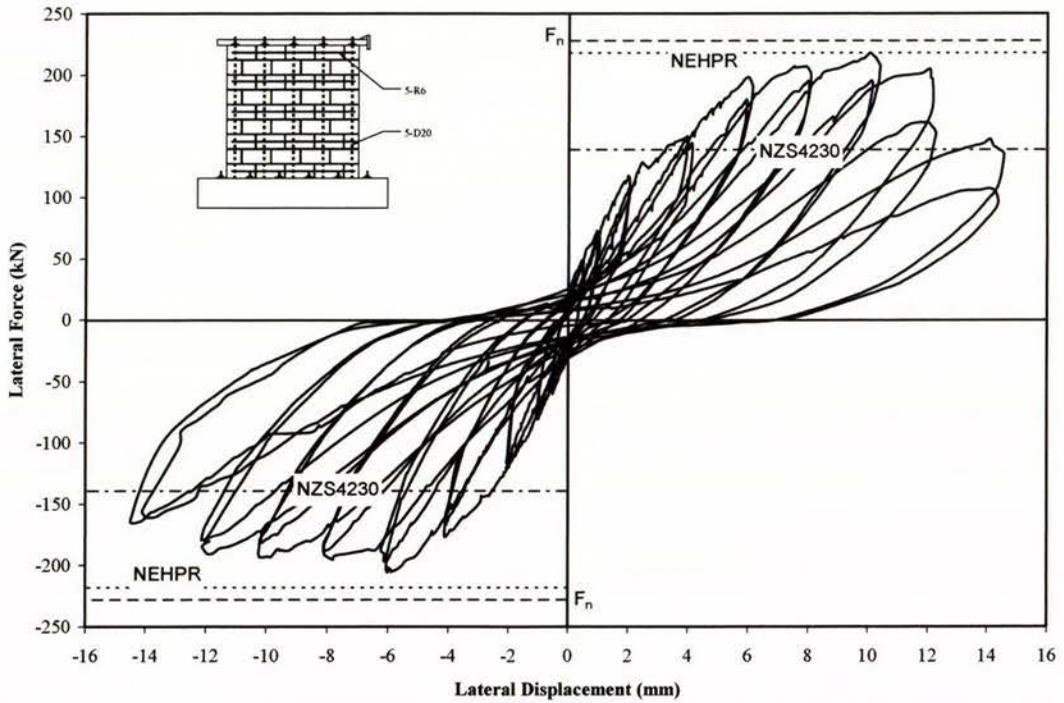
Figure 4.1 Force-displacement history for Wall 1.

An initial wall stiffness of 108 kN/mm was calculated from the peak strength measured during the cycle to ± 0.5 mm displacement. The wall stiffness dropped significantly to 22 kN/mm when maximum push direction strength developed at +10 mm displacement.

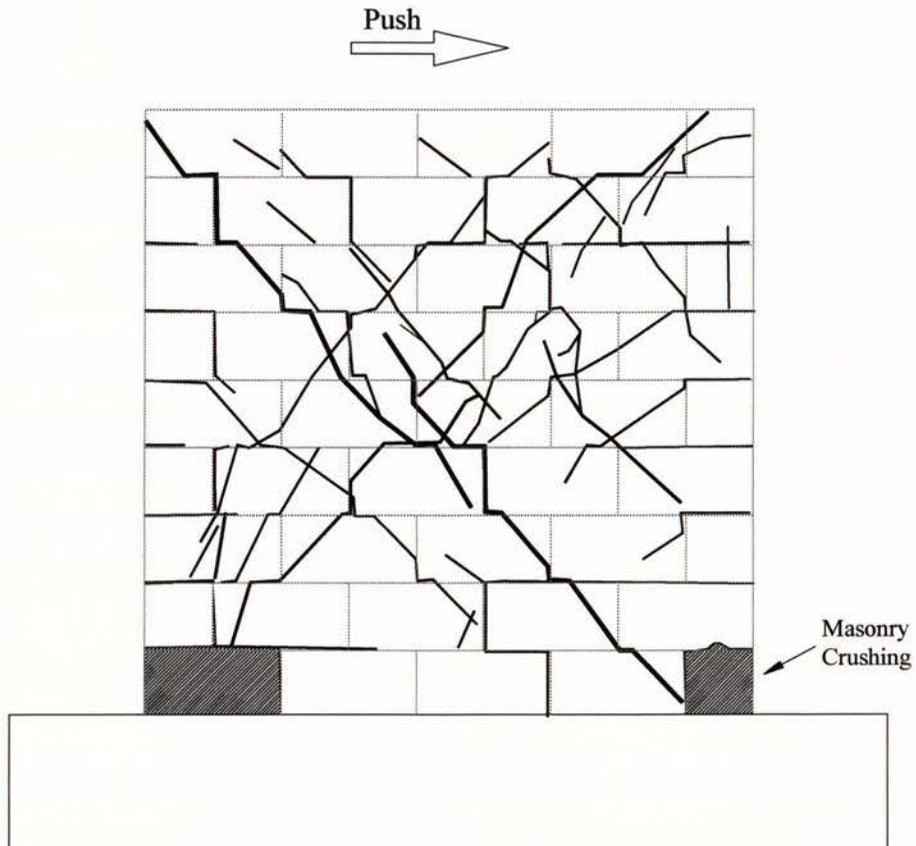
Figure 4.2 Wall 1 cracking pattern at end of testing.

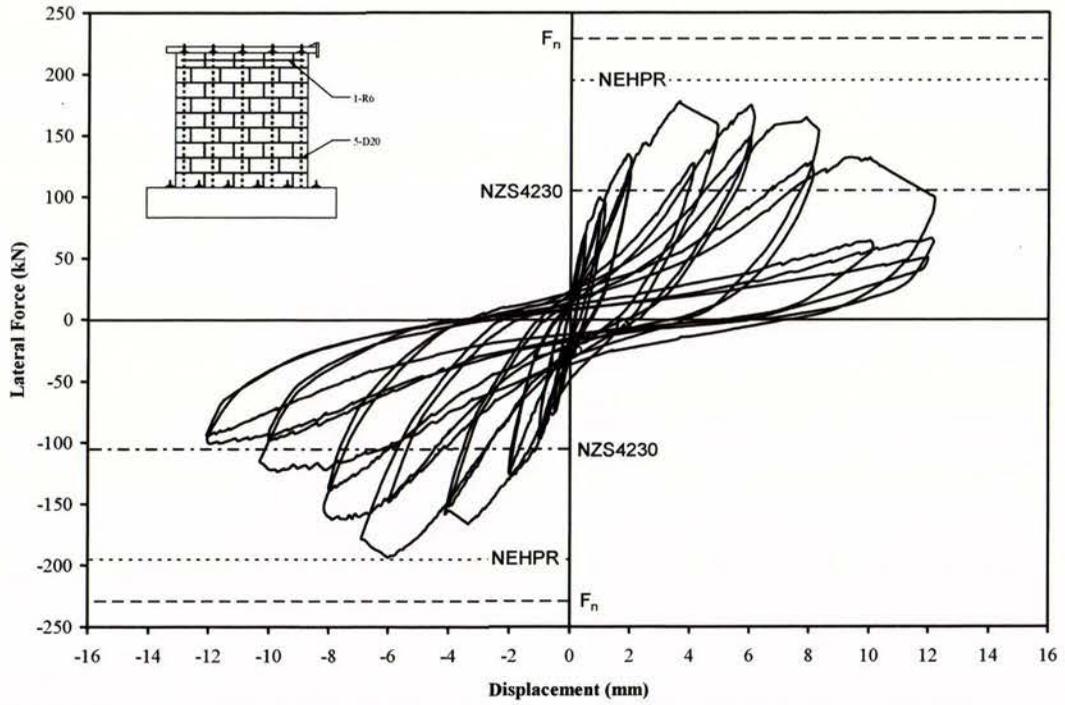
Figure 4.3 Force-displacement history for Wall 2.

An initial wall stiffness of 144 kN/mm was calculated from the peak strength measured during the cycle to ± 0.5 mm displacement. The wall stiffness dropped to 30 kN/mm when maximum wall strength developed during the first cycle to ± 6 mm displacement.

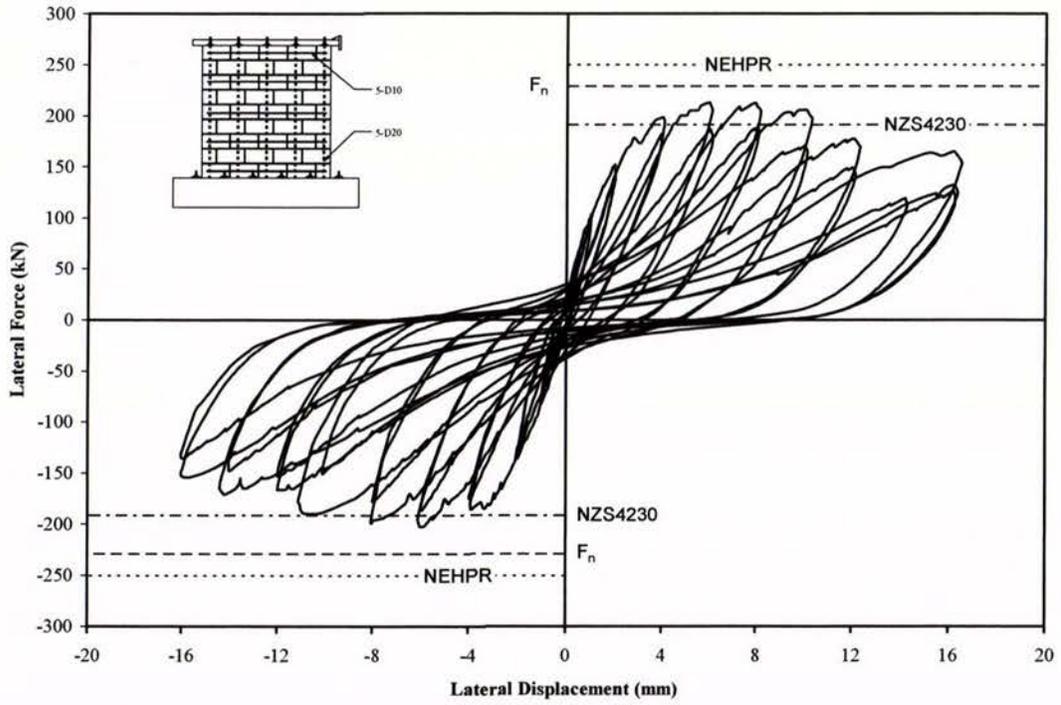
Figure 4.5 Force-displacement history for Wall 3.

An initial wall stiffness of 114 kN/mm was calculated from the peak strength measured during the cycle to ± 0.5 mm displacement. The wall stiffness dropped significantly to 34 kN/mm when the maximum strength developed at -6 mm displacement.

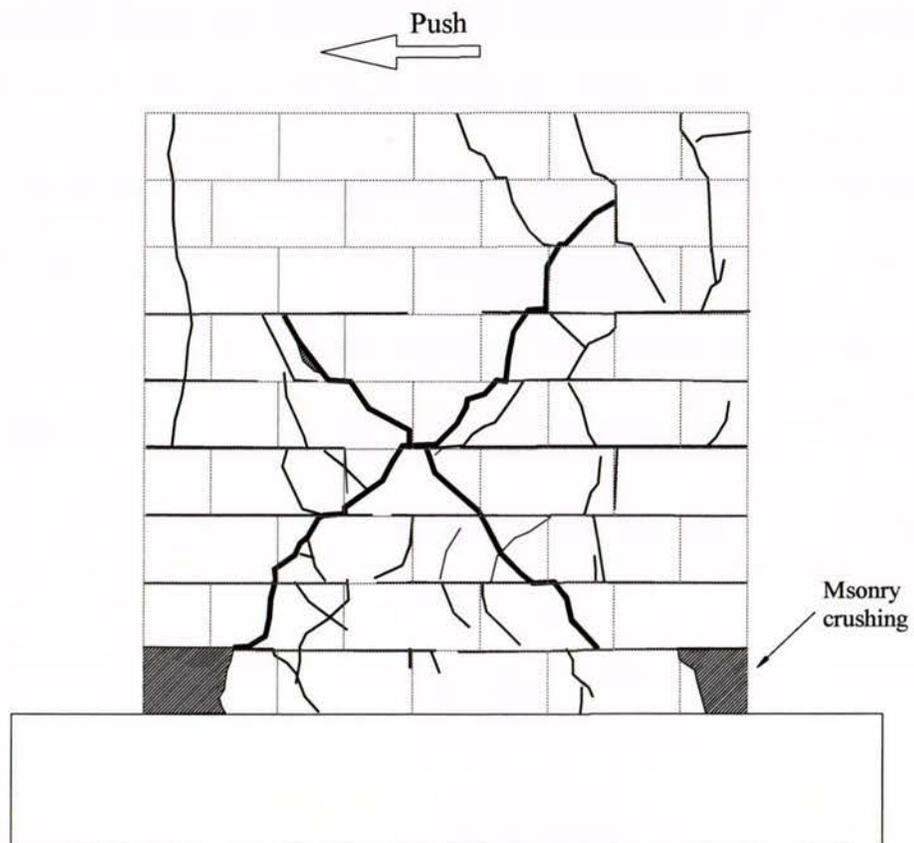
Figure 4.6 Wall 3 cracking pattern at end of testing.

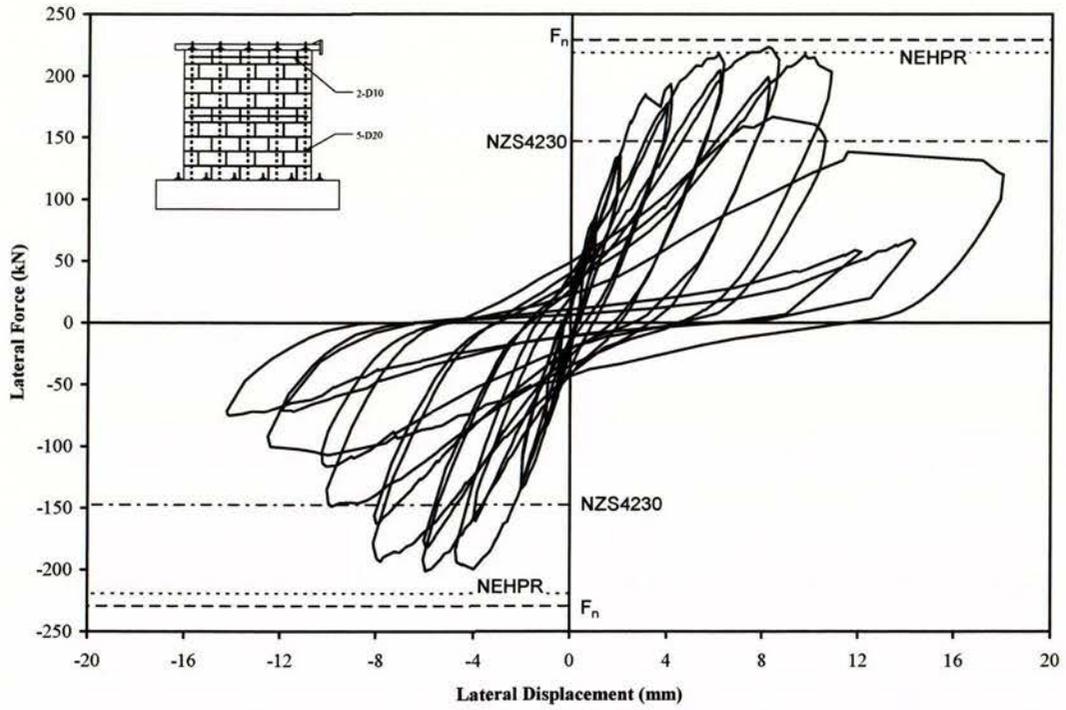
Figure 4.7 Force-displacement history for Wall 4.

An initial wall stiffness of 111 kN/mm was calculated from the peak strength measured during the first cycle to ± 0.5 mm displacement. The wall stiffness dropped to 34 kN/mm when maximum strength developed during the cycle to -6 mm displacement.

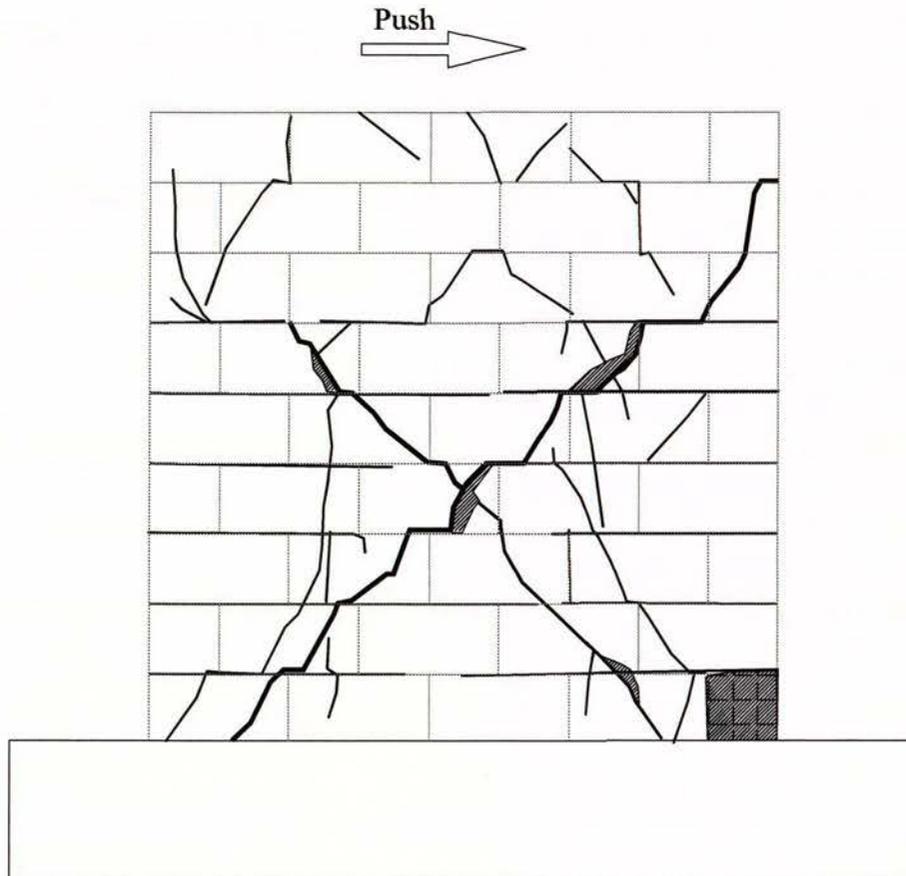
Figure 4.8 Wall 4 cracking pattern at end of testing.

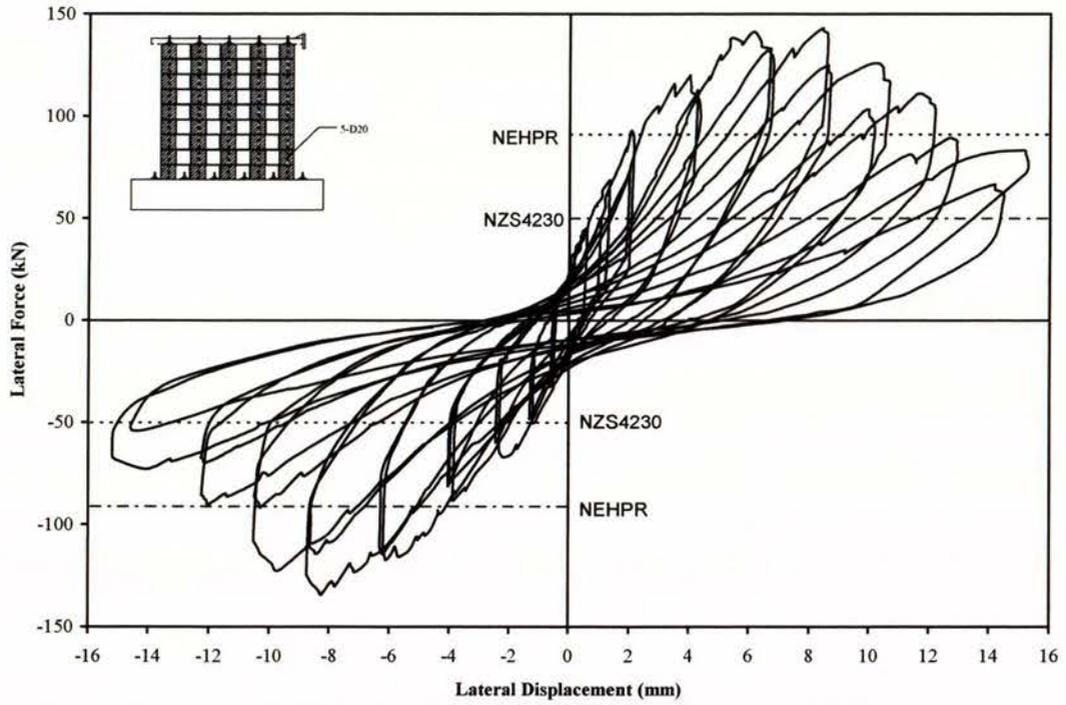
Figure 4.9 Force-displacement history for Wall 5 ($F_n = 229$ kN).

The yield displacement for this partially grouted wall was evaluated to be 4.68 mm. The wall was defined as failing during the second push cycle to 10 mm displacement. A wall stiffness of 74 kN/mm was calculated during the first cycle to +0.5 mm displacement. The stiffness dropped significantly to 17 kN/mm when the wall developed its maximum strength during the first push cycle to +8 mm displacement.

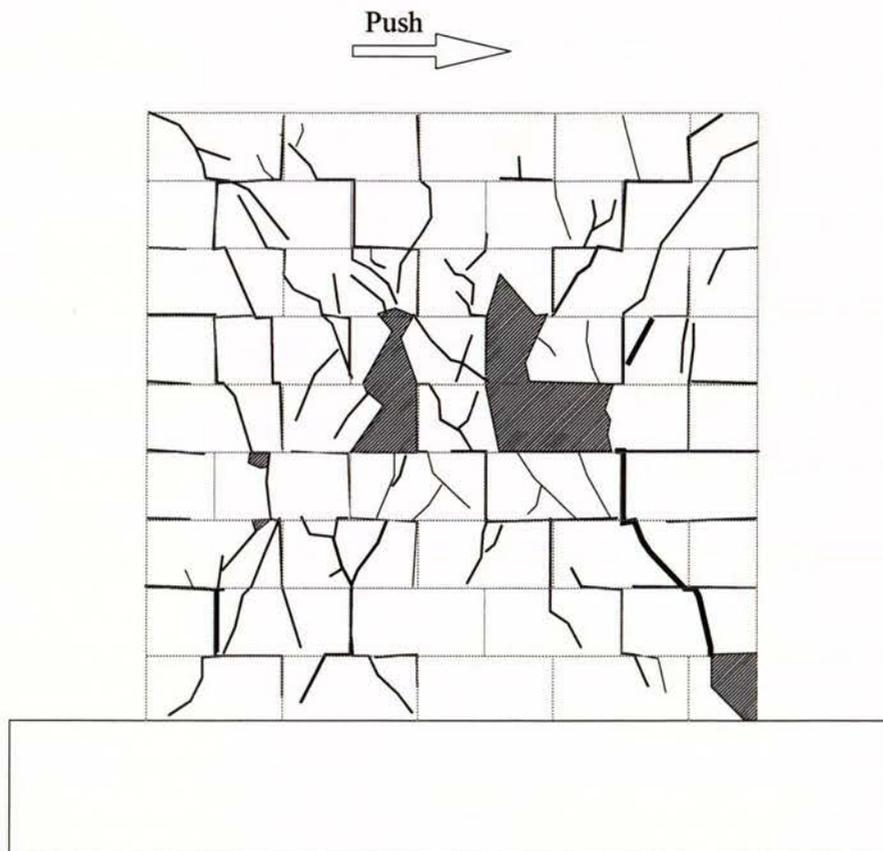
Figure 4.10 Wall 5 cracking pattern at end of testing.

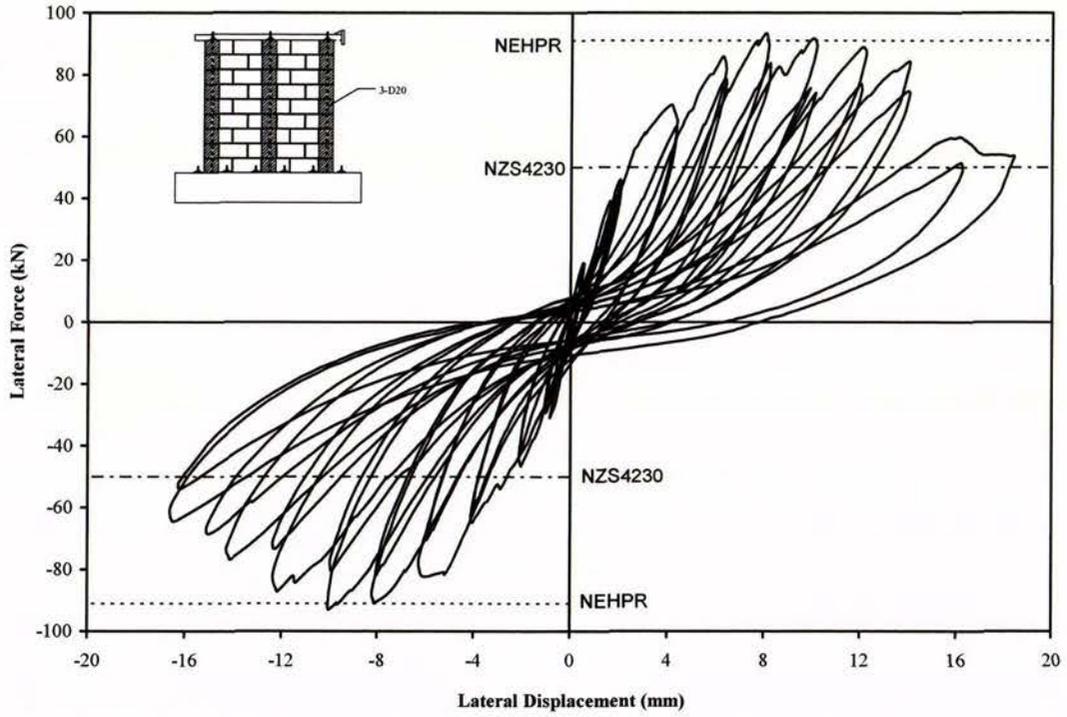
Figure 4.11 Force-displacement history for Wall 6 ($F_n = 142$ kN).

A wall stiffness of 35 kN/mm was calculated during the first cycle to ± 0.5 mm displacement. However, the stiffness dropped to 11 kN/mm when the wall developed its maximum strength in the first push cycle to +8 mm displacement.

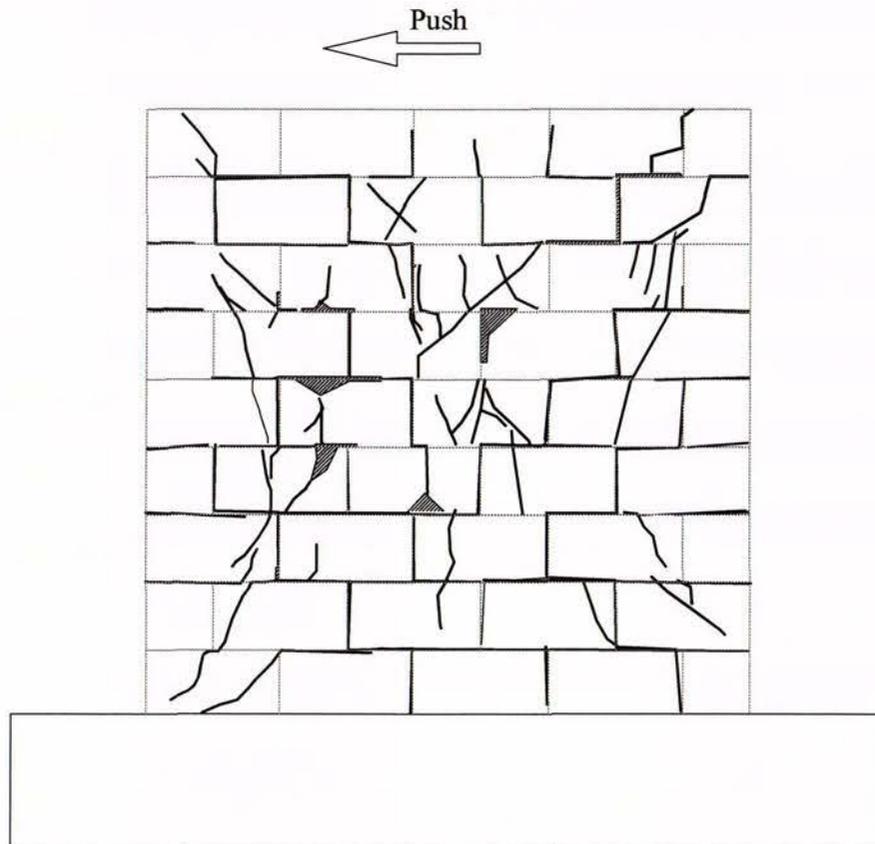
Figure 4.12 Wall 6 cracking pattern at end of testing.

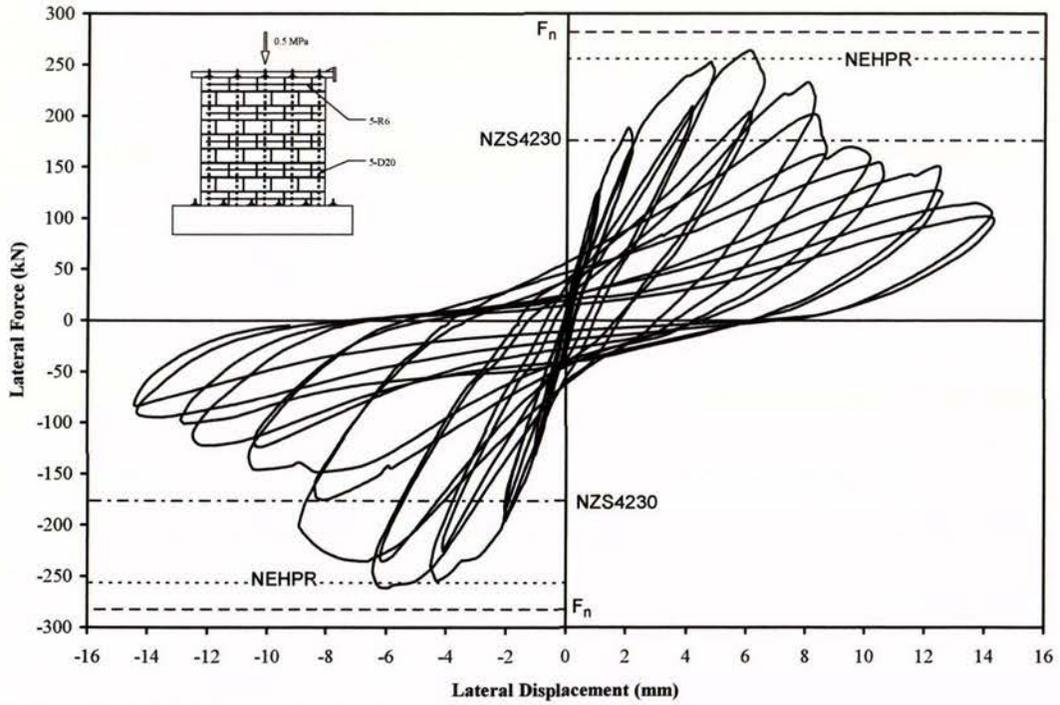
Figure 4.13 Force-displacement history for Wall 7.

The yield displacement of Wall 7 was evaluated to be 2.20 mm. The wall was defined as failing during the second cycle to +8 mm displacement. A wall stiffness of 147 kN/mm was calculated at the first cycle to ± 0.5 mm displacement. The stiffness dropped to 43 kN/mm when maximum strength developed in the first cycle to ± 6 mm displacement.

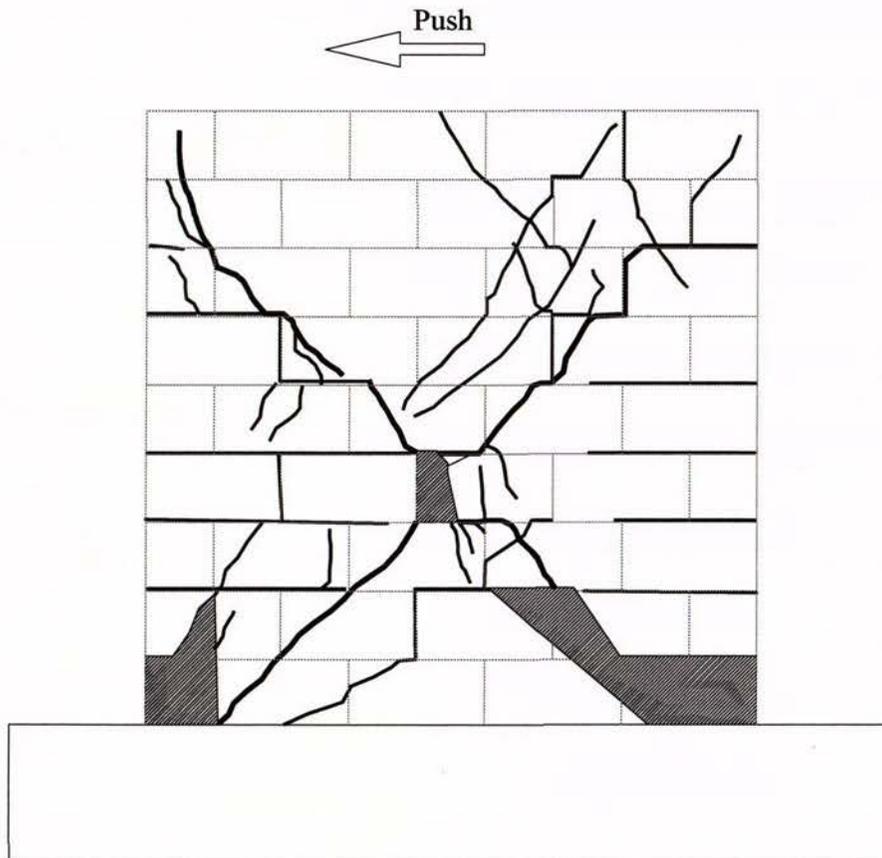
Figure 4.14 Wall 7 cracking pattern at end of testing.

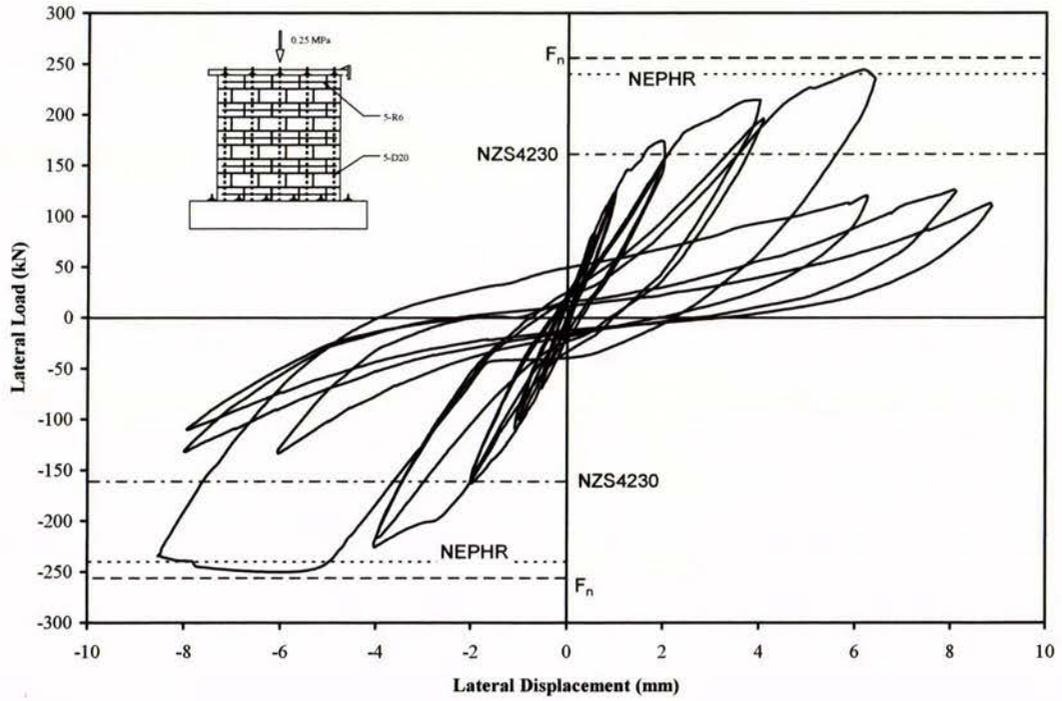
Figure 4.15 Force-displacement history for Wall 8.

A wall stiffness of 138 kN/mm was calculated during the first cycle to ± 0.5 mm displacement. The stiffness dropped to 40 kN/mm when maximum strength developed during the first cycle to ± 6 mm displacement.

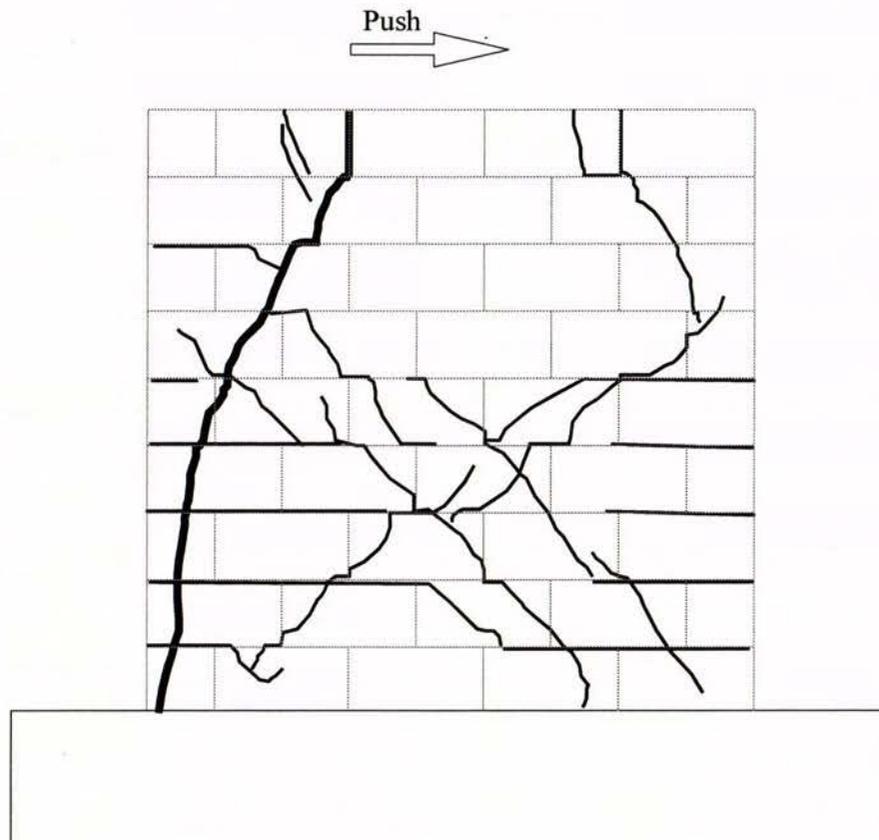
Figure 4.16 Wall 8 cracking pattern at end of testing.

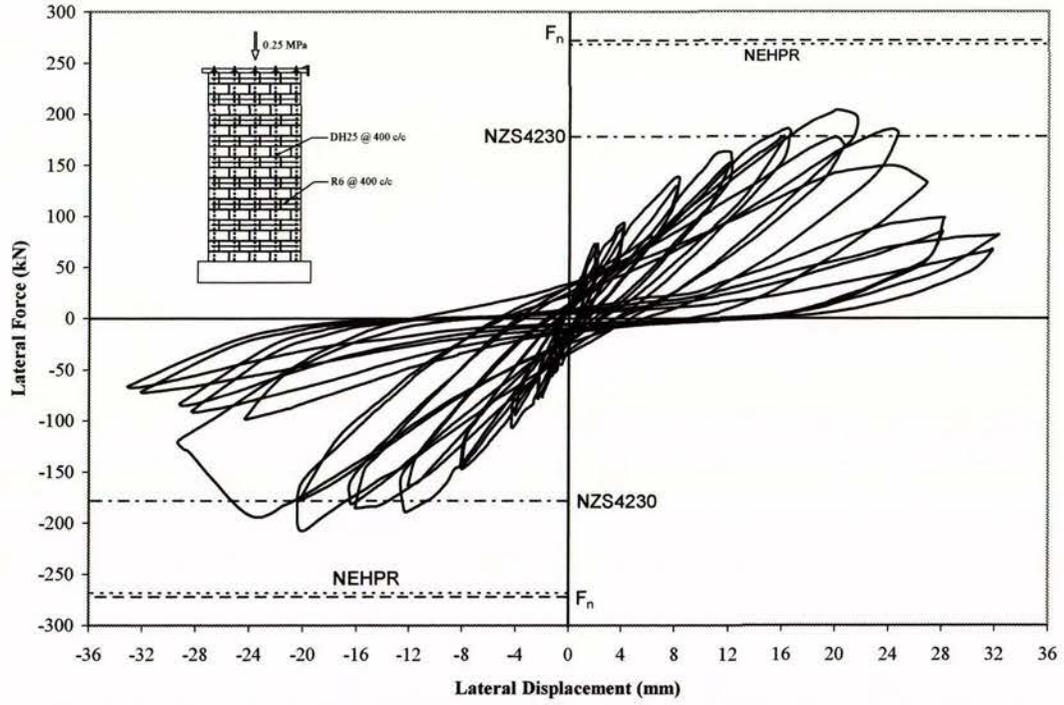
Figure 4.17 Force-displacement history for Wall 9.

The yield displacement for Wall 9 was evaluated to be 7.0 mm. The wall was defined as failing during the first cycle to -24 mm displacement. A wall stiffness of 43 kN/mm was calculated during the first cycle to ± 1.0 mm displacement. The wall stiffness dropped to 10 kN/mm when maximum wall strength developed at ± 20 mm displacement.

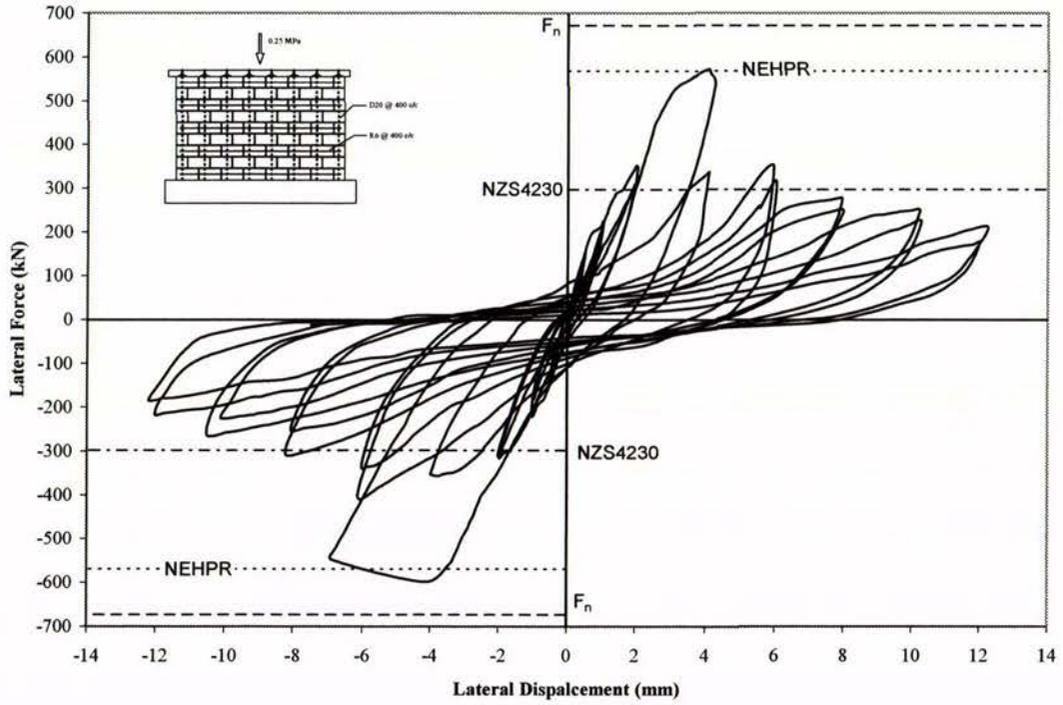
Figure 4.19 Force-displacement history for Wall 10.

The yield displacement of Wall 10 was evaluated to be 3.0 mm. The wall was defined as failing during the second push cycle to +4 mm displacement. A wall stiffness of 283 kN/mm was calculated when the wall was loaded to ± 0.5 mm displacement. The wall stiffness dropped to 142 kN/mm when maximum strength developed during the first cycle to ± 4 mm displacement

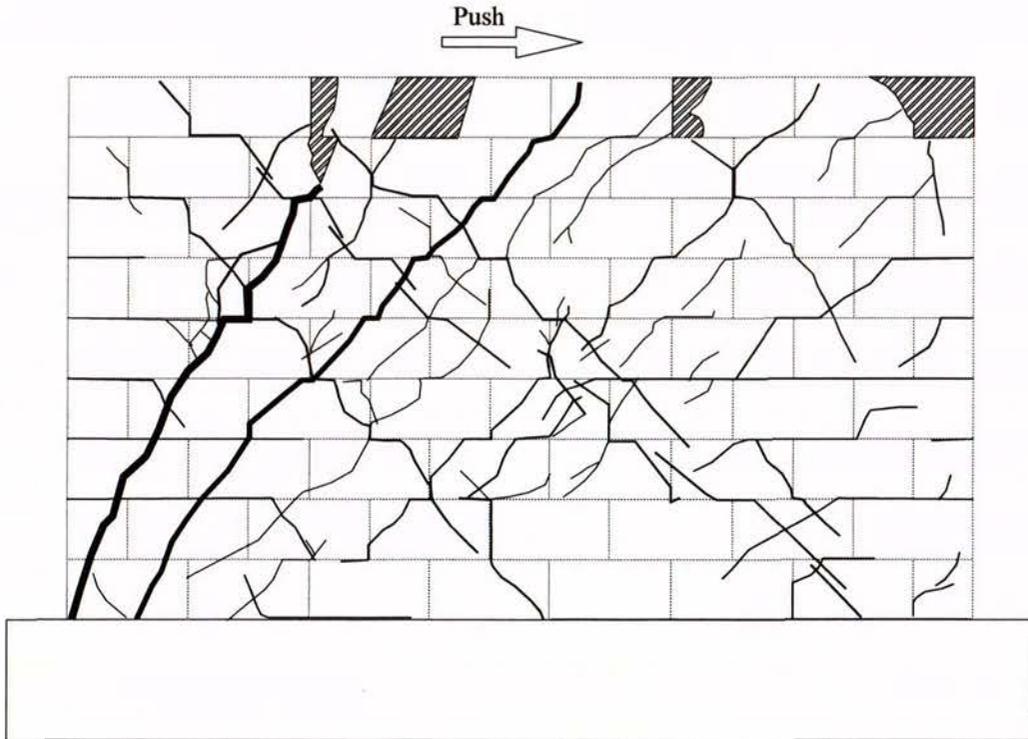
Figure 4.20 Wall 10 cracking pattern at end of testing.

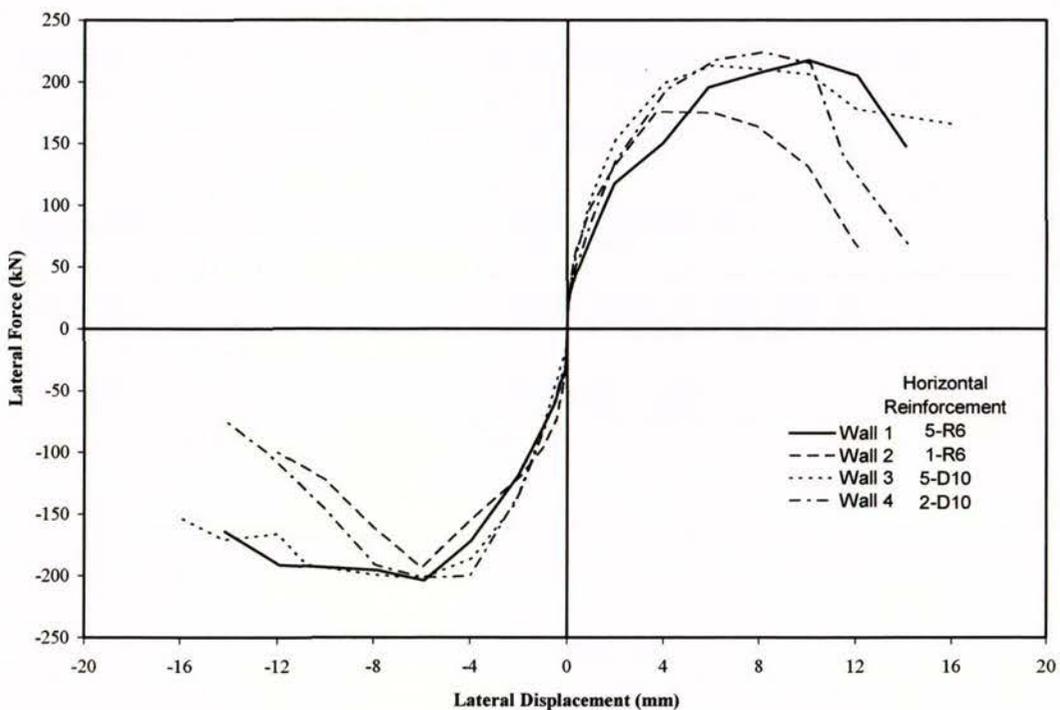
Figure 5.1 Effect of horizontal reinforcement on masonry shear strength.

In this study both the amount and distribution of horizontal reinforcing bars was varied throughout the height of the wall. The general comment that can be made is that a change in the amount of horizontal reinforcement resulted in relatively little change in the maximum shear strength of the wall. This is illustrated in Figure 5.1, which shows the force-displacement envelopes for all fully grouted walls that had the same dimension and vertical reinforcement, but with varying horizontal reinforcement and no applied axial compression stress. The maximum shear strength increased from about 186 kN (average for push and pull) for Wall 2 to 210 kN for Wall 1 when the horizontal reinforcement increased from 1-R6 to 5-R6, resulted in a strength increase of about 12%. However, this increase in the maximum

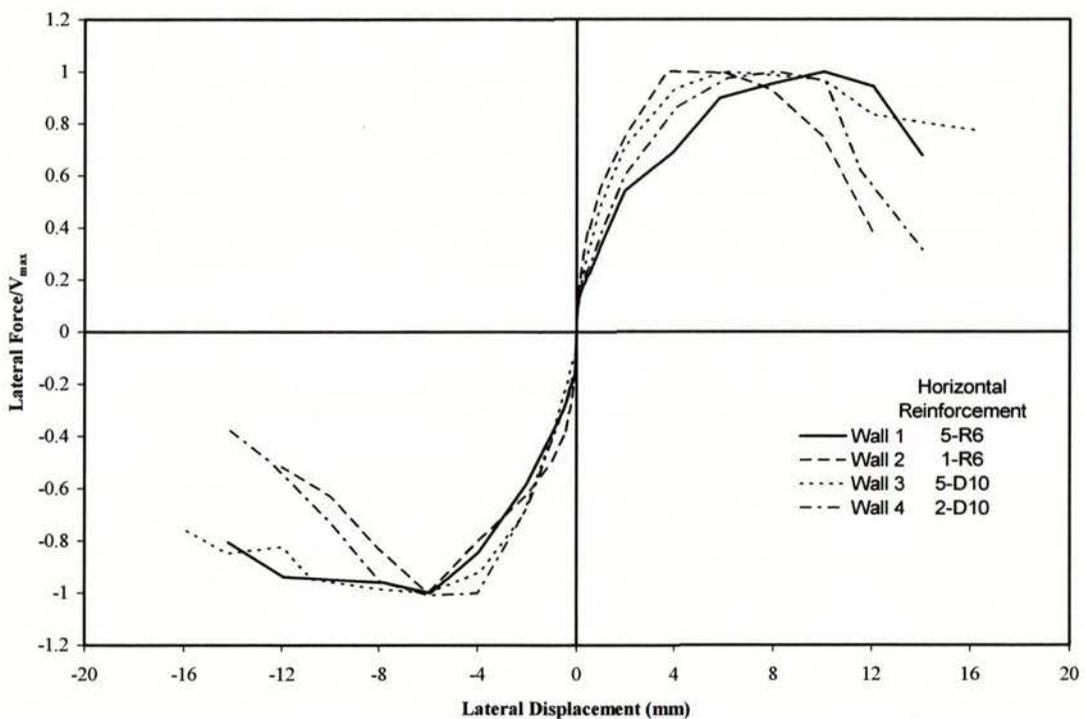
Figure 5.2 Force-displacement envelopes normalised with V_{max} .

Figure 5.2 shows the effectiveness of horizontal reinforcement in enhancing the post cracking performance of the walls. It can be seen that the form of the F-D envelopes improved when the amount of horizontal reinforcement increased from 1-R6 to 5-R6 reinforcing bars for the case of Walls 2 and 1, and when the horizontal reinforcement increased from 2-D10 to 5-D10 reinforcing bars for the case of Walls 4 and 3. However, the advantage of distributing horizontal reinforcement (using a larger number of reinforcing bars of smaller diameter) throughout the height of the wall can be undoubtedly observed from the F-D envelopes of Walls 1 and 4. The two walls contained approximately the same total cross-sectional area of shear reinforcement, but the shear reinforcement was distributed differently according to Figure 3.5. As shown in Figure 5.2, Wall 4 exhibited abrupt strength degradation after the peak wall strength was attained, whereas Wall 1 exhibited much more gradual strength degradation. This type of failure was made possible for Wall 1 due to the adoption of 400 mm

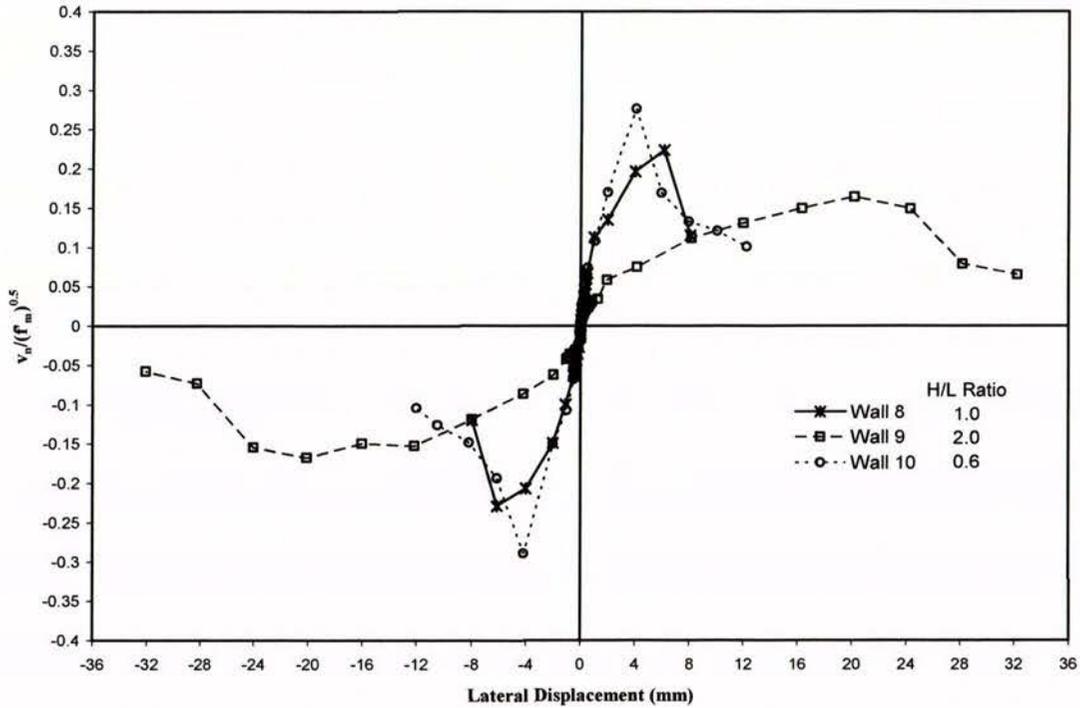
Figure 5.7 The relationship of $v_n/\sqrt{f'_m}$ vs H/L ratio.

observed in Figure 5.6 is evident. Consequently, it is concluded that H/L has an inverse effect on $v_n/\sqrt{f'_m}$ since the figure shows that $v_n/\sqrt{f'_m}$ decreases when the H/L ratio is increased.

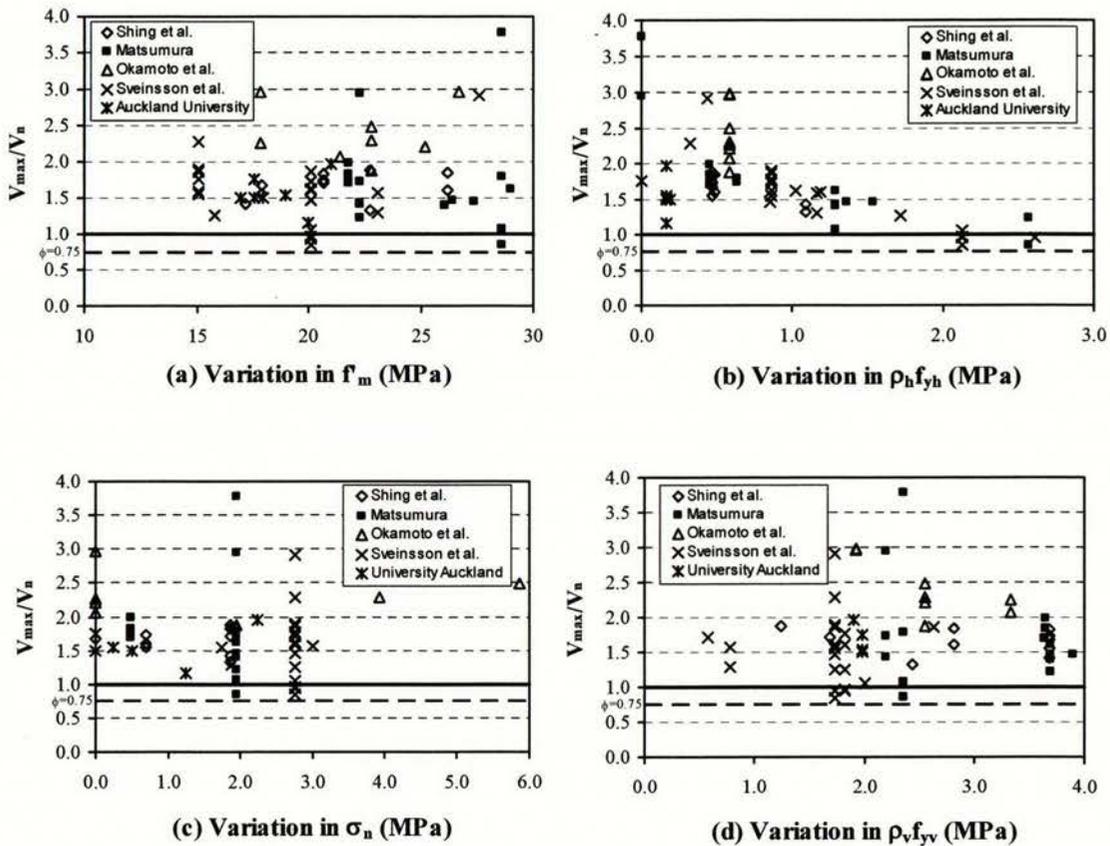
Figure 6.4 Experimental results versus prediction by NZS4230:1990.

Figure 6.4 presents masonry shear prediction using NZS4230:1990. It shows that the NZS4230:1990 approach for masonry shear strength does not provide a particularly good estimate. The figure shows v_{max}/v_n varies from 0.84 to 3.78, with an average v_{max}/v_n of 1.72. The normalised plots show that NZS4230:1990 over-predicts the shear strength of 5 specimens (about 8% of total), but under-predicts the shear strength of 42 specimens by more than 50% of their actual strengths (i.e. $v_{max}/v_n \geq 1.50$). Scatter of results in Figure 6.4(b) demonstrates the tendency of Equation 2-28 to under-predict the contribution of shear

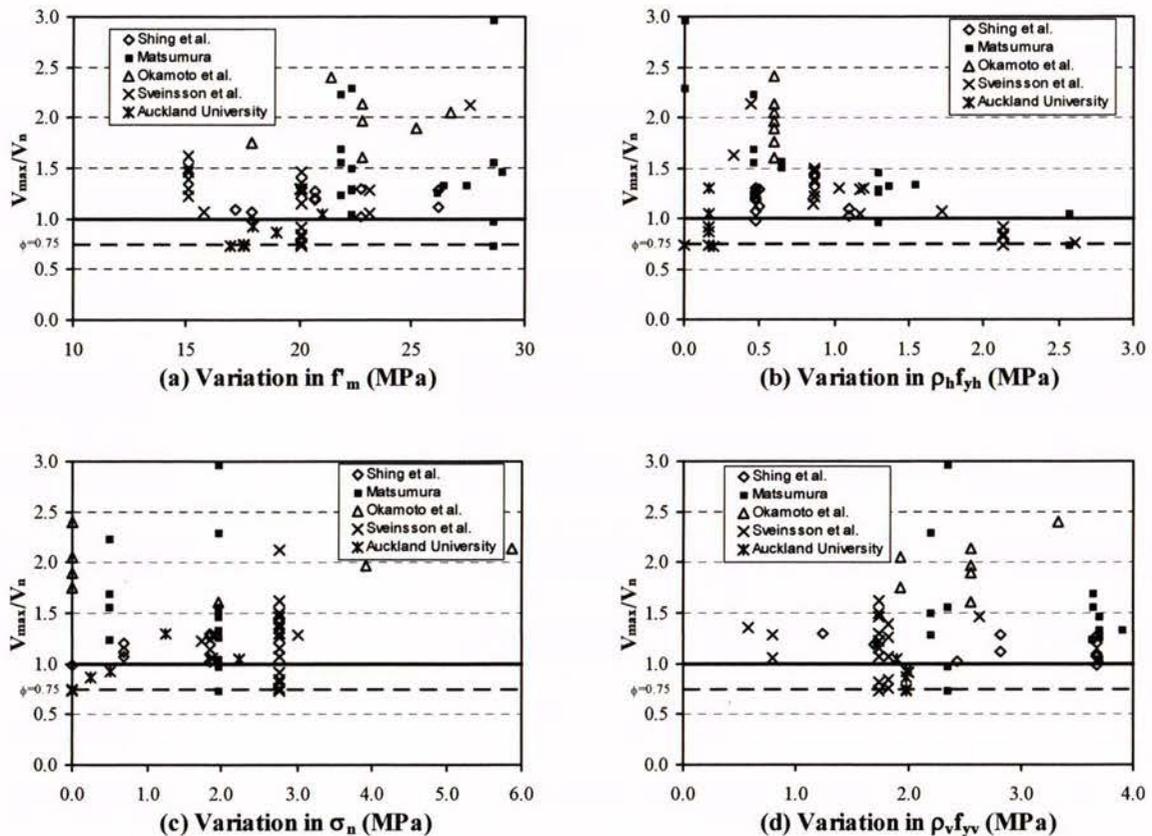
Figure 6.5 Experimental results versus prediction by AS3700.

The Australian masonry standard is unsuccessful in accurately predicting the masonry shear strength, as shown in Figure 6.5. The figure shows that v_{max}/v_n varies from 0.73 to 2.97. The AS3700 expression over-predicts the shear strength of 13 specimens (about 20% of total), of which 5 specimens have $v_{max}/v_n < 0.75$. When closely studying Figure 6.5(a), it is evident that v_{max}/v_n tends to increase with increasing f'_m . This is most likely to be caused by the absence of the f'_m term in Equation 2-26. In addition, the beneficial effect of vertical reinforcement and axial compressive load is not considered in AS3700, causing the scatter in Figures (c) and (d).

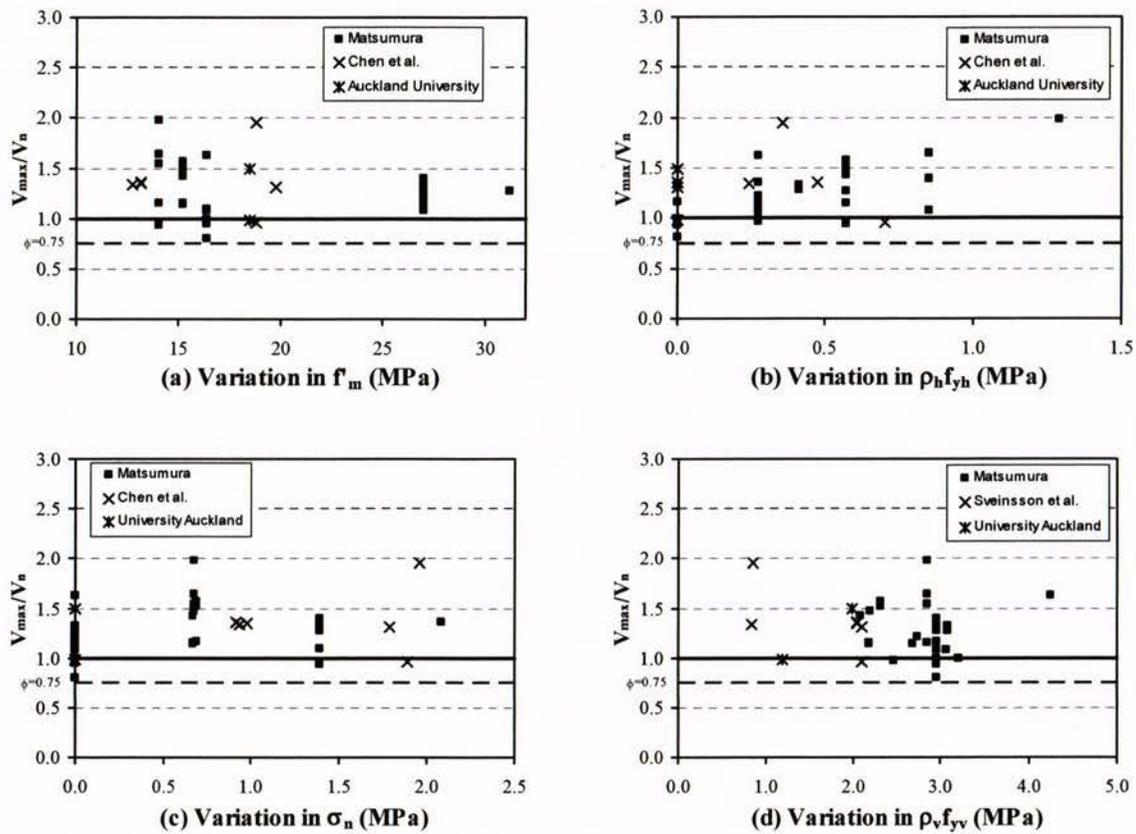
Figure 6.13 Experimental results versus prediction by NEHPR.

Despite the simple form of the formulation, NEHPR is capable of providing an improved shear strength prediction than either the New Zealand or the Australian masonry design standards. Figure 6.13 illustrates that v_{max}/v_n varies from 0.80 to 1.98, with a mean v_{max}/v_n of 1.28. The NEHPR expression under-predicts the shear strength of 29 specimens, of which 7 specimens have $v_{max}/v_n > 1.5$. The NEHPR expression over-predicts the shear strength of 7 partially grouted specimens, of which 1 specimen (3% of the total) has $v_{max}/v_n < 0.9$.
