THE UNIVERSITY OF AUCKLAND
NEW ZEALAND

Department of
Civil and
Environmental
Engineering

**SHEAR STRENGTH OF CONCRETE
MASONRY WALLS**

School of Engineering
Report No. 611

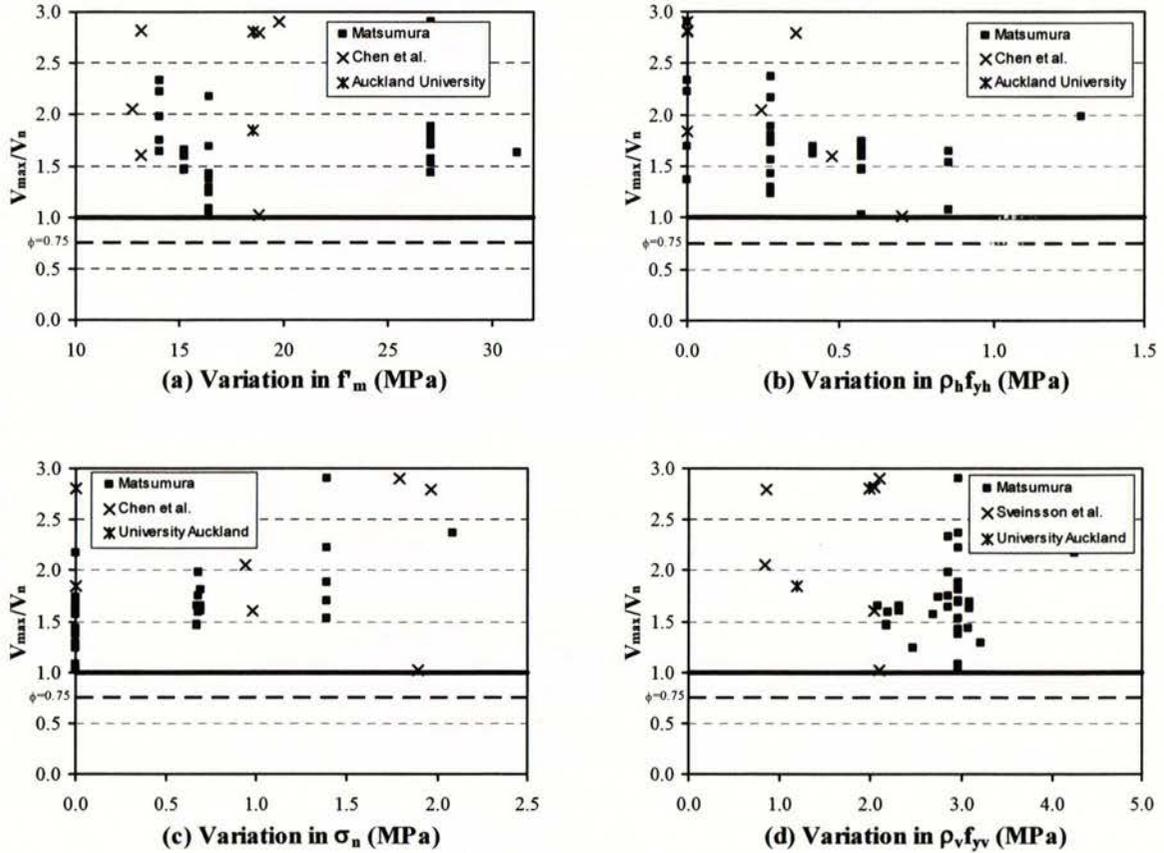
Figure 6.14 Experimental results versus prediction by UBC.

high values of $\rho_h f_{yh}$. The normalised plots show that v_{max}/v_n varies between 1.02 and 2.90, with 72% of the specimens having $v_{max}/v_n > 1.50$.

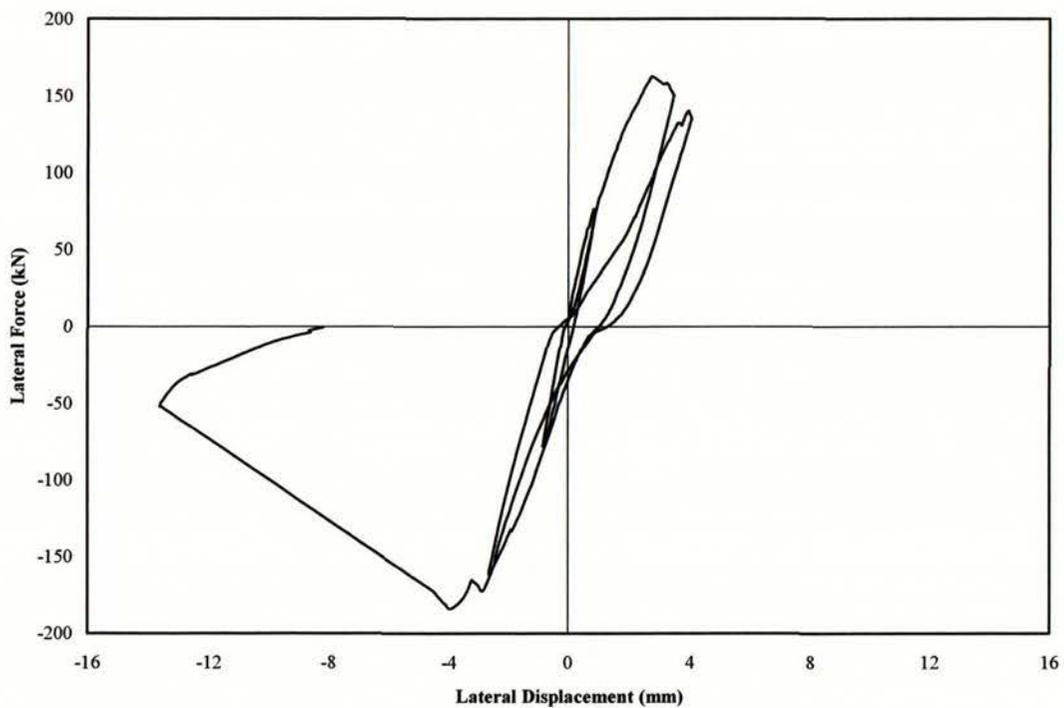
Figure A.4 Force-displacement behaviour for Wall A1.

The force-displacement (F-D) plot is presented in Figure A.4. As can be seen in the figure, abrupt strength degradation and significant increase in lateral displacement took place in the pull direction after significant damage occurred at the bond beam.

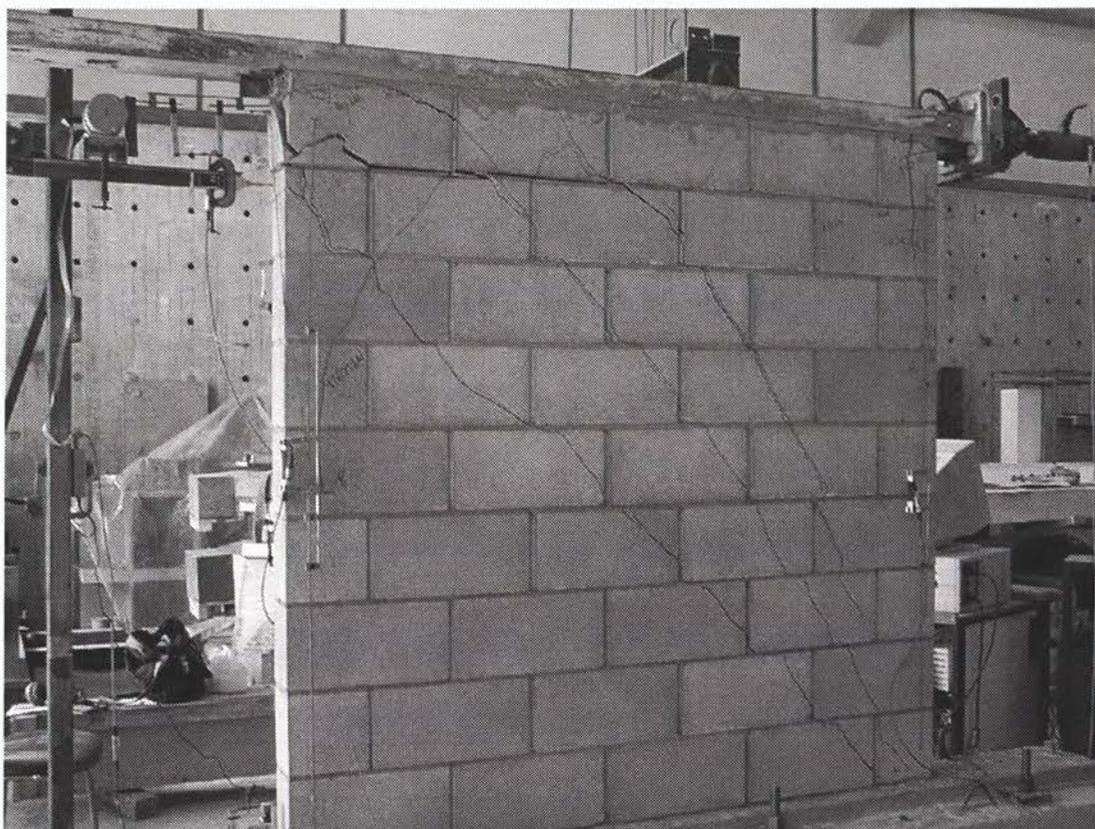
Figure A.5 Structural damage at the bond beam accompanied by diagonal cracks after ductility 1 displacement.

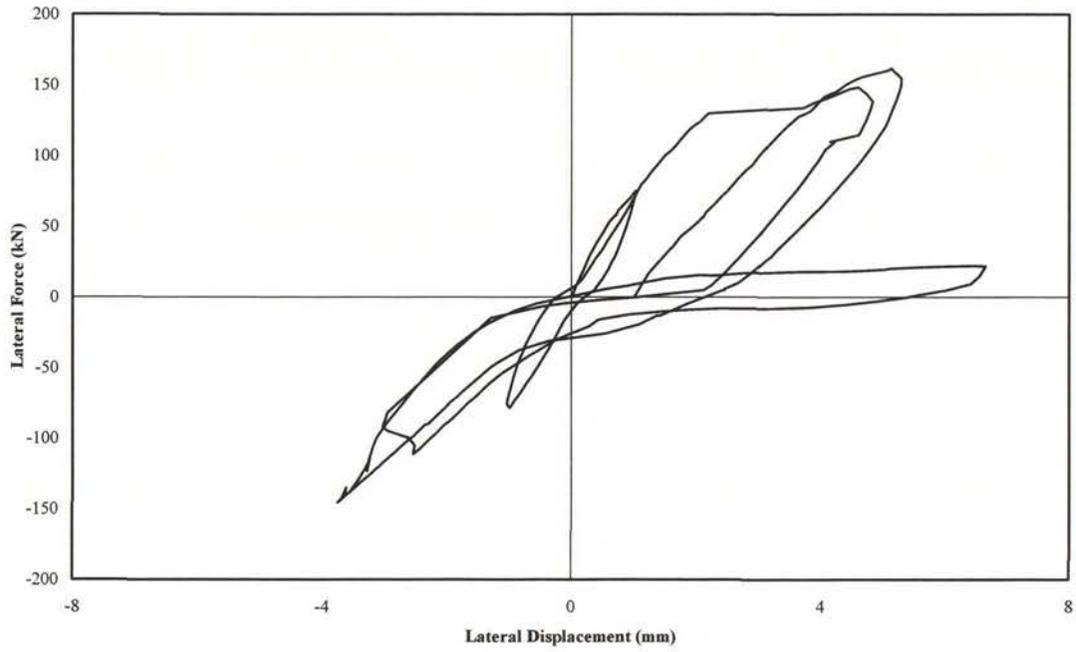
Figure A.6 Force-displacement behaviour for Wall A2.

Similar to Wall A1, Wall A2 suffered premature failure caused by inability of the bond beam to properly transfer shear stress to the entire masonry wall. The force-displacement (F-D) plot presented in Figure A.6 shows that rapid loss of strength took place after degradation of the bond beam (see Figure A.7) at ductility 1 displacement (about 5.5 mm). The maximum strengths of +162 kN and -148 kN were measured during the first cycle to ductility ± 1 displacement.

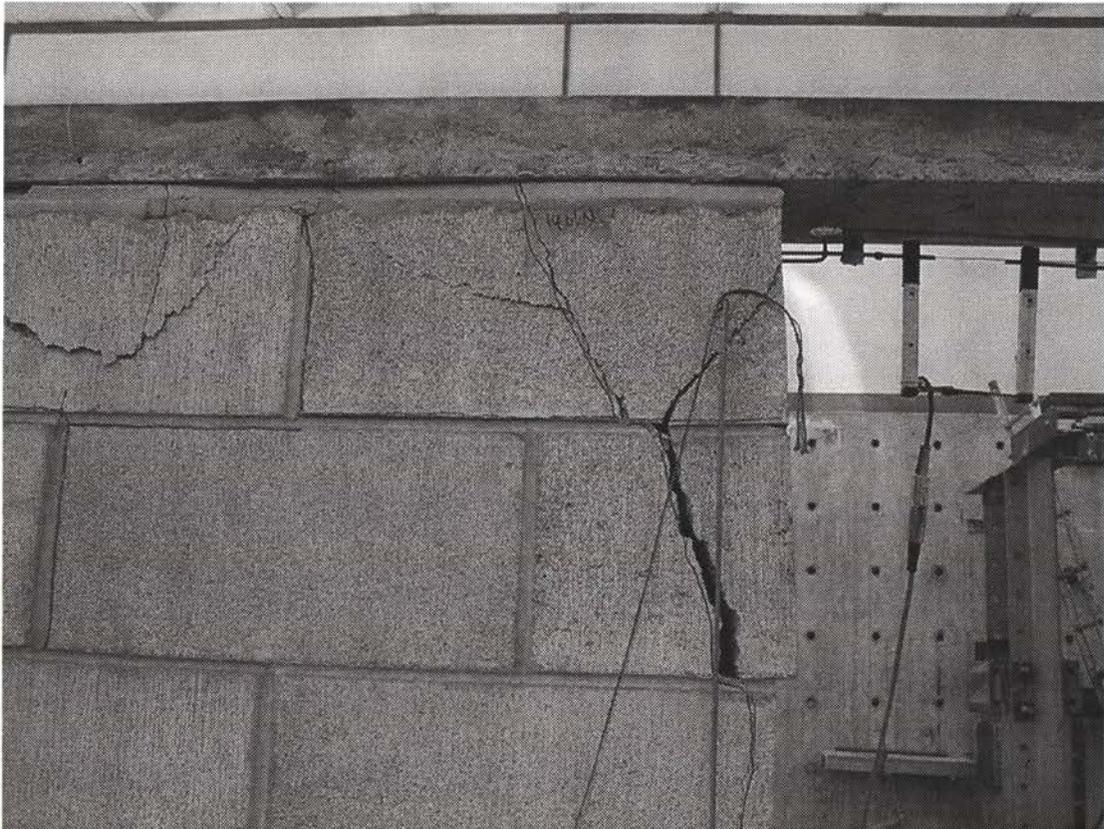
Figure A.7 Structural damage at bond beam causing significant steel channel-masonry wall slippage.

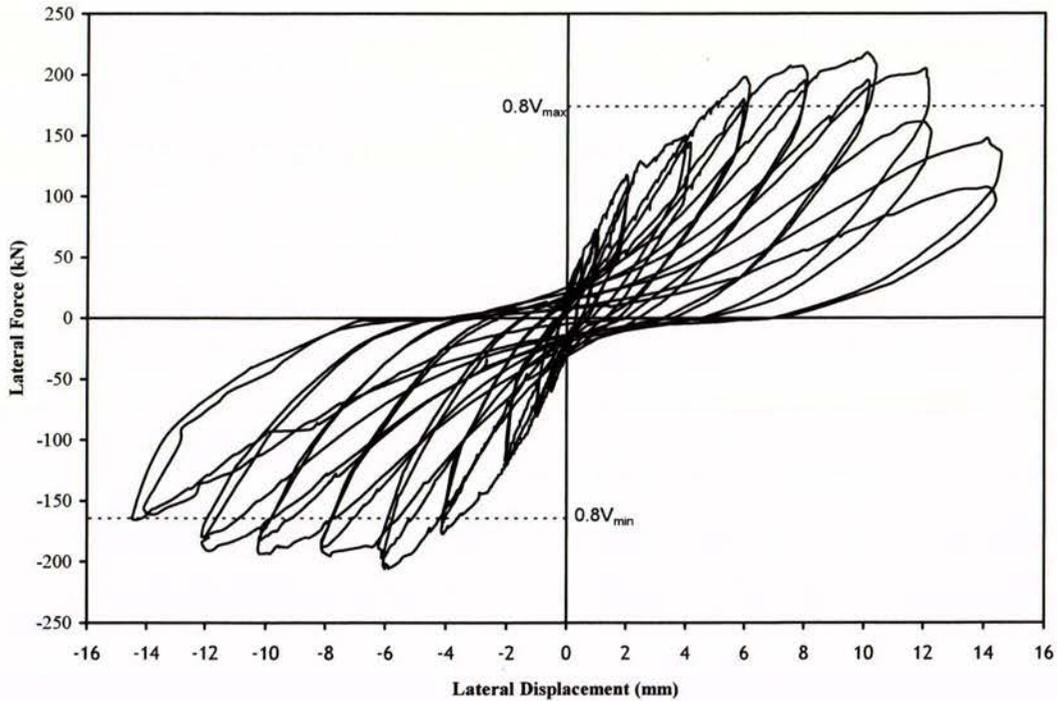
Figure B.1.2 Force-displacement behaviour for Wall 1.

The yield displacement for Wall 1 was evaluated to be 3.0 mm. The wall was defined as failing during the second cycle to 12 mm displacement.

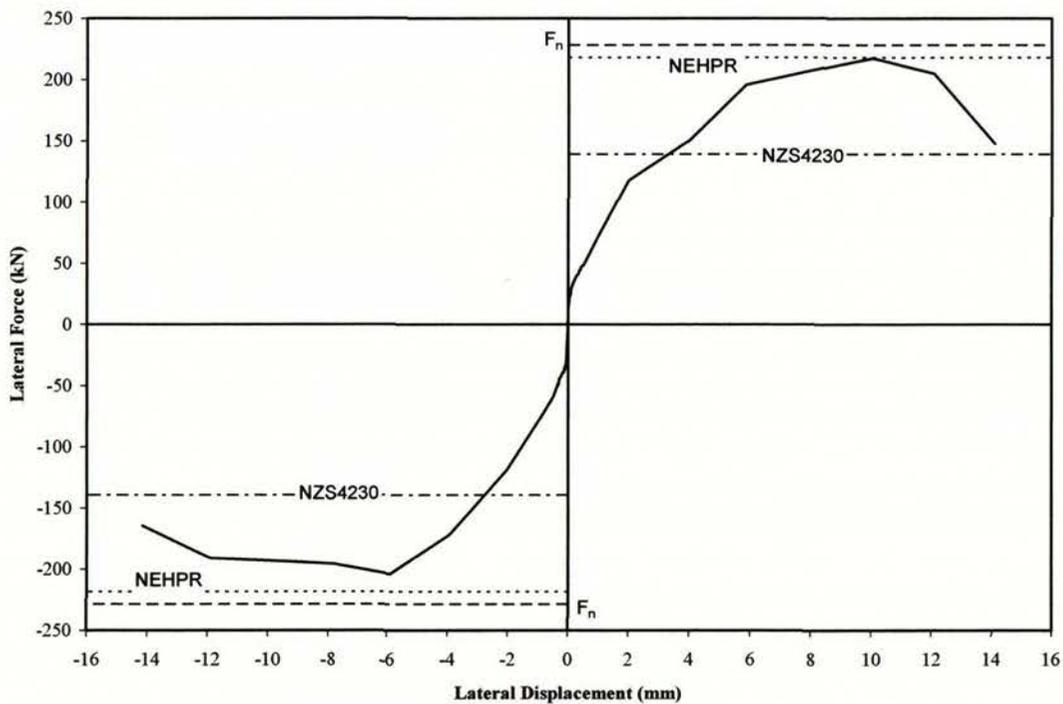
Figure B.1.3 Force-displacement envelope of Wall 1.

strength degraded significantly after 10 mm displacement in the push direction, but strength degradation in the pull direction happened more gradually. It is clearly shown in the figure that the maximum strength developed by Wall 1 was less than the calculated flexural strength, therefore indicating that the wall failed in shear. It is also shown in Figure B.1.3 that the shear strength predicted by NZS4230:1990 was significantly lower than the actual shear strength achieved by the masonry wall. The shear strength predicted by NEHPR closely matched the measured wall shear strength.

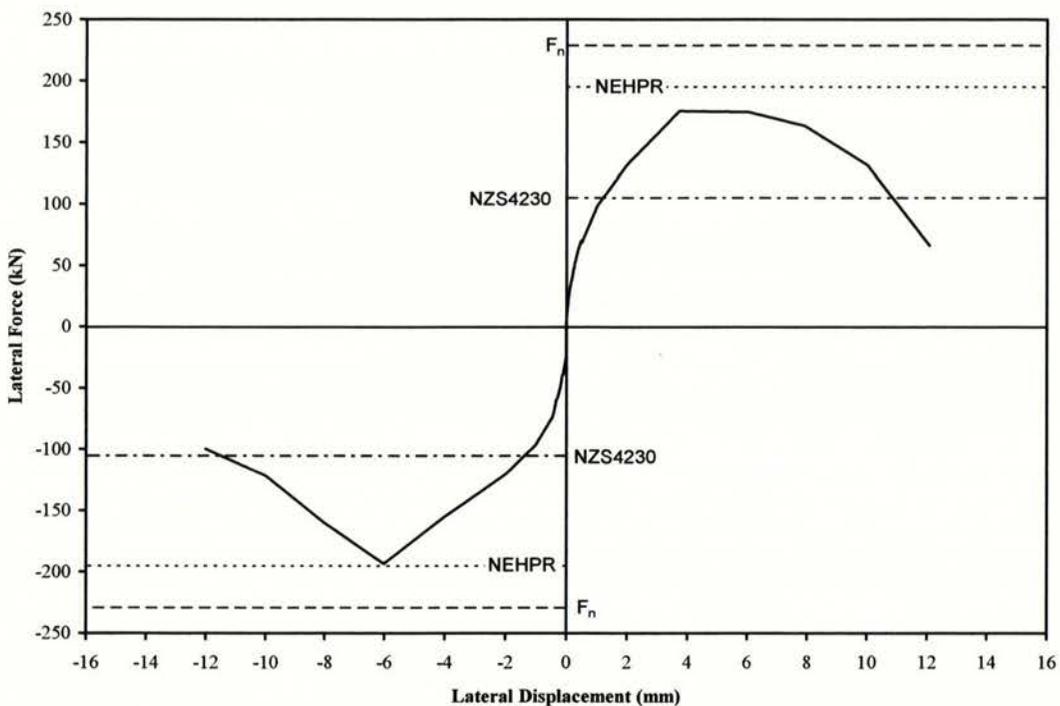
Figure B.2.3 Force-displacement envelope for Wall 2.

Figure B.2.3 shows the force-displacement envelope for the test. The plot was constructed from the peak force recorded in the first cycle for each displacement level. It is shown in Figure B.2.3 that rapid strength degradation took place after the wall developed its maximum strength at ± 6 mm displacement. It was observed that the maximum strength developed by Wall 2 was less than the calculated flexural strength, therefore indicating the wall failed in shear. Figure B.2.3 shows that the shear strength predicted by NZS4230:1990 was significantly lower than the actual shear strength achieved by the tested masonry wall, and that the shear strength predicted by NEHPR more closely matched the measured wall shear strength.

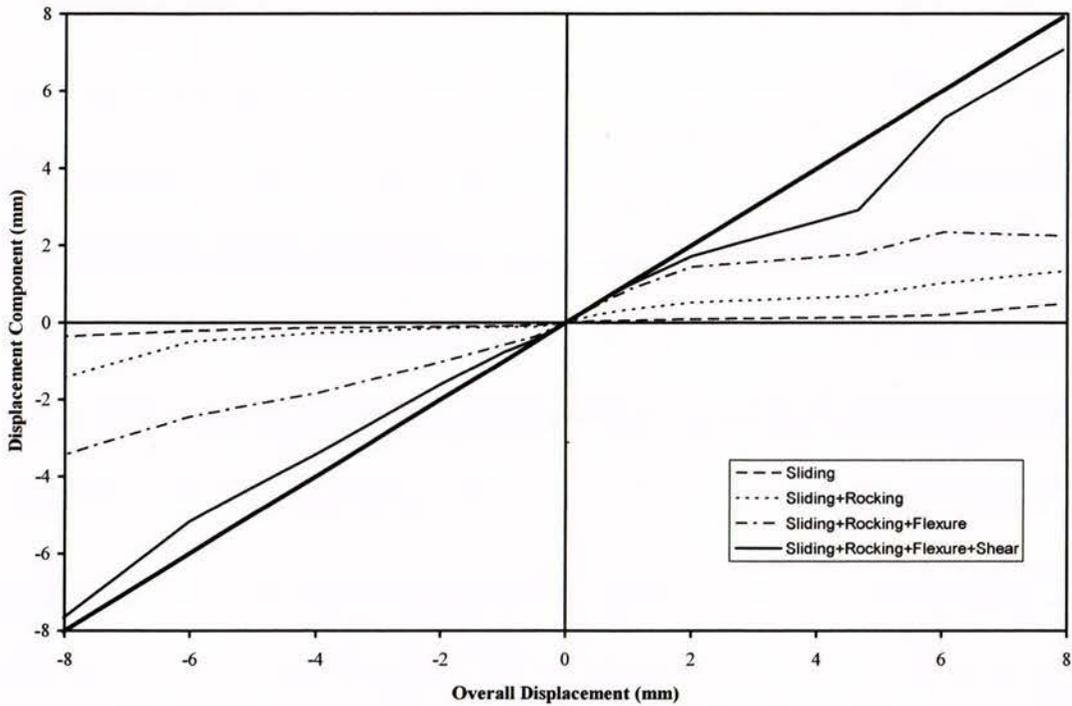
Figure B.2.4 Components of displacement.

displacement, rocking displacement and sliding of the wall on its base. It is noted in Figure B.2.4 that the summed up displacement (shear + flexural + rocking + sliding) does not add up to match the overall displacement measured at the loading beam. It is seen that rocking and flexure were the dominant modes for displacements up to ± 2 mm displacement, and beyond that the shear displacement component increased significantly, becoming the most significant displacement component at later stage of testing. Figure B.2.4 was plotted up to 8 mm displacement, due to severe face shell spalling that occurred at this displacement level, which subsequently caused faulty reading in the displacement transducers.

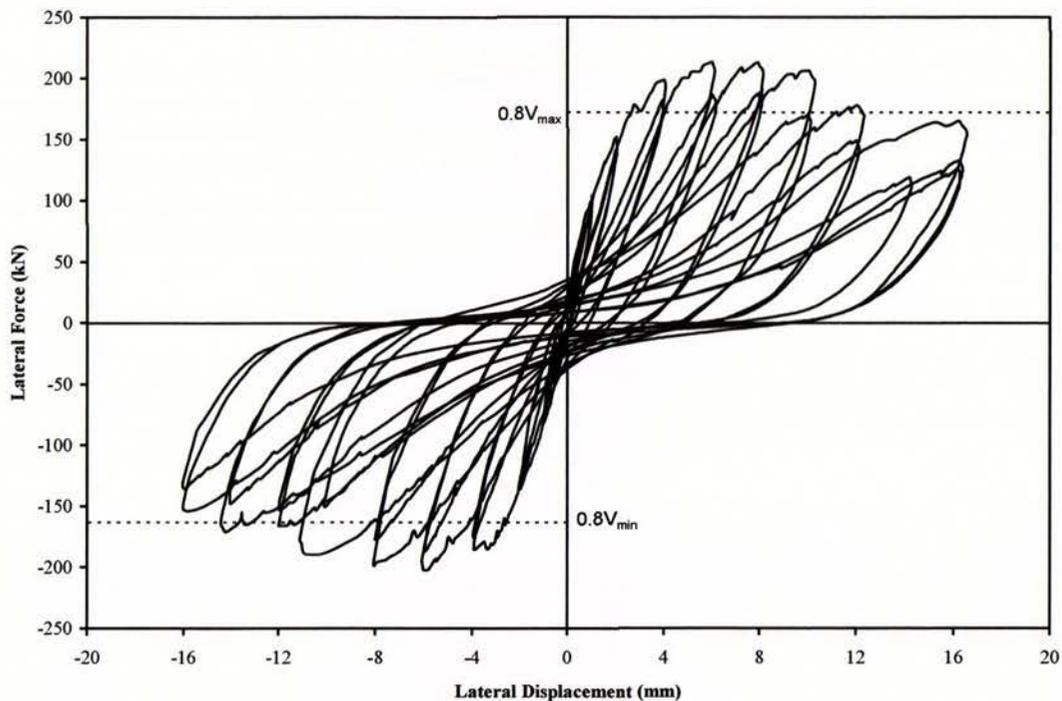
Figure B.3.2 Force-displacement behaviour for Wall 3.

The maximum strength achieved by the wall was about 94% of the calculated flexural strength. It was observed that a cracking at the wall-foundation base interface had caused significant sliding to take place along wall base. Due to sliding displacement that occurred during load reversal, a significant portion of the shear force was transferred primarily by dowel action of the vertical reinforcement. This, in turn, led to a reduction in wall strength, and consequently led to the failure of the wall to develop its predicted flexural strength.

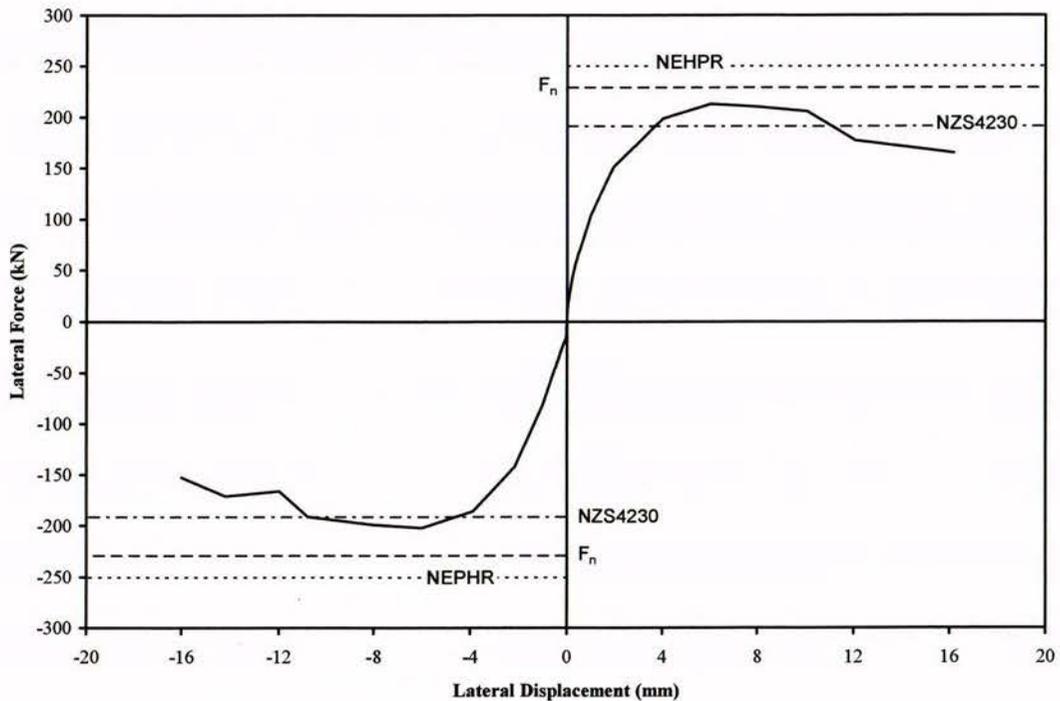
Figure B.3.3 Force-displacement envelope of Wall 3.

The force-displacement envelope is represented in Figure B.3.3. The plot was constructed from the peak force recorded in the first cycle for each displacement level. As can be seen in the figure, strength degradation occurred gradually after the maximum strength was reached in both directions. It is also shown in Figure B.3.3 that the wall failed to achieve the calculated flexural strength, but that the maximum strength developed exceeded the shear strength predicted by NZS4230:1990, indicating the New Zealand masonry standard is conservative in predicting masonry shear strength.

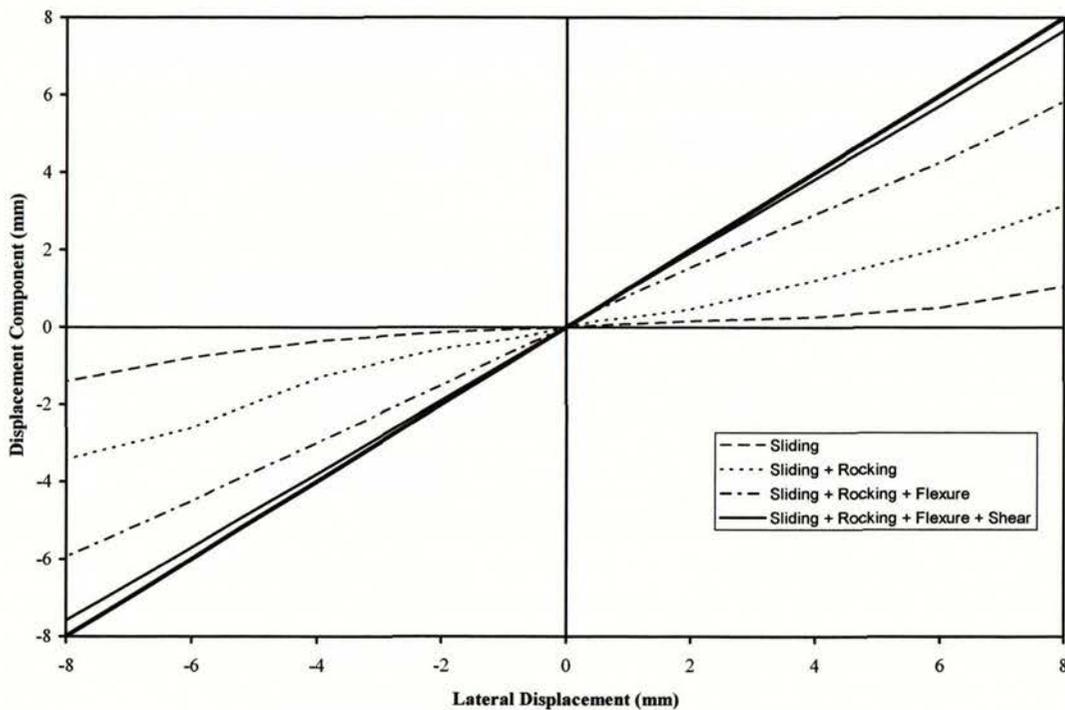
Figure B.3.4 Components of displacement

these two components increased in magnitude as the wall was being loaded to larger displacement. However, the rocking and flexure were the two most dominant displacement modes throughout the test. Figure B.3.4 provides an indication of the relative size of each component for various stages of displacement until ± 8 mm of displacement. Significant errors in the deformation plot when the wall was loaded beyond ± 8 mm of displacement were undoubtedly the result of the profuse cracking (which eventually caused the spalling of face shells) affecting the displacement transducer readings.

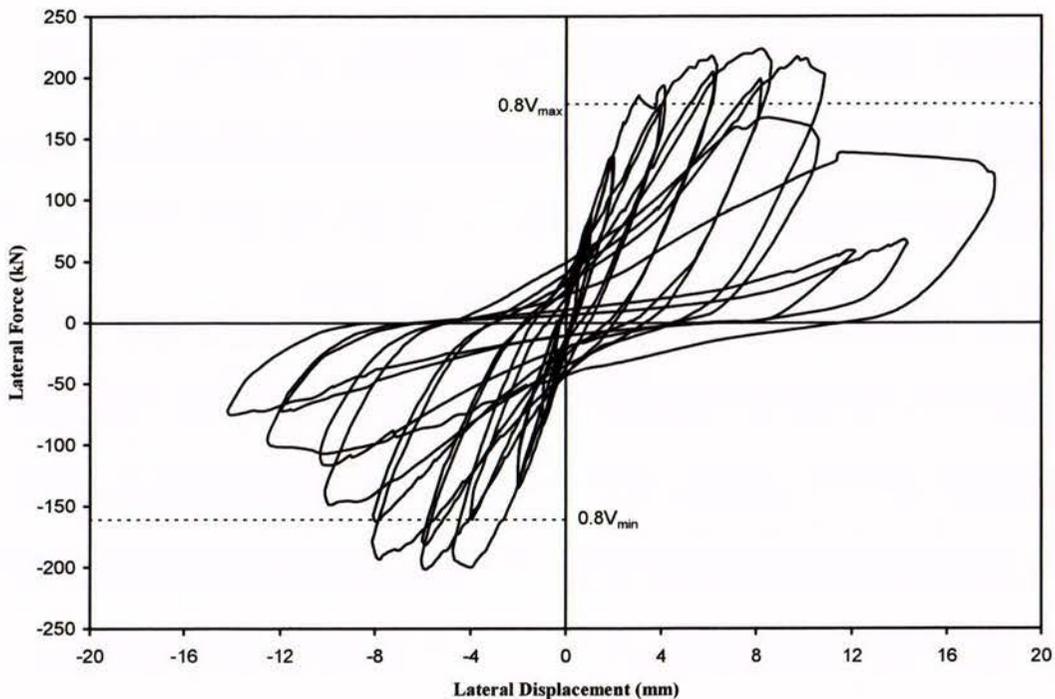
Figure B.4.2 Force-displacement history of Wall 4.

The wall had a shear type of failure, this failure mode was expected because the predicted nominal flexural strength was larger than the predicted shear strength. Shear type of failure was characterised by the initiation of visible horizontal cracks at low displacement levels. As the wall was pushed/pulled to further displacement, initiation of diagonal cracking occurred when the principal stresses due to applied lateral force exceeded the tensile strength of masonry.

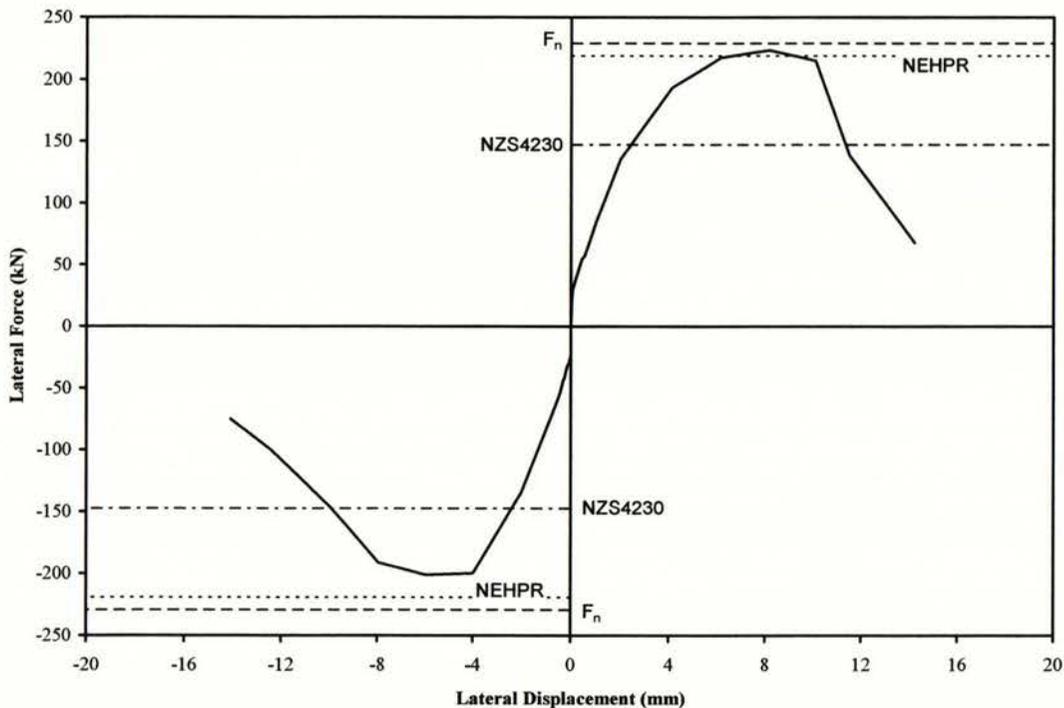
Figure B.4.3 Force-displacement envelope of Wall 4.

The force-displacement envelope for Wall 4 is presented in Figure B.4.3. The plot was constructed from the peak force recorded in the first cycle for each displacement level. It can be seen that the wall strength degraded rapidly in both directions after the maximum wall strength was developed. Although Wall 4 had approximately the same amount of shear reinforcement as Wall 1, its F-D response after failure was more closely matched to that of a horizontally unreinforced wall, i.e. Wall 2.

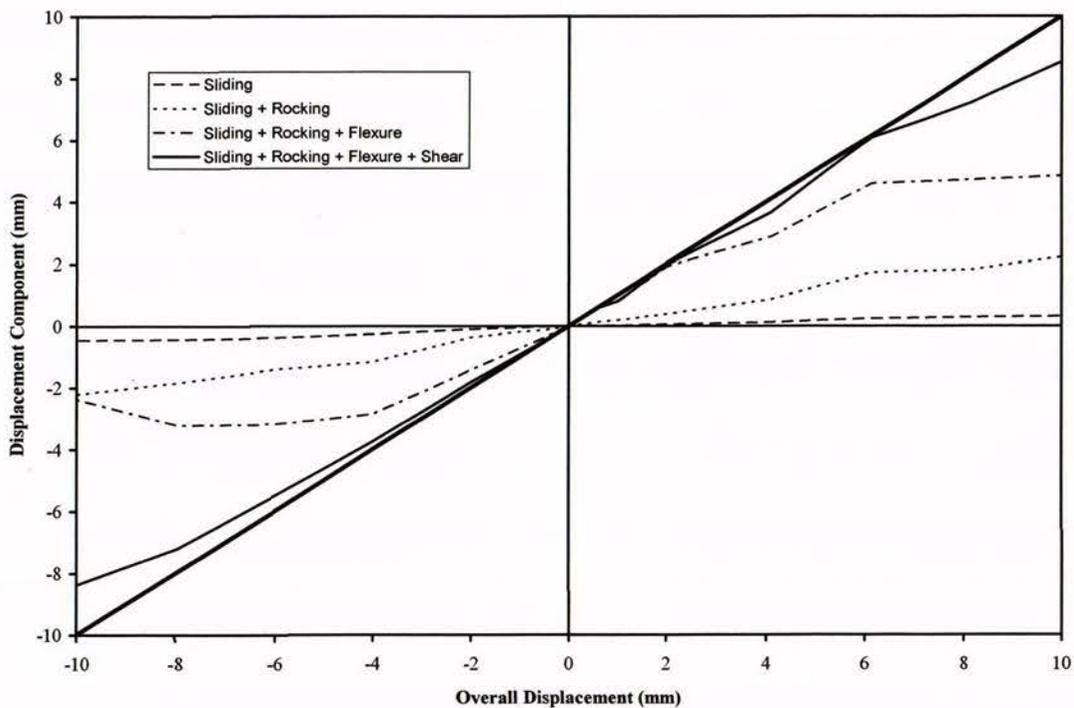
Figure B.4.4 Components of displacement.

From the sliding, rocking, flexure and shear displacement components plotted in Figure B.4.4, it is seen that wall sliding was not a significant feature for this wall's behaviour. Shear displacement component increased significantly when the wall was pulled beyond -6 mm of displacement. For the push direction, the shear component increased in magnitude when the flexure and rocking displacement component remained relatively constant at a larger displacement level. Figure B.4.4 was plotted up to ± 10 mm displacement due to significant face shells spalling that occurred beyond this displacement level, which subsequently influencing the displacement transducer readings.

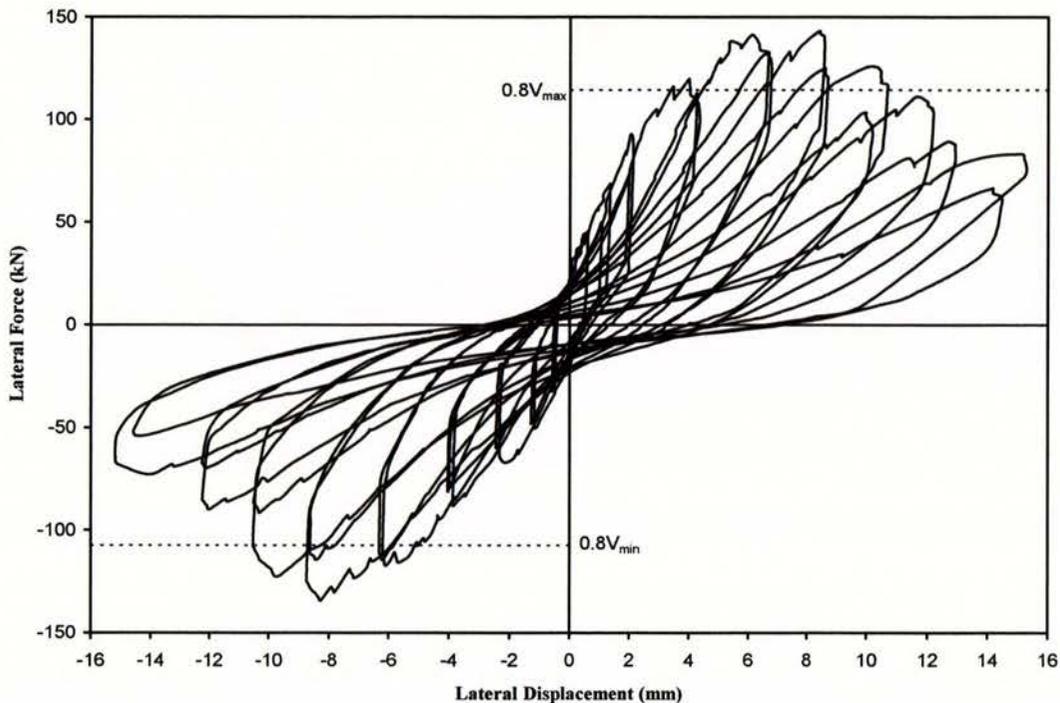
Figure B.5.2 Force-displacement behaviour of Wall 5.

The yield displacement (Δ_y) for this partially grouted wall was evaluated to be 4.68 mm. The wall was defined as failing during the second push cycle to 10 mm displacement.

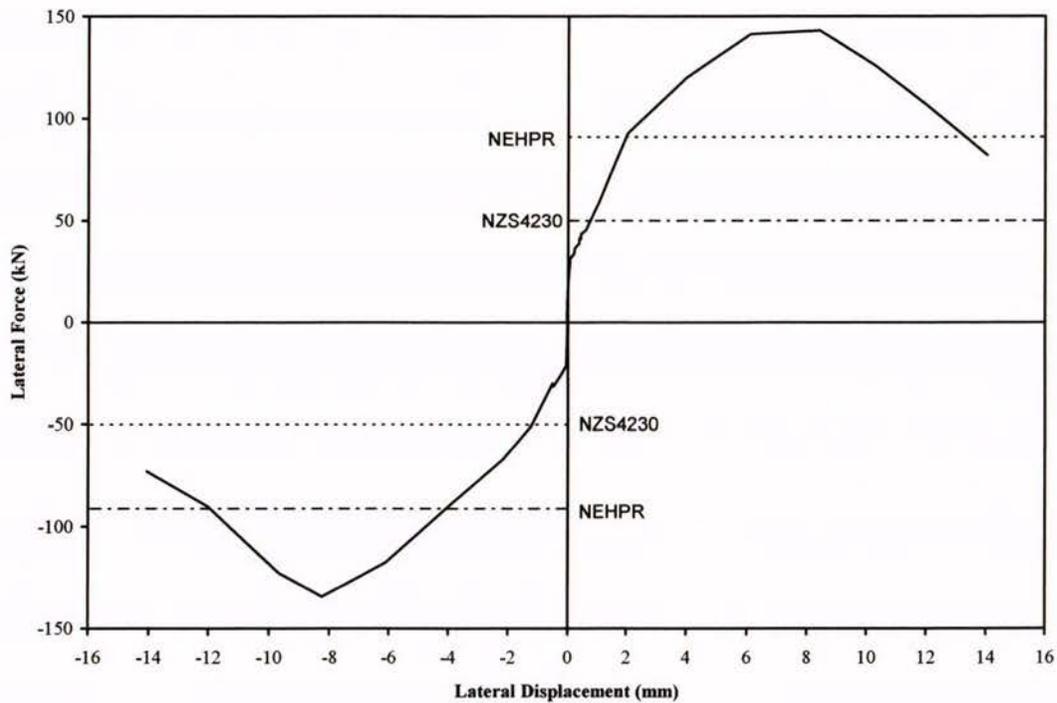
Figure B.5.3 Force-displacement envelope of Wall 5.

It is clearly shown in Figure B.5.3 that the masonry shear strength predicted by the New Zealand masonry design standard, NZS4230:1990, was significantly lower than the actual shear strength achieved by the masonry wall.

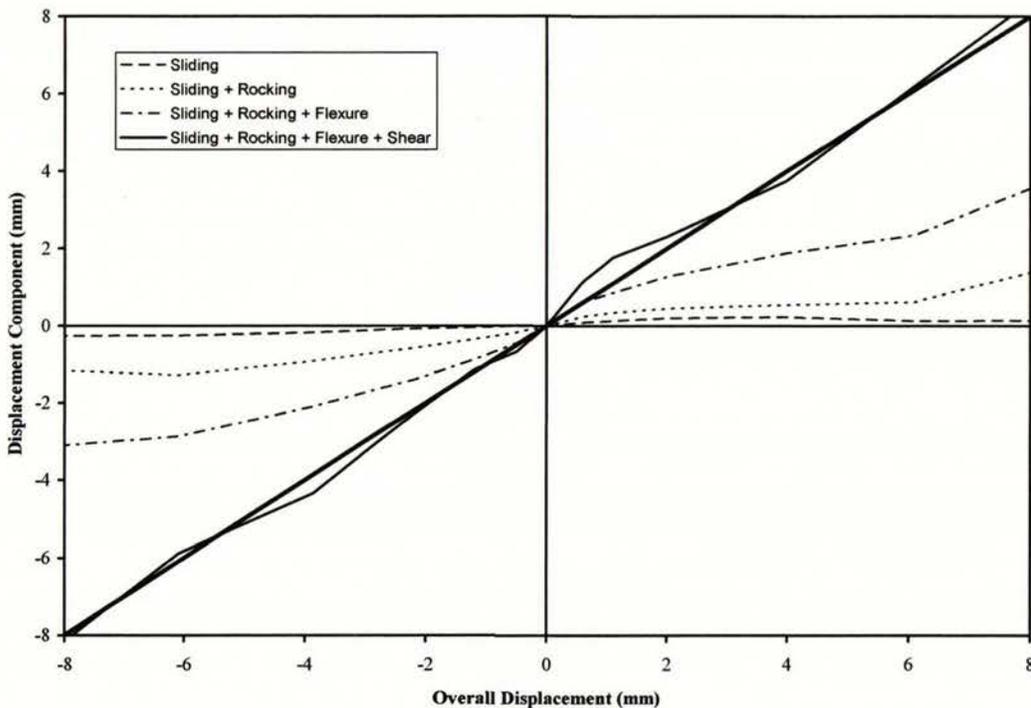
Figure B.5.4 Components of displacement.

Figure B.5.4 provides an indication of the relative size of each component for various stages of the displacement envelope until the displacement of ± 8 mm. It is noted that the summed up deformation (sliding + rocking + flexure + shear) nearly add up to match the overall displacement measured at the top of the wall.

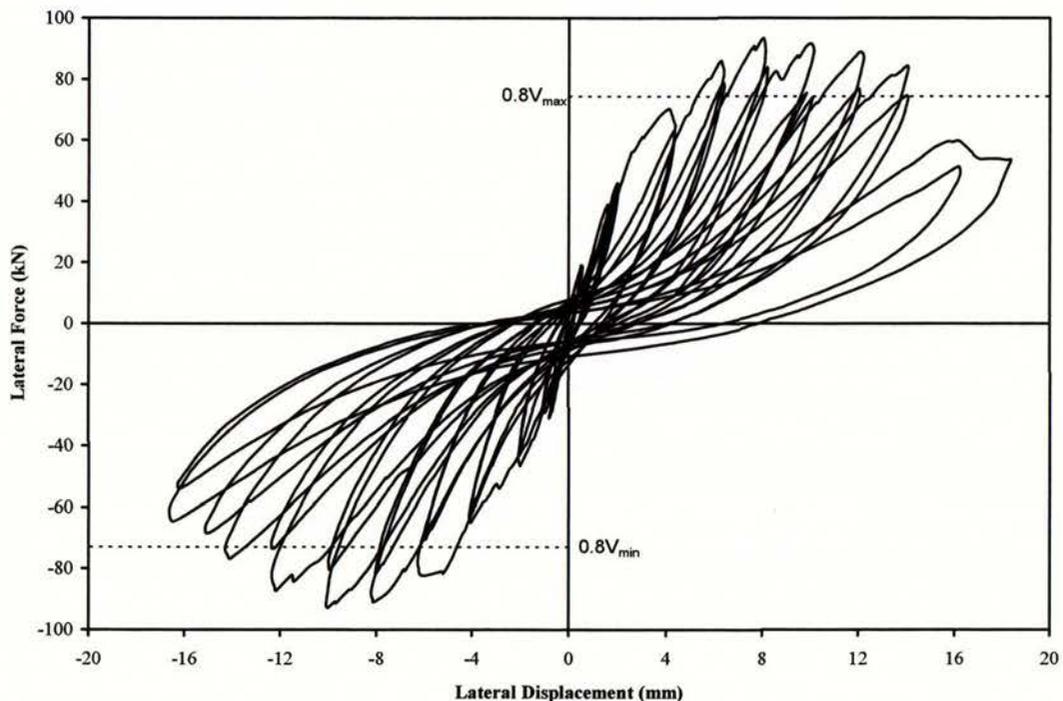
Figure B.6.2 Force-displacement behaviour of Wall 6.

The yield displacement of Wall 6 was evaluated to be 5.09 mm. The wall was defined as failing during the second cycle to -14 mm displacement.

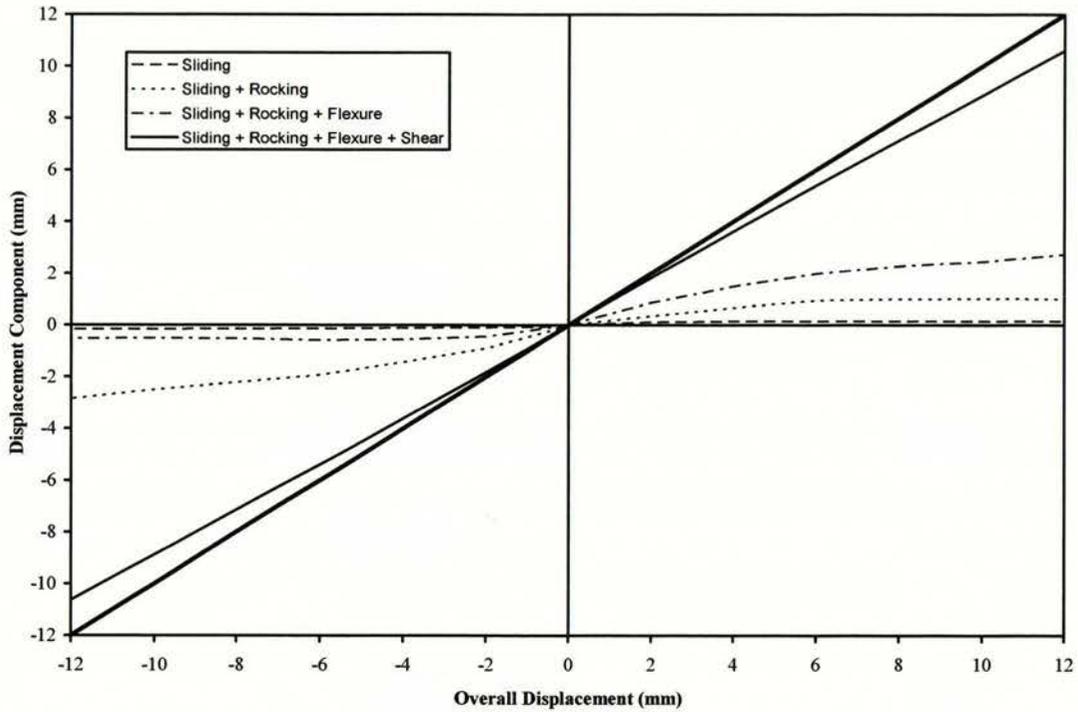
Figure B.6.4 Components of displacement.

It is noted the summed up displacement (sliding + rocking + flexure + shear) did not add up to match the overall displacement measured at the top of the wall.

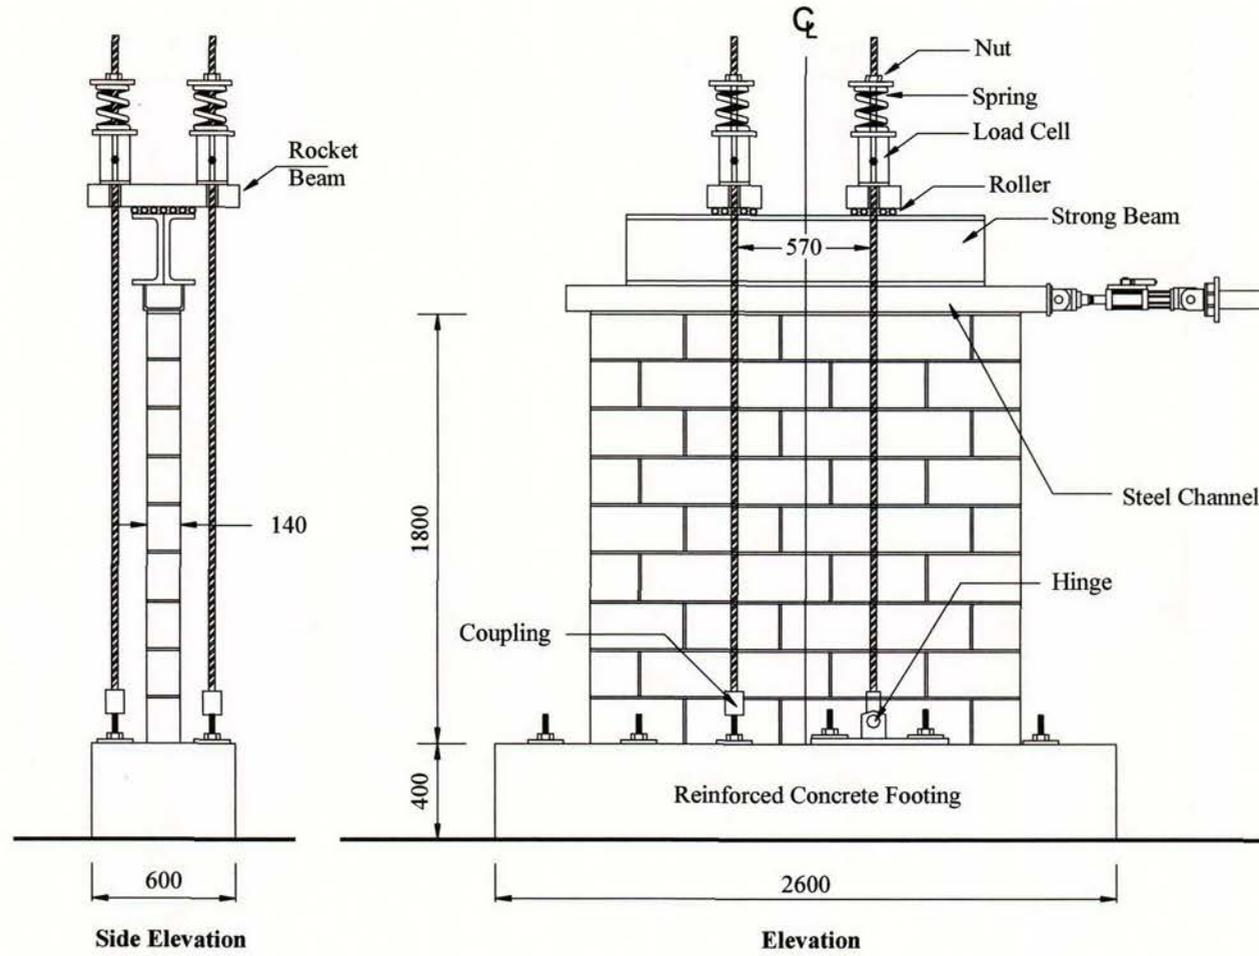
Figure B.7.2 Test set-up for Wall 7.

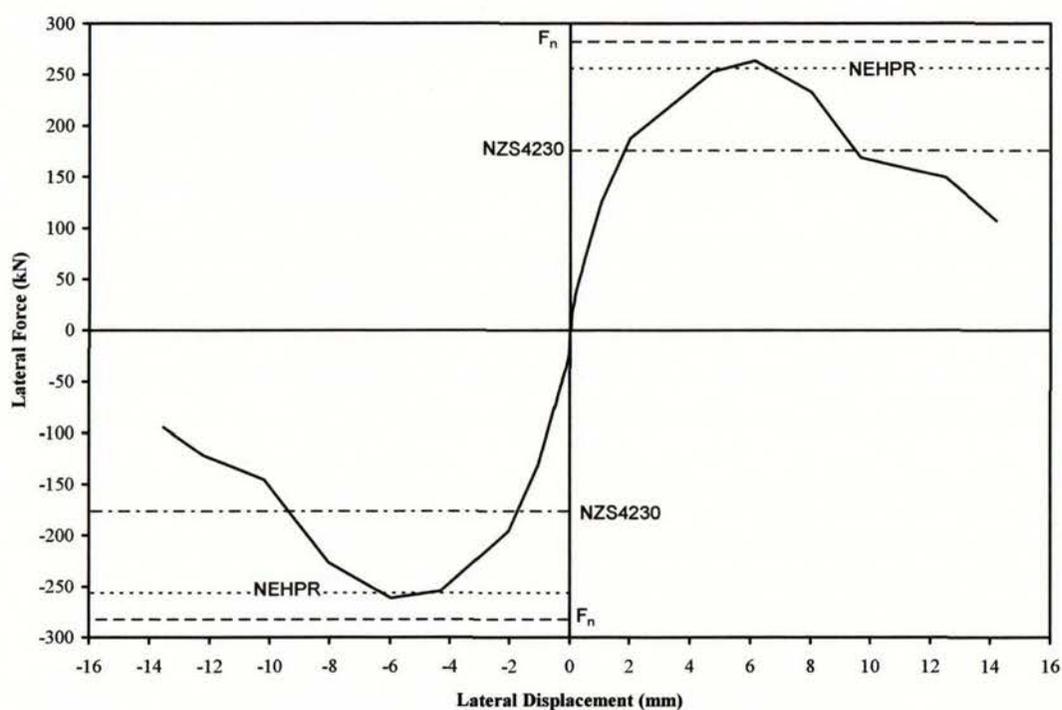
Figure B.7.4 Force-displacement envelope of Wall 7.

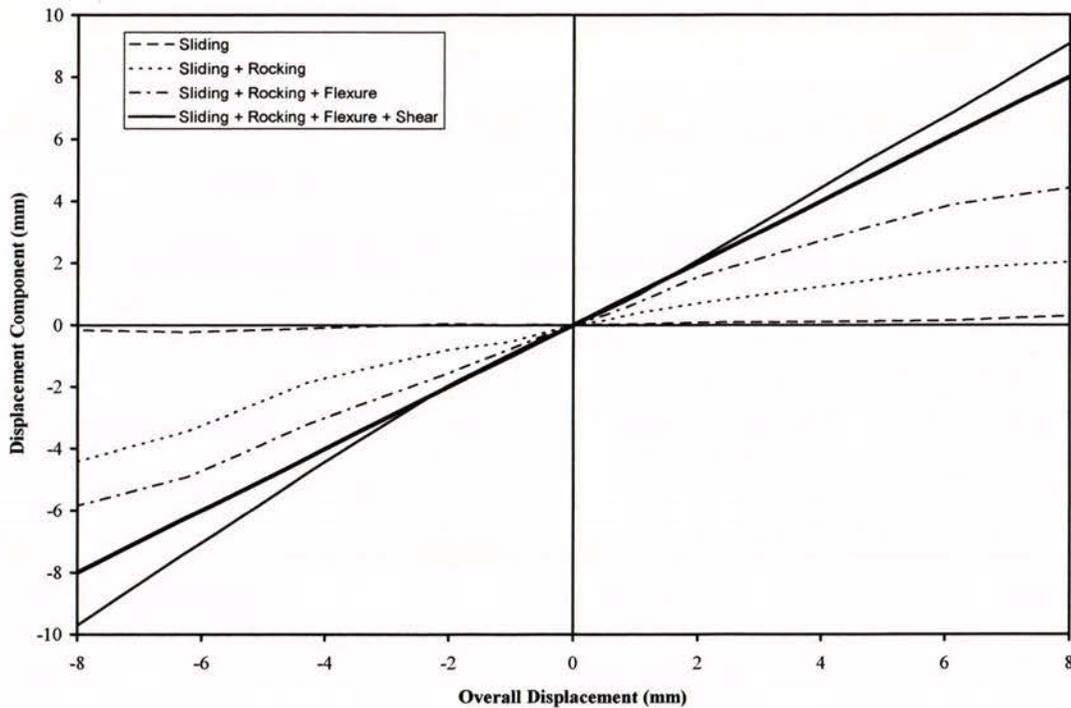
Figure B.7.5 Components of displacement.

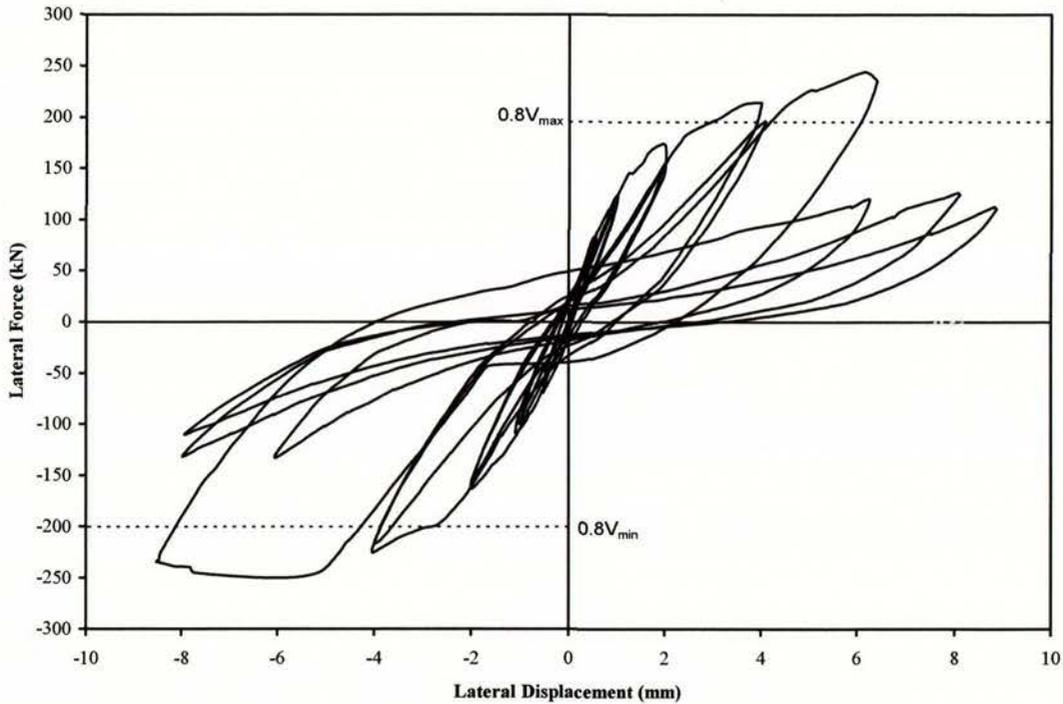
Figure B.8.2 Force-displacement behaviour for Wall 8.

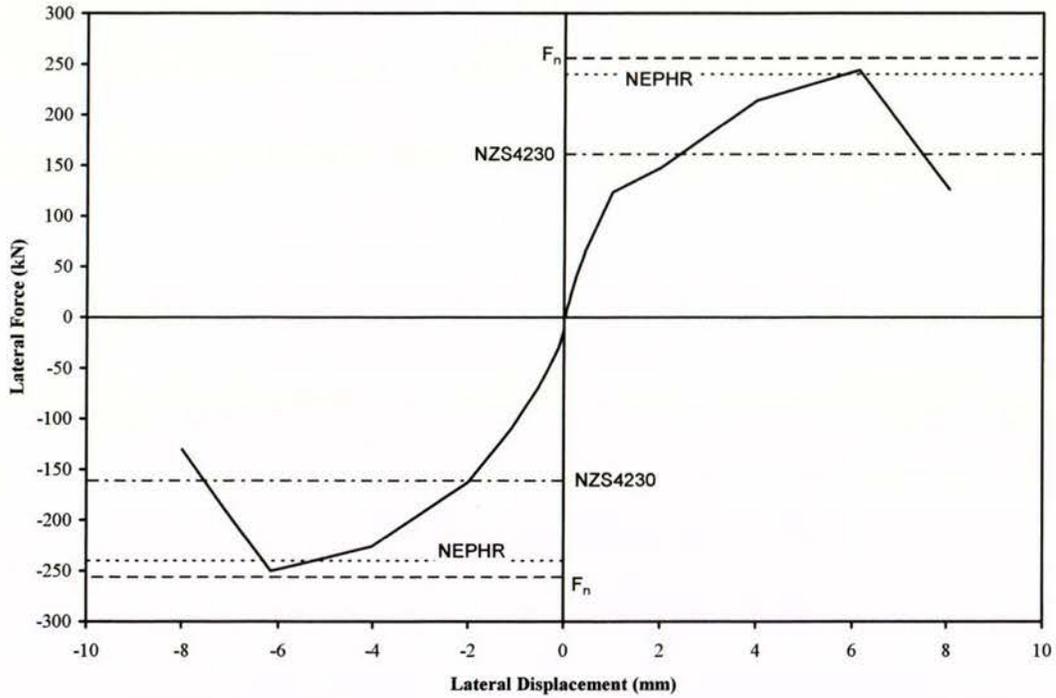
Figure B.8.3 Force-displacement envelope of Wall 8.

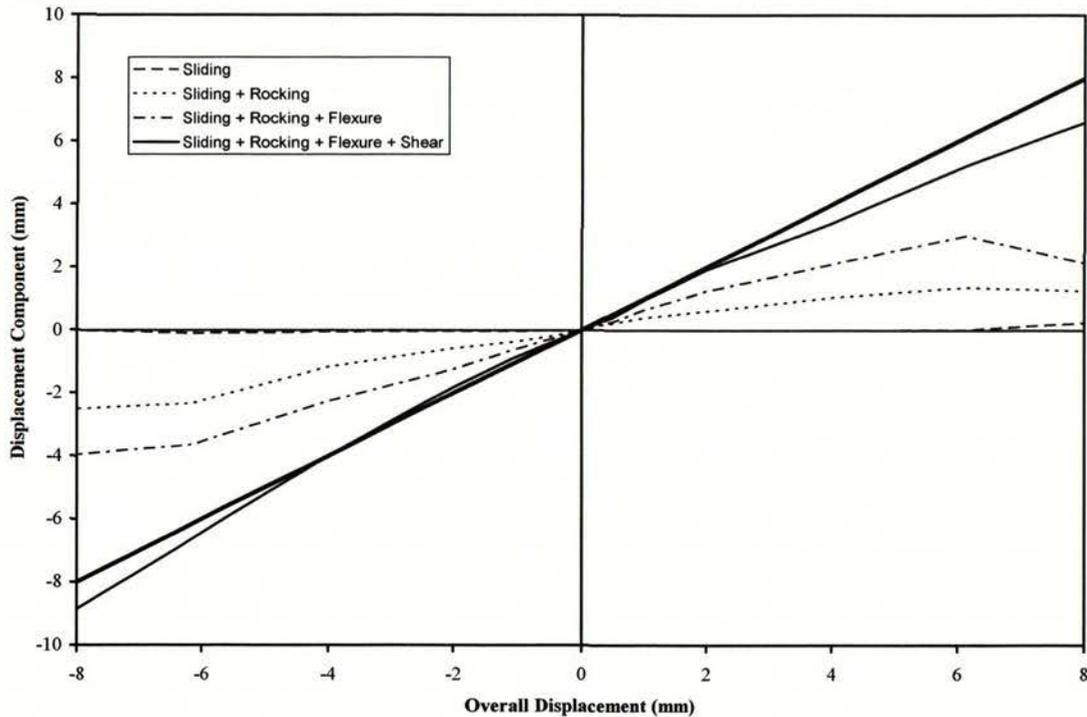
Figure B.8.4 Components of displacement.
