THE UNIVERSITY OF AUCKLAND
NEW ZEALAND

Department of
Civil and
Environmental
Engineering

**SHEAR STRENGTH OF CONCRETE
MASONRY WALLS**

School of Engineering
Report No. 611

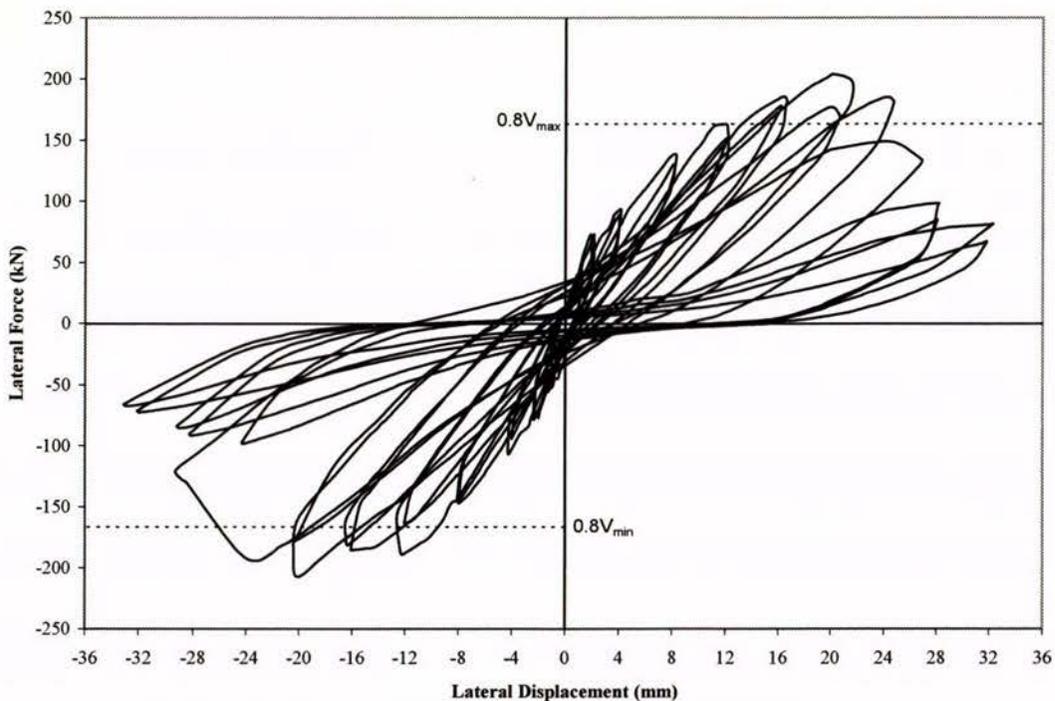
Figure C.1.2 Force-displacement behaviour for Wall 9.

The yield displacement for Wall 9 was evaluated to be 7.0 mm. The wall was defined as failing during the first cycle to -24 mm displacement.

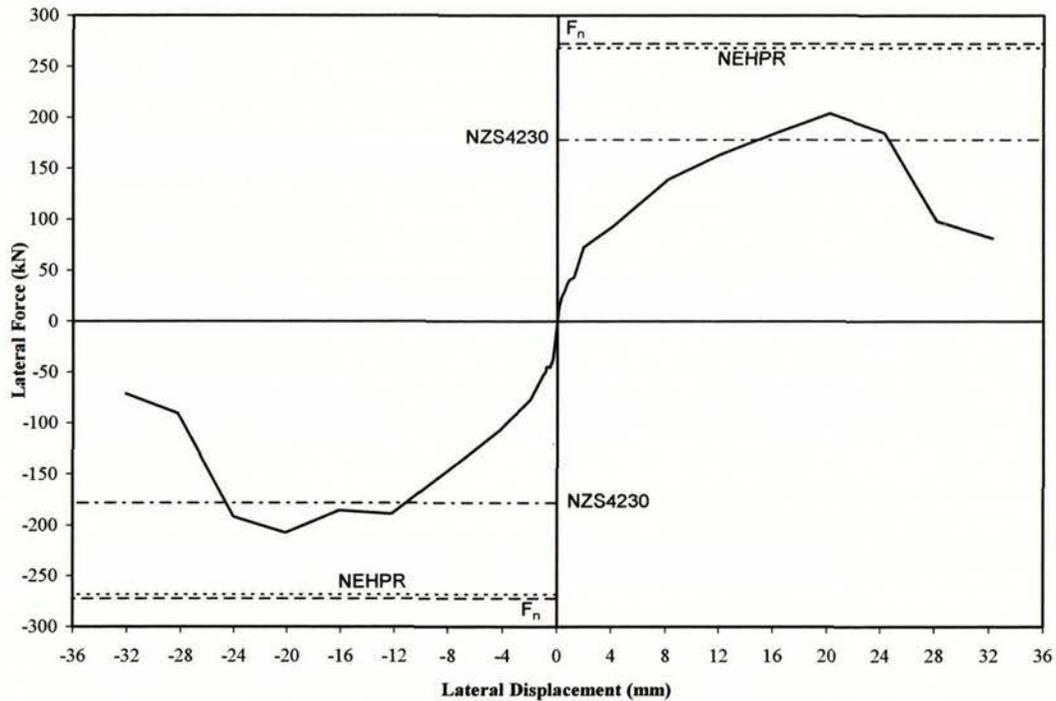
Figure C.1.3 Force-displacement envelope of Wall 9.

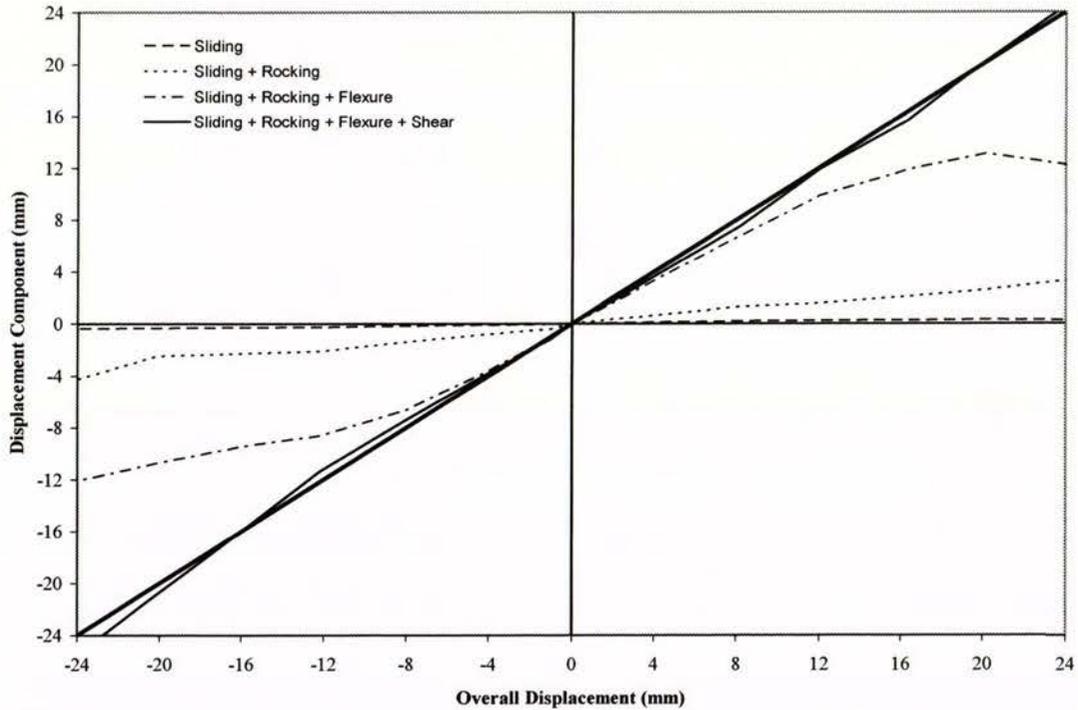
Figure C.1.4 Components of displacement.

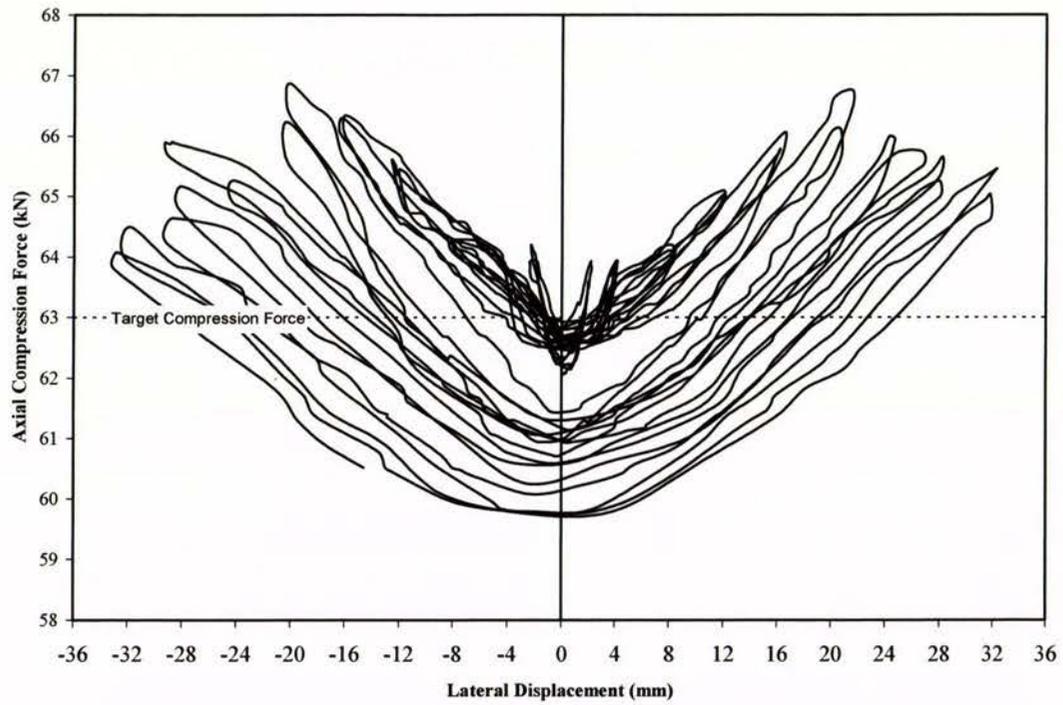
Figure C.1.7 Axial compression force history.

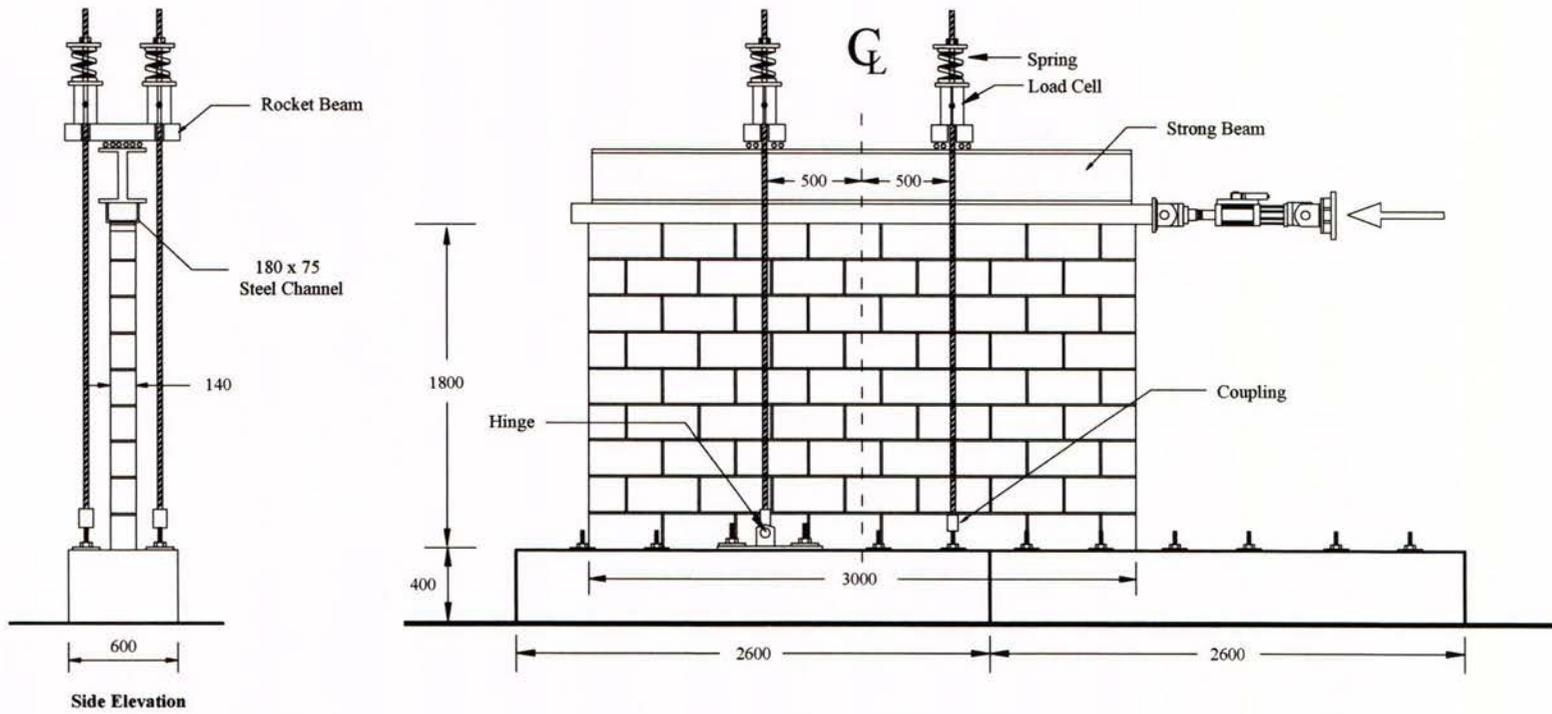
Figure C.2.2 Test set-up for Wall 10

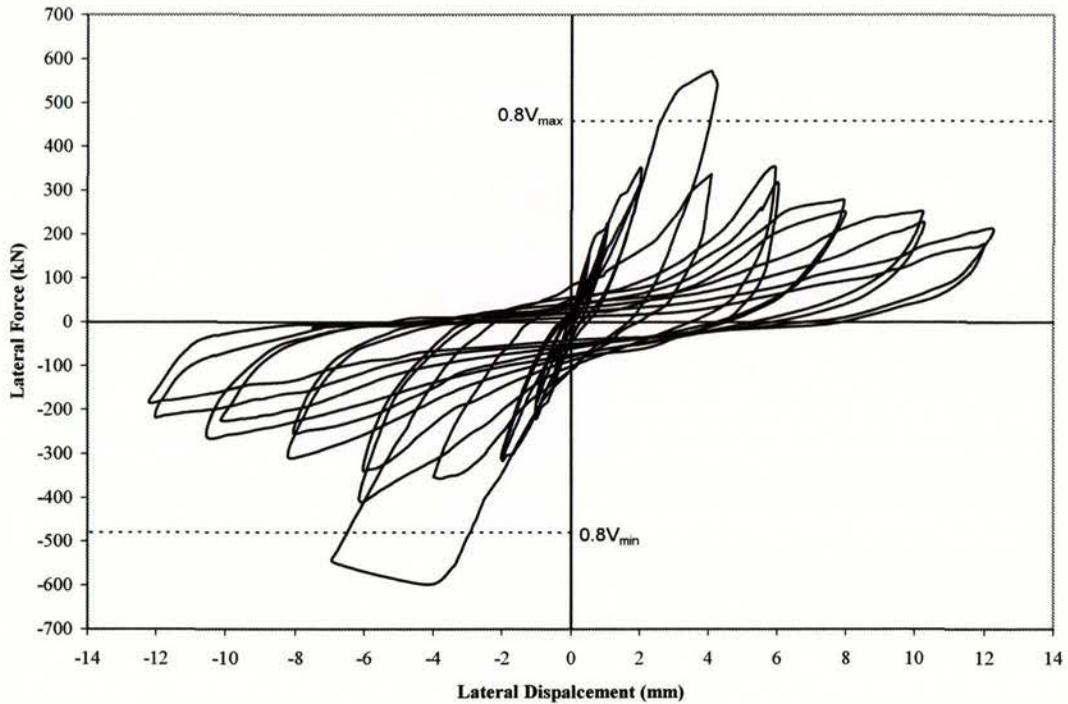
Figure C.2.3 Force-displacement behaviour for Wall 10.

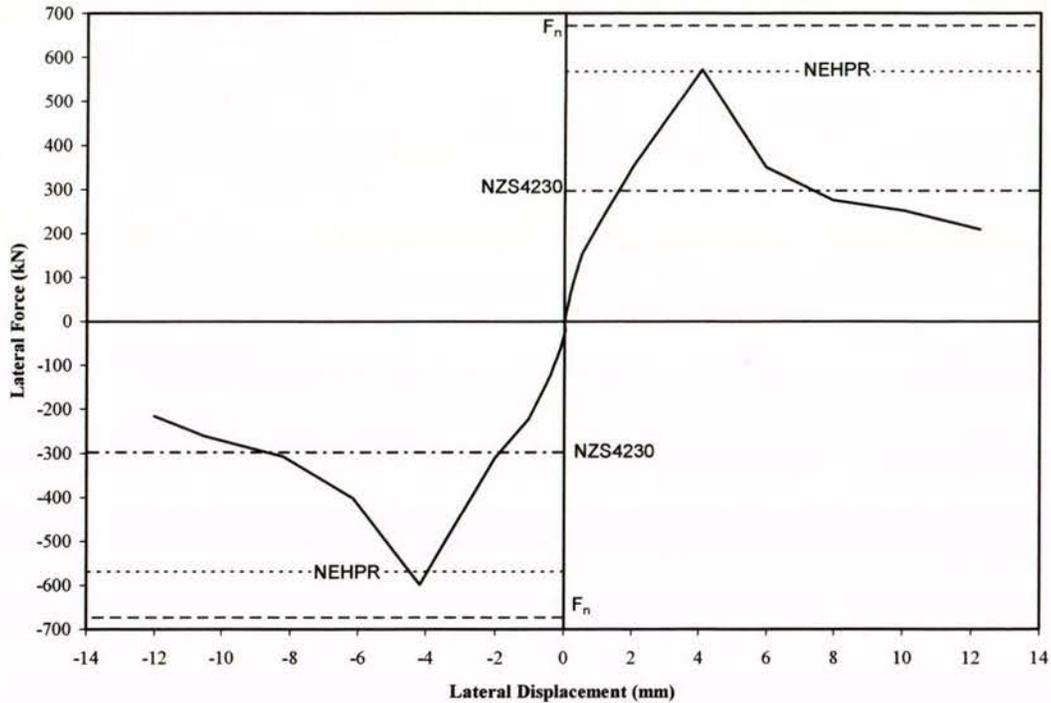
Figure C.2.4 Force-displacement envelope of Wall 10.

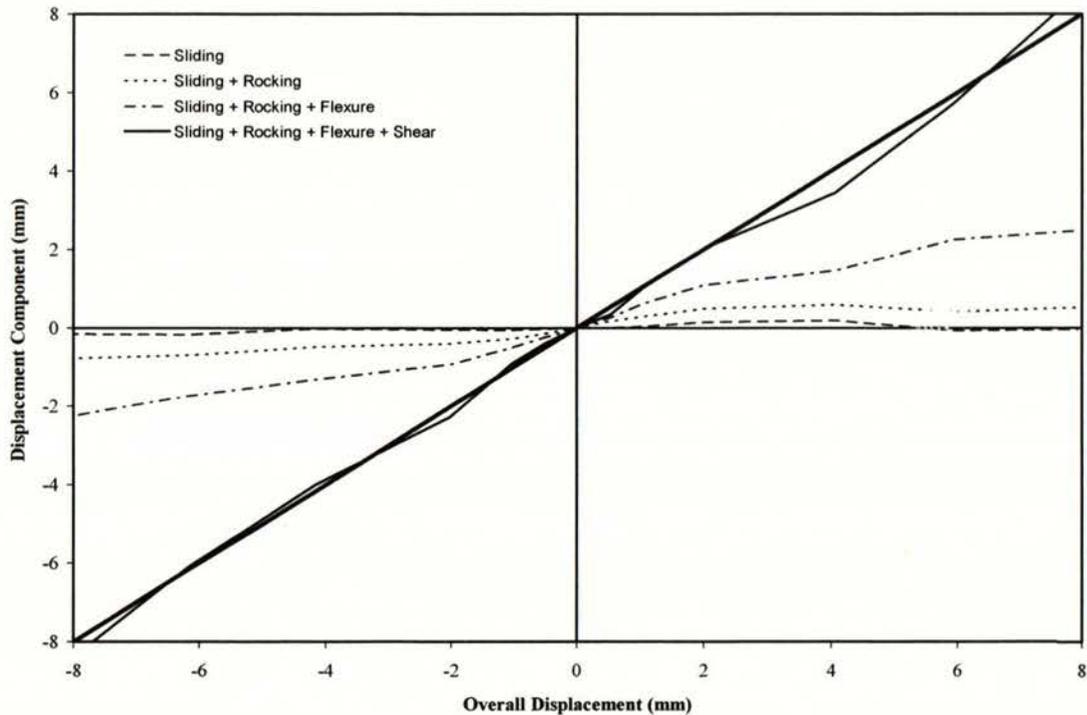
Figure C.2.5 Components of displacement.

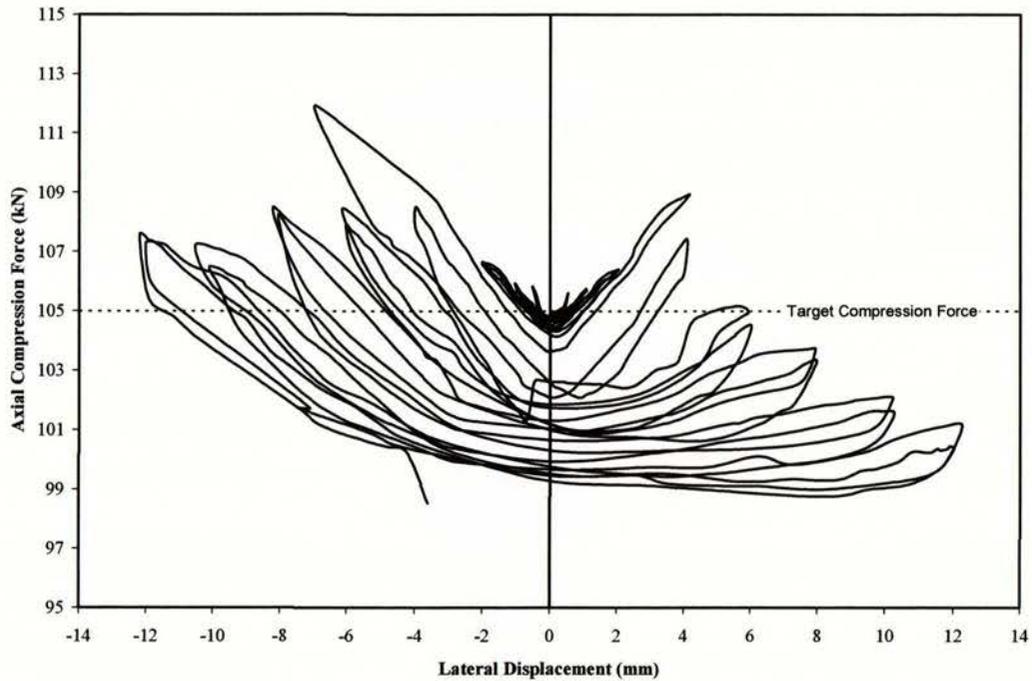
Figure C.2.8 Axial compression force history.

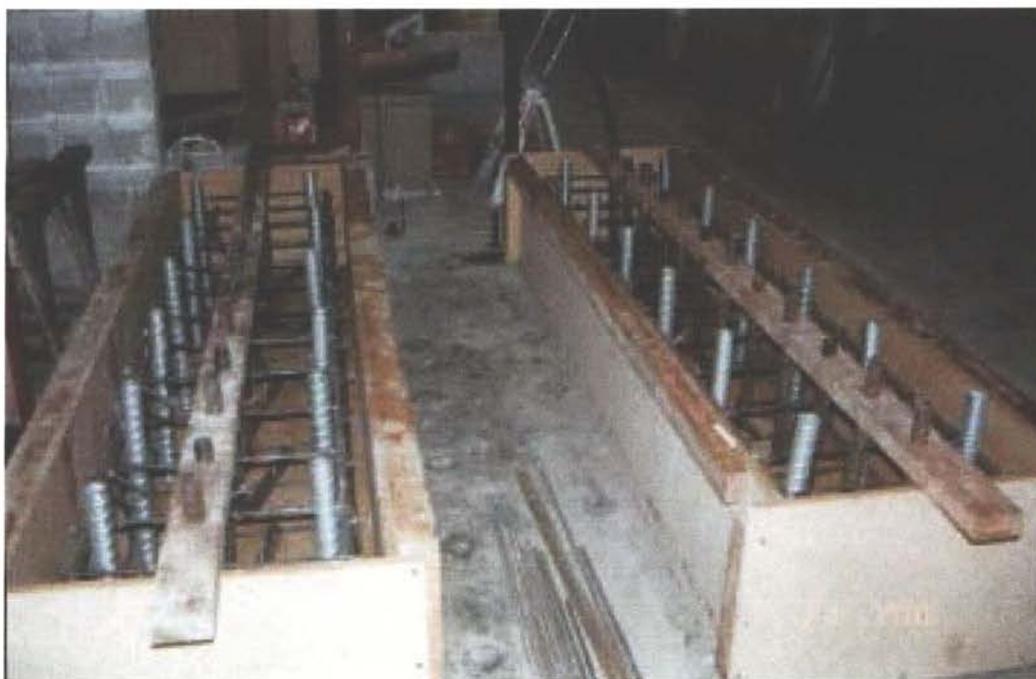
Photo 1 Footing reinforcement cages positioned in boxing.

All walls were constructed on two identical re-usable reinforced concrete footings so that two walls were built during each construction cycle. The concrete footing shown in Figure 3.2 and Photo 1 (all photos are presented in Appendix G) had DH32 starter bars spaced at 400 mm centres that were drilled and tapped to accommodate D20 vertical reinforcement. The concrete footing was stressed down to the laboratory floor with 12 high strength steel rods, each loaded to approximately 300 kN so that sufficient shear friction was provided to eliminate any slip between the footing and the floor. Each of the wall vertical reinforcement bars was first tapped at both ends, then threaded into the DH32 starters that protruded from the reinforced concrete base. Once the loading beam was placed on top of the concrete masonry wall using a pack of trade mortar for best possible shear force transfer between the wall and the loading beam, the vertical reinforcement was tightened. It was verified through bar testing that threading on the D20 reinforcing bars had negligible effect on the yield strength for this type of reinforcing bar (please refer to Figure F.1 in Appendix F). If the test set-up for any particular wall in Series B differed from that described above, the difference is detailed in Appendix B for the relevant wall.

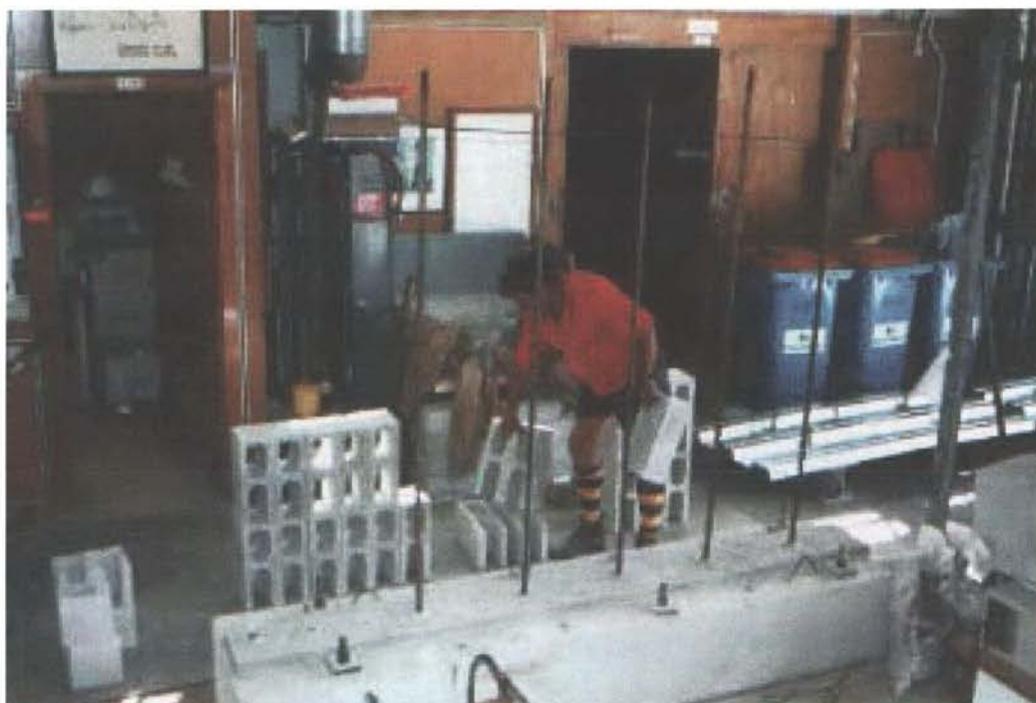
Photo 2 Position of vertical reinforcing bars.

The walls were constructed by experienced blocklayers under supervision, and consisted of a running bond pattern of standard grey precast concrete masonry block units using DRICON™ trade mortar. Prior to wall construction, the vertical reinforcing bars were first tapped at both ends and then threaded into the starters, reaching an approximate height of 1.9 m above the base as depicted in Photo 2.

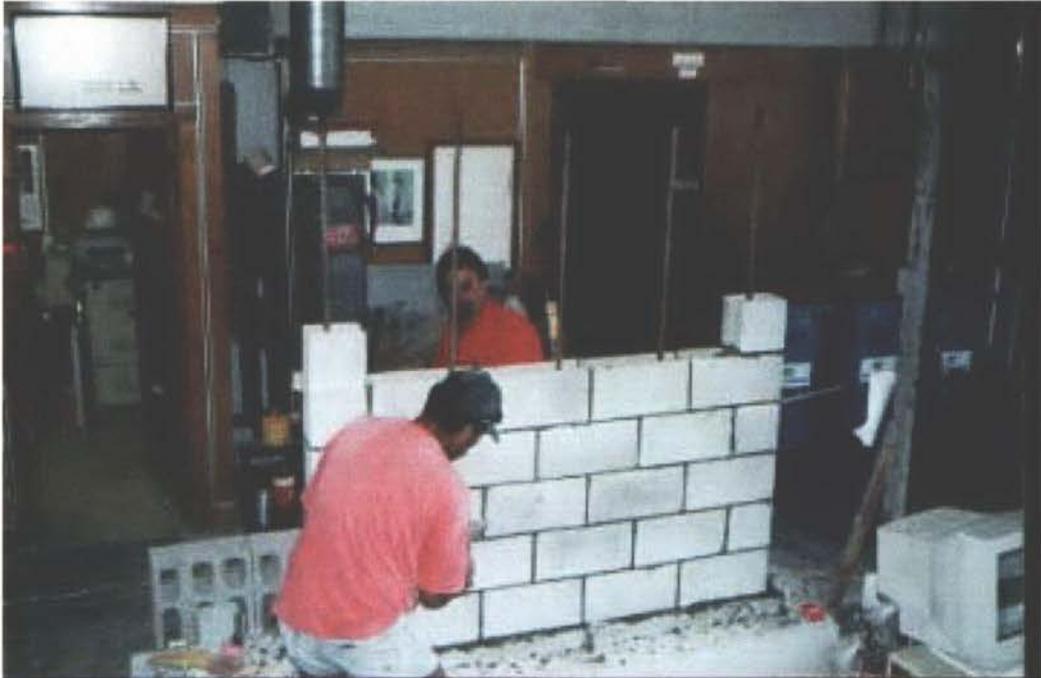
Photo 3 Masonry wall construction.

DRICON™ mortarmix – a mortar that is commonly used in masonry construction throughout New Zealand, was used as mortar for construction of the test walls. High slump ready-mix grout using small aggregate was employed to ensure full dispersion through the cavities within the test walls. An expansive chemical additive (SIKA Cavex) was also added to the grout to avoid formation of voids caused by high shrinkage of the grout. Photo 3 shows wall construction and Photo 4 shows the grouting process.

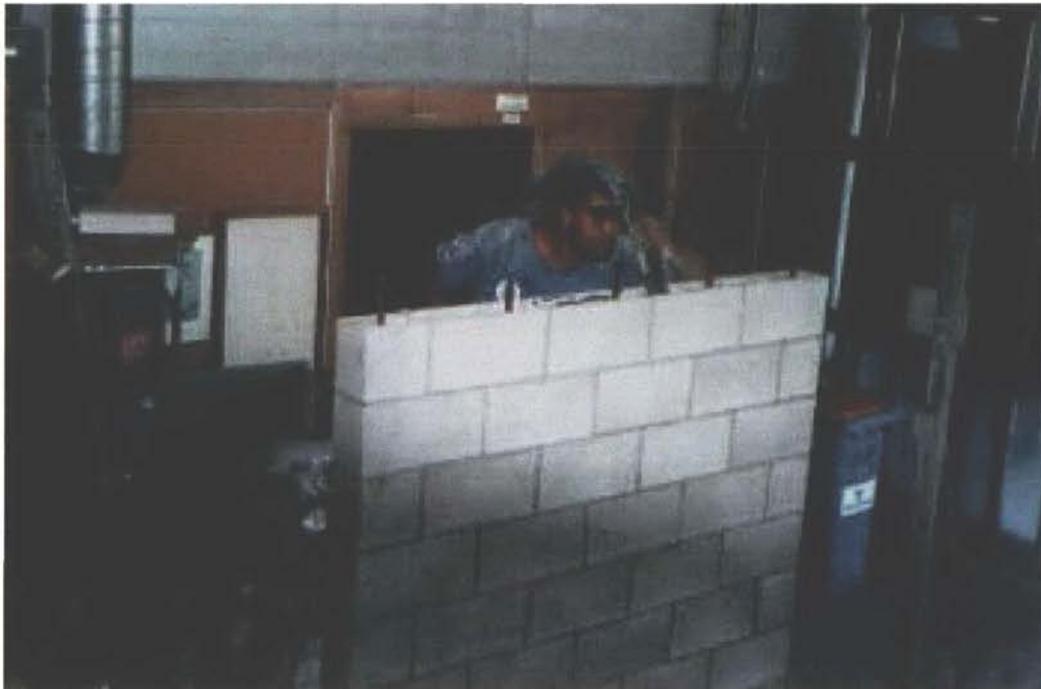
Photo 4 Masonry wall grouting.

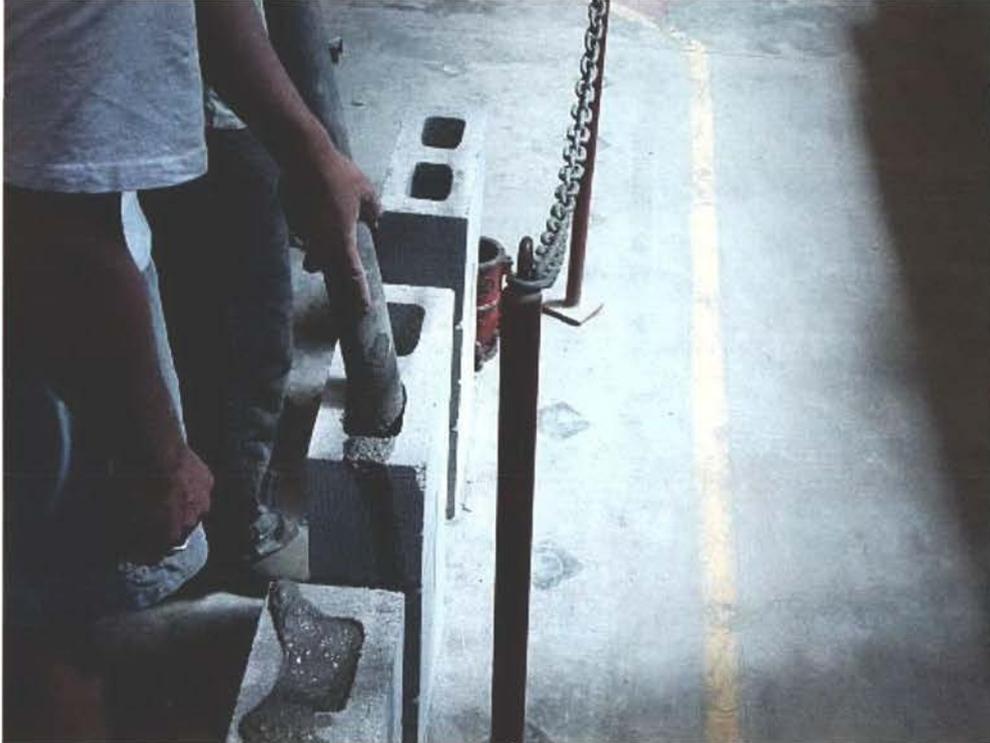
Photo 7 Masonry prisms grouting.

Masonry prisms were built at the completion of laying each wall (see Photo 7), using the same mortar and CMUs used in the wall. These prisms were built of three CMUs stacked on top of each other using the same construction technique as was used for the wall. The prisms were then filled at the same time as the walls, using the same grout. The prisms were tested using an Avery Testing Machine as shown in Photo 8. This type of test specimen provided the most accurate estimate of masonry wall compressive strength, f'_m . It is noted that f'_m for concrete masonry walls constructed of regular materials, found by prism testing at the University of Auckland, has consistently been around 17 MPa, which is about twice the value given in NZS4230:1990.

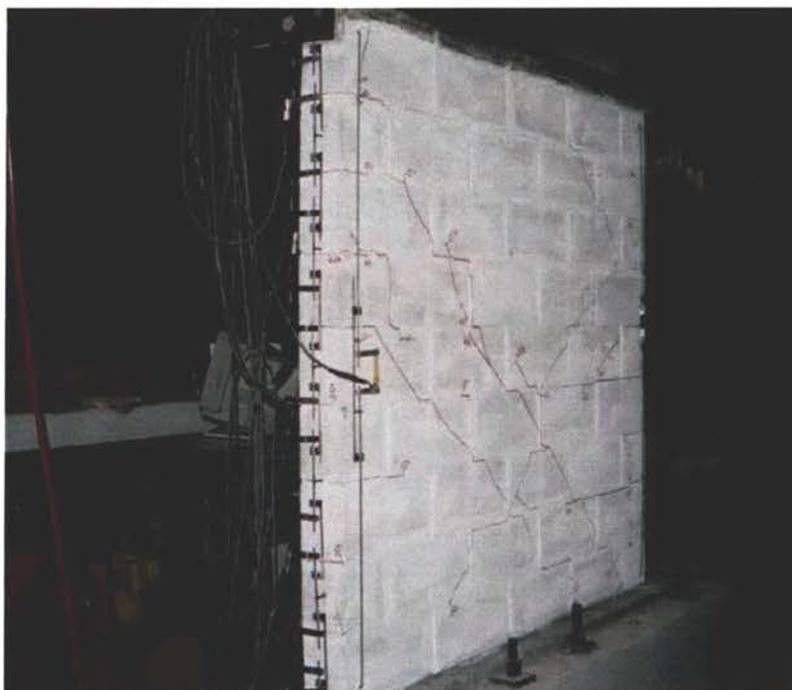
Photo 9 Diagonal cracking after first cycle of ± 4 mm displacement.

4.0 mm push, 1st cycle (see Photo 9, Appendix G)

4.0 mm pull, 1st cycle (see Photo 9)

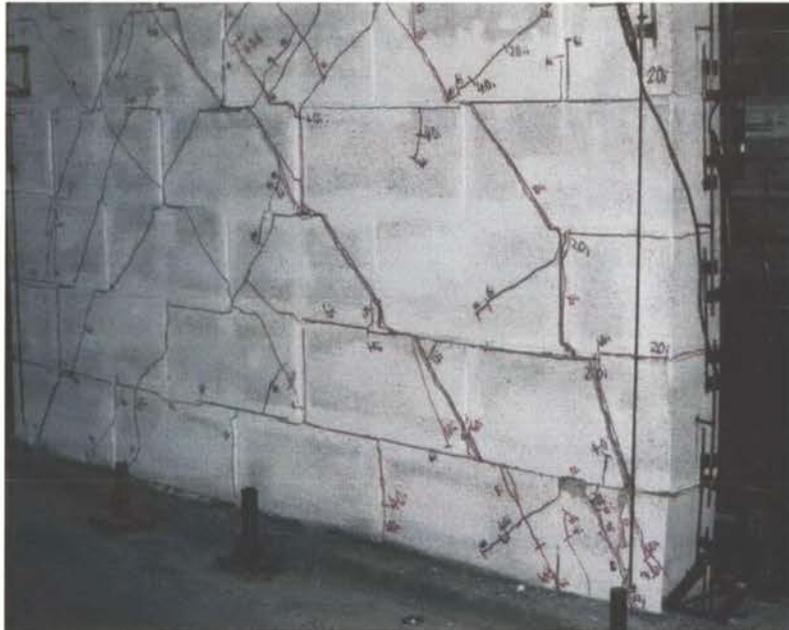
Photo 11 Compression toe degradation at +10 mm displacement.

10 mm push, 1st cycle (see Photo 11)

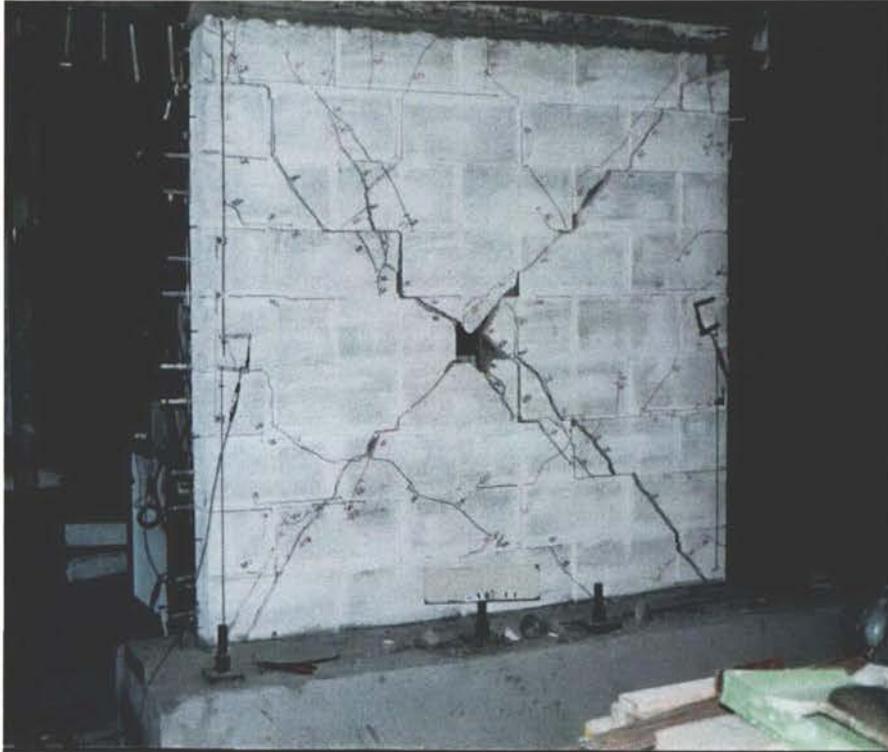
Photo 15 Crushing of masonry at second cycle of -10 mm displacement.

10 mm pull, 2nd cycle (see Photo 15)

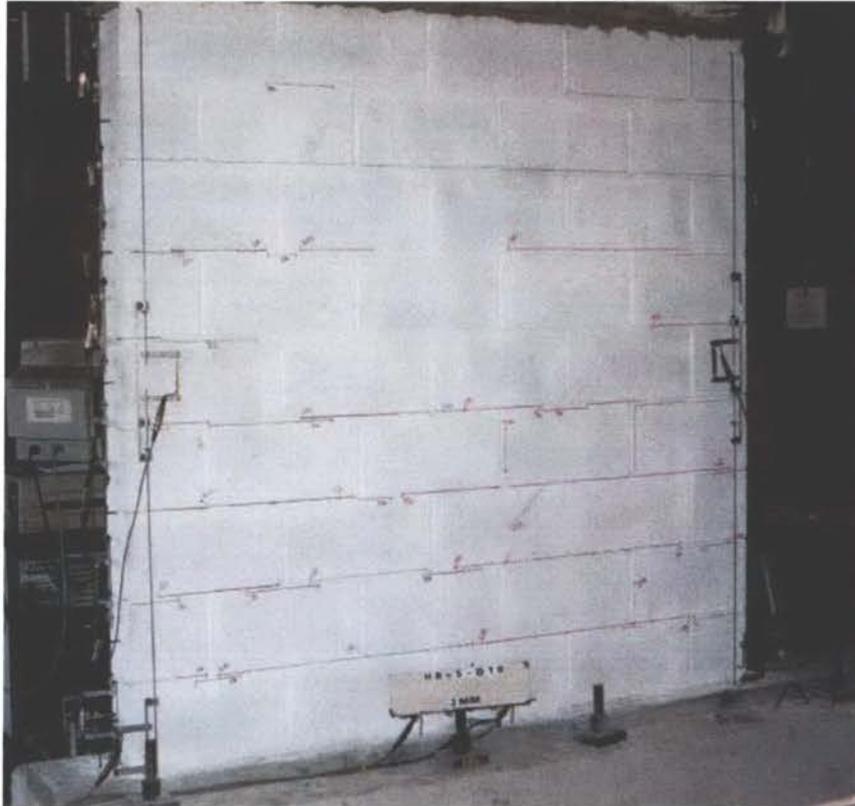
Photo 17 Condition of test wall after first cycle to ± 2 mm displacement.

2.0 mm push, 1st cycle (see Photo 17)

2.0 mm pull, 1st cycle (see Photo 17)

As shown in Photo 17, the wall's response mirrored that of the previous push cycle. The wall developed a maximum strength of -135 kN for this load step.

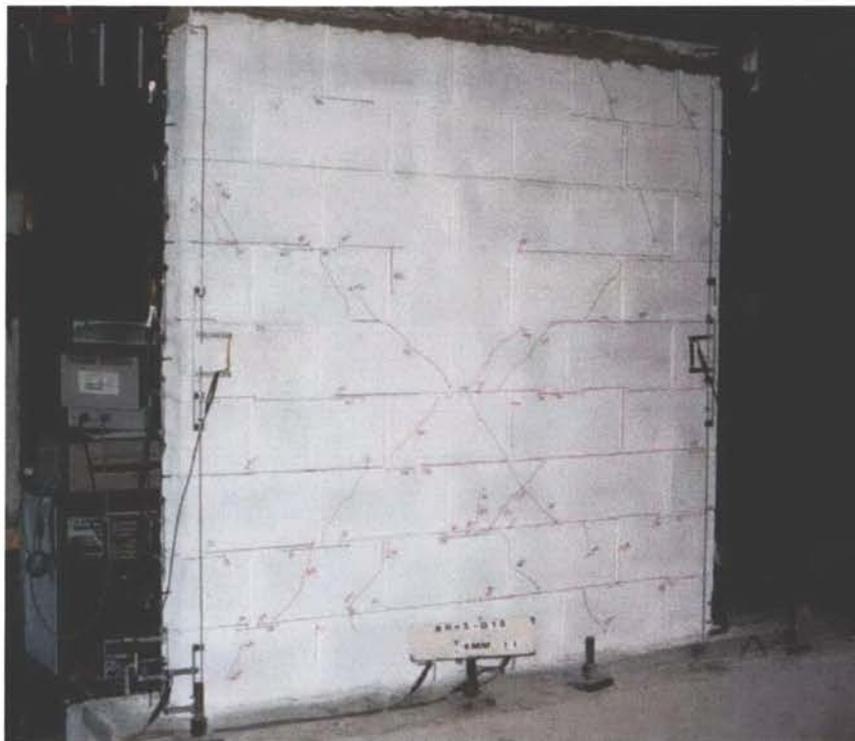
Photo 18 Formation of x-shaped diagonal crack after first cycle to ± 4 mm displacement.

4.0 mm push, 1st cycle (see Photo 18)

4.0 mm pull, 1st cycle (see Photo 18)

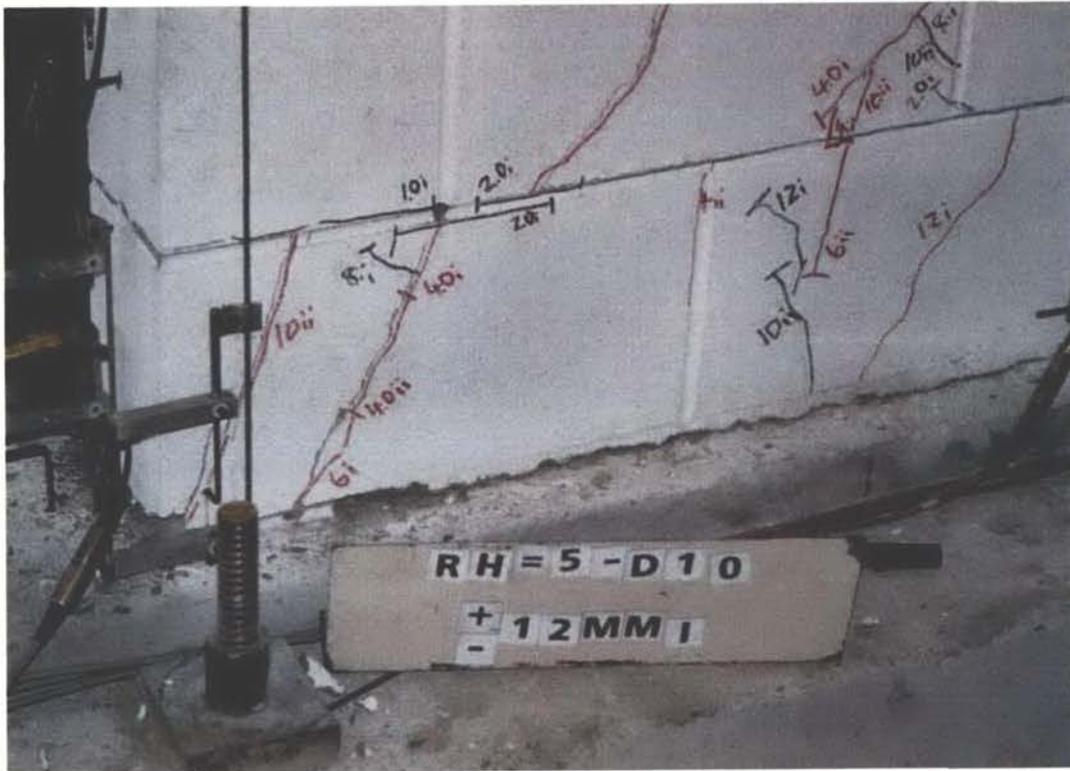
Photo 19 Wall toe condition after first cycle to ± 12 mm displacement.

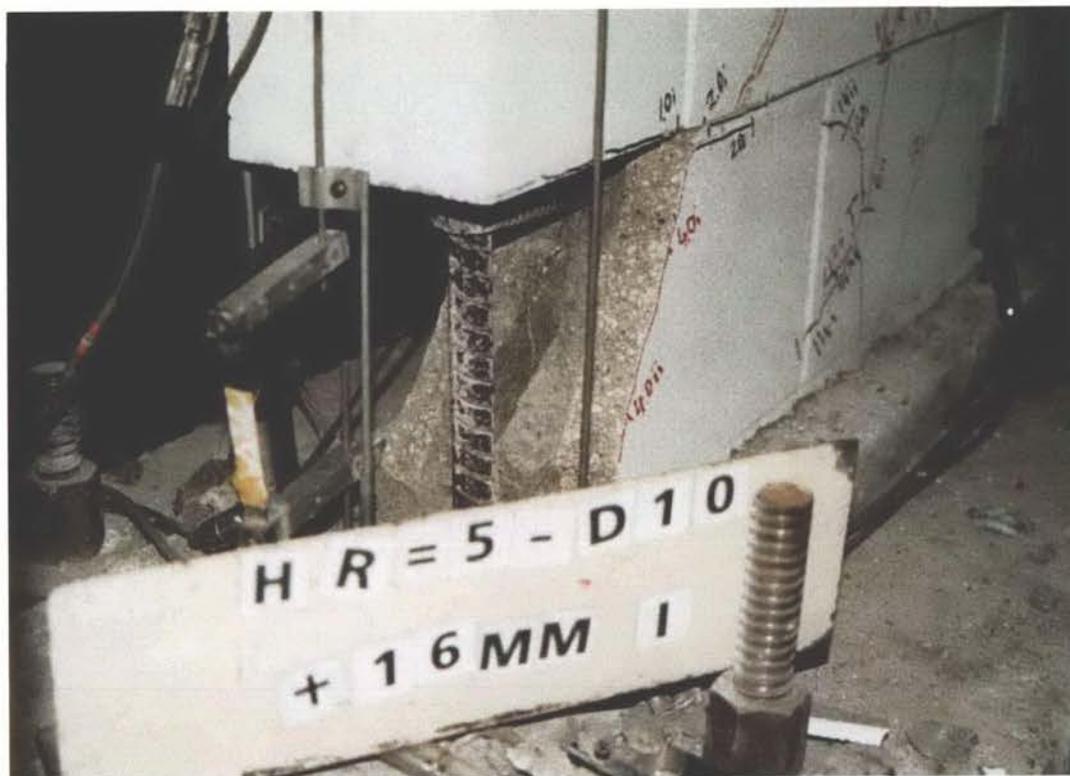
Photo 20 Wall toe condition after first push cycle to 16 mm displacement.

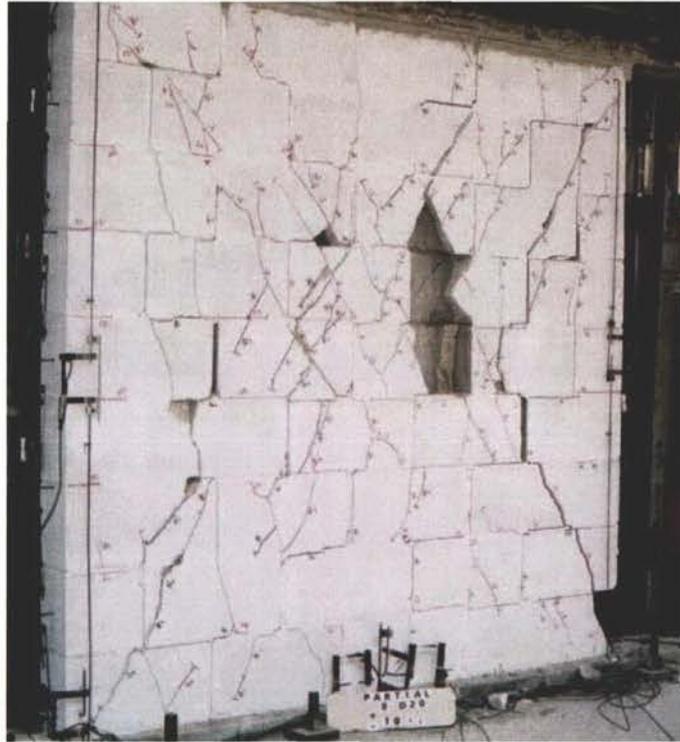
Photo 27 Wall condition after second cycle to ± 10 mm displacement.

10 mm push, 2nd cycle (see Photo 27)

10 mm pull, 2nd cycle (see Photo 27)

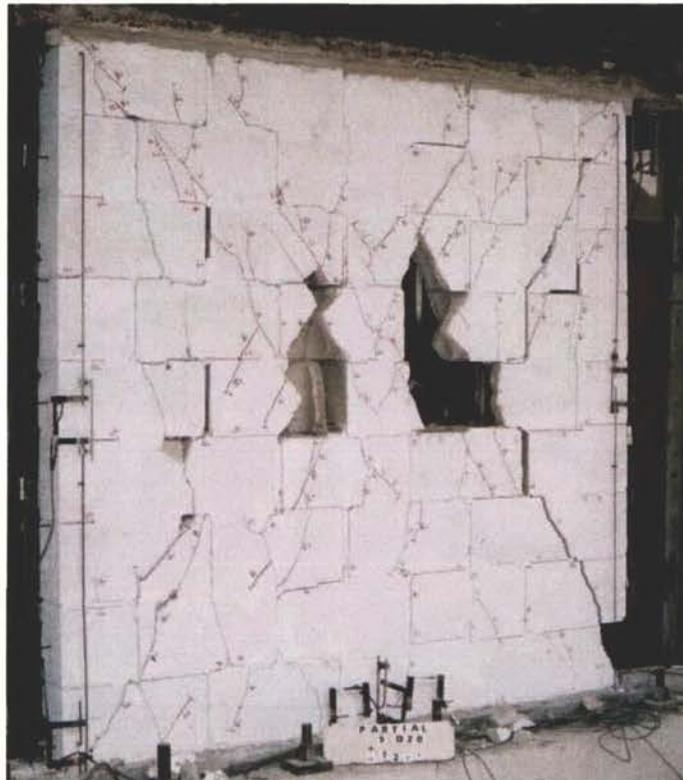
Photo 28 Wall condition after second cycle to ± 12 mm displacement.

12 mm push, 2nd cycle (see Photo 28)

12 mm pull, 2nd cycle (see Photo 28)

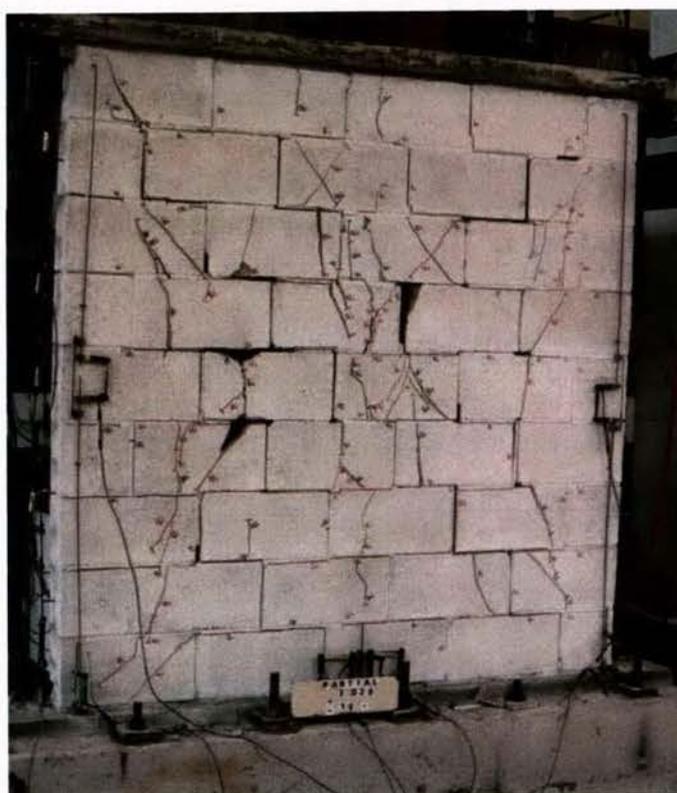
Photo 30 Condition of test wall after first cycle to ± 16 mm displacement.

16 mm push, 1st cycle (see Photo 30)

16 mm pull, 1st cycle (see Photo 30)

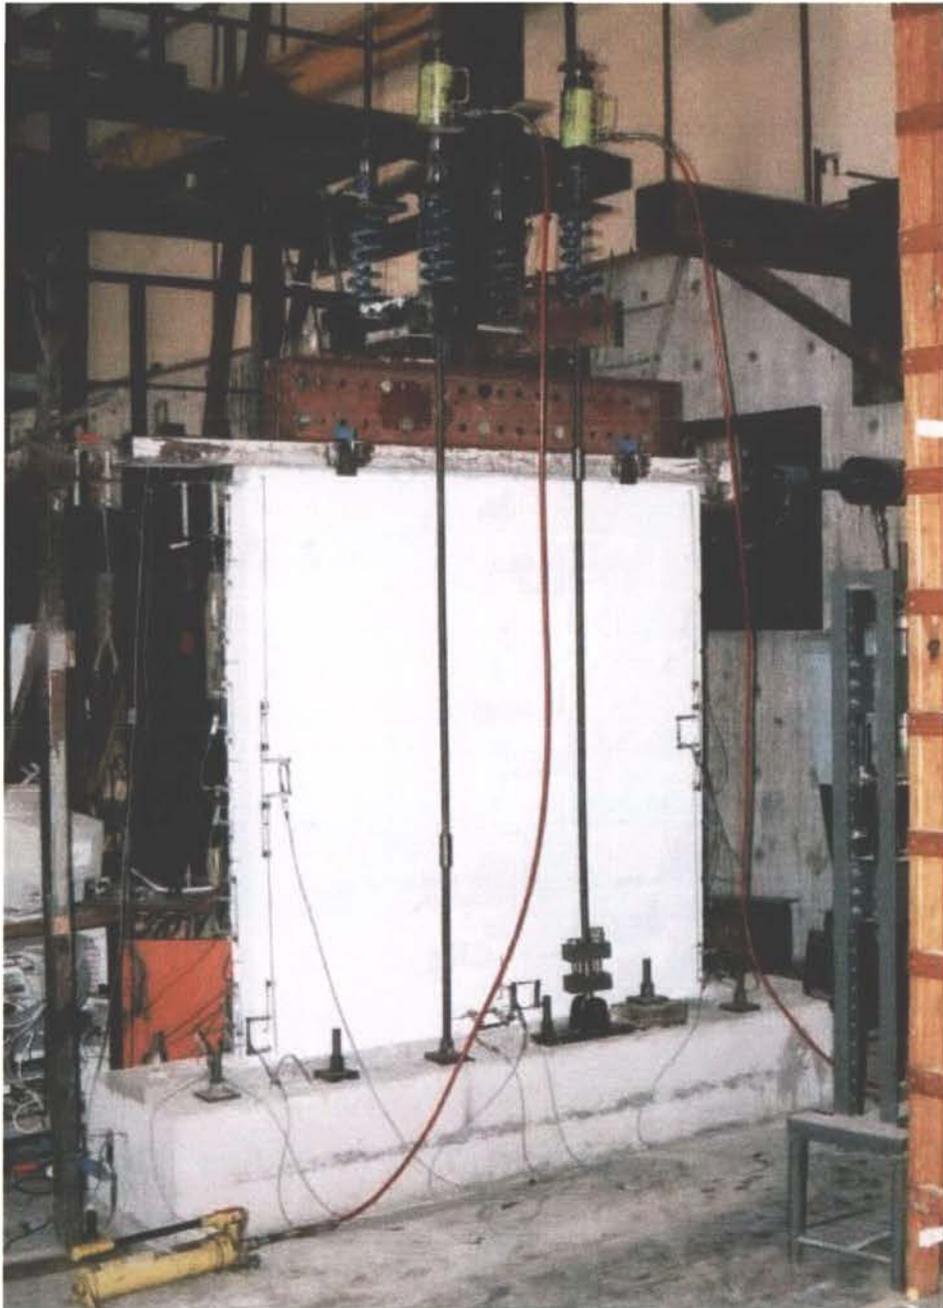
Photo 31 Test set-up for Wall 7.

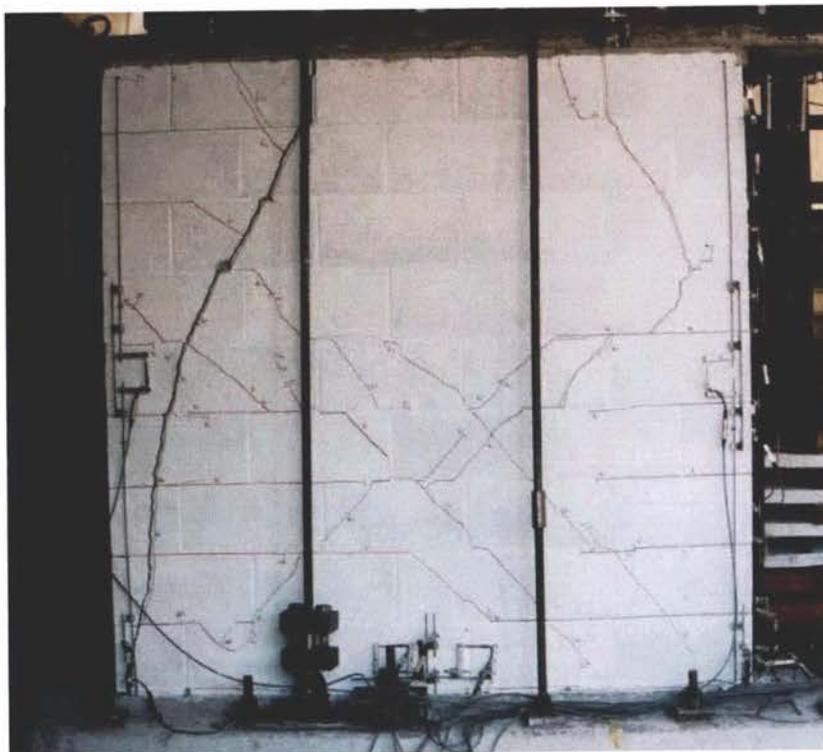
Photo 37 Condition of test wall after first cycle to -6 mm displacement.

6.0 mm pull, 1st cycle (see Photo 37)

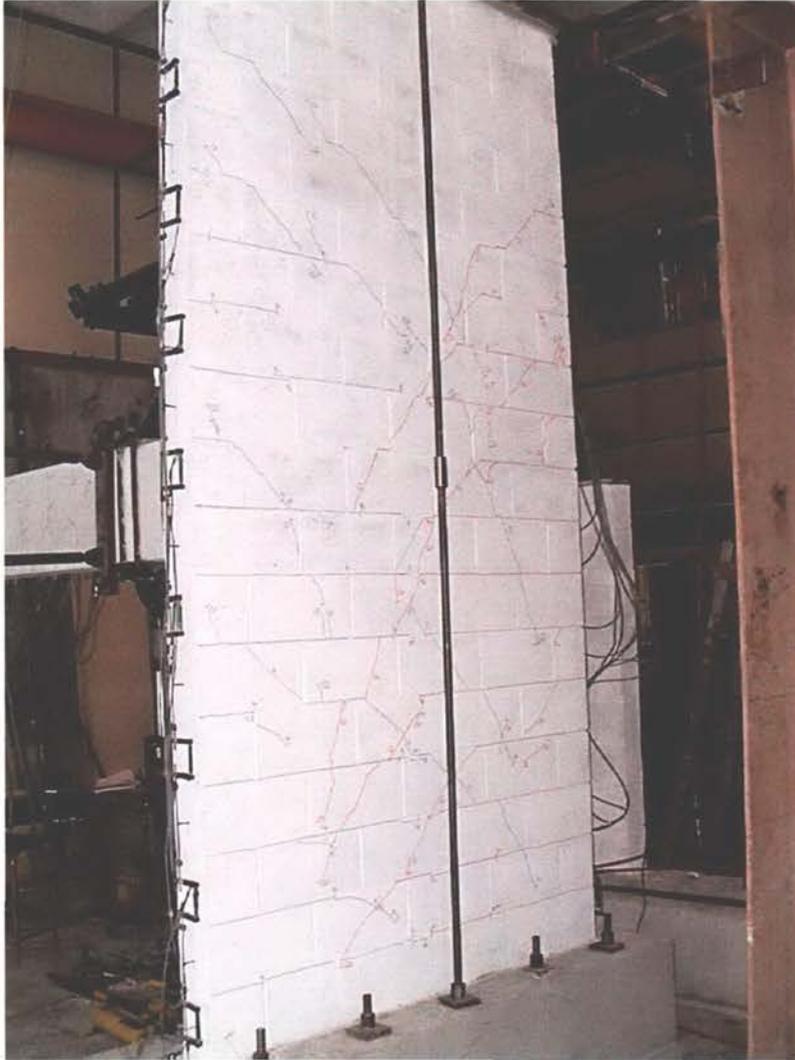
Photo 39 Condition of test wall after first cycle to ± 12 mm displacement.

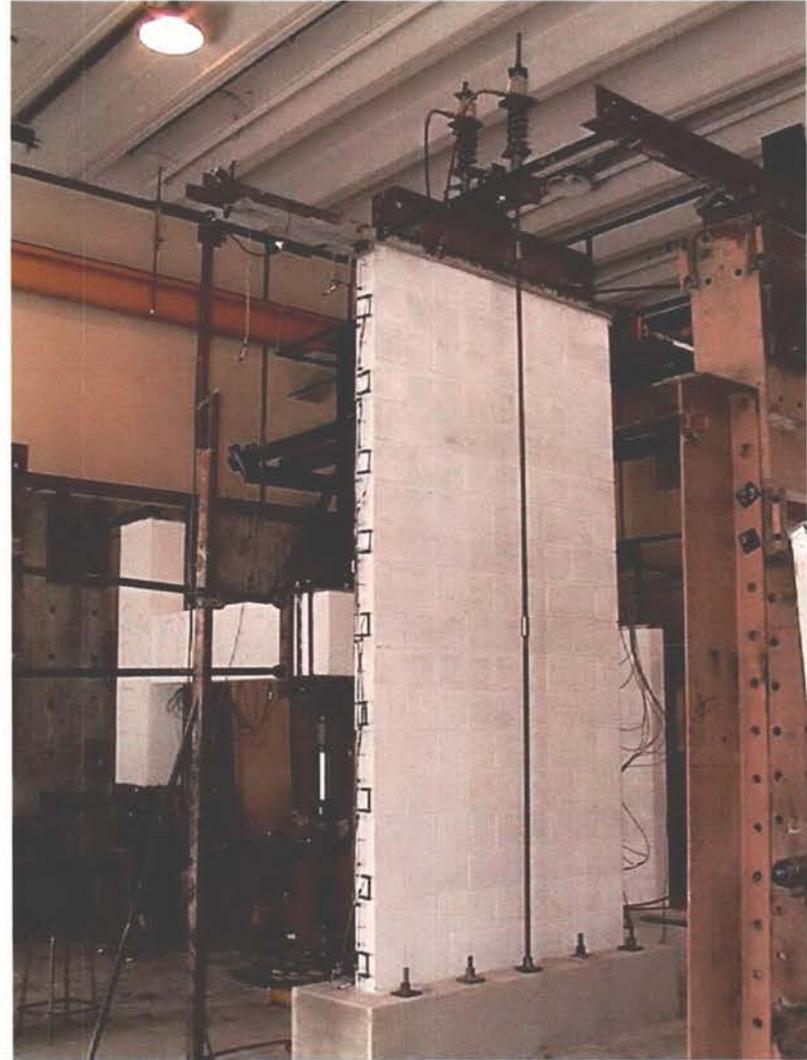
Photo 38 Test set-up for Wall 9.

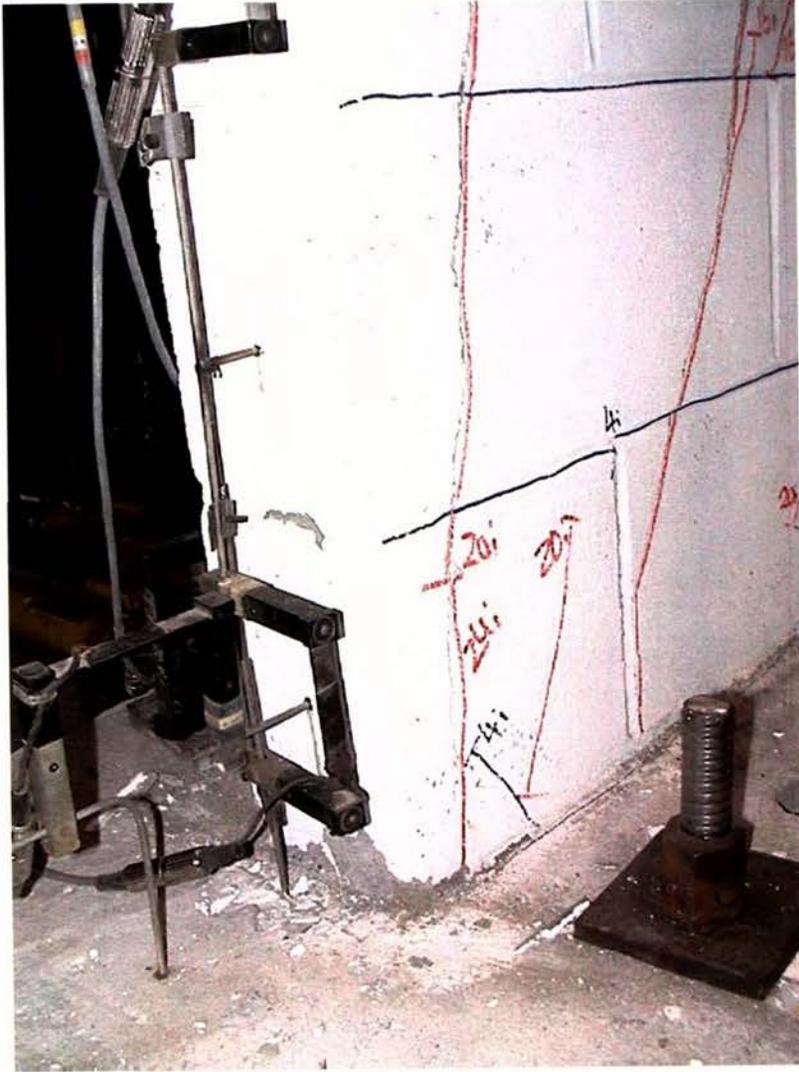
Photo 41 Condition of test wall after first cycle to ± 24 mm displacement.
