THE UNIVERSITY OF AUCKLAND
NEW ZEALAND

Department of
Civil and
Environmental
Engineering

**SHEAR STRENGTH OF CONCRETE
MASONRY WALLS**

School of Engineering
Report No. 611

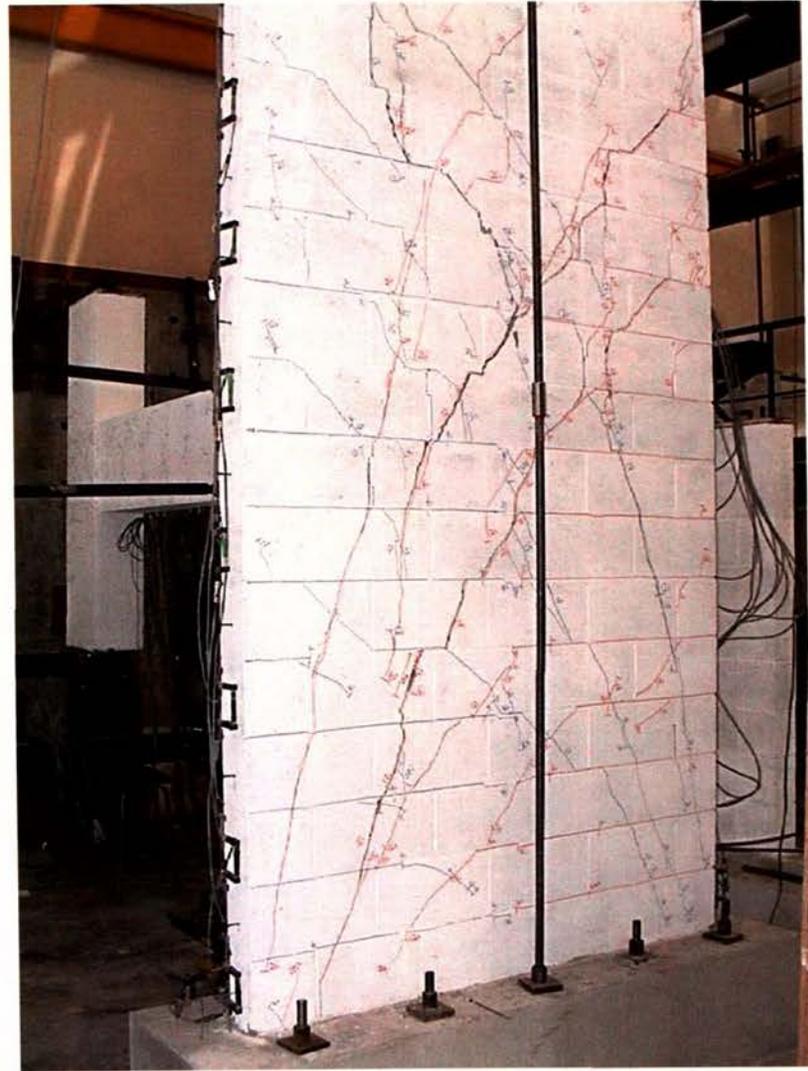
Photo 40 Condition of test wall after first cycle to ± 20 mm displacement.

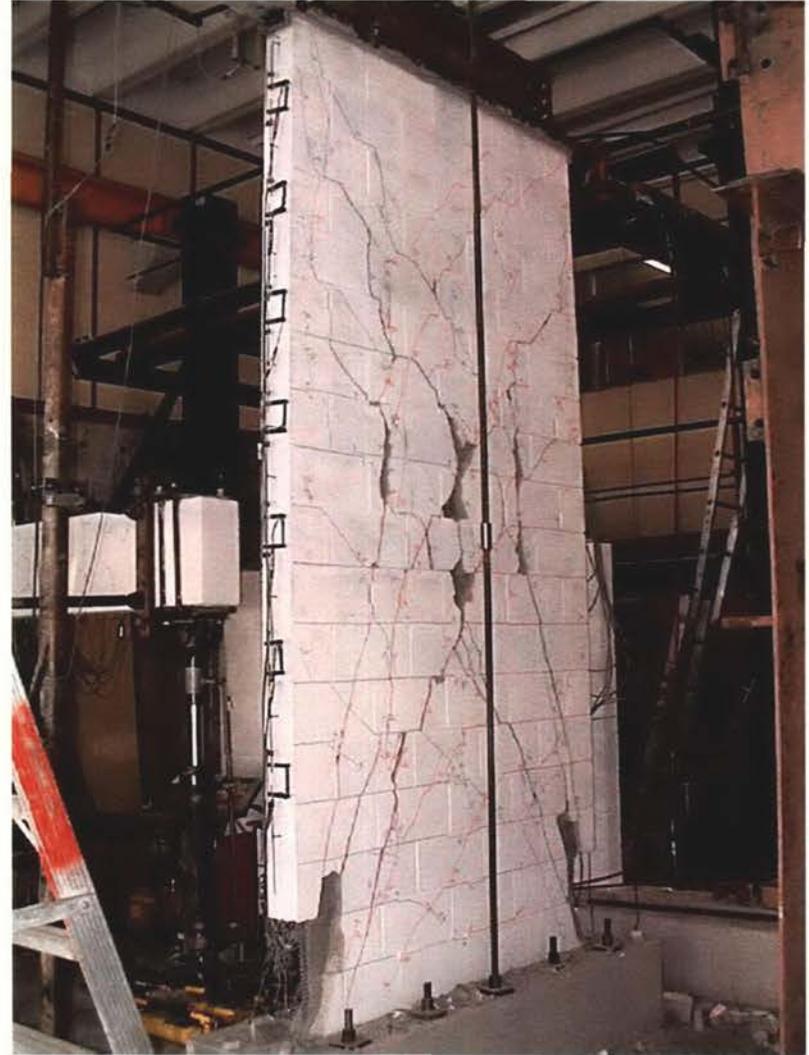
Photo 42 Condition of test wall after first cycle to ± 32 mm displacement.

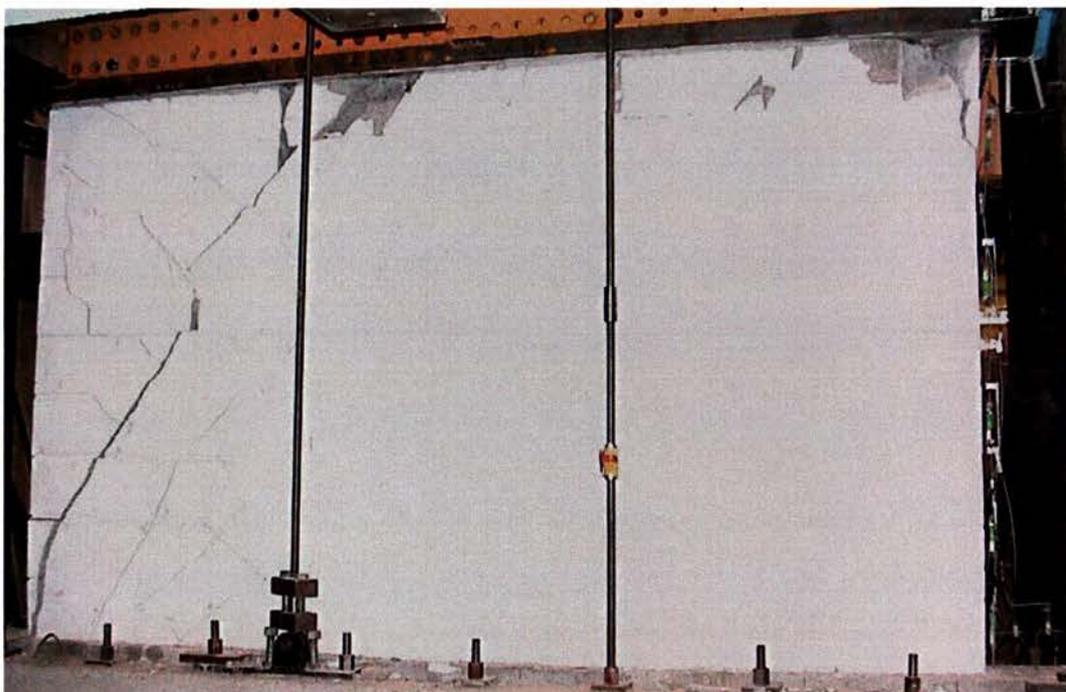
Photo 43 Condition of test wall at end of testing.

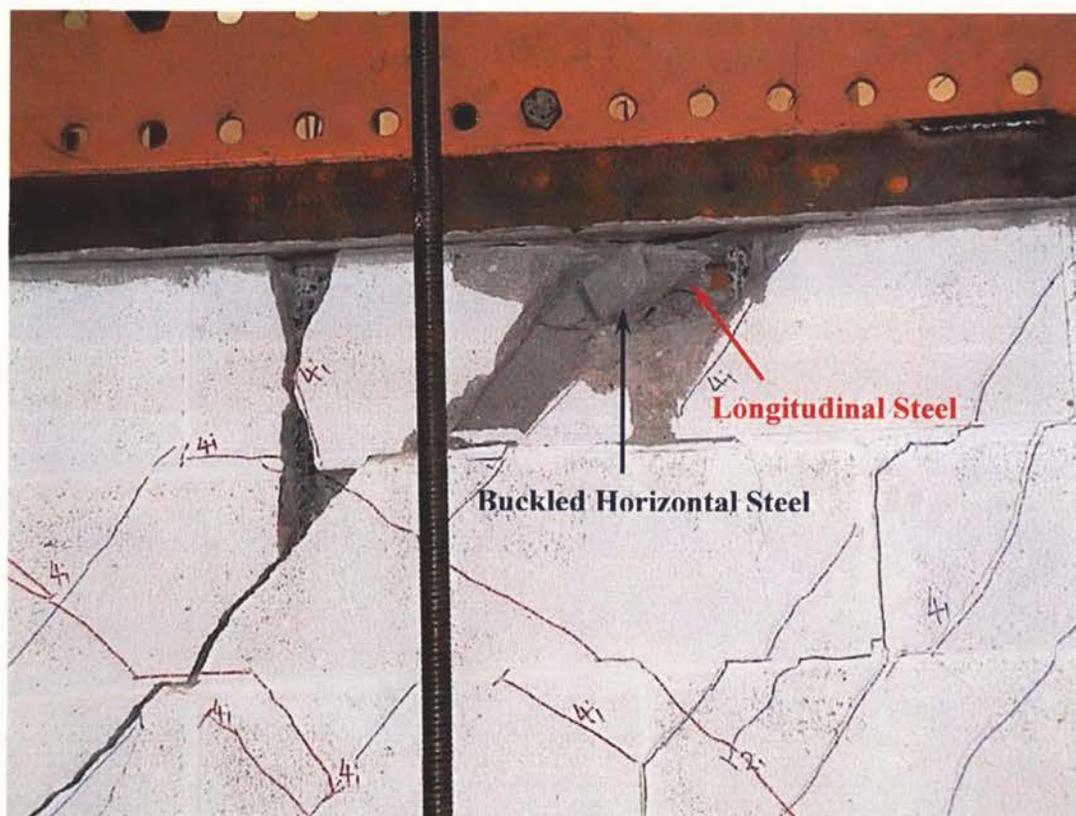
Photo 44 Crushing of masonry at bond beam layer exposing reinforcing steels.
