Design of Ductile Reinforced Concrete Moment Resisting Frames Using Grade 500E Reinforcement

April 2005

School of Engineering
Report No. 617

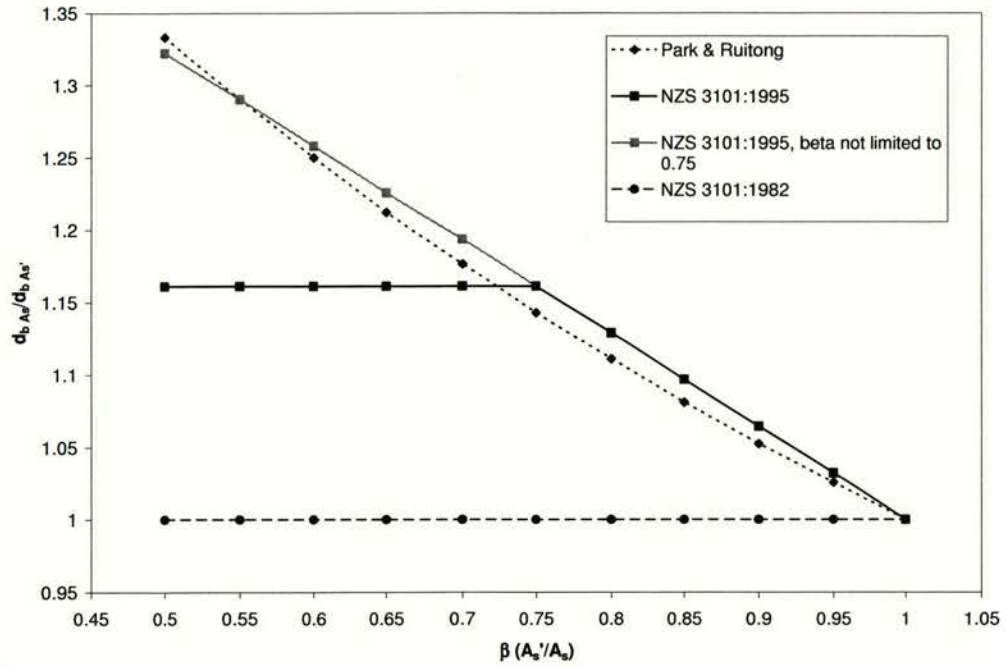
Figure 2-4 Ratio of allowable size of top and bottom reinforcement for different design methods

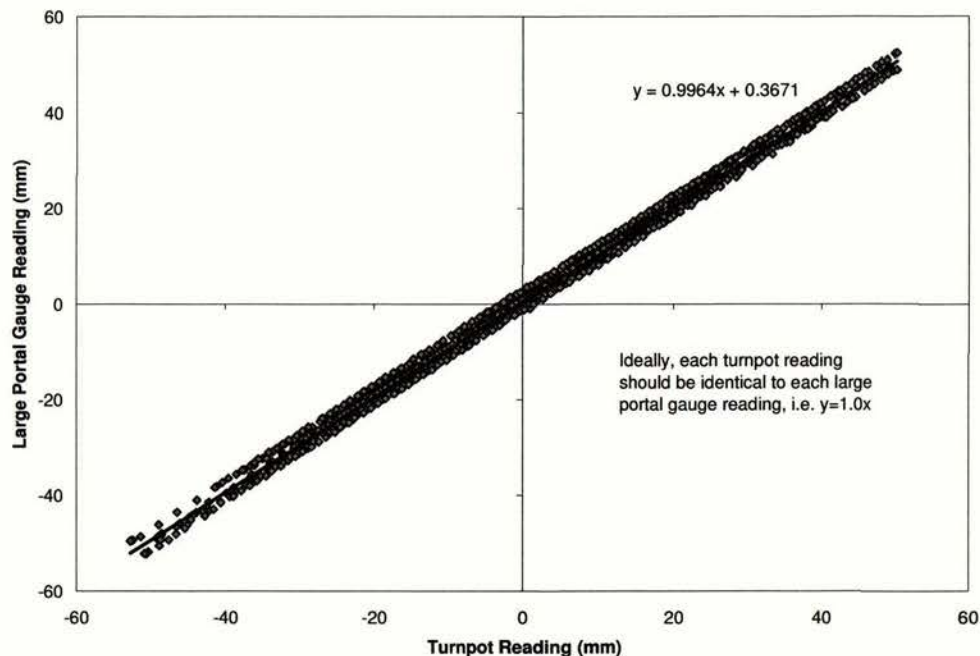
Figure 4-3 Readings of turnpot vs. large portal gauge at beam ends

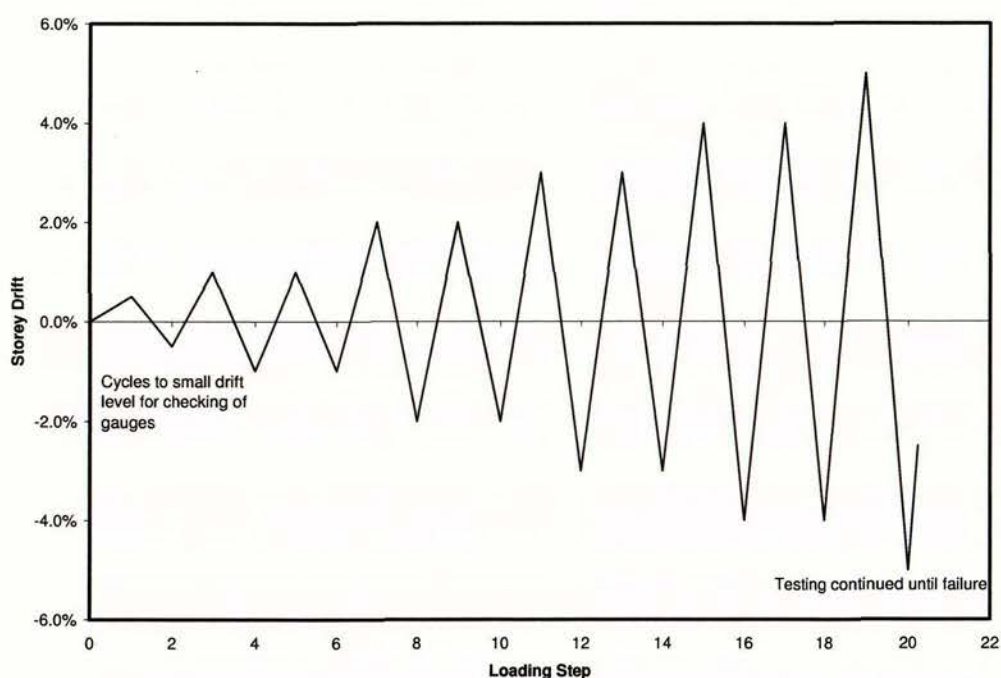
Figure 4-4 Loading history used for units 1B-4B

If there were no apparent problems, loading was continued with two complete (i.e. positive peak to negative peak) loading cycles to 1.0% drift, followed by an increase of the drift level by 1.0% and two more complete cycles. This process was repeated until failure occurred.

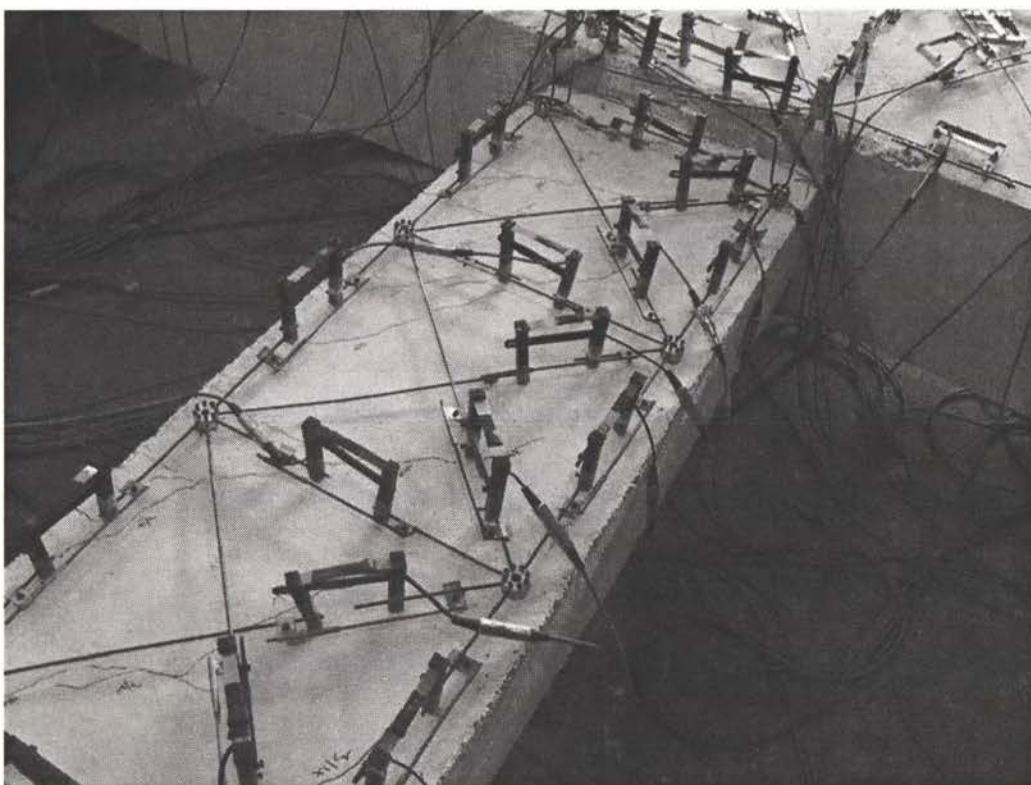
Figure 5-1 Cracking of right hand beam during first cycle to $3/4 M_n$

Upon release of the load, the residual deformation for the left and right beams was approximately 15.4 mm and 21 mm respectively, again indicating yielding had occurred in the beams.

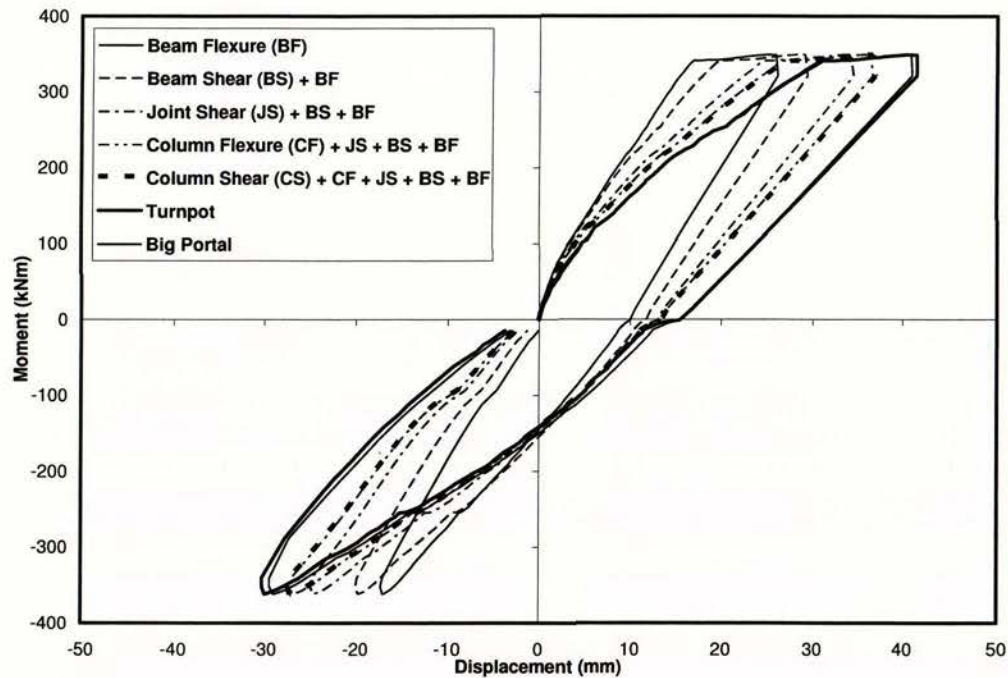
Figure 5-2 Components of displacement for left hand beam, first cycle

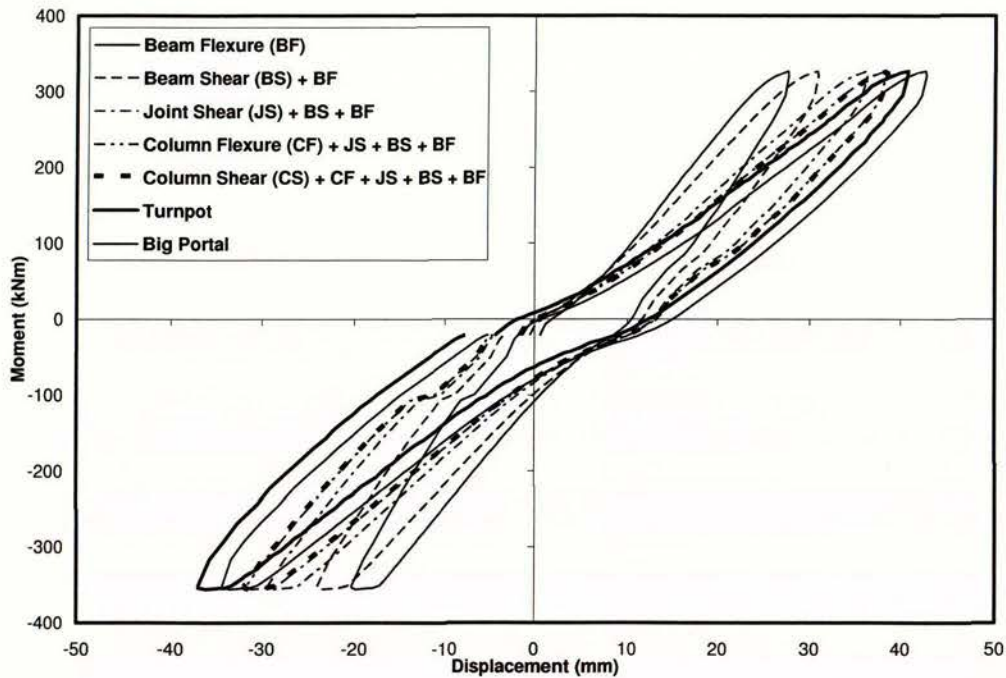
Figure 5-5 Left hand beam displacements for 40 mm push and pull cycles

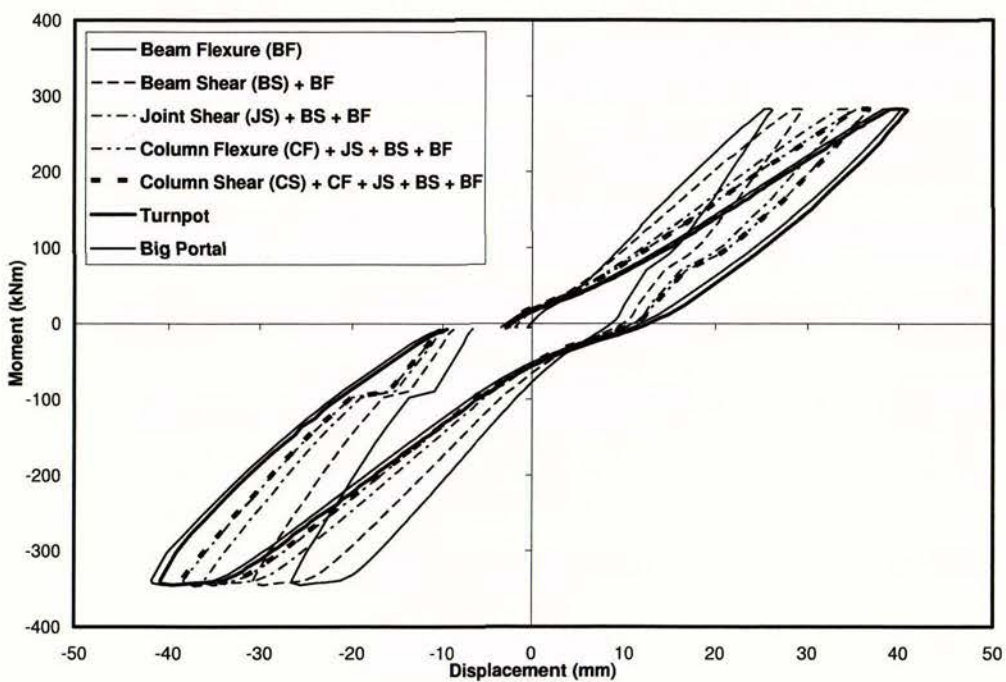
Figure 5-6 Right hand beam displacements for 40 mm push and pull cycles

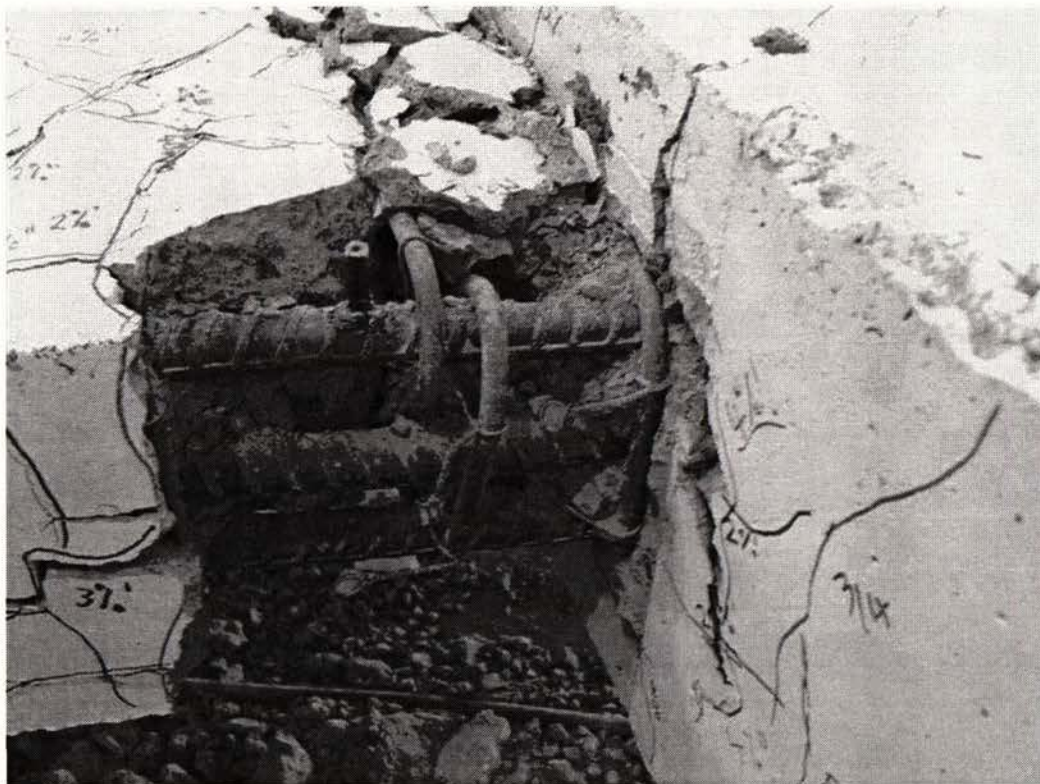
Figure 5-18 End condition of right hand plastic hinge zone showing loss of concrete

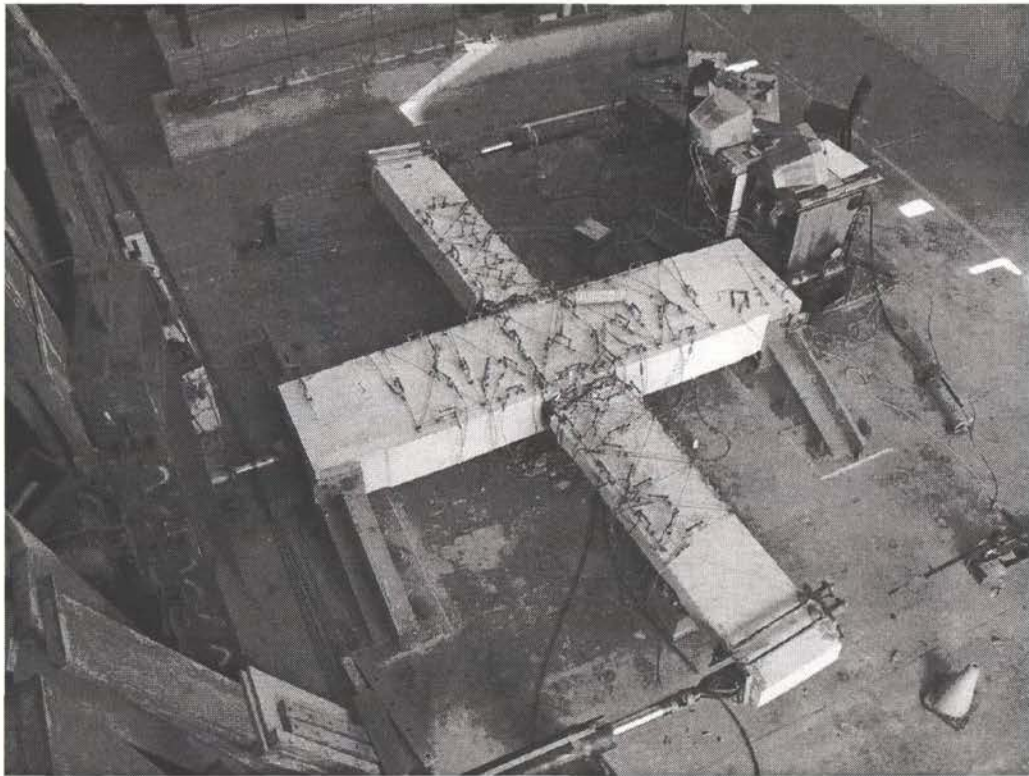
Figure 5-29 Unit 2B at 5% drift showing torsional distortion of both beams
