On improving the seismic performance of precast concrete frames

Final Report to EQC

**ON IMPROVING THE SEISMIC PERFORMANCE OF
PRECAST CONCRETE FRAMES**

February 2006

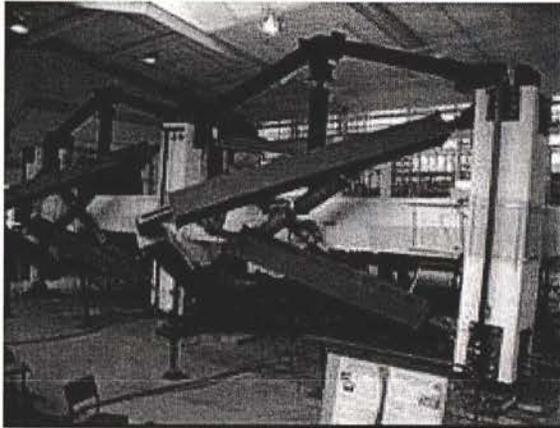
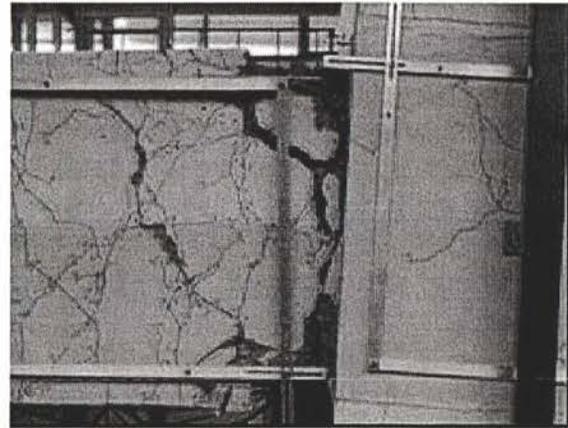
(a) Super-assemblage specimen at +5% interstorey drift.

(b) Damage at the southeast beam-column interface (plastic hinge zone) at +5% interstorey drift

Damage near the end of the super-assemblage test specimen

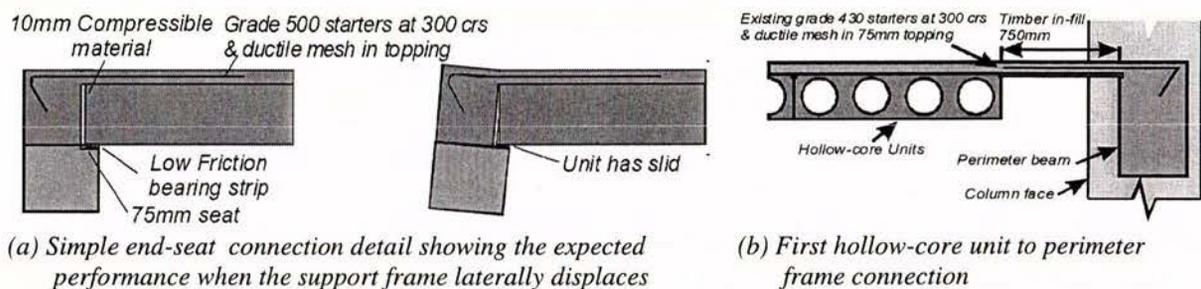
The first of these experiments [9], which was partially supported by EQC funding, investigated a simple (flexible) floor-to-support beam connection as shown in Figure 1.

Figure 1. Simple hollow-core seating connection details [4,5 and 9].

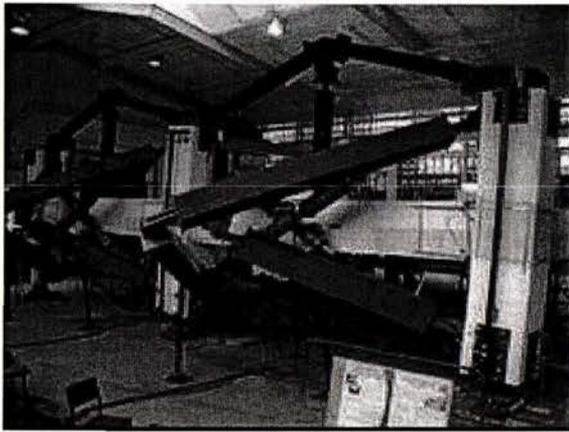
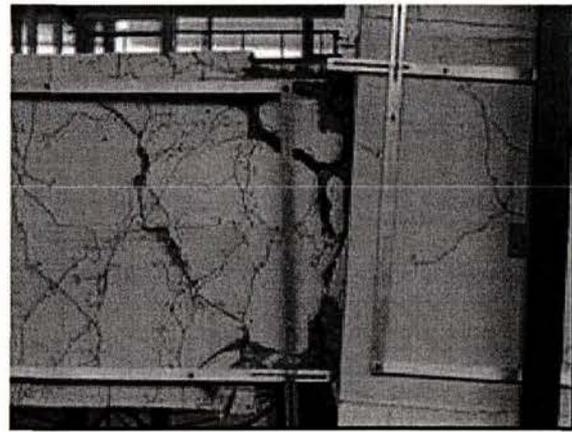
(a) Super-assemblage specimen at +5% inter-storey drift.

(b) Damage at the southeast beam-column interface (plastic hinge zone) at +5% inter-storey drift

Figure 3. Damage of the super-assemblage test specimen

Both experimental specimens performed well under the imposed simulated seismic loading. Although damage was observed, it was of the sort one would expect for a well designed cast-in-place concrete structure. Through post-experiment analysis [3, 9, 10] it was shown that all of the damage patterns were explainable and could be predicted using customary engineering theories. For both proposed construction details it was confirmed that the ultimate goal of achieving life-safety in extreme earthquake events was met, as the specimens were capable of deflecting well beyond the most adverse design limits. An example of the appearance of the last experiment, while under test, at an inter-storey drift limit of 5 percent—which is well beyond the required 3.5 percent drift limit to survive the MCE—is shown in Figure 3.

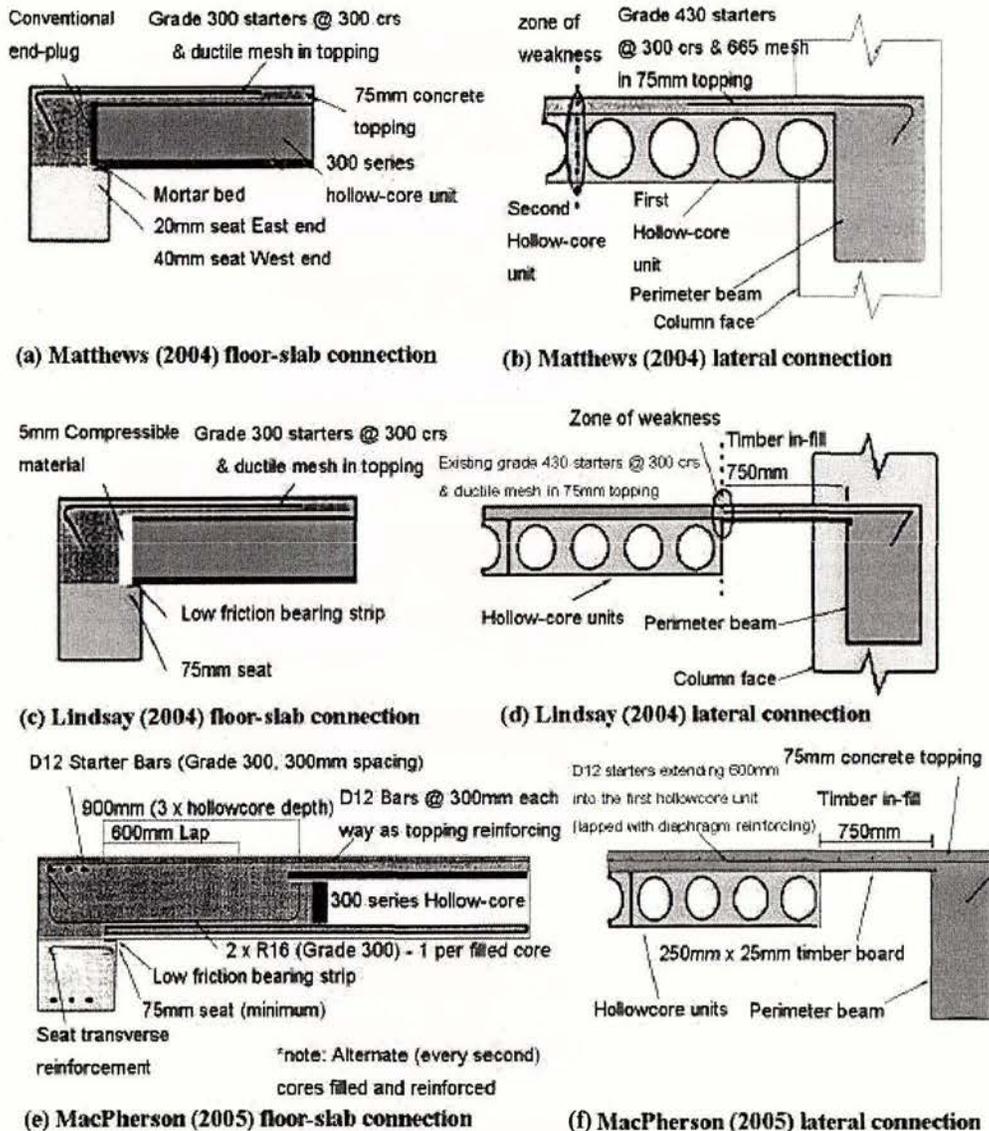
Figure 1: Hollowcore connection details used by Matthews [6], Lindsay [7] and MacPherson [8].

3. Isolating the first hollow-core unit spanning parallel to the perimeter beams from the frame to avoid displacement incompatibility (Figure 1d). This displacement incompatibility was caused by the units being forced to displace in a double curvature manner due to being effectively connected to the edge of the perimeter beam, when hollow-core units are not designed for such displacement profiles.

1. A reinforced connection that rigidly ties the floor into the supporting beam (Figure 1e).
2. An articulated topping slab portion cast on a timber infill that runs parallel to and connects the hollow-core units and edge beams (Figure 1f).
3. Specially detailed supporting beam plastic hinge zones to reduce potential damage to the hollow-core units
4. Grade 500E reinforcing steel used in the main frame elements
5. Mild steel deformed bars in the concrete topping in lieu of the customary welded wire mesh.

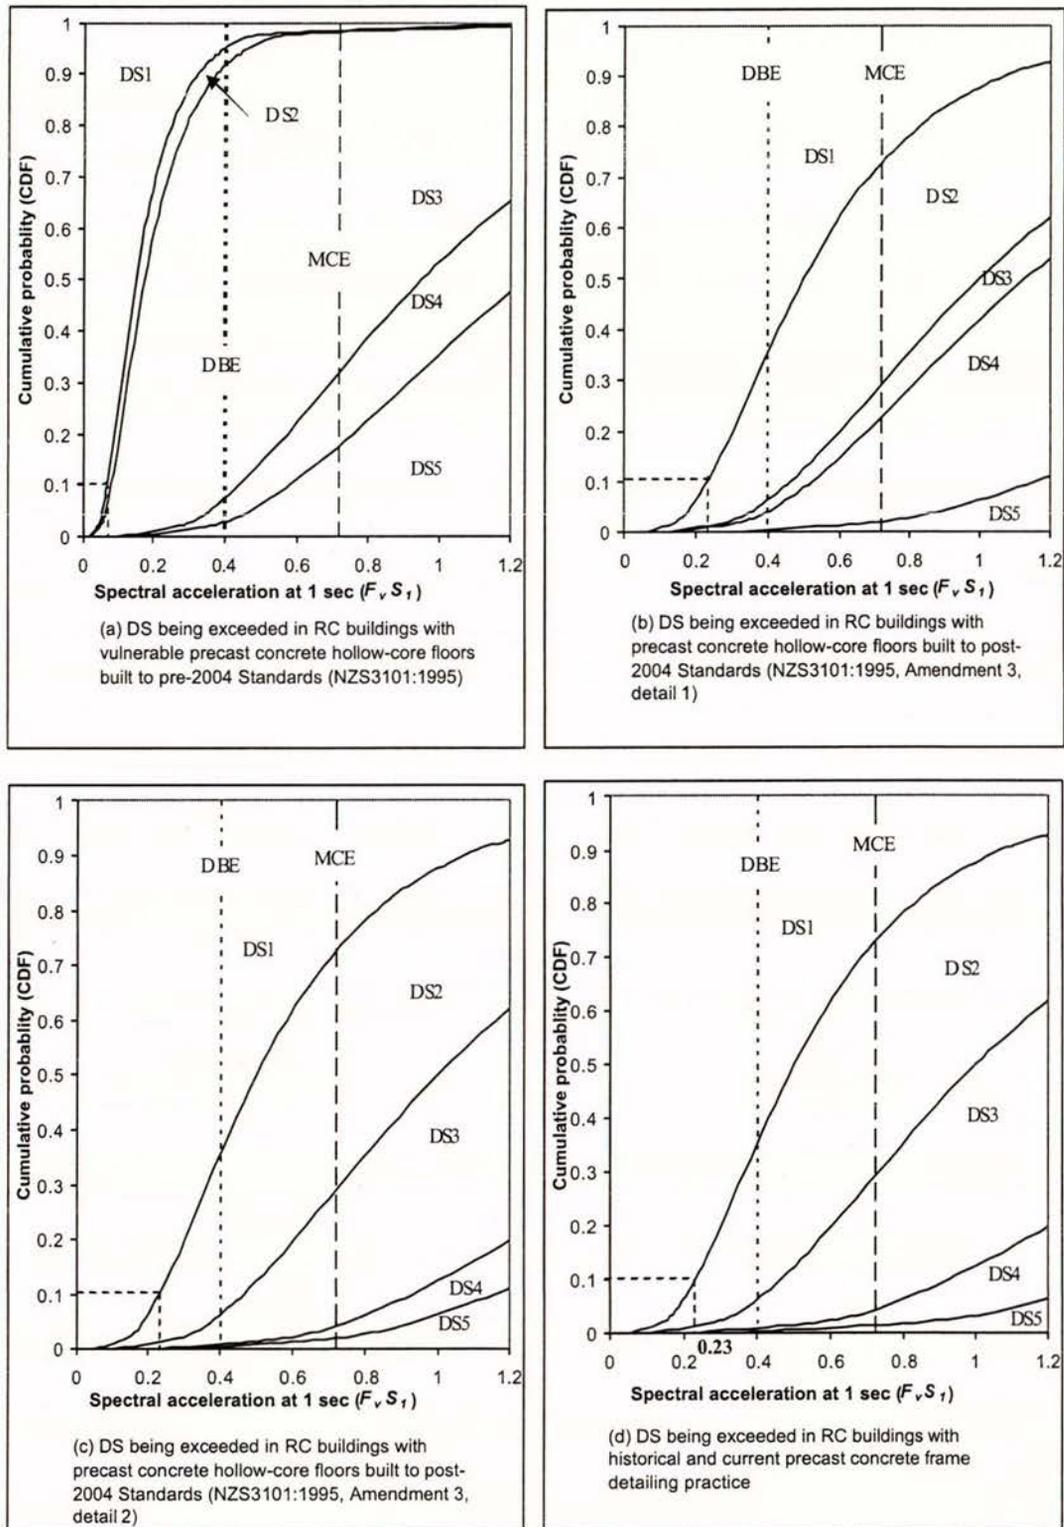
Figure 3: Fragility Curves for New Zealand multi-storey RC buildings related to the HAZUS damage states.

Figure 3a shows that due to the poor performance of the precast hollow-core floor with old reinforcing and connection details only 2% of buildings with such details would be expected to sustain slight or no damage (within damage state DS2) during an MCE. The remaining 98% buildings would be expected to experience moderate to severe damage (above damage state DS2), of these some 32% would be expected to partially or entirely collapse requiring demolition of the building (above damage state DS4). Similarly it is also evident from Figure 3a that even under a DBE, only 4% of these buildings would escape damage whereas some 8% buildings may still be irreparably damaged or collapsed potentially leading to loss of life.

Figures 3b and 3c show the probability of different extent of damage if the buildings performance is classified in terms of the performances of the precast hollow-core floors with detailing 1 and detailing 2 of post-2004 amendment and the frame performance respectively. Figures 3b and 3c indicate that 70% of buildings with improved connection detailing might be expected to sustain either slight or no damage in an MCE. Figure 3b shows that 23% buildings with floor-frame connection detailing 1 would be expected to be severely damaged. On the other hand, probability of severe damage (DS4 or DS5) in an MCE for buildings with floor-frame connection detailing 2 or for similar buildings with perfect/no floor (i.e. damage contributed by the frame only) is only 4% as shown in Figures 3c and 3d. Under a DBE, 93% buildings with post-2004 floor-frame connection details might be expected to sustain repairable damage (see Figures 3b and 3c). This probability is the same in buildings with perfect/no floor (see Figure 3d) because the inter-storey drift corresponding to the DS2 -DS3 boundary is the same in Table 2 for the improved floor-frame connection (both detailing 1

and detailing 2) and for buildings with perfect/no floor. On the other hand, probability of heavy damage leading to partial collapse of buildings with post-2004 connection Detail 1 would be 4%, while only 1% buildings with connection Detail 2 and buildings with perfect/no floor frame detailing would be expected to suffer heavy damage in case of a DBE. Again, this is attributable to the same DS3-DS4 boundary for these two cases in Table 2.

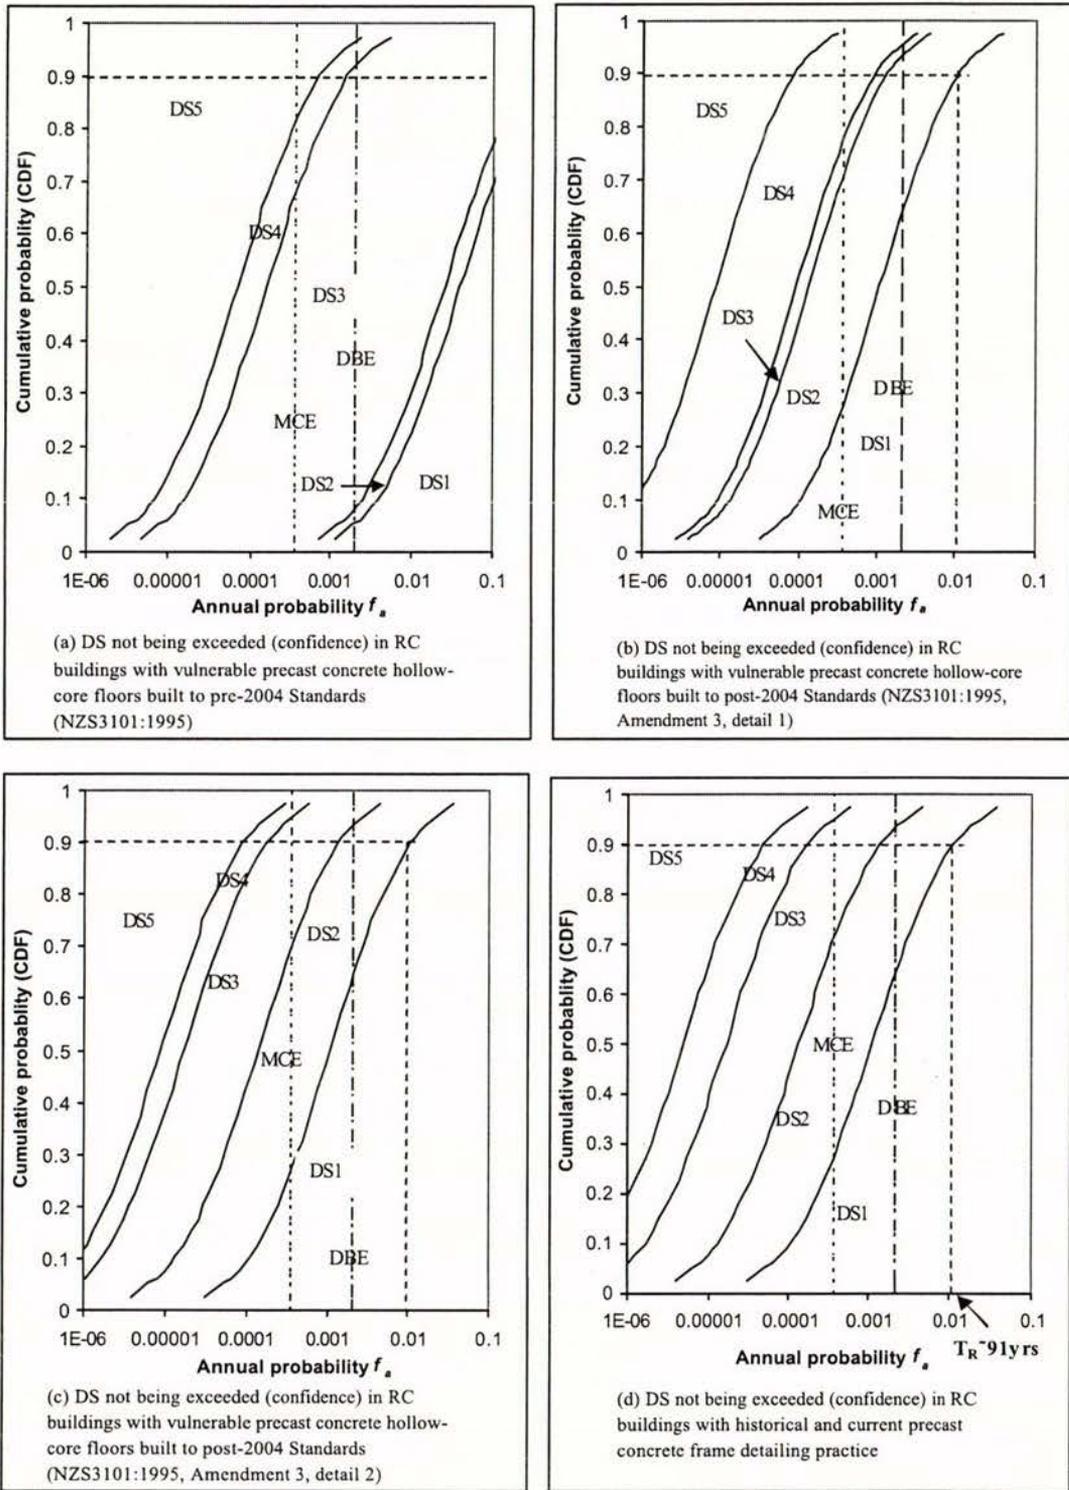
Figure 4: Hazard Survival Curves for New Zealand multi-storey RC buildings related to the HAZUS damage states.

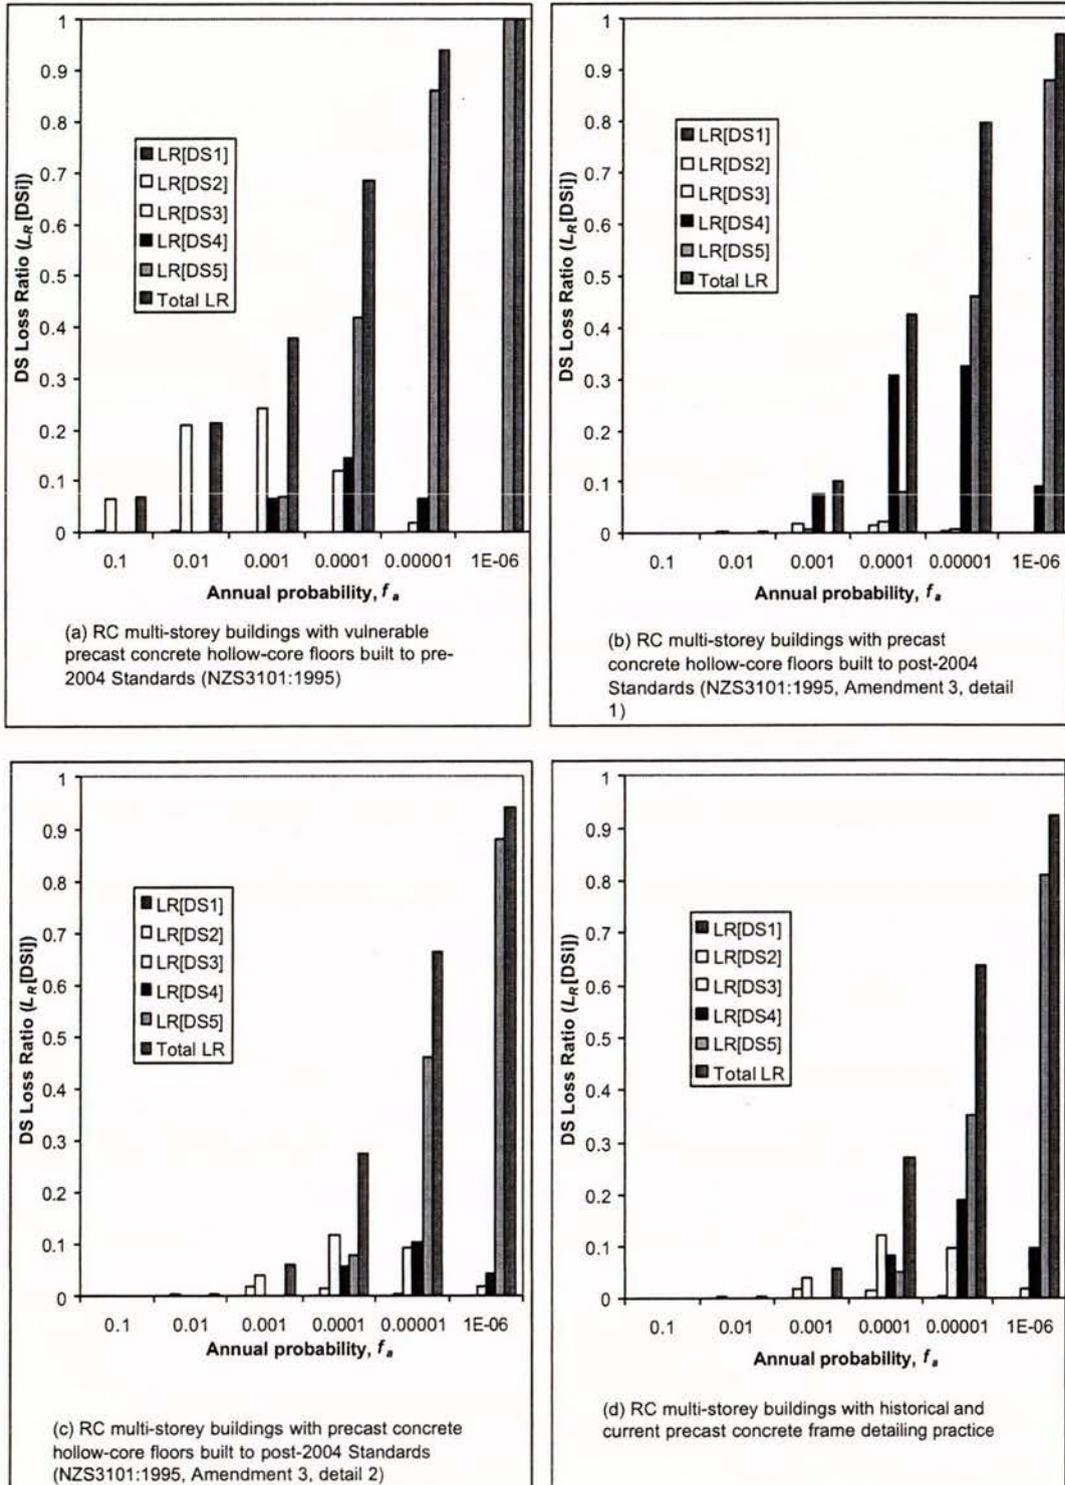
Figure 5: Economic Hazard Probability Curves (Bar Charts) for New Zealand multi-storey RC buildings related to the HAZUS damage states

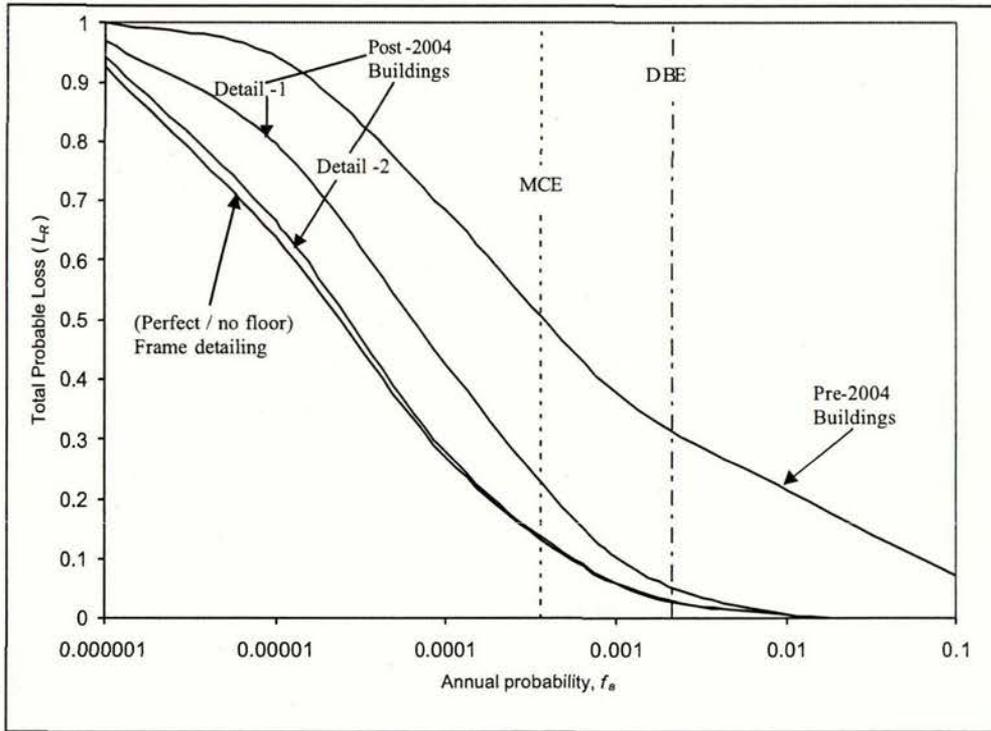
Figure 6: Economic Hazard Probability Curves for New Zealand multi-storey RC buildings

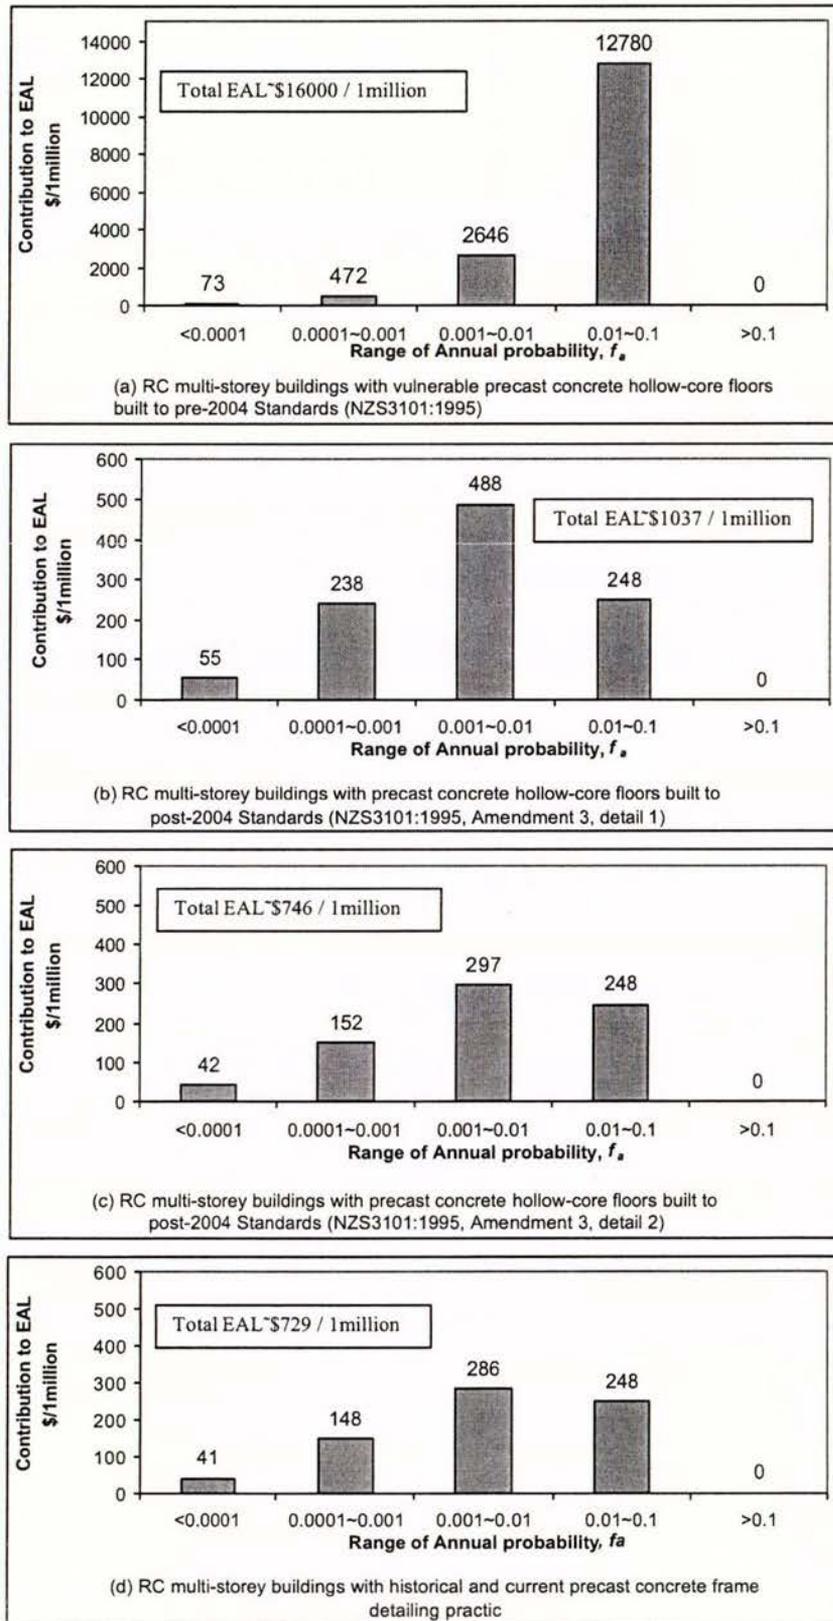
Figure 7: Annual financial risk for New Zealand multi-storey RC buildings due to earthquakes of different probability.

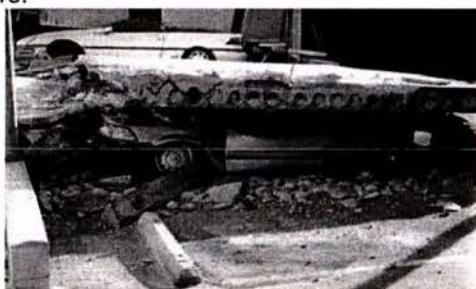
(a) Complete collapse of a floor slab

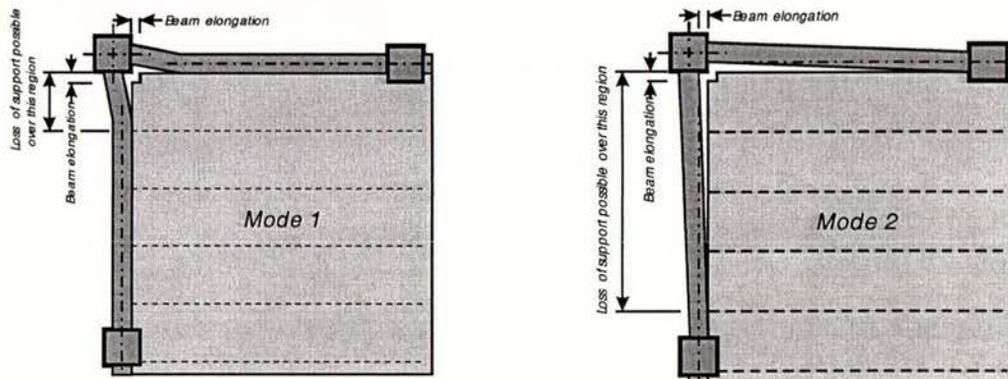
(a) Beam plastic hinge rotates to allow for beam elongation

Two possible mechanisms are expected to occur. The first, and most likely, is where the beam rotates out about the plastic hinge zone next to the corner column. If this occurs then the number of units that loose their seating will be low and will only be a problem in the corners of buildings. This is referred to as a "Mode 1" mechanism as shown in Fig.4(a). The second mechanism is where the entire beam rotates as shown in Fig.4(b). The mechanism could lead to more units being pulled off their support. This is referred to as a "Mode 2" mechanism.

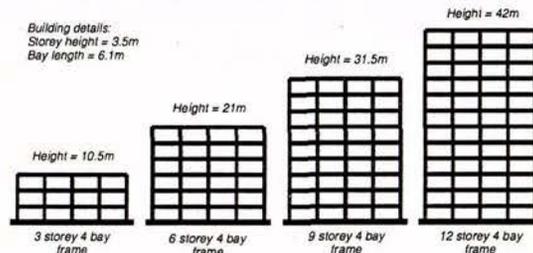
Fig.6 Buildings analysed

Therefore, an analytical study has been undertaken on four different building heights (Fig.6) using numerous earthquake records to determine the expected demand on the sample precast concrete buildings. The earthquake records used in the analytical study have included both near and far field effects. Some records were scaled so that they represented the amount of energy expected from a New Zealand earthquake. From these results it is possible to determine a more realistic loading history that better matches the expected cyclic capacity with the demand.

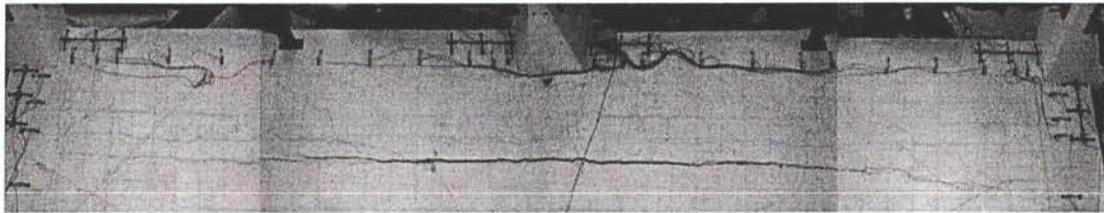
(a) Longitudinal tear that formed at 1.9% drift.

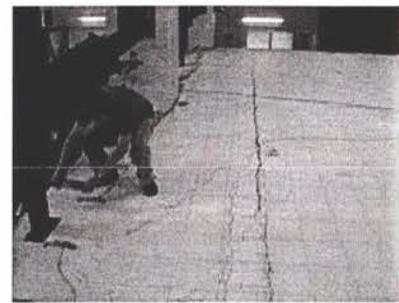
(d) Longitudinal view of floor slab tear at the end of Phase I (-2.0%)

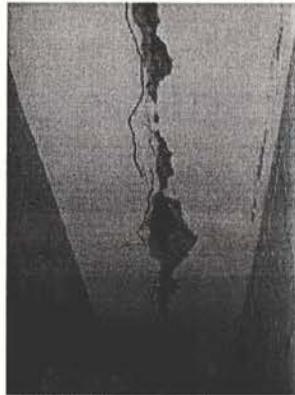
(a) Hollowcore damage

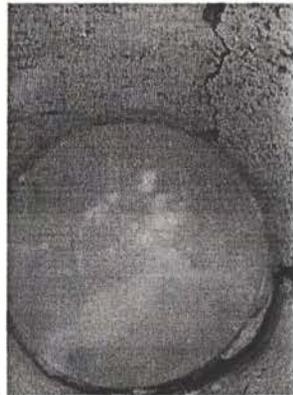
(b) Internal damage looking towards the seat

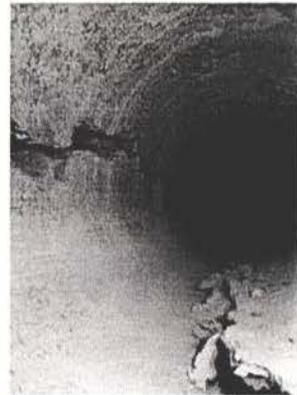
(c) Internal damage looking away from the seat

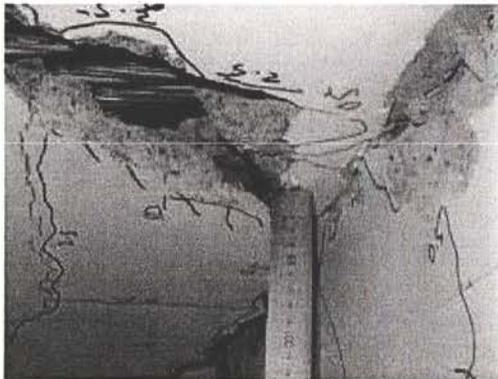
(d) Damage to the underside of the west unit.

It should be noted that the hollowcore unit dropped some 30mm at this stage as shown in Fig.10(d). Fig.10(e) shows the first floor unit after a large piece of floor fell out. At this stage, the floor had dropped by some 60mm.

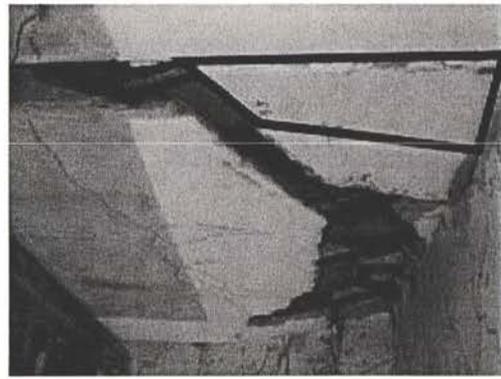
(e) Damage at 3.0% drift.

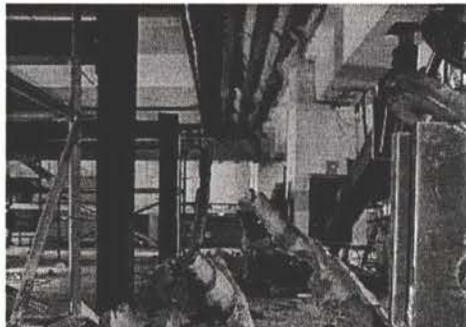
(a) Failure of the first hollowcore unit

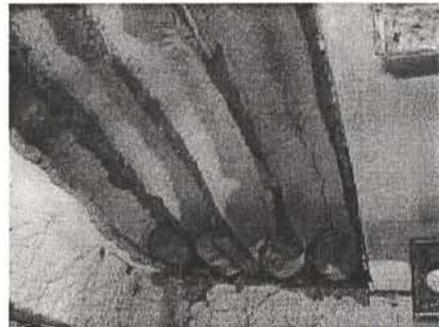
(b) Close up looking at the seat damage

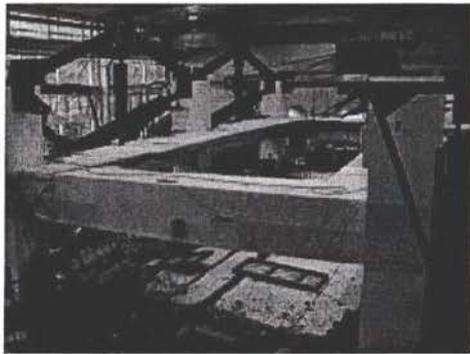
(c) The frame after the floor collapsed

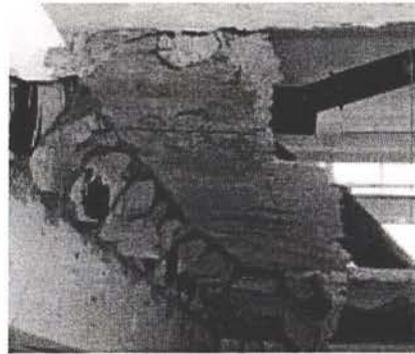
(d) The remaining topping and ends of the hollowcore units after collapse

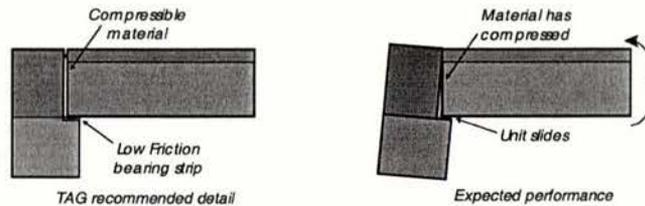
Fig.13 Recommended detail and assumed performance.

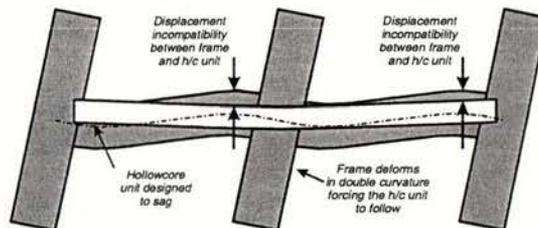
Fig.14 Displacement compatibility between the frame and the hollowcore floor units.

If the unit was not tied along its length, in other words the hollowcore unit was not forced to undergo the displaced shape of the perimeter beam, then the unit would most probably perform better. If the unit is then detached from the perimeter beam then there are problems with the transfer of the forces from the diaphragm to the perimeter moment resisting frame. This area requires further investigation.

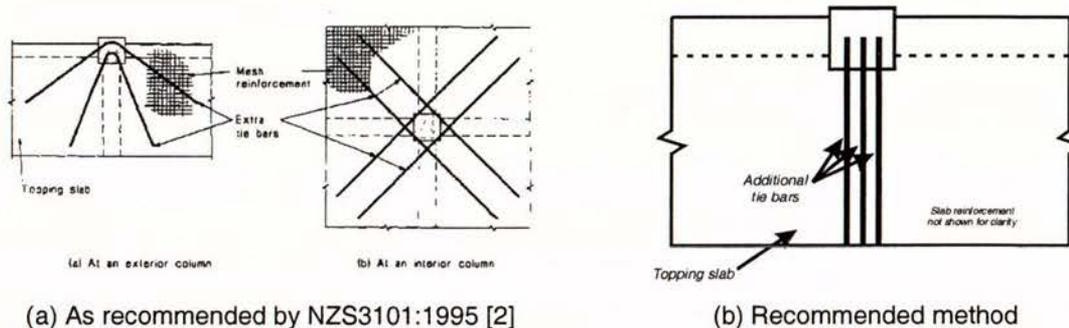
Fig.16 Recommended tie details.

The New Zealand Concrete Standard, NZS3101:1995 [2], states, "additional tie reinforcement must be used to tie the column to the floors at each flooring level. The magnitude of the tie force is equal to the larger of 5% of the maximum total axial compression load on the column or 20% of the column shear force induced by the lateral design forces." The draft joint Australian and New Zealand Structural Design Actions Standard [15] requires that "all parts of the structure shall be interconnected. Connections shall be capable of transmitting 5% of the value of $(G + \psi_c Q)$ for the connection under consideration."

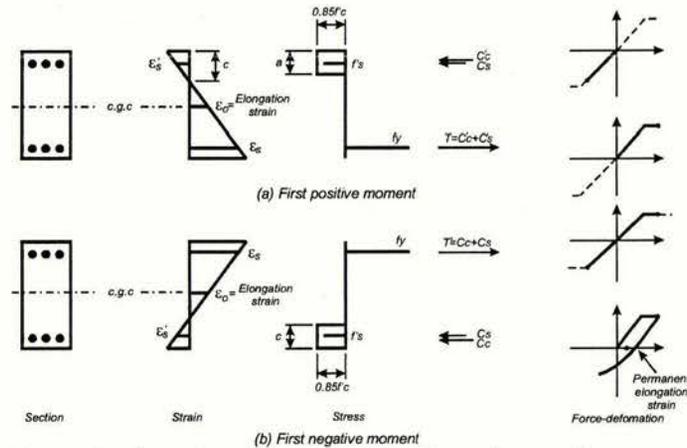
Figure 1 Rigid body kinematics is used to show that beam elongation can be expressed in terms of plastic flexure

The force-deformation graphs on the right hand side of Figure 1 show that for a positive moment the tension reinforcement has yielded and undergone plastic deformation while the compression reinforcement is at a stress below yield. For the negative moment the top reinforcement recovers the elastic compressive stress and then yields in tension while the bottom reinforcement regains its elastic recovery but has a residual strain at zero stress. Therefore, Figure 1 shows that both a positive and negative moment result in a permanent elongation strain at the centre of gravity of the concrete section (c.g.c) of the beam (refer to the strain diagrams). This permanent elongation strain forms within both elastically and plastically responding structures.

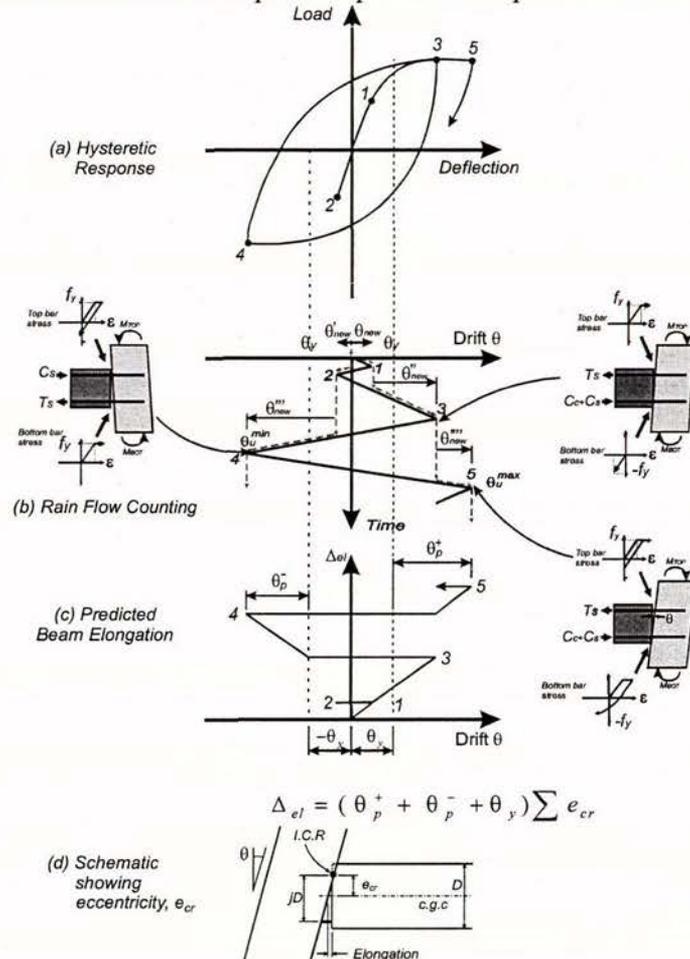
Figure 2 General theory for the determination of beam elongation.

The sub-figures shown at points 3-5 represent the actual deformation of the particular plastic hinge zone and the strain states within the beam reinforcement. Prior to point 1 in Figure 2, whenever the load reverses the reinforcing steel in tension partially recovers its elastic deformation and the crack at the beam column interface closes. From the yield point (point 1), to point 3 top steel yields in tension and undergoes plastic deformation. The bearing of the concrete and the bottom reinforcement in compression resists the compressive force. Upon load reversal toward point 4, as there is significantly more top reinforcement (due to the activated slab reinforcement), the bottom reinforcing yields in tension before the top reinforcing is able to yield back in compression. This beam elongation is caused because the top crack has not closed fully and the bottom reinforcement has been pulled out of the beam. The compressive force now is resisted by the compression reinforcement alone. Further as the load reverses towards point 5 the bottom crack essentially closes except for the aggregate wedged into the cracks, as there is sufficient force to yield these bars back in compression due to the large area of top reinforcement. Now the top beam reinforcement undergoes further plastic deformation and the crack width increases. Each of these three points experience new plastic rotation.

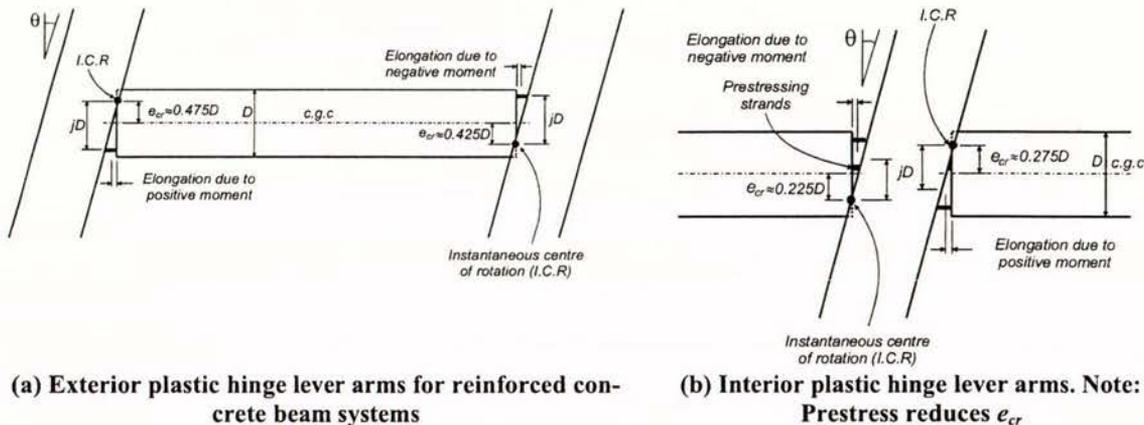
Figure 3 Internal lever arms for an interior and exterior joint

respectively (in which D is the overall member depth)(Figure 3(a)). During the elastic phase of the experiment a moment-curvature analysis confirmed that the values of $e_{cr}=0.425D$ and $0.475D$ were appropriate. The interior plastic hinge zones on either side of the central column have different e_{cr} values when compared to the exterior plastic hinges. This is because the central column has a hollow-core floor unit spanning past it that has a large number of prestressing strands in the central region of the reinforced concrete beam. The prestress effectively reduced the internal leverarm factor e_{cr} by moving the centre of rotation closer to the beam centreline as well as causing the centroids of the tension reinforcement to be closer to the beam centreline (Figure 3(b)). Based on a compatibility and equilibrium section analysis, the values of e_{cr} were $0.225D$ and $0.275D$ for negative and positive moments, respectively (for both elastic and plastic analysis).

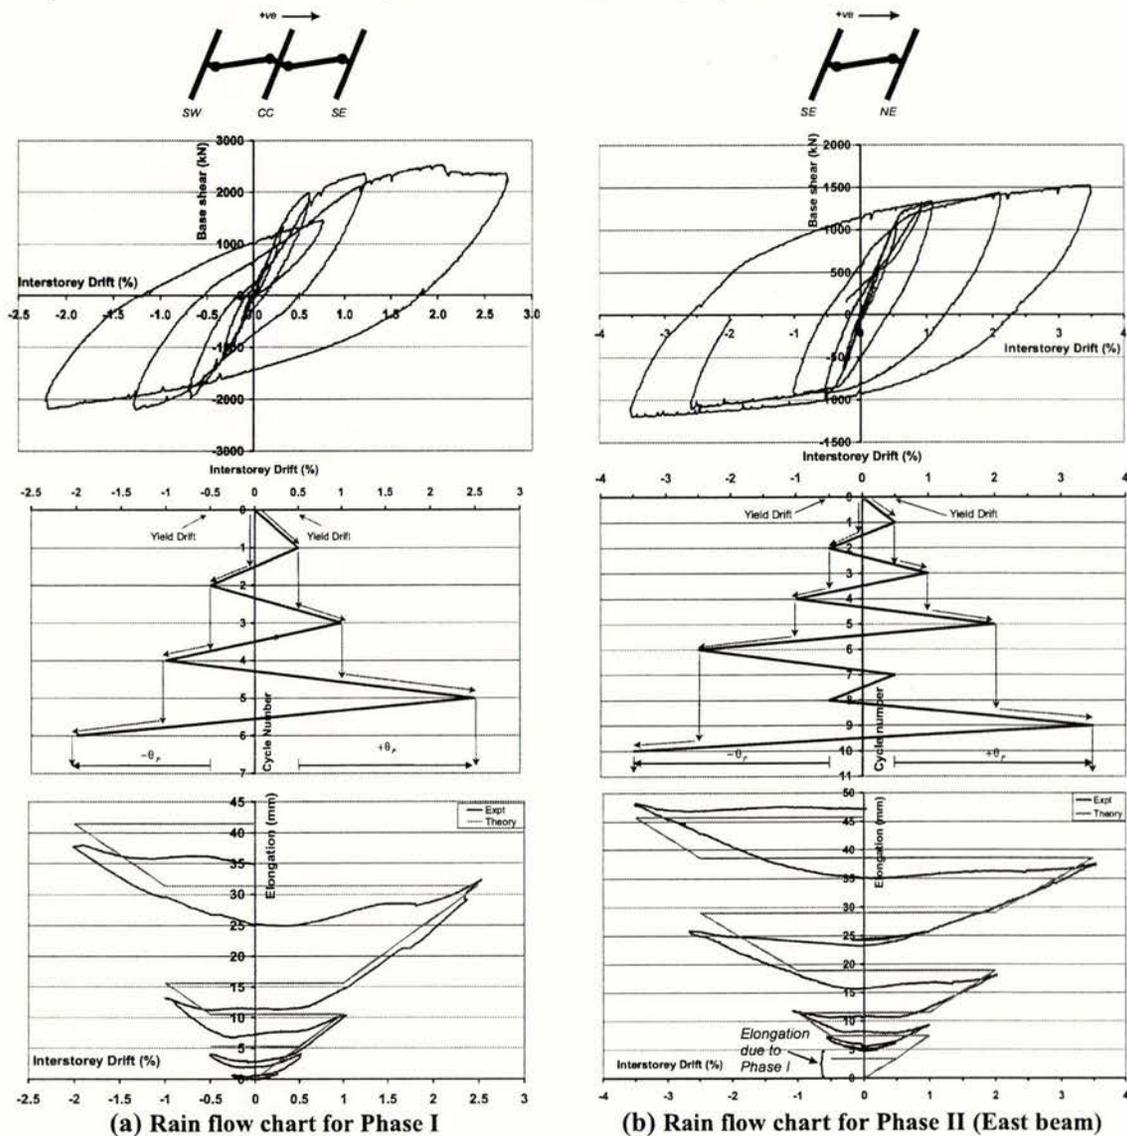
Figure 4 Rain flows charts for Phase I and II: Total Beam Elongation

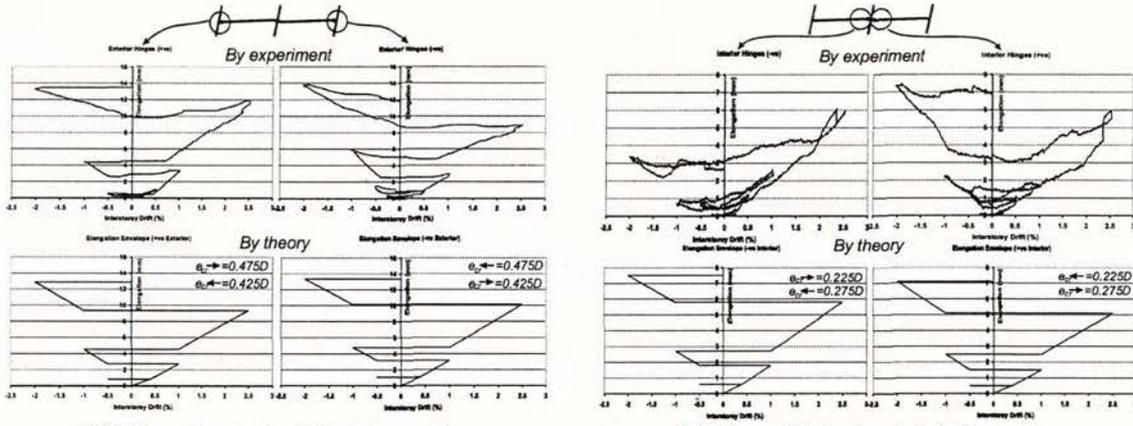
(a) Phase I exterior joint elongation (b) Phase I interior joint elongation
 Figure 5 Phase I experimental versus predicted beam elongation graphs

Figure 5(b) shows good agreement between the predicted and observed elongations for the interior plastic hinges. The left hand interior hinge did not elongate as expected during the cycle to -2% drift. The reason for this is that at this stage during the test the first hollow-core unit had severe web splitting and this affected the hinge performance (in particular the affect the prestressing strands had on the hinge performance).

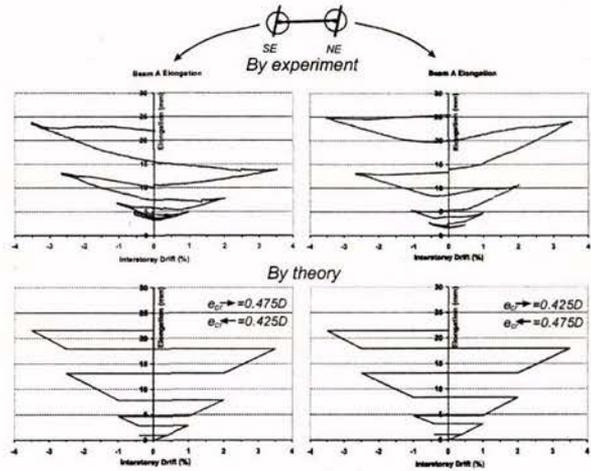
Figure 6 Phase II East beam elongation

Figure 6 shows good agreement between the theoretical and experimentally observed elongation for the individual hinges. The initial off set in the observed beam elongation plots was due to the beam elongation that occurred during Phase I in the form of torsion cracks.

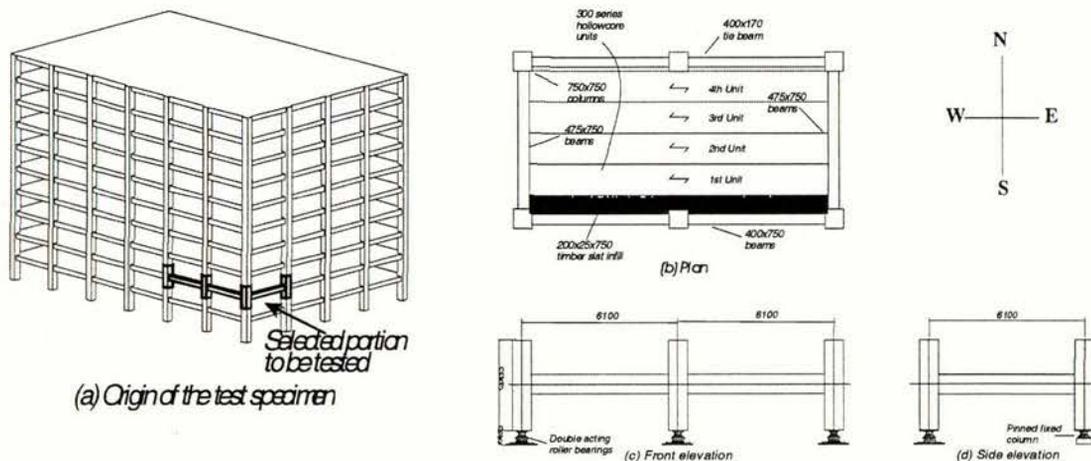
Figure 1. Origin, Layout and dimensions of the Stage 2 (Lindsay) super-assembly.

The entire experiment set-up was based on the Matthews [1] testing rig with connection modifications to improve the performance of the hollow-core units. The building was a two-bay by one-bay section of a lower storey in a multi-storey precast concrete moment resisting frame. The floor units were pretensioned precast hollow-core and were orientated so that they ran parallel with the long edge of the building, past the central column. The buildings origin along with the layout and dimensions are shown in Figure 1.

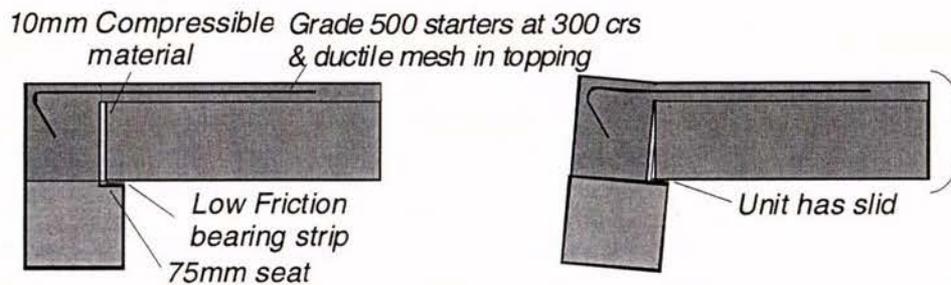
Figure 2. Seating connection detail with expected performance.

When the unit is seated on a low friction bearing strip, the seat length becomes very important; it must be placed back from the face of the beam so that as the unit tries to rotate it does not dig into the bearing strip. The draft 2003 amendment to the New Zealand Concrete Structures Standard NZS3101:1995 (Standards New Zealand [3]) has amended the required seat length of hollow-core floors to span/180 or 75mm based on Matthews' recommendations. A seat length of 75mm was used in this test.

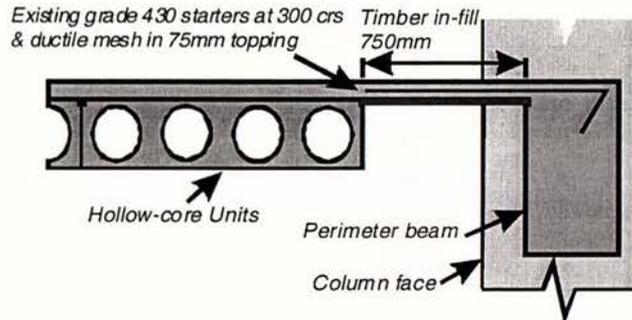
(a) First hollow-core unit to perimeter frame connection.

This connection consisted of moving the first unit away from the perimeter beam and replacing it with a 750mm timber infill with 75mm insitu concrete topping (Figure 3(a)). The infill allows a more flexible interface between the frame and southern hollow-core unit. Some cracking is expected in this interface due to the displacement incompatibility but it is anticipated that the more flexible interface will accommodate this while allowing the beam to deform in double curvature and the hollow-core unit in single curvature, (Figure 3(b)) leaving the floor essentially undamaged. Ductile reinforcing mesh was used in the topping to aid in the performance of the floor by helping to ensure that any damage and cracking would not result in such an early failure of the floor system.

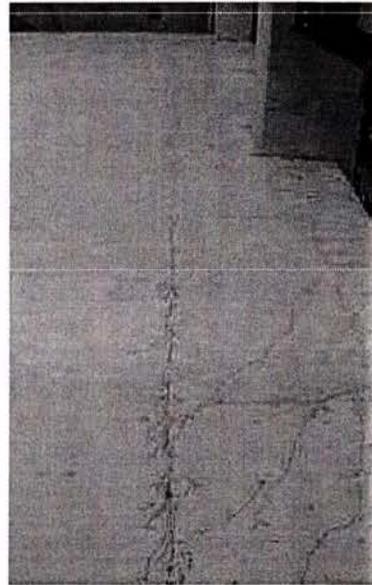
(c) Crack at hollow-core/infill interface at $\pm 2.0\%$

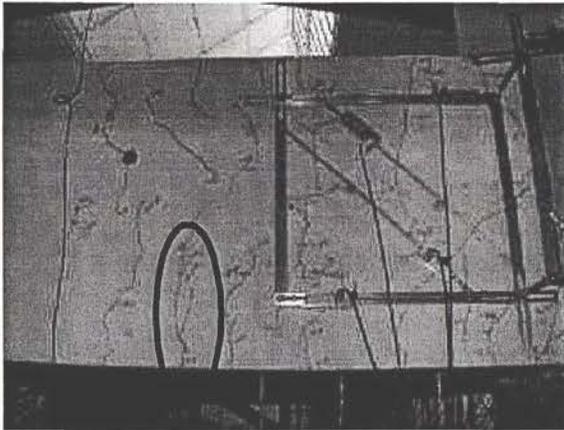
(a) Large crack forming in transverse beam, 1.0m from column face at +1.0%.

Very little new cracking occurred in the early stages of the transverse loading. This was because the transverse beams were pre-cracked from the longitudinal loading and these cracks simply opened during transverse loading. Key behaviour photos are shown in Figure 6. In the $\pm 1.0\%$ cycle a crack (2mm at this stage, opening to 6mm at $\pm 2.0\%$) opened up in the ends of both of the transverse beams about 1.0m from the column face as indicated Figure 6(a). It appeared that the weight of the hollow-core units caused the transverse beams to sag, accentuated by the cracked section, and in turn formed a uni-directional hinge at about 1.0m from the column face at both ends. The north side corner of the fourth hollow-core unit at both ends formed a corner crack at -1.0% drift that progressed up from the bottom of the unit to run along the web (Figure 6(b)).

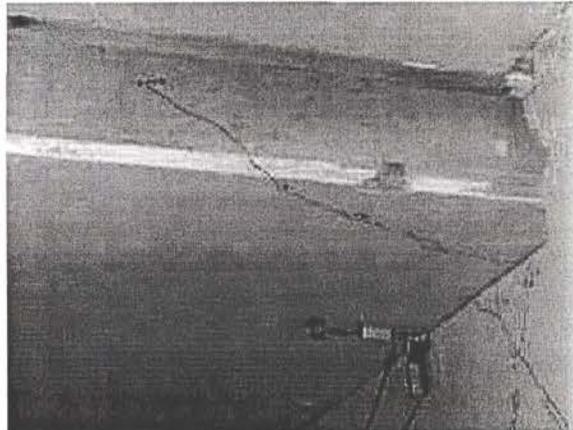
(b) Corner crack in north side of fourth hollow-core unit developing into a web-split at +1.0%.

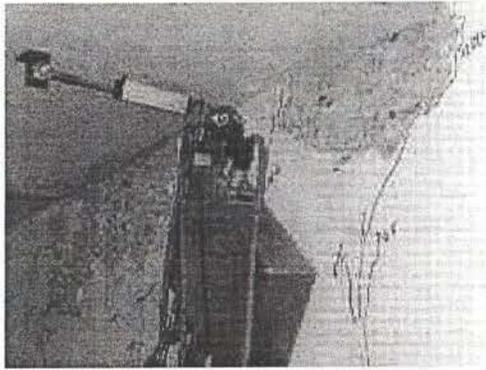
(a) Underside of first hollow-core unit, west end, +3.0% drift.

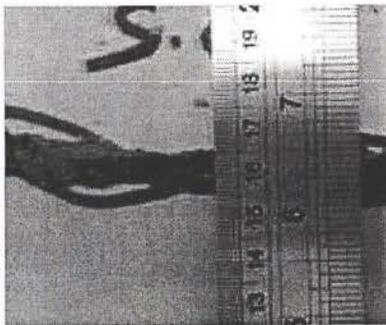
(c) Crack width of 10mm in places after mesh fractures (+3.0%)

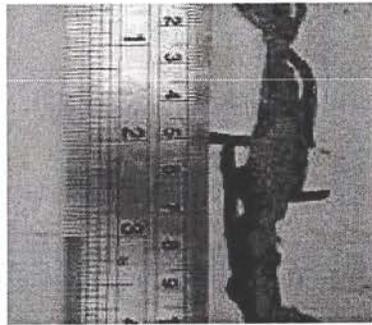
(d) Displacement of 15mm after mesh fractures (+3.0%)

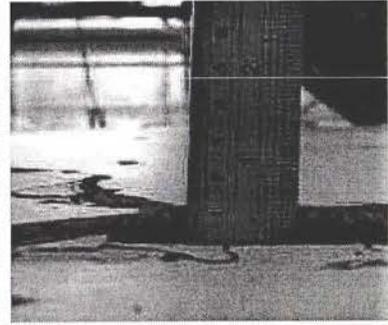
(e) Vertical offset of 10mm after mesh fractures (+3.0%)

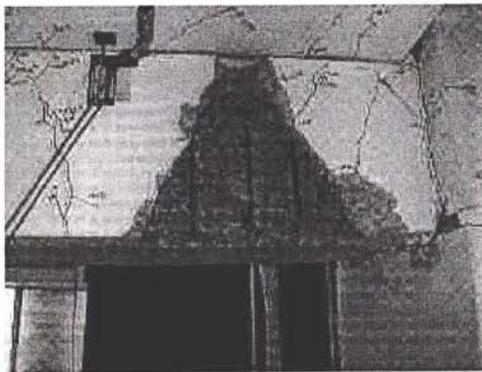
(f) Section of unreinforced seat fallen out at +4.0%
