On improving the seismic performance of precast concrete frames

Final Report to EQC

**ON IMPROVING THE SEISMIC PERFORMANCE OF
PRECAST CONCRETE FRAMES**

February 2006

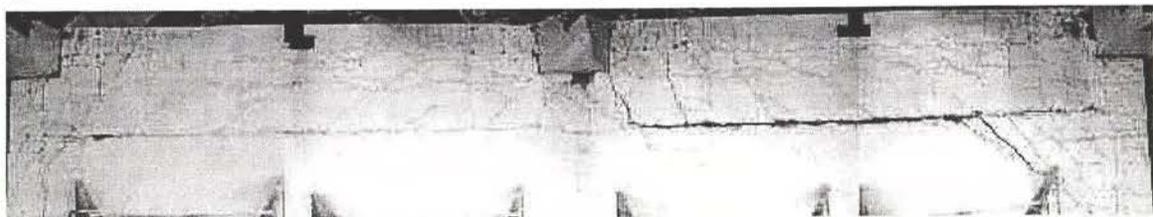
(h) Floor damage at end of test (5.0% drift).

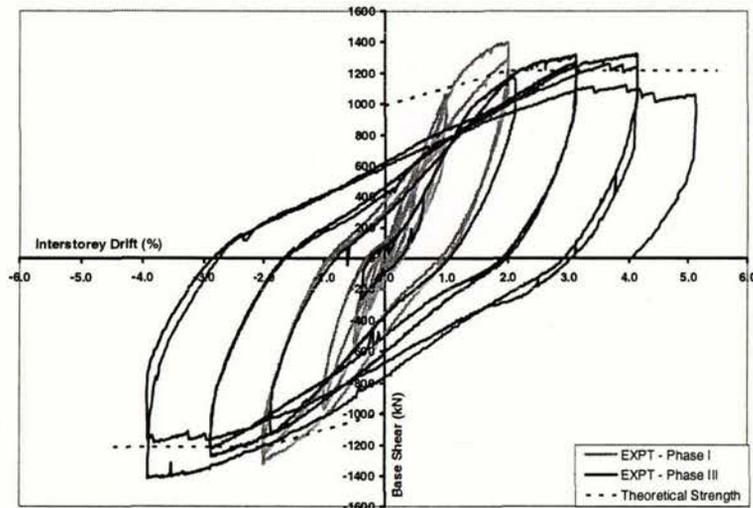
(a) Hysteresis loop for Phase I and III loading

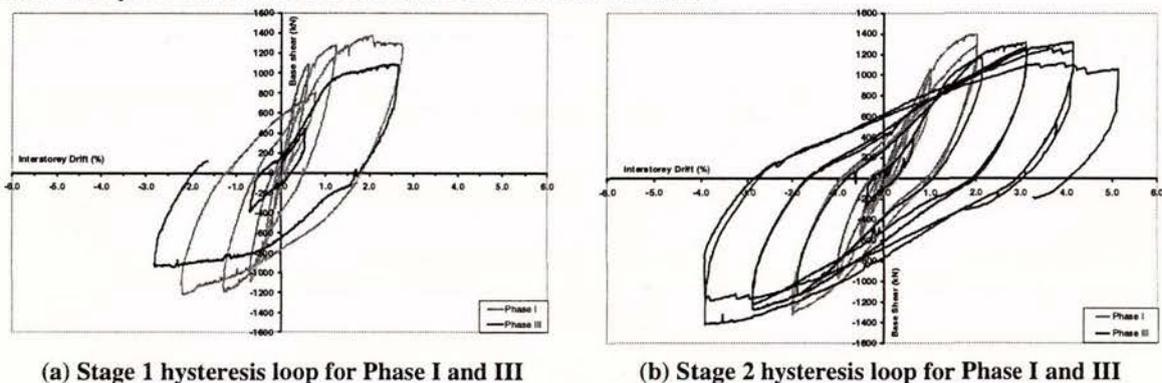
Figure 9. Hysteresis loops for Stage 1 and 2 for comparison of performance.

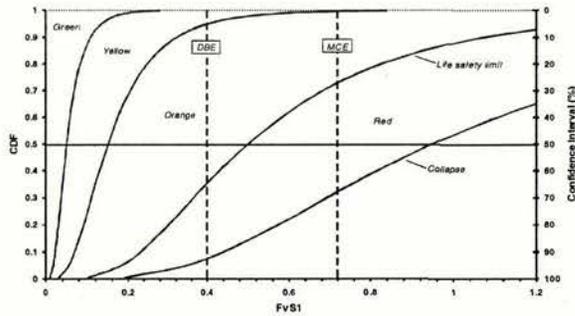
(a) Matthews' fragility curve for the floor performance when rated according to colour coding

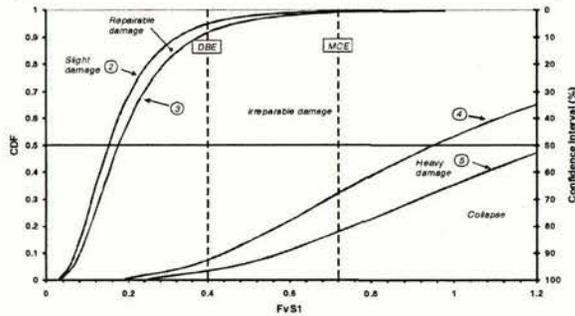
(e) Matthews' fragility curve for the floor performance when rated according to damage states

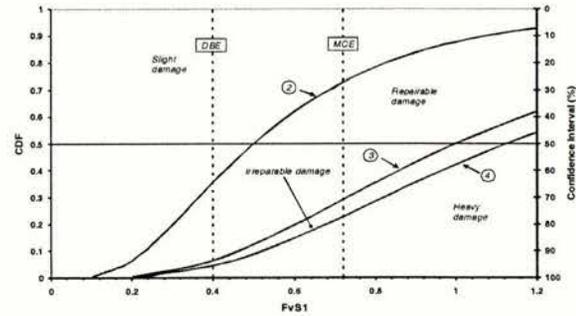
(f) Stage 2 fragility curve for the floor performance when rated according to damage states

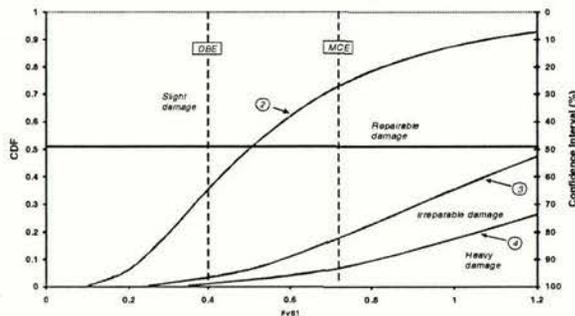
(g) Matthews' fragility curve for the frame performance when rated according to damage states

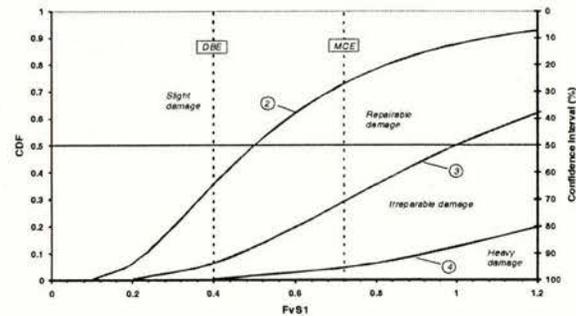
(h) Stage 2 fragility curve for the frame performance when rated according to damage states

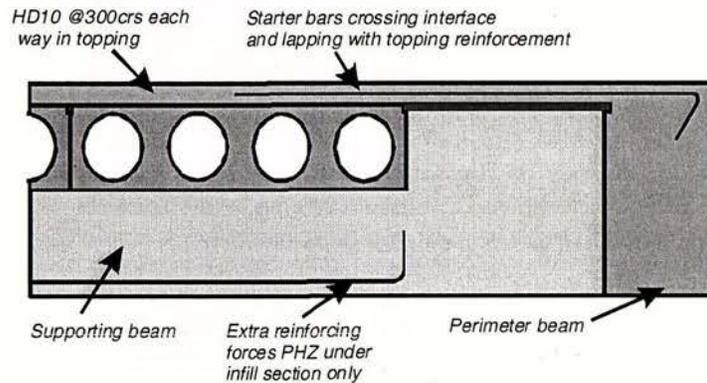
Figure 11. Recommended detail to reduce damage to hollow-core units

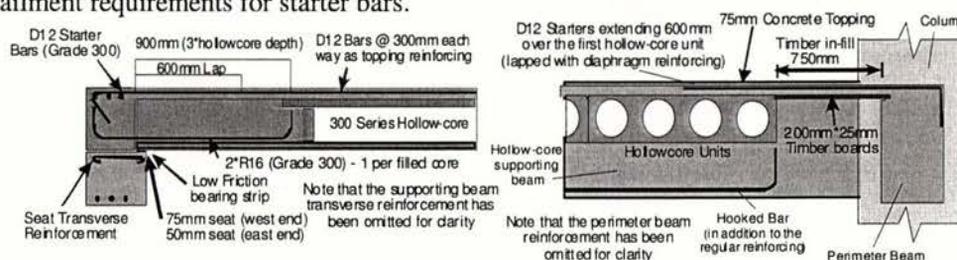
(a) Hollow-core seated connection detail.

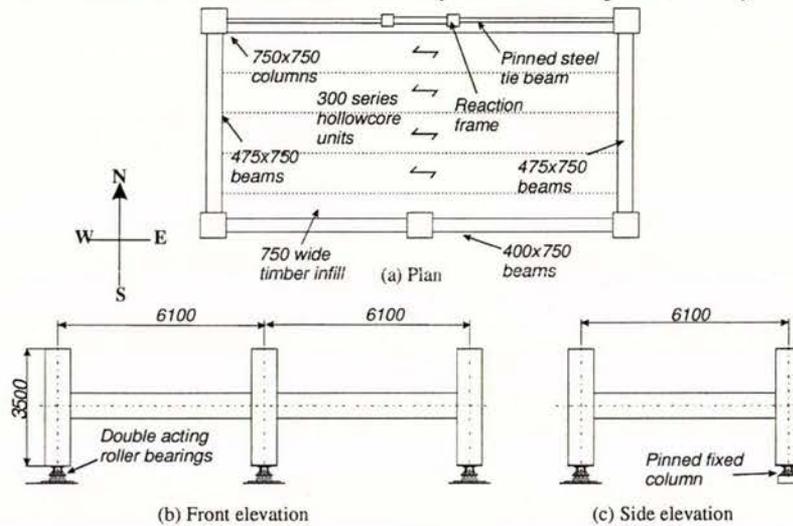
Figure 2. Details and geometry of the super-assembly

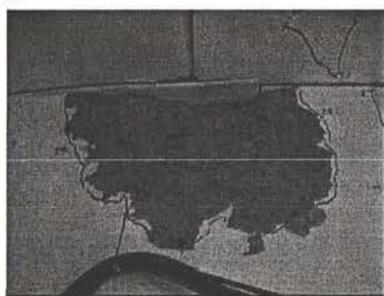
(a) Spalling of seat concrete after Phase I loading.

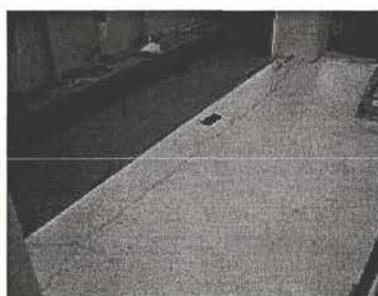
(b) Continuity crack after Phase I.

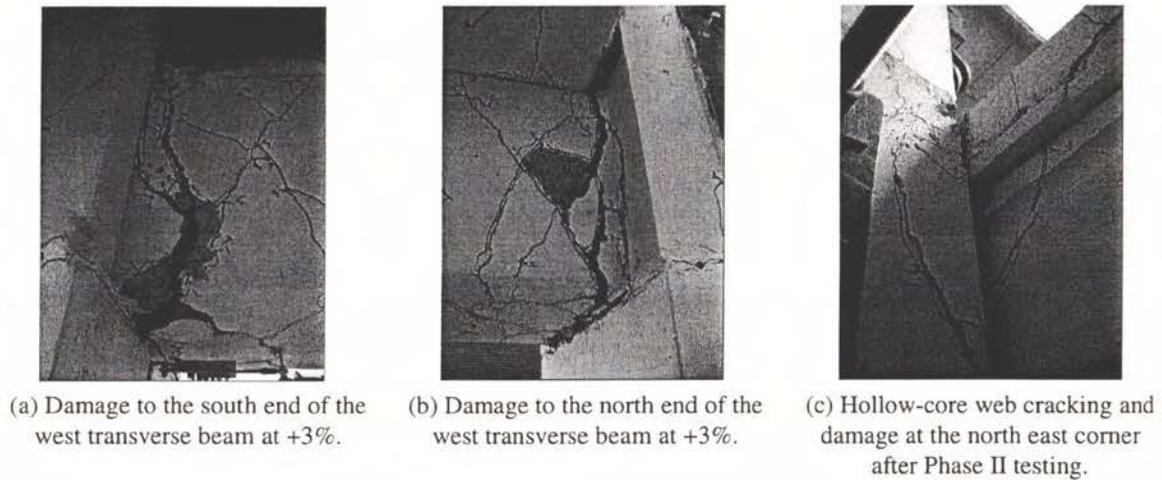
Figure 4 Notable damage from Phase II transverse testing.

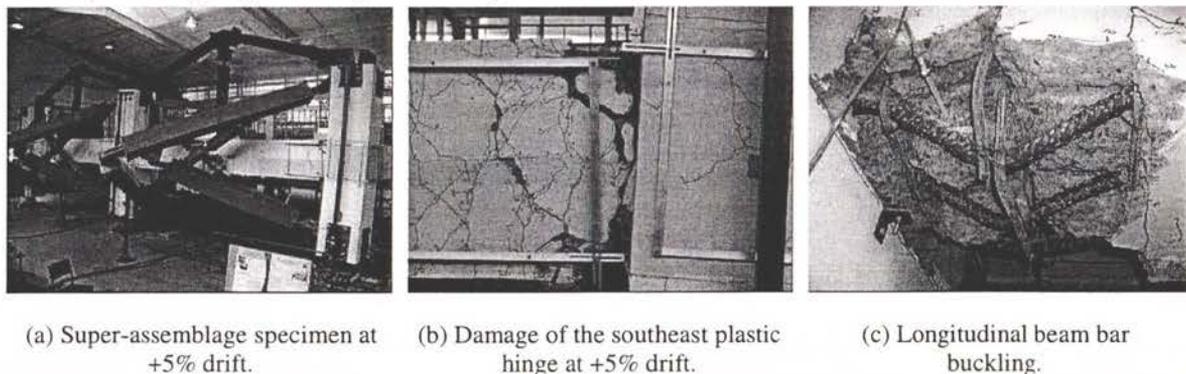
Figure 5. Damage during and after Phase III loading.

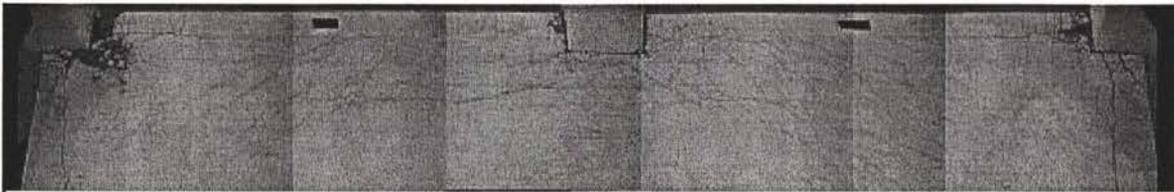
Figure 6. Floor damage after the completion of testing.

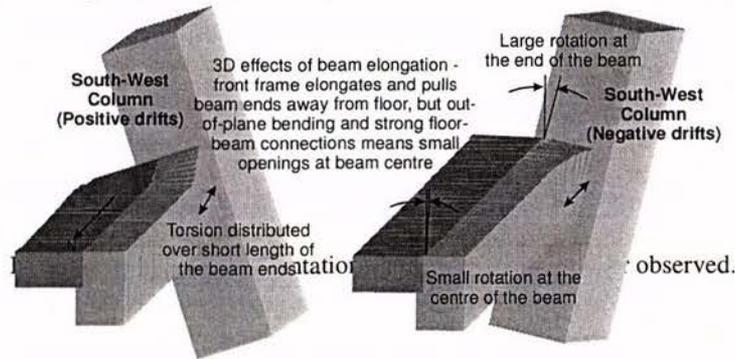
Figure 7. Schematic representation of the torsional behaviour observed

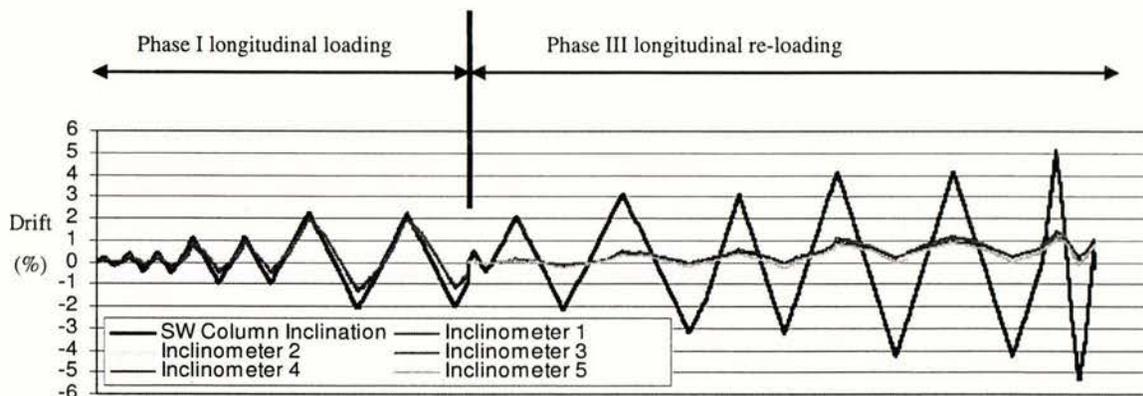
Figure 8. Torsion rotations during Phase I and III longitudinal loading.

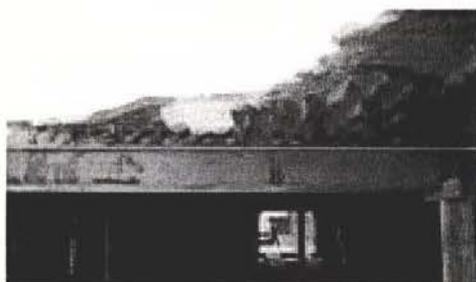
Figure 1 Photograph of precast hollow core floor collapse after the 1994 Northridge earthquake

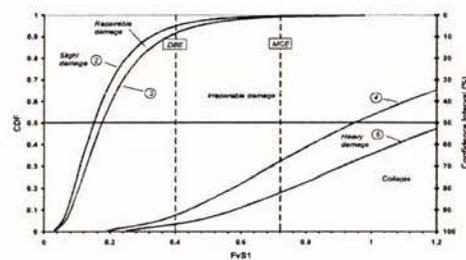
(a) Precast concrete buildings with vulnerable precast concrete hollow-core floors built to pre-2004 Standards (NZS3101, 1995)

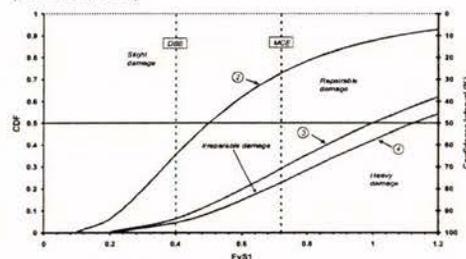
(b) Concrete buildings built to post-2004 Standards (NZS3101, 1995, Amendment 3)

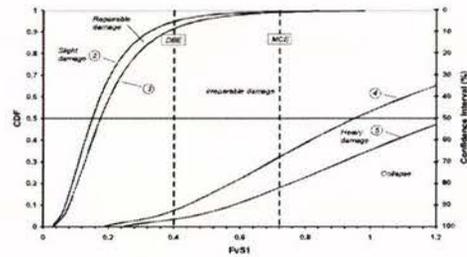
(a) Precast concrete buildings with vulnerable precast concrete hollow-core floors built to pre-2004 Standards (NZS3101, 1995)

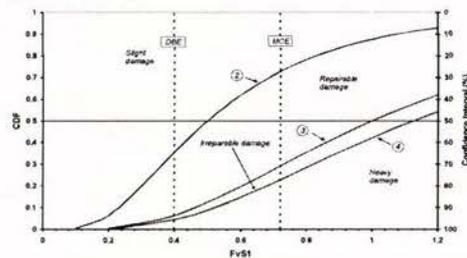
(b) Concrete buildings built to post-2004 Standards (NZS3101, 1995, Amendment 3)
