**Assessment of material strain limits for defining different forms  
of plastic hinge region in concrete structures**

# EQC Project 06/516

**Assessment of Material Strain Limits for Defining Different  
Forms of Plastic Hinge Region in Concrete Structures.**

A Thesis submitted in partial fulfilment of the requirements for the degree of  
Master of Engineering  
at the University of Canterbury by

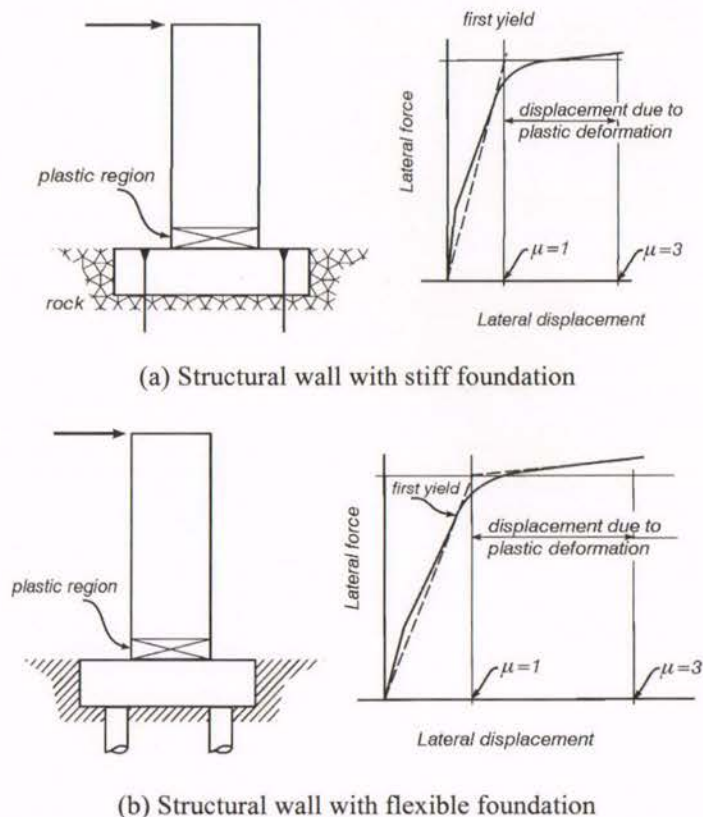
Figure 1.1-Effect of foundation rigidity on displacement ductility (Fenwick and Dhakal, 2007 a)

Fenwick and Dhakal reviewed the standing of the New Zealand design standards relating to reinforced concrete members. The emphasis of the review focussed around the requirement for detailing based upon the expected material strains in individual plastic regions introduced into the loadings standard (NZS 1170.5:2004) and its incorporation in the latest revision of the concrete standard (NZS 3101:2006). Comments over and above what has already been covered in the previous section include; the magnitude of deformation without strength degradation is dependent on the detailing (confinement, anti-buckling and portion of shear resisted by transverse steel). Other factors are the hinge type and the loading history. This new approach is incorporated because of the inadequacies of the structural ductility factor to indicate the deformations of individual plastic regions. Fenwick and Dhakal illustrate this inadequacy using the two walls previously described in Figure 1.1.

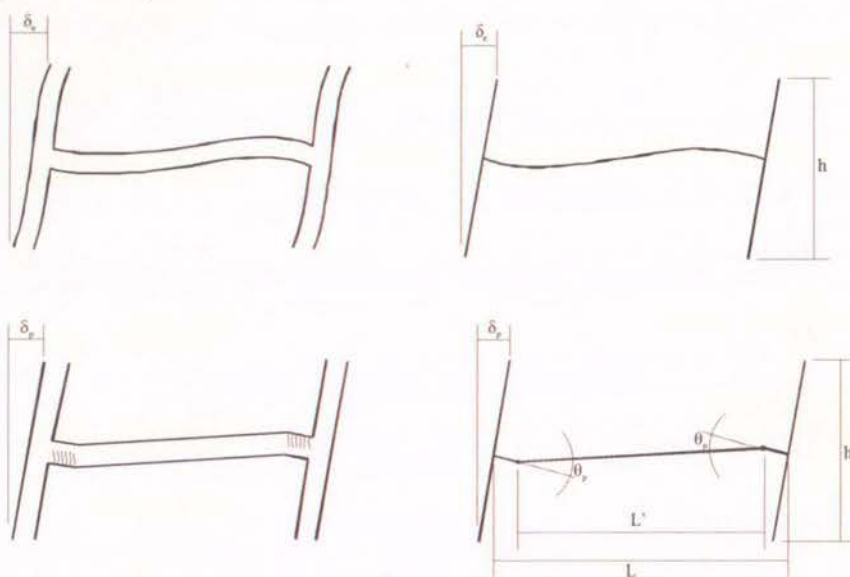
Figure 2.1-Calculating plastic rotation for reversing plastic hinges (NZS 1170.5:2004)

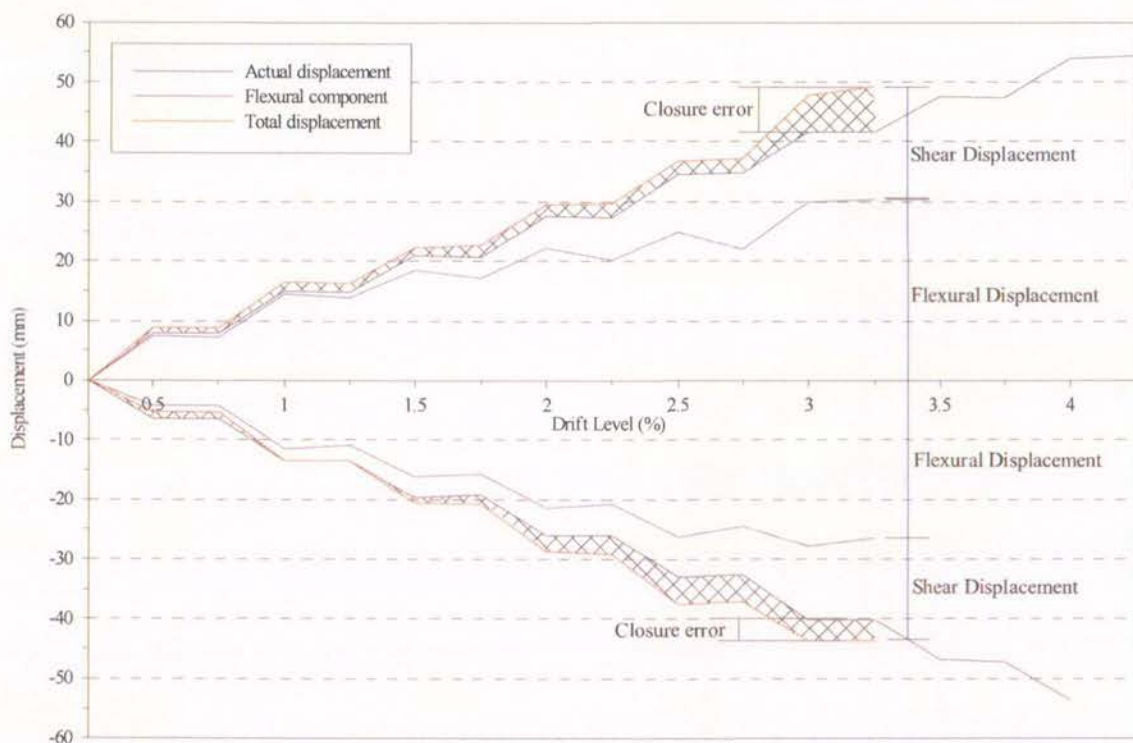
Figure 4.10 shows the breakdown of the total applied displacement into shear and flexural deformations. The rocking of the entire tests unit is included in the calculation of the total displacement but is very small and thus not shown in the figure. It is obvious from the figure that the total end displacement is dominated by the flexural component. The percentage contribution of shear deformation increases as the applied displacement is increased. In general, there is a decrease in the flexural displacement in the second cycle compared to the first cycle of the same displacement level.

Figure 4.10-Contribution of shear and flexure to the total displacement at the peaks of the loading cycle for beam A1

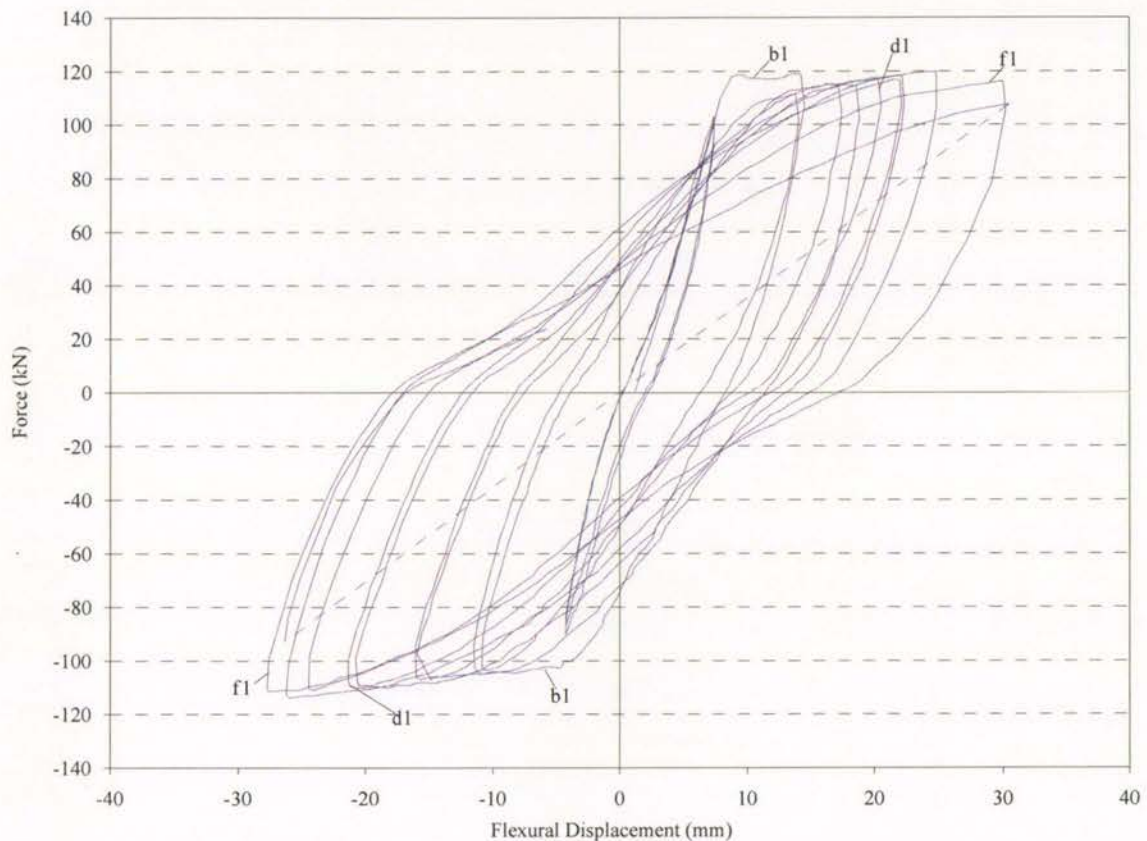
Figure 4.11 plots the applied force against the flexural component of the total displacement. A slight decrease in flexural displacement in the second cycle at the same displacement level can be seen. A slight pinching to the flexural loops is exhibited, the cause of this behaviour could not be ascertained.

Figure 4.11-Flexural displacement versus force curve of beam A1 to 3.0% drift

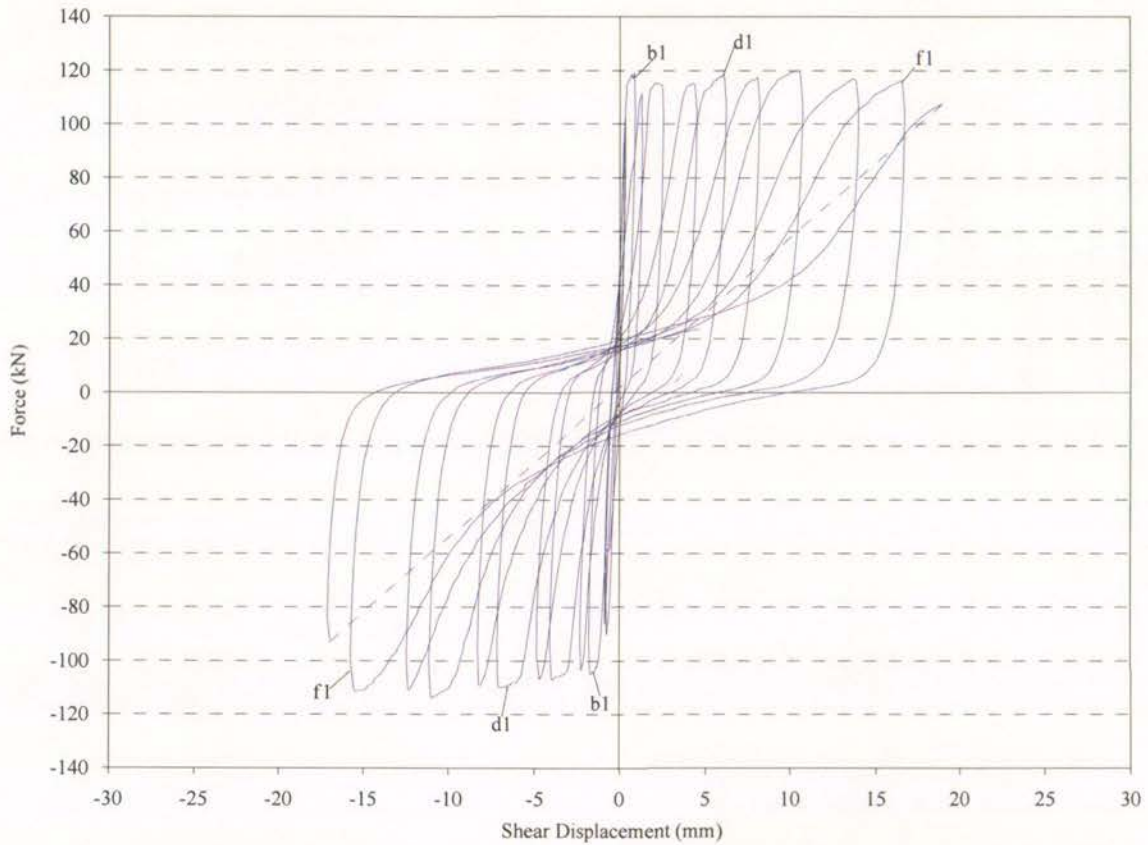
Figure 4.12 shows the shear displacement plotted against the applied force. Note the increase in shear deformation in consecutive cycles although the applied displacement was the same (e.g d1, d2). This explains the decrease in flexural component in consecutive cycles shown in Figure 4.10; the total displacement remains constant on each cycle so as the shear displacement increases the flexural displacement must decrease. The curve shows that the shear component causes the pinching behaviour seen in Figure 4.9.

Figure 4.12-Shear force-shear displacement relationship of beam A1 to 3.0% drift

Figure 4.41 also reinforce the trend observed in Figure 4.39 of no increase in the shear displacement between cycles at the same displacement level, contrary to behaviour of previous tests (see Figure 4.12).

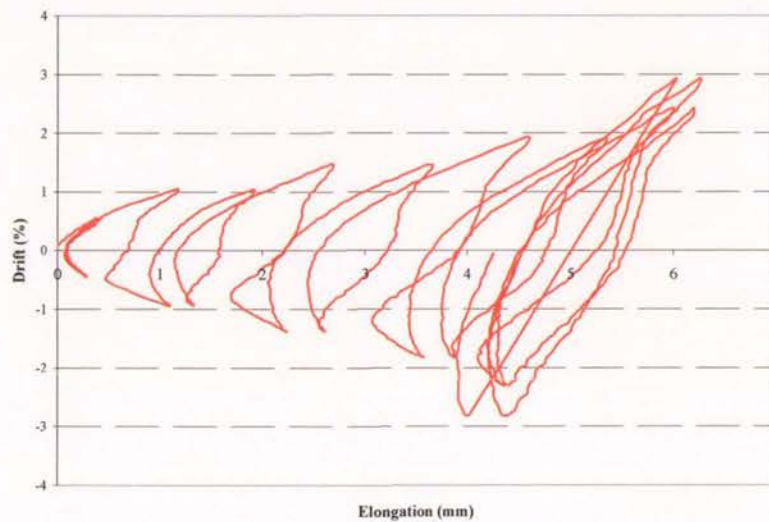
The reinforcing steel experiences a greater tensile strain than compressive strain under cyclic loading. Once cracking occurs the beam begins to elongate and is accelerated when the reinforcement yields (Fenwick and Megget, 1993). Figure 4.13 shows the elongation of beam A1 plotted against the applied drift level. The elongation is found by combining the average elongation of the top and bottom potentiometers of each block of potentiometers. The elongation behaviour is, as expected, increasing as a load is applied and then decreasing slightly as the load is removed. Also observed was the elongation increasing on each consecutive cycle. However, the elongation appears to decrease during 3.0% drift cycles. This is possibly due to the initiation of reinforcement buckling, which caused shortening of the beam.

Figure 4.13-Beam elongation (A1)

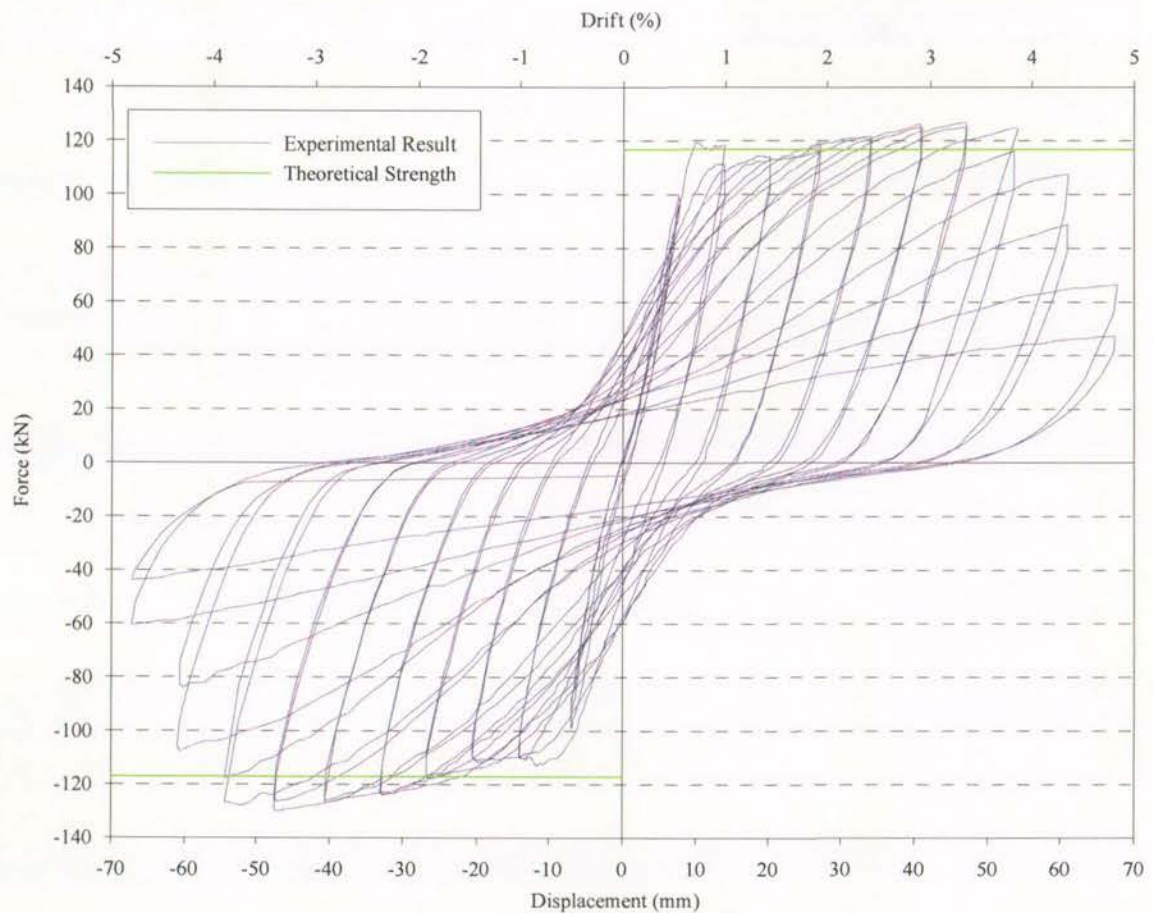
Figure 4.18 shows that the load deflection relationship of beam A2 was in many ways similar to that of beam A1. One of the key differences is that buckling induced degradation of strength is delayed to a higher drift level of 4.5% compared with 3.5% drift in beam A1. The rate of the strength degradation is also reduced along with the level of shear pinching. This can all be contributed to the presence of additional stirrups within the hinge region.

Figure 4.18-Load displacement response of specimen A2

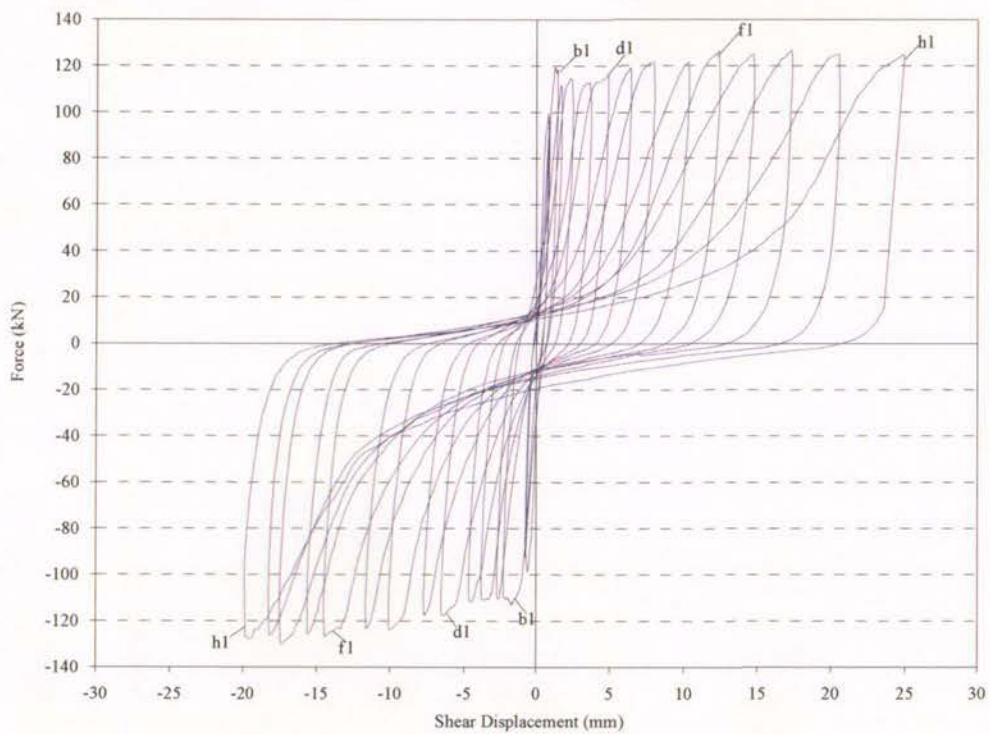
Figure 4.21 shows the shear component of displacement plotted against the applied shear force. As in beam A1, the shear displacement increases on each consecutive cycle. The pinched behaviour of the shear loops is similar to that of beam A1.

Figure 4.21-Shear force versus shear displacement response of beam A2 to 4.0% drift

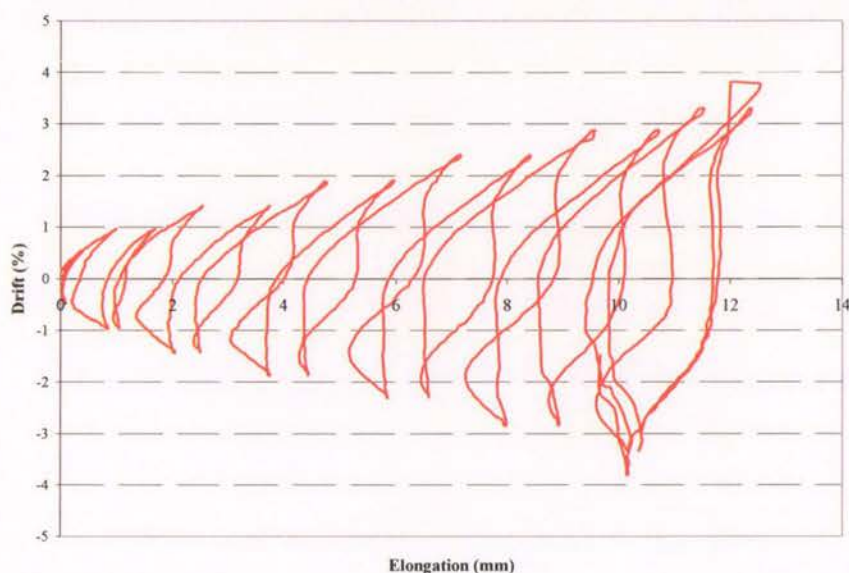
The elongation of beam A2 is plotted against the applied drift level in Figure 4.22. The elongation of beam A2 is significantly larger than beam A1. This is partially due to the delay of buckling in beam A2 allowing the beam to continue elongating at the higher drift levels. Another cause is the decreased level of shear displacement, thereby increasing the strain in the flexural reinforcement (at the same applied drift level) and thus the elongation.

Figure 4.22-Beam elongation (A2)

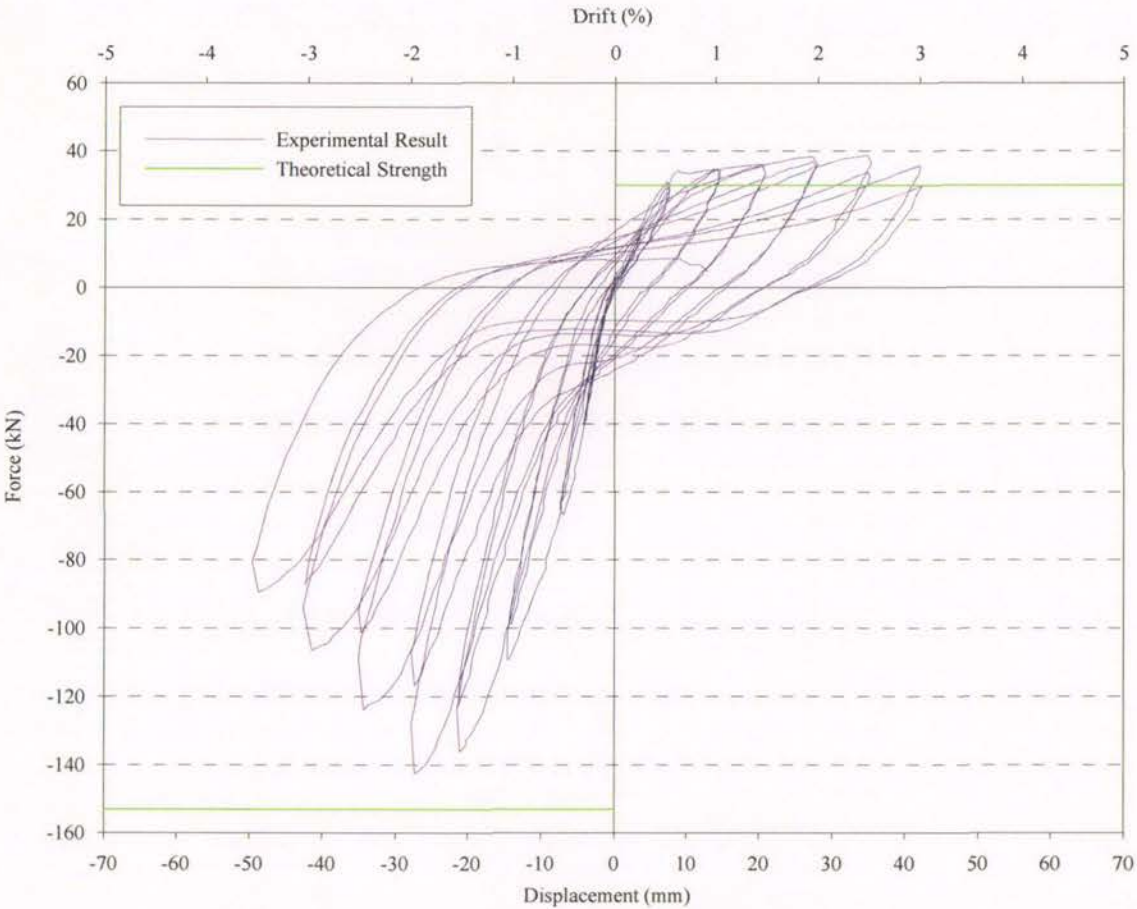
4.18. The initial stiffness in the negative direction is clearly greater than the stiffness in the positive direction. During drift cycles to displacements greater than 2.0% the stiffness of the beam is very low through near zero displacement and increases as the beam reaches its target displacement.

Figure 4.29-Load displacement response of specimen B1

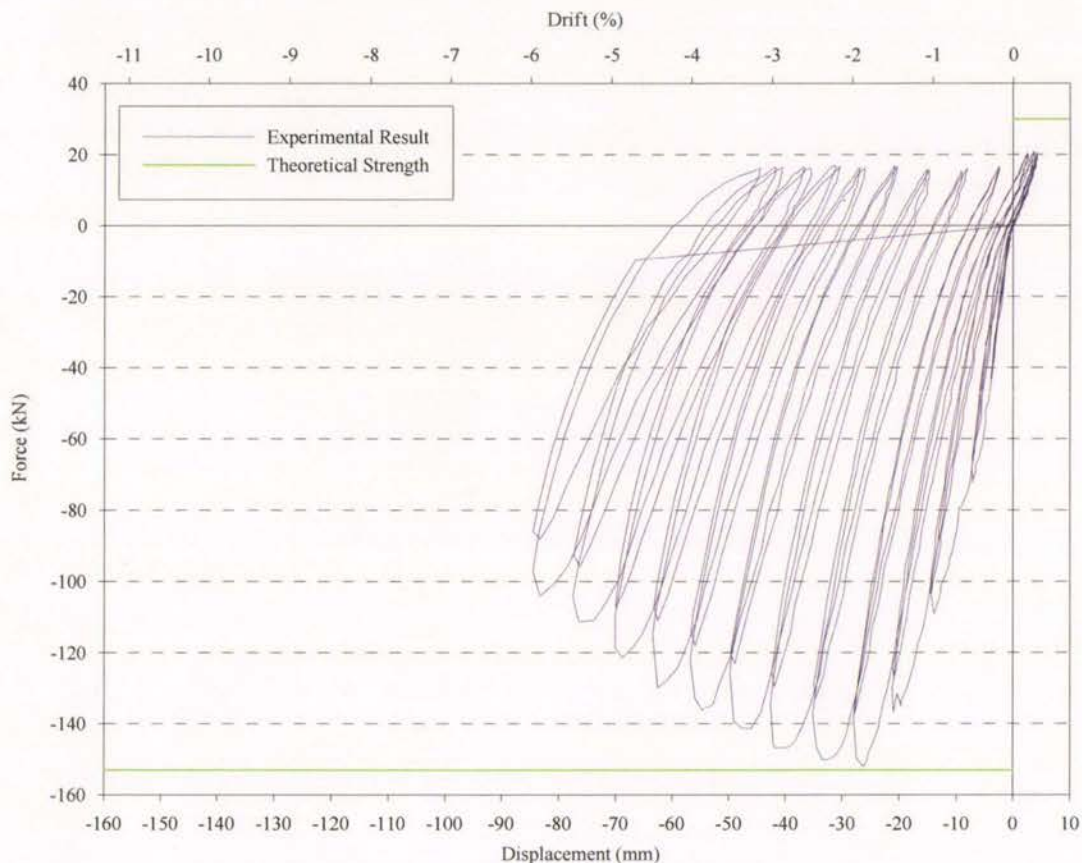
Figure 4.38 shows the load deflection relationship of beam B2. The absence of reinforcement yielding in the negative direction is clear. The beam exhibited a gradual decrease in stiffness at each displacement level until the peak load capacity was reached at 2.0% drift. This behaviour is similar to that seen in beam B1; see Figure 4.29. The uni-directional nature of the test resulted in only a small positive displacement and the beam continually stepping its way down (i.e. negative displacement). The beam loaded and unloaded along approximately the same path during cycles to the same displacement, resulting in narrow loops of low dissipative nature. The shear pinching behaviour seen in the reverse cyclic tests is not observed here. The degradation of strength shown in Figure 4.38 is not as severe as that of Test B1 as damage to the compressive concrete was not as significant due to smaller tensile strains. There is a noticeable decrease in stiffness as the displacement level is increased.

Figure 4.38-Load displacement response of specimen B2

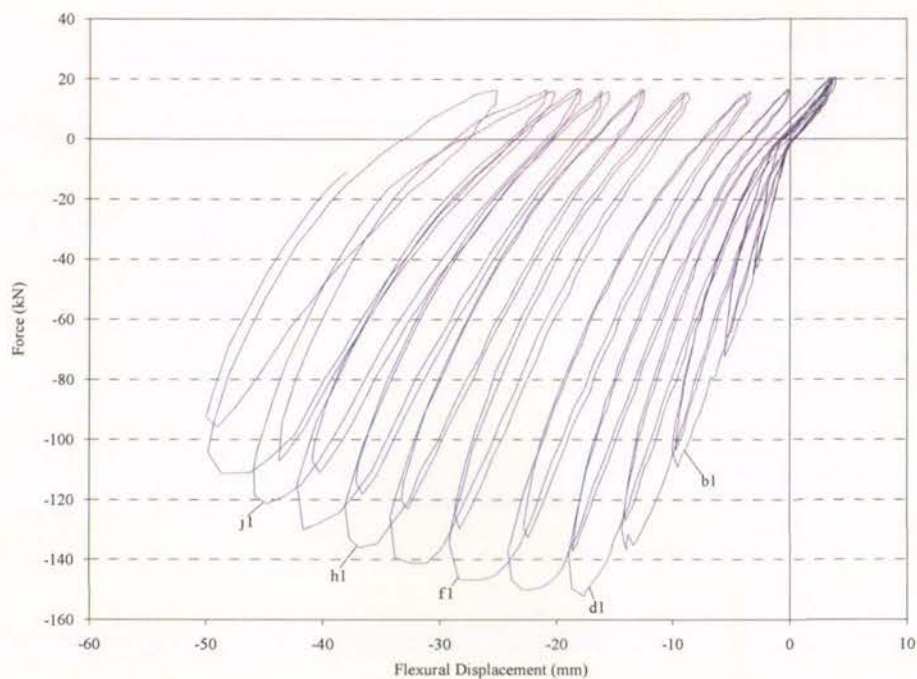
The flexural component of the total displacement is plotted against the applied force in Figure 4.40. The flexural response is similar to the overall beam behaviour. The hysteresis loops of the flexural component are very narrow while the shear component shown in Figure 4.41 exhibits a more dissipative loop.

Figure 4.40-Flexural displacement versus applied force (B2)

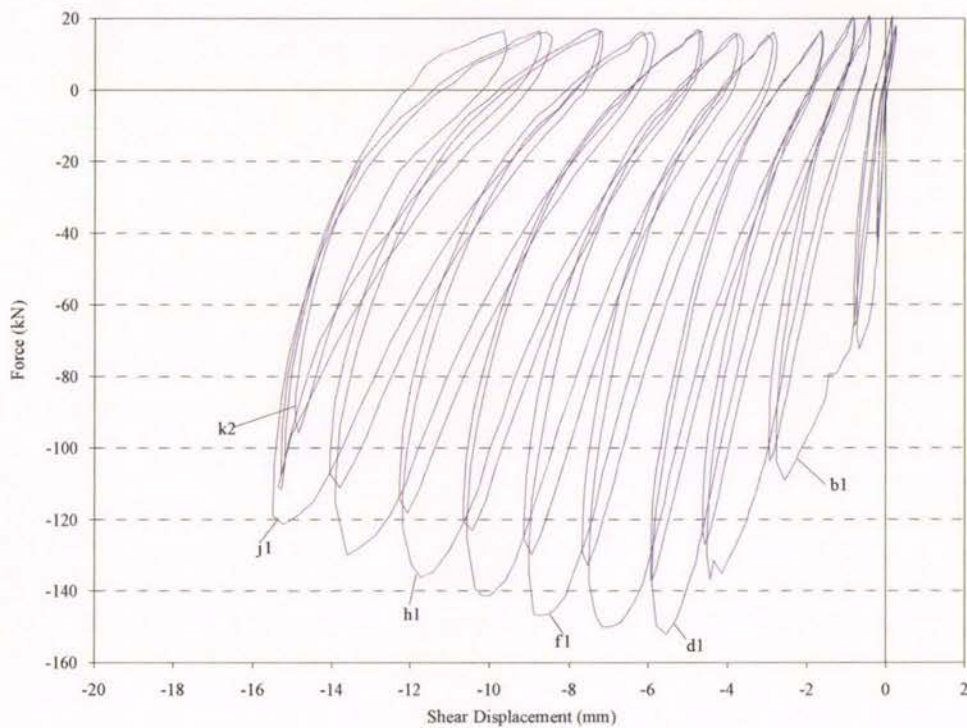
Figure 4.41-Shear displacement versus applied load (B2)

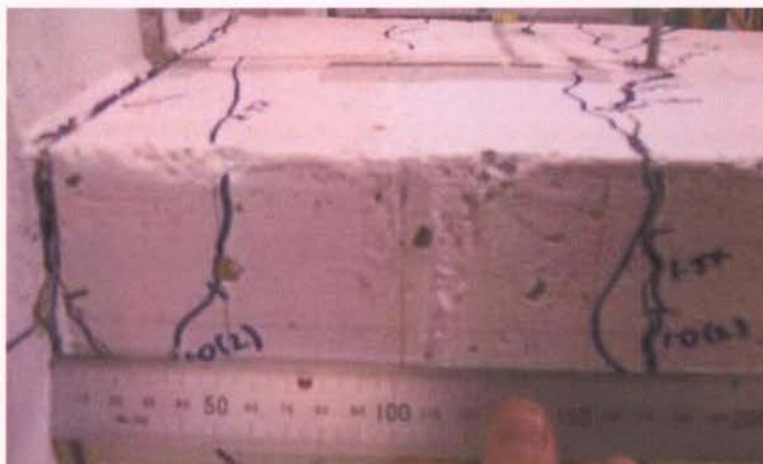
Crushing of concrete occurred during the first negative cycle to 1.5% drift. The crack at the springing had a width of 1.5mm. The load deflection curve in Figure 4.56 shows that the beam reached its maximum load capacity on this cycle. Crushing of concrete continued as the beam was displaced to 2.0% drift and was accompanied by minor spalling when the load was relaxed. A second flexural crack located 150mm out from the beam springing opened to a width of 1.5mm, while the crack at the springing was open to 3.0mm. These cracks can be seen in Figure 4.53.

Figure 4.53-Flexural cracking at 2.0% drift (C2)

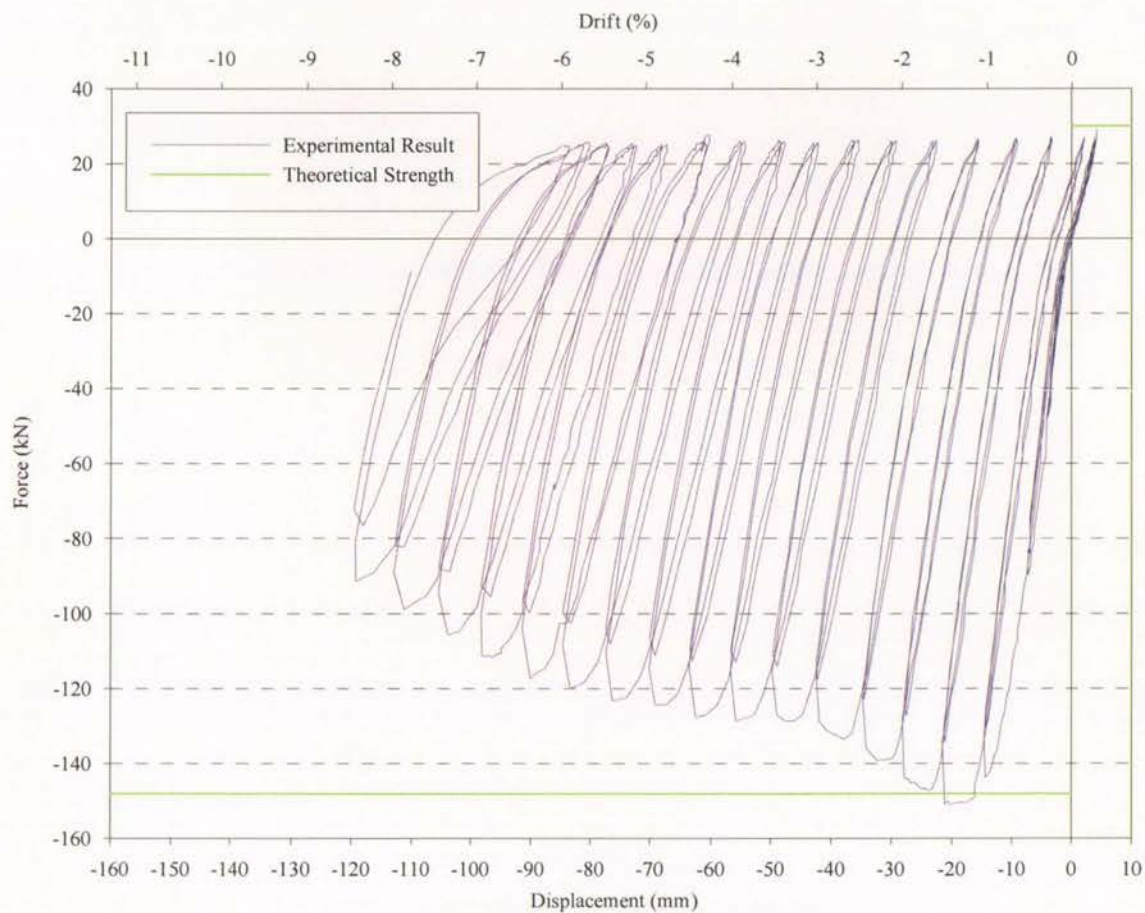
The displacement of beam C2 in Figure 4.56 shows larger ductility for uni-directional hinges compared with the reverse cyclic test of C1 seen in Figure 4.48. The decay in strength is much slower than in beam C1. The beam also retains its stiffness for much longer than in the reverse cyclic test.

Figure 4.56-Load displacement response of specimen C2

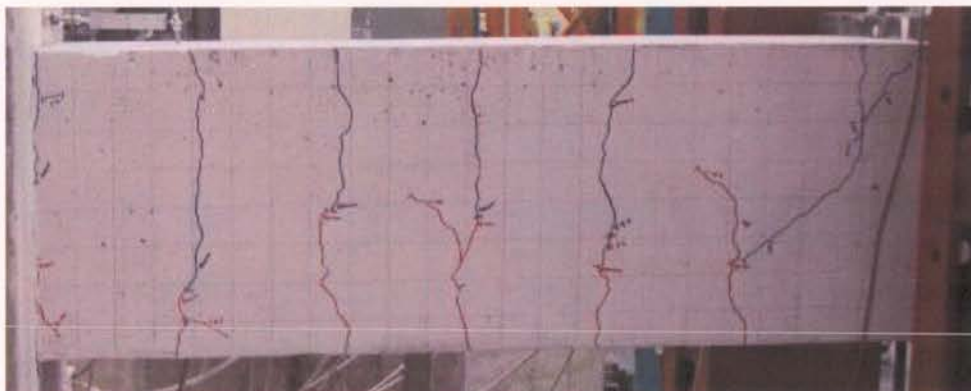
Behaviour in the early stages of the test D1 was similar to that of previous tests. Flexural cracks formed at the approximate location of the transverse reinforcement in the first phase. The load deflection relationship (see Figure 4.67) showed that yielding of flexural reinforcement occurred at 0.77% drift (10.9mm displacement) and 0.70% drift (9.9mm displacement) in the negative and positive directions respectively in the first cycle to 1.0% drift. A crack at the beam springing was open to 0.9mm. Unlike in previous tests, there was little inclination to the cracks except for one diagonal tension crack located near the load application as seen in Figure 4.61.

Figure 4.61-Crack pattern after two complete cycles at 1.0% drift (D1)

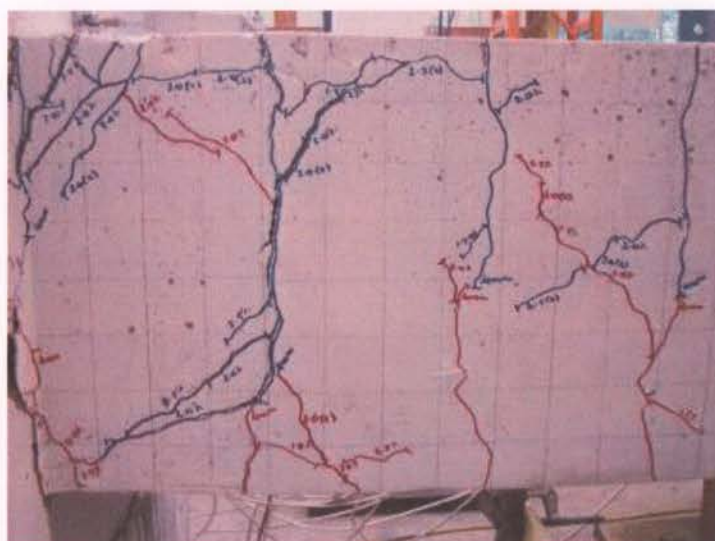
A crack located 210mm from the springing opened to a width of 0.8mm in the first cycle to 2.0% drift. This crack remained open to a width of 0.5mm when the load was removed. Inclined cracks also formed within the hinge zone that intersected the flexural crack located 210mm out from the springing. The diagonal tension crack had a width of 1.0mm during cycles to 2.5% drift. The crack pattern at 2.5% drift can be seen in Figure 4.62.

Figure 4.62-Crack pattern after two complete cycles to 2.5% drift (D1)

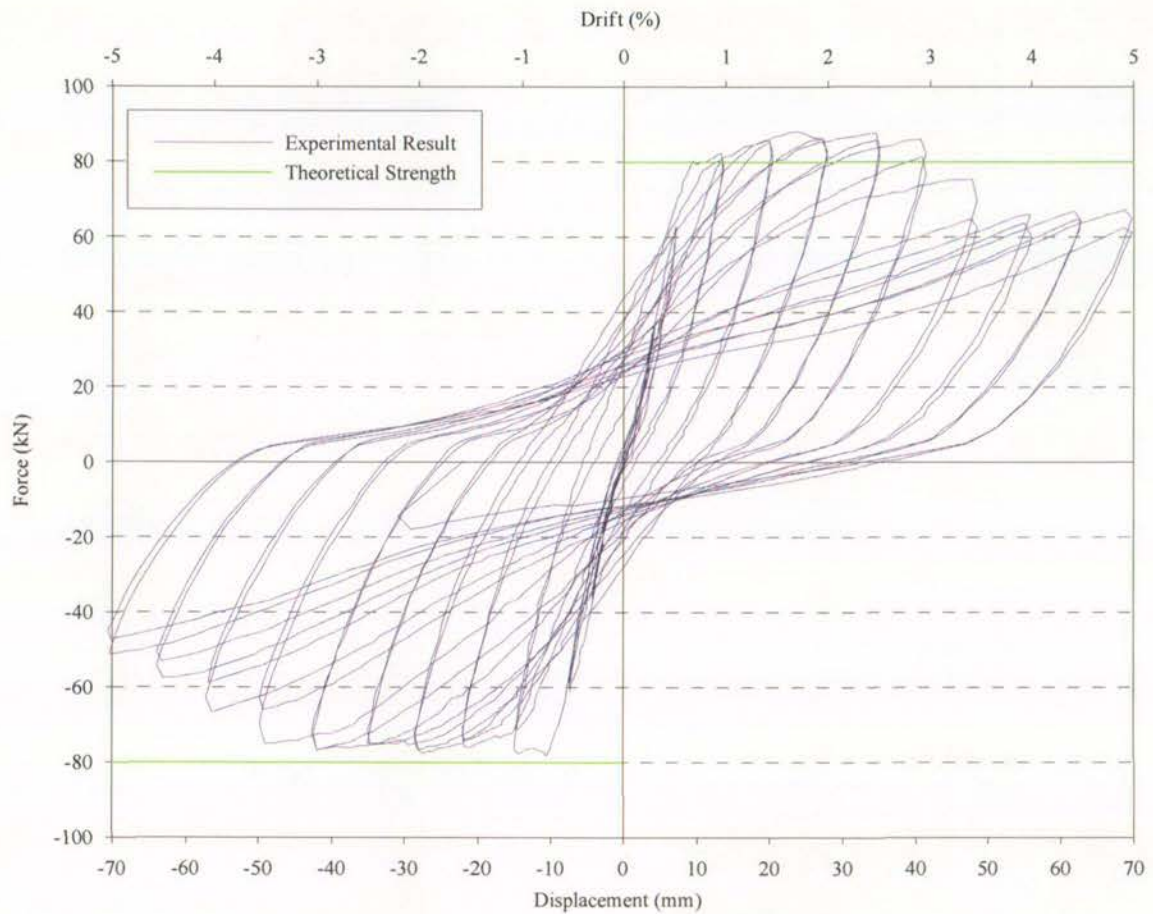
Figure 4.67 clearly shows that the load capacity of the beam was limited by yielding of the flexural reinforcement in both displacement directions. There is an obvious decrease in stiffness on each consecutive cycle. A drop in load capacity is seen at the 3.5% drift level, this was associated with buckling of reinforcement and spalling of cover concrete.

Figure 4.67-Load displacement response of specimen D1

Figure 4.78 illustrates the increased ductility of the uni-directional hinge test compared with the reverse cyclic test (see Figure 4.67). During cycles in excess of 8.0% drift there is a significant increase in the energy dissipation and reduction in stiffness of the hysteresis loops, this is probably related to an increased contribution of shear behaviour.

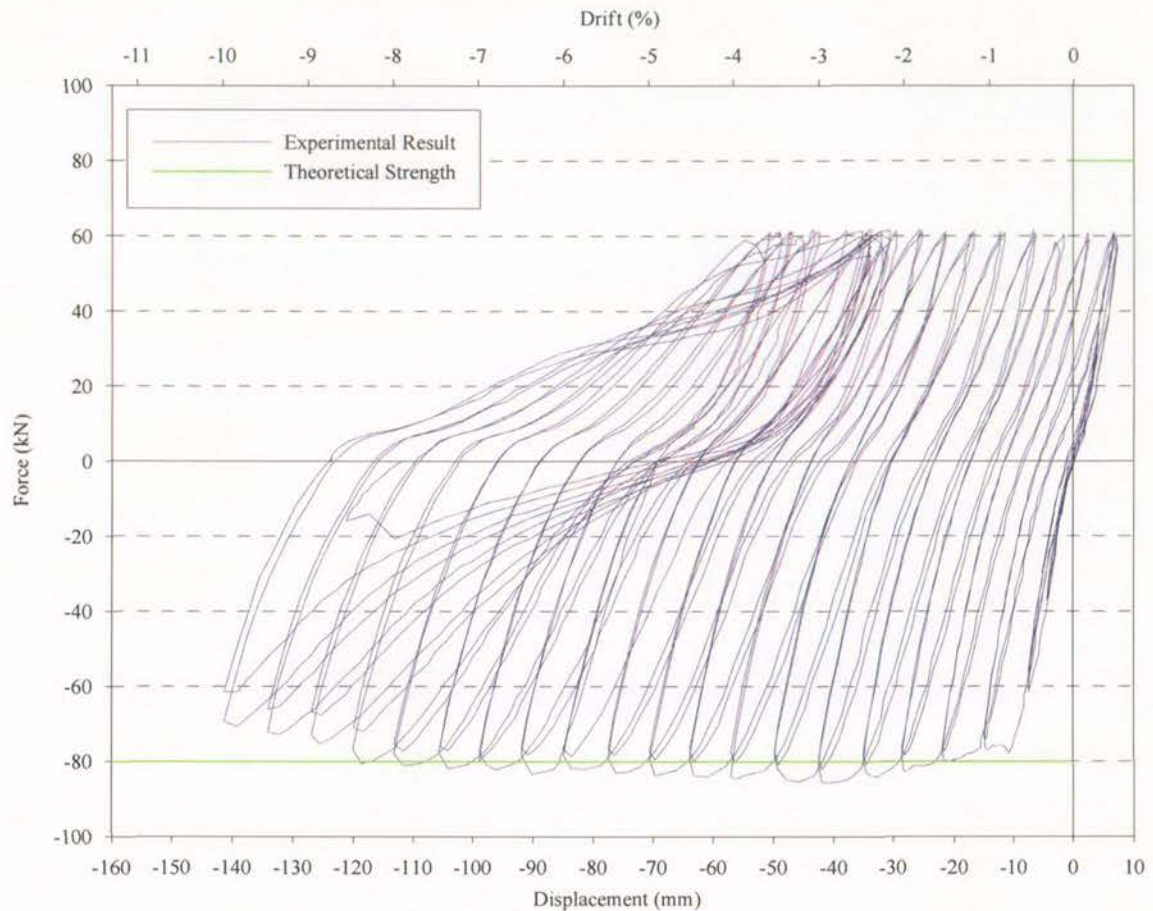
Figure 4.78-Load displacement response of specimen D2

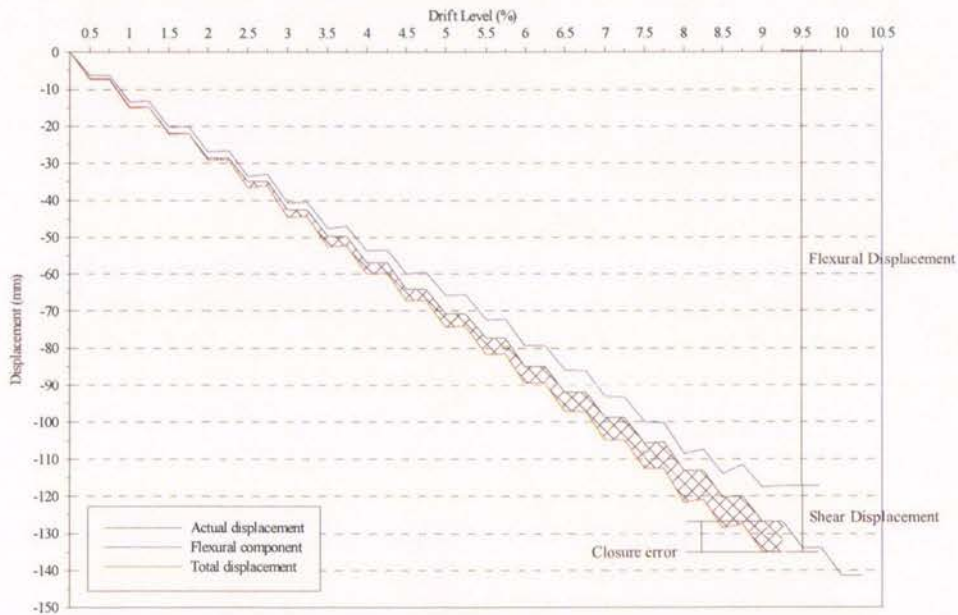
Figure 4.79 shows breakdown of the total beam displacement into shear and flexural components. It illustrates the dominant contribution of flexure to the total displacement. The closure error is small but is of the same order of magnitude as the shear displacement. An increase in shear contribution at higher displacement levels can be seen, however the full extent of this can not be seen due to lack of reliable data at the higher displacement levels due to buckling of the reinforcing.

Figure 4.79-Contribution of shear and flexure to the total displacement at the peaks of the loading cycles for beam D2

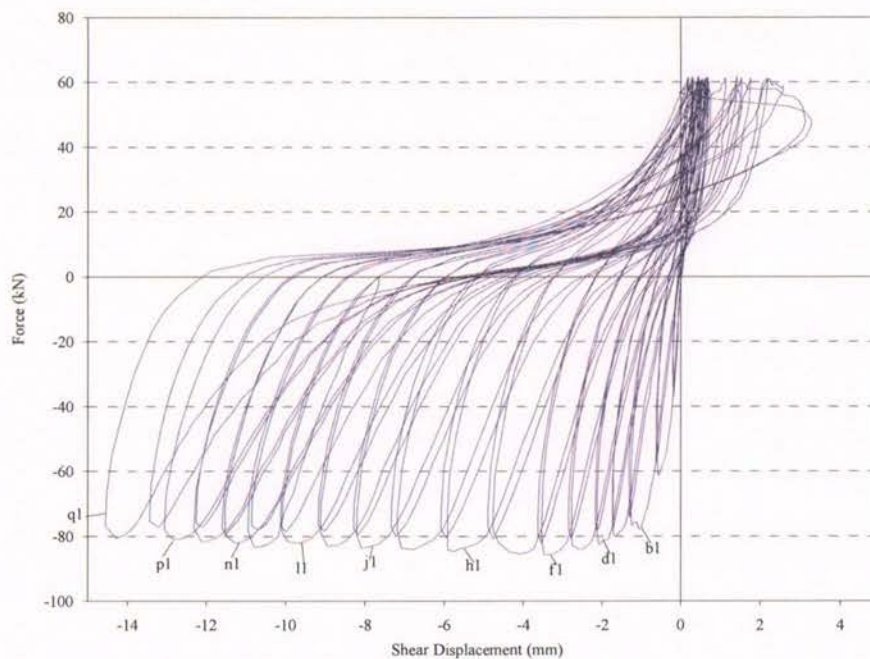
Figure 4.80 shows the shear force-displacement response of test D2. Unlike in previous tests, there is not an obvious increase in the shear displacement on each consecutive cycle. This indicates the shear stiffness was not degrading significantly on each cycle. This is possibly linked to the lower shear stress applied to this beam than the first three test units because of the increased shear area and reduced steel content.

Figure 4.80-Shear displacement versus applied load (D2)

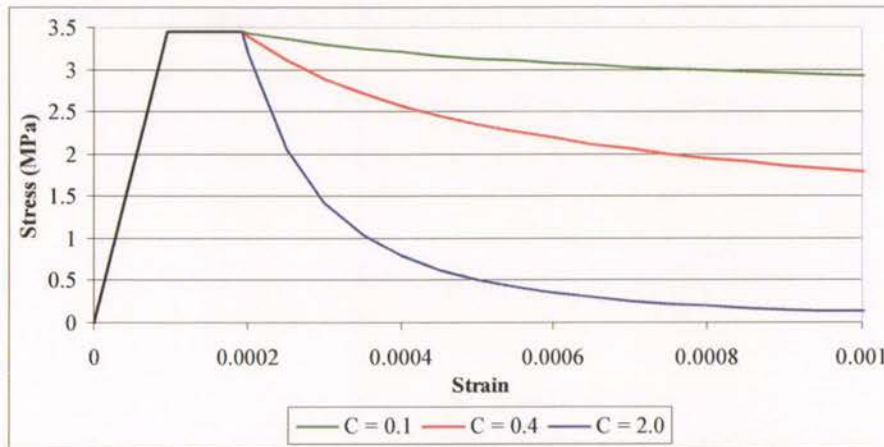
$\varepsilon$  is the strain in the concrete,  $f_t$  is the concrete tensile strength and  $E_t$  is the tensile elastic modulus of concrete. The effect of different values of tension softening factor on the stress-strain curve is illustrated in Figure 5.2.

Figure 5.2-Effect of varying tension softening factor on concrete stress strain behaviour

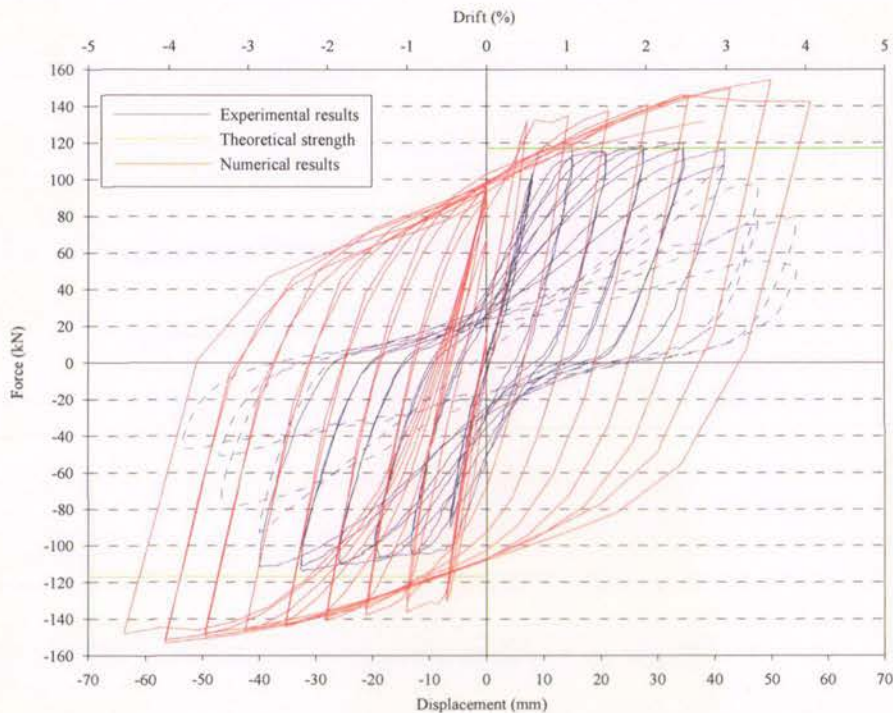
There is a significant degradation of strength in the experimental result after the onset of buckling during the 3.0% drift cycles. The analytical curve does not exhibit any degradation of strength until the last cycle at 4.5% drift after which failure occurs in shear at the top of the beam (see Figure 5.7) and the analysis stops. The programme does not consider buckling of reinforcement so it is expected that the strength degradation caused by buckling in the experiment would not be captured.

Figure 5.4-Numerical and experimental comparison (A1)

Figure 5.4 shows that the experimental result exhibits significant pinching behaviour which is not captured by the analysis. The total response is the combination of the flexural and shear components of displacement. When the shear component is inelastic and large, pinching of the overall result is more prominent. The analysis does not consider shear slip along cracks as the crack model used is a smeared crack model. The analysis also only considers elastic shear contribution. These two factors explain why there is no pinching behaviour in the analytical results. Figure 5.5 shows the flexural displacement from the experiment and the total displacement from the numerical analysis plotted against the applied force up to a drift level of 2.5%. The dramatic difference between the experimental flexural and numerical displacement at 2.5% highlights the magnitude of the shear component in the experiment. The absence of this shear component in the analysis is clearly one of the causes of the poor correlation between the experiment and numerical results.

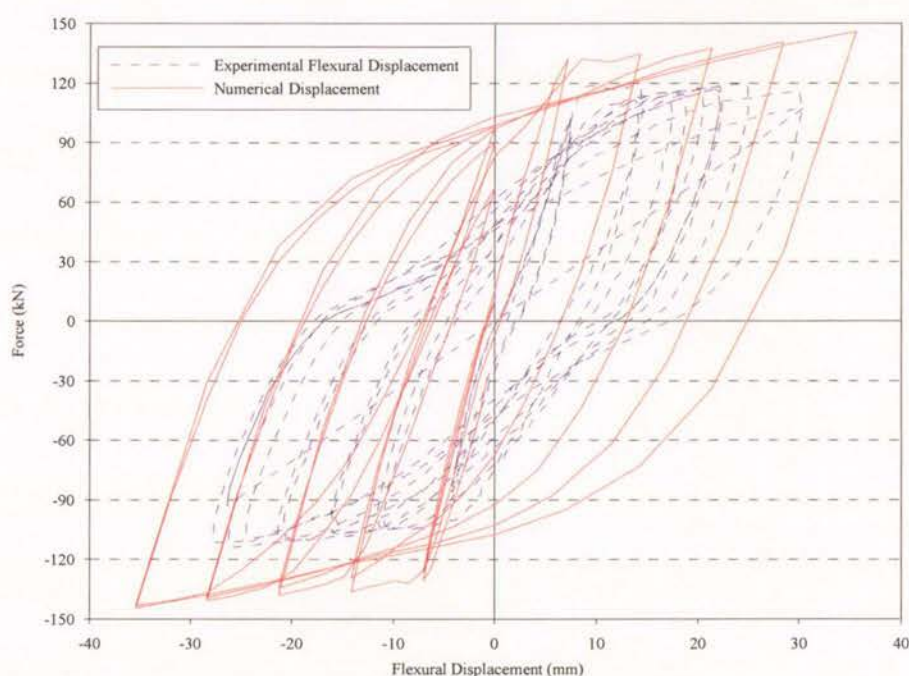
Figure 5.5-Comparison of experimental flexural displacement and the total numerical displacement (A1)

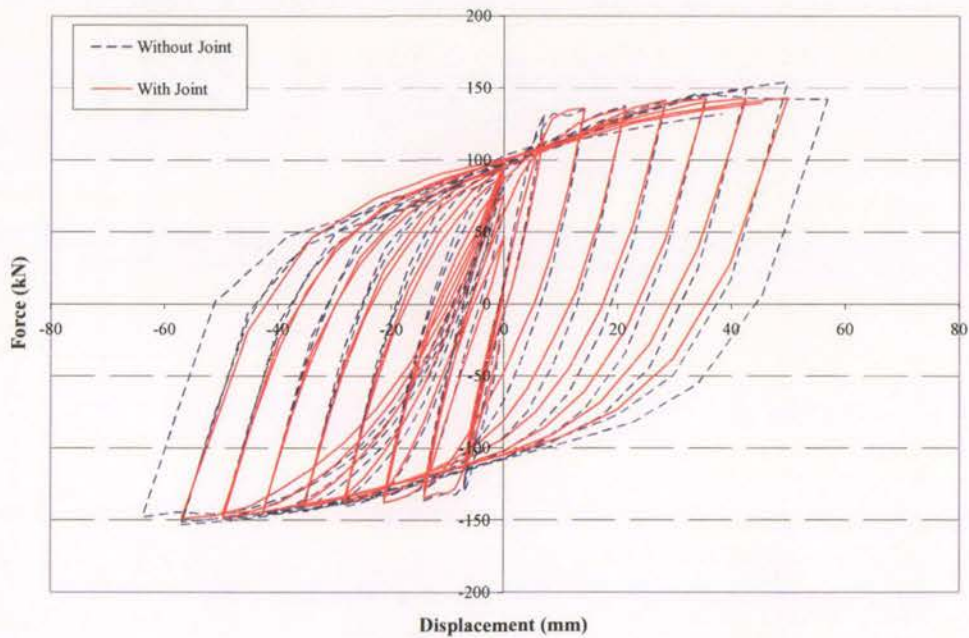
An analysis was carried out using a series of joint elements available in the program at the beam springing using the properties as described in section 5.2. Figure 5.12 shows the force displacement curve obtained from this analysis. This shows that the presence of the joint model does not significantly change the analytical prediction in this case. Thus no further analyses using a joint model were carried out.

Figure 5.12-Comparison of numerical model with and without joint model (A1)

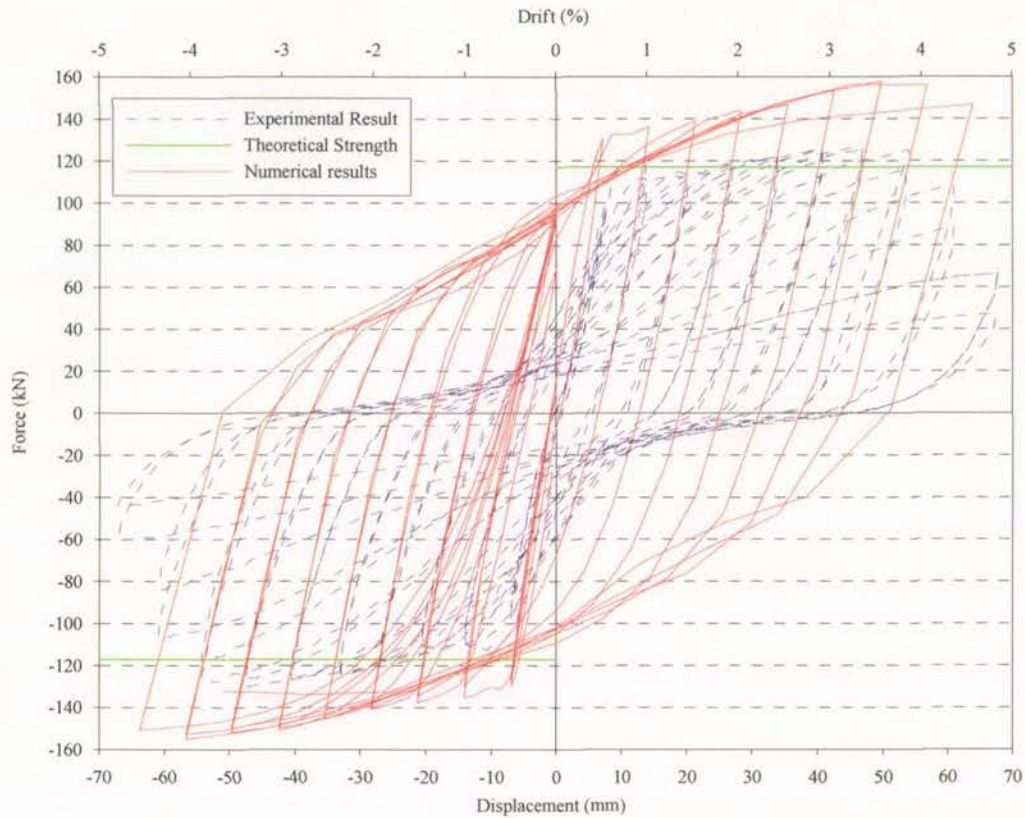
Figure 5.13-Numerical and experimental comparison (A2)
