**Assessment of material strain limits for defining different forms  
of plastic hinge region in concrete structures**

# EQC Project 06/516

**Assessment of Material Strain Limits for Defining Different  
Forms of Plastic Hinge Region in Concrete Structures.**

A Thesis submitted in partial fulfilment of the requirements for the degree of  
Master of Engineering  
at the University of Canterbury by

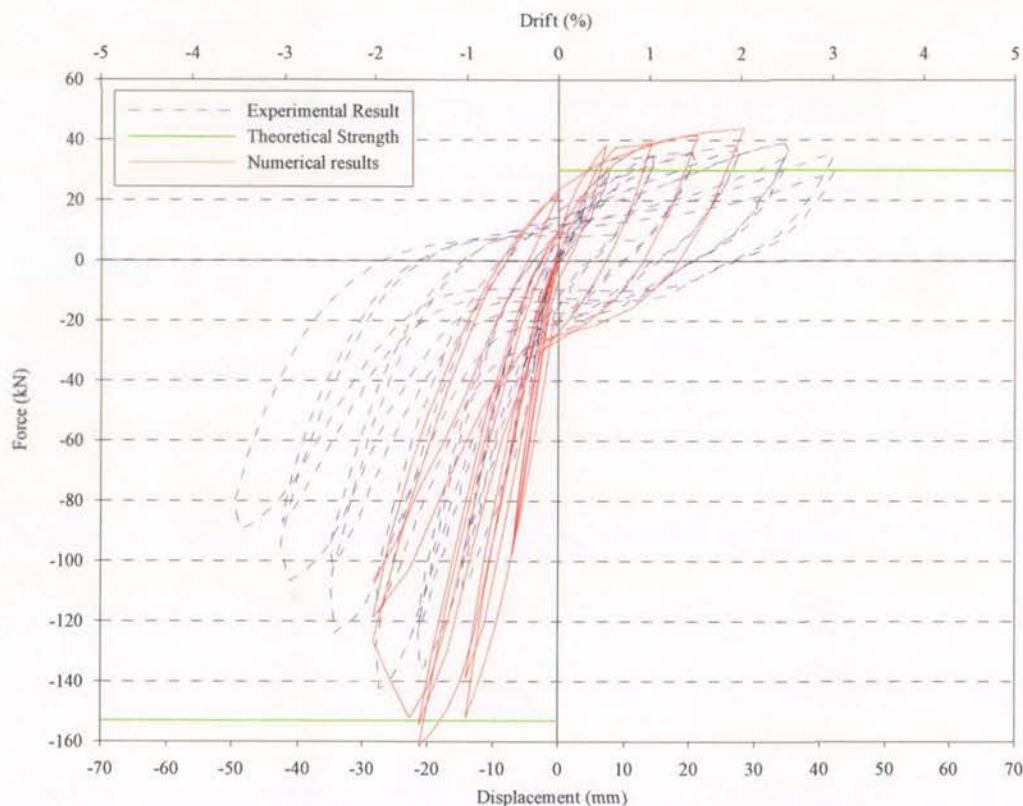
Figure 5.21-Numerical and experimental comparison (B1)

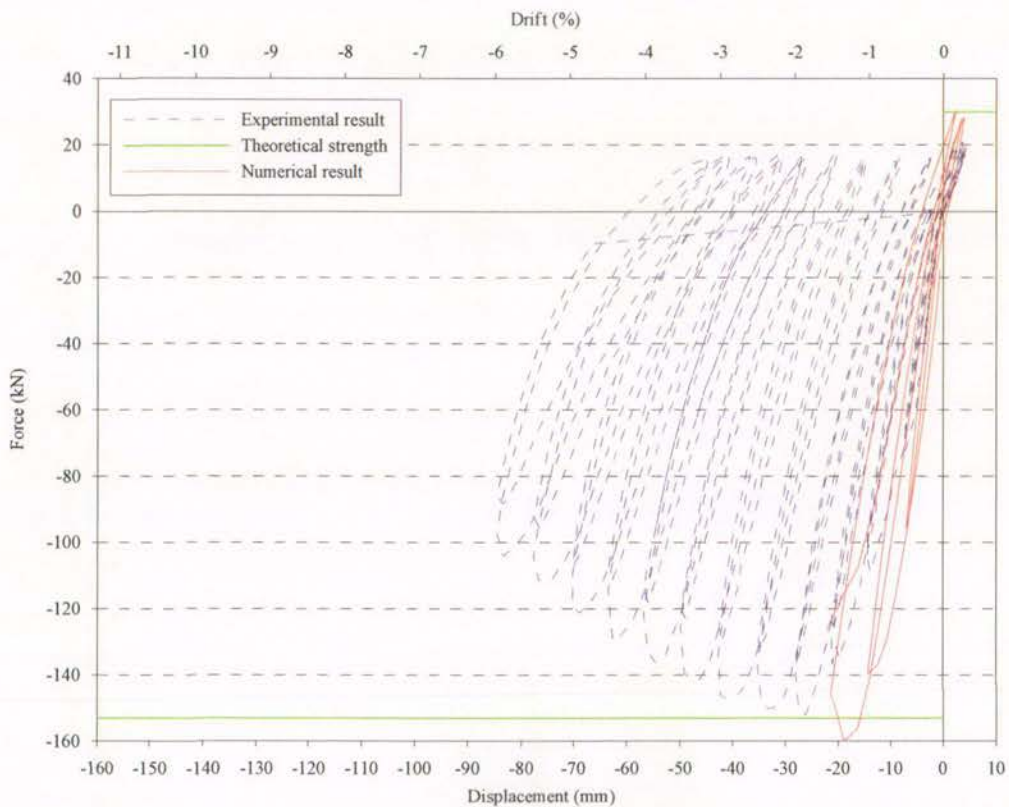
Figure 5.27-Numerical and experimental comparison (B2)

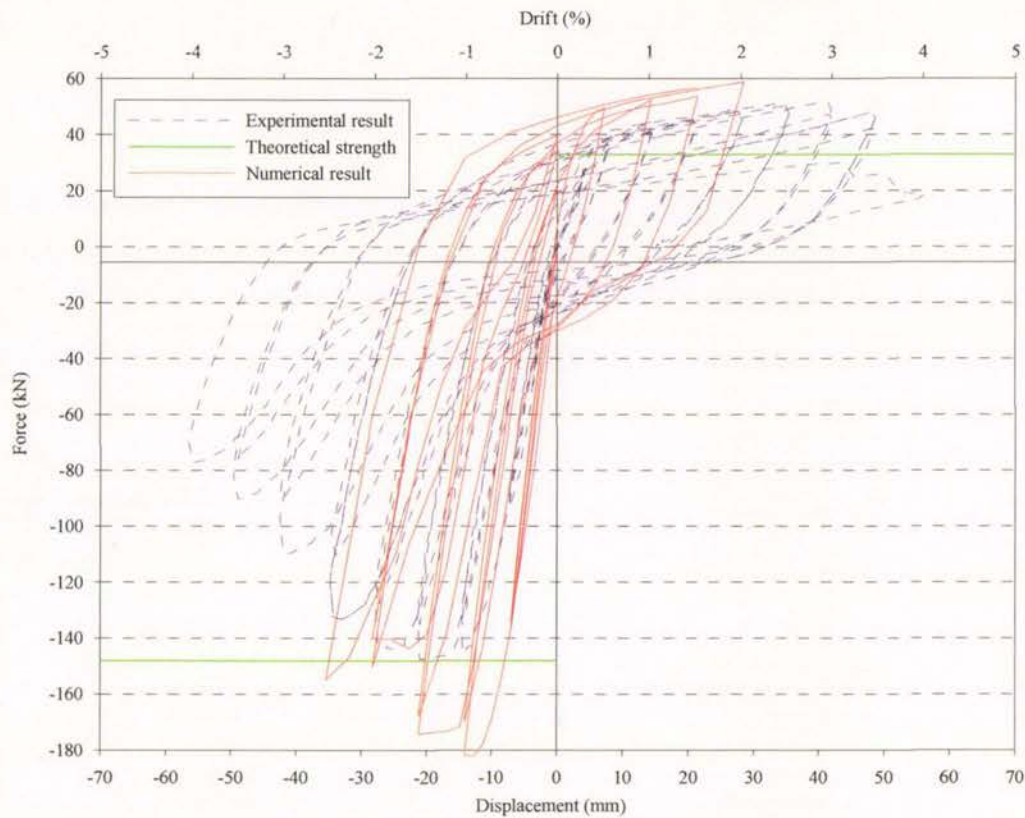
Figure 5.33-Numerical and experimental comparison (C1)

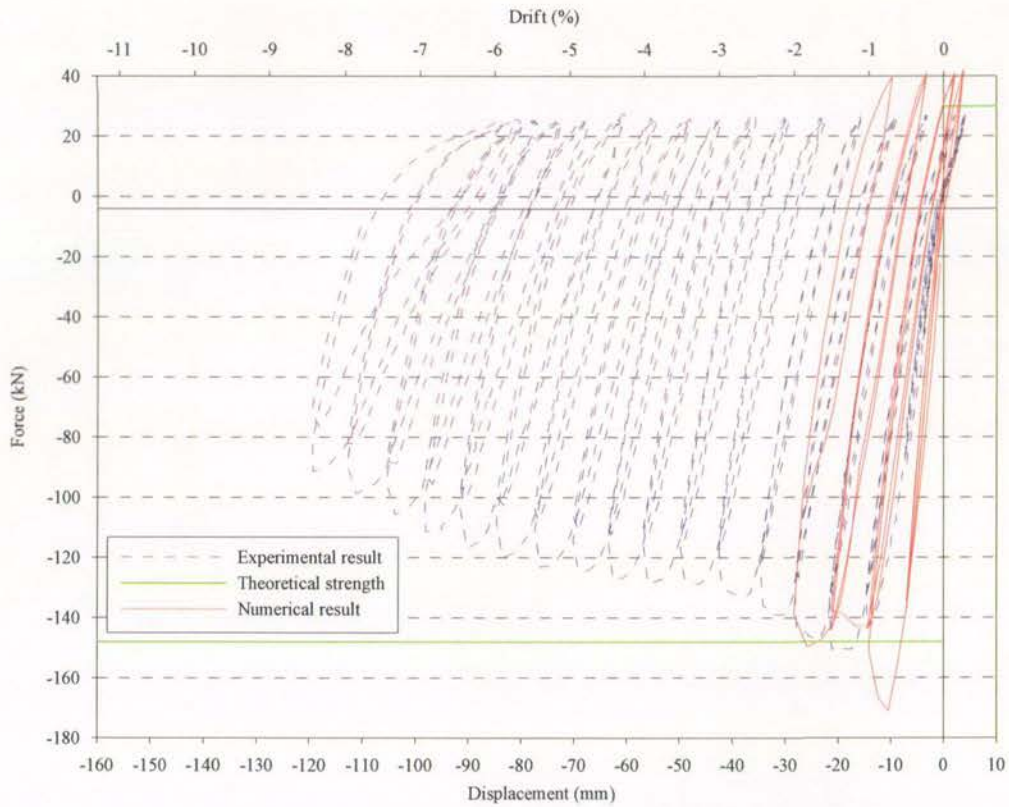
Figure 5.39-Numerical and experimental comparison (C2)

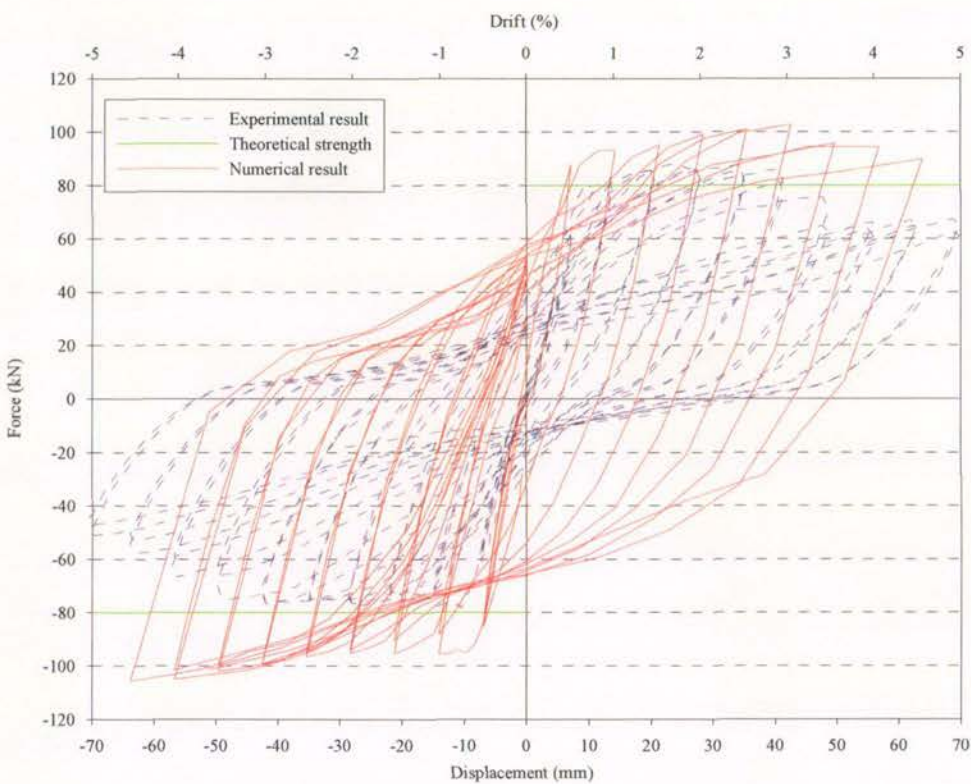
Figure 5.45-Numerical and experimental comparison (D1)

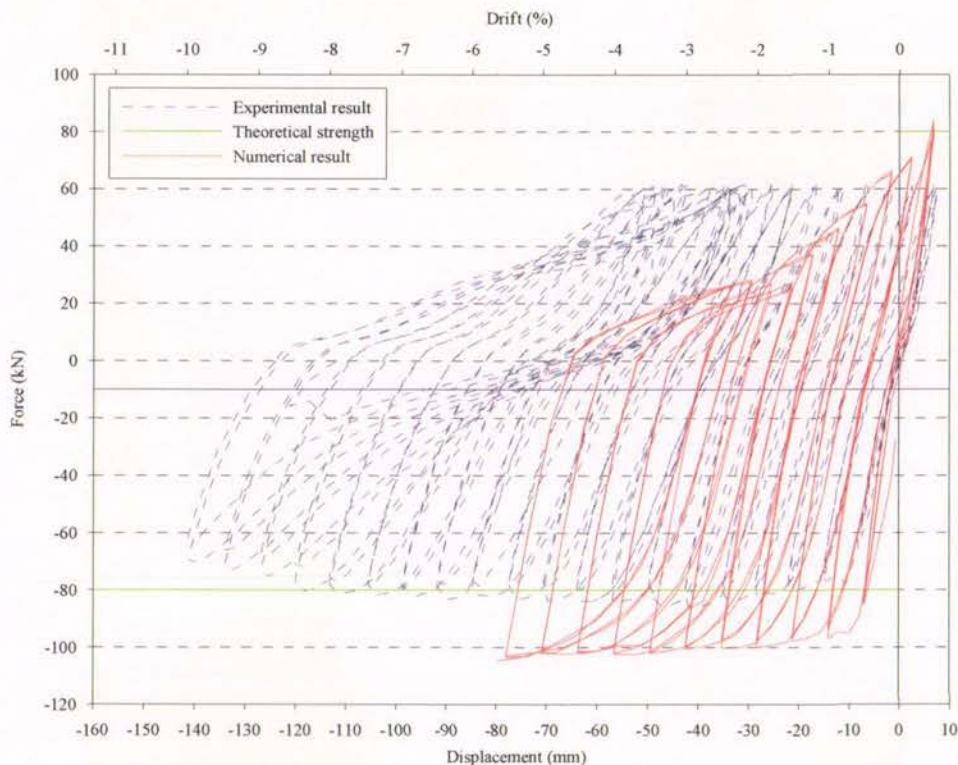
Figure 5.51-Numerical and experimental comparison (D2)

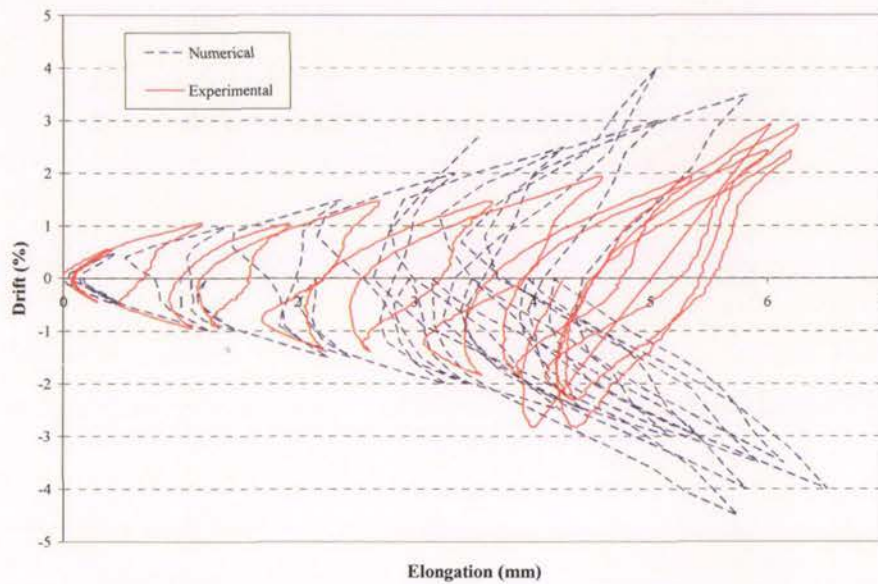
Figure 5.57-Comparison of elongation between the experiment result and the numerical model (A1)

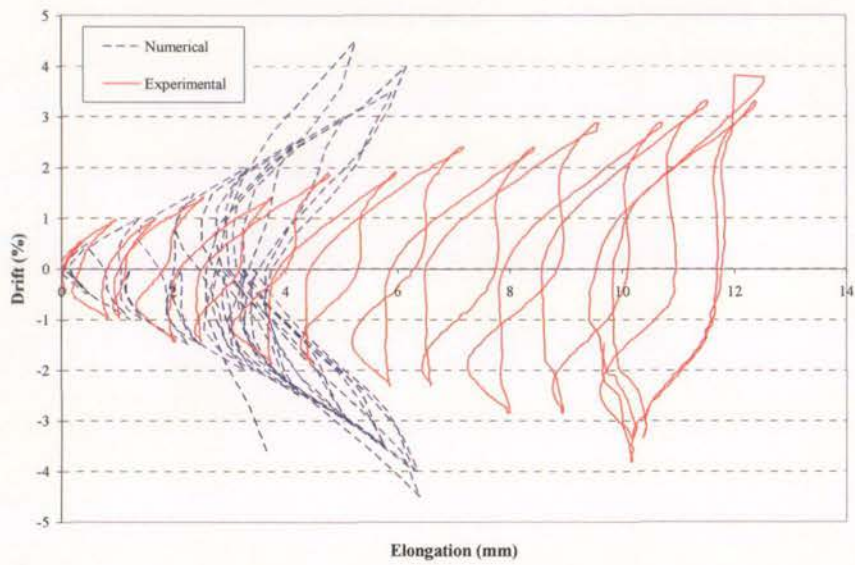
Figure 5.58- Comparison of elongation between the experiment result and the numerical model (A2)

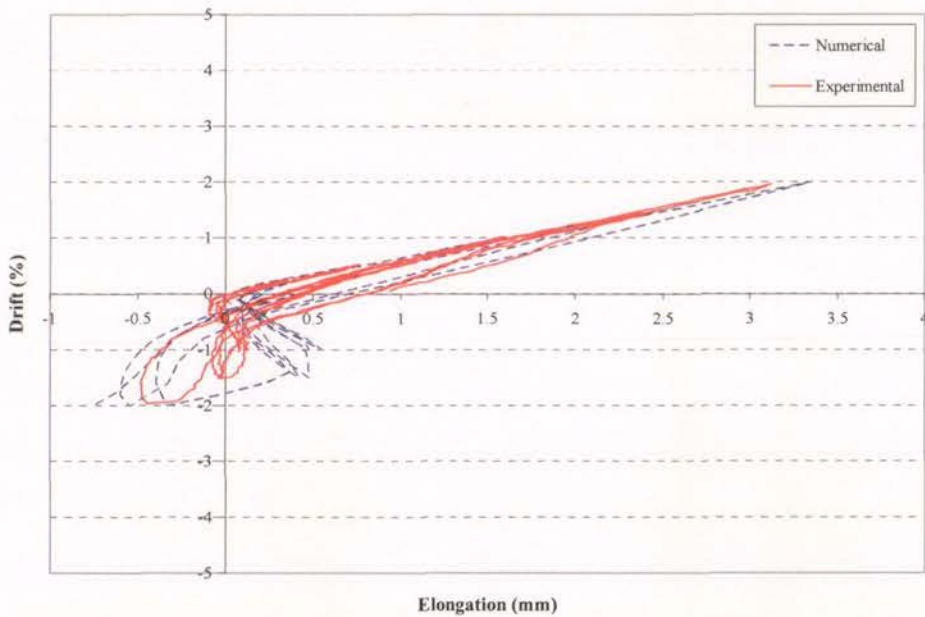
Figure 5.59- Comparison of elongation between the experiment result and the numerical model (B1)

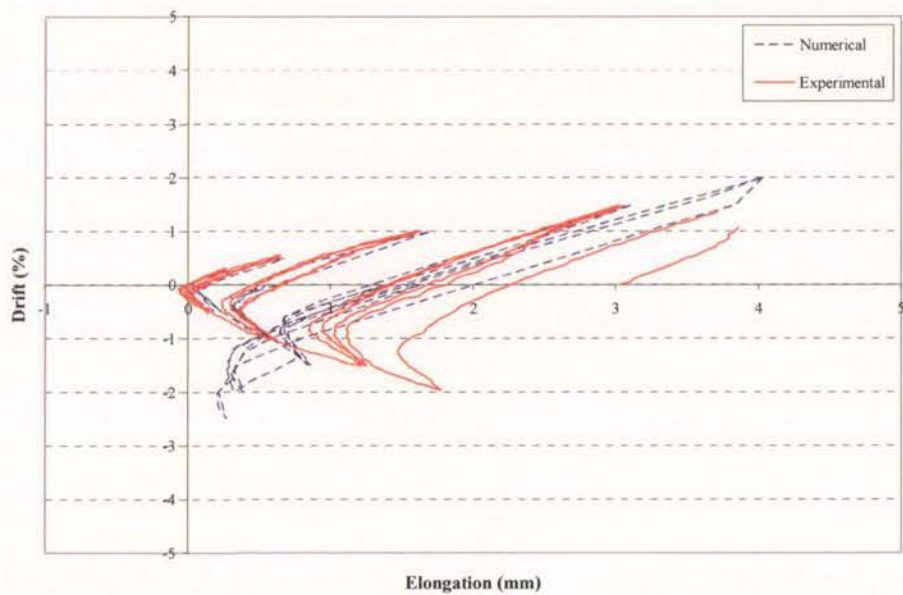
Figure 5.60- Comparison of elongation between the experiment result and the numerical model (C1)

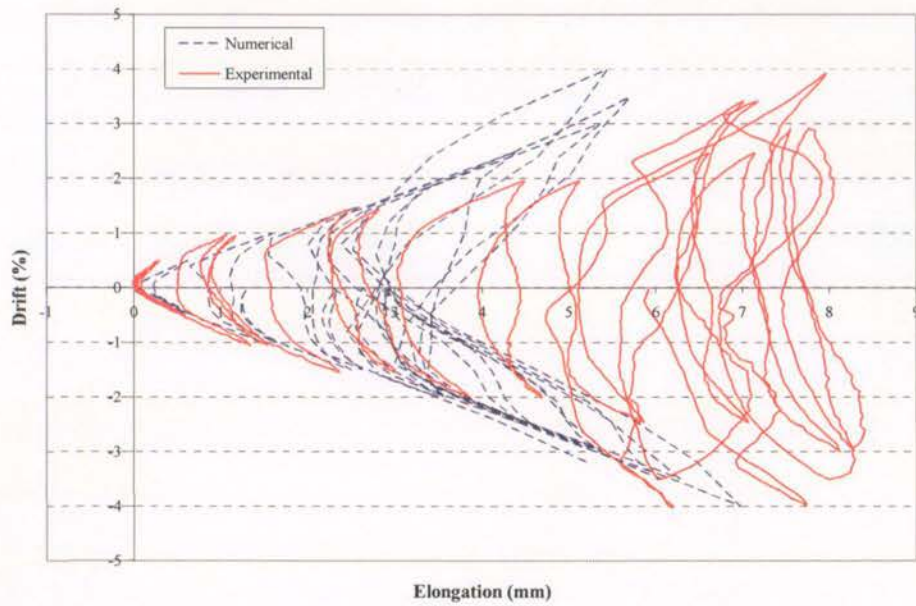
Figure 5.61- Comparison of elongation between the experiment result and the numerical model (D1)

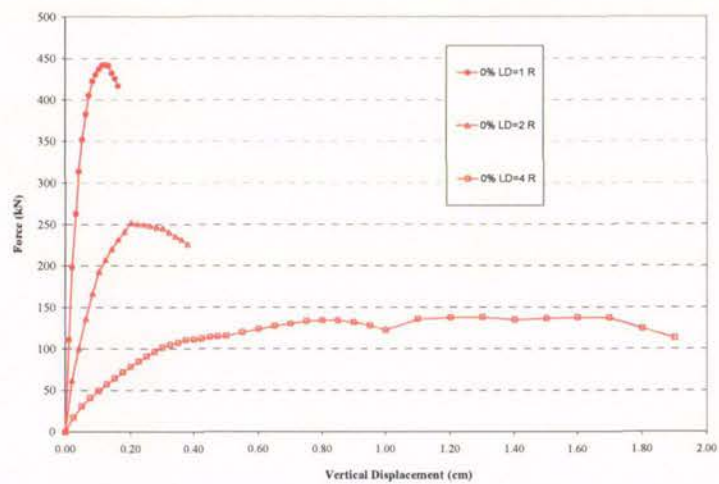
Figure 5.64-Effect of increasing length of restrained beam

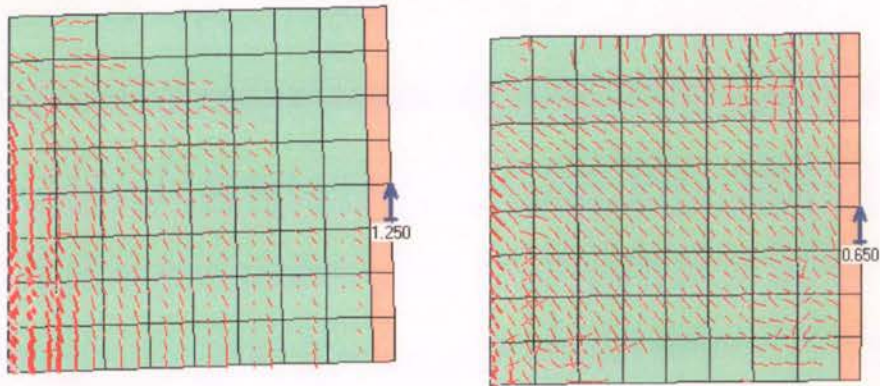
Figure 5.69-Deflection and crack pattern for  $L/d=1$  with a) Unrestrained horizontal displacement and b) Restrained horizontal displacement

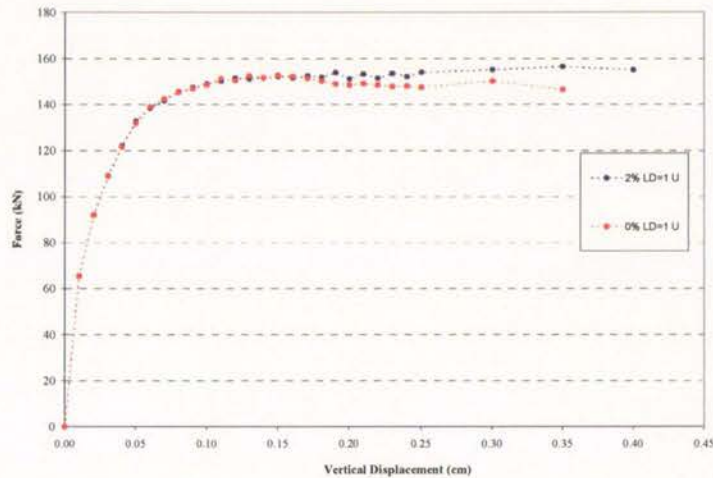
Figure 5.70-Effect of increasing transverse steel content of unrestrained beam

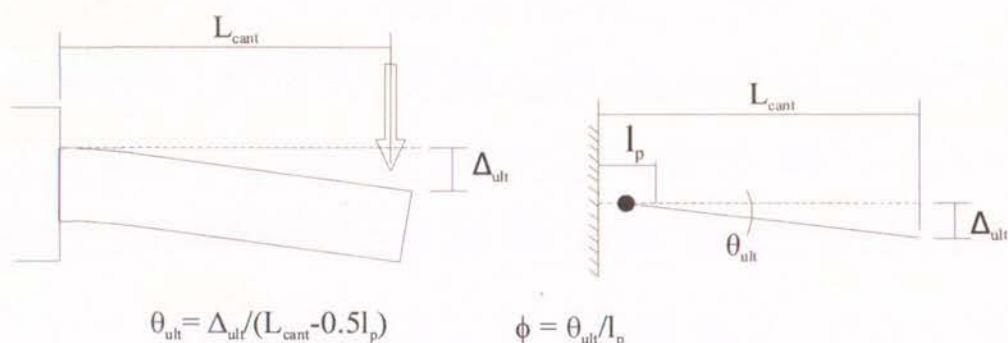
Figure 6.2-Obtaining experimental curvature

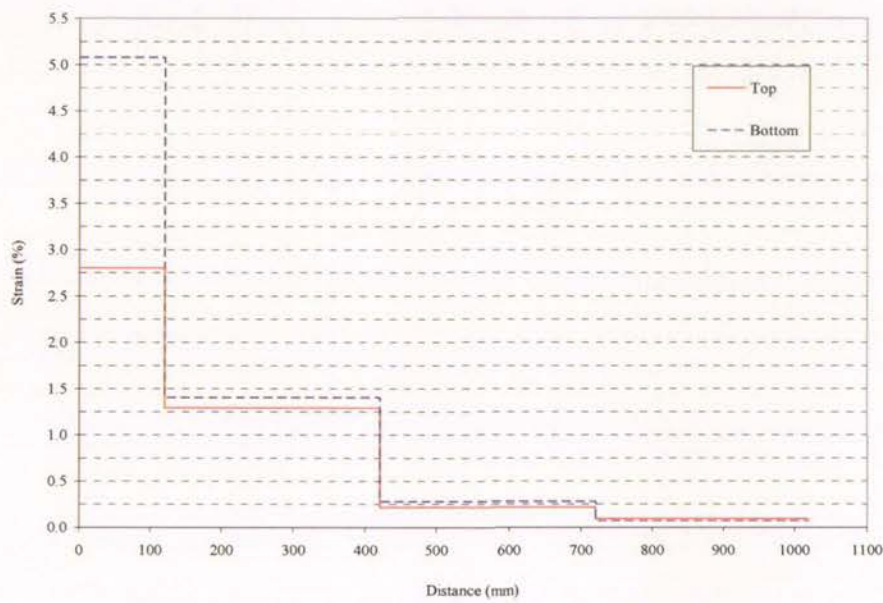
Figure 6.4-Strains obtained from longitudinal potentiometers (A1)

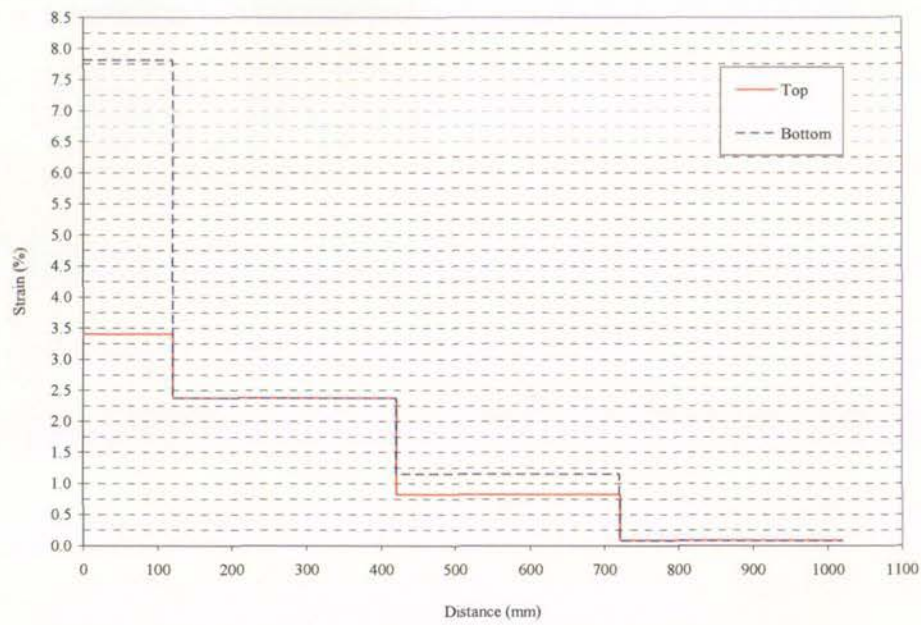
Figure 6.6-Strains obtained from longitudinal potentiometers (A2)

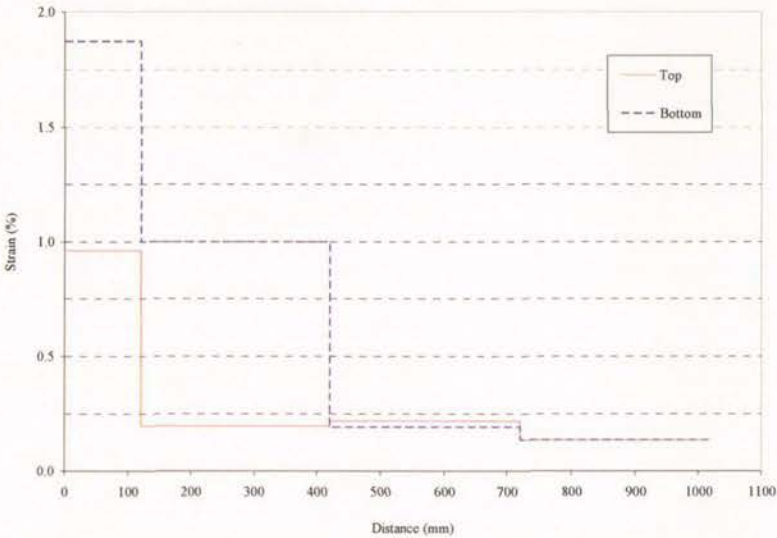
Figure 6.8-Strains obtained from longitudinal potentiometers (B1)

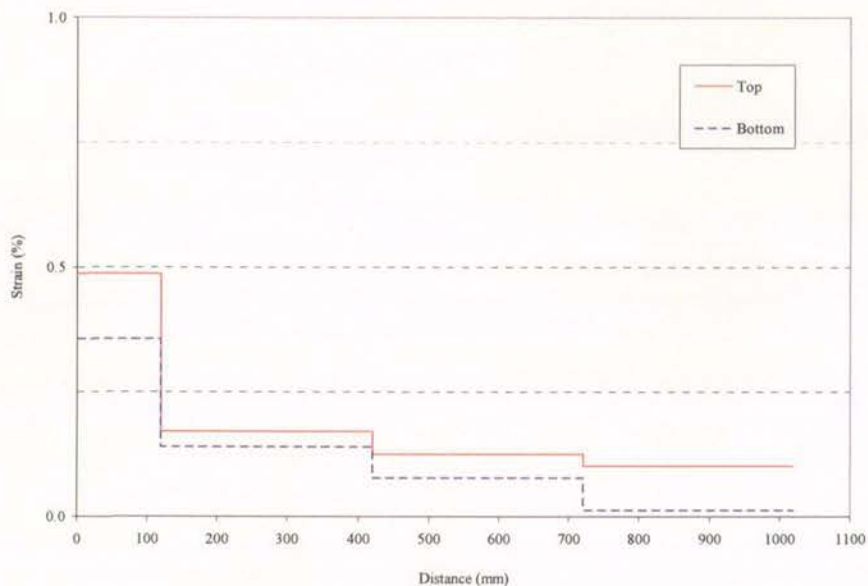
Figure 6.10-Strains obtained from longitudinal potentiometers (B2)

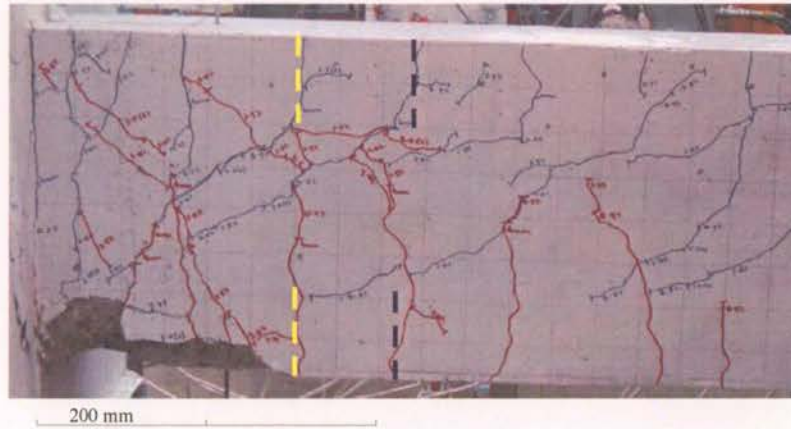
Figure 6.11-Crack width and estimation of yielding length (C1)

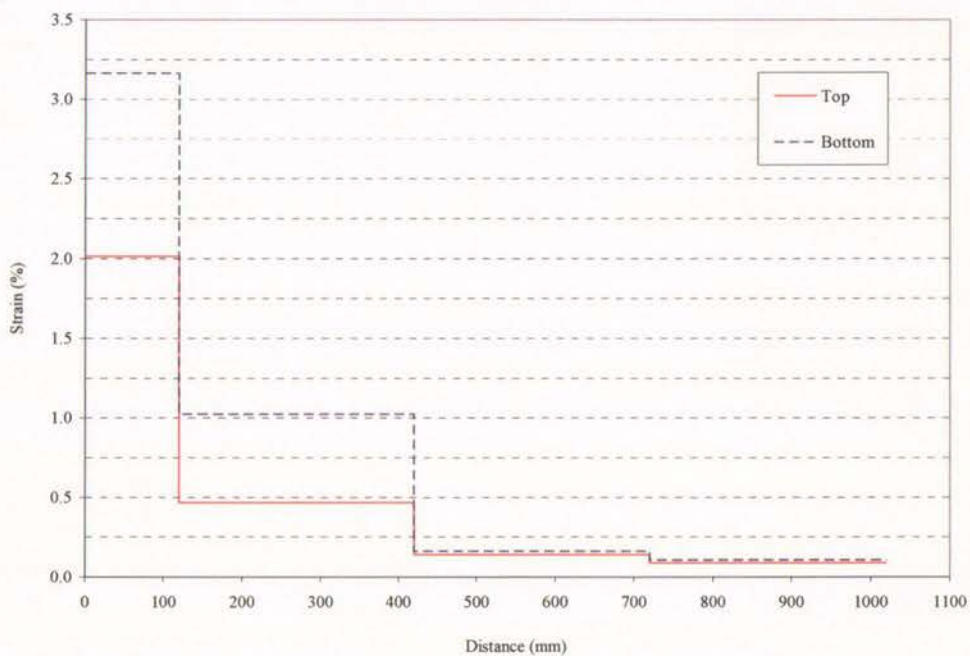
Figure 6.12-Strains obtained from longitudinal potentiometers (C1)

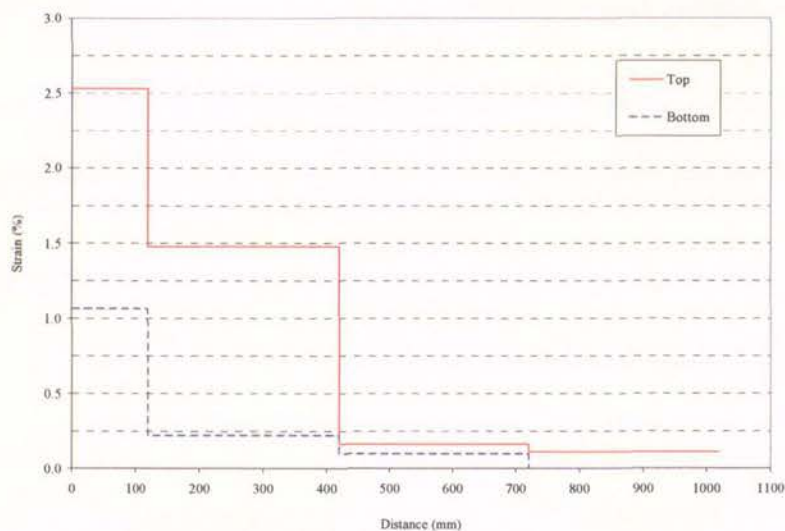
Figure 6.14-Strains obtained from longitudinal potentiometers (C2)

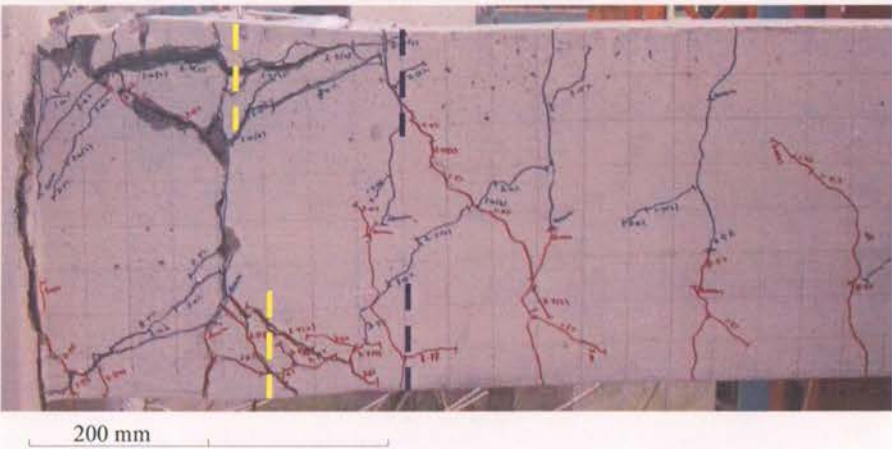
Figure 6.15-Crack widths and estimation of yielding length (D1)

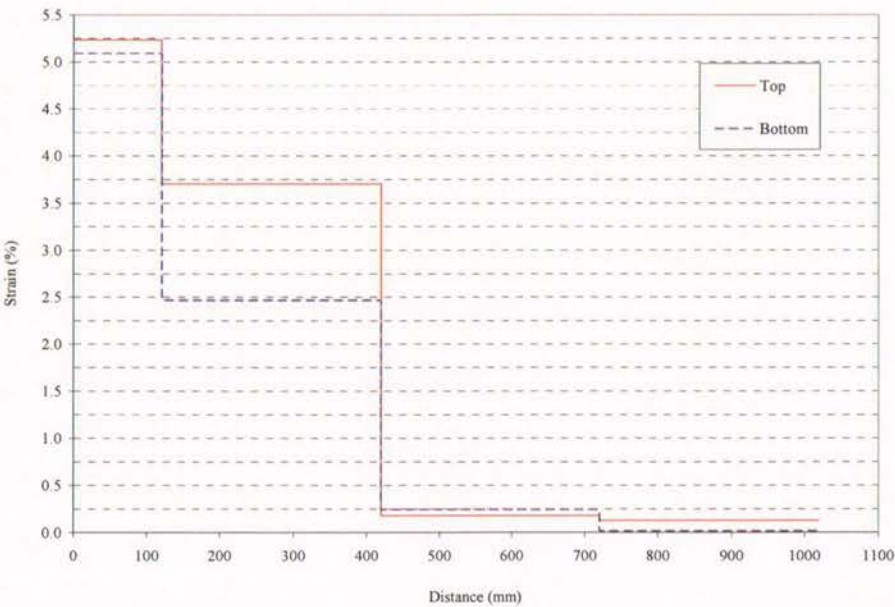
Figure 6.16-Strains obtained from longitudinal potentiometers (D1)

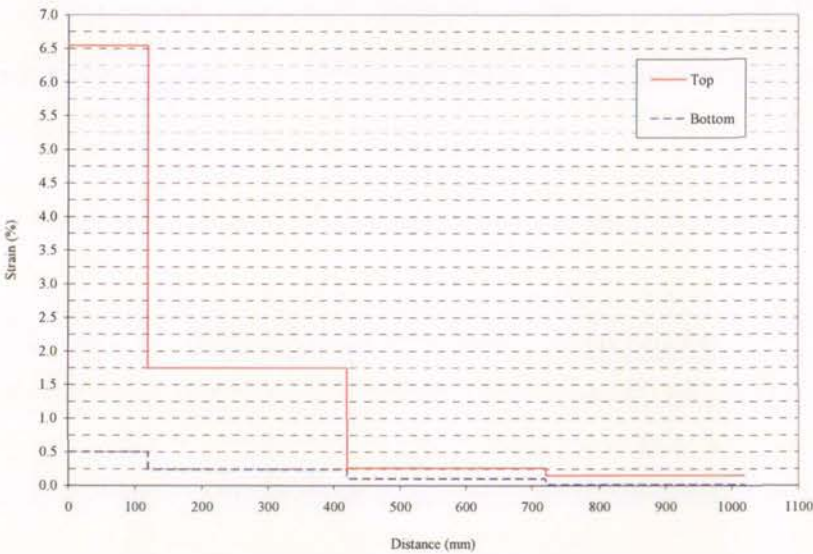
Figure 6.18-Strains obtained from longitudinal potentiometers (D2)

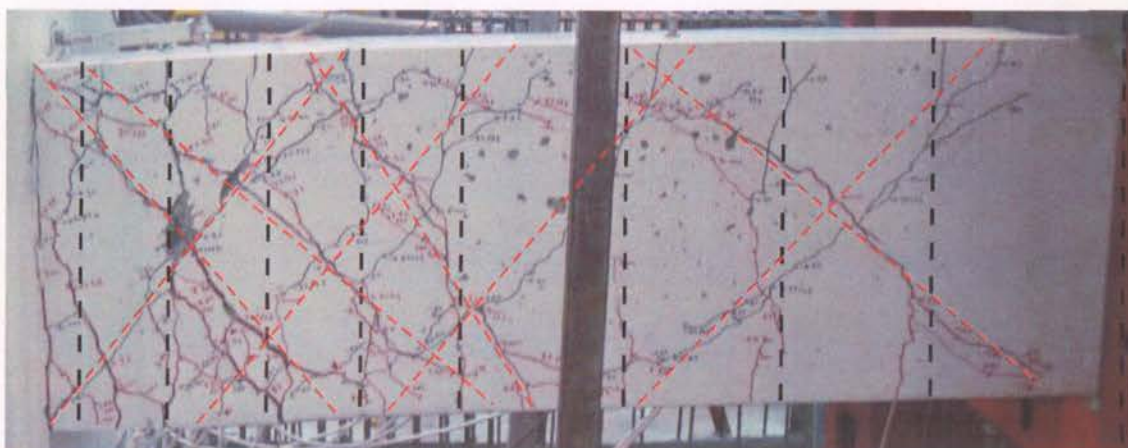
Figure 6.21-Diagonal tension cracks at 3.5% drift (A2)

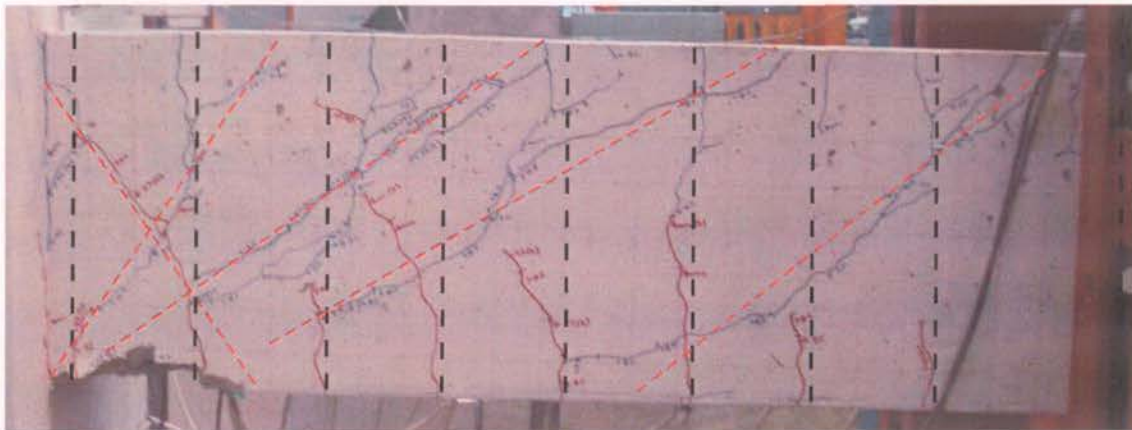
Figure 6.22-Diagonal tension cracks at 2.0% drift (B1)

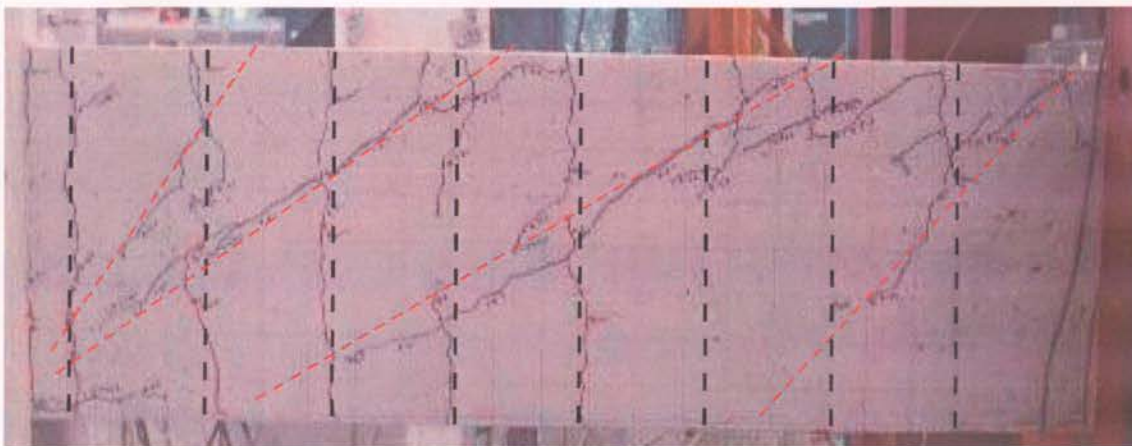
Figure 6.23-Diagonal tension cracks at 2.0% drift (B2)

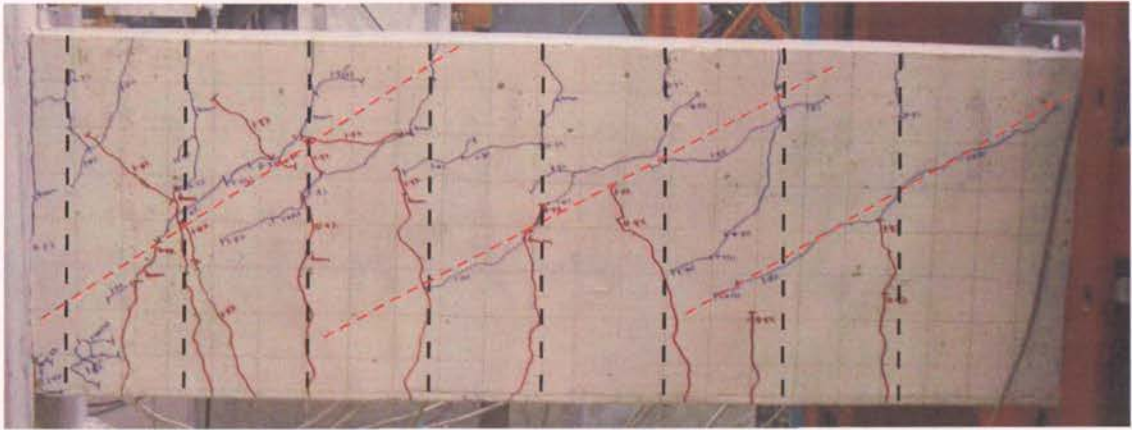
Figure 6.24-Diagonal tension cracks at 1.5% drift (C1)

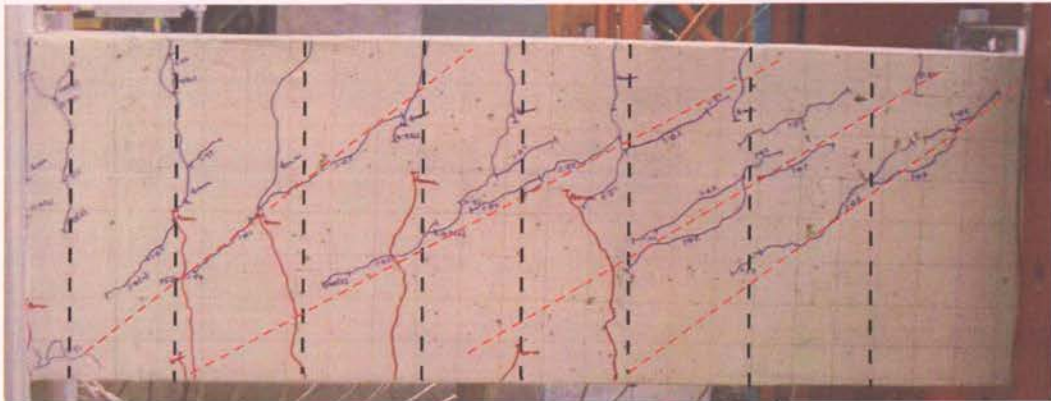
Figure 6.25-Diagonal tension cracks at 1.5% drift (C2)

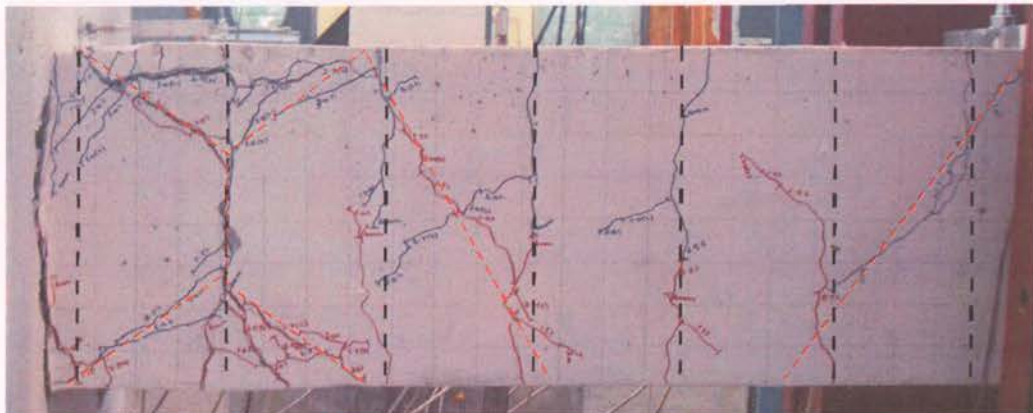
Figure 6.26-Diagonal tension cracks at 3.0% drift (D1)

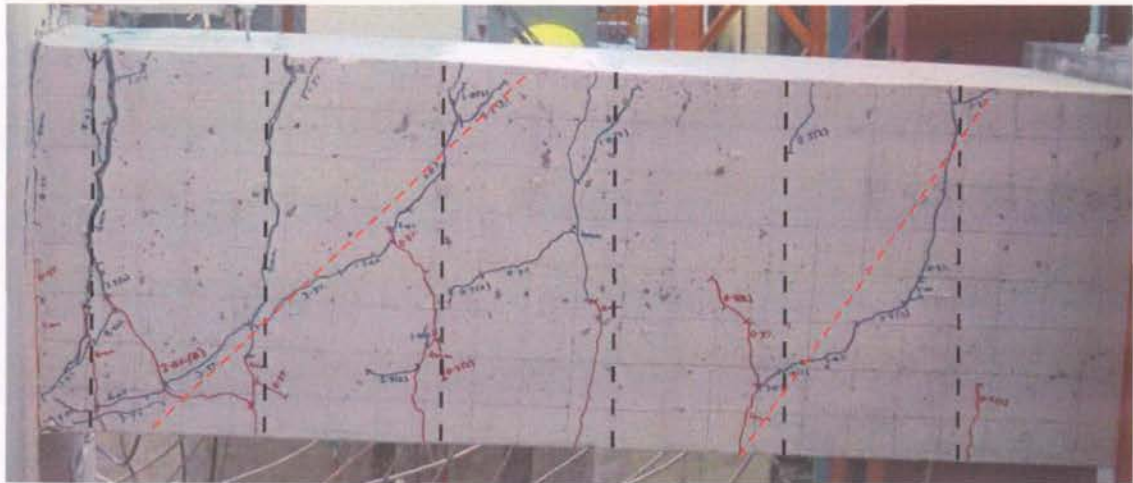
Figure 6.27-Diagonal tension cracks at 4.0% drift (D2)

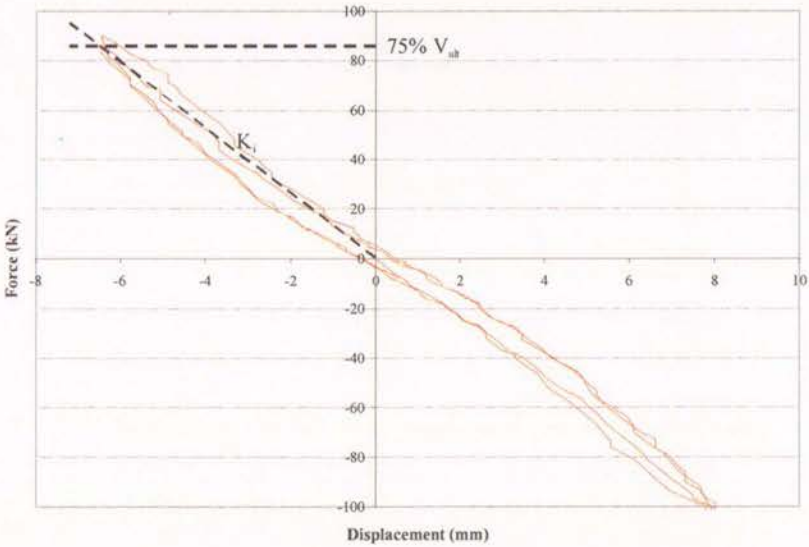
Figure 6.28-Calculating initial stiffness

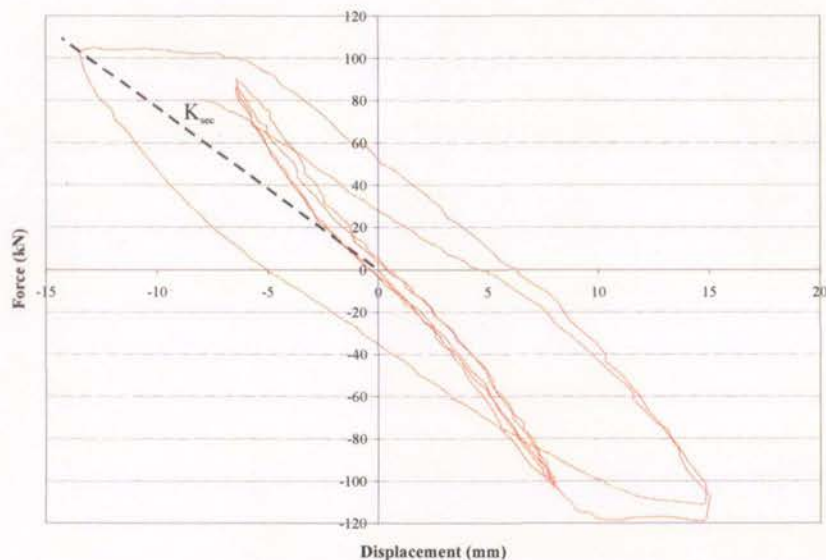
Figure 6.29-Calculating secant stiffness

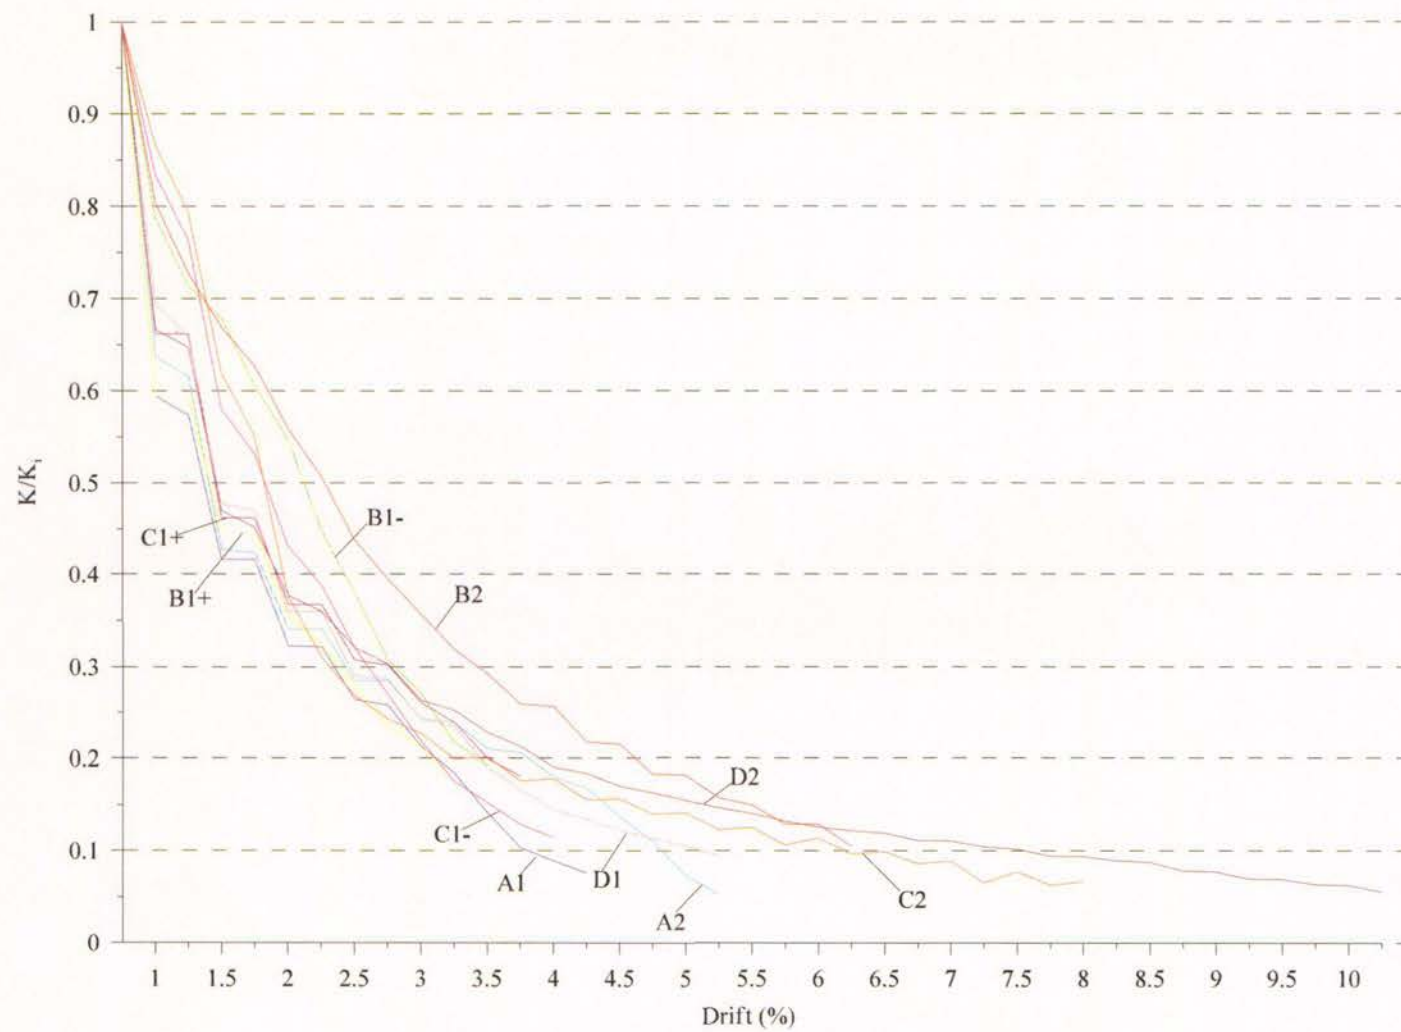
Figure 6.30-Normalised secant stiffness versus drift level

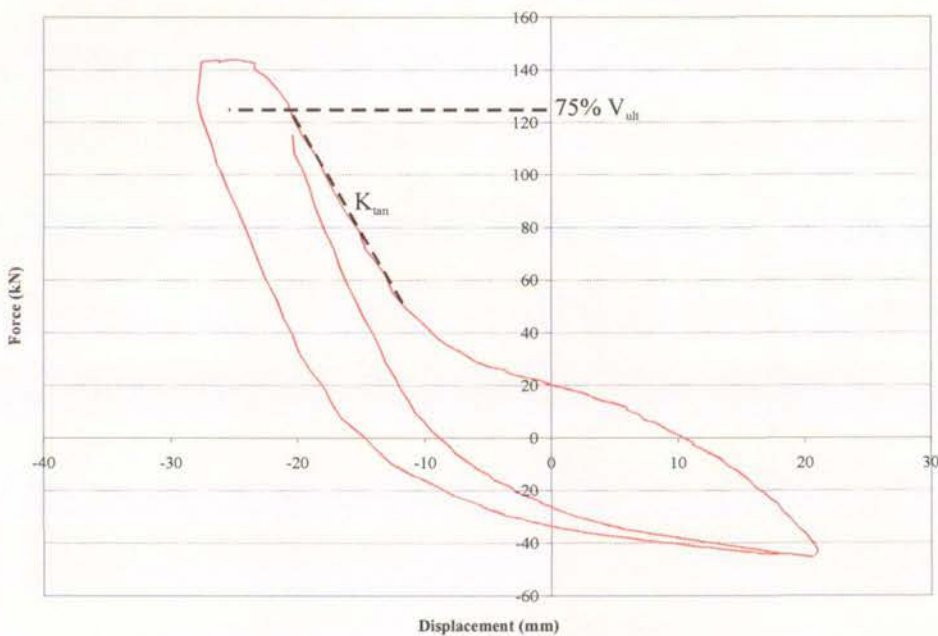
Figure 6.31-Calculating tangential stiffness

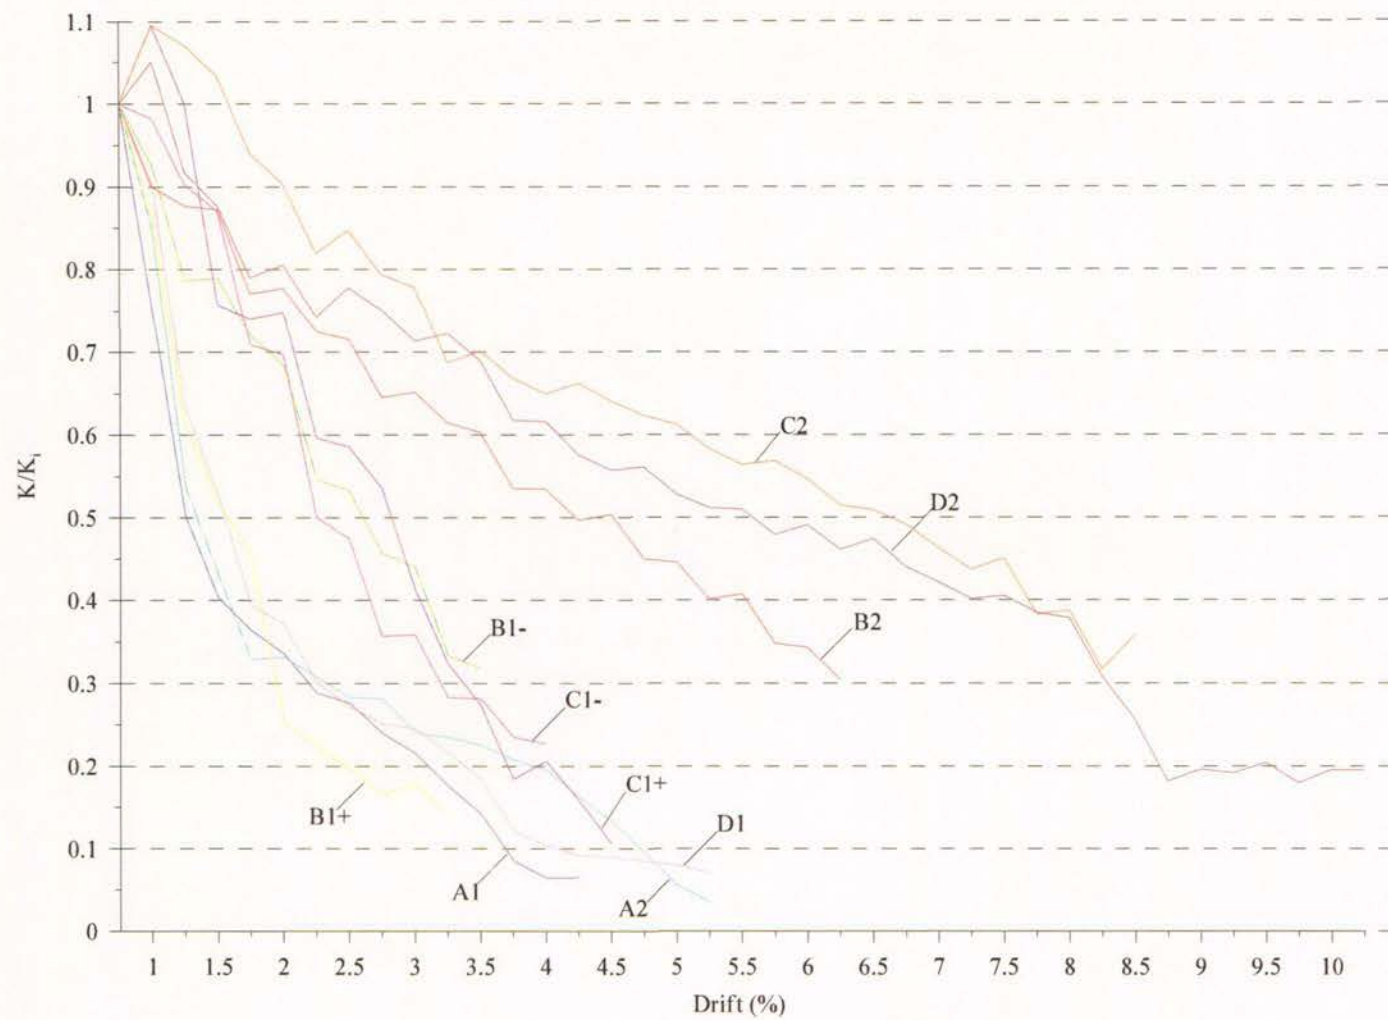
Figure 6.32-Normalised tangent stiffness versus drift level

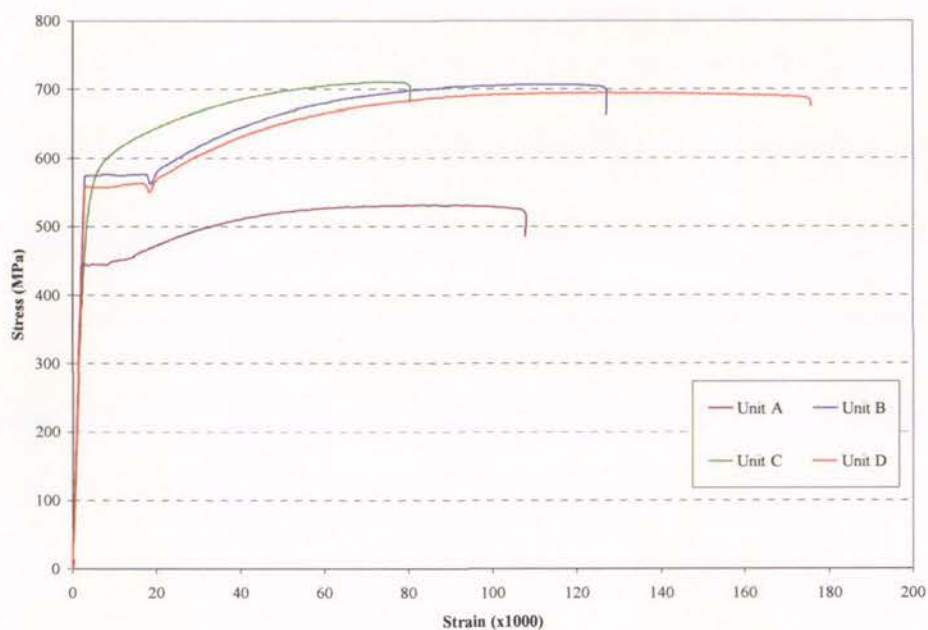
Figure A.3-Stress-strain curves from stirrup samples

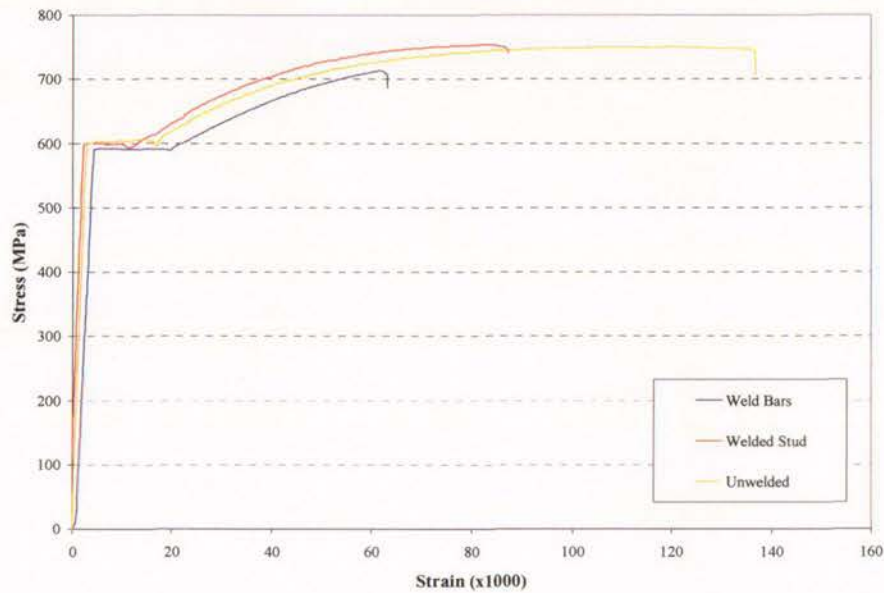
Figure A.4-Stress-strain curves of 25mm Grade 500 reinforcing bars with welds
