**Assessment of material strain limits for defining different forms  
of plastic hinge region in concrete structures**

# EQC Project 06/516

**Assessment of Material Strain Limits for Defining Different  
Forms of Plastic Hinge Region in Concrete Structures.**

A Thesis submitted in partial fulfilment of the requirements for the degree of  
Master of Engineering  
at the University of Canterbury by

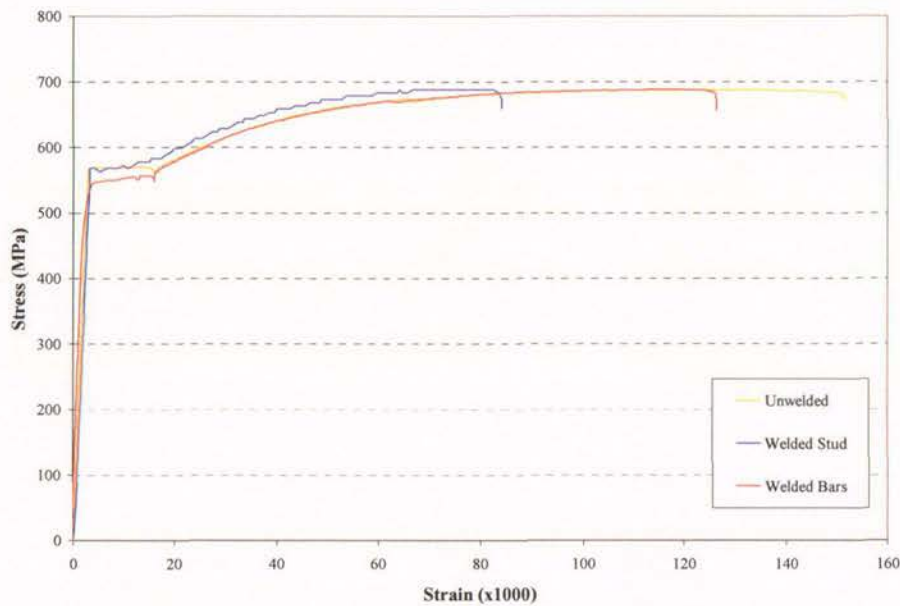
Figure A.5-Stress-strain curves of 12mm Grade 500 reinforcing bars with welds

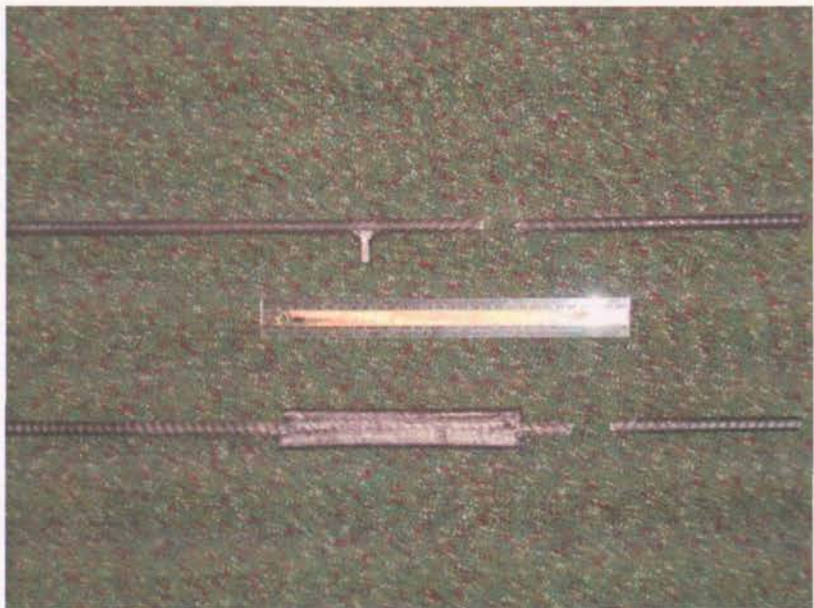
Figure A.6-Fractured steel sample of 12mm bar with stud and round bar welded to it

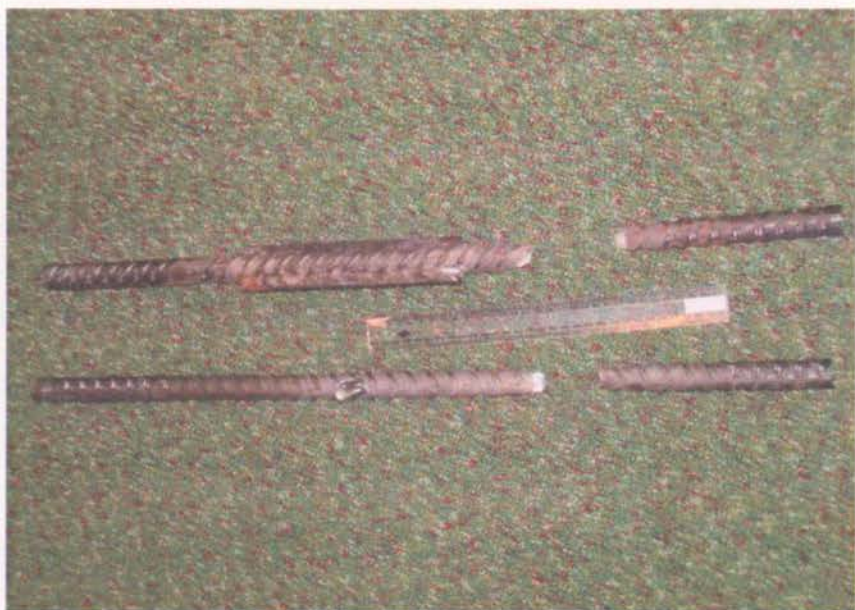
Figure A.7-Fractured steel sample of 25mm bar with stud and round bar welded to it
