***Rapid, cost-effective 3D monitoring of urban landslide displacements
using UAV-Structure from Motion (SfM)
(3714483)***

Martin Brook, Jon Tunncliffe, University of Auckland

Landslide; structure-from-motion; slope stability; Auckland

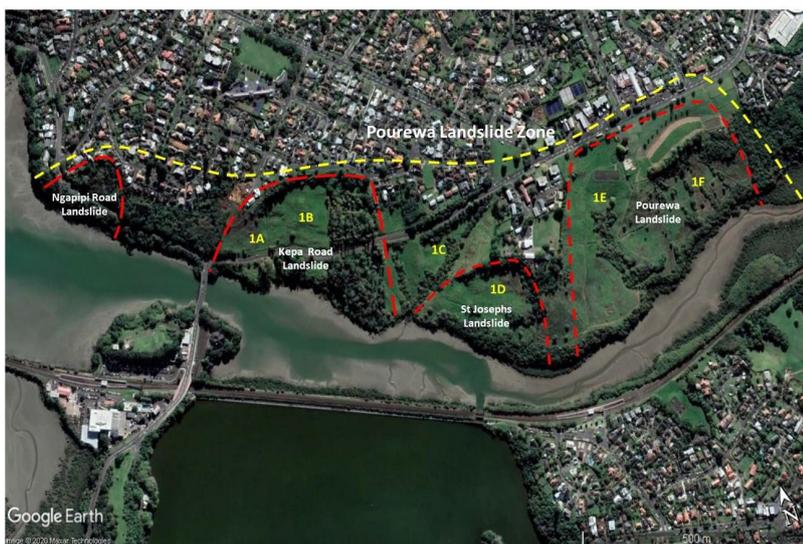
Fig. 2: The 6 landslides surveyed at Orakei.

Sites 1A-1F for this study are positioned along Kepa Road in Orakei, approximately 4.5 km east of the Auckland CBD (Fig. 2), along the NE side of Orakei Basin, overlooking Pourewa Creek (Fig. 2). Sites 1A-1F are located within the “Pourewa Landslide Zone” (PLZ) which is a zone of slope instability. This zone includes four prehistoric landslides on which the sites have been selected. The Ngapipi Road Landslide (not a focus of this study) is situated at the westernmost corner of Kepa Road. The next sites extending east include: the Kepa Road Landslide (1A-1B), St Joseph’s Landslide (1C-1D), and the Pourewa Landslide (sites 1E-1F).

Sites 1A-1B extend vertically by approximately 82 m and 151 m respectively from their head-scarp to the Kepa Road fence boundary. Site 1C extends approximately 310 m vertically from its channel head to the shore platform towards Pourewa Creek. Site 1D extends approximately 180 m vertically from its head-scarp down towards its toe. Finally, Sites 1E-1F extend approximately 172 m and 246 m vertically from their head-scarps to their toe regions. Ongoing slope deformation within the PLZ includes shallow retrogressive failures present in the upper slope regions, and translational and flow movements concentrated towards the toe. Tension cracks are also evident along road surfaces at Kepa Road and Ngaio Road, suggesting that ongoing movement is occurring. Underlying most of Orakei is the Early Miocene, East Coast Bays Formation (Edbrooke, 2001). Late Quaternary AVF volcanics (part of the Kerikeri Volcanics Group) is also present at the site. These largely comprise tephra derived from a phreatomagmatic eruption within the Orakei Basin around 85,000 years BP (Nemeth et al., 2012). With the creation of the maar, widespread tuff deposition produced a tuff ring approximately 6-35 m thick covering most of the slopes in the region. This tuff consists of basaltic fragments, ash and lapilli deposits. Holocene landslide deposits comprised of tuff debris and residual ECBF soils also are present.

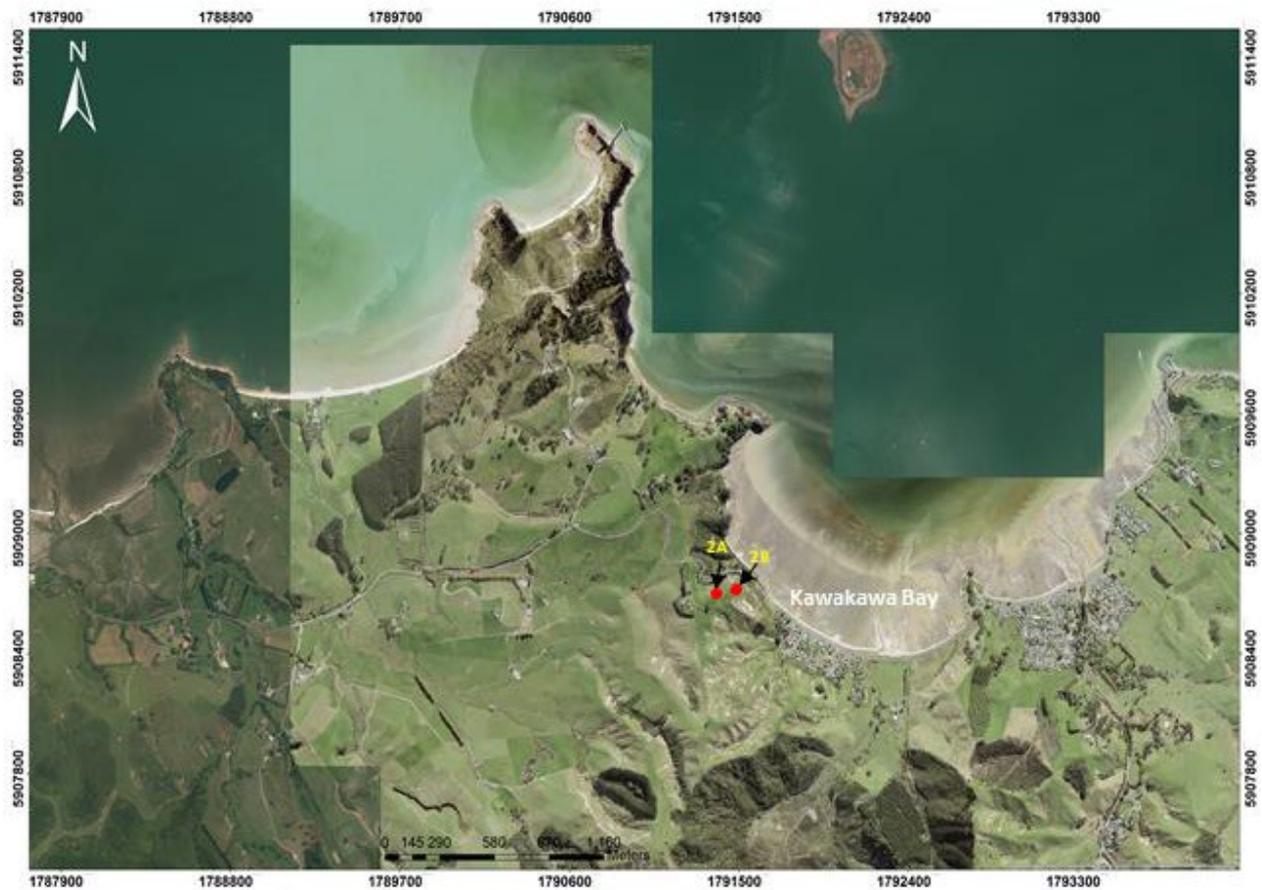
Fig. 3: Location of sites 2A and 2B at Kawakawa Bay.

Located approximately 55 km south-east of the Auckland CBD, sites 2A and 2B are situated along the north-western hill slopes of Turei Hill, Kawakawa Bay (Fig. 3). These study sites are characterised by an undulating topography, with the wider Kawakawa bay region showing widespread surface deformation. This is particularly evident at Turei Hill where shallow soil slips and widespread earthflows are common. This deformation has resulted in widespread slope instability, affecting over 1500 residents within the beachfront community.

Waipapa Group dominates Turei Hill. These rocks are highly weathered and produce weak soil and rock material. The exposed soils across Turei Hill are silty clay in nature and overlay much of the underlying weathered Waipapa Group.

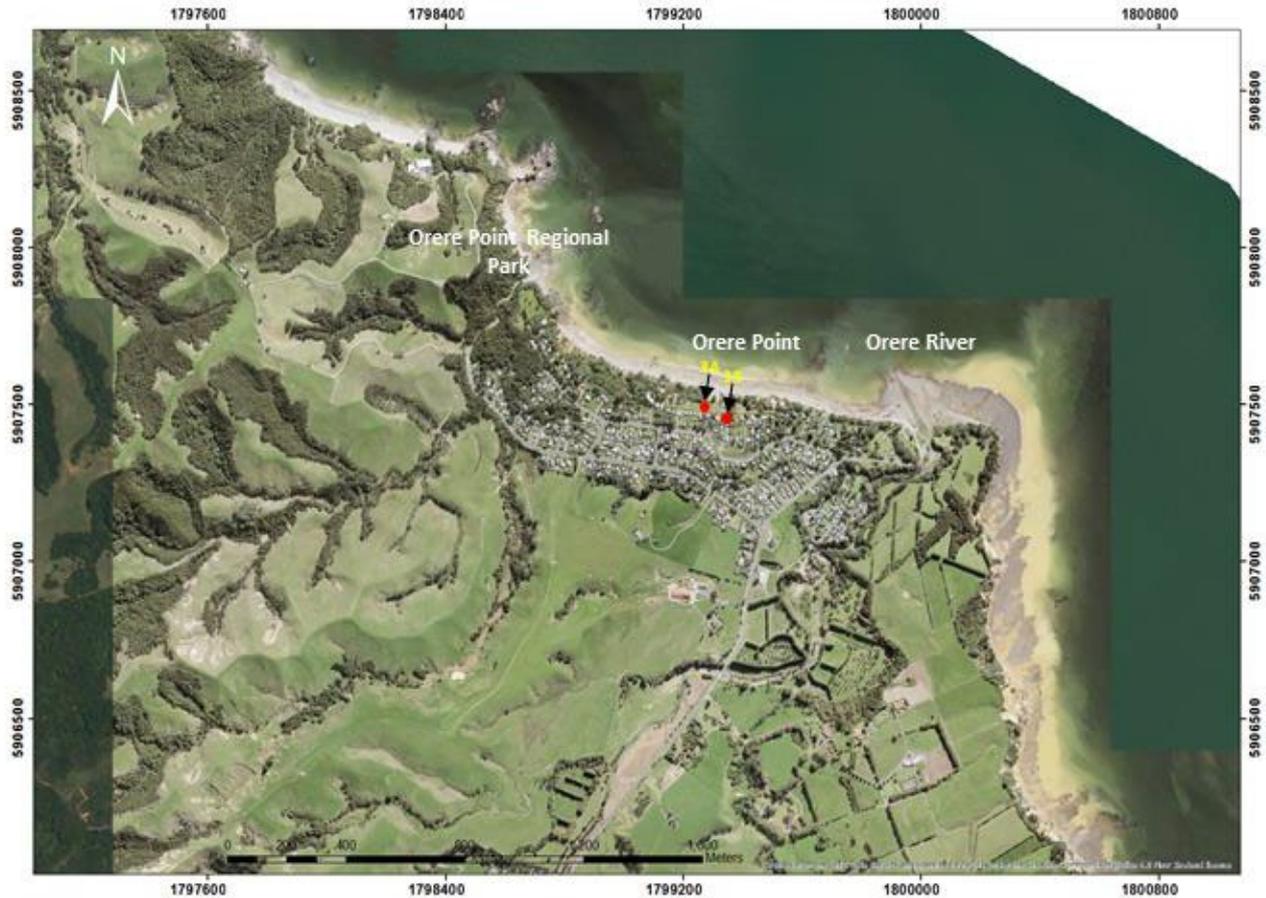
Fig. 4: Location of sites 3A and 3B at Orere Point.

Sites 3A and 3B at Beach Reserve, Orere Point, have a combined horizontal length of approximately 124 m. Their individual vertical heights vary at 43 and 45 m for 3A and 3B, respectively (Fig. 4). Surface exposure appears greater for site 3A compared to 3B, which has approximately 80-90% vegetation cover. Site geology is mainly alluvially-derived Tauranga Group deposits, overlying Waipapa Group, which outcrops as shore platform and cliff in the west of the bay. Slope deformation at Orere Point has been observed since the 1960s. An increase in slope movement was seen in the 1980s which was subsequently reduced considerably due to slope vegetation stabilisation. Slope deformation has been on the increase since the late 1980s, with periods of slip reactivation which had become more prevalent by 2013 (O'Brien, 2019).

Across sites 3A and 3B, both rotational and planar failures are evident, extending vertically from their head-scarp to the beachfront.

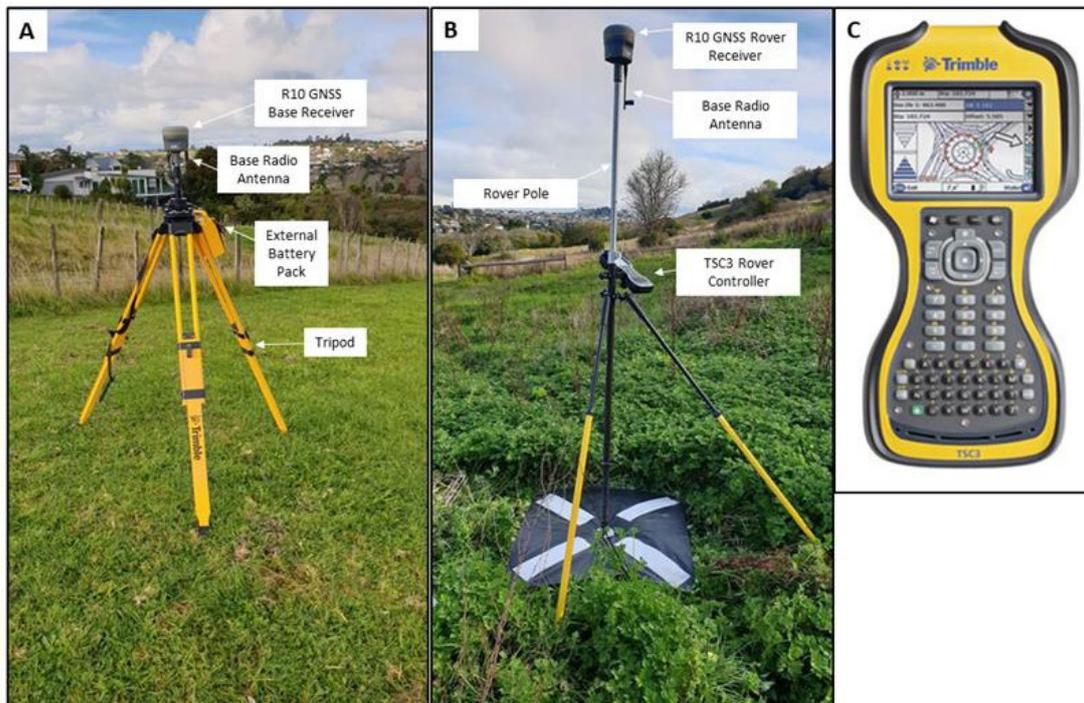
Fig. 5: A) Trimble R10 base station B) Trimble rover receiver C) Trimble TSC3 survey controller at the Orakei Landslide sites.

A Trimble R10 Real-Time-Kinematic (RTK) GNSS system was setup at each site location to collect accurate georeferenced data (Fig. 5). The function of this system was to provide cm level accuracy by eliminating errors present in the GPS. The Trimble R10 base station and rover receiver were utilized through the connection with the TSC3 survey controller.

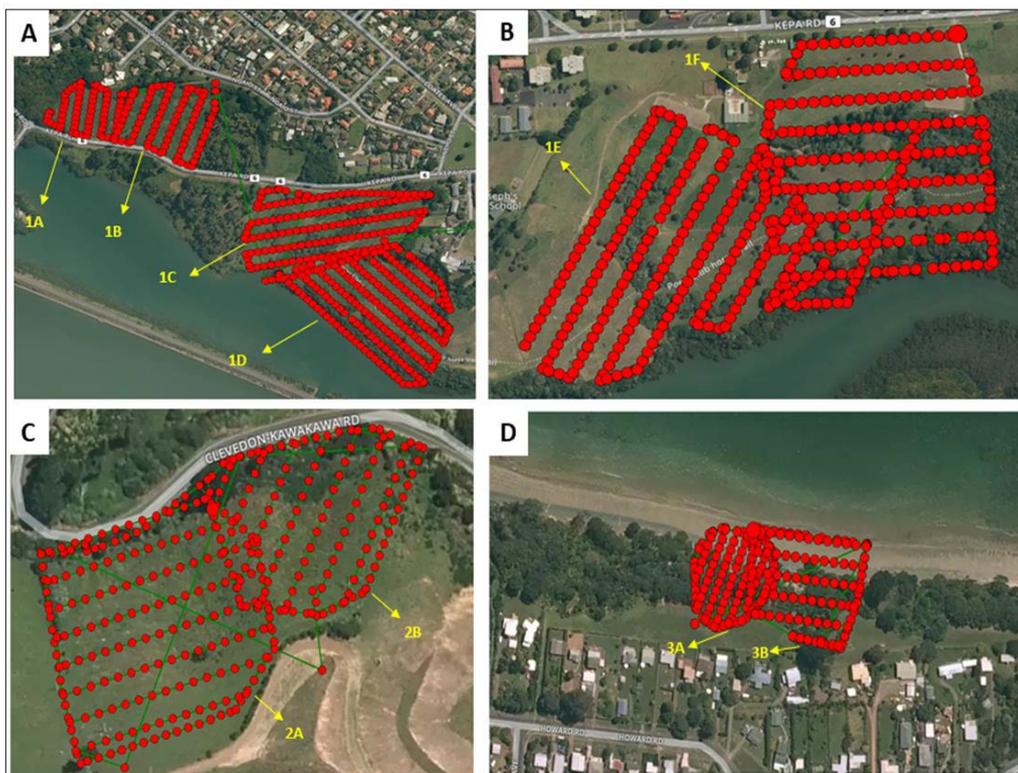
Fig. 6: Example of survey flight pathways (at Orakei). A) and B) Kapa Road, C) Kawakawa Bay and D) Orere Point. Green line = flight pathway, Red dots = Image positioning.

For the production of high-resolution models, a general survey is recommended a minimum 75% overlap and 60% side-overlap (Pix4D, 2019). Surveyed sites for this study attained optimal coverage with an approximate 70-80% of front overlap and 65-75% of side-overlap (e.g. Fig. 6). Surveyed flights complied with the Part 101 regulations of the Civil Aviation Authority (CAA) of New Zealand, and captured aerial imagery within the <120 m ceiling, above ground level (AGL).

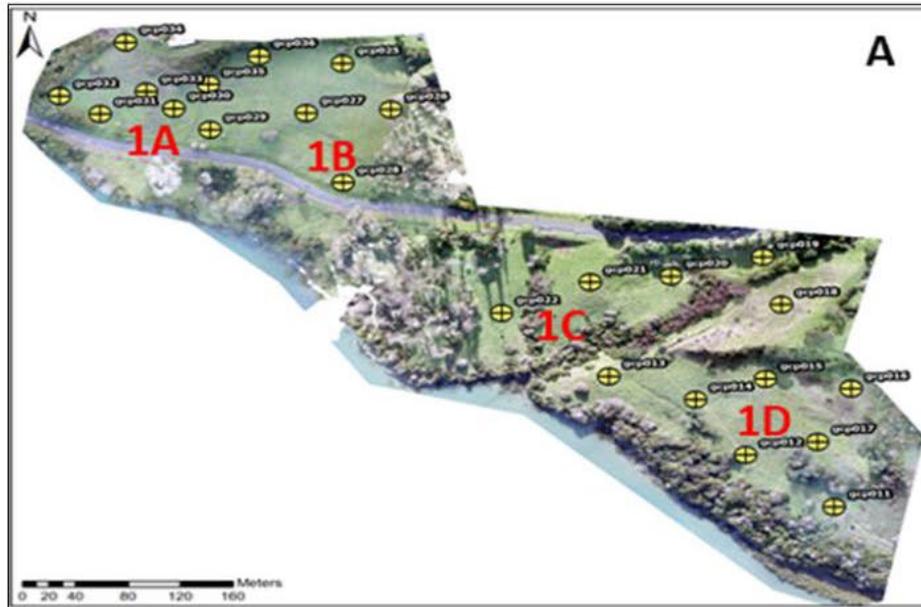
Fig. 7: Example distribution of GCPs implemented across Orakei area. Yellow circle cross = GCP.

For survey control, a minimum of five ground control points (GCPs) were distributed across each landslide site prior to each survey. The GCPs were a combination of 1 m × 1 m plastic cross mats and small wooden checkboards, and were visibility present in the acquired UAV imagery. Each GCP centre would be surveyed with the Trimble rover receiver and controller. An example of GCP distribution is shown for Orakei in Fig. 7.

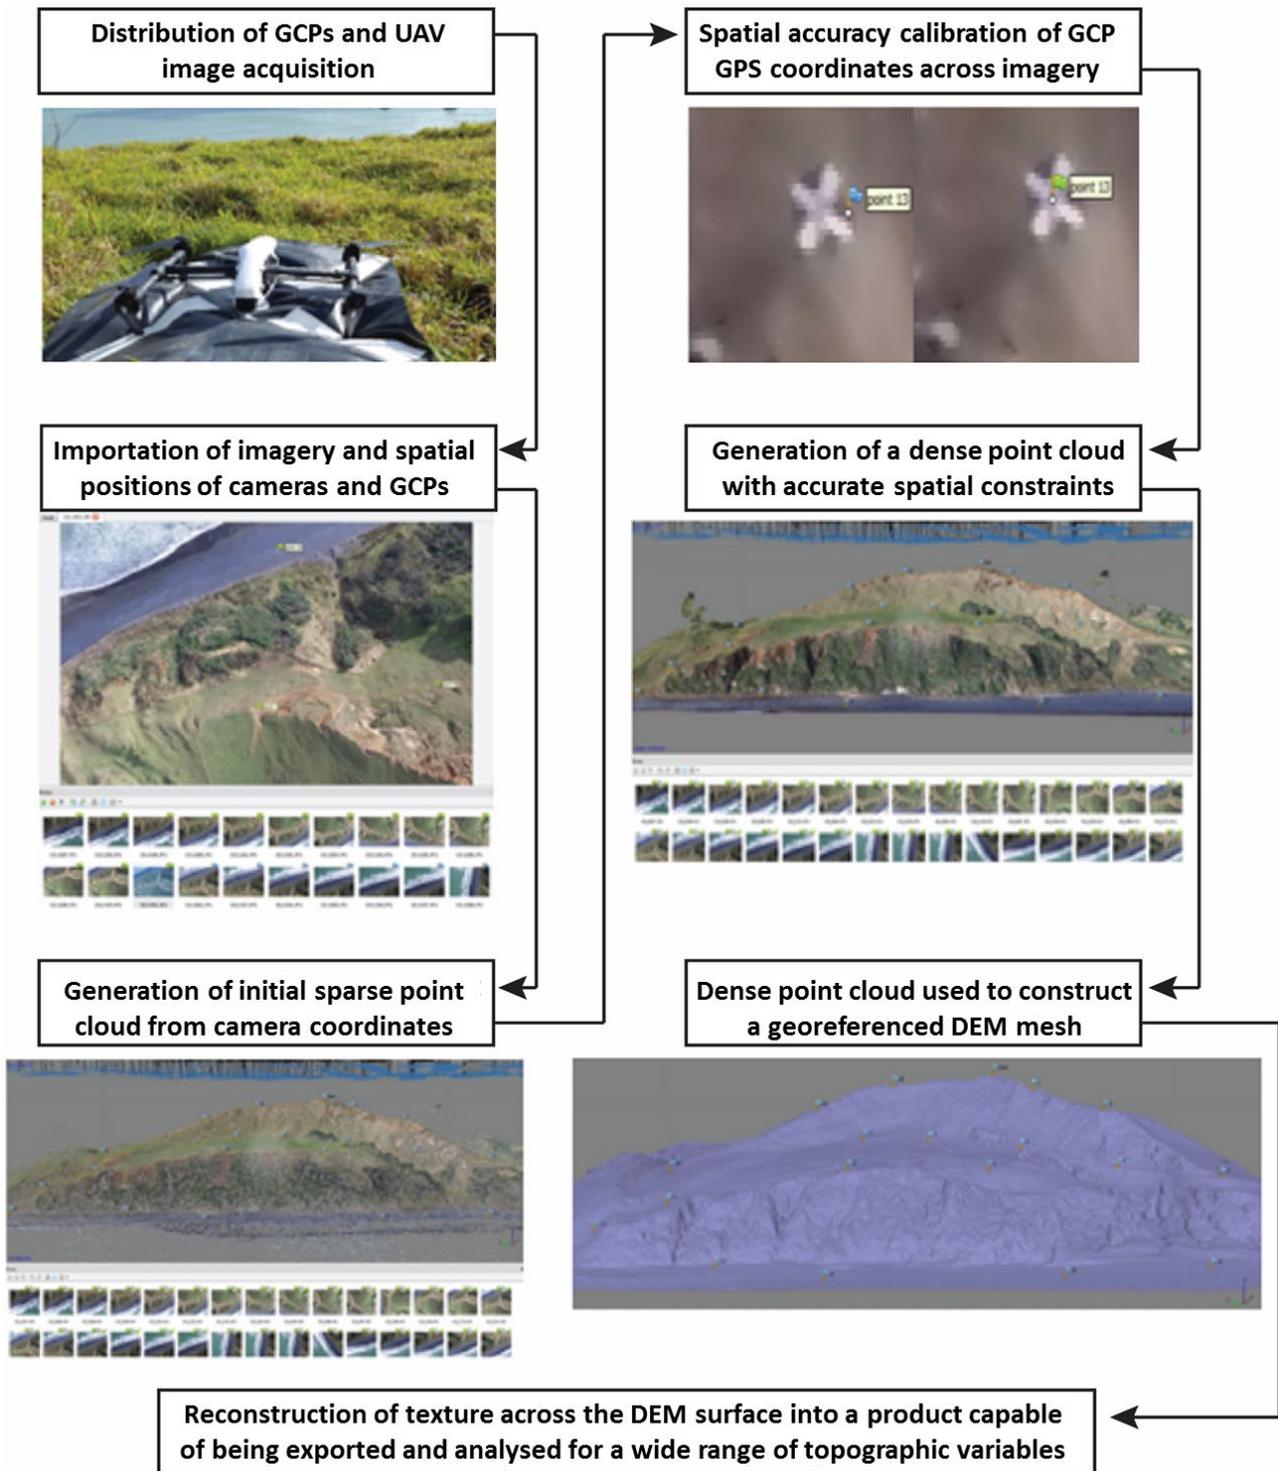
Fig. 8: SfM processing approach using Pix4D Mapper.

Structure-from-Motion photogrammetry process was implemented using the Pix4DMapper Pro 4.1.5 software. The workflow using the UAV-SfM approach for 3D modelling (Lucieer et al., 2014) followed three main phases of processing, post the flight survey acquisition and GCP distribution. These included: “Initial Processing”, “Point Cloud and Mesh generation”, and “DSM, Orthomosaic and Index generation”. An outline of the general workflow followed in this study is illustrated in Fig. 8.

SfM uses algorithms to identify matching features in a series of overlapping digital images and calculates camera location and orientation from the differential positions of multiple matched features. From these calculations, overlapping imagery is then used to reconstruct a “sparse” or “coarse” 3D point cloud model of the photographed object or surface or scene. This 3D model from the SfM method is refined to a finer resolution using Multi-View Stereopsis (MVS) methods, thereby completing the full SfM-MVS workflow (Carrivick et al., 2016). First, each image was individually inspected for image quality where blurry images were removed from the dataset.

Camera positions were loaded from the photo exchangeable image file data and calibrated with camera parameters during an “alignment” process. The camera alignment process matches points between overlapping imagery and estimates the camera positions for each photo to construct a sparse point-cloud model. Accurate GPC positioning and orientation is important (Fig. 9). The point cloud classification tool was used in Pix4D, which then allowed digital terrain models (DTMs) to be developed. In Pix4D, DTMs are

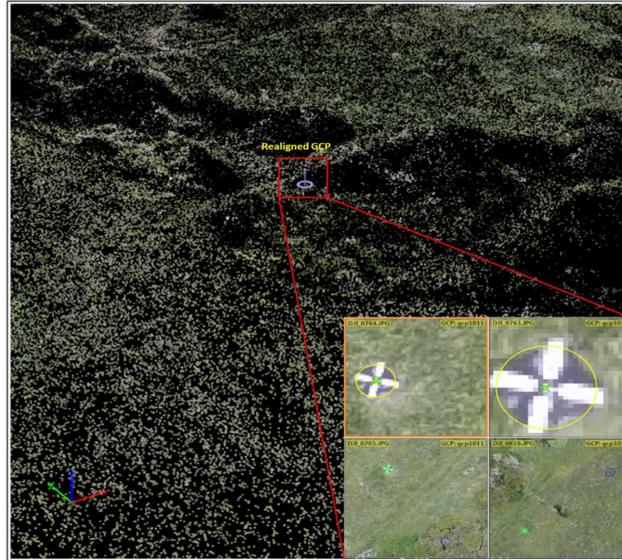
Fig. 9: Example of manual realignment procedure for imported GCPs (Orakei). Blue circle = Estimated GCP position, yellow circle = newly selected position, green cross = Reprojected 3D point and position.

Accuracy and quality assessment of generated UAV-SfM models were determined through analysing resulting quality reports and error estimations for each survey site location modelled in Pix4D. Quality reports for all surveys were utilized to evaluate five major parameters for model quality. These included: (1) keypoint image matches, (2) dataset Image calibration, (3) camera optimisation, (4) calibrated Image matches, and (5) Image georeferencing. The final analytical step was DEM-differencing, for topographic

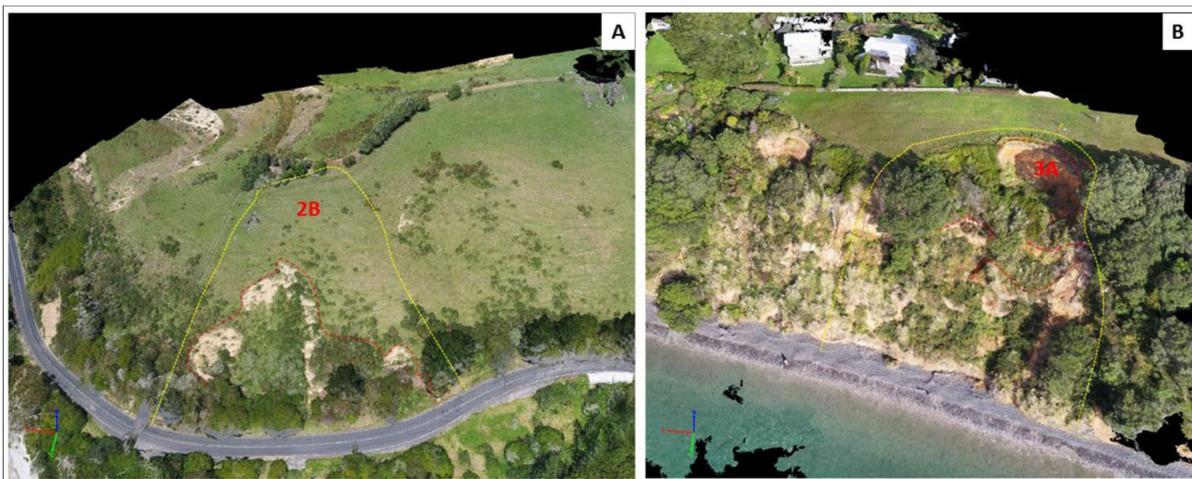
Fig. 10: Sections of interest for the COSI-Corr method for A) Kawakawa Bay 2B and B) 3B at Orere Point. Yellow line = site outline, Red line = sections of interest.

Surface change detection was also trialed using COSI-Corr (Co-registration of Optically Sensed Images and Correlation), at two landslide site locations (e.g. Turner et al., 2015). Sites selected for trialling the COSI-Corr technique included 2B at Kawakawa Bay and 3A at Orere Point (Fig. 10). Both had prominent scarp features present which was ideal for where the method could be applied. For feature tracking, two pairs of DSMs at both sites for July and November of 2019 were chosen. DSMs, along with an applied hill shade effect aims to be more efficient for the COSI-Corr method than other input images like photomosaics according to Lucieer et al. (2014). Larger changes would be better identified on these DSMs with associating illumination, vegetation and surface structure changes (Turner et al., 2015). Additional 2D horizontal displacement measurements with north/south and east/west facing directional vector fields would also be generated through the implementation of this method.

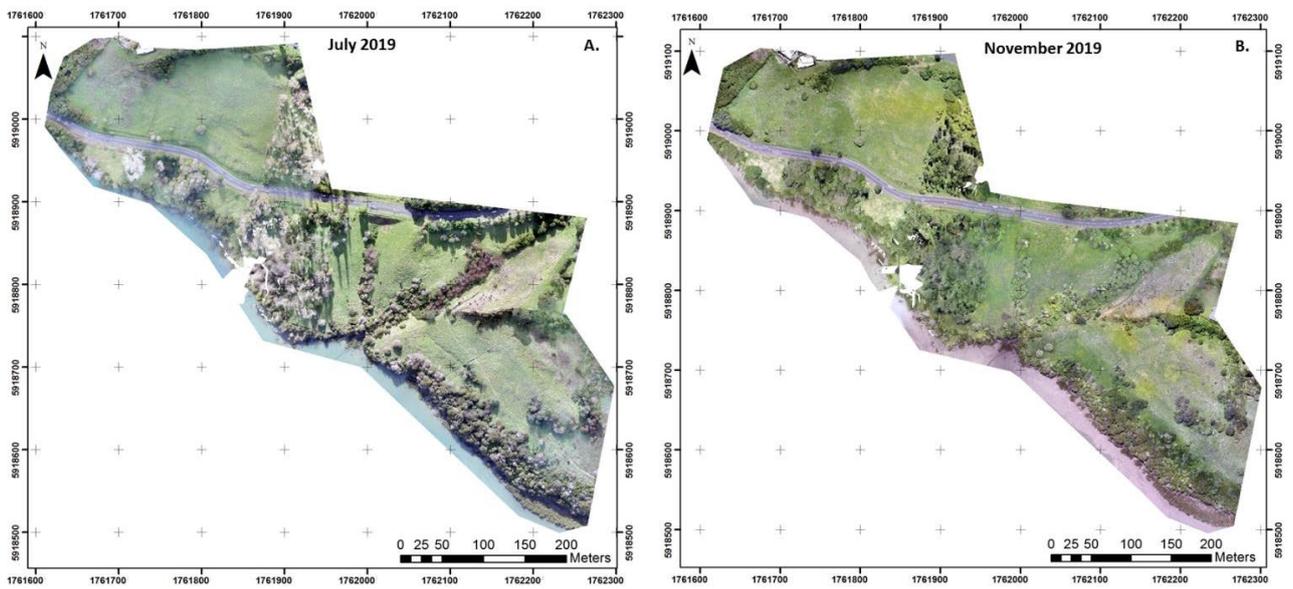
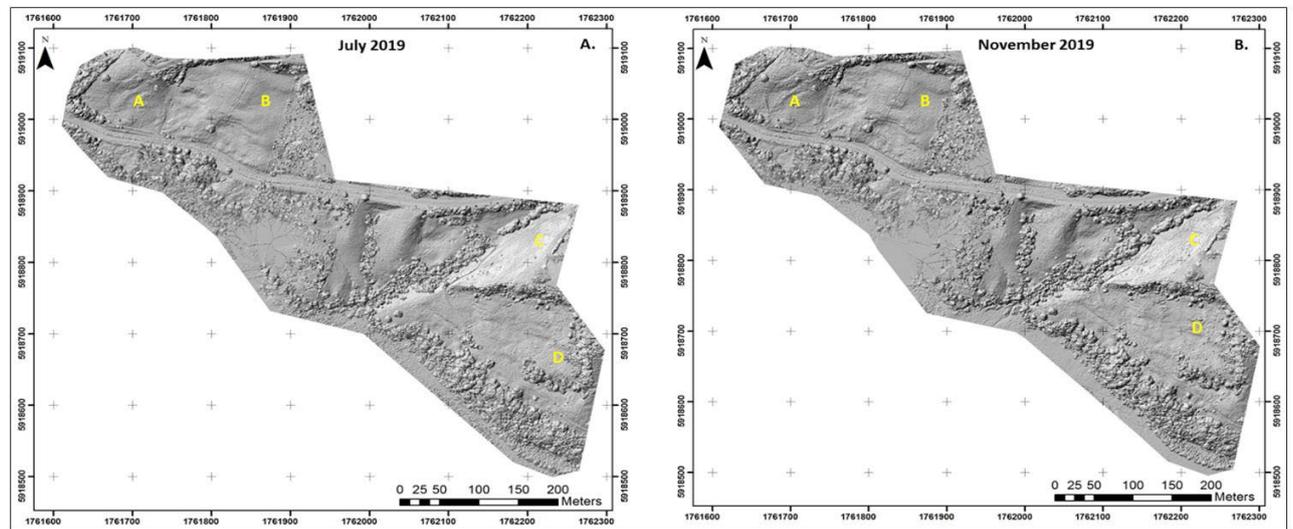
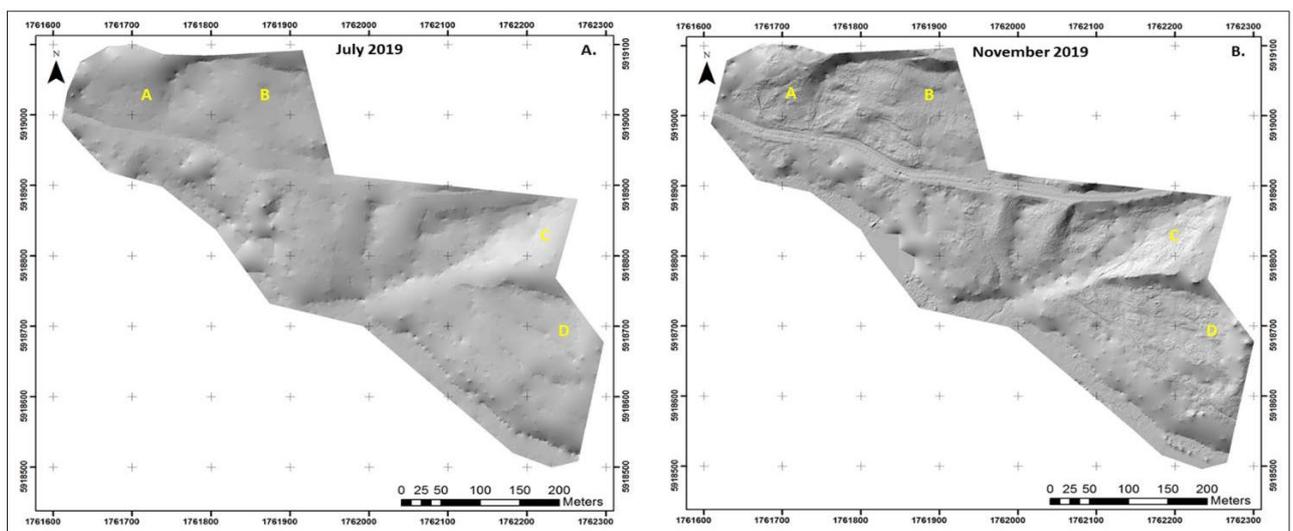
Fig. 11: Photomosaic of Kapa Road sites 1A-1D. A) Left = July 2019, B) Right = November 2019.

Fig. 12: Hillshade DSMs of Kapa Road sites 1A-1D. A) Left = July 2019, B) Right = November 2019.

Fig. 13: Hillshade DTMs of Kapa Road sites 1A-1D. A) Left = July 2019, B) Right = November 2019.

With regard to the resolutions generated in the Kepa Road site models, high levels of detail of surface geomorphological features are evident. Creep is evident in limited areas within sites 1A and 1B, suggesting surface deformation. Indeed, the eastern slope flank of 1C also presents evidence of creep, however, minimal evidence of further movement is apparent during the five-month interval.

Although surface deformation was minimal across each site, changes in surface vegetation was apparent for all sites. This is evident with growth in areas across sites 1A-1C, and the diminishing of vegetation particularly throughout sites 1E -1F.

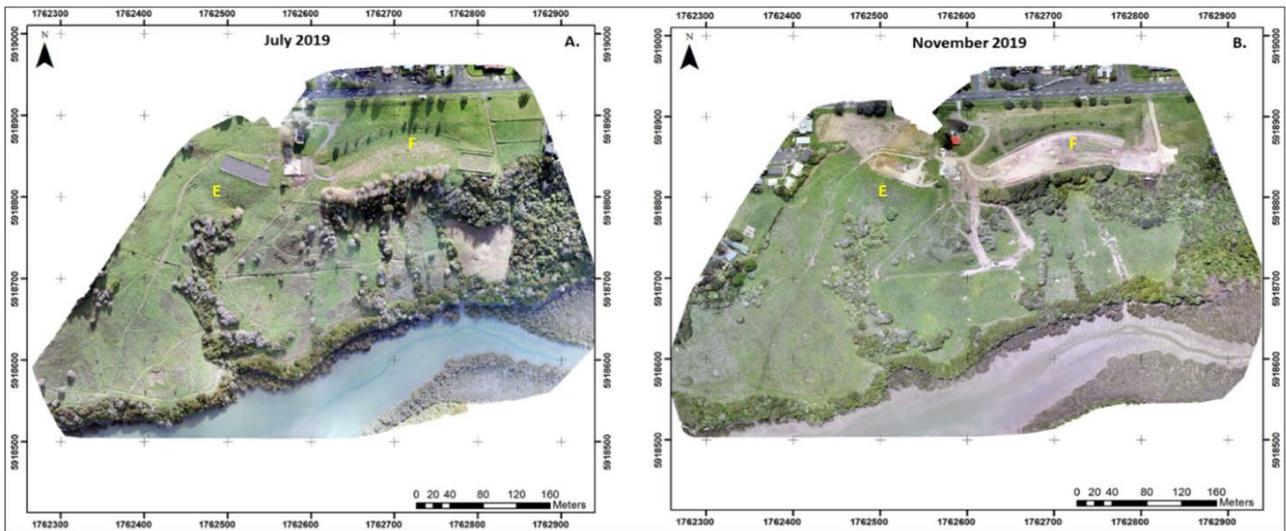
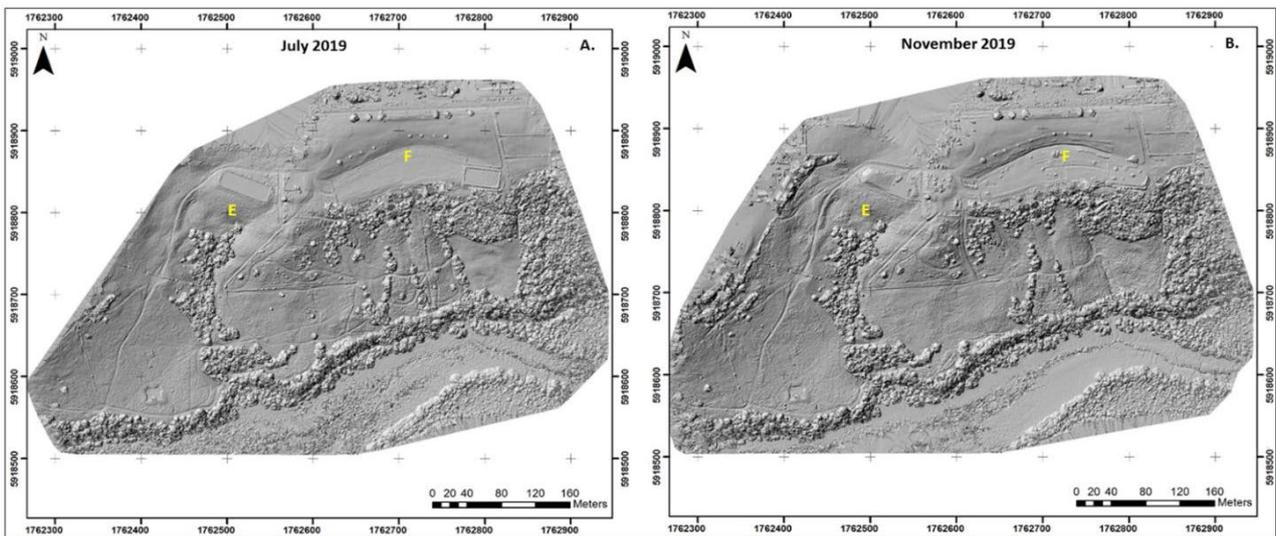
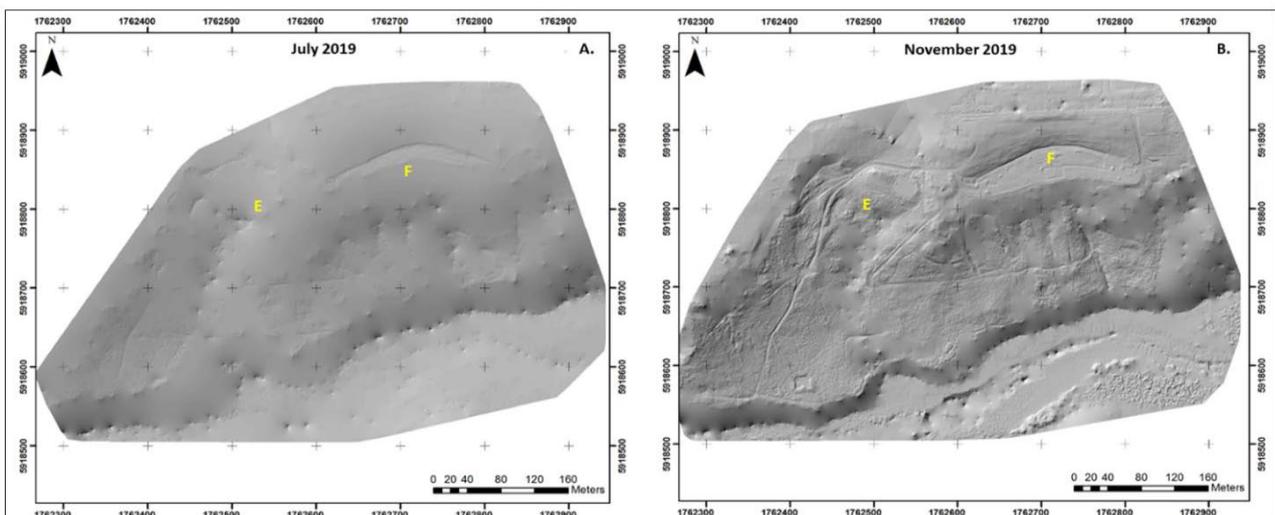
Fig. 14: Photomosaic of Kapa Road sites 1E–1F. A) Left = July 2019, B) Right = November 2019.

Fig. 15: Hillshade DSMs of Kapa Road site 1E –1F. A) Left = July 2019, B) Right = November 2019.

Fig. 16: Hillshade DTMs of Kapa Road site 1E -1F. A) Left = July 2019, B) Right = November 2019.

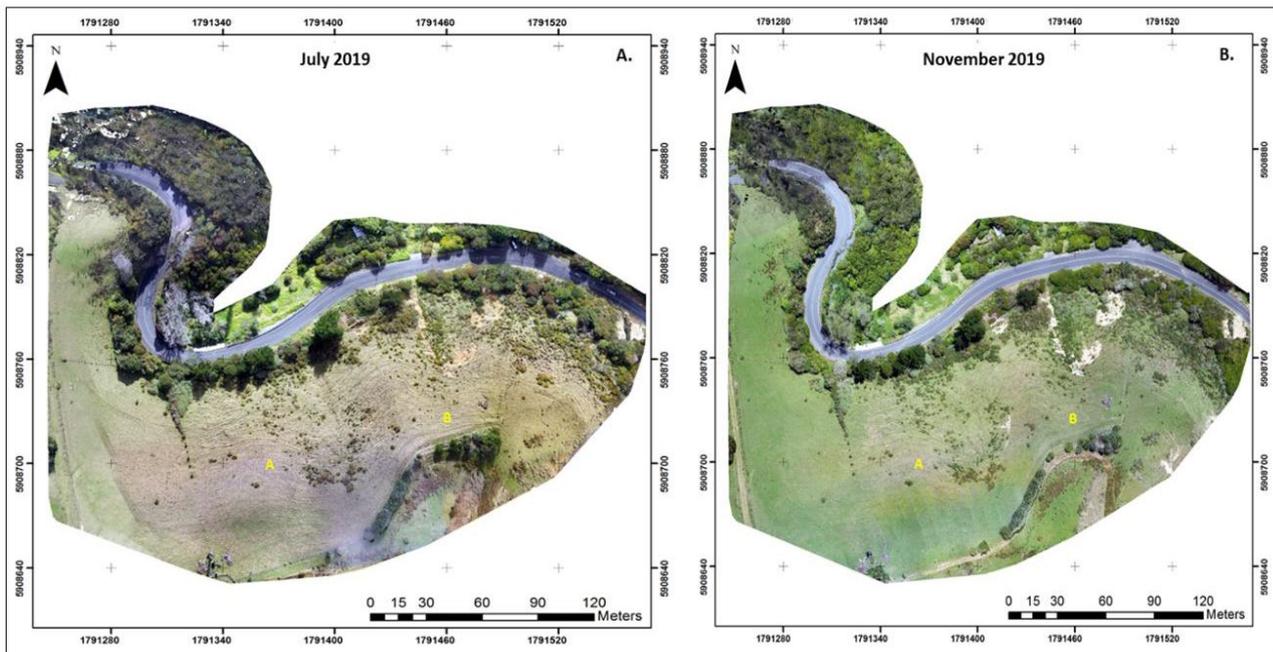
Fig. 17: Photomosaic of Kawakawa Bay sites 2A – 2B. A) Left = July 2019, B) Right = November 2019.

Generated photomosaic and DSMs for Kawakawa Bay sites 2A-2B were of 2.09 and 2.13 cm resolution respectively (Fig. 17-19). The associating DTM resolutions for sites 2A and 2B were 5 × 2.09 and 2.13, respectively (Fig. 19). Photomosaics generated for Kawakawa Bay produced resolutions of c. 2 cm (Fig. 17).

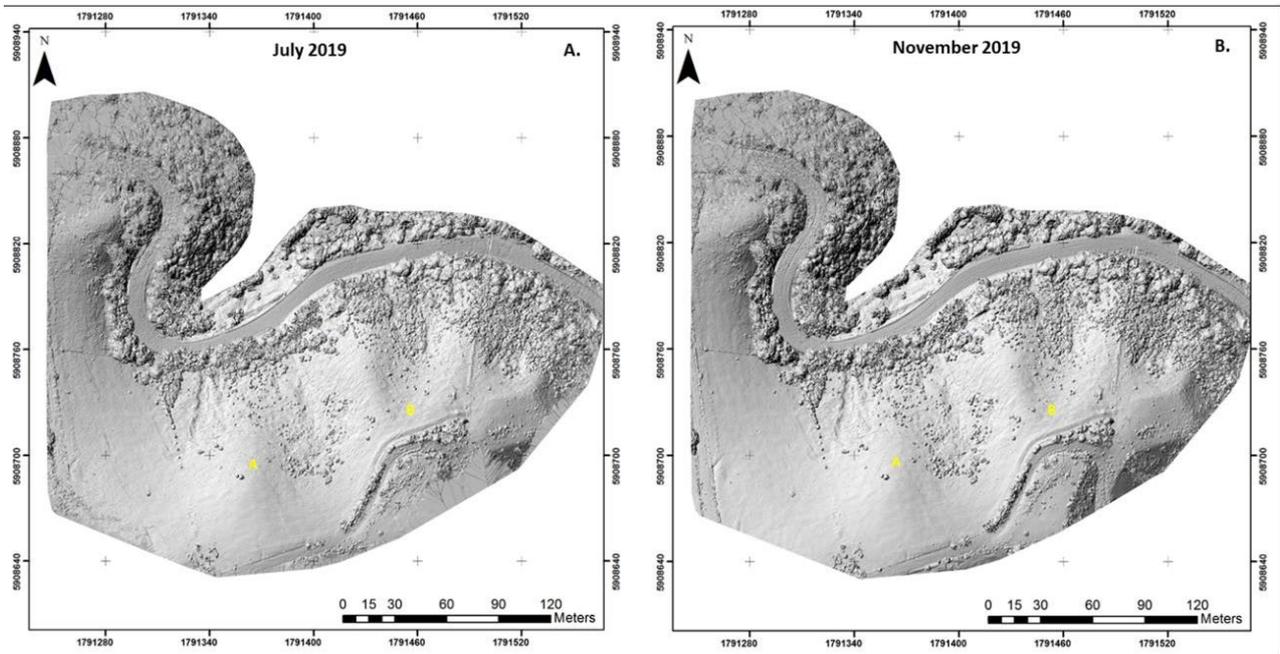
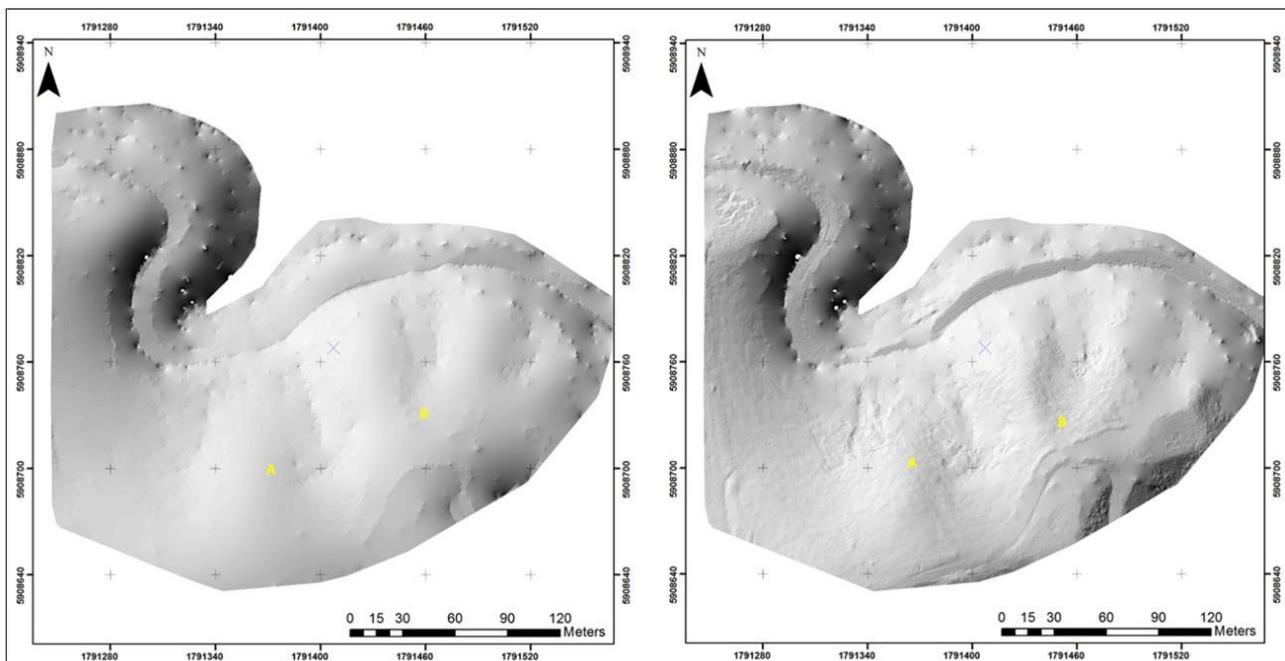
Fig. 18: Hillshade DSMs of Kawakawa Bay sites 2A – 2B. A) Left = July 2019, B) Right = November 2019.

Fig. 19: Hillshade DTMs of Kawakawa Bay sites 2A – 2B. A) Left = July 2019, B) Right = November 2019.

As dense vegetation coverage was removed across sites 2A and 2B in the DTMs, particularly across the toe regions, it was difficult to detect slope deformation across the five-month interval. Changes detected across the Kawakawa Bay sites appear limited to surface vegetation.

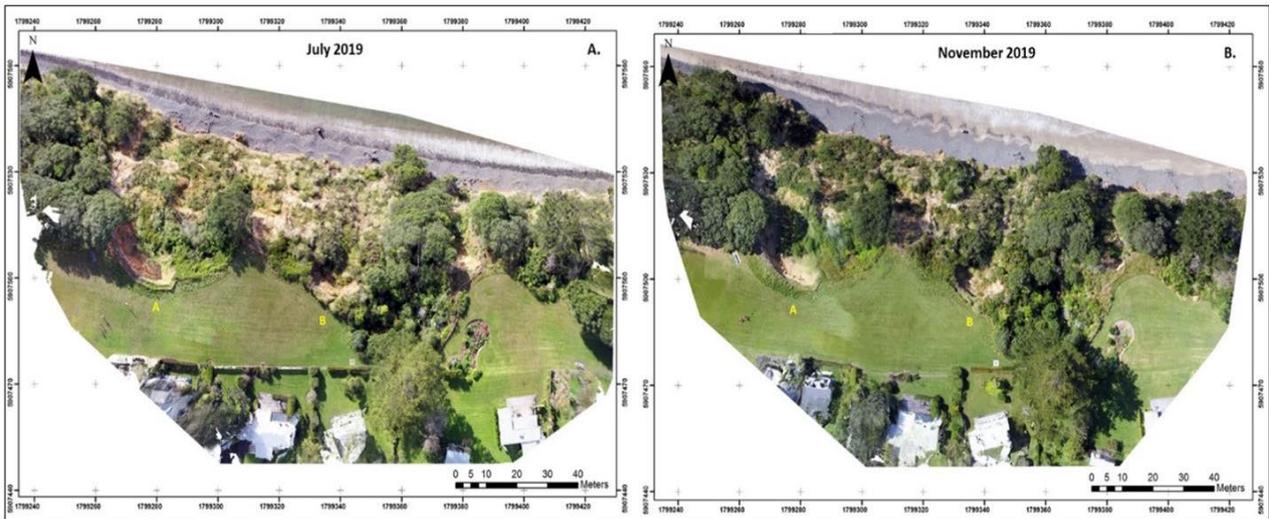
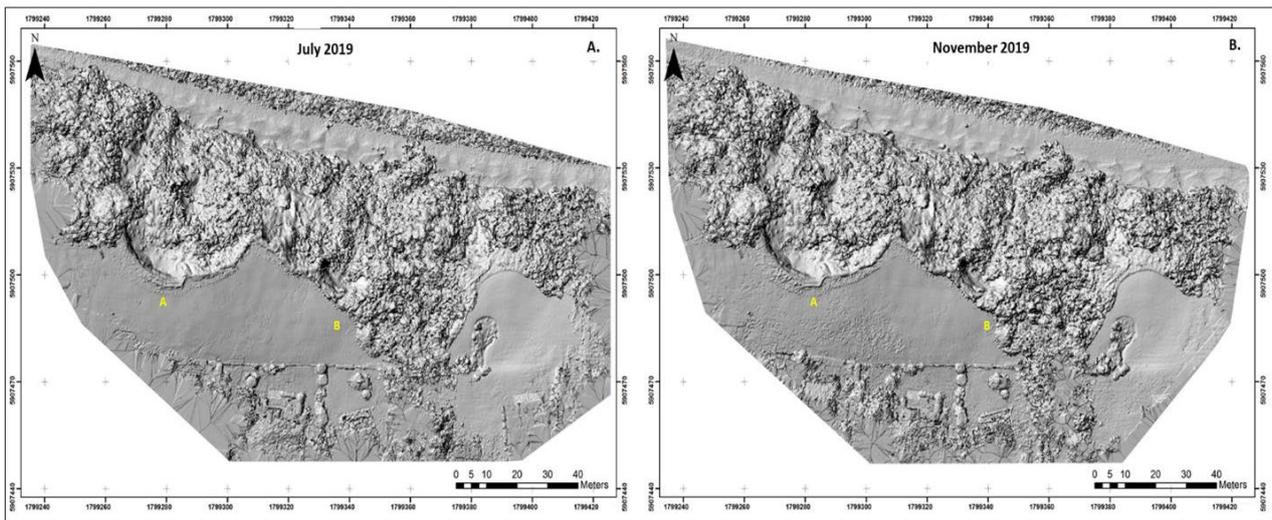
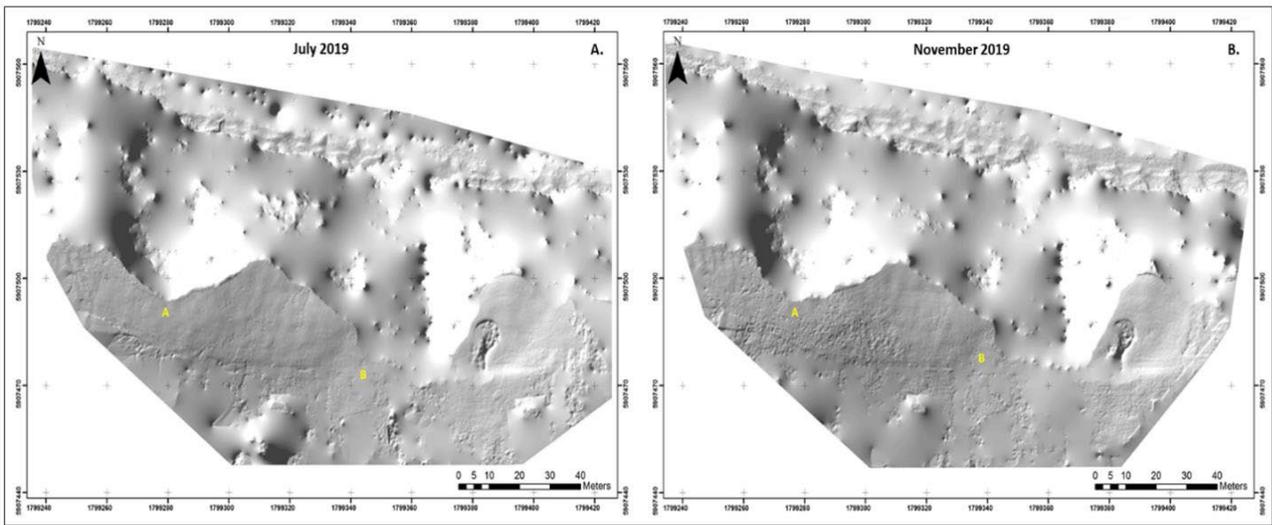
Fig. 20: Photomosaic of Oরে Point sites 3A – 3B. A) Left = July 2019, B) Right = November 2019.

Fig. 21: Hillshade DSMs of Oরে Point sites 3A – 3B. A) Left = July 2019, B) Right = November 2019.

Fig. 22: Hillshade DTMs of Orere Point sites 3A – 3B. A) Left = July 2019, B) Right = November 2019.

These are the smallest sites in this research project, with the surveying area covering 0.017 in July and 0.022 km² in November. The average generated GSD recorded for sites 3A and 3B were 1.72 and 1.80 cm, respectively (Table 9). Surface vegetation change is likely the cause of c. 122.08 point/m³ difference between July and November. Photomosaics and DSMs had the same 1.72 and 1.80 cm model resolution (Fig. 20-22). As with previous DTMs for July and November, model resolution was generated at 5 × that of

the photomosaic and DSM. Photomosaic resolutions were <2 cm for both July and November, although vegetation coverage is apparent across both sites 3A and 3B. Nevertheless, the headscarps at both 3A and 3B are dominant features highlighted on both the photomosaic and DSMs.

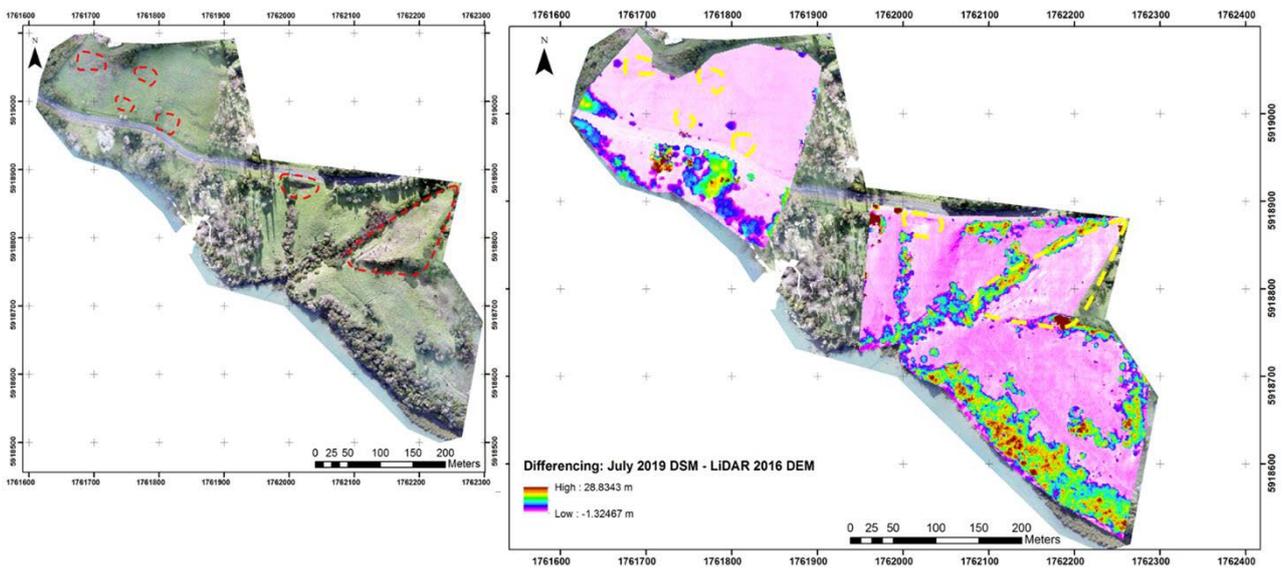
Fig. 23: DSM-differencing model of Kepa Road sites 1A-1D from UAV-SfM derived July 2019 DSM and 2016 LiDAR DEM. Red boundaries on photomosaic (left), correlating with yellow boundaries (right). Boundaries illustrate regions of interest.

Analysing the generated DSMoD for Kepa Road sites 1A-1D, the total deformation defined was between +28.83 m and -1.32 m across the wider site between 2016-2019 (Fig. 23). However, the high of + 28.83 m is likely to be an artefact of the tall tree vegetation present along the lower slope regions of sites 1A-1B. Real, non-artefact surface movement due to creep and deformation was visible around gully heads, but was minimal with a range between -0.010 m and -0.056 m.

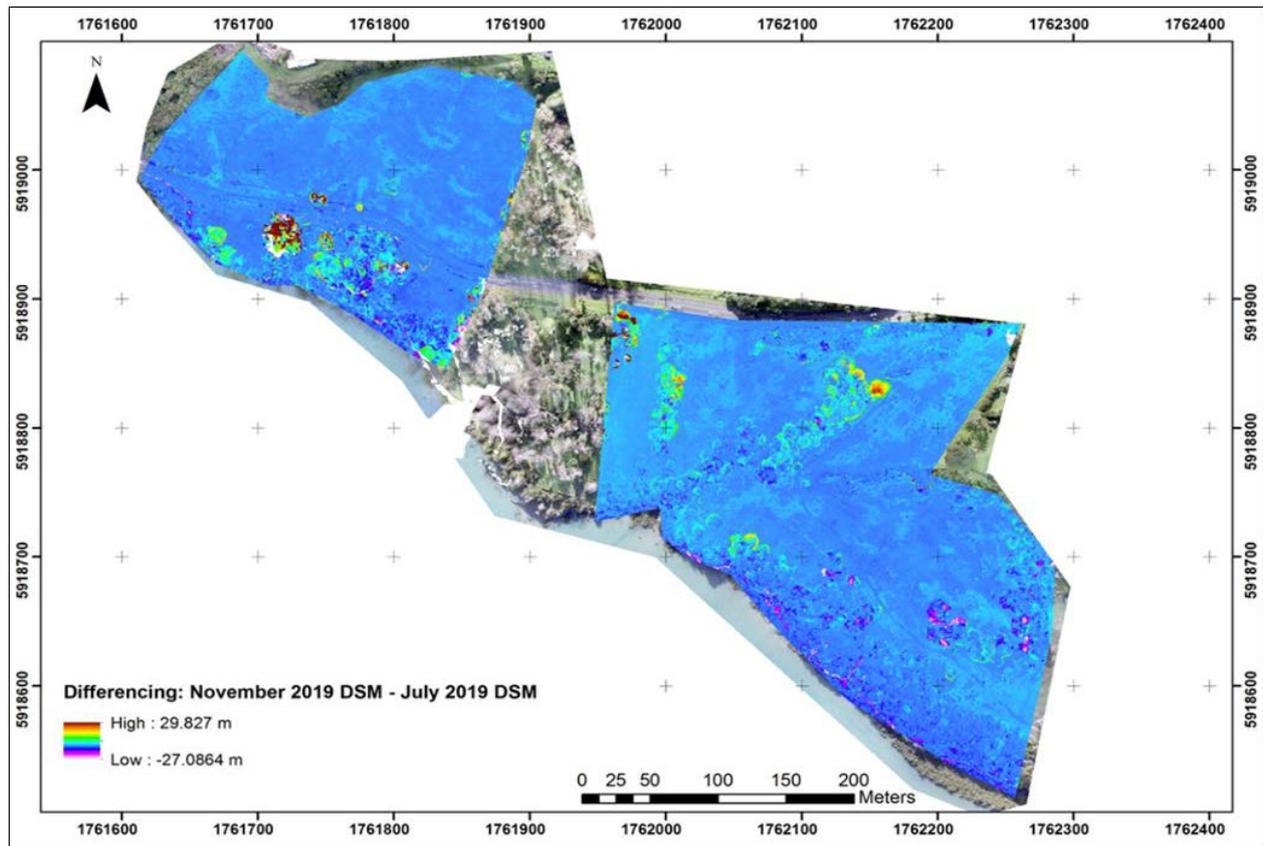
Fig. 24: DSM-Differencing model of Kepa Road sites 1A-1D. July 2019 DSM subtracted from the November 2019 DSM.

A five-month survey interval (July-November 2019) DSMoD was generated for comparison with the three year multi-temporal period. Visual deformation was minimal across the slope faces, for sites 1A-1D (Fig. 24). The DSMoD of sites 1E-1F across the 2016-2019 period produced deformation between +14.71 m and -2.86 m (Fig. 25). When evaluating the generated site 1E-1F DSMoD for the five-month interval, no differences indicative of surface deformation were visible (Fig. 26). Rather, any changes are probably due to earthworks.

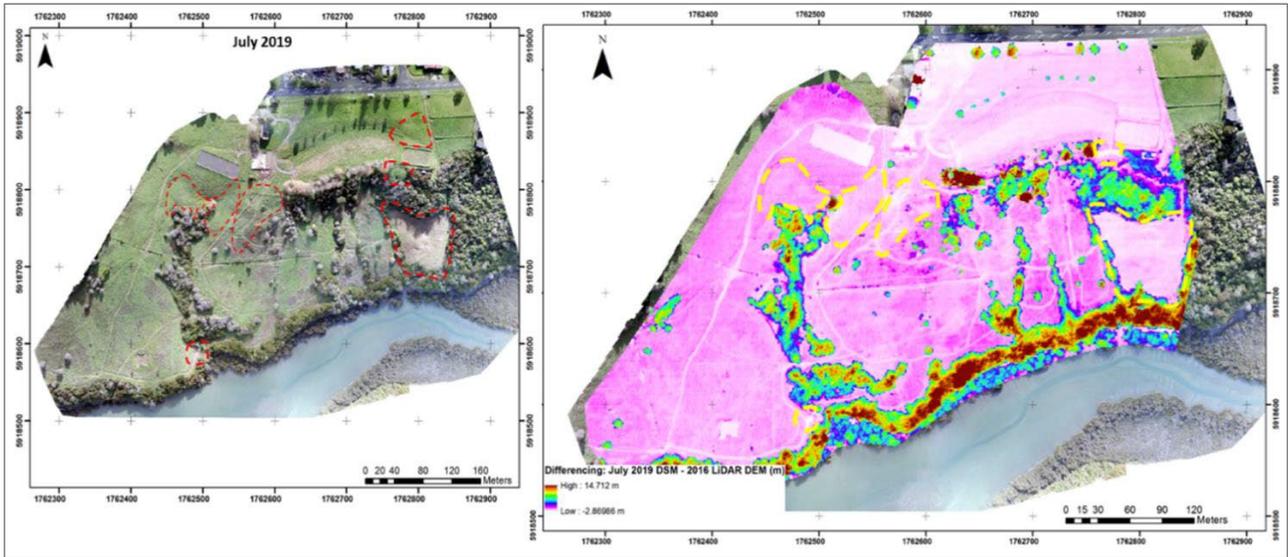
Fig. 25: DSM-differencing model of Keka Road sites 1E-1F. UAV-SfM derived July 2019 DSM and 2016 LiDAR DEM. Red boundaries on photomosaic (left), correlating with yellow boundaries (right). Boundaries illustrate regions of interest.
