***Rapid, cost-effective 3D monitoring of urban landslide displacements
using UAV-Structure from Motion (SfM)
(3714483)***

Martin Brook, Jon Tunncliffe, University of Auckland

Landslide; structure-from-motion; slope stability; Auckland

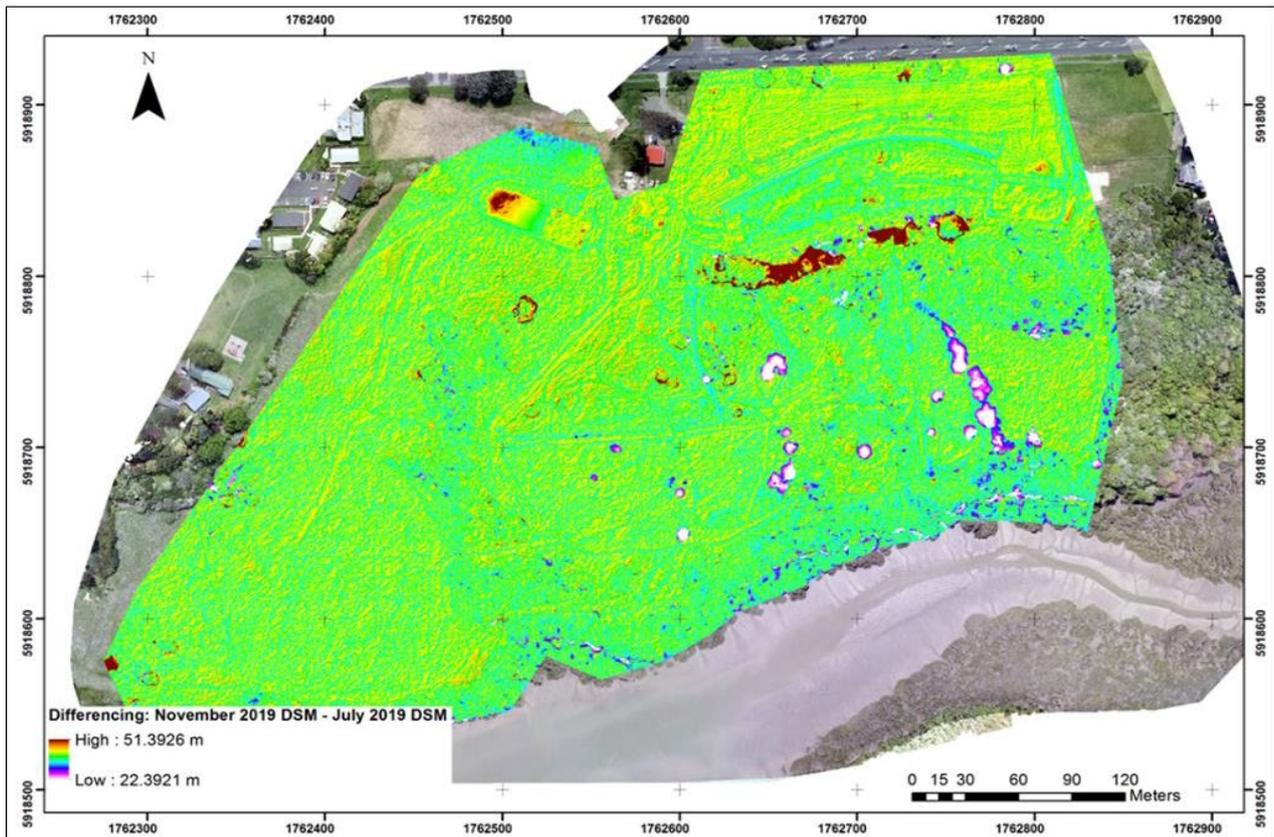
Fig. 26: DSM-Differencing model of Keka Road sites 1E-1F. July 2019 DSM subtracted from November 2019 DSM.

A five-month survey interval (July-November 2019) DSMoD was generated for comparison with the three year multi-temporal period. Visual deformation was minimal across the slope faces, for sites 1A-1D (Fig. 24). The DSMoD of sites 1E-1F across the 2016-2019 period produced deformation between +14.71 m and -2.86 m (Fig. 25). When evaluating the generated site 1E-1F DSMoD for the five-month interval, no differences indicative of surface deformation were visible (Fig. 26). Rather, any changes are probably due to earthworks.

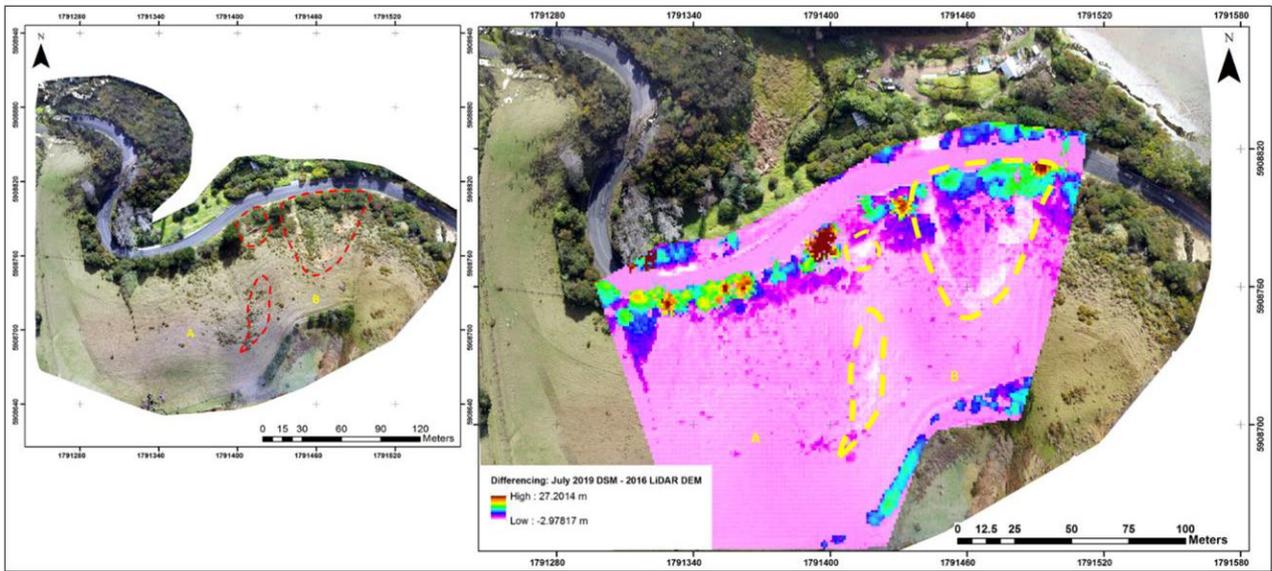
Fig. 27: DSM-differencing model of Kawakawa Bay sites 2A and 2B. UAV-SfM derived July 2019 DSM and 2016 LiDAR DEM. Red boundaries on photomosaic (left), correlating with yellow boundaries (right). Boundaries illustrate regions of interest.

DSMoD models produced for sites 2A-2B at Kawakawa Bay recorded a range between +27.02 m and -2.97 m over the three-year period 2016-2019 (Figure 27, 28).

The high of 27.02 m was actually an artefact of vegetation across the toe regions of sites 2A-2B. However, the loss of -2.97 m was present south of site 2B, past the Clevedon-Kawakawa Bay Road. This represents landslide activity in the form of a minor roadside slump.

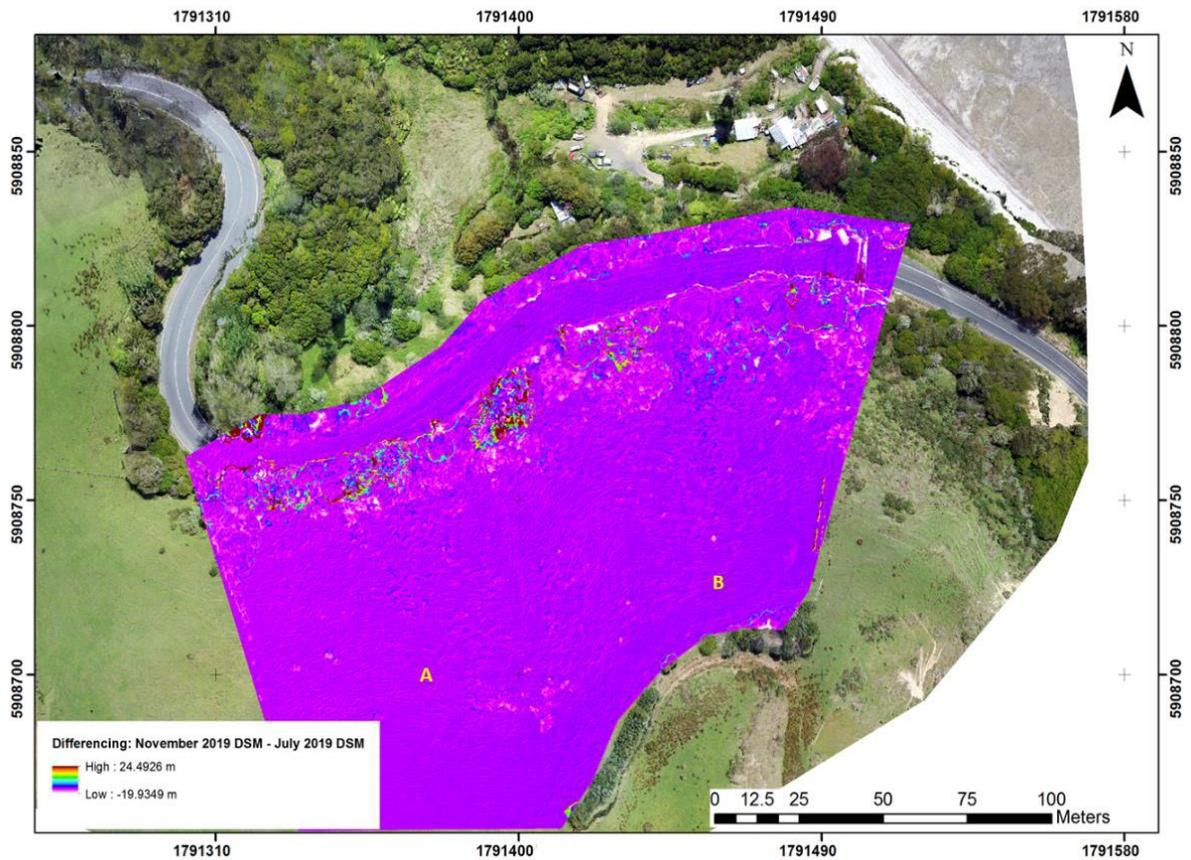
Fig. 28: DSM-Differencing model of Kawakawa Bay sites 2A and 2B. July 2019 DSM subtracted from the November 2019 DSM.

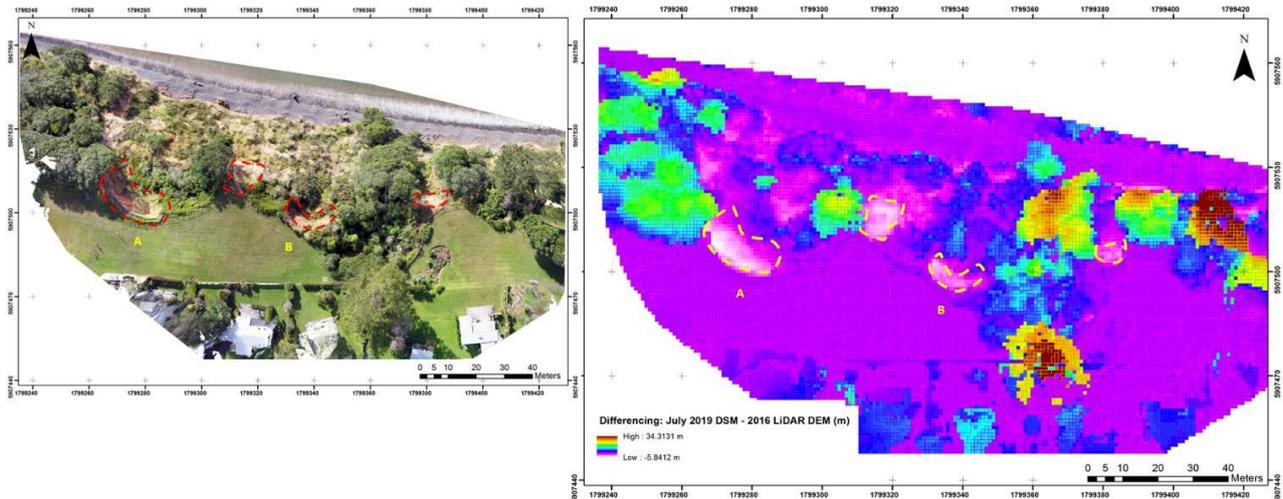
Fig. 29: DSM-differencing model of Orere Point 3A–3B. UAV-SfM derived July 2019 DSM and 2016 LiDAR DEM. Red boundaries on photomosaic (left), correlating with yellow boundaries (right). Boundaries illustrate regions of interest.

The generated DSMoD model for sites 3A-3B at Orere Point generated change of +34.31 m (mostly vegetation) and -5.84 m over 2016-2019 (Fig. 29). However, the “low” of -5.84 m indicates formation of a rounded-scarp at site 3A. Notable deformation zones are highlighted in Fig. 29. Surface loss across site 3A appears to have a range between -5.84 m and -0.0084 m. This is due to a small scarp failure at the border of site 3A-3B, and a planar slide. Site 3B shows deformation ranging from -4.7 m to -0.01 m across the slope surface as illustrated on the DSMoD, but these seem to be survey artefacts, rather than landslide activity. The generated DSMoD across the five-month interval July-November 2019, produced a range between +36.71 m and -4.48 m (Fig. 30), but this seems to be vegetation growth artefacts.

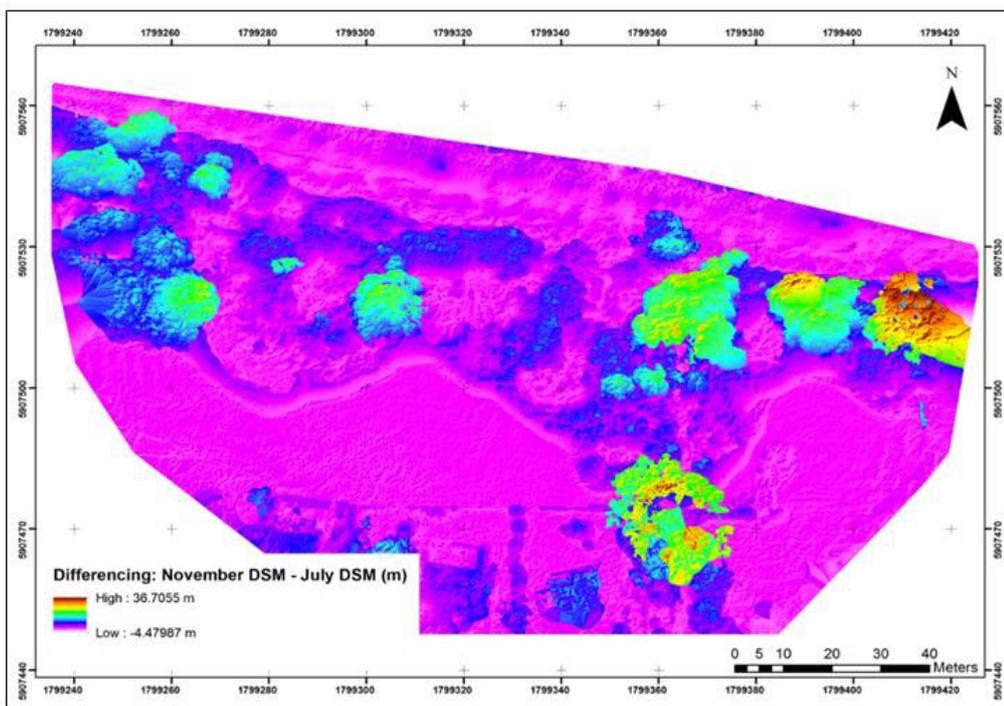
Fig. 30: DSM-Differencing model of Orere Point 3A–3B (July 2019 DSM subtracted from Nov 2019 DSM).

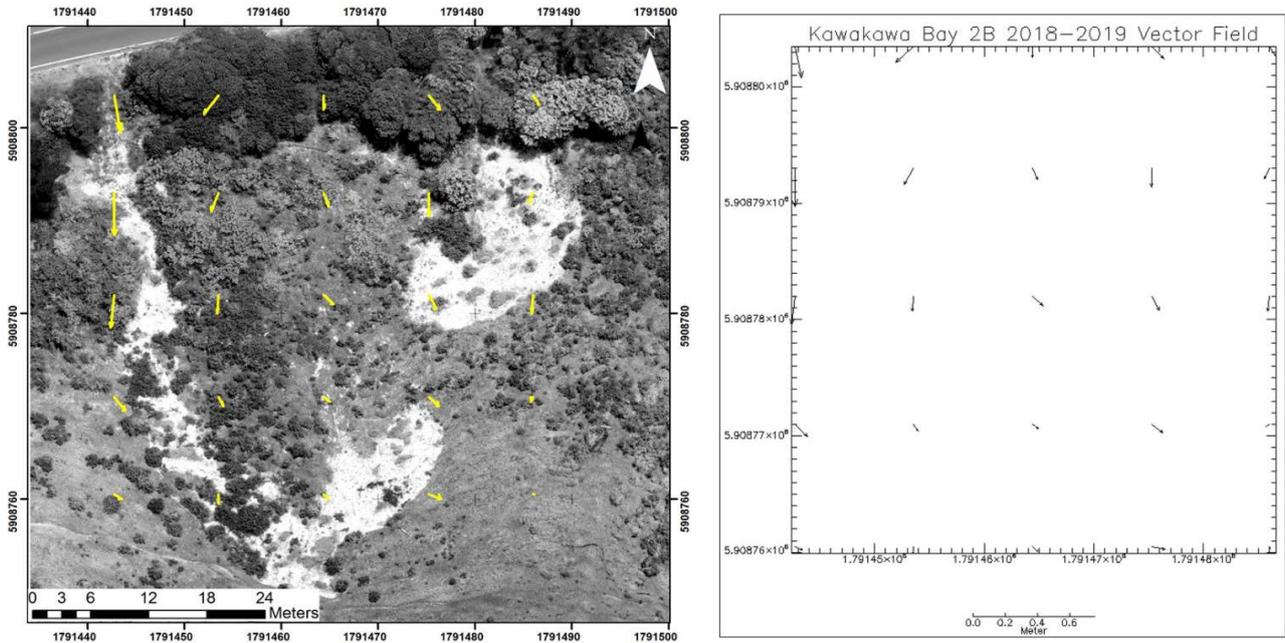
Fig. 31: Vectors overlain across site 2B (left). Associated vector field outlining displacement magnitude and direction (right).

COSI-Corr surface change analysis was limited to trials at Kawakawa bay (sites 2B) and Orere point (site 3A), as these seemed to provide scope for the method to be successful. Following Lacroix et al. (2018), a “Layer Stacking” procedure of the “Pre-event” and “Post-event” orthomosaics for sites 2B and 3A was conducted. This was followed by the final correlation of the two layers which produced displacement maps in the east/west and north/south directions along with a signal-to-noise ratio (SNR) generated map. The resultant deformation vectors and magnitudes are shown in Figures 31 and 32, respectively.

However, vector directions do not appear to deform in the expected direction, and the geomorphological characteristics of sites 2B and 3A show clear downslope (or sometimes, cross-slope) movement. COSI-Corr appears of limited value, possibly due to a lack of time-consuming manual filtering (e.g. Ding et al., 2020).

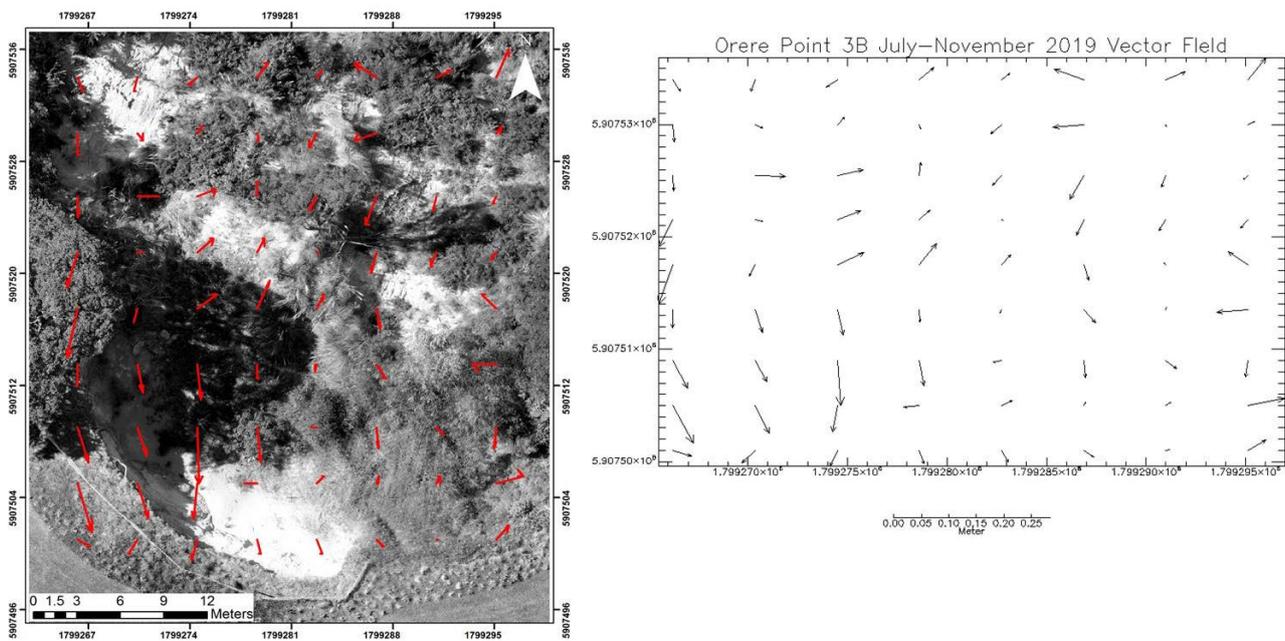
Fig. 32: Vectors overlain across site 3A (left). Associated vector field outlining displacement magnitude and direction (right).
