**FINAL REPORT ON RESEARCH PROJECT**

**Project No. 03/499**

**Monitoring and effects of landslide-induced  
aggradation in the Poerua Valley, Westland**

**June 2005**

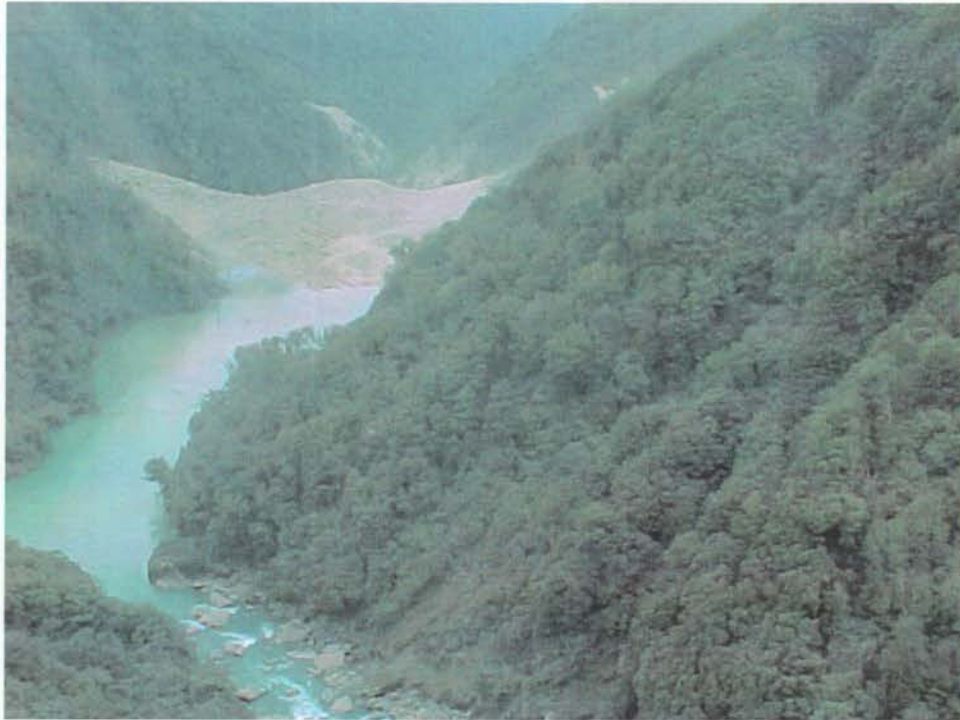
Fig. 3 Poerua landslide dam before overtopping; looking downstream.  
(R Daniel Westland District Council)

The 1999 Mt Adams landslide (Hancox *et al*, 1999, 2000, 2005) deposited  $10\text{--}15 \times 10^6 \text{ m}^3$  of rock debris in the gorge of the Poerua River, Westland (Figs. 1 and 2). This formed a temporary landslide dam (Figs. 3 and 4), which failed some days later (Fig. 5), generating a flood wave that caused deposition (Fig. 6) of mainly sand-sized sediment on parts of the alluvial fan downstream of the gorge exit, together with substantial (but unmeasured) aggradation of the existing river bed (Fig. 7). Subsequently, river reworking of the landslide deposit has caused severe aggradation and avulsion of the river on the fan head (Fig. 8). Prior to the 1999 landslide the Poerua River was substantially incised into the alluvial fan head to the extent that the fan surface was never affected by rainstorm-generated flooding, but the aggradation (of the order of tens of metres) within the gorge and at the fan head has elevated the river bed so that it presently flows (and deposits sediment) across the fanhead. Severe damage has been caused to the farm that occupied the fan (Figs. 9, 10, 11), and the aggradation on the fan is still continuing in mid-2005.

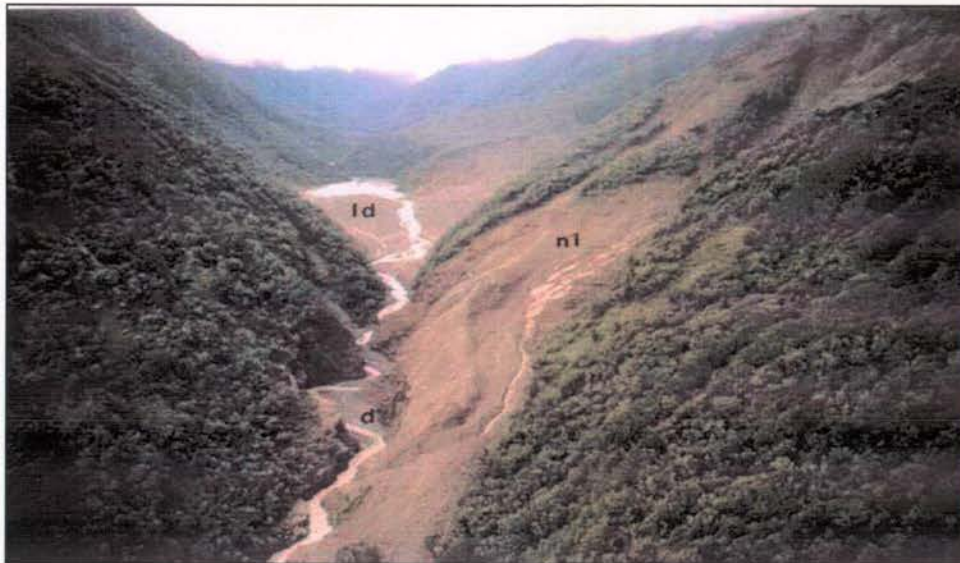
Fig. 4 Poerua landslide dam after overtopping and before failure; looking upstream  
(Hancox *et al*, 1999)

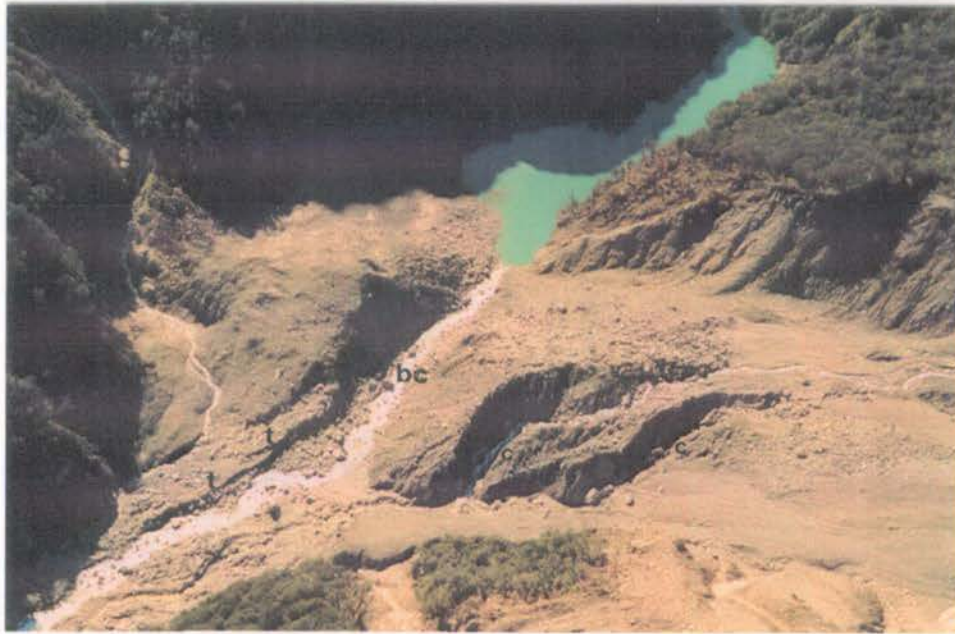
Fig. 5 Poerua landslide dam after failure, October 1999  
(Hancox *et al*, 1999)

The dam immediately following the failure is shown in Fig. 5, while Figs. 18 (a) – (c) show the subsequent erosion of the dam and the adjacent deposits.

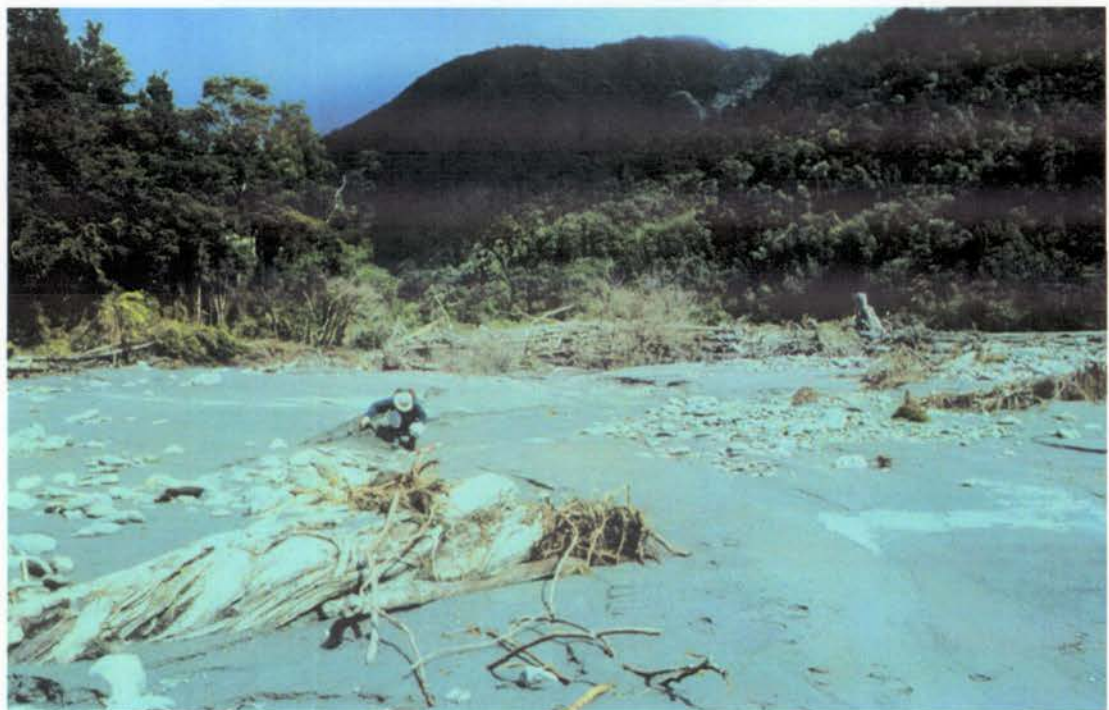
Fig. 6 Sandy deposits from dambreak flood

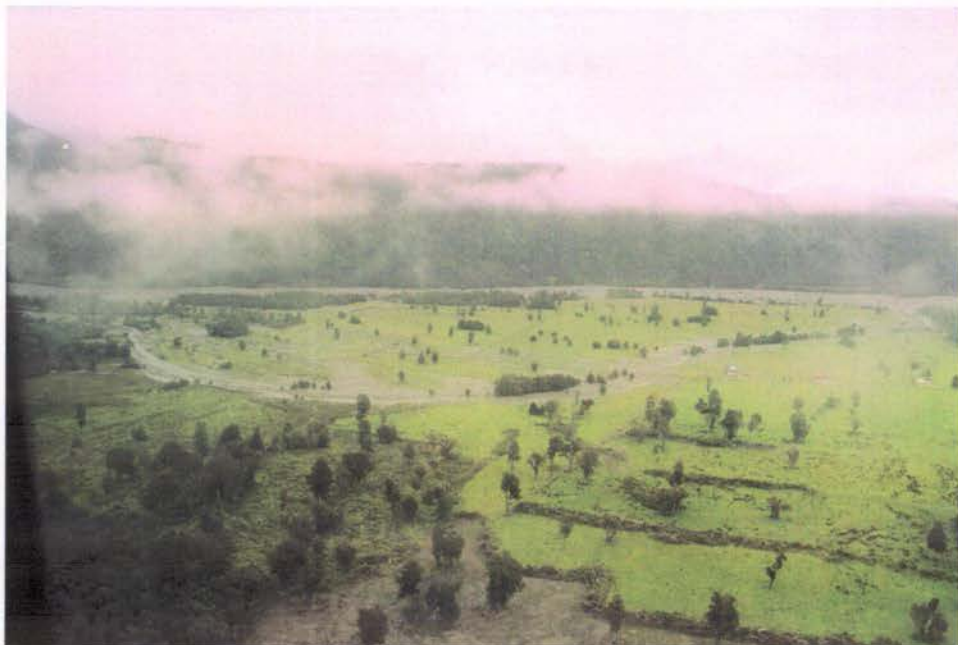
Fig. 8 River avulsing over fanhead 2 months after dambreak; flow from left to right.

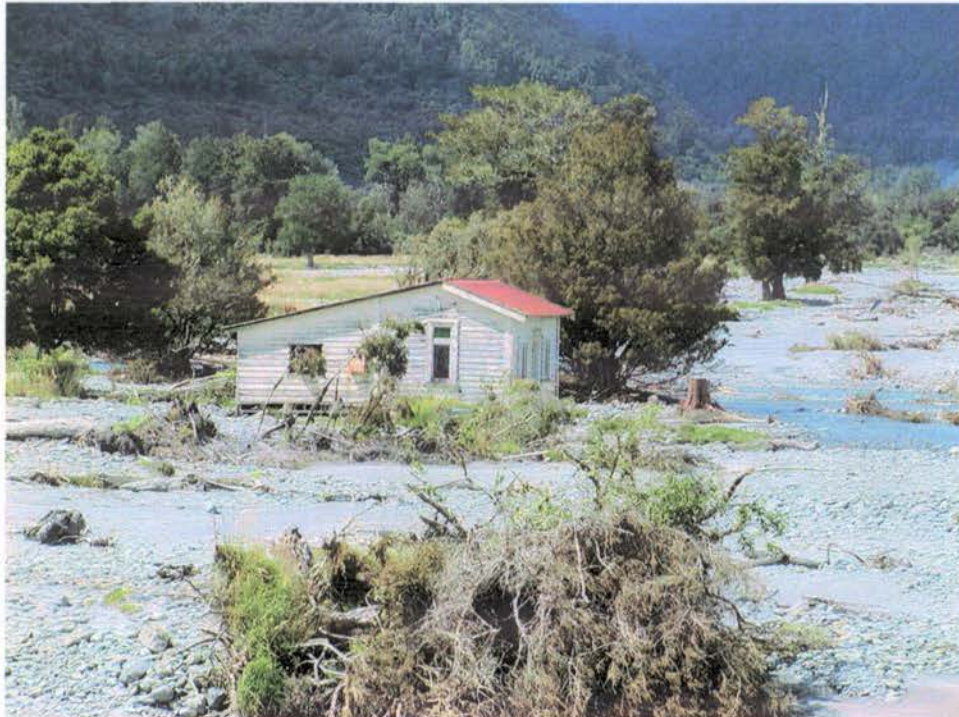
Fig. 9 Cottage surrounded by gravel deposits one year after dambreak

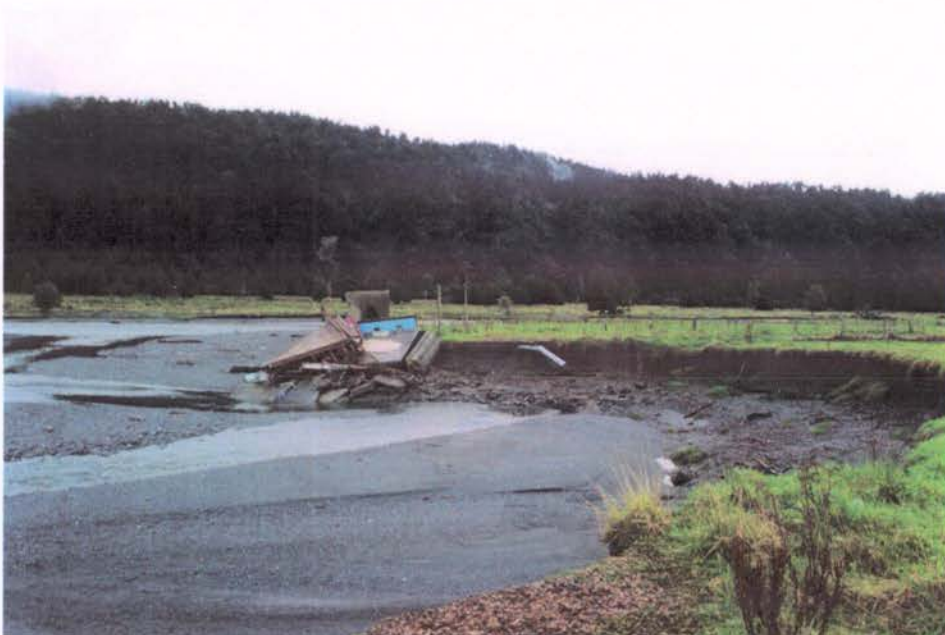
Fig. 10 New milking shed undermined by river eroding into valley-side fan deposit 3 years after dambreak

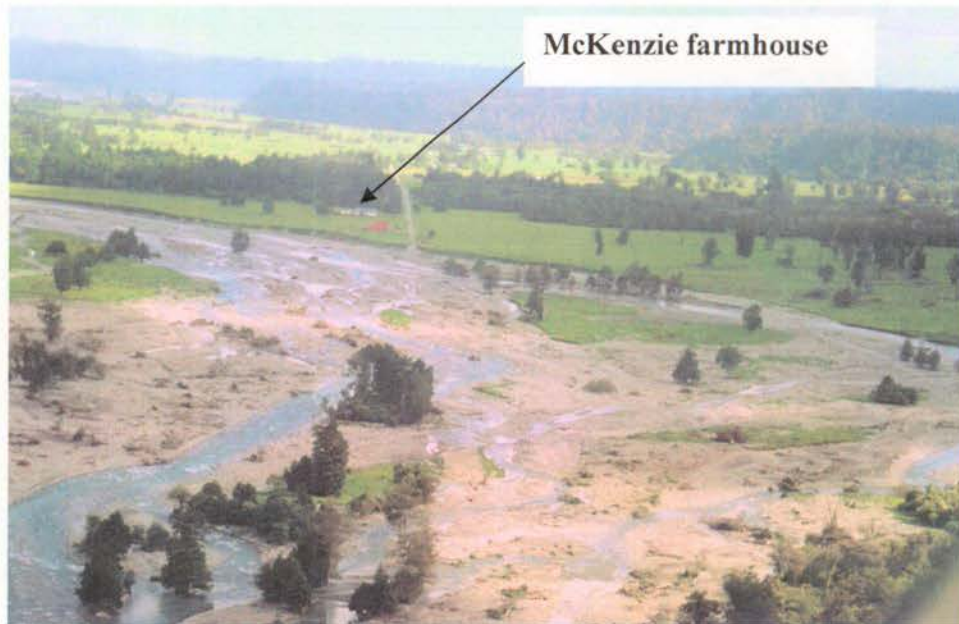
Fig. 11 Devastated farmland on fanhead 3 years after dambreak; looking downstream.

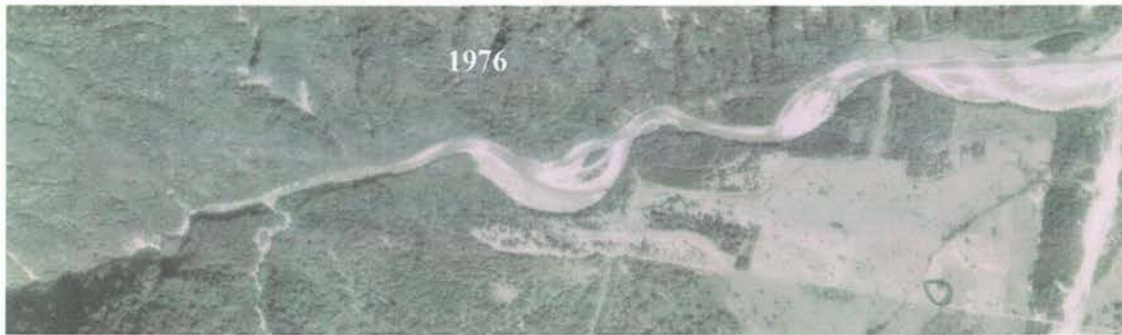
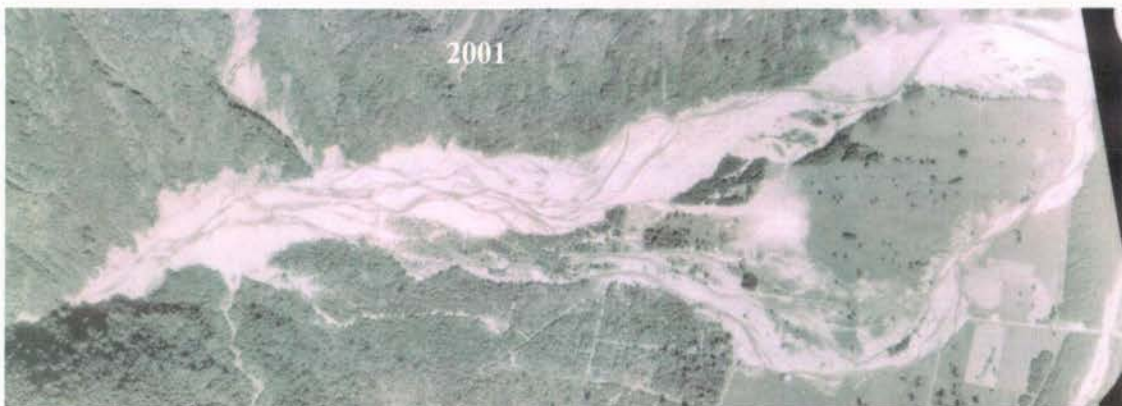
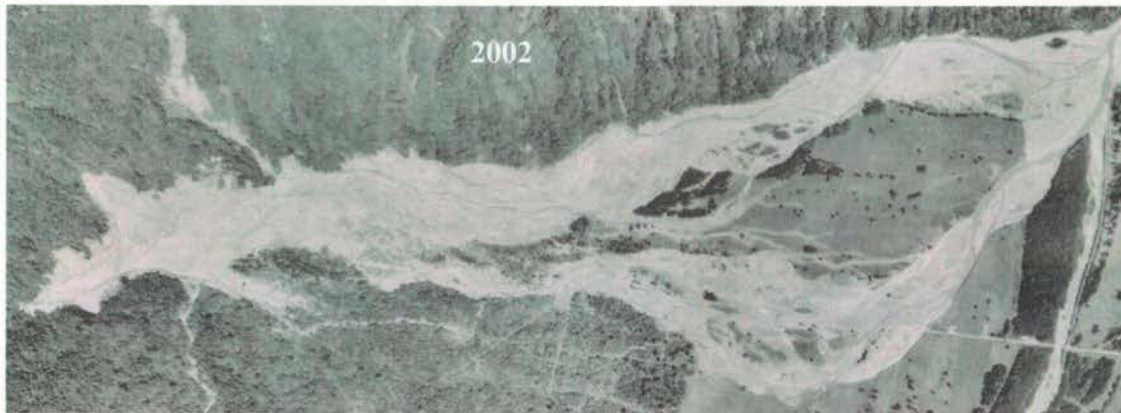
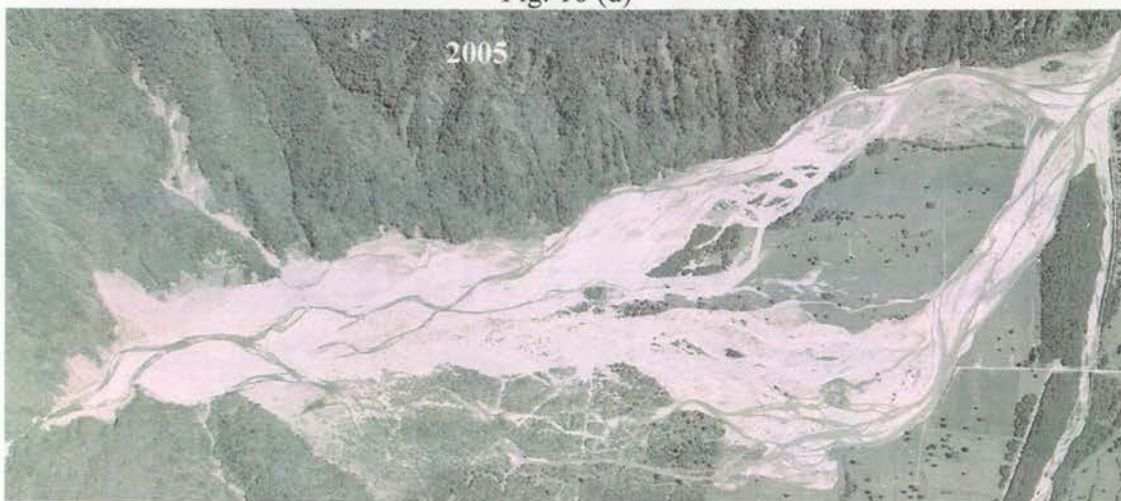
Fig. 16 Poerua river aerial photos 1976-2005

*pers. comm.* 2005). The progressive increase in the flow to the true right of the fan between 2001 and 2005 is clear, as is the gradual erosion of the true right bank (which is in fact the lower part of the tributary fan of Dry Creek) at the lower part of the fan. This has also occurred in earlier events of this type; the toe of the Dry Creek fan downstream of its confluence with the Poerua is trimmed, and this can only have been accomplished by the Poerua, after it had completely eroded away the lower 1 km of the Dry Creek fan deposit (Fig. 17) existing at the time.

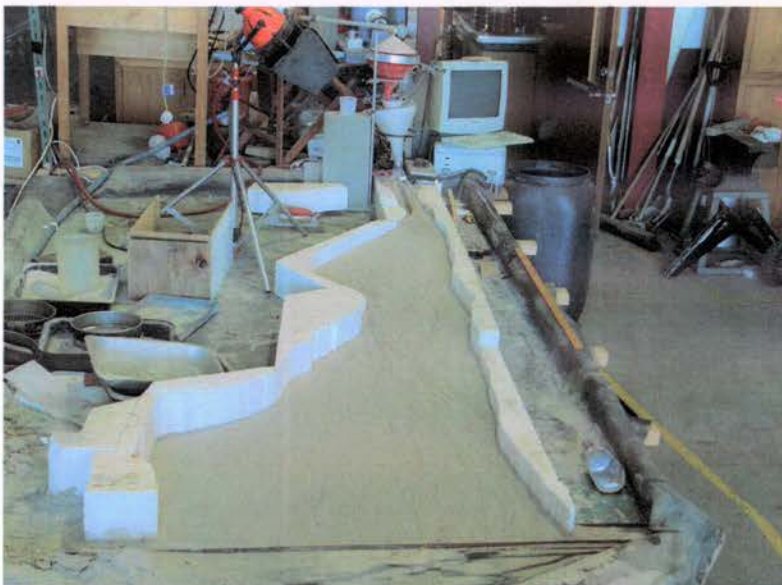
Fig. 26 Laboratory model fan, looking upstream

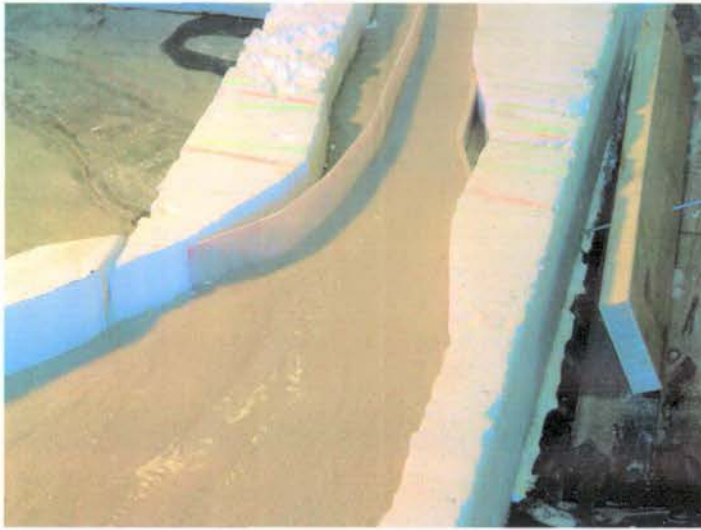
Fig. 29 Aggraded fanhead  
(2005 Series 3)

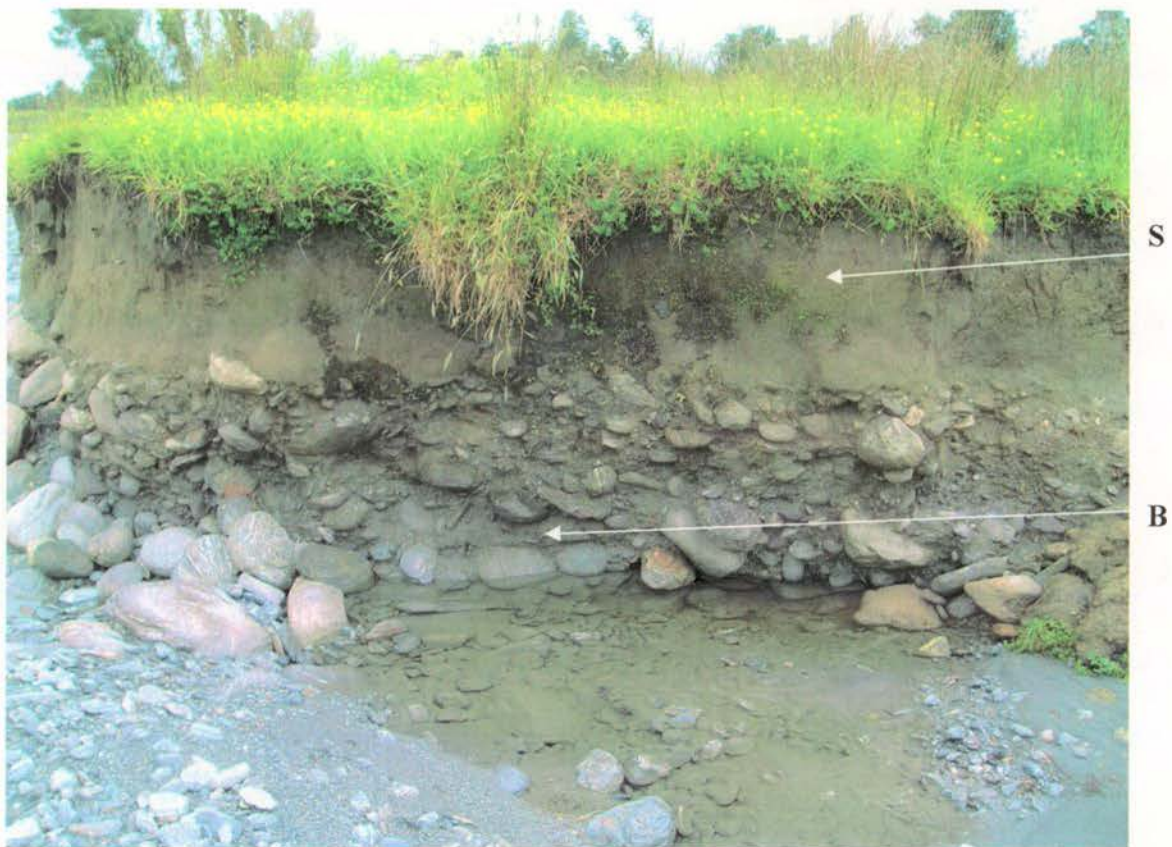
Fig. 31 Poerua soil section

At the Poerua site several pits were dug to about 2-3 m depth below the surface of the presently active fan, the achievable depth being limited by rapid ingress of water below the water table. A number of pits yielded no sign of buried soils to a depth of 3 m; this was interpreted as resulting from the most recent aggradation episode causing the pre-existing soil to be removed by erosional flow prior to sediment being deposited. However, in a number of places buried soils were found, mostly in lower-energy environments towards the edge of the fan, although one site in mid-fan yielded two buried soils. Figs 31 - 34 show some of the buried soils at Poerua (indicated by "B"; surface soils are indicated by "S").

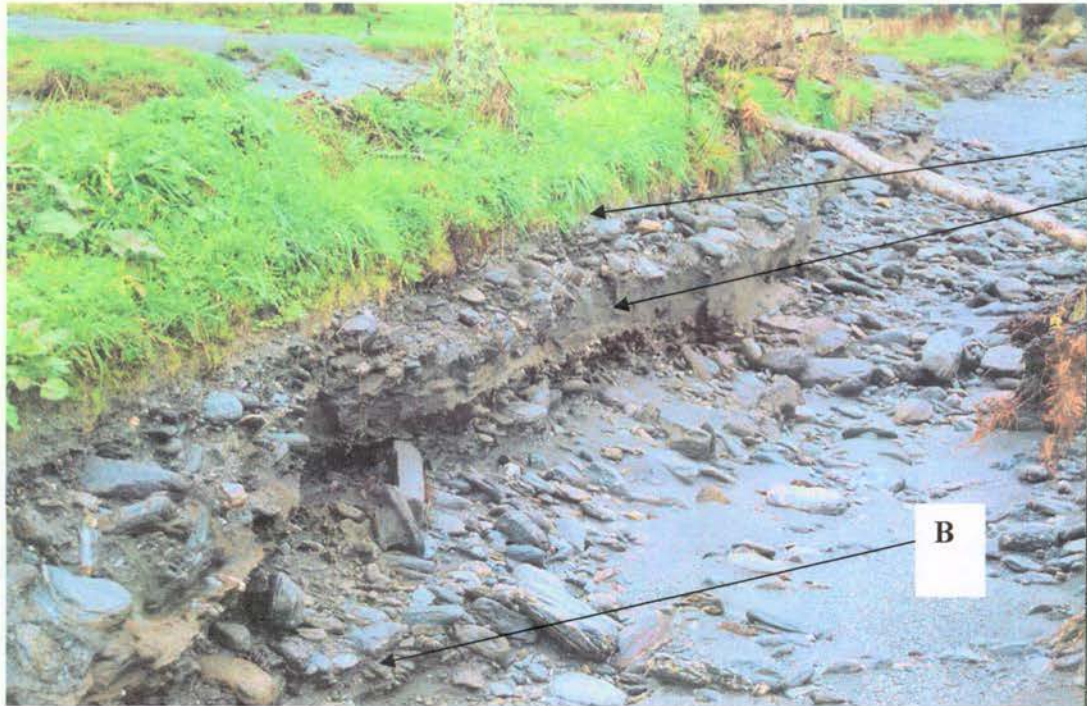
Fig 32  
Poerua  
soil  
section

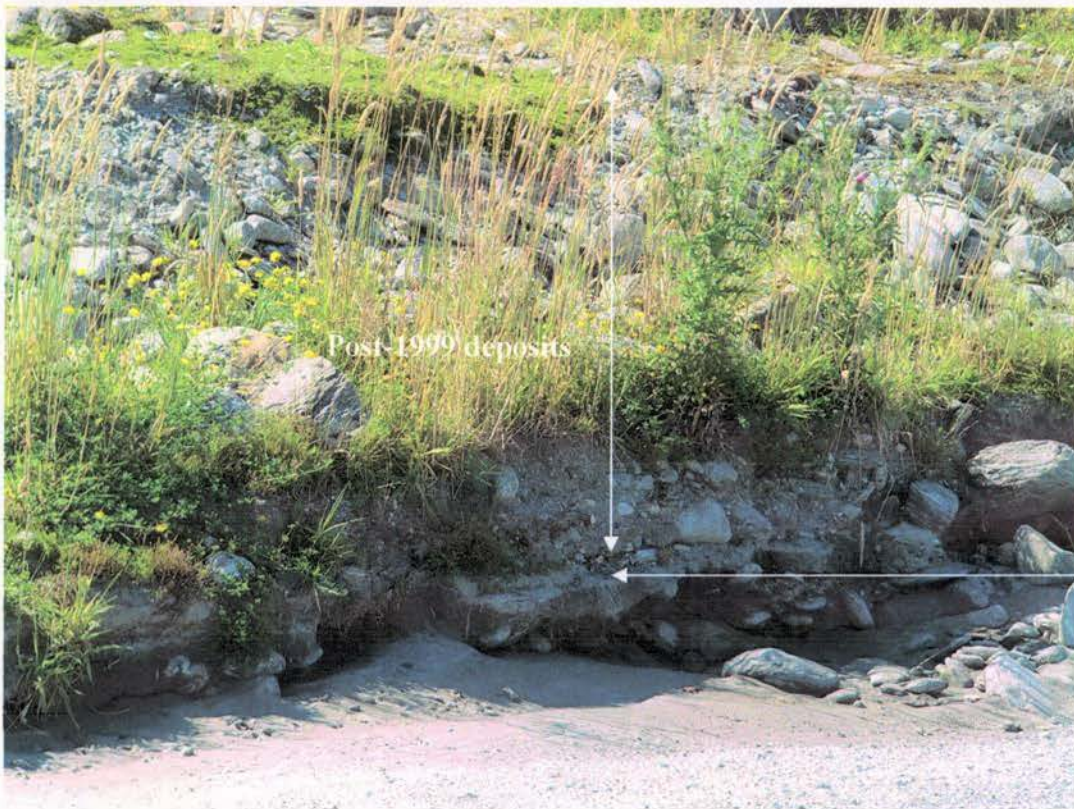
Fig.33 Poerua soil section

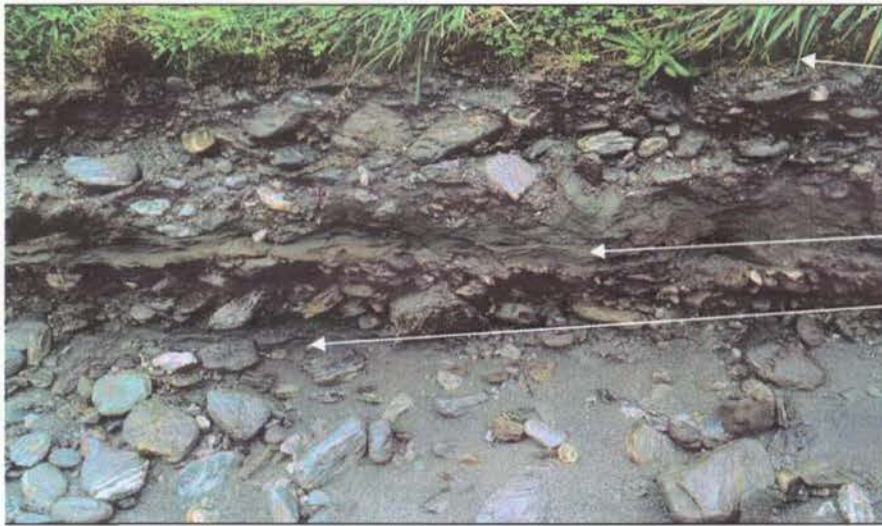
Fig. 34 Poerua soil section

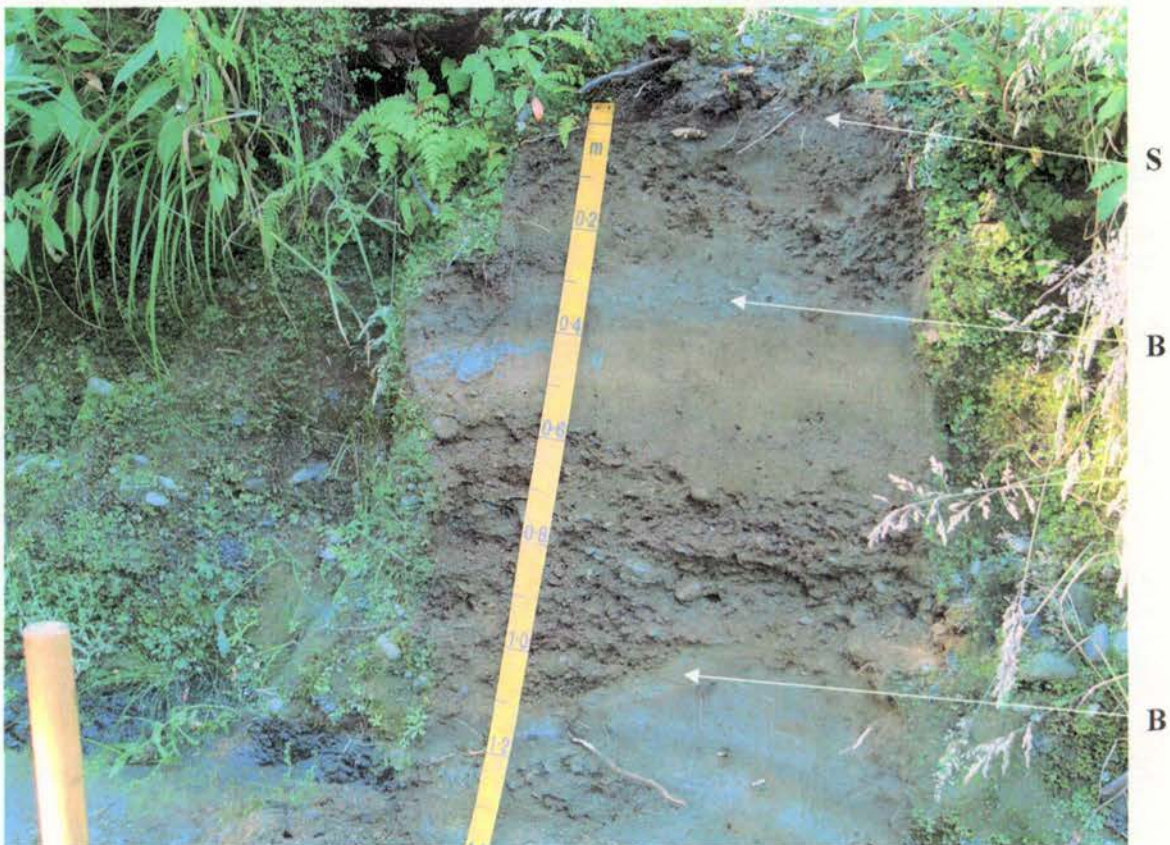
Fig. 35 Tatare soil section

At the Tatare site buried soils were exposed in a diversion drainage ditch at the edge of a new residential subdivision. Investigation revealed two soils below the surface soil, with river gravels in between (Fig. 35). This site was at the edge of the Tatare subfan, and of the order of 10 m above present-day river level in the Tatare. The vegetation on the surface soil suggested a surface age of the order of 100-200 years or so.

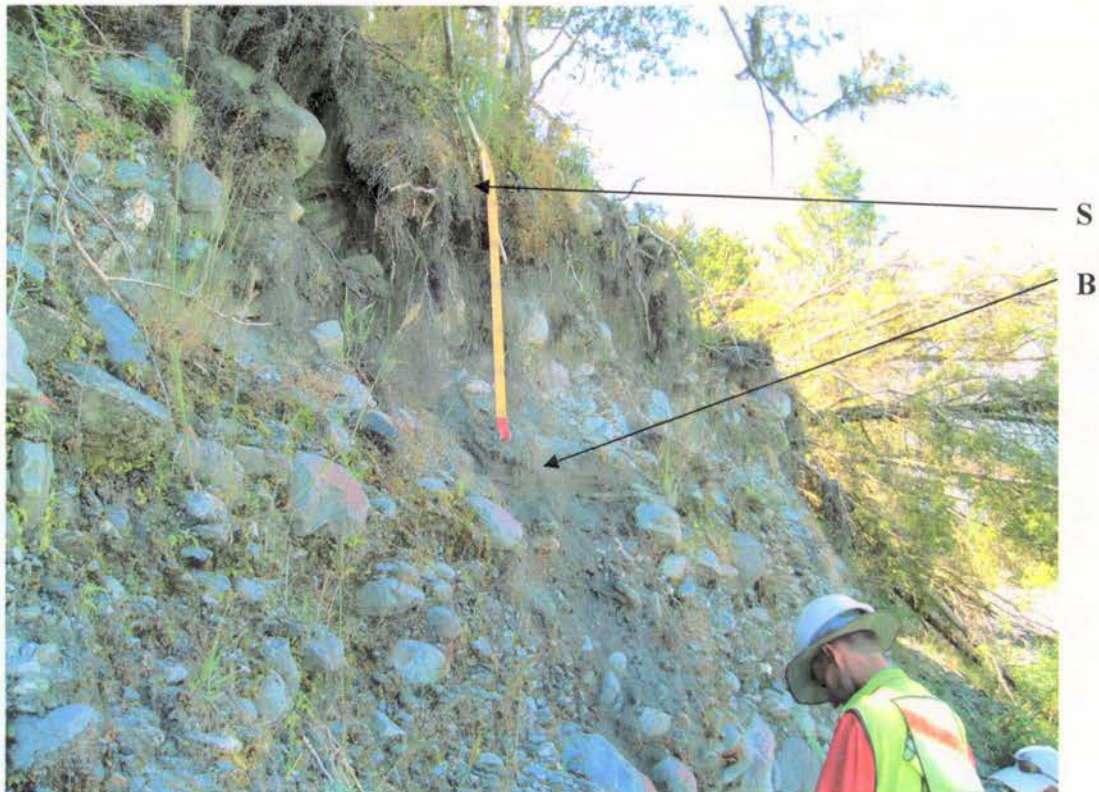
Fig. 36 Fox River bank soil section

Two pits at the Fox River yielded no buried soils to a depth of about 5 m, but again massive sand deposits were found at this depth. However, in the naturally-cut bank of the Fox River a remnant of soil was found buried to a depth of about 1 m beneath the surface soil (Fig. 36).

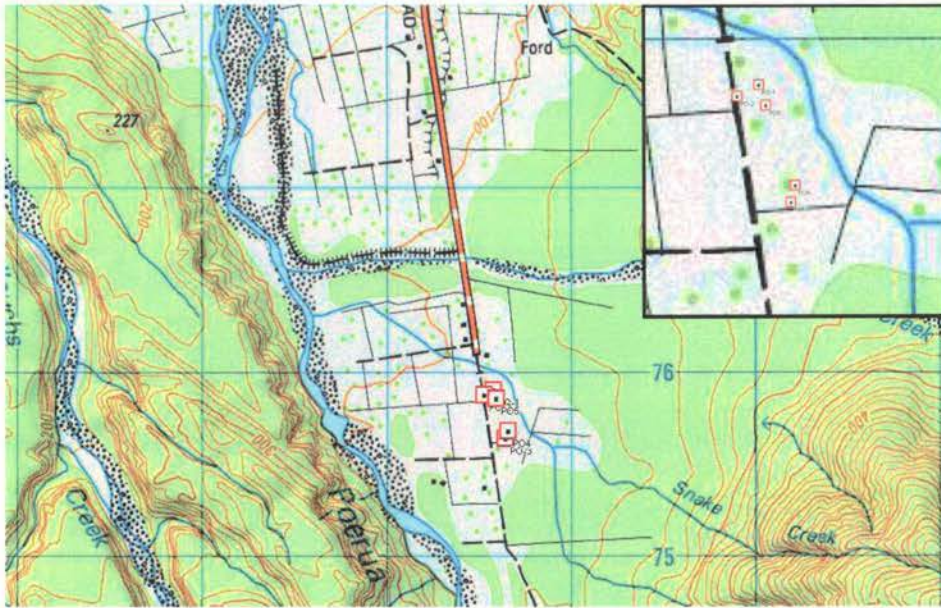
Figure 2. Sites on the Poerua river fan (Inset: details of site locations).

The stratigraphy is consistent with a stable land surface, represented by the soil at PO3 and the buried soils in PO1, PO4, PO5, having been buried by the 1999 aggradation event. The B horizon of the soil beneath the older land surface has a colour of 2.5Y 4/2 and varies between 10 and 60 cm deep. This level of B horizon expression equates to a few hundred years of soil development.
