# **PERFORMANCE OF HOLLOWCORE FLOOR SEATING CONNECTION DETAILS**

A thesis  
submitted in partial fulfilment  
of the requirements for the Degree  
of  
Master of Engineering  
at the  
University of Canterbury  
by  
Horng Yih, LIEW

University of Canterbury  
Christchurch, New Zealand

2004

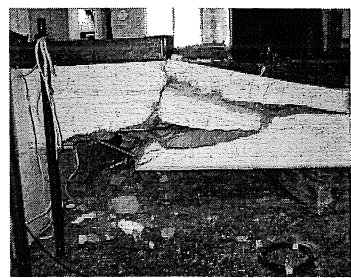
**Figure 2-8 Photographs of damage observed during the experiments**

(i) Shear crack at -1.0%

(ii) Unit dropped at 1.75%

(iii) Connection at failure

(a) Observed damage to Specimen 1

(ii) Strand seen at 4.0%

(b) Observed damage to Specimen 2

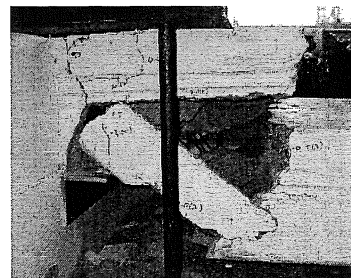
(i) Bearing strip slipped

(iii) Floor unit at failure

(c) Observed damage to Specimen 3

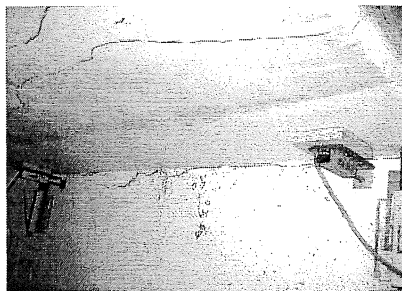
(i) Cracks at the underside of the unit at 1.0%

(ii) Northern view at -1.0%

(iii) Southern view at -1.0%

(b) Damage of hollowcore unit at  $\pm 1.0\%$

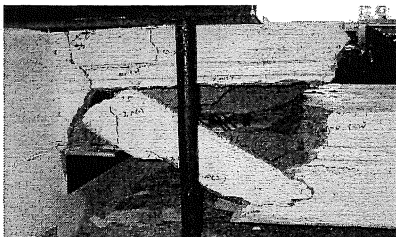
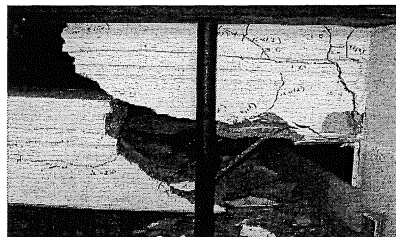
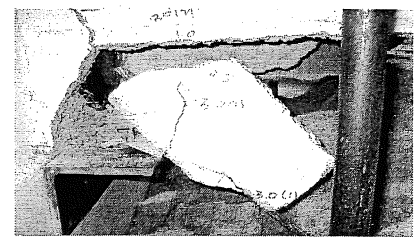
(i) Floor unit at failure

(ii) Unit being hang on by  
strand at failure

(iii) Hollowcore strand been  
pull off

(c) Floor unit at failure
