# Lava flow impacts on buildings and infrastructure: taking lessons from La Palma to New Zealand

February 2026

## **Executive Summary**

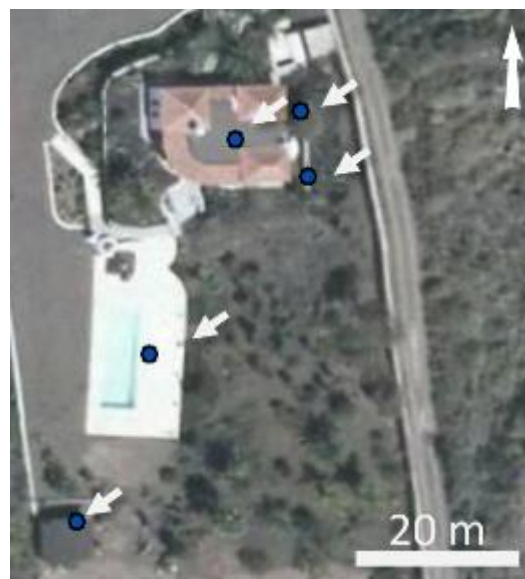
**Figure 4.** An example of one property with five damage grades. Here, we assigned a damage state of 4 for this building. White arrows indicate flow direction.

In this study, 206 buildings around flow boundaries were assessed based on accessibility and availability of data. For these properties, satellite data, drone data, and in-person assessments as well as the Copernicus damage states. Of the 206 buildings, 18 of these were assigned DS0, 10 DS1, 27 DS2, 54 DS3, 44 DS4, and 53 DS5 (Figure 5). This does not include the majority of buried buildings below the lava flow field that would have an assigned DS5. For many structures, it was difficult to assign a DS as they were on the boundary of two. An additional aspect of undertaking this assessment two and three years after the eruption was the removal of lava from properties and from the inside of buildings.

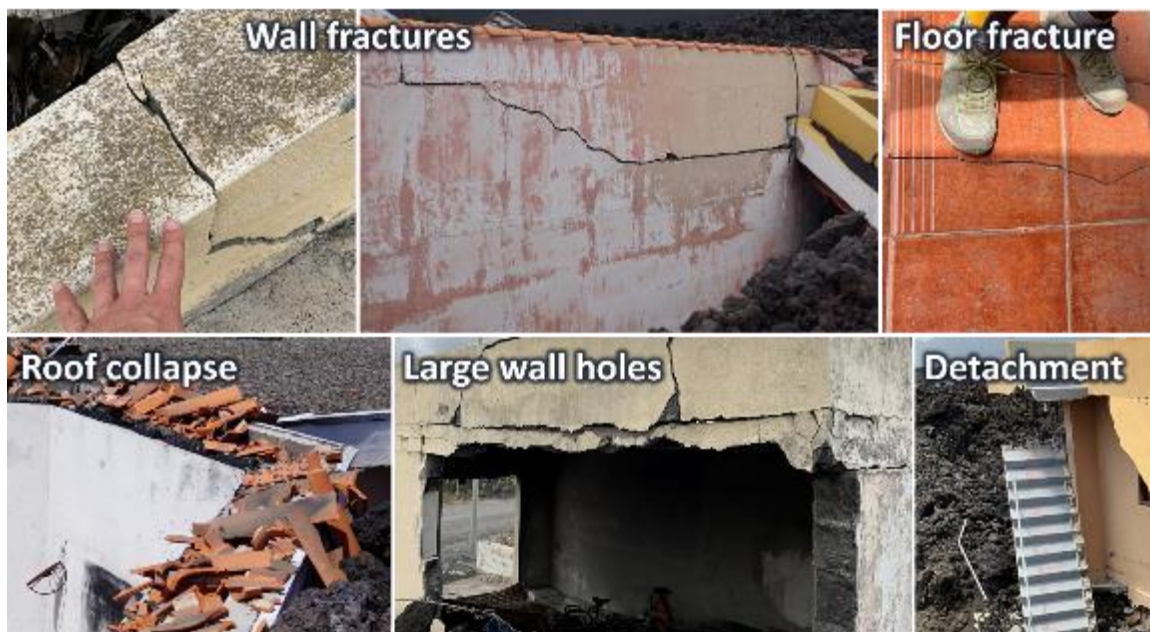
The majority of observed buildings were reinforced concrete or masonry, with very few buildings of unidentifiable materials (i.e., large warehouse-style buildings). Damage included deterioration to paint (discolouration, chipping, bubbling), broken windows, cracking or pitting of the building exterior, cracking, roof collapse, wall collapse, inundation (variable levels of lava filling the buildings), bulldozing (pushing the building horizontally), and burial (Figure 6). Structural damage from lateral load varied from fractures through structural walls, the ground and building floors, and forming holes through structural walls (Figure 7).

**Figure 7.** Examples of damage caused by lateral load, or pushing by the lava flows.

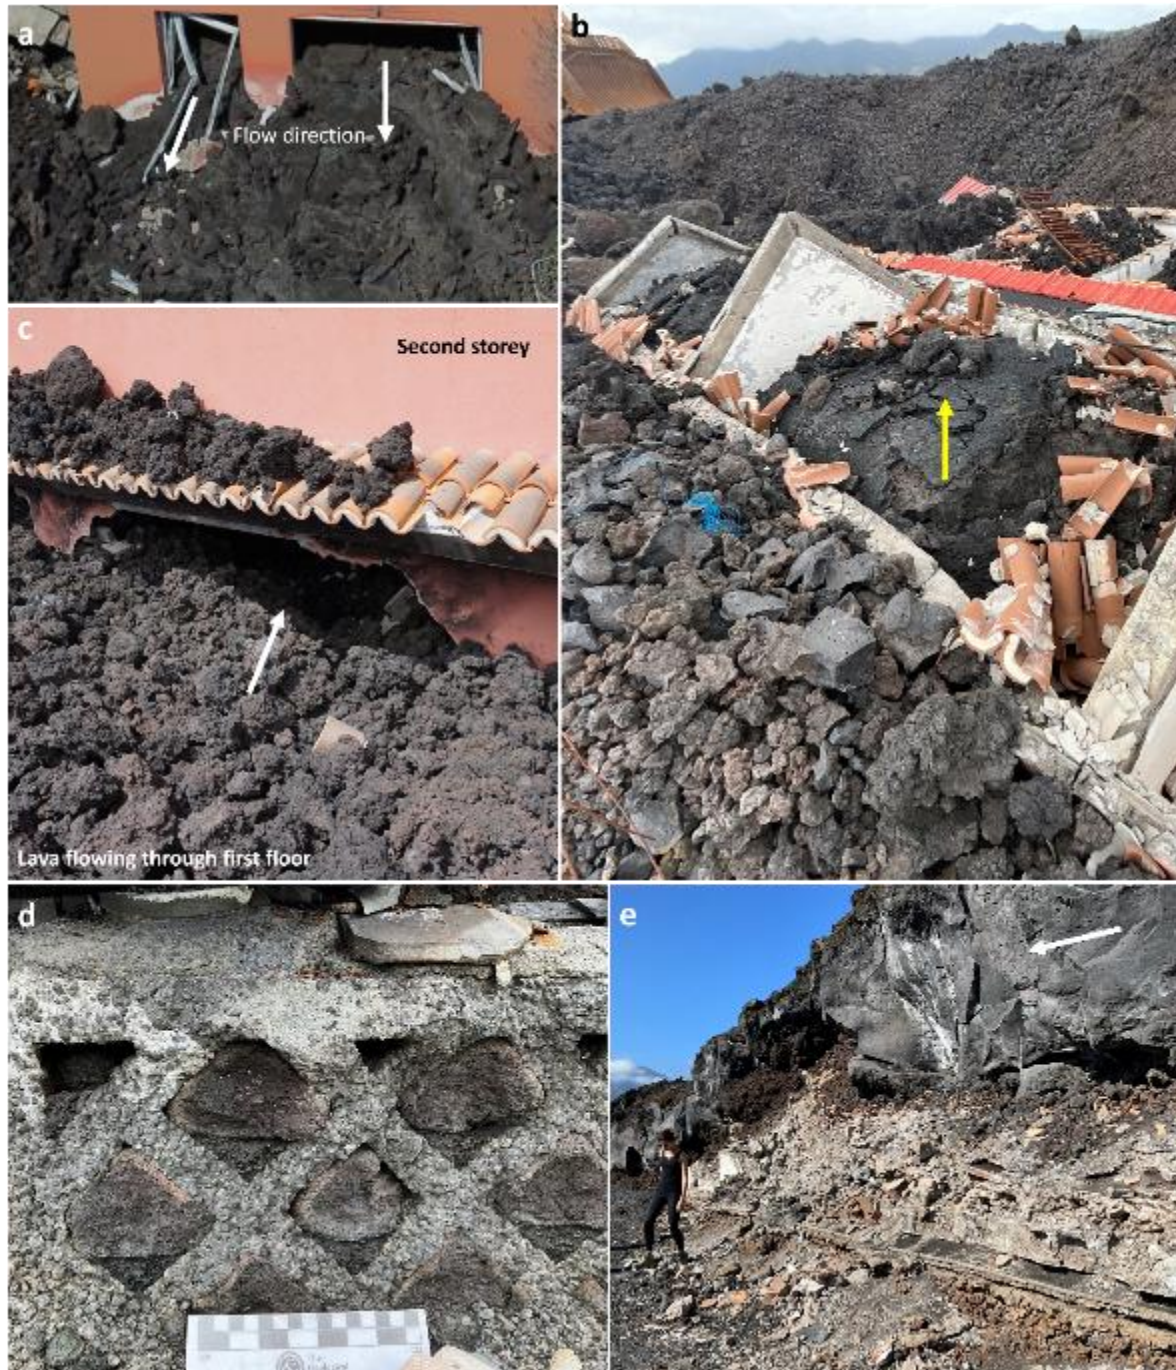
Lava inundation was variable around the flow margins, from inundating part of a building, flowing through windows or other openings and inundating a single floor of a multi-storey

building, lava flowing across properties and through boundary walls, and complete burial (Figure 8).

**Figure 8.** Variable lava flow inundation across structures: a) lava flowing through a building and out of the window and door with the structure still standing; b) lava flowed through the back wall then rose up into the structure (yellow arrow); c) lava flowing into the lower floor of a two storey building while the structure remains standing; d) lava flowing through gaps in a boundary wall, the upper marks on the scale are 1 cm; e) complete inundation and burial. The white arrows show lava flow direction.

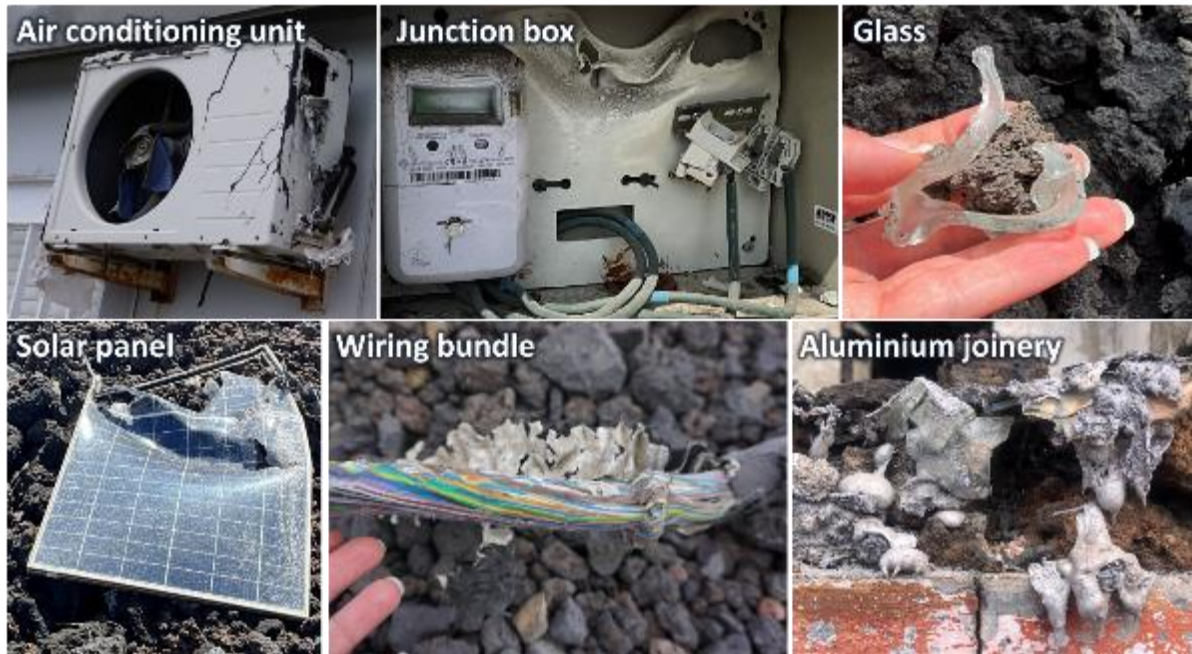
Thermal damage caused by the radiative heat from the lava produced melting of building materials including glass, plastic, and metals, and discolouration and bubbling of paint (Figure 9). While evidence of fires was not widespread in the buildings we inspected, fire and smoke damage was present in some cases.

**Figure 9.** Thermal damage to different materials around the lava flow field boundary.

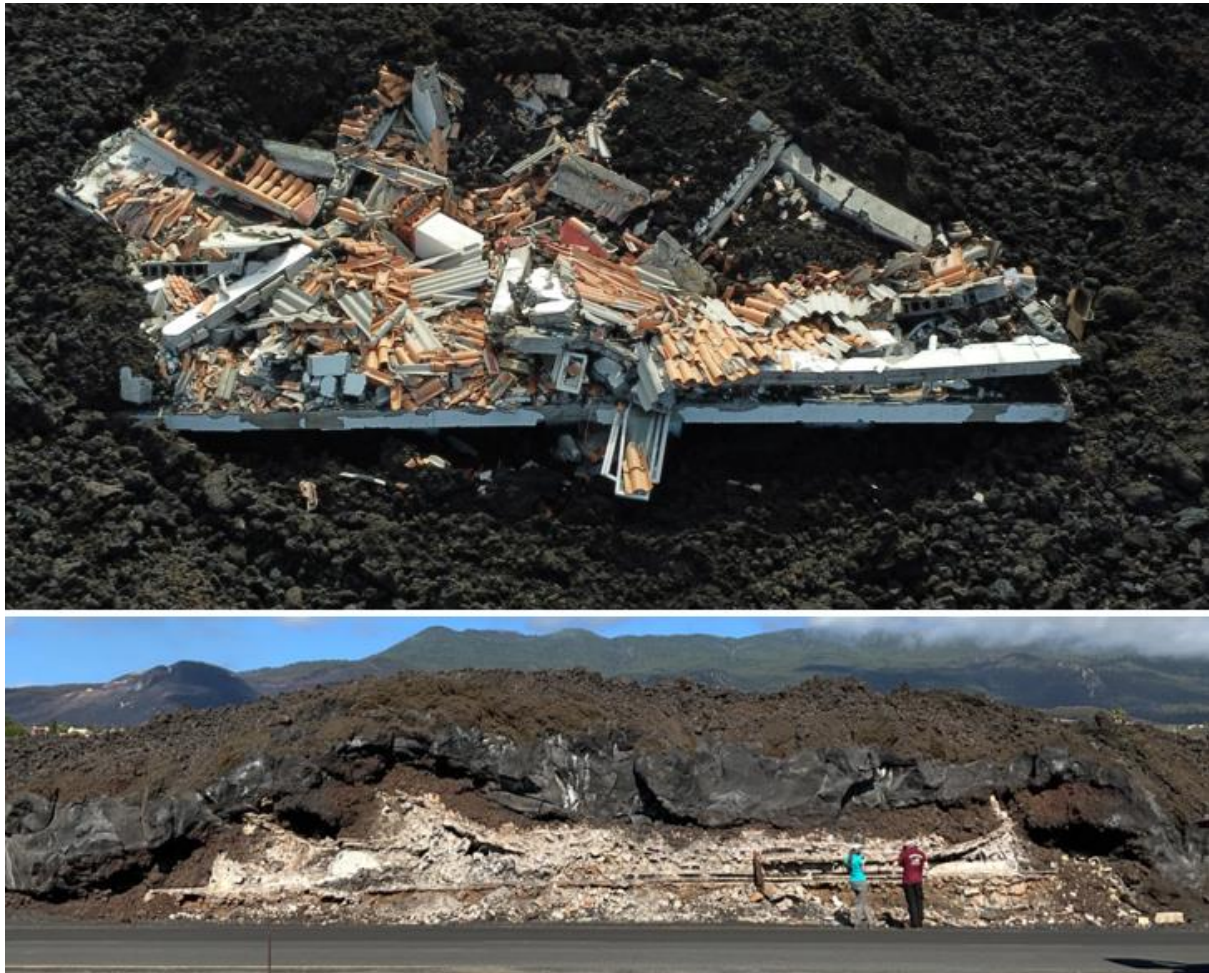
Finally, due to the re-establishment of roads, other infrastructure, and in fortuitous regions of the lava flow field, we were able to make observations of completely destroyed buildings (Figure 11; Damage State 5). In these cases, lava flow bulldozing via 'a'ā cause flattening and fragment dispersal. In these cases, remnants of the buildings were limited, yet we were able to observe that buildings were clearly transported a short distance within the flows.

**Figure 11.** Complete damage to houses and other buildings as examples of Damage State 5 within the lava flow field.
