Tahunanui Slump

August 2022 Nelson Storm Event
Geotechnical Assessment

Prepared for
Earthquake Commission

Prepared by
Tonkin & Taylor Ltd

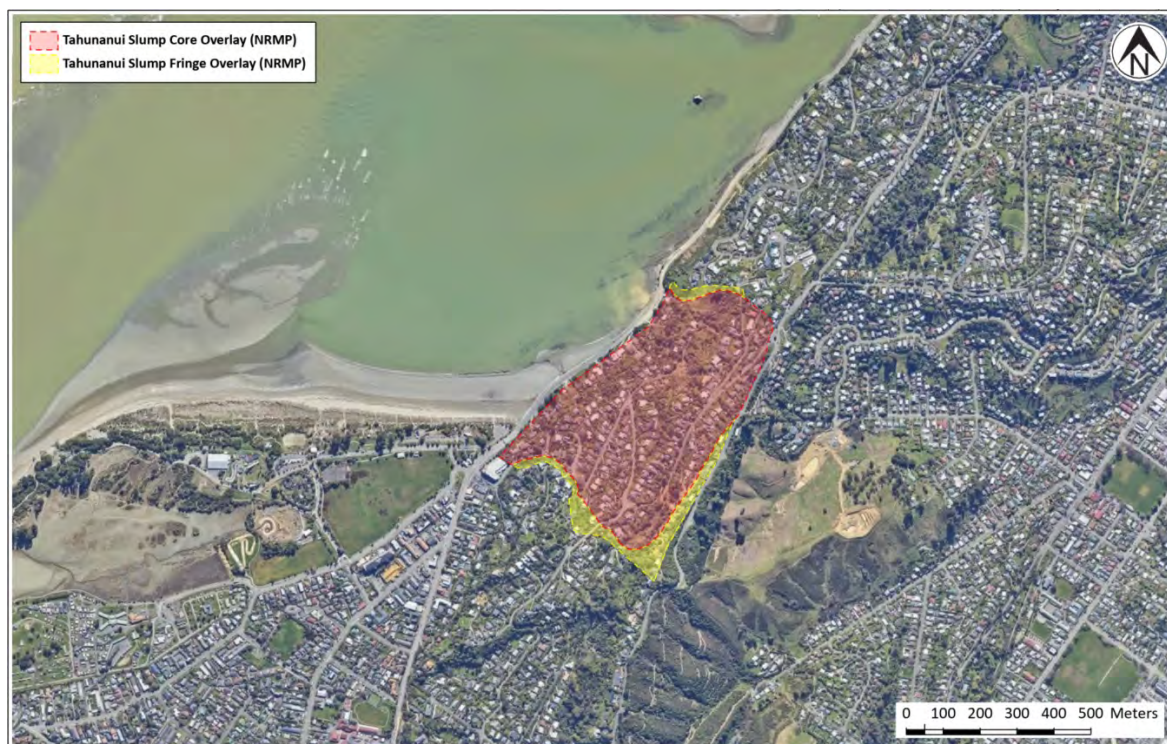
Figure 2.1: Tahunanui Slump Core Overlay and Fringe Overlay (NRMP)².

The Nelson Resource Management Plan (NRMP) has defined the TS as an area of slope risk where specific building or development rules control development¹. The Tahunanui Slump Risk Area (TSRA) is defined on planning maps and consists of a core area where the landslide has been considered to

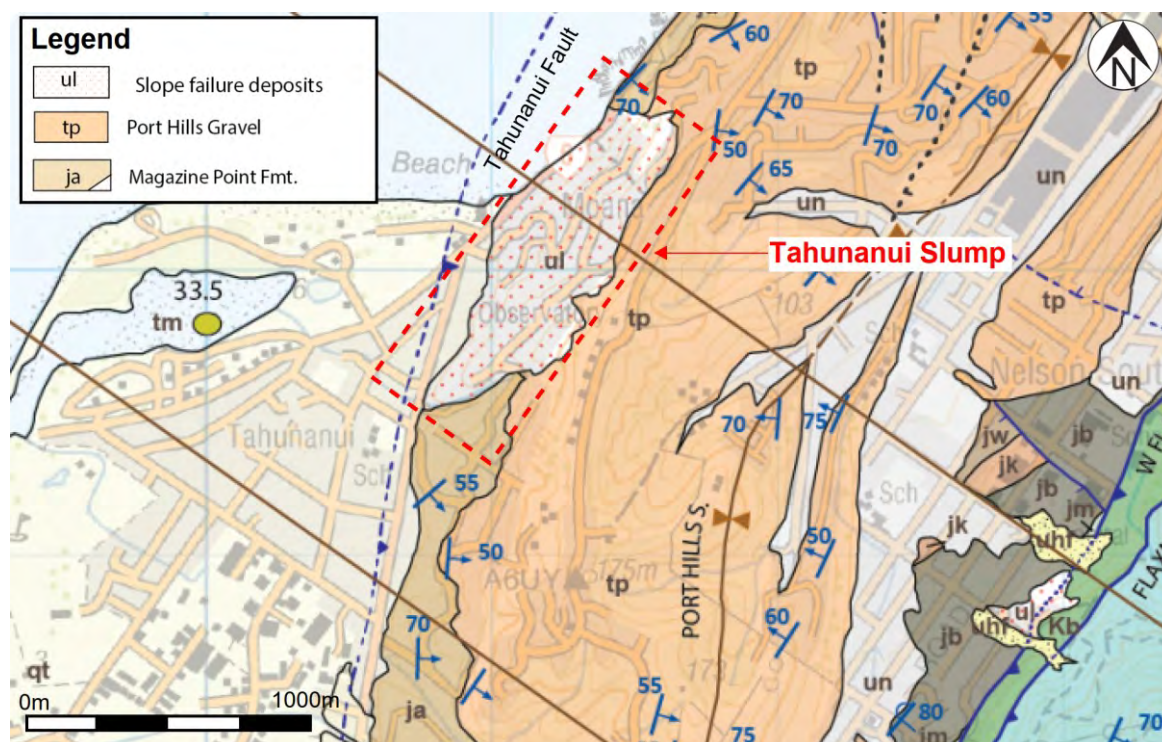
Figure 2.2: Geological setting (obtained from the Revised Geological Map of the Nelson-Richmond-urban area³).

A recently published geological map of the area⁶ (Johnston et al, 2021) indicates that the TS comprises slope instability deposits of a Holocene to Late Quaternary age. The location of the TS (mapped as *ul*) is shown in the context of the regional geology on Figure 2.2 below.

The TS is located on the northwest limb of the Port Hills Syncline, with bedding of the Pliocene-aged Port Hills Gravel Formation (PHG) bedrock mapped to be dipping steeply (50–60°) to the east to southeast. PHG is mapped as a 500 m thick deposit consisting of a clay-bound gravel with local beds

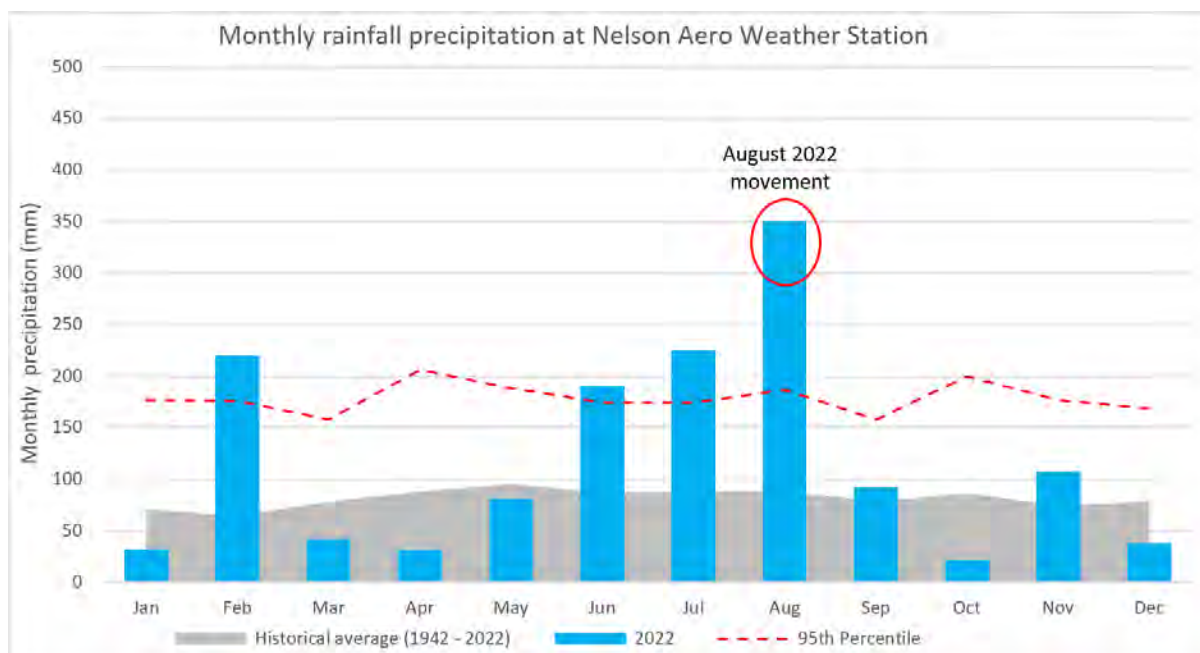
Figure 4.1: August rainfall accumulations compared with historical average and 95th percentile rainfall accumulations.

Antecedent monthly rainfall accumulations through June and July exceeding the 95th percentile compared with historical data dating back to 1942, are presented in Figure 4.1.

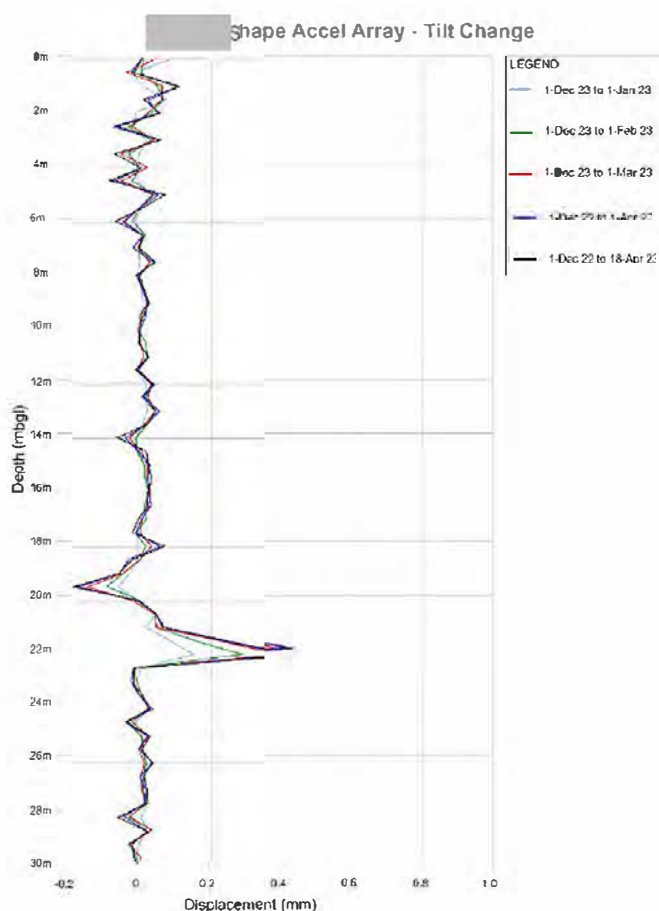
Figure 5.1: SAA tilt change plot indicating incremental displacement from December 2022 to April 2023

The data received to date (18 April 2023) is not sufficient to enable meaningful conclusions to be drawn other than confirming the depth of the surface of rupture of the TS previously indicated by inclinometer reading in [REDACTED] and that the rate of movement post the event is similar to average rates of movement monitored during the years preceding the event .

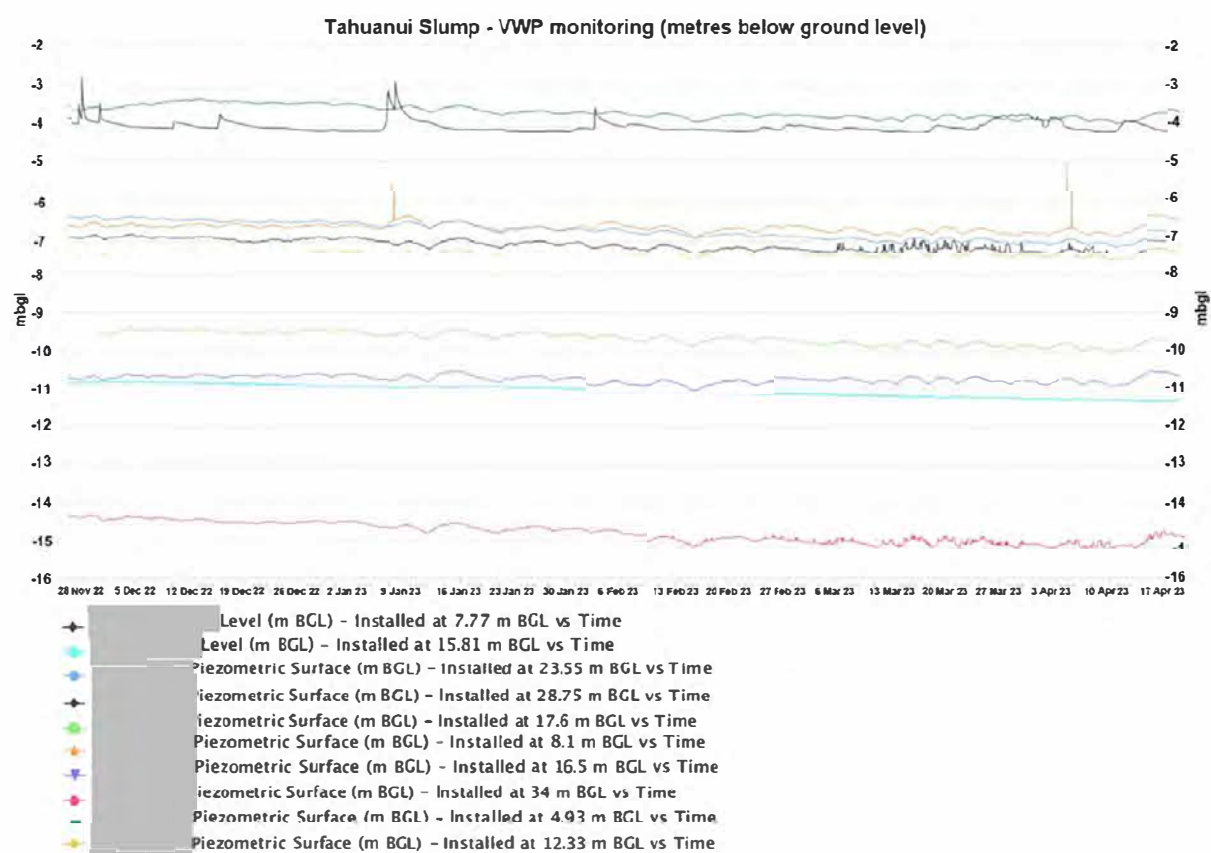
Figure 5.2: Times series graph of groundwater monitoring levels from 26 November 2022 to 19 April 2023.

The piezometer tip depths were selected to target potential unconfined, confined, and potential perched piezometric levels. to develop a groundwater model to be developed for the TS. The depth and screened geological unit for each piezometer location is attached in Table D.1 attached in Appendix D. The groundwater monitoring to date is presented below in Figure 5.2.

Based on review of the five months of groundwater monitoring, from 26 November 2022 to 18 April 2023 the following observations were made:

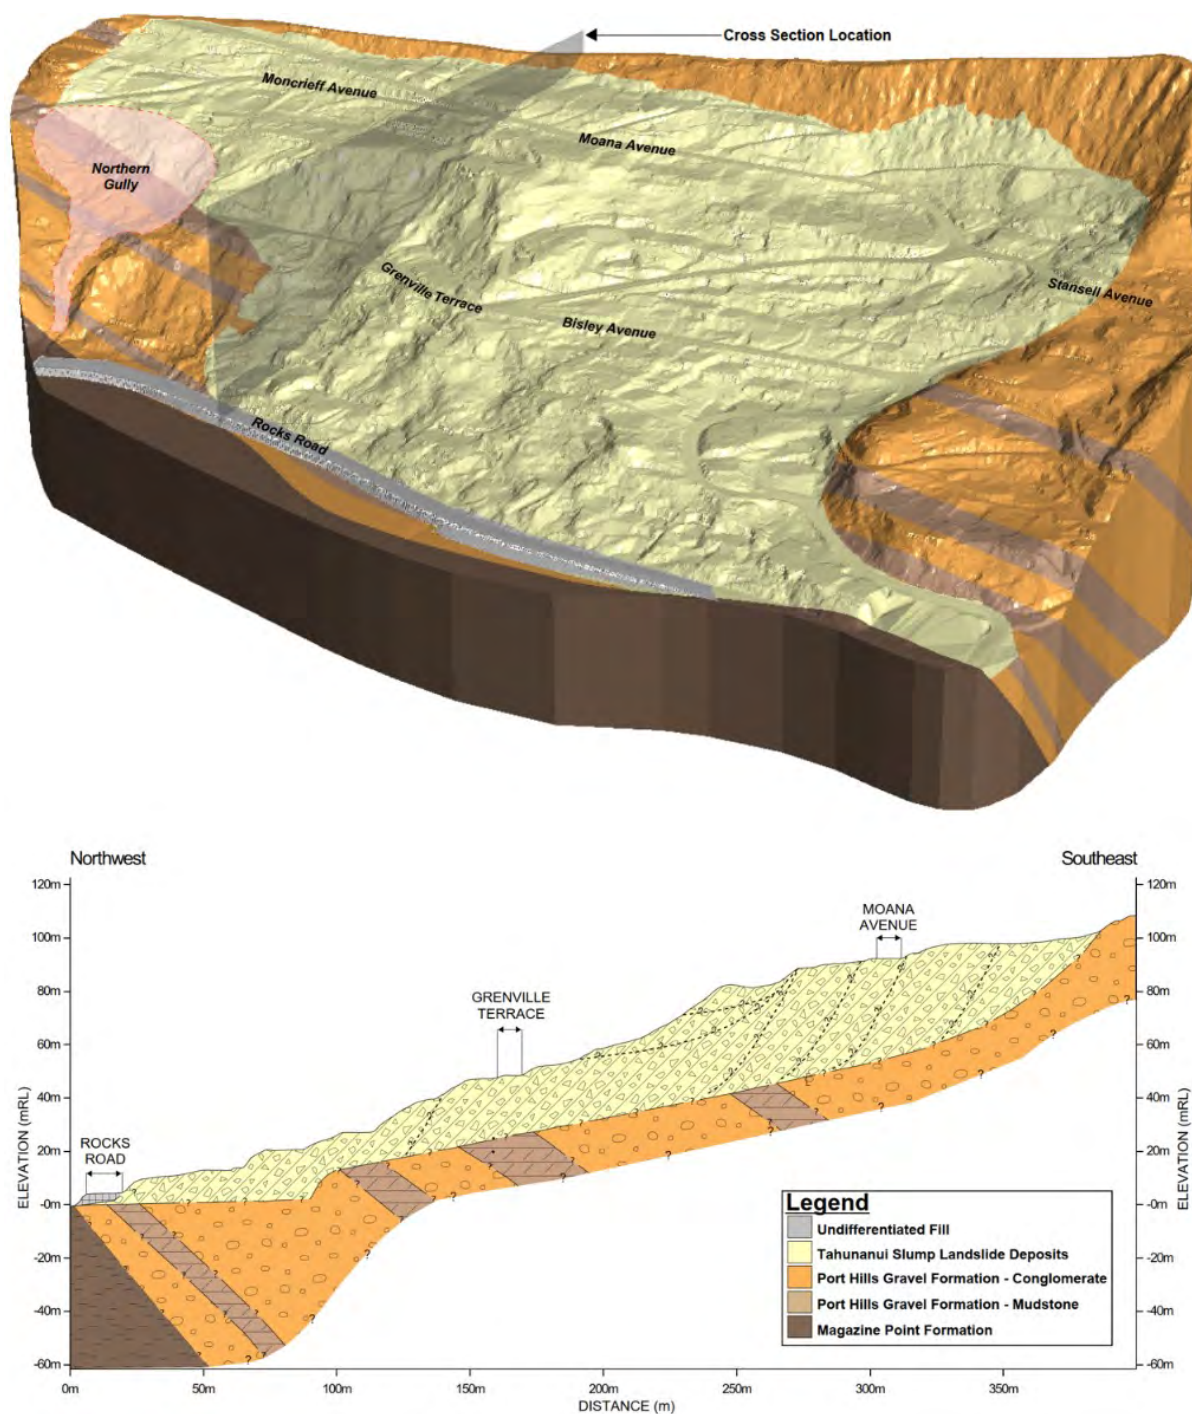
Figure 6.1: 3D Geological model and illustrative cross section of the Tahunanui Slump.

An overview of the engineering geological model and an engineering geological cross section through the Grenville Terrace area are presented below in Figure 6.1 below. Note that this model does not show supplementary landslide features within the body of the main TS. Further cross sections generated by the 3D model (Cross-sections 1 to 3, Figures 10189612-F5 to F7) are included in Appendix A.

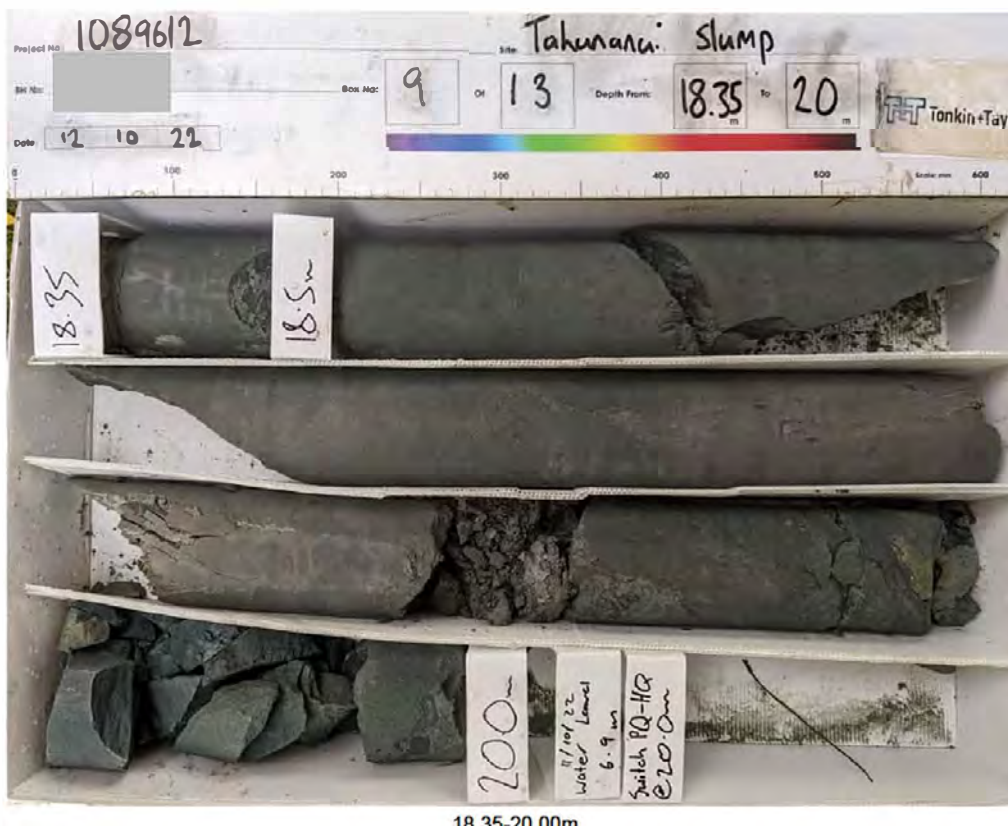
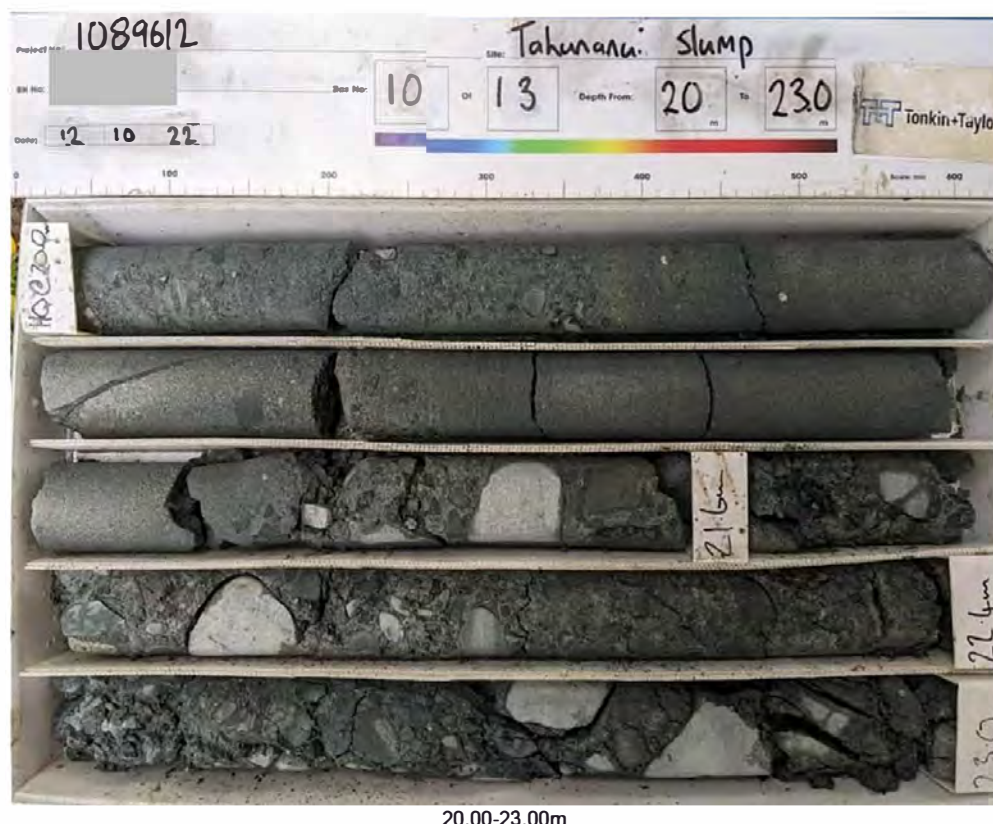
BOREHOLE No.
SHEET: 5 OF 7

CORE PHOTOS

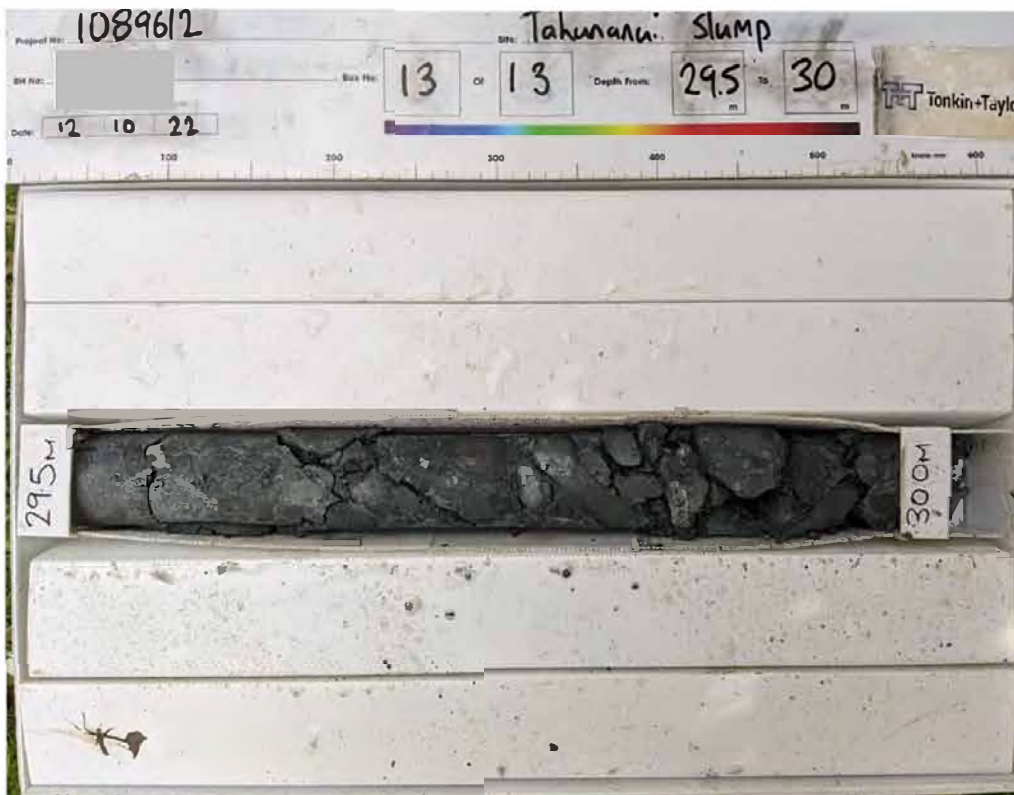
SHEET: 7 OF 7

29.50-30.00m

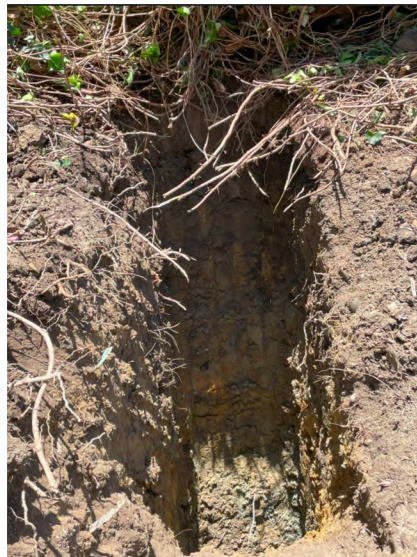
SKETCH / PHOTO:

COMMENTS: 1. Minor groundwater seepage at 2.5 mbgl, along the contact between the clay and underlying clayey gravel.

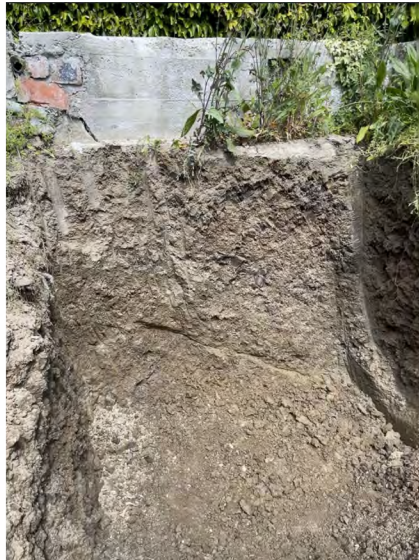
SKETCH / PHOTO:

0.00m: Silty fine to coarse GRAVEL; greyish brown. Very stiff to hard, dry, gap graded. Gravel, angular, mudstone. Pervasively sheared.	D		10 25 50 100 200		Tahunanui Slump Landslip Deposits
					41	2.0		1.8m: END OF INVESTIGATION

COMMENTS: 1. Sheared siltstone striking at approximately 050° and dipping upslope (south-east) at 30°
