Earthquake Commission

Report into the History of the Development of the Kuirau Park side of Tarewa Road Rotorua, as it relates to Geothermal Activity

Jack T Just
Consulting Engineer
13 Holland Street
Rotorua

22 July, 1998

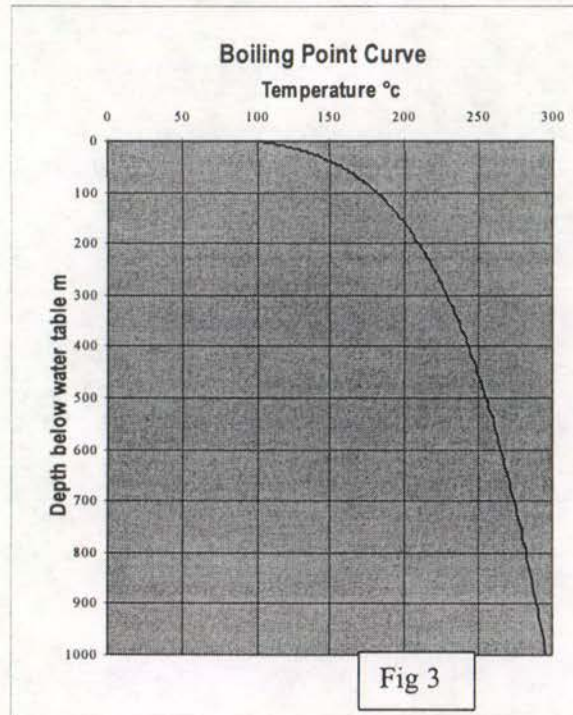
The idea to grasp here is that the boiling point of water rises rapidly, the deeper one goes below the ground water table. This can be seen in the graph in Fig 3 where the boiling point of water is plotted against depth (without adjustment for changing density).

From this graph it will be seen that if the open pipe was not 10m deep, but 500m deep, still water at the bottom would boil at about 263 °C. Water at that depth would be under so much pressure from the weight of water above it, that even if the temperature of the water at that depth rose to 200°C, (twice the boiling point at the ground level), it would not boil. It would remain as docile as if it was in a puddle.
