NHC PROJECT # 4454: SEISMICALLY RESILIENT PARTITION

WALL DESIGN AND TESTING

Final Report

Submitted to: Natural Hazards Commission Toka Tū Ake

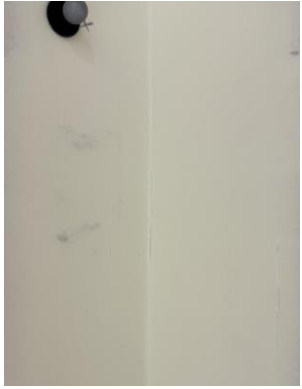
<p data-bbox="268 1048 775 1077">Timber In plane East and Timber inclined East</p>

<p data-bbox="858 734 963 860">Hairline shrinkage cracks of plaster</p>

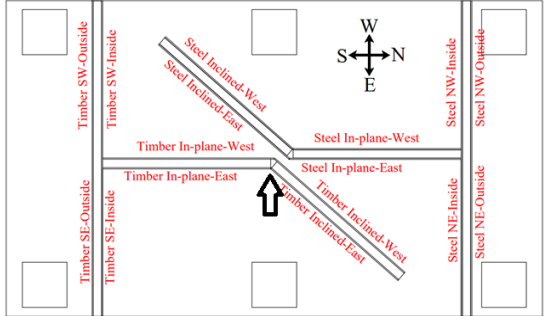
<p data-bbox="831 1182 995 1308">The plaster not completely on the junction line</p>

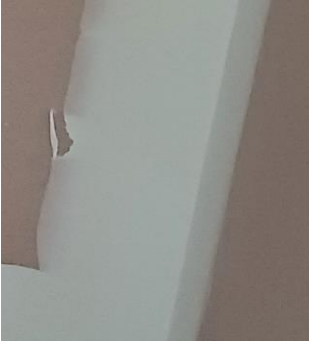
<p style="text-align: center;">Timber SW outside</p>	<p>Plasterboard cracks at plasterboard corner and mid-height of the ends</p>	
<p style="text-align: center;">Timber SW outside, Top corner, next to the top plate near the joint of stud and top plate</p>	<p>Damage to plasterboard</p>	
<p style="text-align: center;">Timber SE Outside, bottom corner</p>	<p>Damage to plasterboard and bottom timber plate</p>

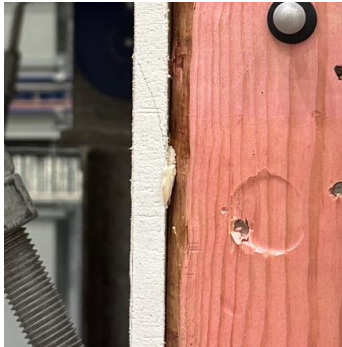
<p>Slight crack in plasterboard</p>

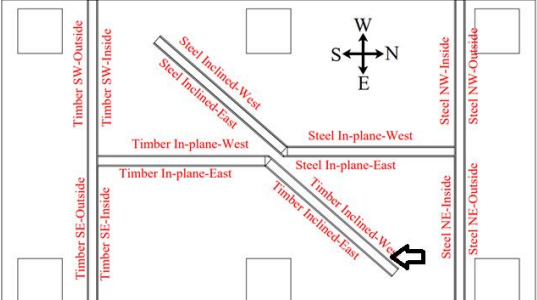
<p style="text-align: center;">Timber Inclined West wall</p>

<p>Screw impressions at the bottom</p>

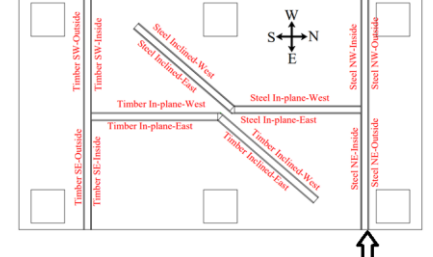
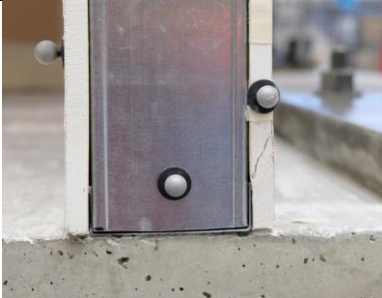
Location	Observation	Photo
<p style="text-align: center;">Steel NE outside</p>

<p>Crack on plasterboard corner</p>

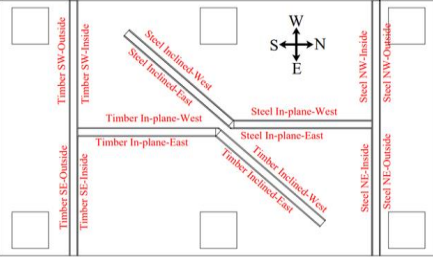
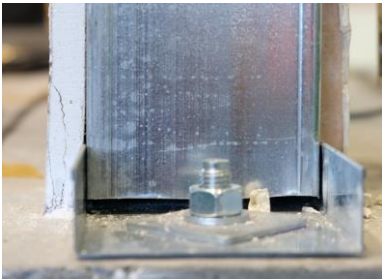
<p style="text-align: center;">Steel NW outside</p>

<p>Crack on plasterboard corner</p>

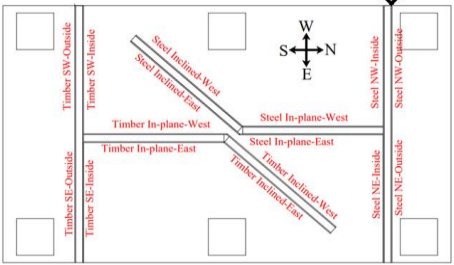
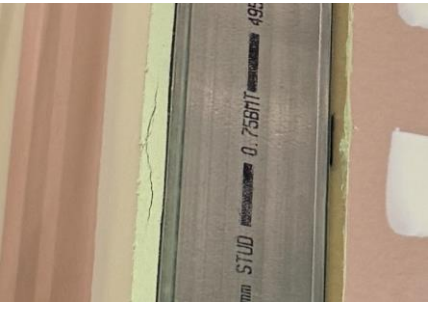
<p style="text-align: center;">Steel NW outside</p>

<p>Crack on plasterboard edge around mid-height</p>

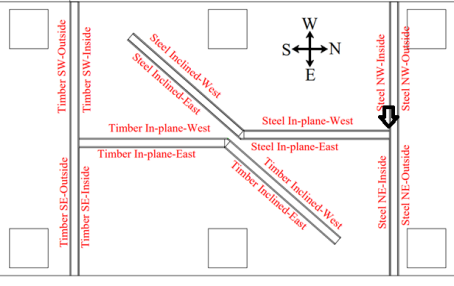
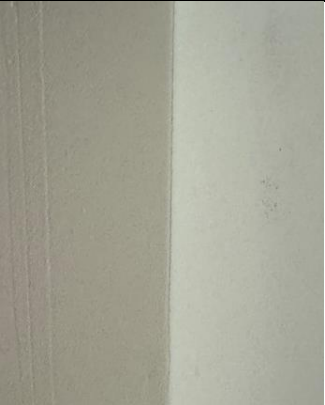
<p style="text-align: center;">Steel NW inside and Steel In-plane west junction</p>

<p>Minor hairline shrinkage cracks</p>

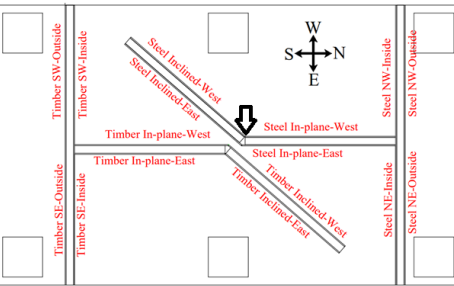
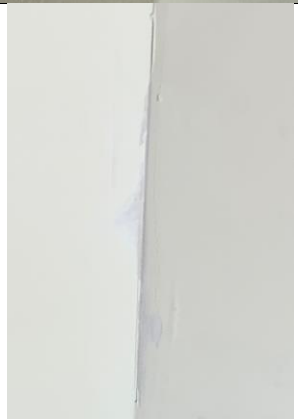
<p style="text-align: center;">Steel In-plane West and Inclined West junction</p>

<p>Either the plaster not throughout the junction line or visible hairline plaster shrinkage cracks</p>

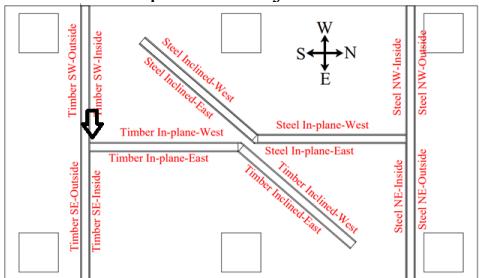
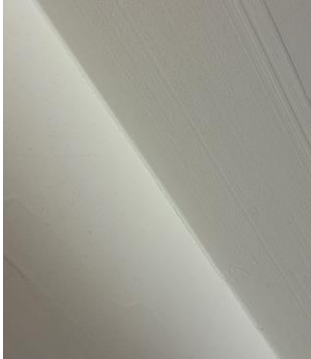
Location	Observation	Photo
<p style="text-align: center;">Near the bottom of Timber SW and Timber In-plane West junction</p>

<p>Hairline crack at wall junction</p>

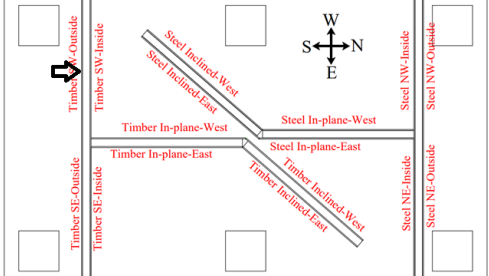
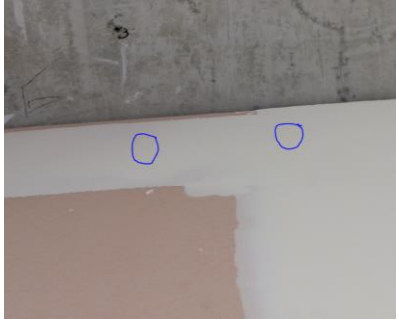
Location	Observation	Photo
<p>Near mid-length at the top of Timber SW Outside wall</p>

<p>Screw impressions</p>

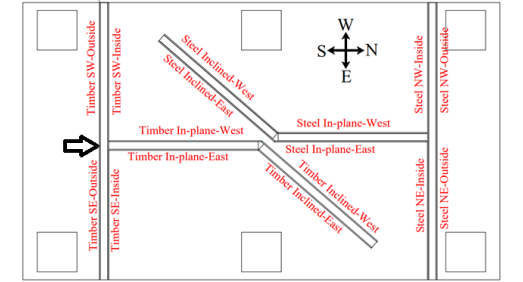
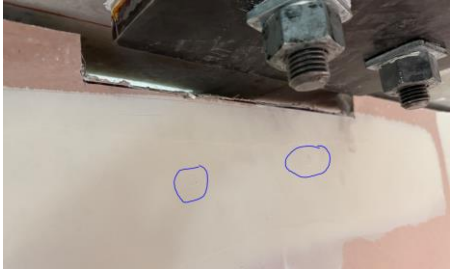
Location	Observation	Photo
<p>Near mid-length at the top of Timber SW/SE outside wall</p>

<p>Screw impressions</p>

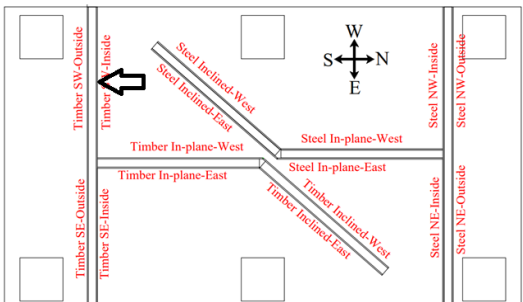
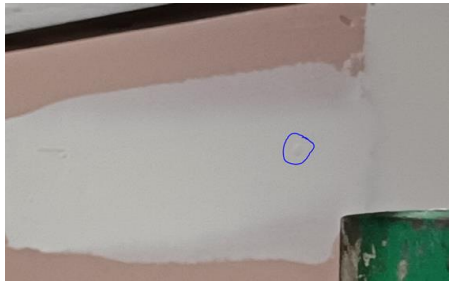
<p>Near mid-length at the top of Timber SW inside wall</p>

<p>Screw impressions</p>

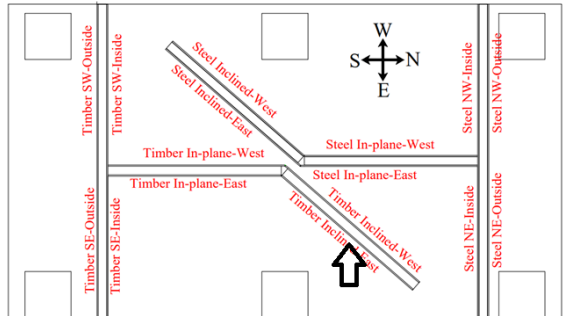
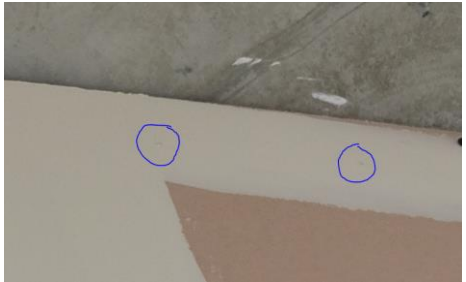
Location	Observation	Photo
<p>Top of Timber inclined east wall</p>

<p>Screw impressions</p>

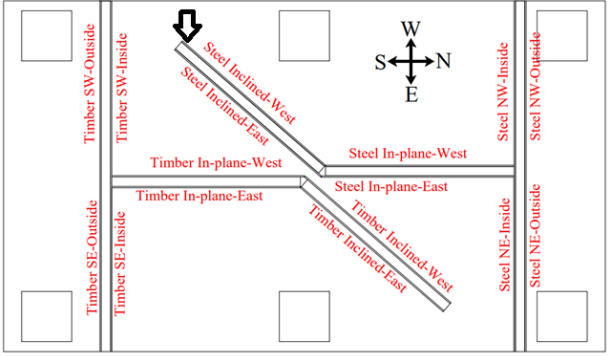
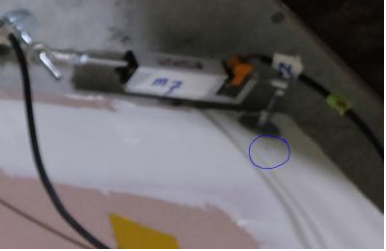
Location	Observation	Photo
<p>Top Corner of Steel Inclined West wall</p>

<p>Screw impressions; The screw is likely to be driven into the head track (not in the nearest noggling)</p>

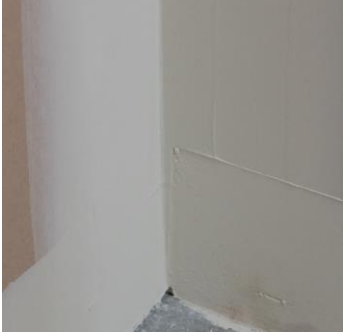
<p>At the bottom of Steel NE inside and In-plane East wall junction</p>

<p>Hairline crack in the plasterboard</p>

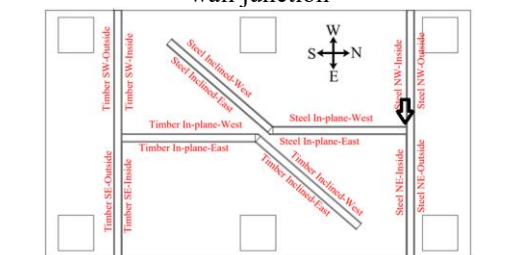
Location	Observation	Photo
<p>at bottom of the steel NW and In-plane West wall junction</p>

<p>Hairline crack</p>

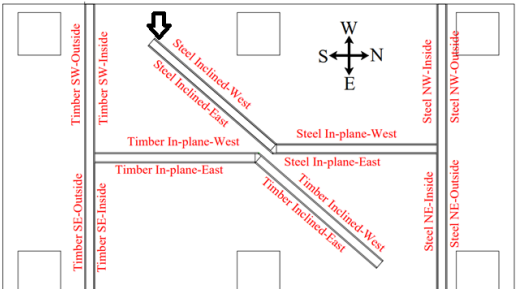
<p>Top Corner of Steel Inclined West wall</p>

<p>Progressive damage - screw popping out</p>

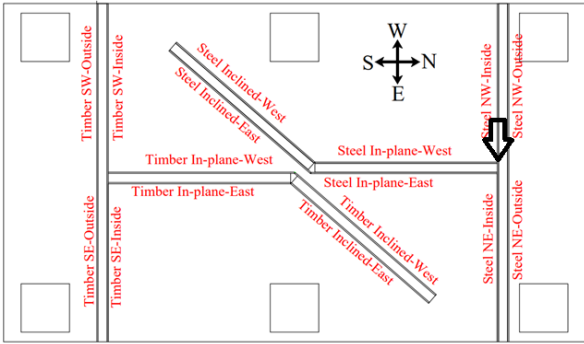
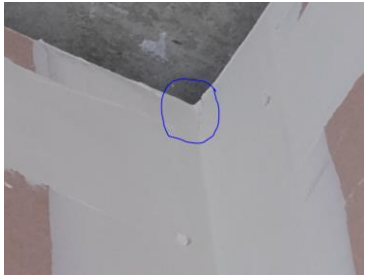
Location	Observation	Photo
<p>At the top of the Steel NW and Steel In-plane West wall</p>

<p>Tearing of joint paper tape</p>

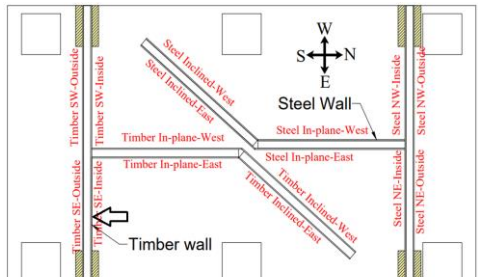
Location	Observation	Photo
<p>At the end of the DHT in Timber wall SE Inside</p>

<p>Progressive damage: Crack in the plasterboard (Observed earlier in the unrestrained specimen at 0.8 % drift)</p>

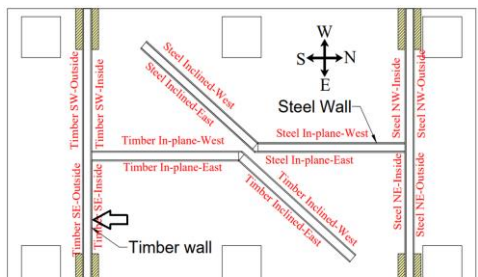
Location	Observation	Photo
<p>At the end of the DHT in Timber wall SE Inside</p>

<p>Progressive damage: Crack in the plasterboard</p>

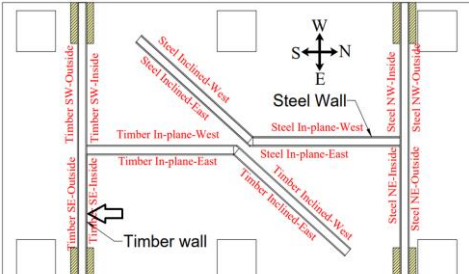
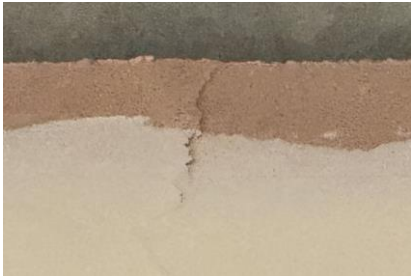
Location	Observation	Photo
<p>At the end of the DHT in Timber wall SE Inside</p>

<p>Progressive damage: Crack in the plasterboard Perhaps the crack is severe enough to compromise the fire seal.</p>

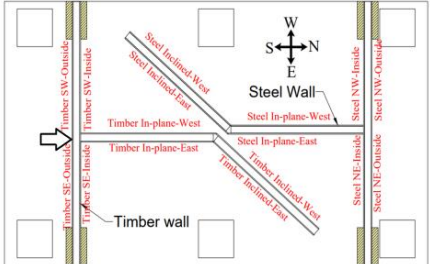
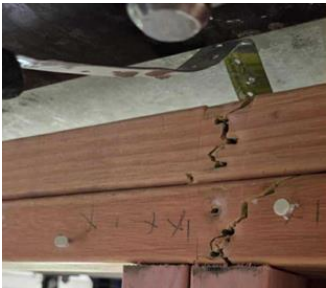
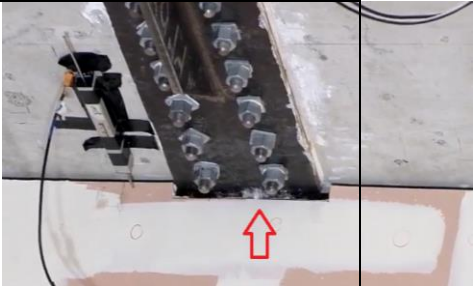
Location	Observation	Photo
<p>Timber wall SW/SE and Timber in-plane wall junctions and where there were nails securing the strap</p>

<p>One loud “popping” sound of brittle damage – damage to crack in the top plates</p>

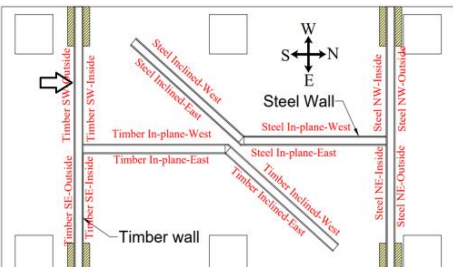
<p>Video link</p> <p>DSCF0059.MOV</p> <p>DSCF4003.MOV</p>
<p>At the top of Timber SW outside wall near end of DHT</p>

<p>Hairline crack</p>

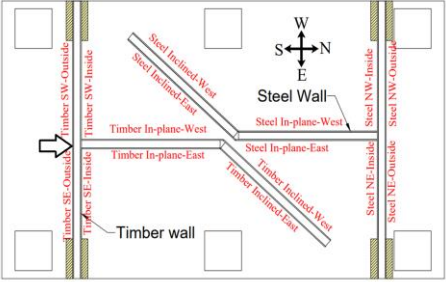
Location	Observation	Photo
<p>Timber wall SW/SE and Timber in-plane wall junctions and where there were nails securing the strap</p>

<p>Three loud “popping” sounds of brittle damage – damage to crack in the top plates</p>	<p>Video link: DSCF0060.MOV DSCF4004.MOV</p>

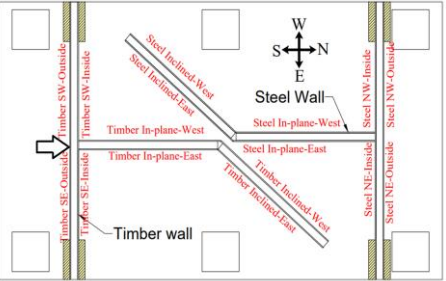
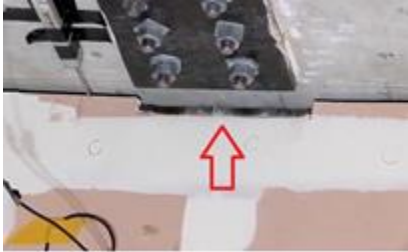
Location	Observation	Photo
<p>Timber wall SW/SE and Timber in-plane wall junctions and where there were nails securing the strap</p>

<p>More loud “popping” sounds of brittle damage – damage to crack in the top plates</p> <p>Video link: DSCF0061.MOV DSCF4005.MOV</p>

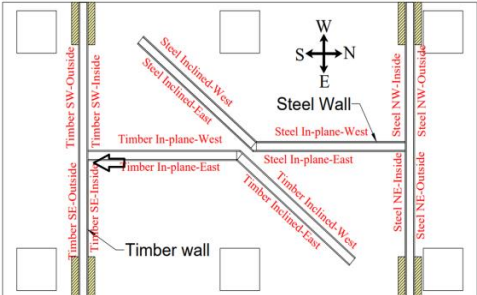
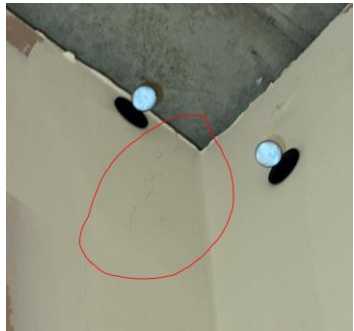
Location	Observation	Photo
<p>At the Timber SE Inside wall at the top of the junction with Timber In-plane East wall</p>

<p>Hairline crack in the plasterboard</p>

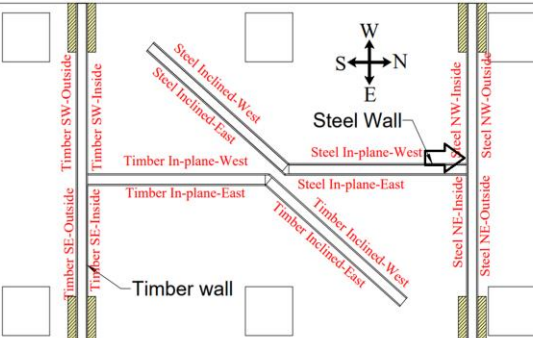
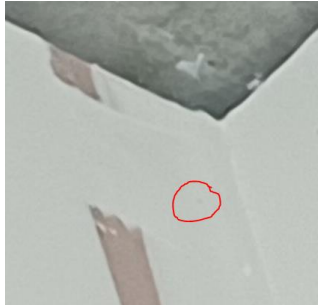
Location	Observation	Photo
<p>Top of Steel NW inside wall at the junction with steel in-plane wall West</p>

<p>Screw impression</p>

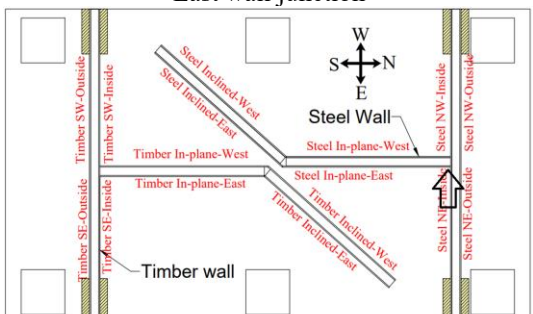
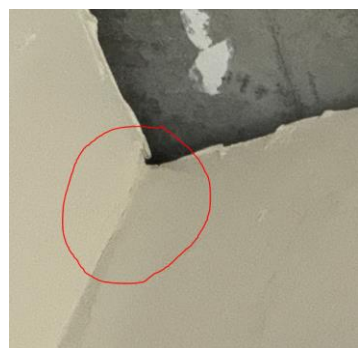
Location	Observation	Photo
<p>At the top of the Steel NE inside and Steel in-plane East wall junction</p>

<p>Tear in the plaster paper</p>

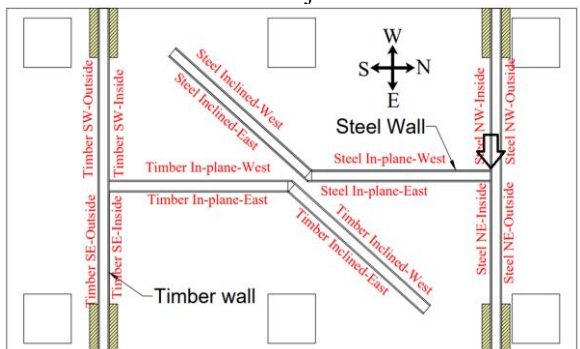
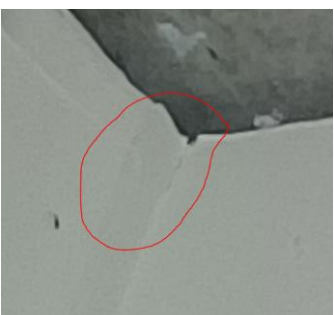
<p>At the top of the Steel NW inside and Steel in-plane West wall junction</p>

<p>Tear in the plaster paper</p>

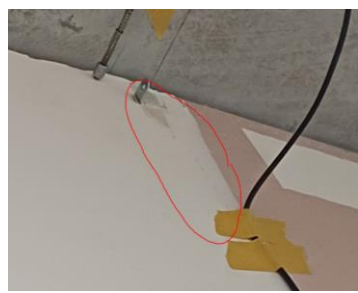
Location	Observation	Photo
<p>At the top Steel wall NW/NE outside at mid-length</p>

<p>Crack in the plasterboard</p>

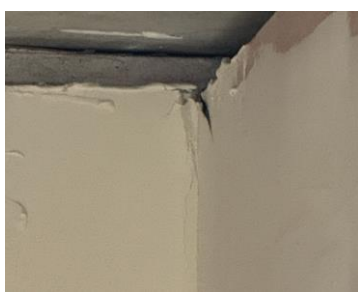
<p>At the top of the Steel NE inside and Steel in-plane East wall junction</p>

<p>Progressive damage: Tear in the plaster paper</p>

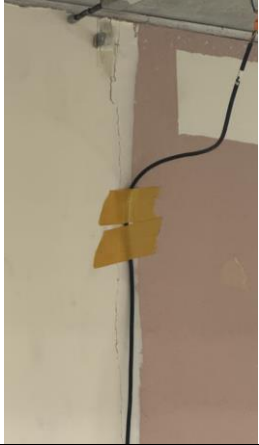
Location	Observation	Photo
<p>Steel wall NW/NE outside at mid-length</p>

<p>Progressive damage: Crack throughout the 1/3rd height of the plasterboard from the top</p>

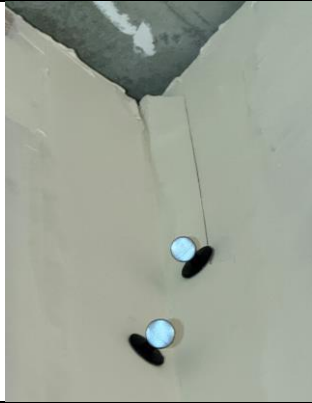
<p>At the top of the Steel NE inside and Steel in-plane East wall junction</p>

<p>Progressive damage: Tear in the plaster paper</p>

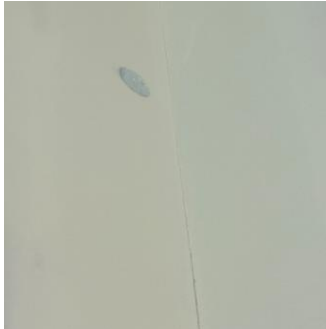
<p>Near the top Steel NE inside and Steel in-plane East wall junction</p>

<p>Cracks are slightly wider than hairline</p>

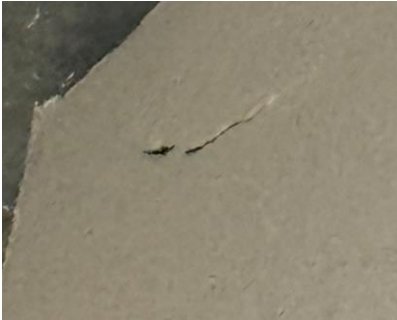
<p>At the top of the Steel inclined east wall at the Steel in-plane East junction</p>

<p>Crack in the plasterboard</p>

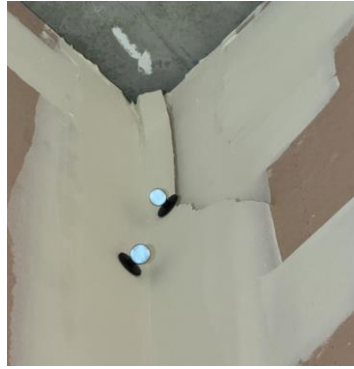
Location	Observation	Photo
<p>At the top of the Steel NE inside and Steel in-plane East wall junction</p>

<p>Progressive damage: Tear in the plaster paper</p>

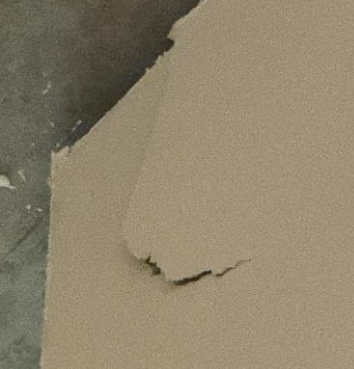
<p>At the top of the Steel inclined east wall at the Steel in-plane East junction</p>

<p>Progressive damage: Crack in the plasterboard</p>

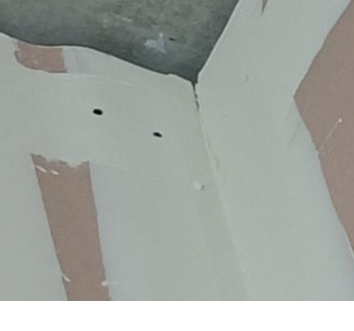
<p>At the top of the Steel NW inside and Steel in-plane West wall junction</p>

<p>Progressive damage: Tear in the plaster paper</p>

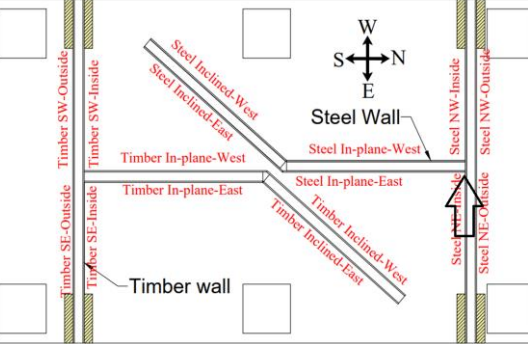
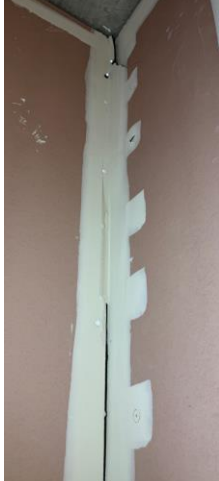
Location	Observation	Photo
<p>At junction Steel NE Inside wall from the Steel in-plane East Wall</p>

<p>Separation of the walls at the junction</p>

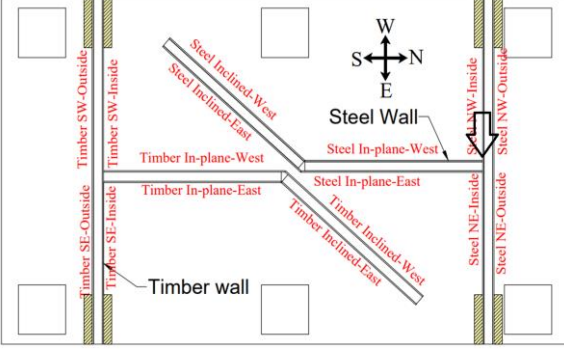
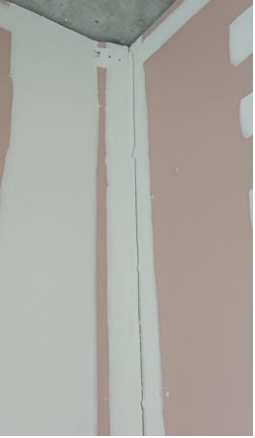
<p>At junction Steel NW Inside wall from the Steel in-plane West Wall</p>

<p>Separation of the walls at the junction</p>

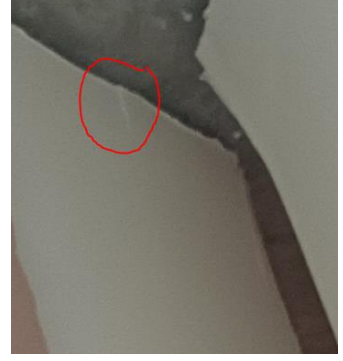
<p>At the top corner of the steel inclined east wall at the steel in-plane east junction</p>

<p>Crack in the plasterboard</p>

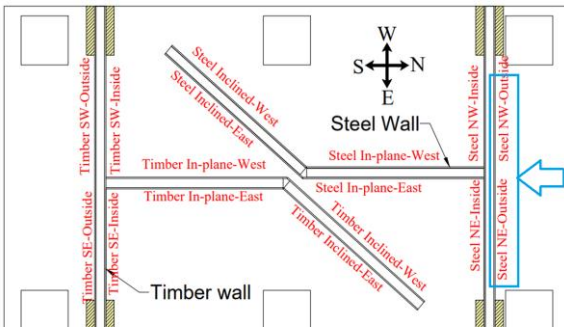
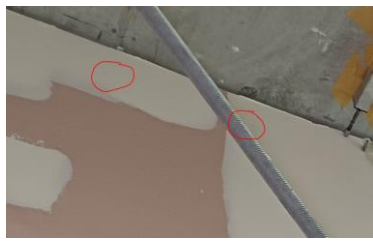
<p>Along the length at top of the Steel NE/NW outside Wall</p>

<p>Screw impressions</p>

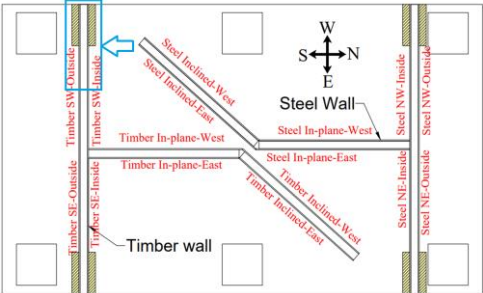
<p style="text-align: center;">Timber SW wall</p>

<p style="text-align: center;">Bending of DHT flanges</p>

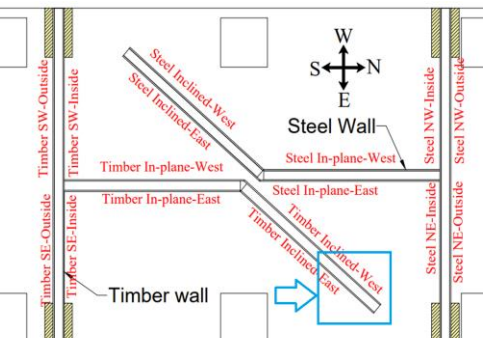
<p style="text-align: center;">Timber Inclined wall</p>

<p style="text-align: center;">Bending of DHT flanges</p>

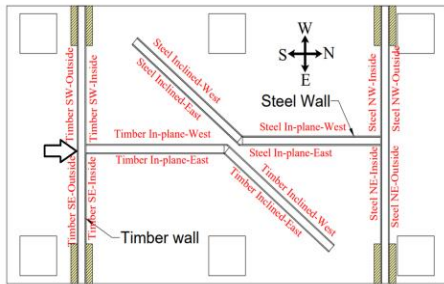
Timber wall SW/SE and Timber in-plane wall junctions and where there were nails securing the strap

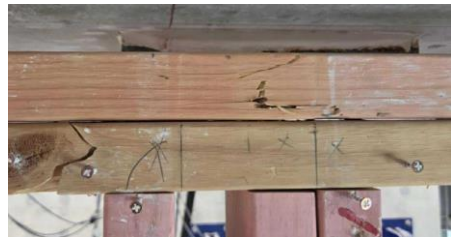
Crack in the top plate

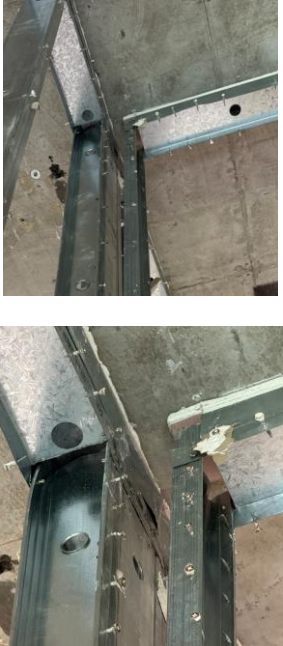
<p data-bbox="858 539 1011 663">Separation of the connected steel Frames (studs)</p>

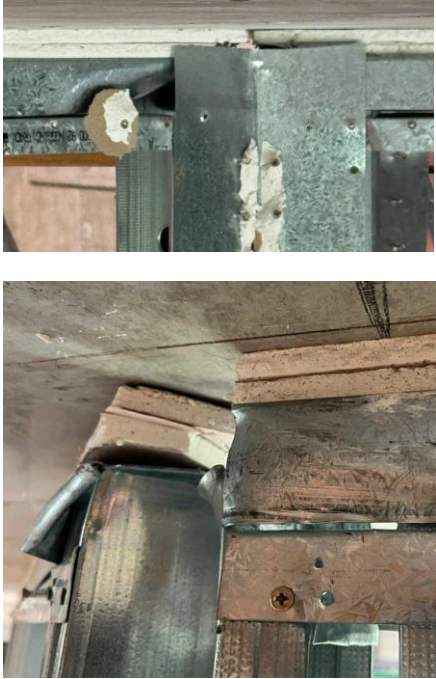
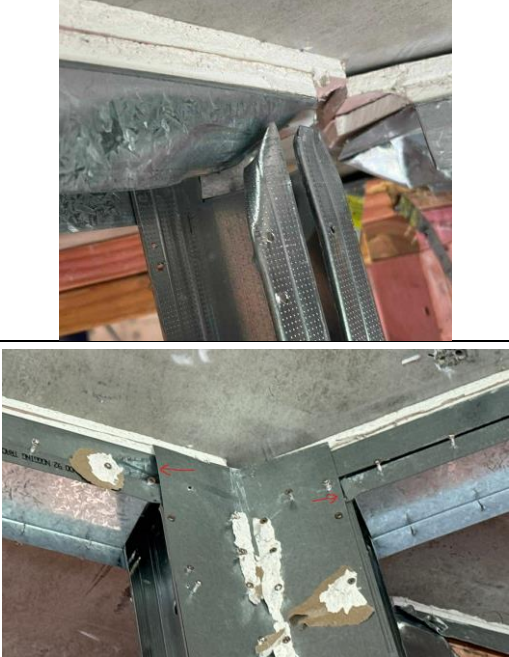
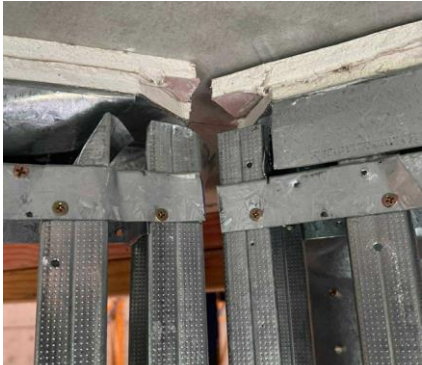
<p data-bbox="261 927 804 987">In steel inclined wall West and Steel in-plane west junction</p>

<p data-bbox="852 1375 1011 1559">Damage to DHT and studs due to interaction with steel angle plate</p>

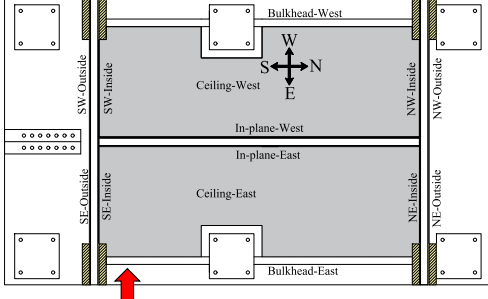
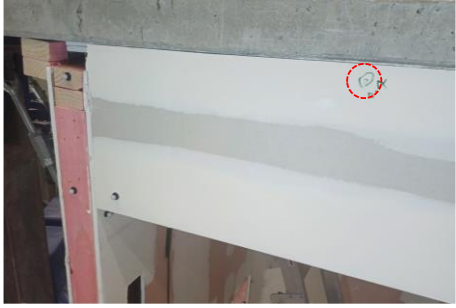
Location	Observation	Photo
<p style="text-align: center;">Southern part of the Eastern Bulkhead</p>

<p style="text-align: center;">Minor Screw Impressions</p>

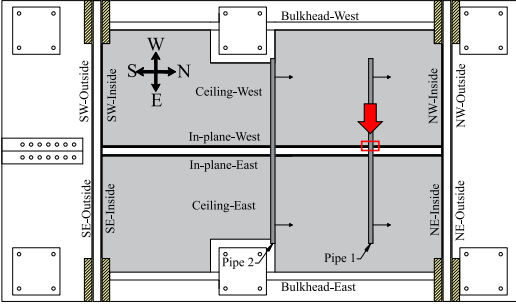
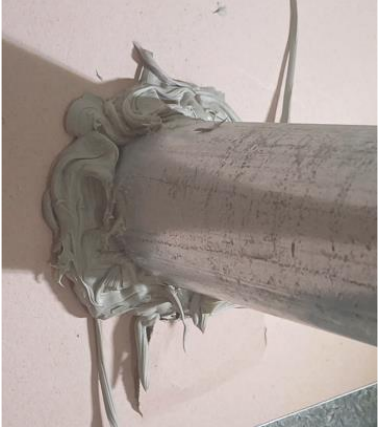
<p style="text-align: center;">Pipe 1-Back Side</p>

<p style="text-align: center;">Minor wear and tear</p>

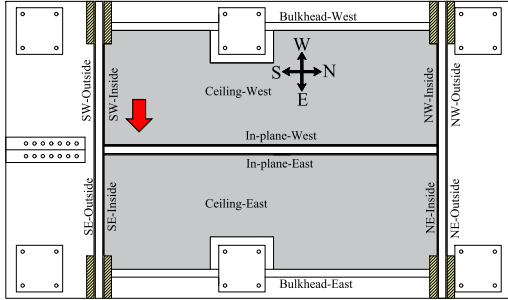
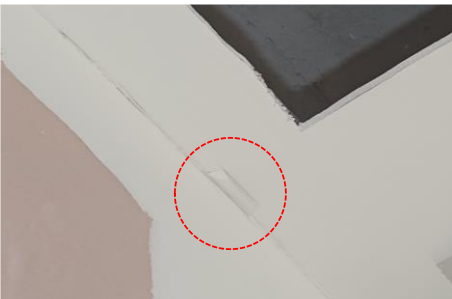
Location	Observation	Photo
<p style="text-align: center;">Corner joint interface between the In-plane-west wall and the west ceiling</p>

<p style="text-align: center;">Minor flaking of the paper tape</p>

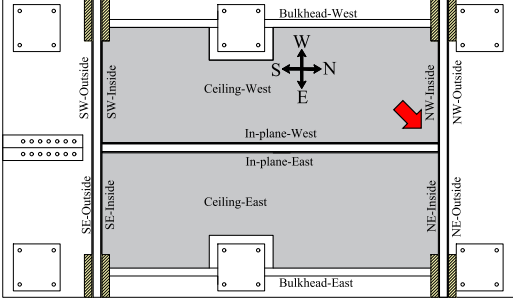
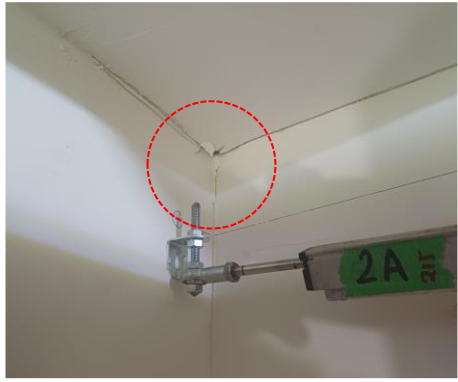
<p>Corner joint interface between the in-plane west wall, the NW inside wall, and the west ceiling</p>

<p>Hairline crack on the plaster</p>

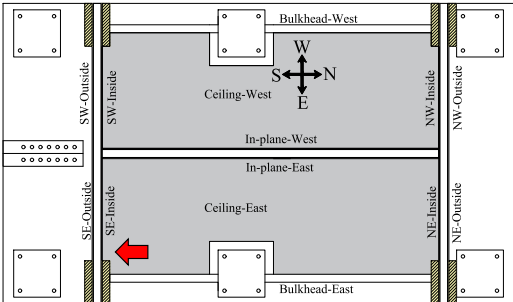
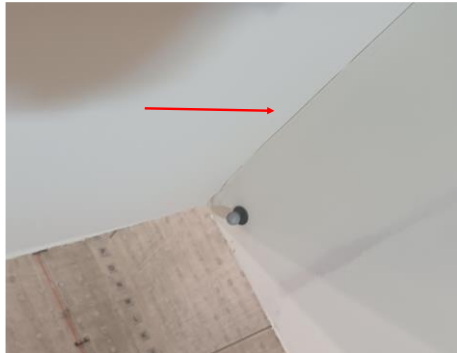
Location	Observation	Photo
<p>Corner joint interface between the SE-Inside wall and the East ceiling</p>

<p>Minor flaking of the paper tape</p>

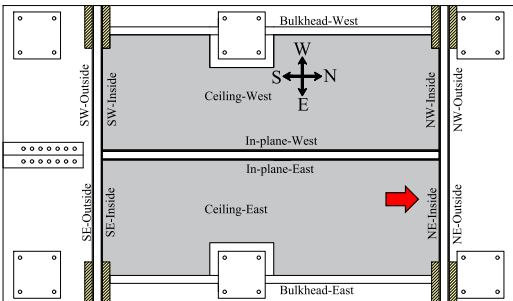
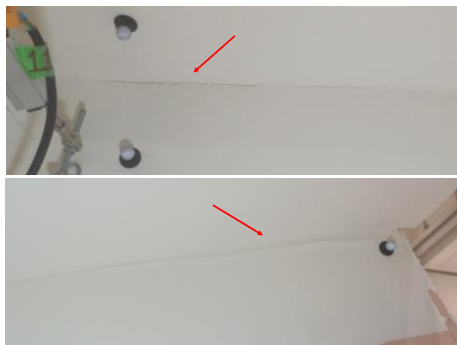
<p>Corner joint interface between the NE-Inside wall and the East ceiling</p>

<p>Minor Crack and Flaking of the Paper Tape.</p>

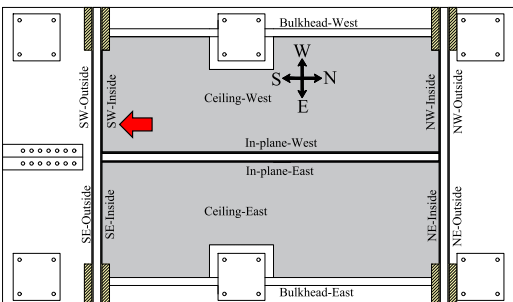
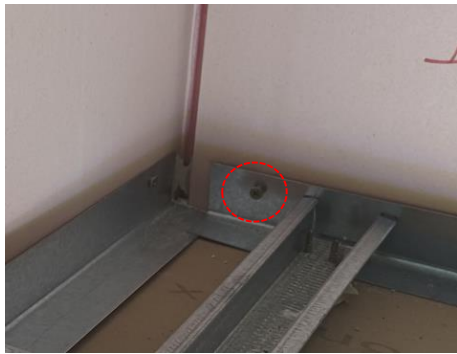
<p>Inside the plenum — joint between the SW-inside wall and the west ceiling</p>

<p>Screw Pulling in the Wall Track</p>

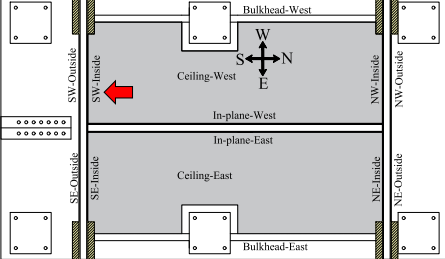
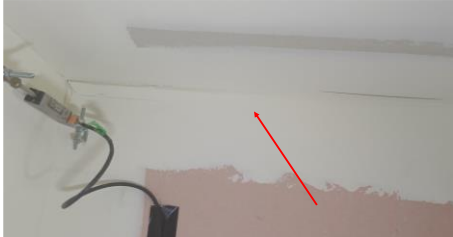
<p>Corner joint interface between the SW- Inside wall and the west ceiling</p>

<p>Flaking of the paper tape</p>

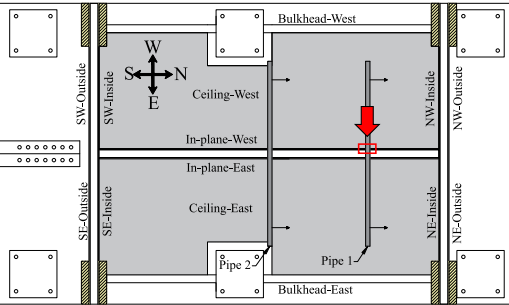
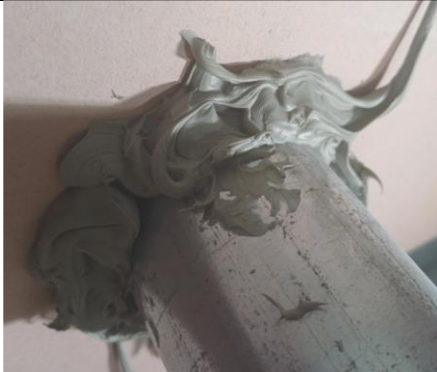
<p>Pipe 1-Back side</p>

<p>Minor wear and tear</p>

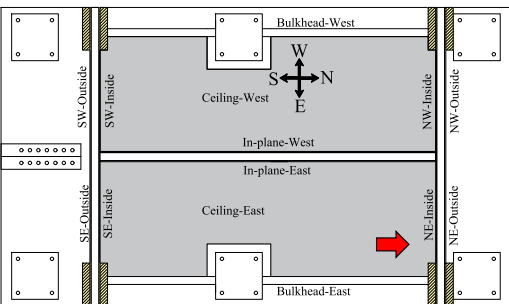
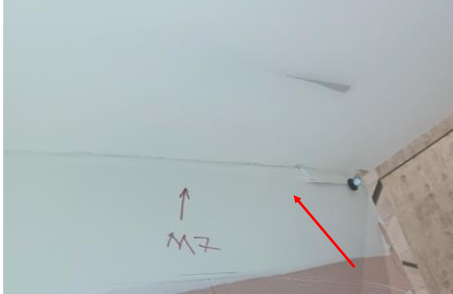
Location	Observation	Photo
<p>Corner joint interface between the NE- Inside wall and the east ceiling</p>

<p>Flaking of the paper tape</p>

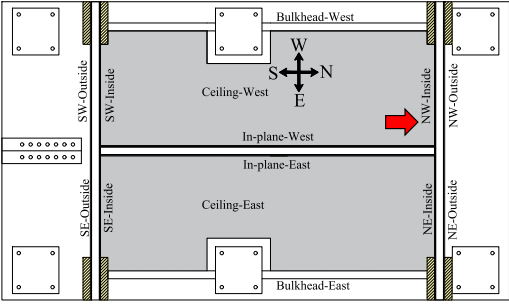
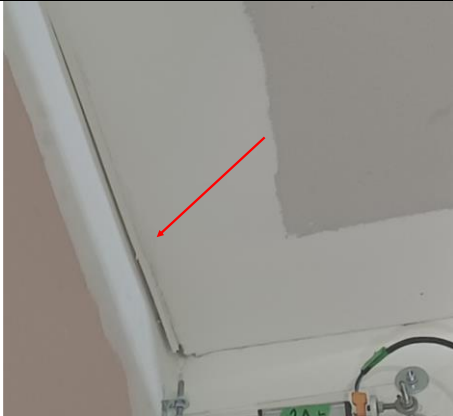
<p>Corner joint interface between the NW- Inside wall and the west ceiling</p>

<p>Separation of the Corner Joint Paper Tape</p>

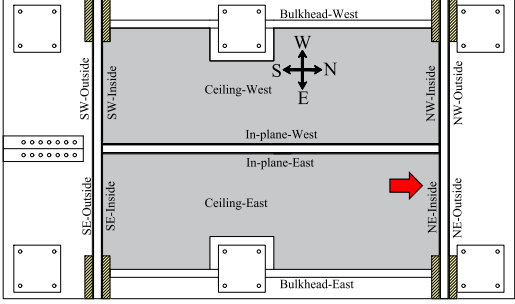
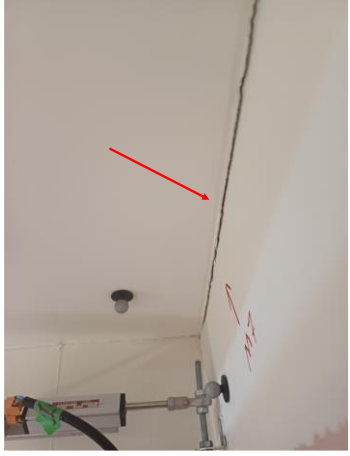
Location	Observation	Photo
<p>Corner joint interface between the NE-Inside wall and the east ceiling</p>

<p>Separation of the Corner Joint Paper Tape</p>

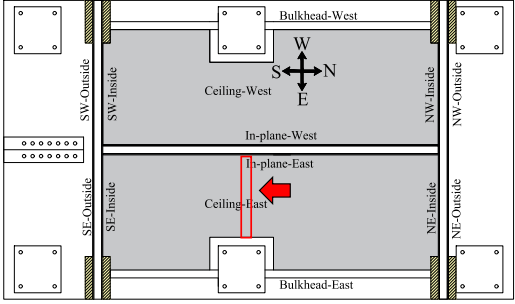
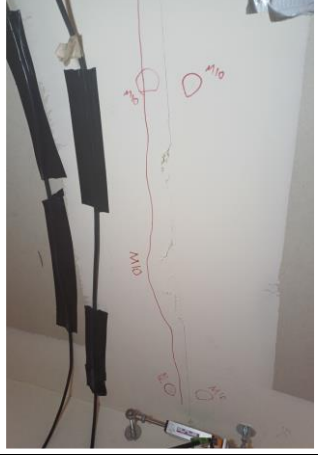
<p>Middle of the East Ceiling</p>

<p>Cracks on the Plaster and Screw Impressions</p>

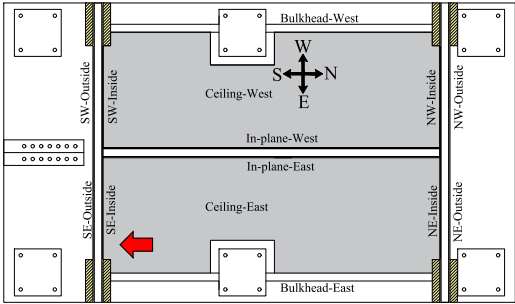
<p>Corner joint interface between the SE-Inside wall and the east ceiling</p>

<p>Cracks on the Plaster and Flaking of the paper tape</p>

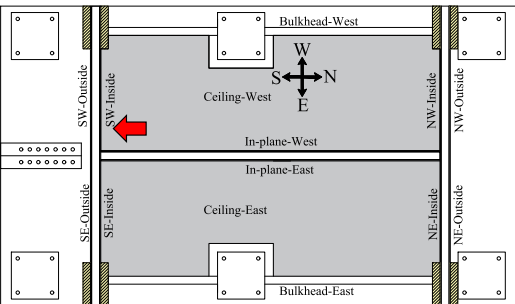
<p>Corner joint interface between the SW-Inside wall and the west ceiling</p>

<p>Separation of the Corner Joint Paper Tape</p>

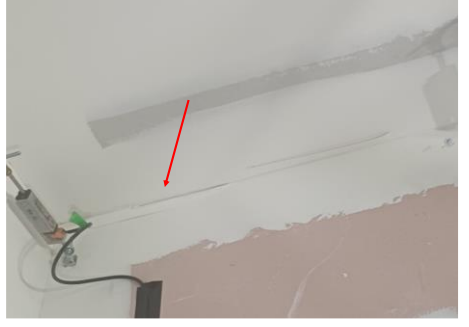
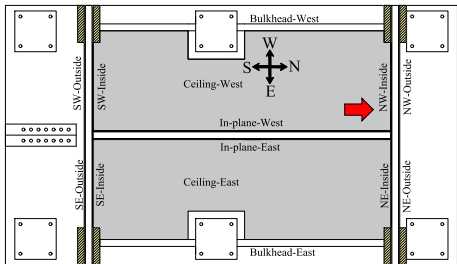
<p>Corner joint interface between the NW-Inside wall and the west ceiling</p>

<p>Separation of the Corner Joint Paper Tape</p>

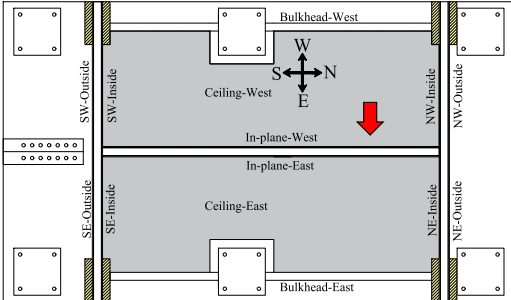
<p>Corner joint interface between the In-plane west wall and the west ceiling</p>

<p>Crack in the Plaster</p>

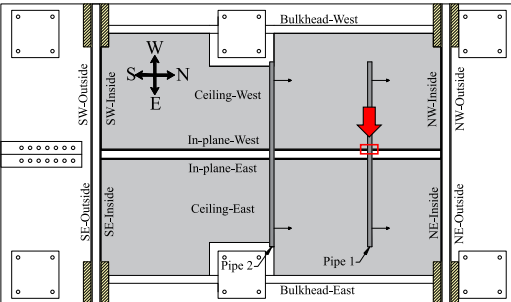
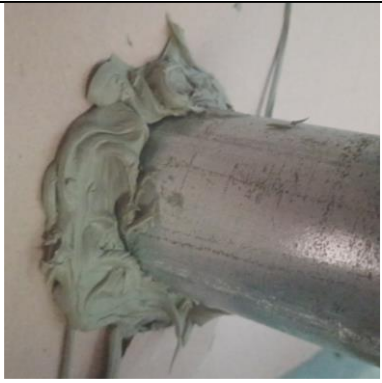
<p>Pipe1-Back Side</p>

<p>Minor separation (unlikely to compromise fire-rating performance)</p>

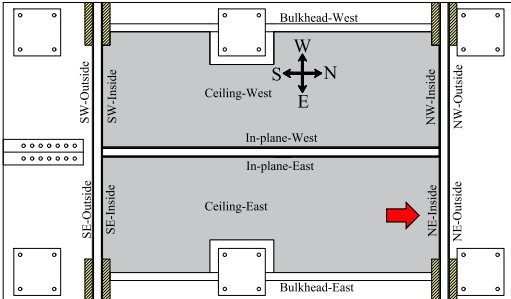
Location	Observation	Photo
<p>Corner joint interface between the NE-Inside wall and the east ceiling</p>

<p>Separation of the Corner Joint Paper Tape</p>

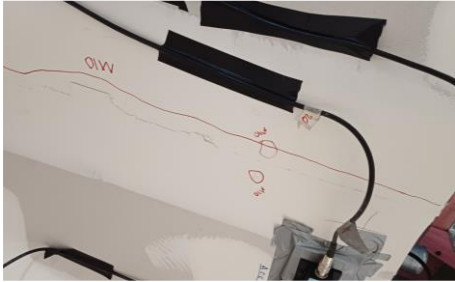
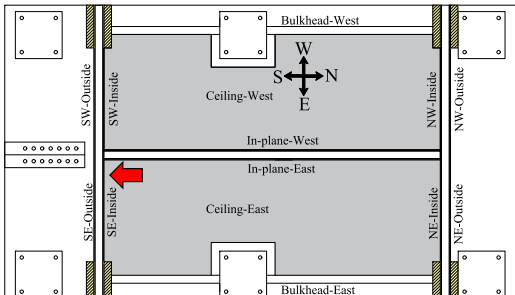
<p>Top corner of the SE inside wall near its corner joint with the in-plane east wall and the east ceiling</p>

<p>Crack in the plasterboard</p>

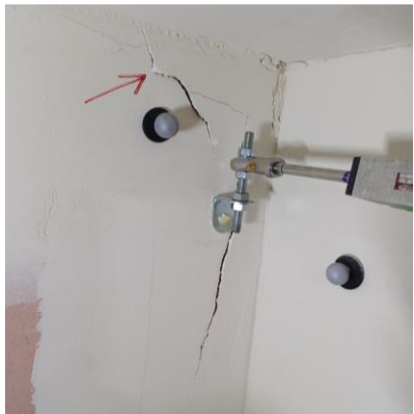
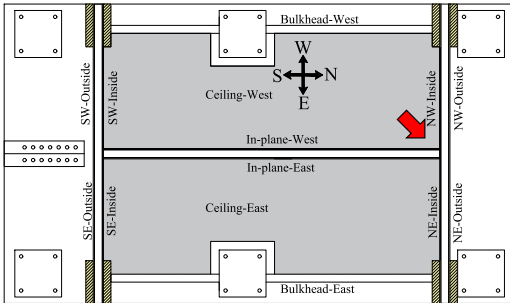
Top corner of the NW inside wall near its corner joint with the in-plane west wall and the west ceiling

Crack in the plasterboard

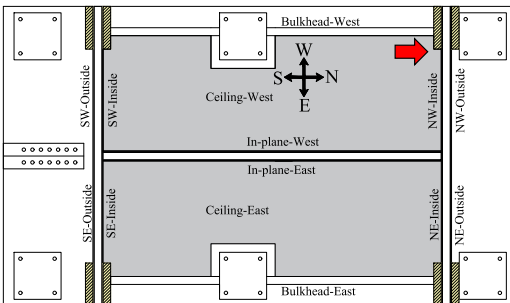
Top corner of the NW inside wall near its corner joint with the west bulkhead and the west ceiling

Crack in the plasterboard

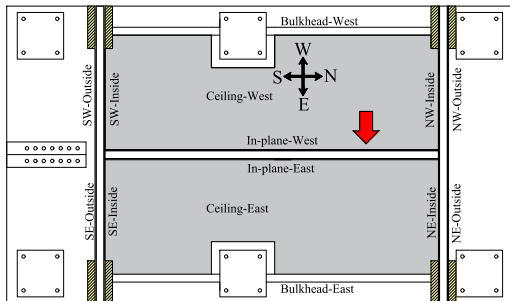
Corner joint interface between the In-plane west wall and the west ceiling

Split in the corner joint paper tape

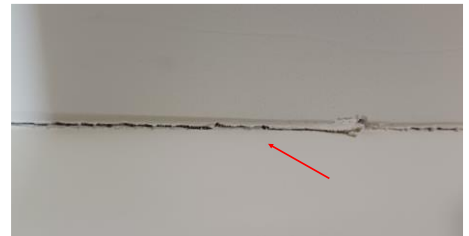
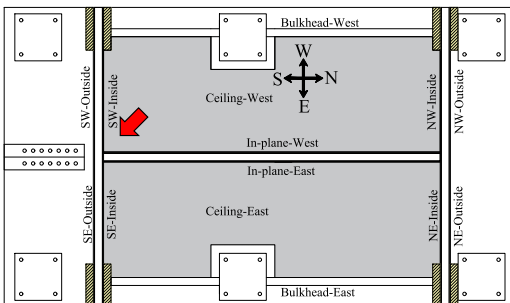
Top corner of the SW-Inside wall near its corner joint with the in-plane west wall and the west ceiling

Crack in the plasterboard

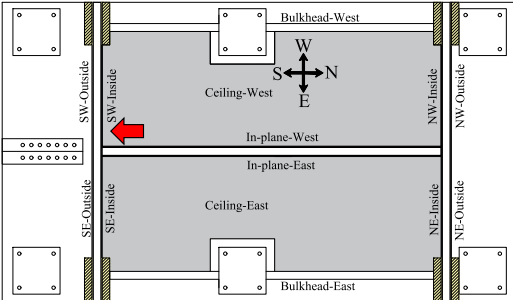
<p>Inside the plenum — joint between the SW-inside wall and the west ceiling</p>

<p>Screw pulling and detachment of the end part of wall track</p>

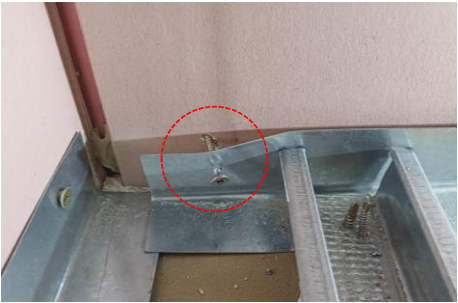
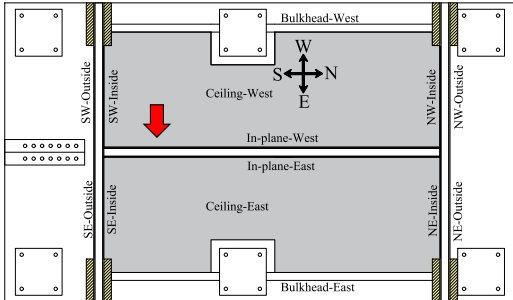
<p>Inside the plenum — joint between the SW-inside wall and the west ceiling</p>

<p>Screws pulled from the wall track</p>

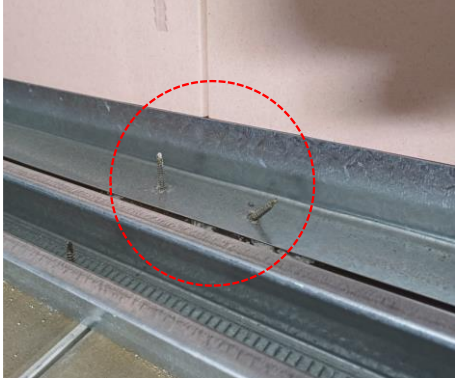
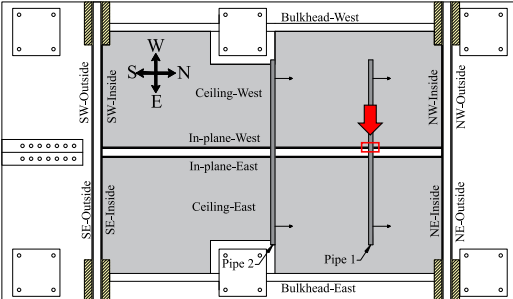
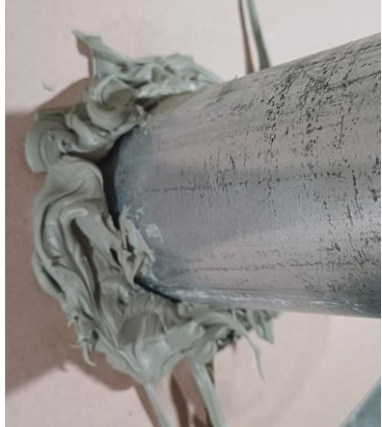
<p>Pipe 1-Back Side</p>

<p>Moderate Separation (Fire-Rating Impact Uncertain)</p>

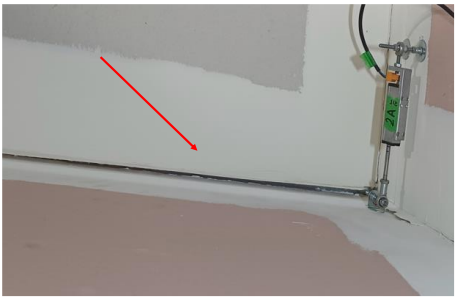
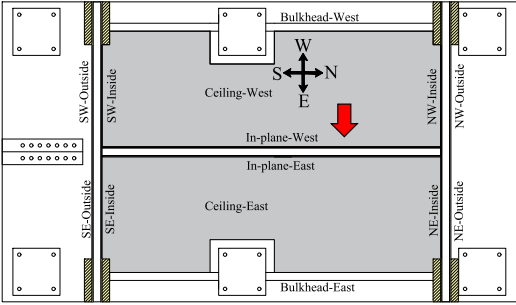
<p>Corner joint interface between the In-plane west wall and the west ceiling</p>

<p>Split in the corner joint paper tape</p>

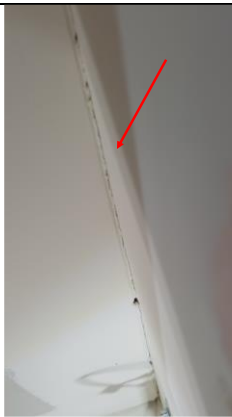
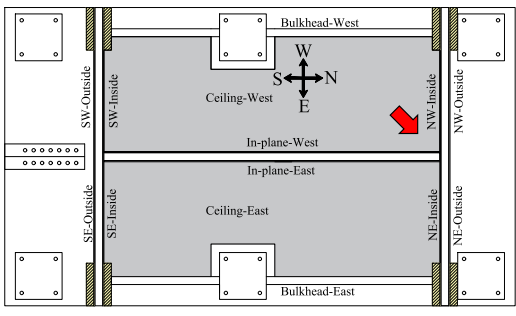
<p>Top corner of the NW inside wall near its corner joint with the in-plane west wall</p>

<p>Crack in the plasterboard</p>

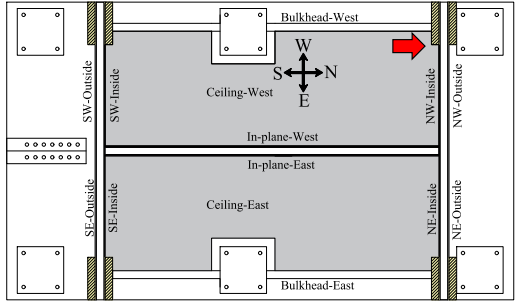
<p>Top corner of the NW inside wall near its corner joint with the west bulkhead and the west ceiling</p>

<p>Crack in the plasterboard</p>

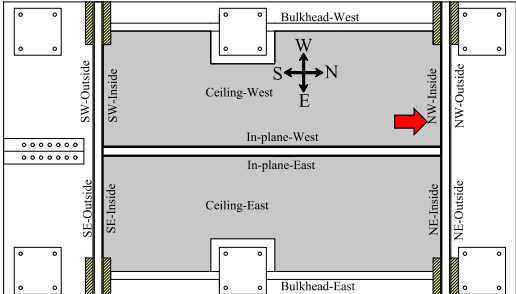
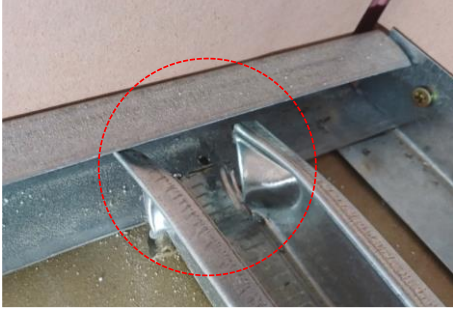
<p>Inside the plenum — joint between the NW-inside wall and the west ceiling</p>

<p>Crumpling at the end of the furring channel (due to inappropriate connection to the wall track)</p>

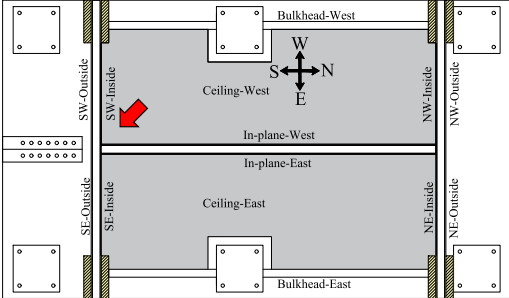
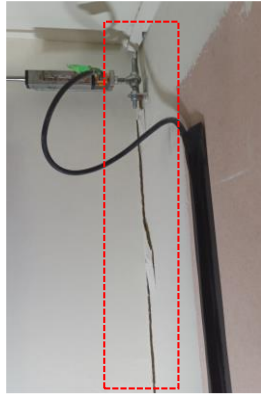
<p>Top corner of the SW-Inside wall near its corner joint with the in-plane west wall and the west ceiling</p>

<p>Crack in the plasterboard</p>

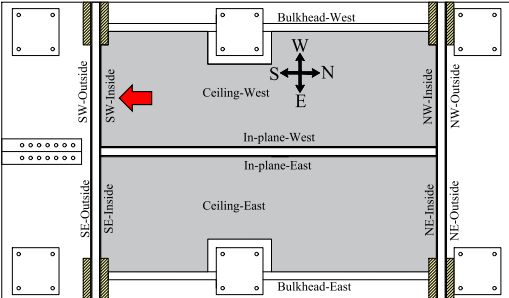
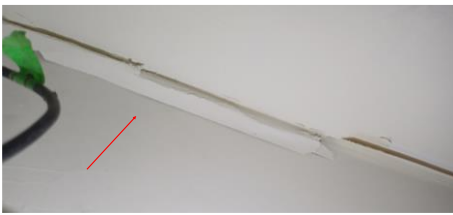
<p>Corner joint interface between the SW-Inside wall and the west ceiling</p>

<p>Separation in the Corner Joint Paper Tape</p>

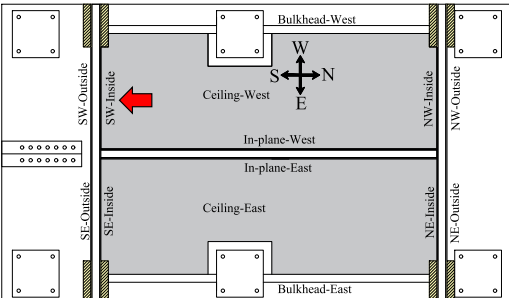
<p>Inside the plenum — joint between the SW-inside wall and the west ceiling</p>

<p>Screw pulling and detachment of the wall track in some parts</p>

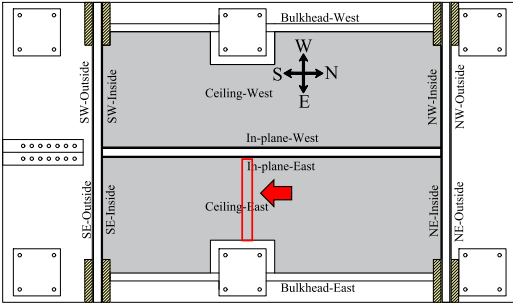
<p style="text-align: center;">Middle of the East Ceiling</p>

<p>Cracks on the Plaster and Screw Impressions</p>

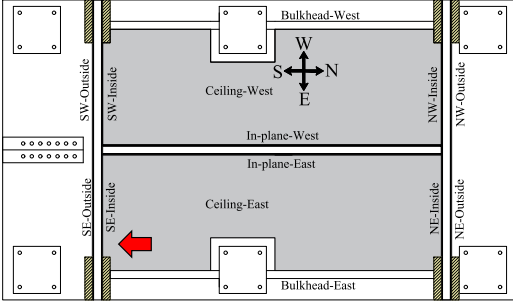
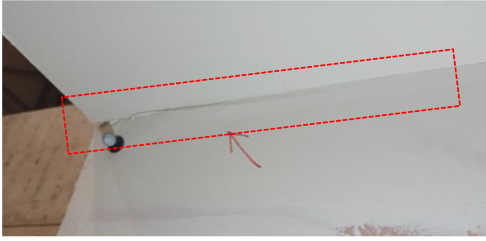
<p style="text-align: center;">Corner joint interface between the SE-Inside wall and the east ceiling</p>

<p>Flacking of the corner joint paper tape</p>
