NHC PROJECT # 4454: SEISMICALLY RESILIENT PARTITION

WALL DESIGN AND TESTING

Final Report

Submitted to: Natural Hazards Commission Toka Tū Ake

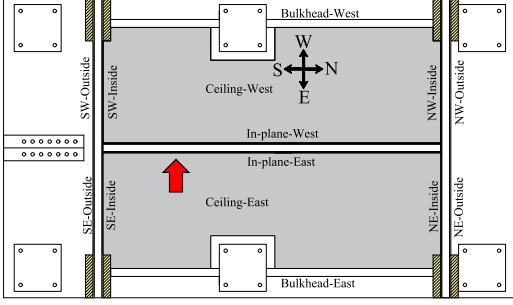
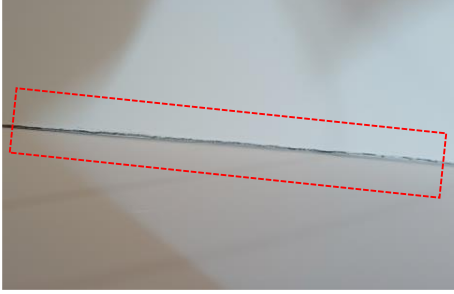
<p style="text-align: center;">Corner joint interface between the In-plane east wall and the east ceiling</p>

<p>Split in the corner joint paper tape</p>

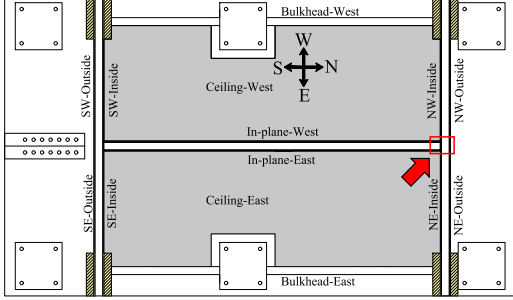
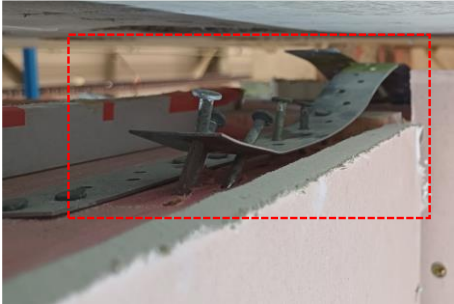
<p style="text-align: center;">Top of the T-junction between the in-plane wall and the Northern wall</p>

<p>Partial detachment of the tie strap connecting two walls to each other at the T-junction due to pulled nails</p>

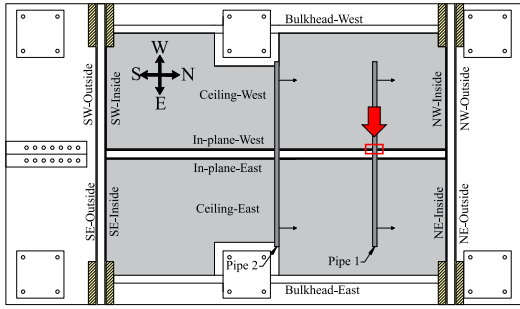
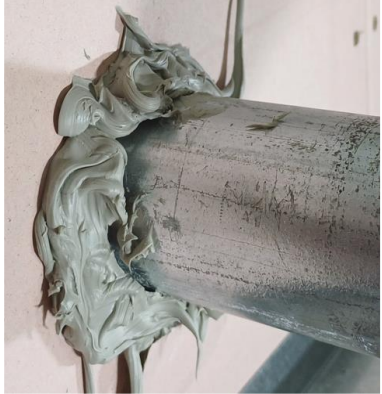
<p style="text-align: center;">Pipe1-Back Side</p>

<p style="text-align: center;">Visible Separation (Likely to Compromise Fire-Rating Performance)</p>

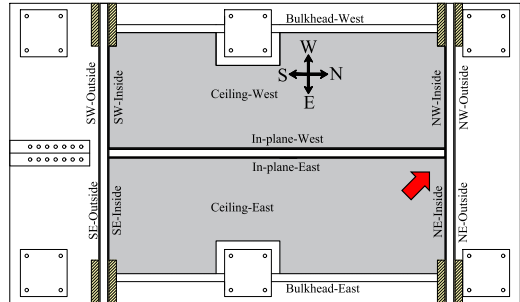
Location	Observation	Photo
<p style="text-align: center;">Top corner of the NE-inside wall near its corner joint with the in-plane East wall</p>

<p style="text-align: center;">Major Crack in the plasterboard</p>

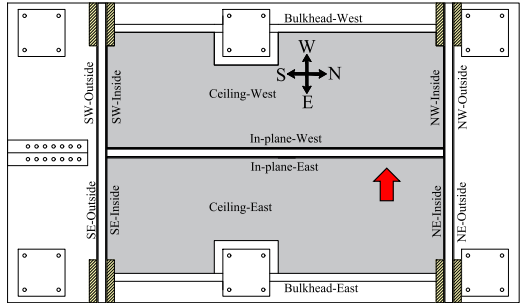
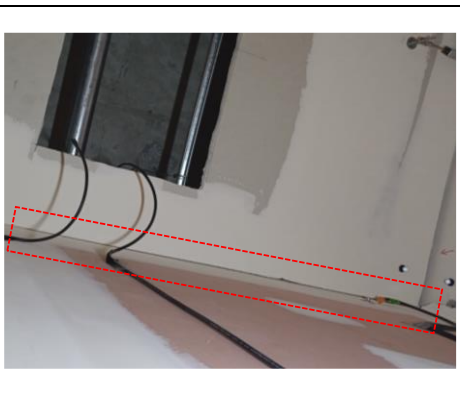
<p style="text-align: center;">Corner joint interface between the In-plane east wall and the east ceiling</p>

<p style="text-align: center;">Split in the corner joint paper tape</p>

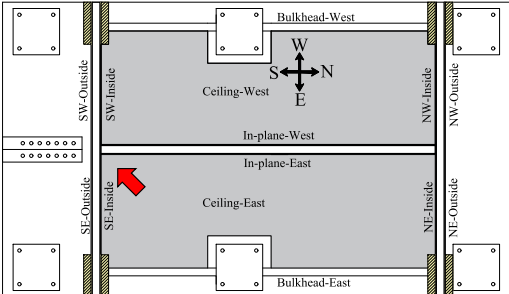
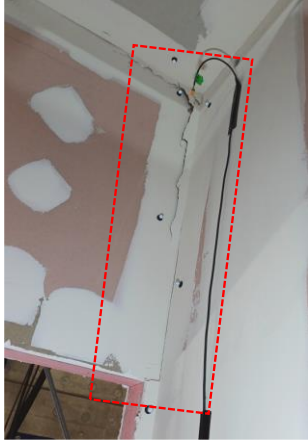
<p>Top corner of the SE-Inside wall near its corner joint with the in-plane East wall</p>

<p>Major Crack in the plasterboard</p>

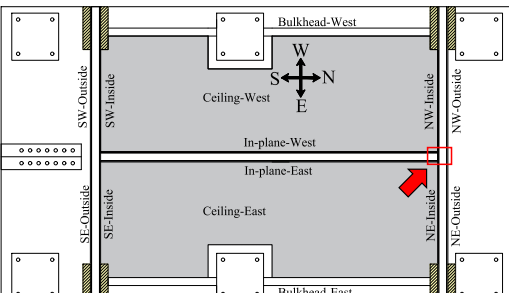
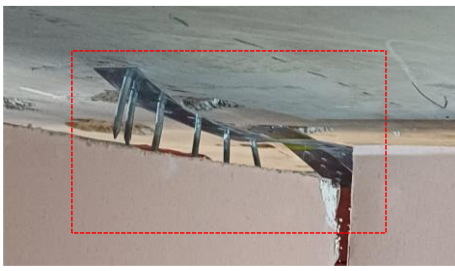
<p>Top of the T-junction between the in-plane wall and the Northern wall</p>

<p>Detachment of the tie strap connecting two walls to each other at the T-junction</p>

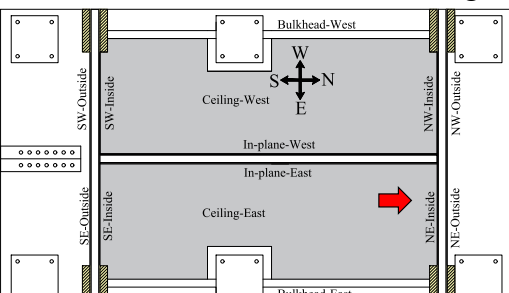
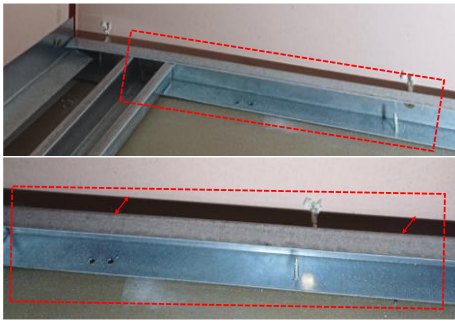
<p>Inside the plenum — joint between the NE-inside wall and the east ceiling</p>

<p>Screw pull-out and detachment of the wall track from the wall plasterboard</p>

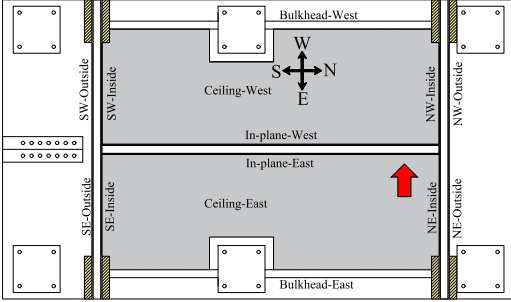
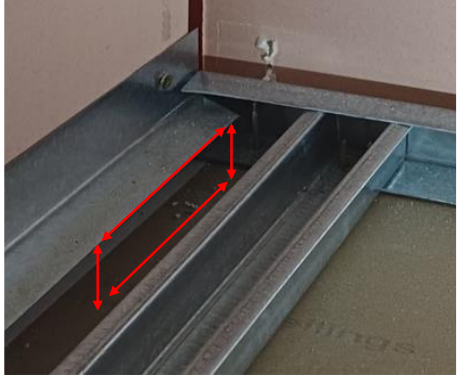
<p>Inside the plenum — joint between the In-plane east wall and the east ceiling</p>

<p>Separation between the wall track and ceiling plasterboard</p>

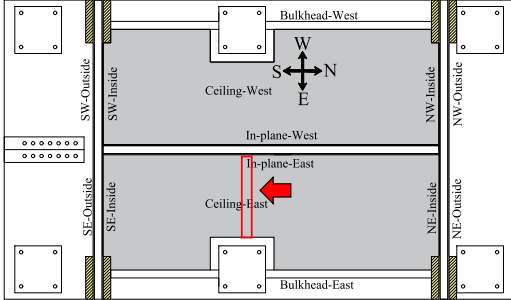
<p>Middle of the East Ceiling</p>

<p>Cracks on the Plaster and Screw Impressions</p>

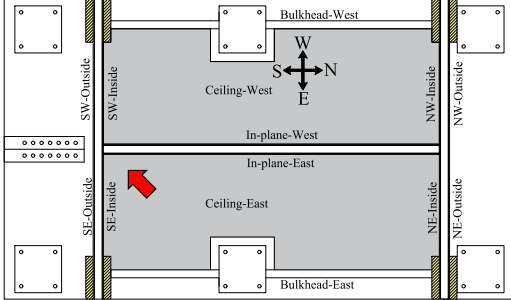
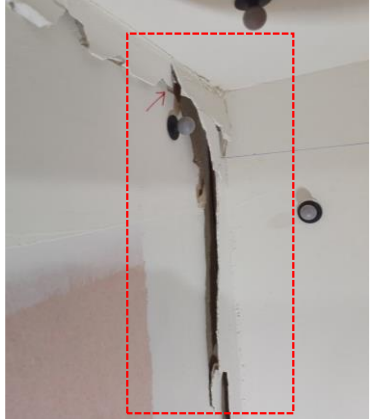
<p>Top corner of the SE-Inside wall near its corner joint with the in-plane East wall</p>

<p>Major Crack in the plasterboard</p>

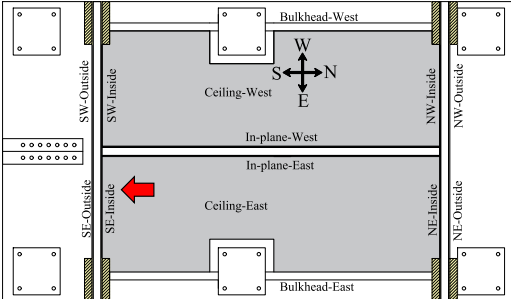
<p>Inside the plenum — joint between the SE-inside wall and the east ceiling</p>

<p>Screw pulling and minor deformation in the wall track</p>

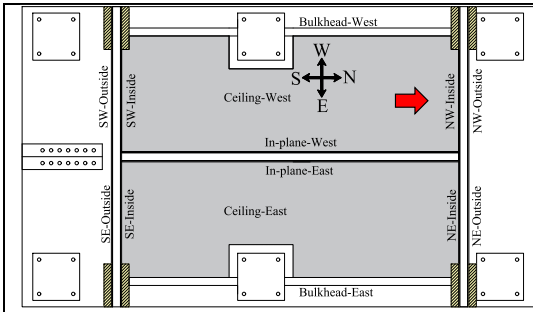
<p>Corner joint interface between the NW-Inside wall and the west ceiling</p>	<p>Separation at the corner joint between the ceiling and wall</p>

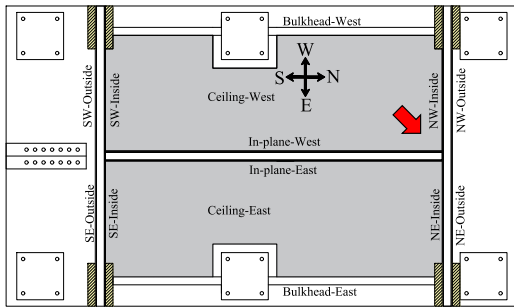
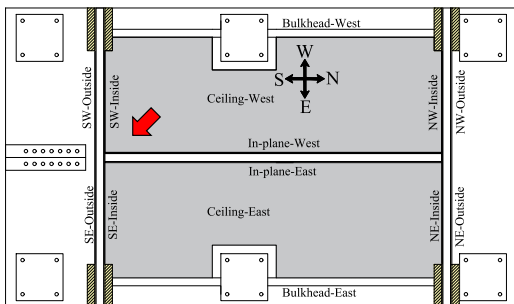
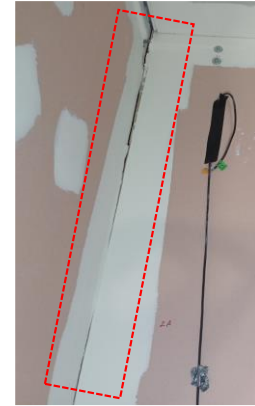
Corner of the NW-inside wall near the joint with the in-plane west wall (from top to middle)

Corner of the SW-inside wall near the joint with the in-plane west wall (from top to middle)

Major Crack in the plasterboard

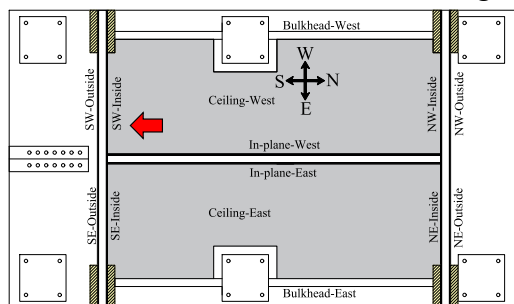
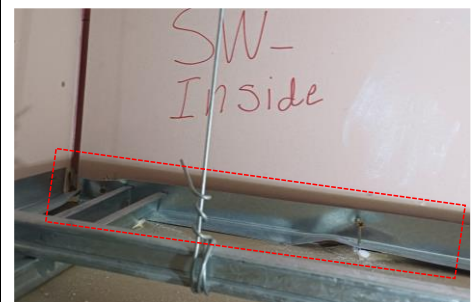
Inside the plenum — joint between the SW-inside wall and the west ceiling

Screw pull-out, detachment and crumpling of the wall track, and localized crushing of the ceiling plasterboard

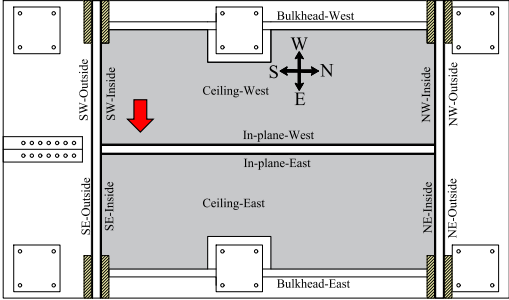
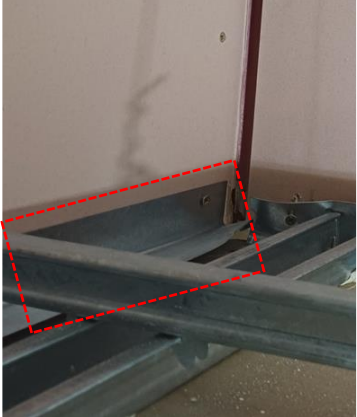
<p>Inside the plenum — joint between the In-plane west wall and the west ceiling</p>

<p>Separation between the wall track and ceiling plasterboard, some deformation in the wall track</p>

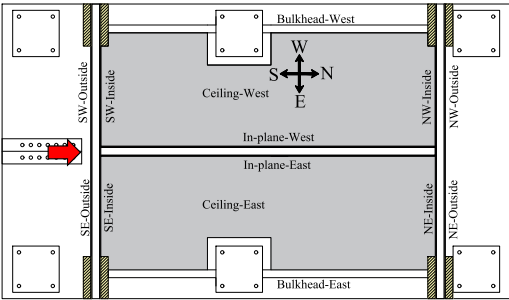
<p>Middle of the southern wall (outside), from top to mid-height</p>

<p>Crack in the plasterboard</p>

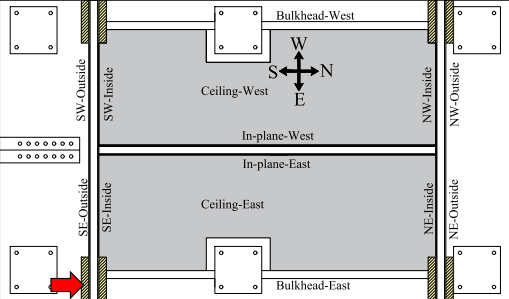
<p>Top corner of the SE-Inside wall near the restraining timbers</p>

<p>Crack in the plasterboard</p>

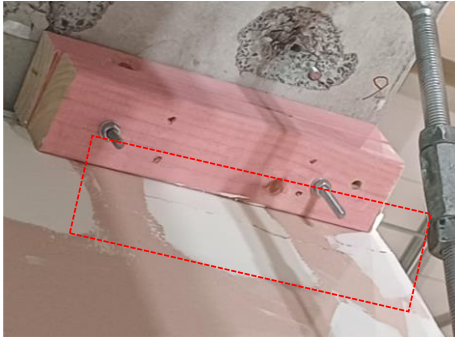
<p>Pipe1-Back Side</p>

<p>Visible Separation (Likely to Compromise Fire-Rating Performance)</p>

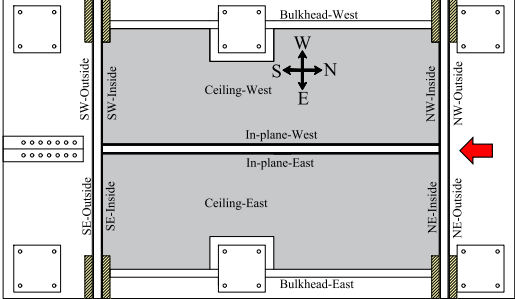
Location	Observation	Photo
<p>Middle of the northern wall (outside), from top to mid-height</p>

<p>Crack in the plasterboard</p>

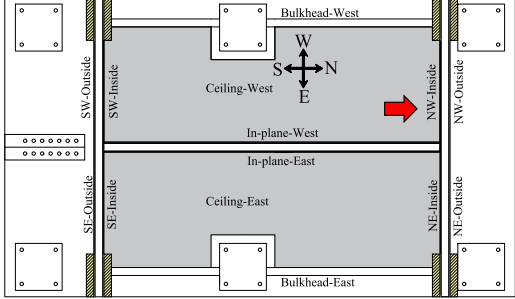
<p>Corner joint interface between the NW-Inside wall and the west ceiling</p>

<p>Separation at the corner joint between the ceiling and wall</p>

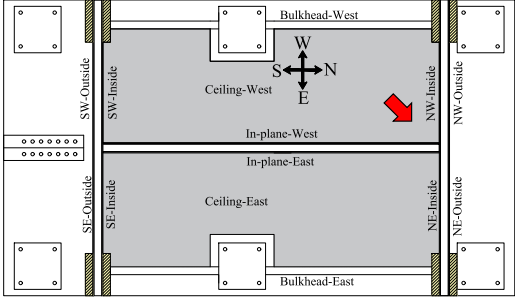
<p>Corner of the NW-inside wall near the joint with the in-plane west wall (from top to middle)</p>

<p>Major Crack in the plasterboard</p>

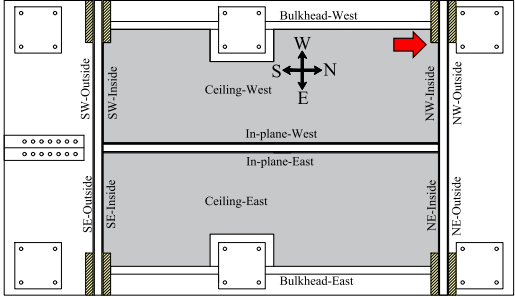
<p>Top corner of the NW inside wall near its corner joint with the west bulkhead and the west ceiling</p>

<p>Crack in the plasterboard</p>

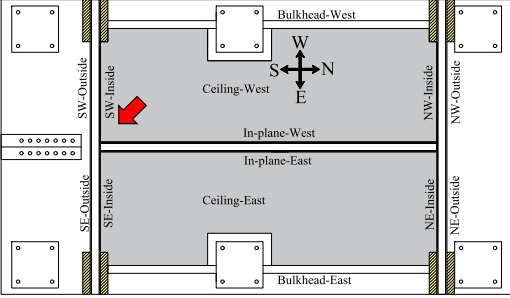
<p>Corner of the SW-inside wall near the joint with the in-plane west wall (from top to middle)</p>

<p>Major Crack in the plasterboard</p>

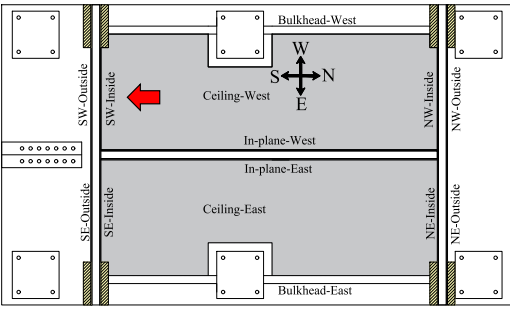
<p>Corner joint interface between the SW-Inside wall and the west ceiling</p>

<p>Separation at the corner joint between the ceiling and wall</p>

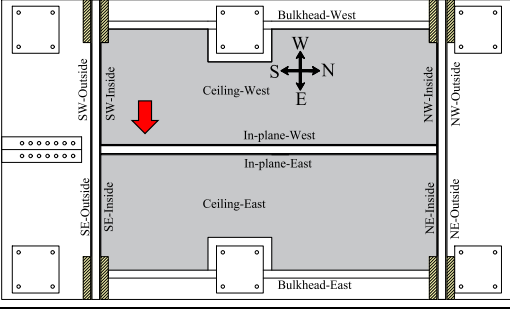
<p>Corner joint interface between the In-plane west wall and the west ceiling</p>

<p>Split in the corner joint paper tape</p>

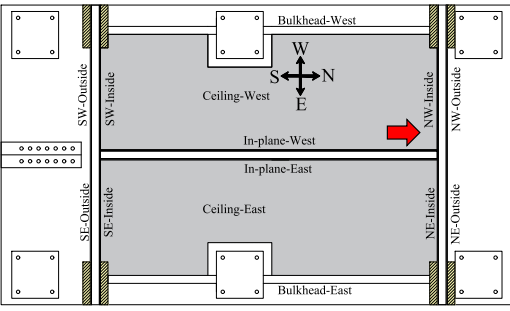
<p>Inside the plenum — joint between the NW-inside wall and the west ceiling</p>

<p>Crumpling at the end of the furring channel (due to inappropriate connection to the wall track)</p>

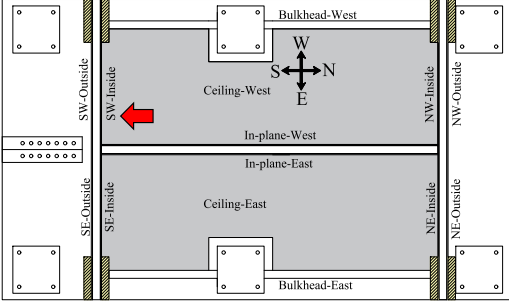
<p>Inside the plenum — joint between the SW-inside wall and the west ceiling</p>

<p>Screw pull-out, detachment and crumpling of the wall track, and localized crushing of the ceiling plasterboard</p>

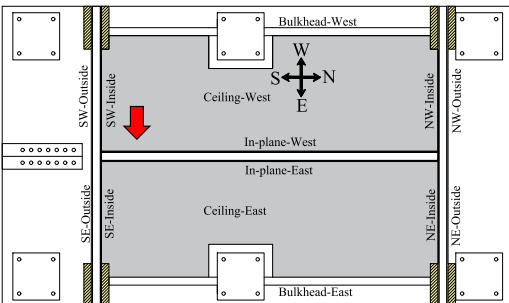
<p>Inside the plenum — joint between the In-plane west wall and the west ceiling</p>

<p>Separation between the wall track and ceiling plasterboard, some deformation in the wall track</p>

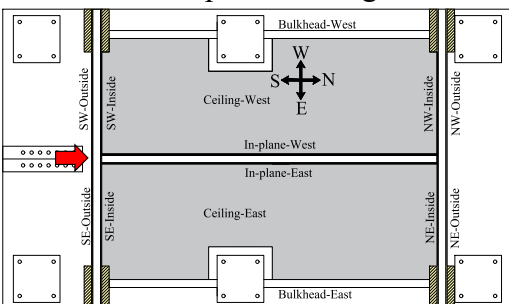
<p>Middle of the southern wall (outside), from top to mid-height</p>

<p>Crack in the plasterboard</p>

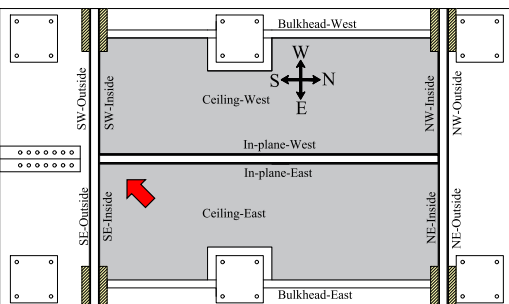
<p>Top corner of the SE-Inside wall near its corner joint with the in-plane East wall</p>

<p>Crack in the plasterboard</p>

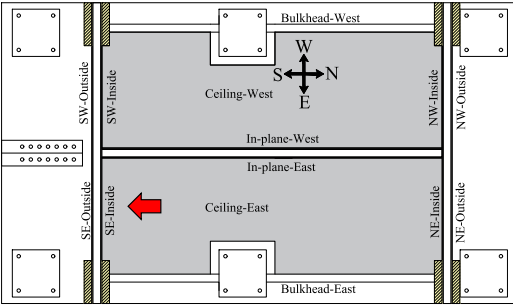
<p>Corner joint interface between the SE-Inside wall and the east ceiling</p>

<p>Separation at the corner joint between the ceiling and wall</p>

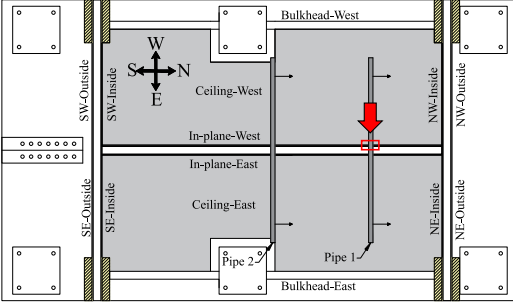
<p>Pipe 1-Back Side</p>

<p>Visible Separation (Likely to Compromise Fire-Rating Performance)</p>

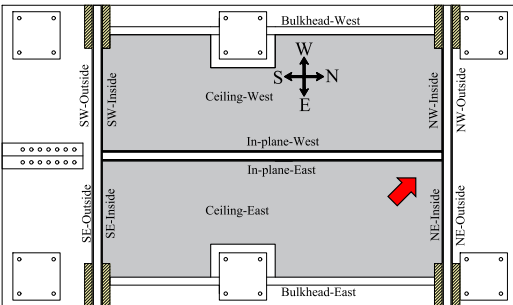
Location	Observation	Photo
<p>Top corner of the NE-inside wall near its corner joint with the in-plane East wall</p>

<p>Major Crack in the plasterboard</p>

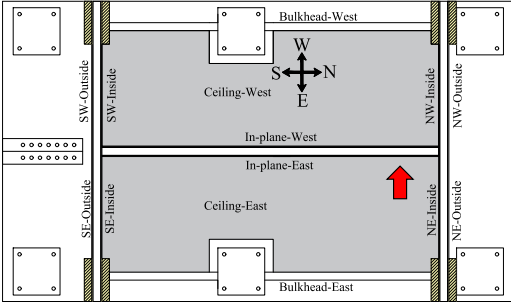
<p>Corner joint interface between the In-plane east wall and the east ceiling</p>

<p>Separation at the corner joint between the ceiling and wall</p>

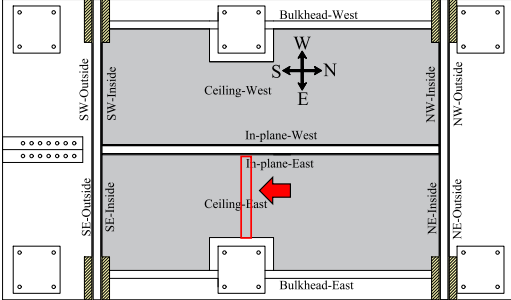
<p>Middle of the East Ceiling</p>

<p>Cracks on the Plaster and Screw Impressions</p>

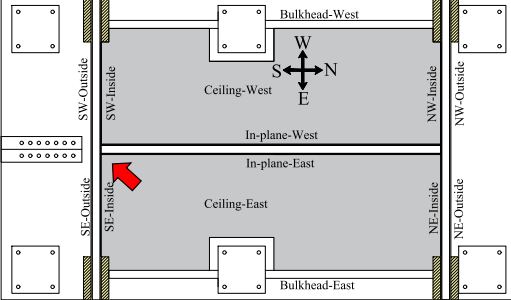
<p>Top corner of the SE-Inside wall near its corner joint with the in-plane East wall</p>

<p>Major cracking and crushing in the plasterboard</p>

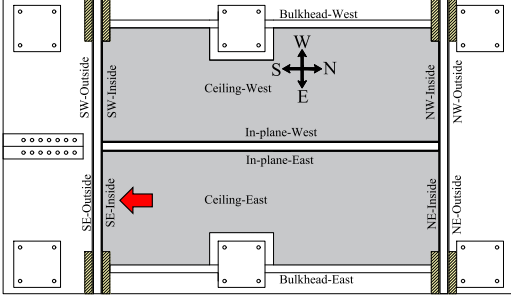
<p>Corner joint interface between the SE-Inside wall and the east ceiling</p>

<p>Separation at the corner joint between the ceiling and wall</p>

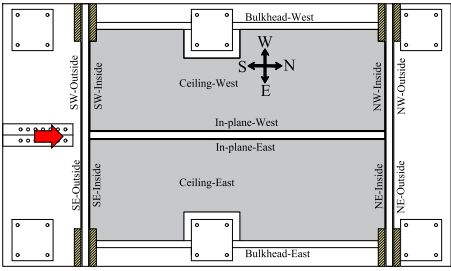
<p>Middle of the southern wall (outside), from top to mid-height</p>

<p>Crack in the plasterboard</p>

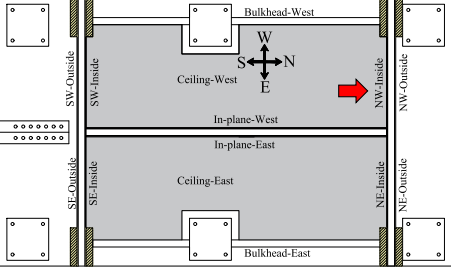
<p>Corner joint interface between the NW- Inside wall and the west ceiling</p>

<p>Separation at the corner joint between the ceiling and wall</p>

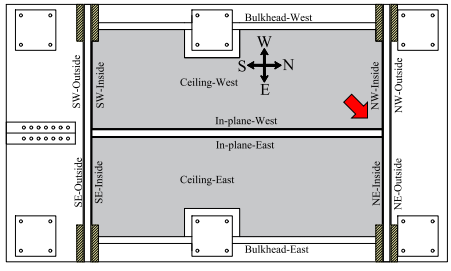
<p>Corner of the NW-inside wall near the joint with the in-plane west wall (from top to middle)</p>

<p>Major Crack in the plasterboard</p>

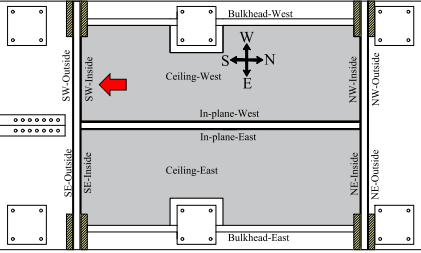
<p>Corner joint interface between the SW- Inside wall and the west ceiling</p>

<p>Separation at the corner joint between the ceiling and wall</p>

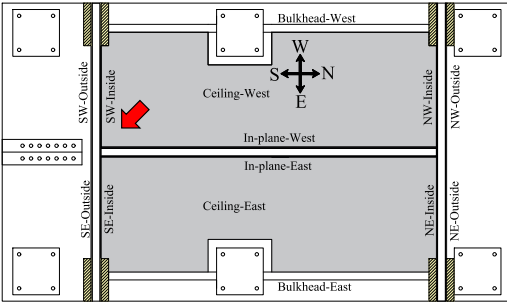
Corner of the SW-inside wall near the joint with the in-plane west wall (from top to middle)

Major Crack in the plasterboard

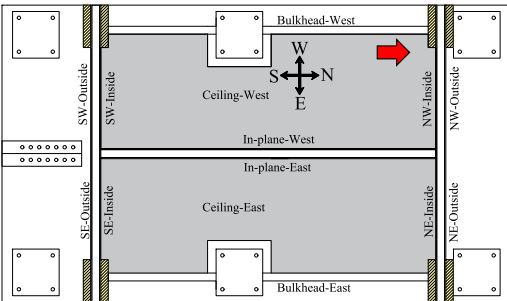
Top corner of the NW inside wall near its corner joint with the west bulkhead and the west ceiling

Crack in the plasterboard

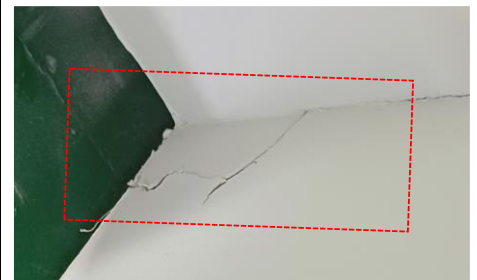
Inside the plenum — joint between the NW-inside wall and the west ceiling

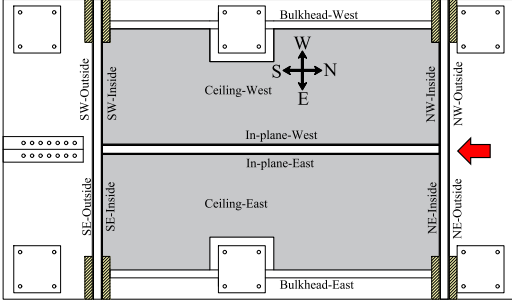
<p>Middle of the northern wall (outside), from top to near the bottom</p>

<p>Crack in the plasterboard</p>

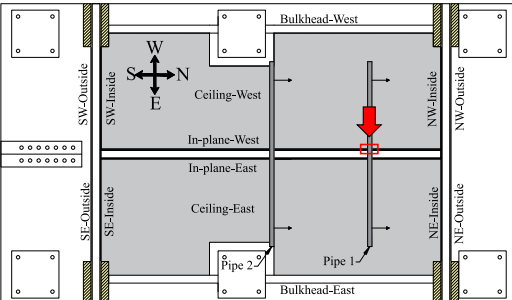
<p>Pipe1-Back Side</p>

<p>Major Separation (Likely to Compromise Fire-Rating Performance)</p>

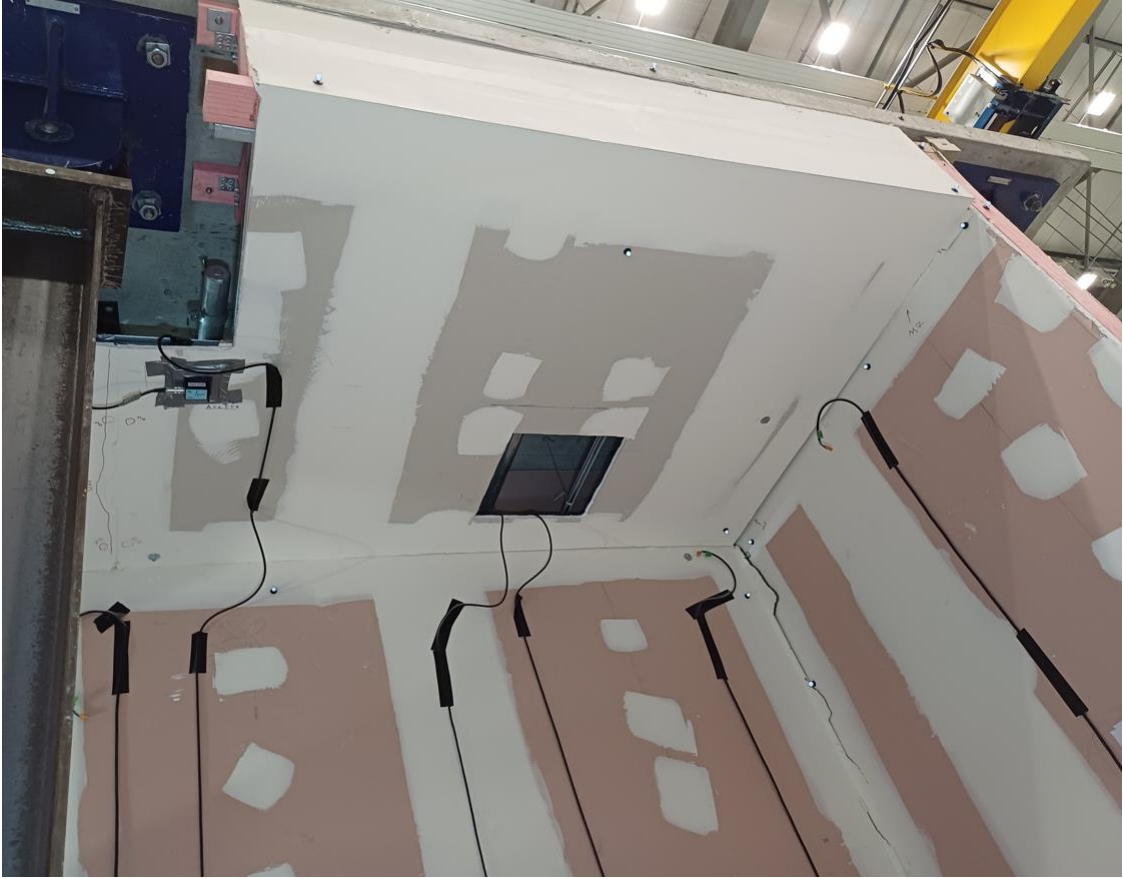
Figure 3.51. Northeast Elevation (looking at East Ceiling)

*Photos and videos of restrained wall specimens after final Test #16, 2.75 %
inter-storey drift*

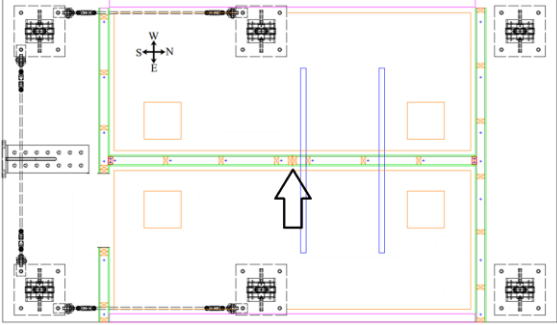
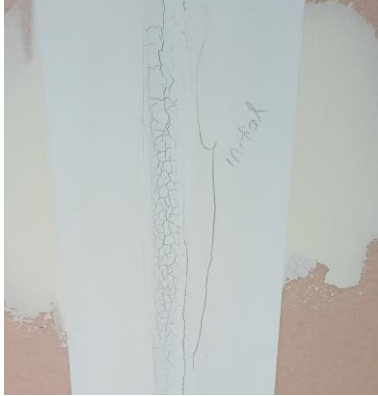
Table 4.5. Test #1, 0.10 % drift (PFA Top: 0.08 g)

Location	Observation	Photo
Bottom part of the vertical joint

Wrinkles in dried paint applied over sealant

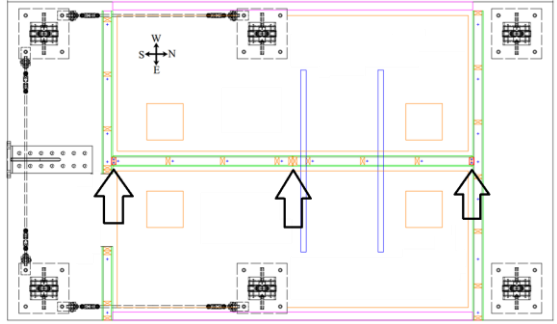
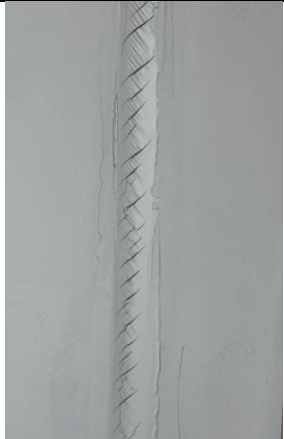
Table 4.6. Test #5, 0.49 % drift (PFA Top: 0.26 g)

Location	Observation	Photo
Throughout the height of the vertical joint

Wrinkles and inclined ties in dried paint and sealant

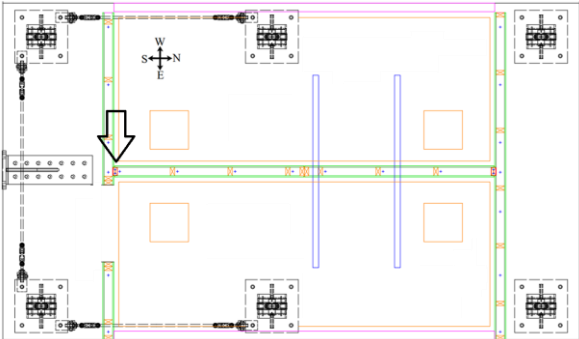
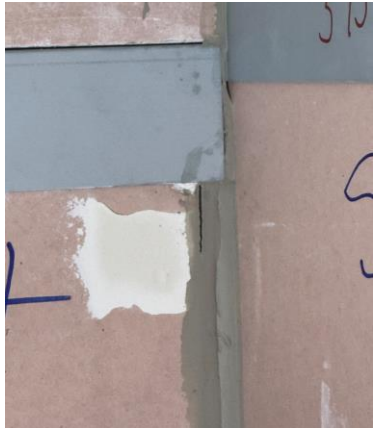
Table 4.7. Test #6, 0.56 % drift (PFA Top: 0.32 g)

Location	Observation	Photo
Top of southwest wall junction above ceiling plenum

Very minor tear in the sealant but the tear gap closes after shake

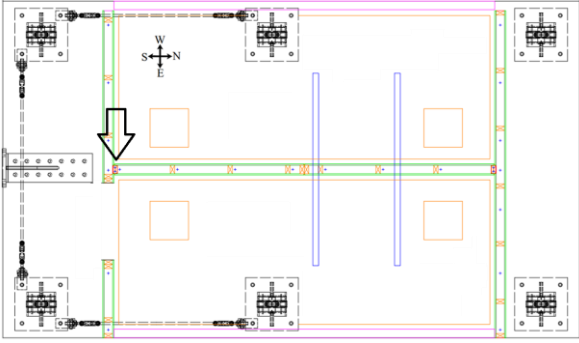
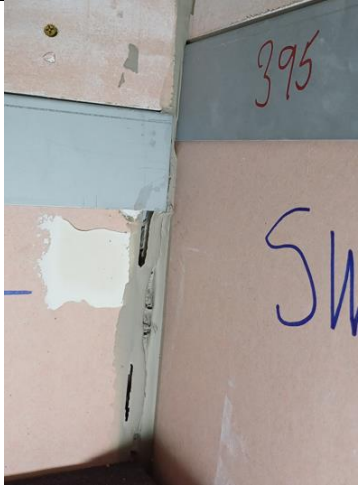
Table 4.8. Test #10, 0.97 % drift (PFA Top: 0.43 g)

Location	Observation	Photo
<p>Top of southwest wall junction above ceiling plenum</p>

<p>Very minor tear in the sealant but the tear gap remains open after shake</p>

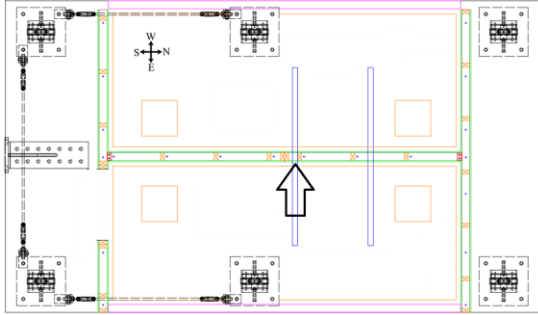
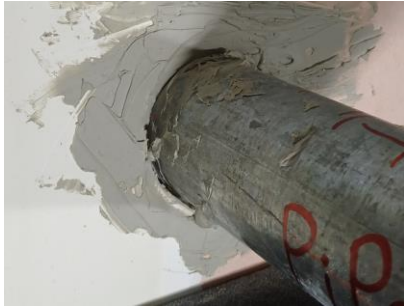
The mechanical pipes exhibited a failure mode defined by sealant detachment at penetrations, a critical loss of fire-stopping integrity. Code comparisons reveal a similar pattern: SNZ TS 1170.5 (2025) ($\mu=1.25$) provides conservative estimates, while ASCE/SEI 7-22 (2022) values were comparable relative to experimental median value of 2.26.

<p>At South Pipe and in-plane wall penetration</p>

<p>Detachment of sealant between pipe and wall at penetration</p>

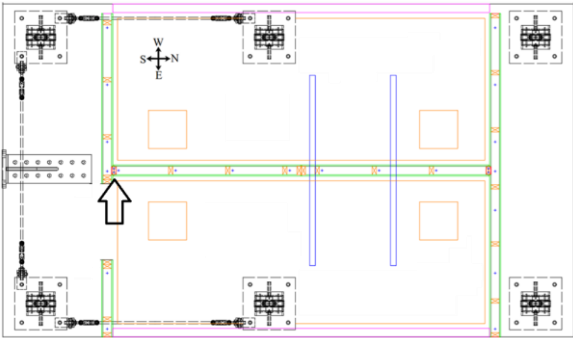
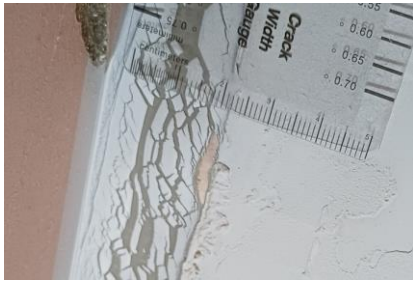
Table 4.9. Test #12, 1.21 % drift (PFA Top: 0.58 g)

Location	Observation	Photo
<p>Near top and bottom of Southeast wall junction</p>

<p>4 mm wide localized separation between the sealant and plasterboard</p>

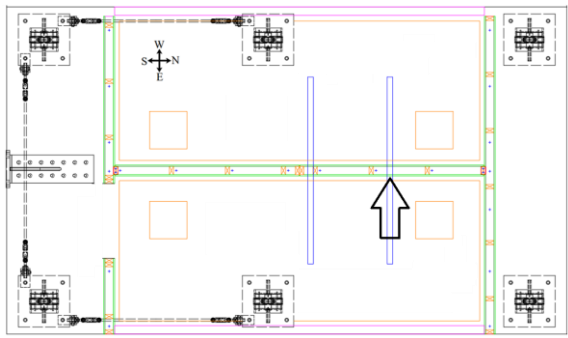
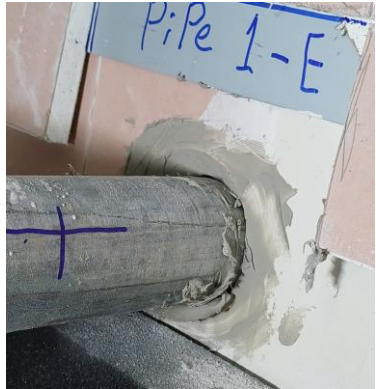
<p>At North Pipe and in-plane wall penetration</p>

<p>Detachment of sealant between pipe and wall at penetration</p>

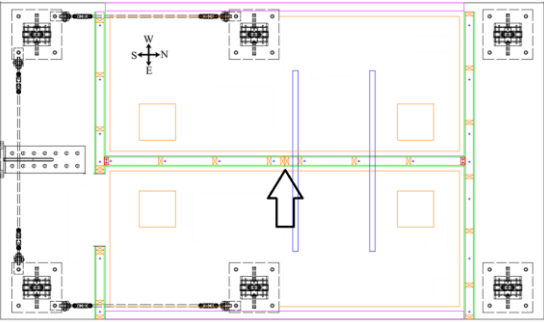
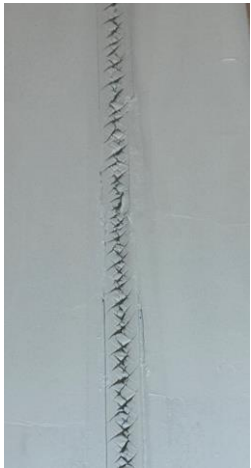
Table 4.10. Test #13, 1.45 % drift (PFA Top: 0.83 g)

Location	Observation	Photo
<p>Throughout the height of the in-plane wall joint</p>

<p>Abundant minor inclined tears in the sealant joint (not see through). This side has a DPC layer behind the sealant in the framing</p>

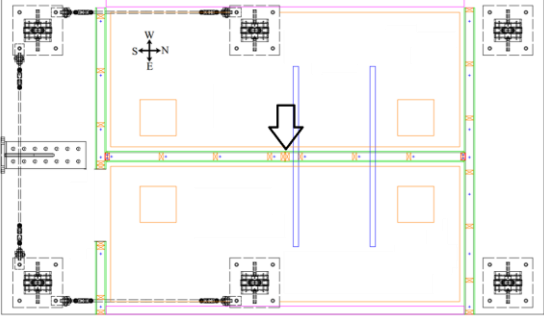
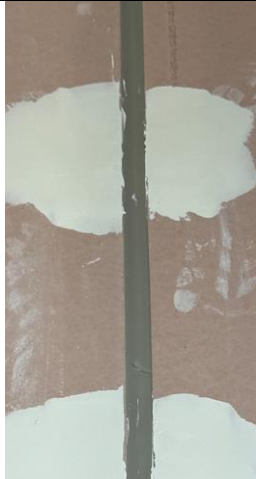
<p>No inclined ties/tears in the joint on the other side. This side does not have a DPC layer behind the sealant in the framing</p>

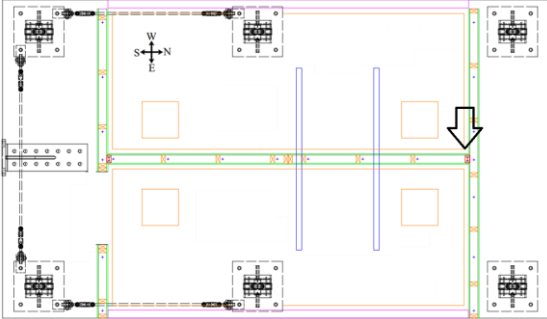
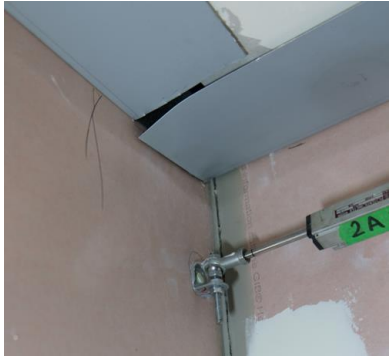
Table 4.11. Test #15, 2.03 % drift (PFA Top: 1.16 g)

Location	Observation	Photo
<p>Near top of Northwest wall junction</p>

<p>Bent in the wall angle</p>

- Redesign and test an improved connection detail (e.g., a thicker or differently configured steel angle) for the rocking wall system to ensure the intended kinematic rocking motion is achieved without premature yielding.
- Evaluate the post-earthquake fire performance of partition walls that have already sustained seismic damage. It may include experimental fire testing of seismically damaged wall assemblies which would quantify the extent to which earthquake-induced damage compromises their fire-rating performance. The findings could provide the empirical basis needed to confirm or refine current code-prescribed drift limits.

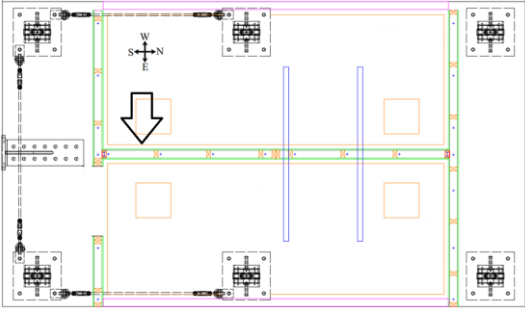
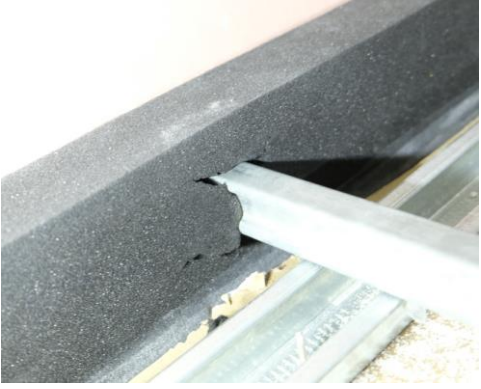
Table 4.12. Test #16, 2.06 % drift (PFA Top: 1.19 g)

Location	Observation	Photo
<p>Near Southwest wall junction</p>

<p>Top cross rail lodged inside the isolation foam</p>

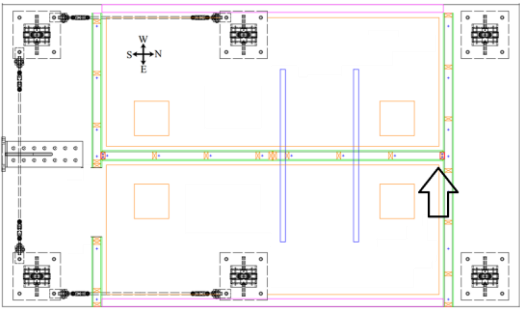
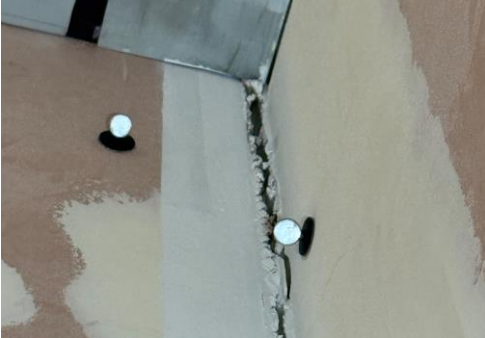
Table 4.13. Test #17, 2.51 % drift (PFA Top: 1.51 g)

drift of 0.56%. The maximum joint widening from the initial position was approximately 25 mm, measured at the top of the North junction during the 2.51% drift test. The top portions of both the South and North junctions opened wider than the bottom portions. In contrast, the opening at the mid-junction of the in-plane wall was almost negligible. Figure 4.48 (c) shows negligible residual displacements after each test, while Figure 4.48 (d) shows a cumulative displacement of 10 mm at 2.51% drift. It should be noted that the 15 mm gap between the timber framing and the plasterboard linings is present only at the North and South wall junctions. At the mid-joint of the in-plane wall, this 15 mm gap exists only between the adjacent plasterboard linings.

Location	Observation	Photo
<p>Near the top of the Northeast wall junction</p>

<p>Opening of the wall joint</p>

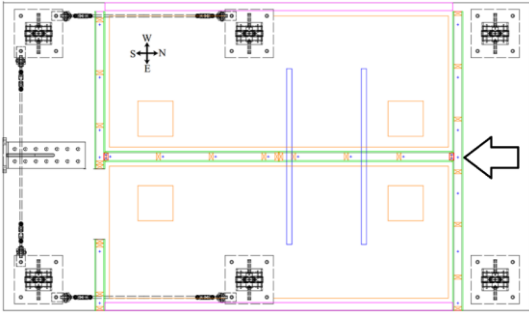
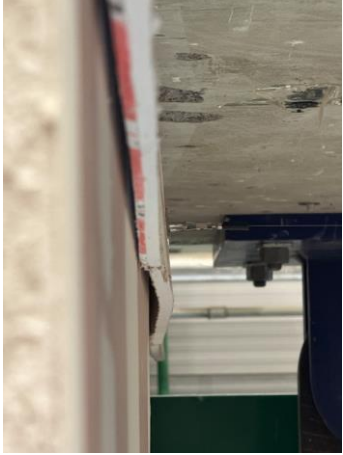
<p>Opposite side of the North wall junction at the top of the North out-of-plane wall</p>

<p>Bent in the top plasterboard strip</p>

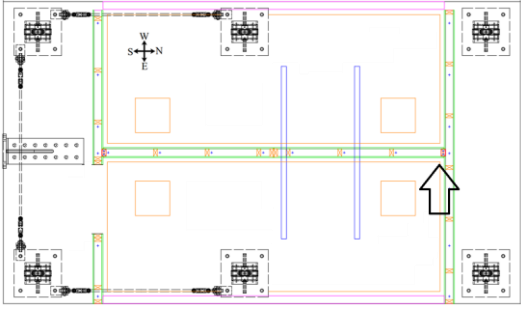
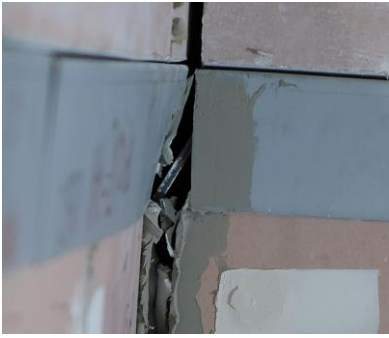
<p>At the top of the North wall junction</p>

<p>Bending of the steel angle at the junction is visible at the joint</p>

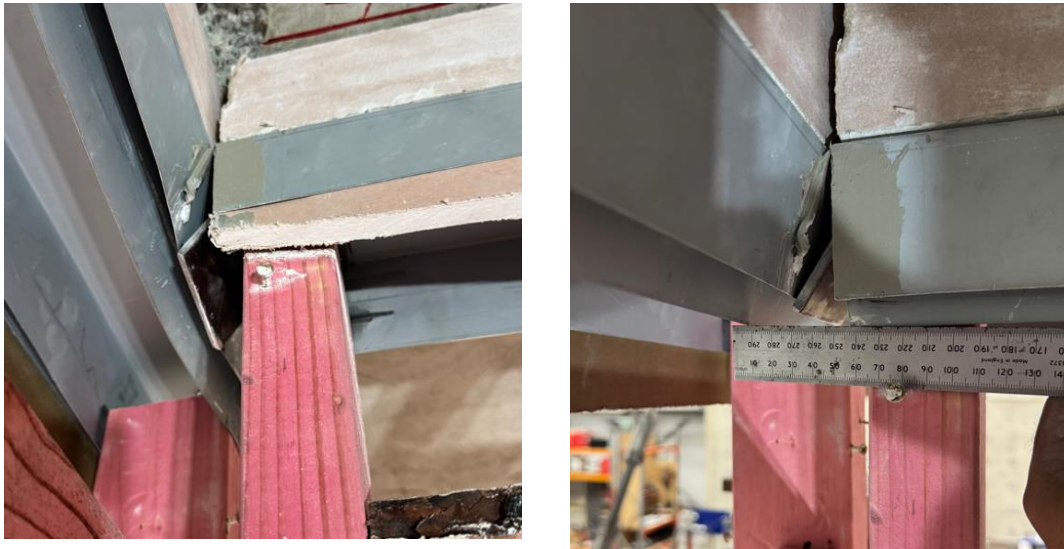
Figure 4.68. Photo of bent top steel angle at North wall junction taken during demolition

- (1) **Rocking Walls:** The damage concentration design philosophy was effective. The sealant joints performed as intended sacrificial elements, protecting the wall framing and linings. The kinematic rocking mechanism requires redesign, specifically of the steel angle connection, to perform as intended.
