Earthquake And War Damage Commission

**EARTHQUAKE RISK ASSOCIATED WITH
1935 - 1975 REINFORCED CONCRETE
BUILDINGS IN NEW ZEALAND**

E.L. Blaikie

D.D. Spurr

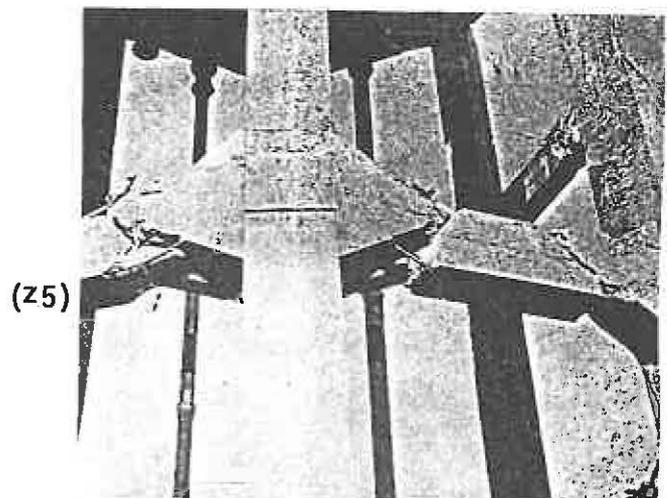
(z5)

Caracas, 1967	<ul style="list-style-type: none"> Laguna Beach Building. A 14 storey RC frame building with hollow masonry infill panels. The 1st floor beams suffered shear failures just outside the normal hinge zone. Beam torsion may have contributed to the cracks. 	-	2.1(z1)	43
Mexico City, 1957	<ul style="list-style-type: none"> Two Storey School Building. Some spectacular beam shear failures occurred without causing the buildings to collapse. The major diagonal crack shown in Figure 2.1(z3) passes through a section where the main steel is cut off. 		2.1(z2), (z3),(z4)	30
Chile, 1960	<ul style="list-style-type: none"> Elevated Water Tank Support Frame. Photo shows beams with very little residual strength after failing in shear. However the tank did not collapse. 		2.1(z5)	30

Fig. 2.1 (cont'd) Beam Shear Failures (See Table 2.1 for details)

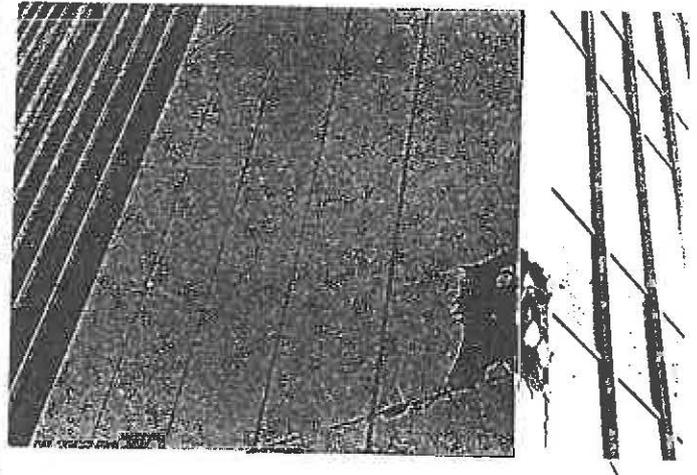
(f)

—Indian Hills Medical Center.
North-side shear wall, west end.

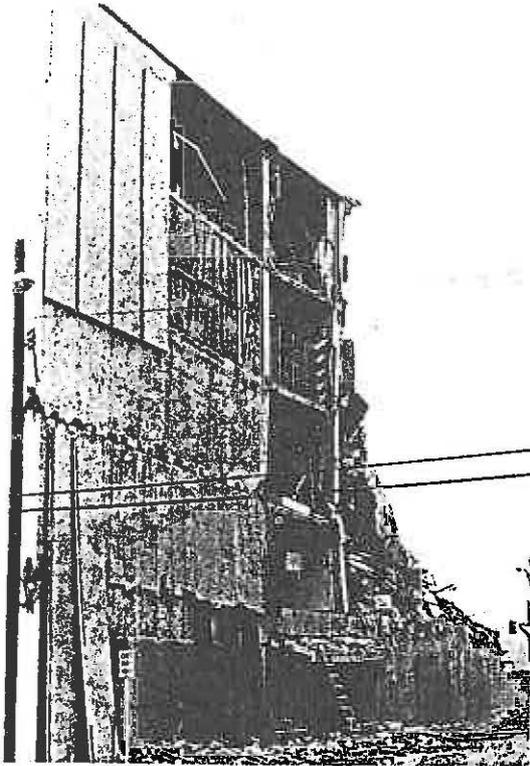
Fig. 2.2 (cont'd) (i) Collapse due to Construction Joint Failure
(j), (k) and (l) Spandrel and Coupling Beam Damage (see
Table 2.2 for Details)

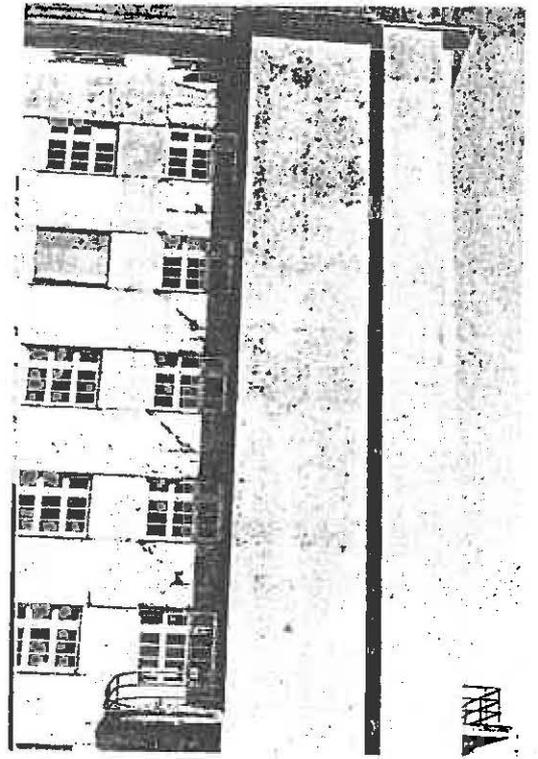
(j)

Anchorage,	<ul style="list-style-type: none"> • Mount McKinley and 1200 L Buildings. Two 14 storey buildings with coupled shear walls and perforated walls built in early 1950s. Coupled walls exhibited crushing failures (see photo 2.2(b)), extensive movement on construction joints and heavy damage to coupling beams. Walls were only lightly reinforced and did not have additional heavy edge members or reinforcement. Perforated walls had extensive shear cracking (X type) to beam and column elements. Tendency for only one significant flexural or shear crack to form suggests low ratios of reinforcement throughout members. Availability of alternative loads paths (redundancy) for gravity loads appears to have saved this building from collapse. • Four Seasons Apartment Building. A six storey lift slab building with twin RC cores providing lateral resistance and with steel columns supporting the floors. Building was structurally complete but not occupied at time of earthquake. Because of complete nature of collapse, sequence and cause of collapse not known. However cores were noted as being "fractured in the first storey". Given detailing of other buildings in Anchorage the cores were probably only lightly reinforced. 	-	2.2(b) also 2.1(j) and (k)	42

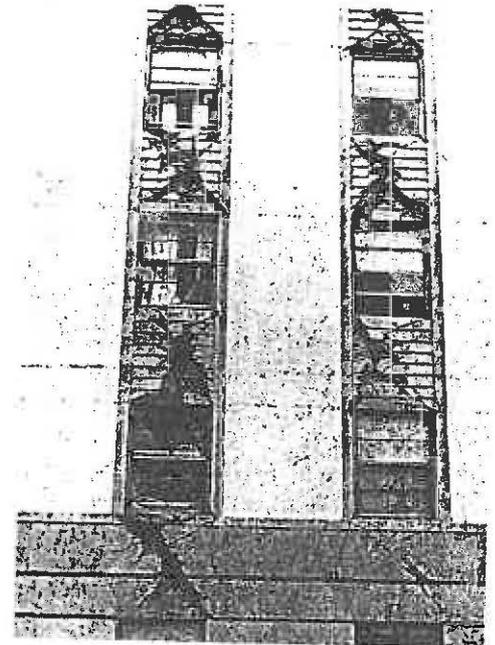
(l)

EARTHQUAKE	EXAMPLES OF FEATURES OF DAMAGE	Building Collapsed = C Building Partly Collapsed = PC Building Demolished = D	PHOTO REF (FIGURE NO.)	SOURCE REF.
	<u>SPANDREL AND COUPLING BEAM FAILURES</u>			
Chile, 1960	<ul style="list-style-type: none"> Valdivia Regional Hospital (Medical Services Tower). An eight storey RC wall and deep member frame building built in 1935. Wide shear cracks (type X) formed in spandrel beams adjacent to walls. Concrete was weak (≈ 12 MPa). 	-	2.2(j)	45
Armenia, 1988	<ul style="list-style-type: none"> Leninakin nine storey apartments. Buildings had coupled walls providing lateral resistance in one direction and frames in other. Coupling beams had little or no shear reinforcement and shattered. Given defects in frames and lack of effective floor diaphragms the contribution of the wall defects to collapses could not be defined. 	some C	2.2(k)	34
Anchorage	<ul style="list-style-type: none"> Mount McKinley and 1200 L Apartment Buildings. Both buildings suffered extensive shear cracking (type X) in coupling beams and spandrel beams. 	-	2.2(l)	42
