Repair and reinstatement of earthquake damaged houses -Derivation of repair techniques

STUDY REPORT No. 100 (2001)

Repair and Reinstatement of Earthquake Damaged Houses – Derivation of Repair Techniques

BRANZ Study Report SR 100 (2001)

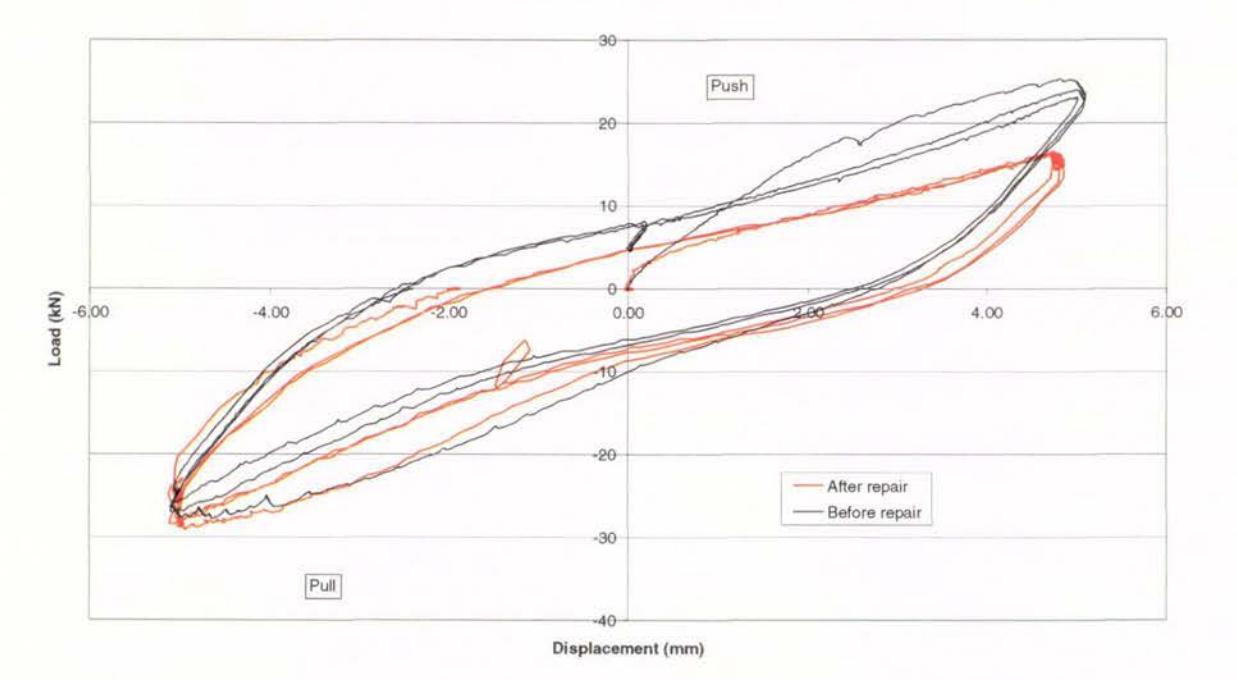
Figure 6: Comparison of performance before and after the first repair work

A small crack had formed up to about 1 mm wide on the fibre cement sheet joints, extending from the bottom corners of the windows to the bottom plate. These cracks were filled with joint filler 1. Overcoating with a new textured coating would have been necessary to hide the repair to the satisfaction of a building owner.

The specimen was then re-cycled to $\pm 5 \text{ mm}$ and the strength and stiffness compared. A plot of the before and after repair cycles is presented in Figure 6. The repaired strength in one direction matched the initial strength but only reached about 65% of the initial strength in the other. There was no clear reason for this asymmetric behaviour.

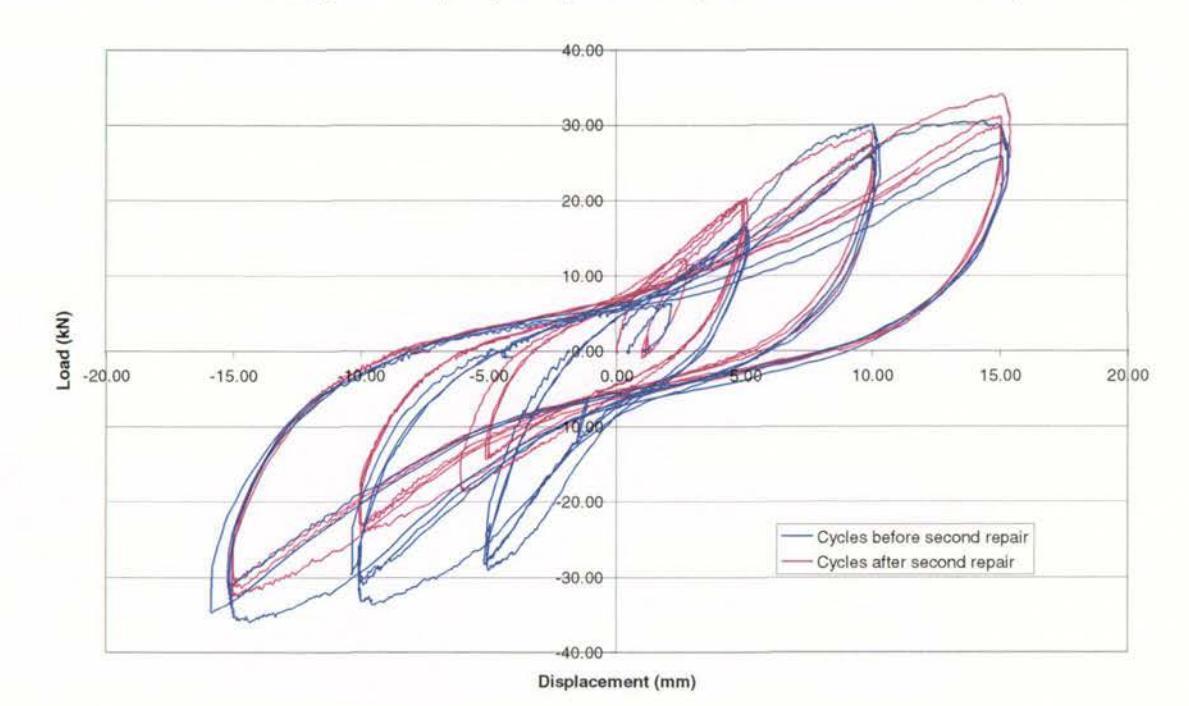
Figure 10: Comparison of the load deflection behaviour before and after the second repair

In one direction the after-repair plots closely matched the before-repair plots but in the other direction there was a significant mismatch until the 15 mm displacement. The reason for the asymmetry is uncertain but because the load levels were almost recovered and well above the design load the wall was still effective as a bracing element.

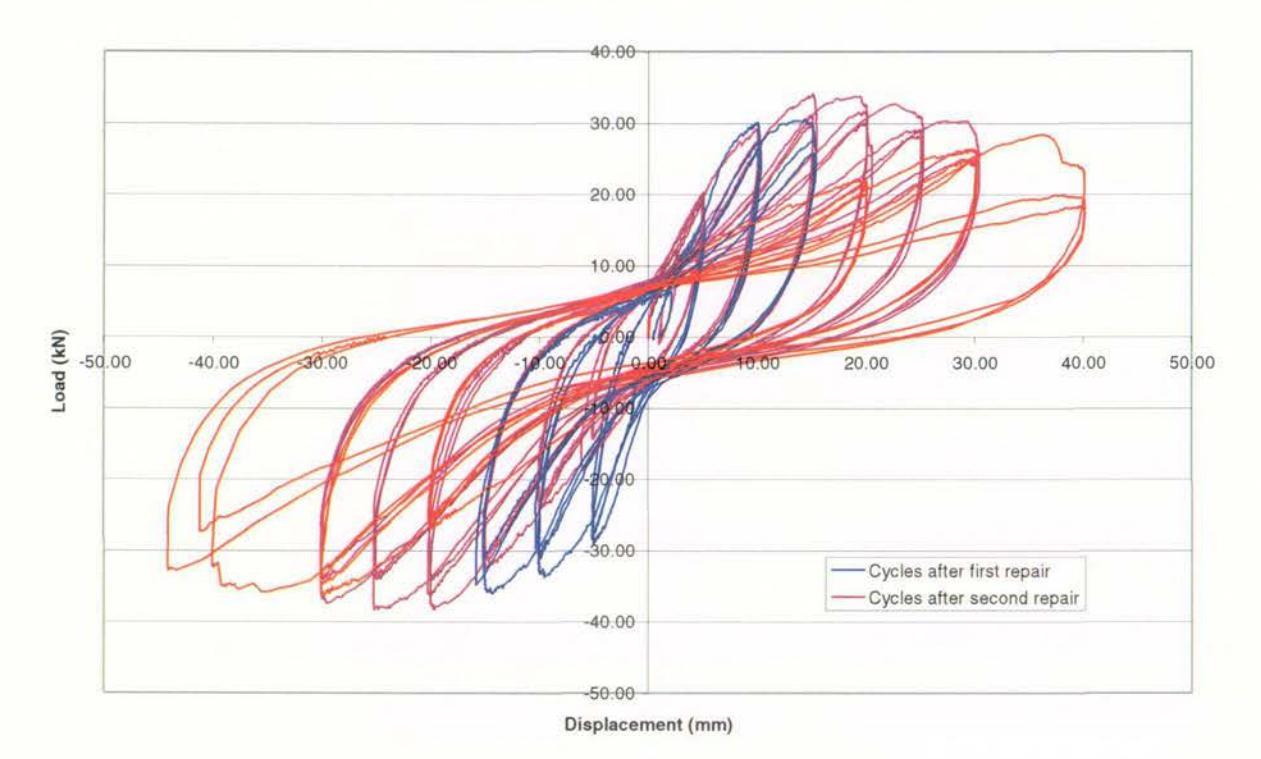
Figure 11: Load displacement history

At the completion of the cycles to $\pm 30 \text{ mm}$ and $\pm 40 \text{ mm}$ the individual fibre cement sheets were still in good condition but the nailing along the bottom plate was in a bad condition. The nail heads had pulled through the sheet and it was hanging proud of the bottom plate.

The sheets could be re-nailed to the bottom plate but with a textured coating in place it may be difficult to find the original nail positions for re-nailing, unless they can be felt from underneath. A plot of the load-displacement cycles up to ± 40 mm is presented in Figure 11.

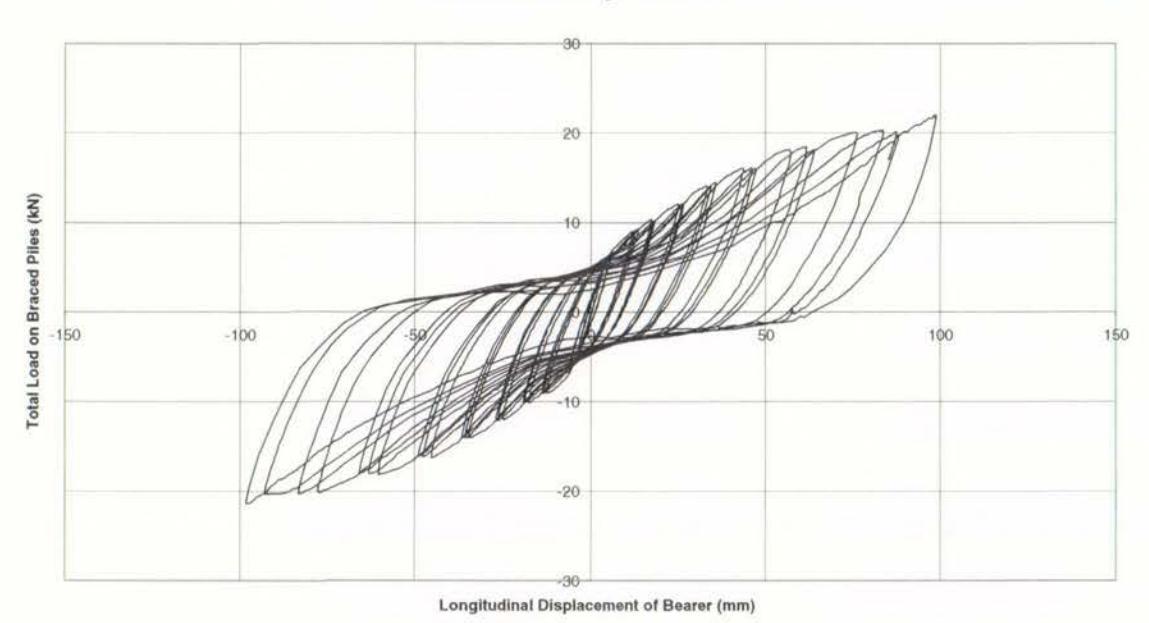
Figure 13: Longitudinal displacement of bearer against load

As cycling progressed, it was difficult to tell what damage was occurring in the joints between the piles and the braces because there was nothing visible happening, except that tell-tale lines on the members at the joints indicated clear movement between them. A major difficulty for an inspector after an earthquake will be that he/she will not have tell-tale lines to refer to, to judge how much movement has occurred. Also, because the damage is hidden, it won't be possible to determine the extent of it without removing a brace and checking the state of the bolt and the timber around it.

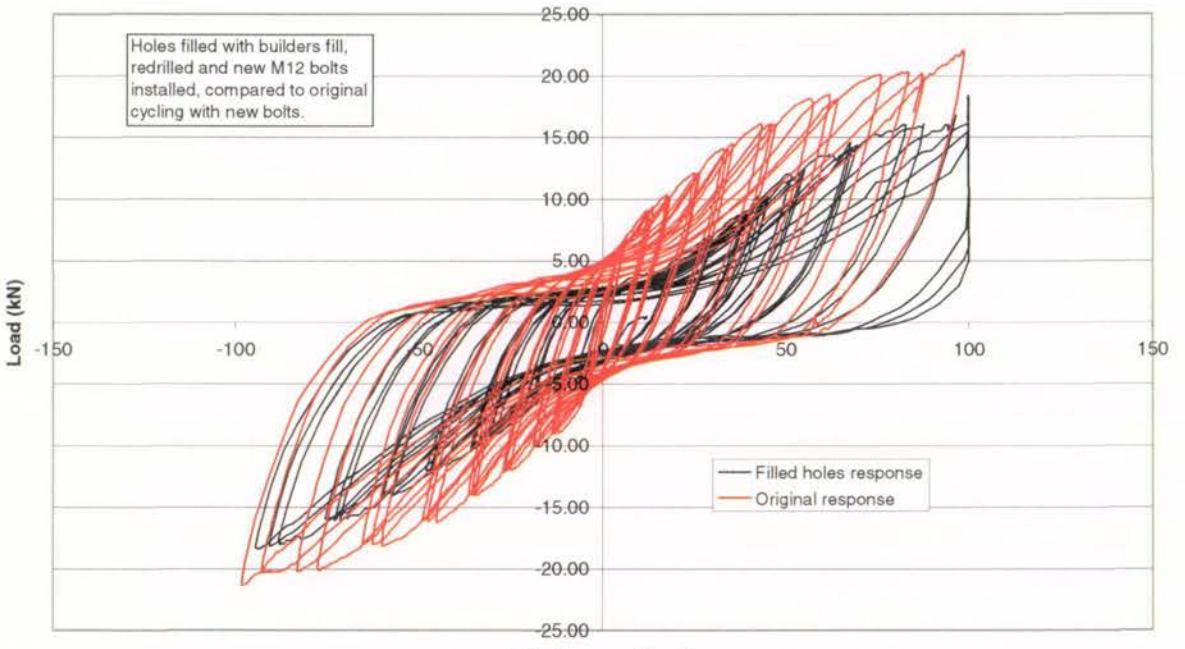
Figure 15: Comparison of performance before and after holes repaired with builders' fill

When the specimen was cycled after the repair the service stiffness was of the order of 50-60% of the stiffness in the initial cycling (Figure 15). As the displacement increased, the difference between the two plots remained relatively constant so that at 100 mm displacement the difference was about 10-15%.

The bracing rating in NZS 3604 for a single braced pile is 120 bracing units which translates to 6 kN. Therefore, the design load for the specimen is 18 kN. To achieve this load with a system that had never been subjected to earthquake loading before, the displacement of the bearer was between 60 and 70 mm. After the repair, the system displaced to 100 mm in one direction and further in the other before the design load could be achieved (note that the right side plot in Figure 15 does not extend beyond 100 mm because the deflection gauge had reached the end of its stroke).

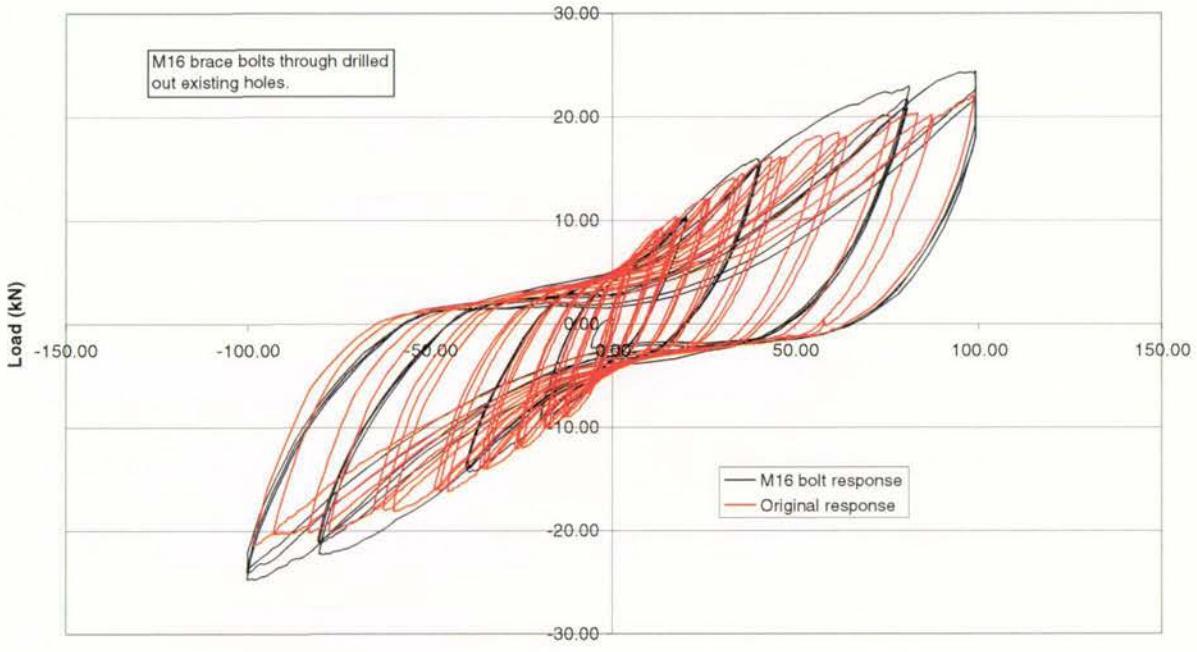
Figure 16: Comparison of performance before and after holes drilled out and m16 bolts installed

The initial stiffness of the repaired specimen was not quite as good as that of the virgin specimen but was likely to be sufficient to provide resistance to movements under service loads after an earthquake. As cycling continued, the strength gain was faster than in the original specimen (Figure 16). Once the displacements had reached approximately 40 mm the strength of the repaired structure was greater than the original and this continued up to displacements of ± 100 mm, when the testing was terminated.

For this alternative, the braces were removed from the piles and turned over so that the hole adjacent to the pile was not damaged. The holes were then drilled out to accept the M16 bolts and these were installed complete with flat square washers beneath the bolt heads and nuts.

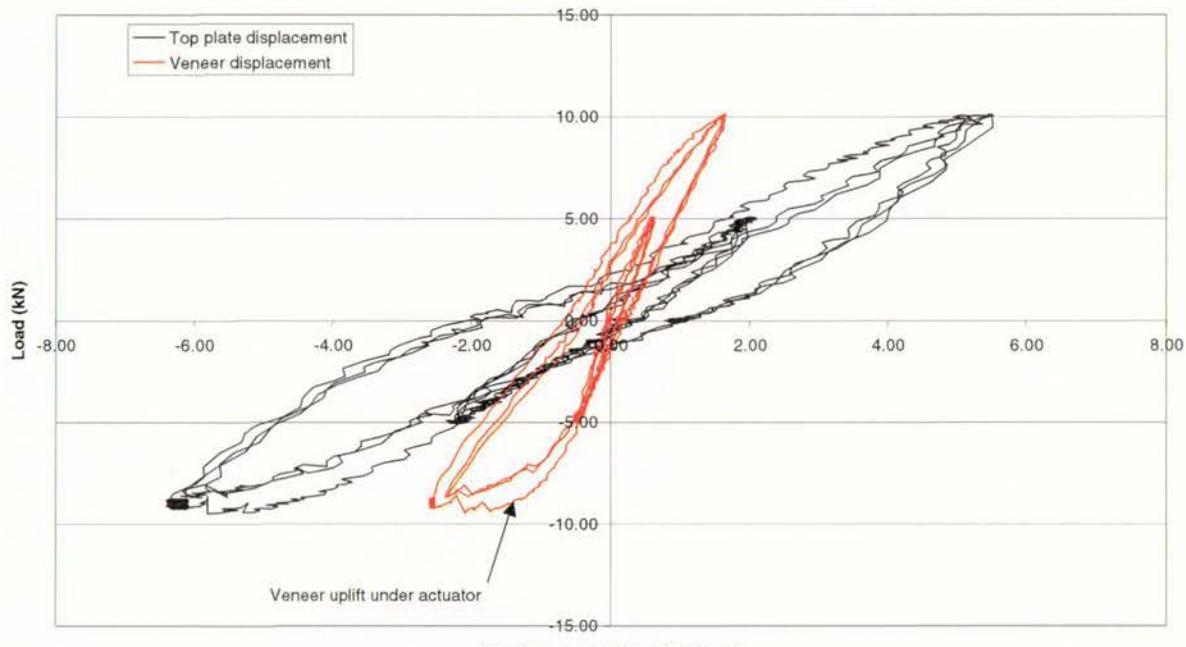
Figure 21: Comparison of top plate displacement and veneer displacement against load – cycles to 10 kN.

The second set of cycles repeated the 5 kN cycles from the initial series and then went on to cycles targeting 10 kN. When approximately 9 kN was reached, the end of the veneer under the actuator began to lift from the slab during the push cycles. For this direction, a target displacement of 6 mm was set so that 3 complete cycles could be achieved to 10 kN in the pull direction. Once again, there was differential movement between the veneer and the framing, in the order of 4 mm at the peak load (Figure 21).

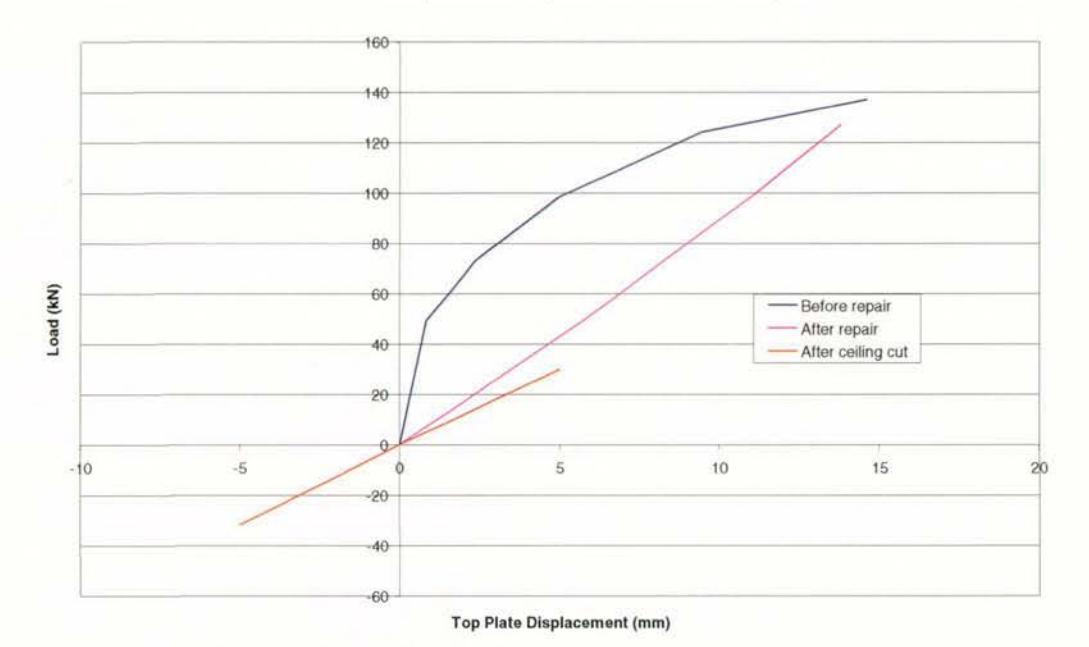
Figure 34: Comparison of the wall strength and stiffness before and after the re-nailing and re-stopping and after ceiling diaphragm interrupted

After carrying out the repairs the wall was again racked to increasing load levels to compare the strength and stiffness with the previous series. A plot showing a comparison of the backbone curve of the load-displacement hysteresis loops is presented in Figure 34. The top plate failed in tension during the last cycle at about mid length of the section of wall between the hallway and the third bedroom.

This section of wall was cycled to compare the strength and stiffness of the wall element with its strength and stiffness before the ceiling was cut. Top plate displacement was set as the controlling parameter for these cycles. Three cycles to ± 5 mm were completed before the top plate failed again, this time in compression at a knot. The backbone curve covering these cycles is also plotted in Figure 34. As expected, the strength was less because of the discontinuity introduced in the ceiling and because then only one wall element was resisting the load.

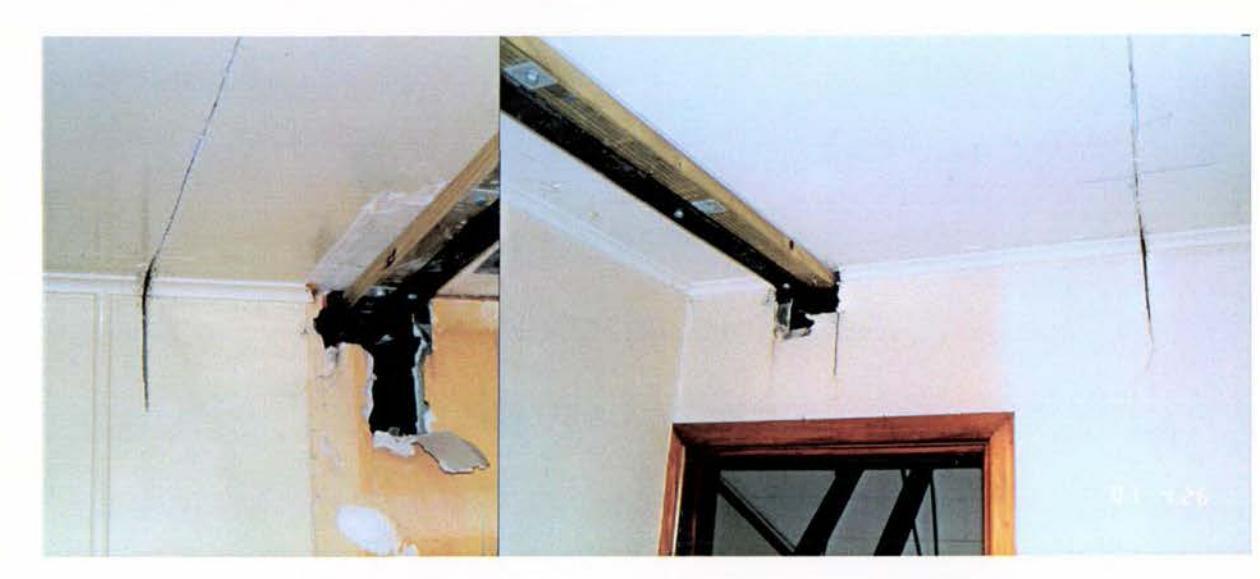
Figure 41: Photographs of the kitchen (left side) and the lounge (right side) showing the cut through the top plate

The top plates of the transverse wall adjacent to the slots cut in the ceiling lining were then cut through so that there was no continuity for force transfer along the transverse wall (Figure 41). The wall was then cycled to 8 mm, then 12 mm before all the linings were removed from the wall between the hall and the laundry to prevent any load-resisting contribution from it.

A comparison of the top plate displacement and the ceiling displacement showed that the top plate was still displacing to about 80% of the ceiling. At the hallway end of the test wall the uplifts were peaking at about 8 mm but at the sliding door opening they were still little more than 1 mm. The reason for this difference is discussed later in the report.

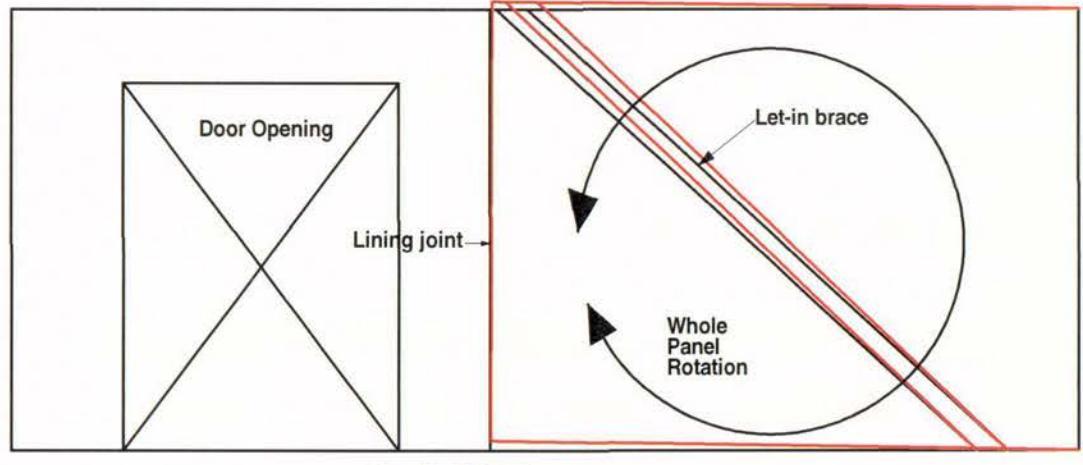
Figure 44: Diagrammatic representation of wall panel rotation during the test

During these cycles the hallway end of the test wall was uplifting to greater than 20 mm (deflection gauge ran out of travel), but at the sliding door the uplift was still only 1.5 mm. Bottom plate slip peaked at 3.2 mm in one direction and 1 mm in the other. Inspection of the lining on the lounge side of the of the wall clearly showed that there was shear slippage occurring on the vertical joint between lining sheets just to the hallway side of the sliding door (Figure 43). All the movement at this joint accounted for the lack of uplift at the sliding door. Other vertical joints along the wall were not showing any signs of differential movement. The reason for this behaviour was that a let-in 150 mm by 25 mm diagonal brace on the kitchen side of the wall was maintaining that part of the wall in a rectangular shape and it was rotating under the applied loads (Figure 44).

Sheet damage was limited to around the perimeter of the individual sheets and could be repaired by removal of the skirting boards and scotias and re-nailing and re-stopping. Replacement of the sheets would not be necessary.
