Darfield Earthquake 4 September 2010  
Geotechnical Land Damage Assessment  
& Reinstatement Report

## STAGE 1 REPORT

**October 2010**

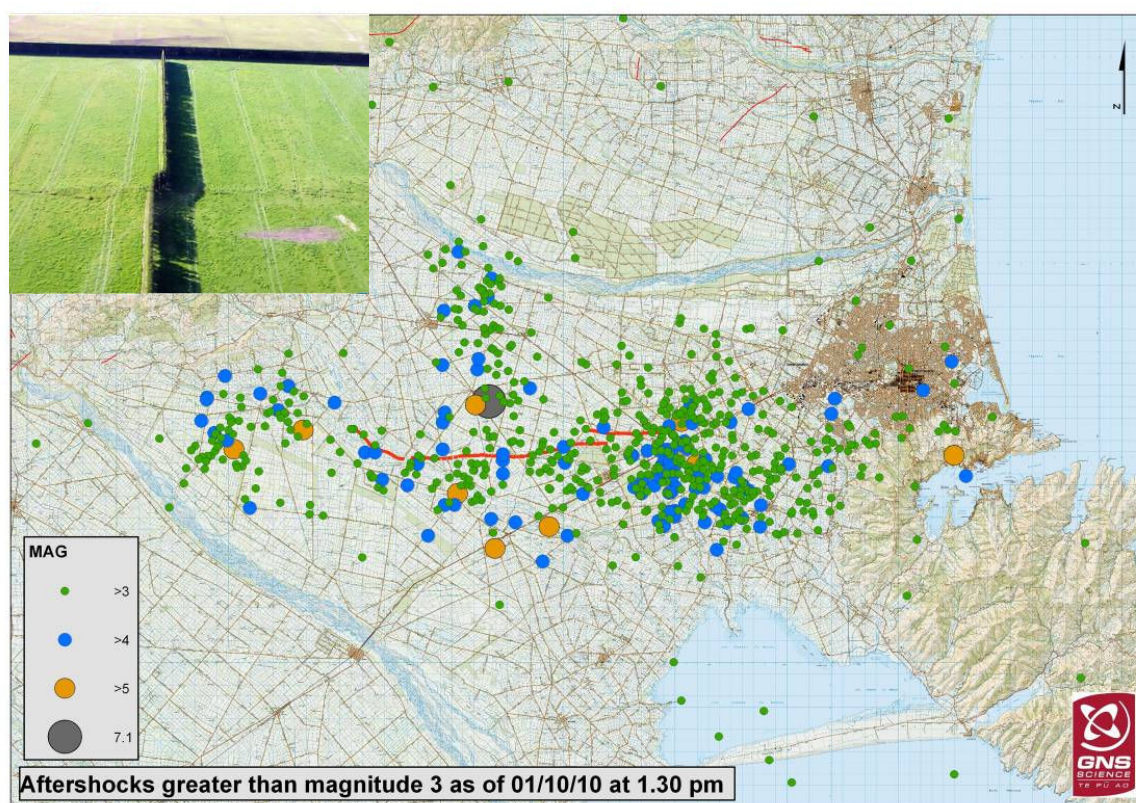
An East-West trending fault rupture on the Canterbury Plains extends to within 12 km of Christchurch. Preliminary analysis of the seismogram records in New Zealand indicate the mainshock had primarily strike-slip (sideways) motion, which agrees with the observed 29 km long surface fault rupture (Figure 2.1). However, the mainshock has been observed to be complex, and an important reverse (compressional) component is observed in strong ground motion and geodetic data. The duration of strong ground motions on firm soils sites was about 15 seconds.

Figure 2.1. Location of mainshock and aftershocks as of 1 October 2010. Inset shows displaced shelter belt and vehicle tracks along the strike-slip fault scarp. Strike-slip displacement of several metres occurred at this locality west of Rolleston. Surface fault rupture illustrated by bold red line to the south of the mainshock. Photo, GNS Science.

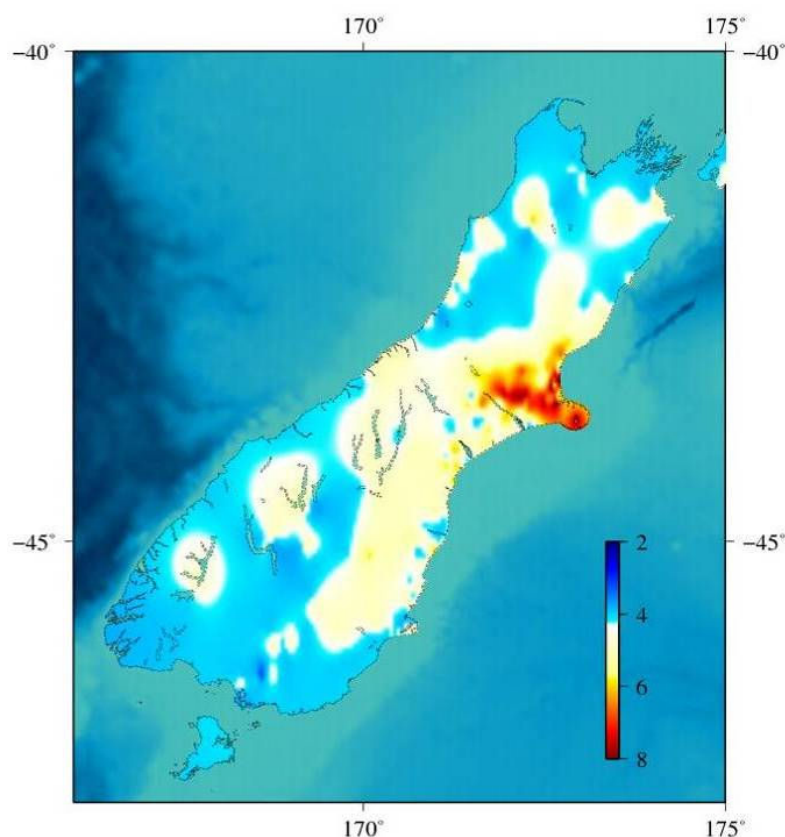
Approximately 6000 felt reports from the mainshock have been reported to GeoNet, extending from Auckland to Invercargill. Modified Mercalli Intensities (MM) of 7-8 were predominantly reported in Christchurch City and to the west in the vicinity of the epicentre (Figure 2.2). Numerous strong ground motion recorders were triggered by the mainshock and many of the aftershocks, with maximum peak ground accelerations exceeding 100% of gravity (1g) in the epicentral area and 20-30% of gravity (0.2 – 0.3g) in the city. Further analysis of the ground motion data (particularly in relation to energy release at wave periods pertinent to structures, potential instability of the recording sites, and effects of weak near surface ground conditions in parts of Christchurch and the wider region) is indicating that the earthquake was below the ultimate limit state (ULS) design spectra at spectral frequencies pertinent to low rise buildings, but significantly above the design spectra for high rise (above approximately 20 stories) (Figures 2.3 and 2.4). Note that spectral acceleration assessment is most relevant to building shaking damage and is only indirectly related to liquefaction and ground damage. The reason for the high accelerations at long spectral periods are under investigation and could result from earthquake source characteristics, site characteristics or earthquake propagation effects from depth to the surface.

Figure 2.2. Preliminary assessment of Modified Mercalli Intensity in the South Island, compiled from several thousand reports to GeoNet. The prevalent intensity in the epicentral area and Christchurch is MM8.

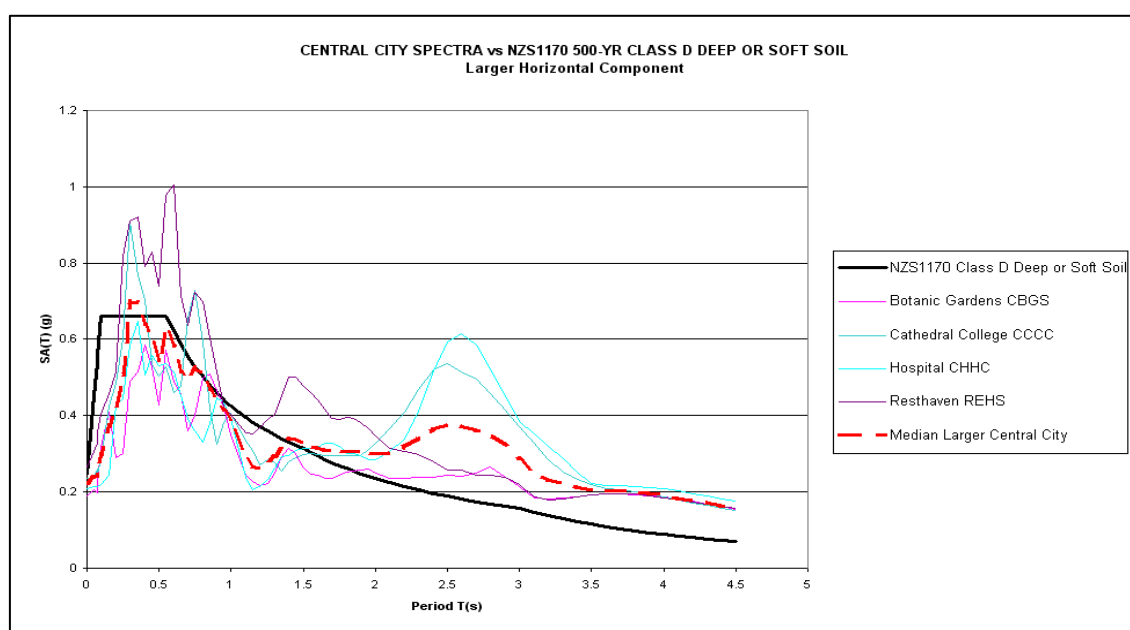
Figure 2.3. Spectra for four sites within 1-1.5 km of the Central Business District compared with 500-year code design-level motions. Their average corresponds approximately to code motions for structures with periods from 0.3s to 1s (approximately 3- to 10-storey buildings), but lie below code motions for periods up to 0.3s. The recorded motions were stronger than code motions for periods longer than about 1.5s. The peaks around 2.5s are likely to be related to response of the several hundred metre deep gravels under Christchurch City amplifying long-period content in the incoming waves.

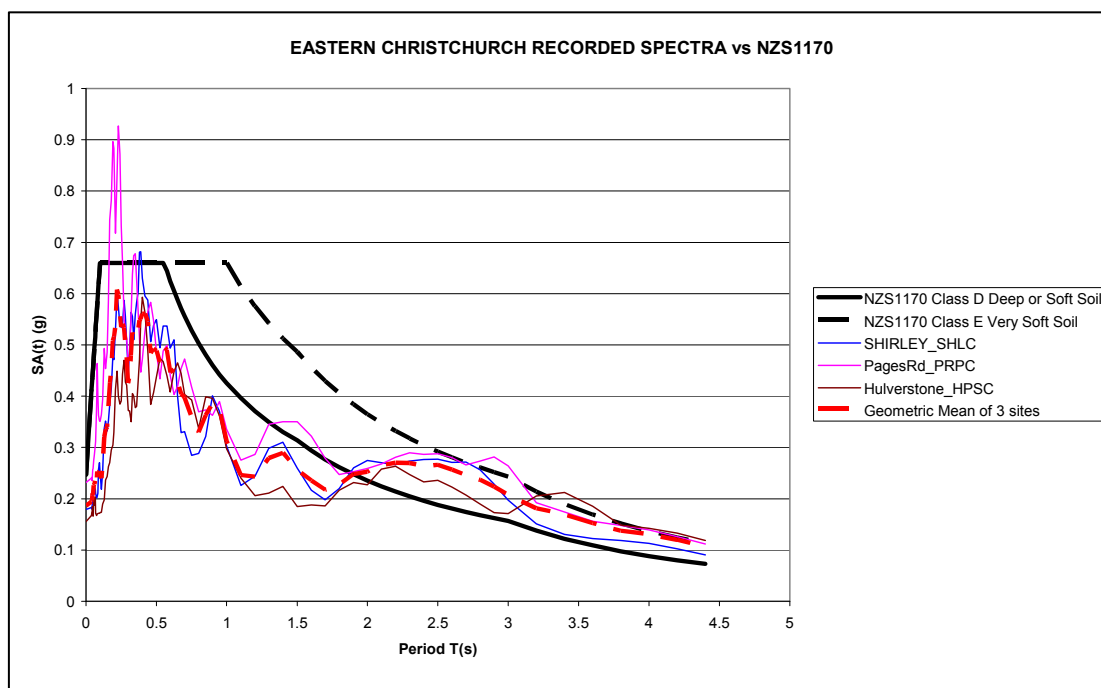
Figure 2.4. Spectra for three sites in the eastern suburbs compared with 500-year code design-level motions for deep or soft soil sites (solid line). The peak ground accelerations and motions for periods of about 0.3s to 1s are about 80% of design motions, but are more deficient in the short period range below 0.3s. Long-period motions exceed deep soil code motions for periods longer than about 2s, approaching code-level motions for very soft soils (dashed line) around 2.5s period. The Hulverstone Road Pumping Station record was from a site that suffered extensive liquefaction and spreading.

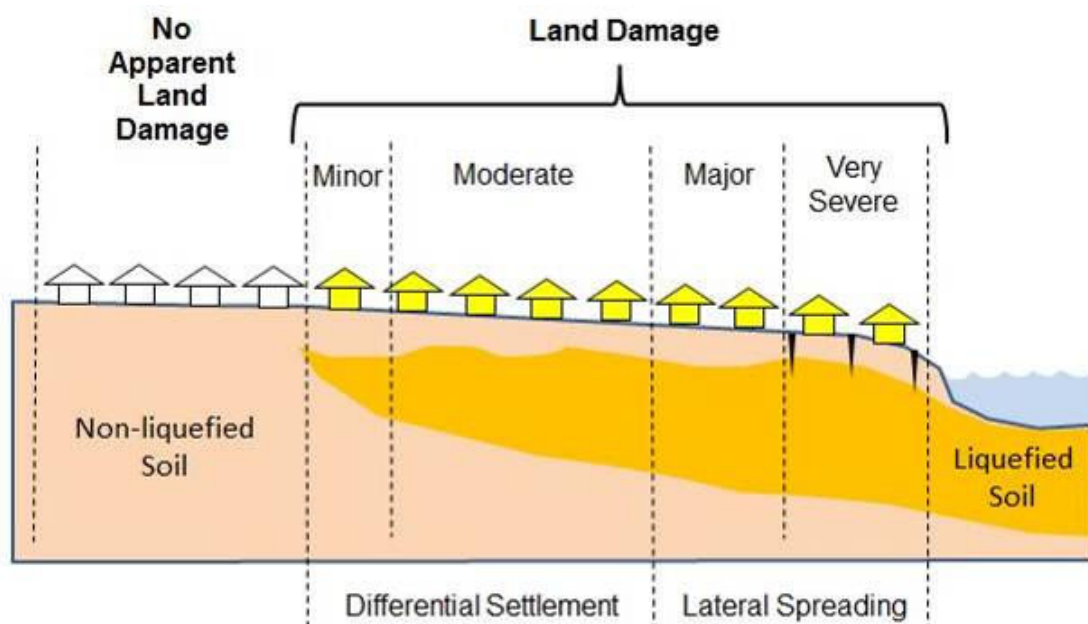
The spatial distribution of the zones of typical land damage, as discussed in the table above is illustrated in a generic section shown in Figure 5.1.

Figure 5.1. Schematic section of spatial distribution of zones of land damage
