Earthquake Commission

Canterbury Earthquakes 2010 and 2011
Land report as at 29 February 2012

Report prepared for: Earthquake Commission
Report prepared by: Tonkin & Taylor
Distribution: Earthquake Commission, Electronic copy and
Tonkin & Taylor, Electronic copy (File)

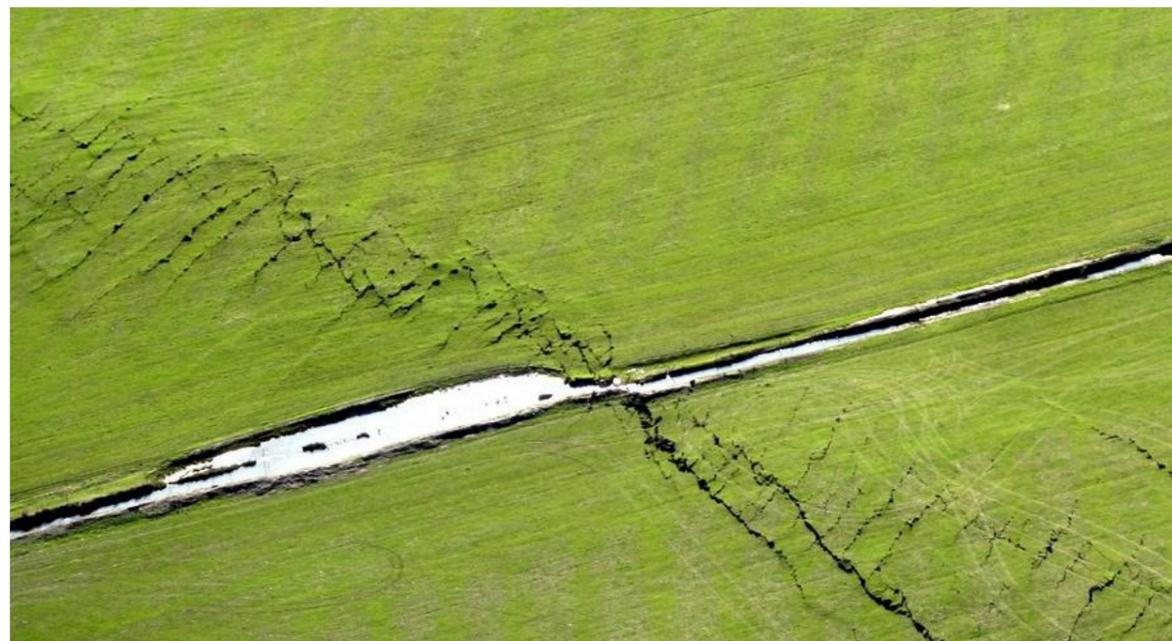
The September 2010 earthquake Greendale Fault trace. The fault trace is the intersection of a fault with the ground surface; also, the line commonly plotted on geologic maps to represent a fault. Photo: Environment Canterbury.

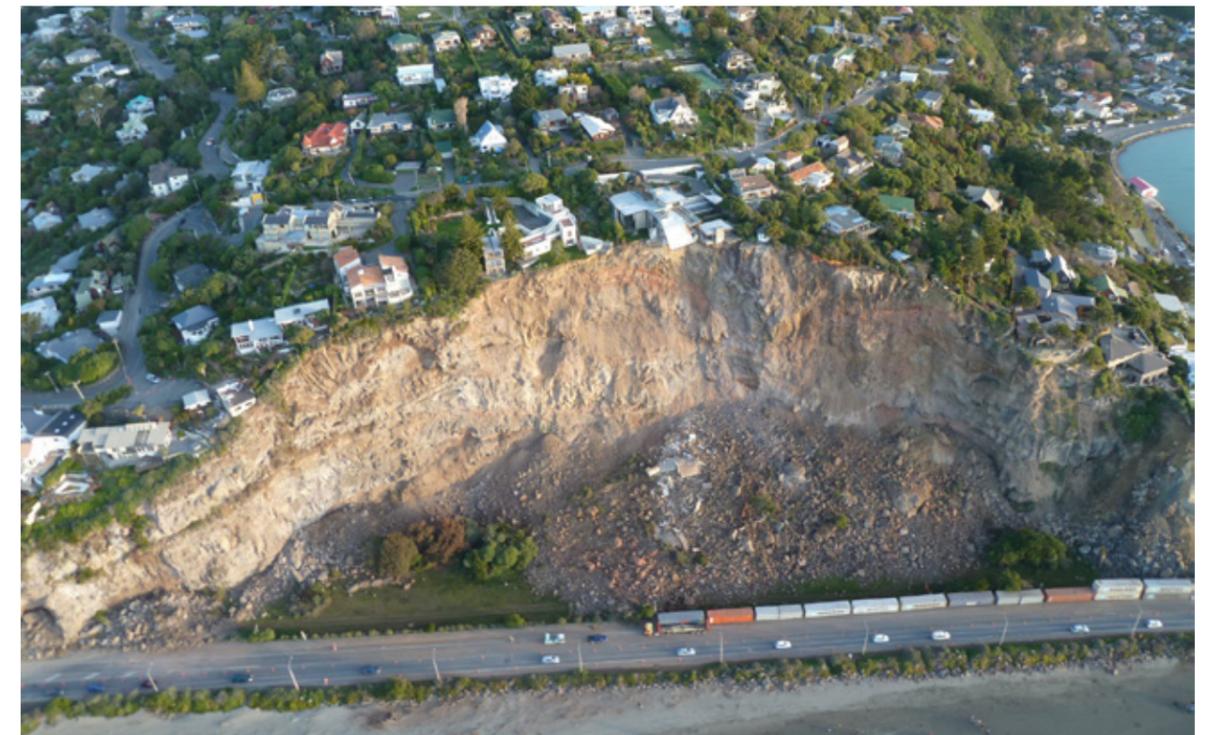
An aerial view of cliff collapse in the Port Hills after the 22 February 2011 Christchurch 1 Earthquake. Photo: Tonkin & Taylor.

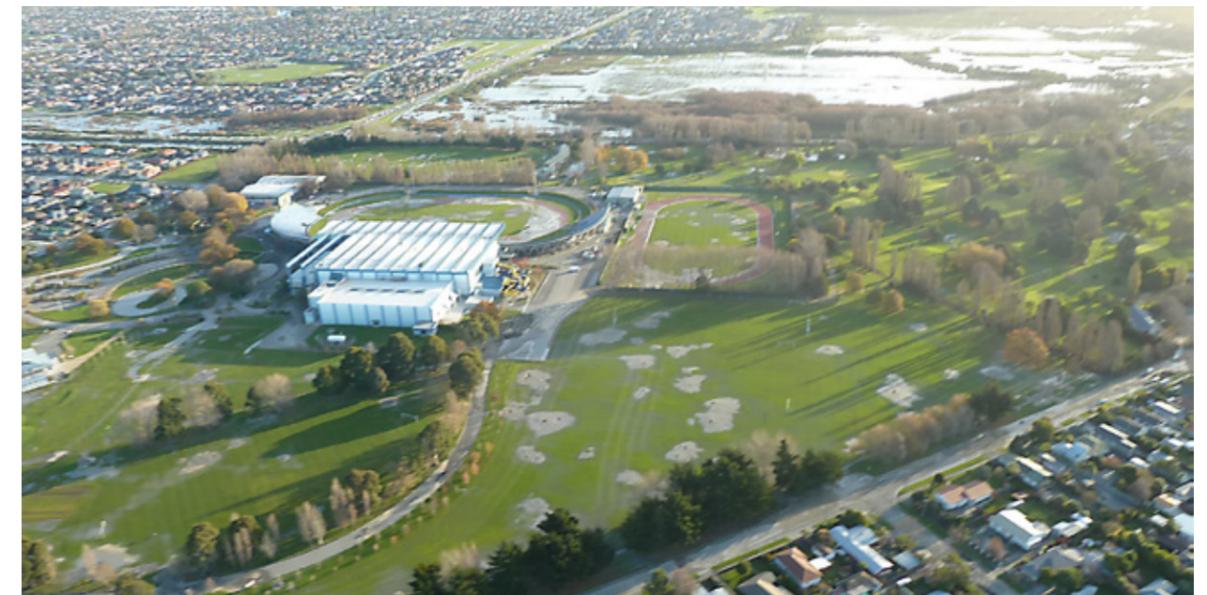
Aerial view of liquefaction effects around QEII park. Photo: Tonkin & Taylor

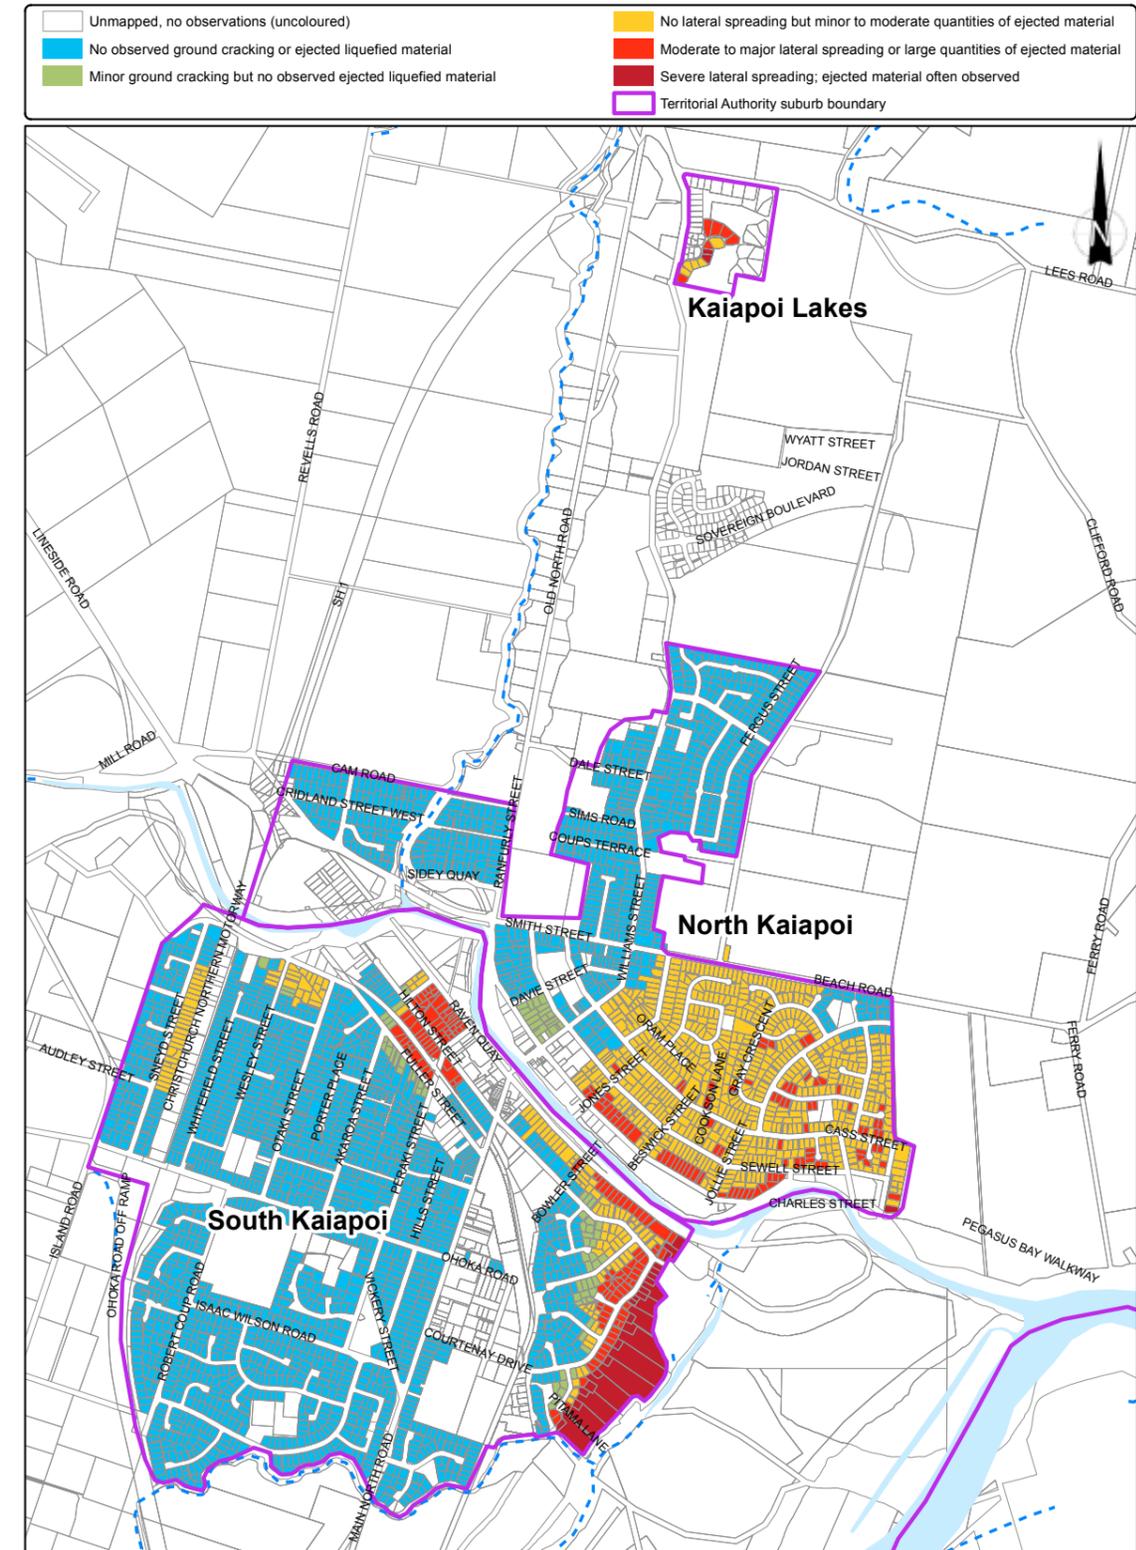
Kaipoi Lakes, North Kaiapoi and South Kaiapoi

| Suburb | Observations |
|---|--|
| Kaipoi Lakes | Moderate to major localised lateral spreading caused by slumping of material around the perimeter of the lakes. Further away from the lake, no surface evidence of liquefaction or related land damage was observed. |
| North Kaiapoi | Widespread moderate to severe liquefaction, sand ejection and settlement. Moderate to major lateral spreading towards Kaiapoi River, however majority of spreading confined to reserve area alongside the river. In the west and north of the suburb, away from the river or on higher ground, no surface evidence of liquefaction or related land damage was observed. |
| South Kaiapoi | Moderate liquefaction in the eastern and riverside areas, causing sand ejection and settlement. Widespread major to very severe lateral spreading in the east, towards the terrace edge and Courtenay Stream. Moderate to major lateral spreading towards Kaiapoi River and small watercourses in some areas, although generally localised to the immediately adjacent properties. Settlement and minor ground cracking has occurred in several areas without any obvious surface evidence of liquefaction, likely due to relaxation of the ground caused by lateral spreading of adjacent areas, or to minor liquefaction occurring at depth below the surface but not being ejected. For the remainder of the suburb, away from the river and streams or on higher ground, no surface evidence of liquefaction or related land damage was observed. |

Figure C1.1 - Overview of liquefaction and lateral spreading observations, from mapping undertaken following the earthquake of 4 September 2010

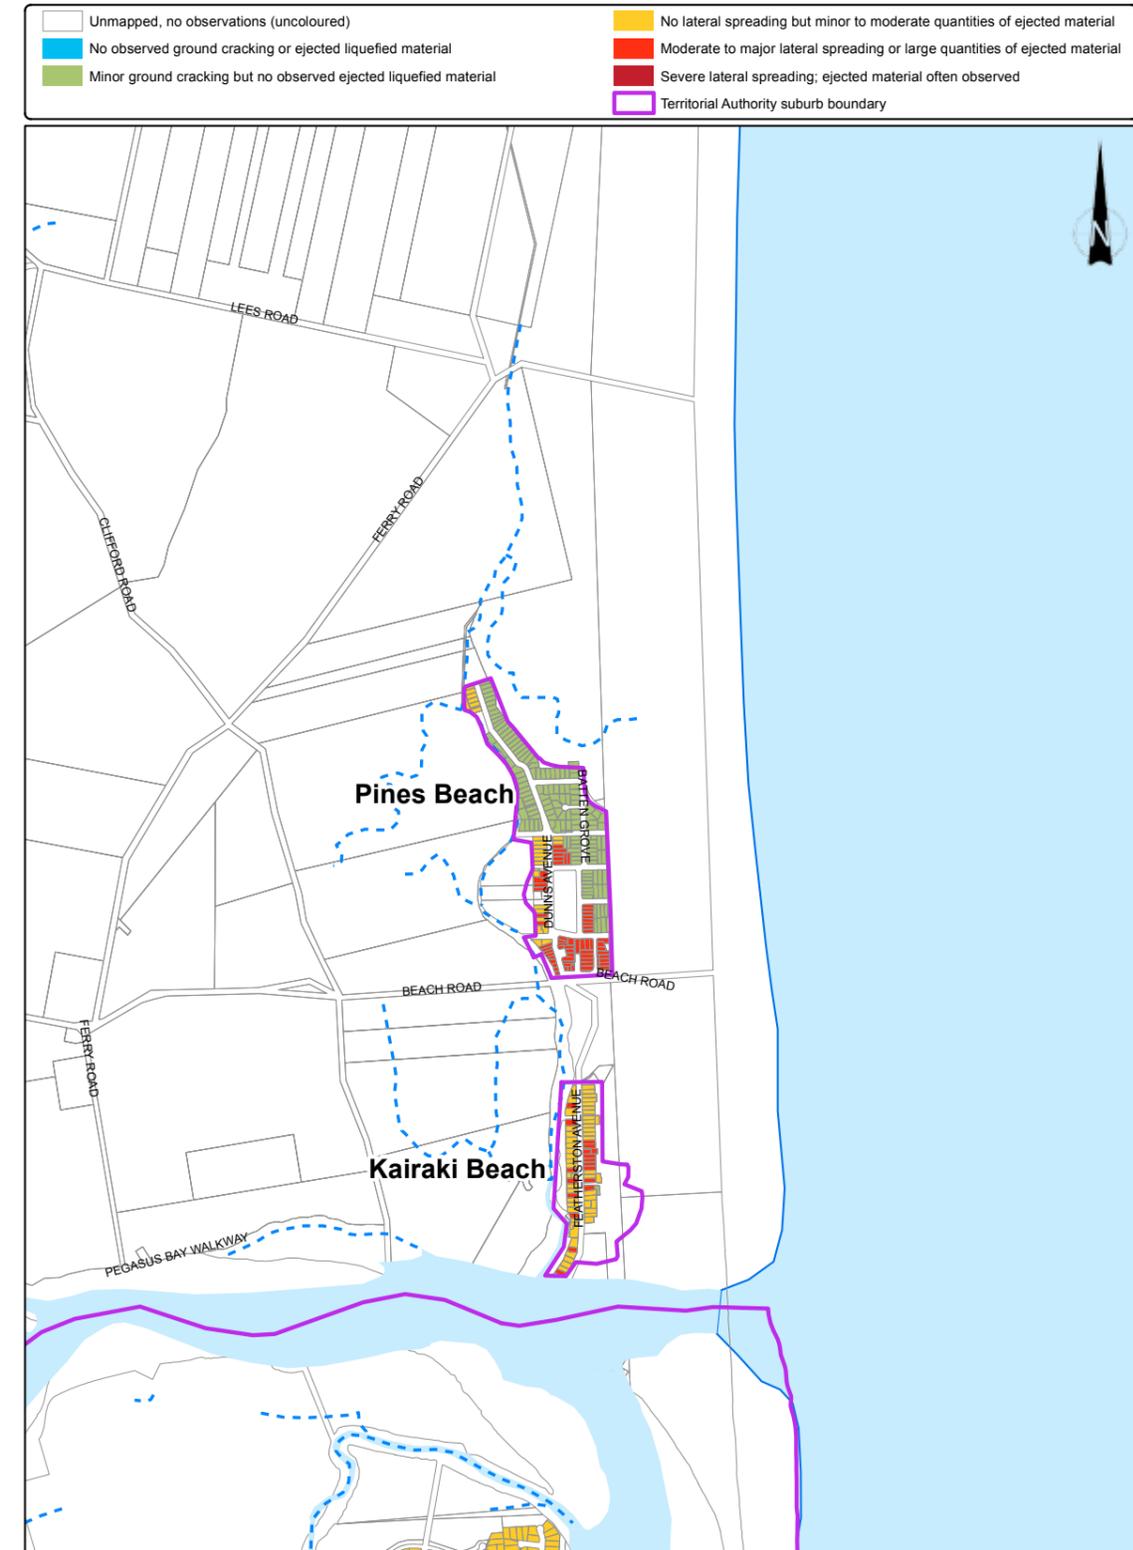
Kairaki Beach and Pines Beach

| Suburb | Observations |
|---|---|
| Pines Beach | In the south and west of the area (surrounding the domain), moderate to severe liquefaction, sand ejection and settlement. Seismic densification and shaking of the sand dunes to the north and east has resulted in minor settlement and ground cracking in this area. Localised moderate lateral spreading towards the creek and lower-lying ground to the west, and at the foot of the dunes towards the domain. |

Figure C2.1 - Overview of liquefaction and lateral spreading observations, from mapping undertaken following the earthquake of 4 September 2010

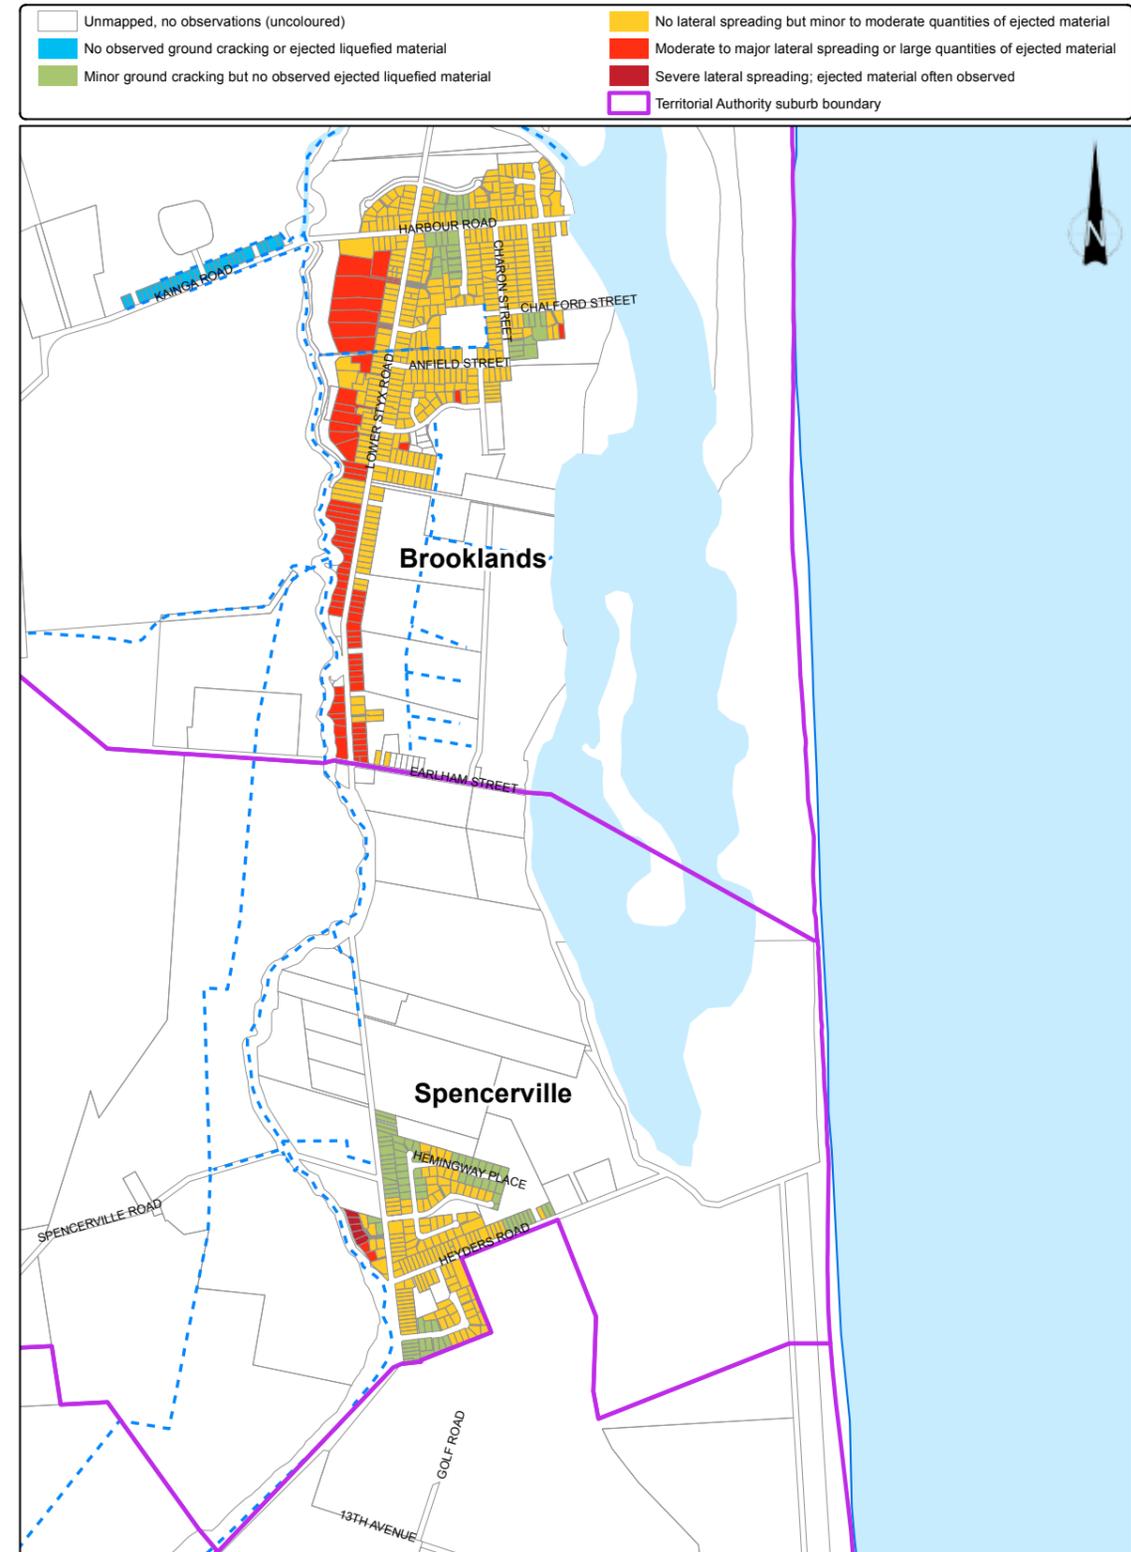
Brooklands (includes Kainga) and Spencerville

| Suburb | Observations |
|---|--|
| Brooklands (incl. Kainga) | <p>Widespread moderate liquefaction in the main residential area, causing sand ejection and settlement.</p> <p>Widespread major lateral spreading in the west of the main residential area, towards the Styx River. Localised moderate lateral spreading in Stewarts Gully (near Kainga) associated with movement of the stopbank towards the Waimakariri River.</p> <p>Settlement and minor ground cracking in several areas without any obvious surface evidence of liquefaction, likely due to minor liquefaction occurring at depth below the surface but not being ejected.</p> <p>For the residential properties to the west of the main Brooklands township (including most of Kainga), there was no surface evidence of liquefaction, but minor ground cracking in some areas.</p> |
| Spencerville | <p>Widespread moderate liquefaction across most of the residential area, causing sand ejection and settlement.</p> <p>Major to severe lateral spreading towards the Styx River, but localised to the properties immediately adjacent.</p> <p>Settlement and minor ground cracking in several areas without any obvious surface evidence of liquefaction, likely due to minor liquefaction occurring at depth below the surface but not being ejected.</p> |

Figure C3.1 - Overview of liquefaction and lateral spreading observations, from mapping undertaken following the earthquake of 4 September 2010

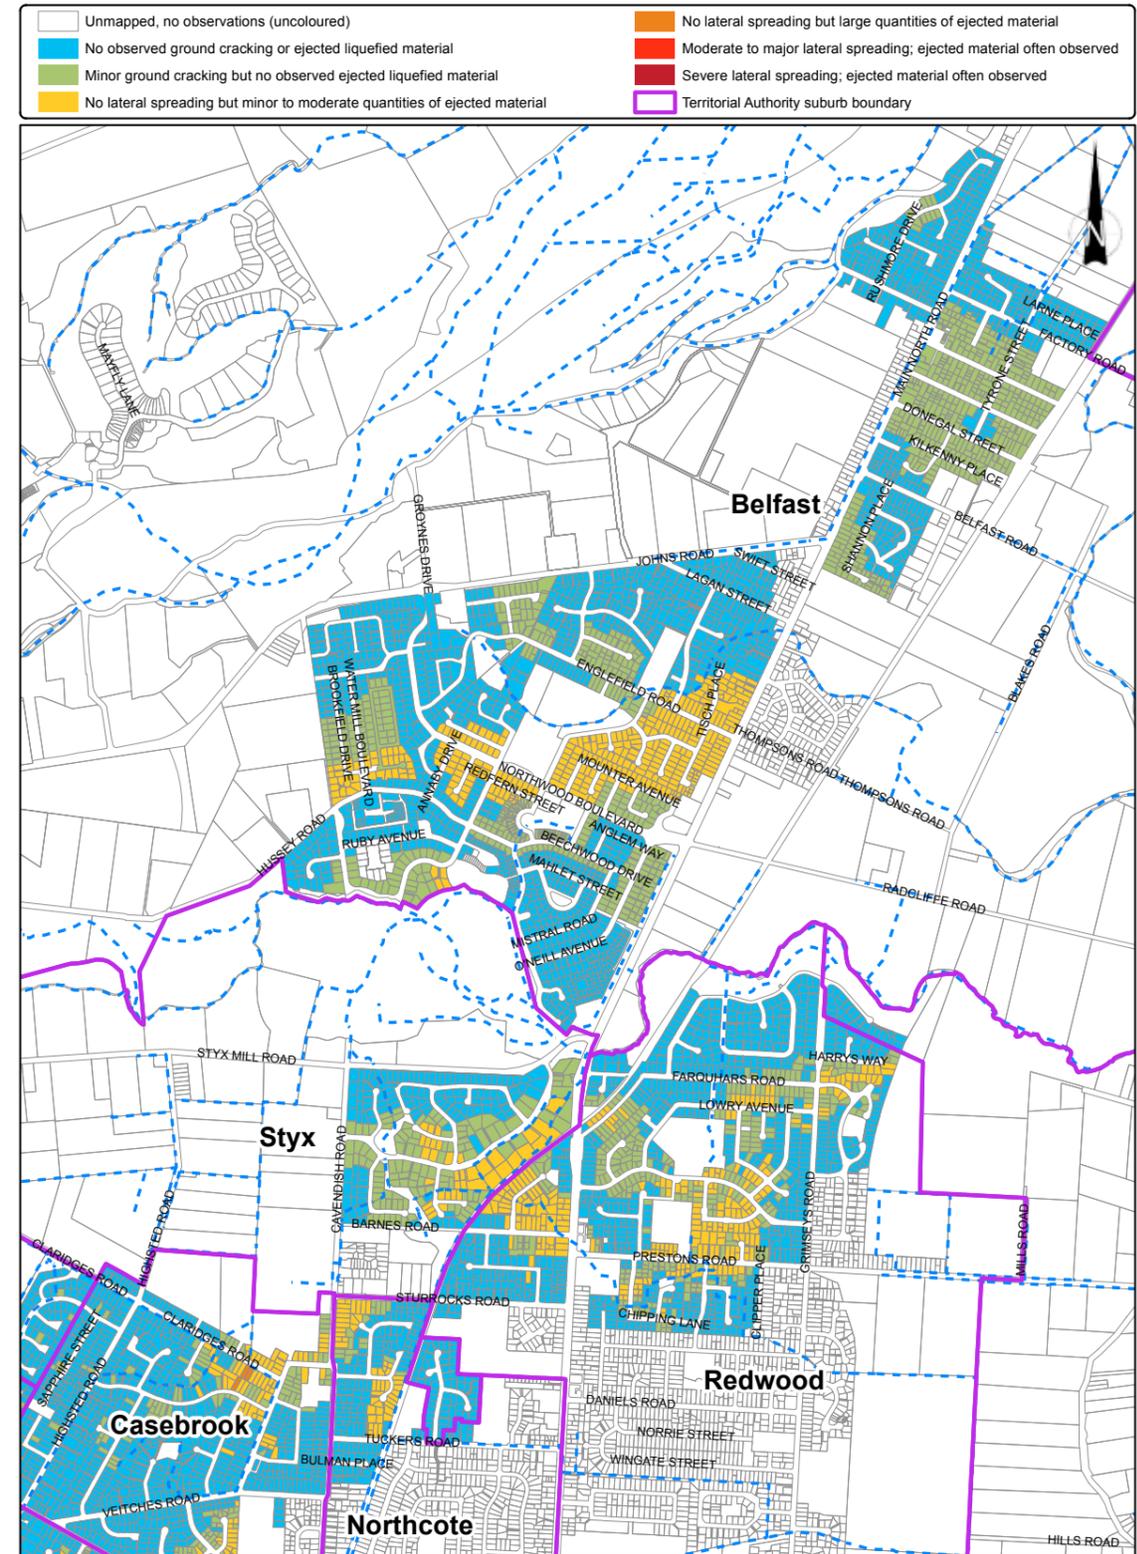
Belfast, Casebrook, Northcote, Redwood and Styx

Figure C4.1 - Overview of liquefaction and lateral spreading observations, aggregated from mapping undertaken following the earthquakes of 4 September 2010 and 22 February 2011.

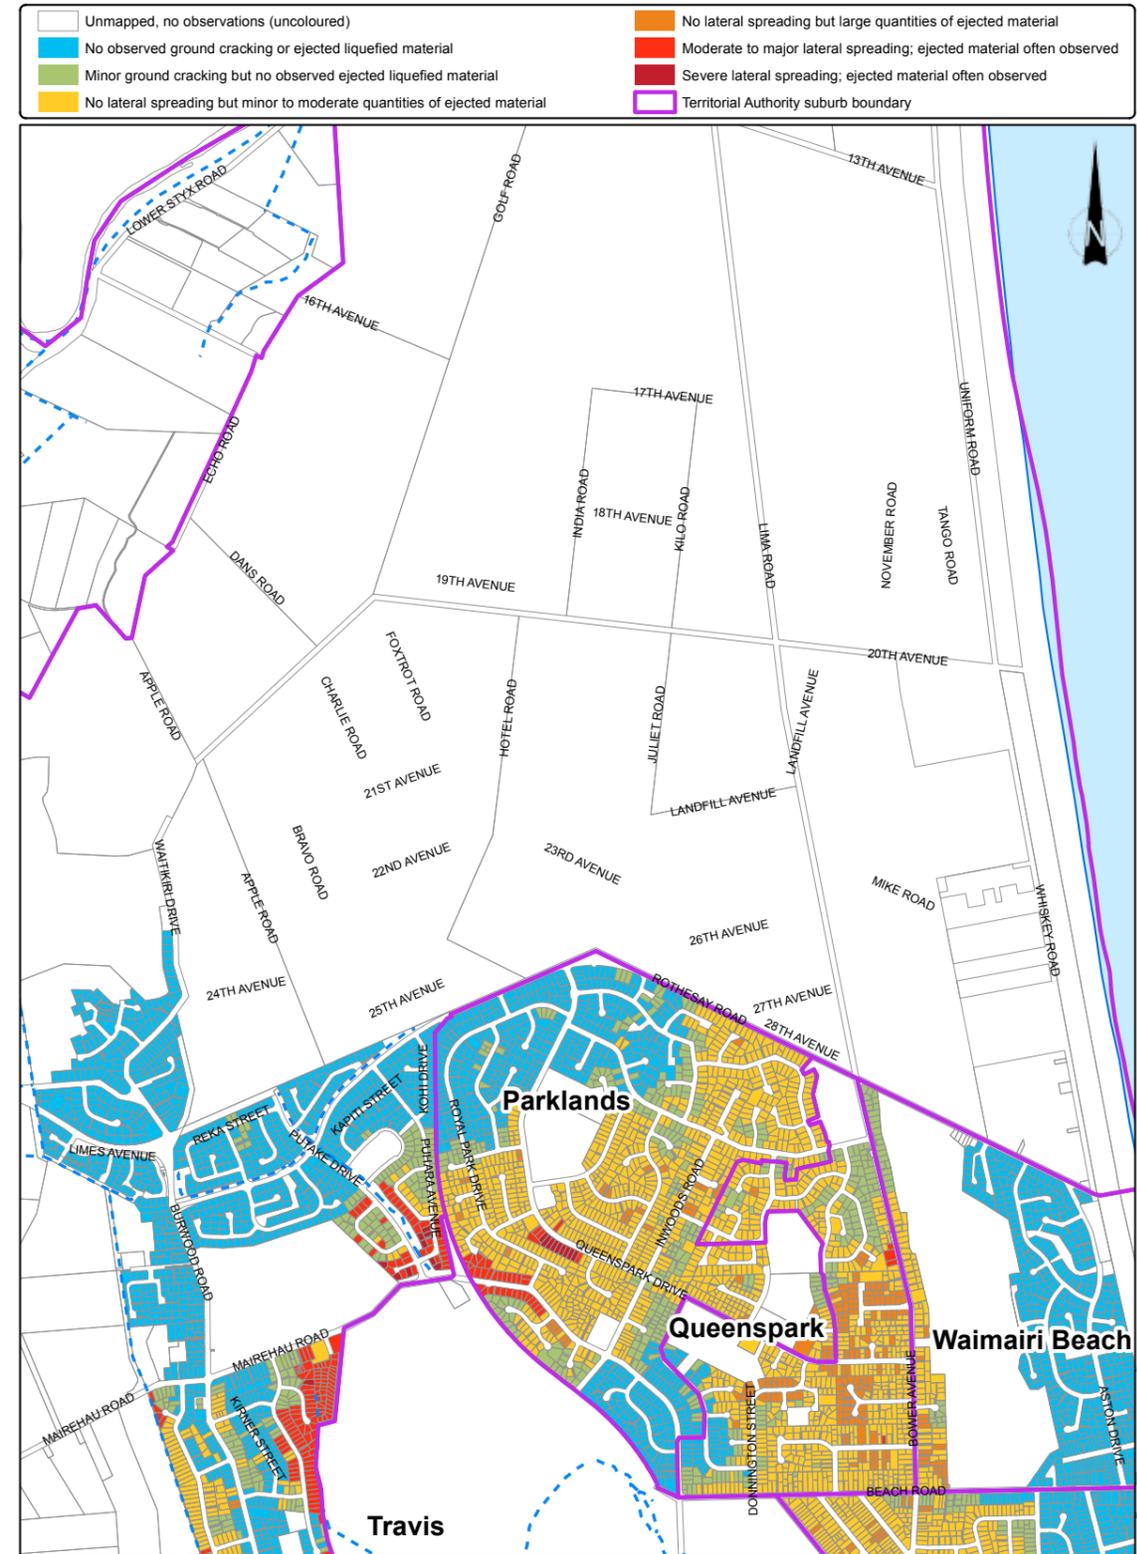
Parklands, Queenspark and Waimairi Beach

Figure C5.1 - Overview of liquefaction and lateral spreading observations, aggregated from mapping undertaken following the earthquakes of 4 September 2010 and 22 February 2011.

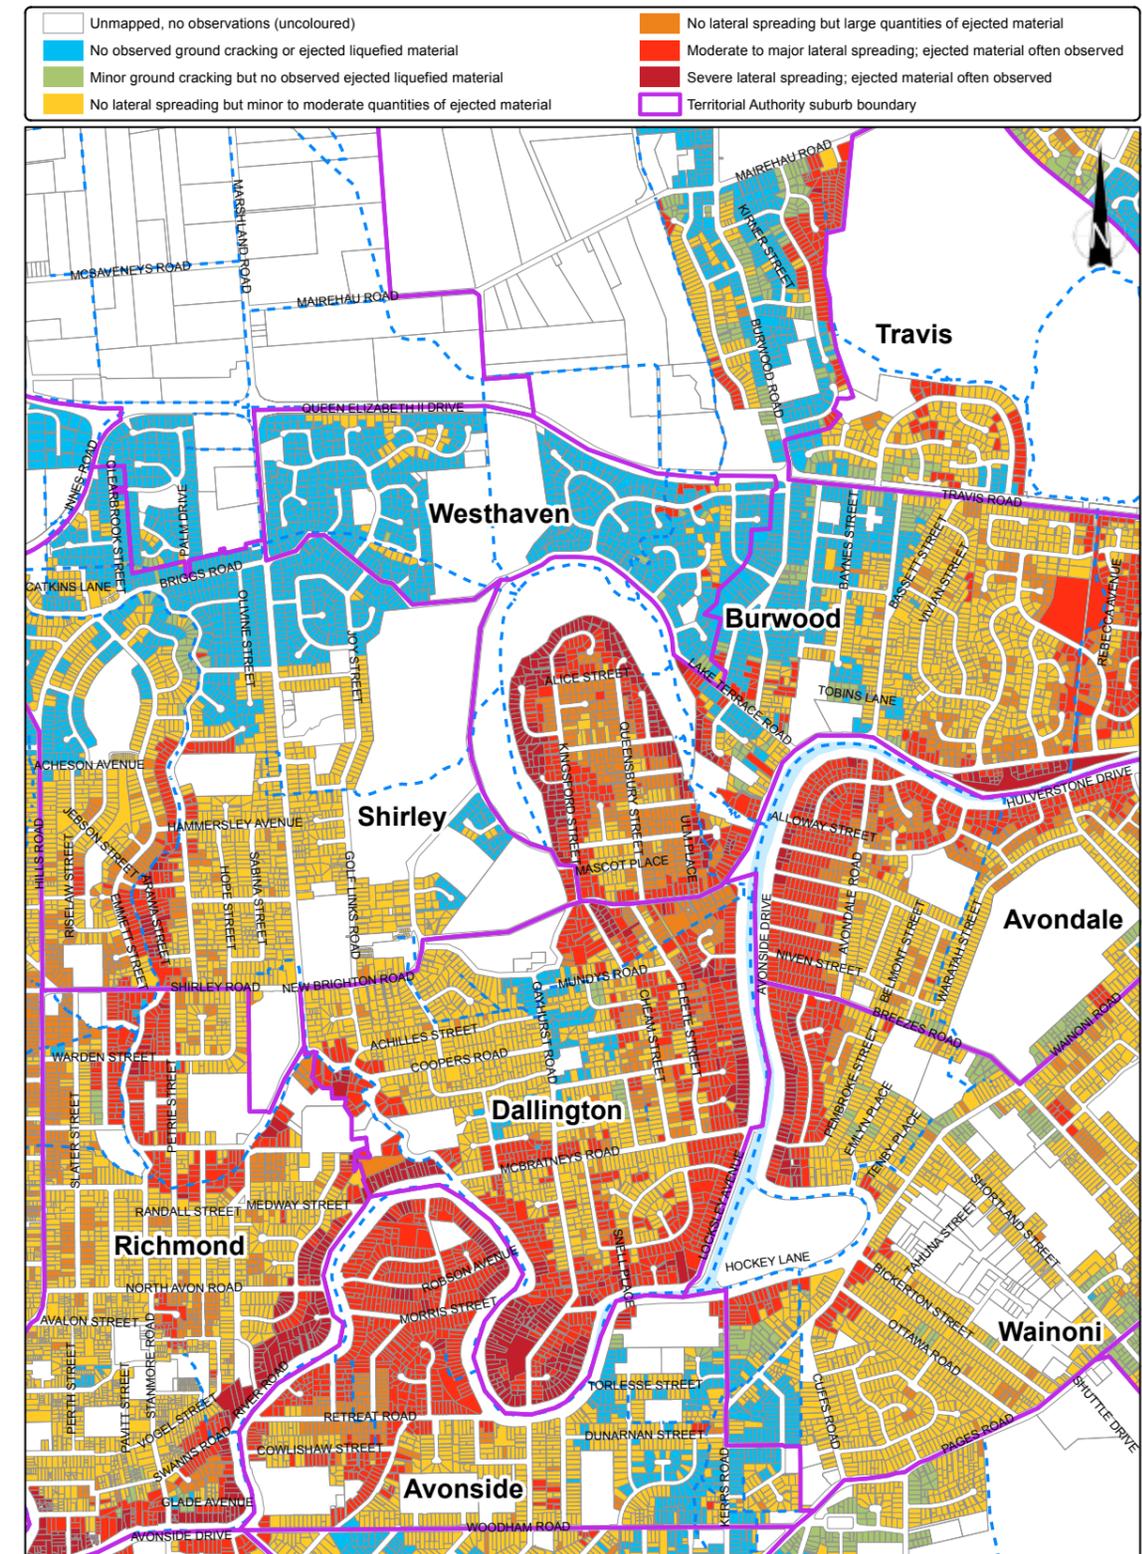
Avondale, Avonside, Burwood, Dallington, Richmond, Shirley, Travis, Wainoni and Westhaven

Figure C8.1 - Overview of liquefaction and lateral spreading observations, aggregated from mapping undertaken following the earthquakes of 4 September 2010 and 22 February 2011.

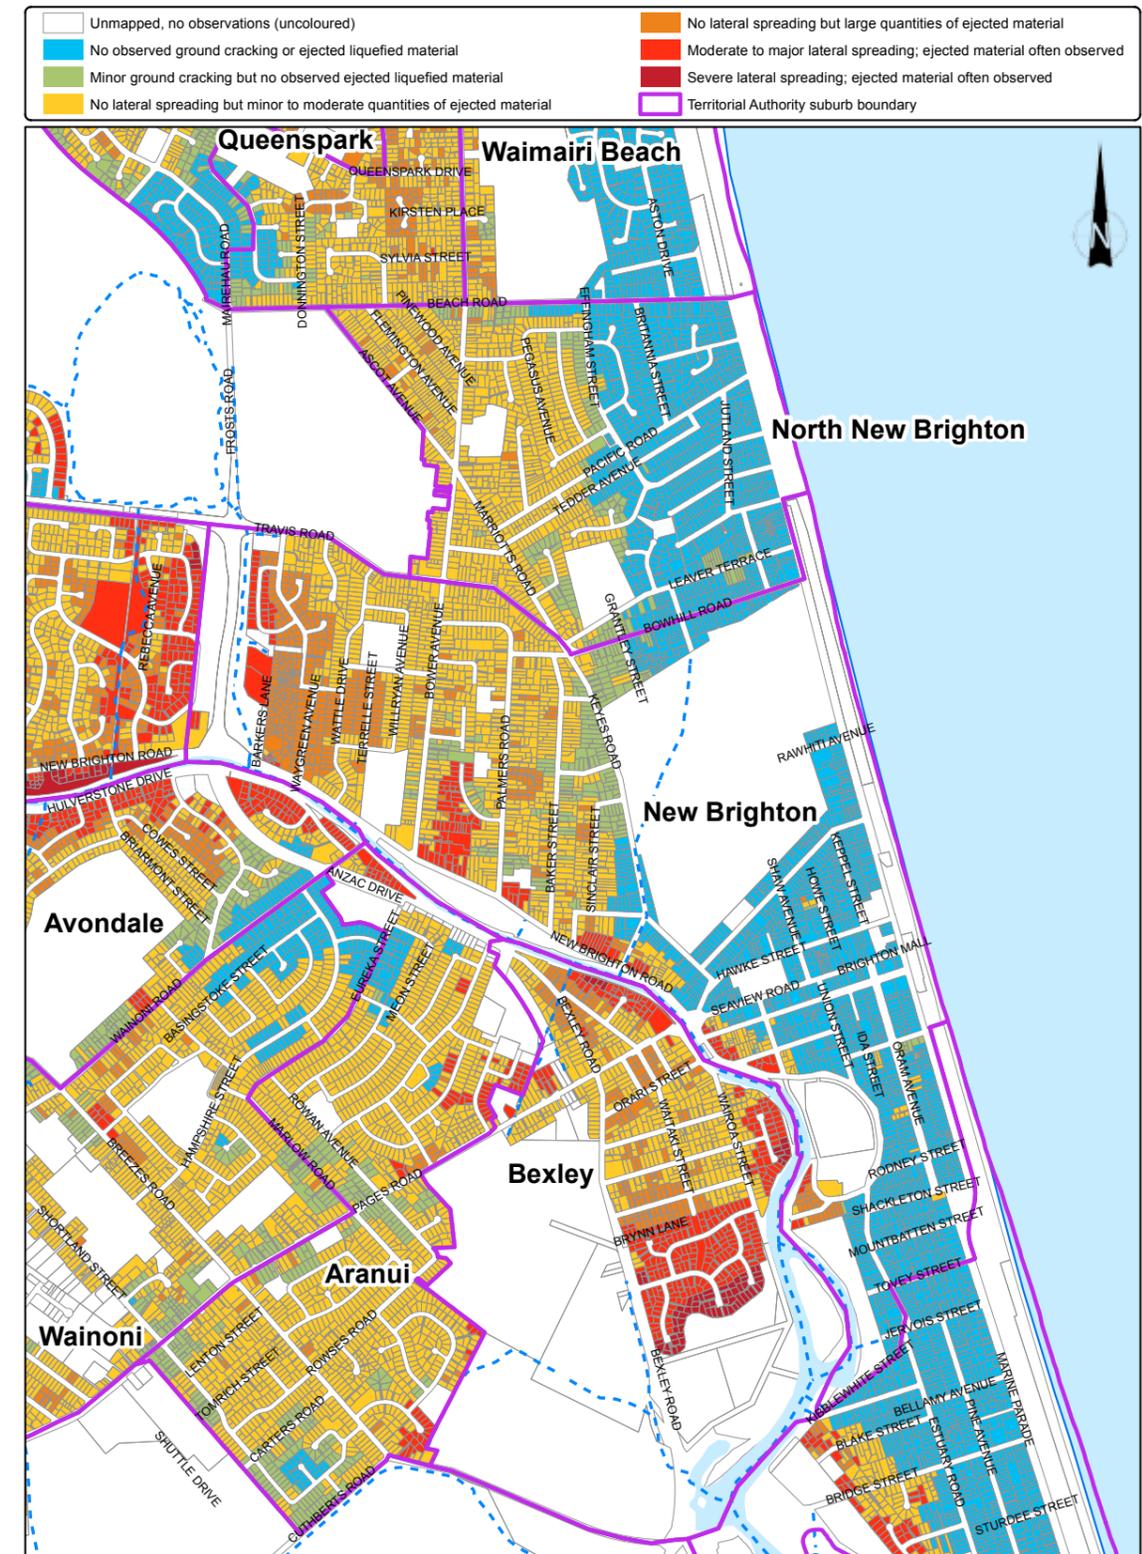
Aranui, Bexley, New Brighton and North New Brighton

Figure C9.1 - Overview of liquefaction and lateral spreading observations, aggregated from mapping undertaken following the earthquakes of 4 September 2010 and 22 February 2011.

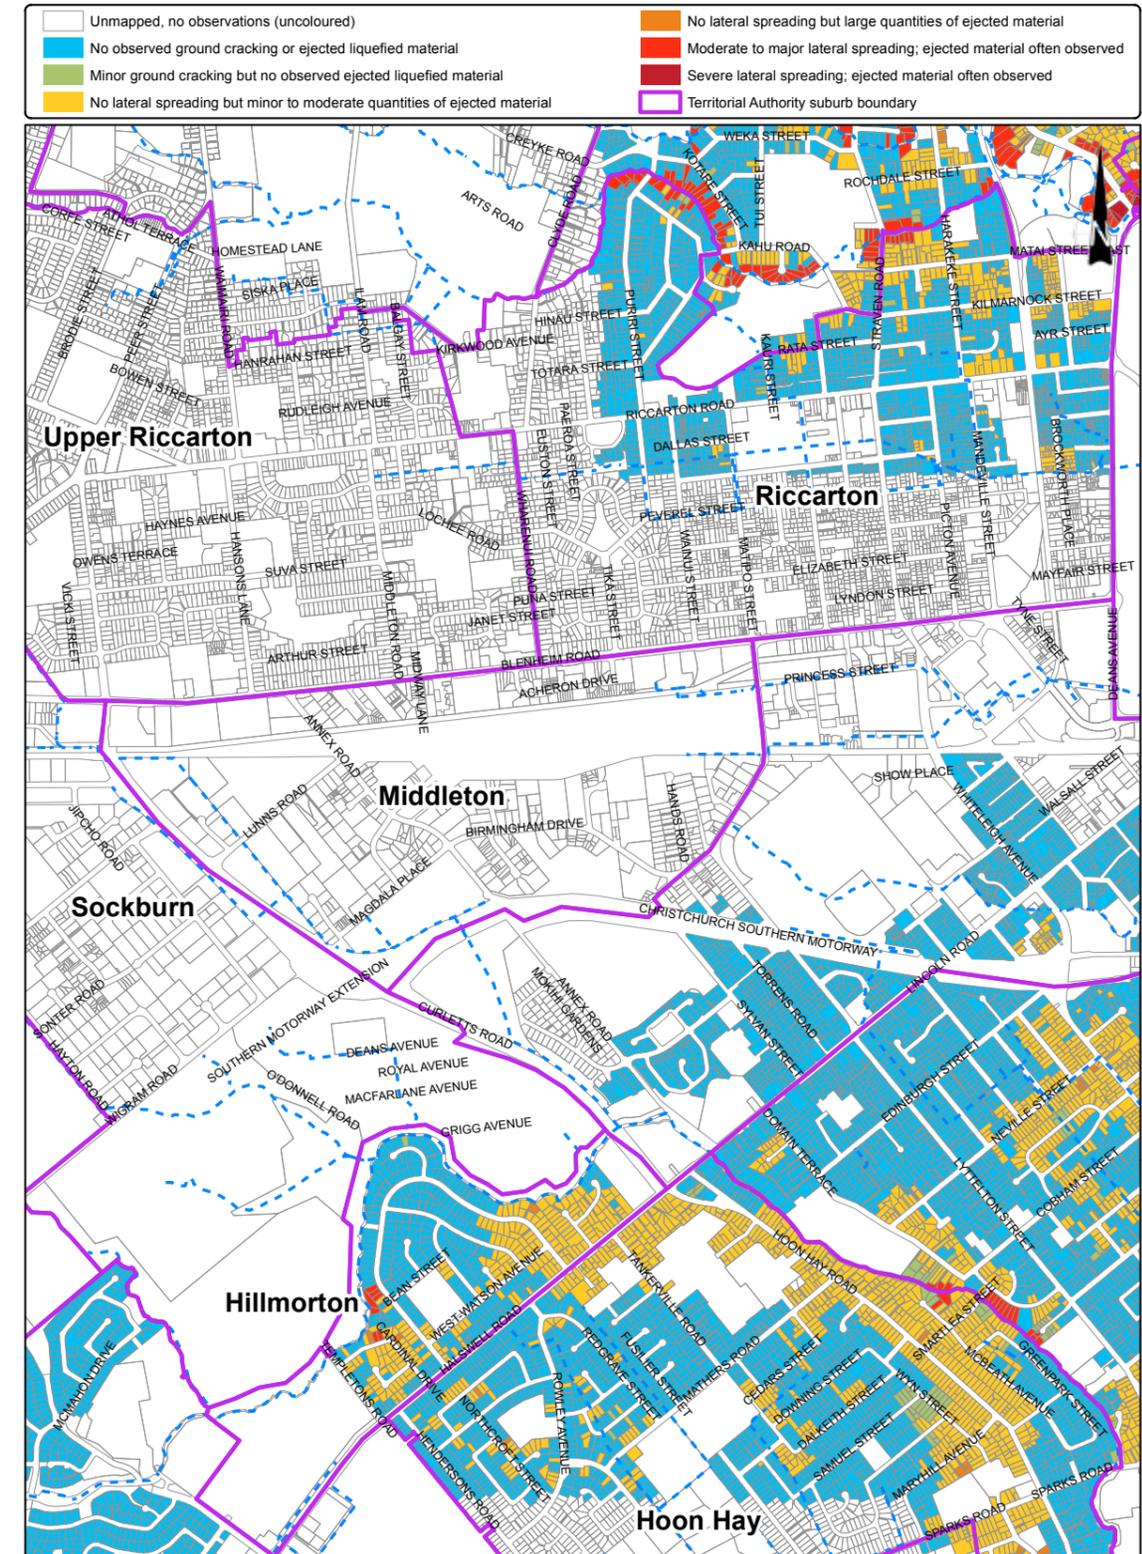
Hillmorton, Hoon Hay, Riccarton and Upper Riccarton

Figure C10.1 - Overview of liquefaction and lateral spreading observations, aggregated from mapping undertaken following the earthquakes of 4 September 2010 and 22 February 2011.

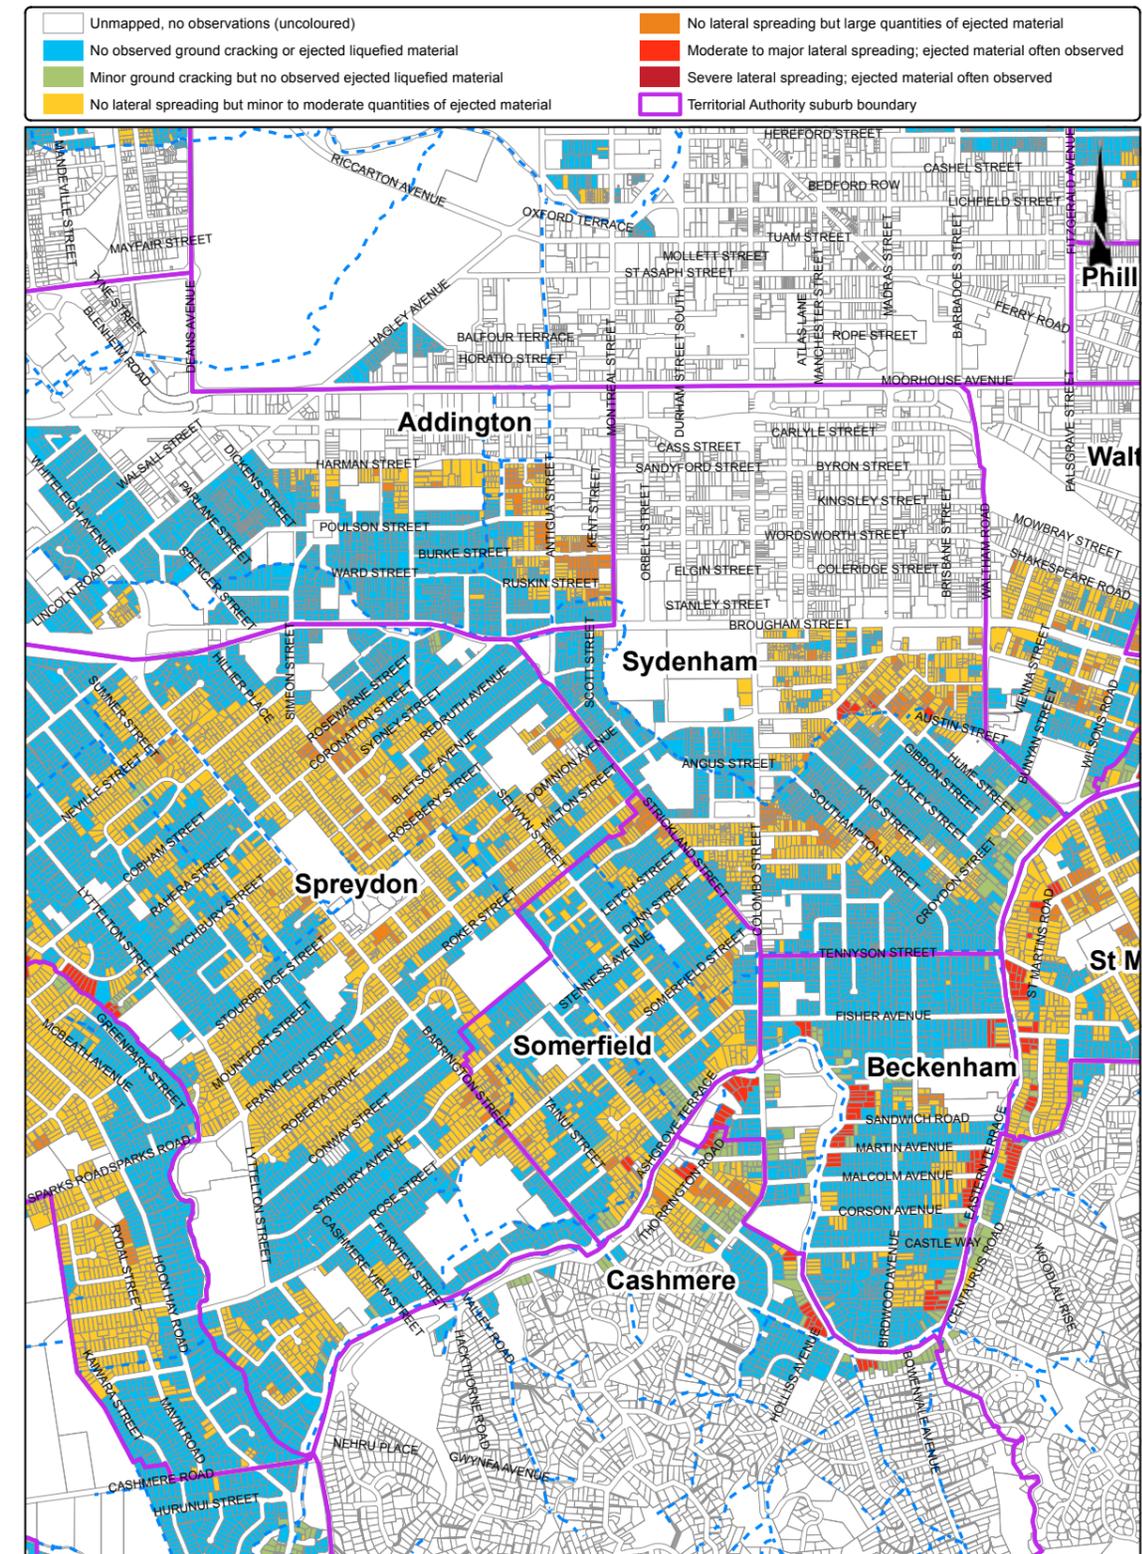
Addington, Beckenham, Cashmere (on the flat), Somerfield, Spreydon and Sydenham

Figure C11.1 - Overview of liquefaction and lateral spreading observations, aggregated from mapping undertaken following the earthquakes of 4 September 2010 and 22 February 2011.

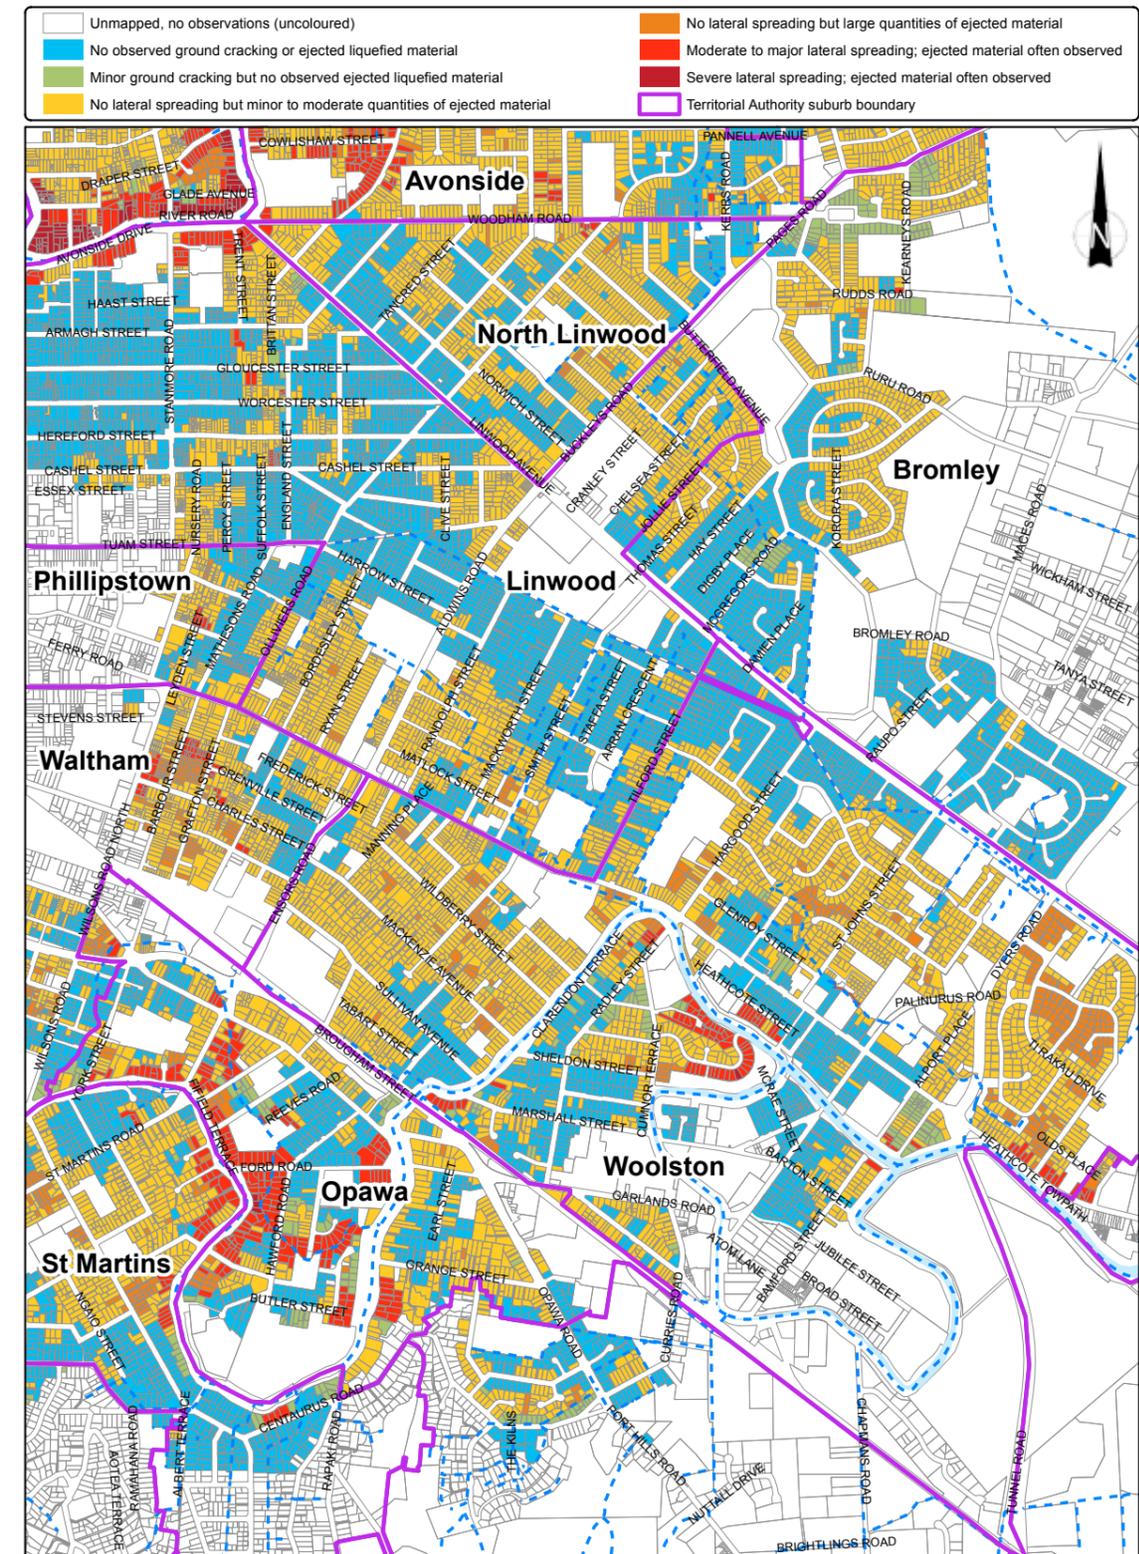
Bromley, Linwood, North Linwood, Opawa, Phillipstown, St Martins, Waltham and Woolston

Figure C12.1 and Table C12.3 present a summary of the property-by-property rapid mapping of liquefaction and lateral spread observations in this area. The observations following the 4 September 2010 and 22 February 2011 earthquakes have been aggregated by assigning each property the most severe observation from either of these two earthquakes. These observed liquefaction and lateral spread mapping colours have completely different meaning to the colour codes used by the Canterbury Earthquake Recovery Authority (Cera) for residential land zoning and the Department of Building and Housing (DBH) for technical categories.

| Suburb | Observations |
|--|---|
| Bromley Linwood North Linwood Phillipstown Waltham | Extensive areas of minor to moderate liquefaction across much of these suburbs (severe liquefaction on a small number of properties), causing sand ejection and settlement. Localised minor to moderate lateral ground displacement and cracking in some areas of sloping ground at the edge of sand dune deposits. For the remainder of these suburbs (often associated with higher ground of dune deposits), no surface evidence of liquefaction or related land effects was observed. |
| Opawa St Martins Woolston | Minor to moderate liquefaction in many areas, with some areas of severe liquefaction, causing sand ejection and settlement. Minor to moderate lateral spreading towards the Heathcote River and Jacksons Creek in several areas, but localised to the immediately adjacent properties. In some areas, settlement and minor ground cracking observed without any obvious surface evidence of liquefaction, likely due to minor liquefaction occurring at depth below the surface but not being ejected. For the remainder of these suburbs, no surface evidence of liquefaction or related land effects was observed. |

Figure C12.1 - Overview of liquefaction and lateral spreading observations, aggregated from mapping undertaken following the earthquakes of 4 September 2010 and 22 February 2011.
