Earthquake Commission

Canterbury Earthquakes 2010 and 2011
Land report as at 29 February 2012

Report prepared for: Earthquake Commission
Report prepared by: Tonkin & Taylor
Distribution: Earthquake Commission, Electronic copy and
Tonkin & Taylor, Electronic copy (File)

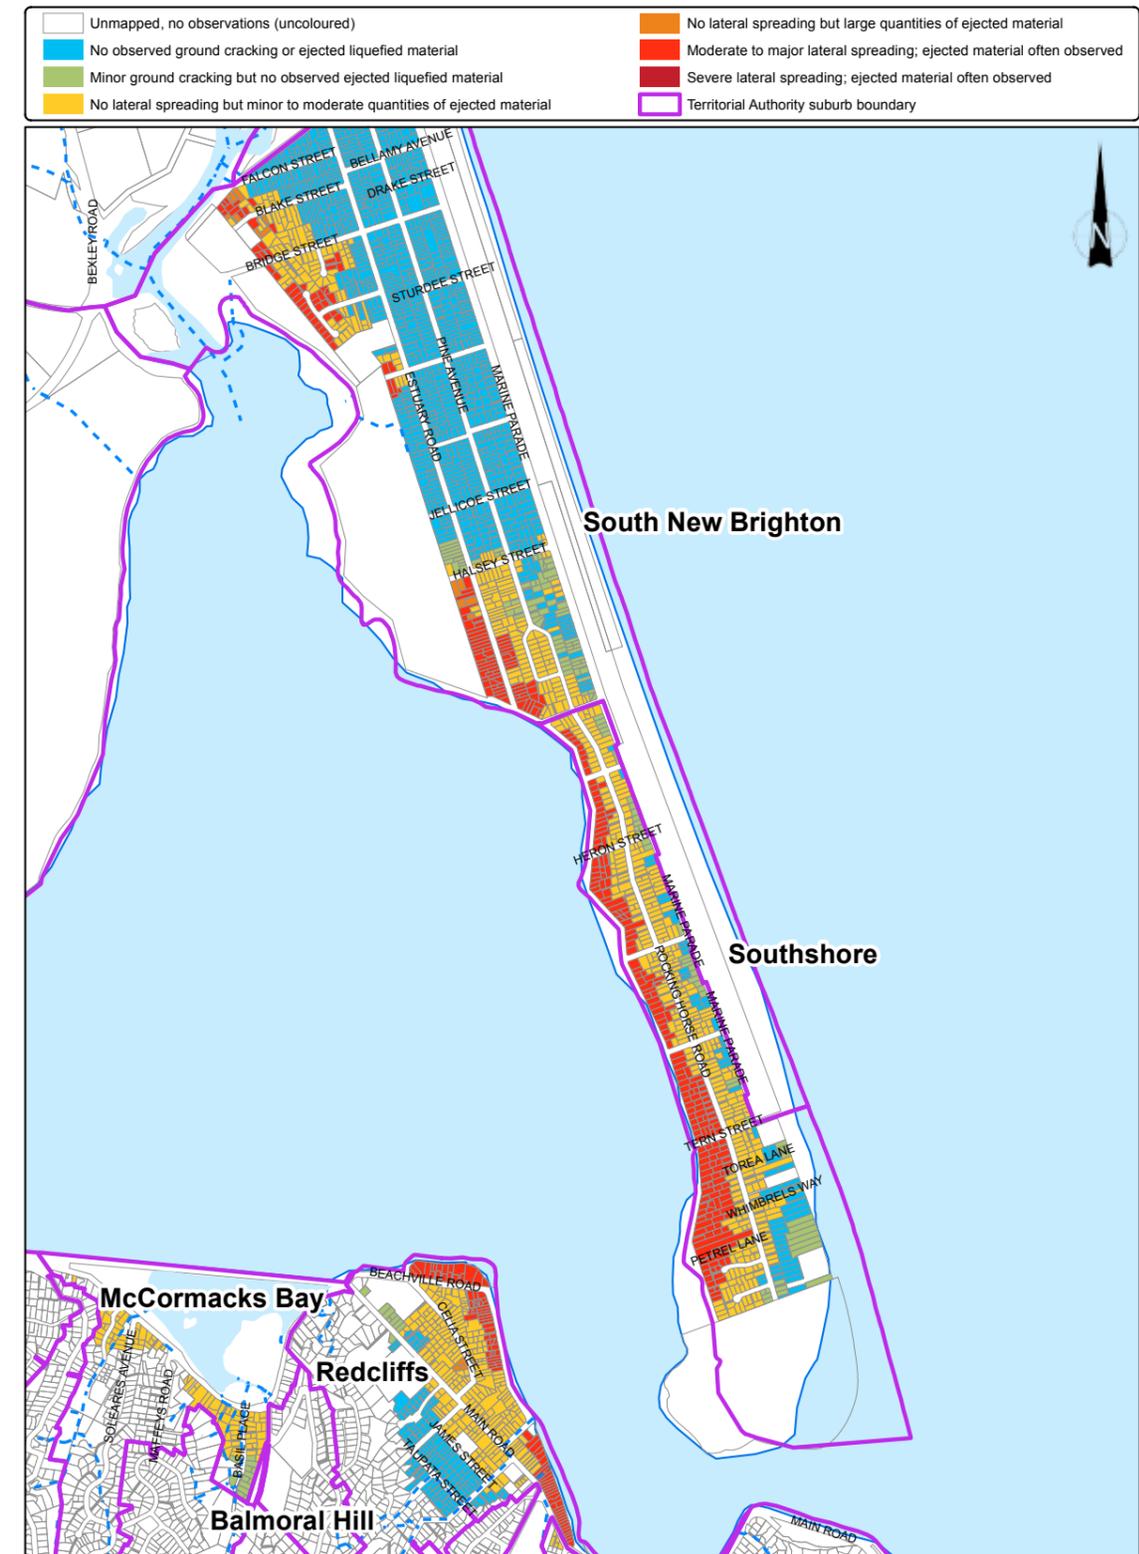
Redcliffs (on the flat), South New Brighton and Southshore

Figure C13.1 and **Table C13.3** present a summary of the property-by-property rapid mapping of liquefaction and lateral spread observations in this area. The observations following the 4 September 2010 and 22 February 2011 earthquakes have been aggregated by assigning each property the most severe observation from either of these two earthquakes. These observed liquefaction and lateral spread mapping colours have completely different meaning to the colour codes used by the Canterbury Earthquake Recovery Authority (Cera) for residential land zoning and the Department of Building and Housing (DBH) for technical categories.

| Table C13.5 - Liquefaction and lateral spread observations | |
|--|--|
| Redcliffs (on the flat) | <p>Extensive areas of minor to moderate liquefaction across most of the lower-lying part of the suburb, causing sand ejection and settlement.</p> <p>Moderate to major lateral spreading towards the estuary, but generally localised to the immediately adjacent properties.</p> <p>In the areas of higher ground further inland, no surface evidence of liquefaction or related land effects was observed.</p> |
| South New Brighton Southshore | <p>Extensive areas of minor to moderate liquefaction across most of Southshore and parts of South New Brighton, causing sand ejection and settlement.</p> <p>Major lateral spreading towards the estuary, varying in extent from one to several rows of houses back from the estuary edge.</p> <p>In some areas, settlement and minor ground cracking observed without any obvious surface evidence of liquefaction, likely due to minor liquefaction occurring at depth below the surface but not being ejected.</p> <p>For the remainder of these suburbs, no surface evidence of liquefaction or related land effects was observed, often associated with the higher ground of dunes or beach deposits.</p> |

Figure C13.1 - Overview of liquefaction and lateral spreading observations, aggregated from mapping undertaken following the earthquakes of 4 September 2010 and 22 February 2011.

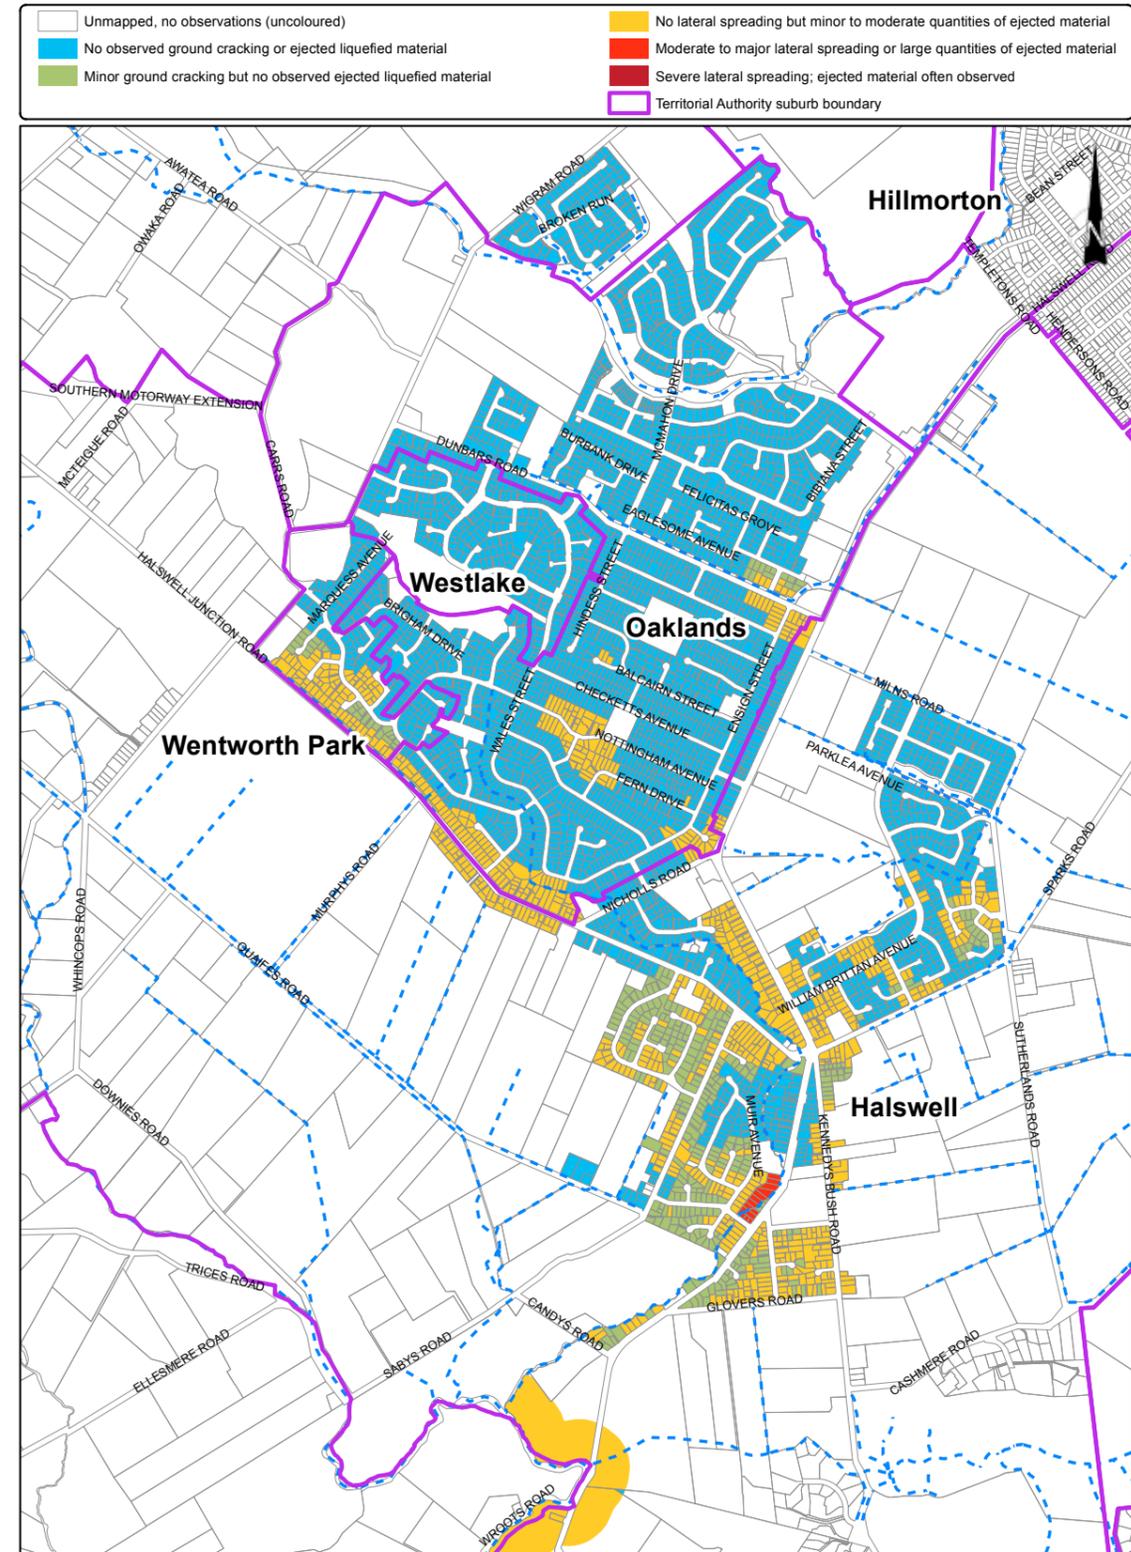
Halswell, Oaklands, Wentworth Park and Westlake

Figure C14.1 - Overview of liquefaction and lateral spreading observations, from mapping undertaken following the earthquake of 4 September 2010

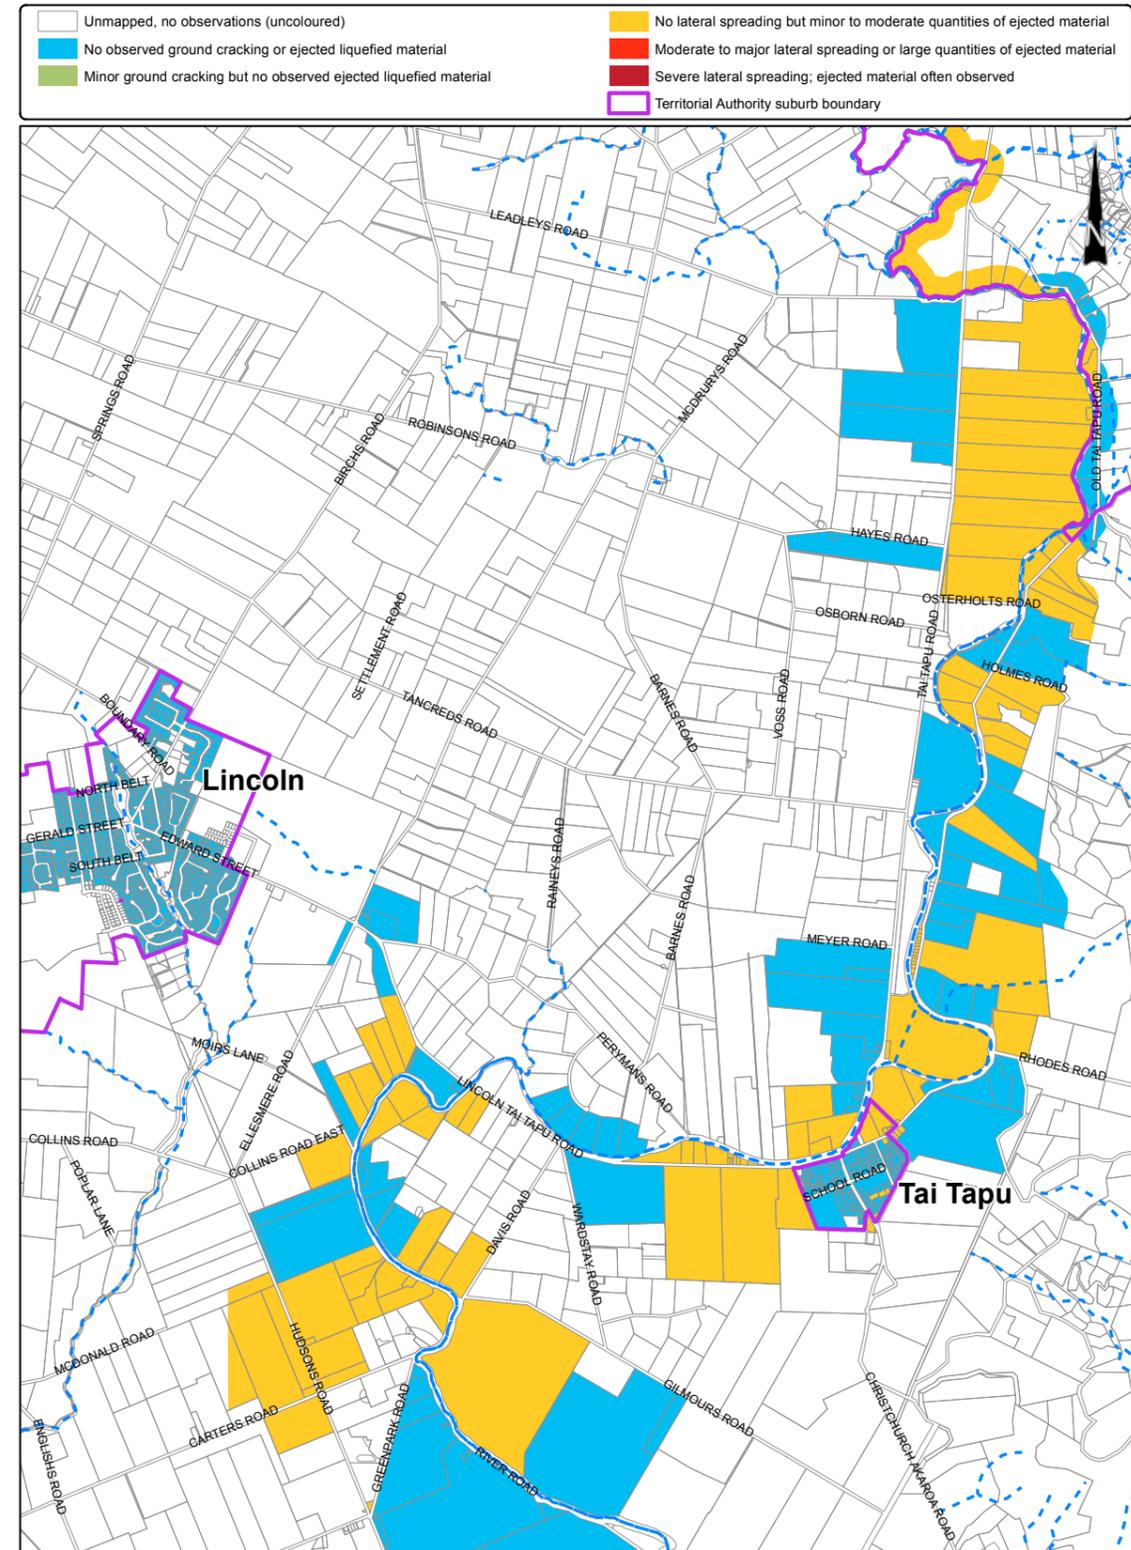
Halswell River, Lincoln and Tai Tapu

Figure C15.1 - Overview of liquefaction and lateral spreading observations, from mapping undertaken following the earthquake of 4 September 2010.
