# Earthquake Reconnaissance in Bangkok, Thailand, following the 28 March 2025 Mandalay Earthquake

Prepared by: Andrew Stolte, Catalina Miranda, Andrew Baird, Jitendra Bhatta, Jitendra Bothara, Chungwook Sim, and Lucas Hogan

March 2026

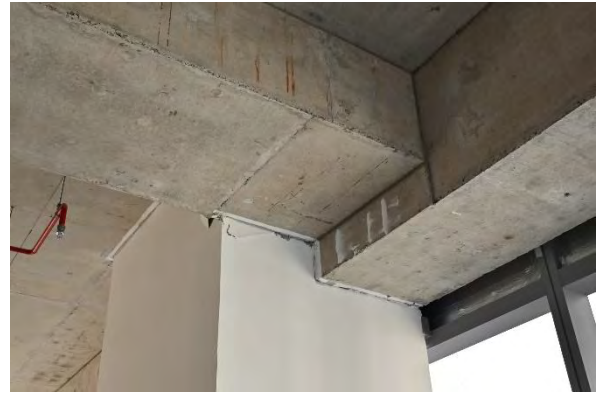
(b) Joint at beam and slab damage

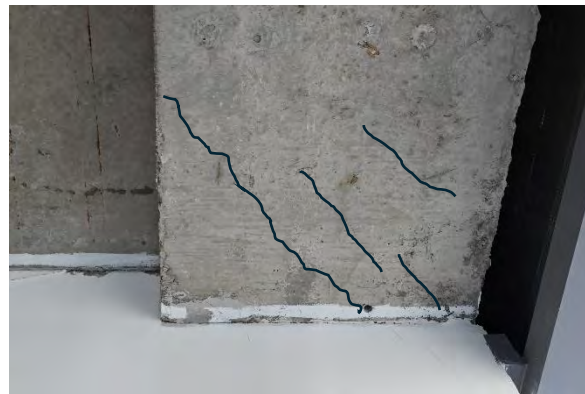
(c) Cracking on soffit of beam (crack width ~0.2 mm)

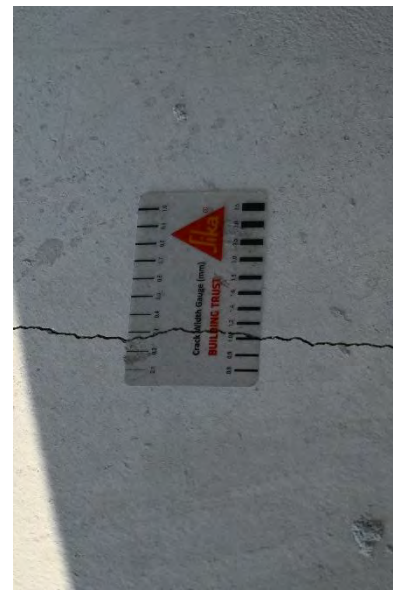
(e) Measurement of floor topping crack (crack width = 1.0 mm)

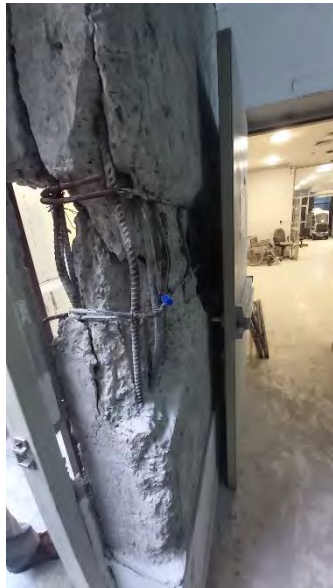
building at what appears to be the top of a lap splice in the ground floor (Figure 11). No other structural walls or columns exhibited damage.

(c) Through-thickness failure of the wall in the north-south direction

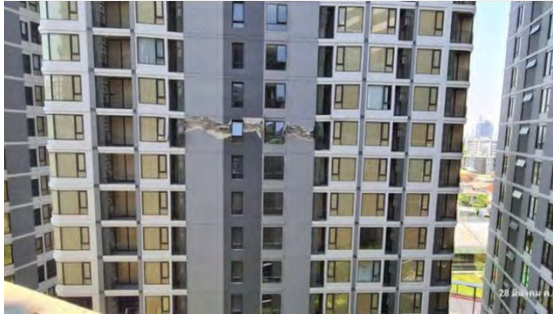
The building suffered severe damage through an axial compression failure at the 9<sup>th</sup> floor the core walls on the south elevation of the building (Figure 14). This resulted in a 150 mm settlement at floor 9, resulting in a residual roof drift of 500 mm (approx. 0.5% residual drift). The walls around the stairwell and lift core were crushed and shortened, as evidenced by the buckled bars that were left protruding from the walls after emergency repairs were conducted. The floors below level 9 either had no damage or very minor cracking.

The likely causes of this damage are not clear. Potential exacerbating factors would be the very narrow aspect ratio and the limited walls in the building's transverse direction, generating large overturning demands on relatively thin (200 mm) core walls on the southern elevation of the building. No lap splices were evident in the buckled bars or damage photos, so it is unlikely that this damage was a result of the termination of longitudinal reinforcement. Another possible contribution is that it is common construction practice in Thailand to use 3-storey jump forms. It is possible that there was an issue with the concrete pour at the start or termination of one of these lifts. No concrete materials testing was available to the reconnaissance team, so the influence of material properties is conjecture at this time. While only one building exhibited significant damage, one of the adjacent towers appeared to have the onset of similar damage at the 9<sup>th</sup> floor, with a bulging of the wall in a horizontal line (Figure 15). This bulging is also visible one storey above the axial failure in the damaged building.

*(a) Wall damage on the 9<sup>th</sup> floor*

The building was undergoing emergency stabilisation while the reconnaissance team visited. The stabilisation included propping of the wall with steel columns and corbels to connect the sections above and below the failure plane. The failed core walls were cast with concrete to provide compression capacity, and the buckled longitudinal bars were left on the interior of the building. Following the initial stabilisation, the building was being repaired with a variation of the “speed core” system from AISC using 16 mm plates with bolts cored through the existing wall spanning between floors 8 to 10. Gap between plates and wall will be filled with grout and the plates are connected together with a single groove full penetration weld. Once the grout has cured, the anchors through the thickness of the wall will be pre-stressed.

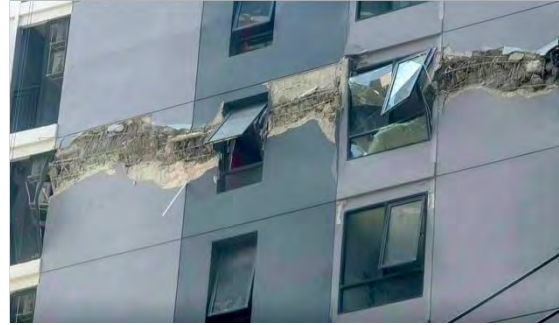
*(b) Wall damage on the 9<sup>th</sup> floor*

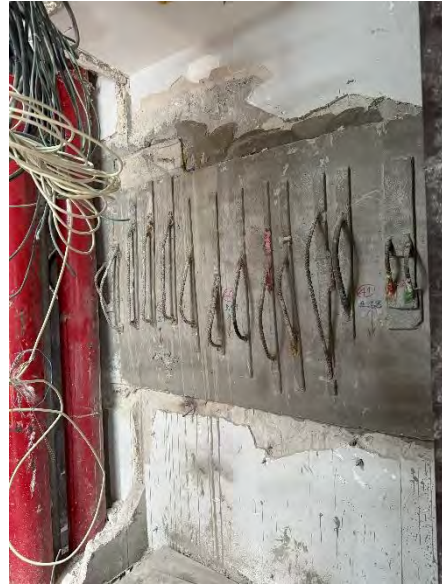
(j) Buckled rebar in stair well

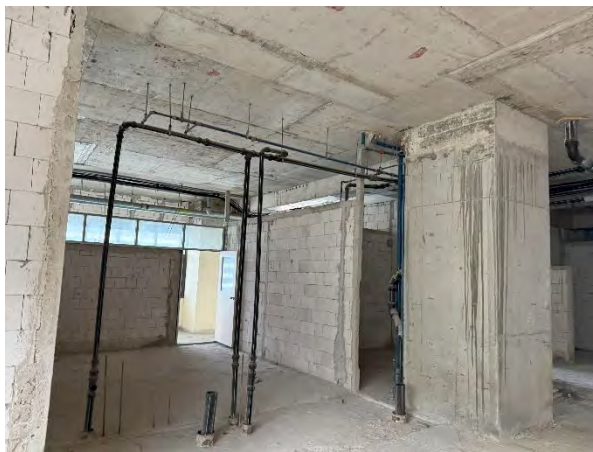
(c) Services pipes layout, note no bracings

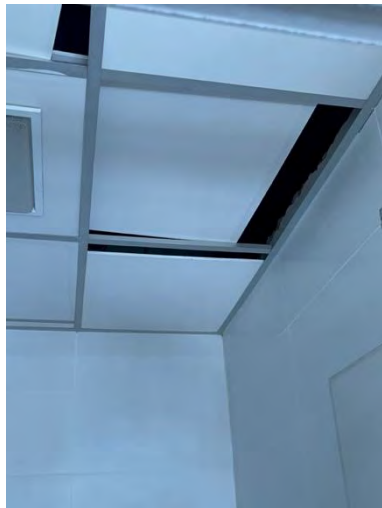
Plasterboard ceiling (prevalent in 80% of buildings) showed consistent damage at perimeters (at wall interfaces) (for e.g. in buildings H1, R2, and C2) whereas grid-and-tile ceilings were less commonly reported as damaged (only tile displacement was observed in building H1). The damage severity correlated with building height, with stories one-third to one-half up the building experiencing more pronounced cracking, perhaps due to greater drift demands. The wall-to-ceiling interfaces are observed to be recurring weak points, possibly indicating inadequate edge detailing. Typical damage to ceilings is shown in Figure 19.

(a) Damage to grid-and-tile ceiling on Floor 18 of Building H1

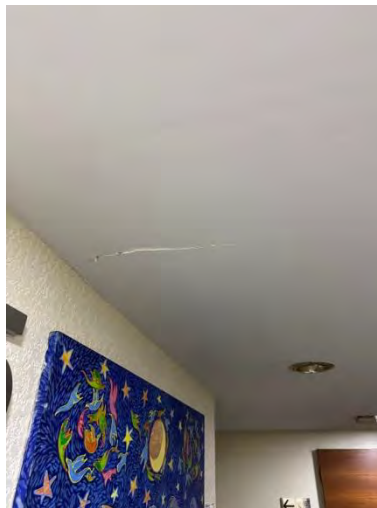
(b) Damage ceiling on Floor 15 of Building R2

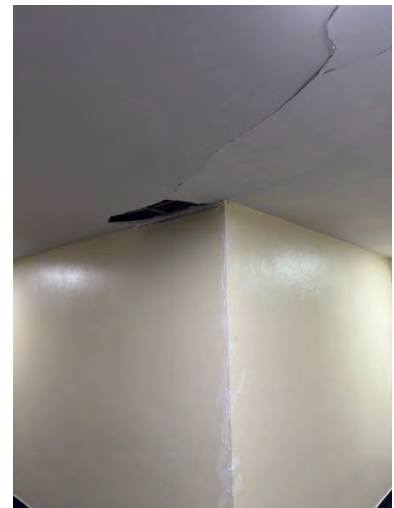
(b) Damage ceiling on Floor 18 of Building R2

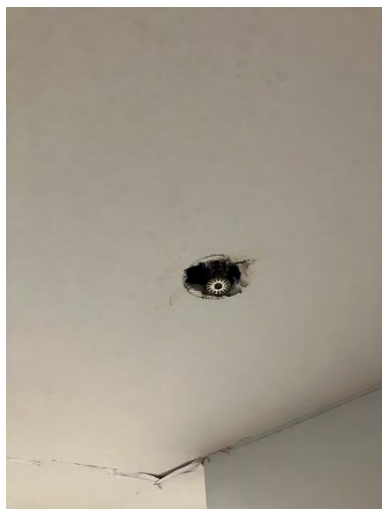
Mechanical services revealed almost no damage and most of them remained functional. Sprinkler pipe interactions caused wall damage in building R1. Water pipework damage led to rebar corrosion and the shutdown of water supply to affected taps in building R3 (in 5th and 6th stories). Although, ejection of sprinkler escutcheons (in building H1) is considered as minor damage it indicates possible interaction between sprinkler heads and adjacent ceiling. There was swimming pool surge tank leakage in building R3 and water tank damage in building R4. Typical damage to mechanical and plumbing services is shown in Figure 20.

(a) Ejection of sprinkler escutcheon on Floor 18 of Building H1

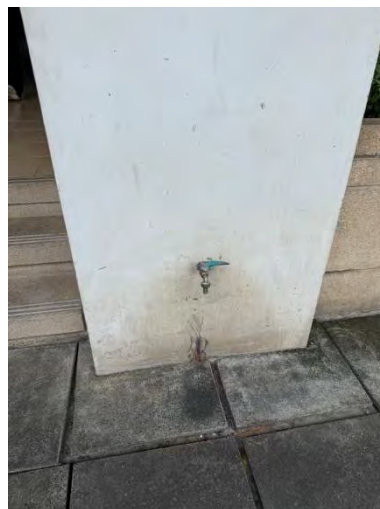
(b) Damage to water supply tap on Floor 5 of Building R3

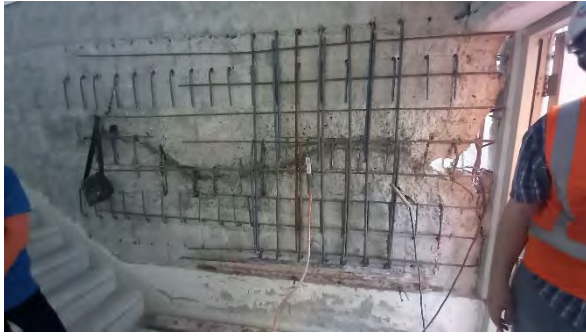
| Main Structural damage | <ul style="list-style-type: none"> <li>Through-thickness failure of two walls in the southeast corner of the building in ground floor only</li> <li>Longitudinal bars buckled along the wall length</li> </ul> |
| Likely causes | <ul style="list-style-type: none"> <li>Appears to have occurred at a cold joint in the wall above the lap</li> <li>Poor confinement</li> <li>Low concrete strength – samples gathered by Thai engineers showed approx. 15 MPa while 30 MPa specified</li> </ul> |

*(a) Repair to through-thickness failure of wall in y-direction*

| Comments | <ul style="list-style-type: none"> <li>Damaged walls on the exterior of the stairwell.</li> <li>Repair being undertaken while on site, repair is utilizing 90-degree hooks at the boundary for transverse reinforcement</li> <li>Building did not lose functionality immediately after the earthquake (11 operations active during the earthquake), no issues with backup generators, decision was made to vacate the building due to wall damage and repairs required to internal wall finishes.</li> <li>Building renovation happening simultaneously - building expected to be fully operable in July 2025 – opening floor-by-floor.</li> <li>Aerated infill block (block + CS plaster on both faces with chicken mesh) and hollow clay block (with CS plaster). Block thickness 75 mm. Bond beams are included in the tall wall.</li> <li>No diagonal bracing to hanging services ducts.</li> </ul> |

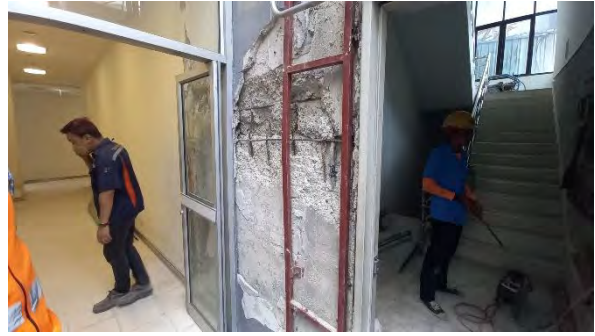
*(b) Repair to through-thickness failure of wall in x-direction*

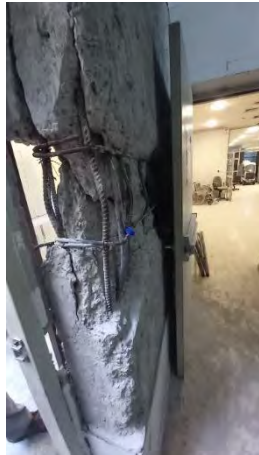
*(c) Through-thickness failure of the wall in the X-direction*

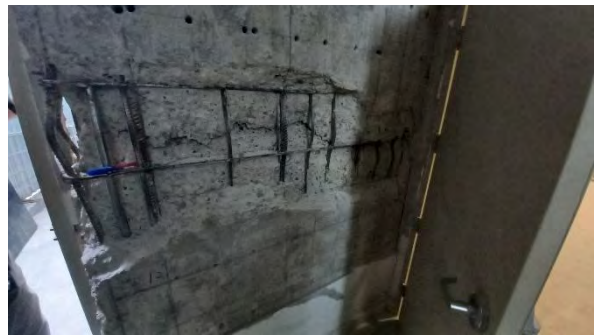
*(d) Through-thickness failure of short wall in X-direction with repair initiated, looking from inside*

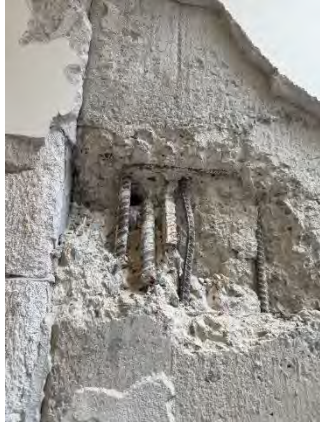
(e) Rebar splicing in the short RC wall along X-Dir

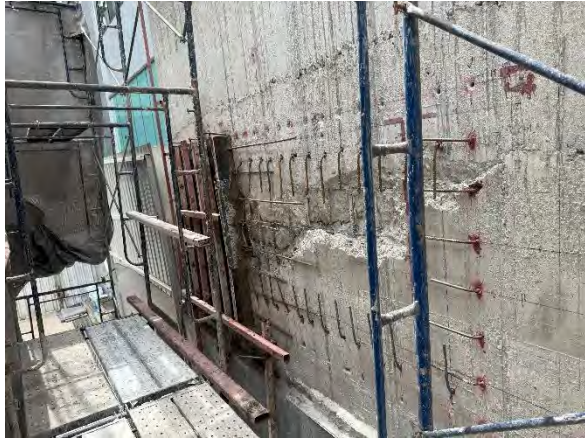
*(i) Damage to Y-dir wall on the perimeter (next to stair), wall under repair*

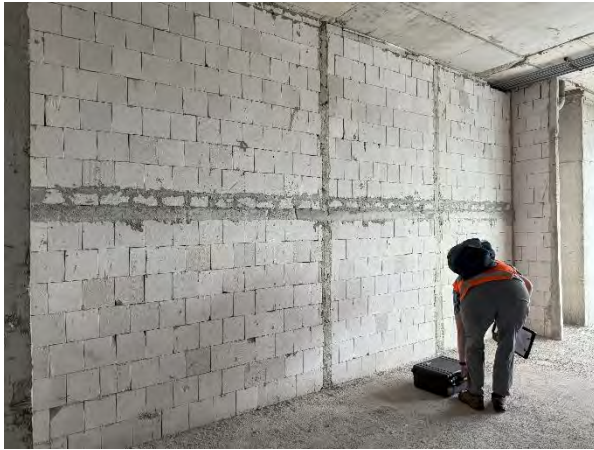
(a) AC infill wall (75 mm thick), note mostly dry joints

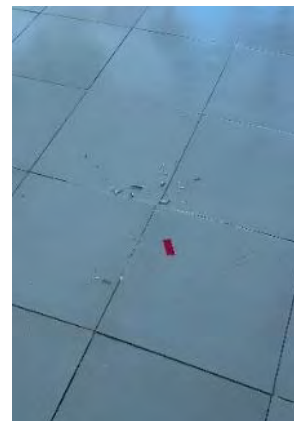
*(d) Damage to ceramic tile floor covering*

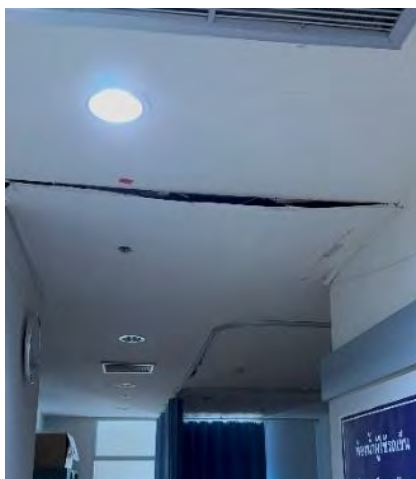
*(e) Damage to plasterboard ceiling*

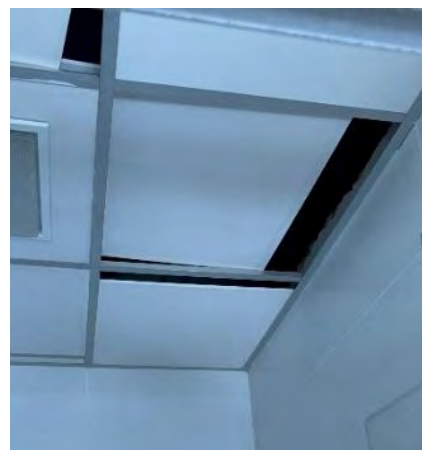
*(f) Ceiling tile dislodgement*

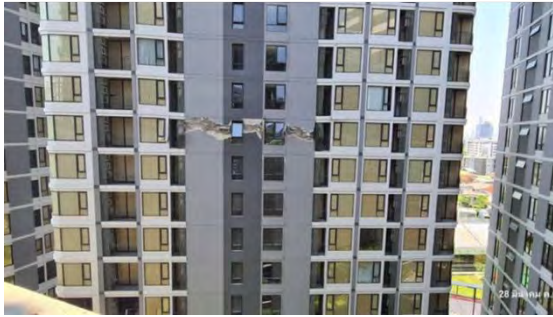
| Main Structural damage | <ul style="list-style-type: none"> <li>Horizontal compression failure at floor 9 in all core walls</li> <li>150 mm settlement at floor 9, resulting in a roof drift of 500 mm (approx. 0.5% residual drift)</li> </ul> |
| Likely causes | <ul style="list-style-type: none"> <li>Overturning of the building in the transverse direction and overloading of stairwell/ lift core walls, resulting in concrete compression crushing/ buckling of bars</li> <li>Too few walls (2 walls, app 4 m long and 200 mm thick) in the building’s longitudinal direction to carry overturning demand</li> <li>Higher mode effects or poor concrete quality in one pour. Similar wall-crushing damage (see below) has been observed in an adjacent building (at least one building). Bar buckling damage in the adjacent building is manifested by a ripple in the wall at level 9.</li> </ul> |

(a) Wall damage on 9<sup>th</sup> floor

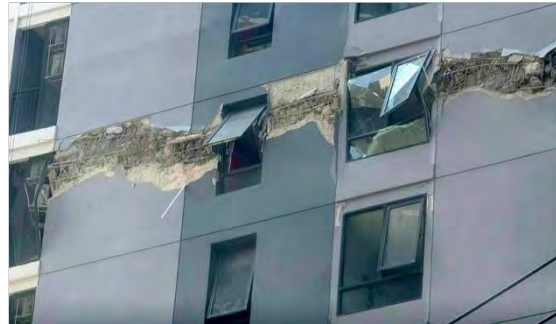
(b) Wall damage on 9<sup>th</sup> floor

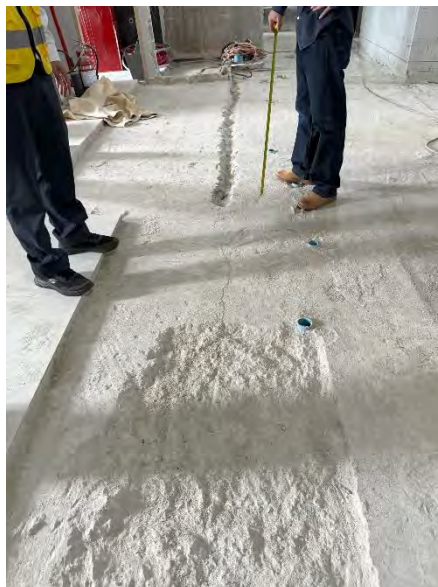
Figure 32: Cracking to the floor in Building R1

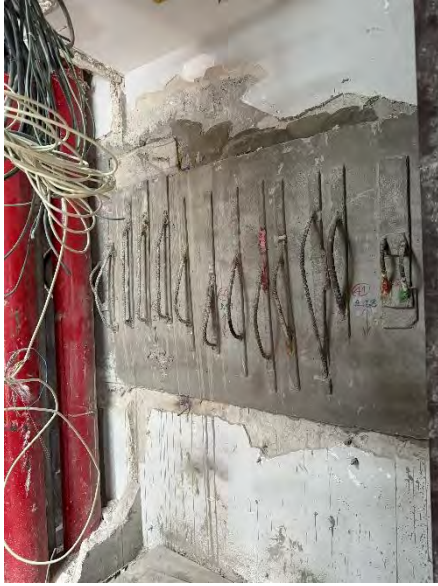
(i) Buckled rebar in stair well

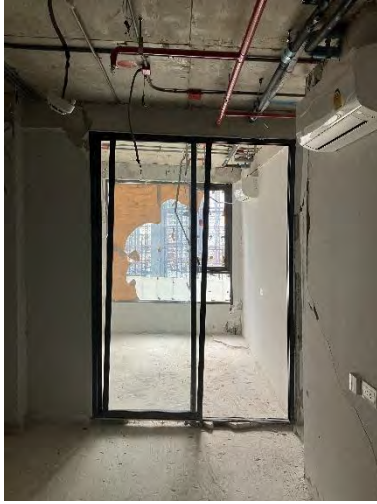
(c) Damage to glass door frames, 9<sup>th</sup> storey

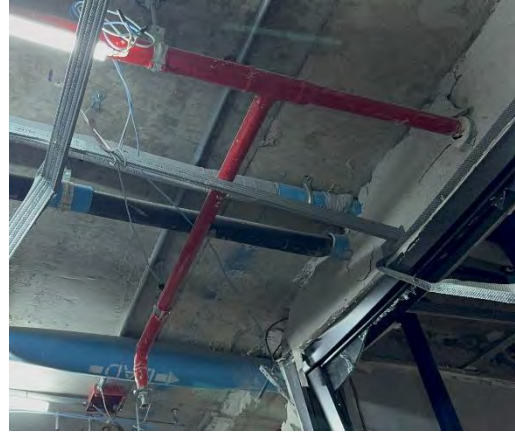
(d) Damage to infill walls due to interaction between pipes and wall, 9<sup>th</sup> storey

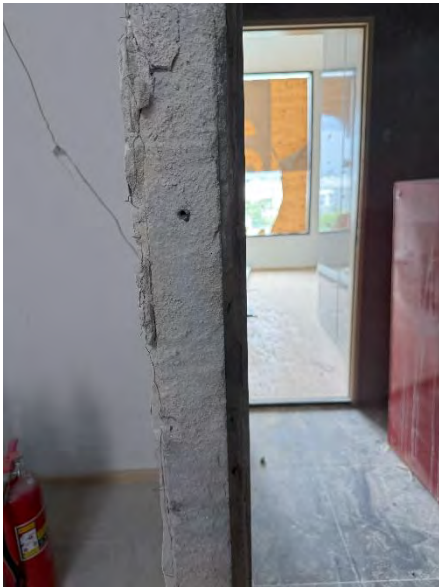
(e) A typical infill wall constructed of AC blocks with chicken mesh plastering

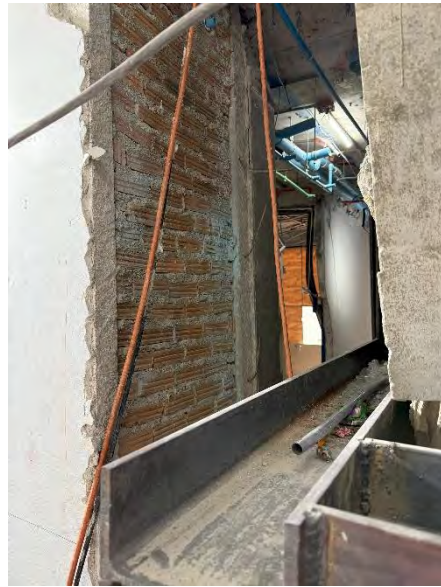
(f) Infill walls in toilet areas

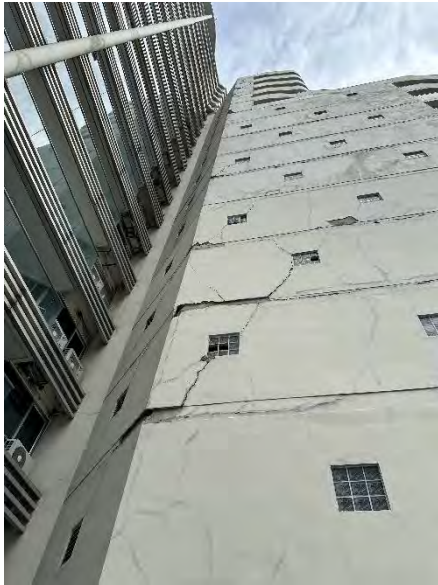
*(a) Moderate cracking around the perimeter of the exterior masonry partition wall*

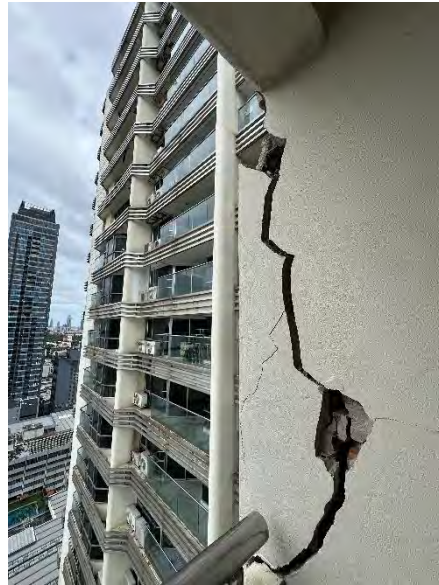
*(b) Severe cracking to the stairwell and masonry partitions*

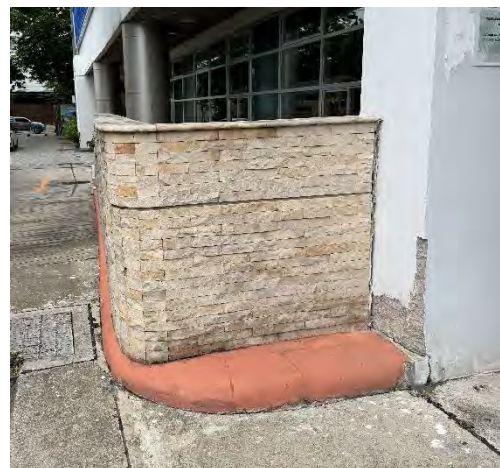
(b) Damage to short boundary wall (Ground Floor)

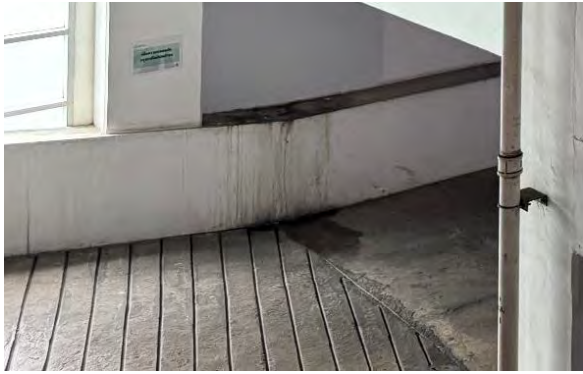
(c) Location of water leakage from the surge tanks of swimming pools due to joint cracks (Floor 5A)

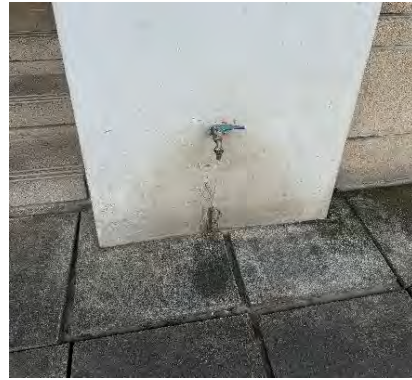
(d) Damage to the water pipe and water shut off to the tab (Floor 6)

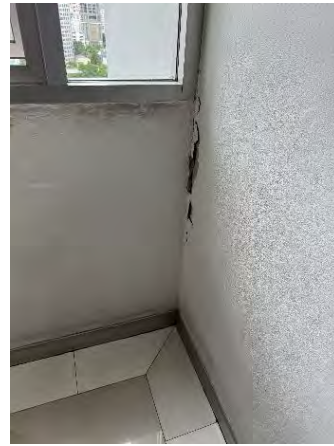
(f) Damage to infill wall joints

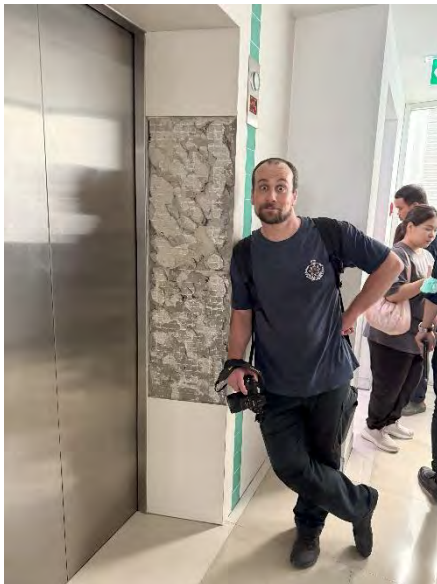
(g) Tile spalling

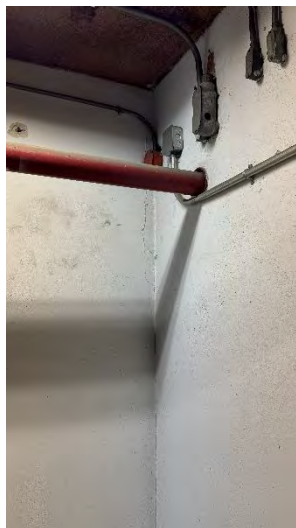
(a) Damage to infill wall (Story 34)

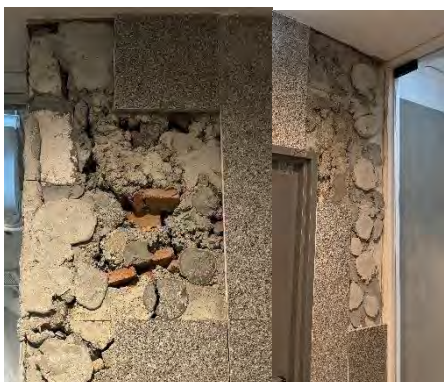
(c) Damage to granite tiles on core walls (Story 20)

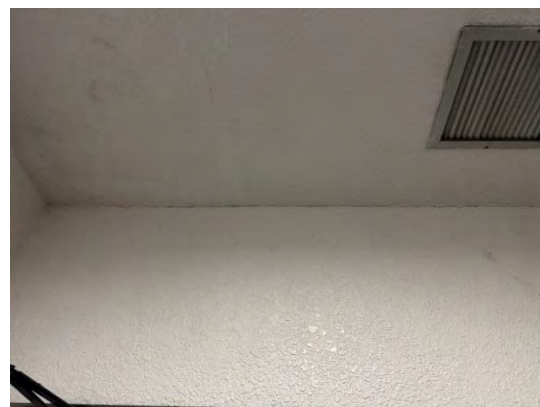
(d) Damage to the infill wall and plasterboard ceiling joint

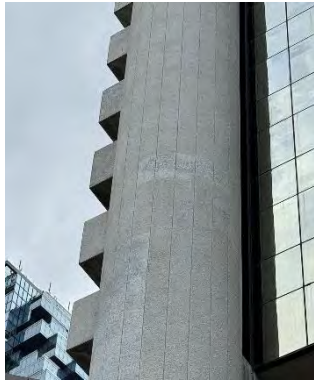
(e) Damage to the exterior concrete block wall (plaster spalling, relatively lighter white colour) has already been repaired.

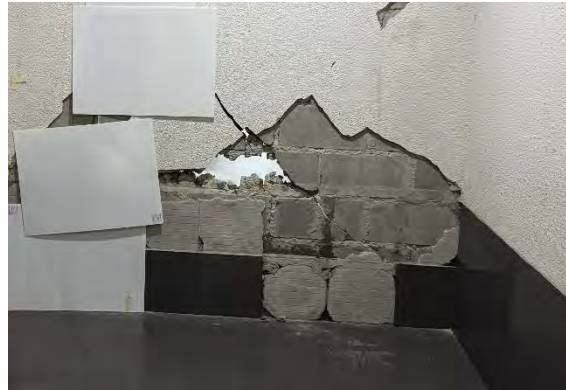
(f) Damage to infill wall (Story 17).

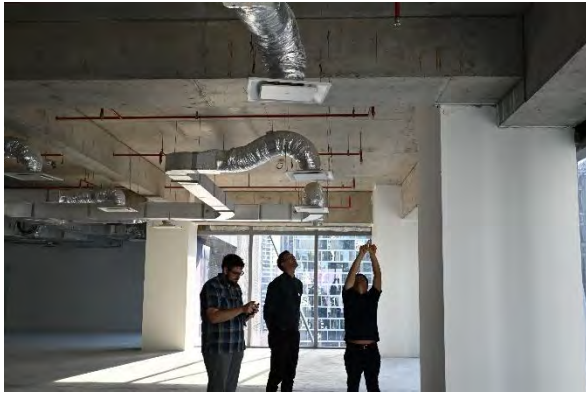
| Main damage | Some slight cracking in the soffit of beams at the exterior of 14 <sup>th</sup> floor |

(a) Location of beam and ceiling slab damage

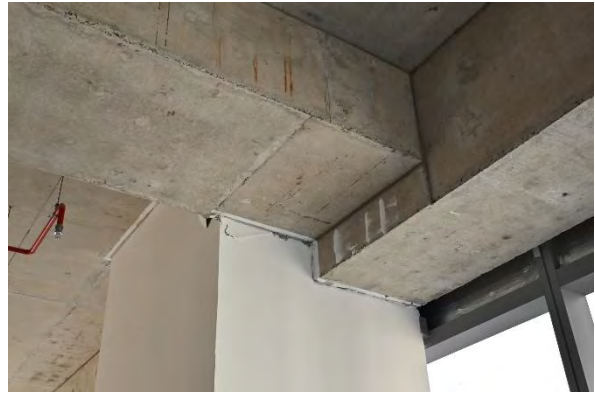
(b) Joint at beam and slab damage

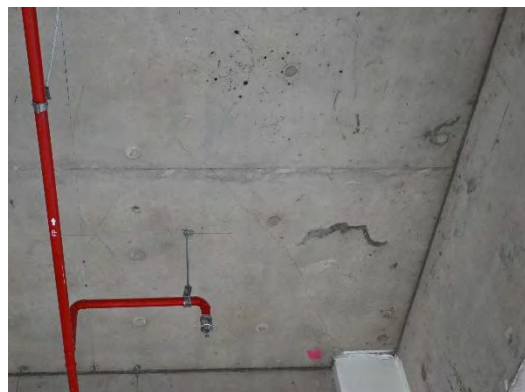
(e) Cracking on the soffit of the floor slab by the beam exterior beam-column joint (crack width ~0.3 mm)

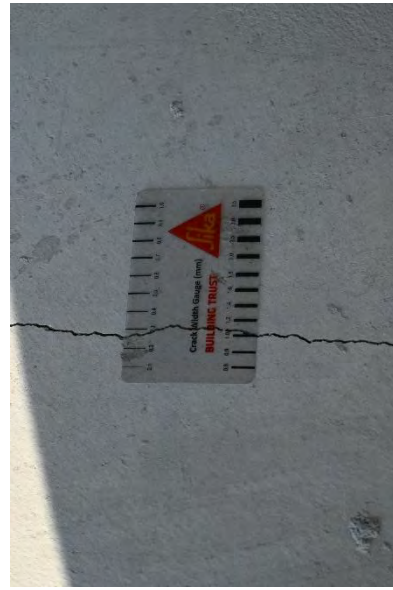
(g) Measurement of floor topping crack (crack width = 1.0 mm)

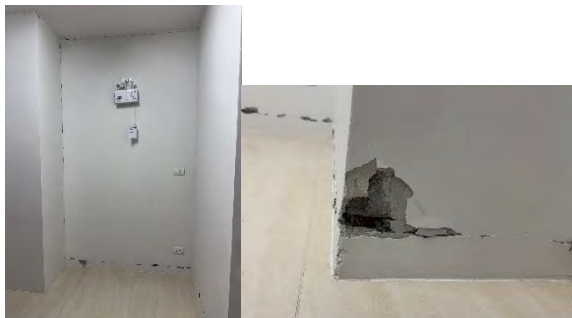
(a) Damage to infill wall (Storey 18)

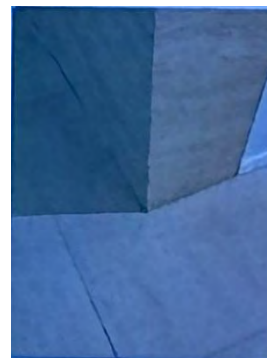
(d) Cracks on ceramic tiles (Floor 14)

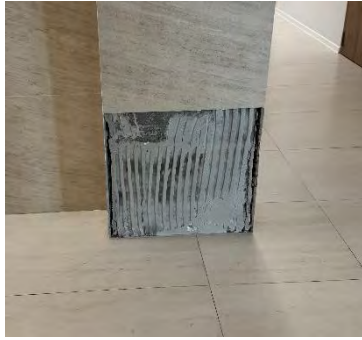
(e) Falling of granite tile (Storey 18)

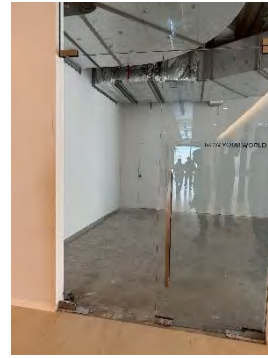
(f) Damage to the glass door (Storey 18)

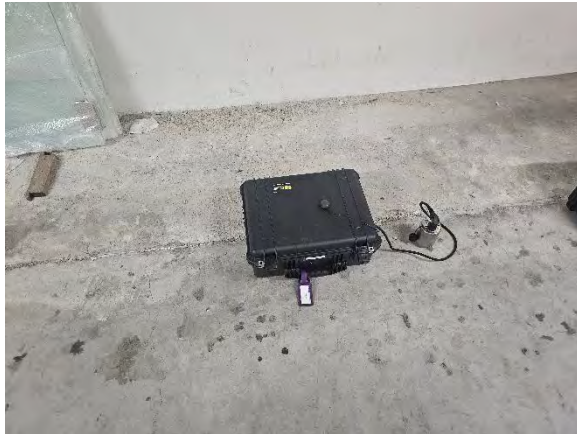
(a) Photo of Station 01 in the basement, positive y-direction to the right of the image

Station 01 was placed in the basement of H1, the north arrow on the instrument aligned with the damaged wall (y-direction). Note the long-period and short-period peaks.
