# Earthquake Protection Of Chattels and Light Office Equipment

Report to The New Zealand  
National Society for Earthquake  
Engineering

Prepared by A.W.Charleson  
School of Architecture  
Victoria University of Wellington

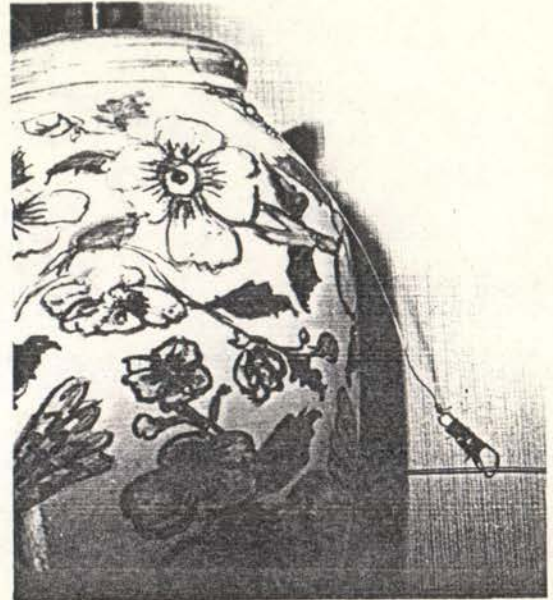
Securing of a Vase

In Figures 7 and 8 dining room shelves are shown. All the significant items are restrained. In both these situations a horizontal length of nylon has been run along the back of the shelf and all the heavier items are attached by snaplinks to it. Figures 9, 10 and 11 show the restraint details. In Figure 9 the gib-board fastener and hook is seen. Because it is placed behind the case it cannot be seen from the room, but if it were it could be painted white to make it less obtrusive. The bookcase and television set in Figure 7 are also restrained. The TV is attached to a large snap link (strong enough to take the weight of the set) which clips into a brass coated 40mm eye screw fastened to the shelf bracket. This restraint can just be seen.

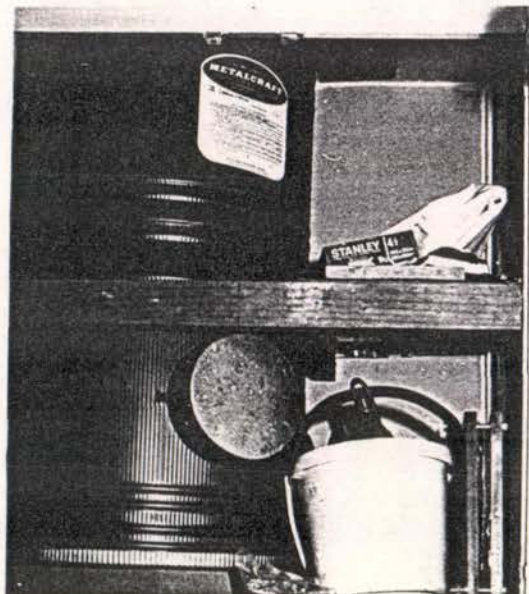
Figure 14: Use of Curtain-Wire

The use of curtain-wire is illustrated in Figure 14. The magnetic catches on the cupboard doors would be ineffectual in restraining the preserving jars so the curtain-wire is necessary. As a result of the findings of the shaking table tests an extra wire is required for each shelf.
