**The adequacy of existing house foundations to resist earthquakes: Cost benefit of upgrading**

*GC Thomas, JD Irvine (School of Architecture, VUW)*

# Adequacy of Existing House Foundations for Resisting Earthquakes: the Cost-Benefit of Upgrading

2007 NZSEE  
Conference

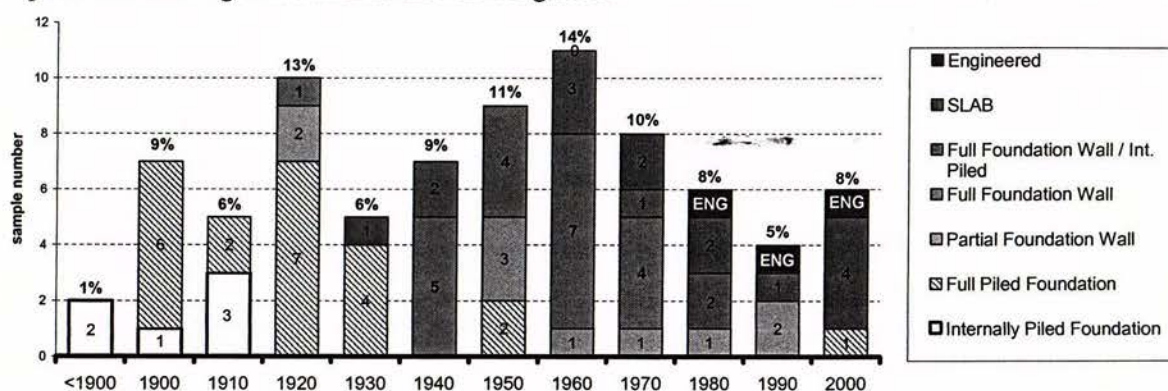
Figure 1. Foundation type for age of dwelling, percentages of the total sample.

We carried out a study which aimed to assess a wide cross section of different house foundations. The Wellington City Council provided a random selection of dwellings from their rating database, from which a sample of 80 dwellings was taken as shown in Figure 1.

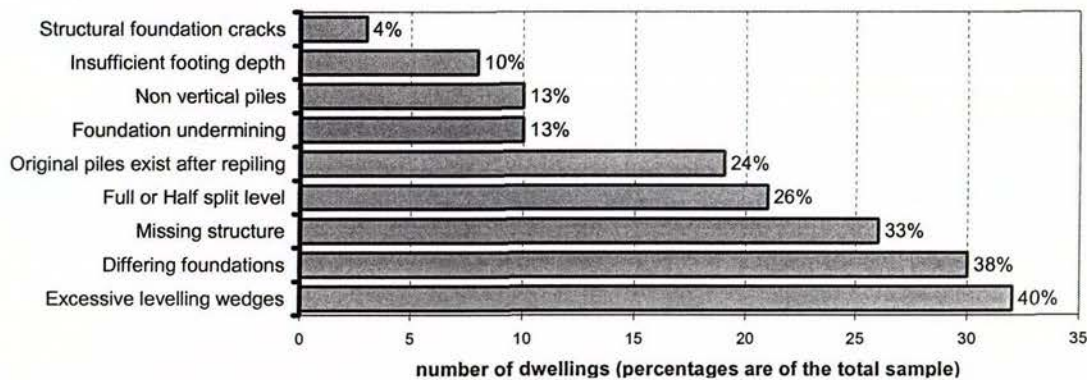
Figure 3. General conditions pertaining to foundation durability

The general conditions observed onsite correlated well with the 2005 House Condition Survey (Clark et al., 2005), however more issues such as excessive levelling wedges in repiled and re-levelled dwellings were observed in the sample. Figure 3 shows the percentage of the sample with general condition issues. However, overall, a number of dwellings had a combination of these issues, especially in older dwellings that have missing structure, insufficient footing depth and non-vertical piles. Dwellings that had been renovated often had full or half split level additions usually made to the lower floor by excavating the foundations, and almost half of these dwellings had differing foundations likely to cause serious

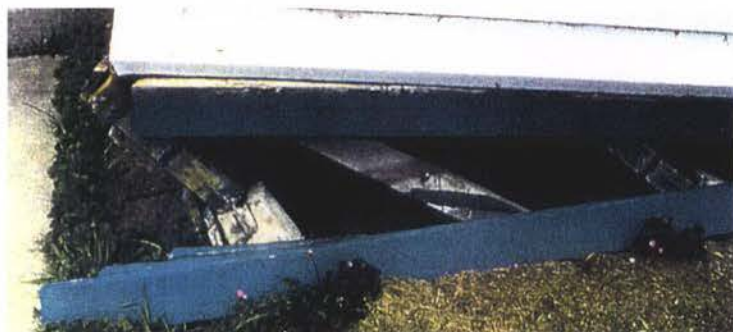
**Figure 2-2 Corner of Foundation showing Piles swayed to one side (Source: BRANZ 2003)**

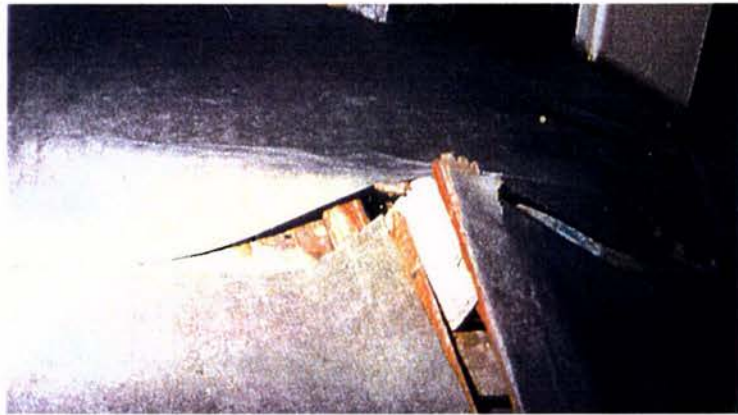
**Figure 2-4 Example of Piles punching through the Floor due to Sub-floor Framing slipping off Piles**  
(Source: BRANZ 2003)

Observations of Full Piled Foundations with sheet bracing attached to exterior piles have shown good bracing performance in past earthquakes (Norton et al. 1994). However, much of the extensive damage to dwellings during the 1989 Loma Prieta earthquake was attributable to pre 1940's piled dwellings with unbraced exterior piles (Norton et al. 1994). Similarly, dwellings with walings or weatherboards on exterior piles also performed poorly and slipped from piles, which can result in the piles being punching up through the floor [Figure 2.4].

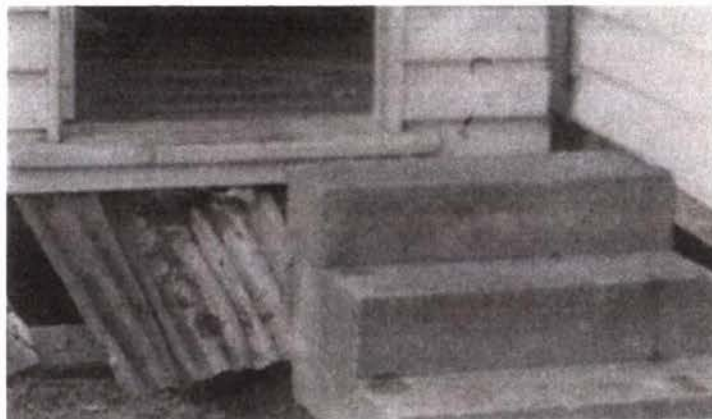
**Figure 2-5 Full Piled Foundation slipped off Foundations, with Concrete steps remaining in place**  
(Source: Cooney 1979)

Full Piled Foundation dwellings have also tended to sway heavily on piles during earthquakes, utilising the strength of the soil surrounding the piles to dampen loads. As a result many dwellings with limited soil ductility, or shallow footings have resulted in sideways collapse, especially if no large concrete ‘anchors’ [refer Section 3.2.2] were integrally connected to sub-floor framing (Norton et al. 1994) [Figure 2.5]. If concrete ‘anchors’ were present and not fixed to the framing, smashing between the piles and concrete could also potentially occur.

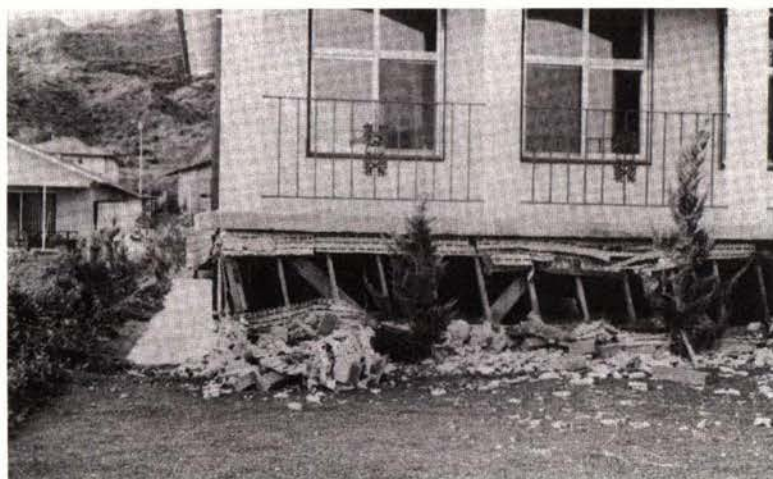
**Figure 2-7 Jackstudded Sub-floor showing Cladding broken off and a slumping to one side (Source: Jennings and Housner 1971)**

This foundation type has performed well in past earthquakes, with many examples escaping with only superficial damage to cladding (BRANZ 2003). Other foundation types that are also considered Partial Foundation Walls are jackstudded sub-floor walls, where timber studs span between the wall bottom plate and the concrete foundation wall below. As evidenced in past earthquakes, unbraced jackstudding can cause full or partial collapse to the foundation and therefore requires sheet bracing fixed to the interior or exterior of the jackstudding (Norton et al. 1994) [Figure 2.7].

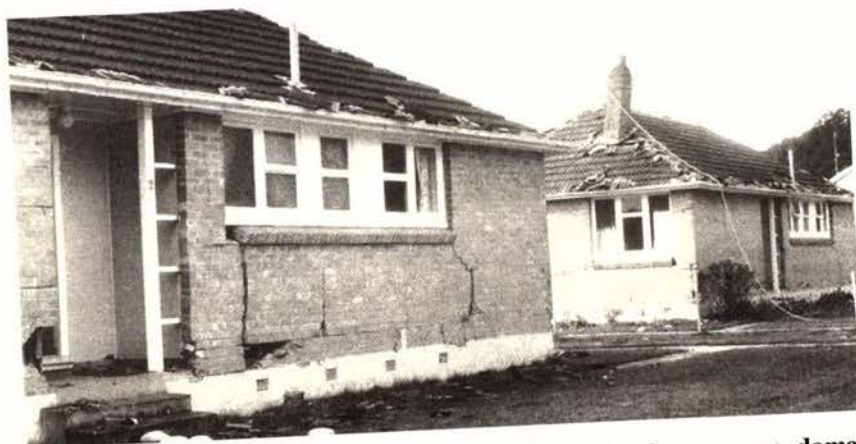
Figure 2-9 Superficial Damage to brick veneer on State Dwellings, however no damage to the Foundation Wall is evident (Source: Eiby 1980)

This method of construction found favour in post Second World War New Zealand construction and was also promoted by the State Housing Scheme, whose focus was on strength and durability. Each dwelling would be constructed using quality labour and materials, and was designed to last up to 60 years (Schrader 2005). The Full Foundation Wall has been tested extensively by many earthquakes in the last 50 years, showing to sustain only light or moderate damage to the superstructure (Adams et al. 1970). Damage to the foundation area was usually limited to small cracks or subsidence (Pender and Robertson 1987) [Figure 2.9]. A Full Foundation Wall is necessary for dwellings with heavy wall cladding, such as brick veneer. Although these dwellings have more weight to resist in earthquakes, the bracing provided by the concrete ring foundation is often more than adequate

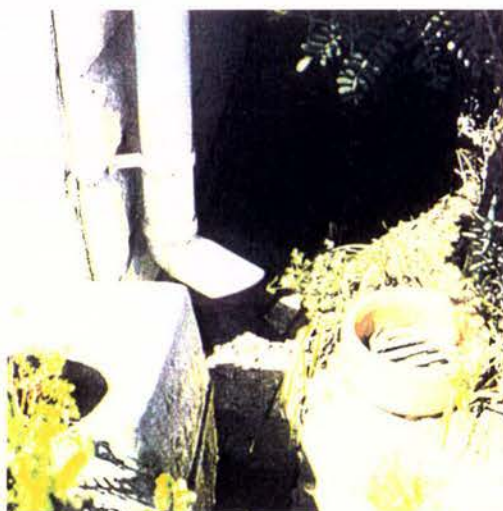
**Figure 2-15 Slab on Ground showing relative sliding difference between the Dwelling and Ground; note the prior location of Services (Source: BRANZ 2003)**

Since a slab foundation floats on the ground, differential settlement can cause foundations to move [Figure 2.15], crack and possibly separate [Figure 2.16]. It is for this reason that slab constructions suit reasonably flat consistent sites with gentle and flat topography.

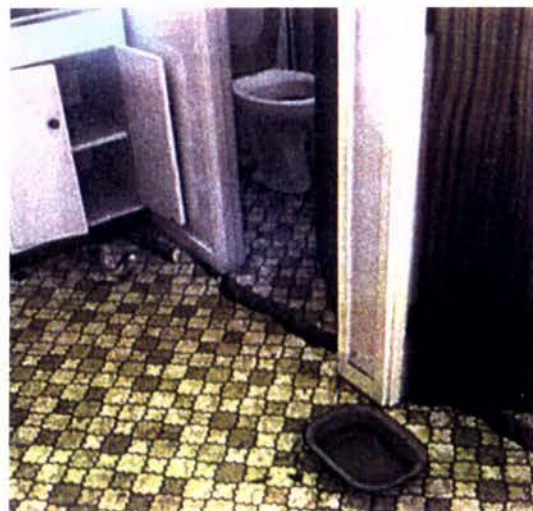
**Figure 2-16 Severe Cracking through a Concrete Slab (Source: BRANZ 2003)**

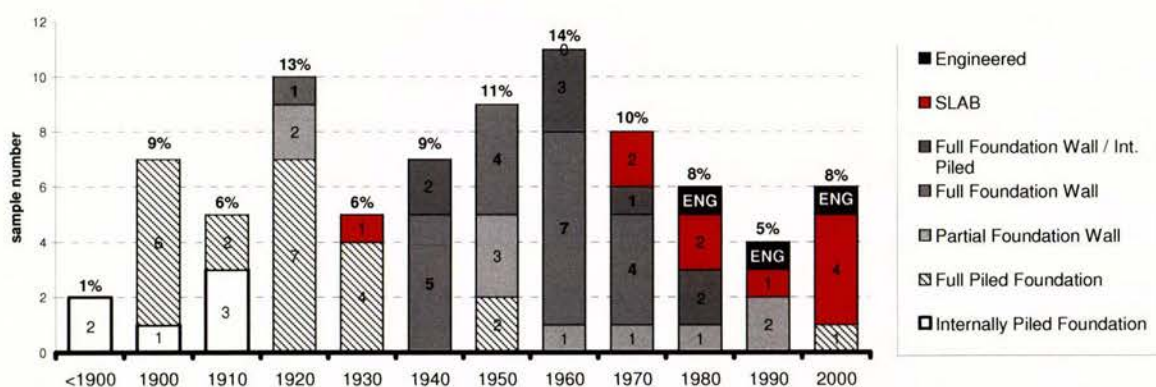
**Figure 2-17 Foundation Type for Age of Dwelling, Percentages of the Total Sample.**

The sample of dwellings was obtained from the Wellington City Council rates database which provided a random selection of dwellings, from which a sample of 80 dwellings was taken. Each dwelling was assessed by the foundation type and it was found that most dwellings have either a Full Piled Foundation or Full Foundation Wall, usually dictated by the architectural style of the dwelling [refer Appendix A]. Piled dwellings were most common prior to 1940, where as Full Foundation Wall dwellings were common between 1950 and 1990 [Figure 2.17].

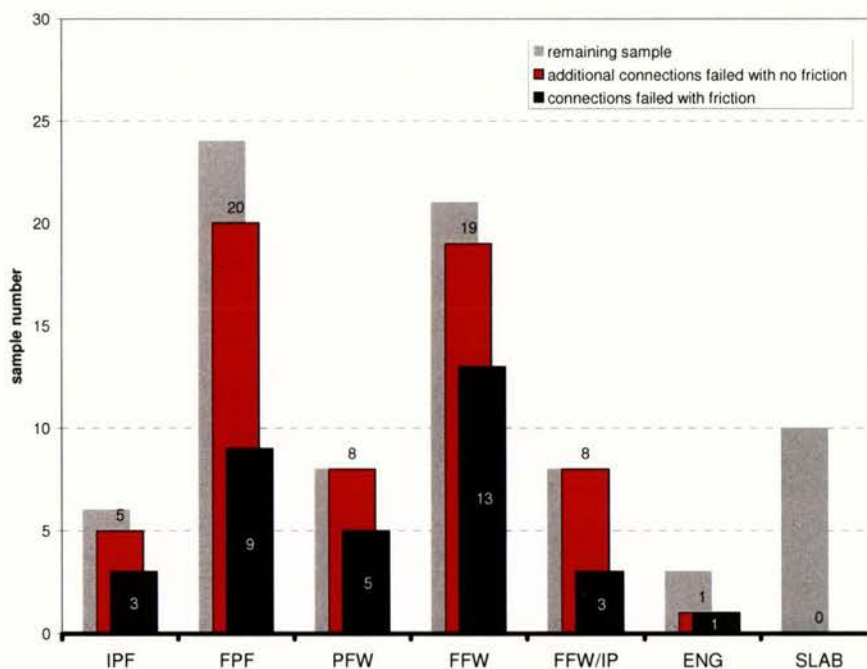
Overall, an average of 13% of connections providing load paths to the bracing members (in four significant locations sampled), were inadequate. Excluding the effects of friction, the number of connections failing increases by 24% for the Joist to Bearer connections and 65% for connections from Bearers or Plates to the concrete Foundation wall. The Ordinary pile to Bearer connection was inadequate in 56% of the sample, so about half of the connections were inadequate even after repiling. Although some connections failed due to poor construction or materials, older dwellings failed as connections used are weaker than those prescribed by modern Standards. The Plate to Foundation wall connection has had changes in most significant Standards since 1924. As the standards have developed fixing spacings have reduced. However, only 5% of the Plate to Foundation wall sample would fail to transfer loads adequately. The Figure below show the number of dwellings with inadequate connections with and without friction included in the calculations [Figure 4.2]. It shows that all foundation types rely heavily on friction to transfer load, except the slab foundation construction. It should be noted that the earthquake scenario chosen [refer Section 6.1] may result in vertical accelerations up to 1g (gravities) or more (Cousins, Pers. Comm.). Hence, no friction between framing elements can be assumed to contribute to the overall strength of a framing connection [refer Section 3.3.2].

Figure 4-2 Connection failure Including and Excluding Friction compared with Foundation type

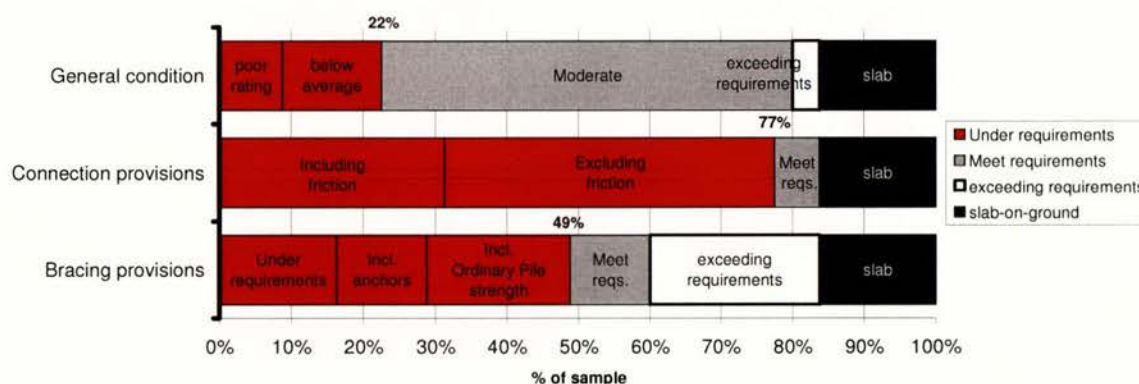
**Figure 4-4 Overall failure for key foundation elements**

Figure 4.4 shows that overall, bracing was inadequate in 49% of the dwellings with sub-floor foundations (e.g not Slab-on-Ground dwellings) of this about half relied on the strength of Ordinary Piles and one quarter relied on large concrete anchors. A significant number of fixings failed to comply with NZS3604:1999 however, were still calculated to adequately transfer loads through to the bracing and other connections. Just over 25% of the sample showed adequate fixing capacity under conditions where friction cannot be expected. However, no dwellings exceeded minimum requirements of fixings. The condition of foundations was generally adequate, with 18% of the sample having excellent overall general condition, usually seen in newer dwellings and 58% had only moderate condition issues. To understand the impact of remedying these dwellings, we must first understand the overall cost and benefit of the remedial action and the potential risk, and then we can estimate the economic cost of remedial action to the individual and the direct economic savings for society.

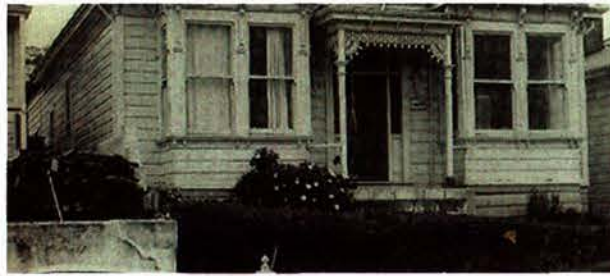
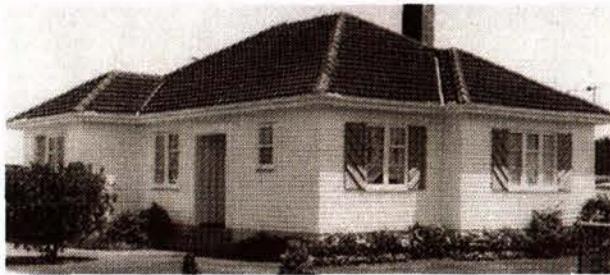
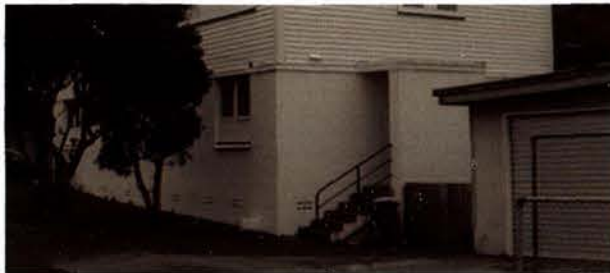
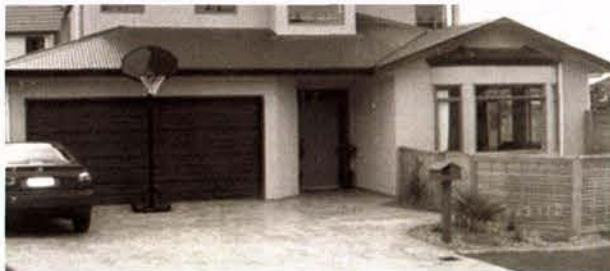
Foundation Definitions

Piled foundation where exterior shell is separately piled from the internal flooring. Usually seen in older dwellings with timber cladding and generally lower to the ground

Concrete or timber piles supporting entire dwelling in unison, no special detailing given to exterior piles. Usually clad with similar material to superstructure

Concrete slab on ground used commonly in modern dwellings in gentle topography. Slab is usually reinforced and essentially floats on the underlying soil.
