Department of  
Building and Housing  
*Te Tari Kaupapa Whare*

# Guidance on house repairs and reconstruction following the Canterbury earthquake

A summary of geotechnical and structural  
engineering recommendations to guide  
house repairs and reconstruction

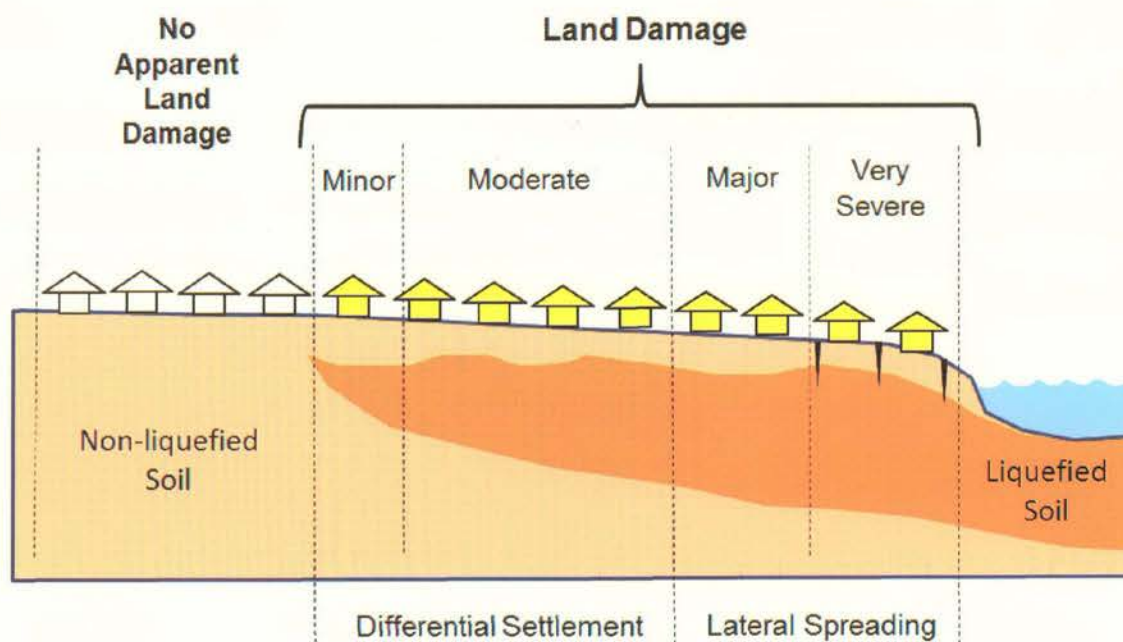
Figure 3.1: Schematic section of spatial distribution of categories of land damage

Local damage maps of the most affected suburbs of greater Christchurch have been completed. The spatial distribution of the categories of land damage, as detailed in Table 3.1, is illustrated in a generic section shown in Figure 3.1 below.

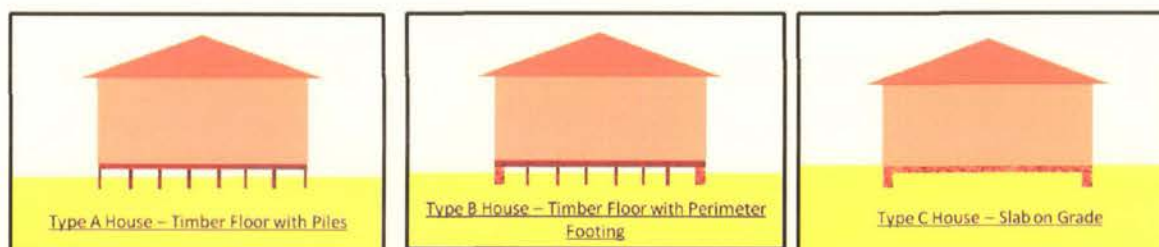
Figure 3.2: Dwelling Types A, B and C

Type A	Timber framed suspended timber floor structures supported only on piles
Type B	Timber framed suspended timber floor structures with perimeter concrete foundation
Type C	Timber framed dwelling on concrete floor

The apparent damage to Type A buildings is generally easier and less costly to repair, provided there has not been sufficient lateral spreading to cause the piles to detach from the floor system and punch through the floor. Type C buildings are typical of the newer subdivisions of Kaiapoi, Bexley and Brooklands, with a significant number of buildings being less than 10 years old. These buildings are typically supported on a shallow reinforced concrete perimeter strip footing, with concrete cast-on-grade floors. The floors are, in many cases, unreinforced, and not tied in to the perimeter foundations. These foundation and flooring systems have been observed to perform poorly in those areas that have undergone land deformation. In addition, such buildings will be difficult and more costly to repair.

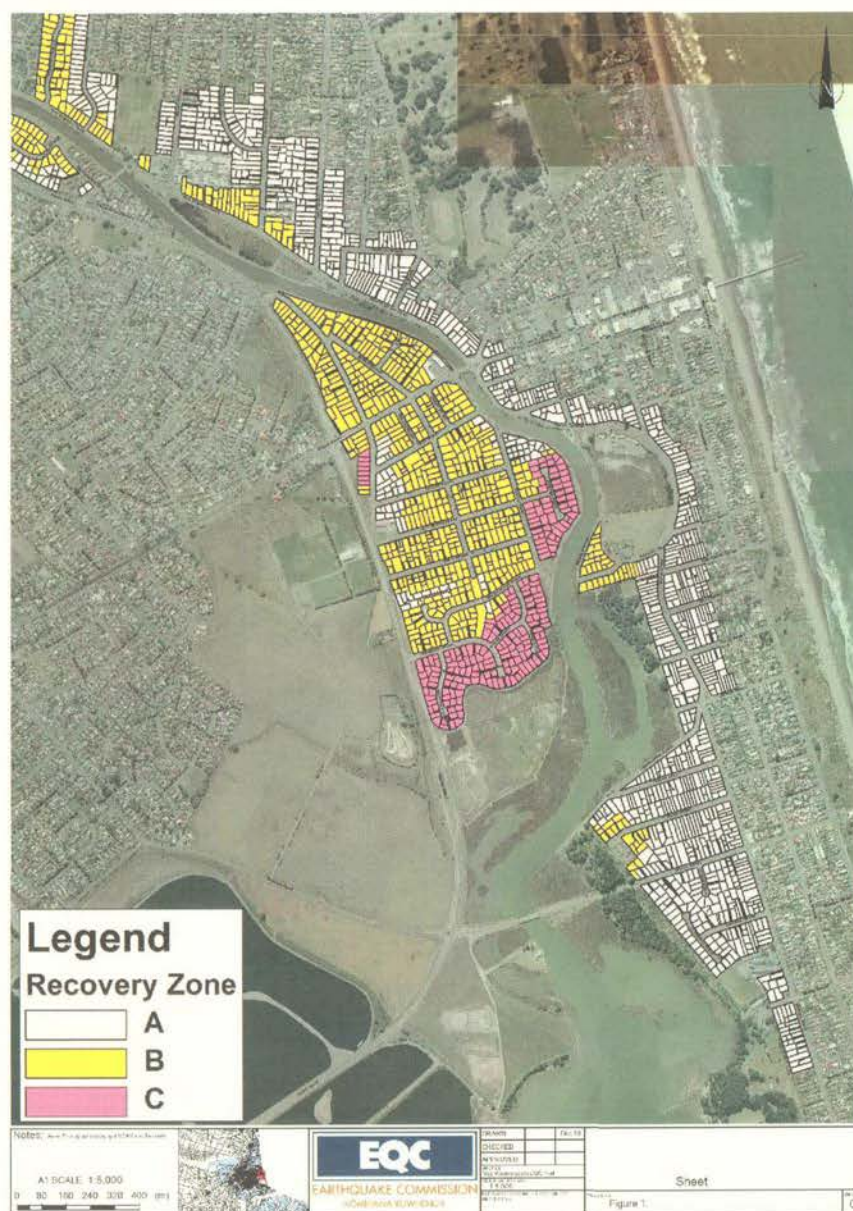
Figure 3.3: Example of Bexley Recovery Zone map

An example representation of the land recovery zoning is shown in Figure 3.3.

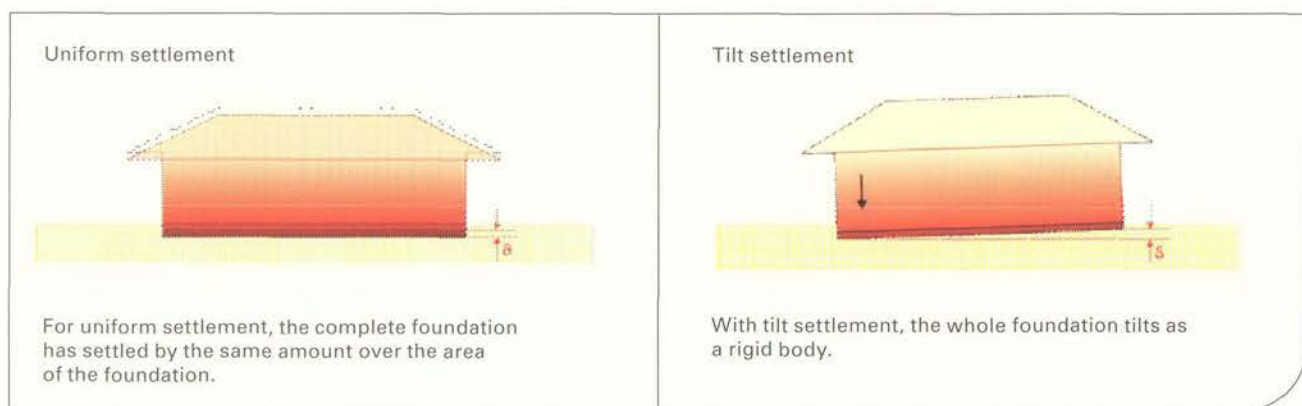
#### (i) Simple settlement cases

To assist with the understanding of the descriptions provided in this and subsequent sections, the following pictorial definitions for floor displacement are provided.

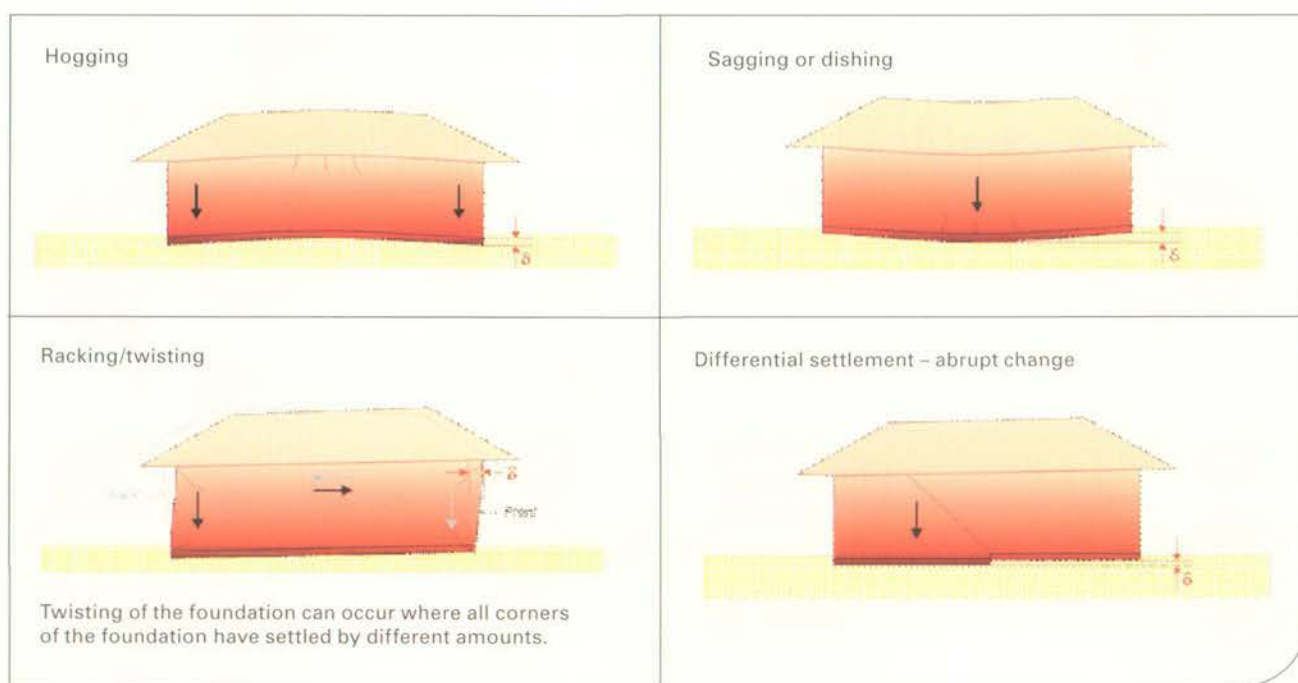
## (ii) Differential settlement cases

Parts of the foundation settle by different amounts resulting in uneven slopes in the floor. Differential settlement is the most difficult behaviour for which to set acceptable limits.

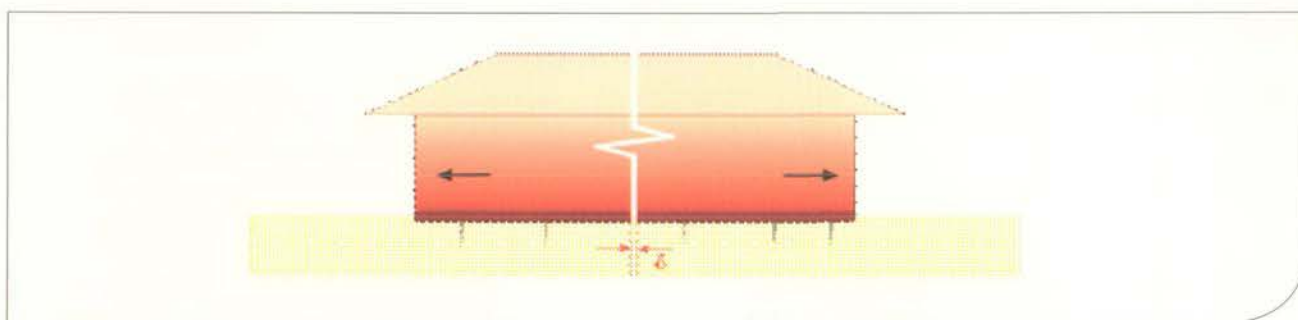
## (iii) Lateral Stretching

Lateral stretching of a foundation may occur when the ground beneath it spreads laterally during the ground shaking. If the floor plate of the dwelling is not strong enough, then the lateral spreading will cause an extension of the floor plate (ie, the concrete floor slab will crack or the timber floor will fracture, generally at joints between framing members).

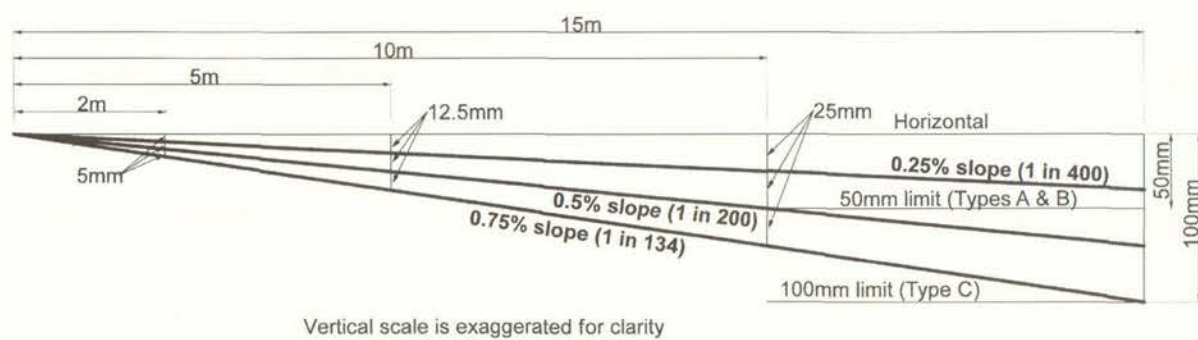
Figure 4.1: Diagrammatic representation of slope and category criteria

Note that beyond 10 m, the 50 mm criteria governs over the 0.5% criteria

The different slope criteria are represented in Figure 4.1 overleaf.

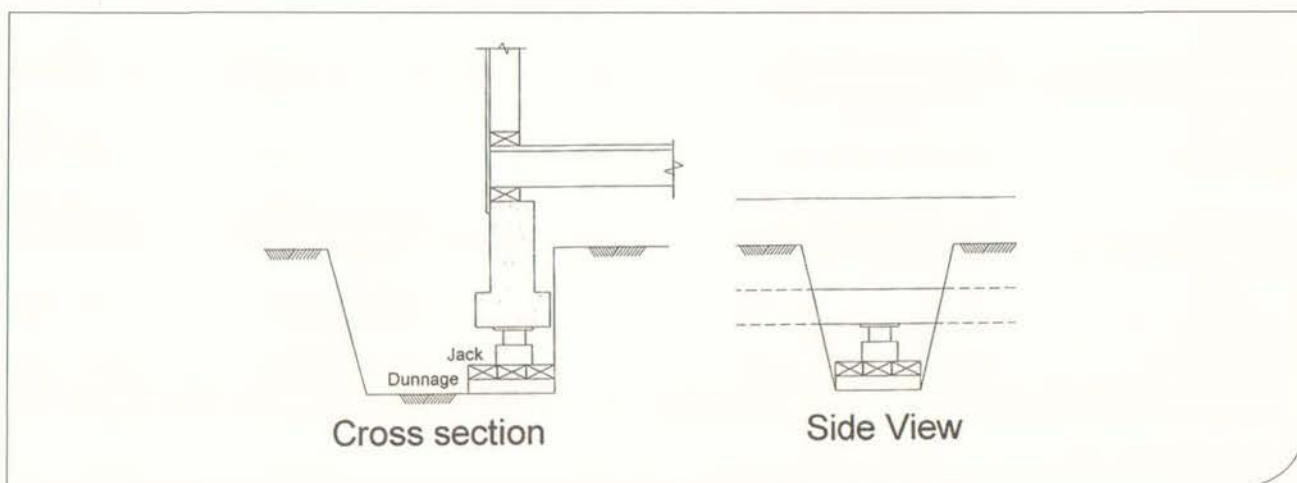
- Lifting Option 1: Perimeter foundation re-levelling using portable jacks

Foundation re-levelling involves excavating pits at discrete locations to the perimeter of the foundation wall, and installing jacks in each pit to the underside of the wall or beam to raise it to the correct level. With the foundation repositioned, flowable grout is introduced to the cavity created under the raised foundation. Once the grout is cured, the jacks are removed and the pits refilled.

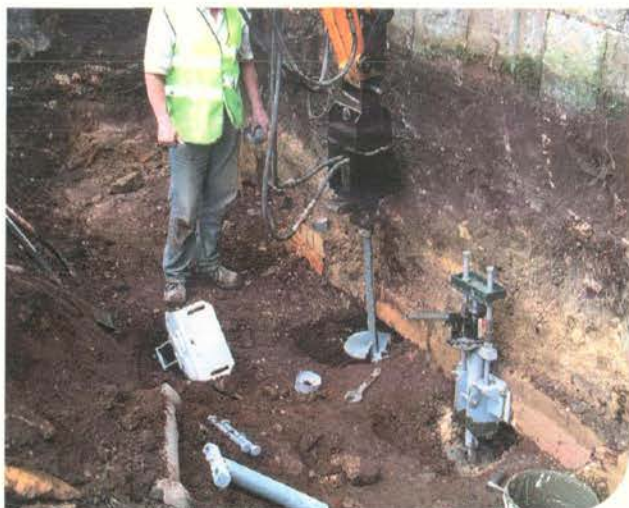
- Lifting Option 2: Perimeter foundation jacking using piles (screw or similar)

Foundation re-levelling using screw piles involves installing piles at discrete locations to the perimeter of the foundation wall, and installing under-beam shoes fitted with jacks to raise the foundation to the correct level. With the foundation repositioned, flowable grout is introduced to the cavity created under the raised foundation. Once the grout is cured the jacks are removed, and the screw piles removed. The screw piles may also be used as a permanent support.

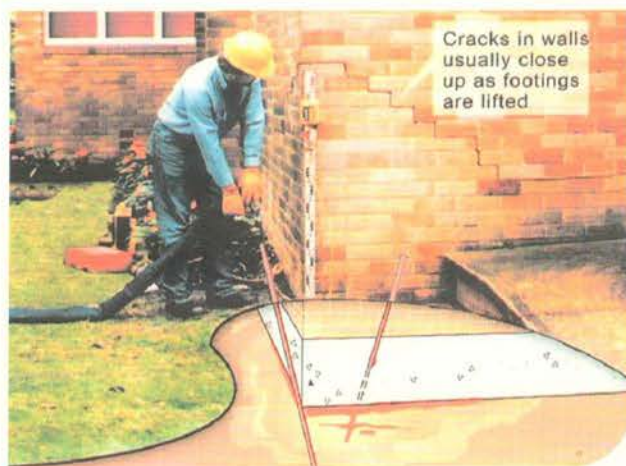
- Lifting Option 3: Perimeter foundation jacking using engineered resin

This option is a proprietary lifting process where engineered resin is injected into the ground at multiple points along the foundation. The expanding resin lifts the foundation. The process also densifies the surrounding ground which serves as a reaction layer for the lifting operation.

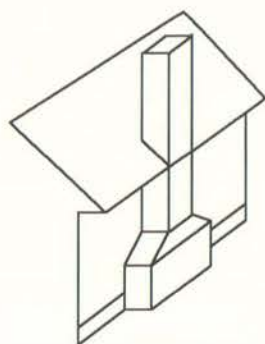
Existing chimney prior to earthquake damage

Unreinforced masonry or precast concrete blocks

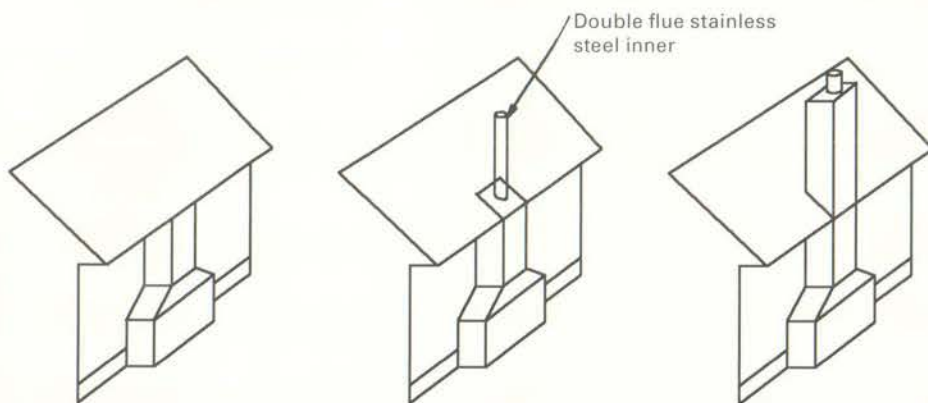
Repair Option 2:

Demolish the chimney to the top of the base and gather and weatherproof. Seal fireplace. Repair external cladding, roof and soffit.

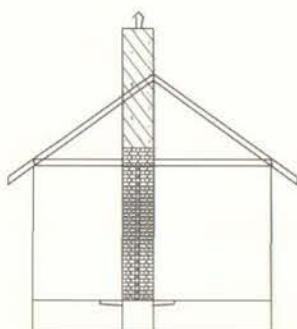
Remediation Option 2:

Demolish chimney to a point just above the ceiling framing and fit steel flue from burner and flash at roof line. Combine flues if back to back stacks present. Install metal heat shield to vent brick chimney stack to exterior.

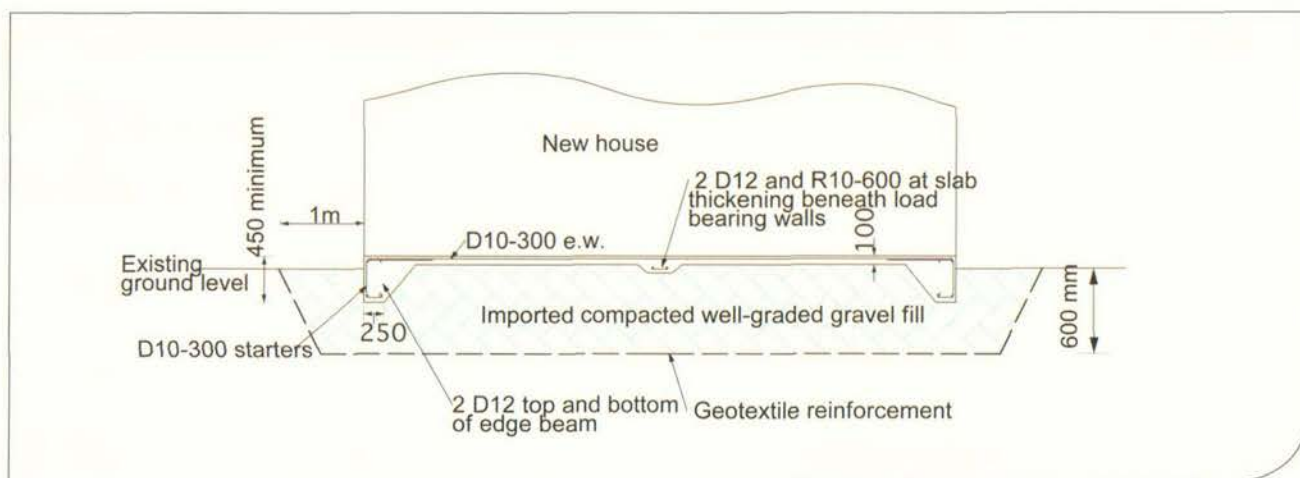
**Option 1** – Excavation and replacement of the upper layers of soil with compacted well graded gravels and construction of a reinforced NZS 3604 slab foundation (only suitable for thin layers of liquefiable soils).

External service lines will need to be beyond the outer extent of the gravel raft.

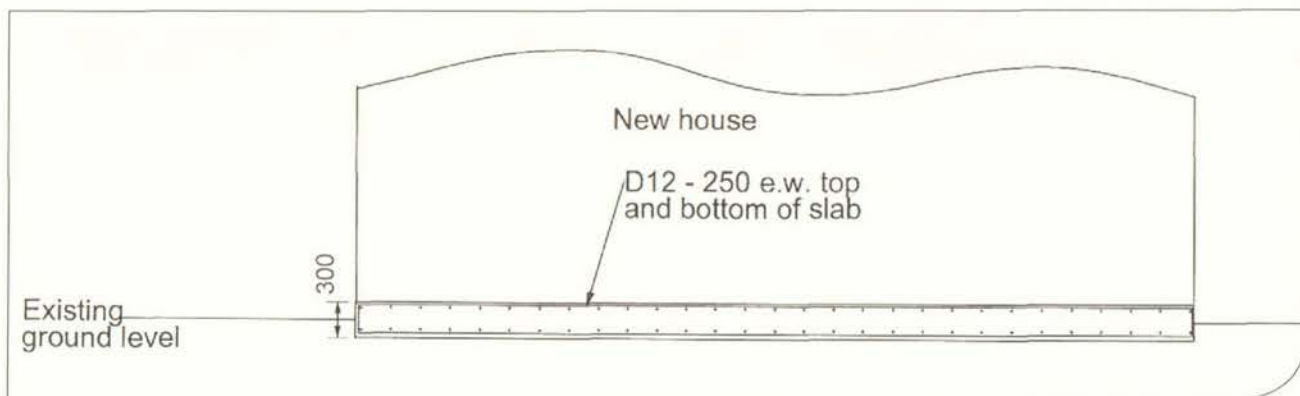
**Option 2** – Construct a thick slab foundation over the existing soil.

The ground immediately beneath the slab must have a minimum ultimate bearing strength of 300 kPa, or the slab should be subject to specific engineering design.

The treatment of service lines as they enter and travel within the slab requires careful consideration.

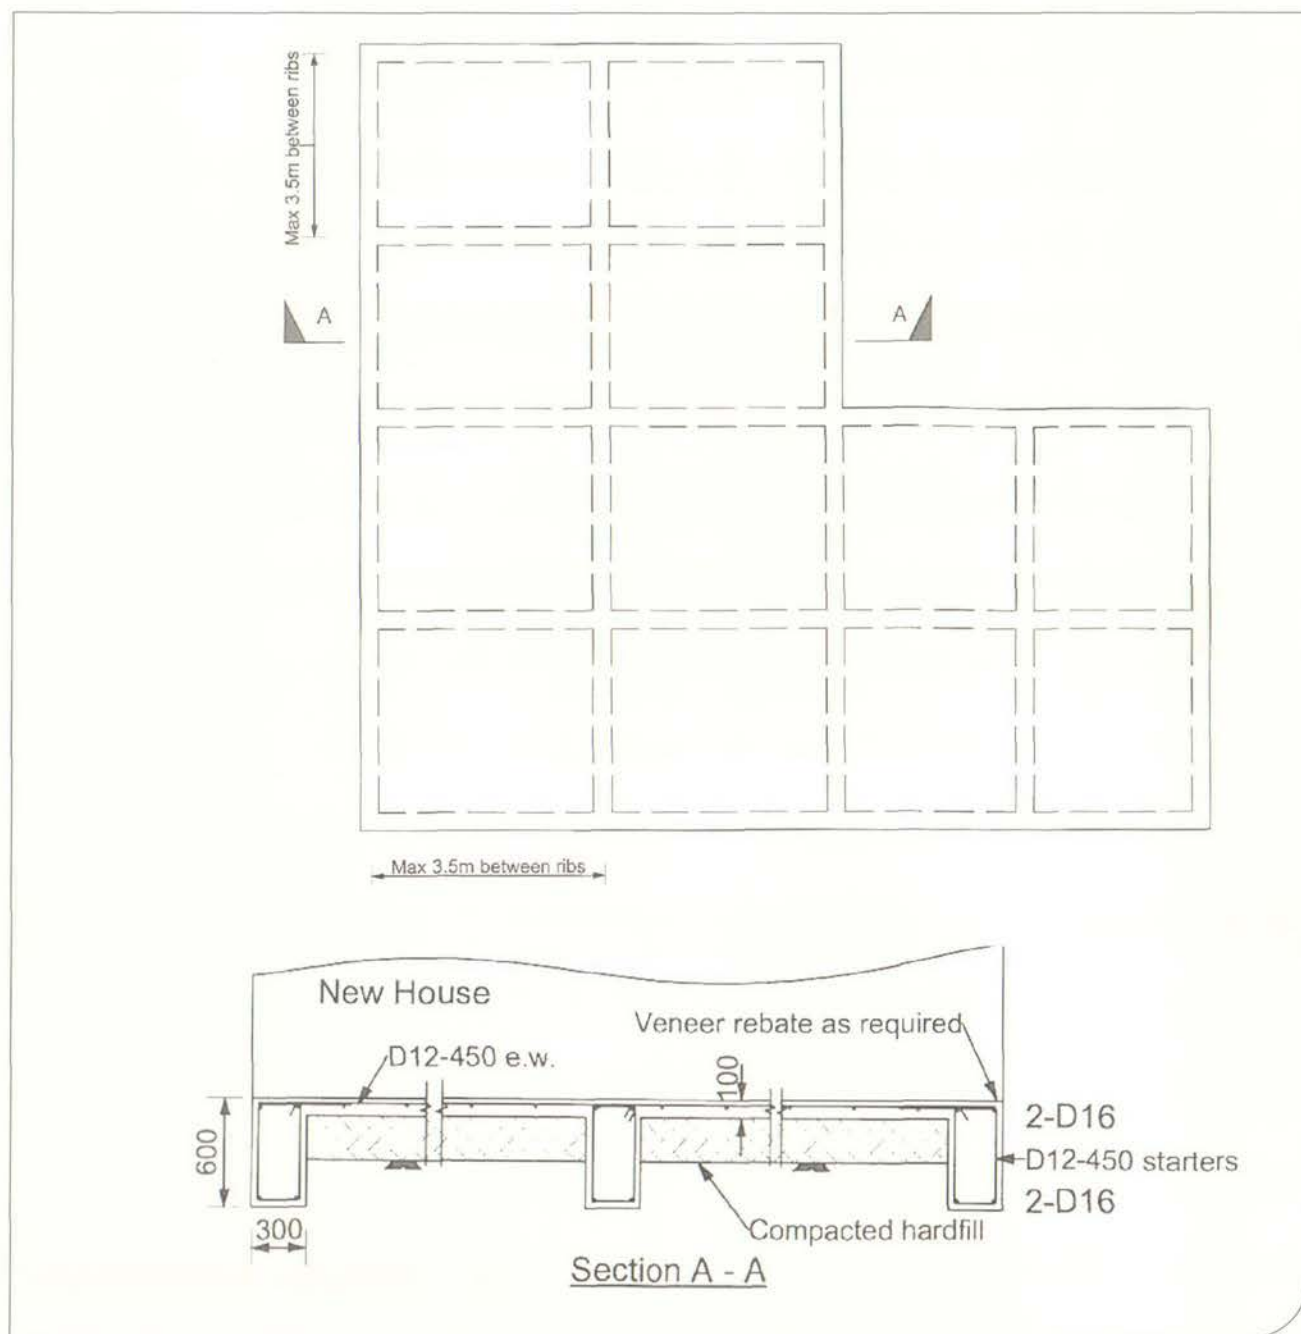
**Option 3** – Construct a generic beam grid and slab foundation.

The ground immediately beneath the slab must have a minimum ultimate bearing strength of 300 kPa, or the slab should be subject to specific engineering design.

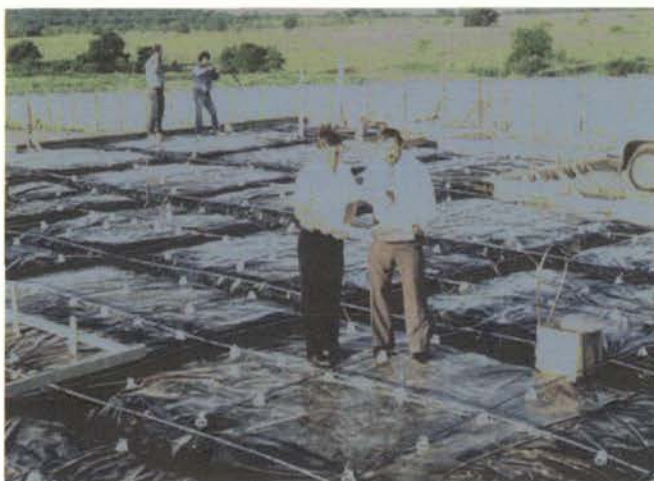
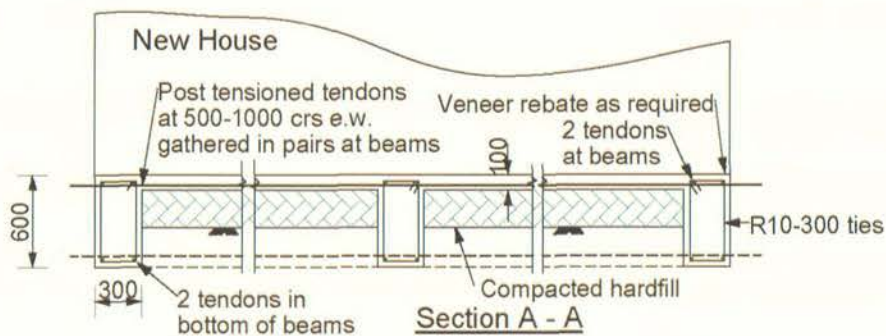
A variation to this option involves post-tensioning the waffle slab, using single 12.9 mm or 15.2 mm strand tendons in an un-bonded format. The factory applied greased and sheathed strands are supported in the slab on bar chairs and tensioned through mono-strand anchorages fixed at both ends through the perimeter formwork. Tensioning is carried out using calibrated centre-hole hydraulic jacks.

Post-tensioned slabs are tensioned to between 0.5 and 1 MPa (in time) to overcome drying shrinkage and give some bridging capacity. Spacing of the tendons is nominally one metre centres each way.

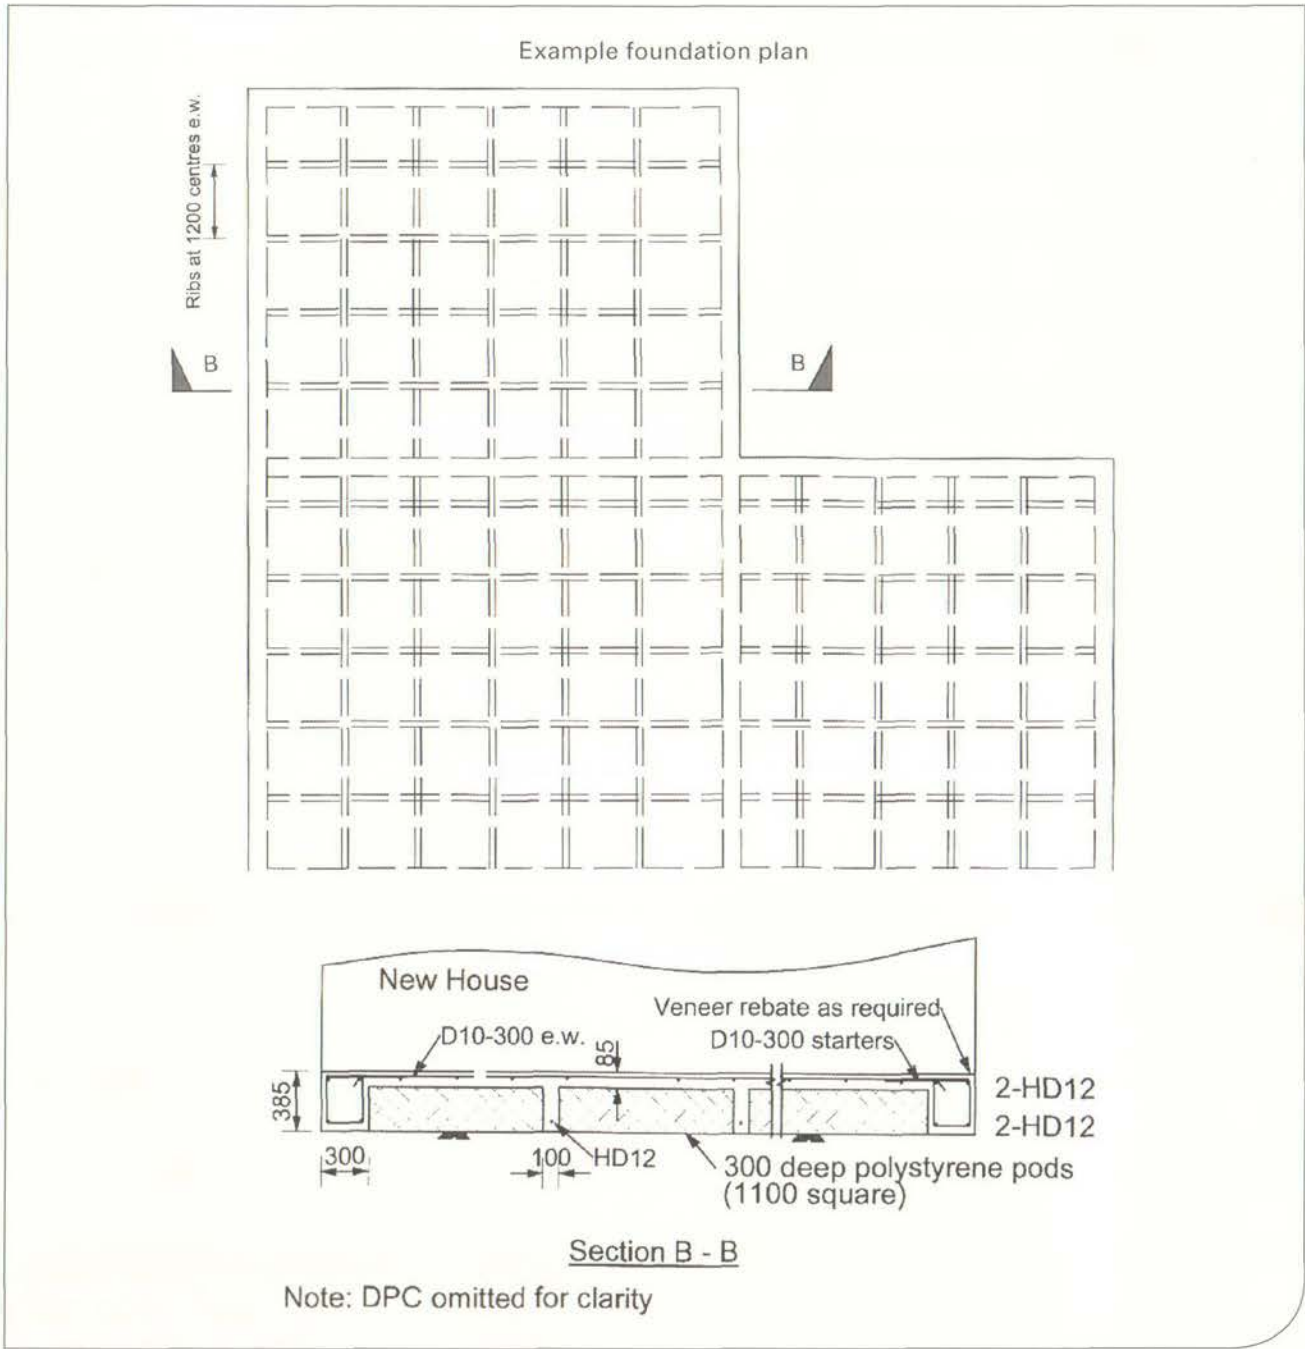
Option 4 – Construct a stiffened waffle slab over the existing soil.

The ground immediately beneath the polystyrene and ribs must have a minimum ultimate bearing strength of 300 kPa, or the system should be subject to specific engineering design.

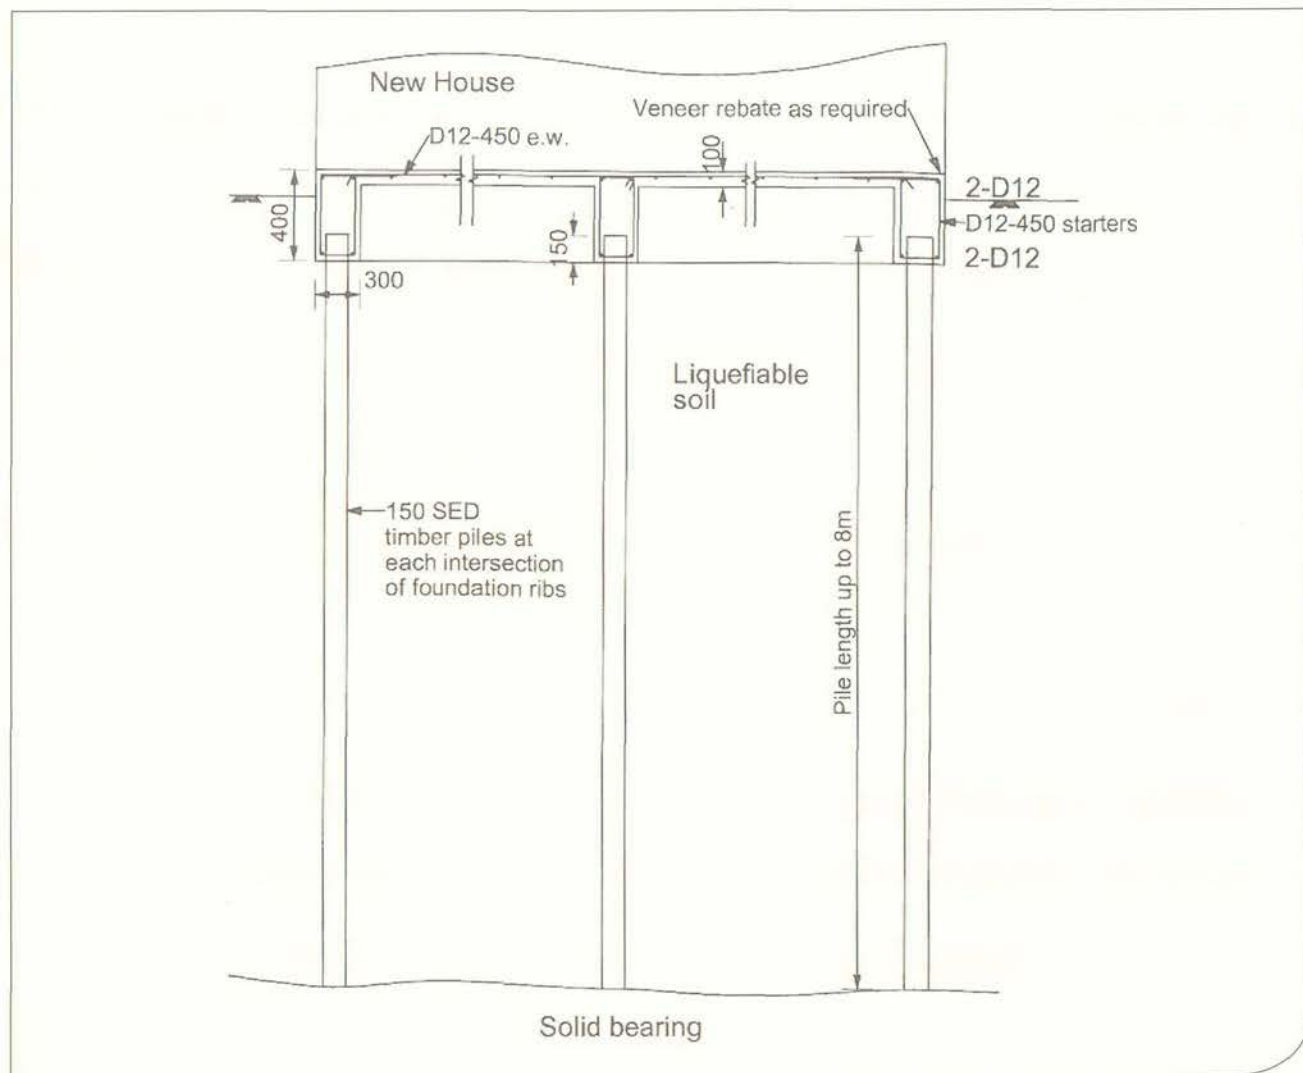
**Option 5** – Drive piles to solid bearing beneath a liquefiable layer and construct a floor slab with reinforced beams on pile rows in both directions to tie the tops of the piles together (no special soil preparation).

The option indicated below is based on a ribbed slab layout with ribs at a maximum spacing of 3.5 m (as per the layout for Option 3).

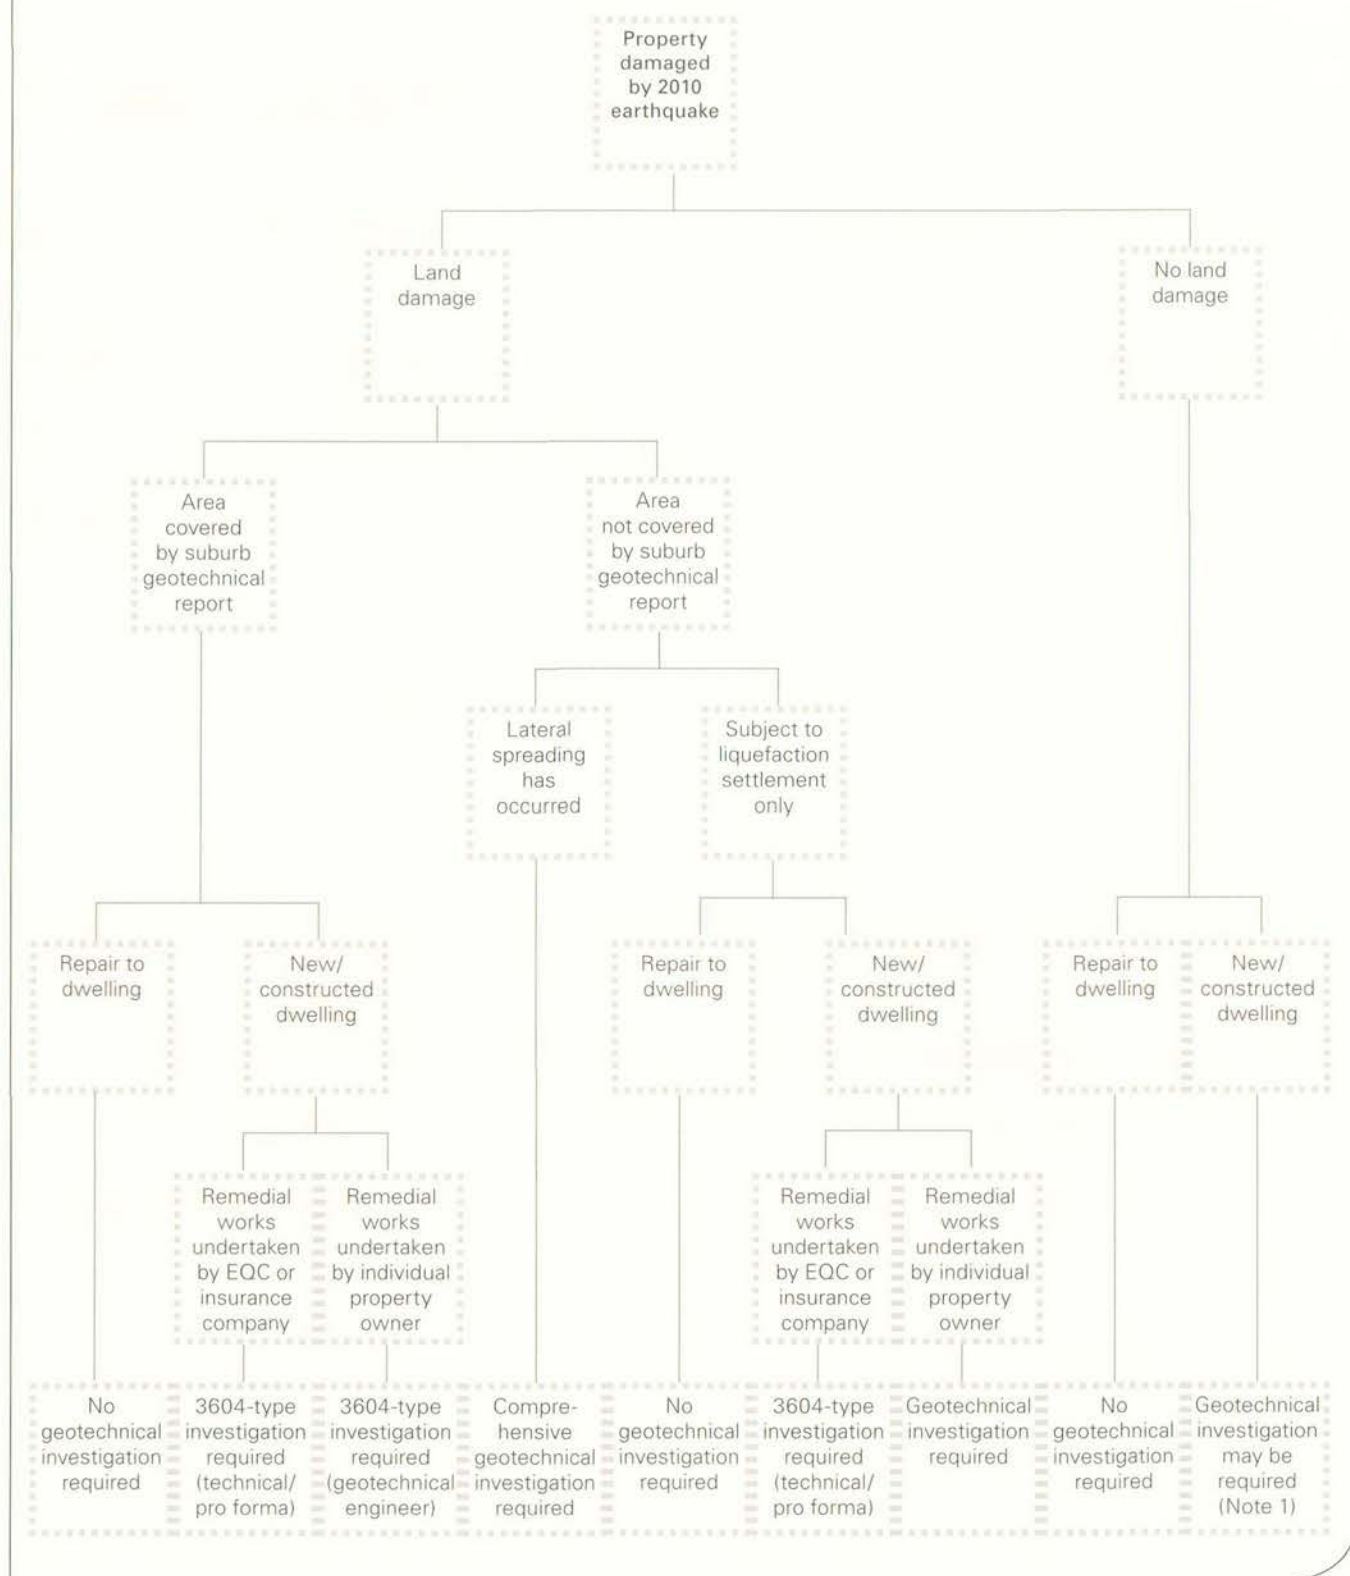
Figure 7.1: Summary of relationship between individual site investigation and land damage

The overall process outlined on the previous pages is summarised in Figure 7.1.

Note 1: The extent of the investigation, if required, should be determined on a case by case basis and should be overseen by a Geotechnical Engineer.

Field investigations for individual sites may, therefore, be limited to Scala Penetrometer Testing and hand augers to confirm that the upper two metres of land meets NZS 3604 requirements for **static bearing**. It is expected that these reports need not be more than a one page letter or template that details the observed damage and provides confirmation that the upper two metres has sufficient bearing capacity. For a summary of the relationship between individual site investigation and land damage see Figure 7.1 on page 52.
